USAAVSCOM TR-84-D-7

OIL DEBRIS DETECTION SYSTEM (ODDS)

Final Report

APPLIED TECHNOLOGY LABORATORY

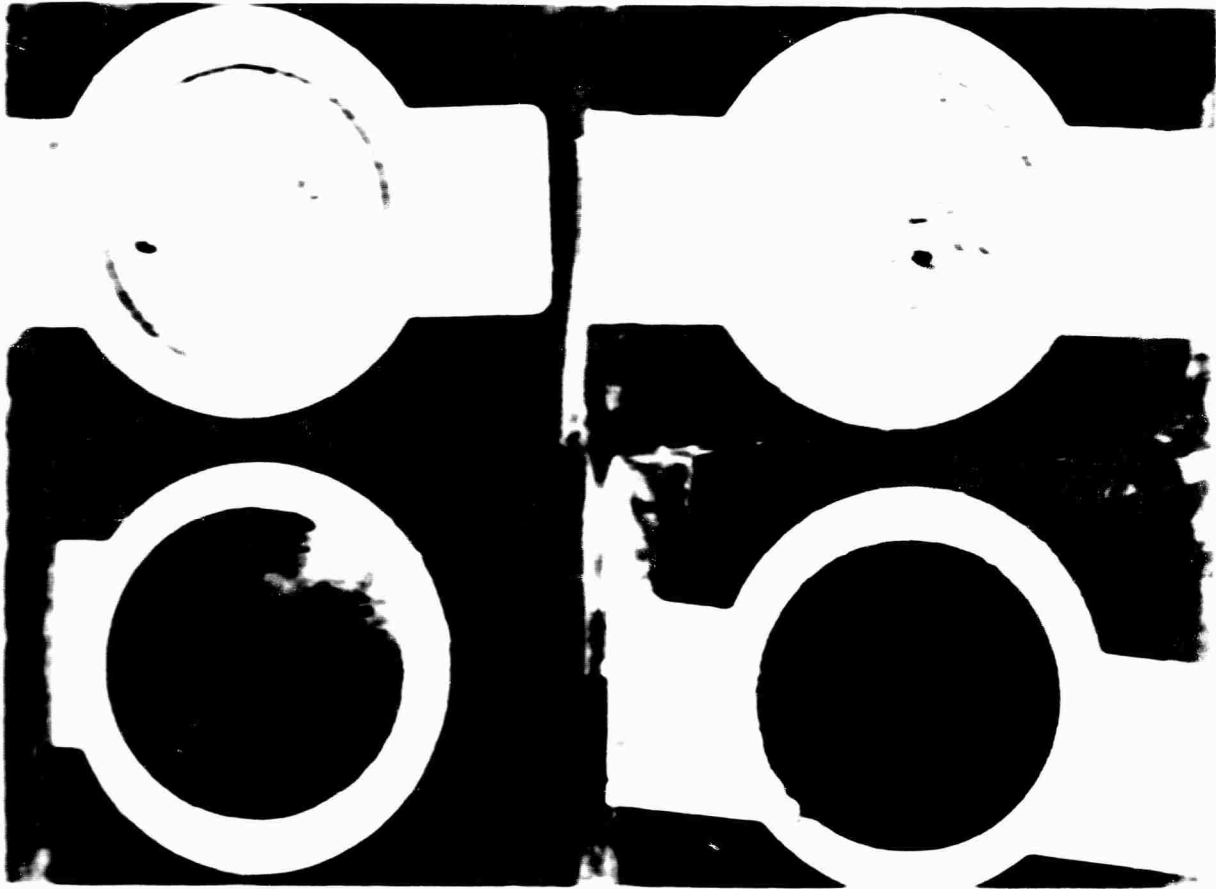
In several engines, it was found that the No. 21 engine bearing cage had failed. These engines were removed for inspection due to multiple chip light indications. Although the burn-off detector plugs did not reveal massive quantities of metal, special oil samples taken from the filter were microscopically examined and found to contain bronze particles; therefore, the engines were removed for metal contamination and inspected. Microscopic examination of oil samples was an established procedure when uncertainty existed with regard to quantity of particles on the detector. An example of a microscopic debris slide is shown in Figure 12.

Figure 12 Membrane filter debris slides.

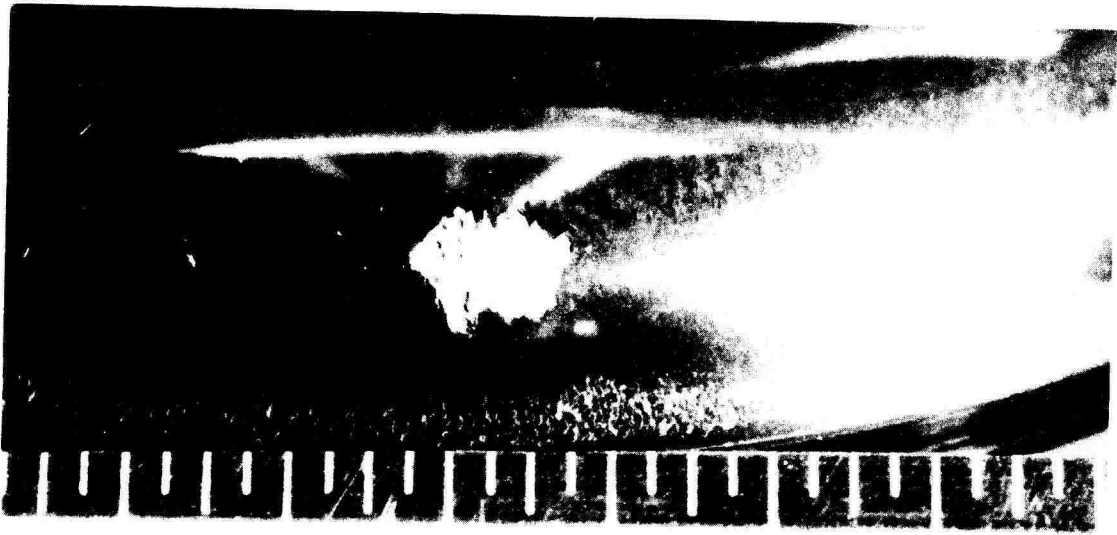
Figure A-1. Inner bearing race from DIR No. 6.

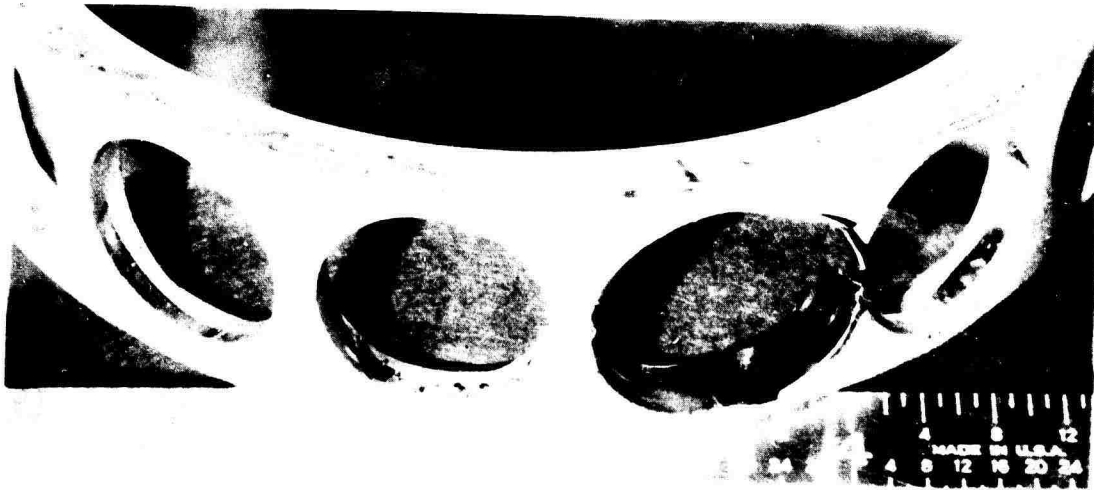
Figure A-2. Bearing retainer from DIR No. 6.

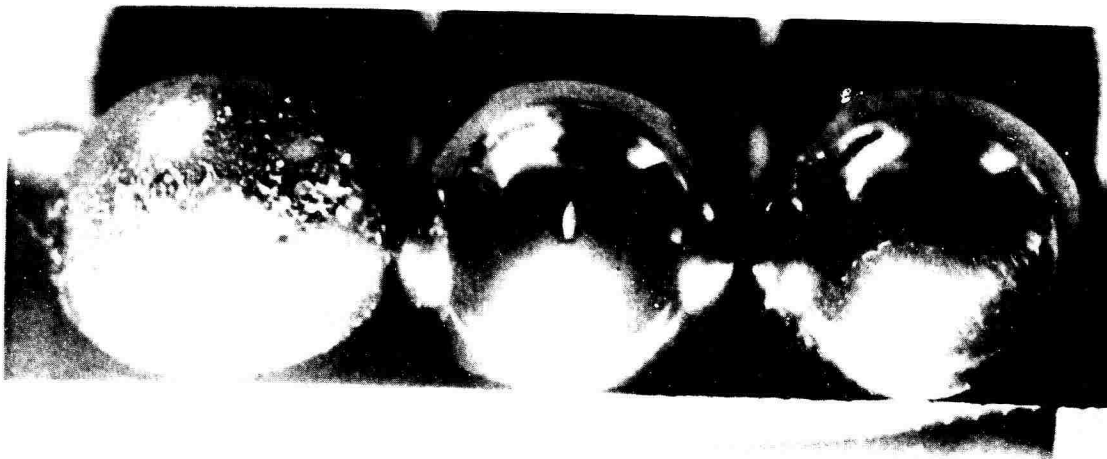
Figure A-3. Balls from bearing of DIR No. 6.

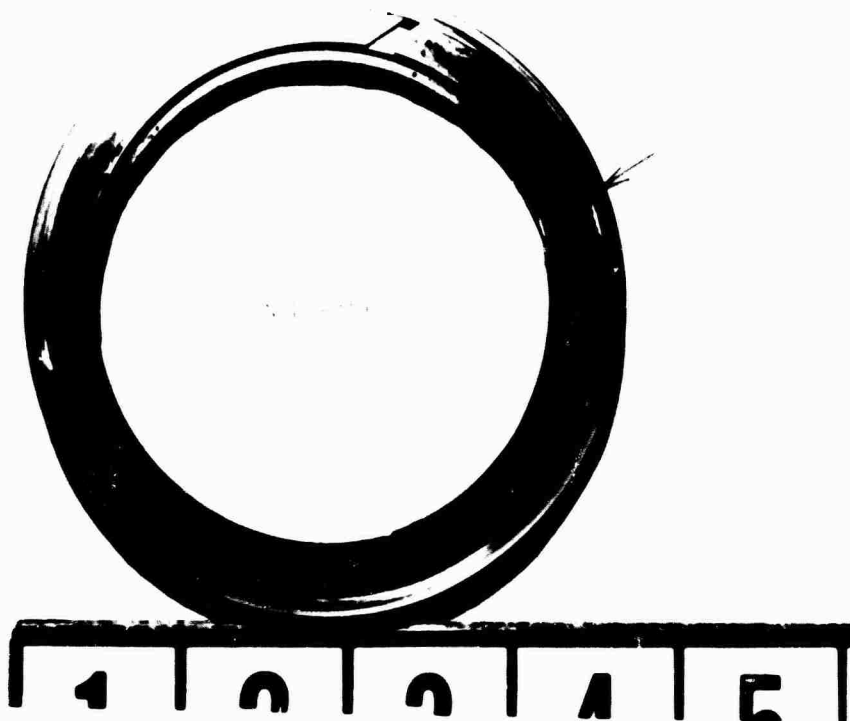
Figure A-7. No. 3 shaft seal from DIR No. 31.
