EVALUATION AND IMPROVEMENT OF COATINGS
FOR COLUMBIUM ALLOY GAS TURBINE ENGINE COMPONENTS

PRATT & WHITNEY AIRCRAFT
DIVISION OF UNITED AIRCRAFT CORPORATION

Technical Report AFML-TR-66-186, Part II

May 1968

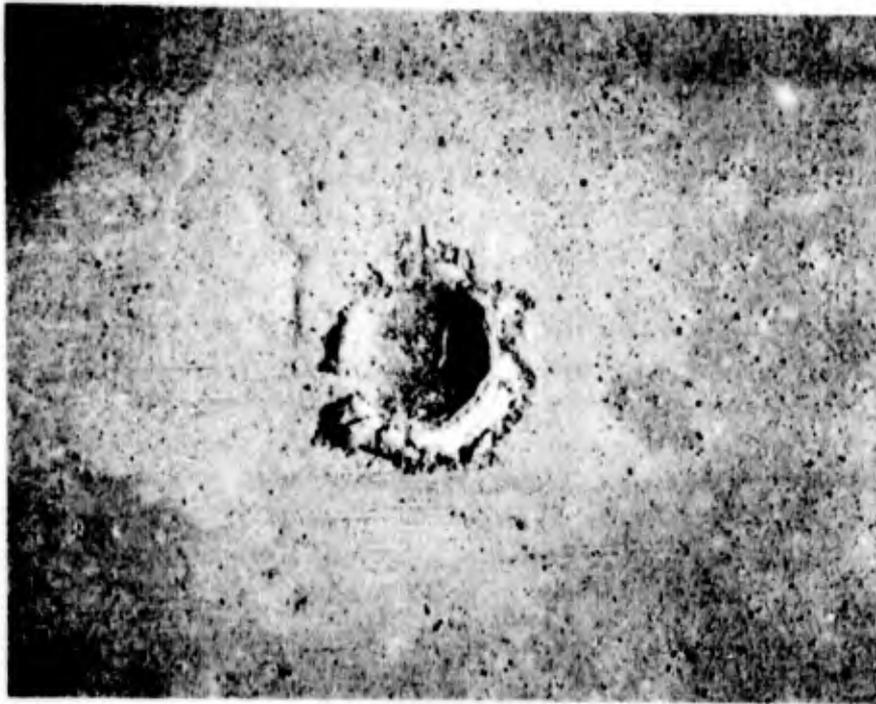
In all cases failure resulted from substrate oxidation surrounding the impact depression (Figure 16). Due to specimen thickness, no adverse effects occurred on the specimen surface behind the point of impact.

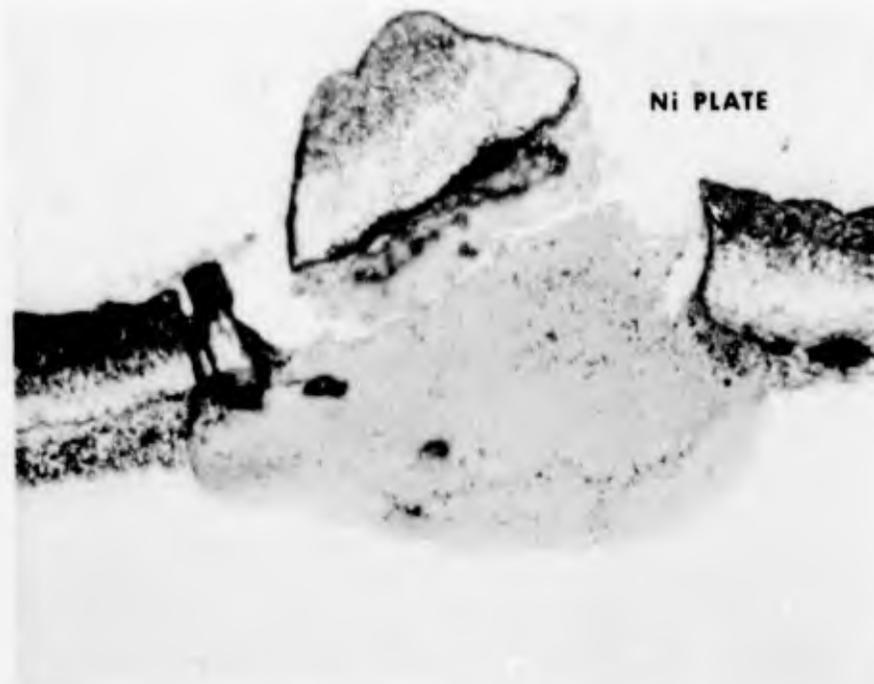
Figure 61. Microstructure of Solar V-CrTi-Si Coated Cb-132M Alloy in Area of Local Oxidation Failure During 2200°F Thermal Fatigue Testing

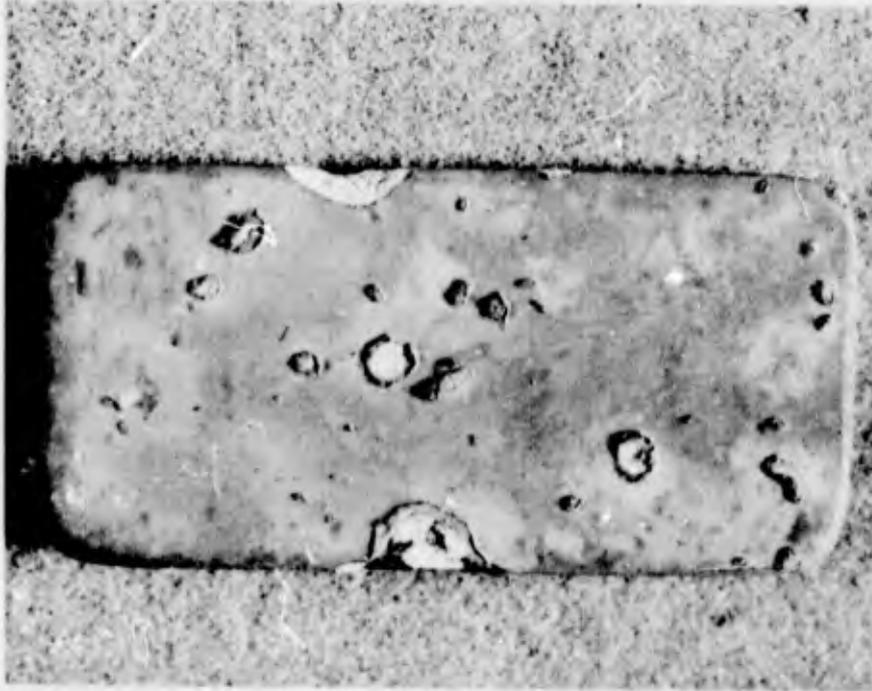
Figure 78. TRW TiCr (Vacuum) Pack Coated Cb-132M Alloy Test Specimen Showing Typical Localized Failures After 54 Hours Static Oxidation Exposure at 1600°F

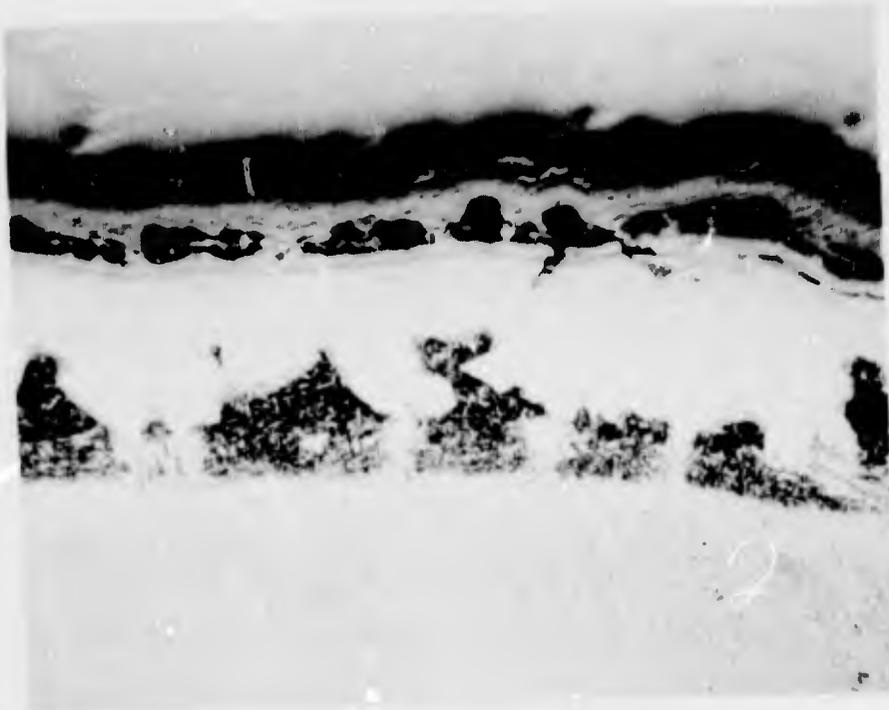
Figure 79. Microstructure of TRW TiCr (Vacuum) Pack Coated Cb-132M Alloy After 54 Hours Static Oxidation Exposure at 1600°F

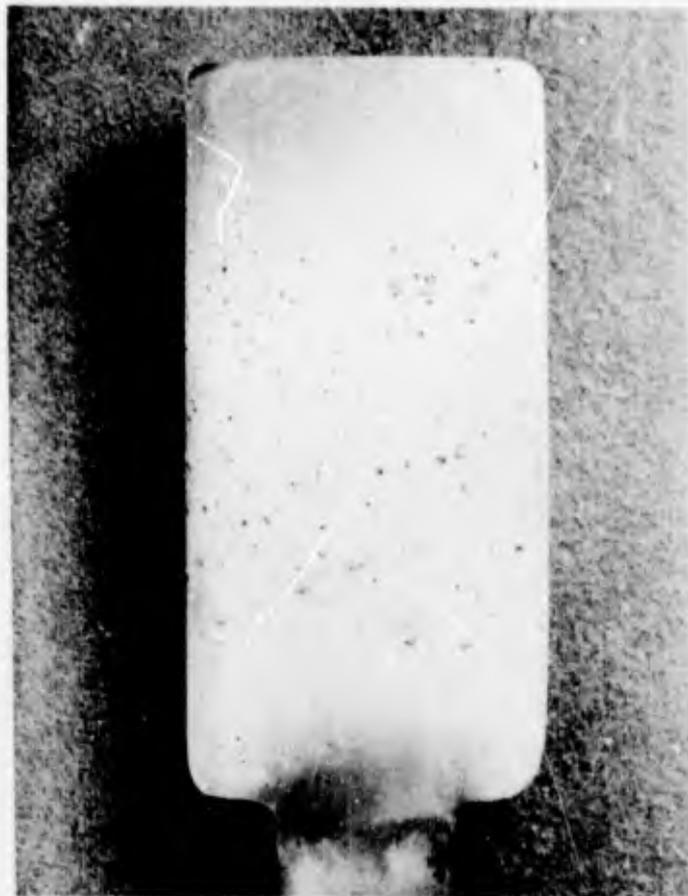
Figure 109. Convex Airfoil Surface of Modified TRW TiCr-Si (Vacuum) Pack Coated XB-88 Alloy Specimen Showing Spot Oxidation Failures After Thermal Fatigue Testing for 600 Cycles to 2200°F
