ERDC/CHL CHETN-IX-63 March 2023

## Underwater Carbon Fiber–Reinforced Polymer (CFRP)–Retrofitted Steel Hydraulic Structures (SHS) Fatigue Cracks

by Guillermo A. Riveros and Hussam Mahmoud

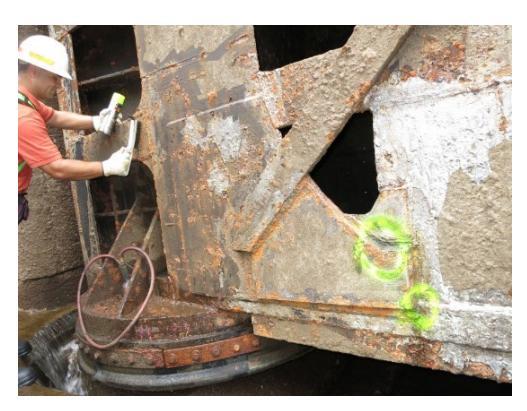
**Miter Gate Inspection:** An inspection of the land and river side leafs was conducted with the purpose to find all fatigue cracks on the gates and areas with severe corrosion. Corrosion was not an issue in this gate, but several areas with fatigue cracks were found, and poor welding was also observed and documented. Figure 3 shows a poor welding connecting the diagonal gusset plate with the girder downstream flange. The two green circles show rough weld profile. The big circle shows weld undercut, while the small circle is pointing to intersecting welds. Figure 4 shows cracks that developed at the intersection between the end diaphragm downstream flange. Cracks at the intersection of intermediate diaphragm and girder flanges are shown in Figure 5. Figure 5 also shows a rough weld profile and weld undercut. Finally, cracks at the downstream tapered end section flange and end plate flange and rough weld profiles are shown in Figure 6.

Figure 3. Poor welding quality at diagonal gusset plate (river side).

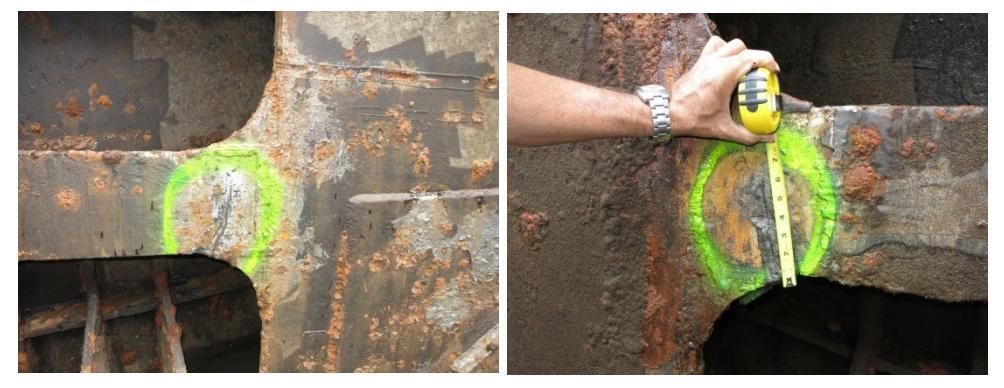
Figure 4. Crack at end diaphragm downstream flange with tapered end section flange and at end diaphragm downstream flange with girder flange.

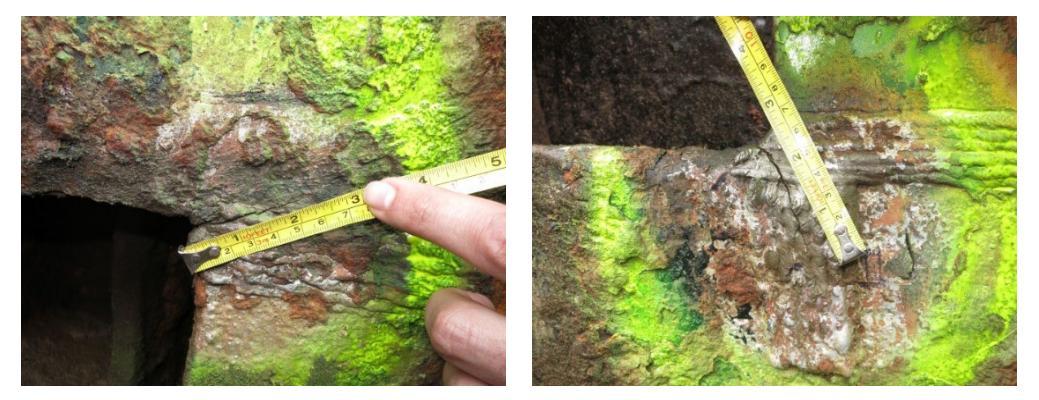
Figure 5. Cracks at intersection of intermediate diaphragm and girder flanges.

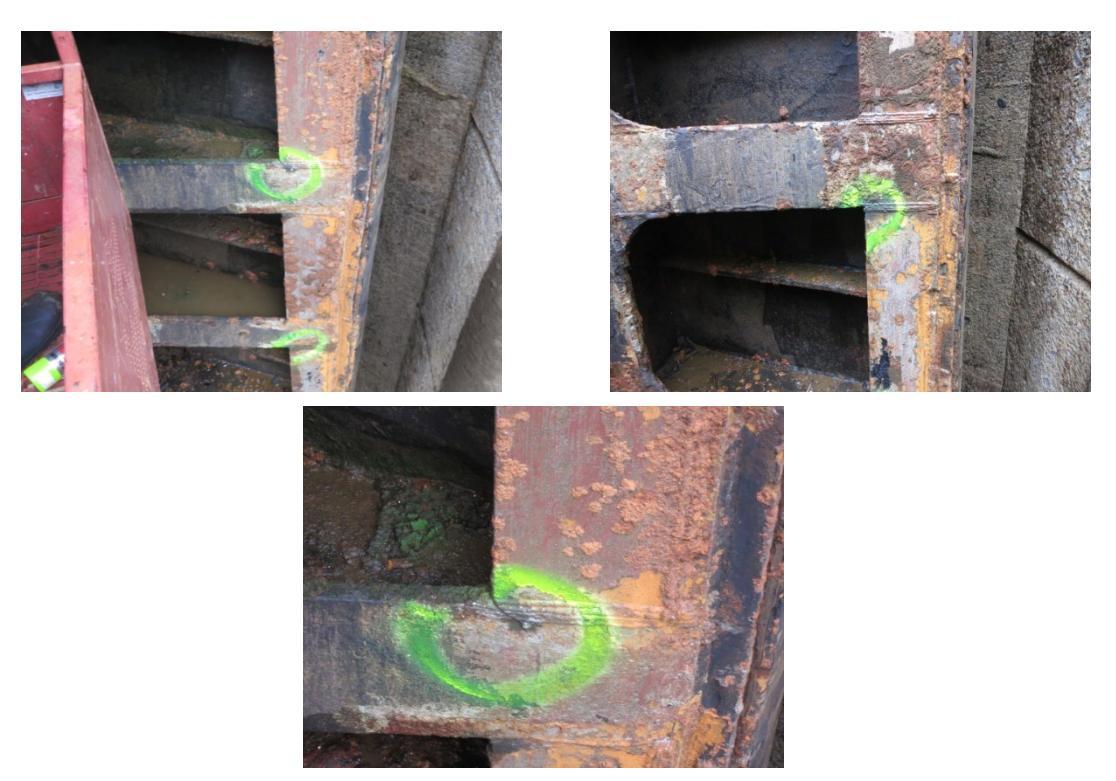
Figure 6. Cracks at downstream tapered end section flange and end plate flange.

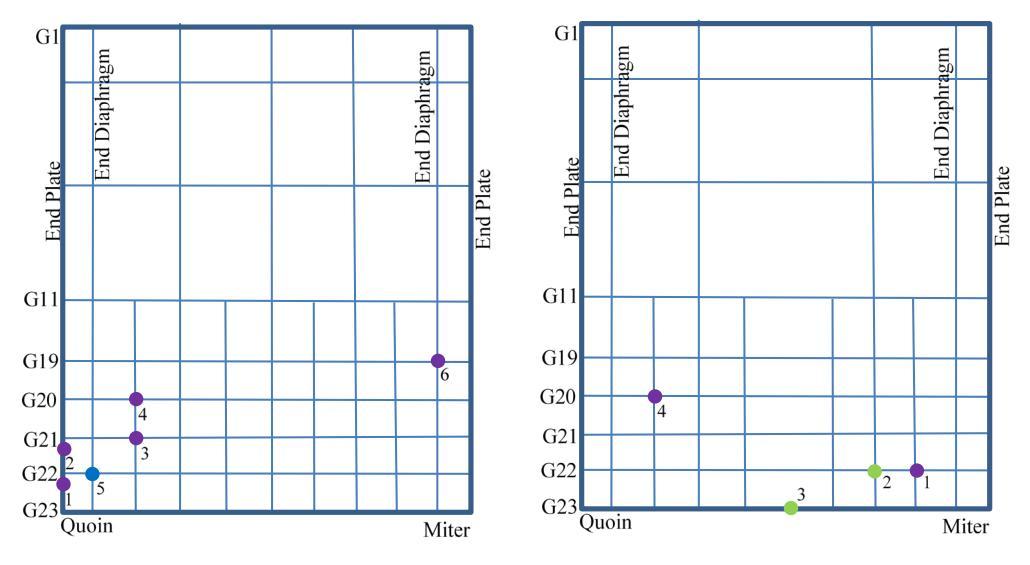
Figure 13. Land (left) and river (right) side leafs showing CFRP applications. Purple: Cracks with CFRP repairs, Blue: Cracks welded and repaired with CFRP. Green: No cracks, poor welds strengthened with CFRP.

**Old Hickory Application:** CFRP patches were applied on five locations on the Old Hickory gate: on cracks, on top of weld repairs of cracks, and on locations with no crack but with a potential to crack due to poor welding. Locations are shown in Figure 13 for the land side (left) and river side (right) leafs.

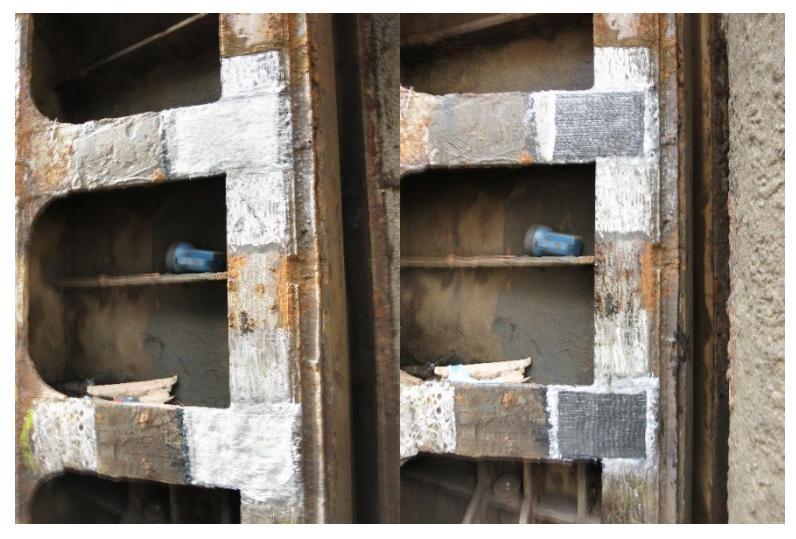
Figure 14. Repairs at locations 1 and 2. At left, glass fiber. At right, carbon fiber.

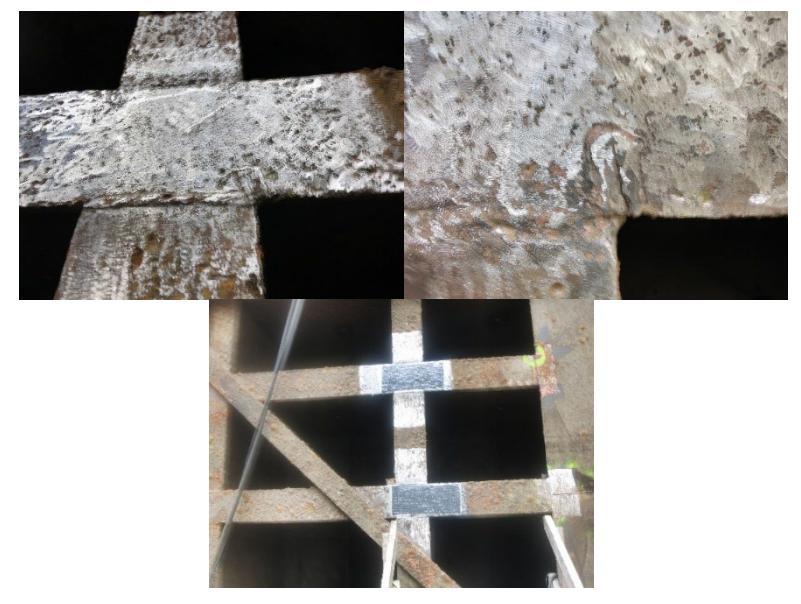
Figure 15. Crack pattern and CFRP repairs at locations 3 and 4.

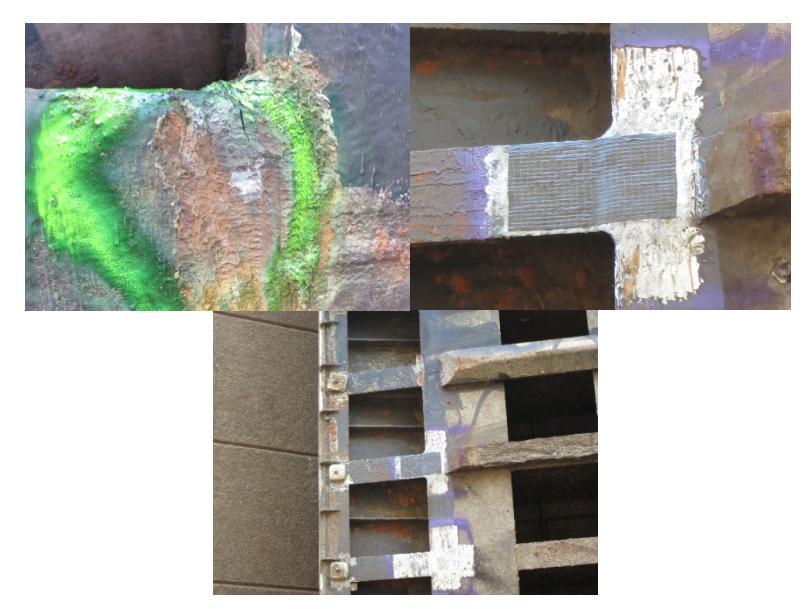
Figure 16. Welded crack repaired with CFRP at location 5.

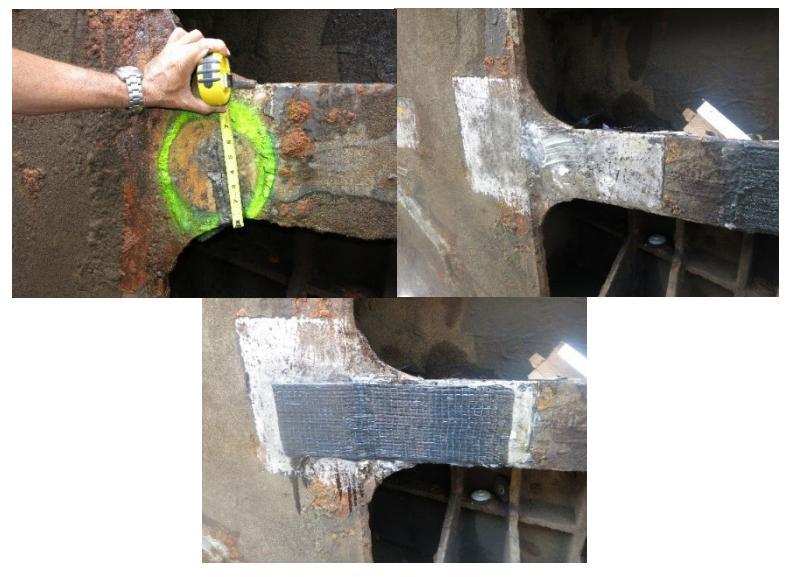
Figure 17. Crack repaired with CFRP at location 6.

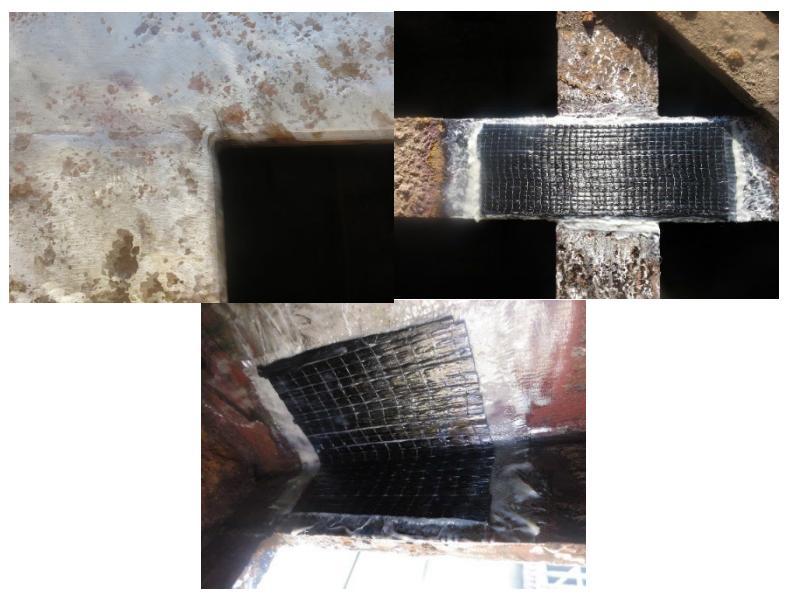
Figure 18. River-side crack repaired with CFRP, location 1.

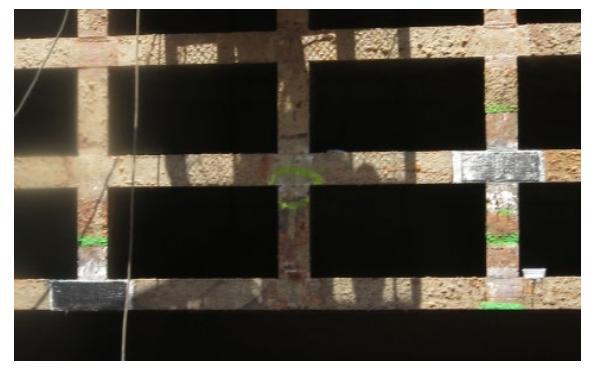
Figure 19. River side showing CFRP repairs when no cracks are present, locations 2 and 3.

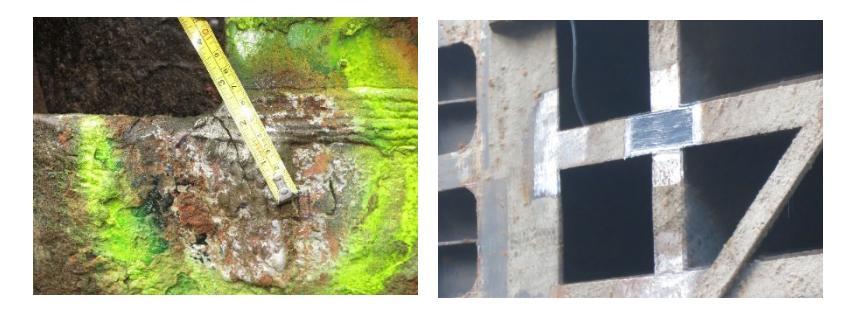
Figure 20. River-side crack repaired with CFRP.
