Special Report 42

**CONSERVATION OF  
M29C WEASEL TRACKS**

by  
John J. Lanyon

U. S. Army Cold Regions Research and Engineering Laboratory  
Hanover, New Hampshire

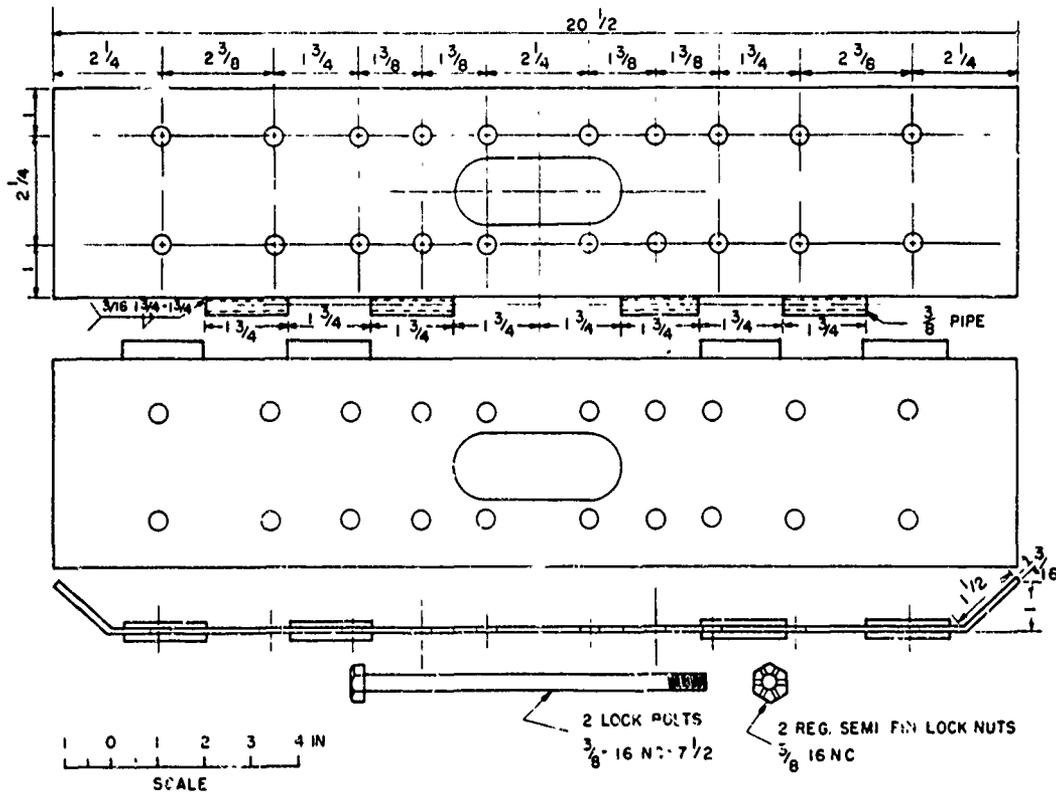
Figure 2. Design of piano-hinge link.

The first type of connecting link designed was a piano-hinge type fabricated by Chief Warrant Officer Martin, then with the 1st Engineer Arctic Task Force. It consisted of two specially constructed plates in the shape of track pads to which 1-in. lengths of  $\frac{1}{4}$ -in. pipe were welded, equally spaced, forming a "piano hinge" (Fig. 1, 2). Two steel pins  $\frac{3}{8}$ -in. diam by  $7\frac{1}{2}$  in. long were used to connect the two pads.

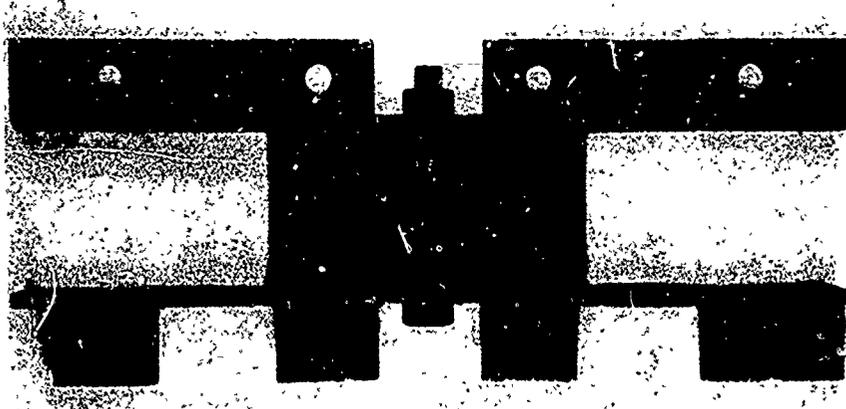
Figure 3. Connecting link of machined cold-roll steel designed to contain the cut ends of the track belts. (Bottom view).

The next link tested was of machined steel, designed to contain the cut ends of the track belts and eliminate the long pin required in the piano-hinge joint (Fig. 3, 4). Two links per section are needed for this type of joint. Each link is connected by a short pin making removal of the pin relatively easy. The existing rivet holes in the pads were enlarged and used to bolt the links to the pads.

The machined steel link (Fig. 3, 4), with a short pin designed to contain the cut ends of the track belts, was used on four of the sections; the fifth section retained the hinge joint.

After several laps around the test course (approximately 223 miles), the links showed no appreciable wear of the moving parts. However, a considerable amount of noise was produced as the links passed over the drive sprocket. Considering the objectionable noise and the high initial cost of machining the link, further testing was considered unnecessary. It was now apparent that a track connection with any of its component parts coming into contact with the drive sprocket would be objectionable because of the additional noise and vibration.

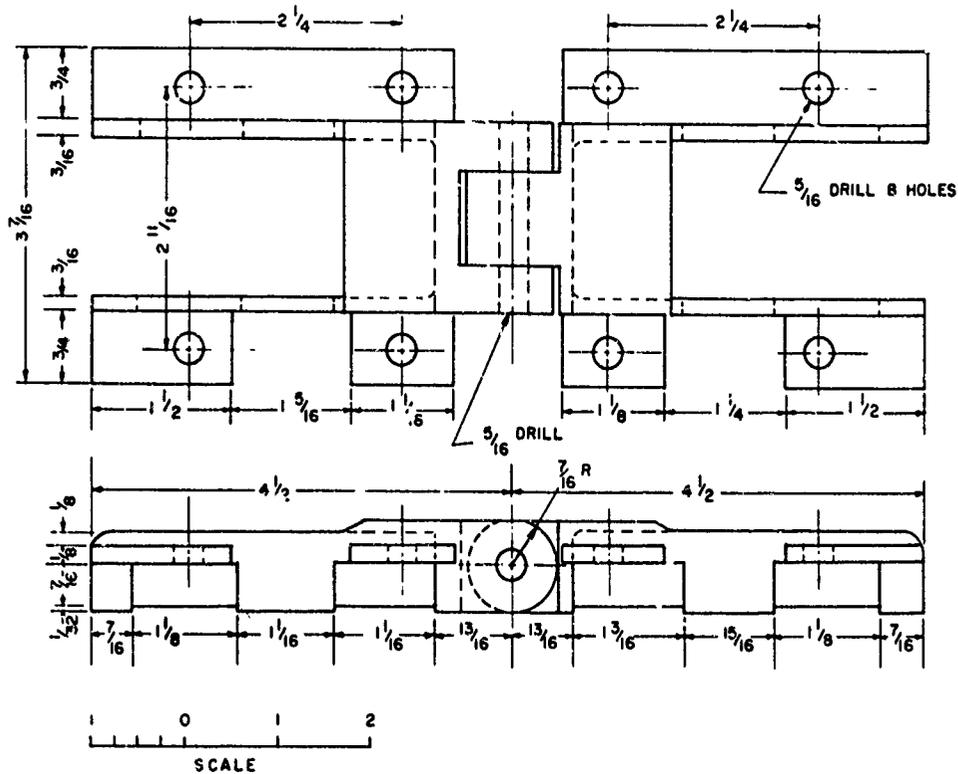
Figure 4. Design of machined cold-roll steel link.

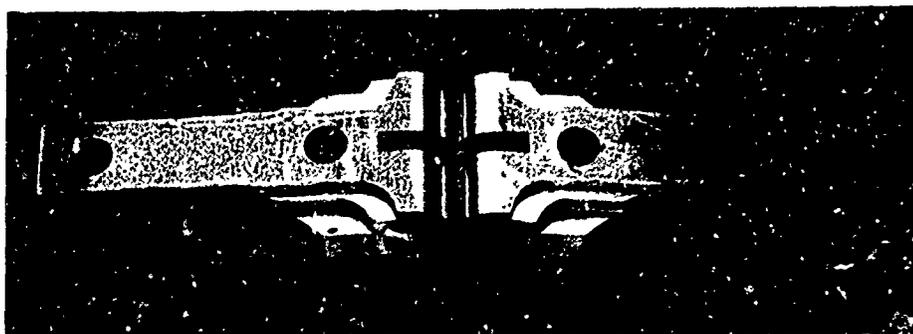
Figure 5. Aluminum connecting link with hardened steel pinhole insert utilizing a #60 double-strand roller chain link. (Bottom view).

The third link consisted of two pieces of steel machined to fit the contour of the track pads between the inner and outer track bands and connected by a standard #60 link of double-strand roller chain (Fig. 5, 6 show configuration). The links were fastened to the pads with high-strength bolts through holes drilled in the pads. Two each per joint are required for this type of link also.

The fourth link was of the same configuration as the third, but was constructed of high-strength aluminum (Fig. 5, 6). A standard #60 double-strand roller-chain link was used to connect this link also. This link was tested with two types of pinhole inserts, self-lubricating bronze and case-hardened steel.

An entirely new link of the configuration shown in Figure 5 was designed and the test track was assembled with all links of this type. Links for two of the joints were machined from cold-roll steel, two joints were 2024-T4 aluminum with one joint containing a bronze insert, and the fifth joint was two links fabricated from 7075-T6 high-strength aluminum. The track was then run over the test course for 100 laps, approximately

The high-strength aluminum link with a hardened steel insert (Fig. 5) proved to be the most satisfactory of the types tested. The ability of the link to absorb the high dynamic stresses without distortion, while its hardened steel pinhole insert provides a wearing surface, sustains its superiority over the other links tested.

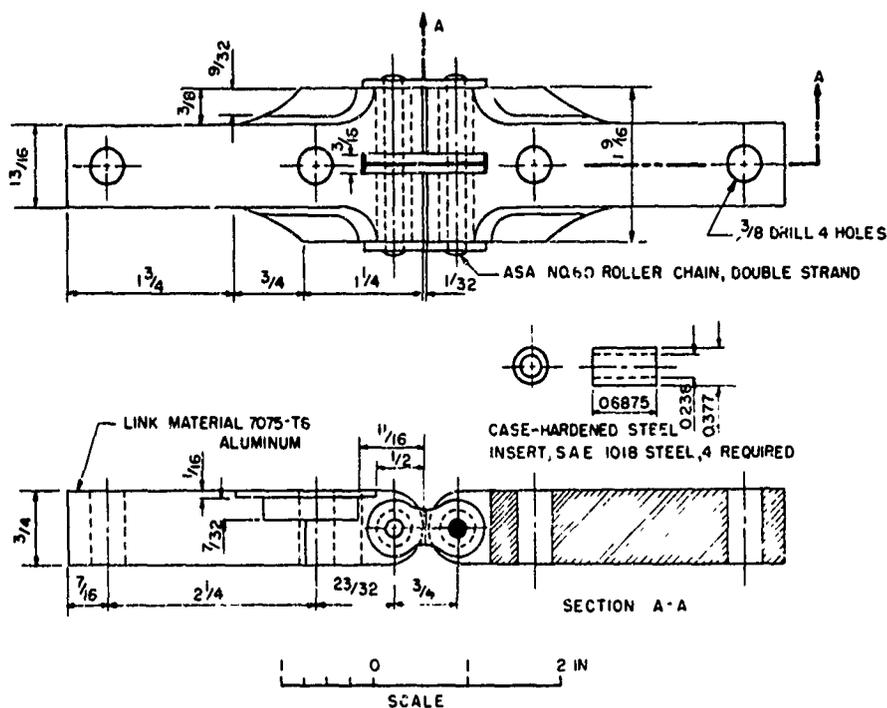
Figure 6. Design of aluminum connecting link.

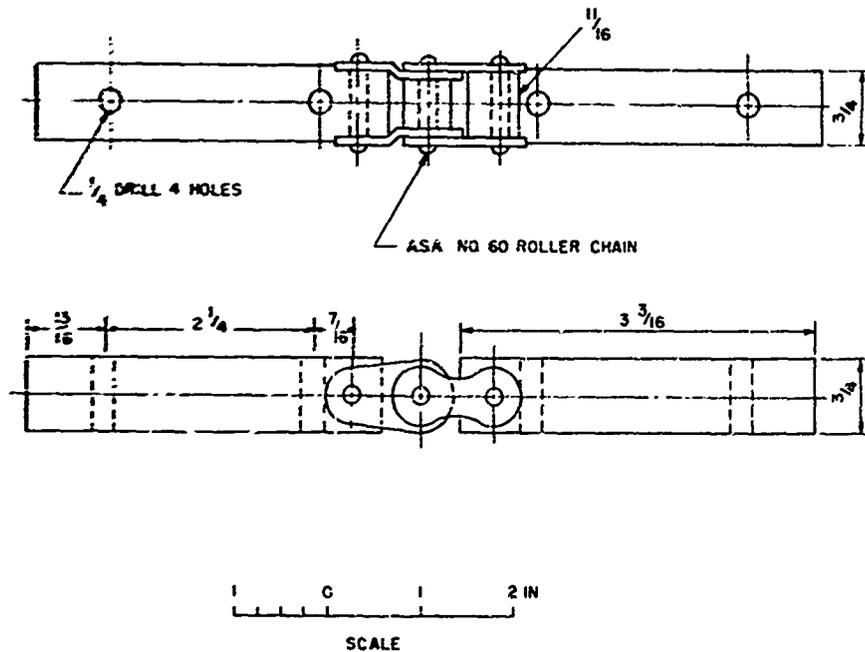
Figure 8. Design of connecting link for emergency repairs.

The fifth link was designed primarily to repair a broken unsectionalized track in the field (Fig. 7, 8). It consisted of two pieces of  $\frac{3}{4} \times \frac{3}{4} \times 4$  in. long steel, machined to accommodate a standard #60 single-chain link.

The track was reassembled and testing resumed with two joints consisting of 7075-T6 aluminum with hardened steel inserts, two joints made up of steel links, and the fifth joint made up of a steel link (Fig. 7, 8), designed for emergency repair of the outer bands in the field. The test track was then driven for a distance of approximately 195 miles. The 7075-T6 aluminum link with the hardened steel insert had no noticeable wear or distortion and proved entirely satisfactory. The all-steel links showed no noticeable amount of further pinhole elongation.
