TECHNICAL REPORT

NO. 12777

M60 CLEAN AIR WINTER TEST

by KEWEENAW RESEARCH CENTER
DIVISION OF RESEARCH
MICHIGAN TECHNOLOGICAL UNIVERSITY

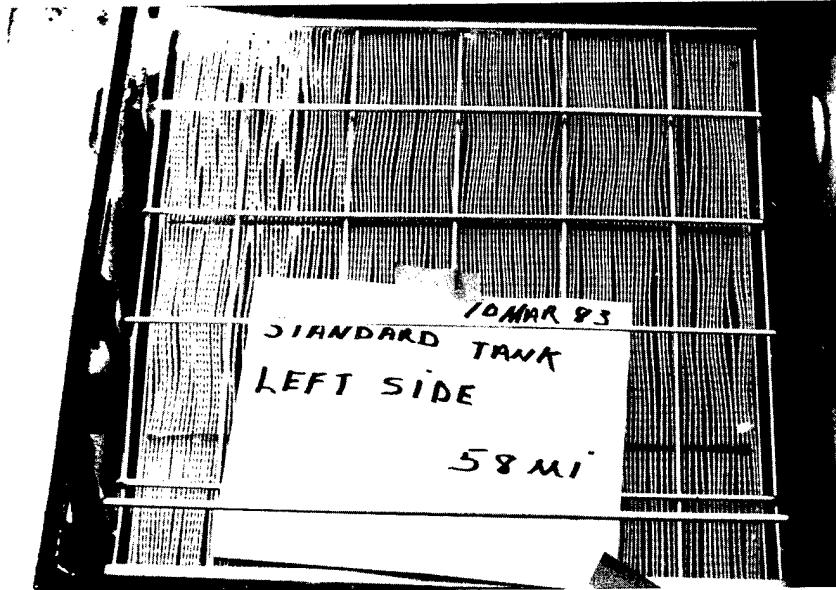
Figure 6. Standard Tank. Left Side Air Filter Element, After Testing 9 March 1983, on Morning of 10 March.

Immediately before beginning operation on 9 March 1983, clean air filter elements were installed in both tanks. The following morning, 10 March, the air box filter covers were lifted and photographs of the "as installed" condition in both vehicles were taken. These are shown in Figures 6 through 9. The filters were then carefully removed, taking care not to disturb any clinging snow, and placed into plastic bags. Next, the filters were weighed within the plastic bags for a gross weight measurement. In all cases, if packed snow was seen, it was packed only at the outlet side. The filter and accumulated snow weights are presented in Table 1.
