To appear: *Shore & Beach*, Vol. 70, No. 4, 2002.

## **Barrier Breaching Processes and Barrier Spit Breach, Stone Lagoon, California**

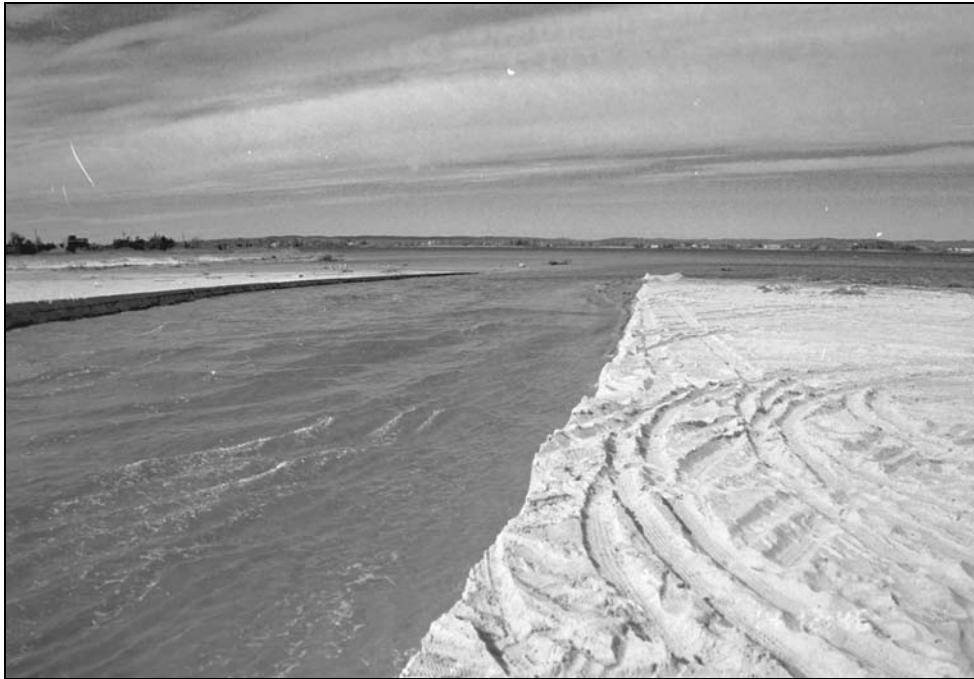
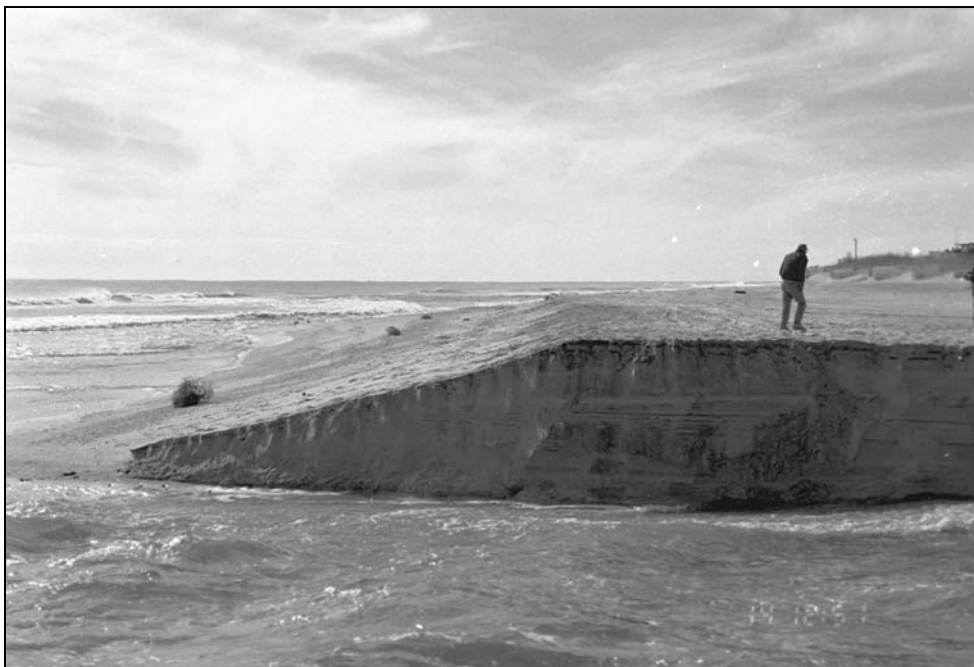
a. Looking north toward Mecox Pond.

b. Looking east, at breach cut through the beach berm.

Figure 1. Mecox Pond, breached the morning of February 14, 1998, (photographs by N. Kraus, afternoon of February 14).

In a coastal context, a breach is a new opening in a narrow landmass such as a barrier spit or barrier island that allows water to flow between the water bodies on each side. Breaching can occur naturally or be artificially induced, and it can have positive or negative consequences. Coastal ponds, lagoons, and blocked river mouths are sometimes breached purposefully and, usually, temporarily. Common reasons for induced breaching are: (a) to reduce water level in the water body that might cause flooding of neighboring property; (b) to decrease or to increase salinity in the lagoon or bay, depending on the situation; (c) to promote water exchange or flushing for improving water quality; and (d) to facilitate migration of marine organisms. Photographs in Figure 1 were taken several hours after a breach was cut by backhoe at Mecox

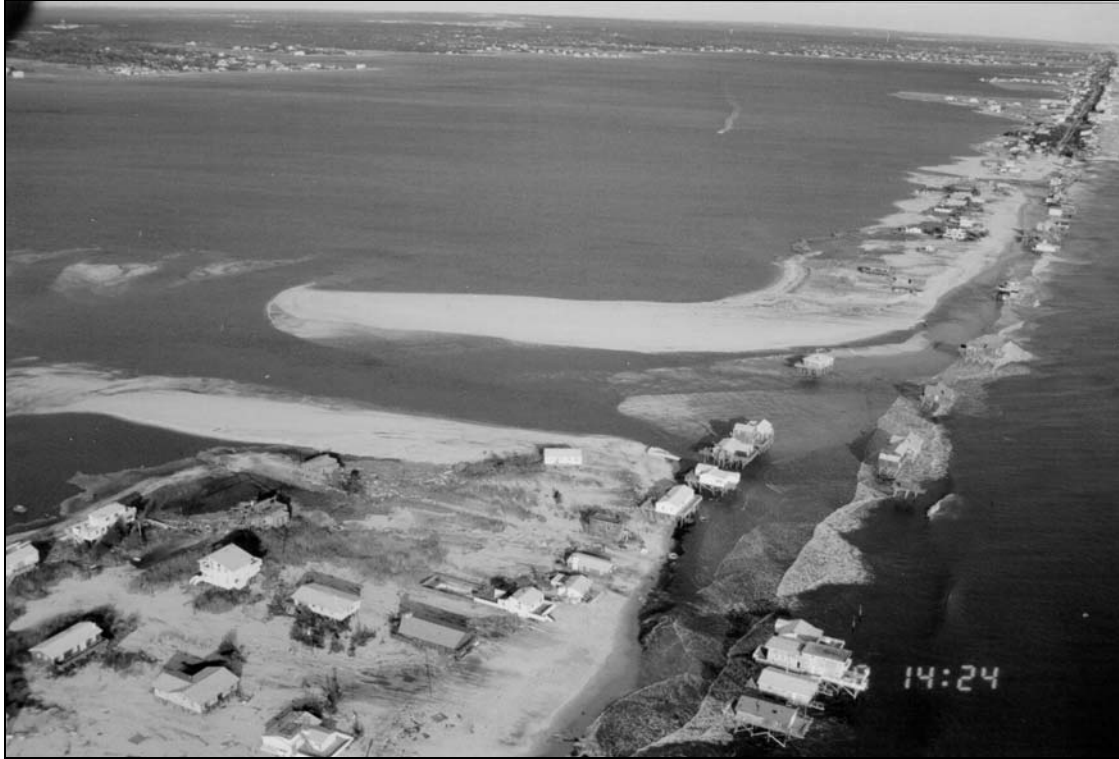
Figure 2. Little Pikes Inlet (barrier island breach), Long Island, New York, shortly after opening (photograph by N. Kraus, December 18, 1991; looking east toward Westhampton Village, with Atlantic Ocean on the right).

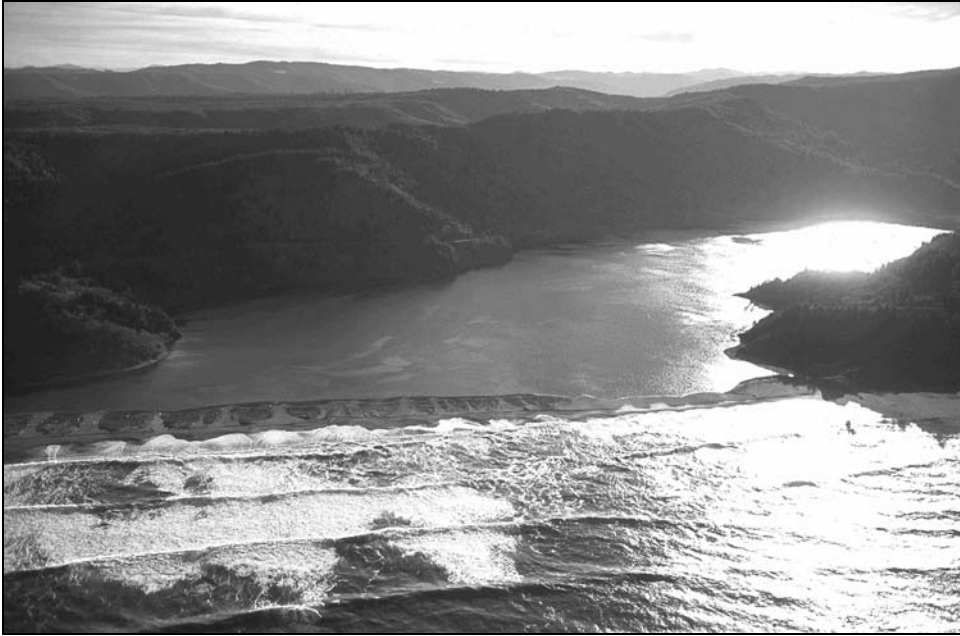
Figure 6. Stone Lagoon, looking northeast, December 1999 (photograph by G. Todoroff).

In discussion with local residents, it is believed that Stone Lagoon breached on its southern side between March 13 and 15, 2002. The Stone Lagoon spit has tended to breach on its southern end, as can be seen by the more narrow width and elevation in Figure 6, a time with no breach present. Persistent breaching on its southern end is attributed to: (a) a line of rocks located on the southern end, aligned normal to the shore (Figure 7; picture taken 5 months before the March 2002 breach), that may tend to promote local erosion on the downdrift (north) side; (b) erosion of the southward end if sediment is not supplied from the headland source area; (c) efficiency of flow in being located nearer to open water in the lagoon; and (d) pre-existing weakness from previous breaches that does not allow full recovery of spit elevation and width.

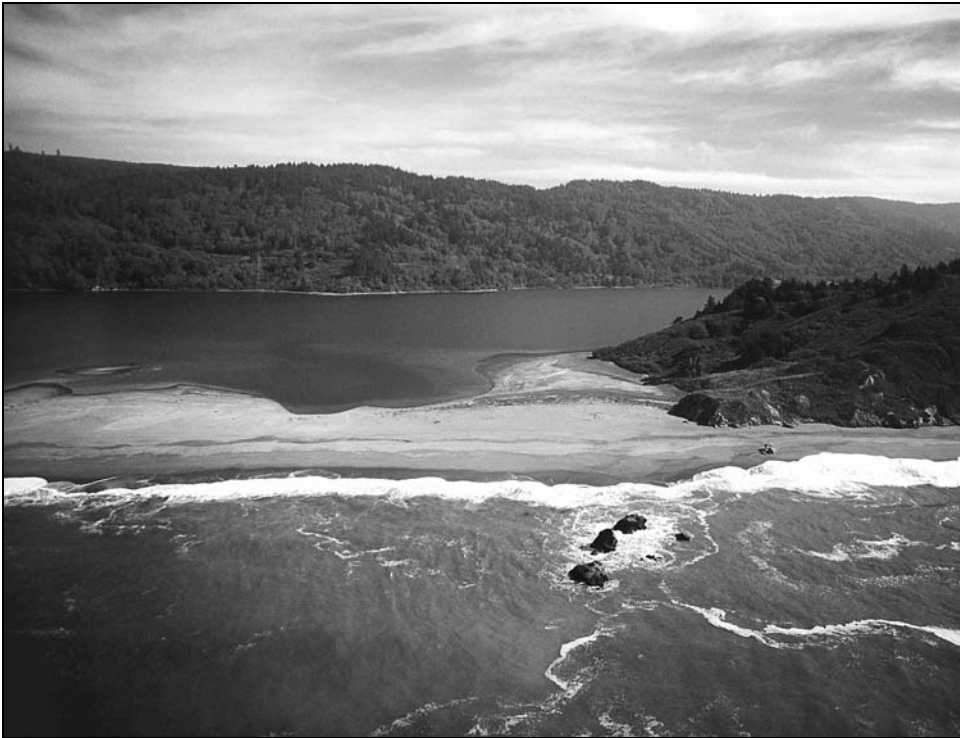
Figure 7. Southern end of Stone Lagoon spit, looking east, October 10, 2001 (photograph by G. Todoroff).

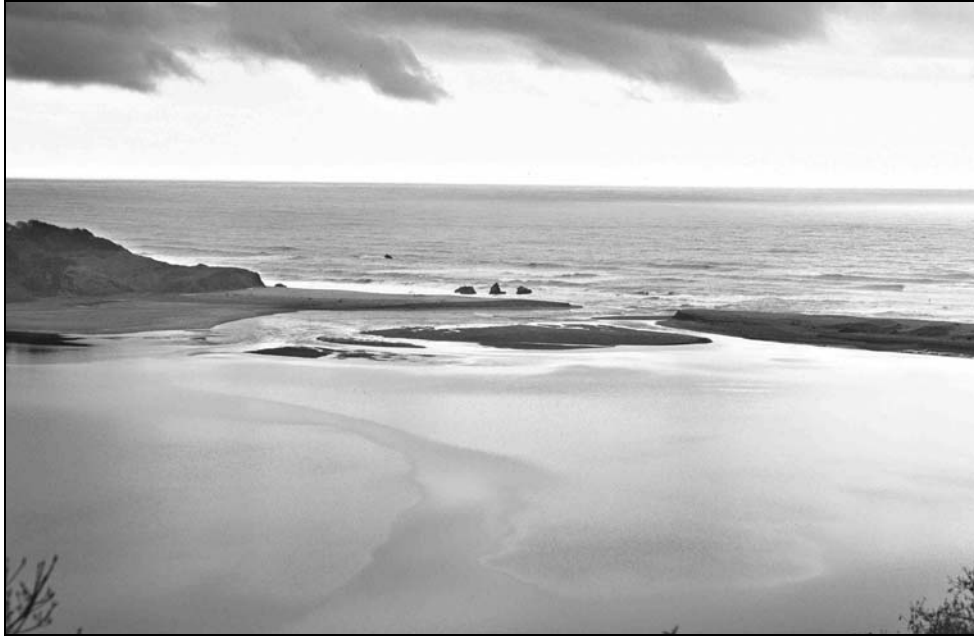
**Figure 8. Stone Lagoon spit breach, looking west, March 16, 2002 (photograph by G. Todoroff).**

Available photographic documentation of the March 2002 breach is summarized in Table 3. The collection includes many photographs, of which only a few can be presented here. The first ground photographs were taken from the eastern bluff (eastern side of Stone Lagoon) on March 16. Figure 8 shows a calm sea, wing spit on the northern side of the breach, and a large multi-crested flood shoal at relatively low tide. Ground photographs were taken near low tide on March 18 from within the breach on the north side. A large log was found lying on the edge of the south bank of the breach (Figure 9), and the horizontal portion on top of the spit berm was measured to be 8 m long. This log was visible in the aerial photographs and served as a scale in their rectification and comparison. Figures 9 and 10 show the presence of steep side banks, estimated on site to be 3.4 m high from crest to toe, along with another 1-m elevation estimated from the toe to the edge of the water in the breach at low tide.

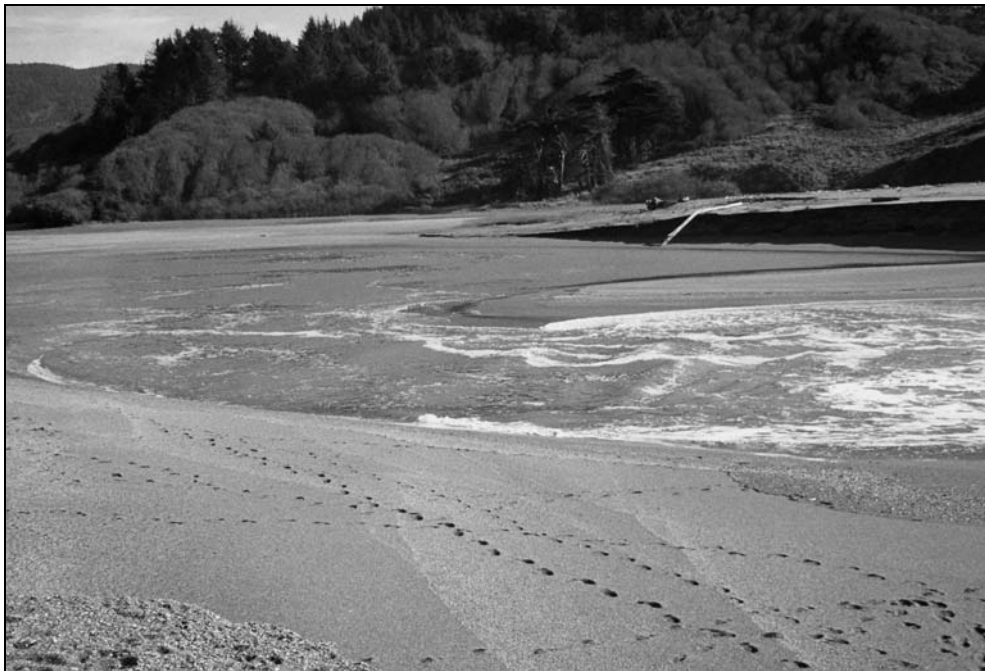
**Figure 9. Stone Lagoon breach with log hanging over south bank, looking southeast, March 18, 2002 (photograph by A. Militello).**

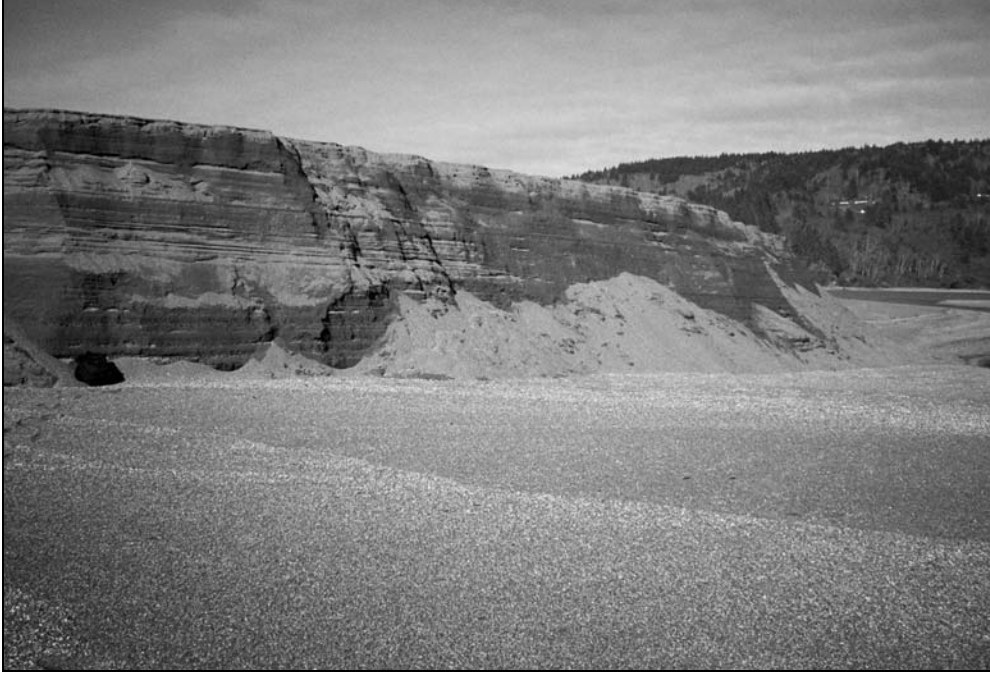
**Figure 10. Stone Lagoon breach, looking east, March 18, 2002 (photograph by A. Militello).**

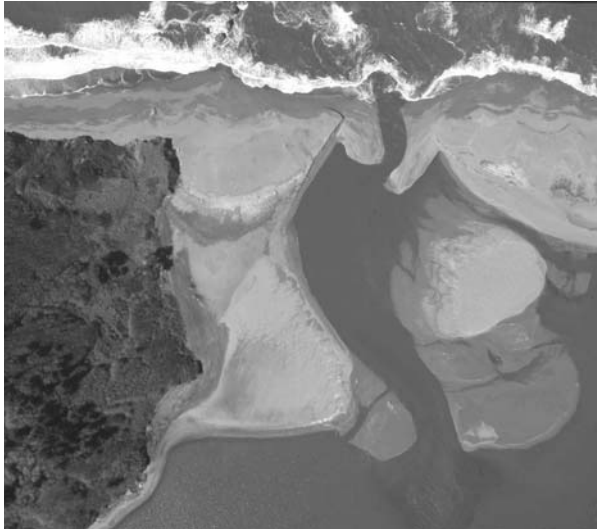
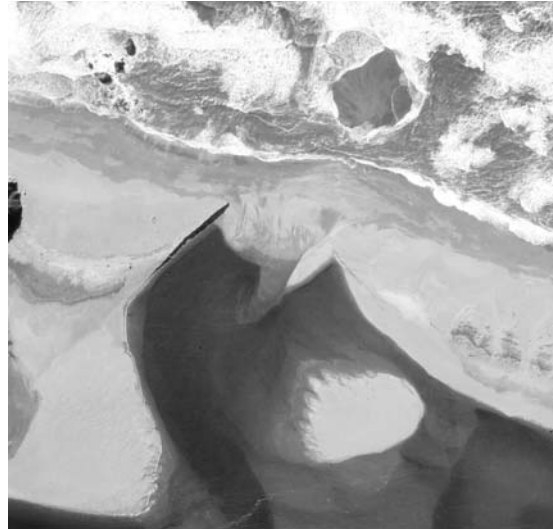
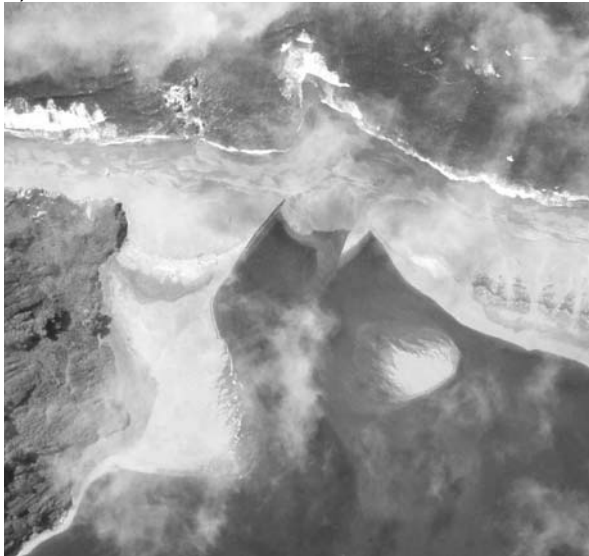
**Figure 11. Time sequence (a-d) of vertical aerial photographs, Stone Lagoon breach, with Pacific Ocean at top of pictures (photographs by G. Todoroff).**

Vertical aerial photographs for March 18, March 27, April 6, and April 18 are shown in Figure 11. The photographs were taken near predicted low tide (Table 3) and can be compared at approximately the same water level. The breach initially cut through the barrier spit at a mild

oblique angle from shore normal, trending northwest to southeast, as evidenced by the shear bank on the south side. Within a few days (March 18), a broad spit had formed on the south side, and a narrower wing spit had also formed on the north side, redirecting the flow along a southwest-to-northeast axis. The minimum width of the breach was 91 m +/-5 m as determined from the March 18 photograph. An ebb shoal deposit is observed on March 27 that is located slightly to the north with respect to the breach, a location consistent with the inferred initial orientation of the breach. By April 6, the breach had closed at low tide, but was observed to have water in it on higher tide. The ebb shoal had begun welding to shore, and it evidently spread north and south to form a wide deposit across the breach by April 18. The flood shoal appears to diminish in area; however, there is no transporting force to remove sediment from this shoal. The apparent diminution in areal extent of the flood shoal and breach margins is an artifact of water level in the lagoon that rose after the breach closed.
