# NAVAL POSTGRADUATE SCHOOL

### COMBAT DAMAGE ASSESSMENT TEAM

A-10/GAU-8 LOW ANGLE FIRINGS

SIMULATED SOVIET TANK COMPANY (ARRAY 22)

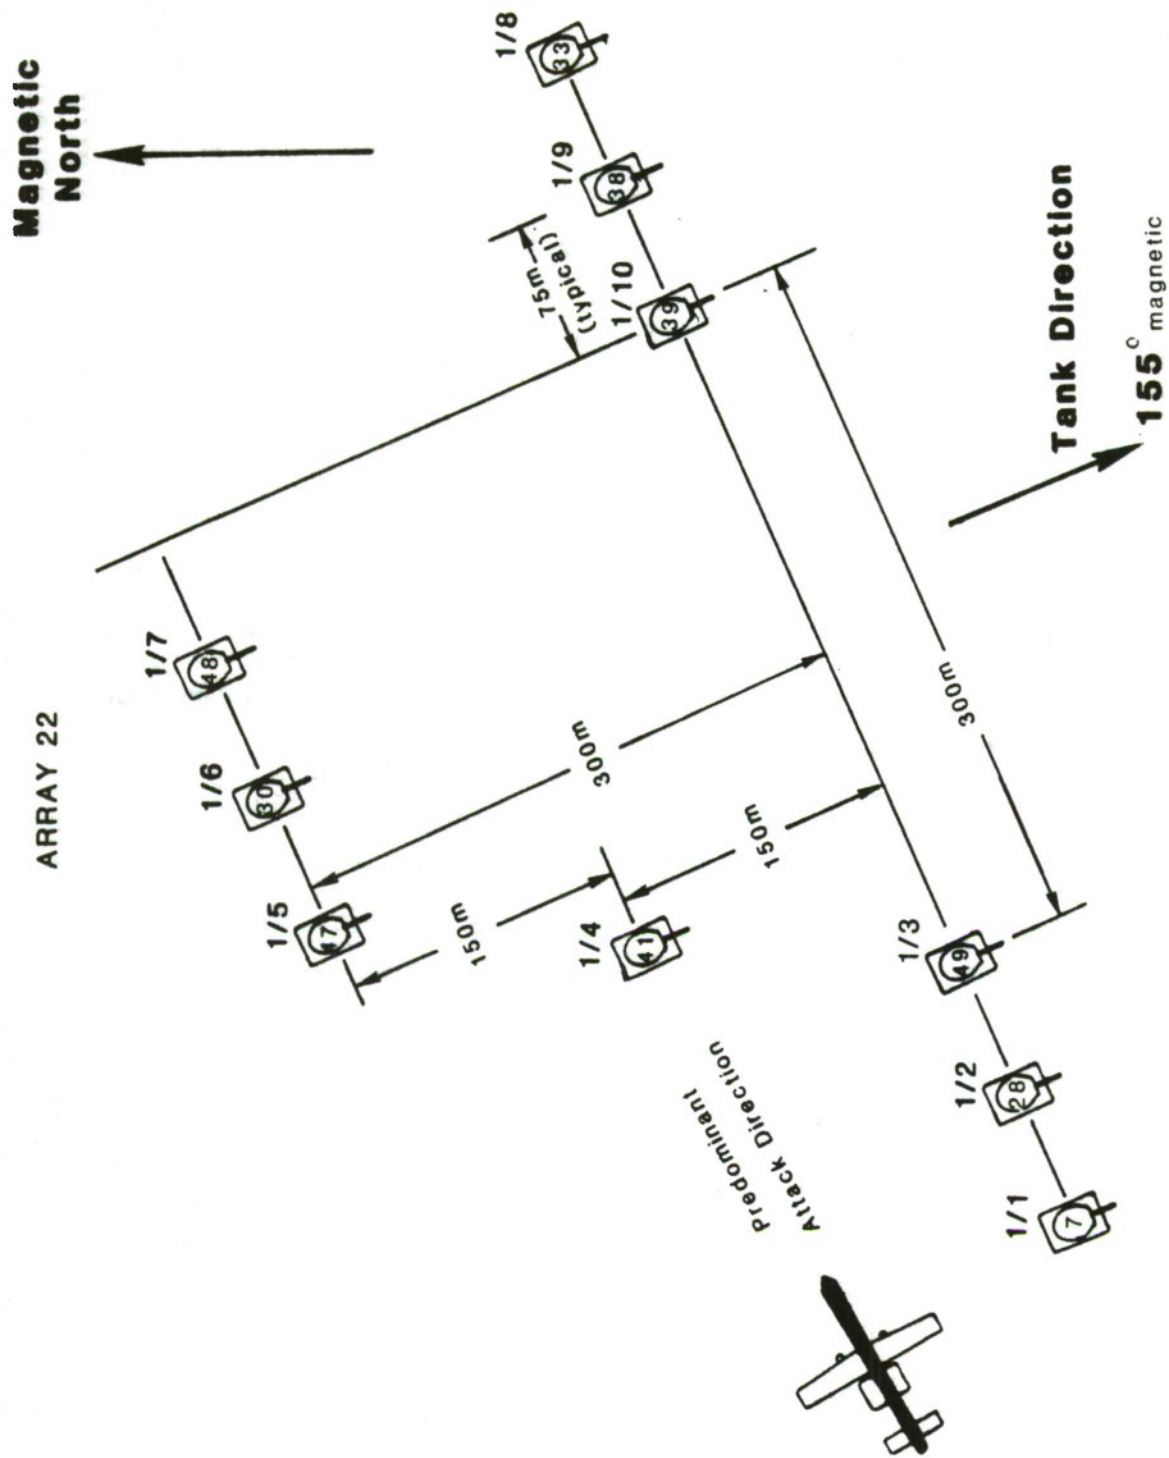
FIGURE 6. Approximate Target Layout.

The data noted immediately above were collected through the combined efforts of the CDAT and range support personnel at Nellis AFB. Aerojet Ordnance Manufacturing Company personnel provided the industrial efforts required to repair, refurbish, and field the tank targets. The CDAT applied various systematic research techniques used to describe weapon effects and combat damage. The most basic materiel used in the test; i.e., the aircraft, gun, and projectile are illustrated in Figures 2, 3, 4, and 5. The targets were arrayed in the tactical formation of a Soviet tank company as shown in Figure 6.

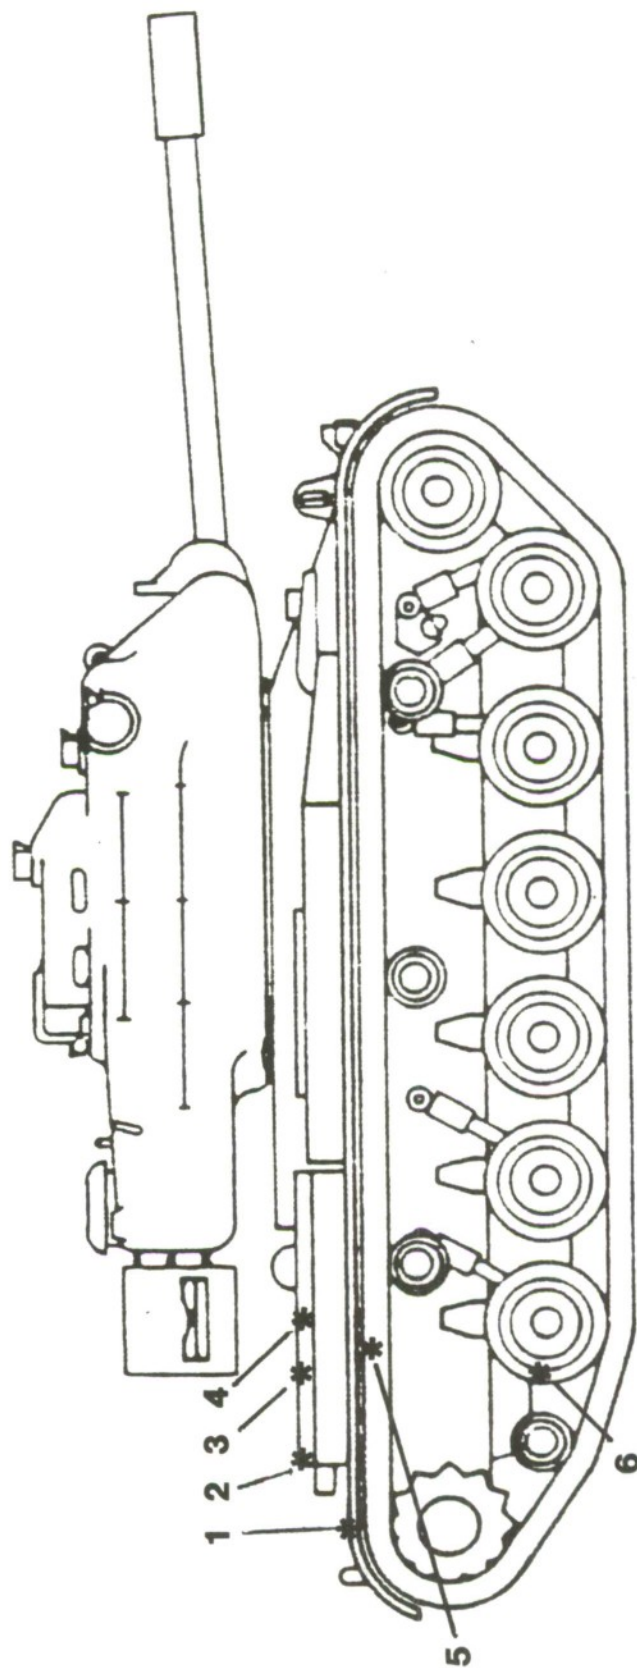
FIGURE 7. Impact Diagram, Tank 7.

The attacking A-10 aircraft achieved impacts on the tank from an attack aspect of 078 degrees (right side) during one firing pass at low altitude and low dive angle. The A-10 expended 26 rounds during the firing pass.

No degradation in mobility or firepower.

a. Perforations	:	0
b. Significant Impacts	:	0
c. Insignificant Impacts:		<u>6</u>

TOTAL IMPACTS : 6 (Figure 7)

No significant damage was inflicted on this target during the test.

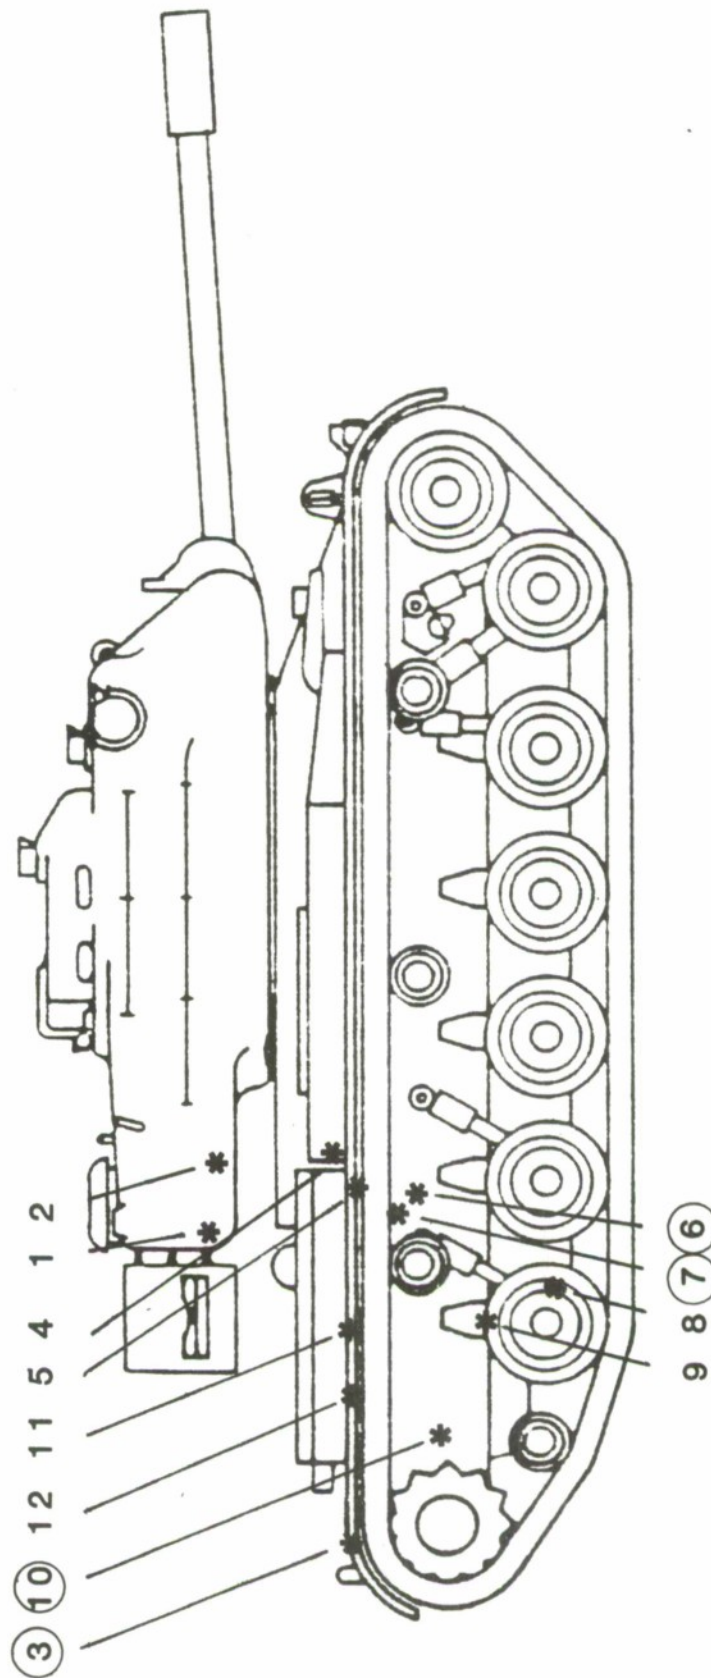
FIGURE 8.    Impact Diagram, Tank 28.

100% M-Kill resulting from the following observed effects (Figure 8):

a. Perforations	:	4
b. Significant Impacts	:	2
c. Insignificant Impacts:		<u>6</u>

The assessment of 100% M-Kill is based on impact 10, which perforated the engine compartment, penetrating the engine block causing loss of engine oil. Three other perforations and two hits contributed little or nothing to the kill.

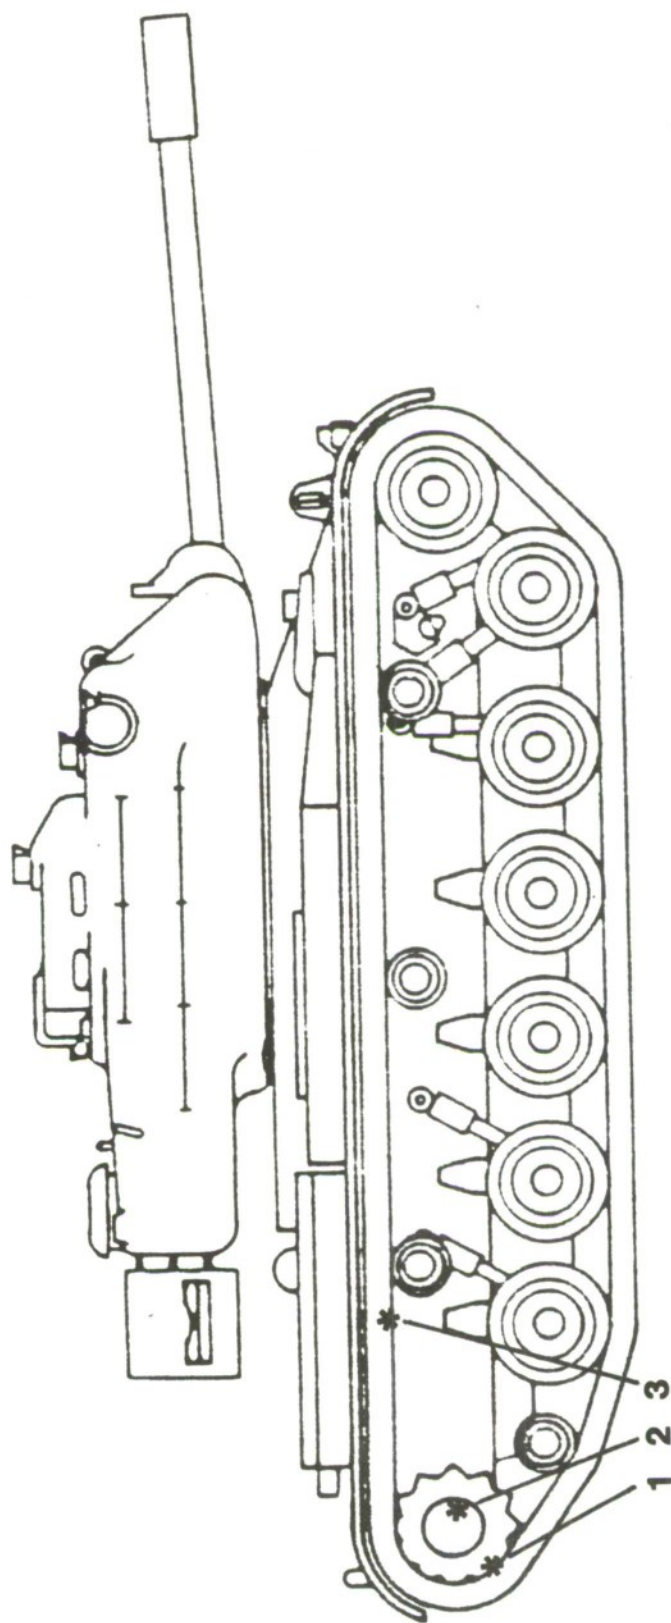
FIGURE 9. Impact Diagram, Tank 49.

No degradation to mobility or firepower.

No significant damage was inflicted on the target tank during the tests.

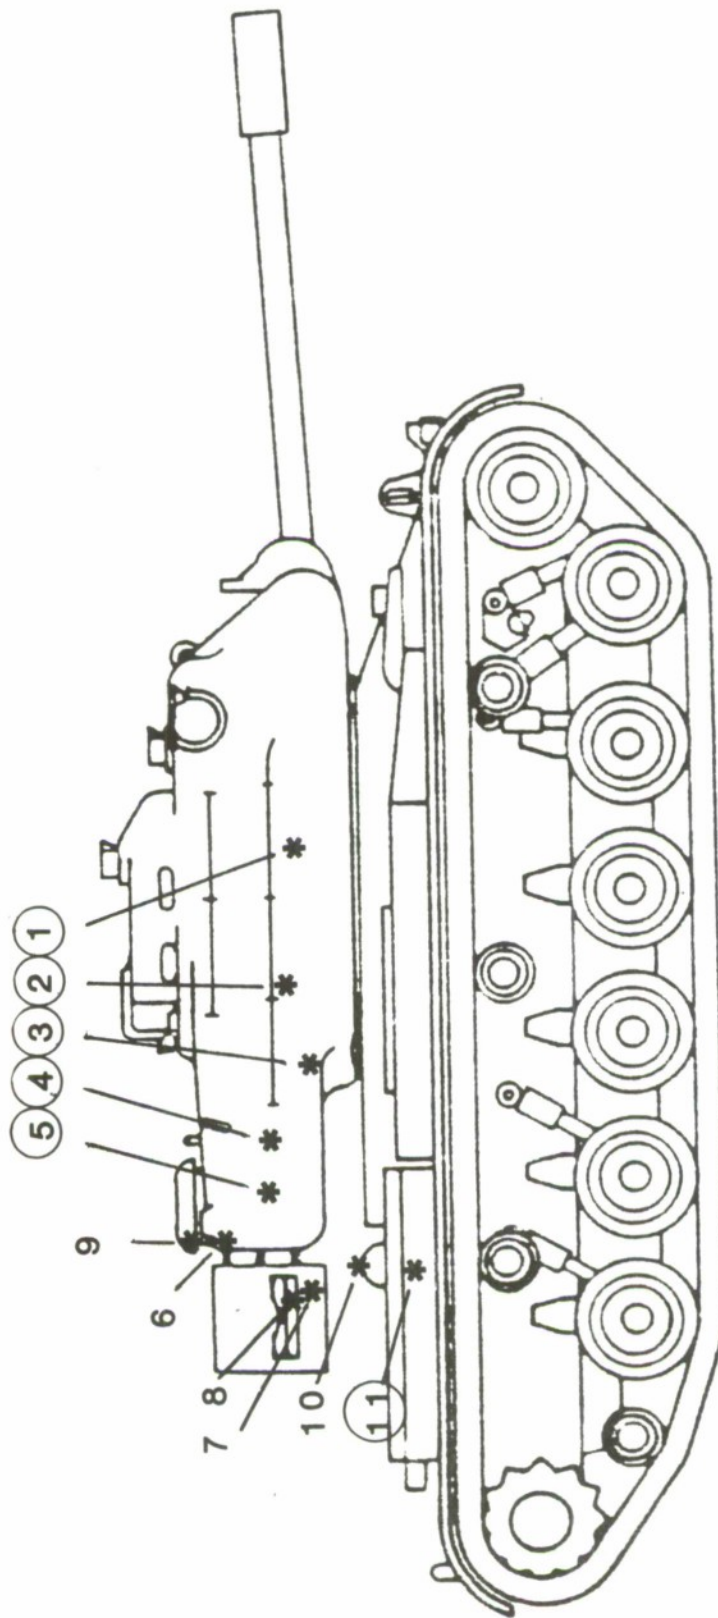
FIGURE 10. Impact Diagram, Tank 41.

100% M-Kill and 95% F-Kill resulting from the following observed effects (Figure 10):

- a. M-Kill: The assessment of 100% M-Kill is based on impact 11, which perforated the right side of the hull into the engine compartment severing an oil cooler line and penetrating one engine valve cover.
- b. F-Kill: The assessment of a 95% F-Kill is based on impacts 1, 2, and 3 which perforated the right turret armor and caused casualties to the commander, gunner, and loader. Two other perforations of the turret caused damage to interior components but contributed nothing to the F-Kill.

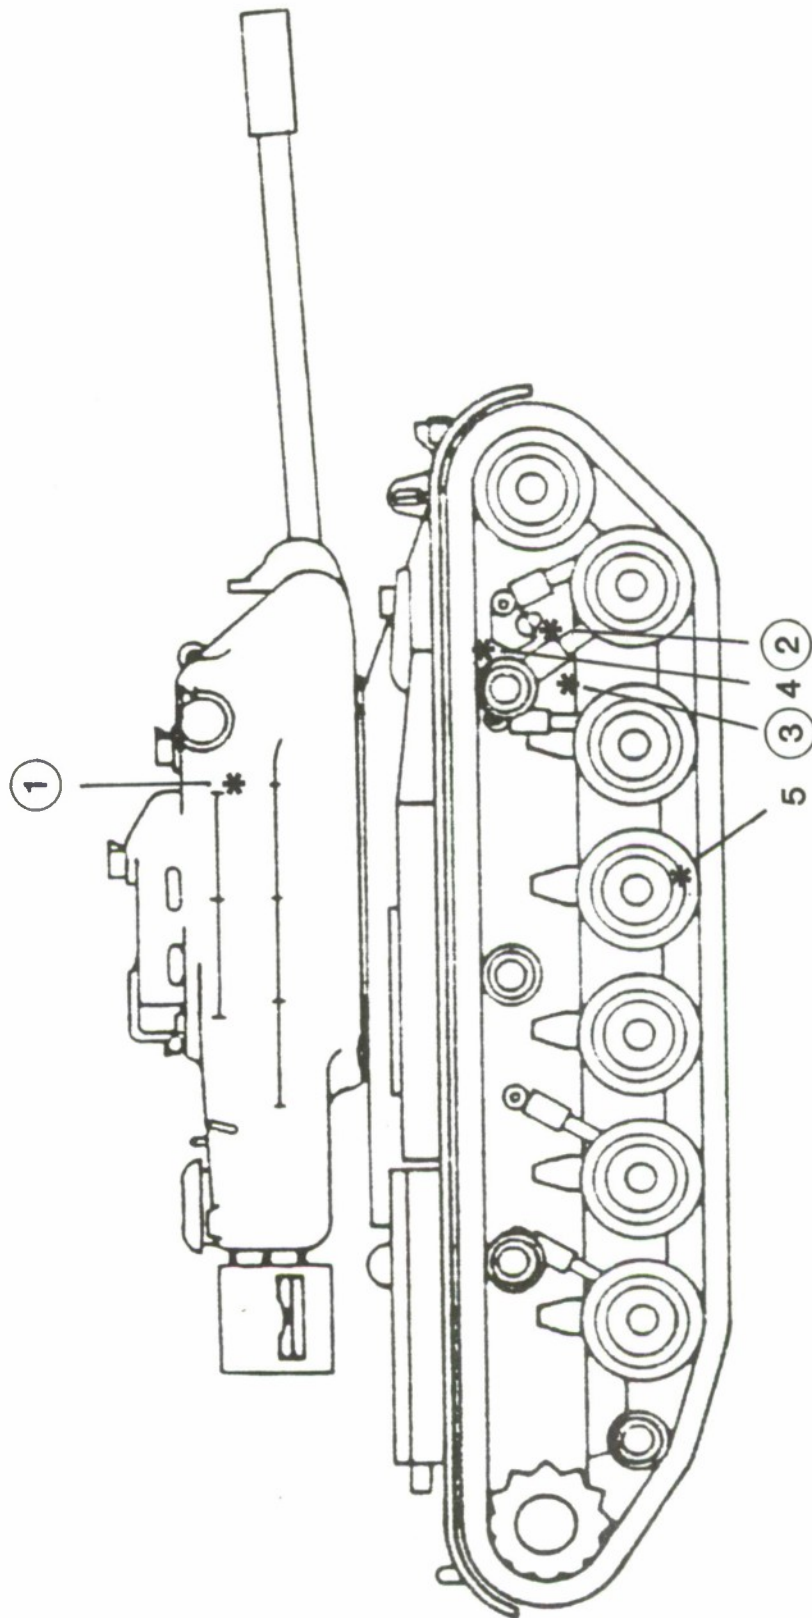
FIGURE 11. Impact Diagram, Tank 47.

Catastrophic K-Kill resulting from the following observed effects (Figure 11):

A 100% K-Kill was assessed based on 1 perforation into the turret and 2 perforations into the driver's compartment. The tank was observed to be smoking immediately after the attack pass and in flames shortly thereafter, but the cause of the fire could not be determined.

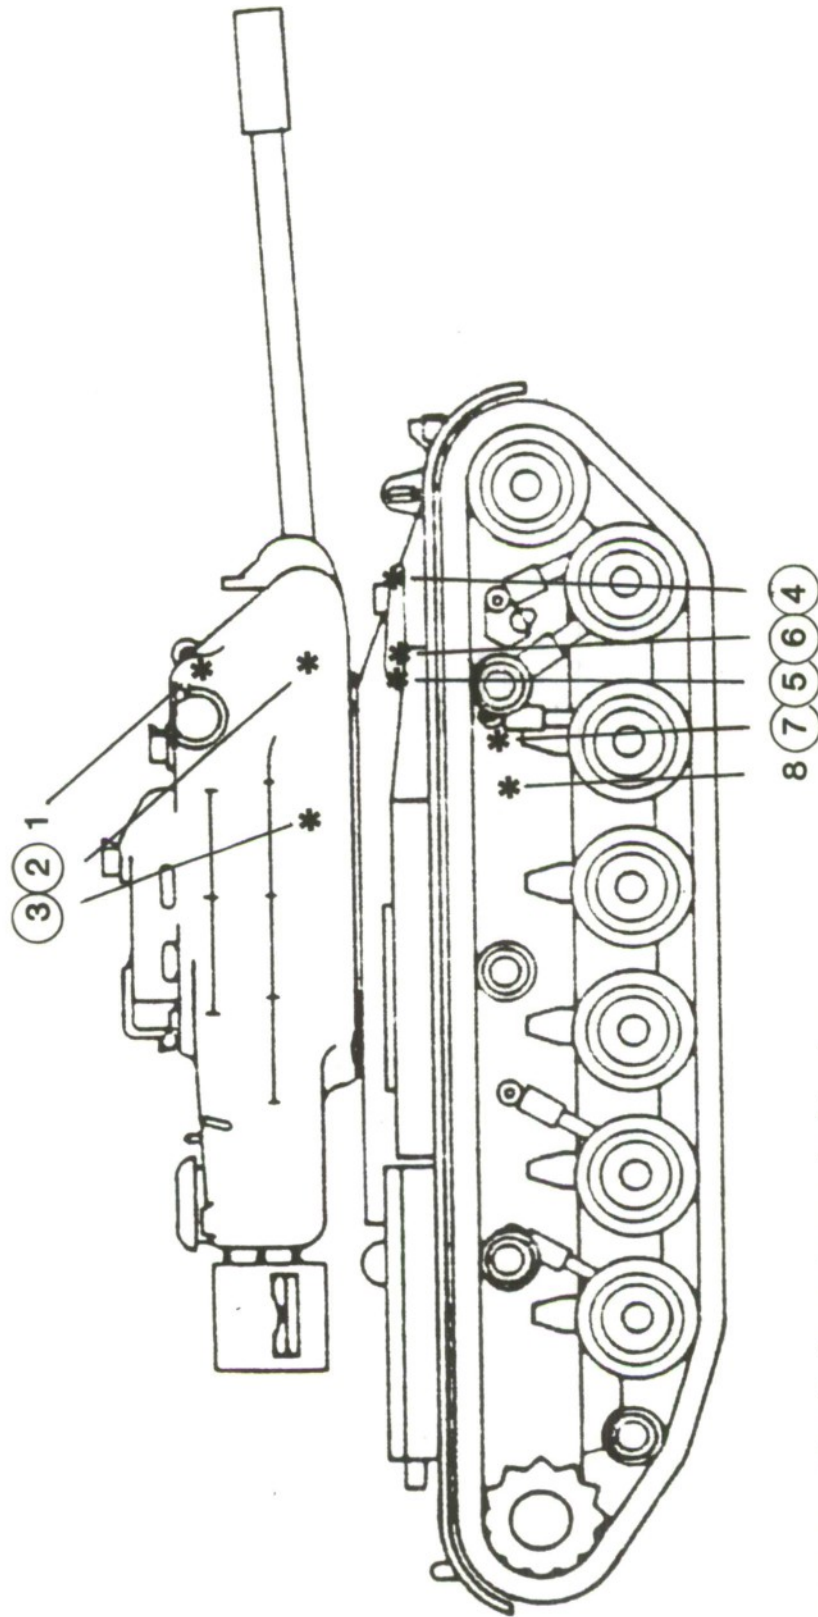
FIGURE 12. Impact Diagram, Tank 30.

Catastrophic K-Kill resulting from the following observed effects (Figure 12):

This tank was observed to explode immediately after the attack. Impact 7, which perforated the right hull armor and penetrated the ammunition stowage area, probably caused the explosion. Impact 6 also perforated the hull and could have impacted stowed ammunition as well.

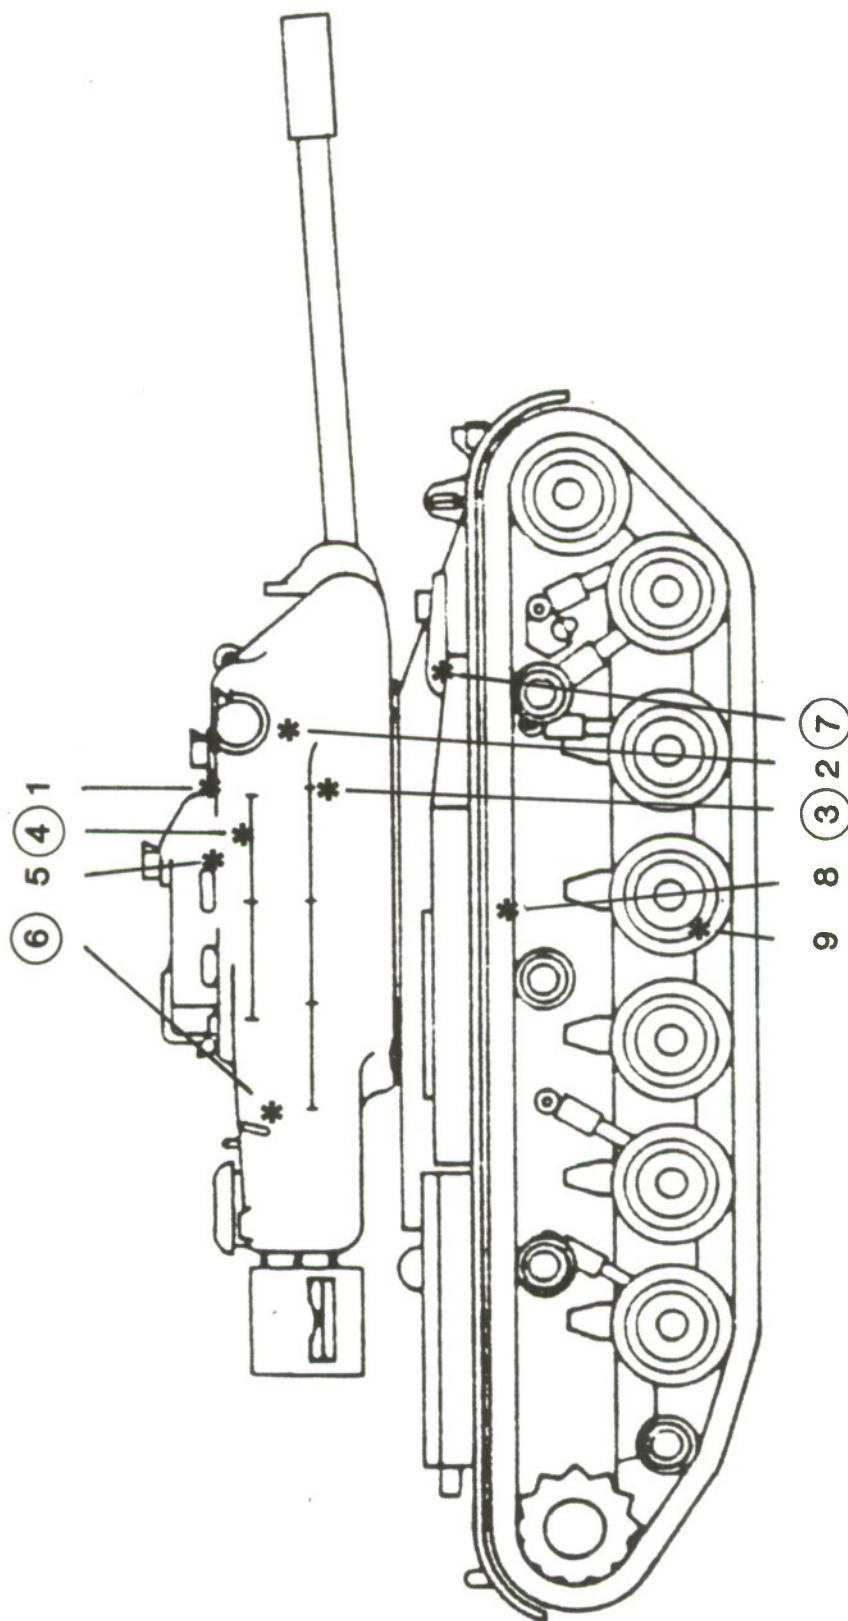
FIGURE 13. Impact Diagram, Tank 48.

100% M-Kill and 100% F-Kill resulting from the following observed effects (Figure 13):

This was a delayed burn occasioned by an explosion and fire occurring a considerable length of time (an estimated 45 minutes) after the A-10 attack, and which damaged only the fighting and driver compartments. There was no evidence of fuel or ammunition fires directly resulting from perforations of the armored envelope. Impacts 3, 4, and 7 were perforations of the hull and turret at locations that could have resulted in casualties to all crewmen. Therefore a 100% M-Kill and a 100% F-Kill was assessed based on a presumption of crew casualties, and the fire was attributed to a cook-off caused by ignition of innocuous materiel such as wooden manikins or crash padding.

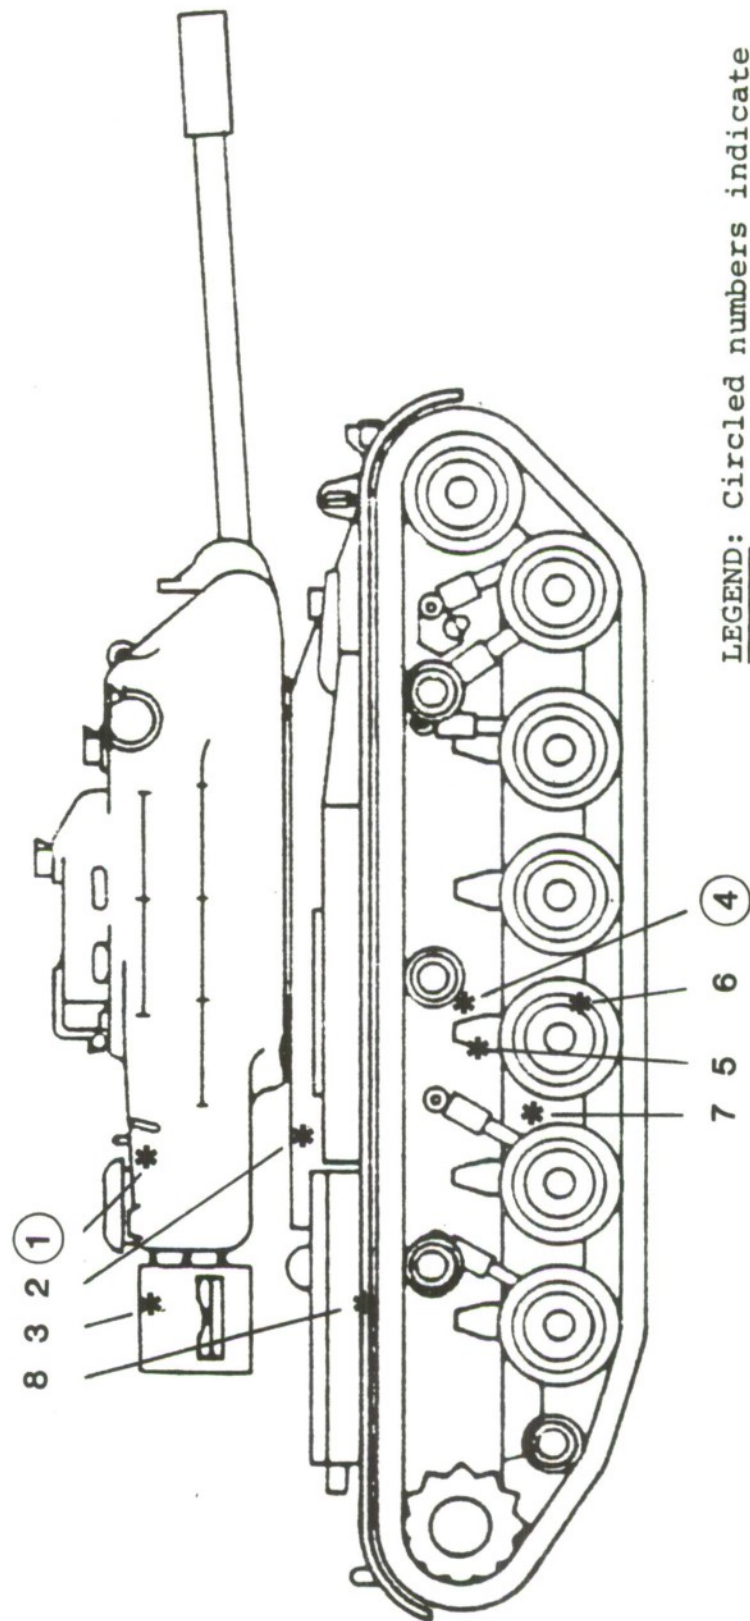
FIGURE 14. Impact Diagram, Tank 33.

100% M-Kill resulting from the following observed effects (Figure 14):

The assessment of 100% M-Kill is based on impact 4 which perforated the right side of the hull, penetrating the fuel tank, causing loss of fuel.

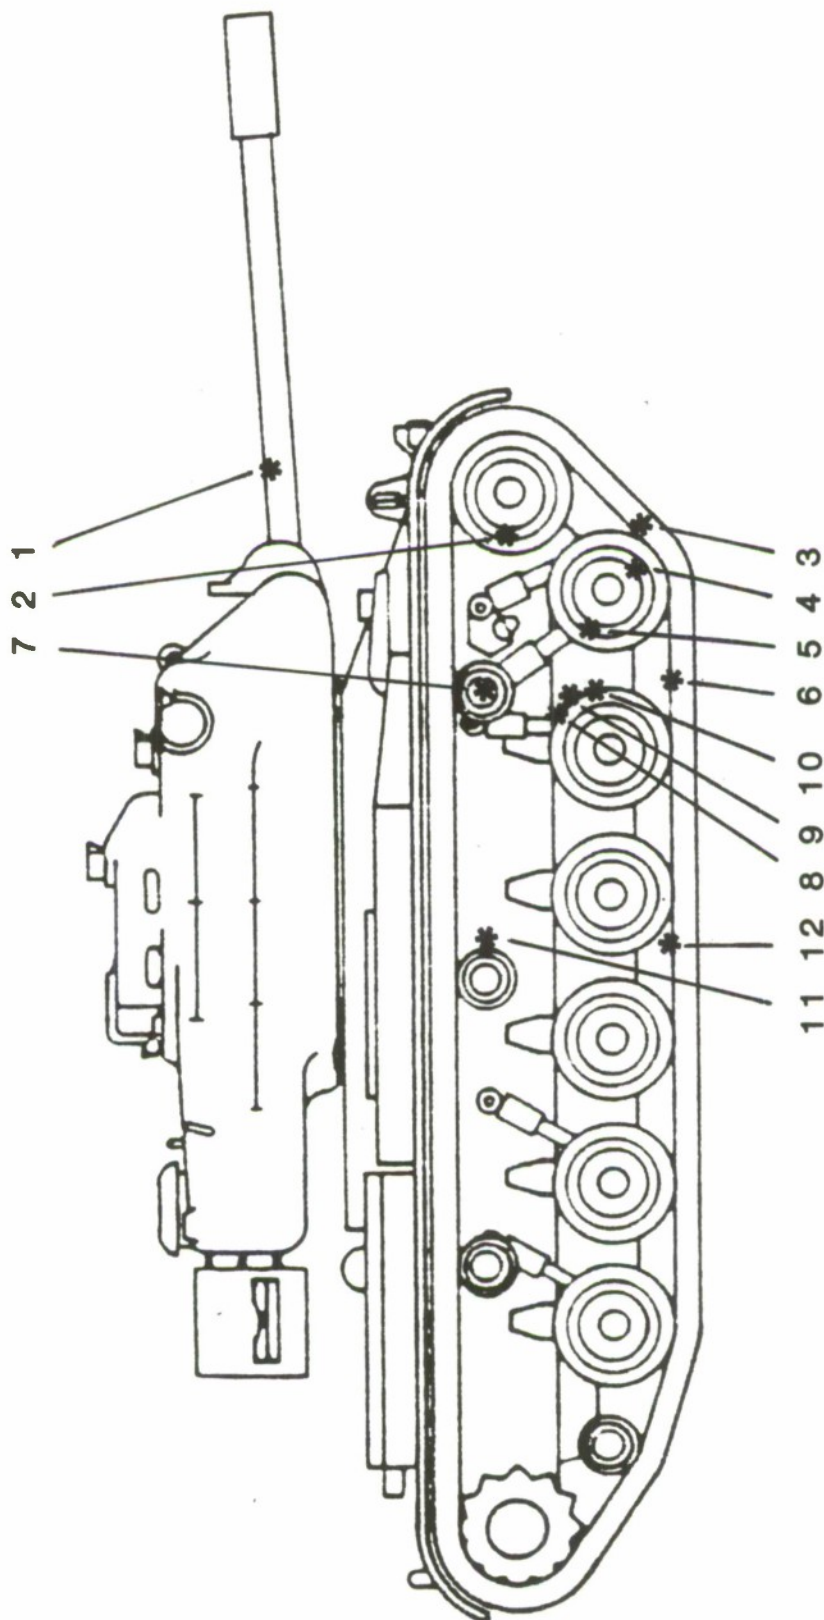
5% M-Kill and 10% F-Kill resulting from the following observed effects (Figure 15):

- a. M-Kill: The assessment of 5% M-Kill is based on minor cumulative damage to track and suspension system caused by impacts 2, 5, 6, 7, and 12.
- b. F-Kill: The assessment of 10% F-Kill is based on damage caused by impact 1 which perforated one wall of the gun tube.

- a. Hits #8 & #9 are behind #2 Road Wheel
- b. Hit #10 is on Inboard #2 Road Wheel
- c. Hit #11 is on Inboard Middle Track Support Roller

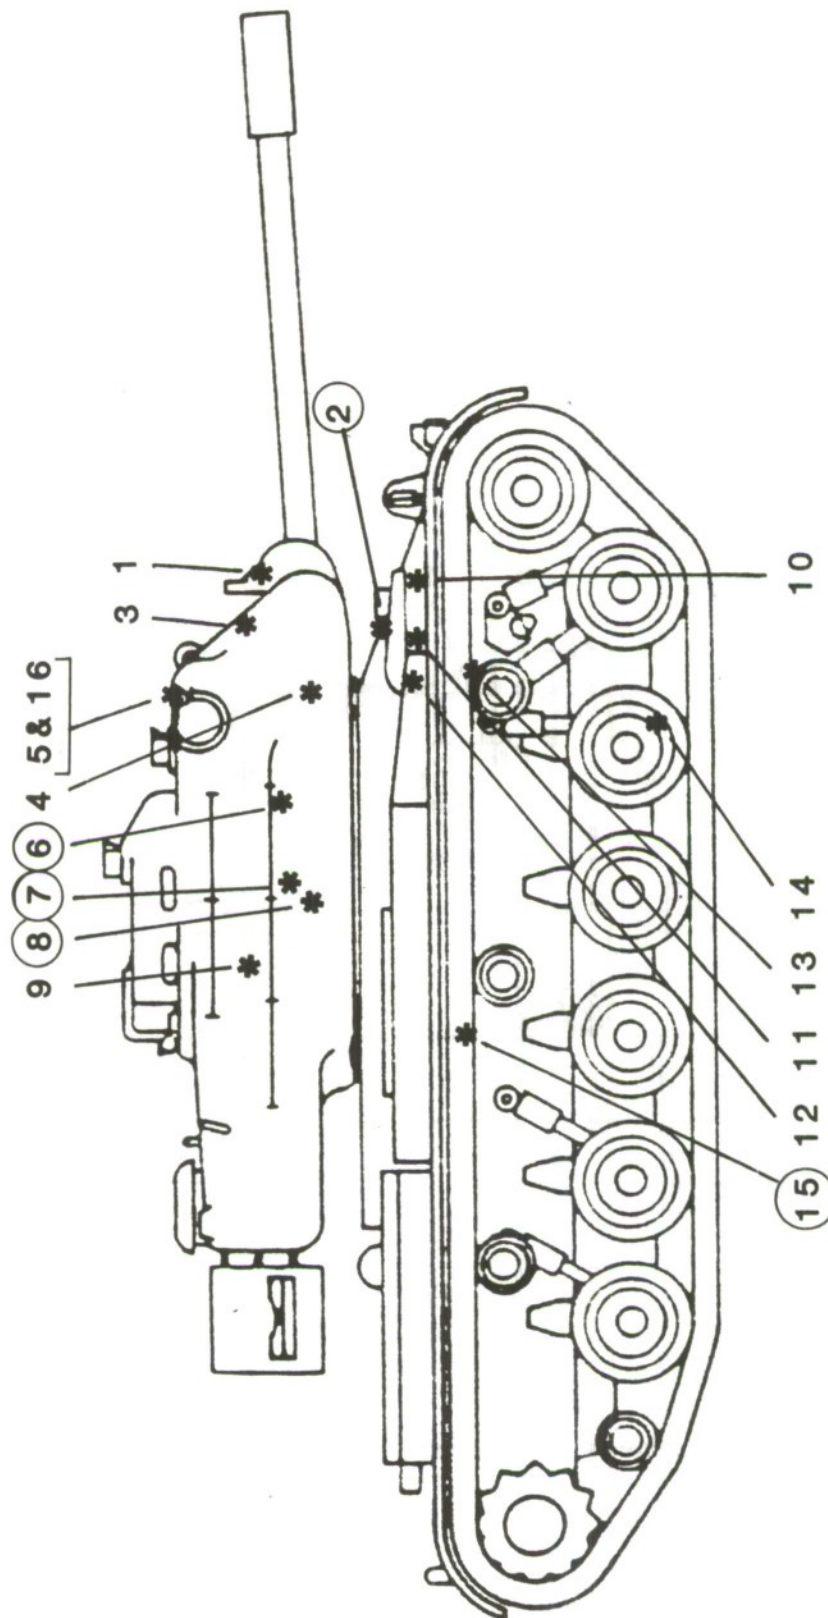
FIGURE 16. Impact Diagram, Tank 39 Right Side.

Catastrophic K-Kill resulting from the following observed effects (Figure 16 and 17):

100% K-Kill resulting from impact 15 which perforated the right hull armor and penetrated the fuel tank causing a fire which could not be extinguished by the crew because of casualties inflicted by perforations 6, 7, and 8 which penetrated into the fighting compartment and perforation 2 which penetrated into the driver's compartment.

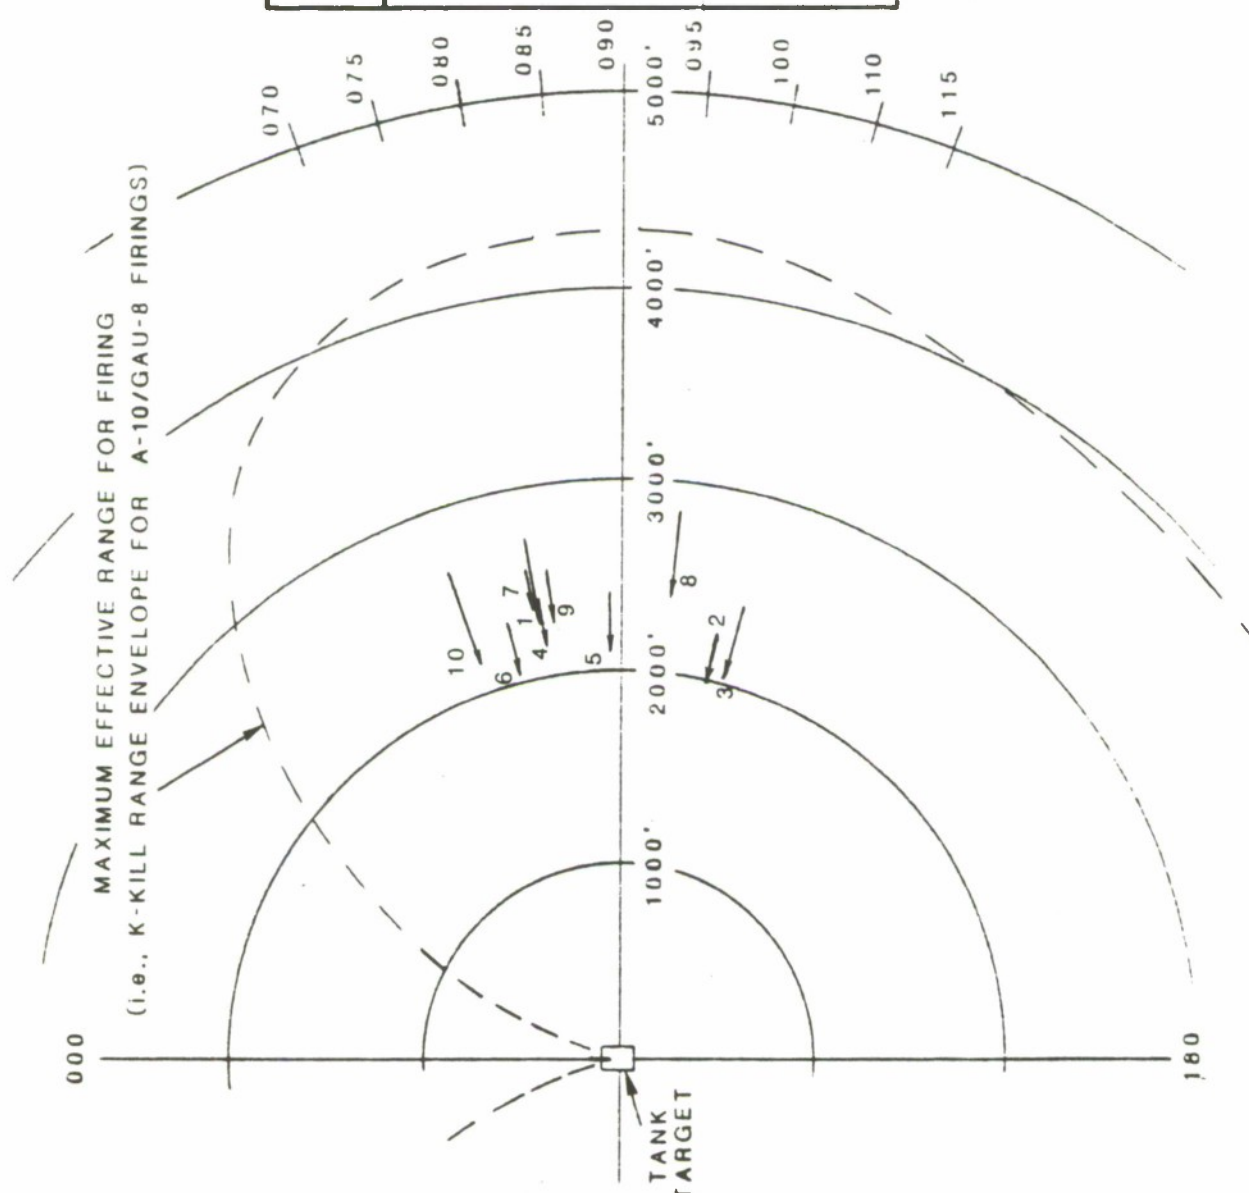
Table A-I contains a summary of the results of mission 22 of 7 November, 1979. Table A-II relates the assessment of damages in Table A-I to locations of perforations. Table A-III summarizes the Aircraft Attack Parameters Altitude, Attitude, Airspeed, Firing Slant Range and Burst length for each pass on each target. Figure A-1 relates aircraft attack aspect by tank number to burst length in feet.

Pass #	Open Fire Range	Cease Fire Range	Relative Approach Angle
1	2699	2227	078
2	2191	*	105
3	2334	2007	110
4	2406	2146	078
5	2334	2097	088
6	2263	2037	075
7	2547	2261	078
8	2758	2404	097
9	2547	2239	082
10	2618	2131	070
