**Mark XIV Torpedo Case Study**

**David F. Matthews, Senior Lecturer**

**Naval Postgraduate School**

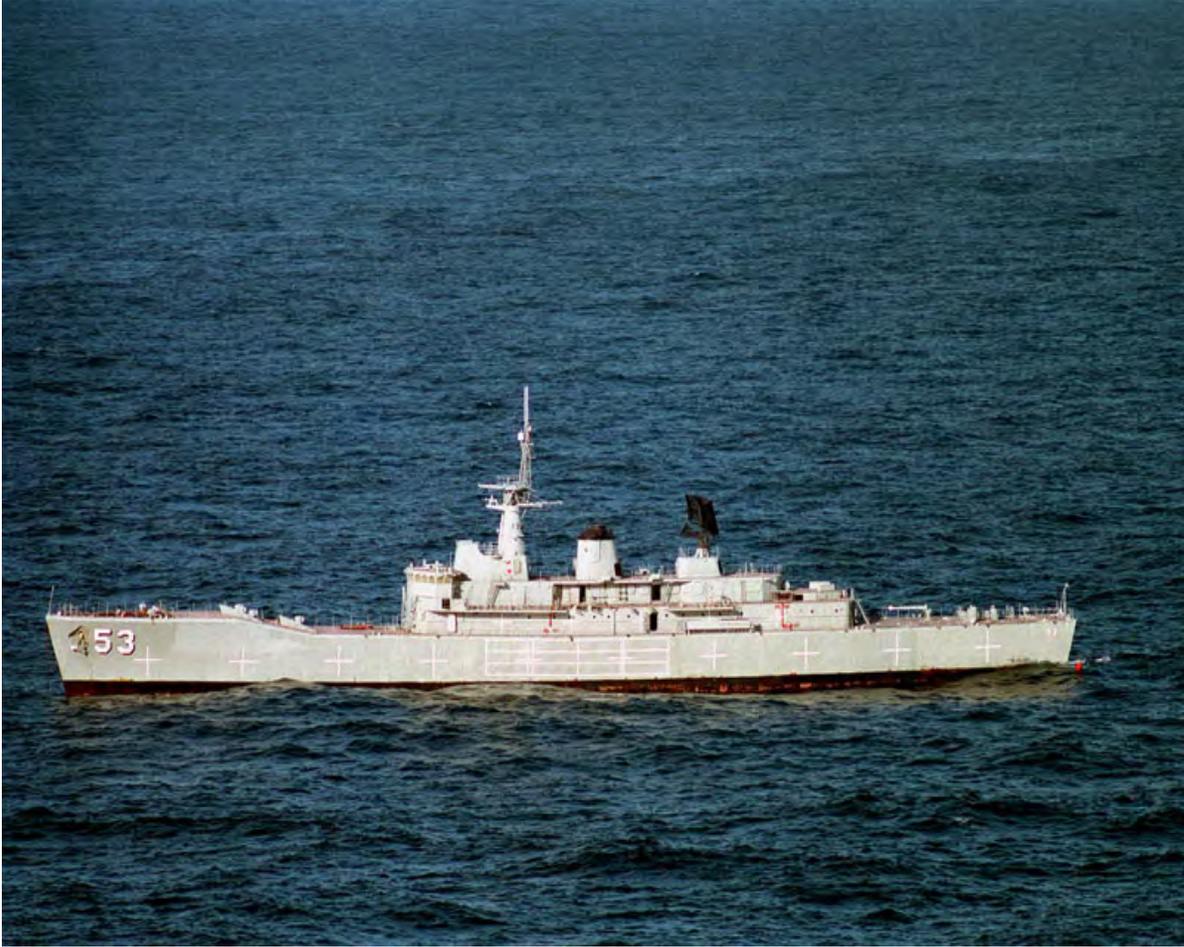
**Figure 2. Destroyer Prior to Detonation**  
(Navy Undersea Warfare Center, 1999)

Figure 2 is a picture of the obsolete full-sized Australian destroyer that served as the test target. Everything useful was removed from the destroyer—all turrets, depth charges, secondary armament, etc. The configuration is visible in subsequent photos. Figure 2 shows the target ship sitting dead in the water waiting to be engaged.

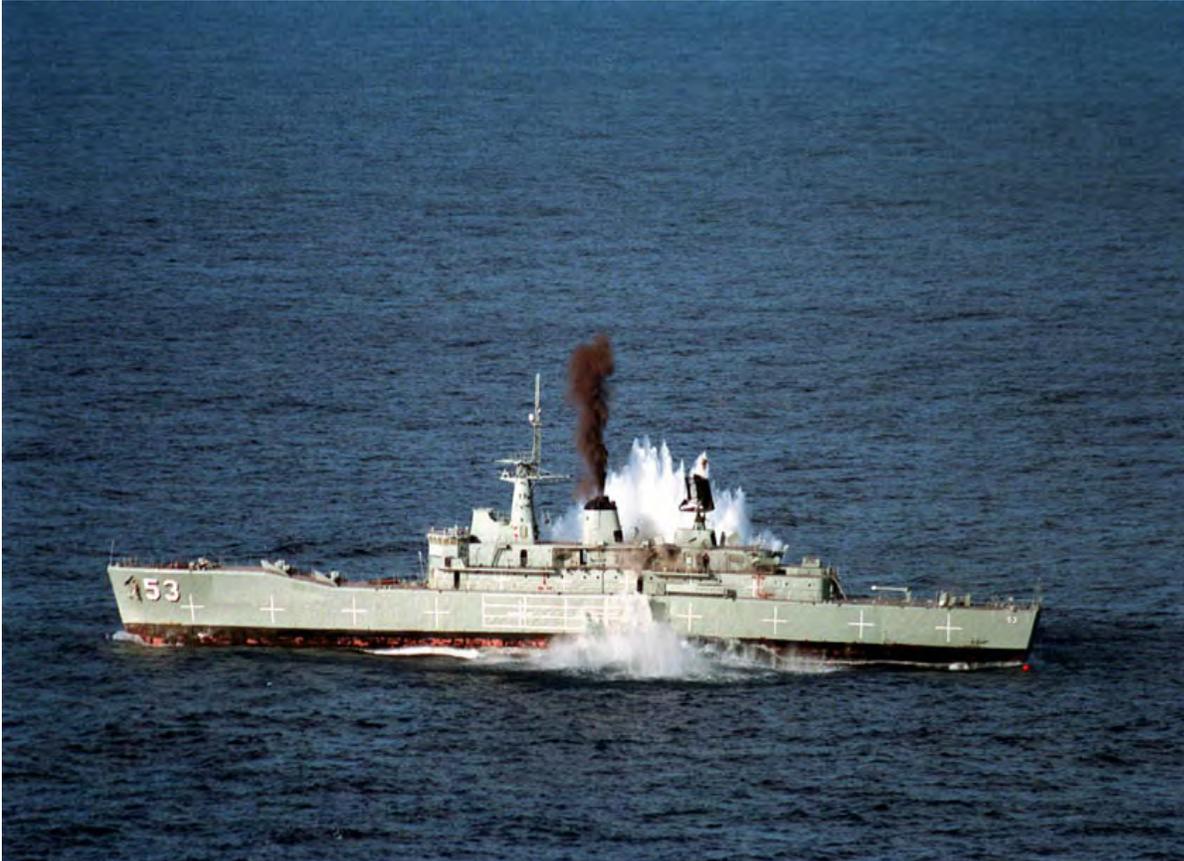
**Figure 3. Initial Reaction**  
(Navy Undersea Warfare Center, 1999)

Figure 3 is a photograph of the moment the torpedo was detonated. The photograph shows that smoke has been blown out of the stack because of the power of the explosion, and it shows that water is starting to erupt on either side of the ship. In Figure 3, the ship already appears to have had its keel broken because the bow and the stern are lower than the center of the ship.

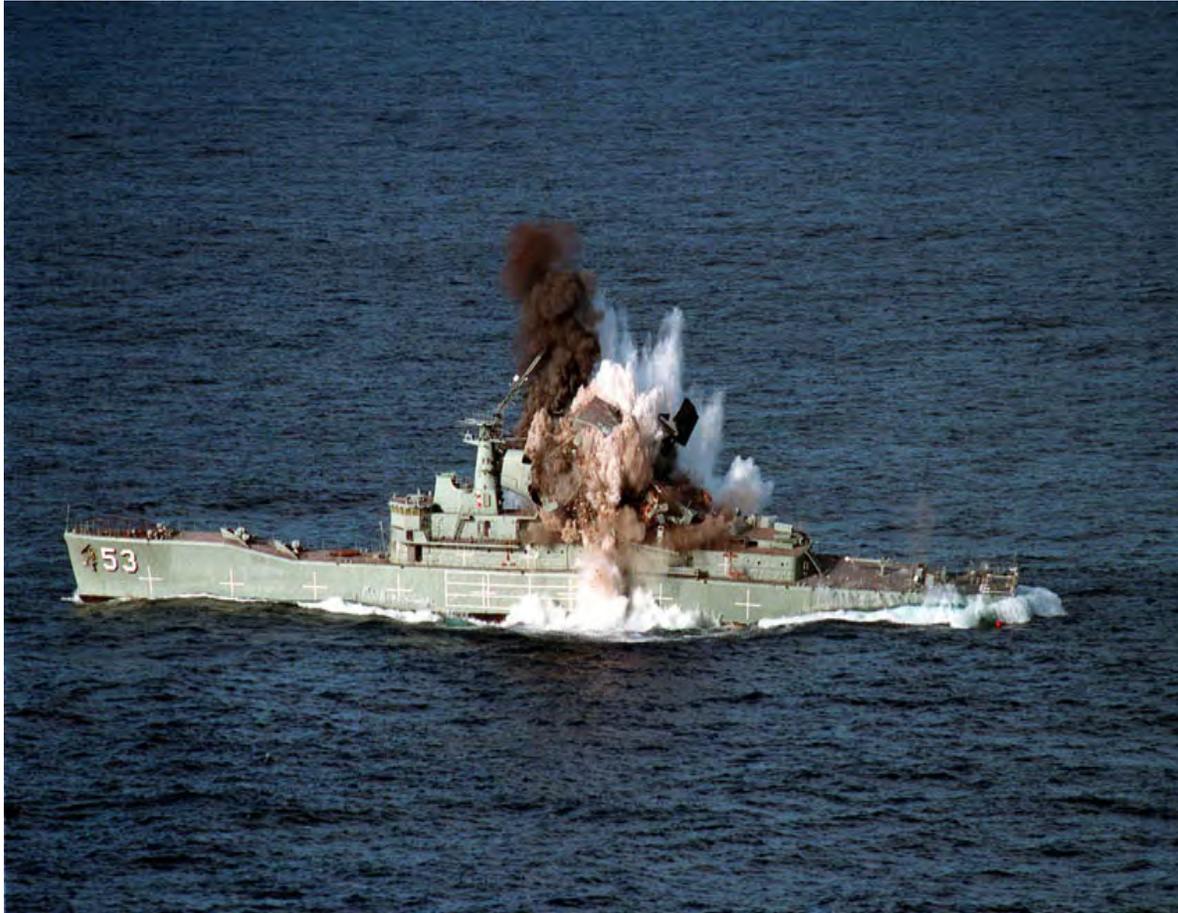
**Figure 4. Further Damage**  
(Navy Undersea Warfare Center, 1999)

Figure 4 is a photograph of a few seconds, maybe even milliseconds, later. The explosion has propagated even further, and the power of the torpedo warhead's explosive is visible as it goes straight up through the bowels of the ship along the center line—and it only gets worse.

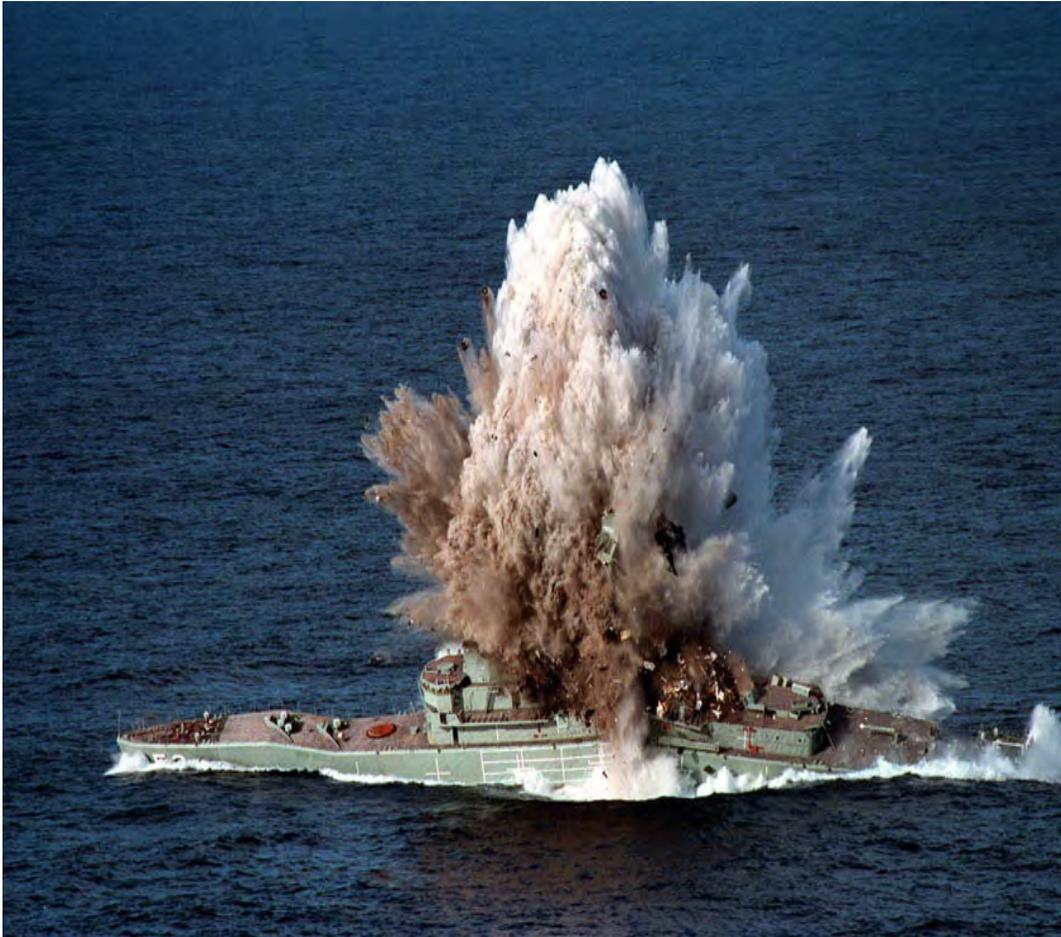
**Figure 5. The Keel Has Broken**  
(Navy Undersea Warfare Center, 1999)

Figure 5 clearly shows that the back of the destroyer has been broken. The extensive level of damage that is taking place is obvious.

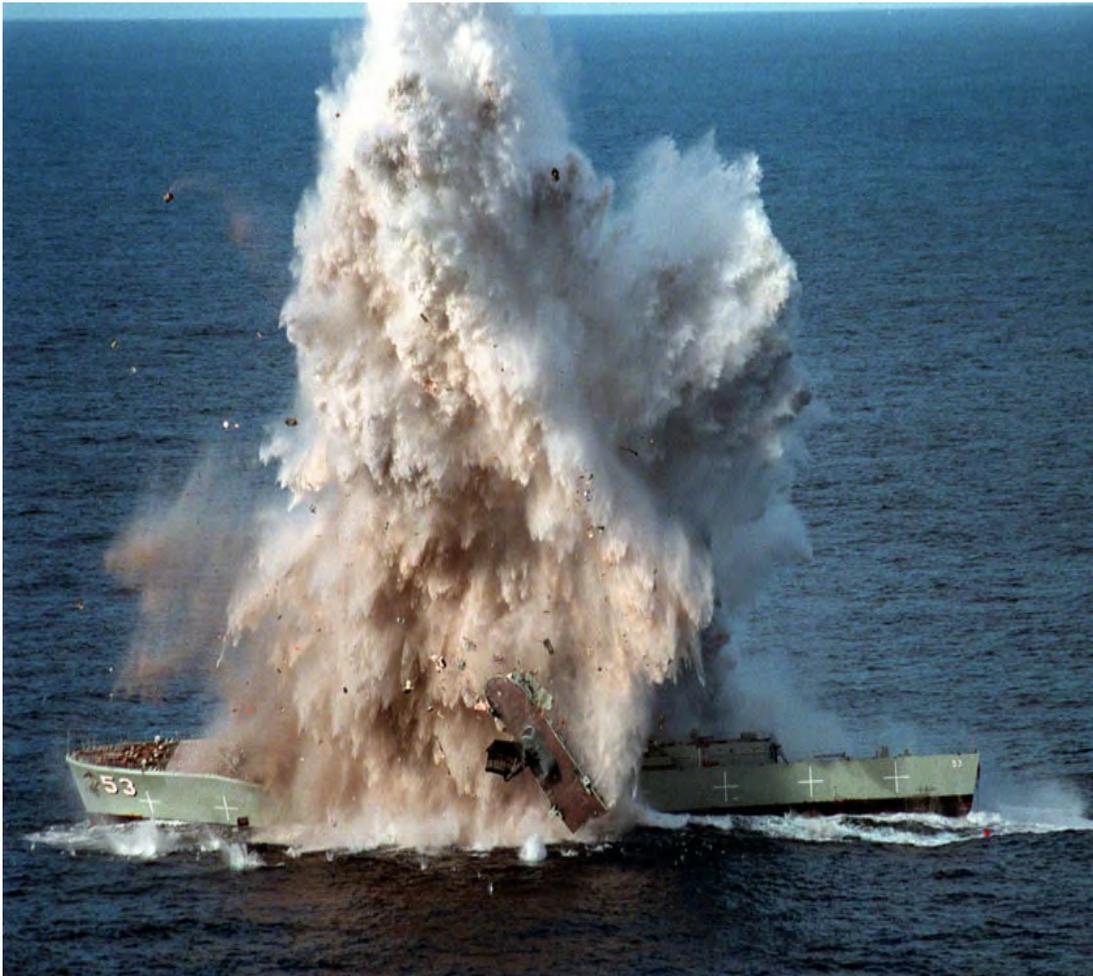
**Figure 6. Bow and Stern Sections Separate**  
(Navy Undersea Warfare Center, 1999)

Figure 6 shows that the level of damage is now catastrophic.

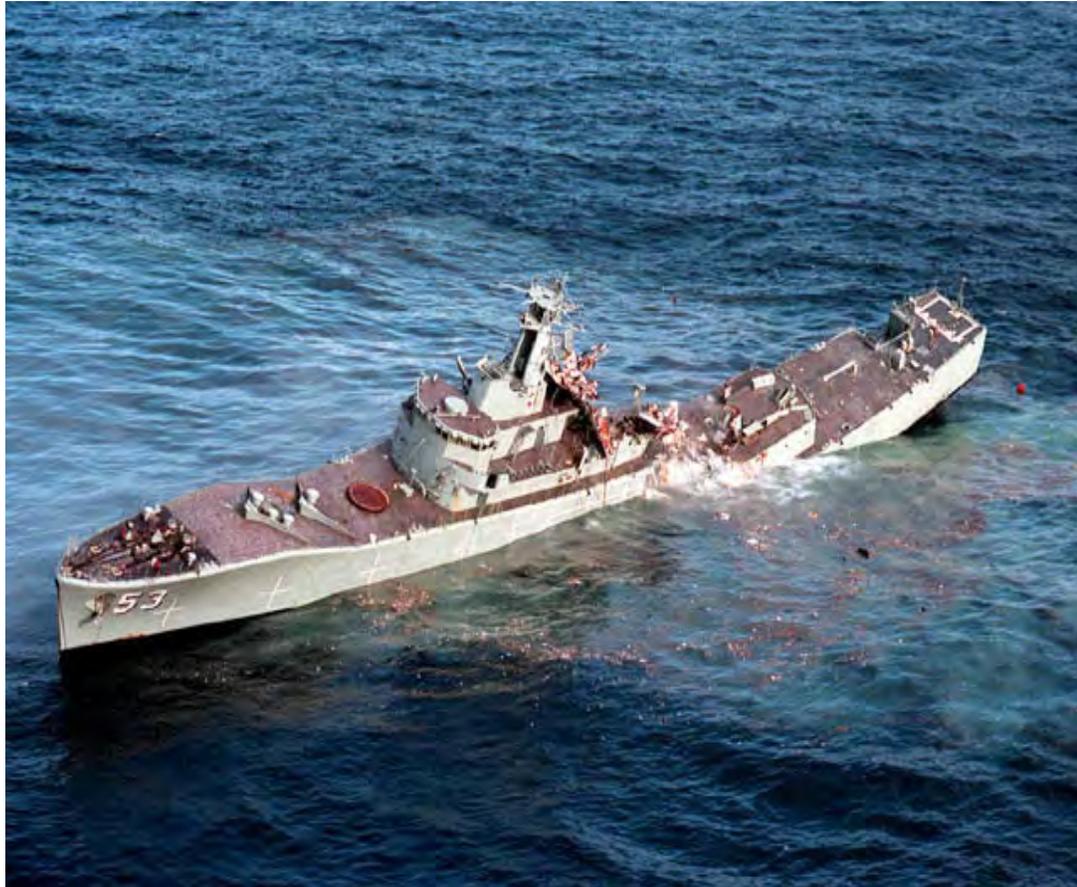
**Figure 7. The Stern Begins to Sink**  
(Navy Undersea Warfare Center, 1999)

As the smoke clears in the photograph in Figure 7, it is clear that the destroyer has broken into two halves and that the stern section is about to sink.

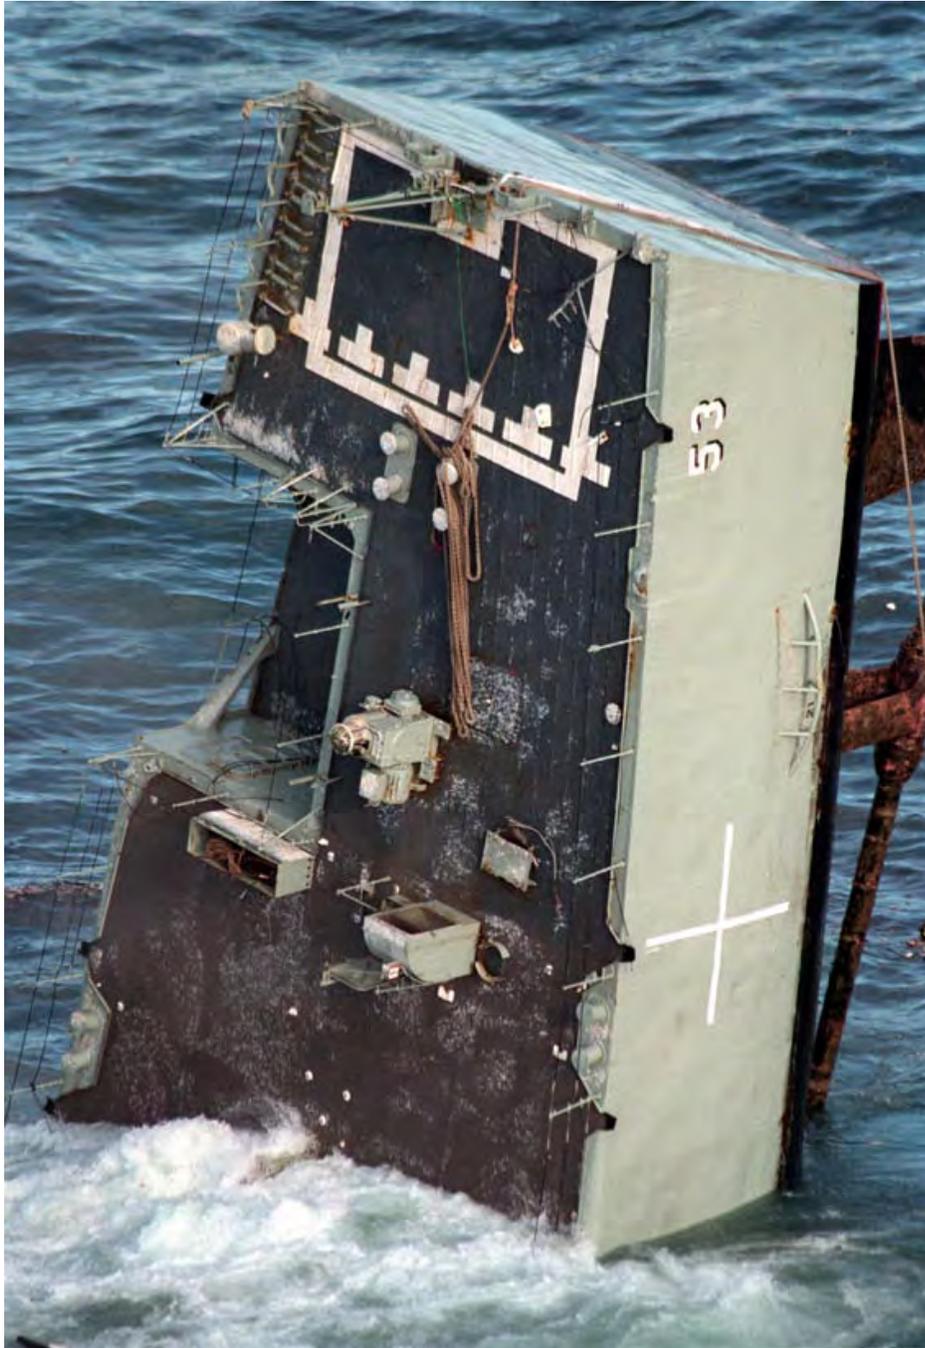
**Figure 8. The Stern Slips Under the Waves**  
(Navy Undersea Warfare Center, 1999)

Figure 8 shows that the observation made in Figure 7 is accurate: the stern section is headed to “Davey Jones’ Locker.” The photograph in Figure 8 is a close-up of the destroyer as it slips beneath the waves.

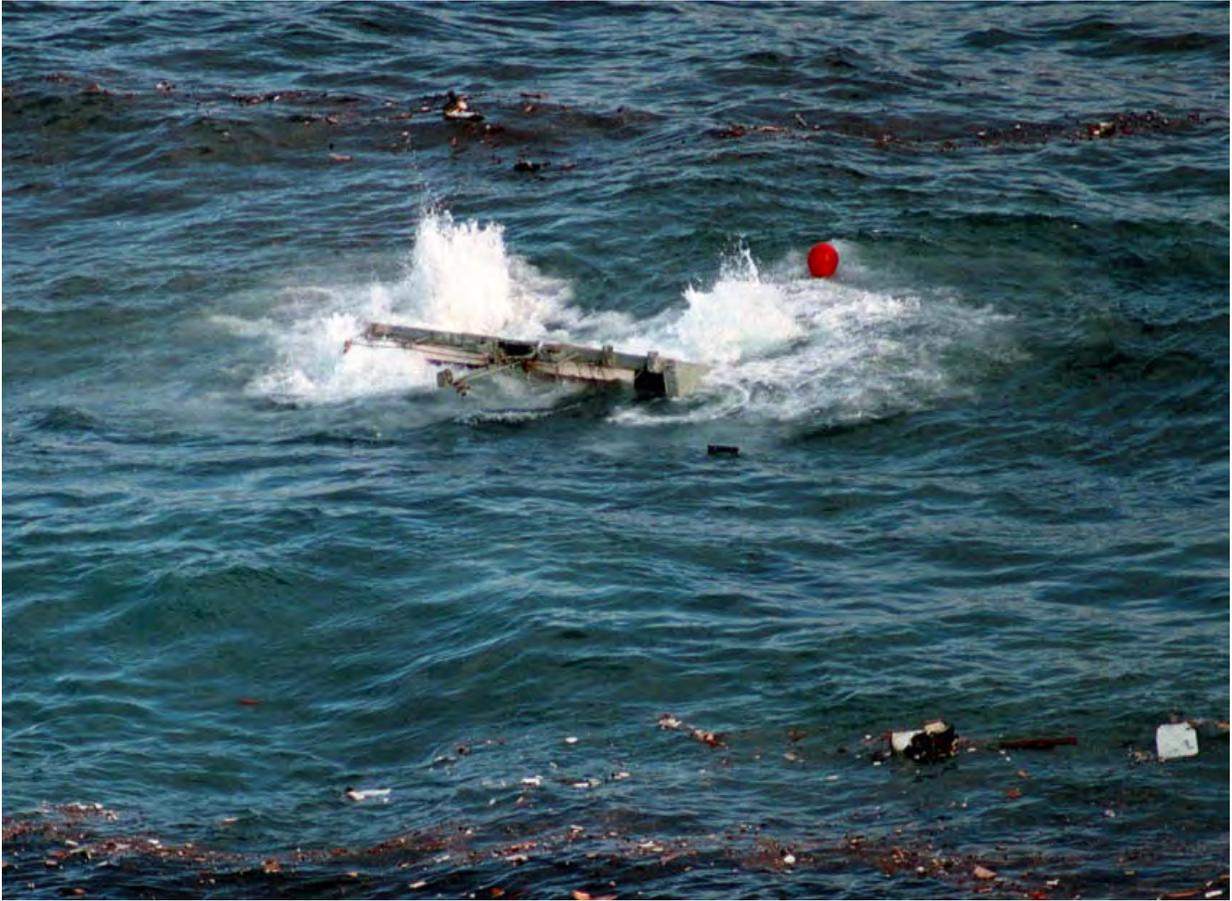
**Figure 9. The Stern Disappears**  
(Navy Undersea Warfare Center, 1999)

Figure 9 is a close-up photograph of the residual debris field.

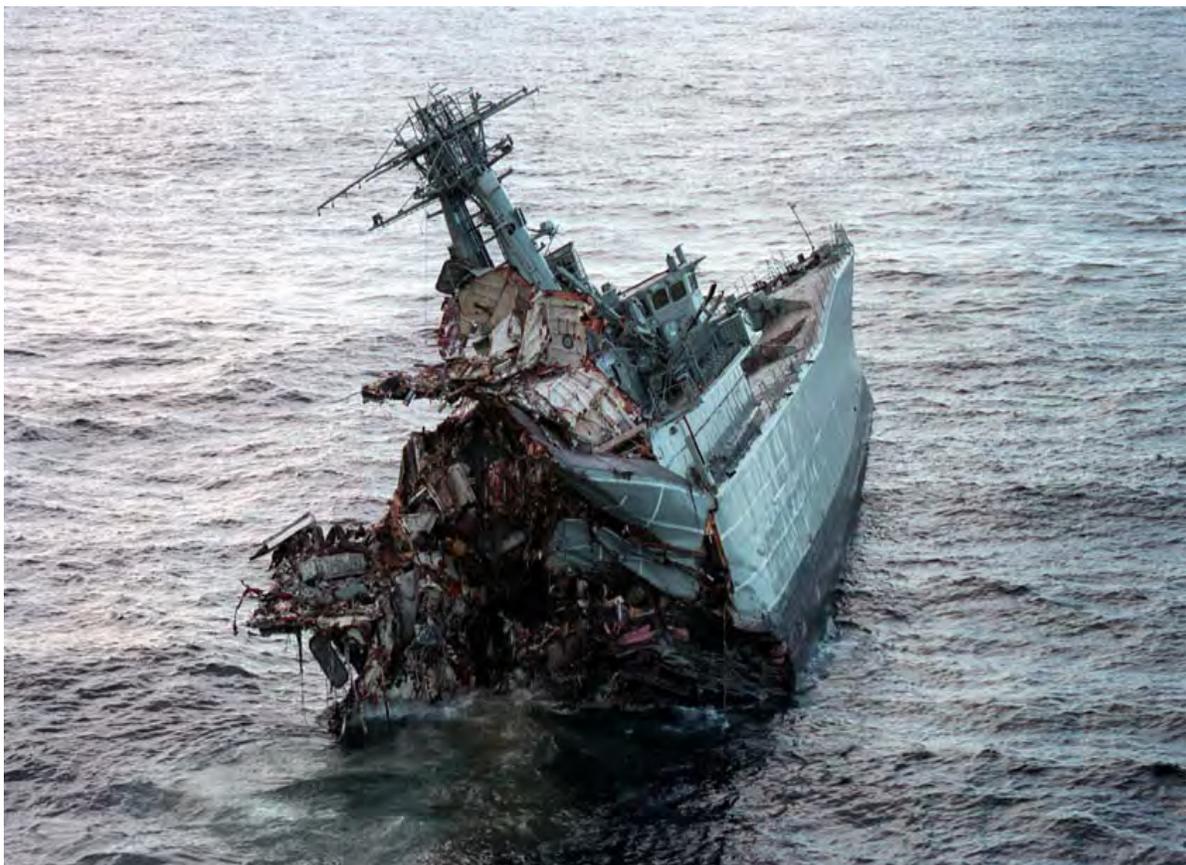
**Figure 10. The Residual Bow Section**  
(Navy Undersea Warfare Center, 1999)

Figure 10 is a photograph of the bow section of the ship. As the photograph shows, it is not economically repairable. The damage is so bad that by the time the Australian Navy would have tried to salvage what is left there in order to rebuild a new ship around it, it would have been better to have started from scratch. Plus, ship designs evolve, and if this were an older ship, it would probably be better from a cost-effectiveness standpoint to acquire a “latest and greatest” warship of a similar class to replace this one. In this test, the bow section actually sank a few hours after the photograph in Figure 10 was taken.
