⑦ Employment of OV-1 (Mohawk) Aircraft

in Support of Counter-Insurgency Operations (C)

⑨ MONTHLY TEST REPORT NUMBER 4,

16 January 1963 - 15 February 1963,

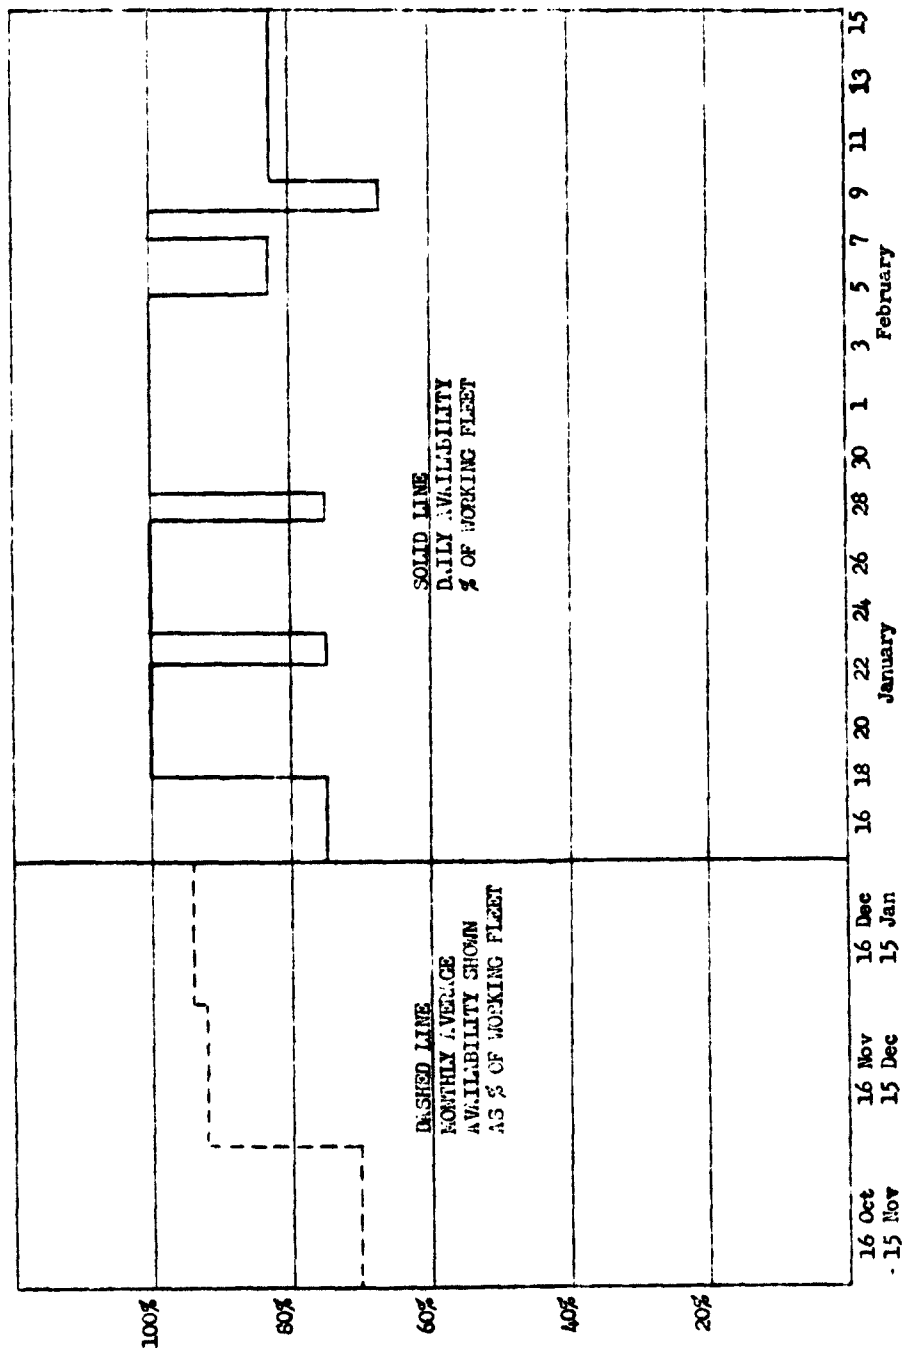
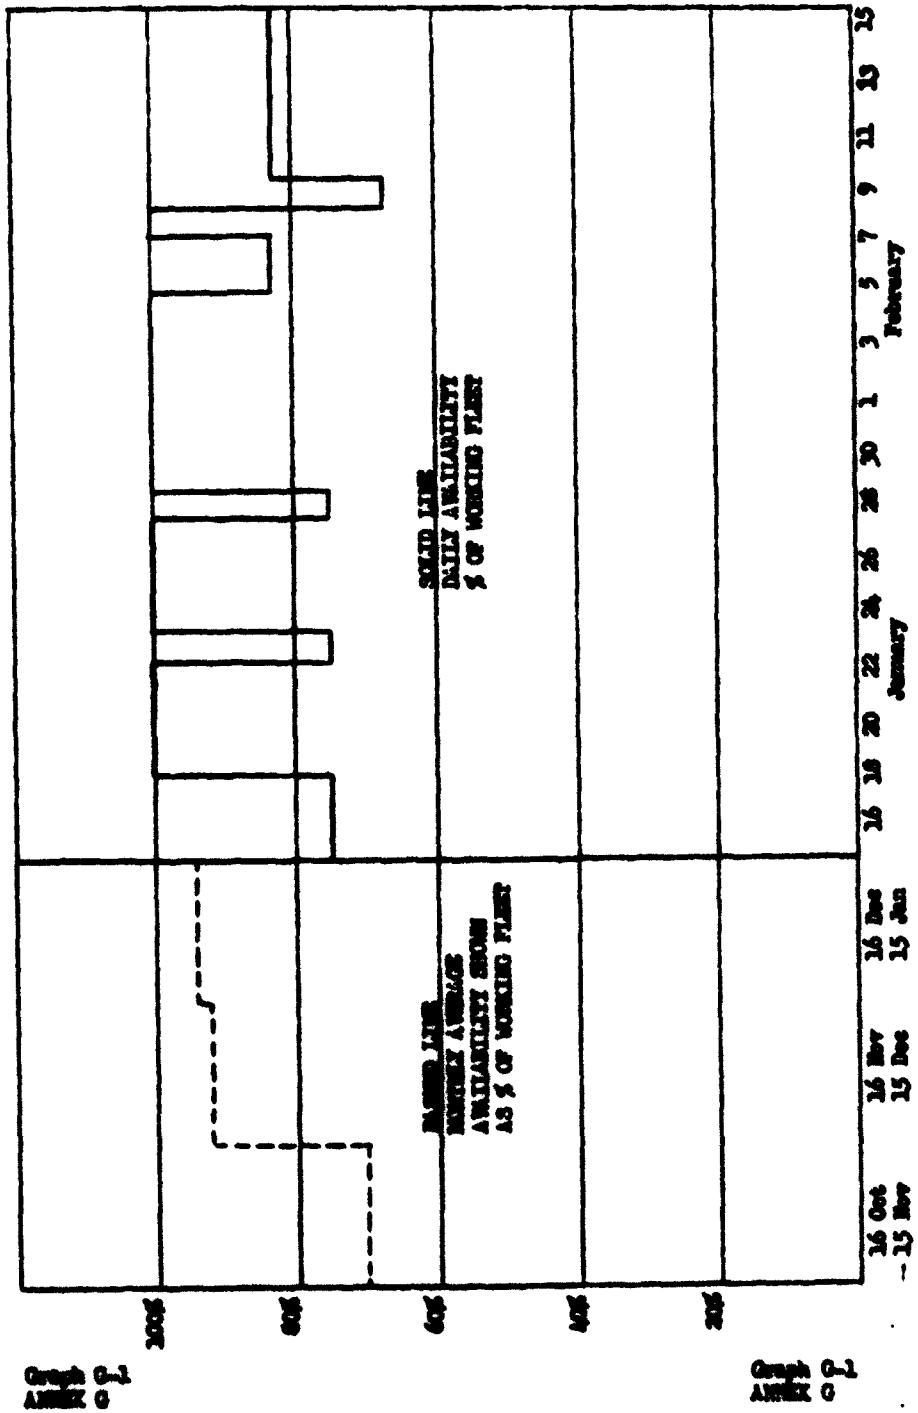
Graph G-1
ANNEX G

a. During the past 30 days the average daily availability of the 23d SWAD aircraft has been 89% of the working fleet. No aircraft were EDP during the period. Graphs of daily aircraft availability and flight hours are attached (Graphs G-1 and G-2).

Graph G-1, ANNEX G -- Aircraft availability.

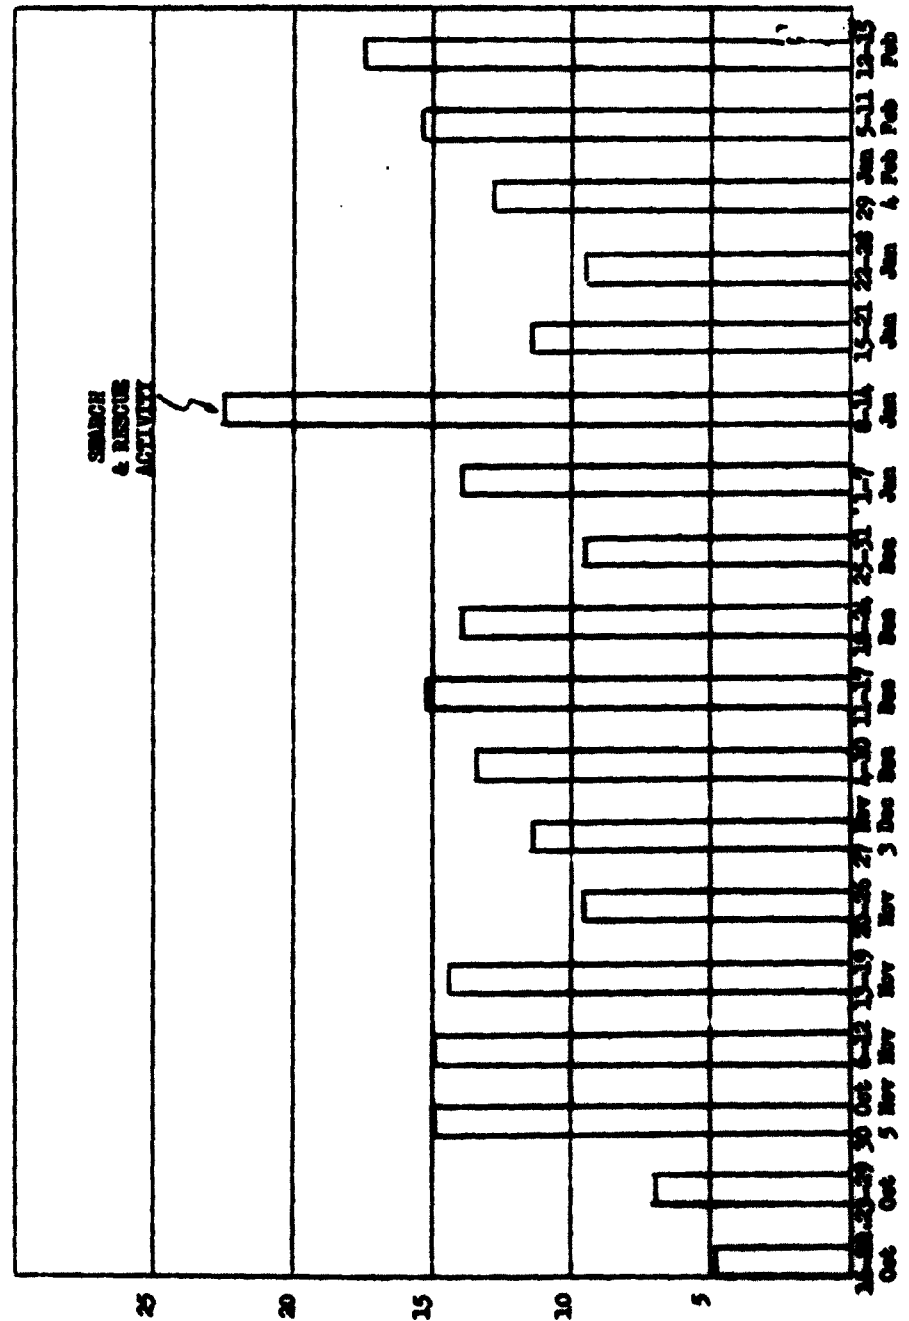
Graph G-2
ANNEX G

Graph G-2, ANNEX G -- Daily flight hours (average per week).

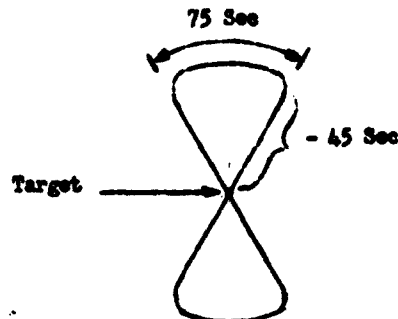
a. Single aircraft: Experience has shown that the best flight pattern to be a figure eight with the target at the center. Ninety-second legs are flown with standard rate 225° turns. Each time the target is crossed, approximately 2-3/4 minutes will have elapsed between flares, giving at least 15 seconds overlap of illumination by each succeeding flare. Pattern will look like this:

(1) The altitude (3000 feet absolute above the fuse setting) must be decided upon and the fuse set prior to the flight. Factors considered in determining flight altitude are terrain elevation, cloud cover, hazards to flight, and requirements for visual observation of the illuminated area by the aircraft crew.

(2) Release point and pattern must be adjusted to allow for wind drift.

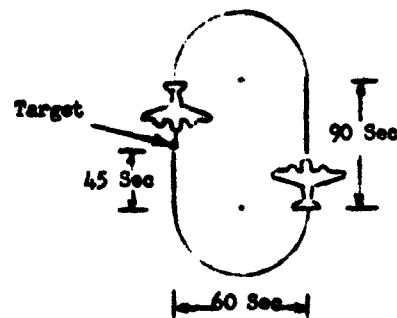
nation over the same point, a rectangular pattern is used with 90-second legs and a standard rate 180° turn at each end to complete the pattern. The pattern is located with the target at the midpoint of either leg, and the aircraft are spaced on opposite sides of the pattern to provide a flare release approximately every 2½ minutes. By this method, approximately 30 minutes of continuous illumination can be provided.

c. If illumination for longer than 30 minutes is required, additional aircraft should be designated to relieve aircraft on station when their flares are expended. . Because of the difficulty of maintaining relative stations at night, this method is preferred over the use of three or more aircraft in a single pattern.
