R.A.R.D.E. MEMORANDUM (B) 66/63

Trials to assess the lethality of a 76 mm HESH shell
against armoured personnel carriers

R. Beresford

December
1963

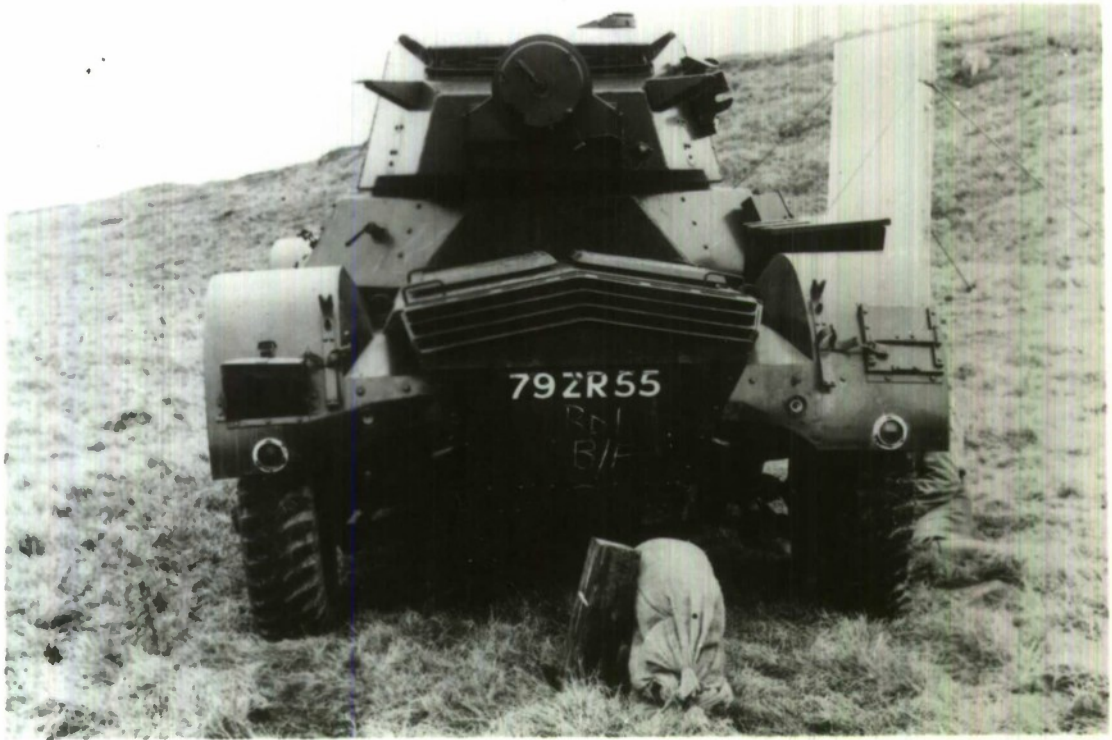
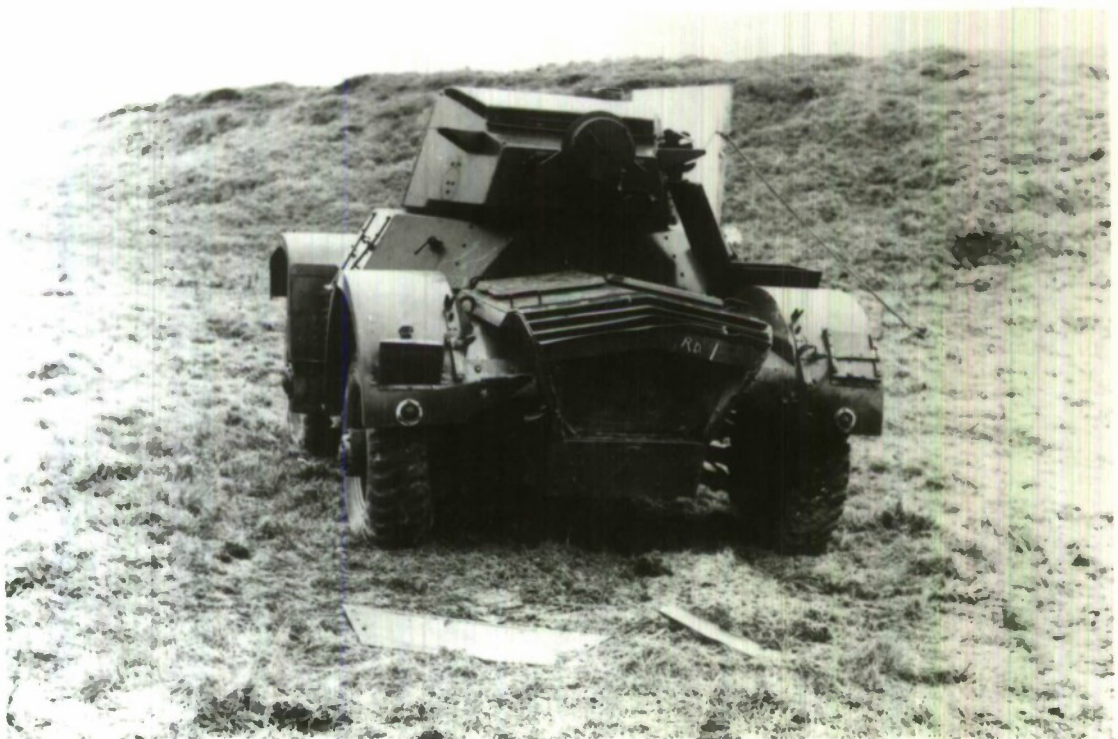
FIG. I NEAR MISS CLOSE TO THE ENGINE COMPARTMENT

- (a) The Engine Compartment (Figure 1). The outer plate (14 mm) was blown off but there was little damage either from fragments or blast except for an unimportant oil leak. The effect on Mobility was considered to be nil.
- (b) Vehicle Front (Figure 2). Damage from many large fragments was apparent. Both tyres on the vehicle R.H.S. were punctured and a hydraulic leak was started. The Mobility loss was assessed at 25%.
- (c) Wheels (Figure 3). The frame of the wheel was undamaged but large fragments stuck in the tyre casing would possibly have caused a puncture before the car had moved very far. The loss of Mobility was considered to be 5%.

| DAIMLER ARMoured CAR TARGET | | |
|---|--|--|
| 1. | Wood block 2 ft. from engine. | Rear plate blown off but otherwise little damage. Effect on Mobility = zero. |

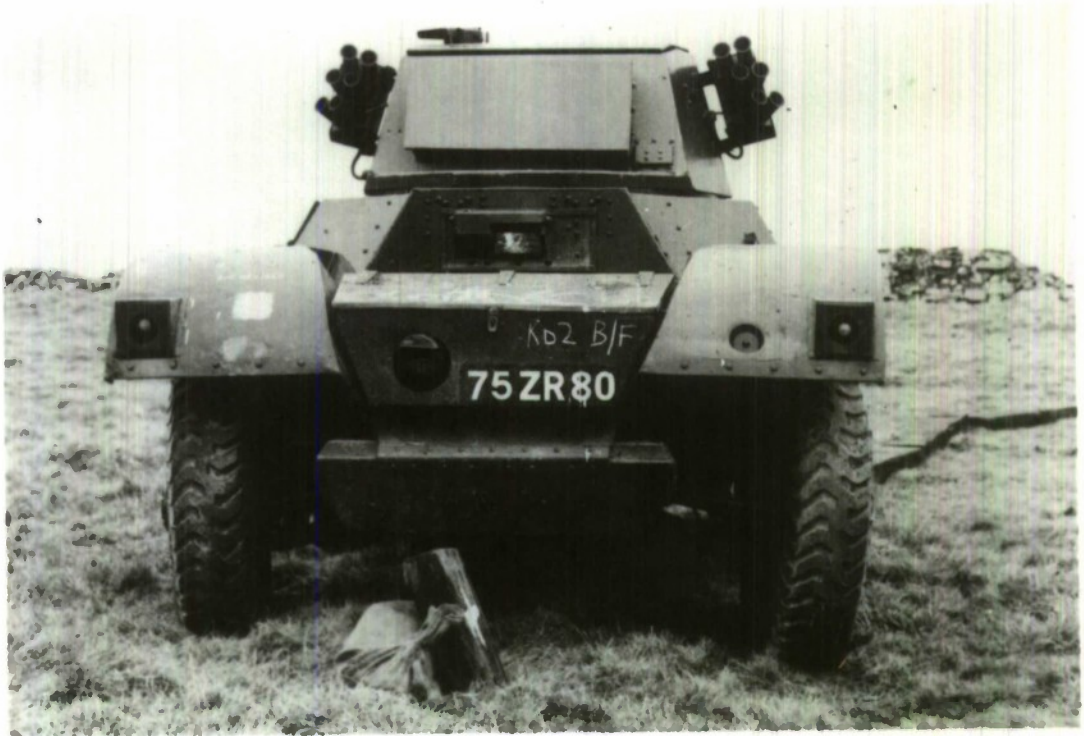
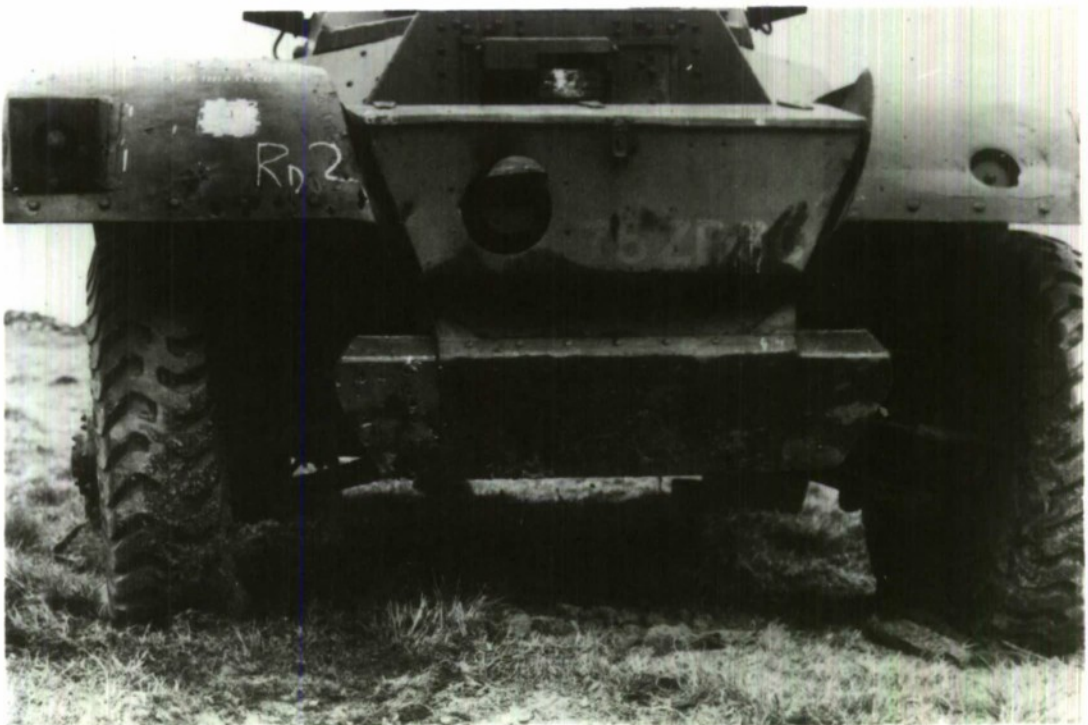
FIG. 2 NEAR MISS CLOSE TO THE FRONT OF THE VEHICLE

| DAIMLER ARMoured CAR TARGET | | |
|---|--|--|
| 2. | Wood block 2 ft. from vehicle front. | Two tyres punctured and hydraulic leak started. Mobility loss = 25% |

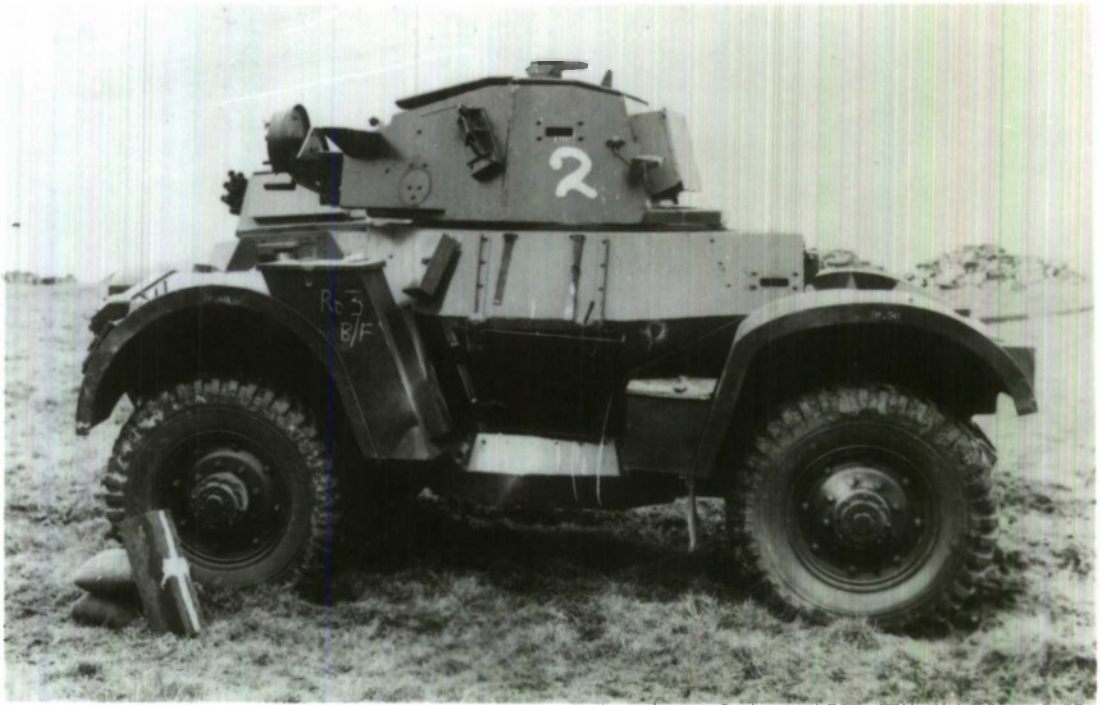
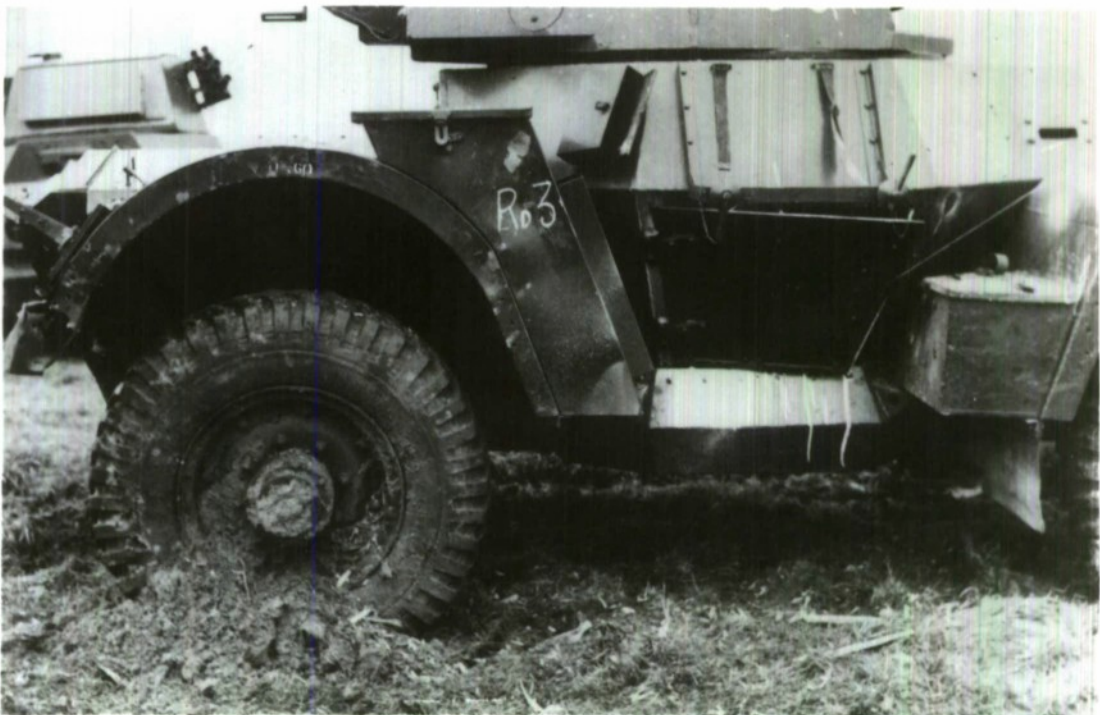
FIG. 3 NEAR MISS CLOSE TO A WHEEL

| DAIMLER ARMoured CAR TARGET | | |
|---|--|--|
| 3. | Wood block 2 ft. from wheel. | Wheel frame undamaged but large splinters present in tyre. Mobility loss = 5% |

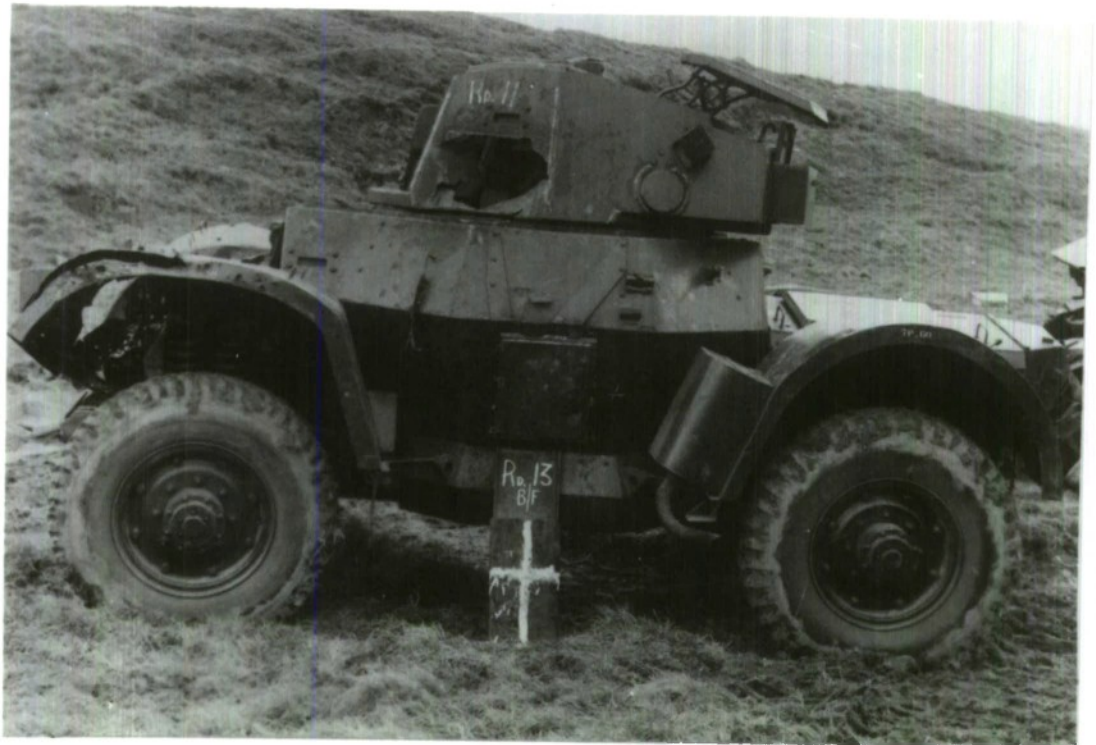
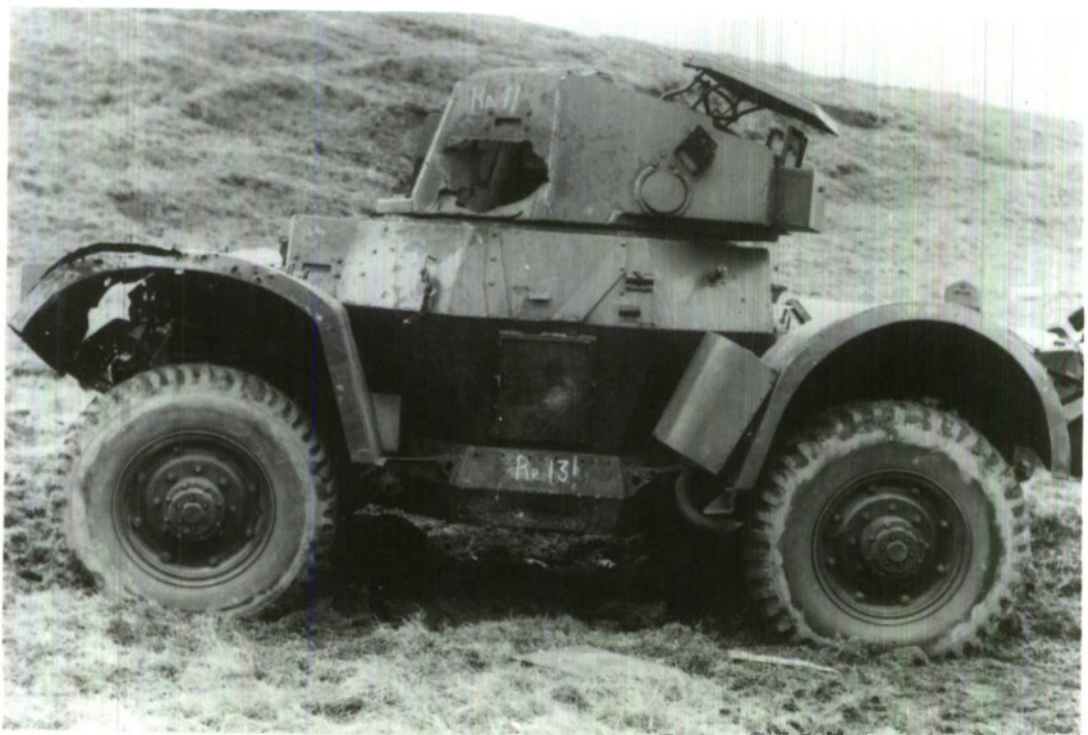
FIG. 4 NEAR MISS CLOSE TO CAR SIDE

- (d) Car Side (Figure 4). There was no effect from fragments and little apparent damage from blast apart from a small fuel tank leak which was considered to have no effect on immediate Mobility.

| DAIMLER ARMoured CAR TARGET | | |
|---|--|--|
| 4. | Wood block close to armoured side of car. | No damage other than small fuel leak which would have no immediate effect. |

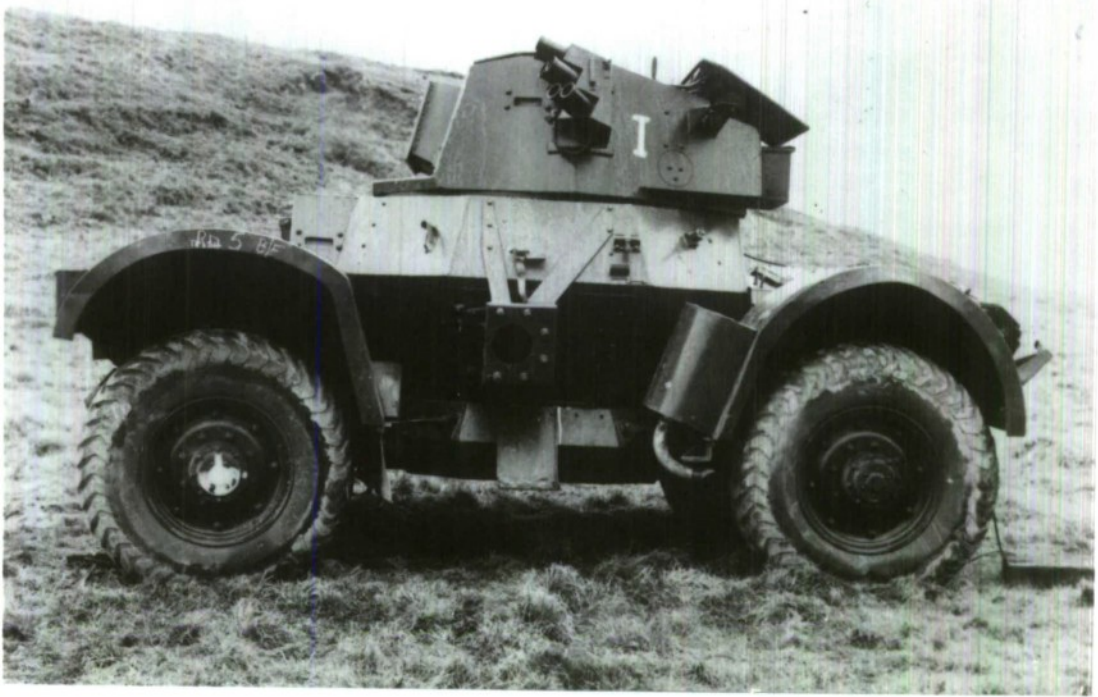
FIG. 5 DIRECT HIT ON WHEEL HUB

- (a) Wheel Hub (Figure 5). The wheel centre was totally destroyed and the tyre severely damaged.

Mobility loss = 95%.

| DAIMLER ARMoured CAR TARGET | | |
|---|--|--|
| 5. | Wheel hub | Wheel centre destroyed and tyre damaged. Mobility loss = 95% |

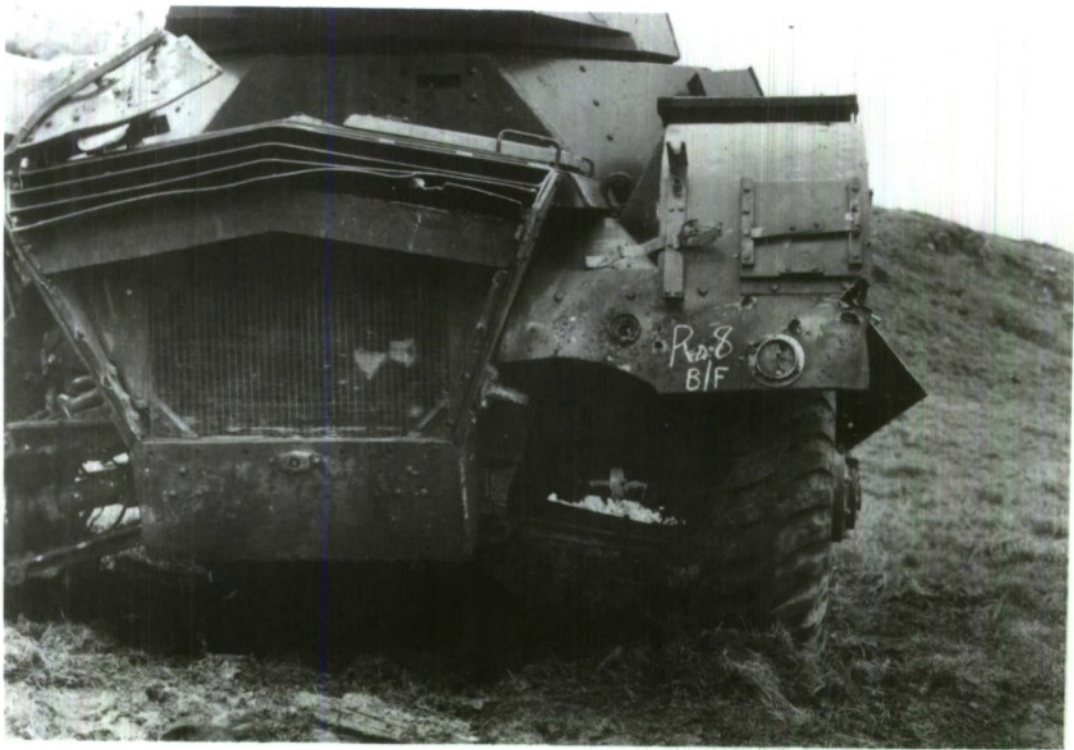
FIG. 7 DIRECT HIT ON SUSPENSION

- (c) Suspension (Figure 7). The wheel was blown off and the suspension wrecked on the side concerned. No crew damage was apparent from blast and fragments but the effects of concussion would have been large.

Mobility loss = 100%.

| DAIMLER ARMoured CAR TARGET | | |
|---|--|--|
| 7. | Suspension | Wheel blowoff and suspension wrecked. Mobility loss = 100% |

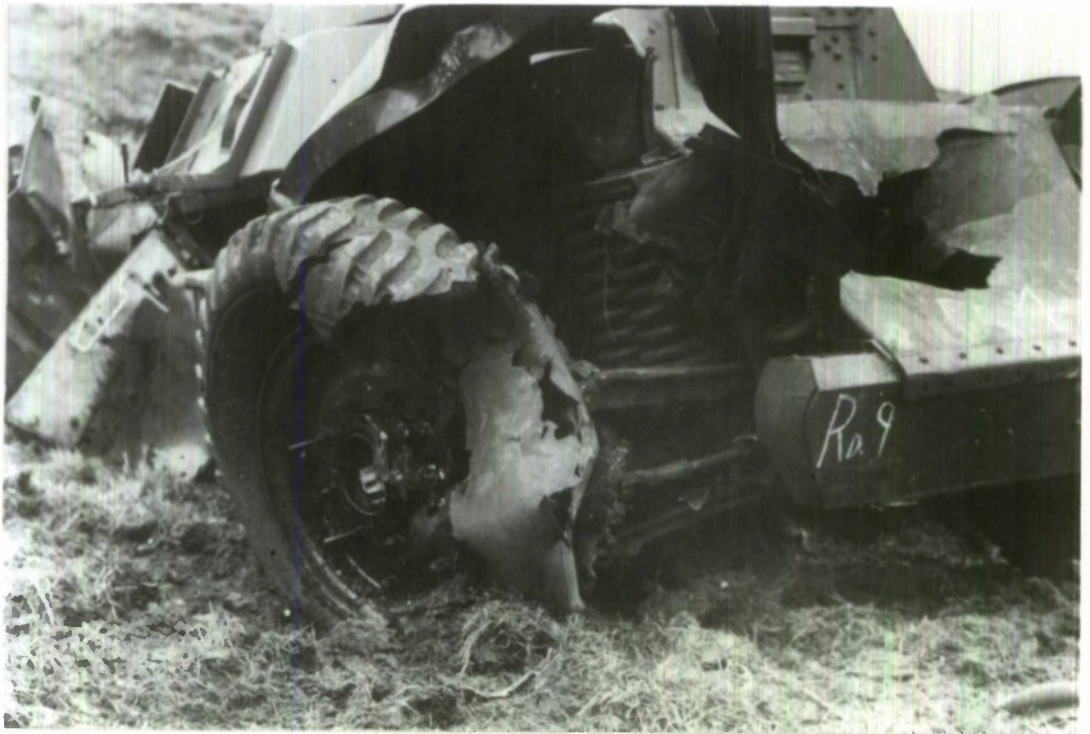
FIG. 8 DIRECT HIT ON WHEEL HUB

- (d) Wheel Hub at 45° to Wheel Plane (Figure 8). The wheel and tyre were severely damaged and removed from the suspension which was also damaged.

Loss of Mobility = 100%.

| DAIMLER ARMoured CAR TARGET | | |
|---|--|--|
| 8. | Wheel hub at 45° to wheel plane. | Wheel and tyre damaged and blown off. Suspension wrecked. Mobility loss = 100% |

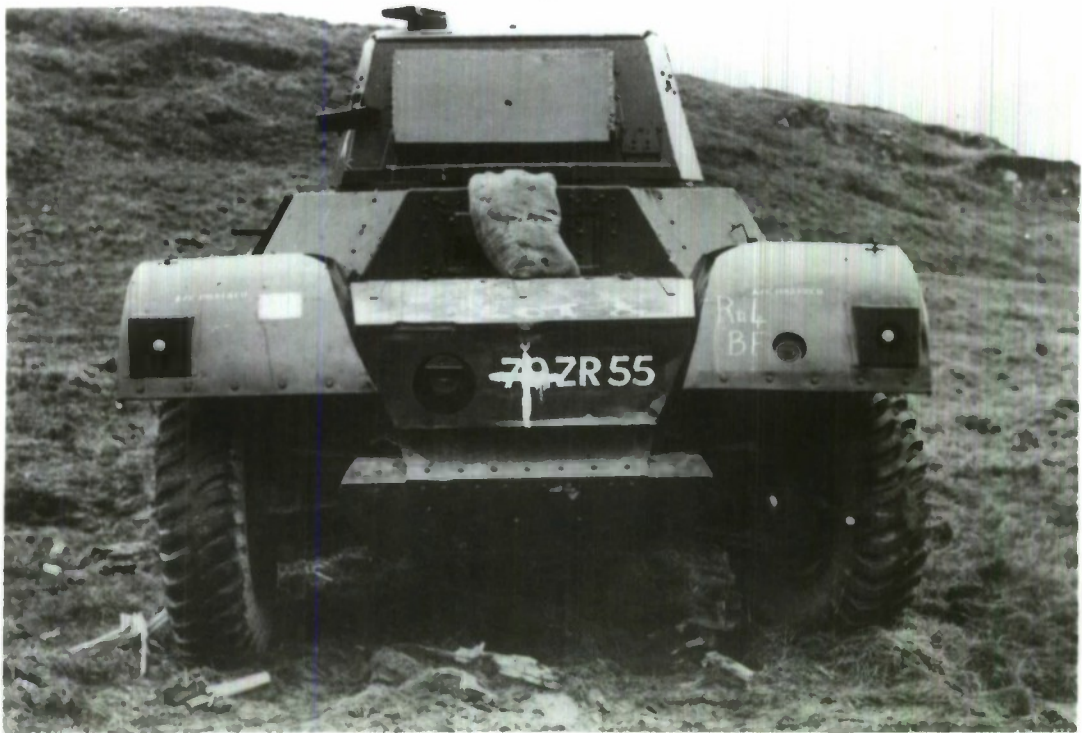
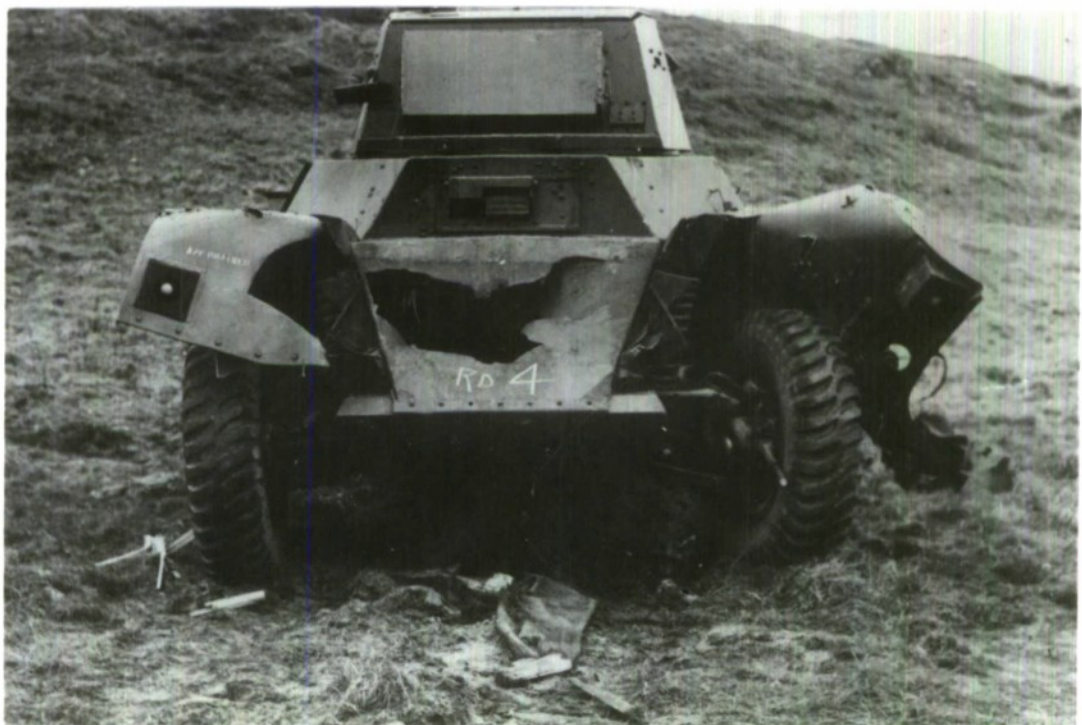
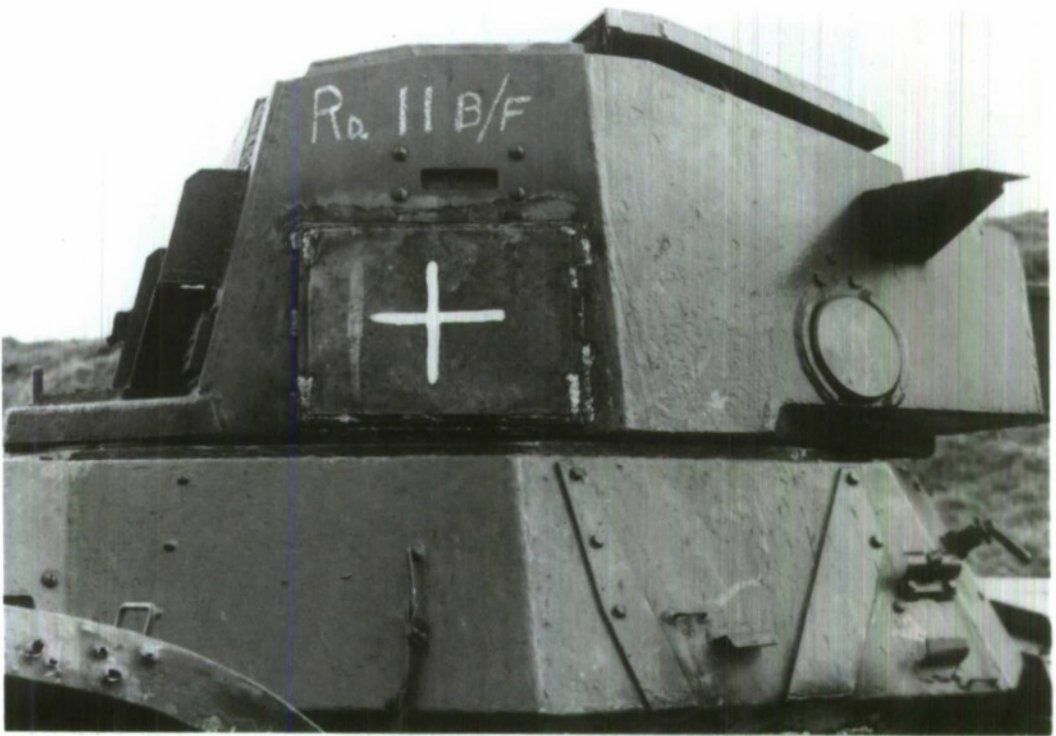
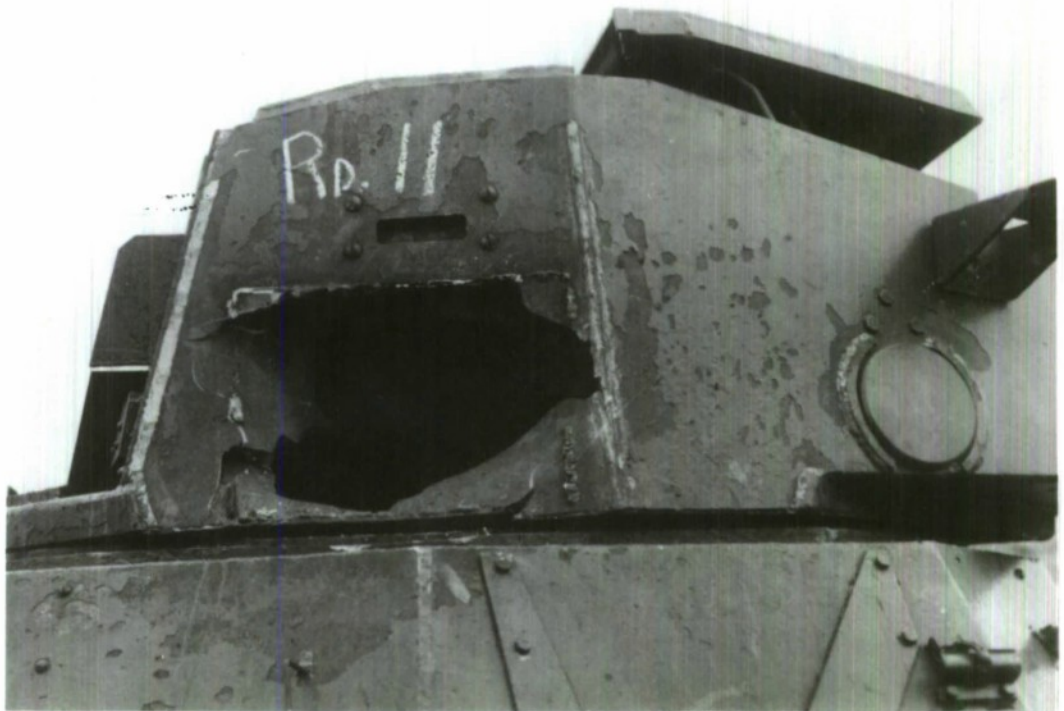
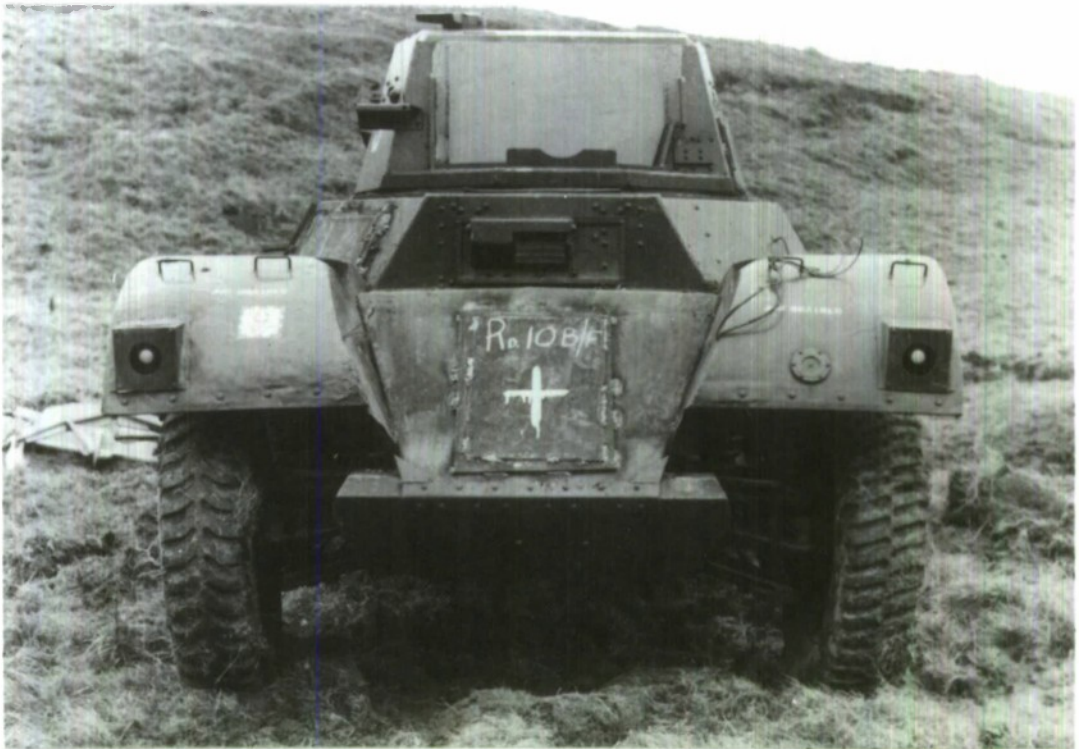
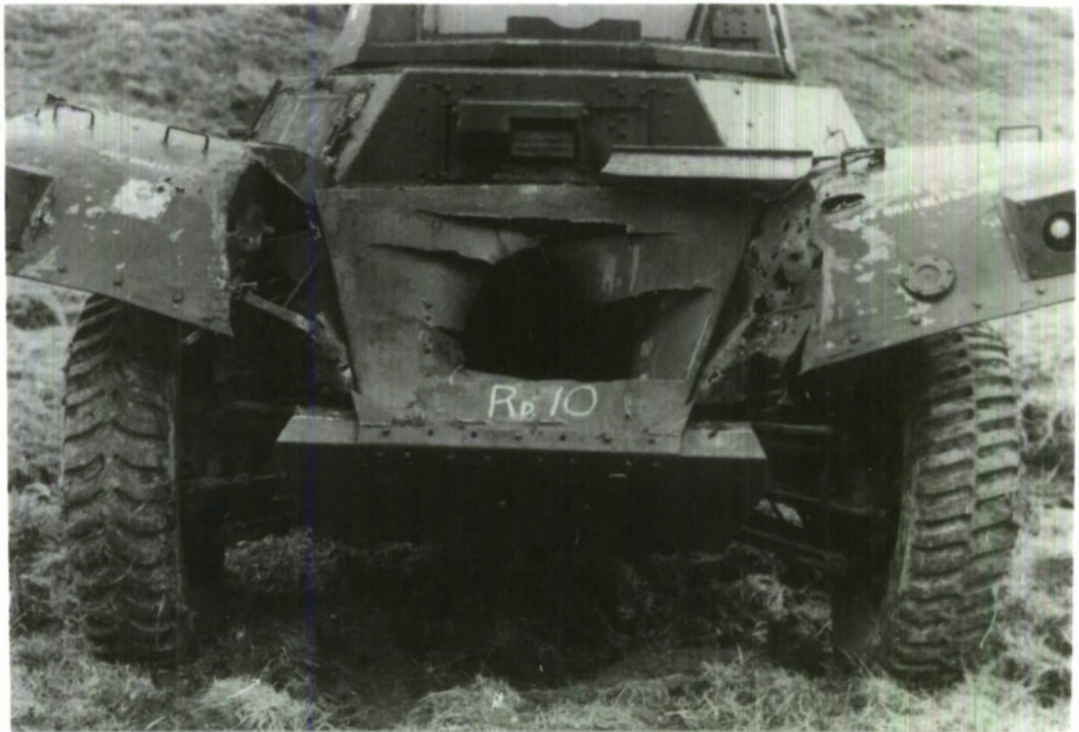
8. Three rounds were fired at the crew compartment with no success from the assessment aspect (Figures 9, 10 and 11). It had been hoped to simulate the APC crew compartment by up-armouring the plates on the car to about 1 inch thick (initially they were only 8 to 16 mm thick), but this could not be achieved. The car bodies were composed of a number of fairly small plates which did not provide sufficient support for the extra armour where the round struck. With each round the up-armouring weld did not hold on impact and the outer plate was driven through the main inner car plate and the round penetrated and detonated inside the car. Little useful information was obtained from these rounds other than confirmation that their effects in a confined space are more than adequate to immobilise the vehicle and incapacitate the crew.

| DAIMLER ARMoured CAR TARGET | | |
|---|--|--|
| 9. | 0° into front plate (7 mm armour). | Round penetrated and burst inside car. |
| 10. | Repeat of 9 up-armoured to 26 mm. | Plate driven back through basic armour. Round detonated inside car. Unsatisfactory. |
| 11. | Turret-side up-armoured to 35 mm armour/65° to normal. | Hole torn, up-armouring weld did not hold. Round burst in car. Unsatisfactory. |

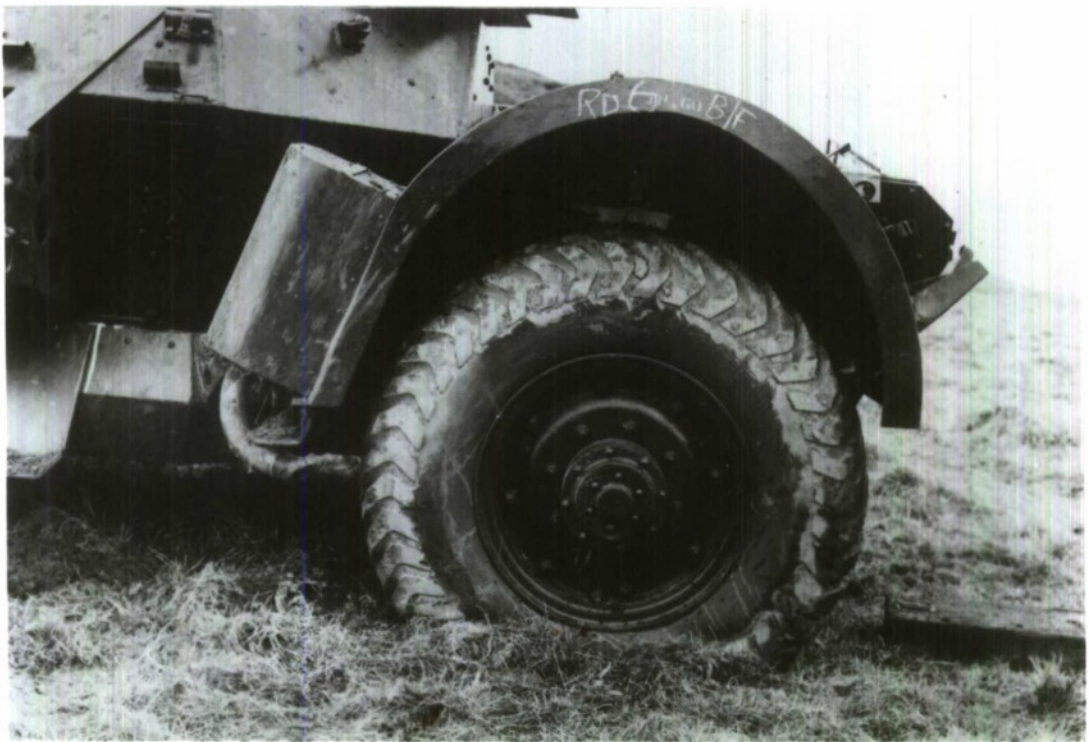
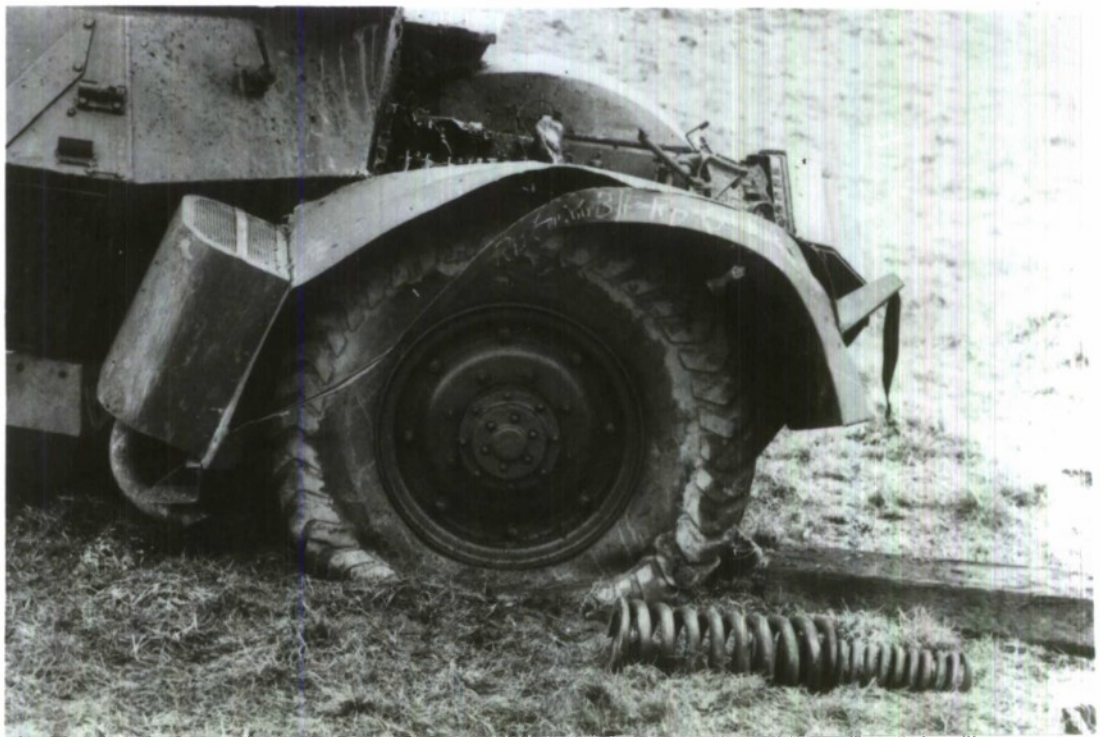
FIG. 12 DIRECT HIT ON SIDE OF ENGINE COMPARTMENT

- (a) Side of Engine Compartment (Figure 12). The round went through the 9 mm plate and detonated inside the compartment. The top cover was blown off and the engine severely damaged resulting in a complete loss of mobility.

| DAIMLER ARMoured CAR TARGET | | |
|---|--|--|
| 12. | Engine compartment side (9 mm armour). | Round penetrated and detonated inside compartment. Engine severely damaged. |

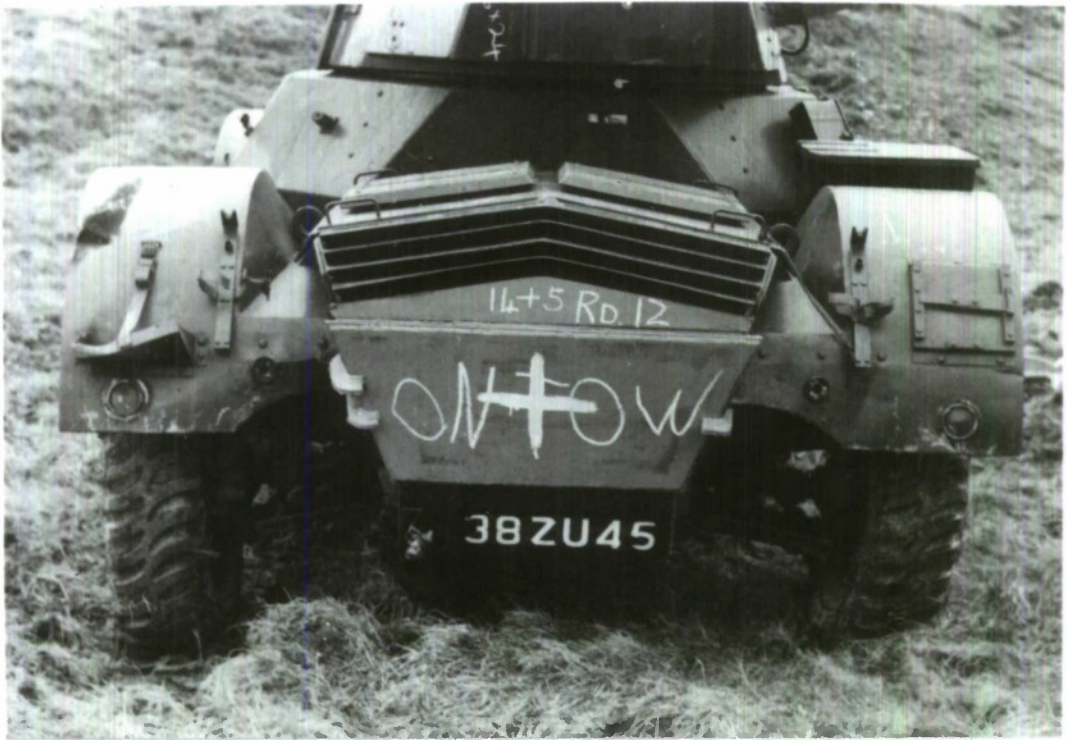
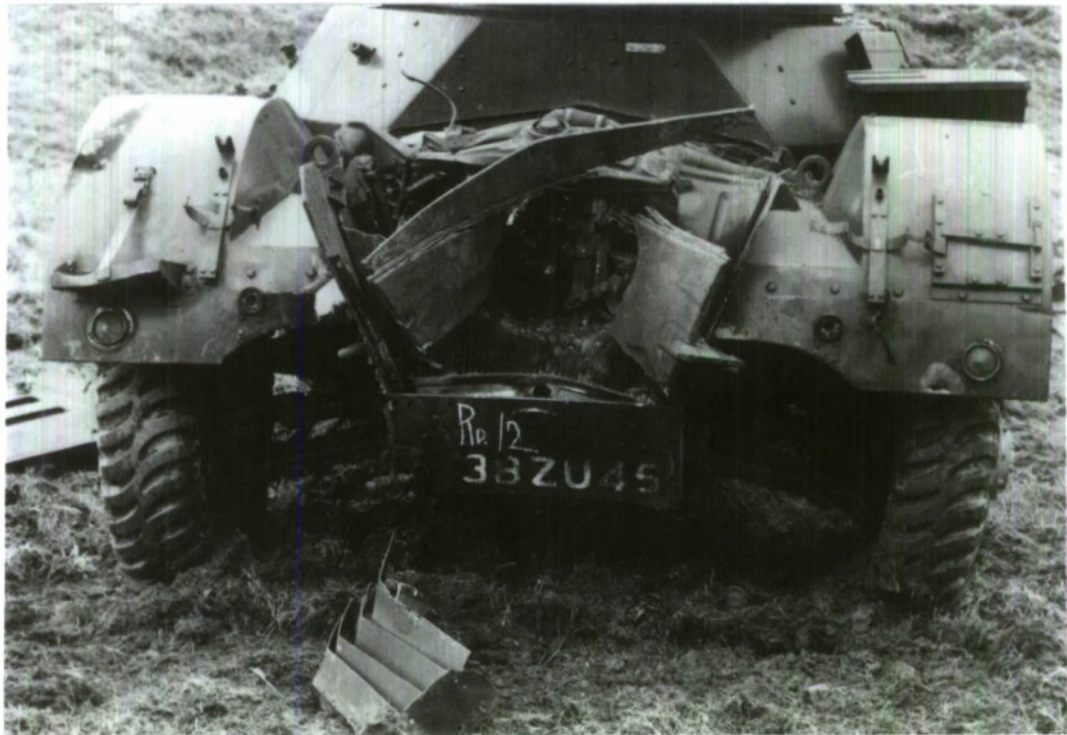
FIG. 13 DIRECT HIT ON REAR OF ENGINE COMPARTMENT

- (b) Rear of Compartment (Figure 13). This round was fired into up-armoured plate in the same way as the unsuccessful firings into the crew compartment, but against strengthened and rigidly clamped up-armouring. However, the results were as before. The welds and clamps broke, the top plate fractured, and the round detonated in the engine compartment with catastrophic results.

| DAIMLER ARMoured CAR TARGET | | |
|---|--|--|
| 13. | Engine compartment rear (29 mm armour). | Up-armouring welds broke and round again detonated in engine compartment. Mobility loss = 100% |

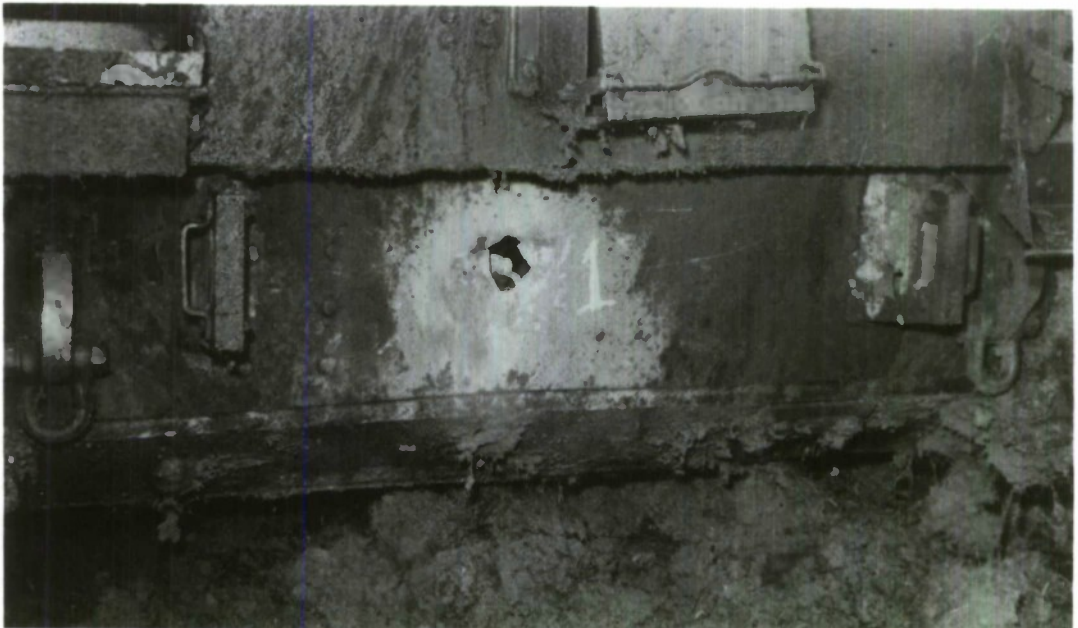
FIG. 14 DIRECT HIT ON REAR HULL PLATE

- (a) Hull Rear Lower Plate. 32mm/18° (Figure 14). The rear plate was holed and scabbed, the gearbox perforated by fragments and the hydraulic pipes to the brakes cut.

Mobility loss = 100%.

| "C O M E T" T A N K T A R G E T | | | | | |
|---|---|--|---|---|---|
| 1. | Hull rear lower plate (32 mm/18°). | Plate holed and scabbed. Gear-box holed. Hydraulics damaged. | 100 | - | - |

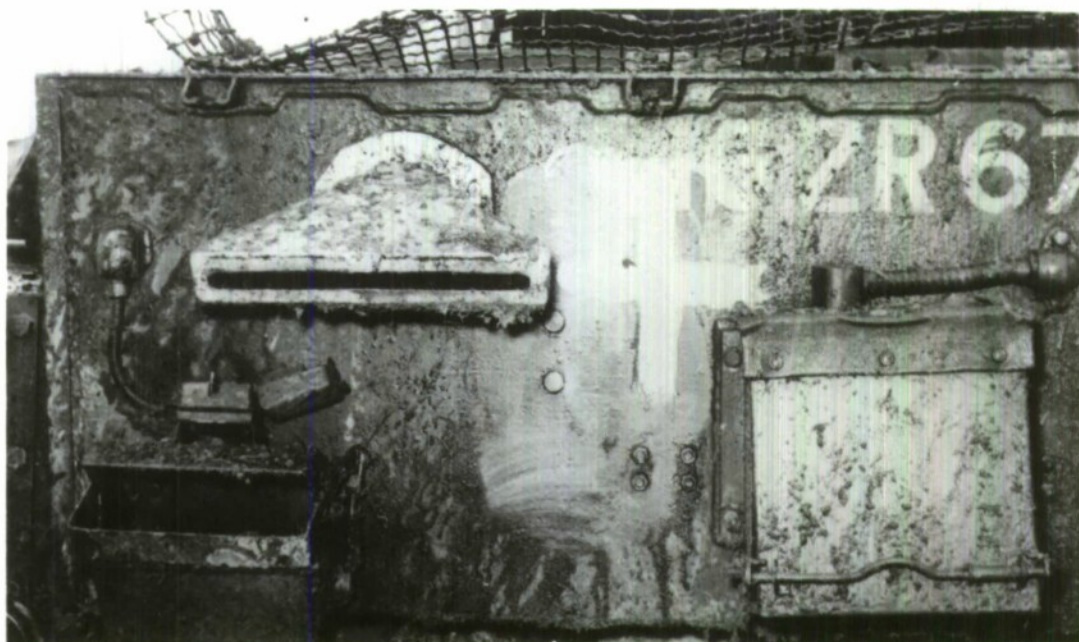
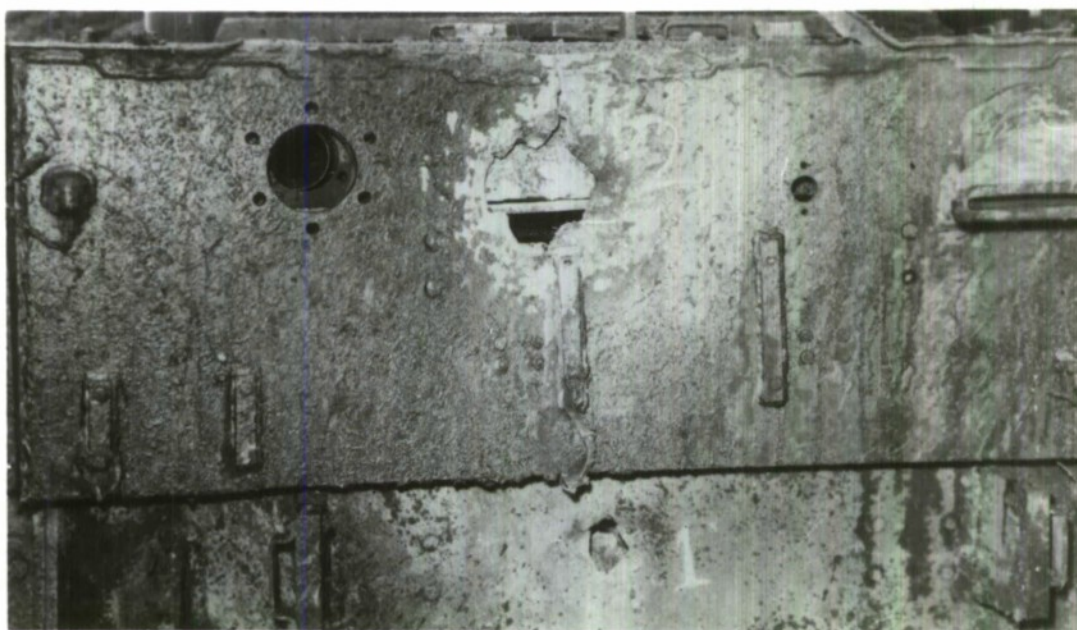
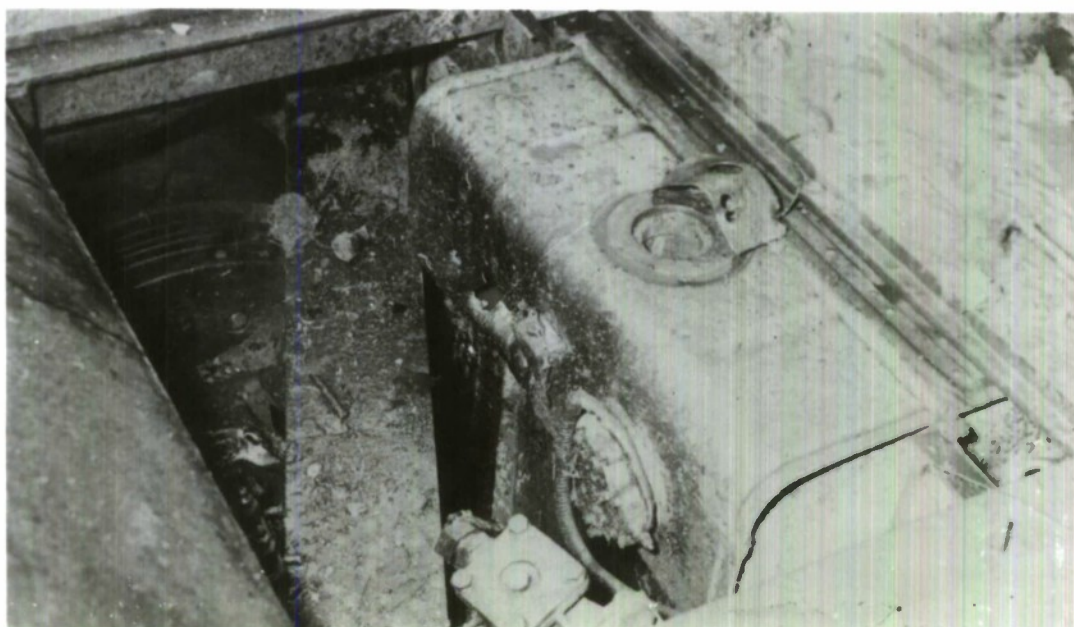
FIG. 15 DIRECT HIT ON REAR UPPER PLATE

- (b) Hull Rear Upper Plate. 25 mm/0° (Figure 15). The rear plate was holed and the resulting scab broken into fragments by a strut immediately behind the plate. The gearbox was destroyed and the coolant pipe and header tank holed. The loss in Mobility was 100% and there would have been a 10% reduction in Fire-power capability.

| "C O M E T" T A N K T A R G E T | | | | | |
|---|---|--|---|---|---|
| 2. | Hull rear upper plate (25 mm/0°). | Plate holed, gearbox smashed, coolant pipe and header tank holed. | 100 | 10 | - |

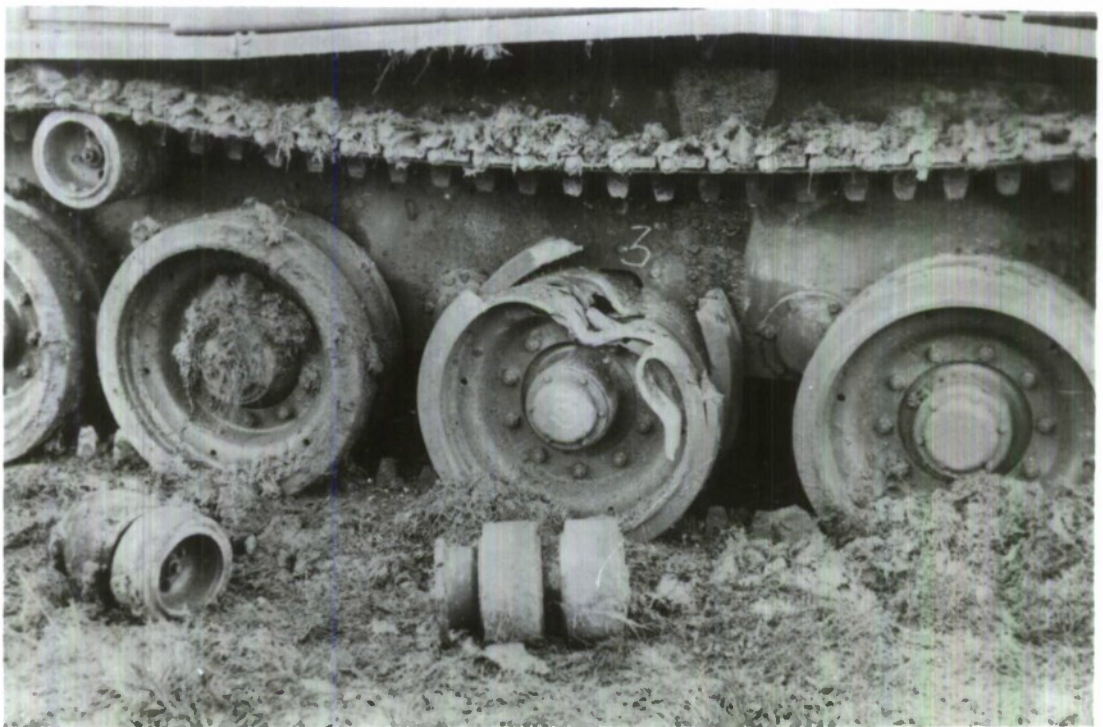
FIG. 16 DIRECT HIT ON CENTRE ROAD WHEEL RIM

- (a) Centre Road Wheel Rim (Figure 16). The wheel rim was severely damaged and two of the roller guides were removed. The tank was still capable of reduced movement.

Loss of Mobility = 10%.

| "C O M E T" T A N K T A R G E T | | | | | |
|---|---|--|---|---|---|
| 3. | Centre road wheel rim | Wheel severely damaged, two roller guides removed. | 10 | - | - |
