R.A.R.D.E. MEMORANDUM (B) 66/63

Trials to assess the lethality of a 76 mm HESH shell
against armoured personnel carriers

R. Beresford

December
1963

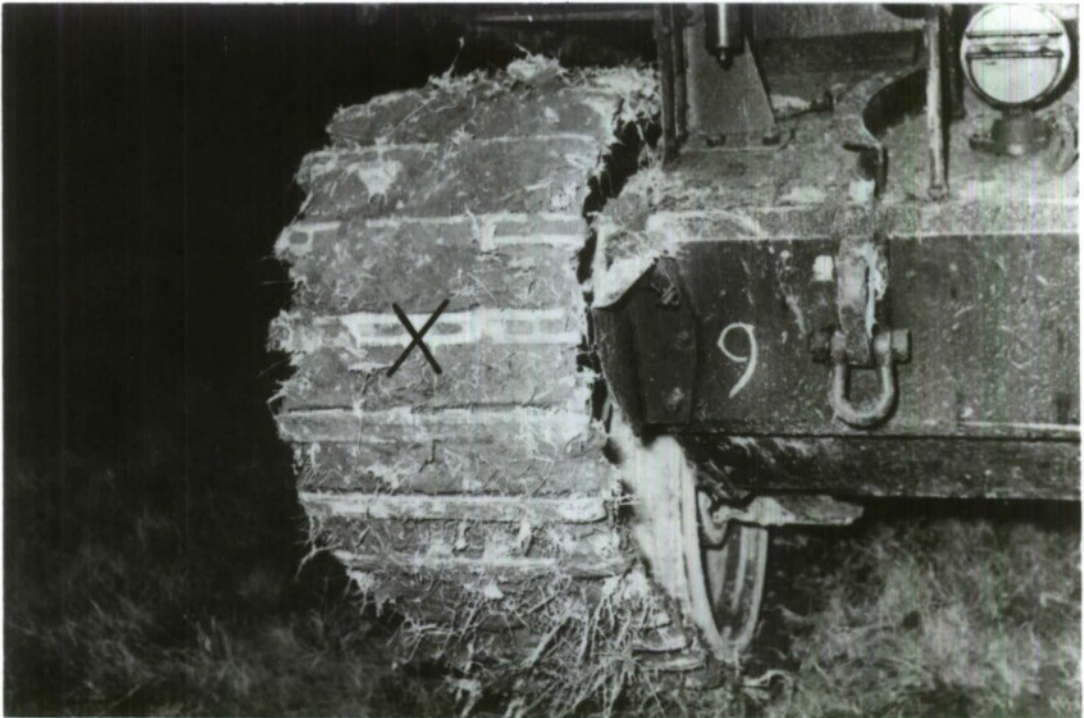
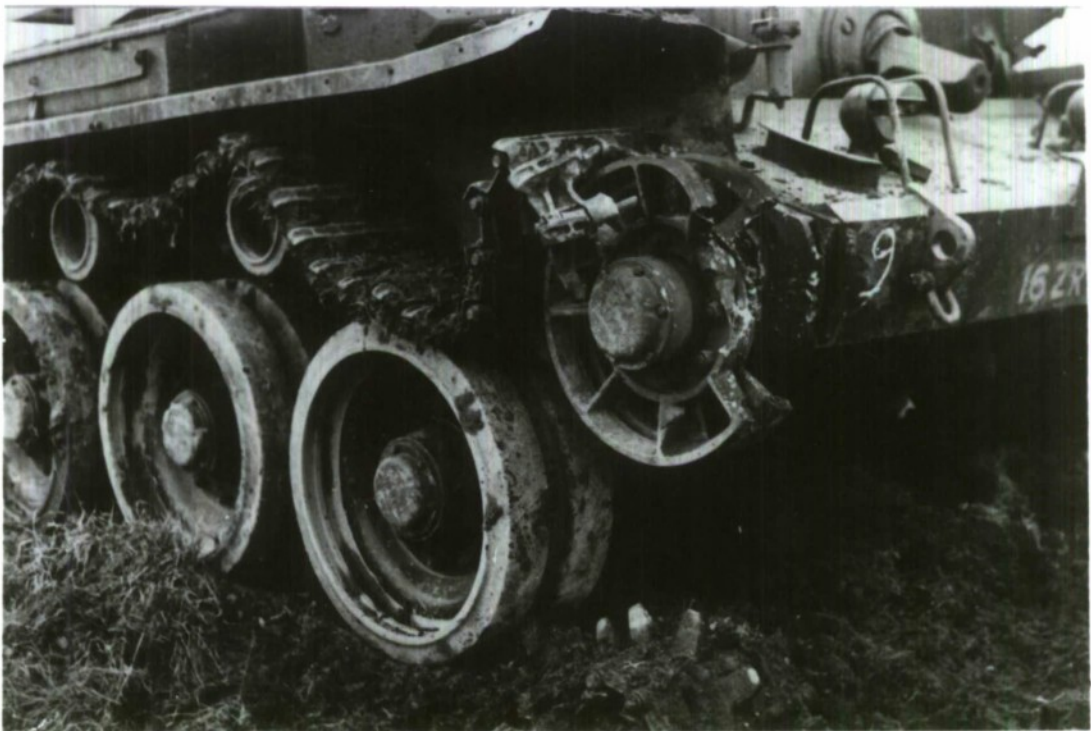
FIG. 22 DIRECT HIT ON TRACK OVER IDLER

- (g) Track over Idler Wheel (Figure 22). The round struck the track at 90° to its plane and completely severed it, severely damaging the idler wheel.

Loss of Mobility = 100%.

| "C O M E T" T A N K T A R G E T | | | | | |
|---|---|--|---|---|---|
| 9. | Track over idler | Track severed. Idler severely damaged. | 100 | - | - |

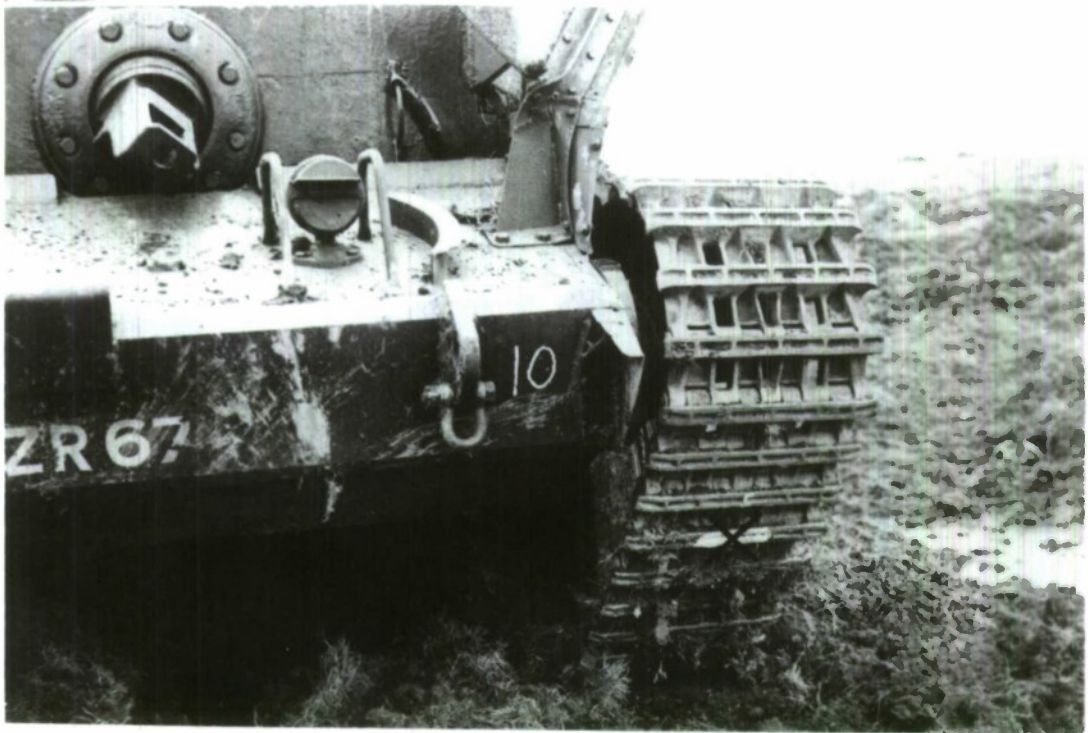
FIG. 23 DIRECT HIT ON LOWER TRACK

- (h) Track between Idler and Road Wheel (Figure 23). The round hit the track at 45° to its plane and completely cut it, removing the idler at the same time.

Loss of Mobility = 100%.

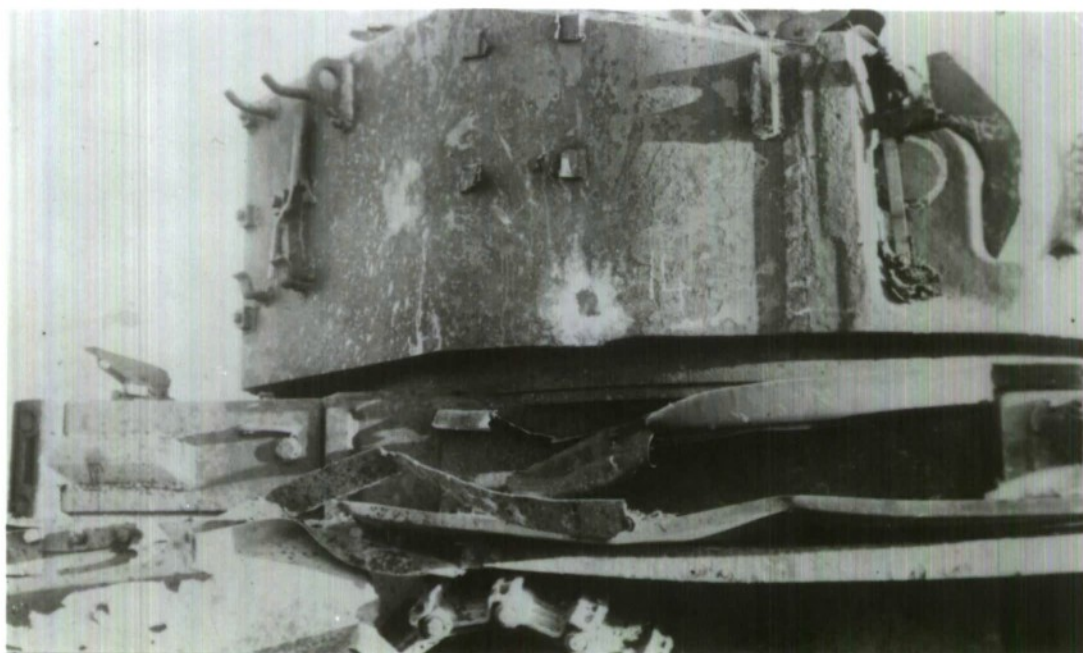
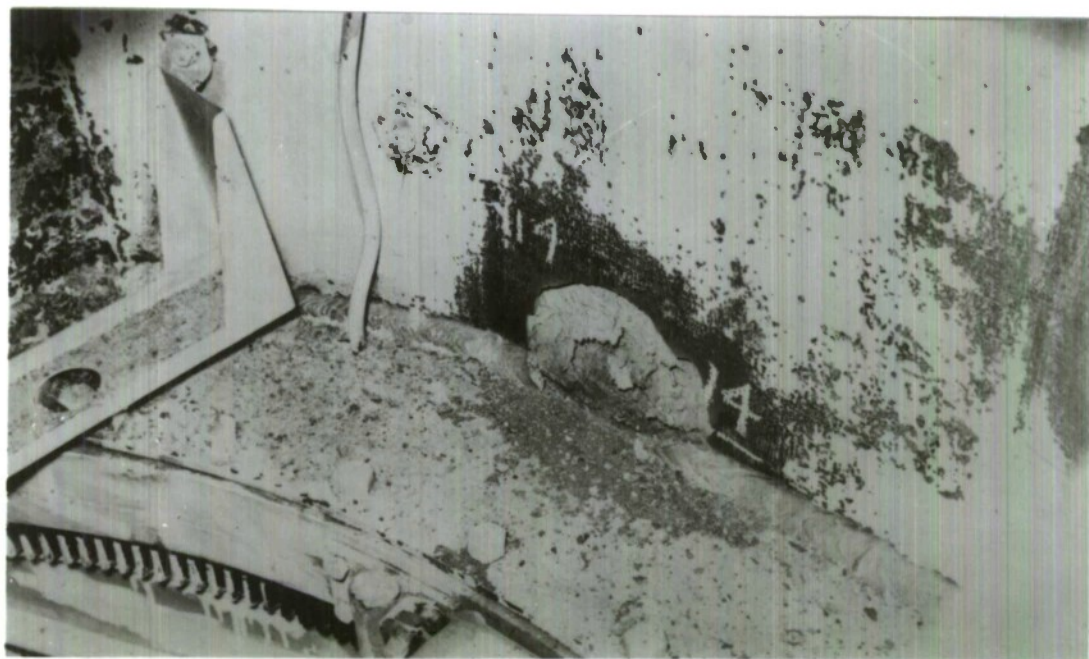
FIG. 25 DIRECT HIT ON PLATE OVER TURRET RING

14. In discussions on anti-tank projectile lethality, there have been differences of opinion regarding the effect of a nearby hit on the turret traversing mechanism of a tank. Since at the end of the present trial there was spare ammunition and a suitable target available, it was decided to investigate this question and several others on which information was lacking. Accordingly a round was fired at the plate skirting the turret ring of the Comet tank (Figure 25). On examination of the turret interior, it was found that the plate had scabbed and that damage to the dummies placed in the turret to simulate crew members showed that the turret crew would have been incapacitated. Damage to the gun and associated equipment from blast and the scab had made it unserviceable. The resulting loss in Mobility was 65% and in fire power 100%. Regarding the mechanical condition of the tank, it is worth recording that the hand-traversing mechanism of the turret was still in working order although a little stiffer than before the attack.
