TECHNICAL INSPECTION REPORT

U.S.S. PENSACOLA (CA24)

TEST BAKER

OPERATION CROSSROADS

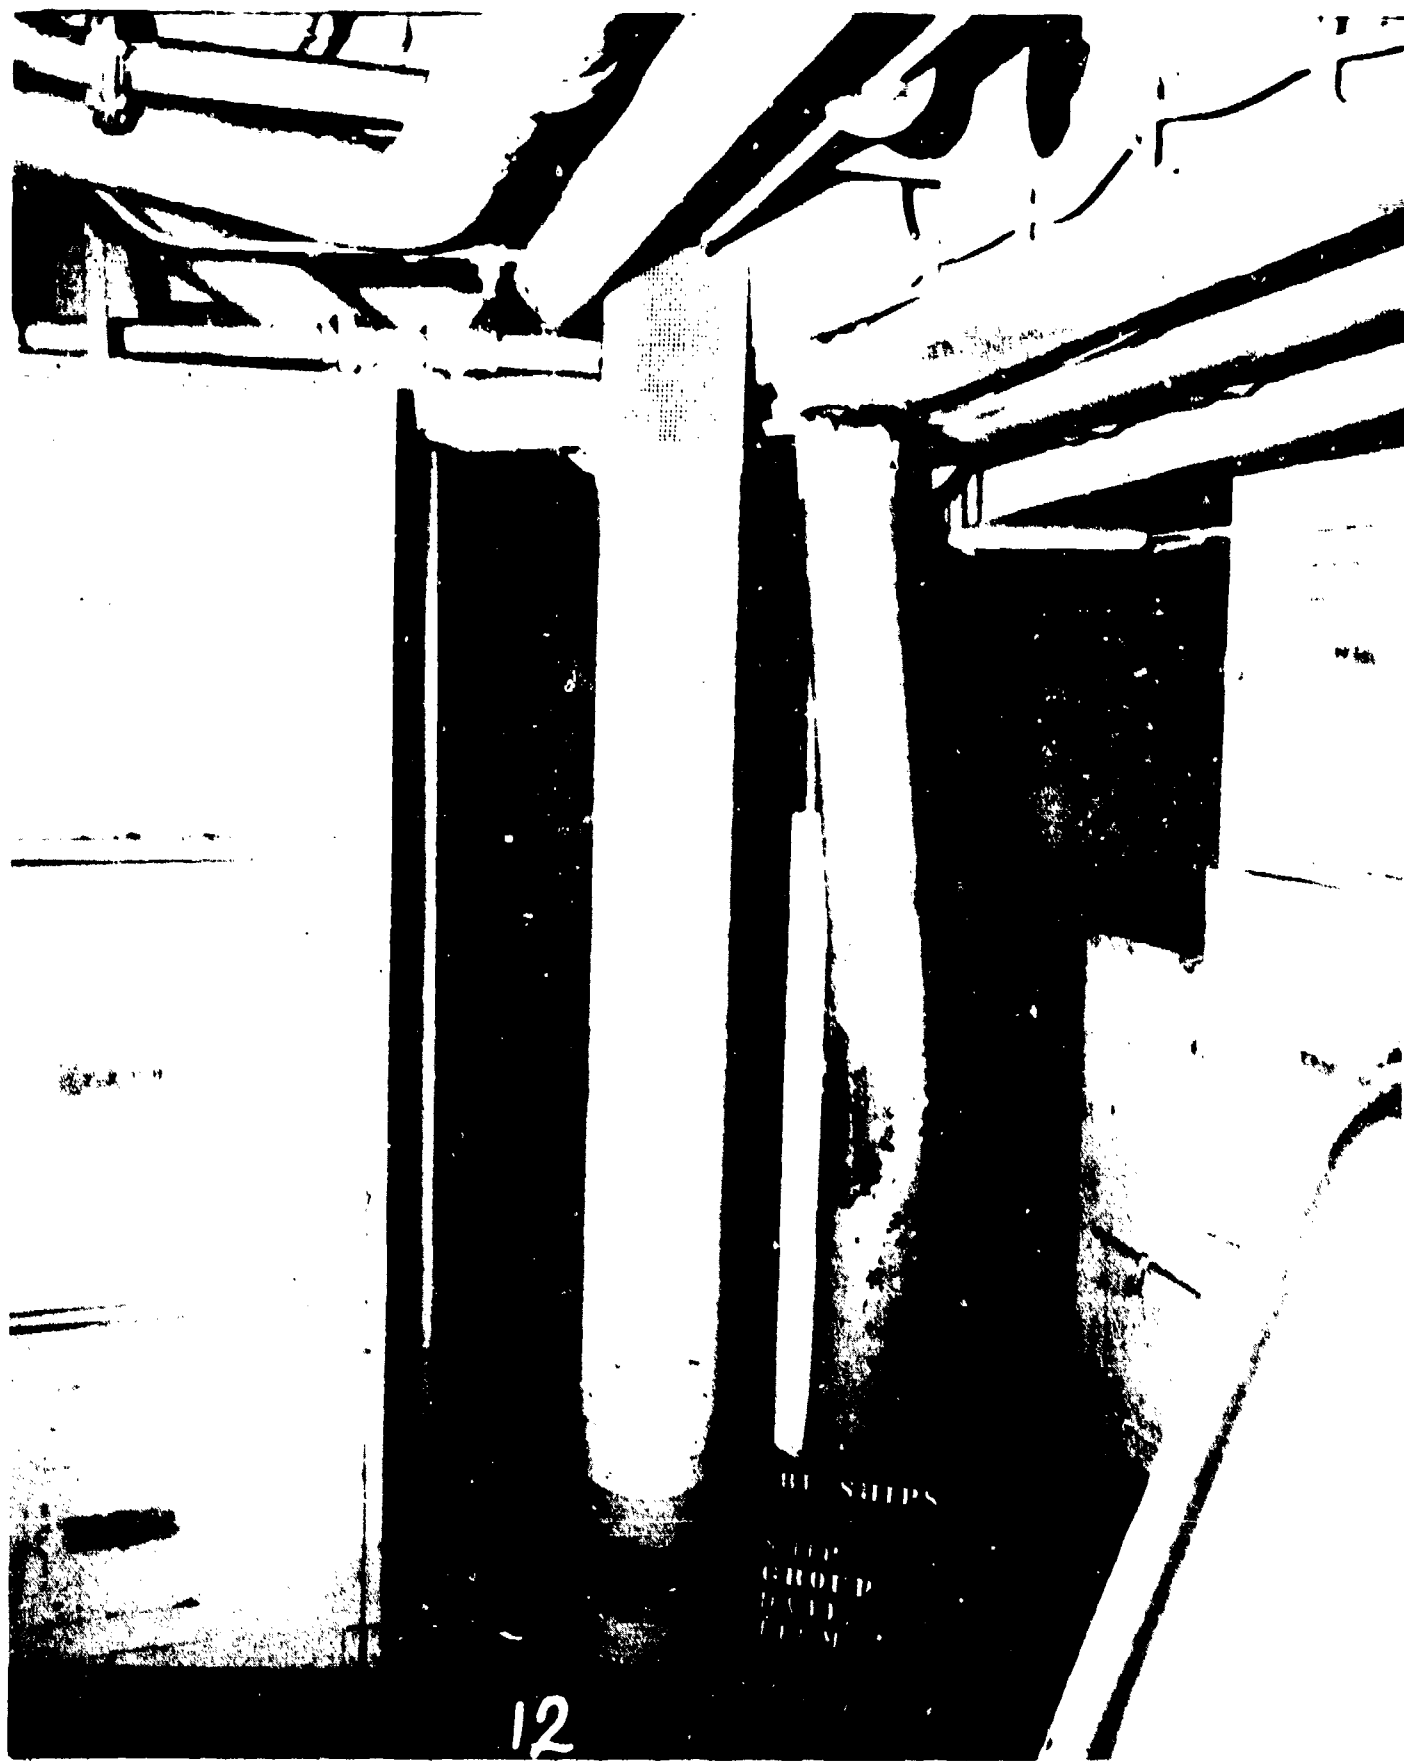
AA-CR-90-574-12. C-202-L. Second deck frame 97, port side. Note deformation of stanchions and crack around top under beam.

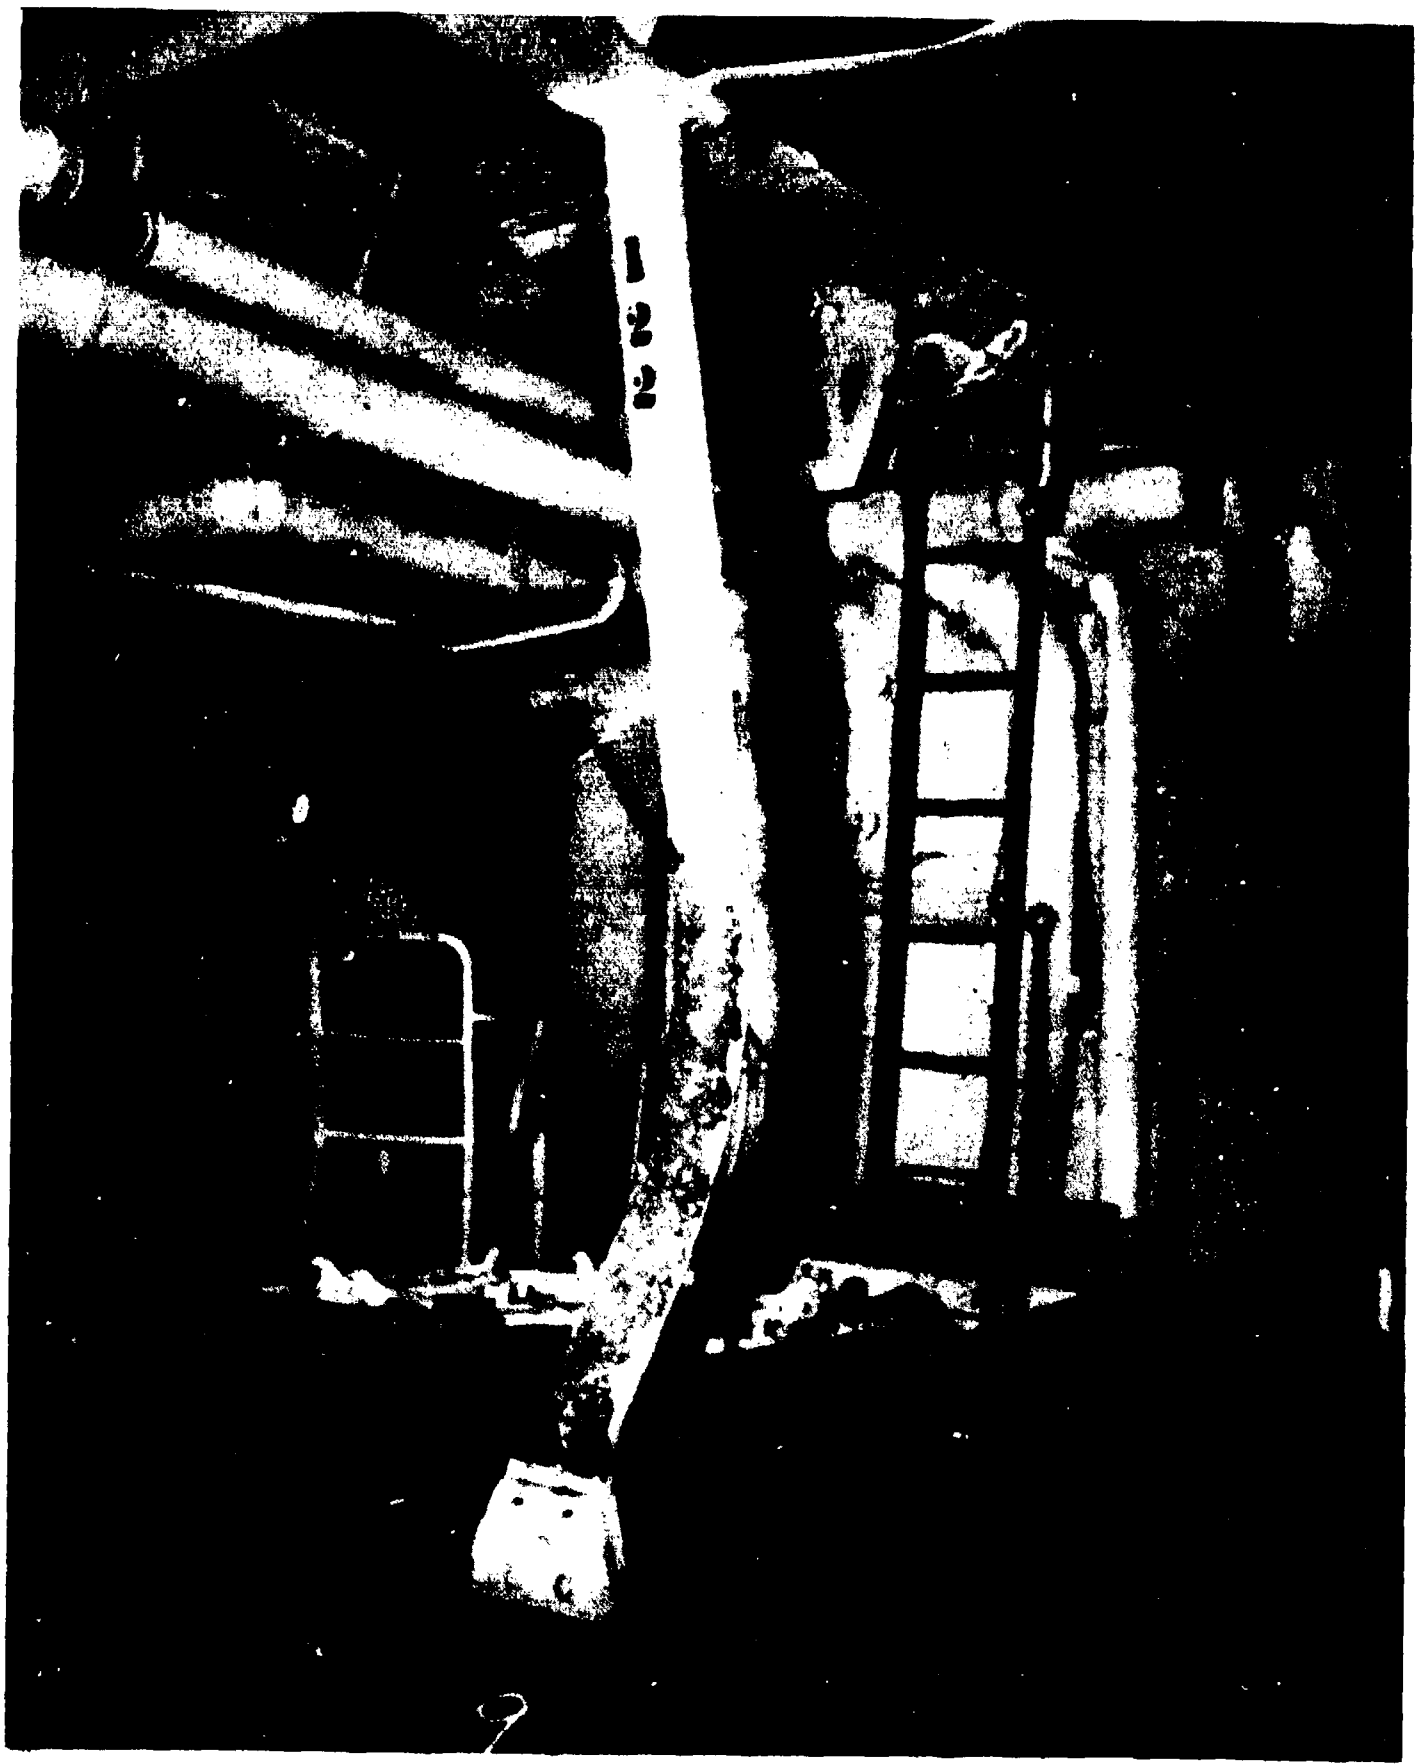
AA-CR-175-2178-9. D-203-L. Test able damage. Looking aft and to port at quarter span stanchion, frame 122, starboard. Compare with 2082-2.

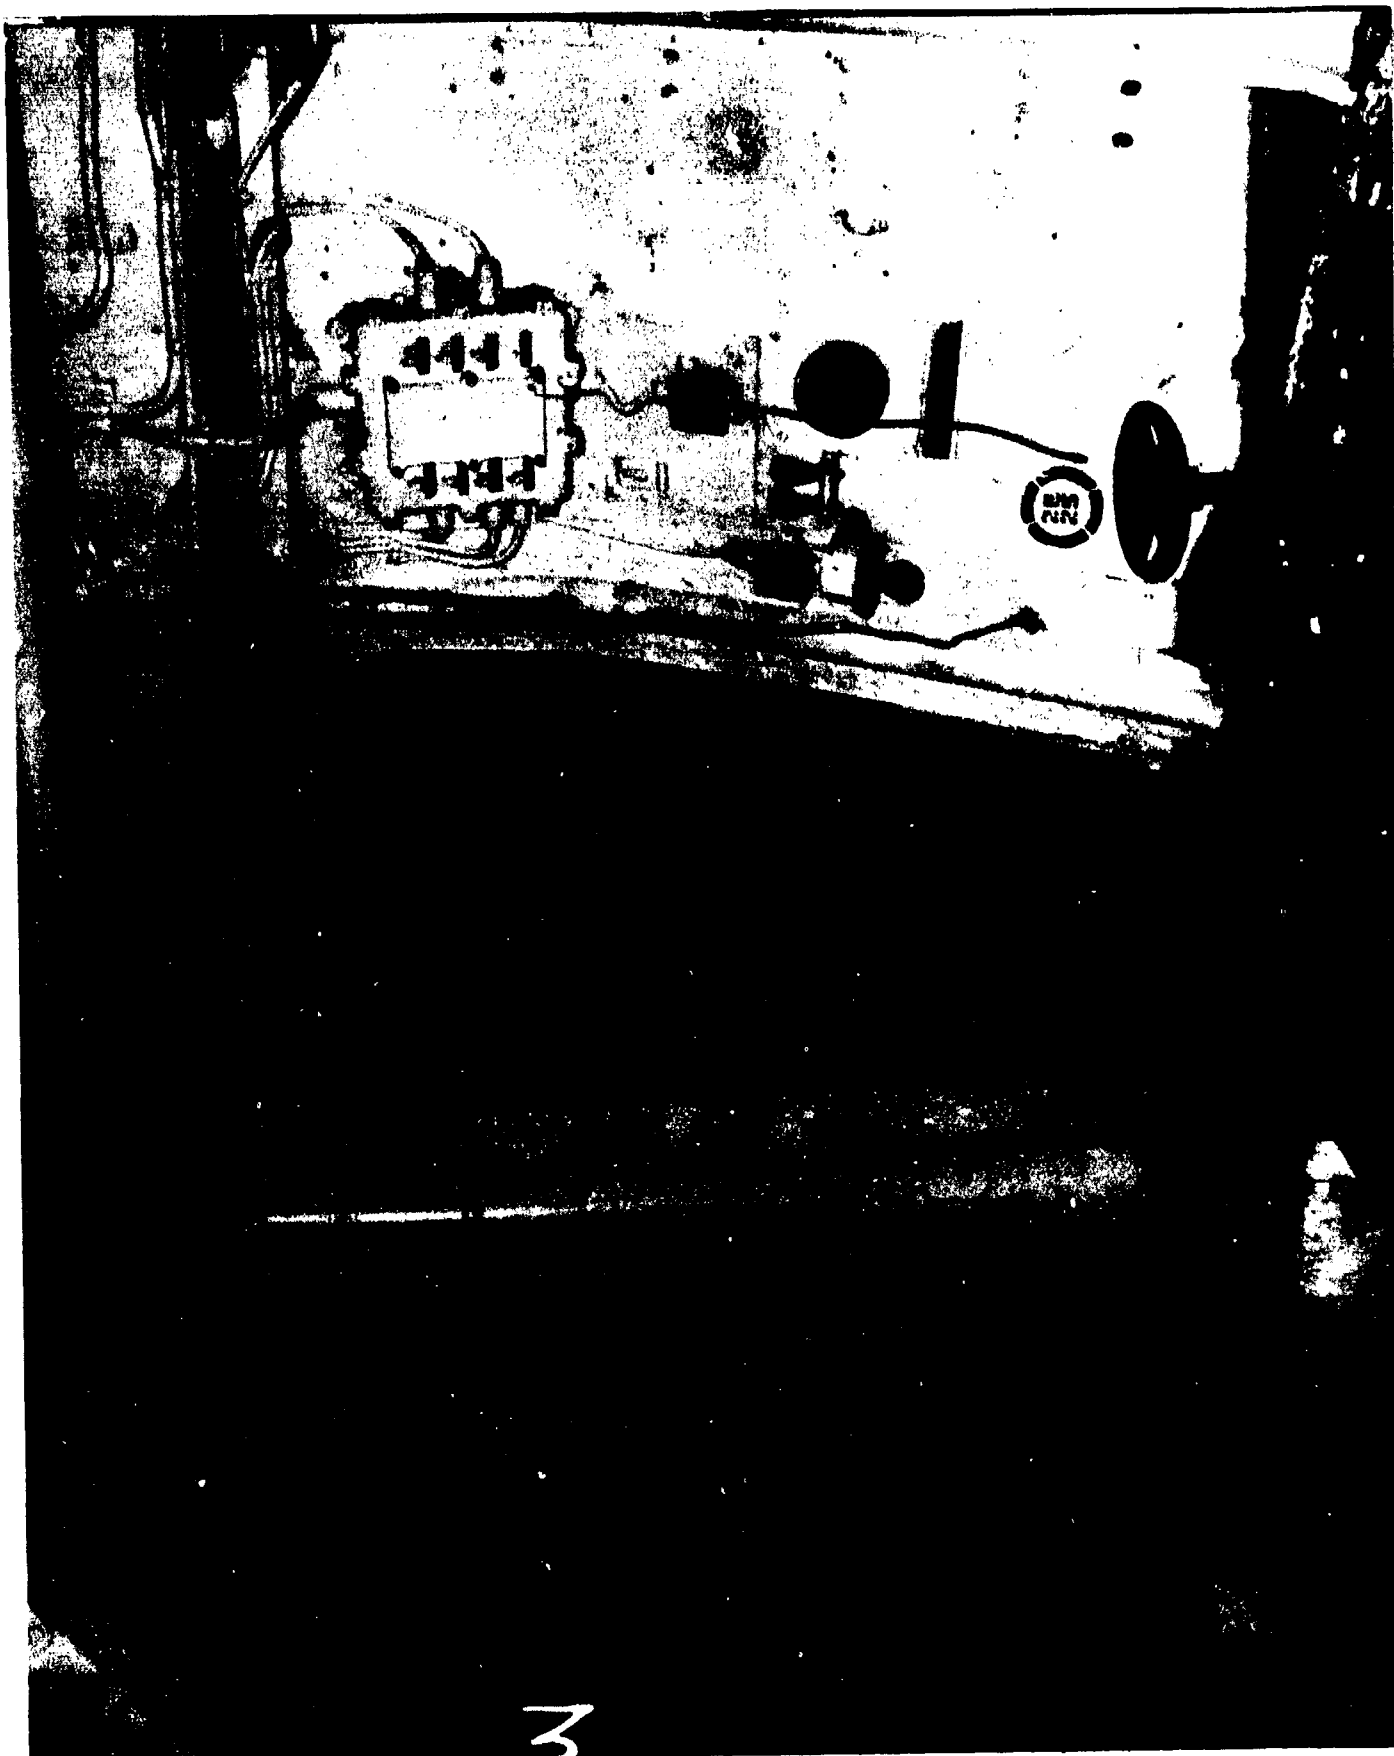
AB-CR-76-2082-3. D-203-L. Looking aft at damage to bulkhead 128, starboard. Compare with test able damage shown in 1755-3.
