Technical Inspection Report
Bureau of Ordnance Group

6
OPERATION CROSSROADS.
TESTS 'A' AND 'B'.
VOLUME IV.
PART X. PHOTOGRAPHIC
APPENDIX [U] 8

GUNS AND MOUNTS PHOTOGRAPHIC INDEX

TEST "A" & "B"

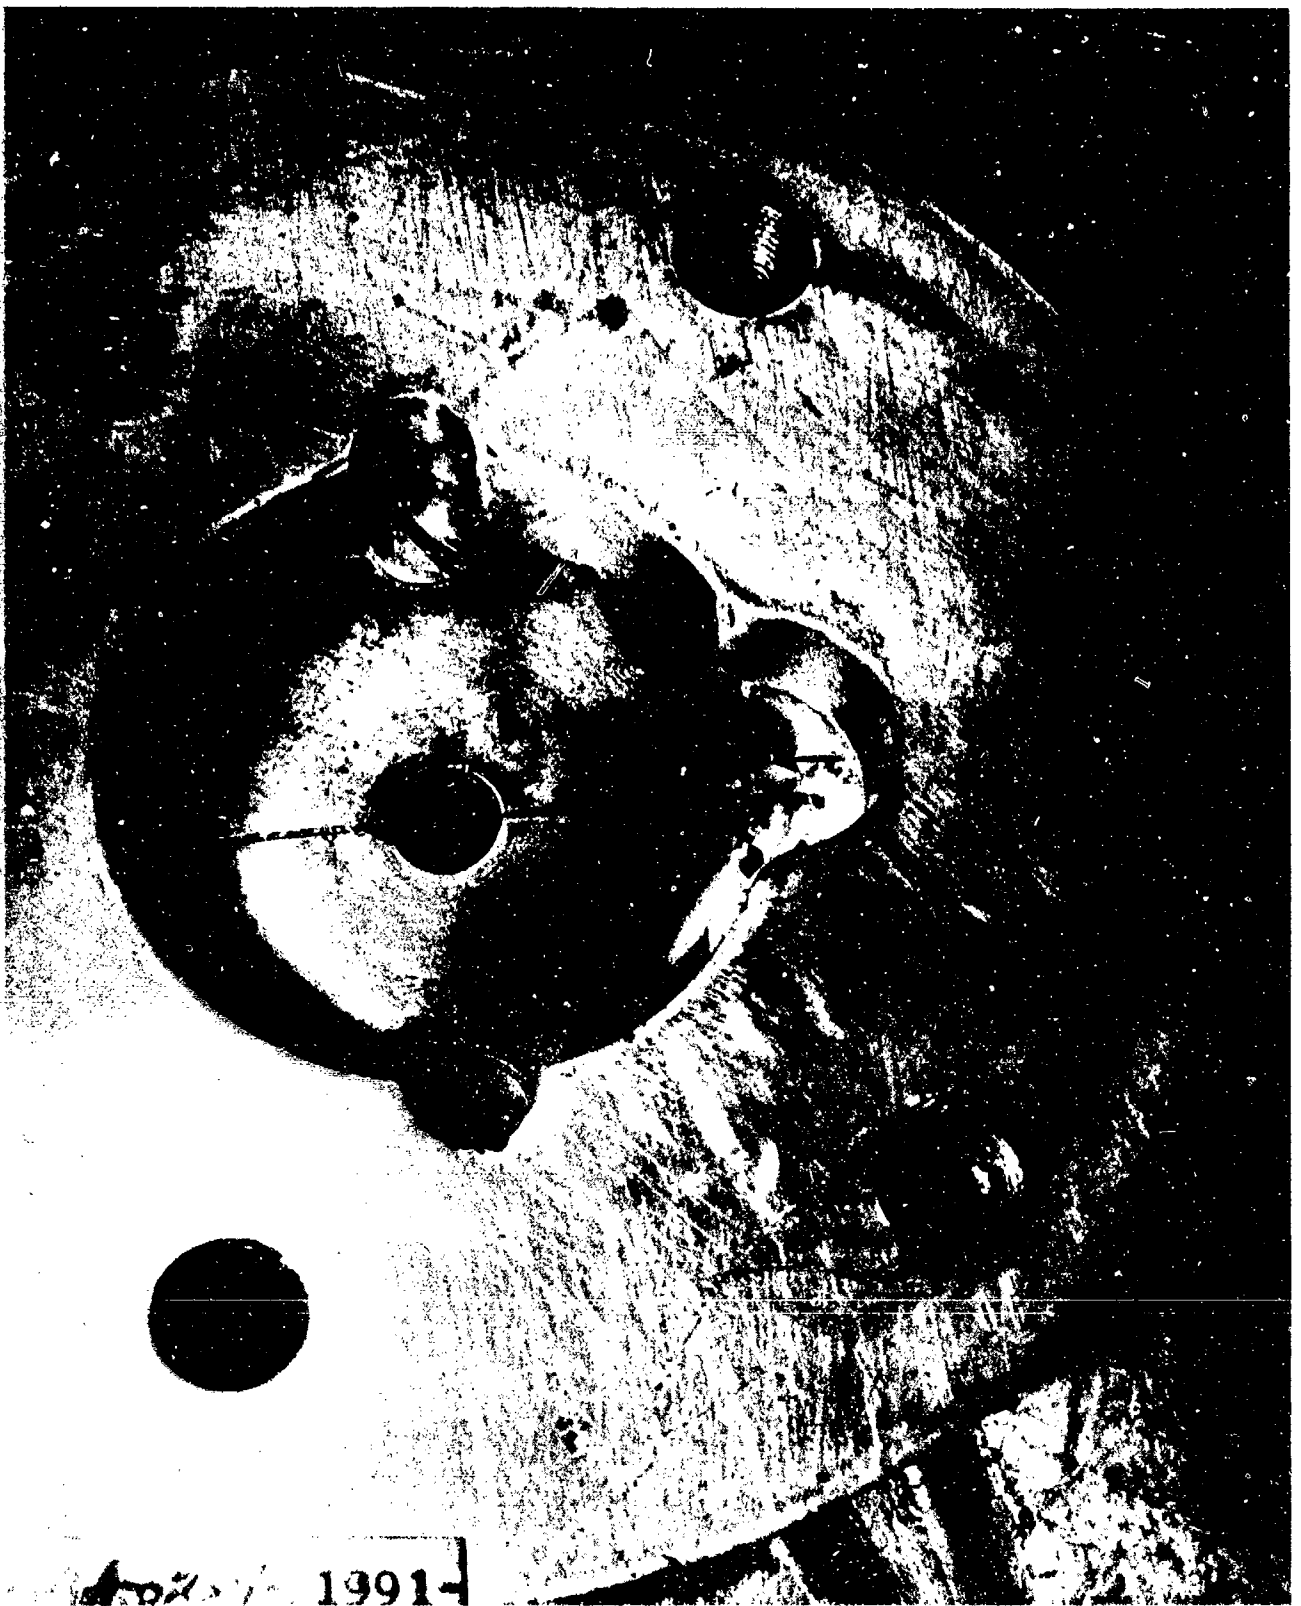
FIG. 1

FIG. 1. AMALGAM (19-23) - aft side
Close up view of 1 1/2" / 50 Cal. ammunition
Block Lt. Mt. Gun Turret No. 4 showing the
distortion of the knife edge.
Photo. No. 40-10-34-1001-4.

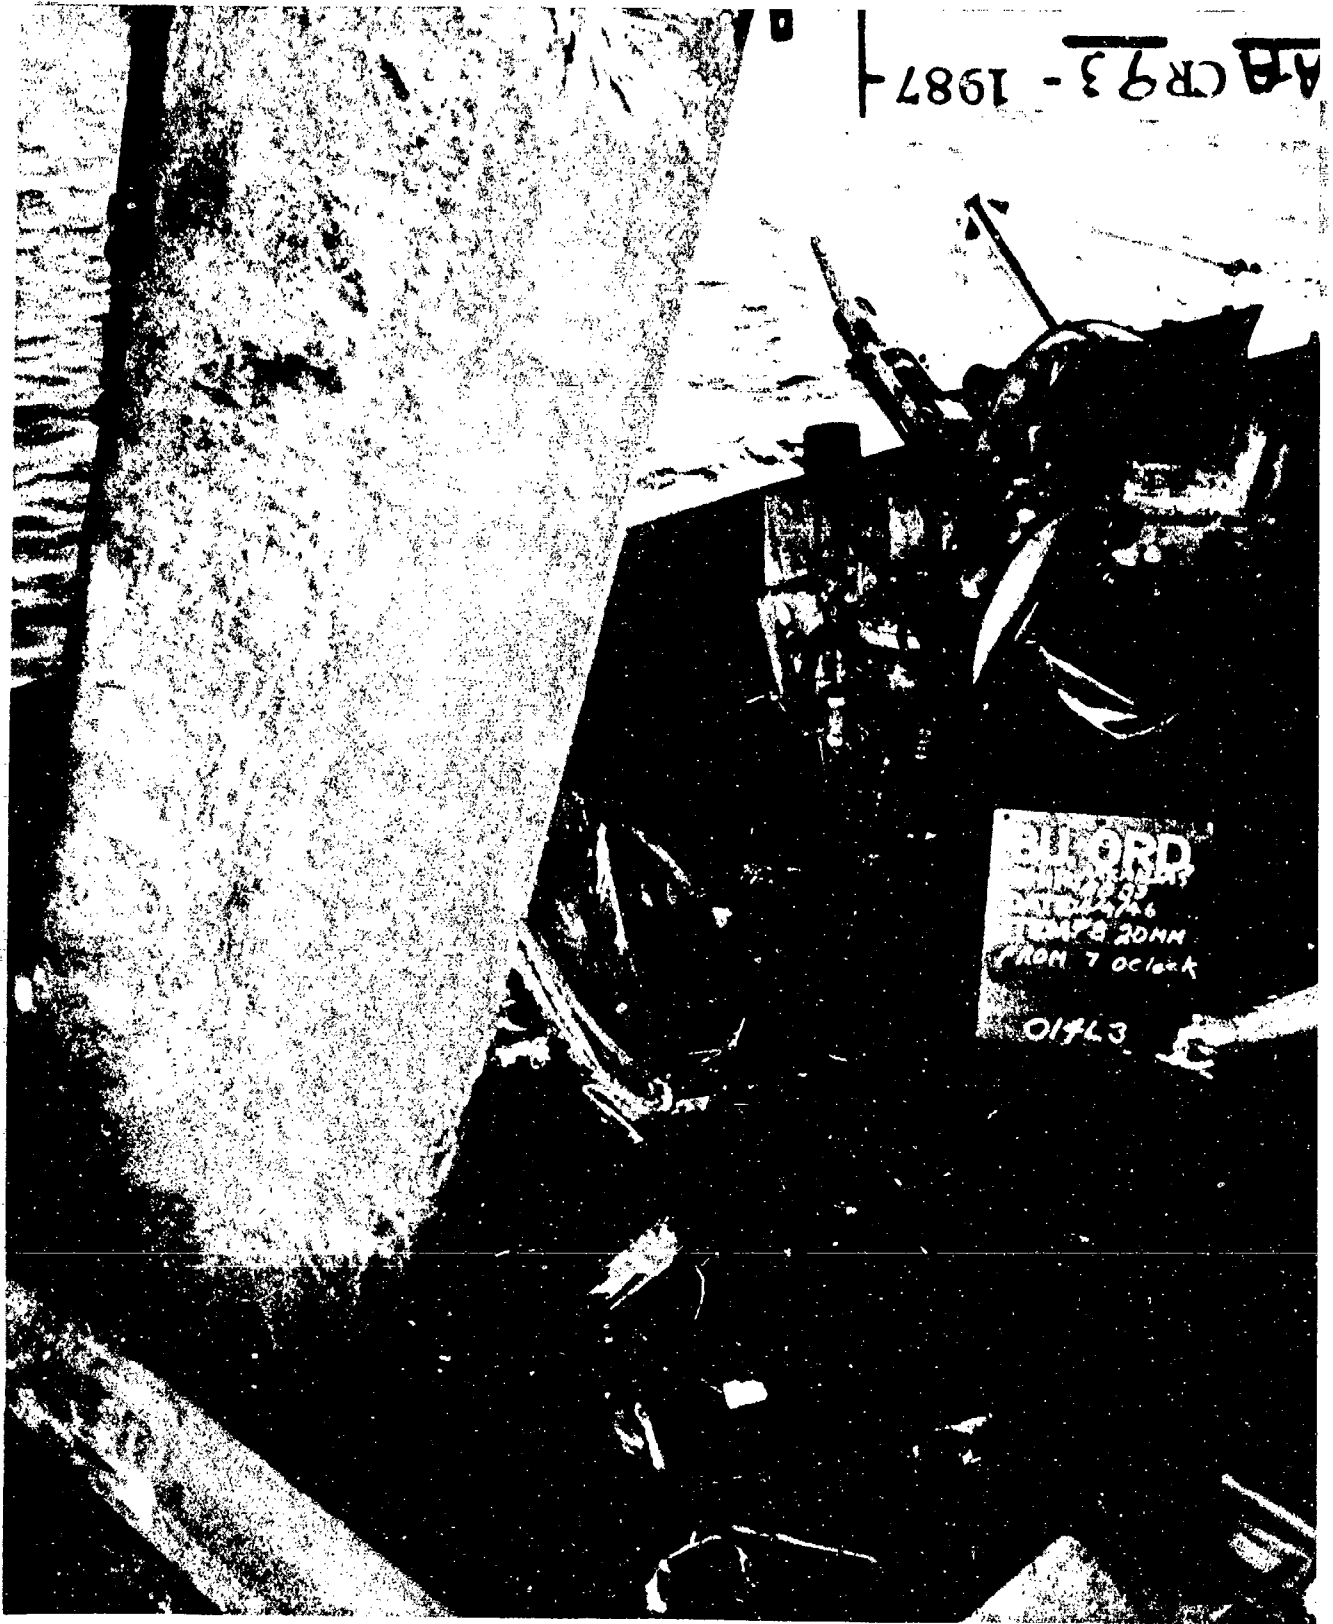
AG-CR-93-1987-19

U.S.S. ASBARGE (ss-33) - After Action
Close up of 20 mm A.A. No. 8 showing
vent barrel and gun mechanism.
Photo. No. AA-CR-93-1987-12.

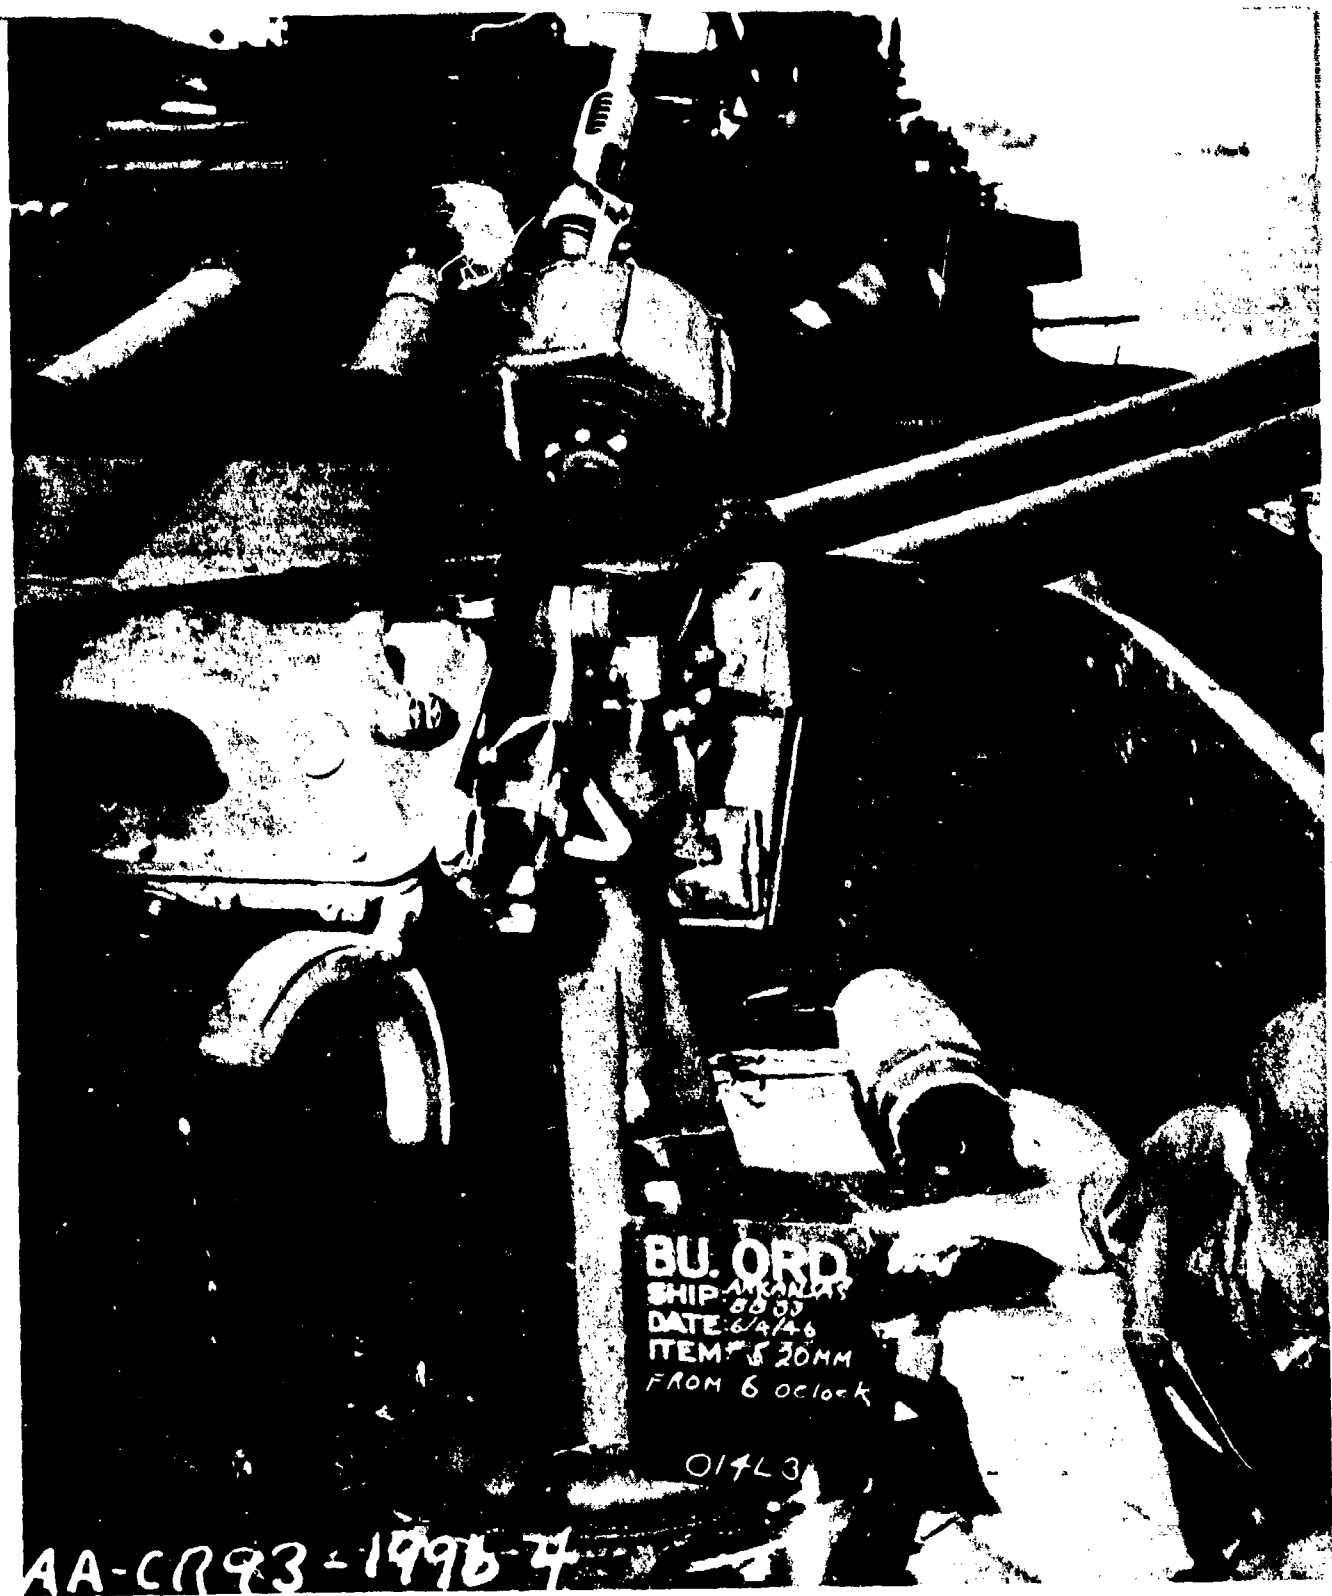
U.S.S. ARKANSAS (BB-33) - After Able
Close up view of 20 MM Mt. No. 5, showing
distorted magazine and empty case bag
burned off.
Photo. No. AA-CR-93-1996-4.

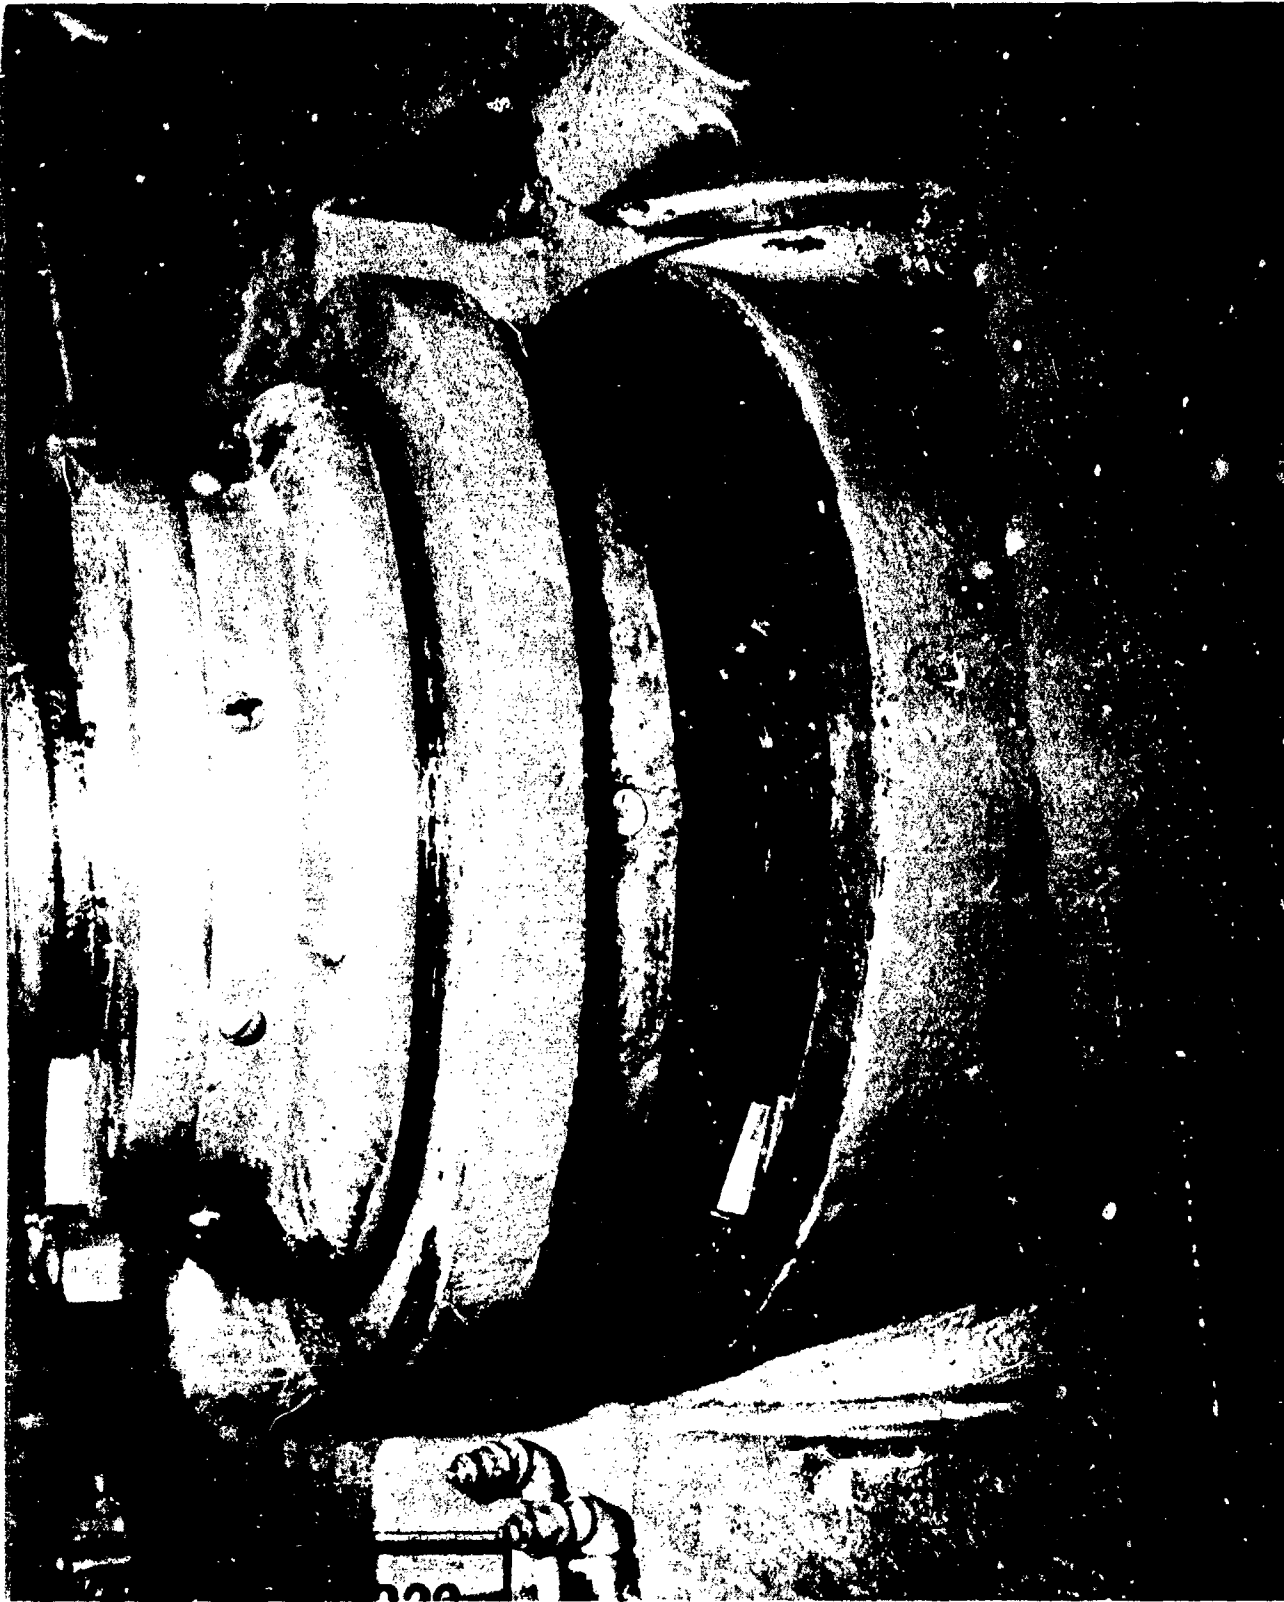
U.S.S. NEW YORK (BB-34) - After Baker
Close up view of left elevating screw in
14"/45 Cal., Turret No. 2. Showing
Elevating Screw Housing with upper Ball
Race in tact.
Photo No. AB-CR-83-4222-8

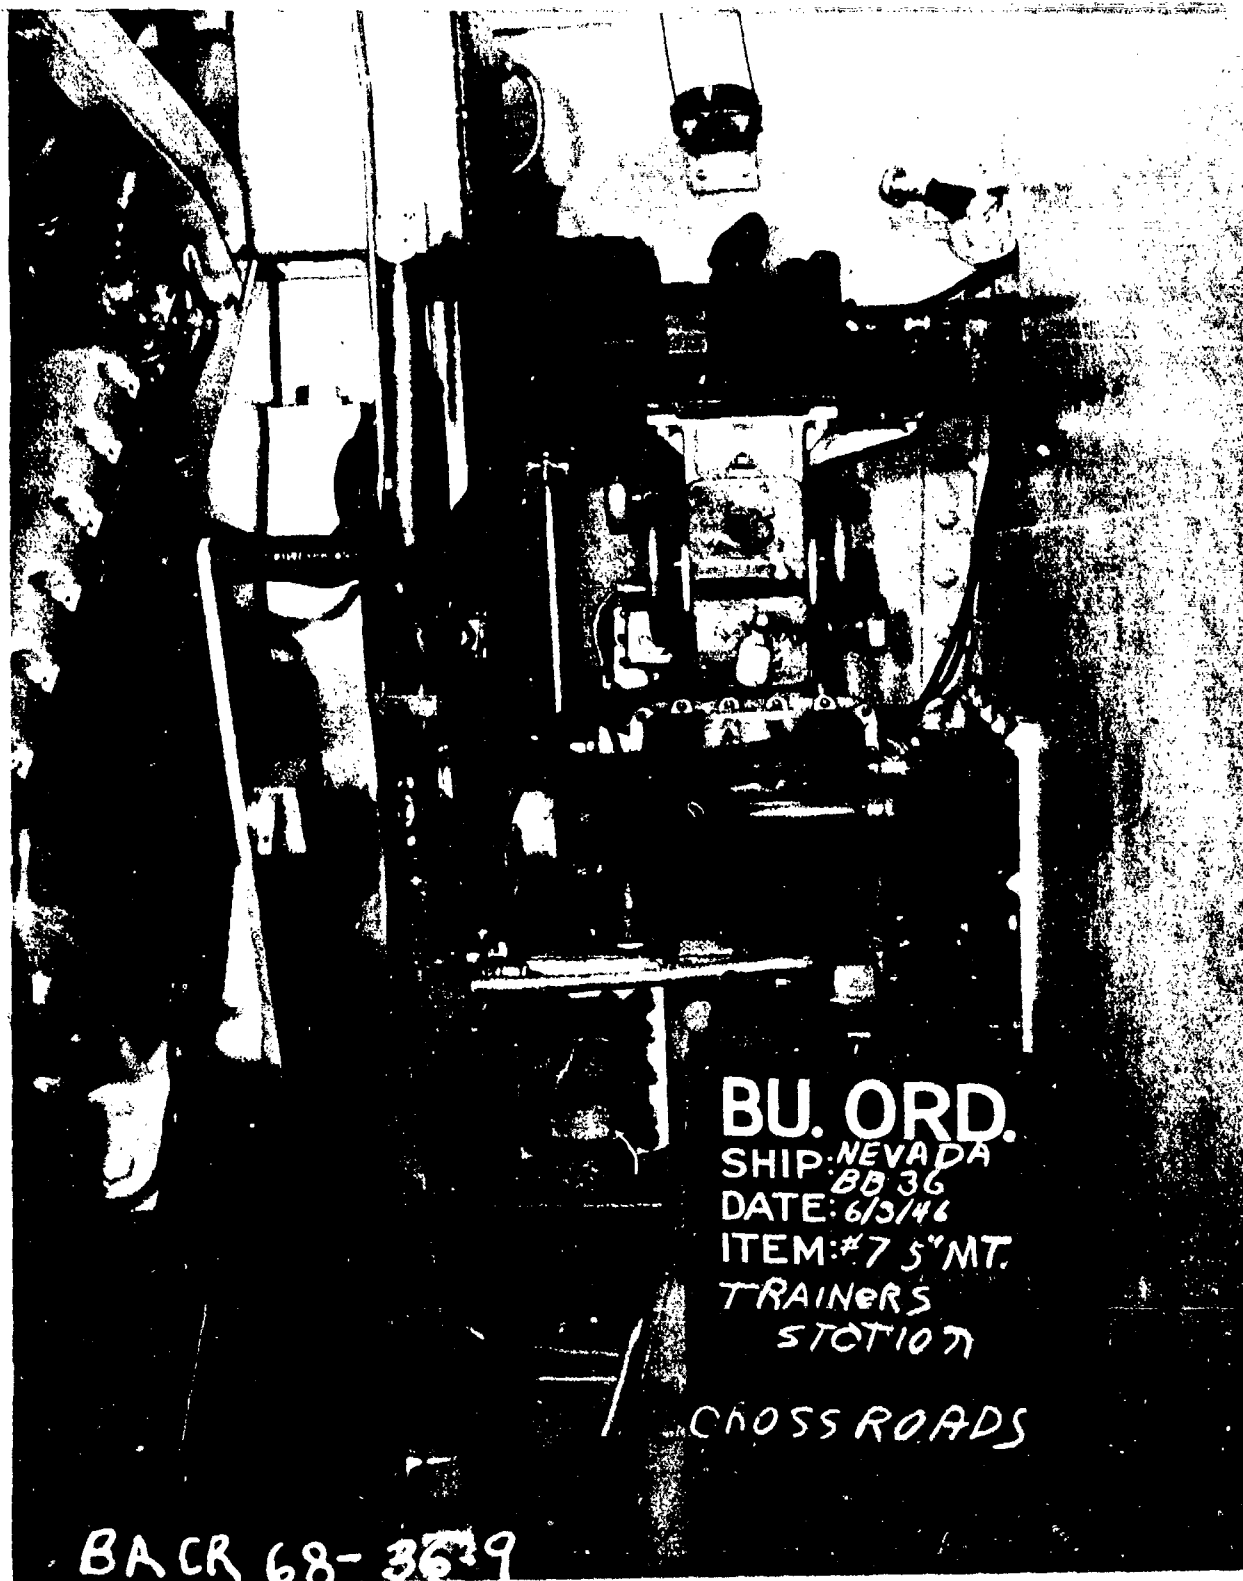
U.S.S. NEVADA (BB-36) - Before ALLE
View of 5"/38 Cal. twin mount No. 7
trainer's station showing condition
before Test "A".
Photo. No. BA-Ch-68-36-9.

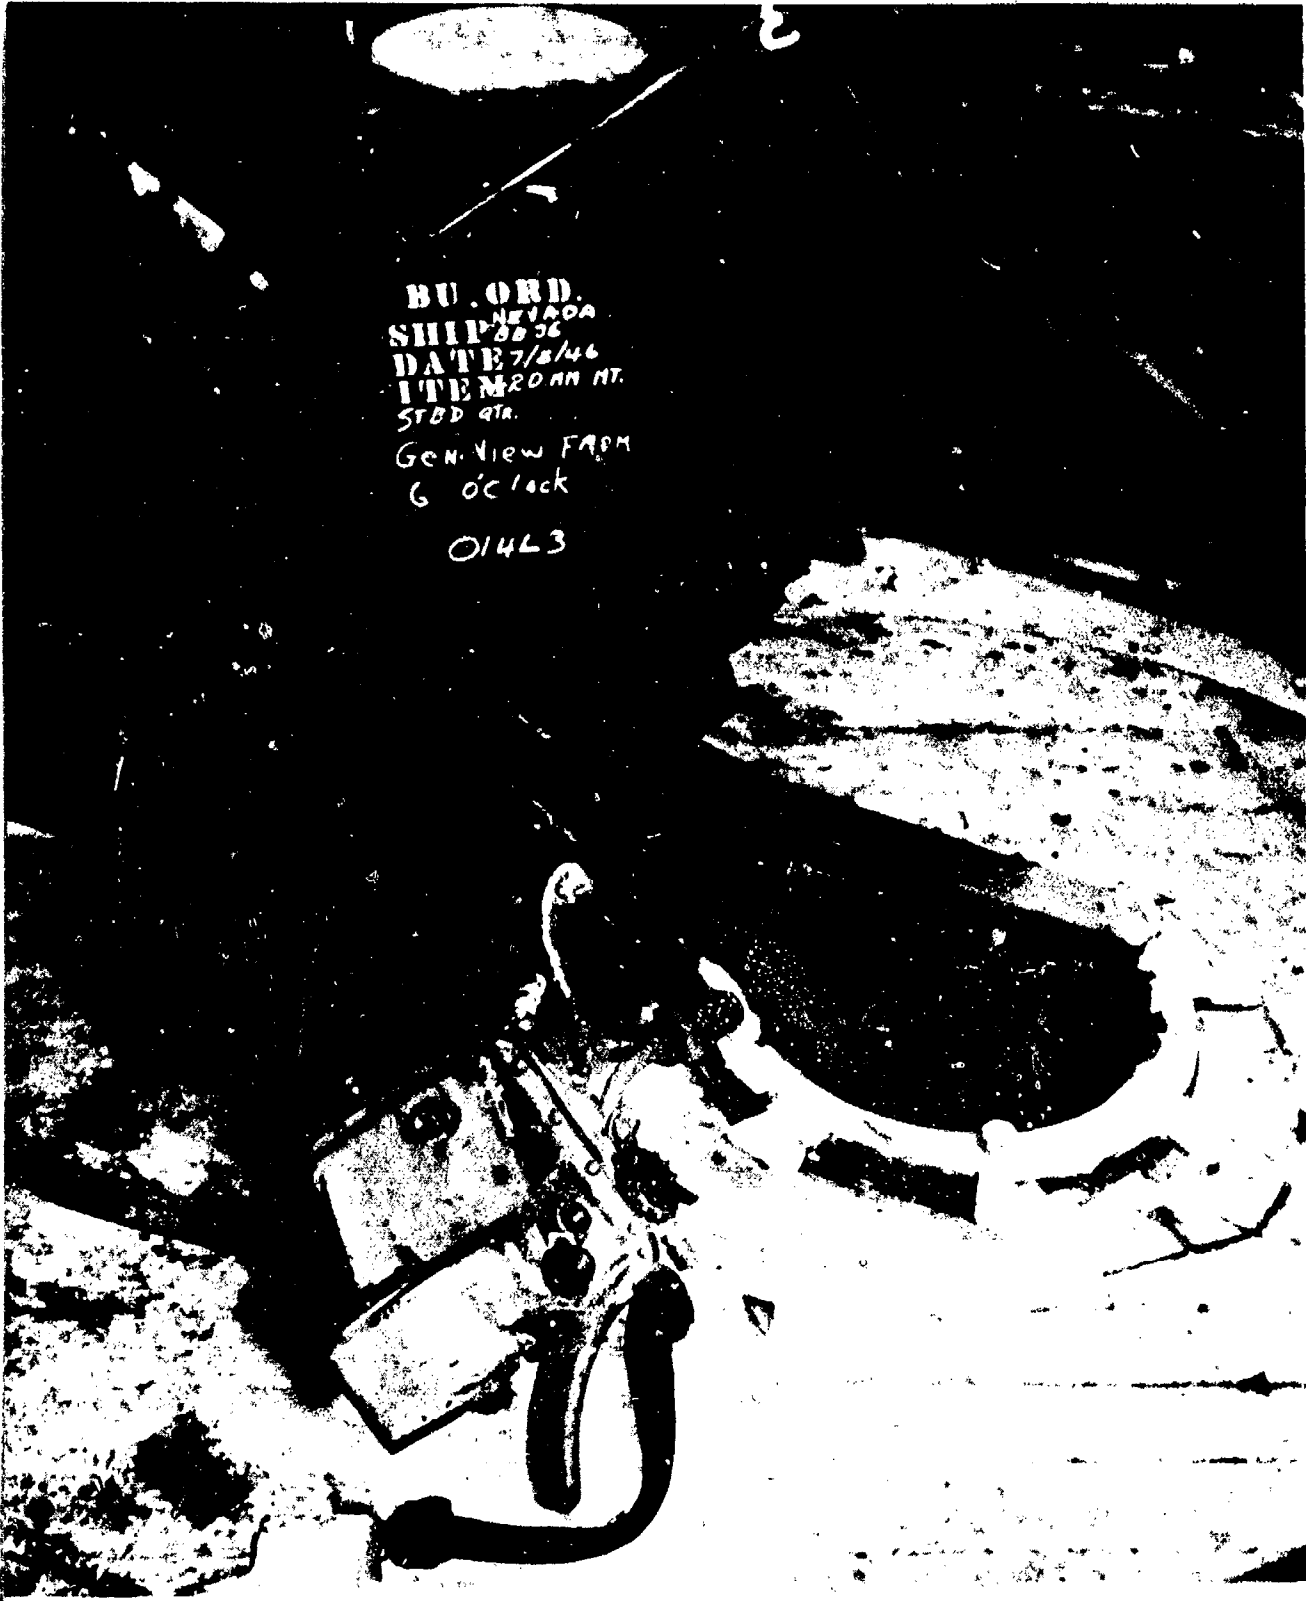
U.S.S. NEVADA (SS-36) - After Able
General view of 20 MM twin Mt. No. 7
showing the demolished stand.
Photo. No. 4A-6K-97-1939-3.

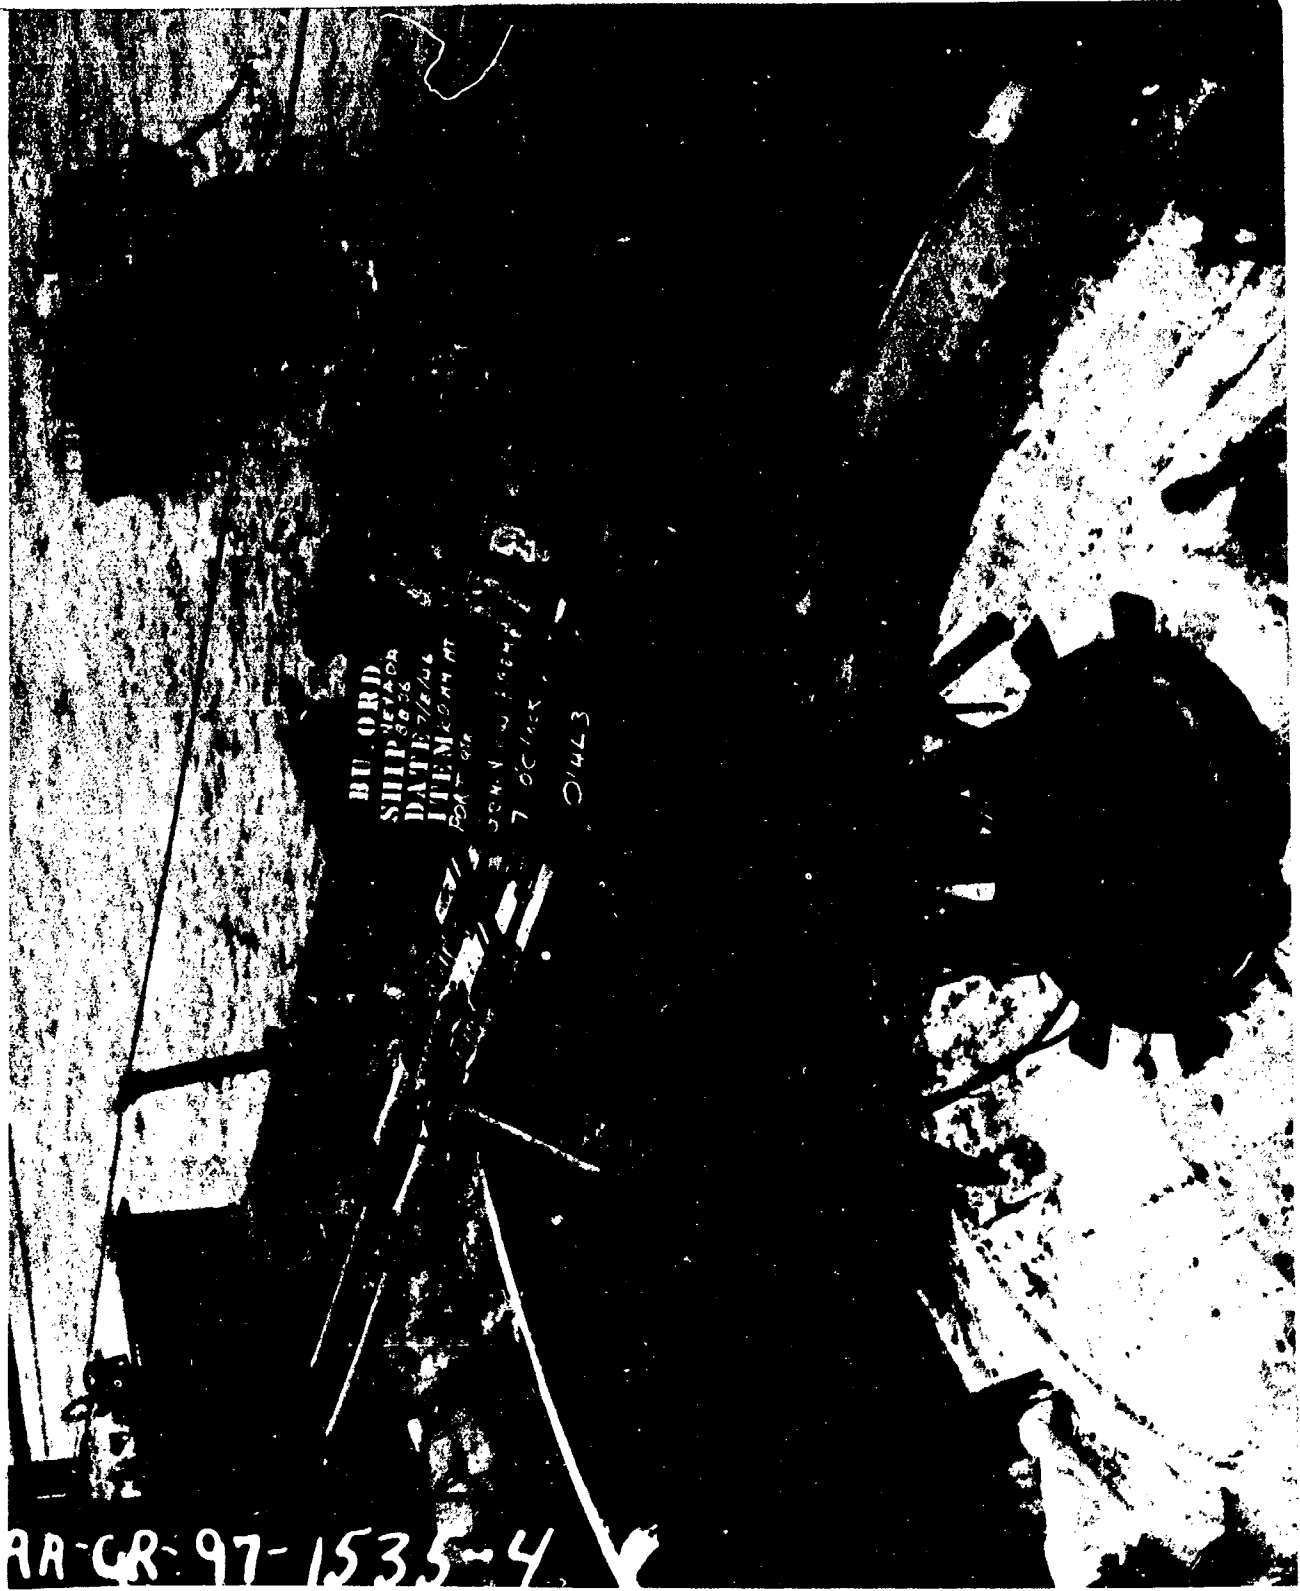
U.S.S. ALBATRA (ES-36) - After Attack
General view of 20 mm Twin Mt. No. 18
showing the tent splinter shield and
the distorted bicycle hand grips.
Photo. No. AA-CR-97-1535-4.

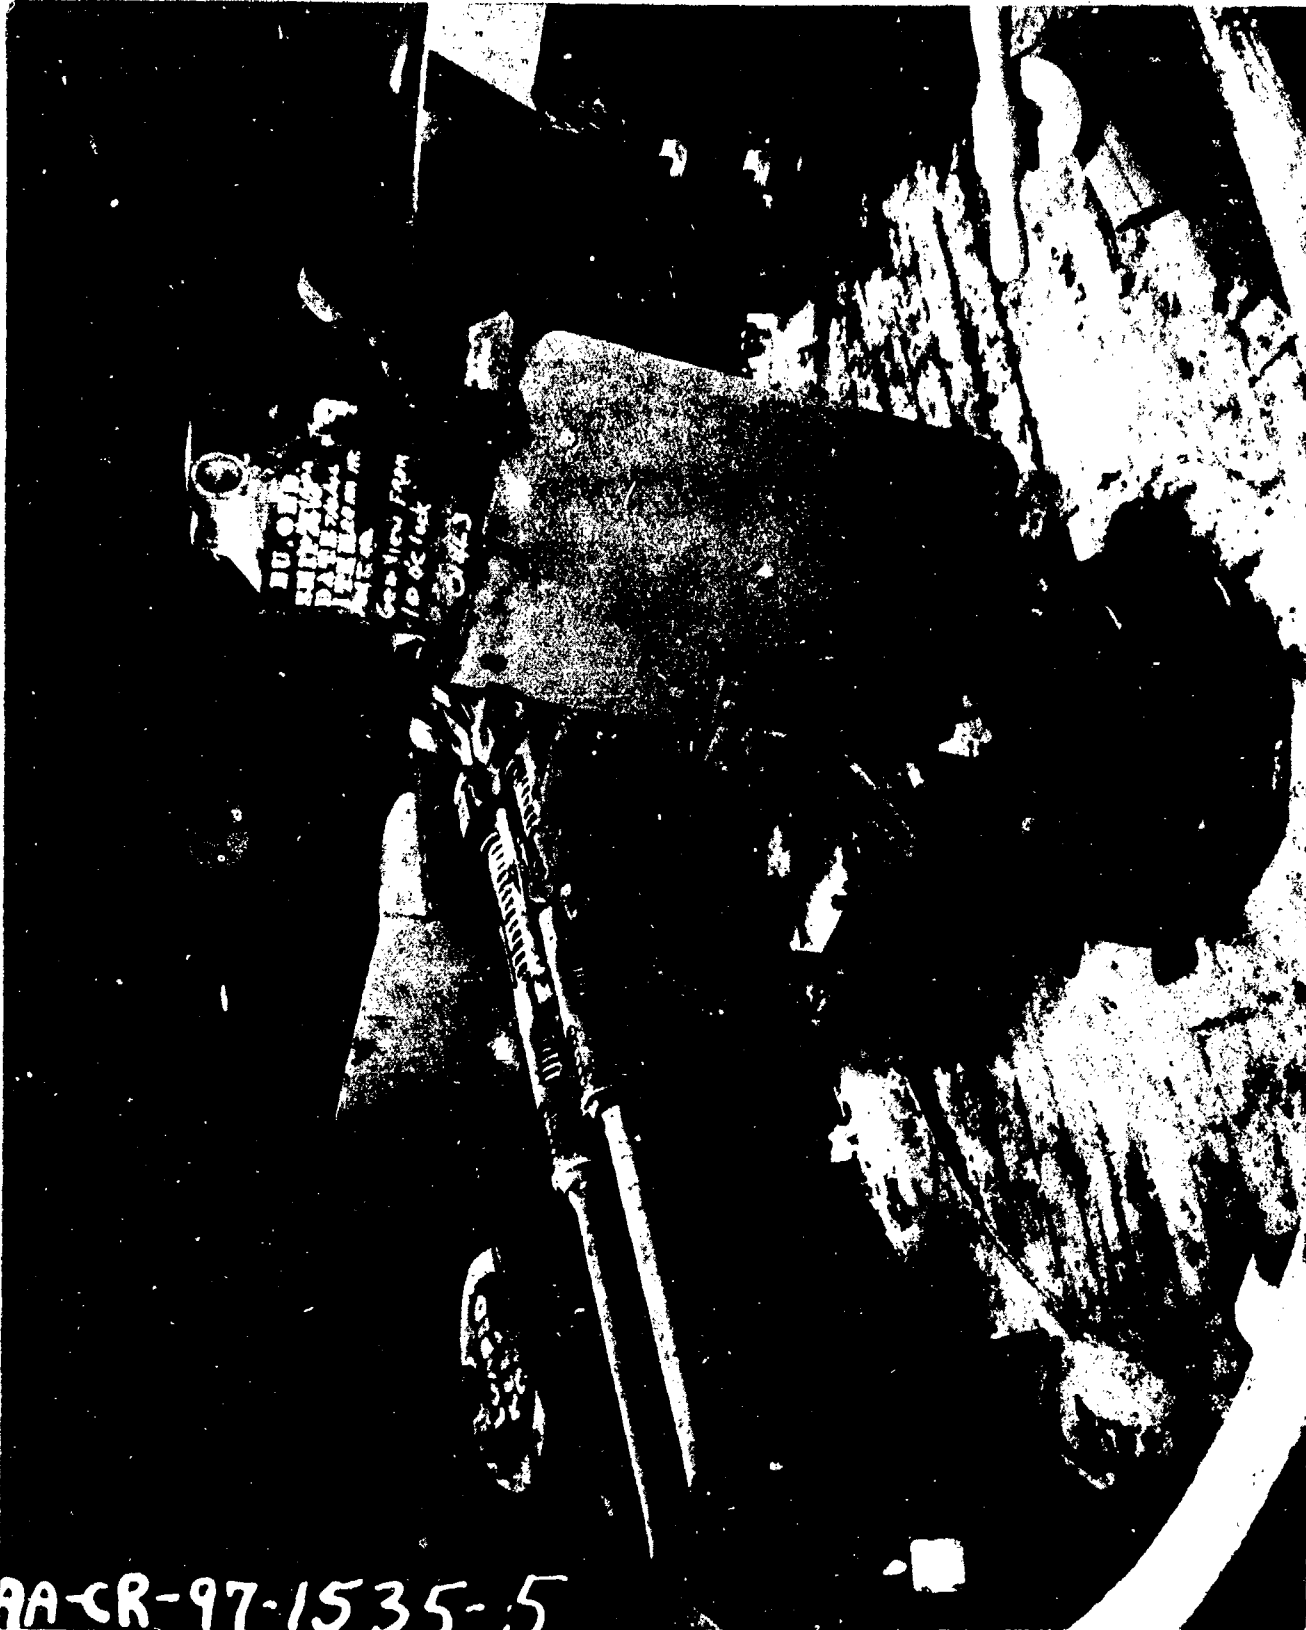
AA-CR-97-1535-5

U.S.S. NEVADA (BB-36) - After ABIC
front view of 20 MM Twin Mt. No. 16
showing the bent splinter 0423.
Photo. No. AA-CR-97-1535-5.

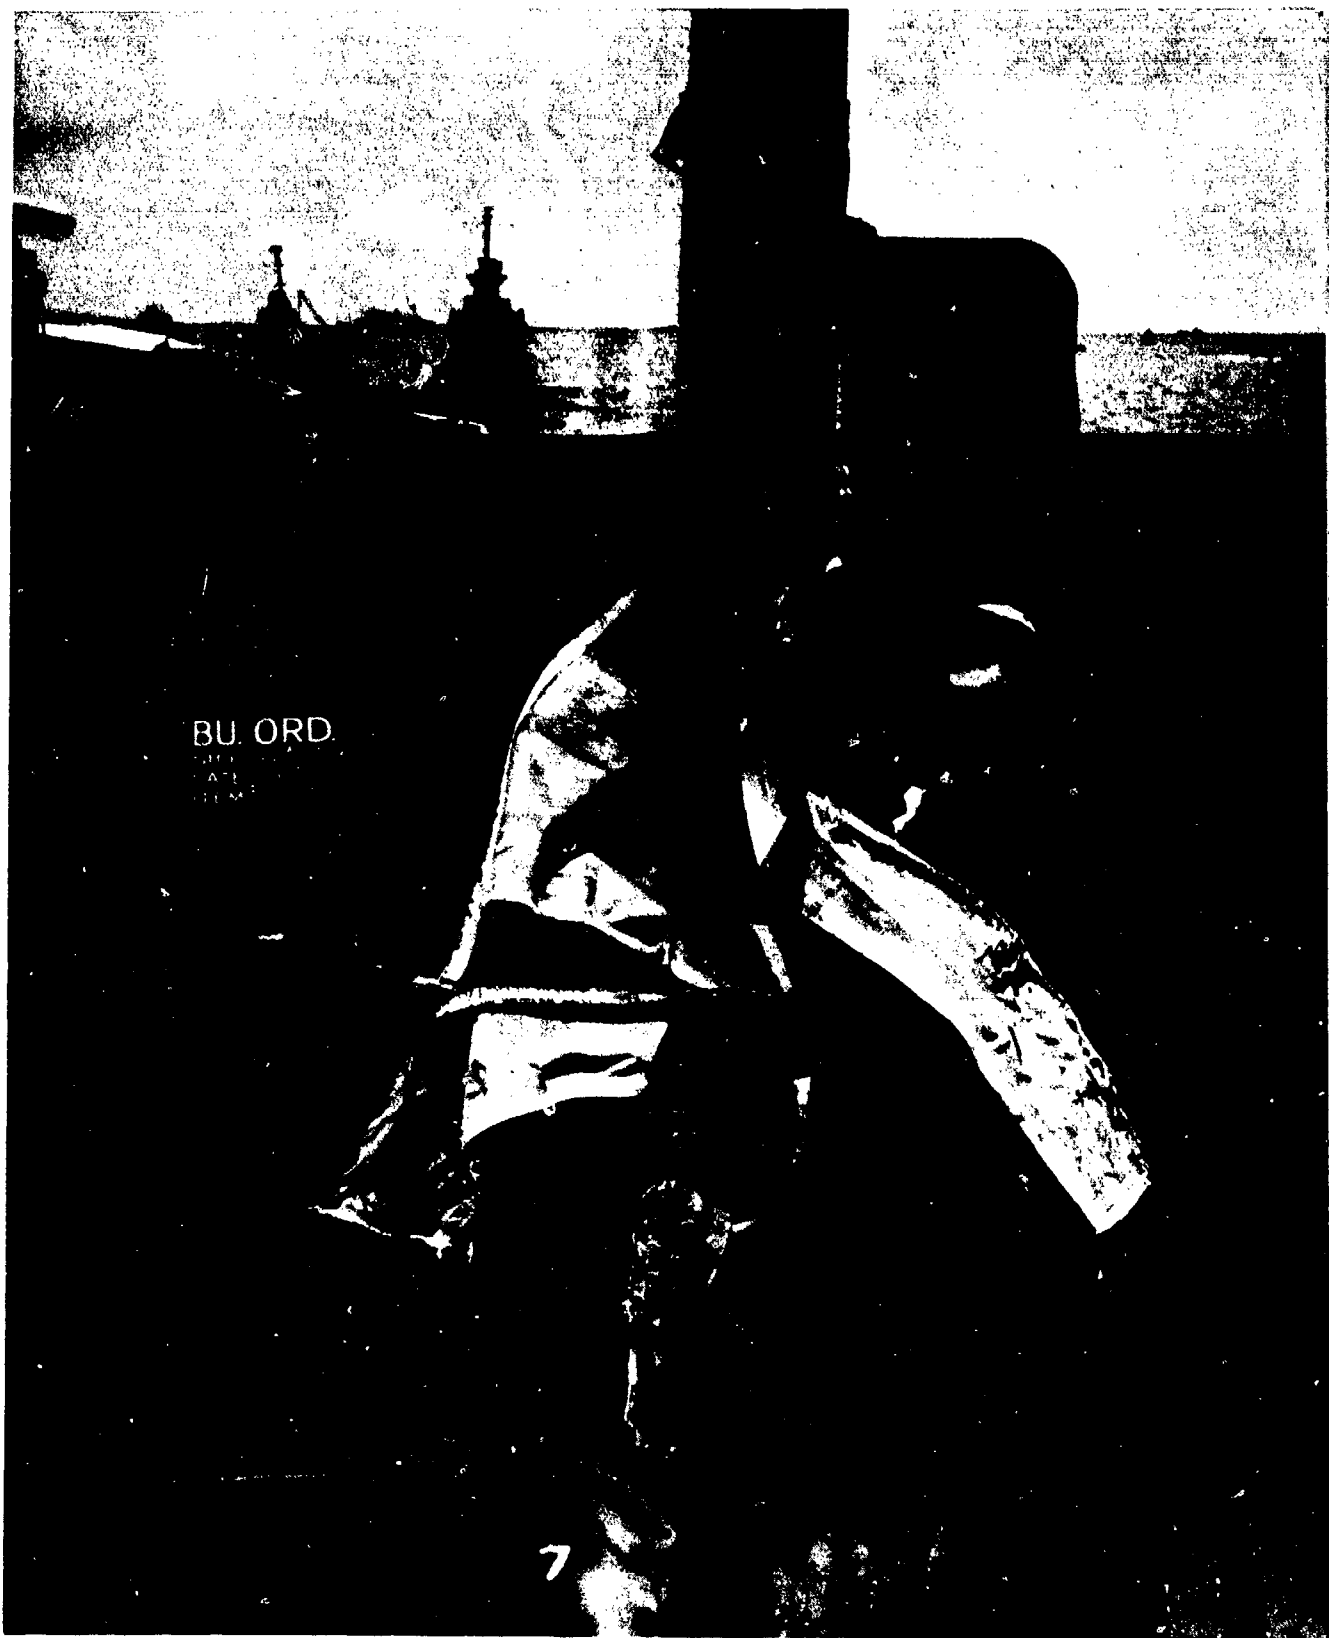
U.S.S. NEVADA (bb-36) - After Able
Close up of damage to the Right Gun Port
Buckler of 5"/38 Mt. No. 1.
Photo. No. AA-CR-93-1996-7.

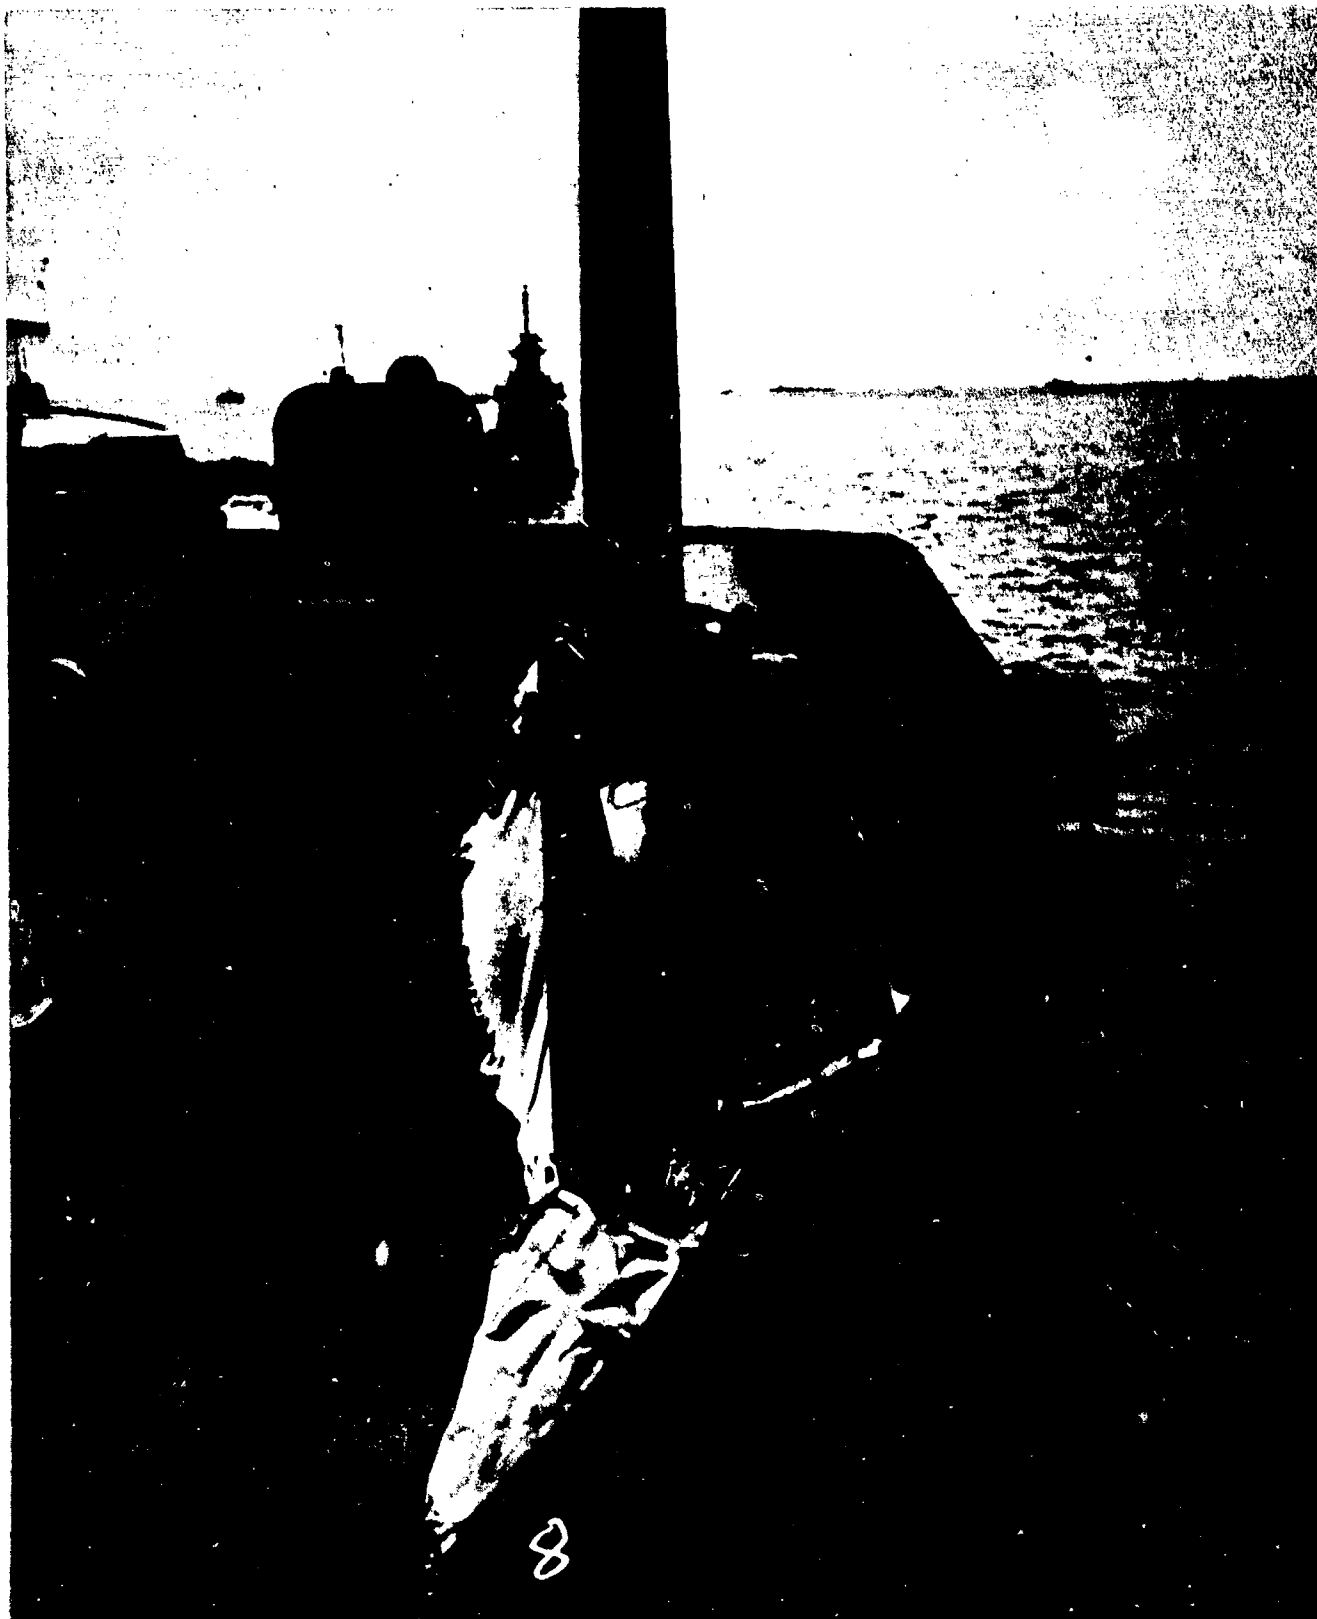
U.S.S. NEVADA (BB-36) - After Attack
Close up of damage to the Left Gun
Fort Buckler of 5"/38 Mt. No. 1.
Photo. No. AA-CH-95-1967-2.
