Technical Inspection Report
Bureau of Ordnance Group

6
OPERATION CROSSROADS.
TESTS 'A' AND 'B'.
VOLUME IV.
PART X. PHOTOGRAPHIC
APPENDIX [U] 8

GUNS AND MOUNTS PHOTOGRAPHIC INDEX

TEST "A" & "B"

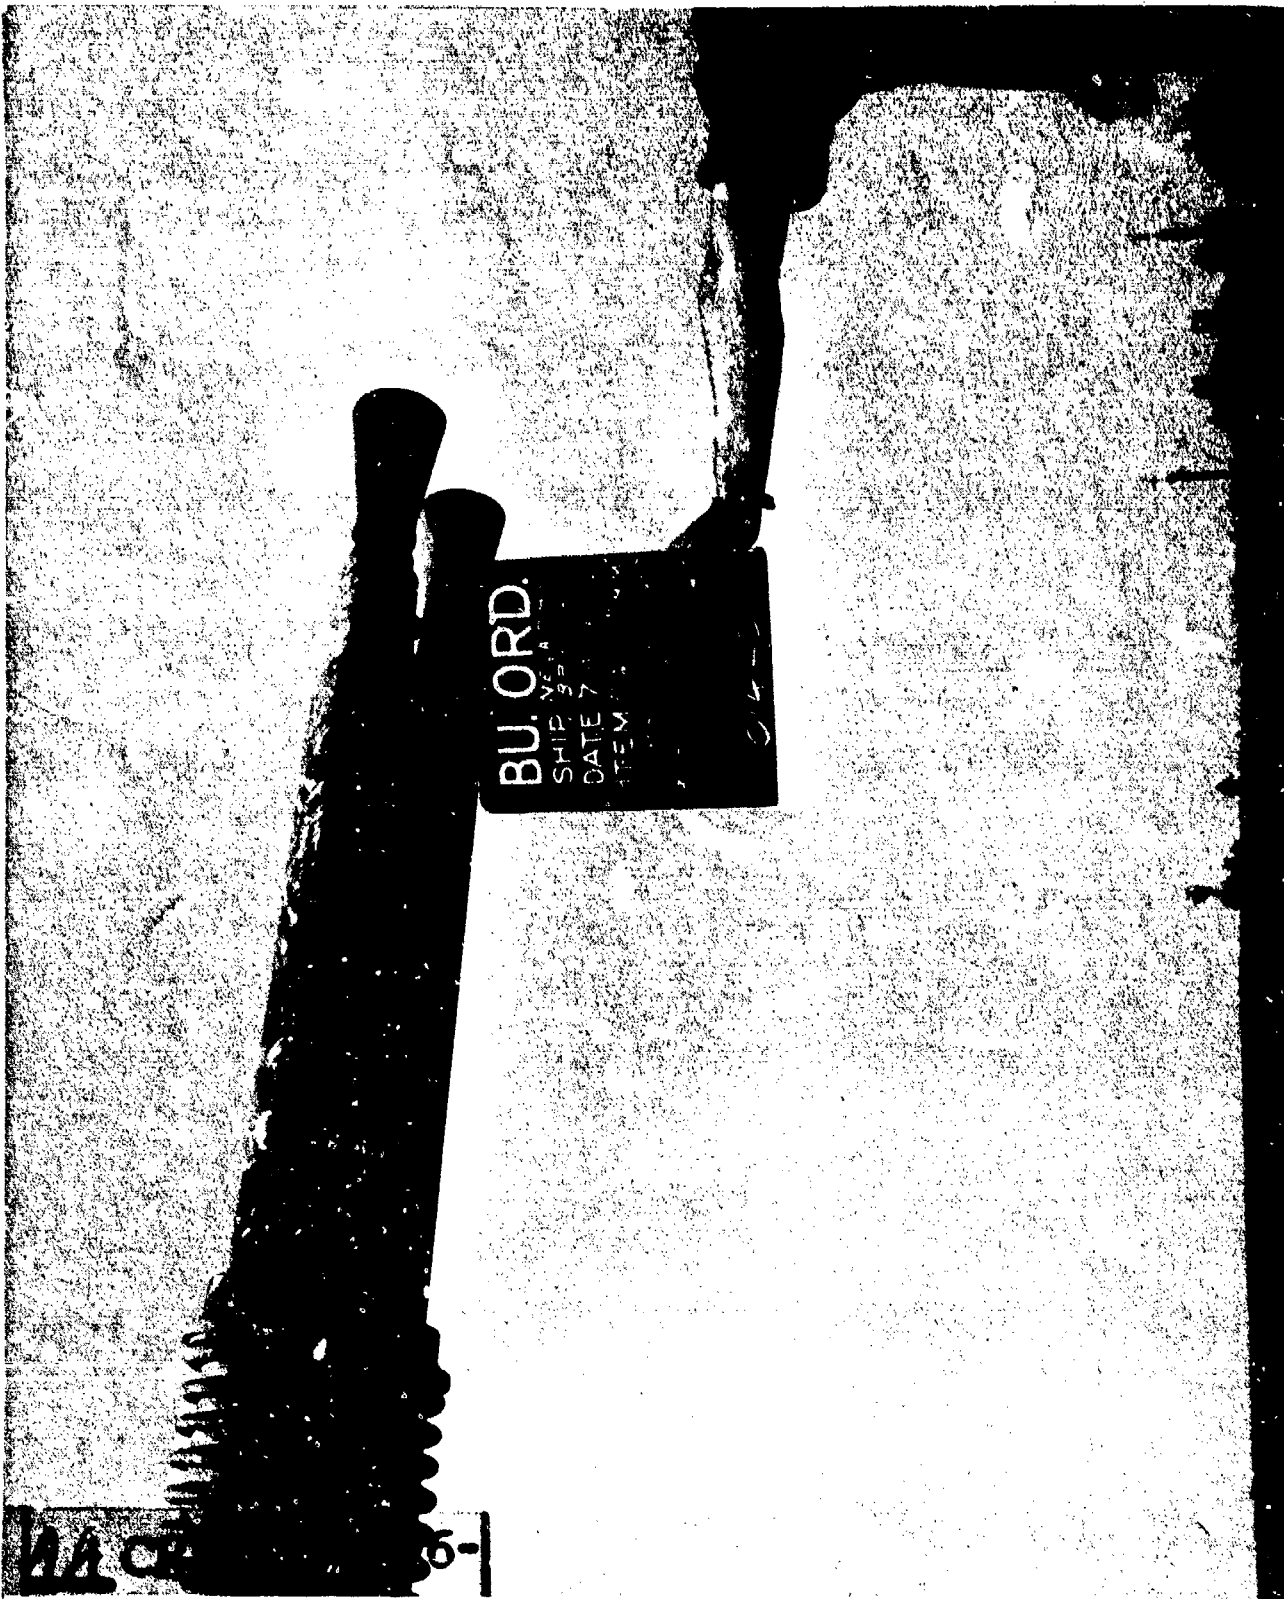
U.S.S. NEVADA (BB-36) - After Able
Close up view of the Right Gun Barrel
of 40 MM Twin No. 3. This design on
the barrel was caused by whipping action of
wire rope.
Photo. No. AA-CR-93-1996-12.

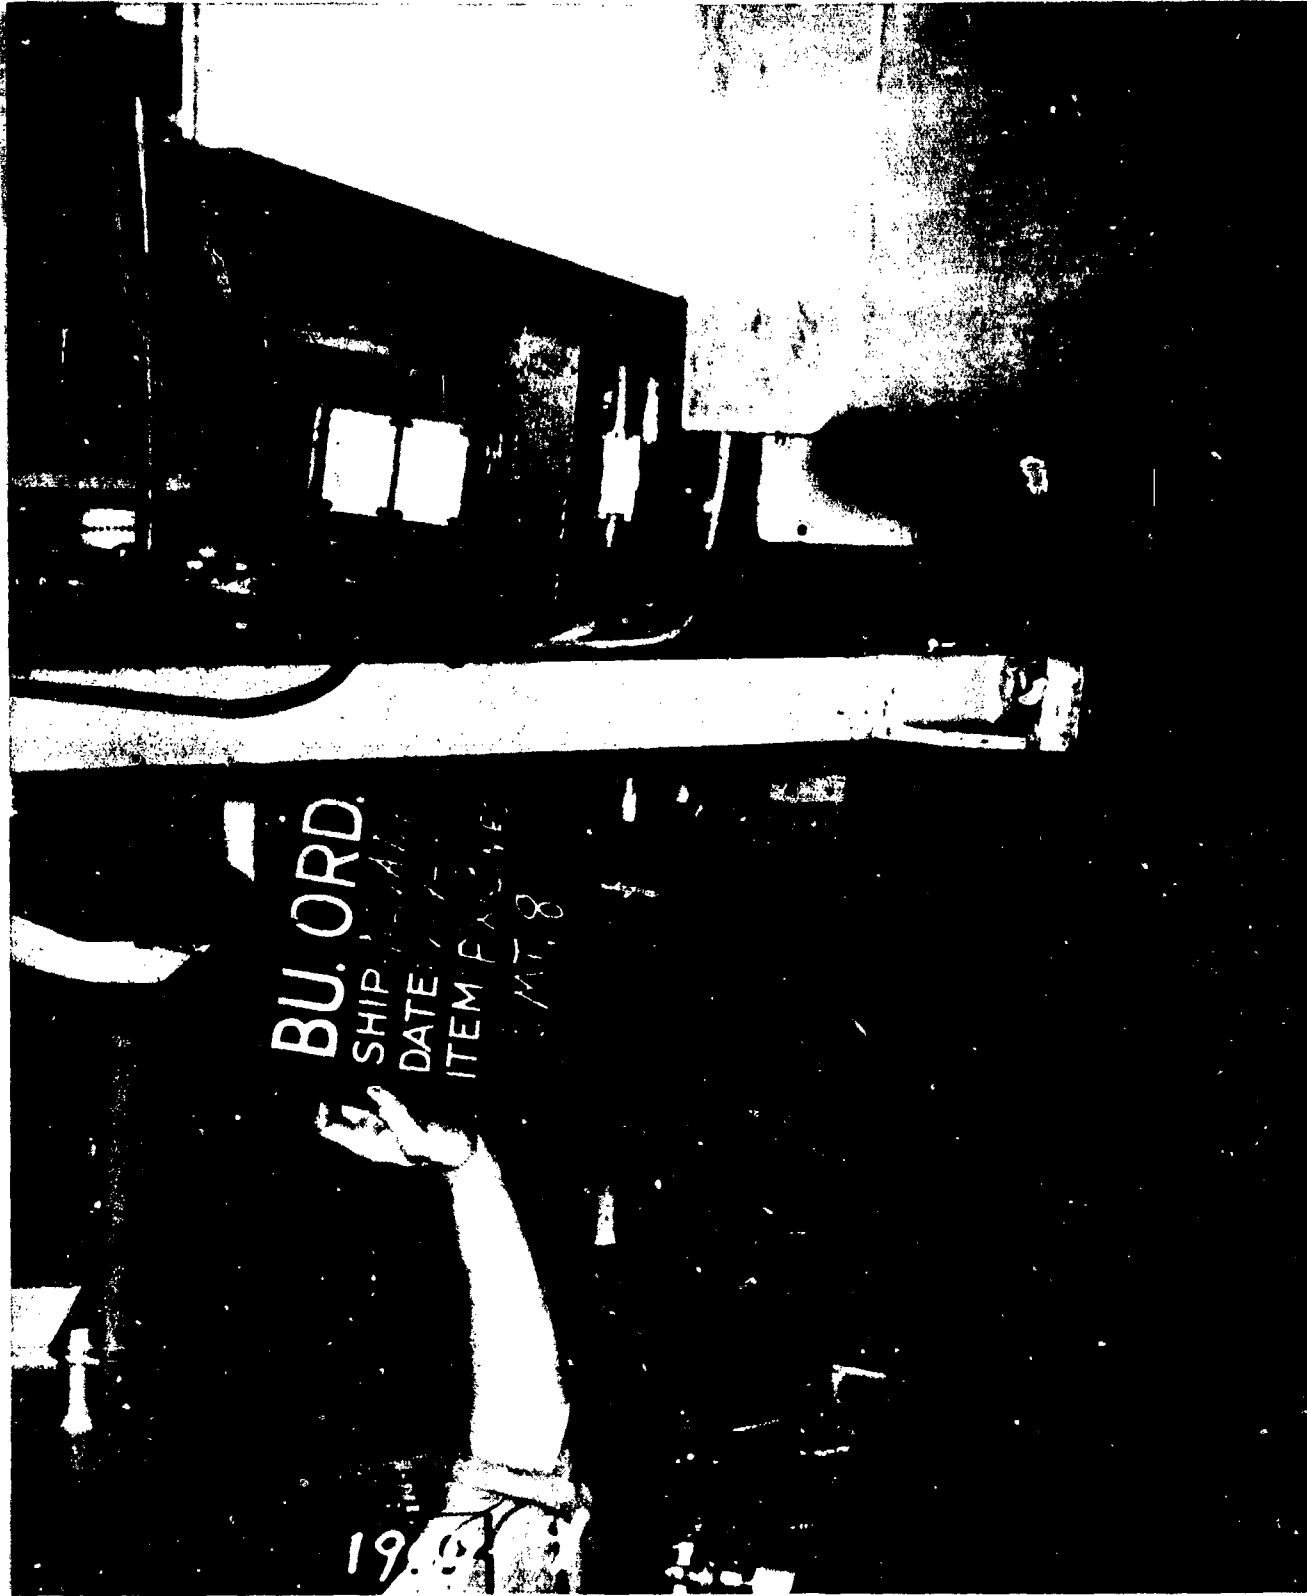
U.S.S. NEVADA (bb-36) - After Able
Interior view of 5"/38 Mt. No. 8,
showing the pinched oil lines at the
trainer's station.
Photo. No. AA-CR-93-1999-4.

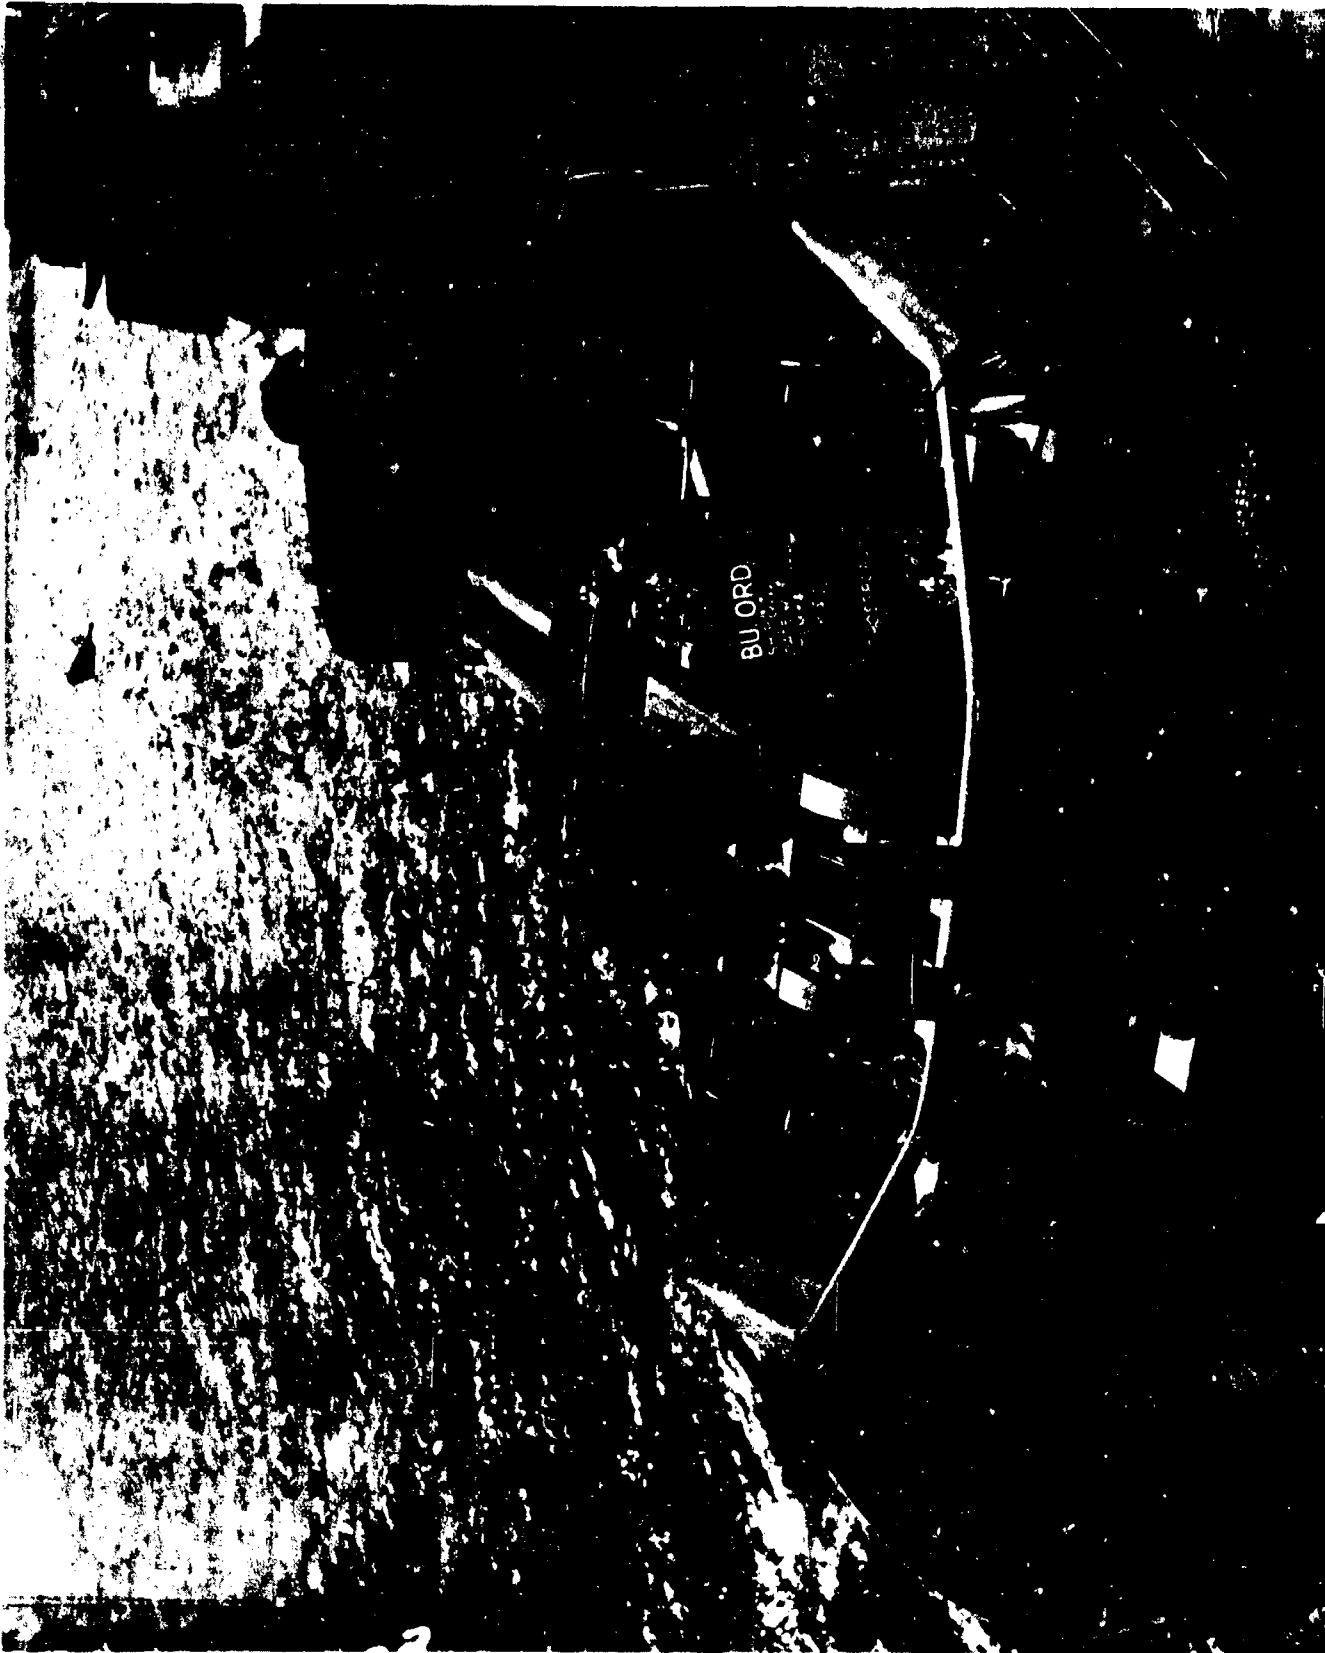
U.S.S. INDEPENDENCE (CVL-22) - Before Able
Condition of No. 4 40 MM Mount before Test "A".
Photo. No. BA-CR 97-313-3.

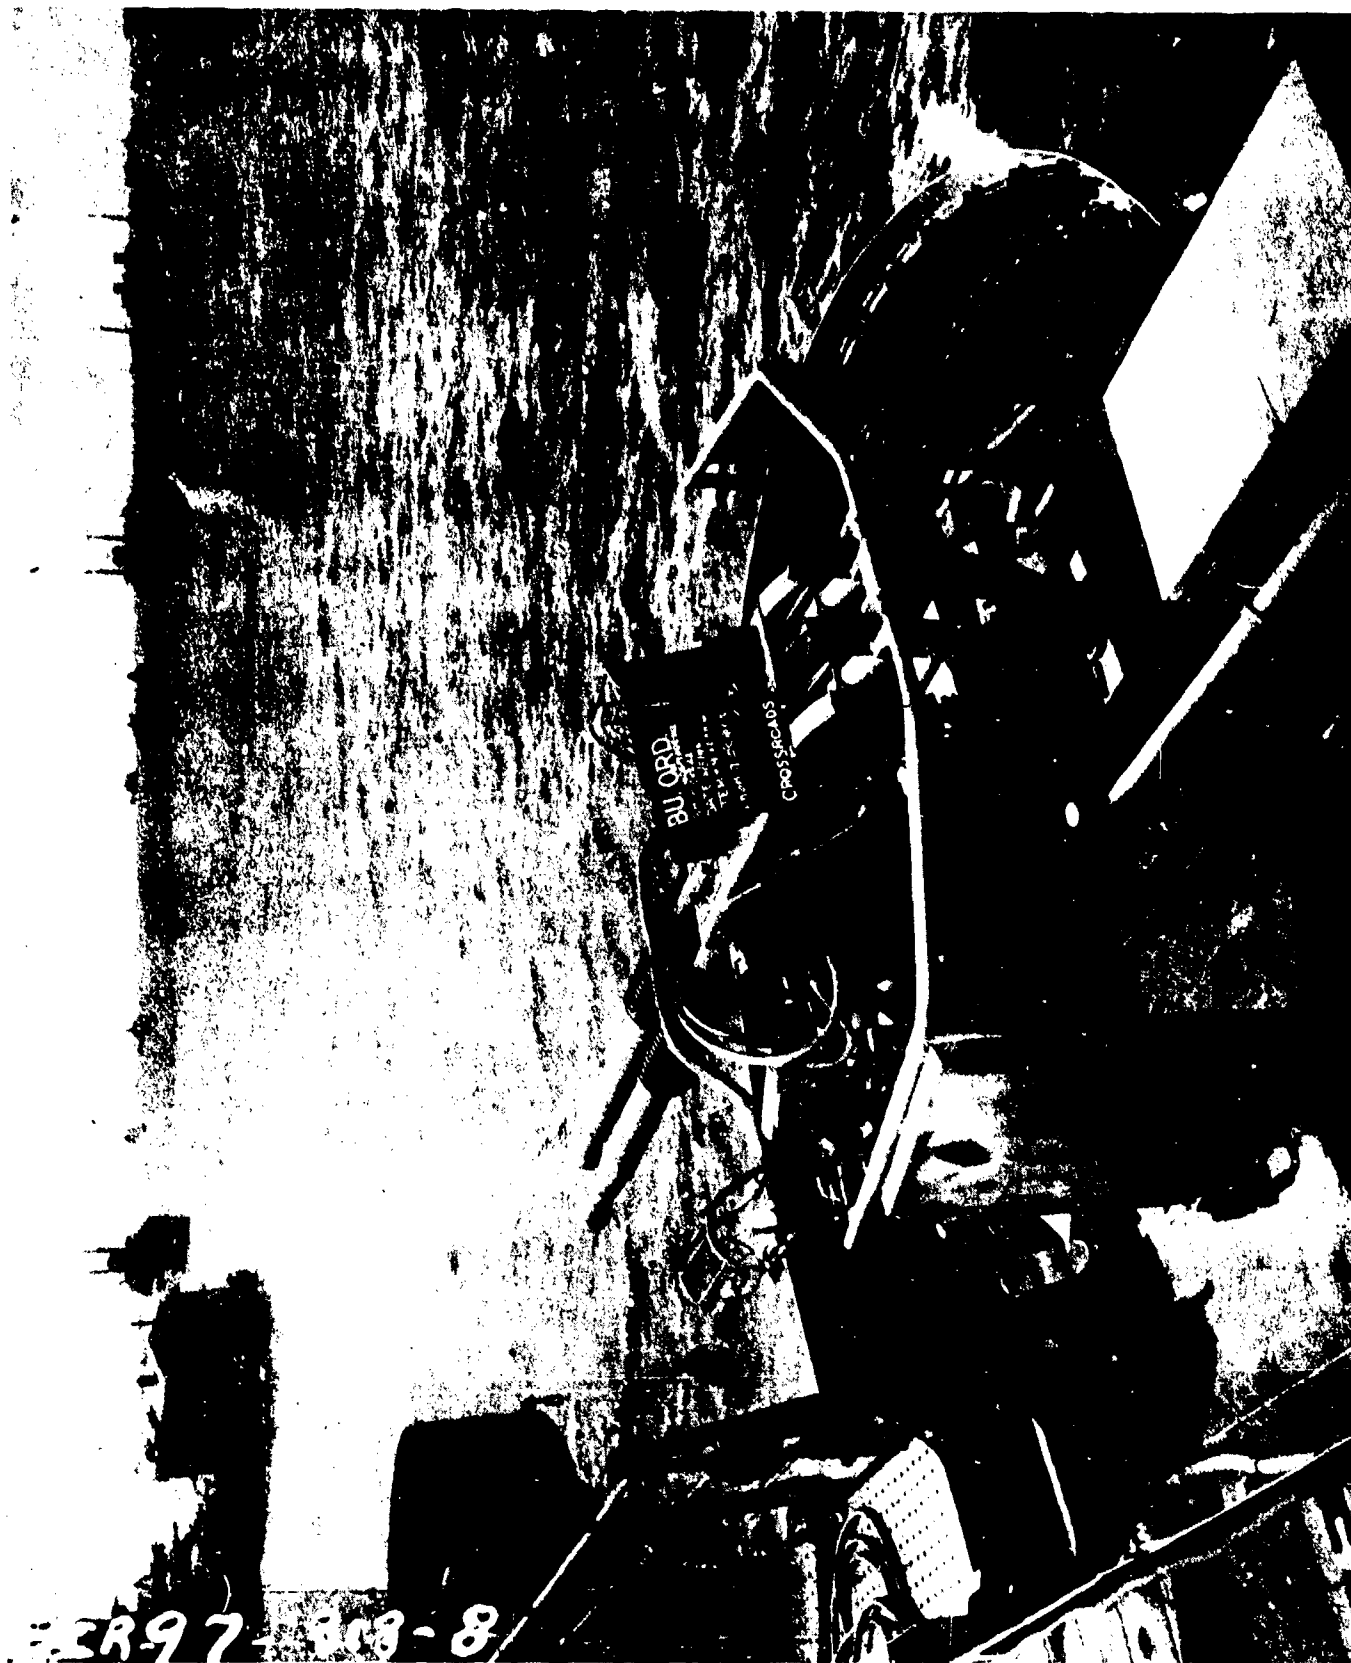
U.S.S. INDEPENDENCE (CVL-22) - before fire
Condition of No. 9 40 MM Mount before Test "A".
Photo. No. BA-CR-97-31-E.

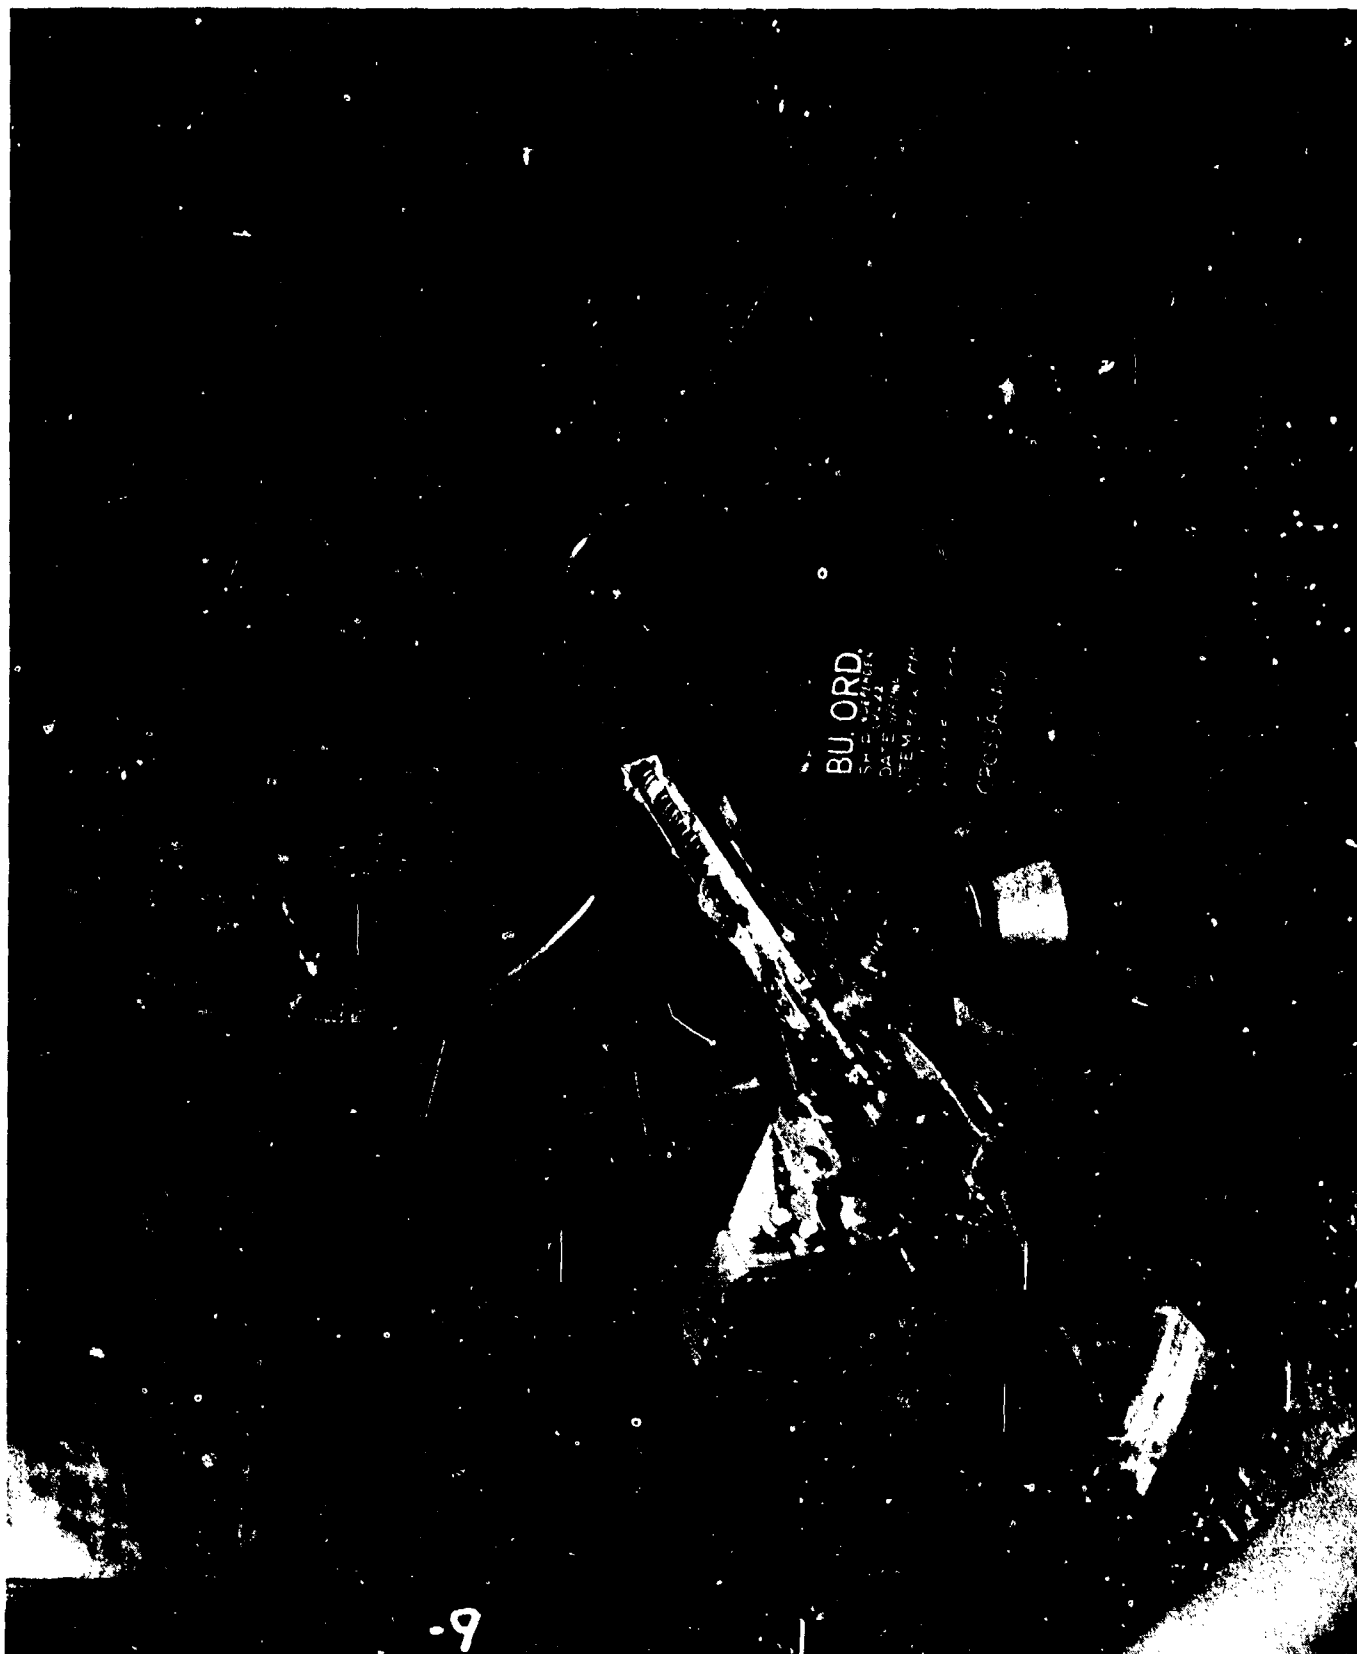
U.S.S. INDEPENDENCE (CVL-22) - Before Able
Condition of No. 6 20 MM Mount before Test "A".
Photo. No. BA-CH-97-313-9.

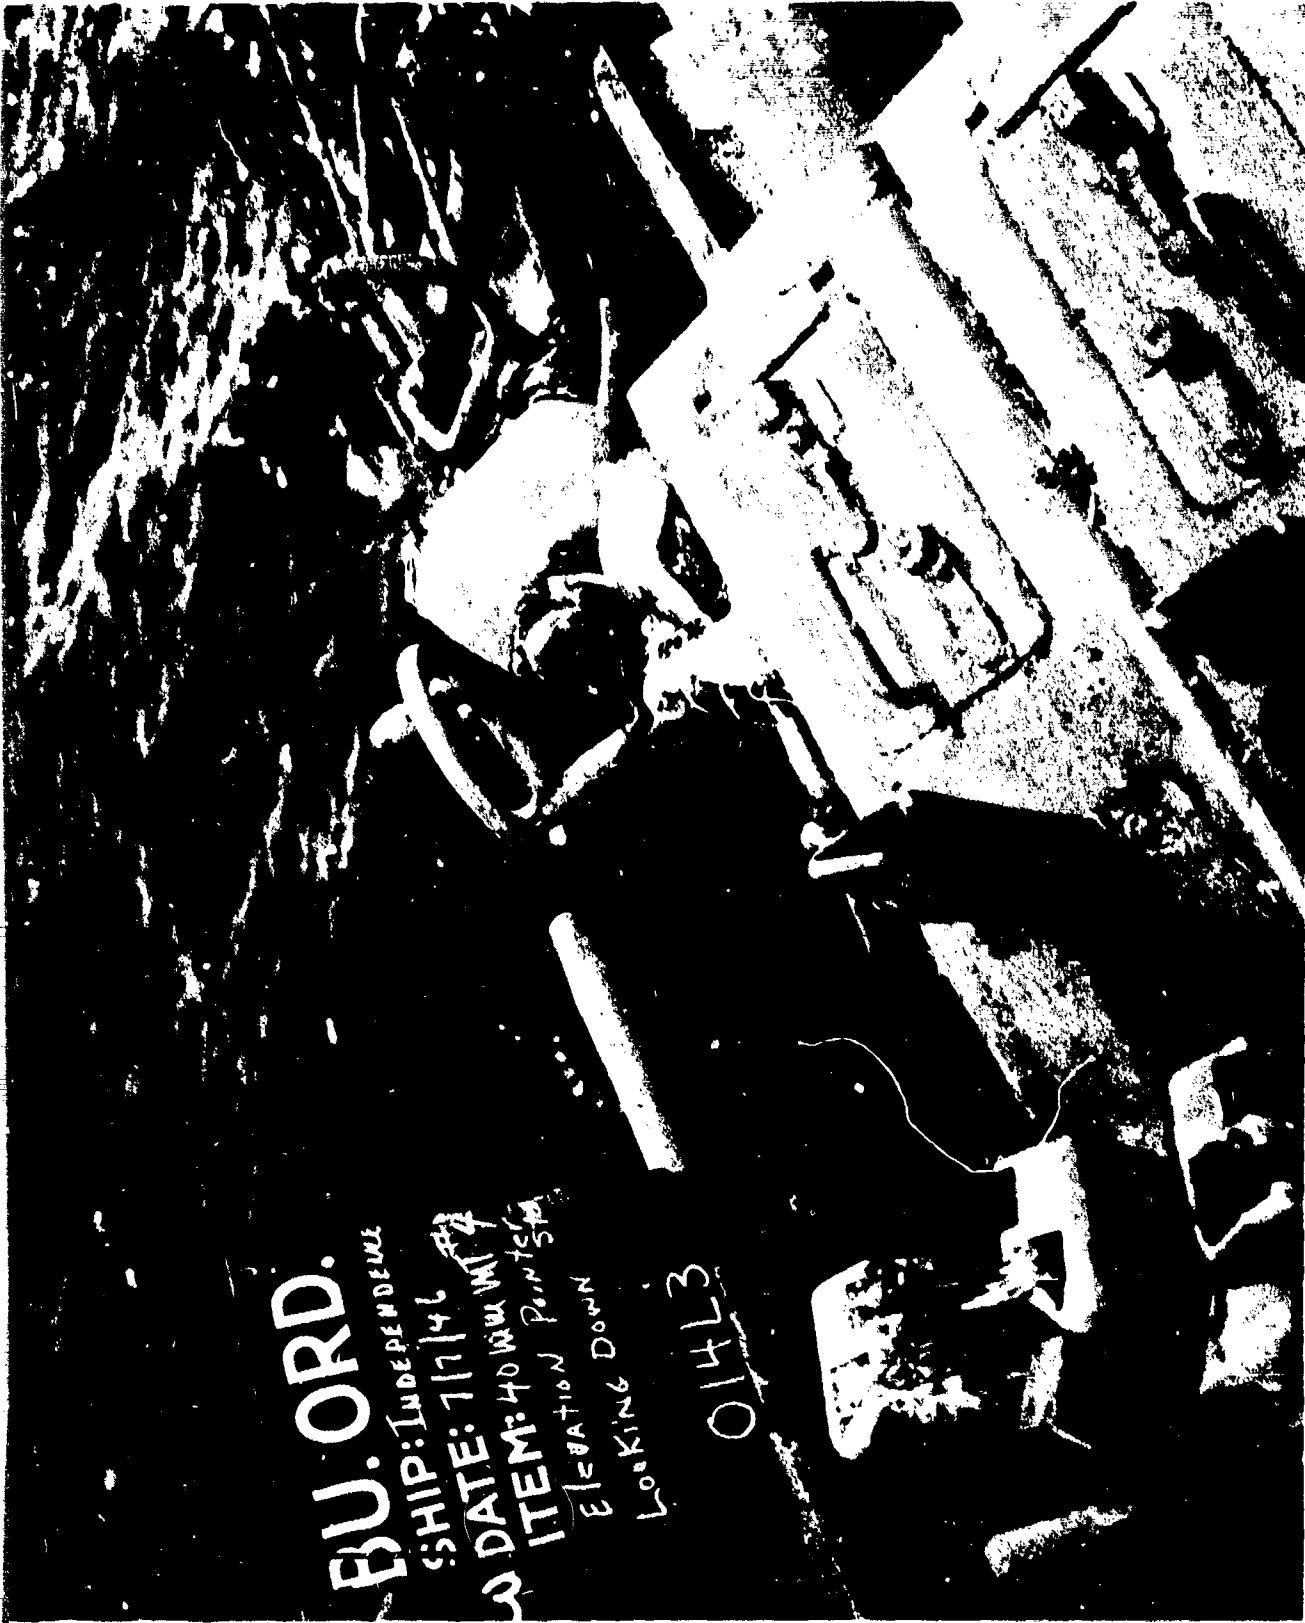
BU. ORD.
 SHIP: INDEPENDENCE
 DATE: 7/7/46 #4
 ITEM: HO W/UM #4
 ELEVATION POINTS
 LOOKING DOWN
 014L3

U.S.S. INDEPENDENCE (CVL-31) - 7/7/46. No. 4.
 Close up of BU. Ord. No. 4 showing the vent
 and the 1/2" and 3/4" service pipes.
 Bu. Ord. No. 01-01-81-1073-9.

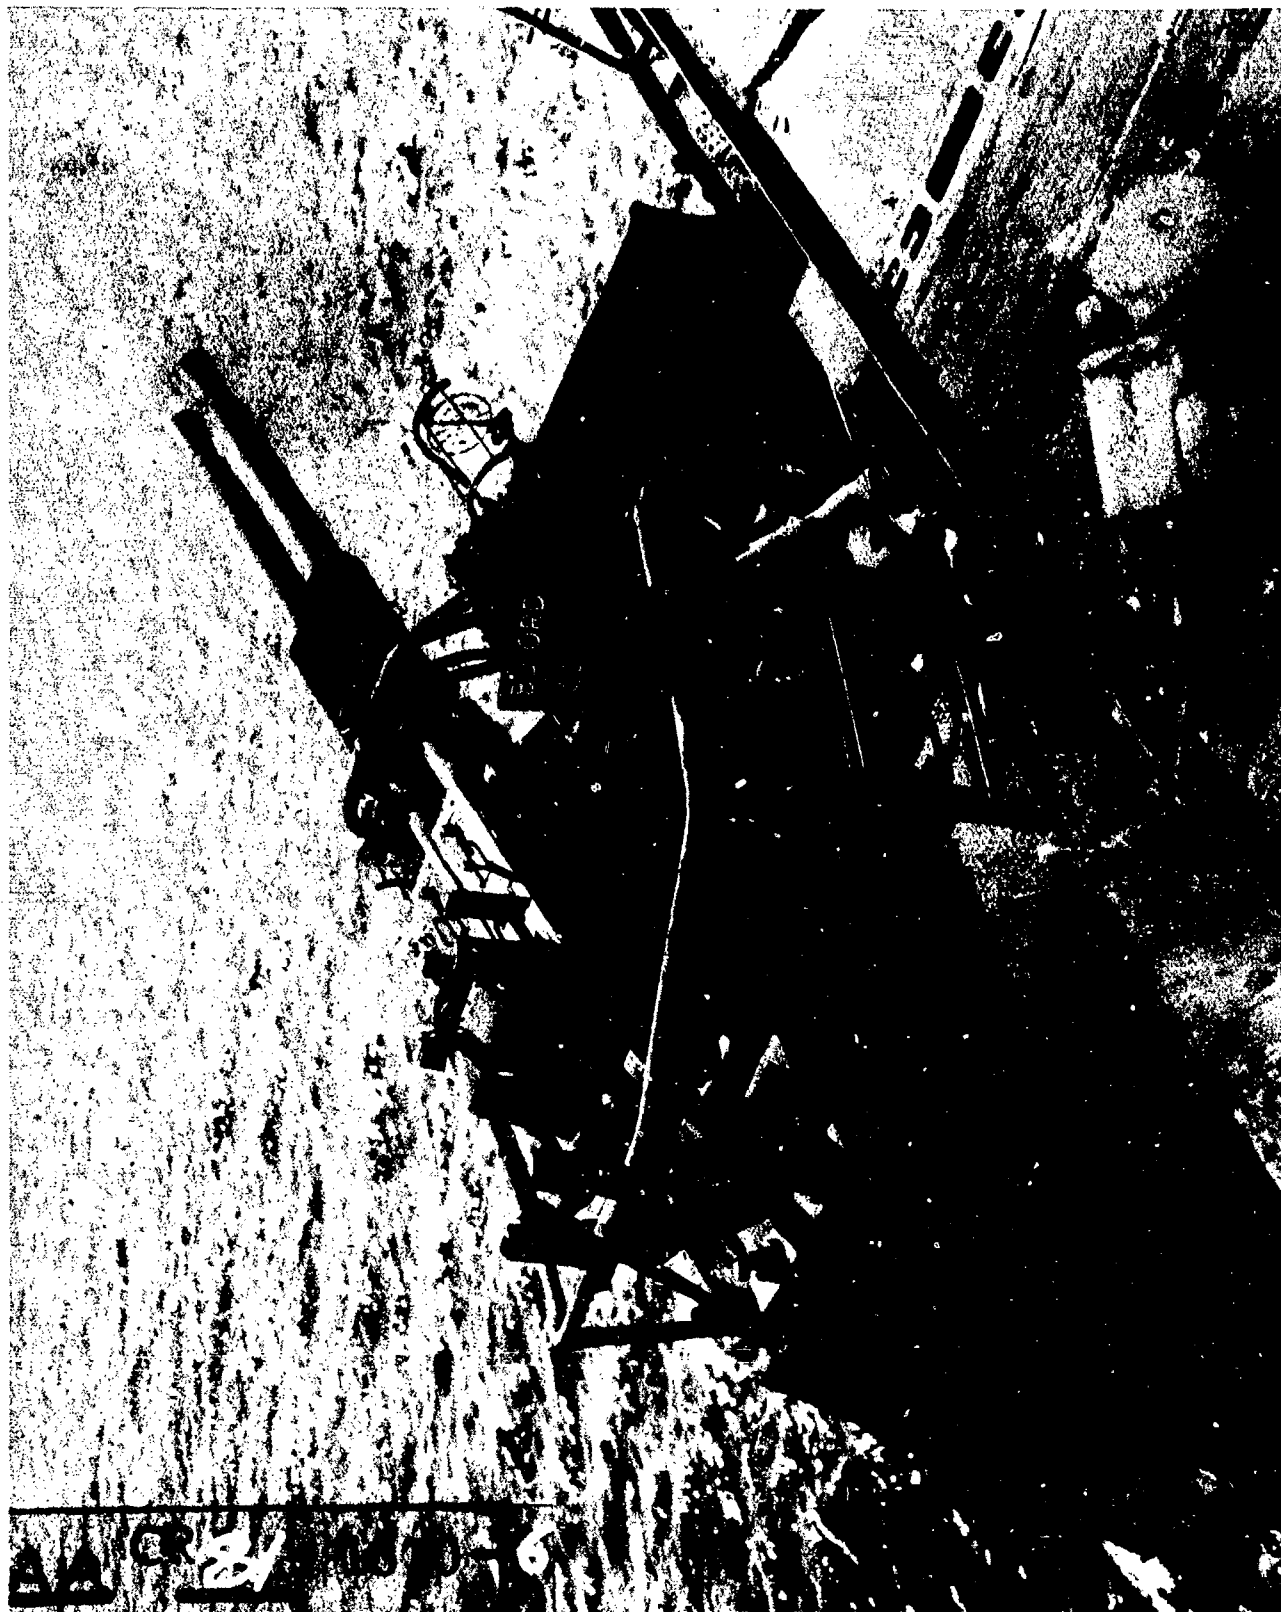
U.S.S. INDEPENDENCE (CVL-22) - After Able
General view of 40 MM Twin Mt. No. 8 showing
the bent automatic loaders, the damaged open
sights and the distorted sponson shield.
Photo. No. AA-CR-81-1670-6.

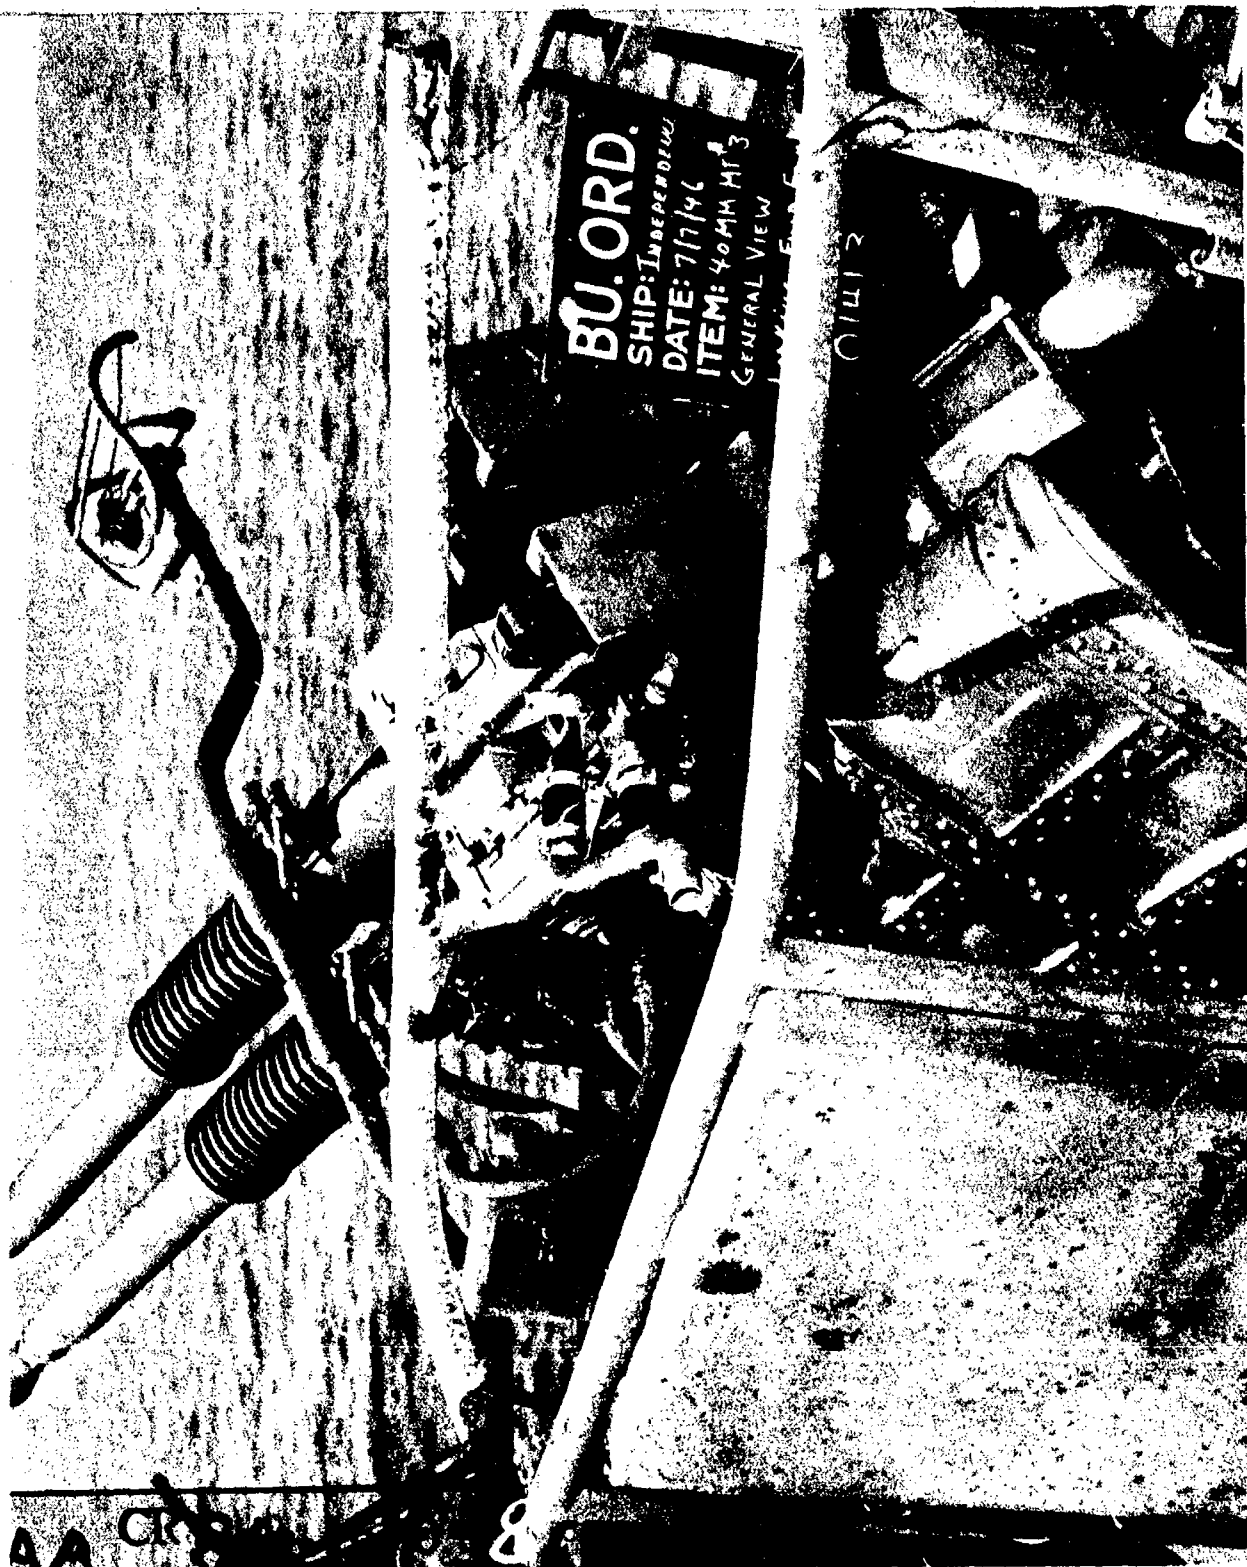
U.S.S. INDEPENDENT (C/L-32) - After 211.
General view of 40 MM twin St. No. 9 showing
the canted gun slice. An aircraft fuel tank
can be seen in the foreground. The white
pipe across the gun mechanism is a piece
of debris.
Photo. No. AA-CR-21-1070-8.

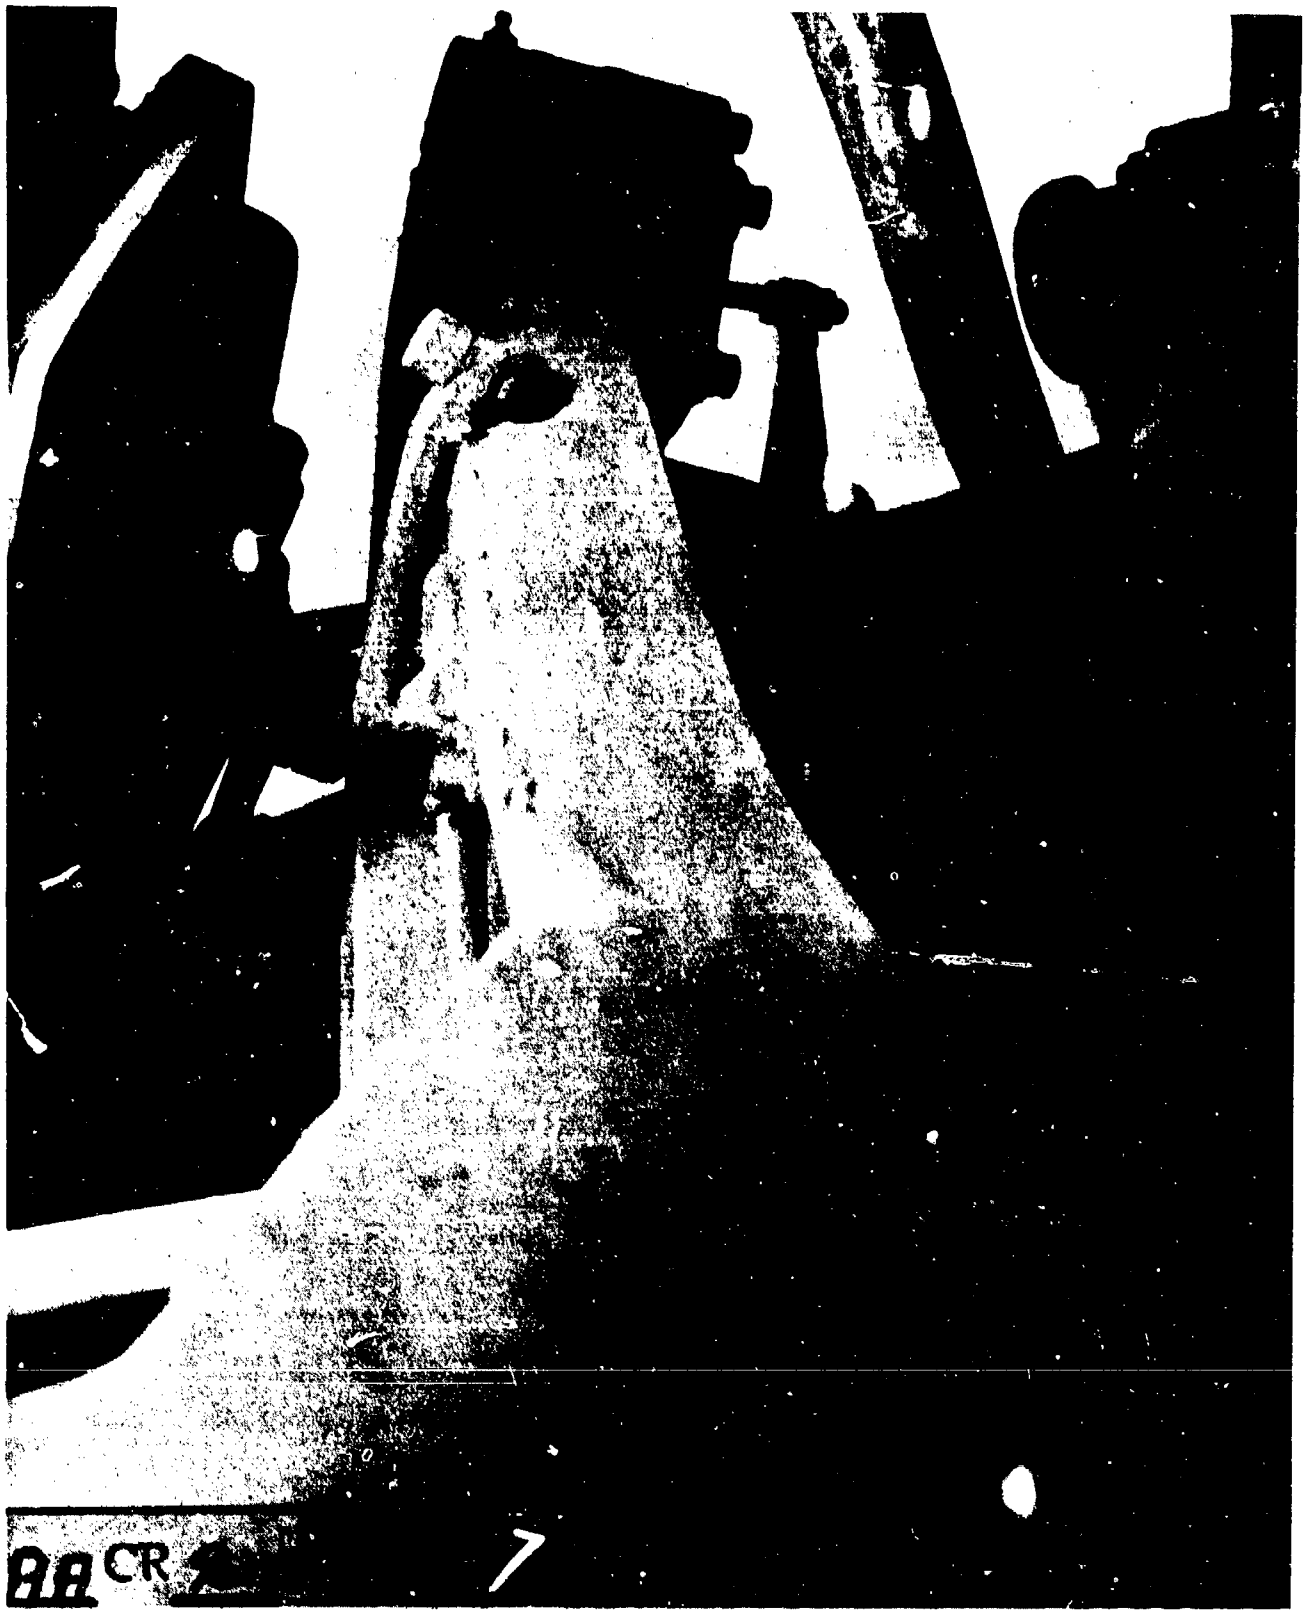
U.S.S. INDEPENDENCE (CVL-22) - After Able
Front view of 40 MM Twin No. 9 showing
the distortion of the left carriage check
and the displacement of the trunnion from
the trunnion housing.
Photo. No. AA-CR-92-1779-7.

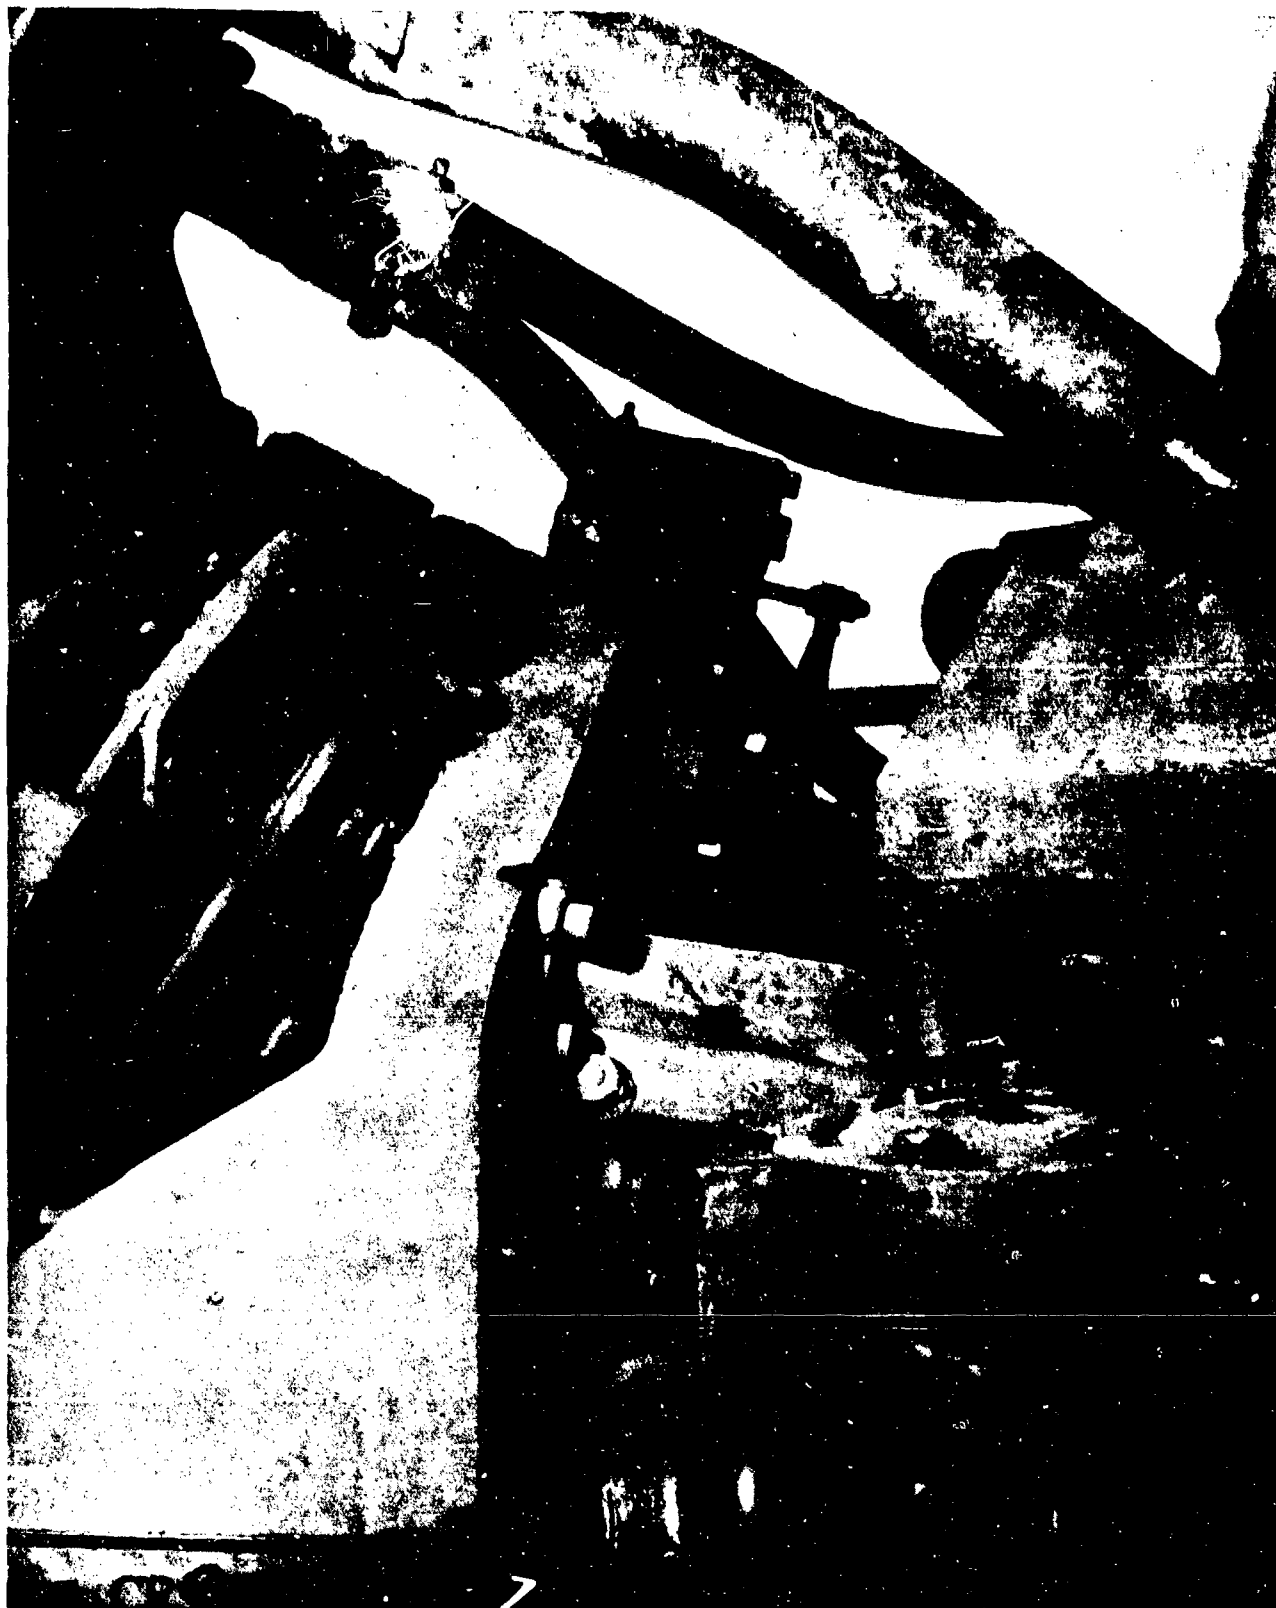
U.S.S. INDEPENDENCE (CVL-22) - After Able
Front view of 40 MM Twin Mt. No. 9
Showing the distorted left carriage check and
displaced trunnion. The bent elevating cam
follower can be seen against the carriage check.
Photo. No. AA-CR-92-1780-7.
