Technical Inspection Report
Bureau of Ordnance Group

6
OPERATION CROSSROADS.
TESTS 'A' AND 'B'.
VOLUME IV.
PART X. PHOTOGRAPHIC
APPENDIX [U] 8

GUNS AND MOUNTS PHOTOGRAPHIC INDEX

TEST "A" & "B"

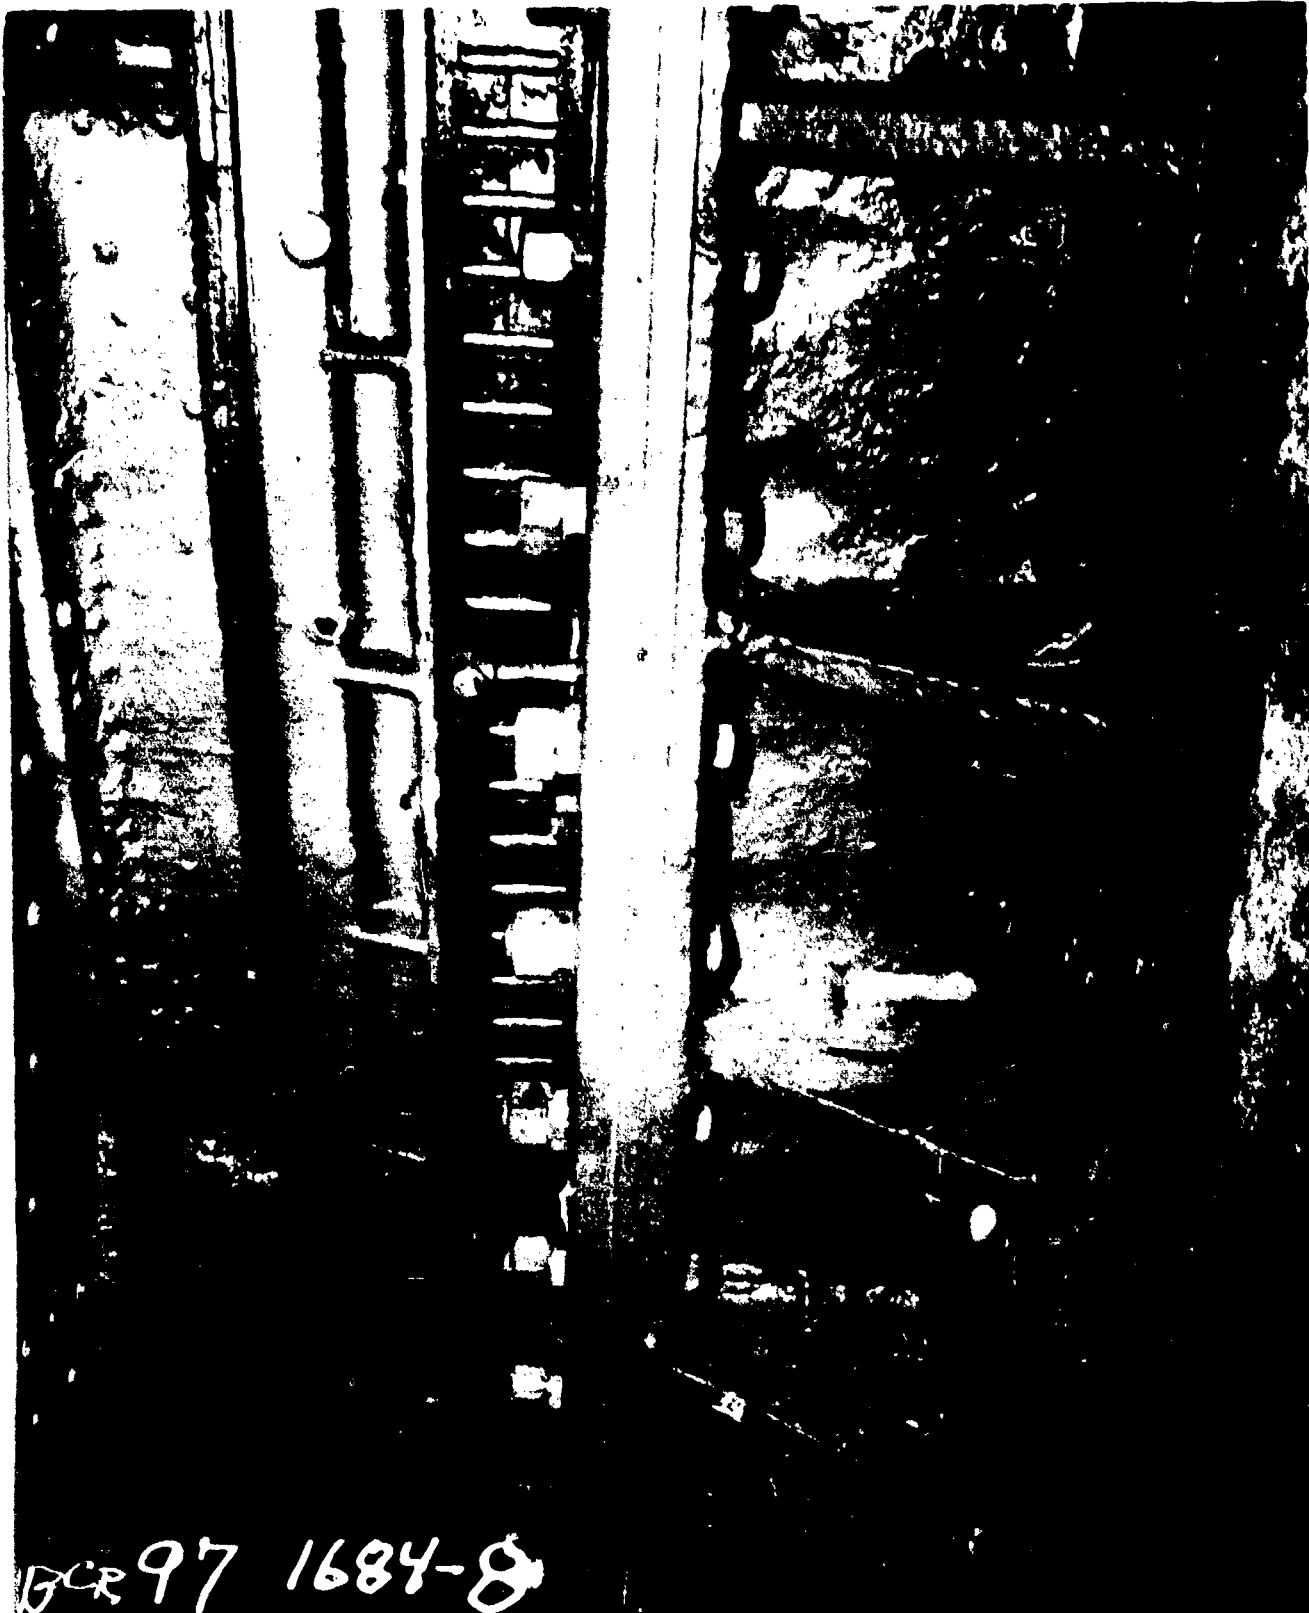
U.S.S. PENSACOLA (CA-24) - After Repair
Close up of the after port section of No. 2
Mt. Showing exposed Horizontal Thrust Bearings.
Photo. No. AB-CR-97-1684-8.

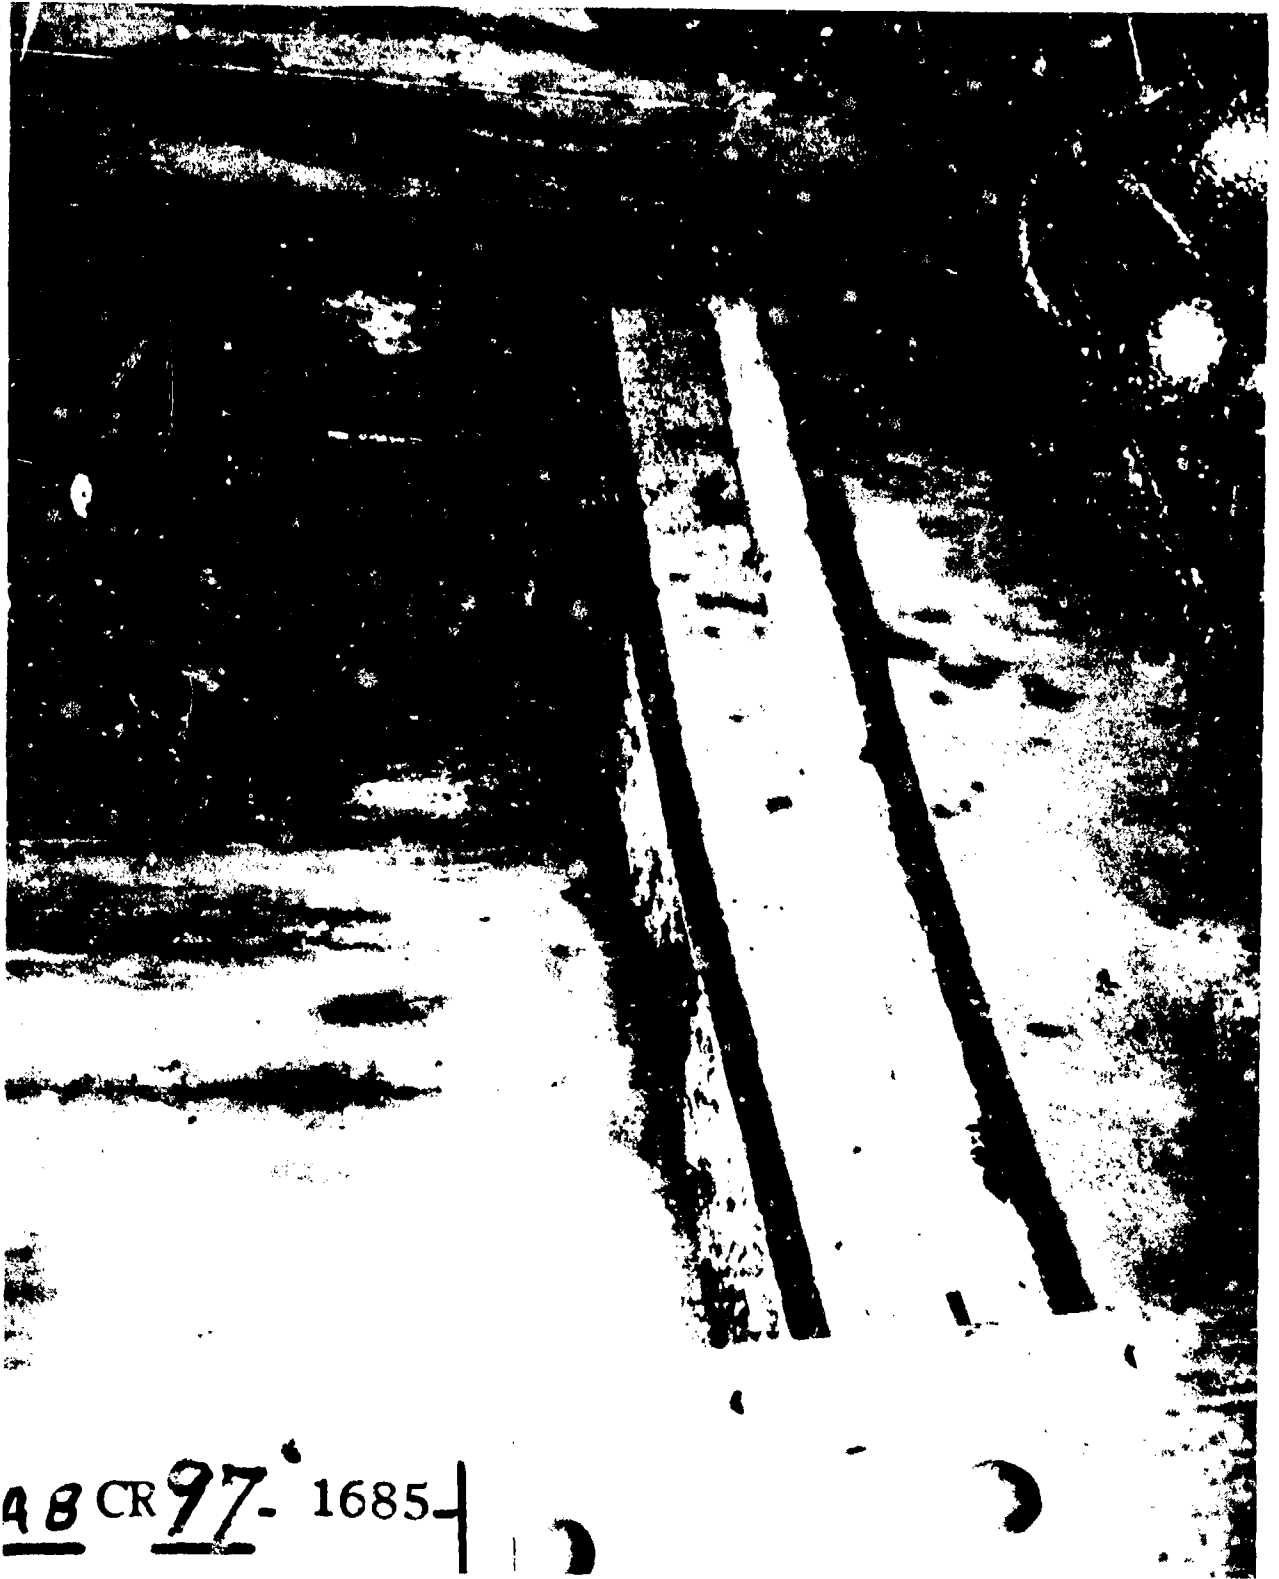
48 CR 97-1685

U.S.S. PINNACOLA (CA-22) - After taker
Close up of the fwd. end of the power
transfer room Mt. No. 2. Shows the
amount the deck was displaced and ball
bearing that fell from the train bearing
assembly.
Photo. No. AB-CR-97-1685-2.

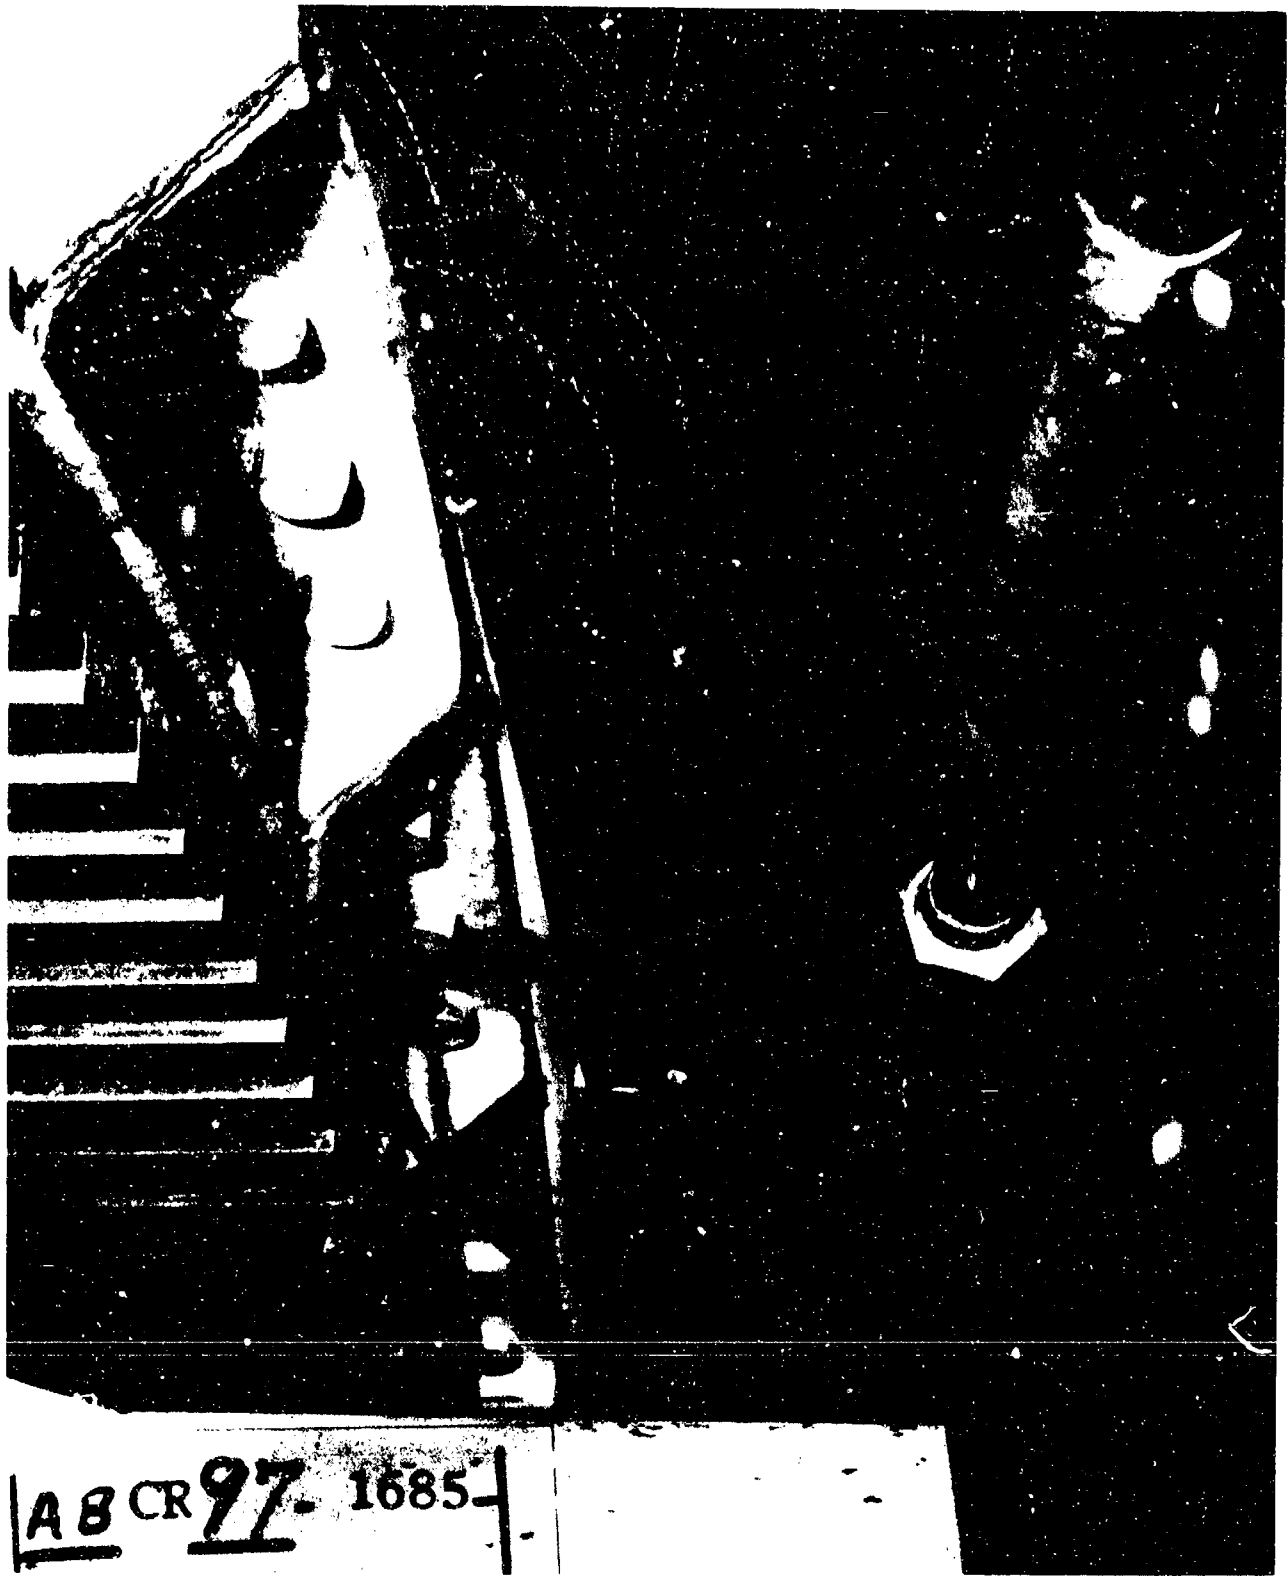
U.S.S. PENSACOLA (CA-24) - After Baker
Close up of training rack and support flange
in 8th/55 Mt. No. 2. Showing how the flange
was torn by the downward force of the
training rack.
Photo. No. AB-CR-97-1685-7.

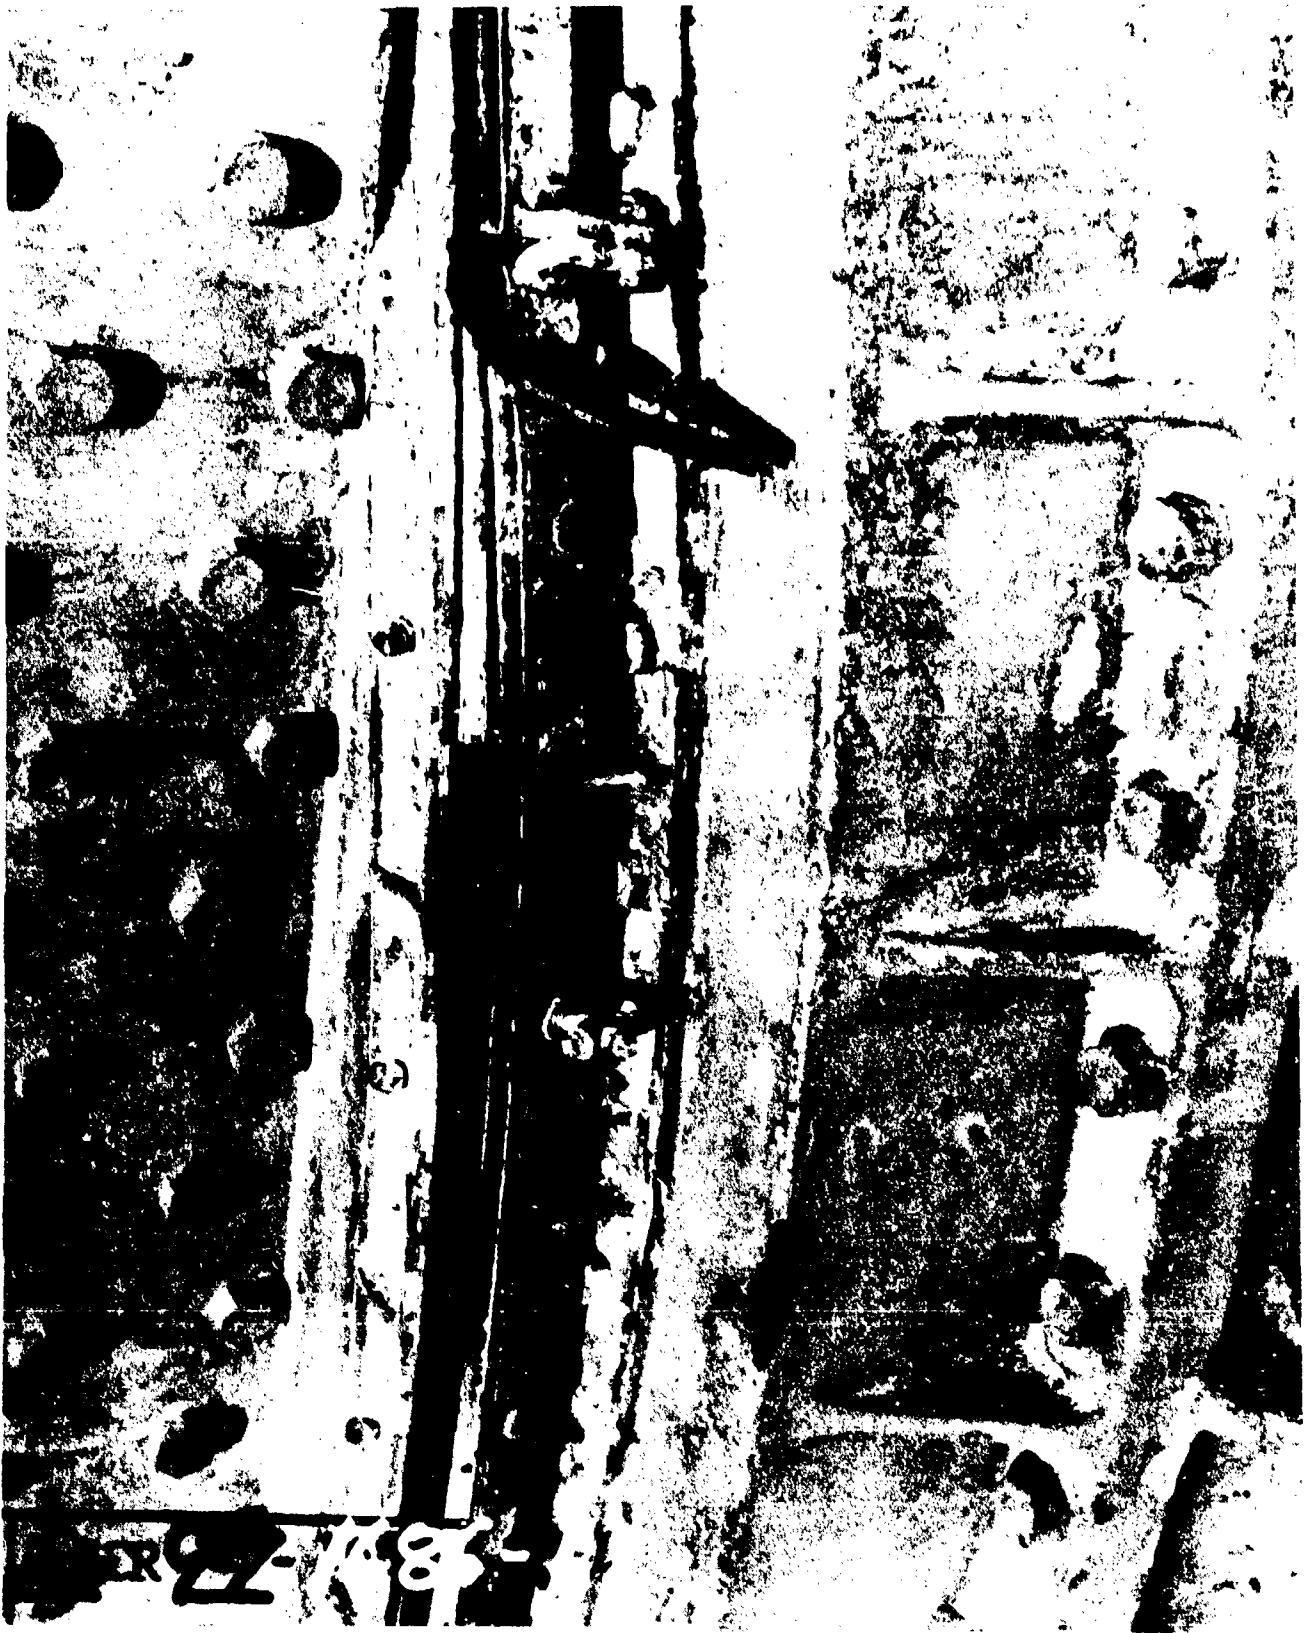
U.S.S. PENSACOLA (CA-24) - After Baker
Close up view of port side weather seal of
8"/55 Cal. Mt. No. 1 showing displaced
weather seal packing.
Photo. No. AB-CR-97-1686-1.

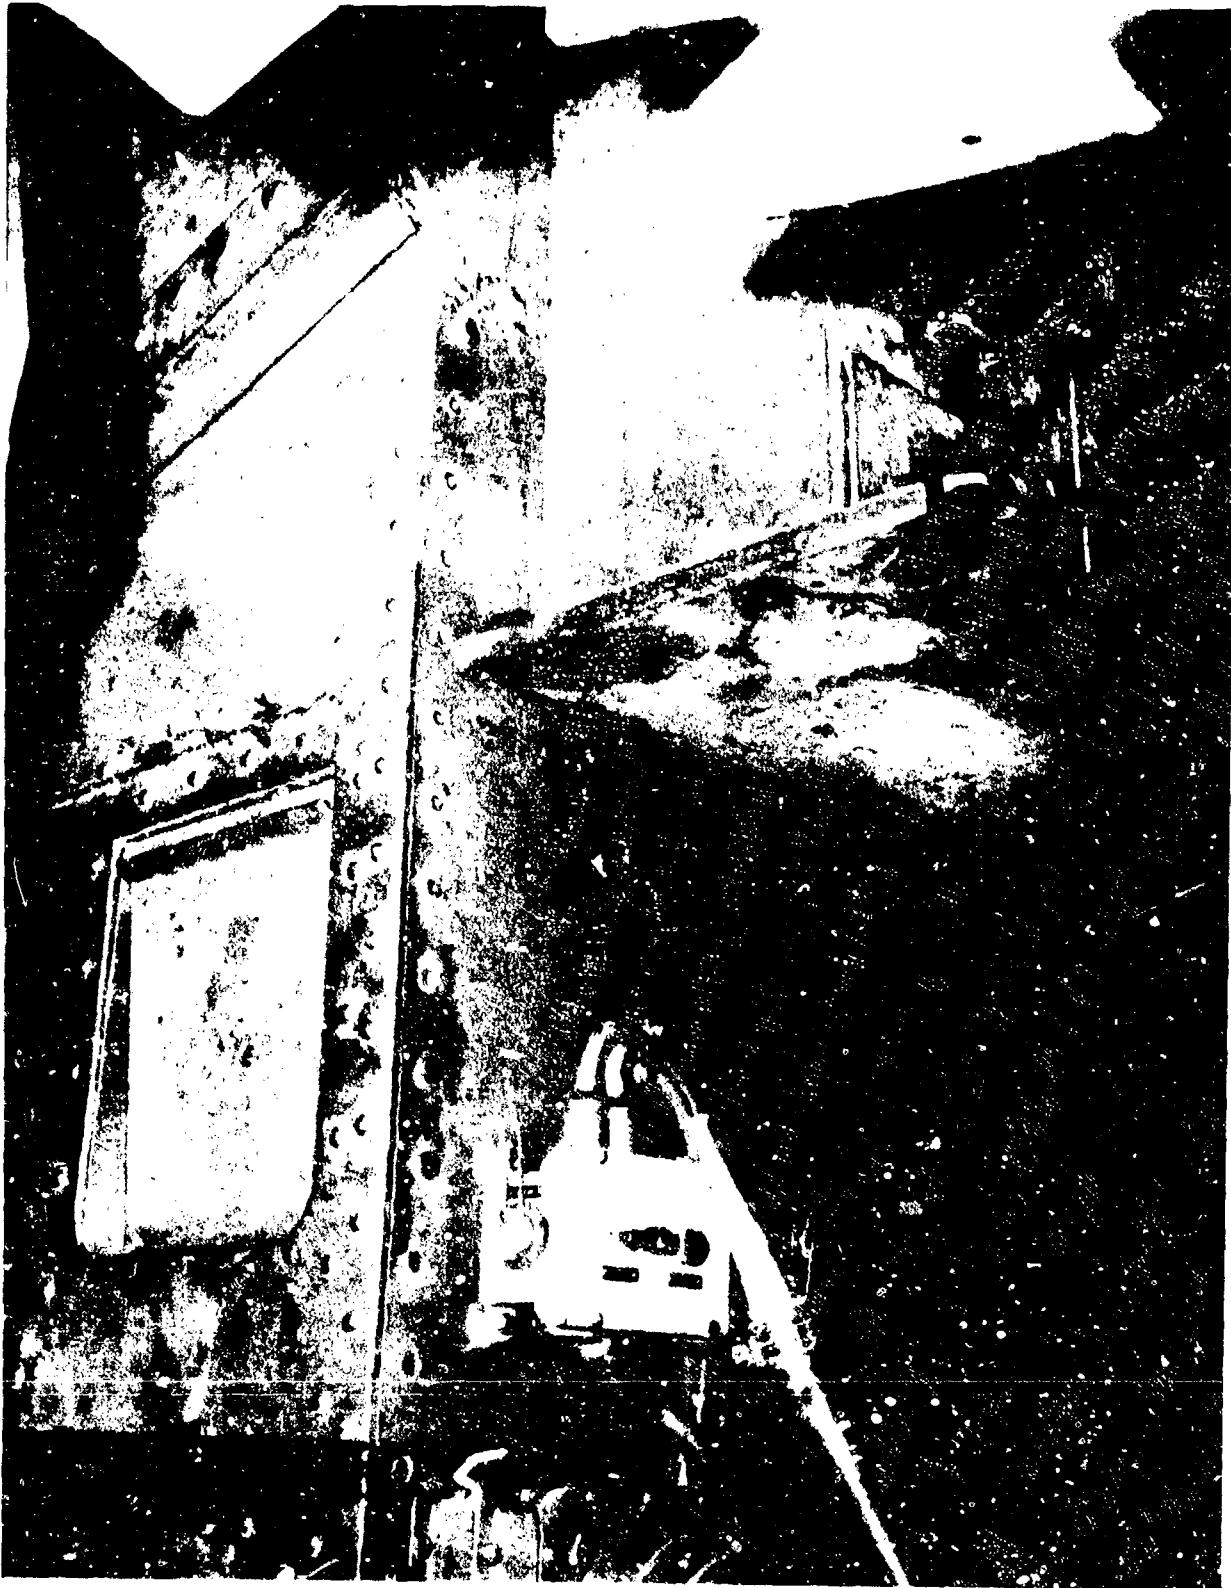
U.S.S. PENSACOLA (CA-24) - After Baker
General view of the left upper Powder
Transfer Trunk 8"/55 Cal. Mt. No. 1
showing ruptured bulkhead and sheared
bulkhead bolts.
Photo. No. AB-CR-97-1686-5.

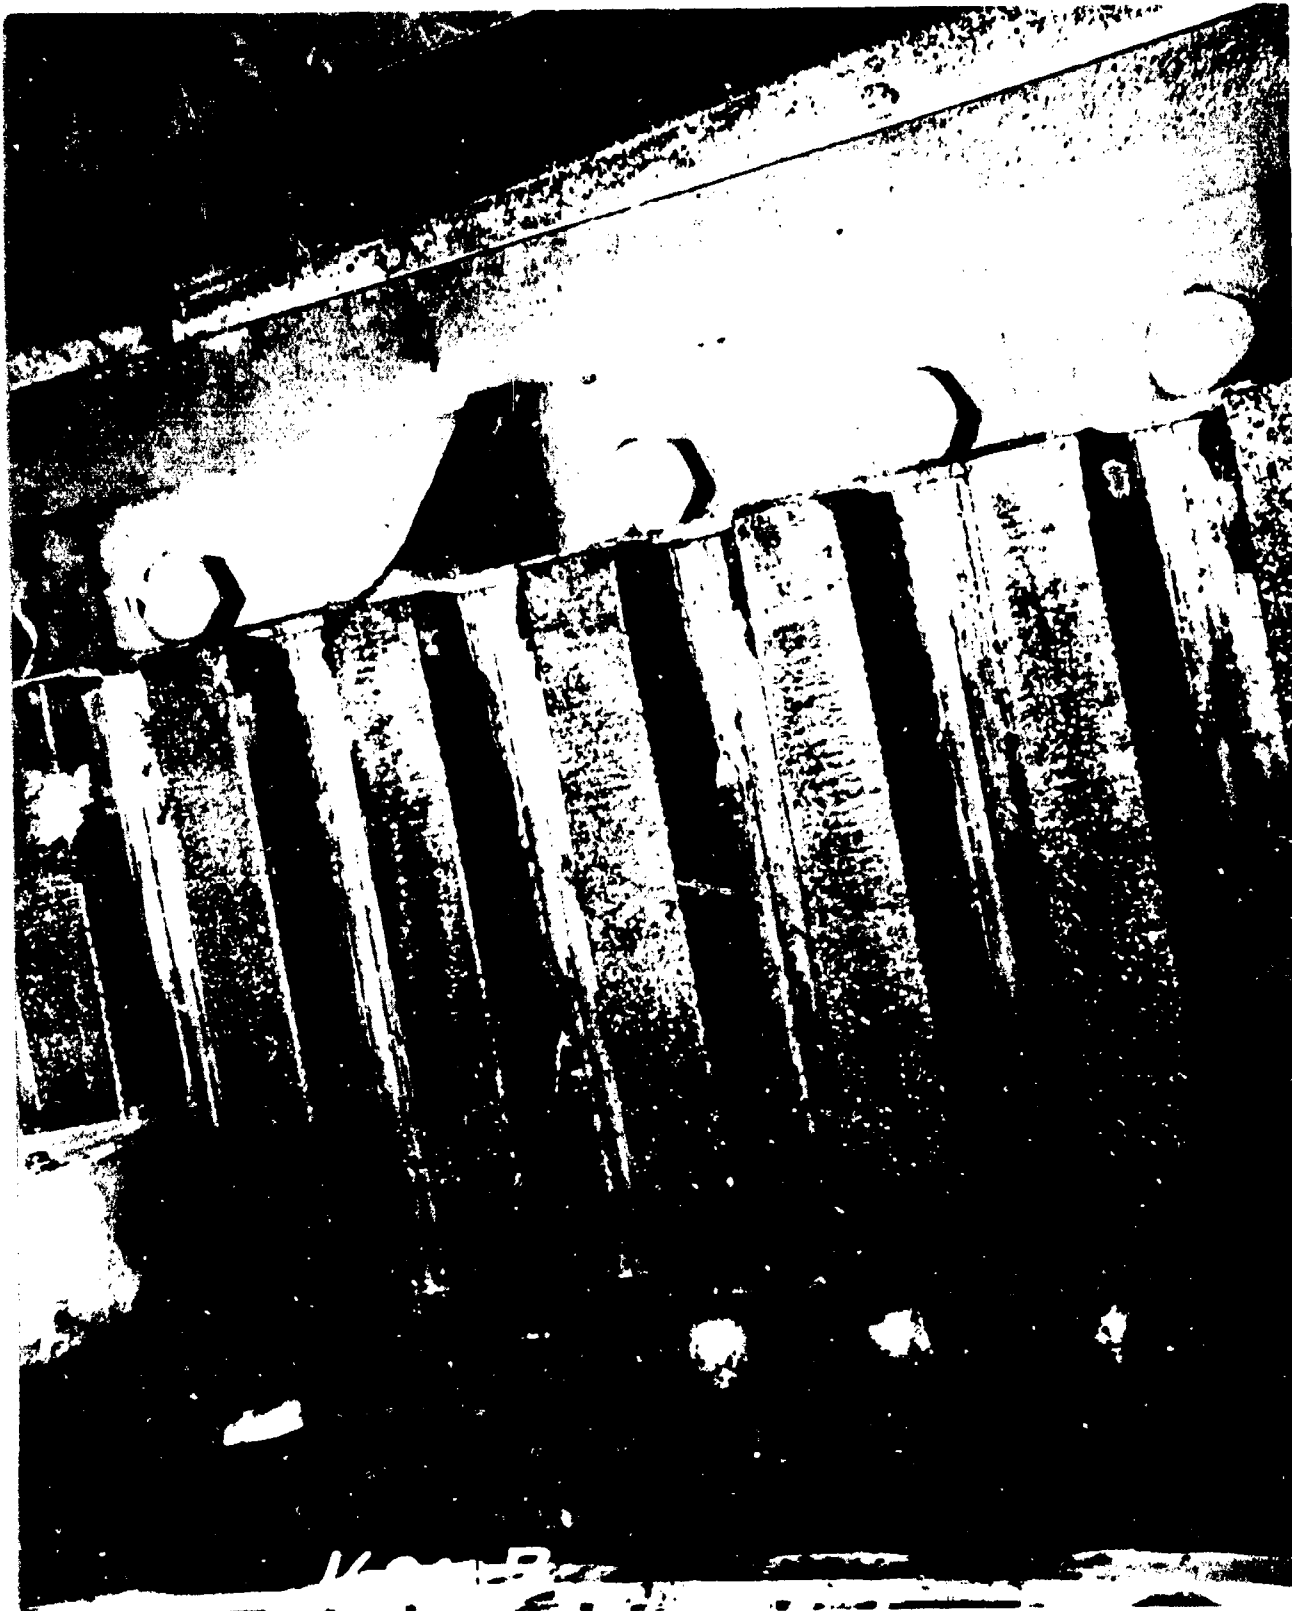
U.S.S. POLARIS (CR-3) - After locker
Close up view of training rack in 8"/5 Cal.
Mt. No. 1 showing displaced and over lapping
of the Ball races.
Photo. No. AI-CR-97-1686-7.

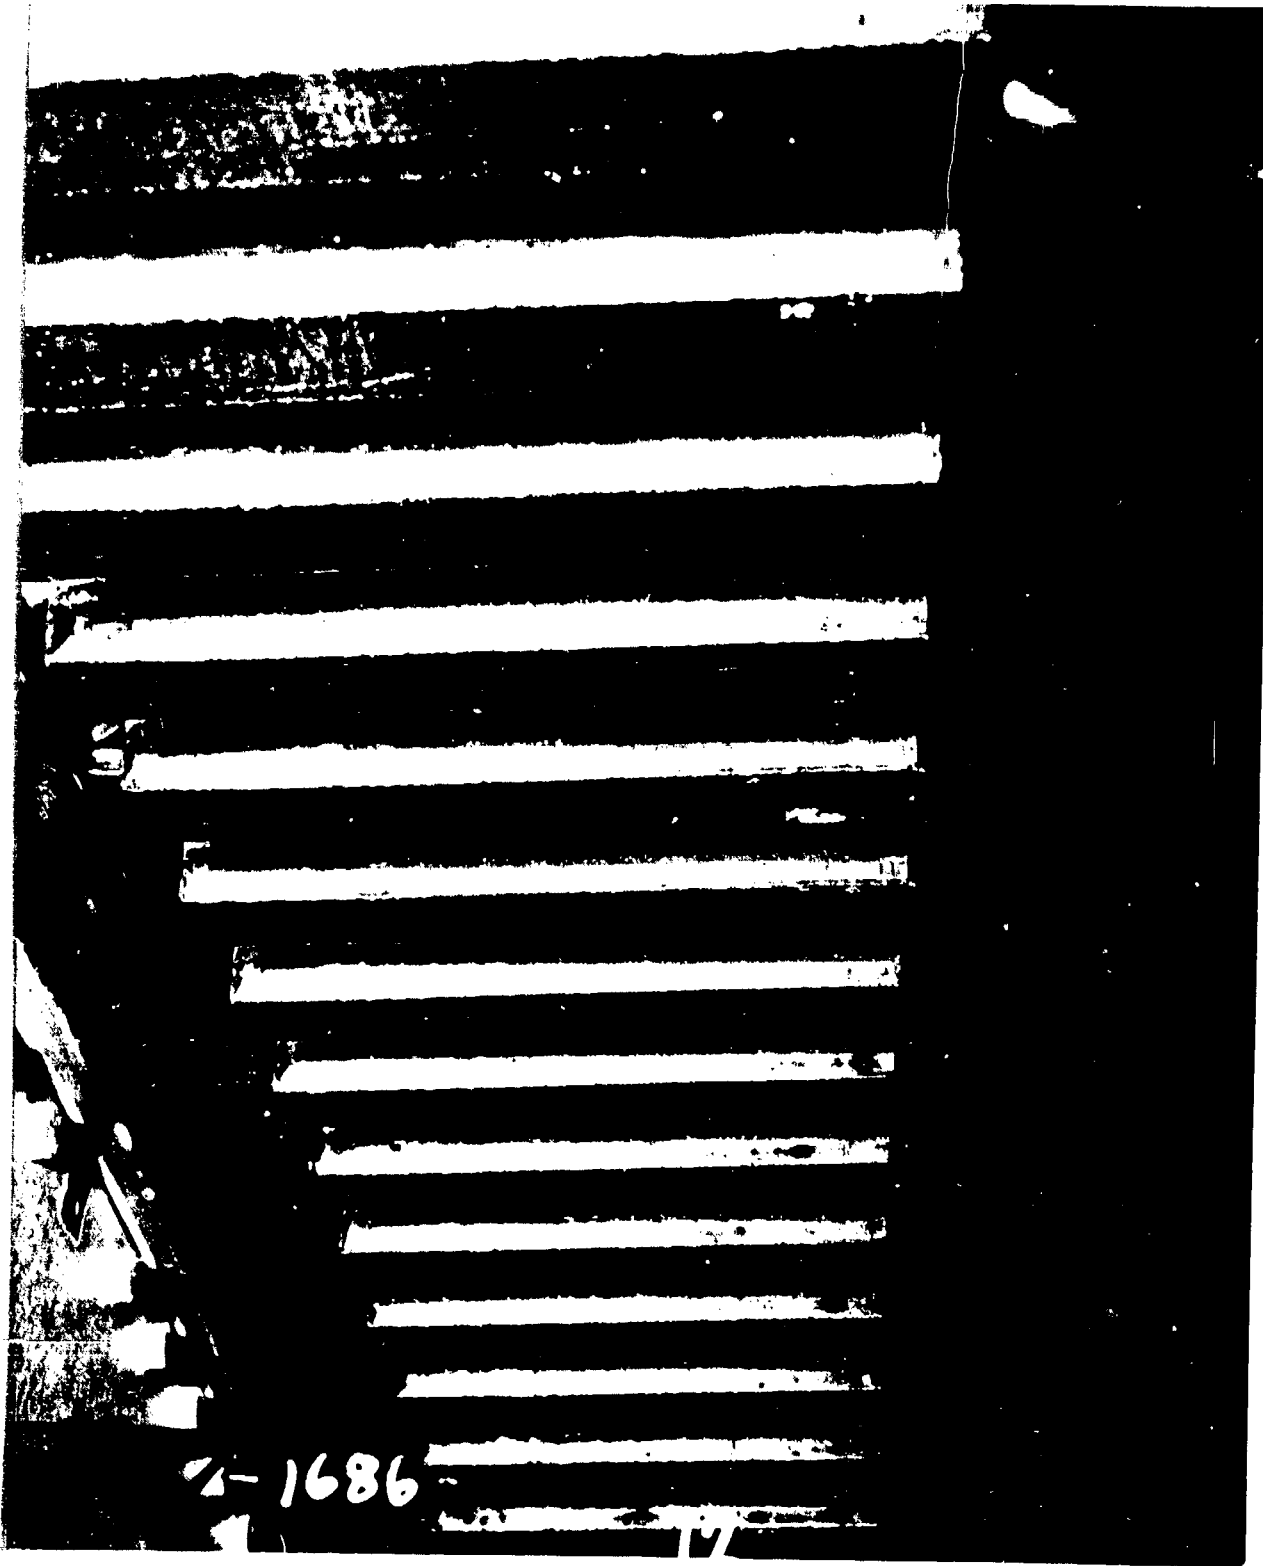
U.S.S. PENSACOLA (CA-24) - After Able
Close up of training rack in 8"/55 Cal.
Mt. No. 1. Showing exposed balls and
ball races.
Photo. No. AB-CR-97-1686-12.

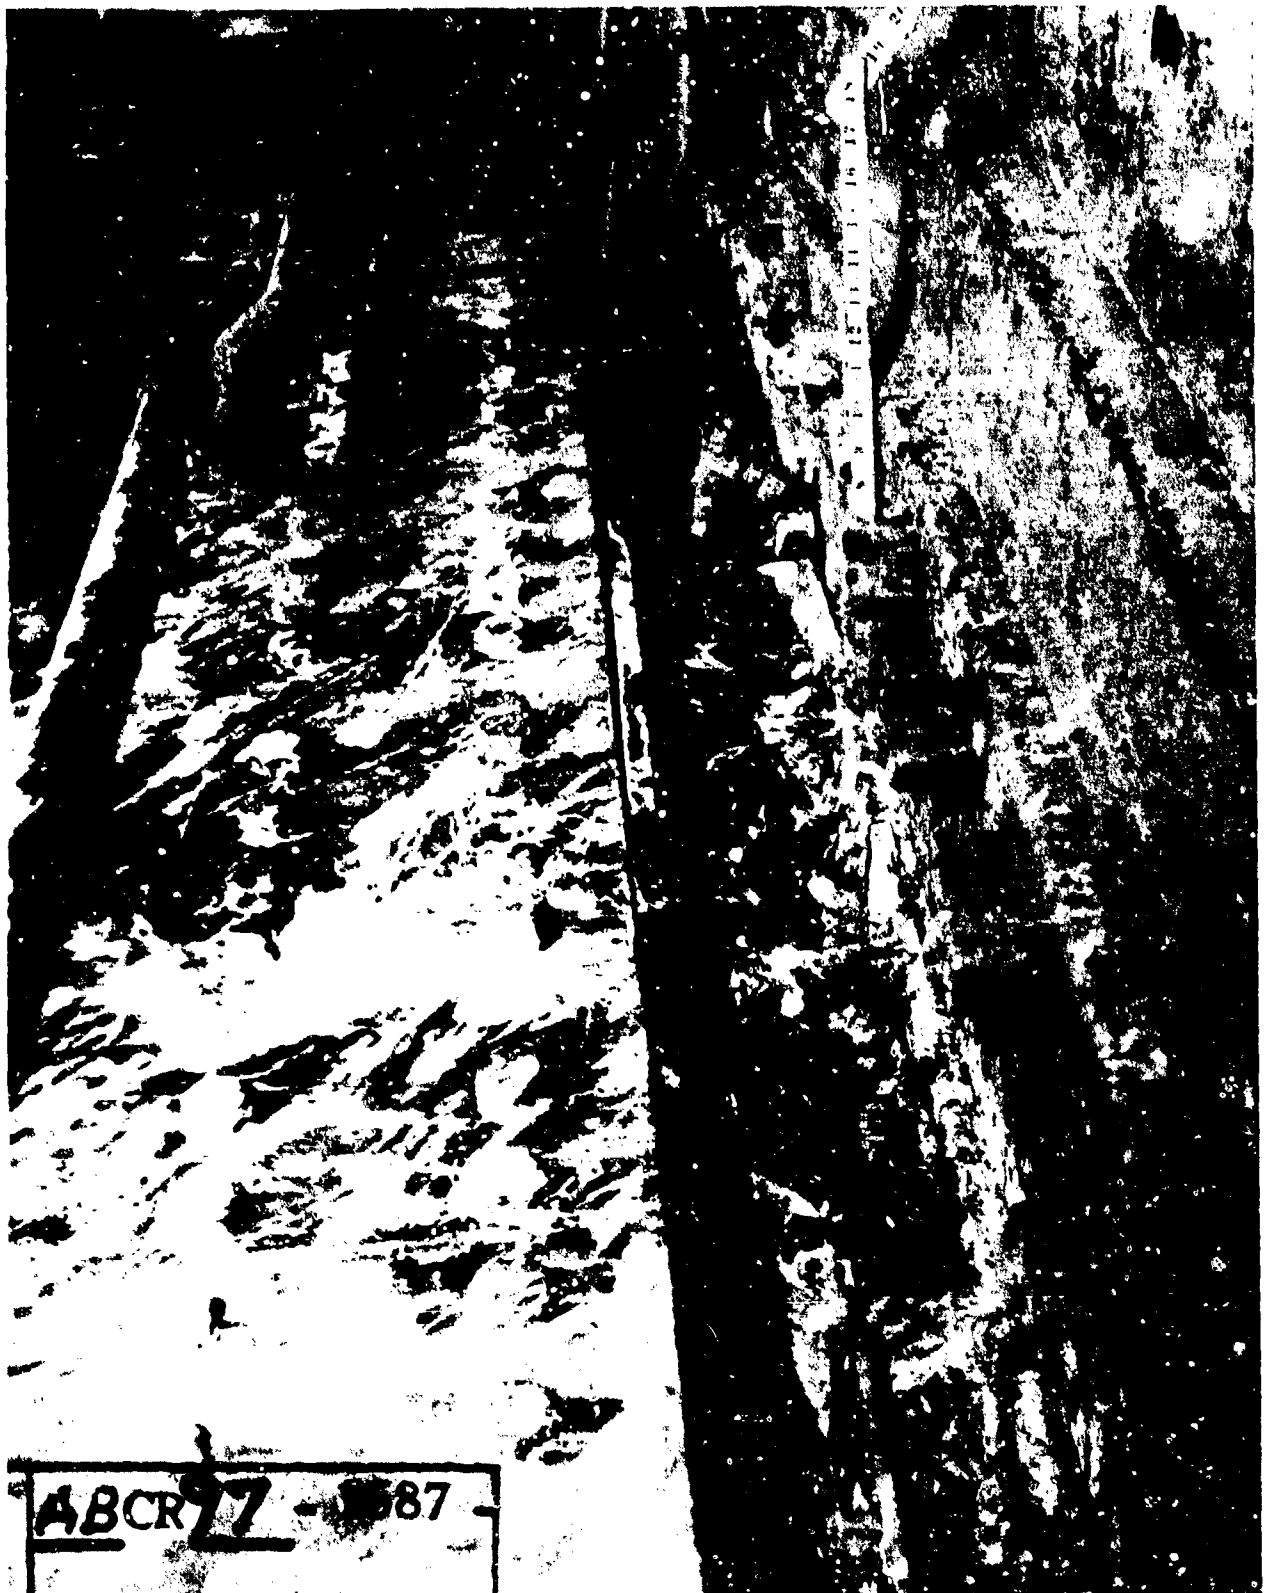
J.S.S. PENSACOLA (CA-24) - After Baker
General view of the port Fwd. section of
weather seal Mt. No. 3. Showing exposed
weather seal packing and crushed weather
seal housing.
Photo. No. AB-CR-97-1687-3.

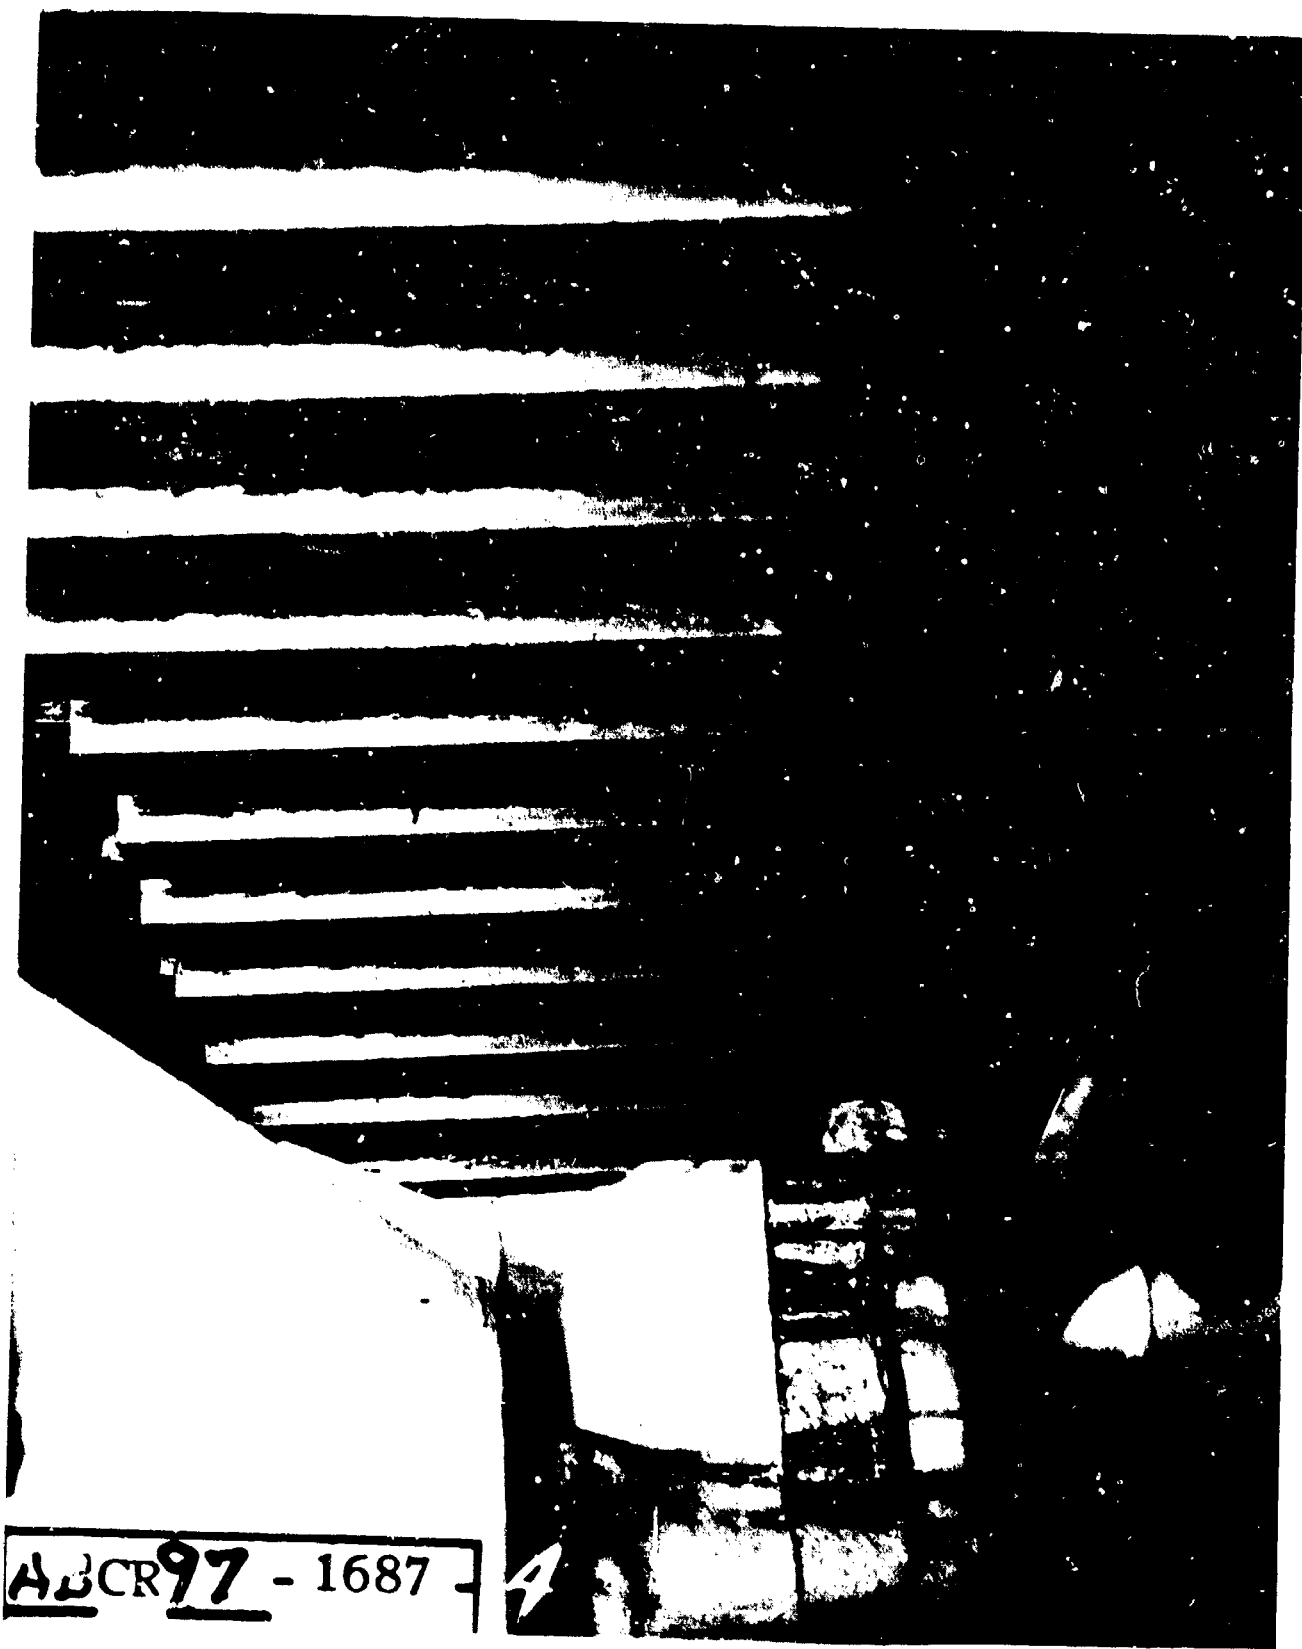
U.S.S. PENSACOLA (CA-24) - After Baker
Close up view of the training rack, Mt.
No. 3. Showing where the training rack
shifted upward.
Photo. No. Ab-Cr-97-1687-4.

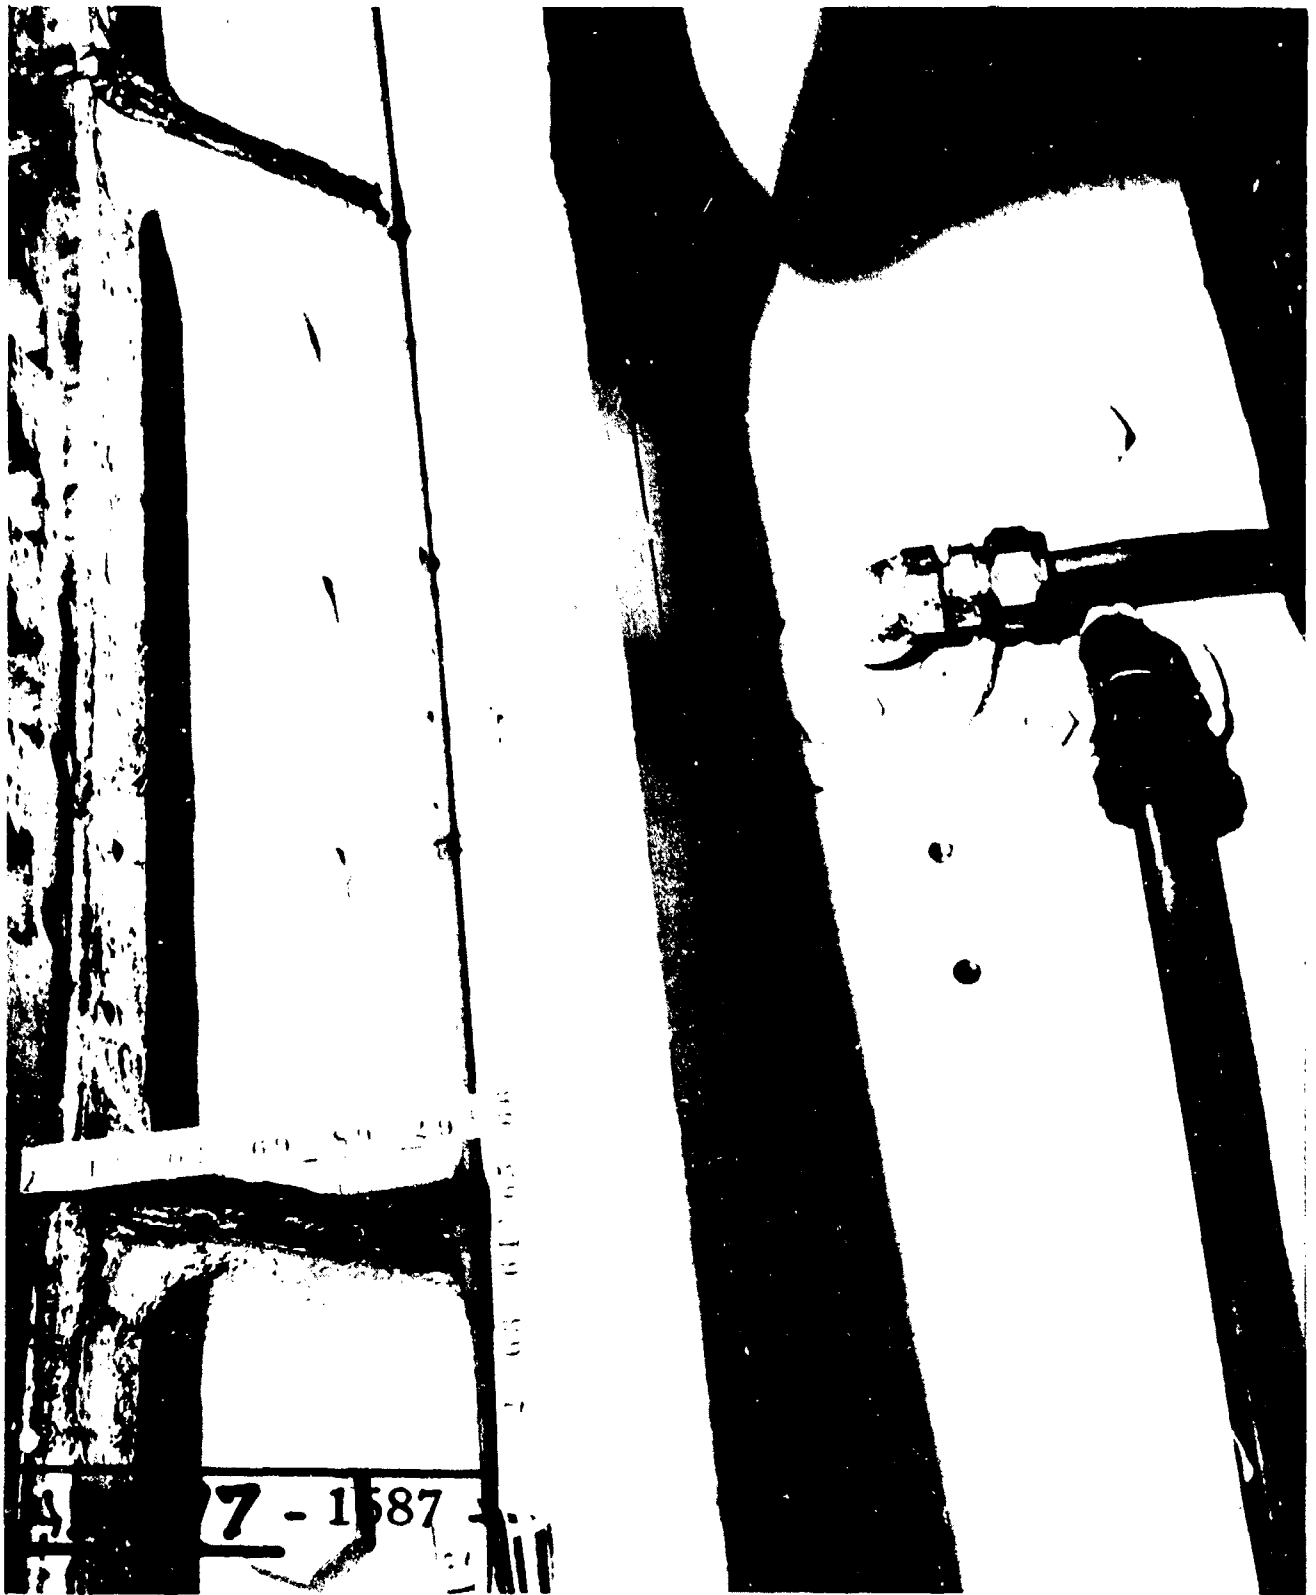
U.S.S. PERISACOLA (CA-4) - After dayer
Close up view of the training rack of
Mt. No. 3. Showing the amount the Fwd.
center line section of the training rack
shifted upward.
Photo. No. AB-CR-97-1687-5.

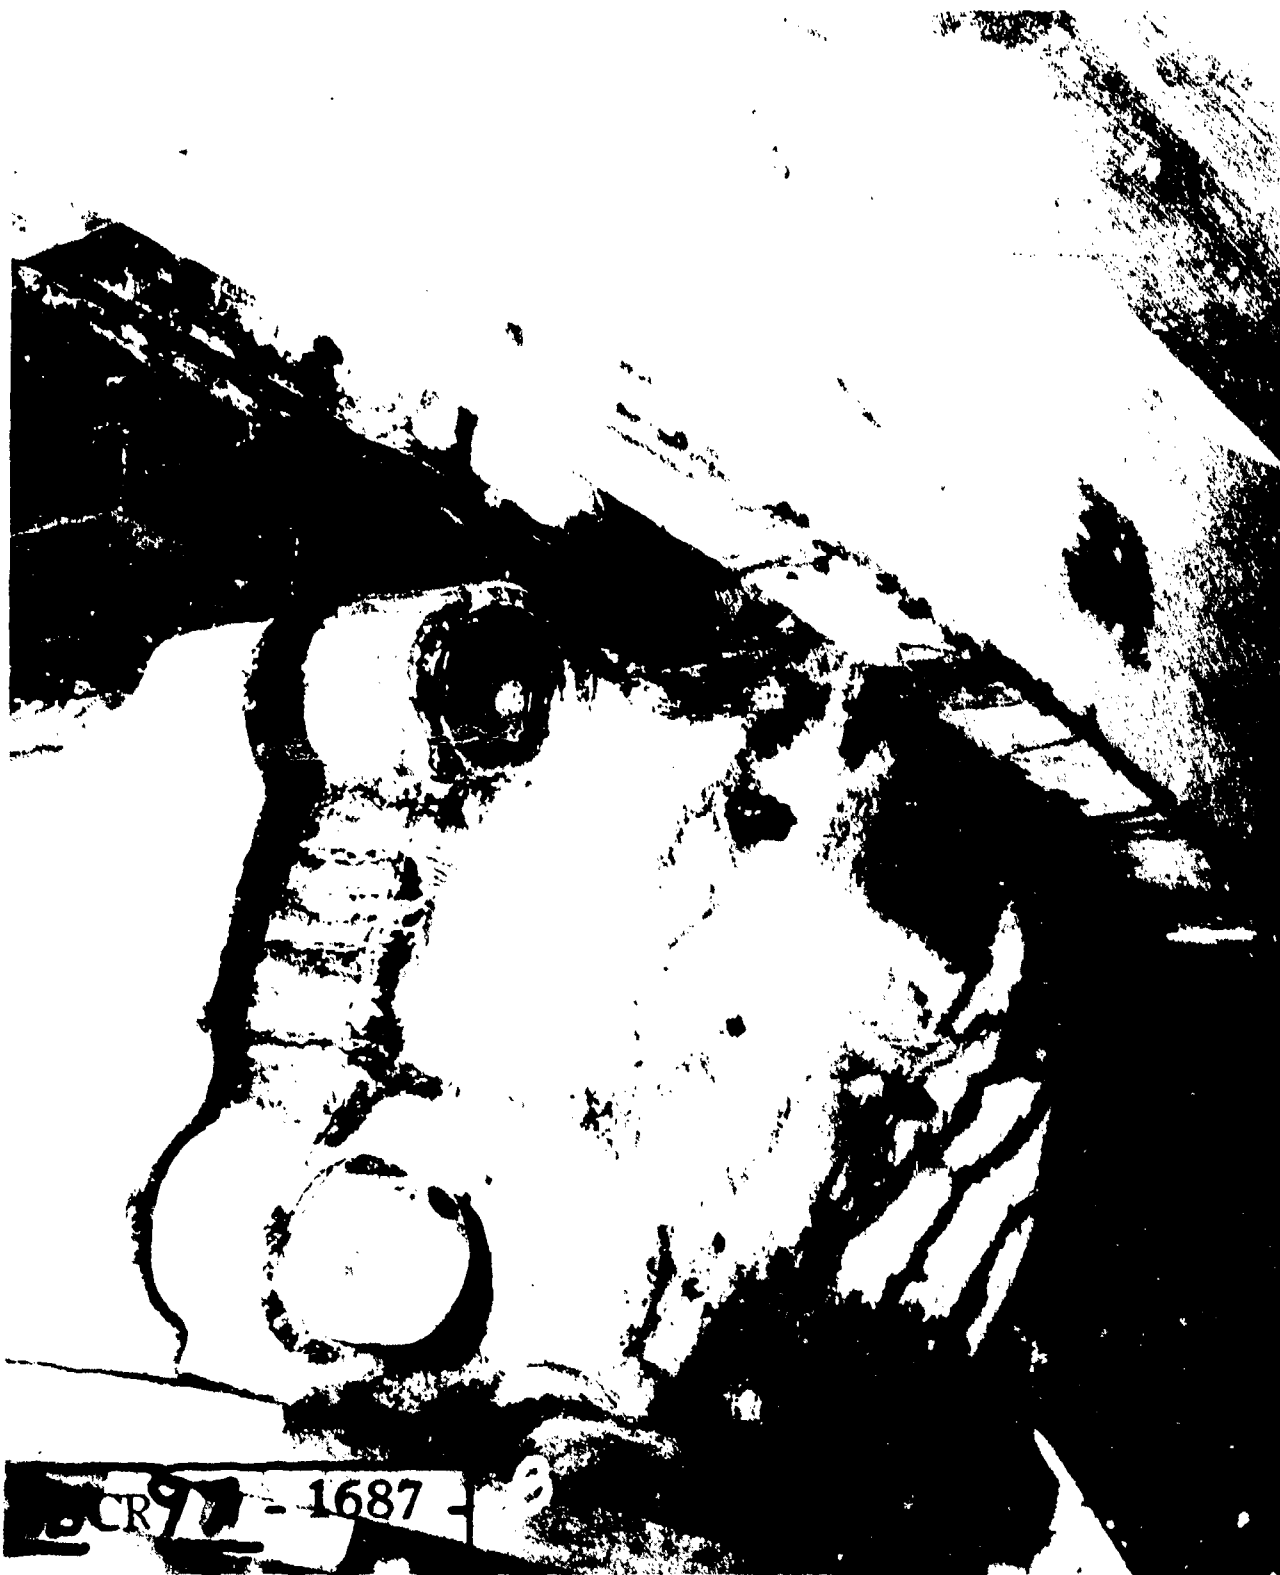
U.S.S. FERRACOLA (CR-21) - AFTER ACTION
Close up view of the lower train pinion
housing plate of Mt. No. 4. Showing
the missing bolt.
Photo. No. AB-CR-97-1687-2.
