Technical Inspection Report
Bureau of Ordnance Group

6
OPERATION CROSSROADS.
TESTS 'A' AND 'B'.
VOLUME IV.
PART X. PHOTOGRAPHIC
APPENDIX [U] 8

GUNS AND MOUNTS PHOTOGRAPHIC INDEX

TEST "A" & "B"

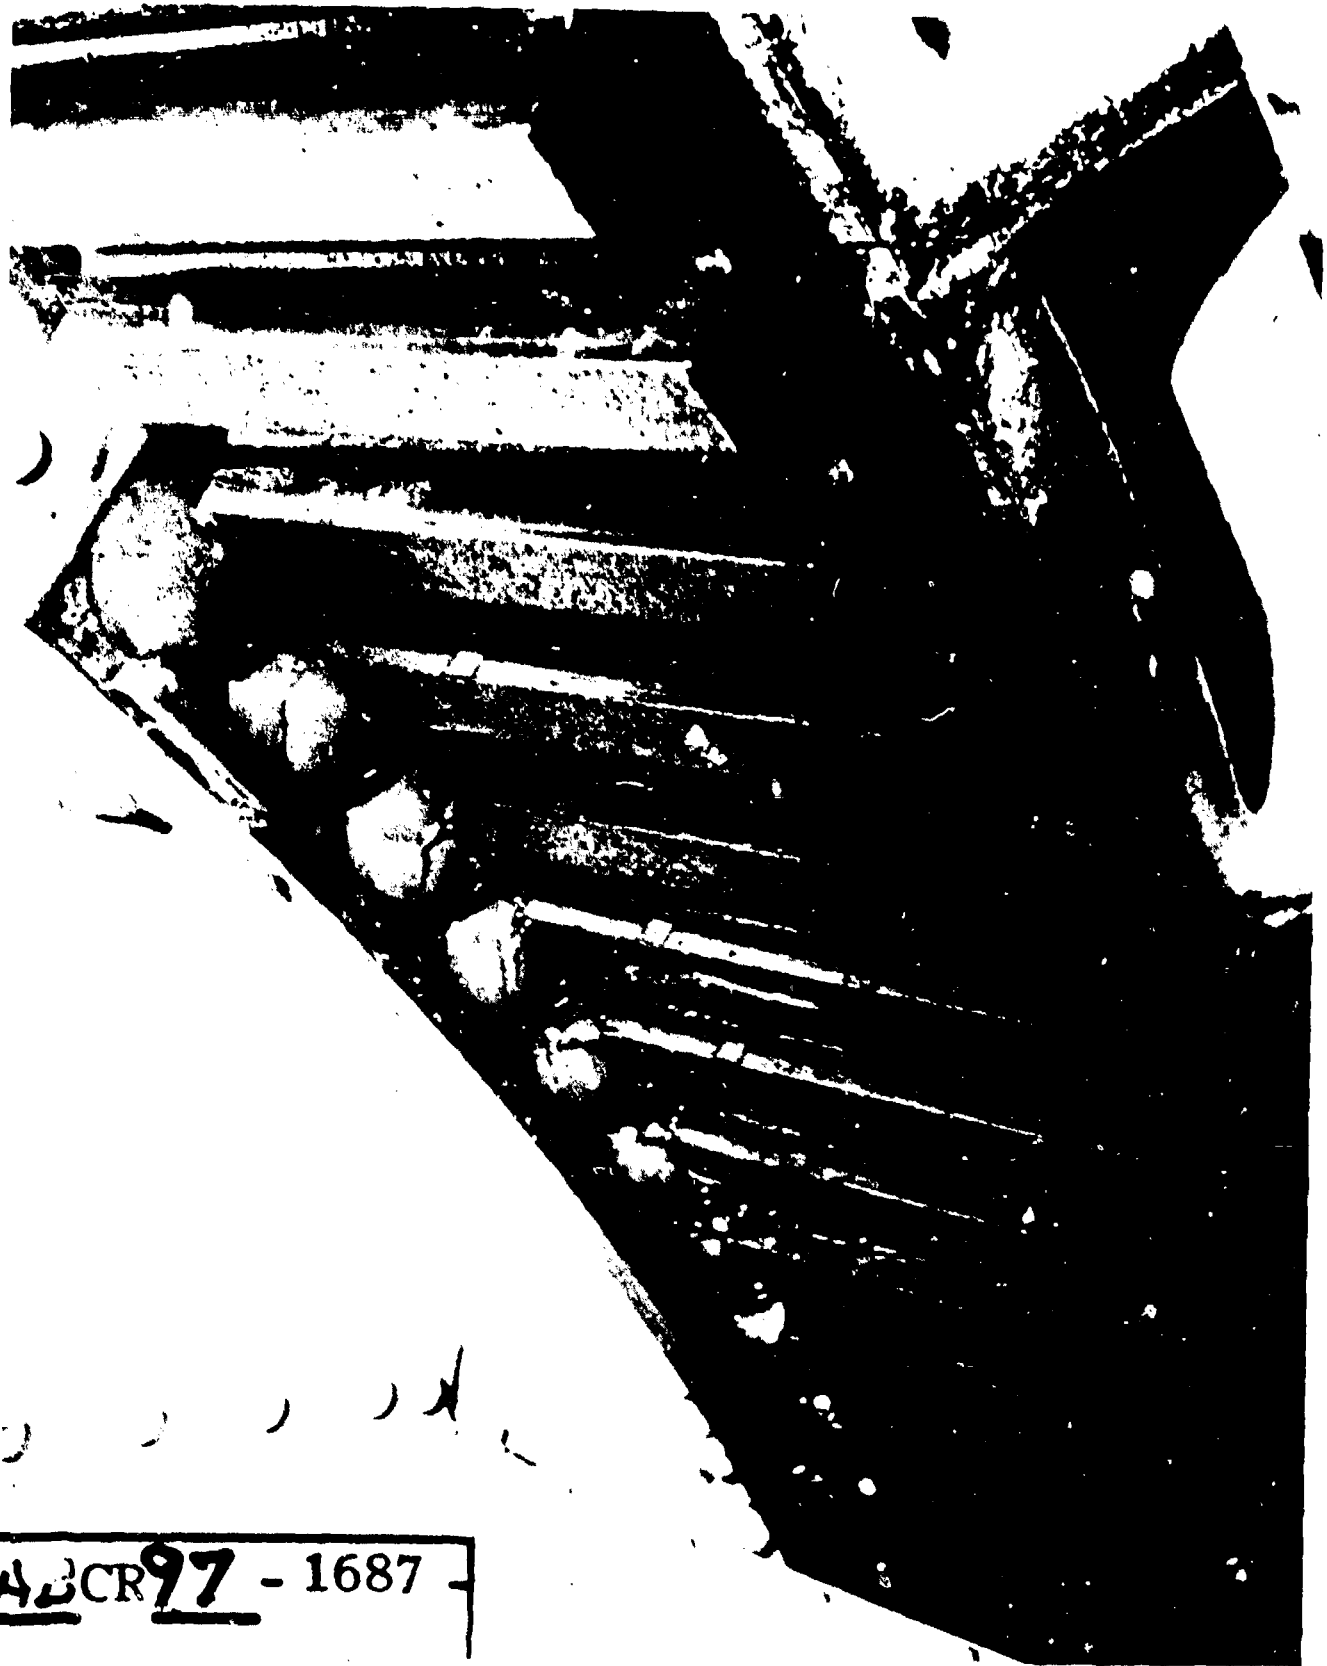
U.S.S. PENACOLA (CA-24) - After Baker
Close up view of after stbd. section of
No. 4 Mt. Showing exposed balls and ball
race.
Photo. No. AB-CR-97-1687-9.

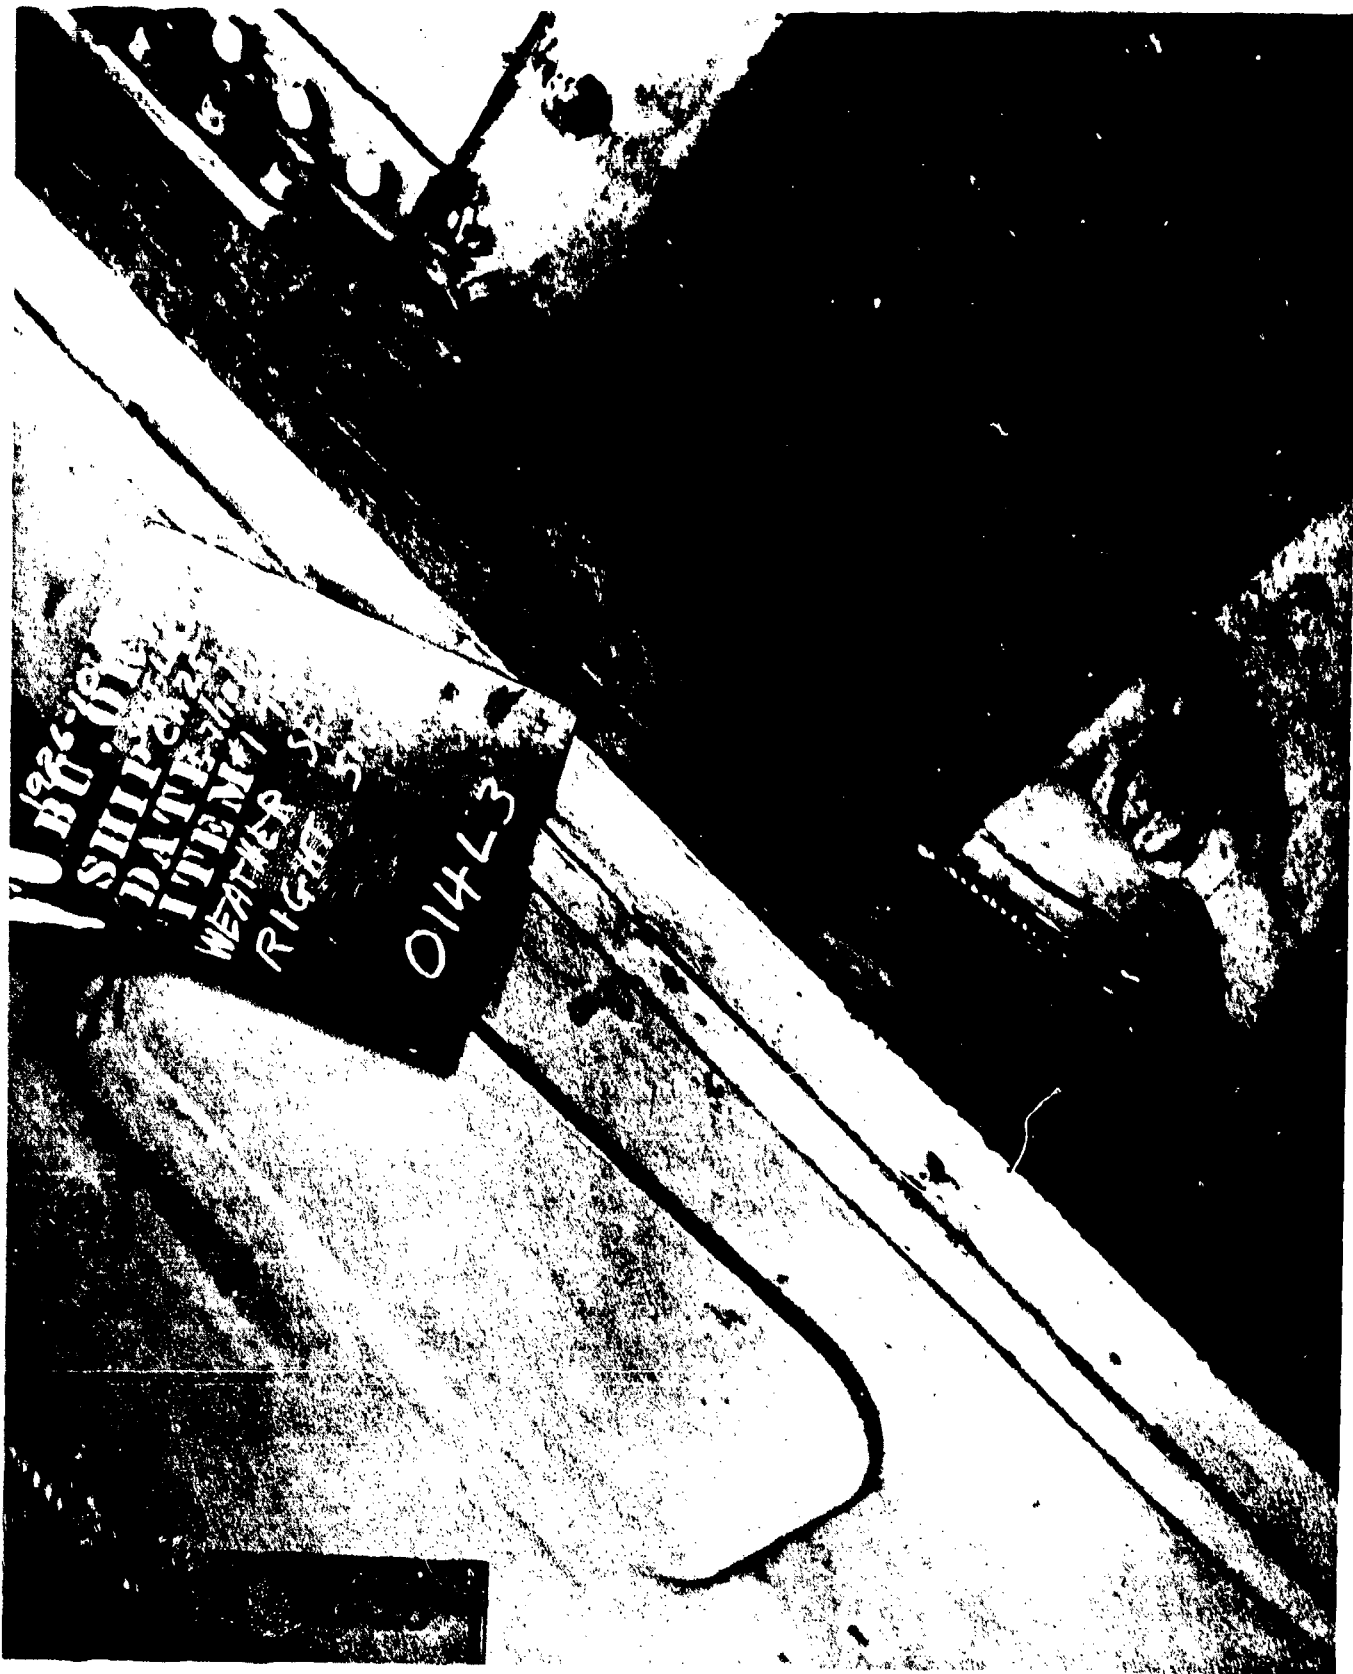
U.S.S. SALT LAKE CITY (CA-25) - After Able
View of 8"/55 Mt. No. 1 showing the blown
out weather seal, right side.
Photo. No. AA-CR 76-1926-10.

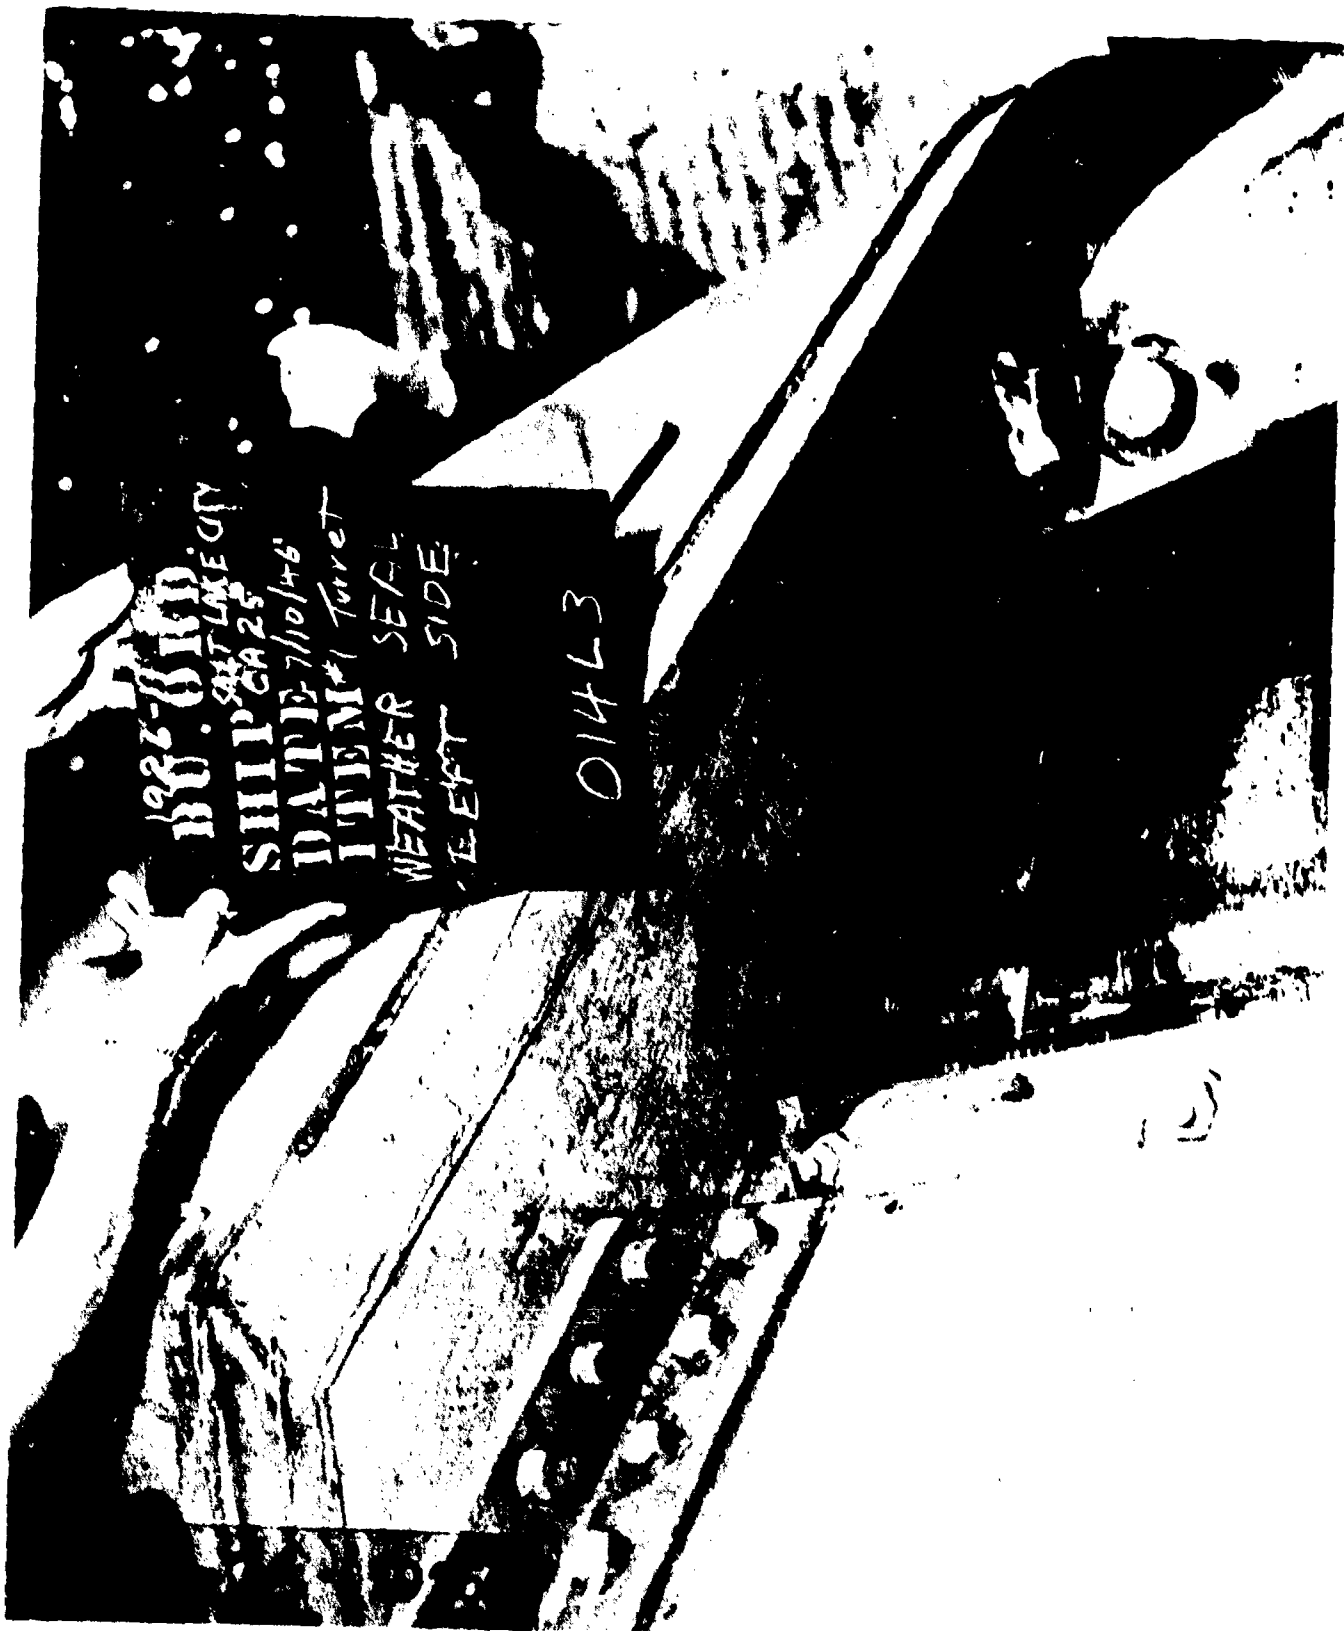
U.S.S. SALT LAKE CITY (CA-25) - After Able
View of 8th/55 Mt. No. 1 showing the blown
out weather seal, left side.
Photo. No. AA-CR-76-1926-11.

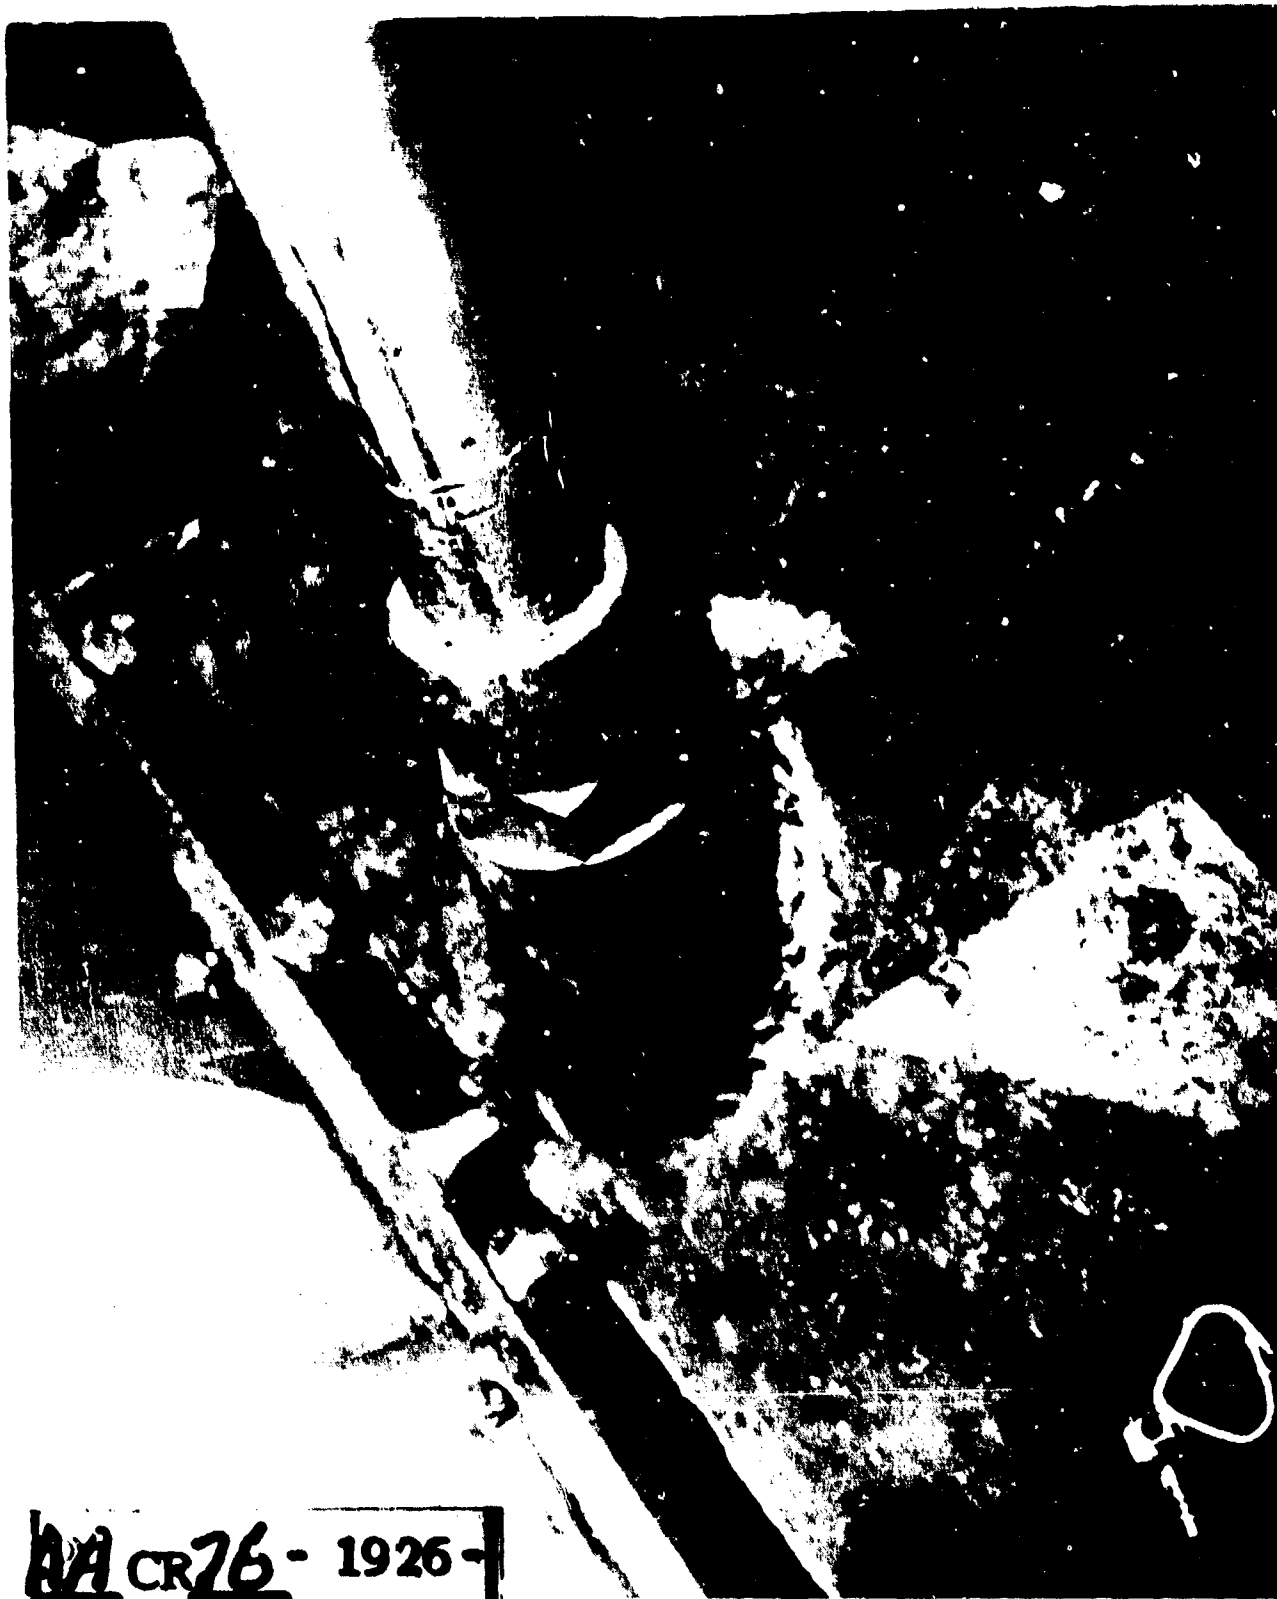
AA CR76 - 1926 -

U.S.S. SALT LAKE CITY (CA-25) - After Able
Interior view of 8th/55 Mt. No. 1 showing the
cracked and chipped paint on the lower end of
the adjustable turnbuckle, pointer's side.
Photo. No. AA-CR-76-1926-12.

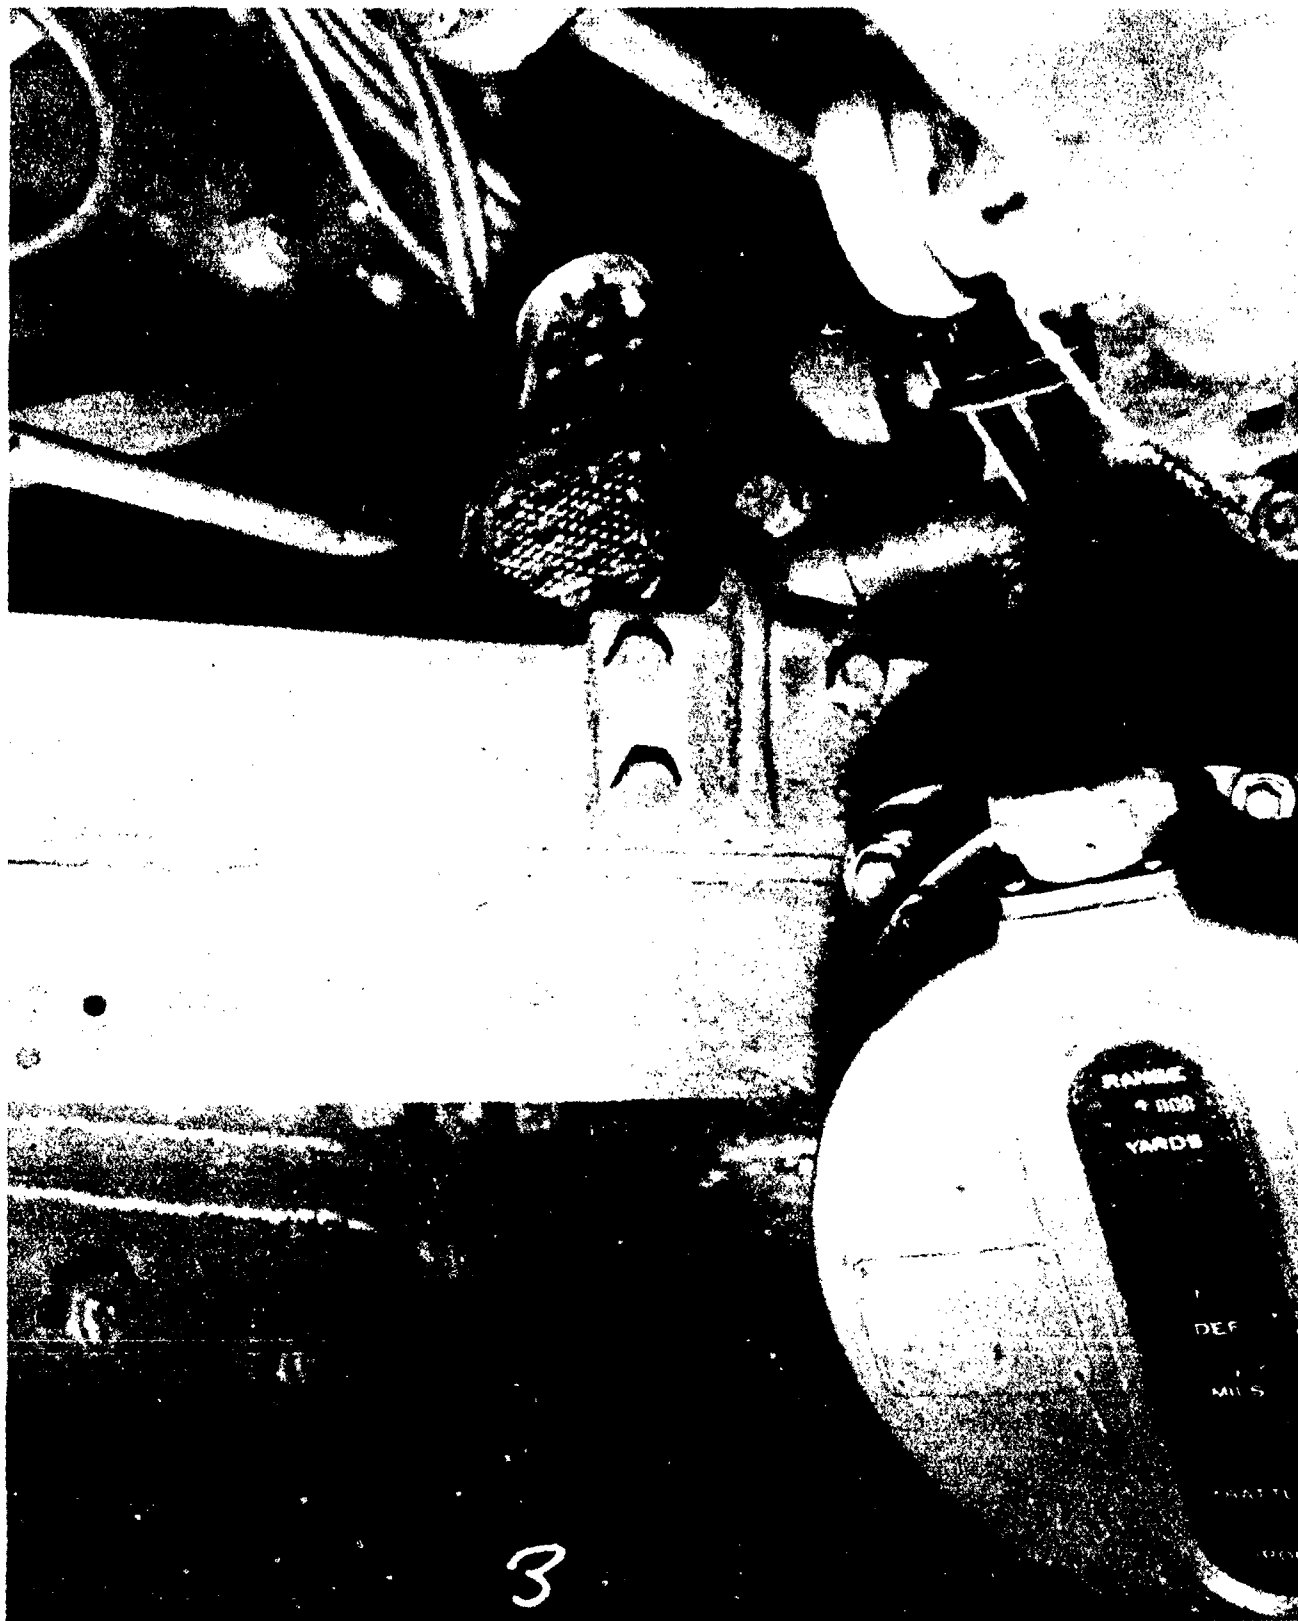
U.S.S. SALT LAKE CITY (CA-25) - After Able
Interior view of 8th/55 Mt. No. 1 showing the
cracked paint on the deck lug support, pointer's side.
Photo. No. AA-CR-76-1927-3.

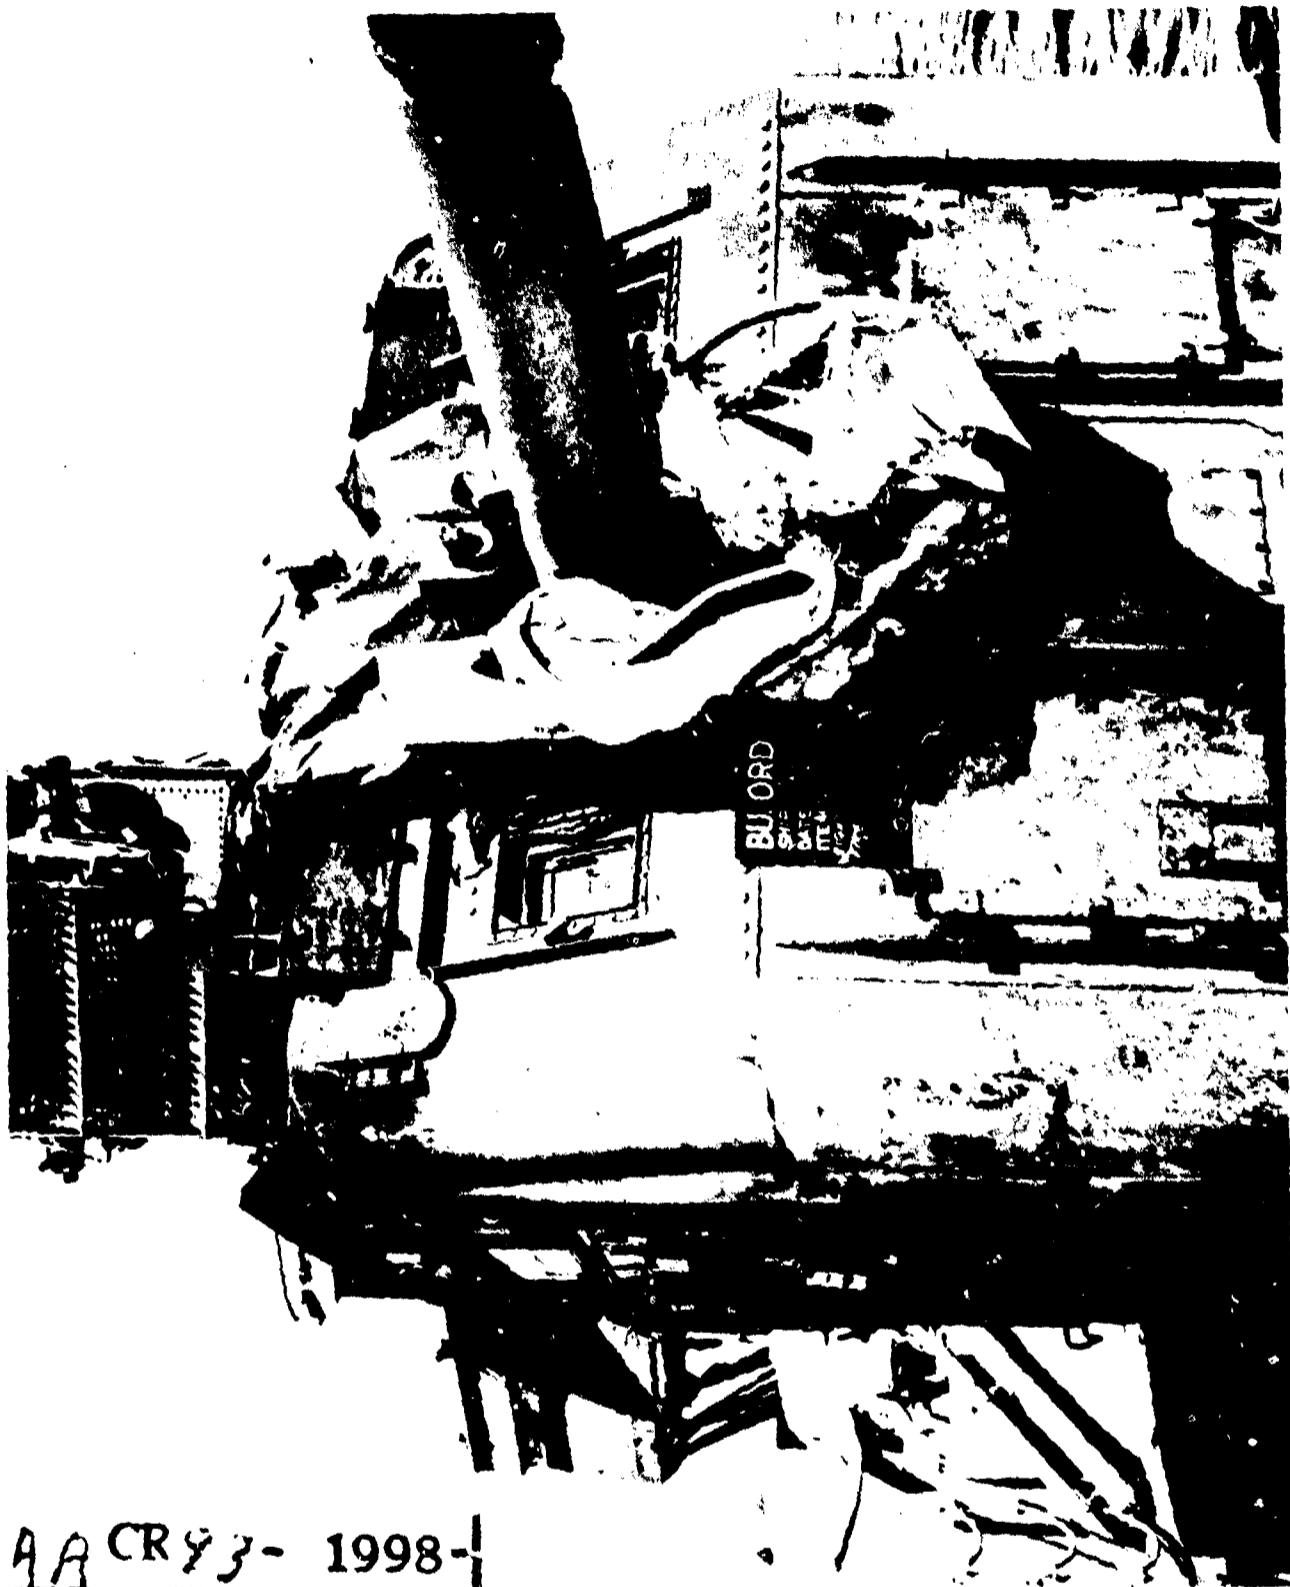
AA CR 93-1998-12

U.S.S. STACK (ED-406) - After Able
Close up of 5"/38 Cal. Mt. No. 1.
Showing torn Gun Port Bloomer and
scorched exterior paint.
Photo. No. AA-CR-93-1998-12.

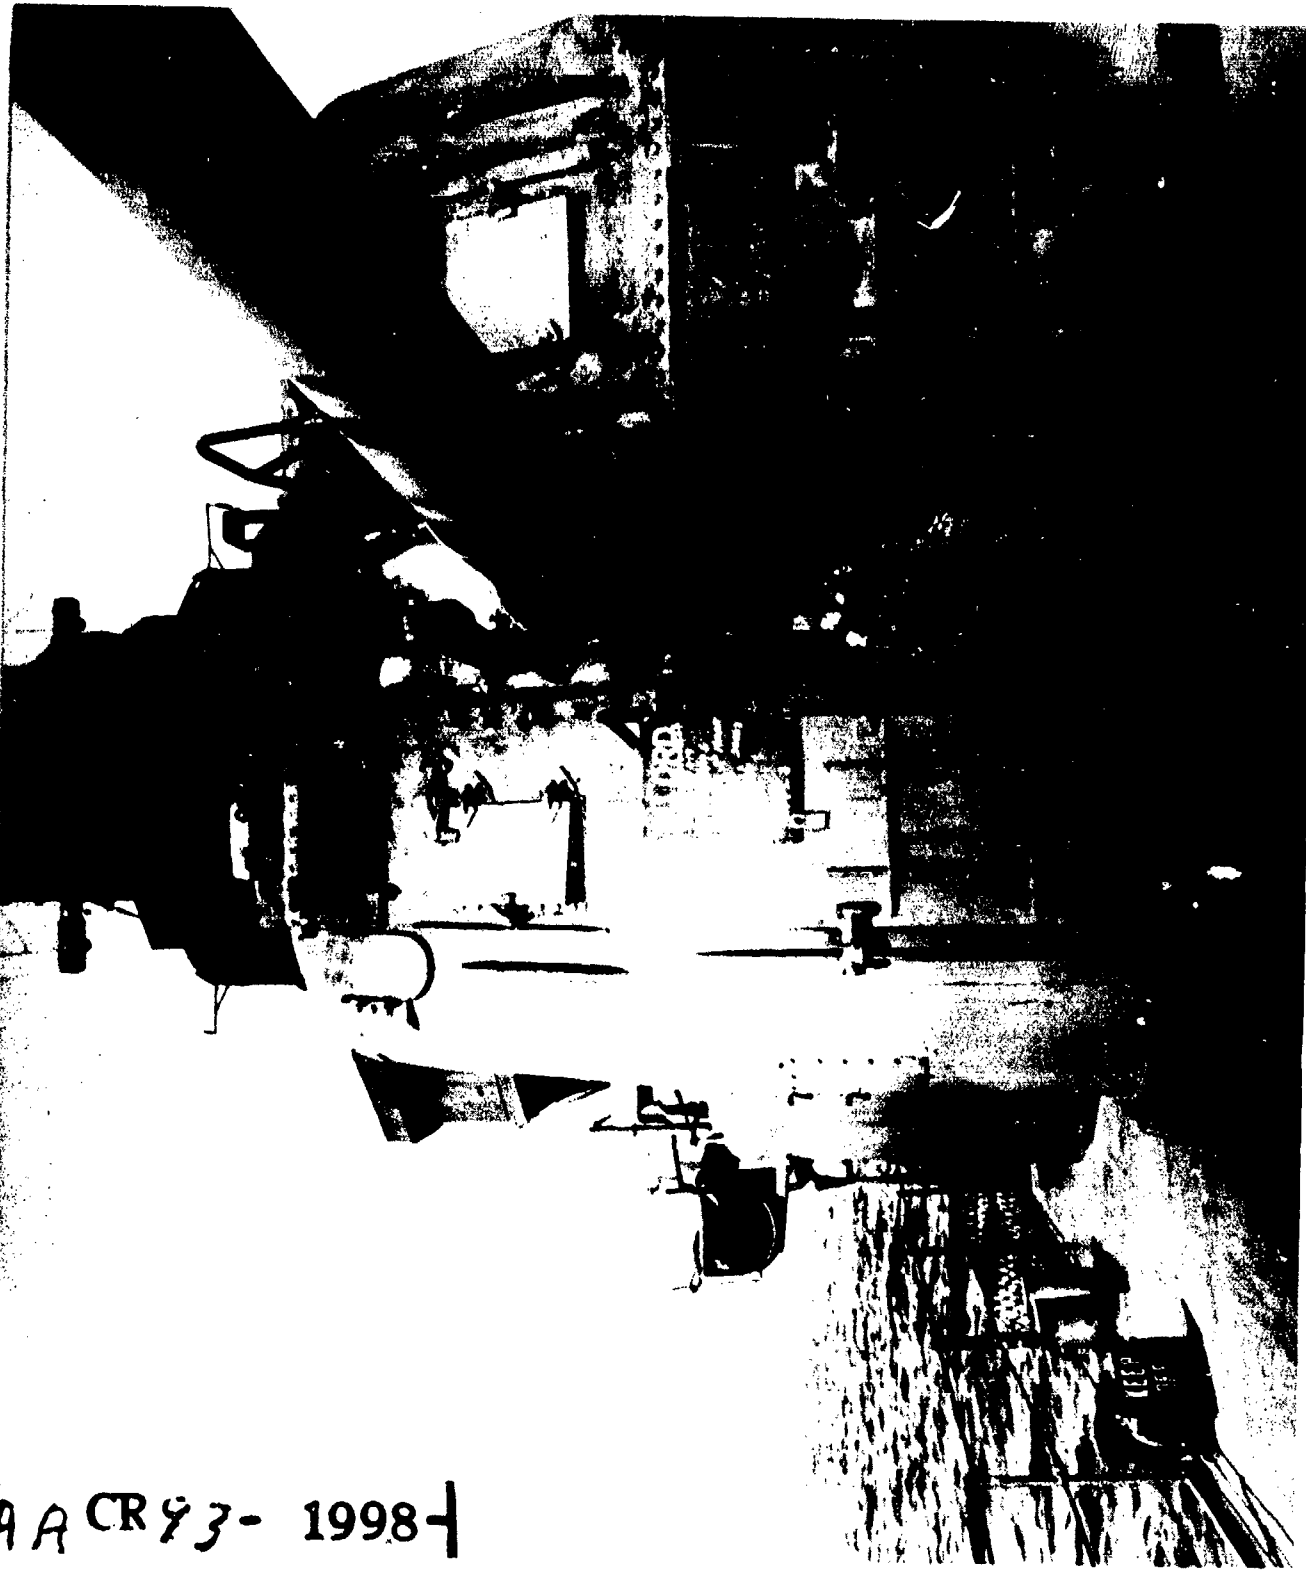
AA CR 93- 1998-7

U.S.S. WAINWRIGHT (DD-219) - After Able
General view of 5"/38 Mt. No. 1,
Showing burned gun port gas seal and
scorched exterior paint caused by
burning Gun Port bloomer.
Photo. No. AA-CR-93-1998-7.

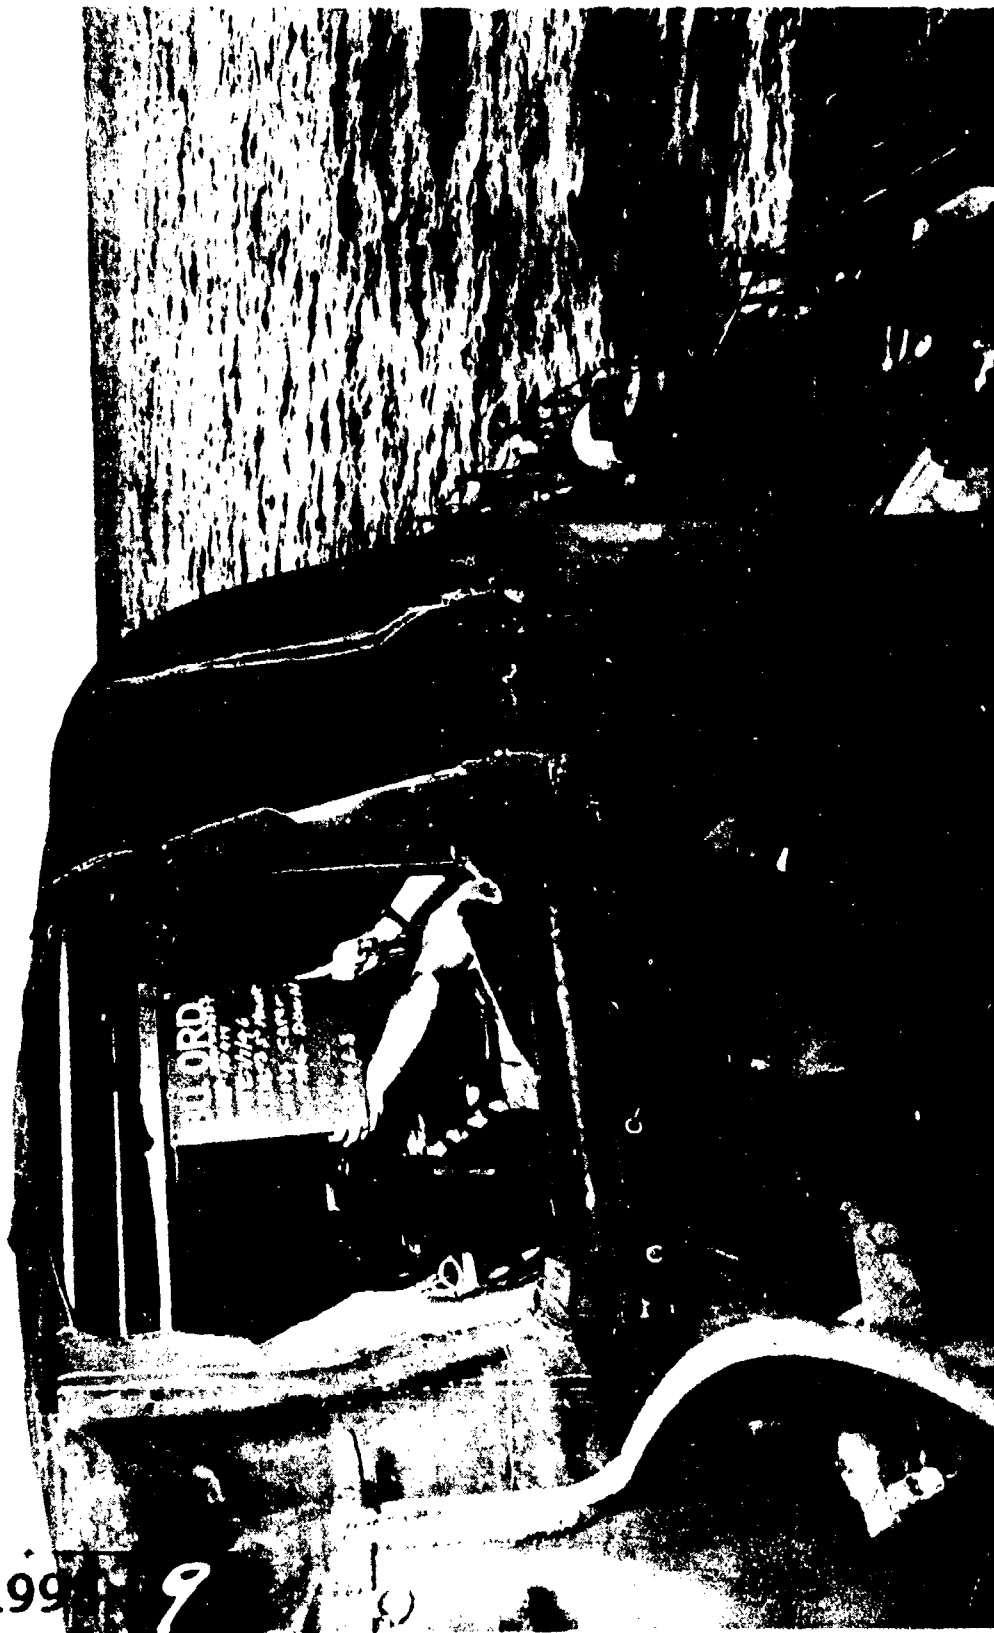
A CR 93- 1998-9

U.S.S. WAINWRIGHT (DD-419) - After Able
Close up of 5"/38 Cal. Mt. No. 3.
Showing torn canvas top.
Photo. No. AA-CR-93-1998-9.

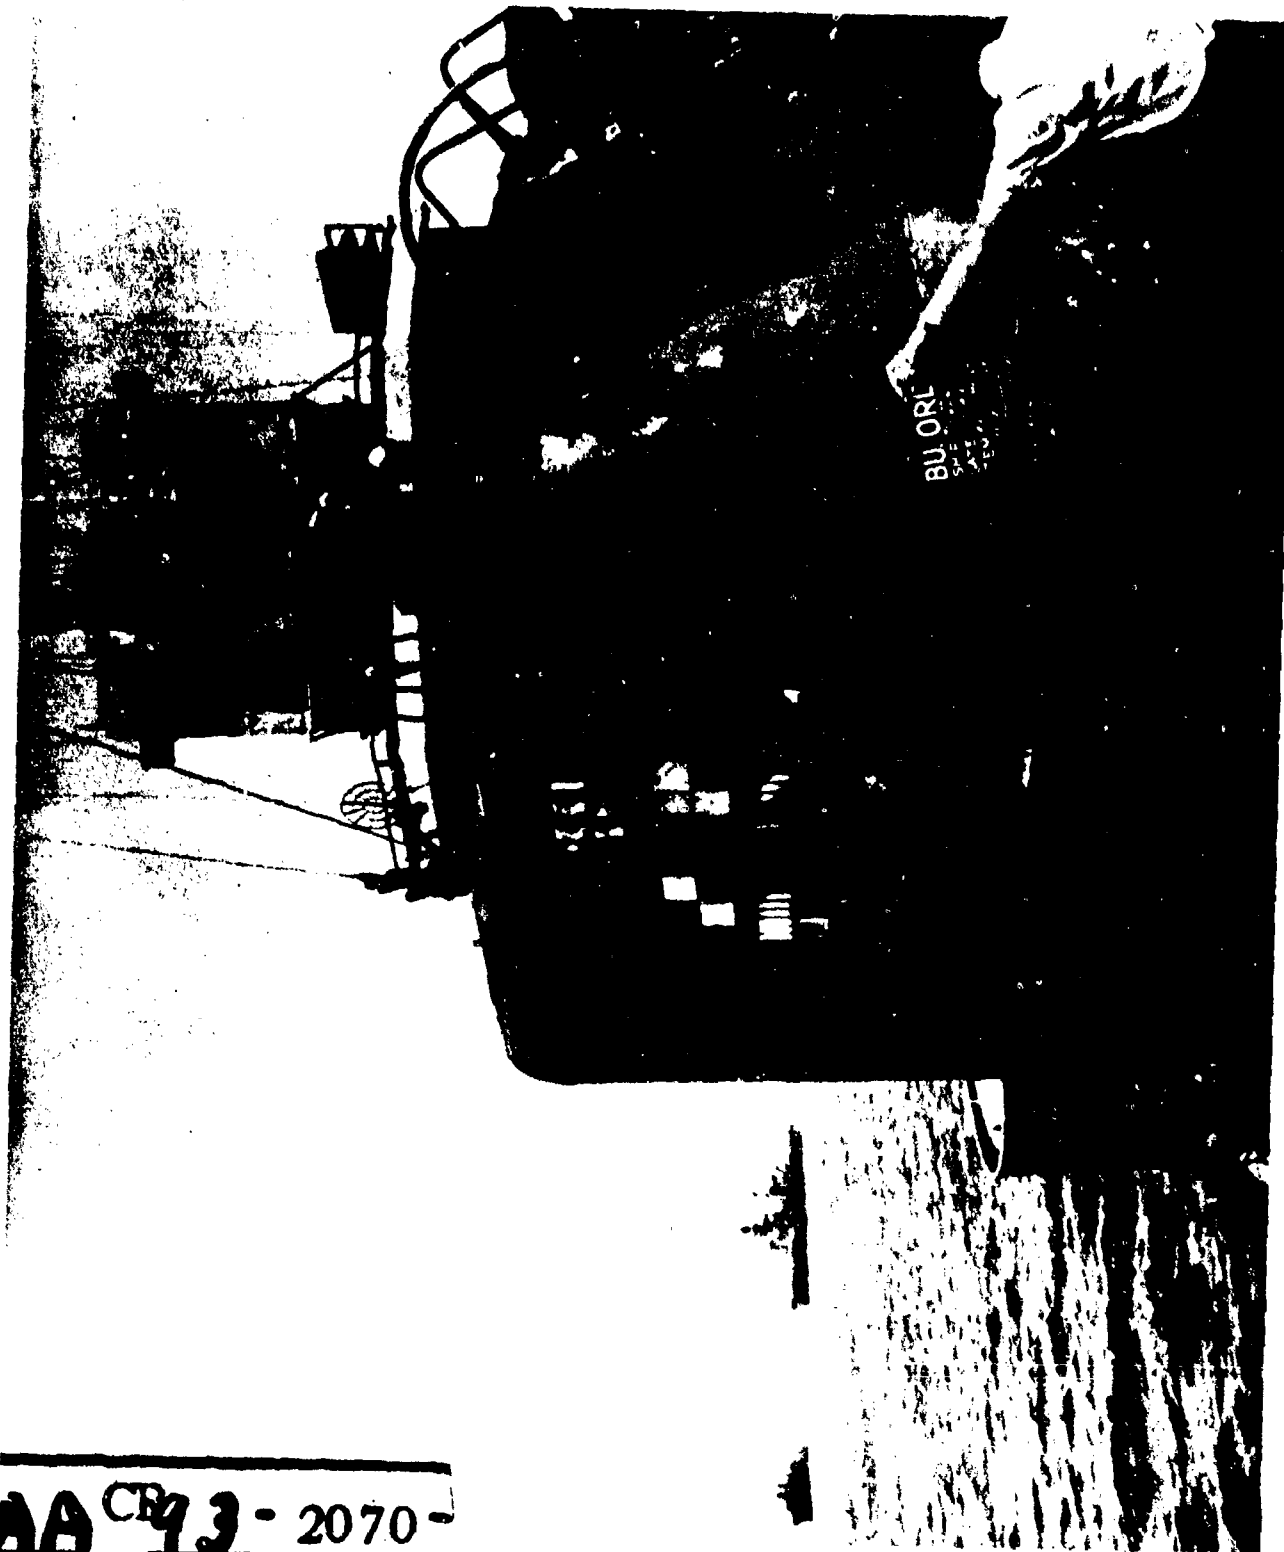
AA ^{CR} **93-2070-1**

U.S.S. WILSON (DD-408) - After Attack
Close up of 5"/38 Cal. Mt. No. 2.
Showing Gun Port Bloomer torn away and
scorched exterior paint.
Photo. No. AA-CR-93-2070-1.

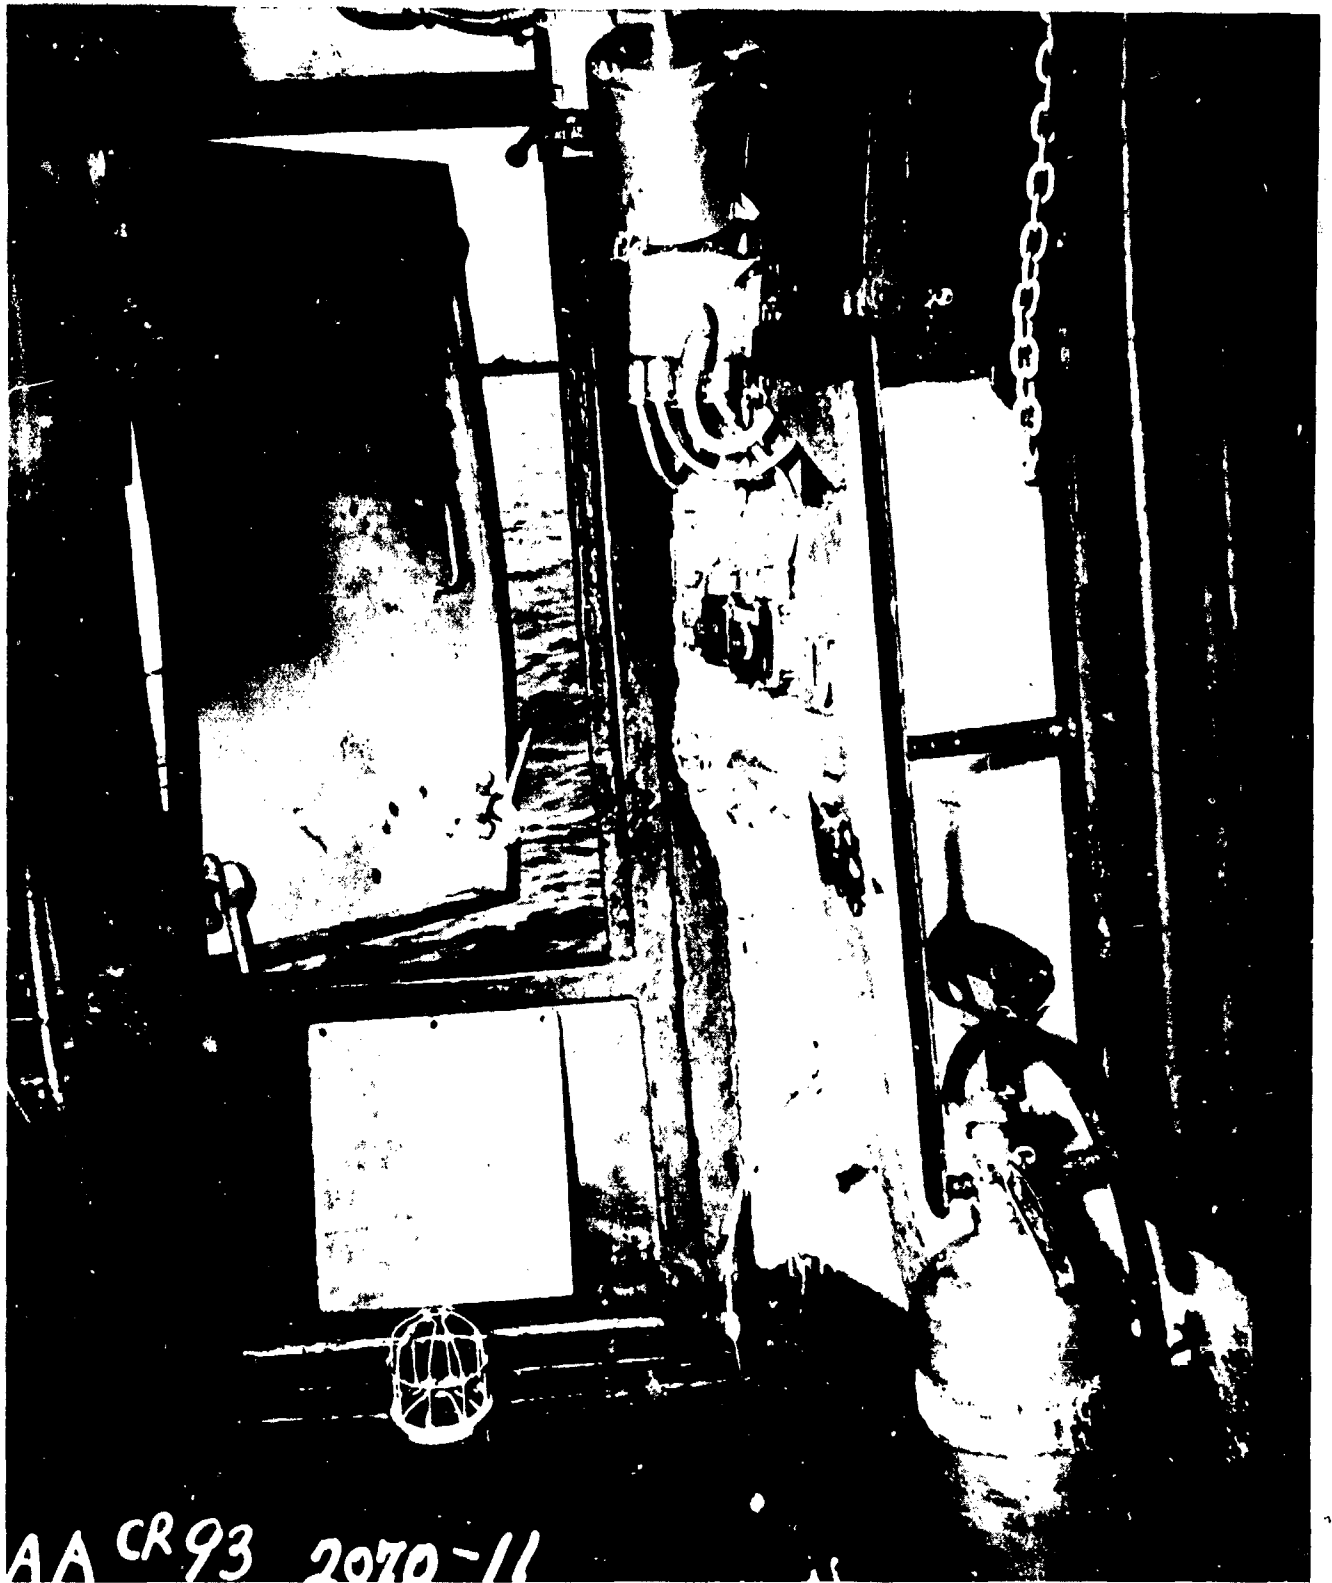
U.S.S. RHINE (DD-404) - After Able
Interior view of 5"/38 Mt. No. 2
Showing the "dishing in" of the
access door and after shield.
Photo. No. AA-CR-93-2070-11.

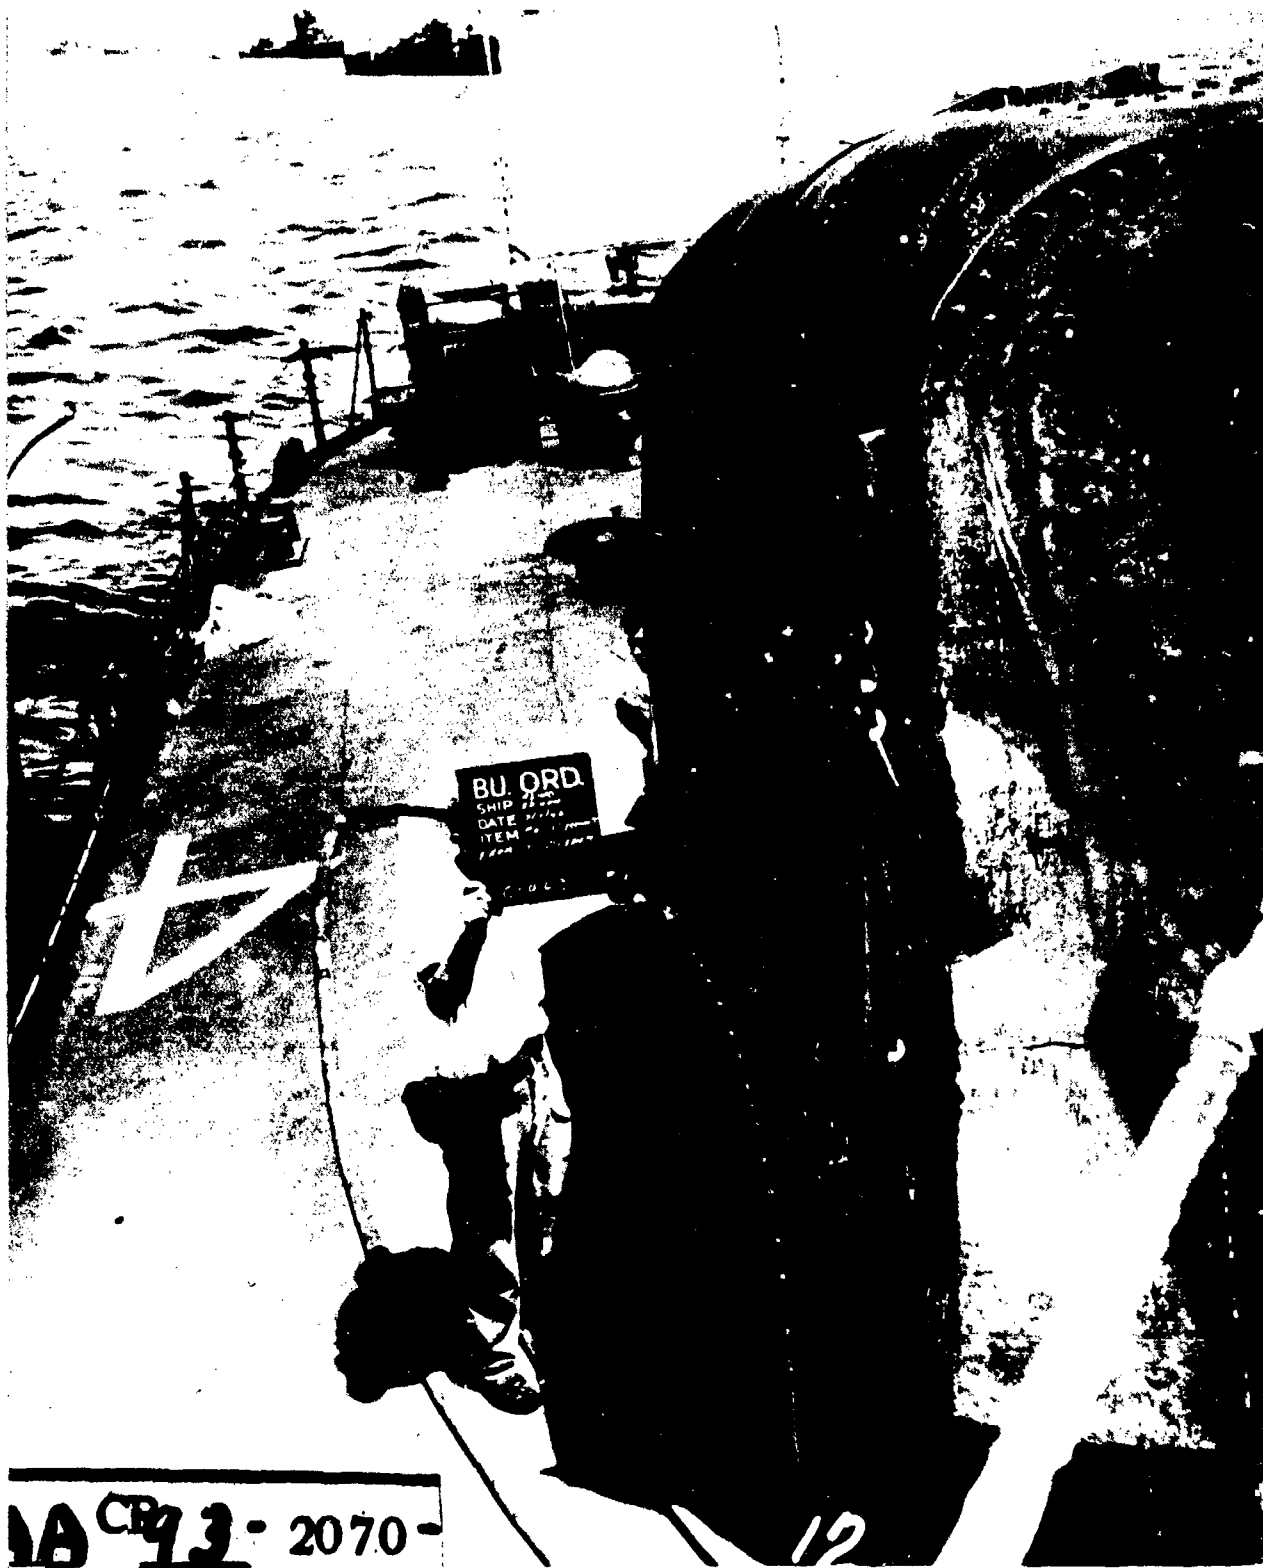
U.S.S. RHIND (DD-304) - After Able
Exterior view of 5"/38 Mt. No. 2
Showing the "dishing in" of the
access door and after side.
Photo. No. AA-CR-93-2070-12.
