Technical Inspection Report
Bureau of Ordnance Group

6
OPERATION CROSSROADS.
TESTS 'A' AND 'B'.
VOLUME IV.
PART X. PHOTOGRAPHIC
APPENDIX [U] 8

GUNS AND MOUNTS PHOTOGRAPHIC INDEX

TEST "A" & "B"

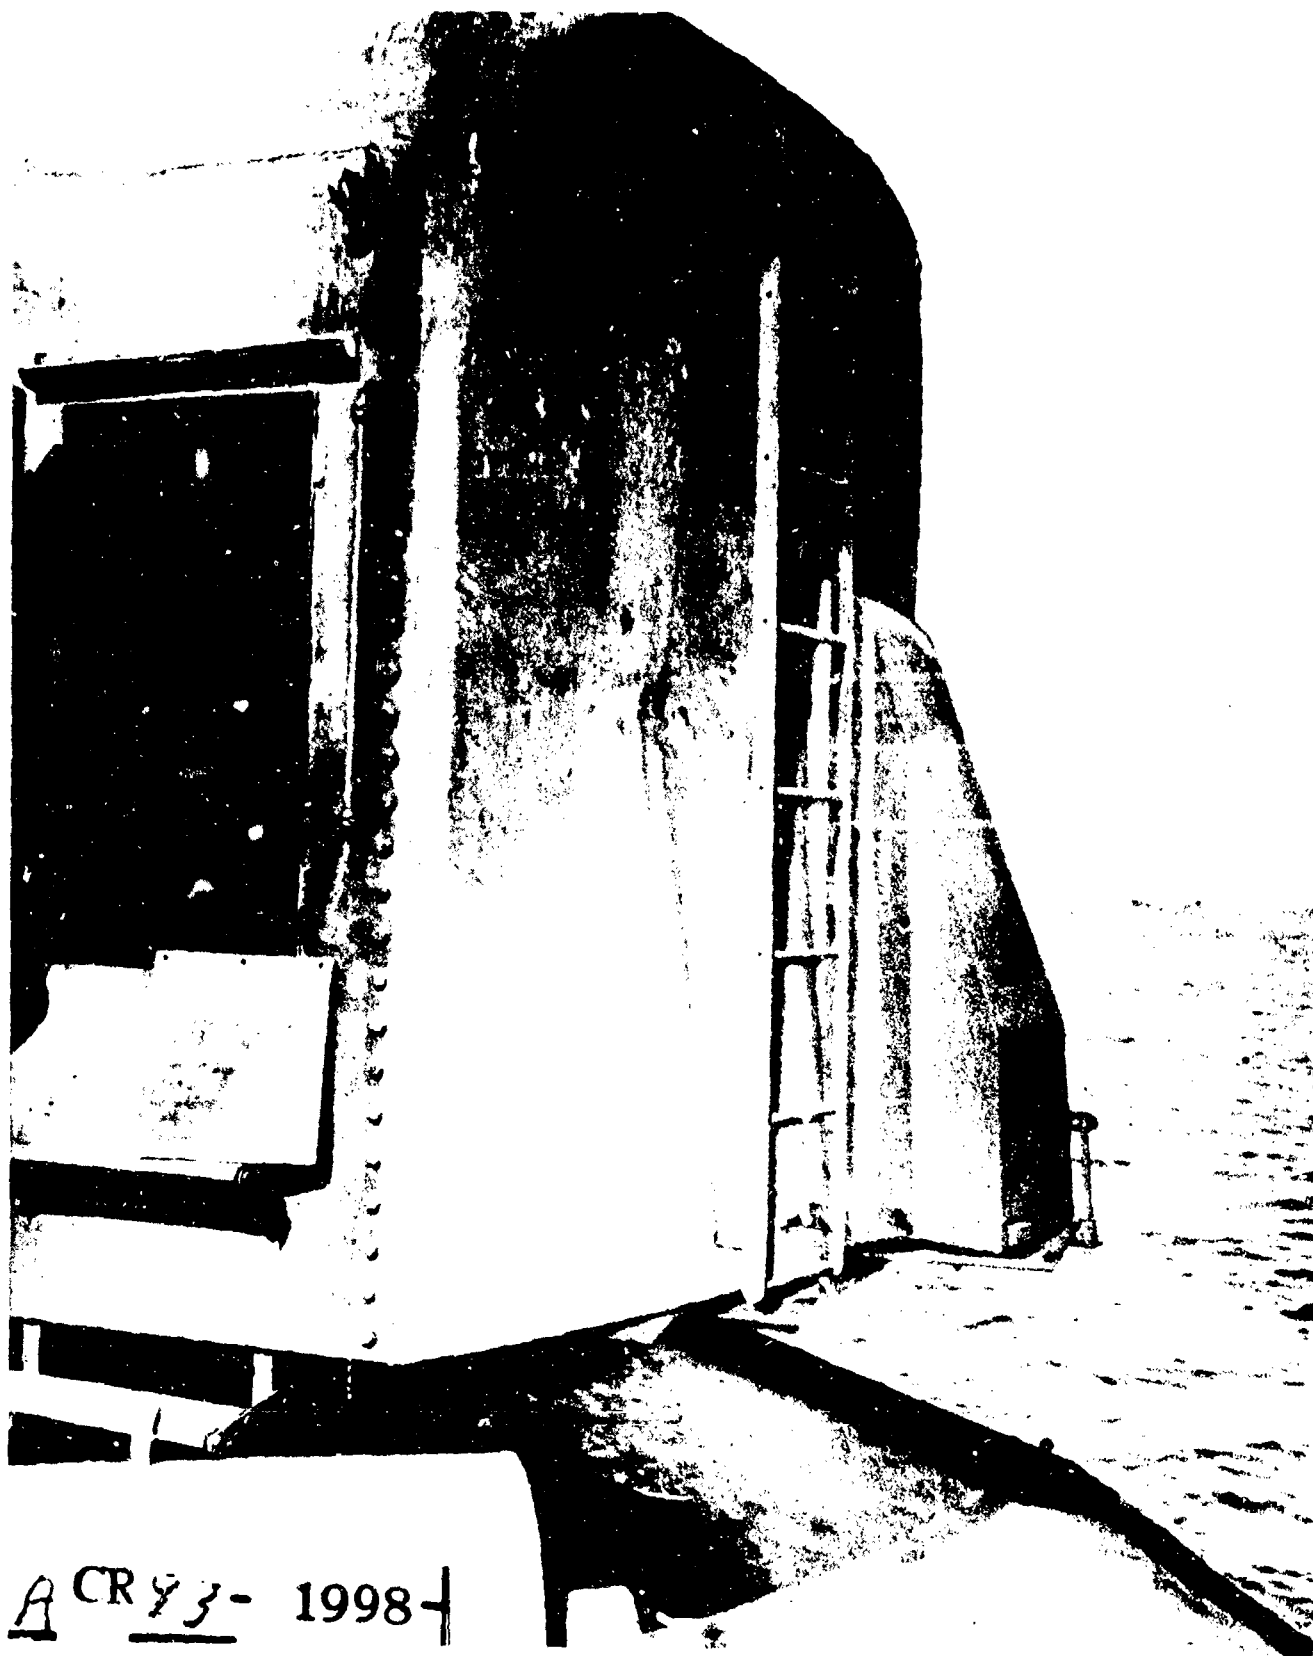
A CR 93- 1998-

U.S.S. RALPH TALBOT (DD-390) - After Able
Exterior view of 5"/38 Mt. No. 2
Showing the "dishing in" of the after shield.
Photo. No. AA-CR-93-1998-3.

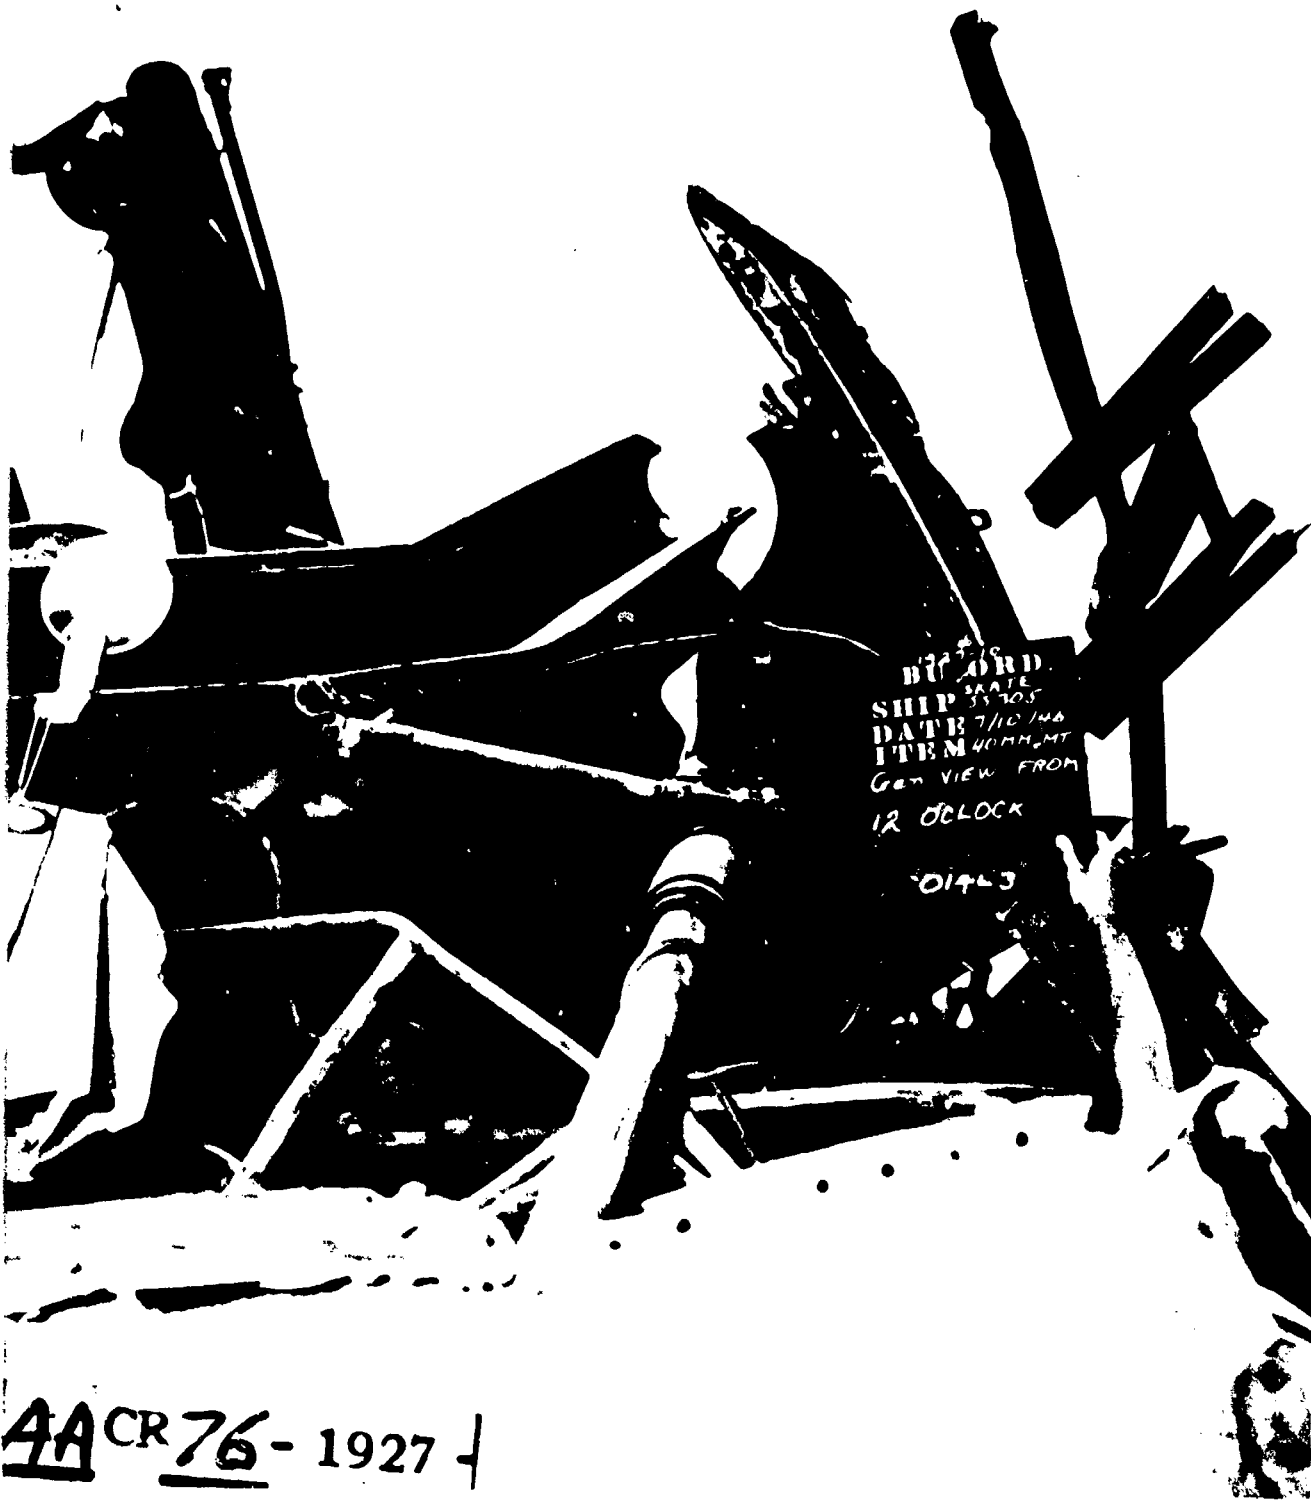
U. S. SHIP (33-305) - After Able
General view of the 40 MM Single Mt.
The gun mechanism, barrel and sight
bar can be seen.
Photo. No. 4A-5K-76-1927-19.

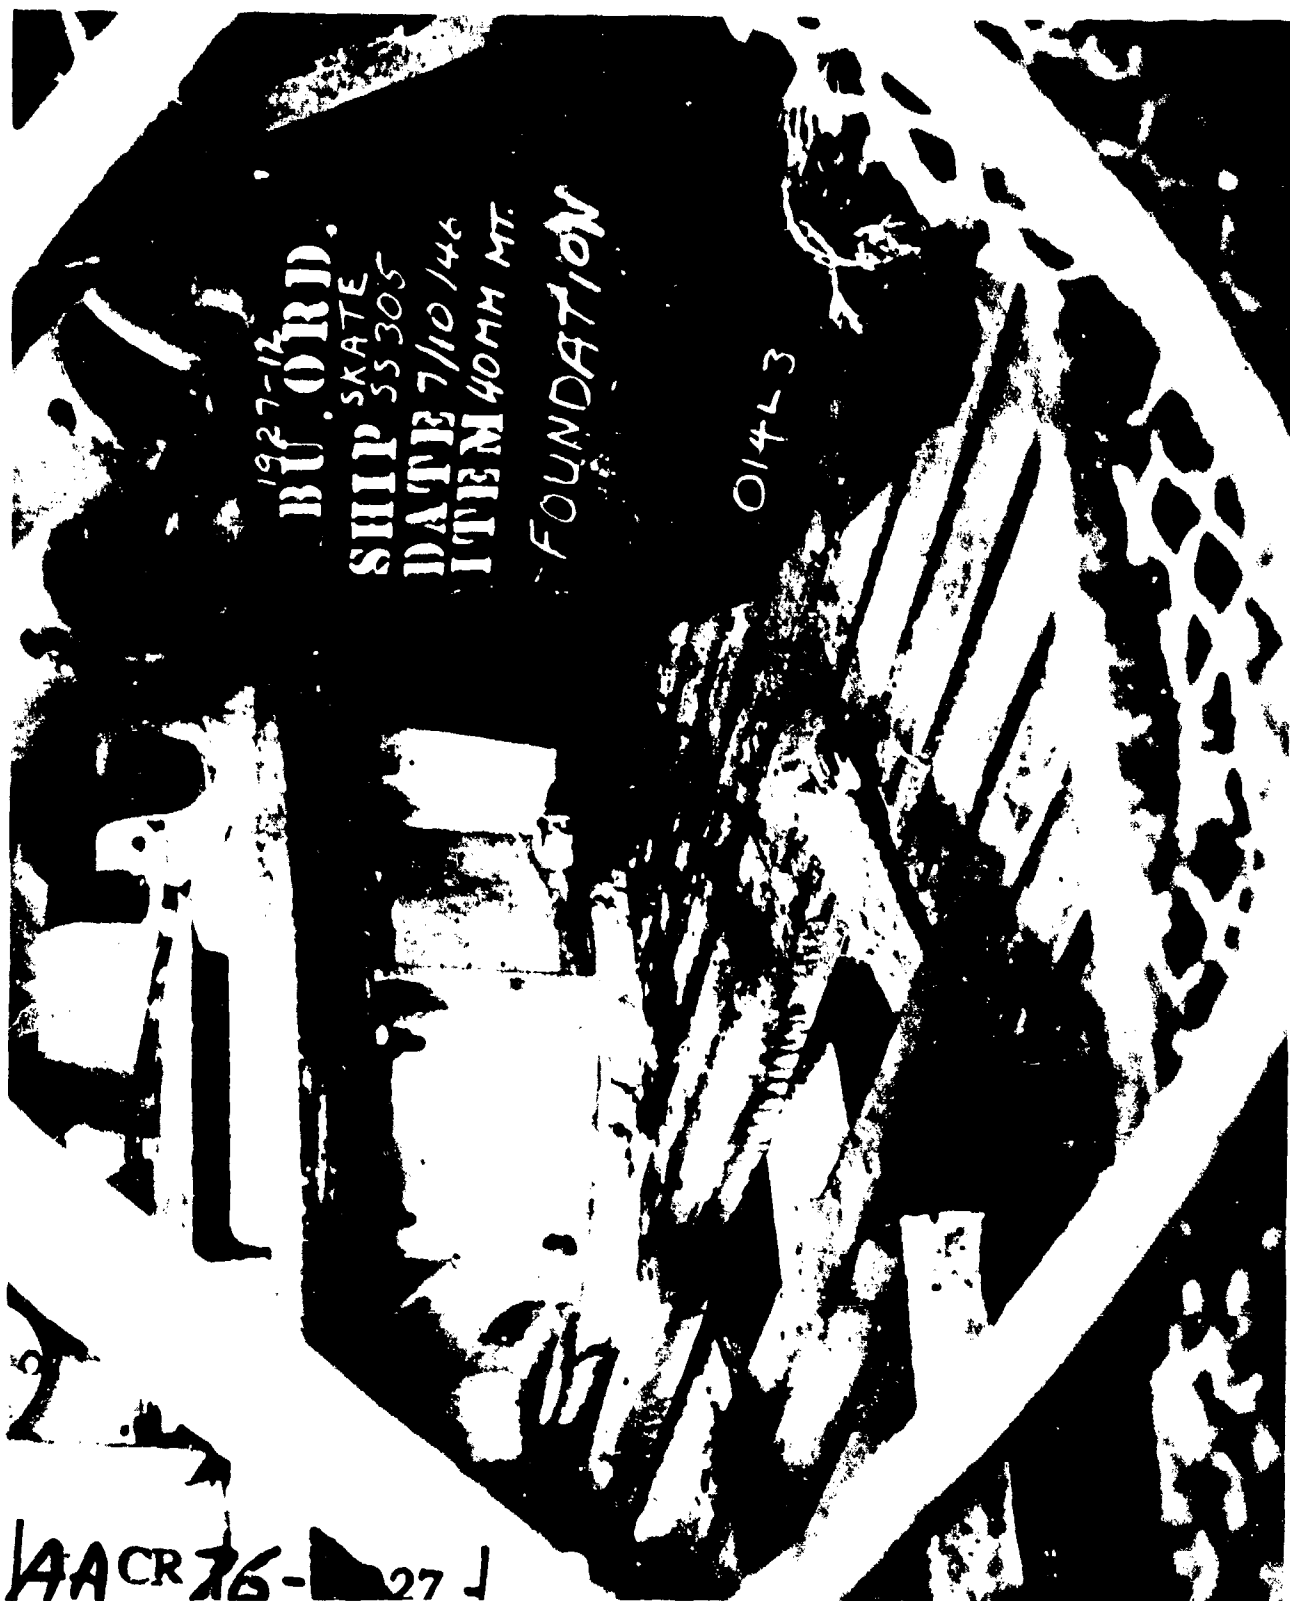
U.S.S. SKATE (SS-305) - After Able
View of 40 MM Single Mt., showing
the foundation intact.
Photo. No. AA-CR-76-1927-12.

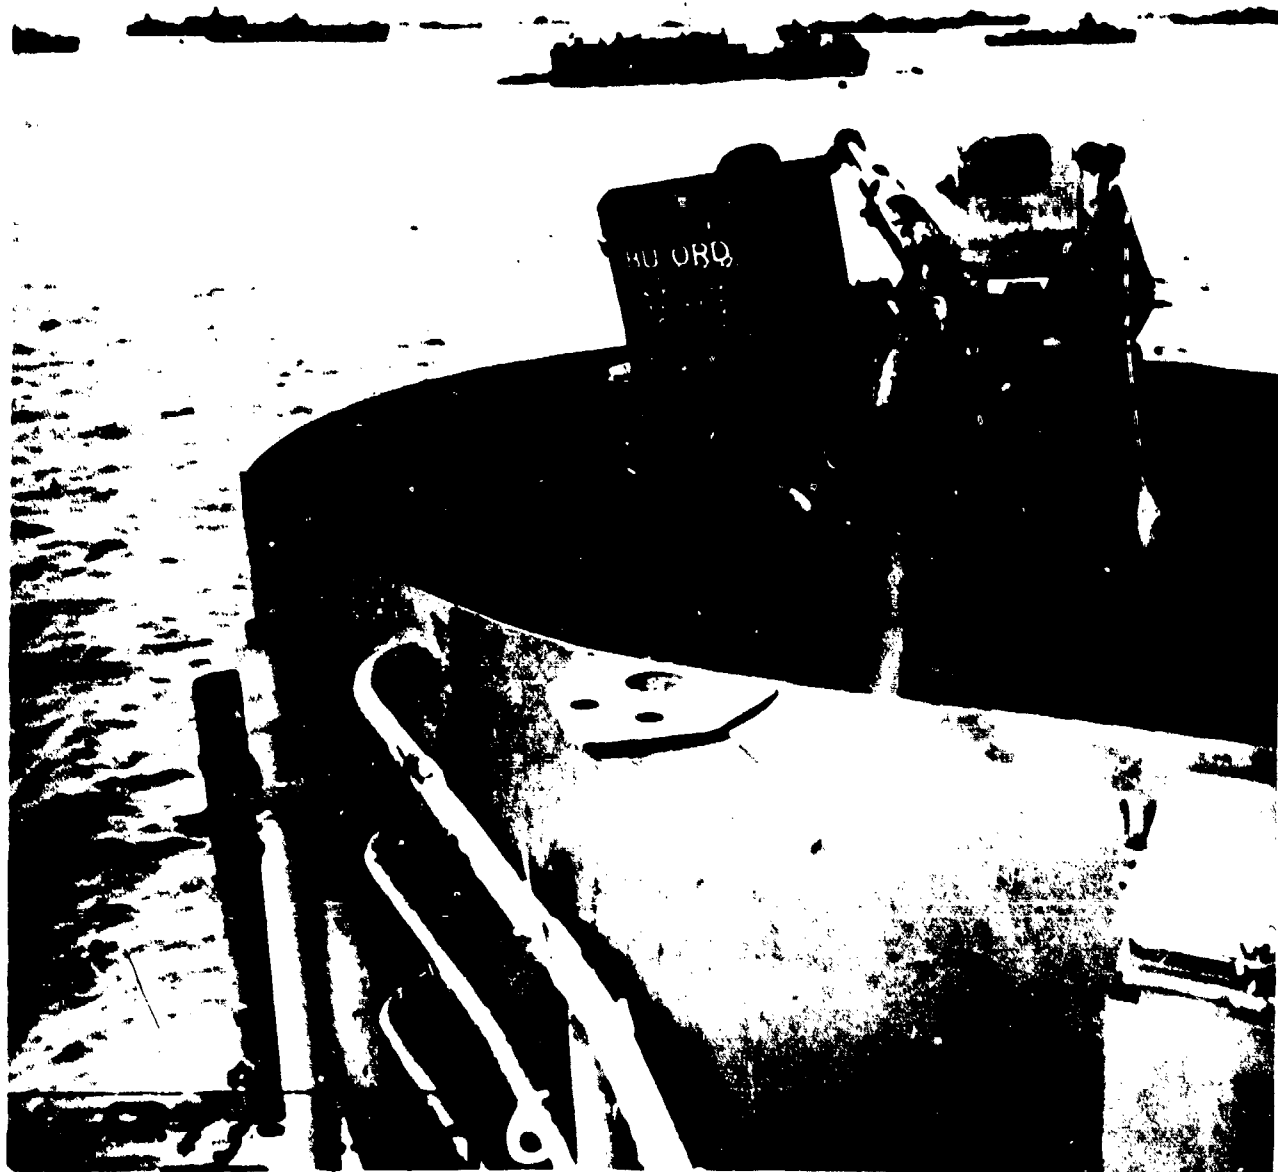
U.S.S. CRITTENDEN (APA-77) - After Able
View showing 20 MM Mt. No. 2.
The right splinter shield was jammed against
the pedestal preventing training of the unit.
Photo. No. AA-CR-93-1998-6.

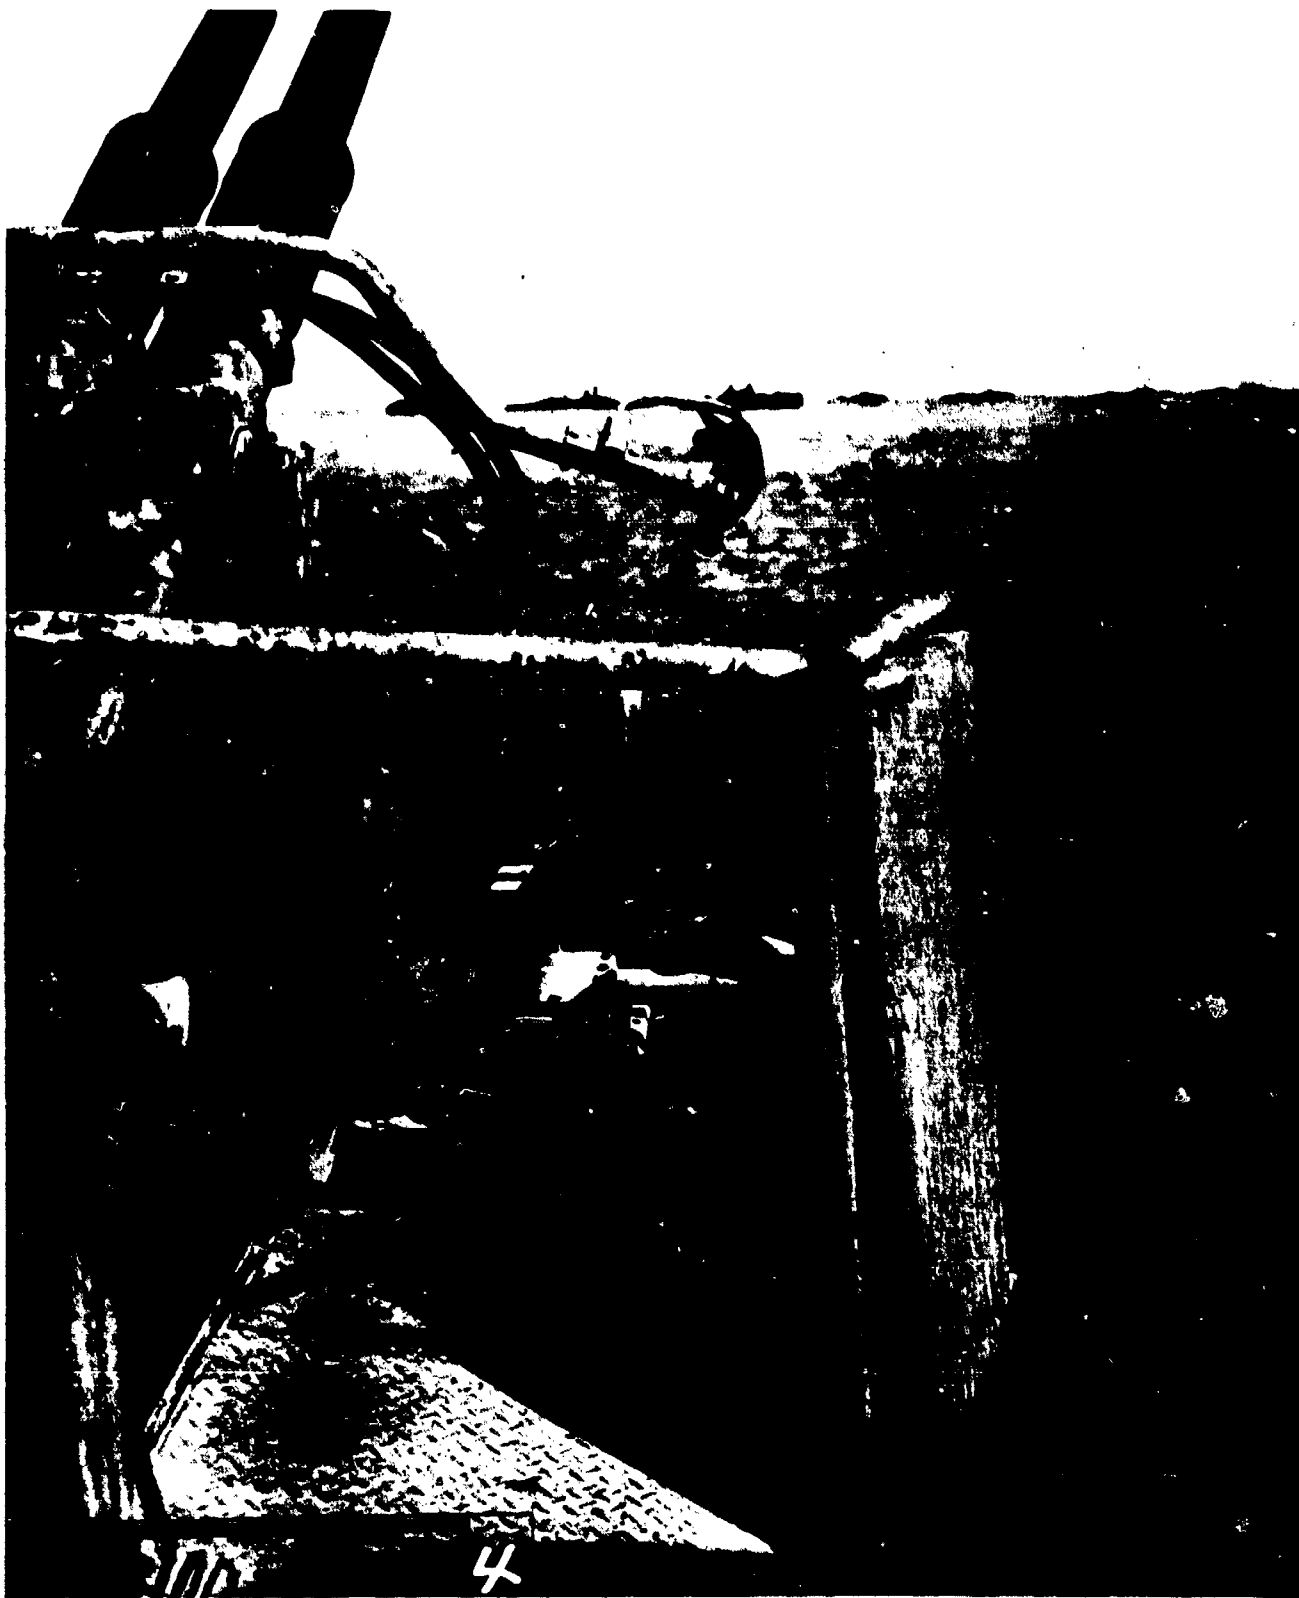
U.S.S. CALCORAL (APA-85) - after boiler
General view of 40 MM. Mt., No. 4.
Showing distorted Gun Platform and bent
sight and sight bar.
Photo. No. 45-GR-100-4710-1.

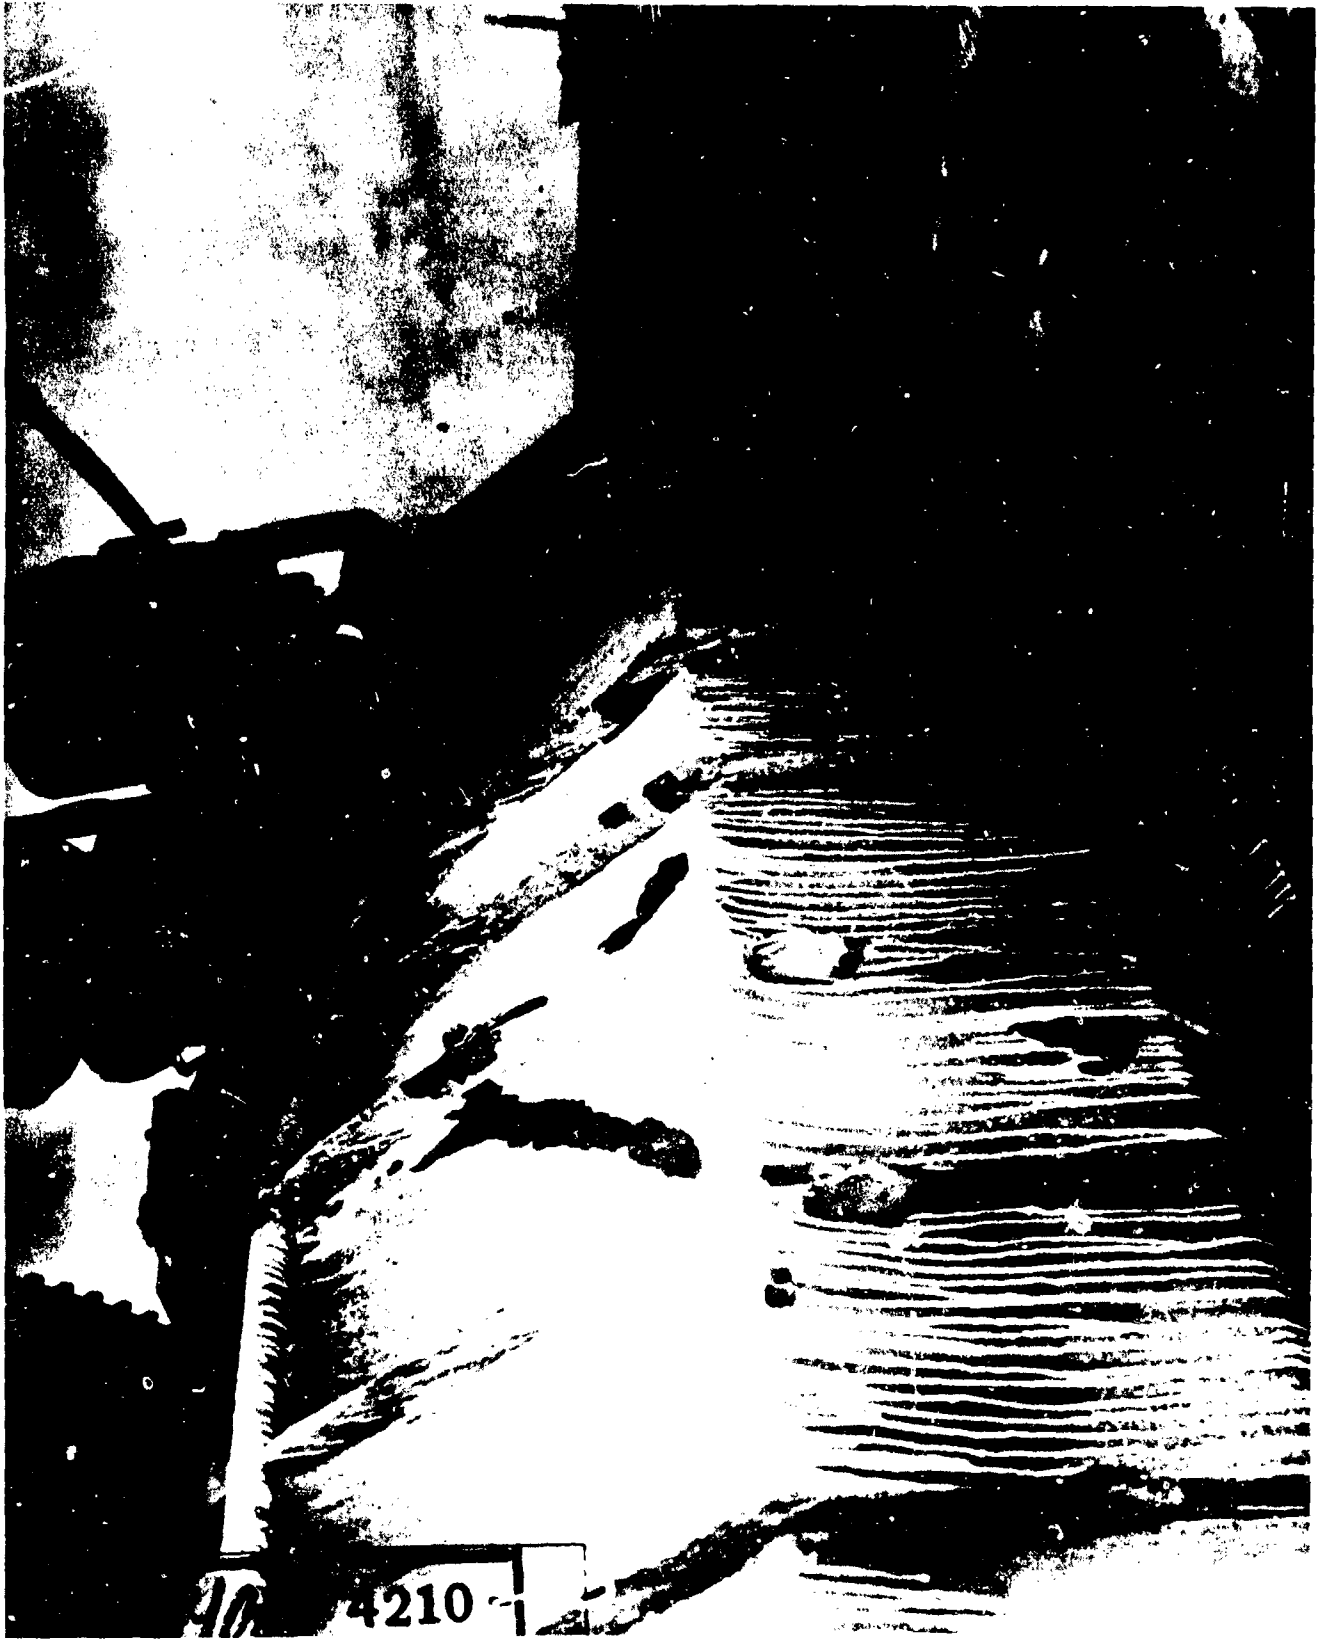
U.S.S. GASCONADE (APA-85) - After Baker
Close up view of 5"/38 Cal. Mt. front
shield. Showing left side dished in.
Photo. No. AB-CR-100-4210-E.

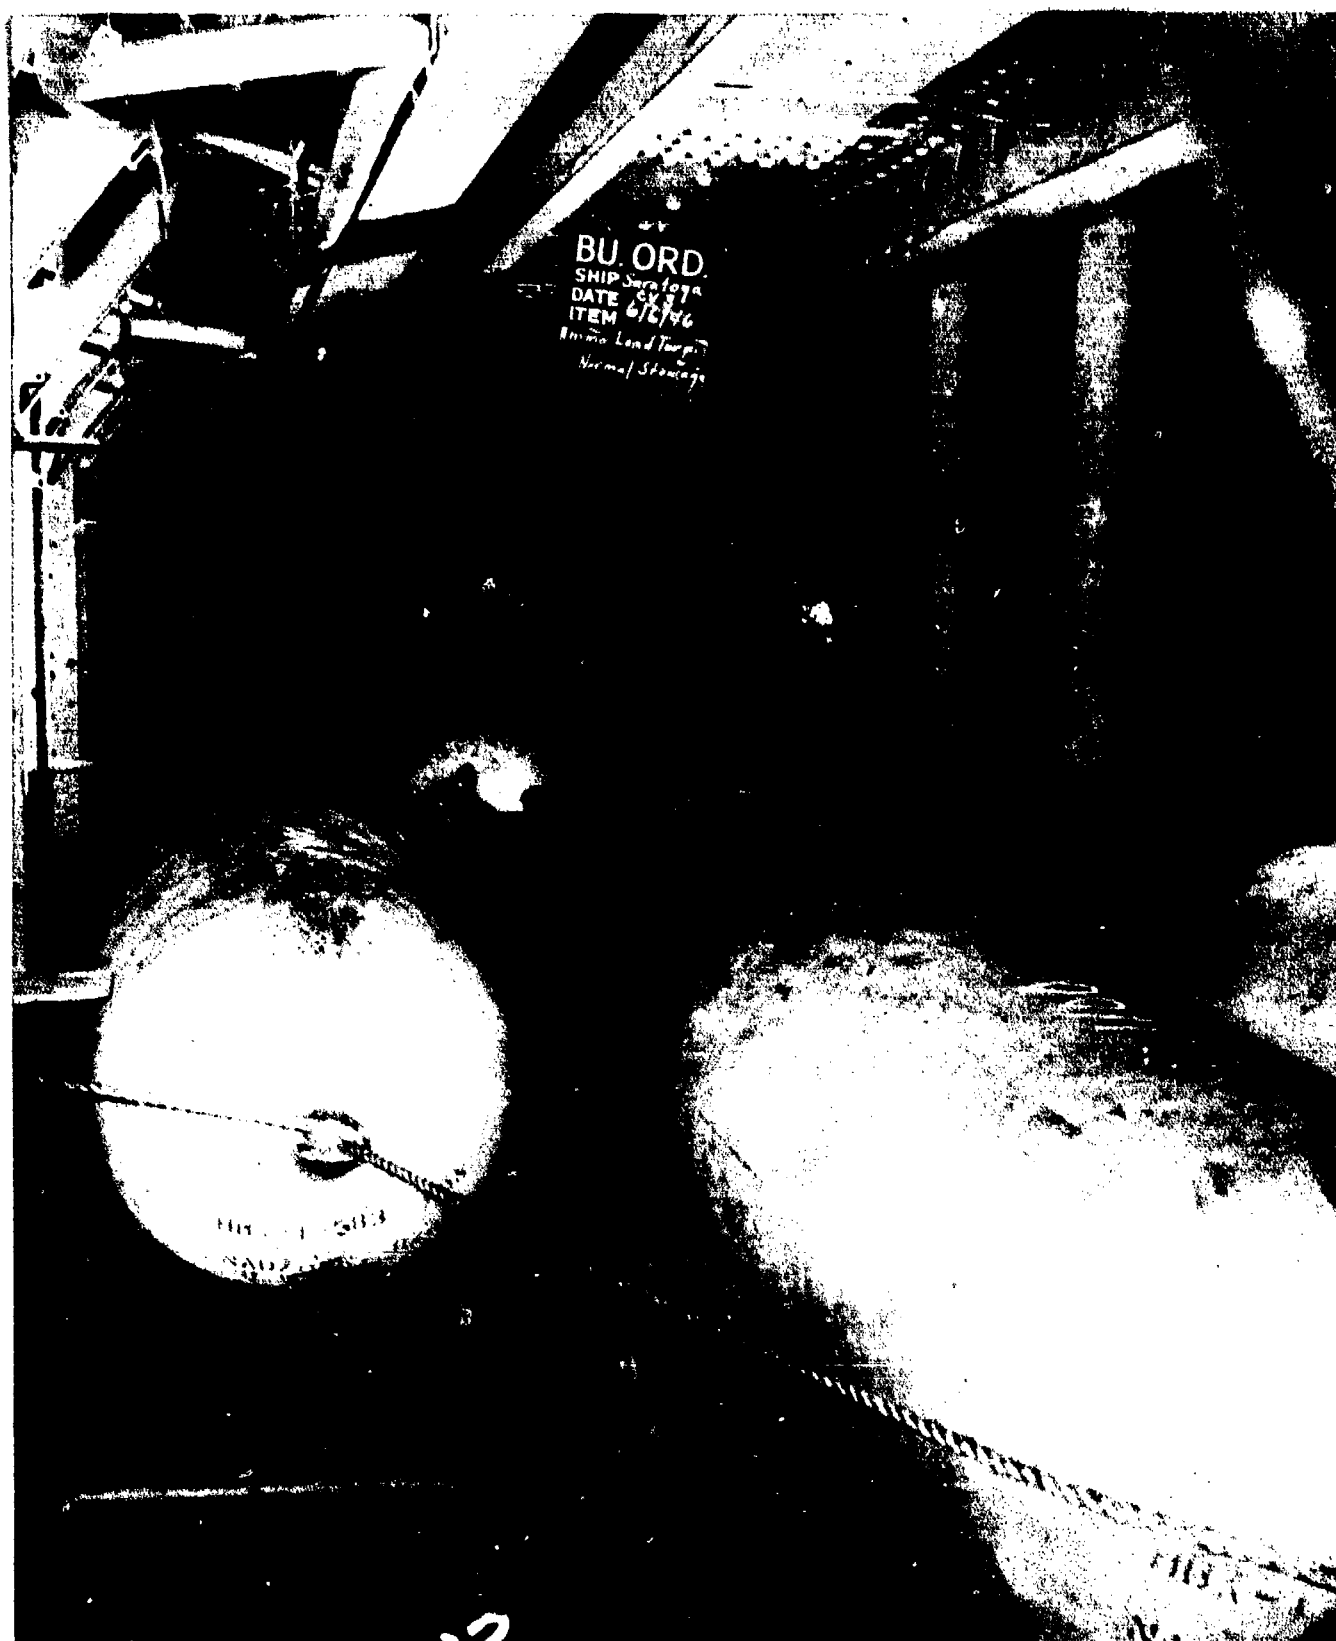
U.S.S. SARATOGA (CV-3) - Before Able
Service Load Torpedoes in normal stowage.
Photo. No. BA-CR-76-295-2.

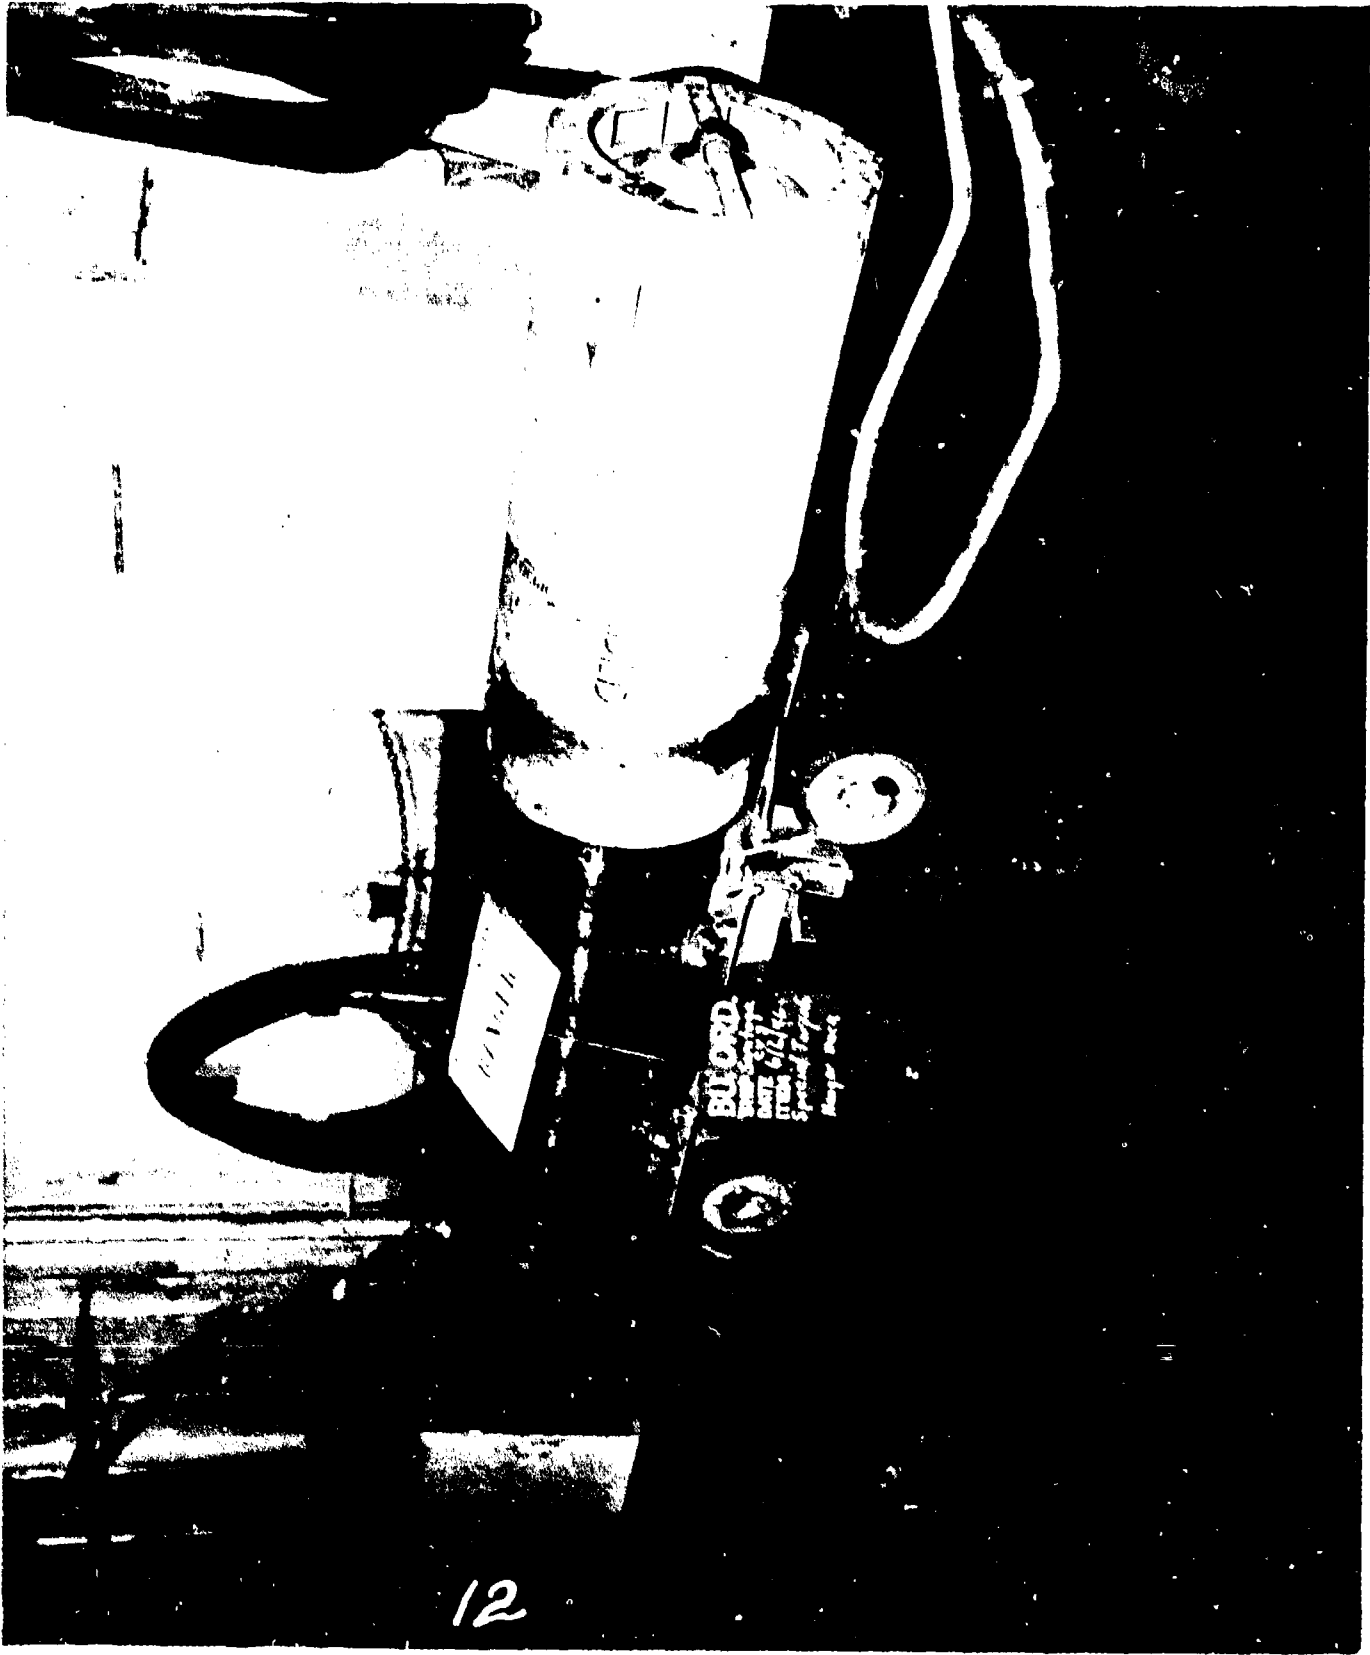
U. S. SALVAGE (CV-3) - Before Tide
Special Test Torpedo, Mk. 13 on Japan Deck.
Photo. No. 14-11 44-30-1.

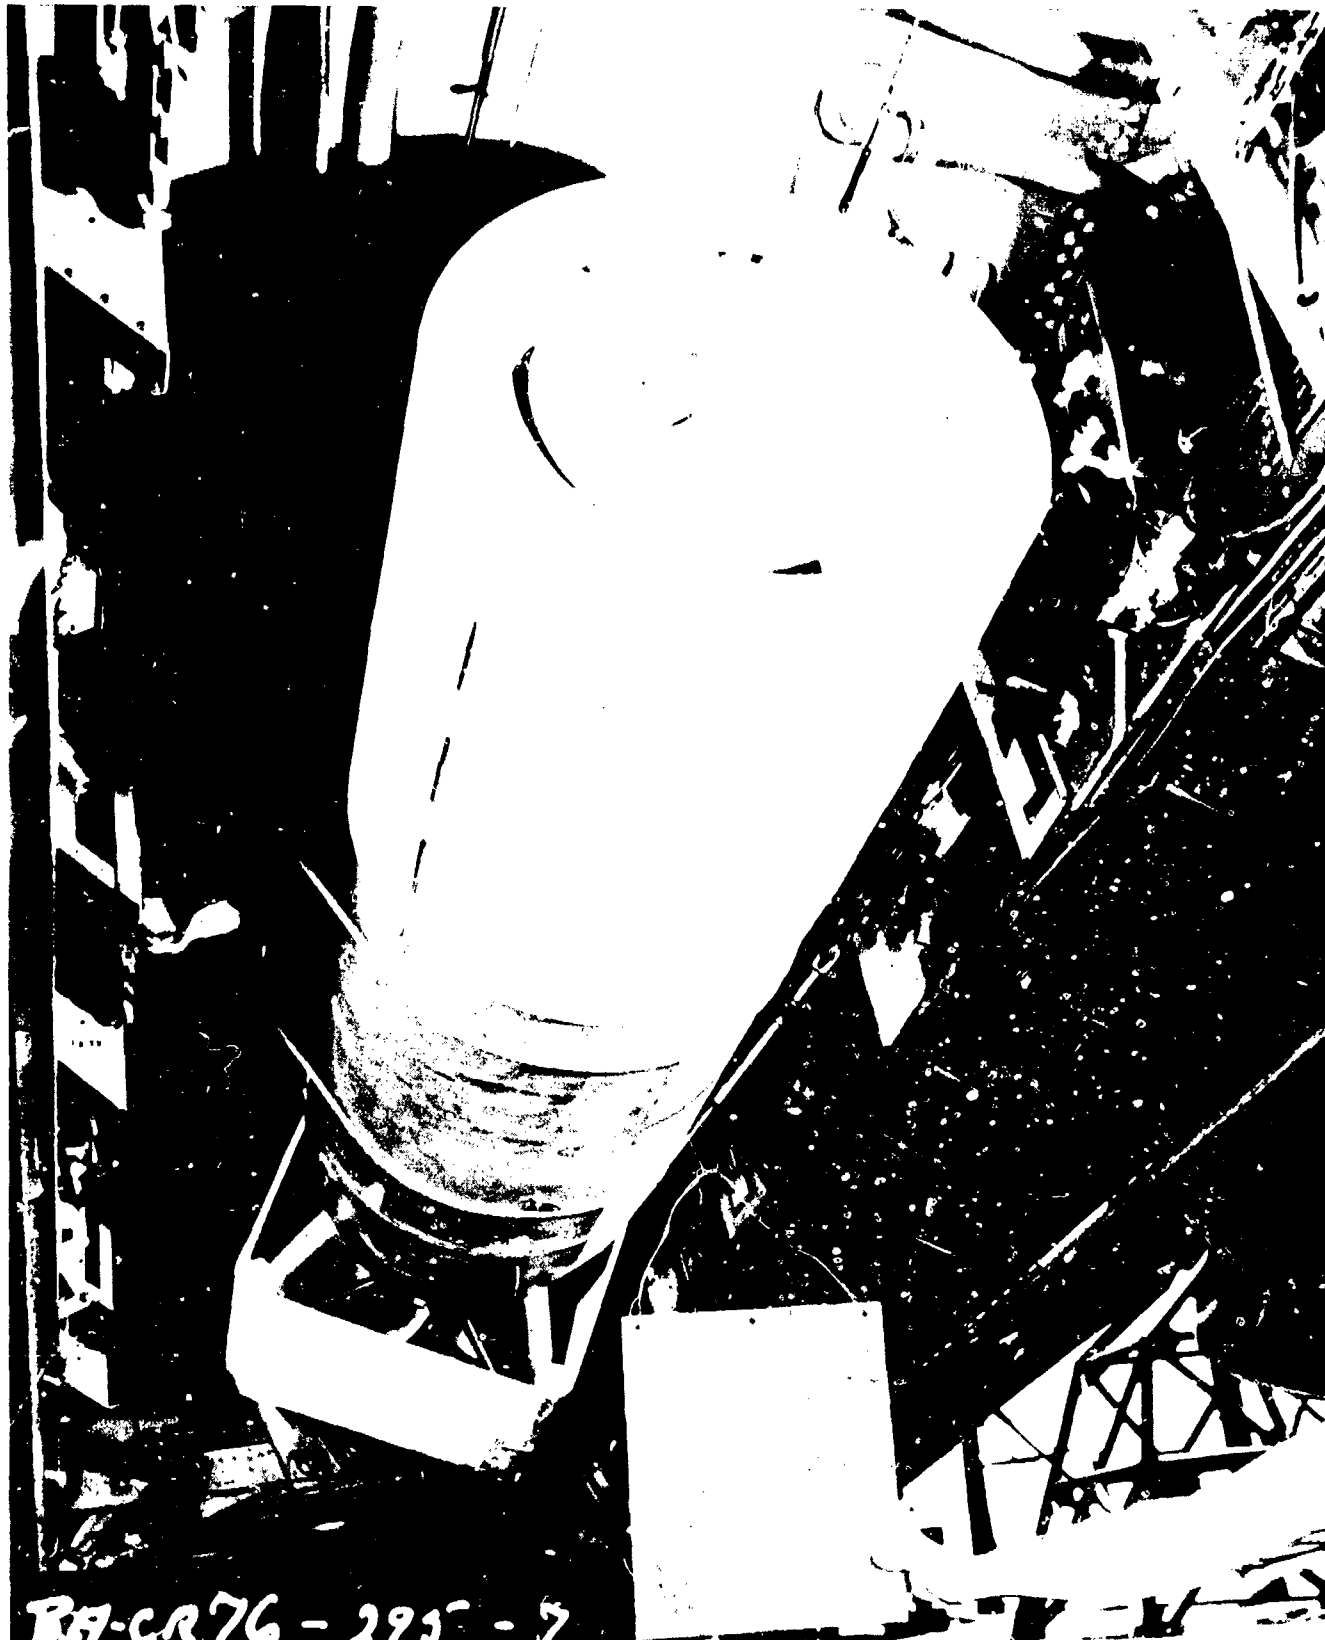
U.S.S. INDEPENDENCE (CVL-22) - Before Able Mine, Mk. 24 loaded in TBM on flight deck. Photo. No. BA-CR-76-295-7.

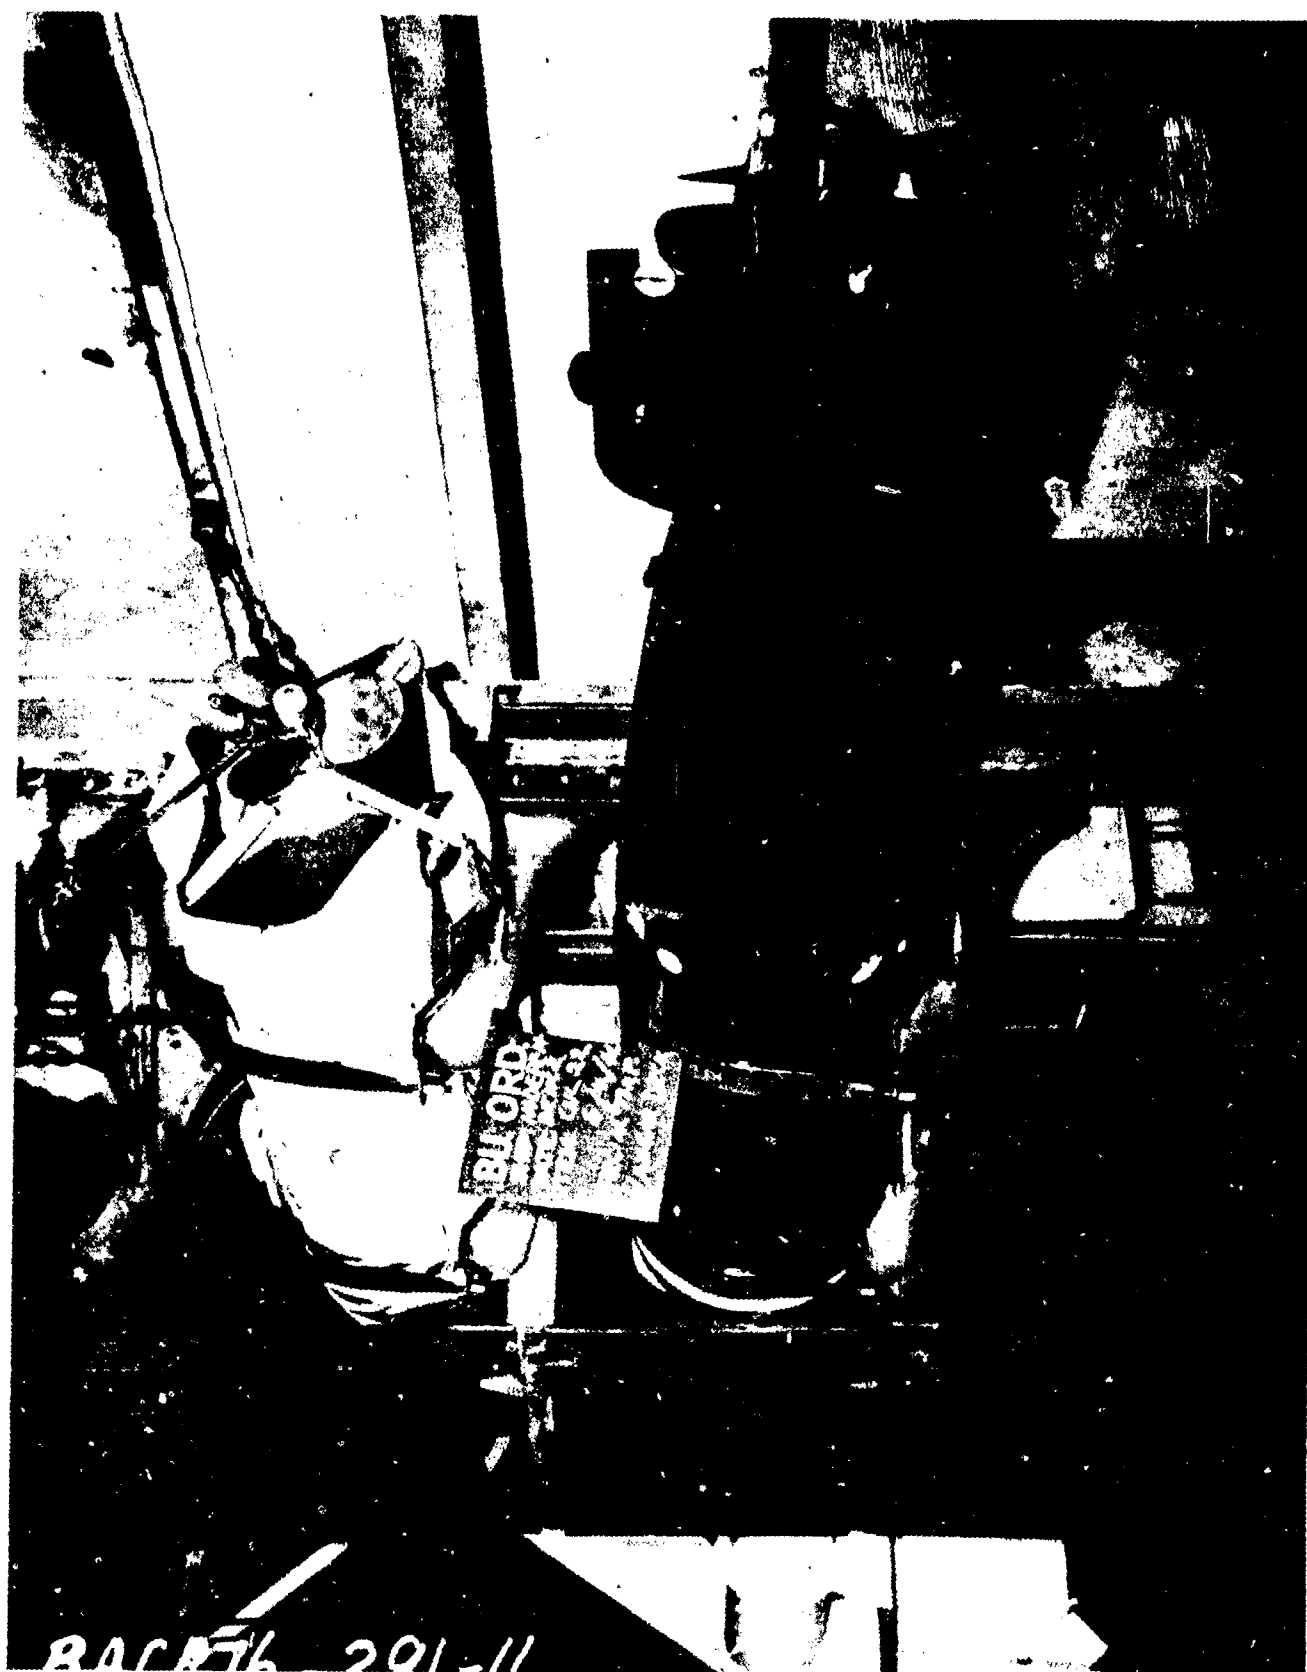
U.S.S. INDEPENDENCE (CVL-22) - Before Able
Showing Aircraft Torpedo and Mine, Mk. 24
in ready stowage on hanger deck.
Photo. No. BA-CR-76-291-11.

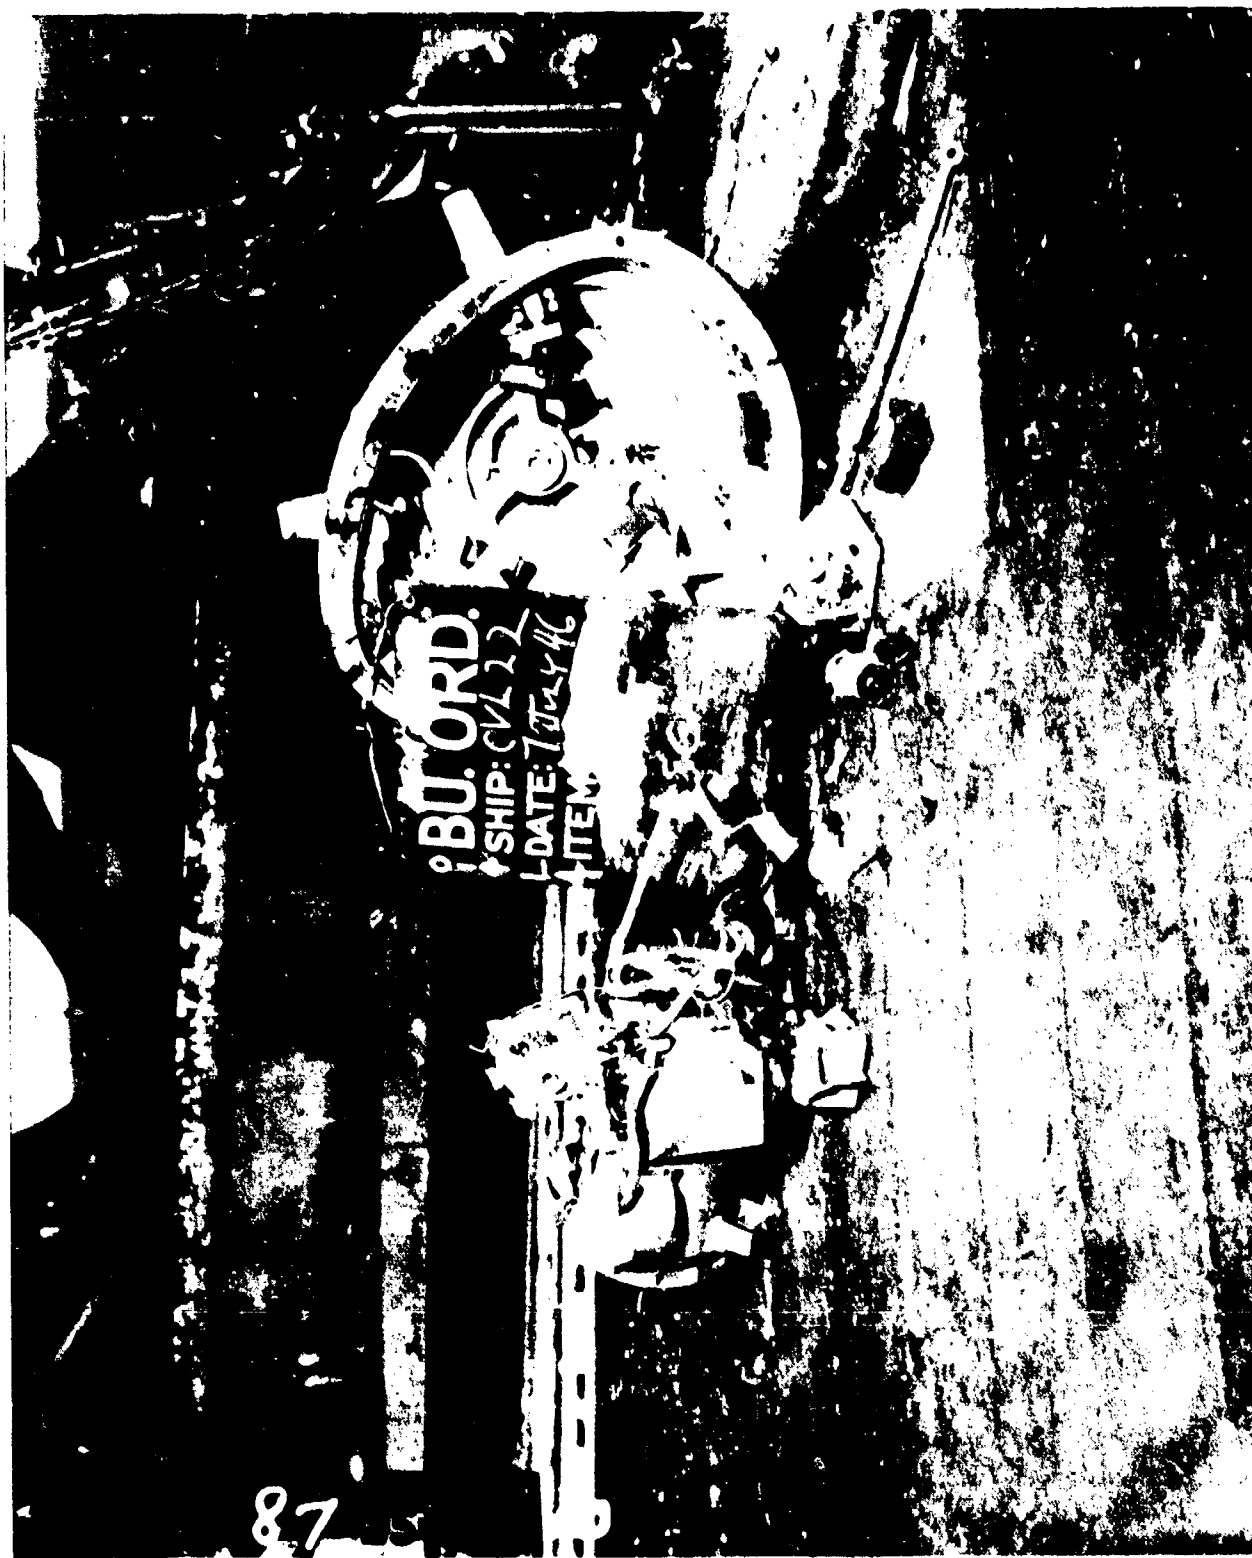
U. S. INDEPENDENCE (CVL-22) - After Able
distorted Tail Section of Mine, Mk. 17 that
originally was in plane on flight deck. Plane
warped and cylinder were blown overboard by
blast.
Photo. No. AA-OR-87-2541-10.
