Technical Inspection Report
Bureau of Ordnance Group

6
OPERATION CROSSROADS.
TESTS 'A' AND 'B'.
VOLUME IV.
PART X. PHOTOGRAPHIC
APPENDIX [U] 8

GUNS AND MOUNTS PHOTOGRAPHIC INDEX

TEST "A" & "B"

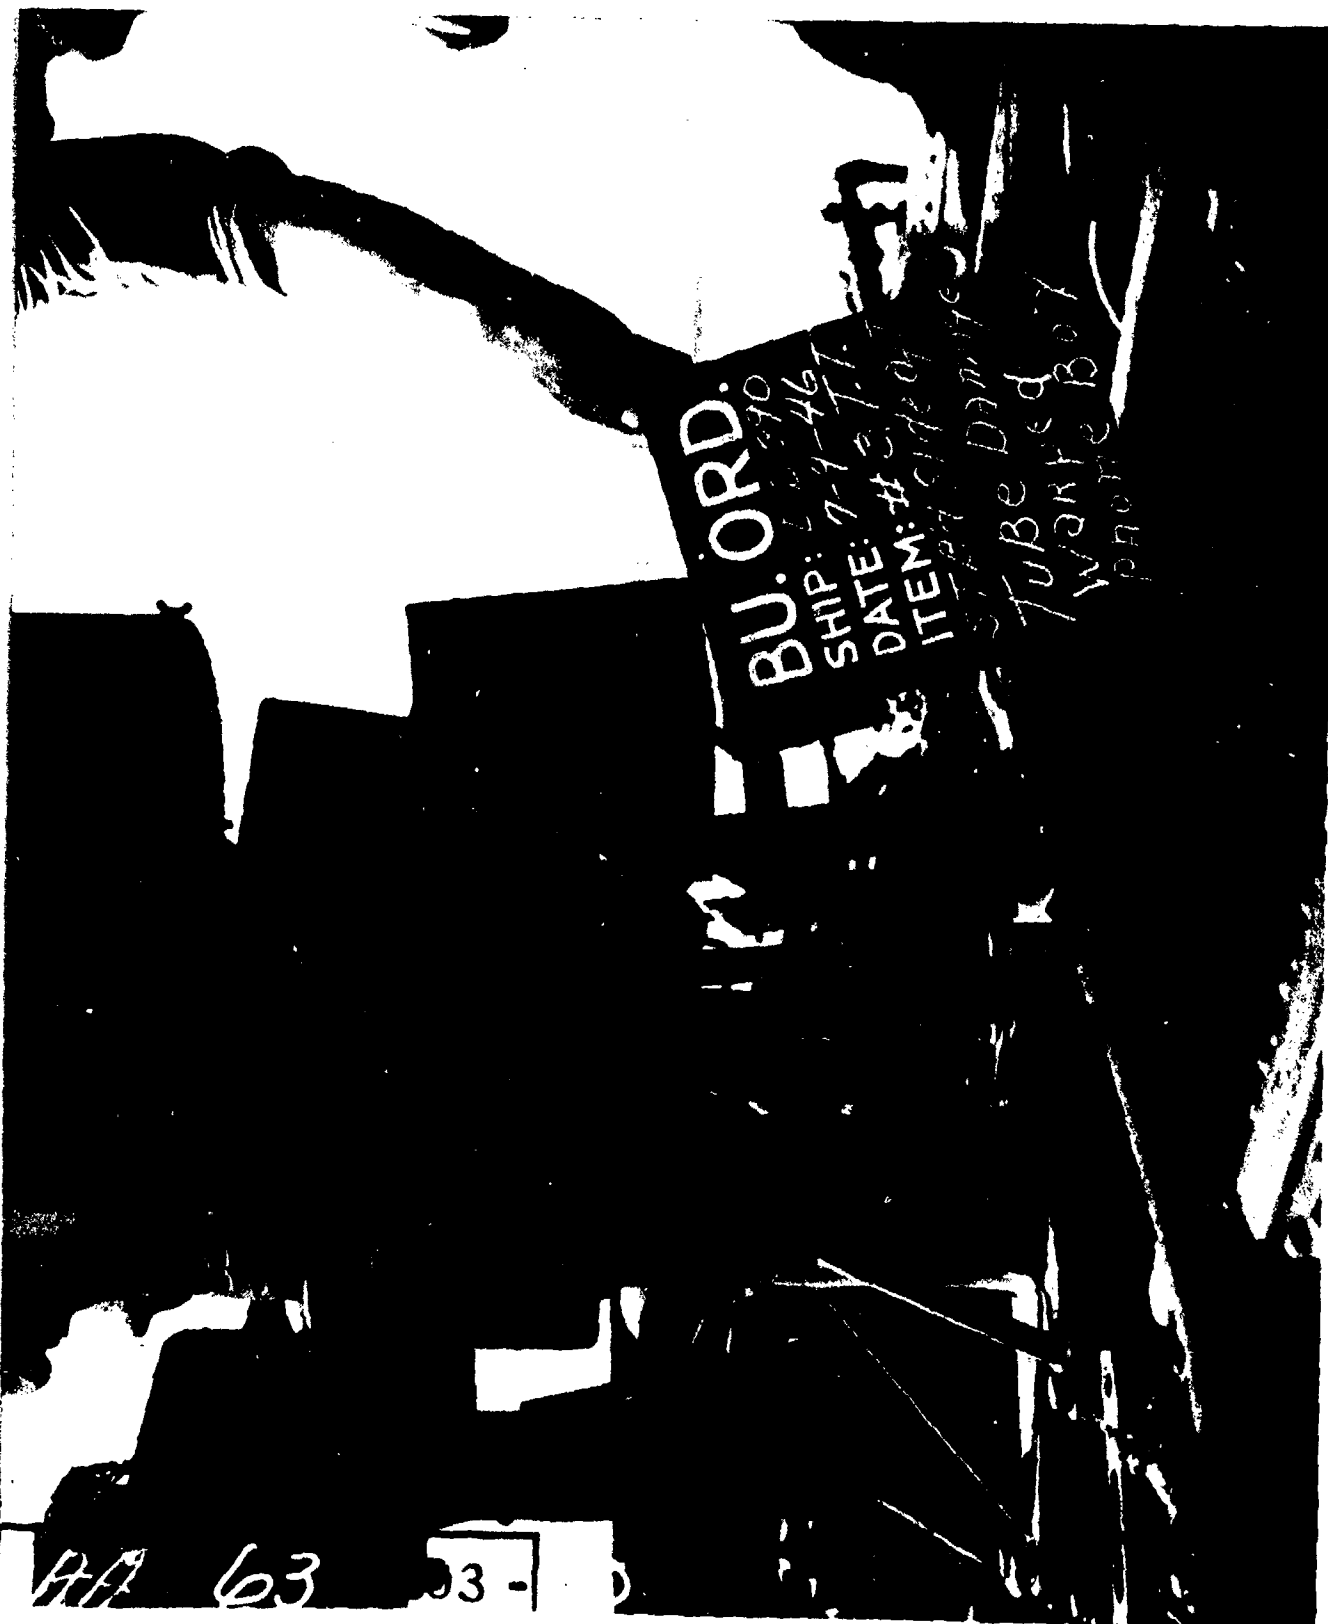
U.S.S. RALPH TALBOT (DD-390) - After Able
Torpedo Tube Aft Starboard Side, showing
damaged phone box.
Photo. No. AA-CR-63-1703-10.

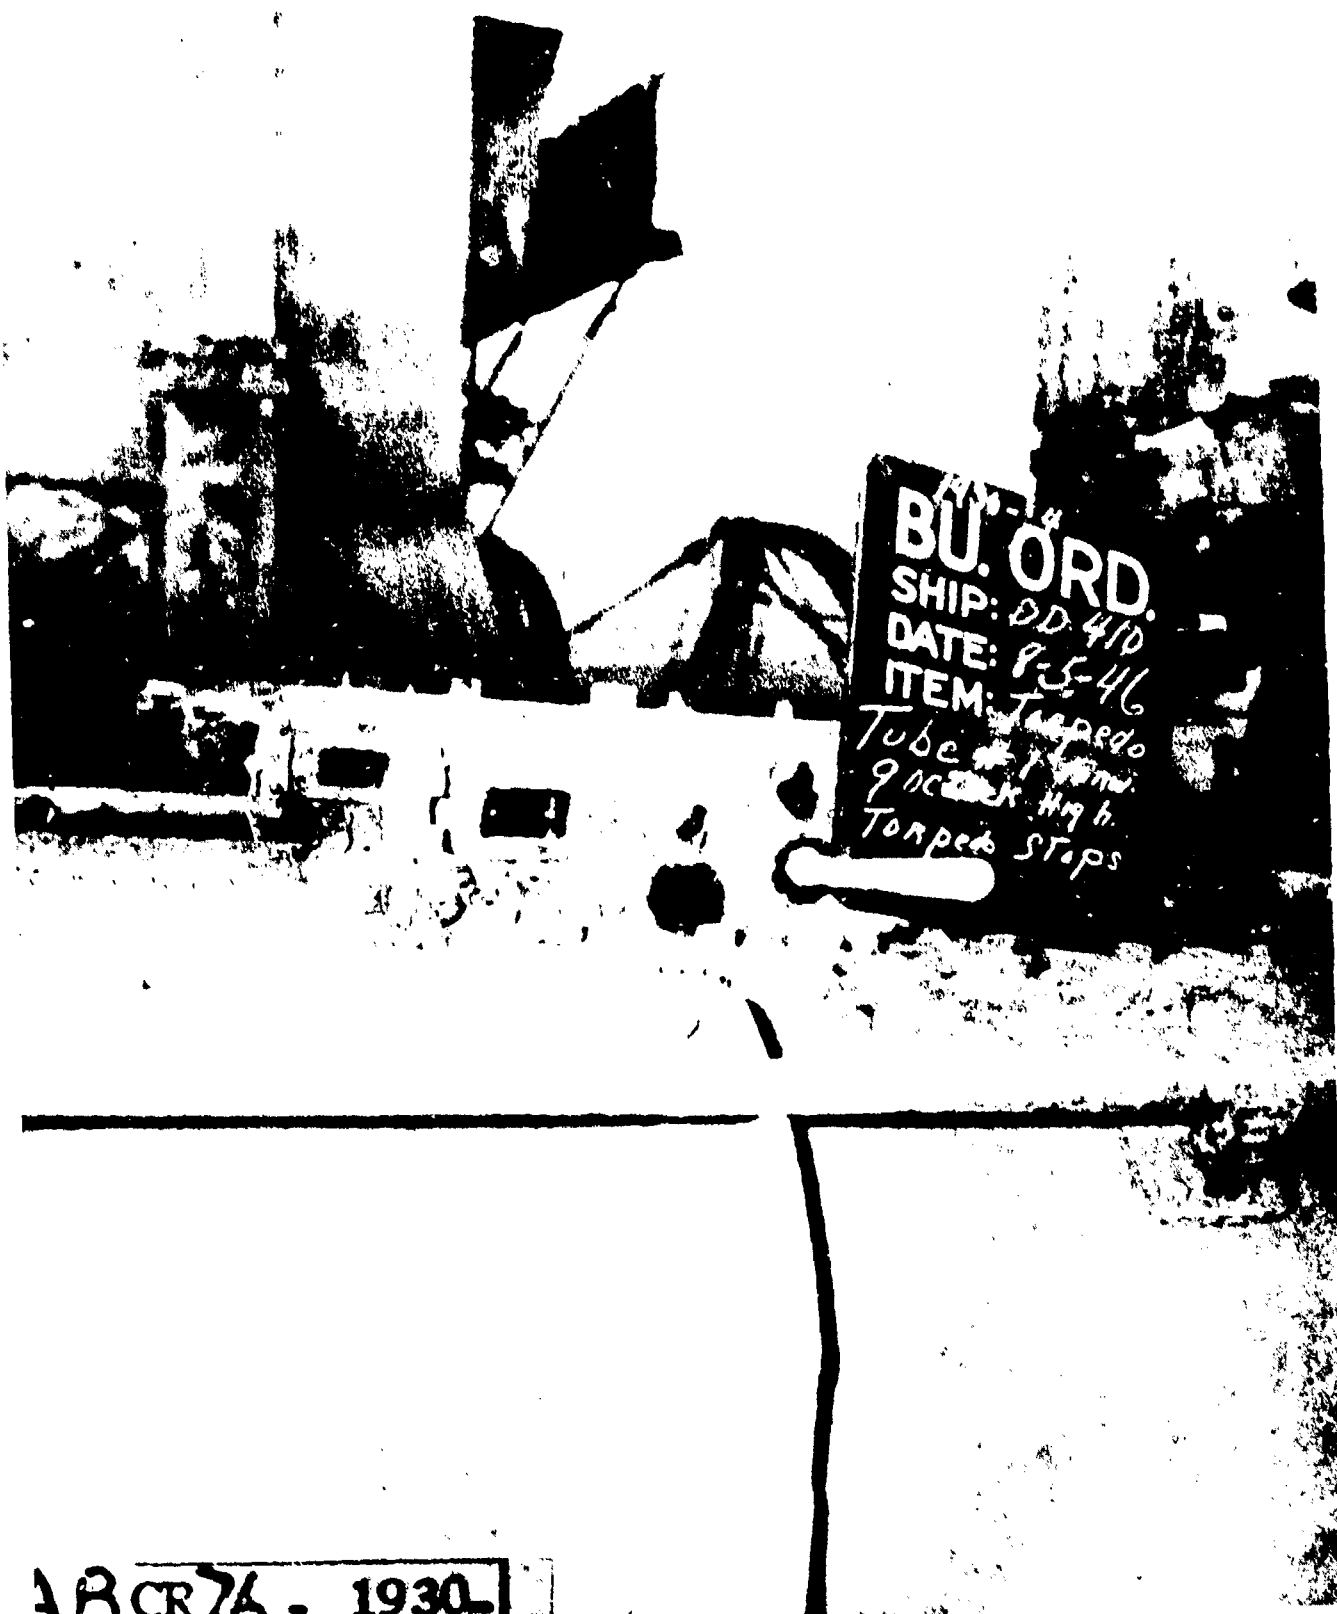
ARCR 76 - 1930

U.S.S. HUGHES (DD-410) - After Baker
Showing torpedo stop tension links carried away.
Photo. No. AR-OR-76-1930-5.
