# DEVELOPMENT OF NONDESTRUCTIVE TESTING TECHNIQUES FOR LARGE SOLID-PROPELLANT ROCKET MOTORS

United Technology Center

FINAL REPORT

UNDER CONTRACT No. AF 04(611)8018  
1 JUNE 1962 THROUGH 31 JANUARY 1963

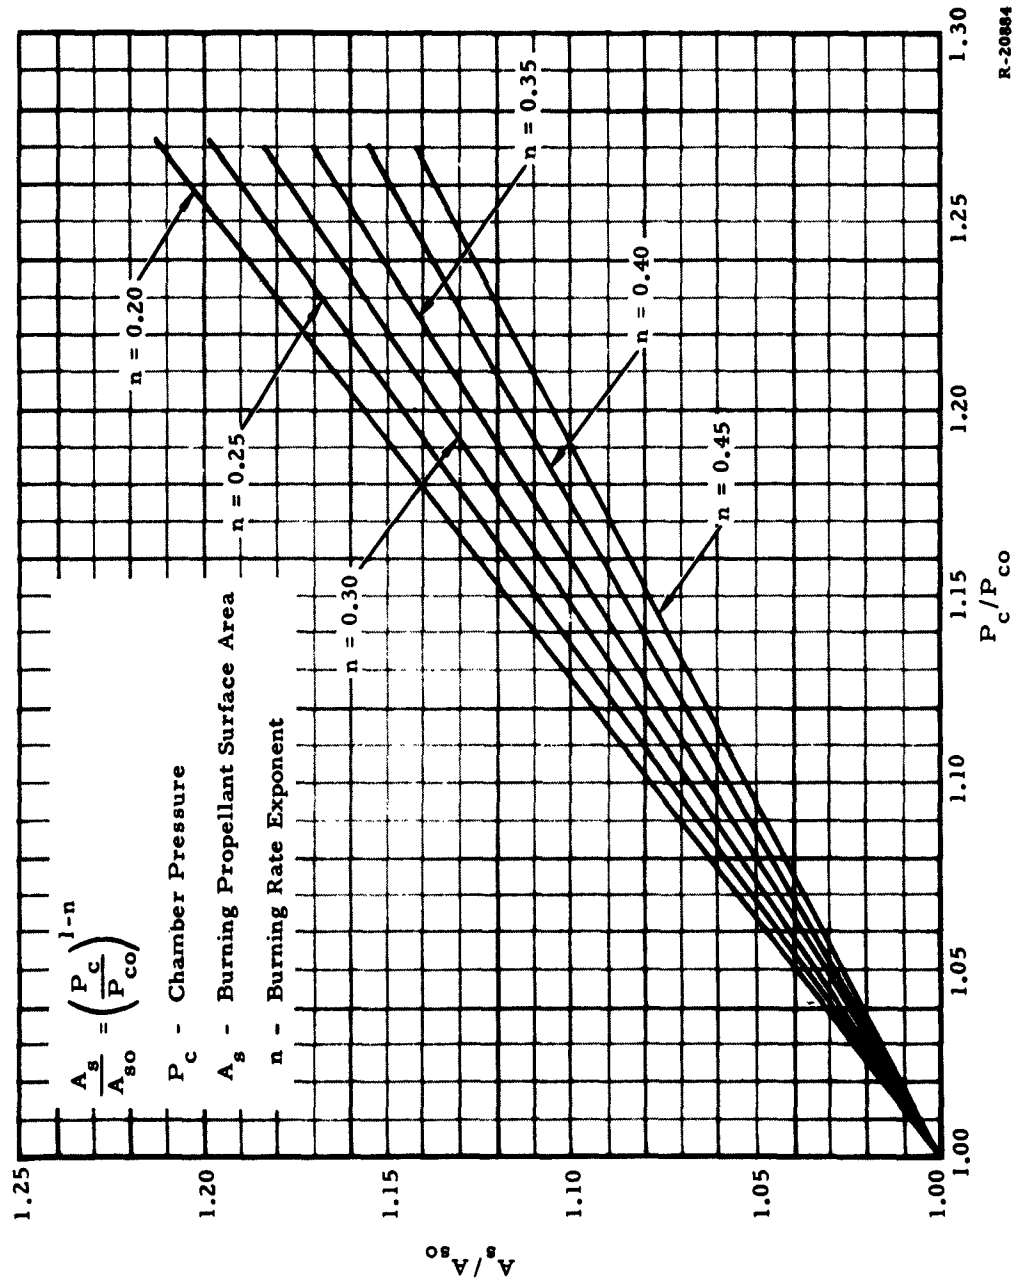
Figure 2. Variations of Propellant Burning Rate Versus Chamber Pressure

case failure. A defect of this type may be evaluated from the information presented in Figure 2. The factors required to class the defect as critical are the propellant burning rate exponent, percent of increase in burning area (actual over design), design chamber pressure, and case pressure failure criteria.

Assuming a case burst pressure of 120 percent of design pressure, and a PBAN propellant with burning ratio of 0.26, a burning area increase of 14.2 percent will result in a catastrophic overpressure.

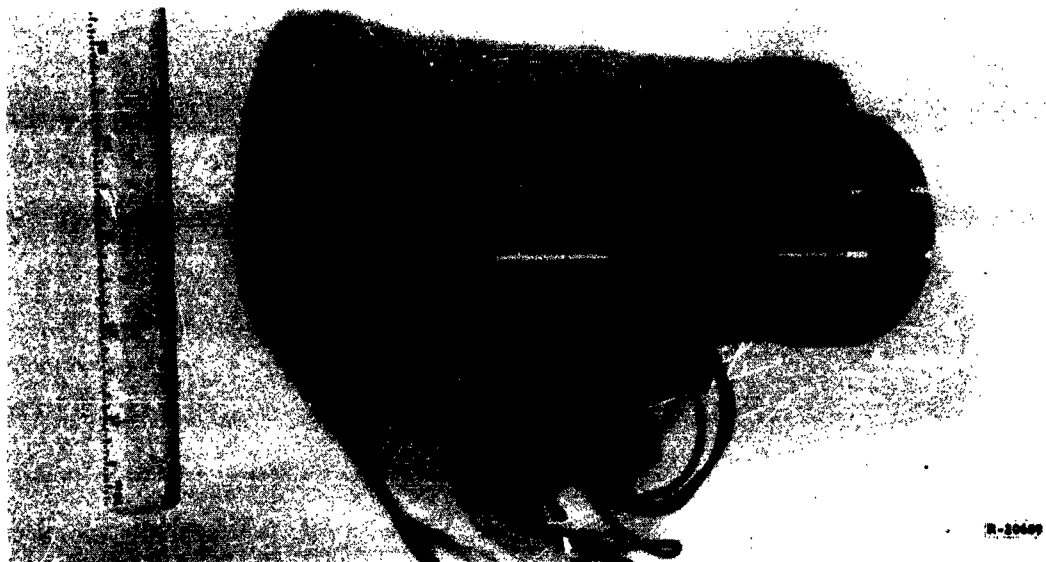
Figure 3. Scale Model Motor

The enlargement of a crack owing to motor pressurization and to the attendant strains imposed on the propellant case structure has been investigated with a small scale model motor (Figure 3).

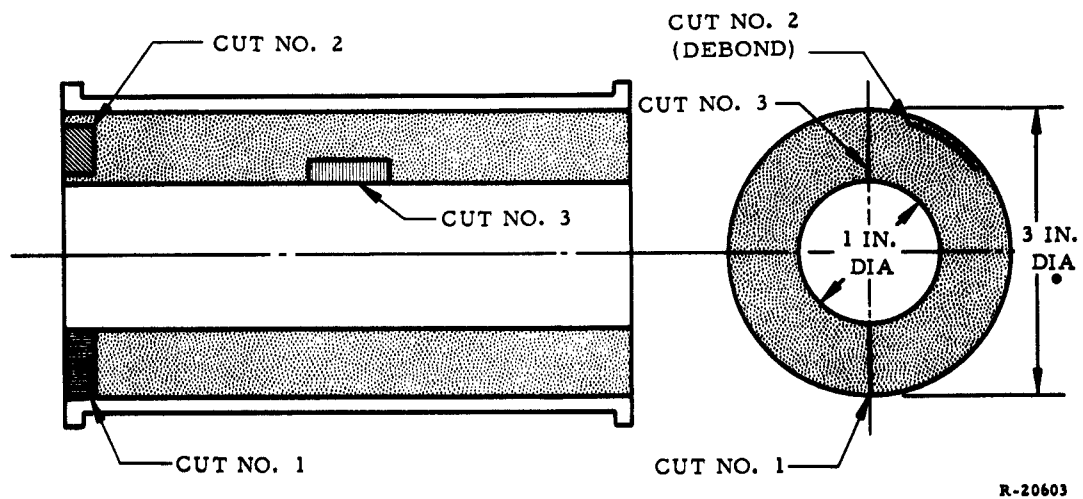
Figure 4. Propellant Cracks and Unbonds - Motor Defects

Propellant cracks and unbonds were incorporated in three motors as shown in Figure 4. The cracks and unbonds were cut in the live propellant and filled with a blue dye. The motors were assembled and pressurized to 800 psig at the

All test results were negative inasmuch as the built-in cracks did not propagate, the debonded areas did not increase, and no new grain ruptures were observed. Dissection of two of these grains substantiates these conclusions.

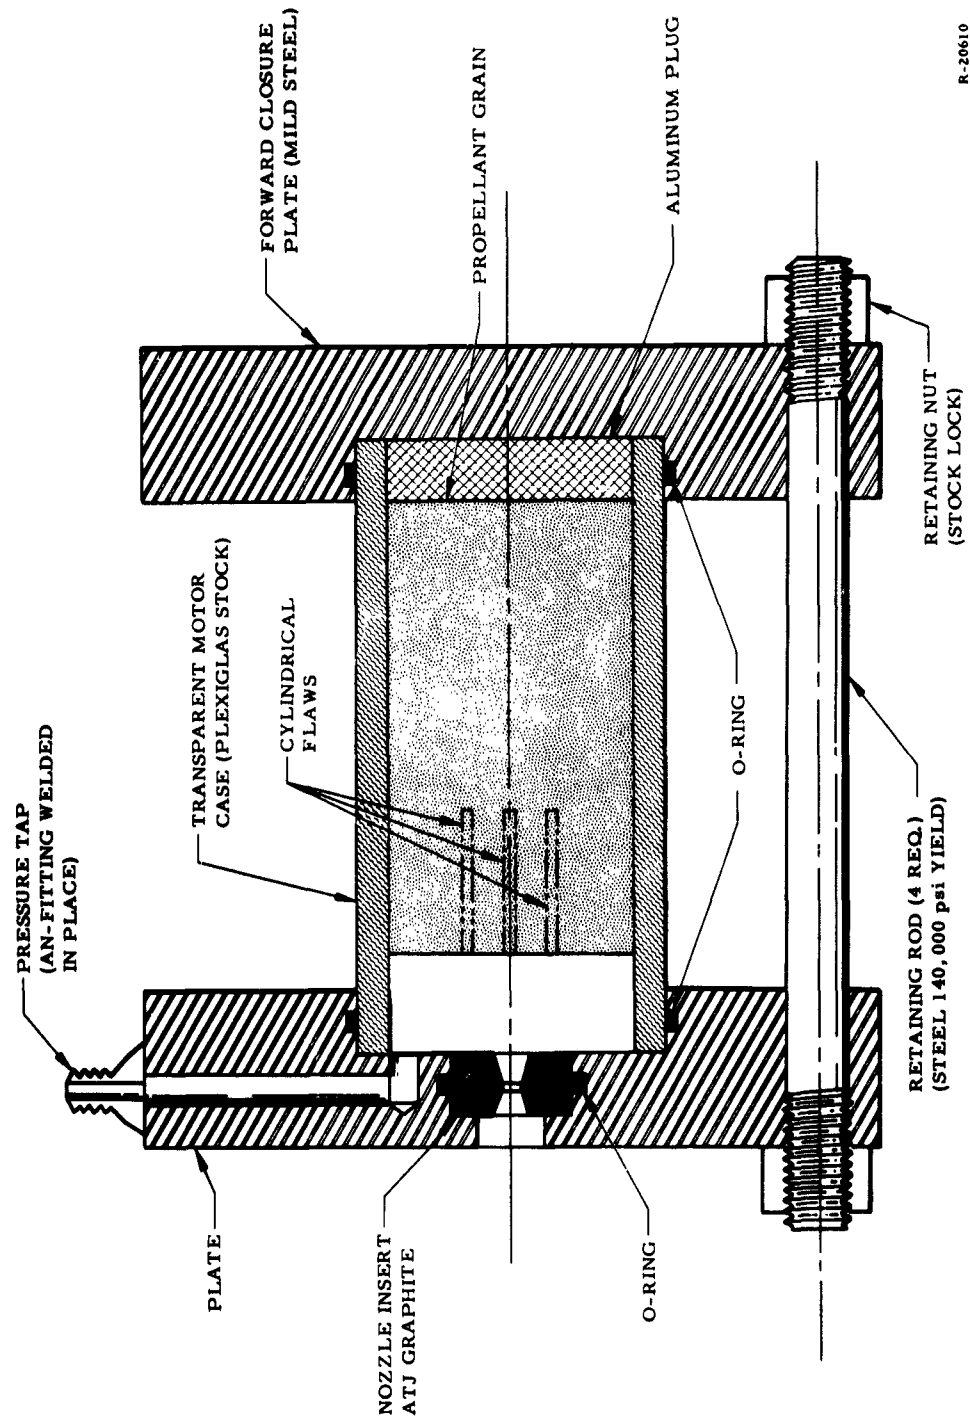
Figure 5. Transparent Motor Assembly

An attempt was made to ascertain the rate of flame propagation down certain defects with a Plexiglas motor (Figure 5). Holes of varying diameter were incorporated

into the grain adjacent to the case wall and high speed photography was used to determine the rate of flame propagation down these defects.

Ignition of the first two motors resulted in catastrophic increase of the burning area. This was traced to an insufficient liner thickness (the liner had originally been designed about 0.005-inch thick to give minimum interference for good photography). A third motor incorporating a thicker liner was successfully fired on 24 August 1962.

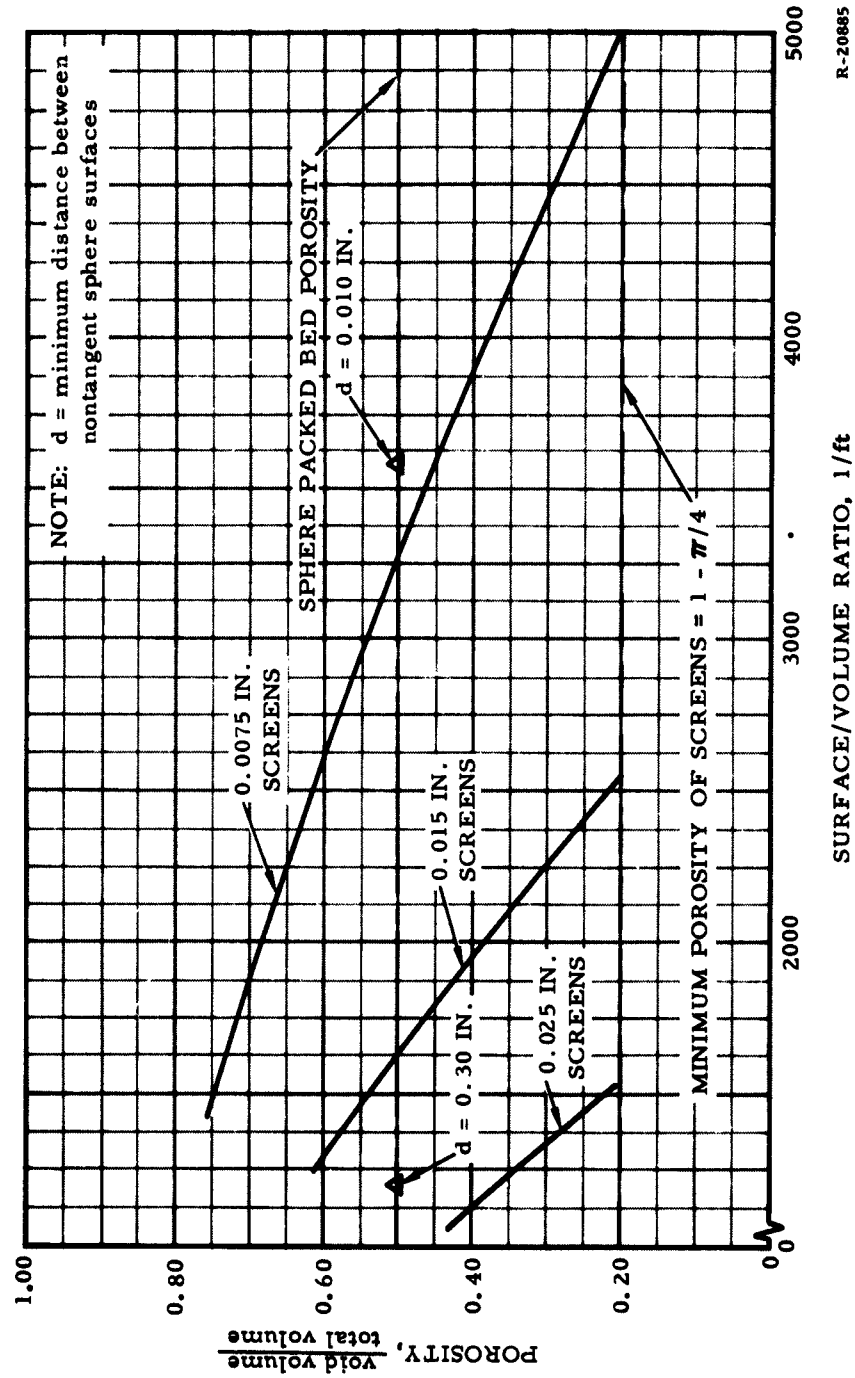
Figure 6. Surface-to-Volume Relationships of Some Typical Geometries of Propellant Pores  
( $d$  = Minimum distance between non-tangent sphere surfaces)

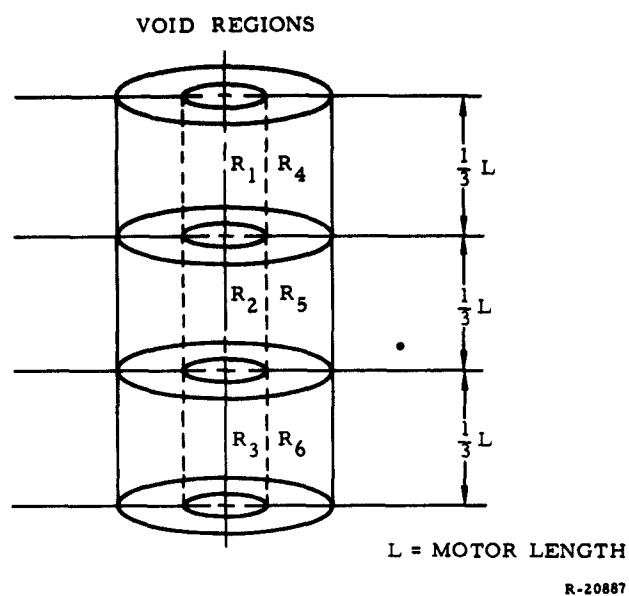
Figure 8. Schematic of Division of Propellant Configuration into Separate Regions

In the manner prescribed by the preceding paragraph and Figure 8, six regions were defined for locating voids. These were labeled  $R_1$ ,  $R_2$ , and  $R_3$  for the three inner regions starting from the top of the motor and  $R_4$ ,  $R_5$  and  $R_6$  for the corresponding outer regions beginning at the top of the motor. Finally, the volumes for these regions have been entered in Table III for both eight-inch and the 120-inch motors. The ratios of the volumes for the various regions were also entered and are useful in the problem of extrapolating the results which appear at the end of this section.

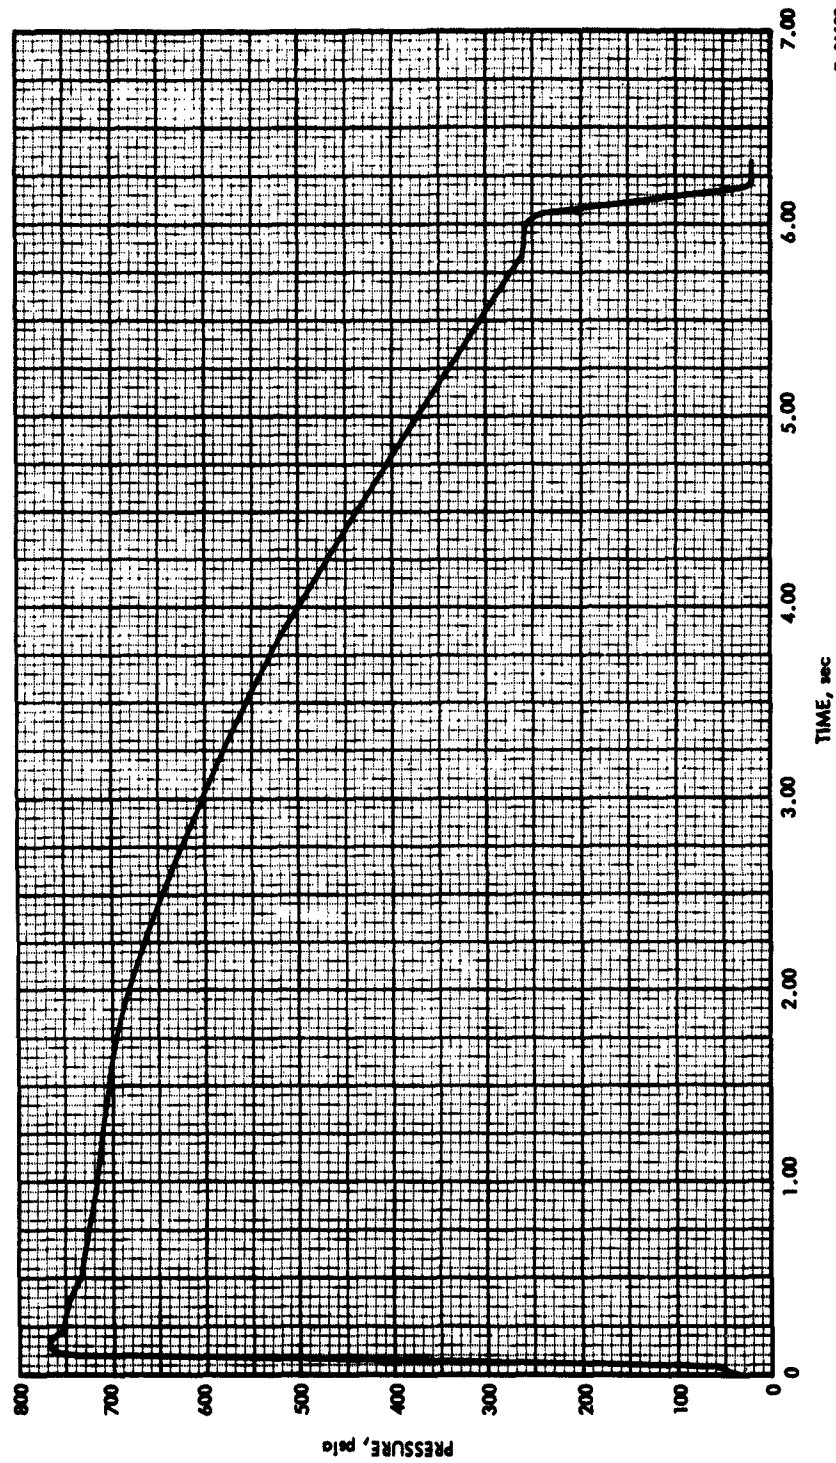
Figure 9. Pressure versus Time for Typical Subscale Motor

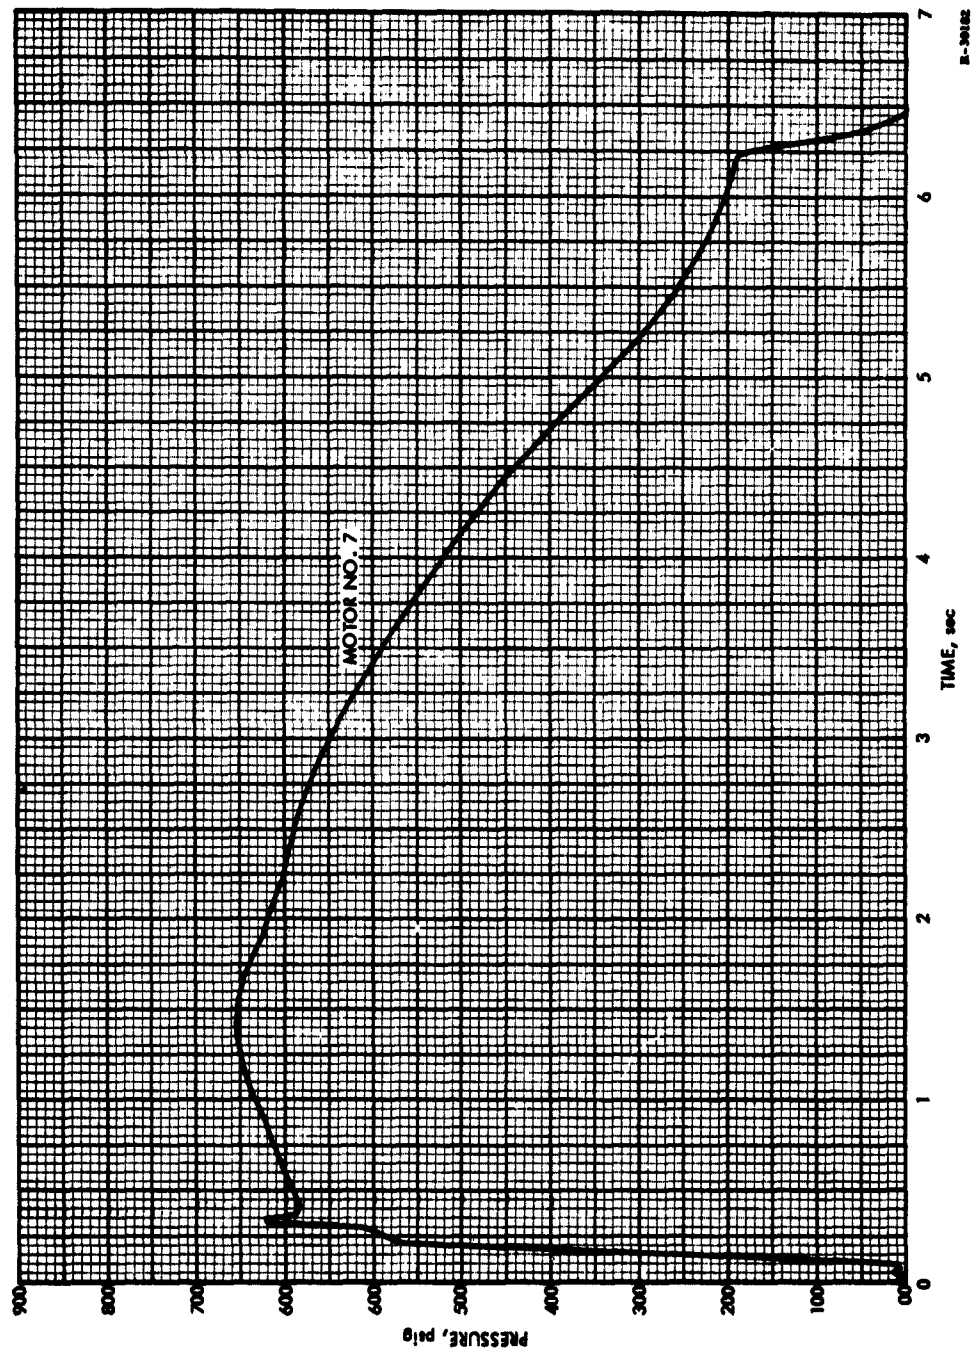
Figure 12. Pressure versus Time trace for Subscale Motor No. 7

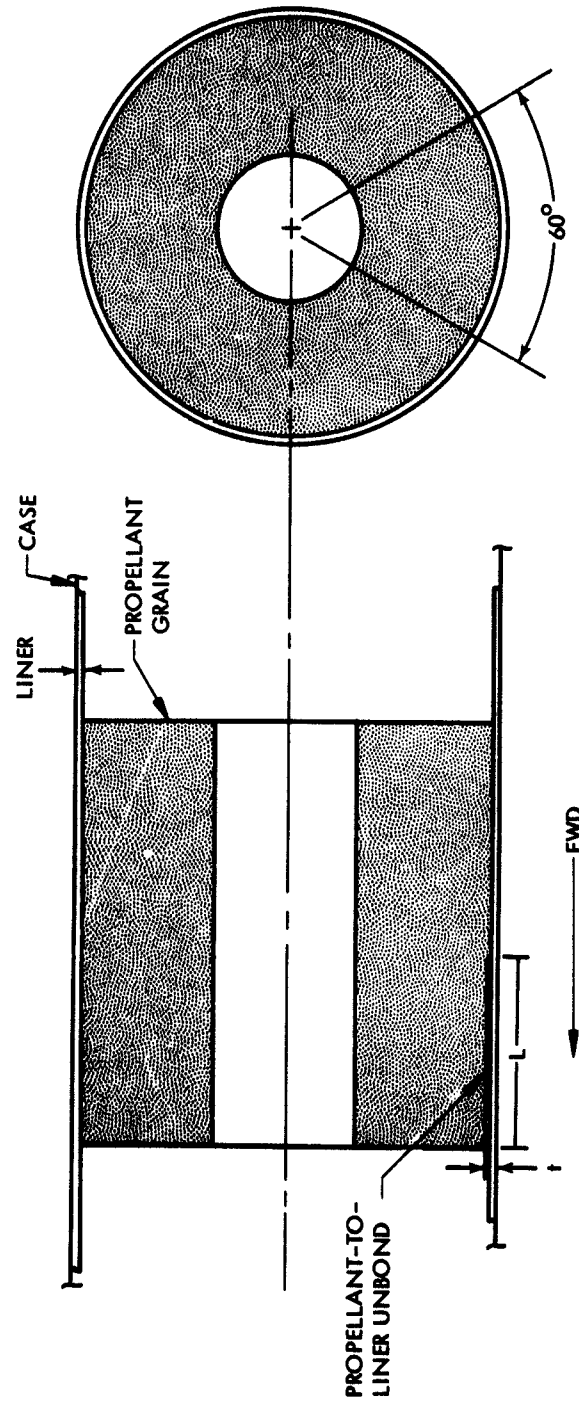
MOTOR NO.	9	10	11	12	13	14	15	16	17	18	19	20
L	2.0	2.0	2.0	3.0	3.0	3.0	4.0	4.0	4.0	5.0	5.0	5.0
t	0	.030	.060	0	.030	.060	0	.030	.060	0	.030	.060

Figure 13. Propellant Grain Defects for Motor No. 9 through 20

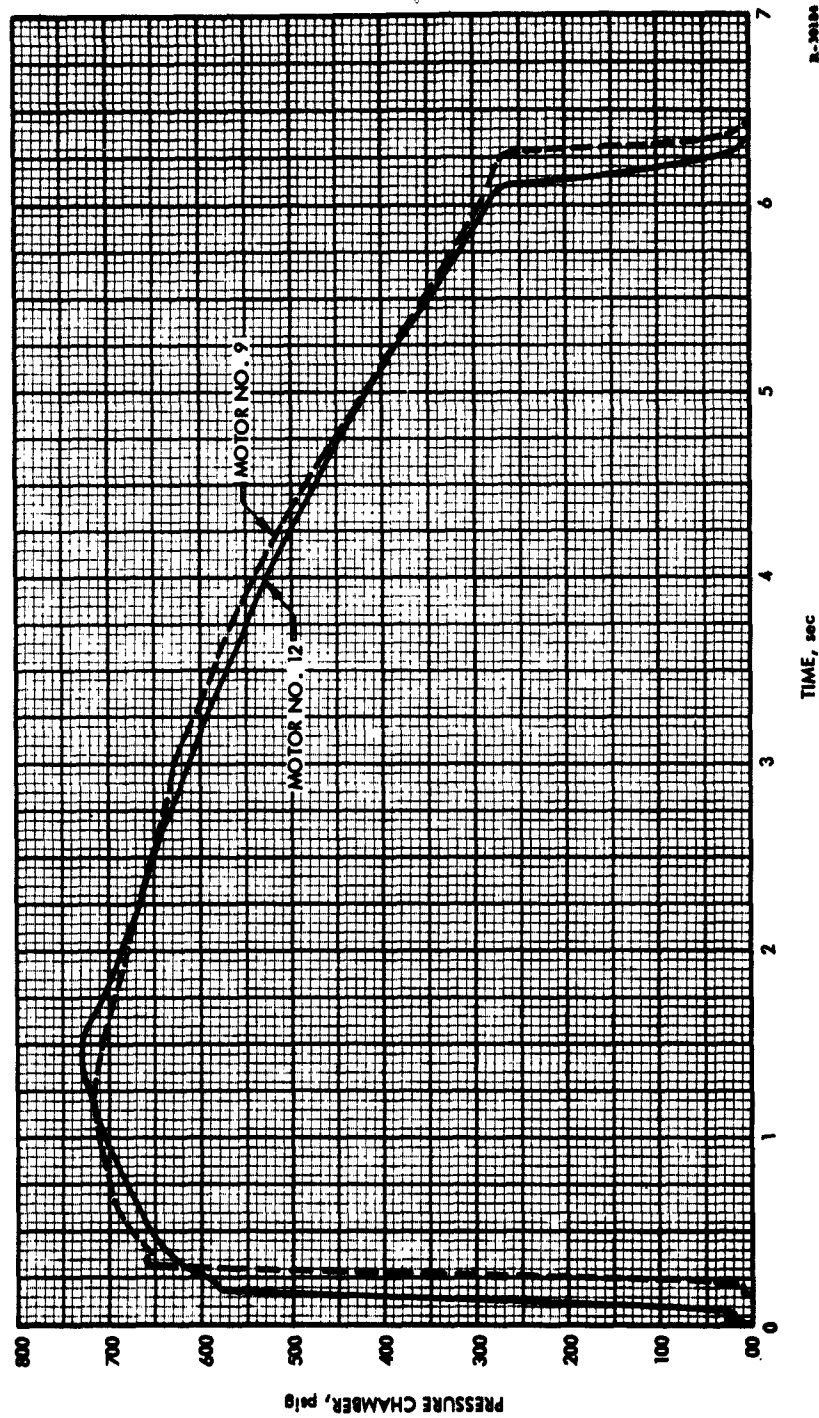
Figure 14. Pressure versus Time Trace for Subscale Motors No. 9 and 12

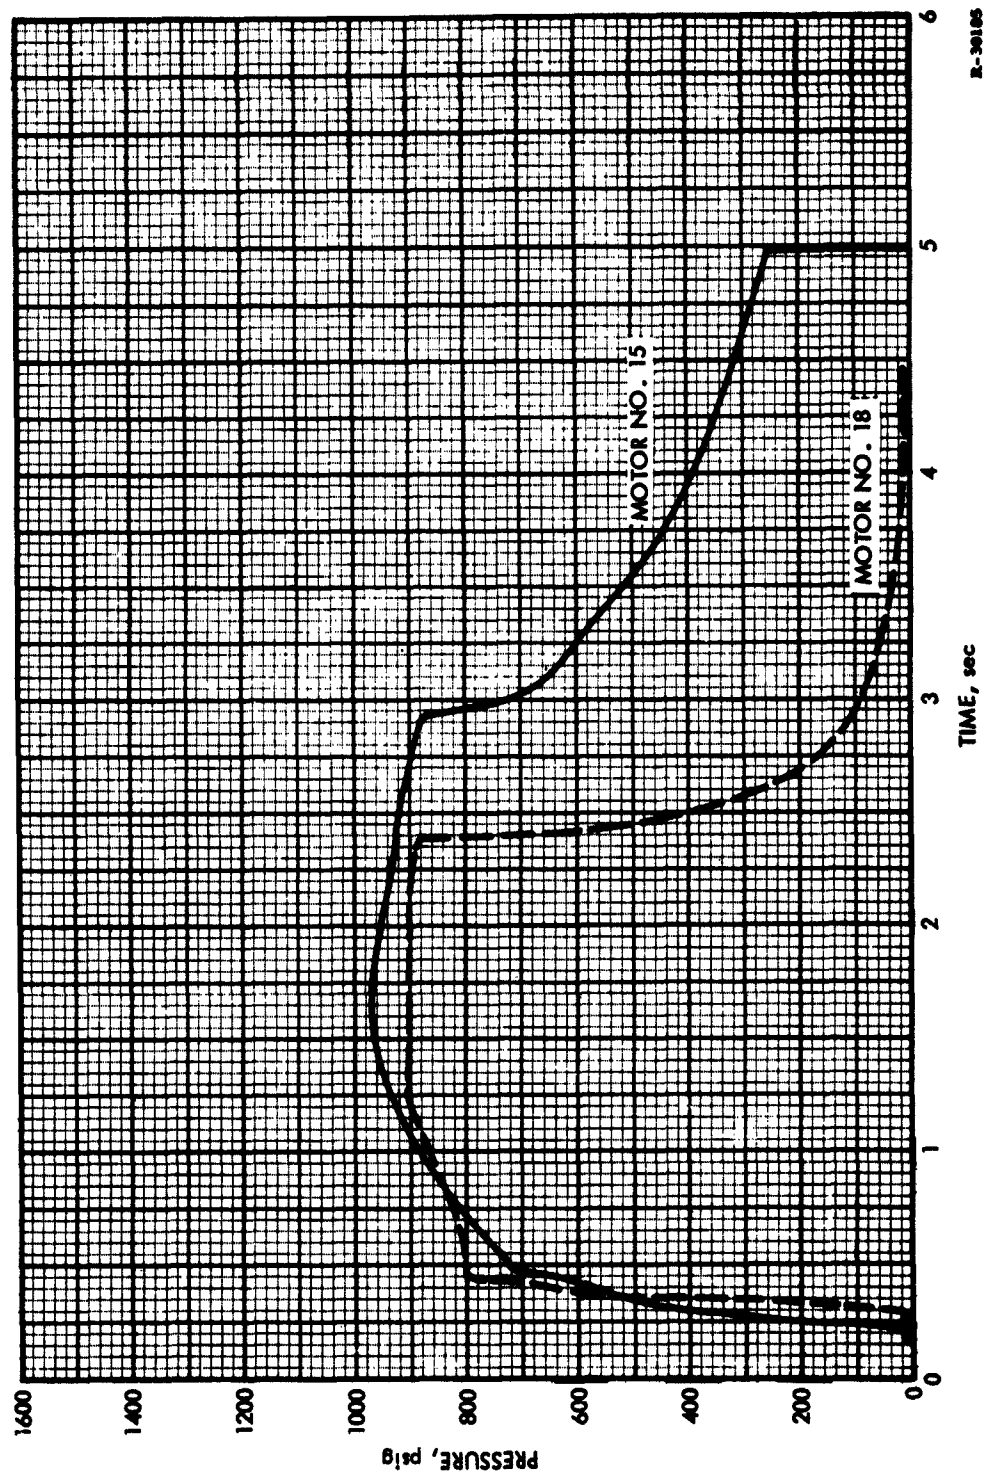
Figure 15. Pressure versus Time Trace for Subscale Motors No. 15 and 18

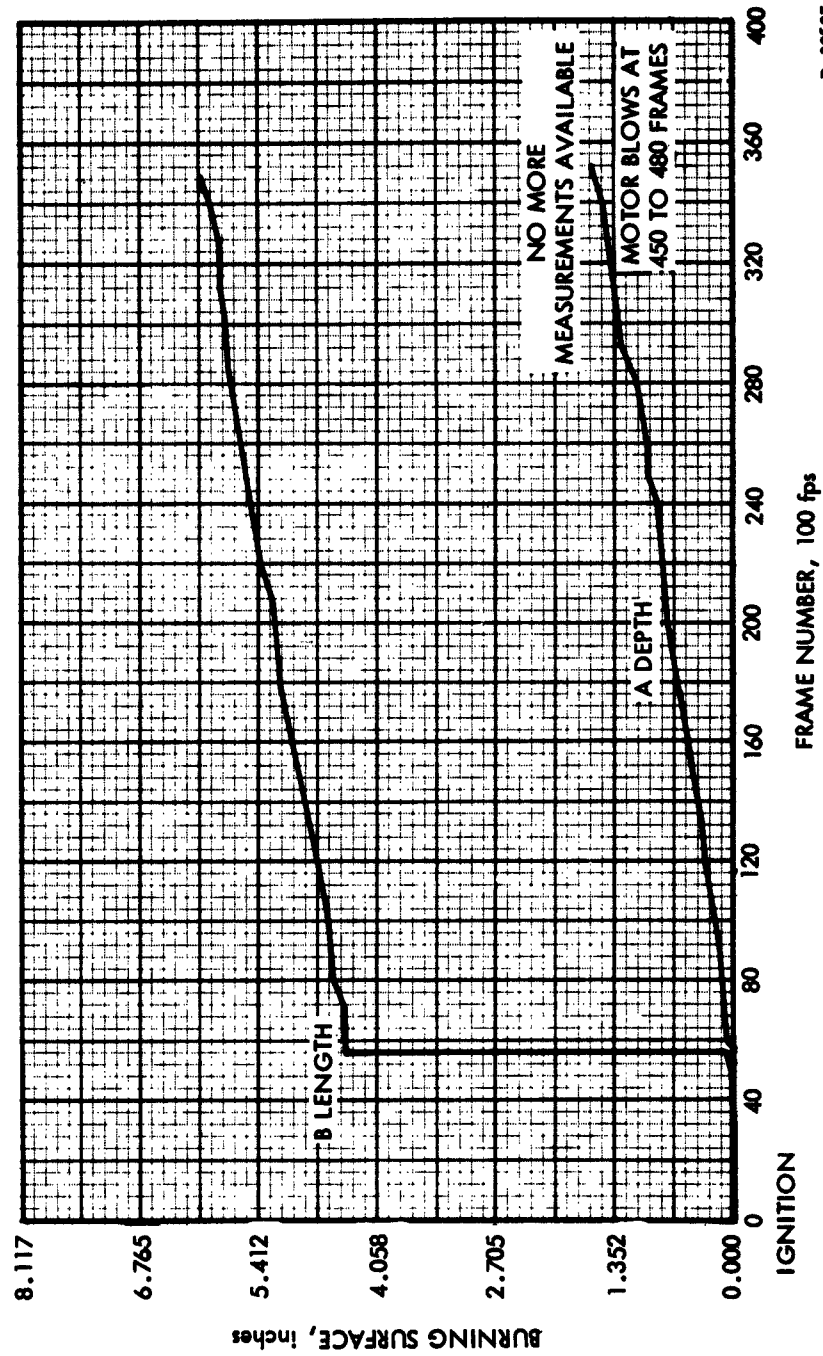
Figure 15a. Length of Burning Unbond and Depth of Unbond Thickness as a Function of Burning Time (Motor No. 15)

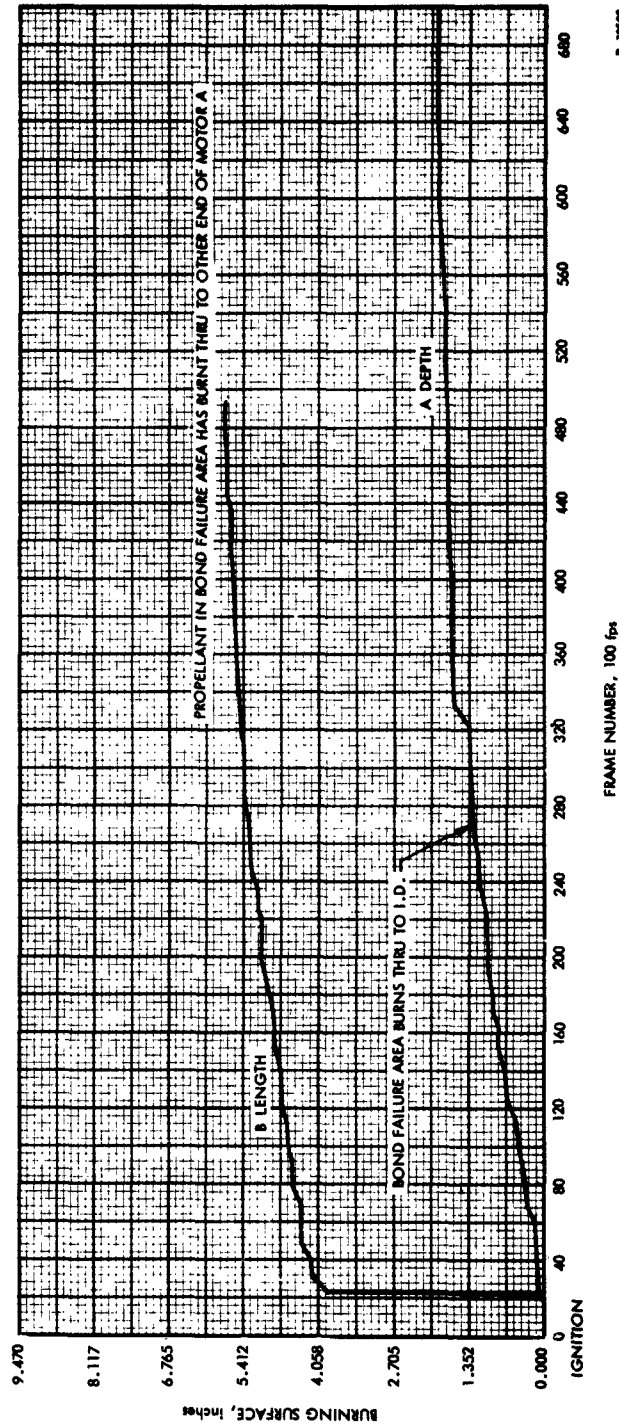
Figure 15b. Length of Burning Unbond and Depth of Unbond Thickness  
as a Function of Burning Time (Motor No. 18)

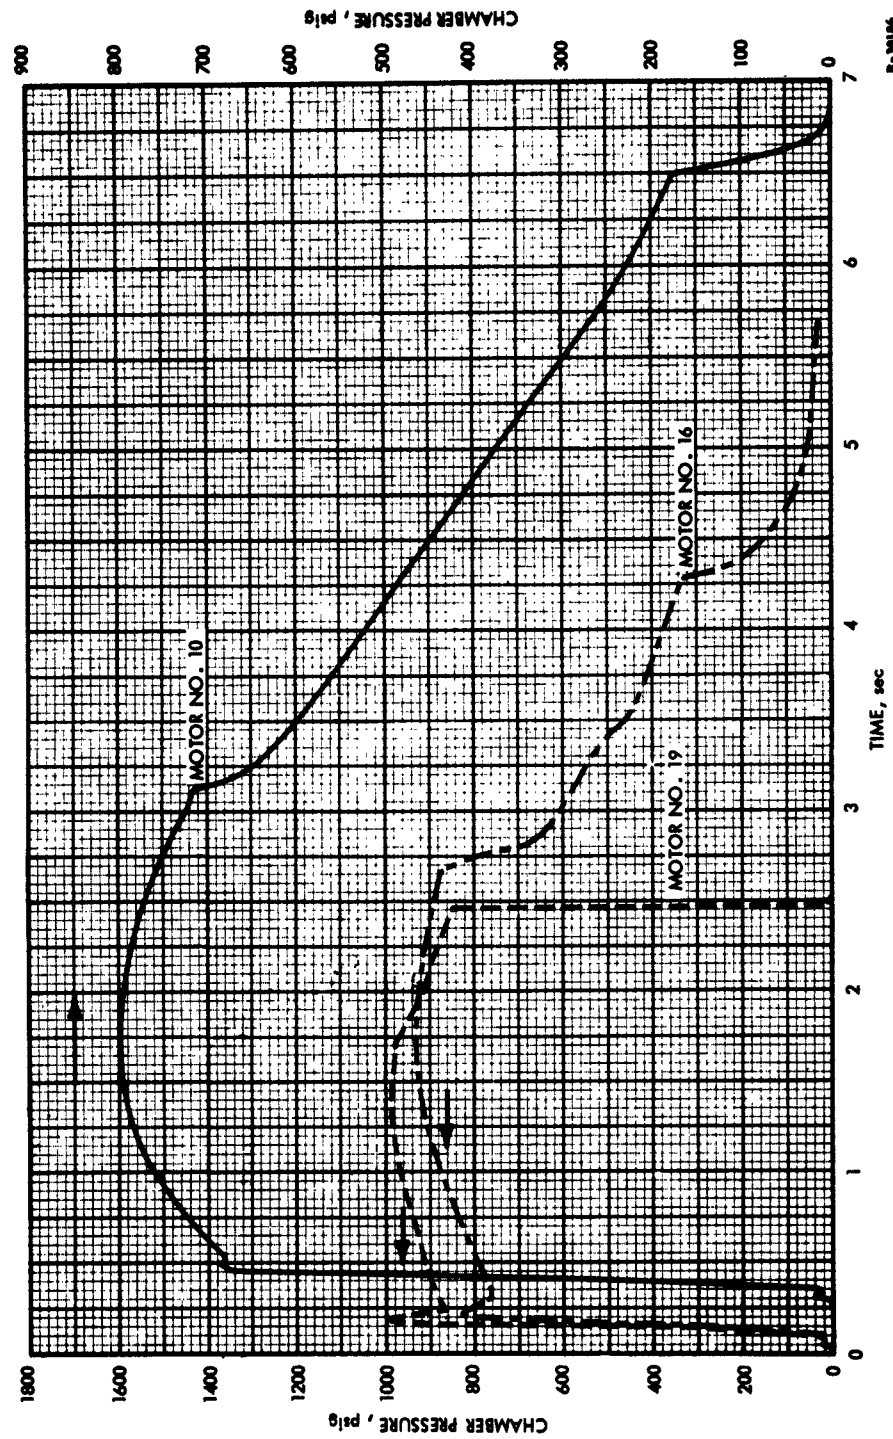
Figure 16. Pressure versus Time Traces for Subscale Motors No. 10, 16, and 19

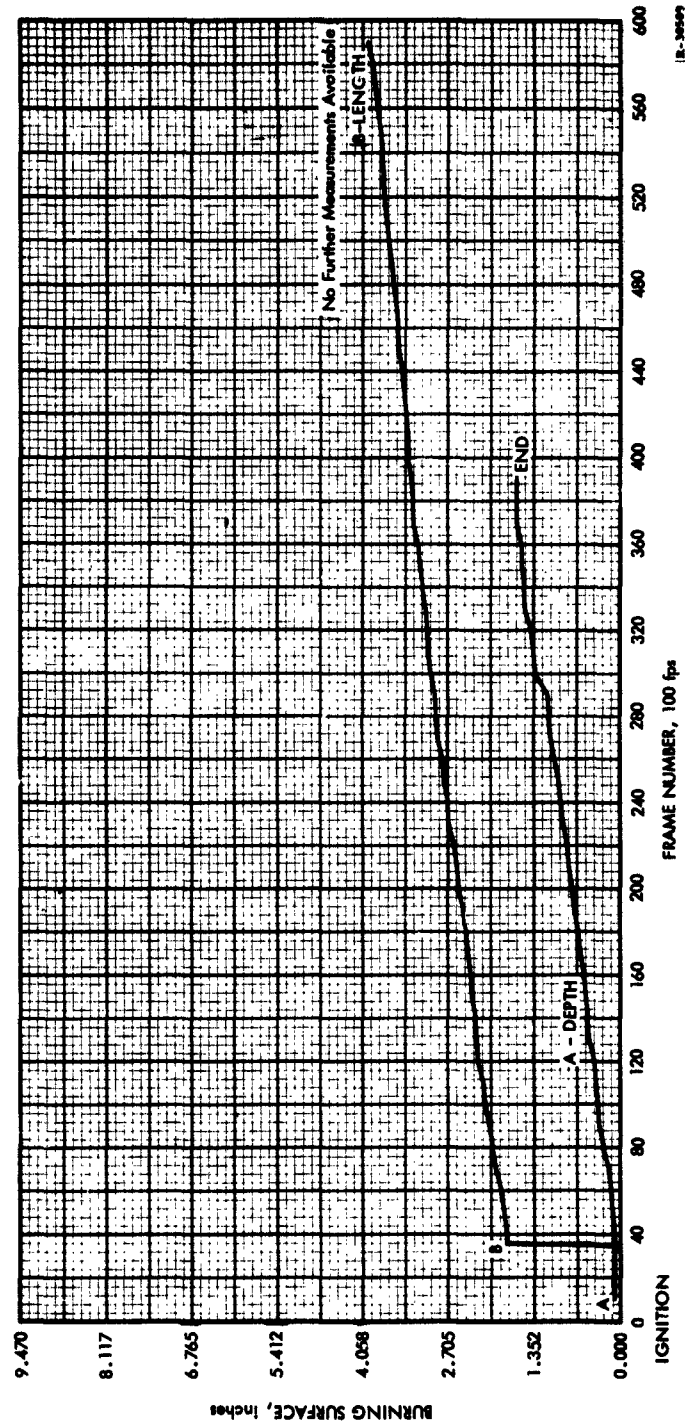
Figure 16a. Length of Burning Unbond and Depth of Unbond Thickness as a Function of Burning Time (Motor No. 10)

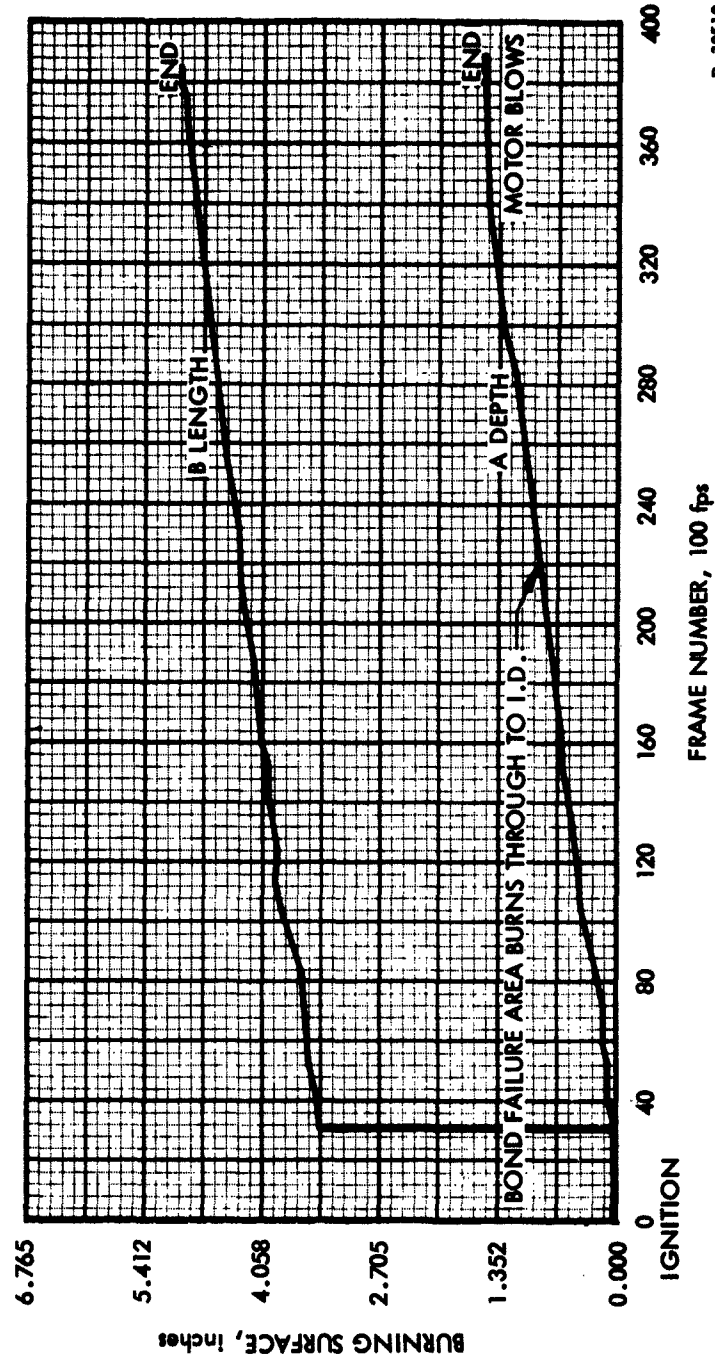
Figure 16b. Length of Burning Unbond and Depth of Unbond Thickness as a Function of Burning Time (Motor No. 13)

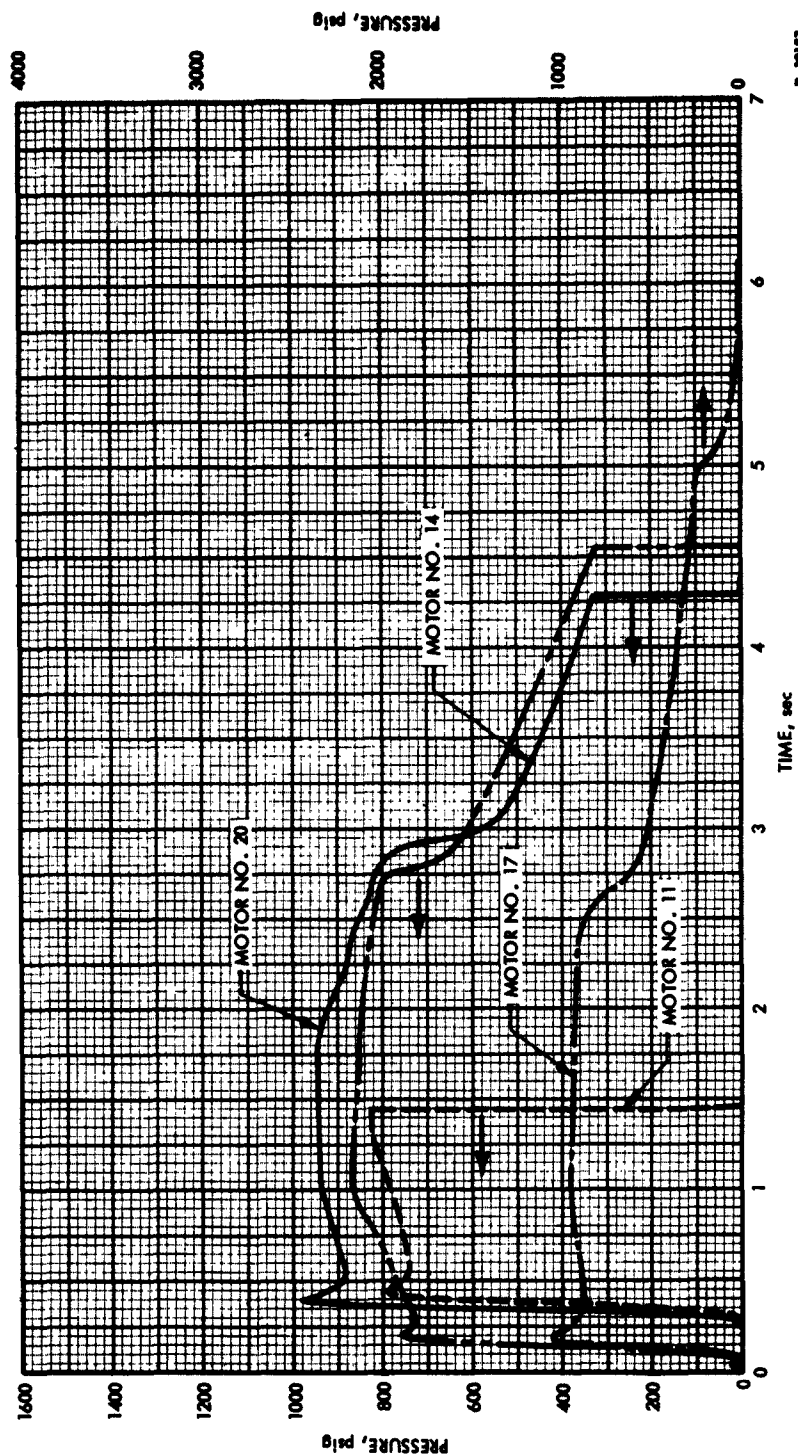
Figure 17. Pressure versus Time Trace for Subscale Motors No. 11, 14, 17, and 20

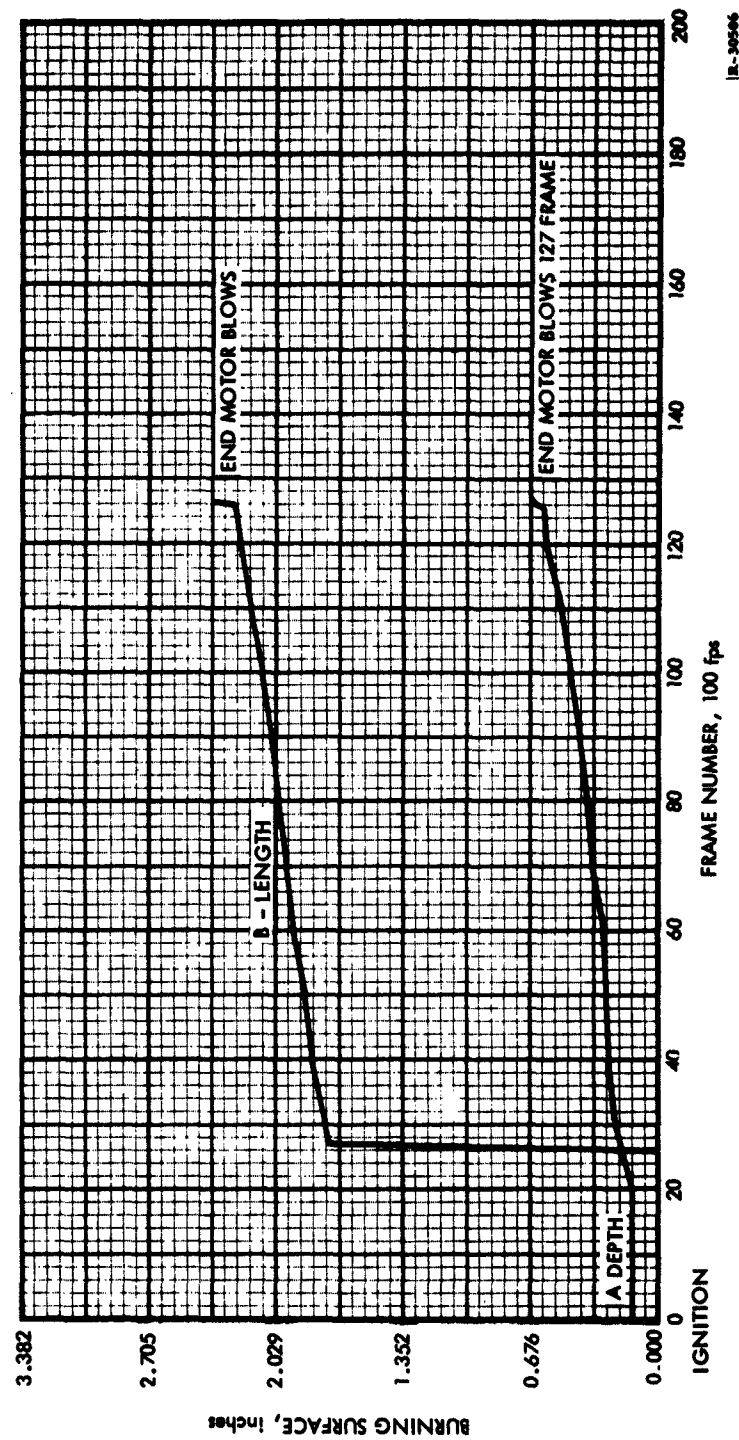
Figure 17a. Length of Burning Unbond and Depth of Unbond Thickness as a Function of Burning Time (Motor No. 11)

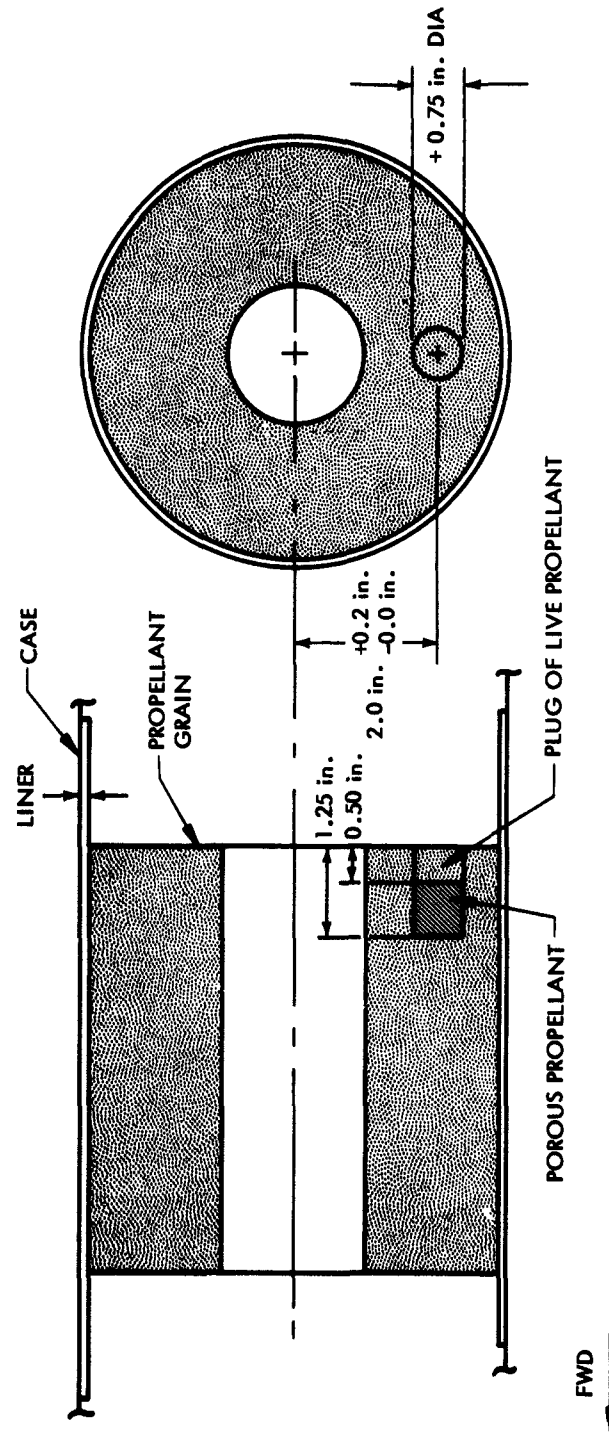
- NOTE: 1. Porous Propellant to be Made of Propellant Particles with Maximum Dimension of 0.060 in.
2. Cement Plug in Place with Liner
3. Catastrophic Overpressure Expected 1.5 sec After Ignition

Figure 18. Propellant Grain Defects for Motors No. 21 and 22

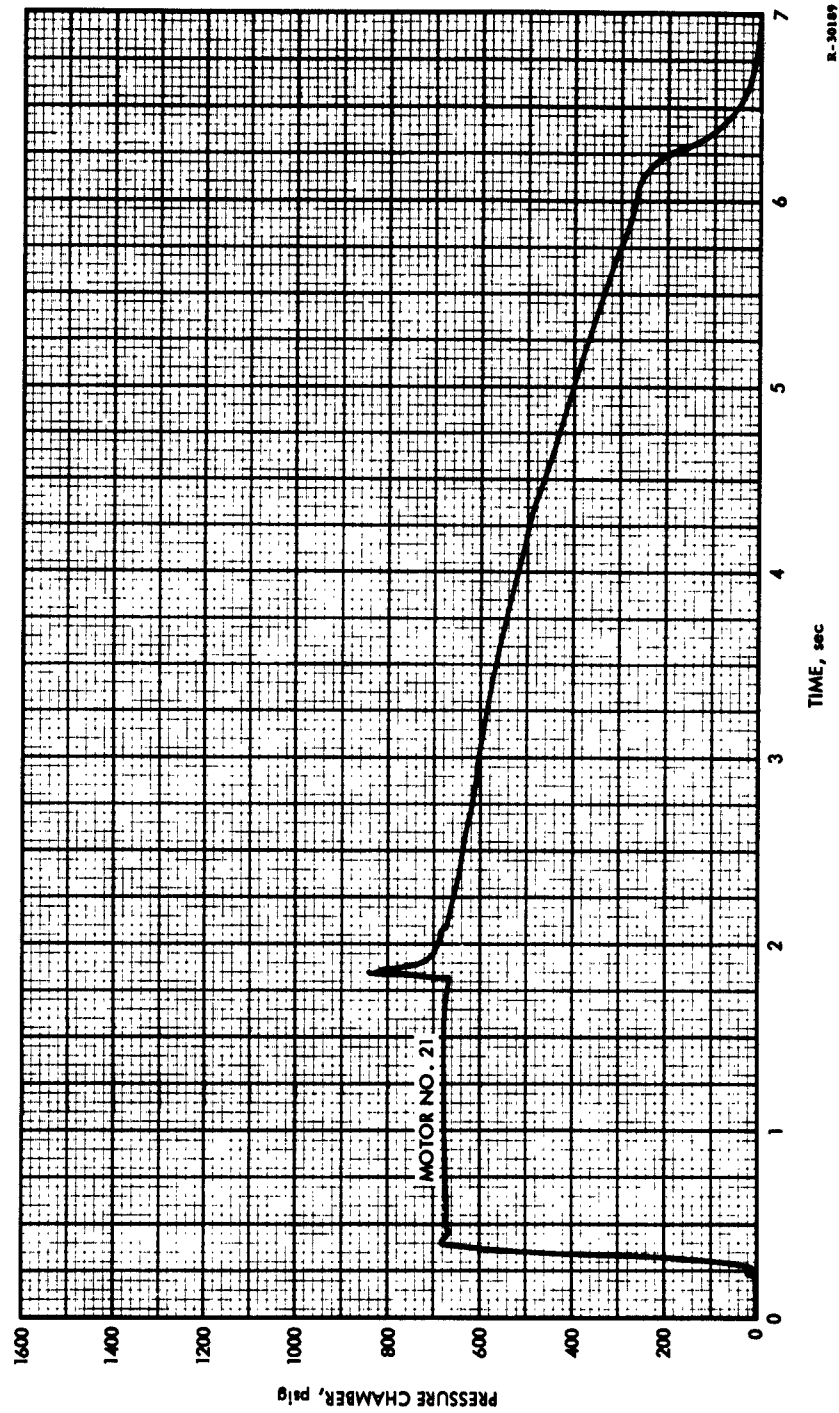
Figure 19. Pressure versus Time Trace for Subscale Motor No. 21

The porosity defects were simulated by producing a cavity into the propellant grain in a manner similar to that for the void defects. This cavity was filled with particles of UTP-3001 propellant, with particle sizes of 0.025 to 0.030 inch. The cavity was located as shown in Figure 18. The pressure-time traces for Motor No. 21 are shown in Figure 19.

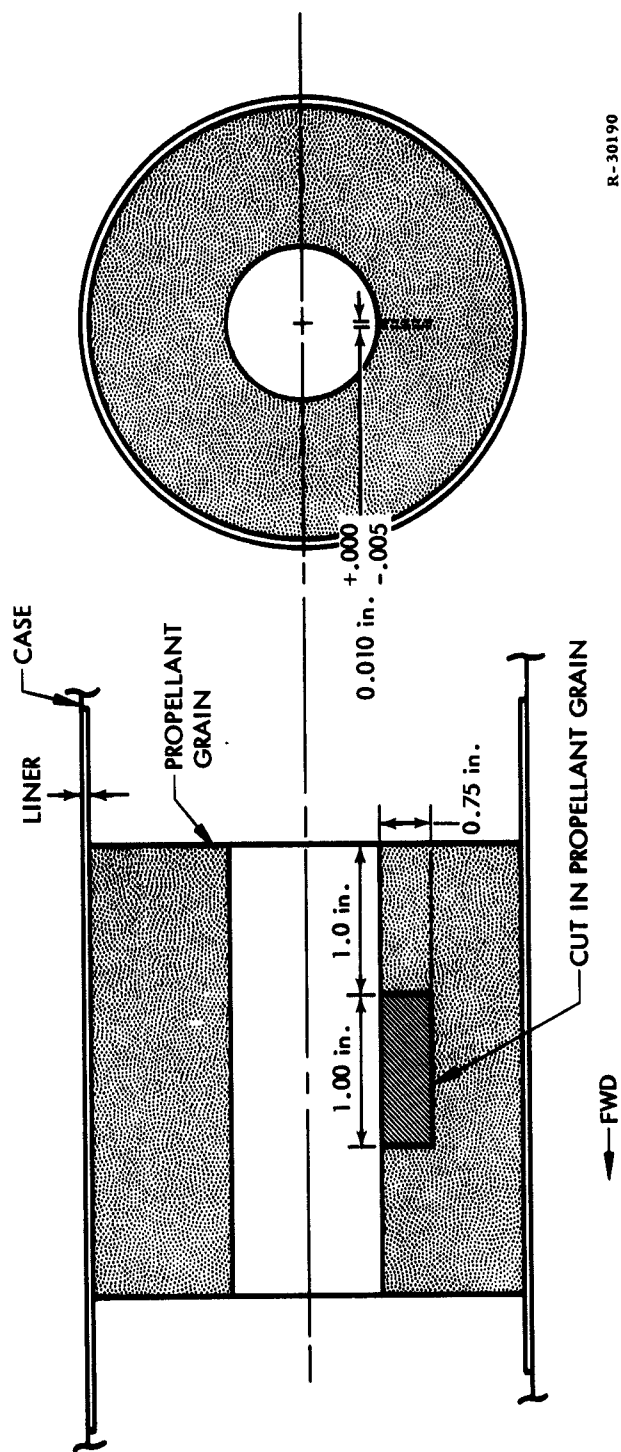
Figure 20. Propellant Grain Defects for Motors No. 23, 24, and 25

In addition to the artificially produced crack in Motor No. 25 (Figure 21) a circumferential crack developed around the periphery
