# DEVELOPMENT OF NONDESTRUCTIVE TESTING TECHNIQUES FOR LARGE SOLID-PROPELLANT ROCKET MOTORS

United Technology Center

FINAL REPORT

UNDER CONTRACT No. AF 04(611)8018  
1 JUNE 1962 THROUGH 31 JANUARY 1963

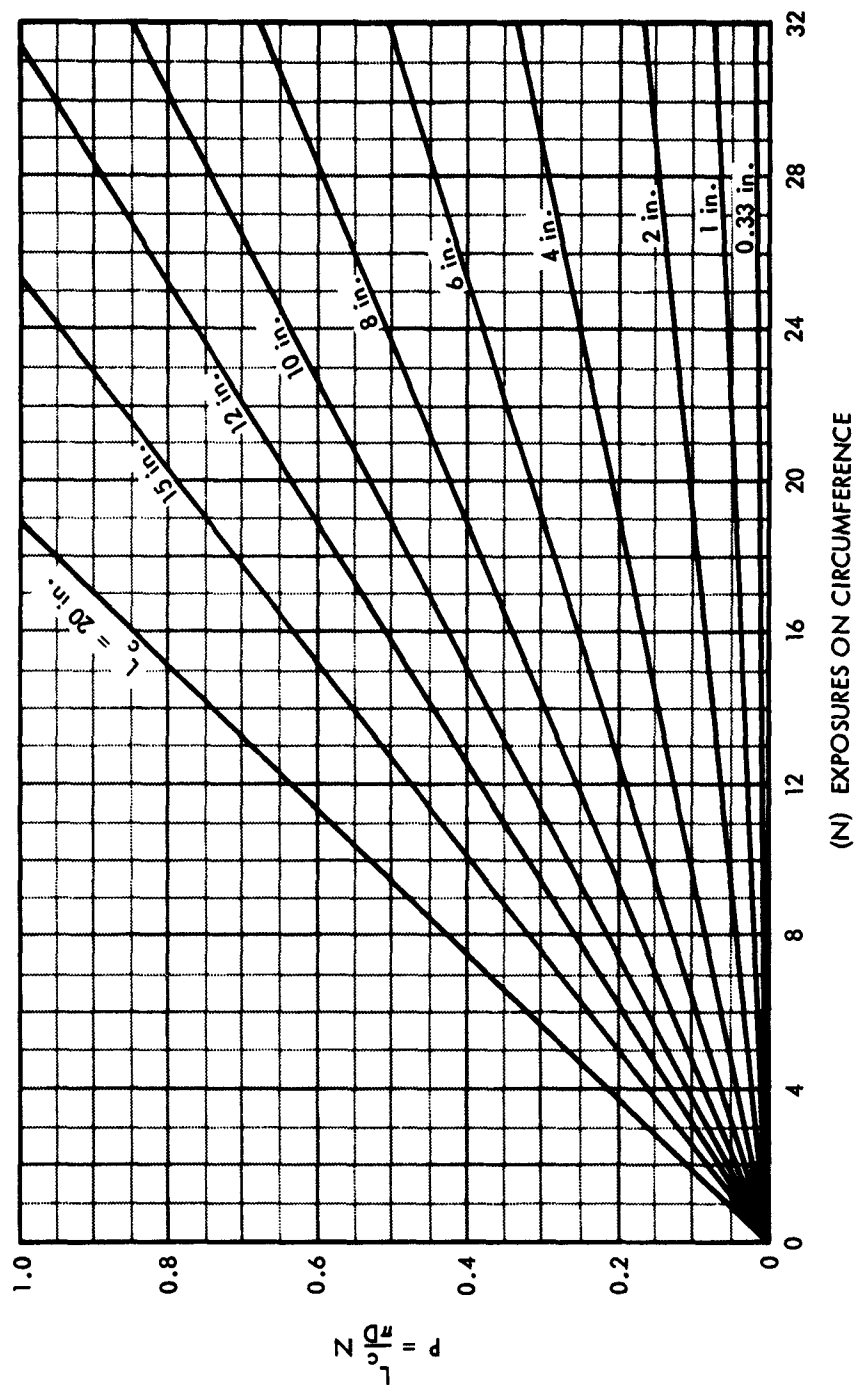
Figure 23. Probability of Demonstrating Liner/Propellant Separations in Tangential Radiography

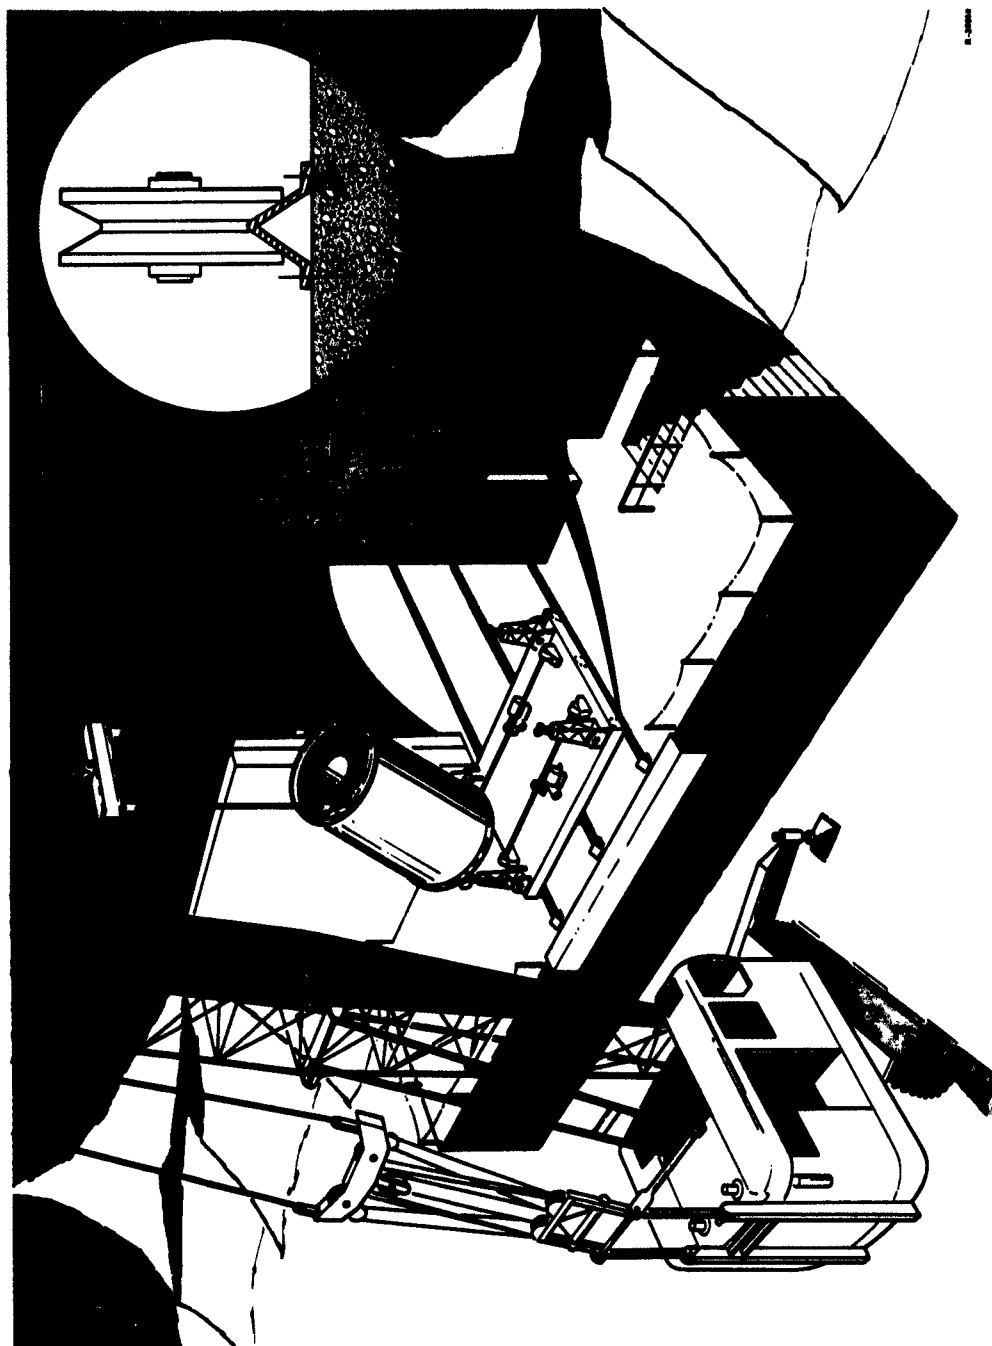
Figure 25. Control of Segment in Radiography

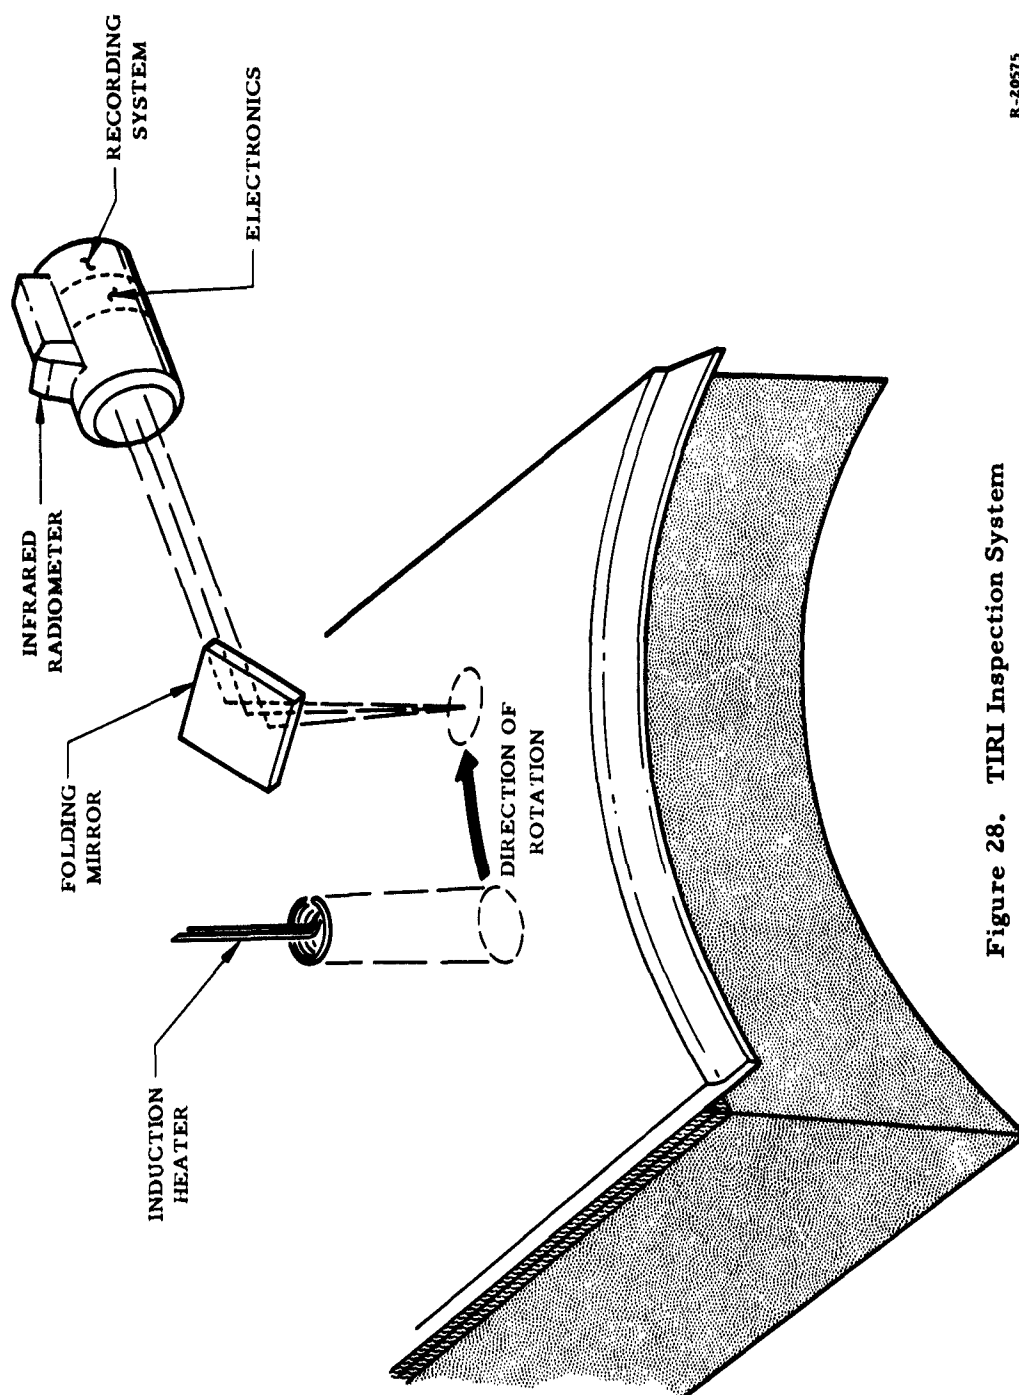
Figure 28. TIRI Inspection System

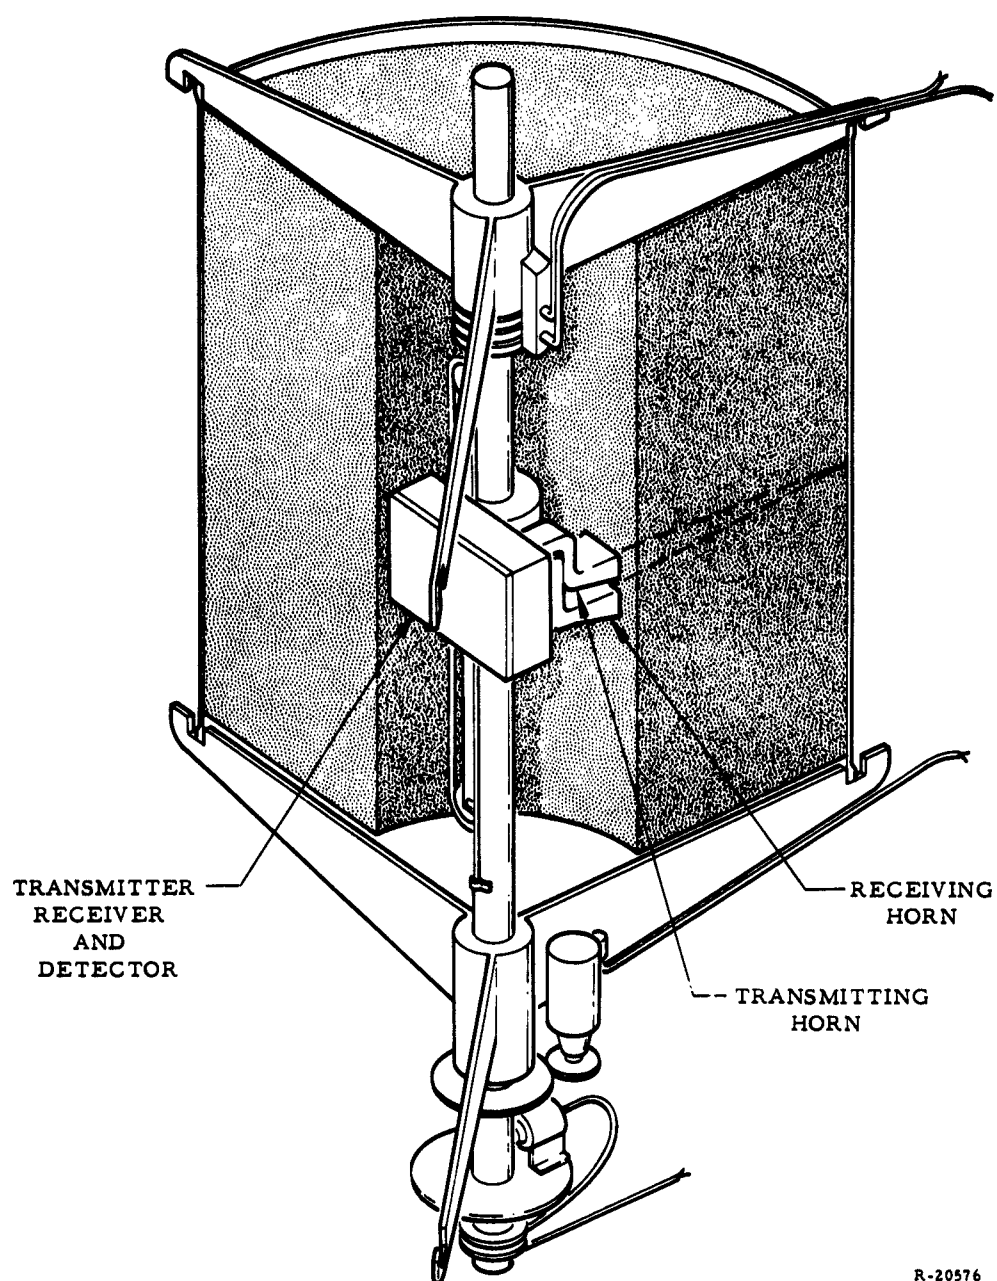
Figure 29. Microwave Scanning System

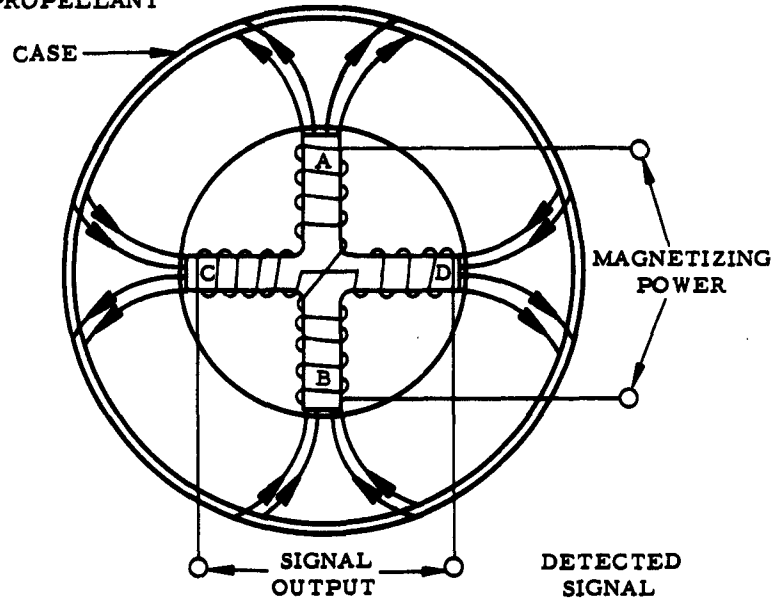
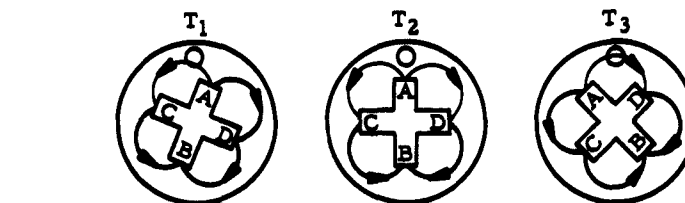
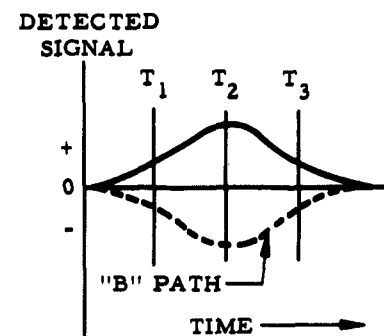
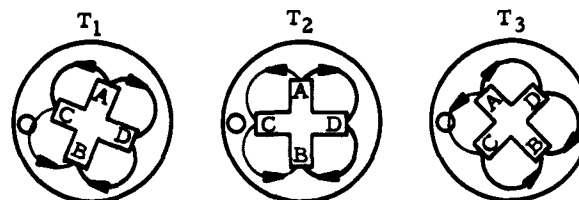
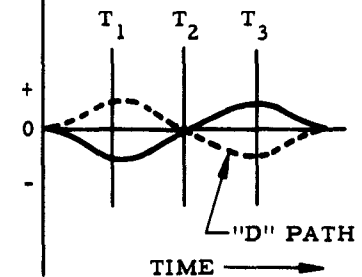
32a. COIL CONFIGURATION AND  
FLUX PATHS IN FLAW-  
LESS PROPELLANT

32b. FLAW IN "A" PATH. LIGHT LINES REPRESENT  
PATHS OF REDUCED FLUX.

32c. RELATIVE INTENSITY OF FLUX LINES FOR  
FLAW IN "C" PATH

A dielectric flux test has been conceived in the course of these study efforts which seems promising as a candidate for development into an applicable system. In this proposed technique, a section of cylindrical conducting material is placed against or very close to the inside surface of the grain, as shown in Figure 31. A small centrally-located segment of that conducting section is insulated from the rest of the conducting surface but maintained at the same potential as the surrounding surface by electronic means. If a potential is then applied between the case and this inner conductor, those flux lines impinging on the small insulated segment would traverse a straight path

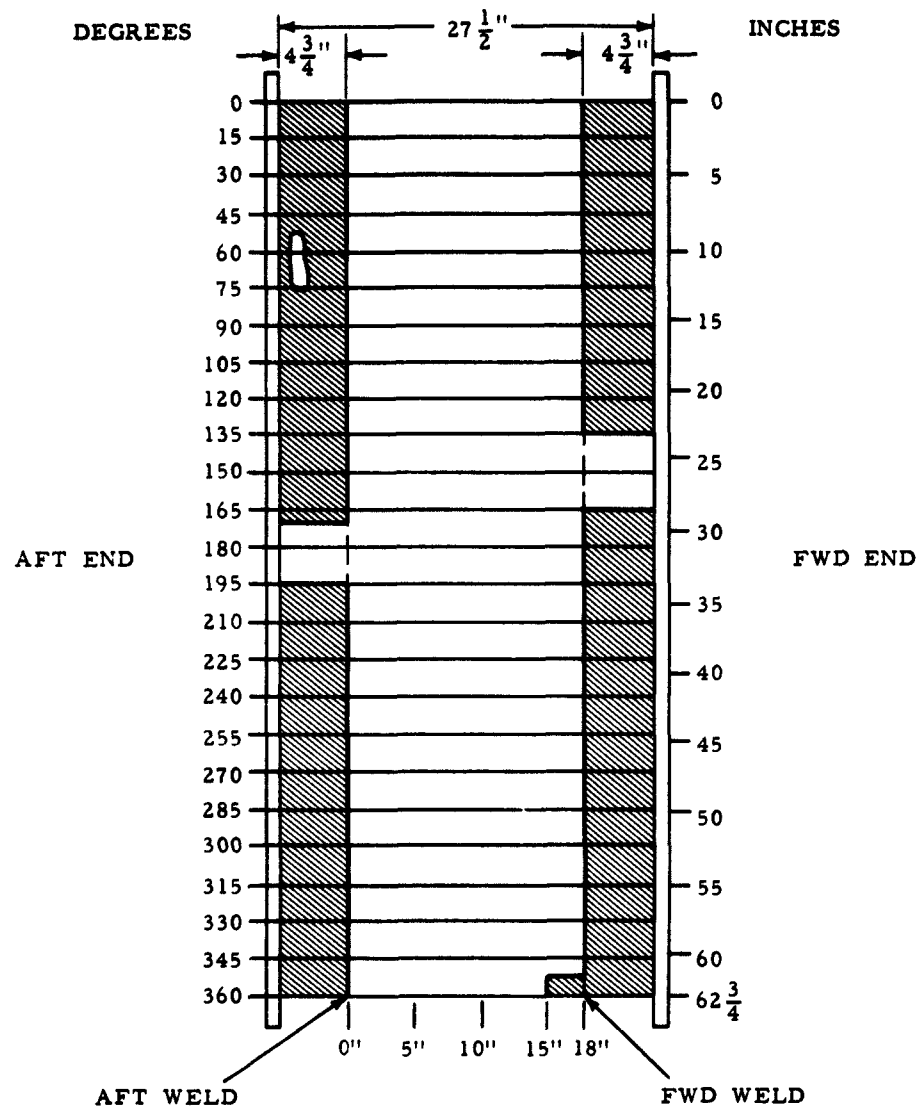
UTC TM-3A DEFECT TEST MOTOR CASE LAYOUT  
S/N 206

- ~~~~~ RADIOGRAPHIC INDICATION OF CRACK OR CRACK-LIKE LINE
- RADIOGRAPHIC INDICATION OF PROPELLANT VOID
- RADIOGRAPHIC INDICATION OF PROPELLANT CUT
- ||||| RADIOGRAPHIC INDICATION OF HIGH DENSITY AREA IN PROPELLANT
- ▨ RADIOGRAPHIC INDICATION OF LOW DENSITY AREA IN PROPELLANT
- ▩ ULTRASONIC INDICATION OF CASE/INSULATION SEPARATION

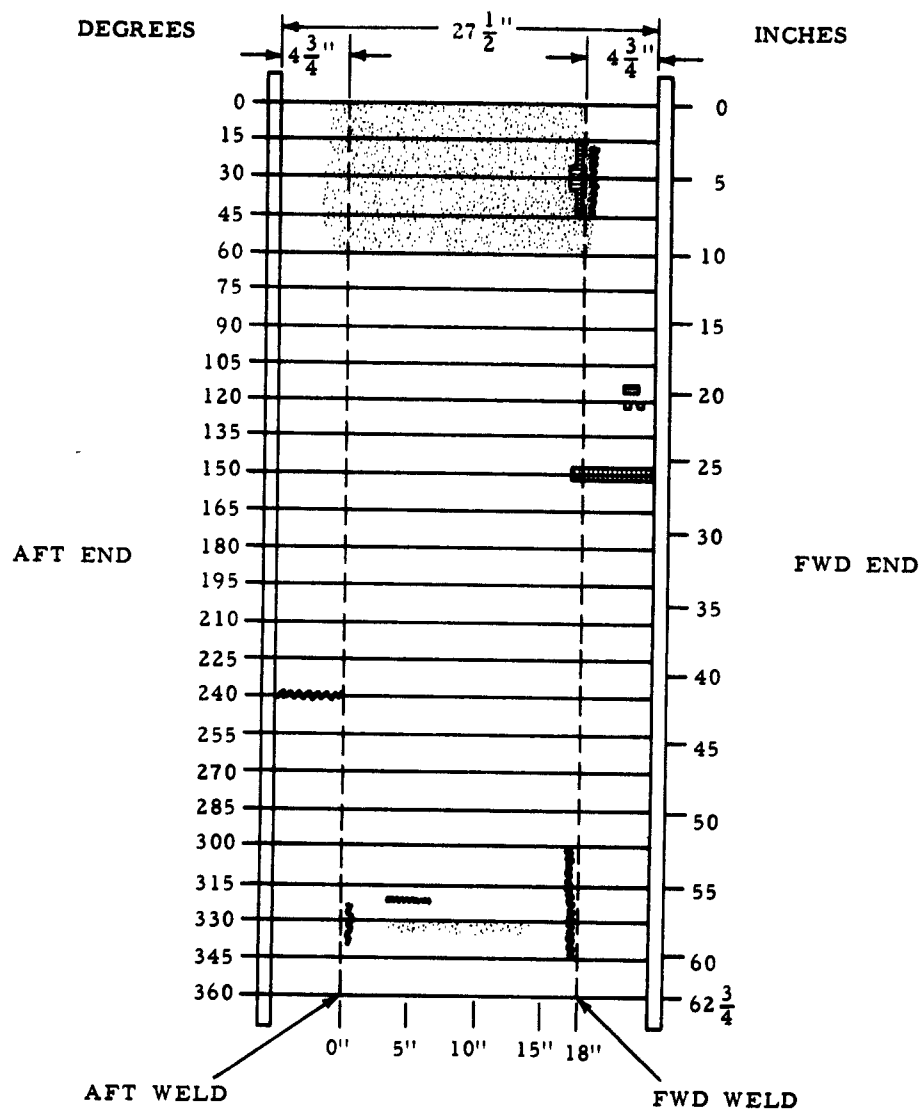
UTC TM-3A DEFECT TEST MOTOR CASE LAYOUT  
S/N 207

- RADIOGRAPHIC INDICATION OF CRACK OR CRACK-LIKE LINE
- RADIOGRAPHIC INDICATION OF PROPELLANT VOID
- RADIOGRAPHIC INDICATION OF PROPELLANT CUT
- RADIOGRAPHIC INDICATION OF HIGH DENSITY AREA IN PROPELLANT
- RADIOGRAPHIC INDICATION OF LOW DENSITY AREA IN PROPELLANT
- ULTRASONIC INDICATION OF CASE/INSULATION SEPARATION

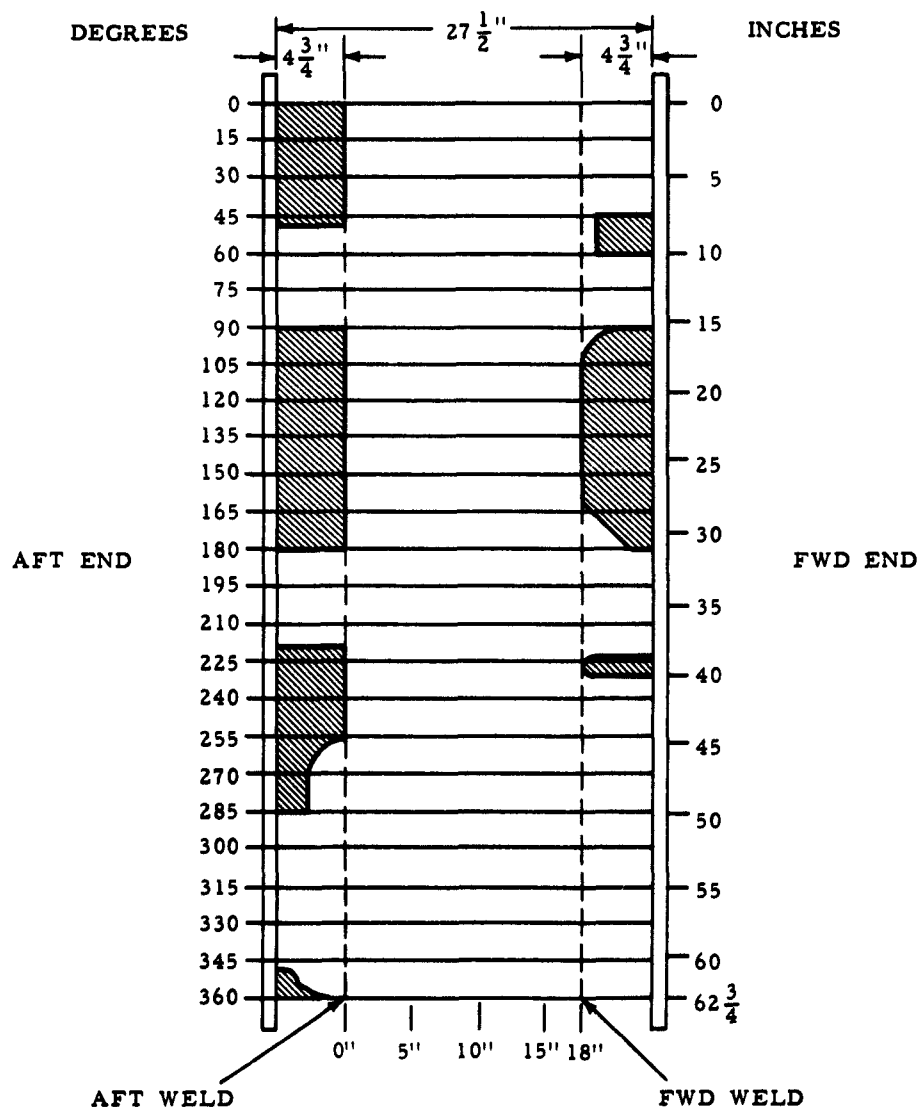
UTC TM-3A DEFECT TEST MOTOR CASE LAYOUT  
S/N 207

- RADIOGRAPHIC INDICATION OF CRACK OR CRACK-LIKE LINE
- RADIOGRAPHIC INDICATION OF PROPELLANT VOID
- RADIOGRAPHIC INDICATION OF PROPELLANT CUT
- RADIOGRAPHIC INDICATION OF HIGH DENSITY AREA IN PROPELLANT
- RADIOGRAPHIC INDICATION OF LOW DENSITY AREA IN PROPELLANT
- ULTRASONIC INDICATION OF CASE/INSULATION SEPARATION

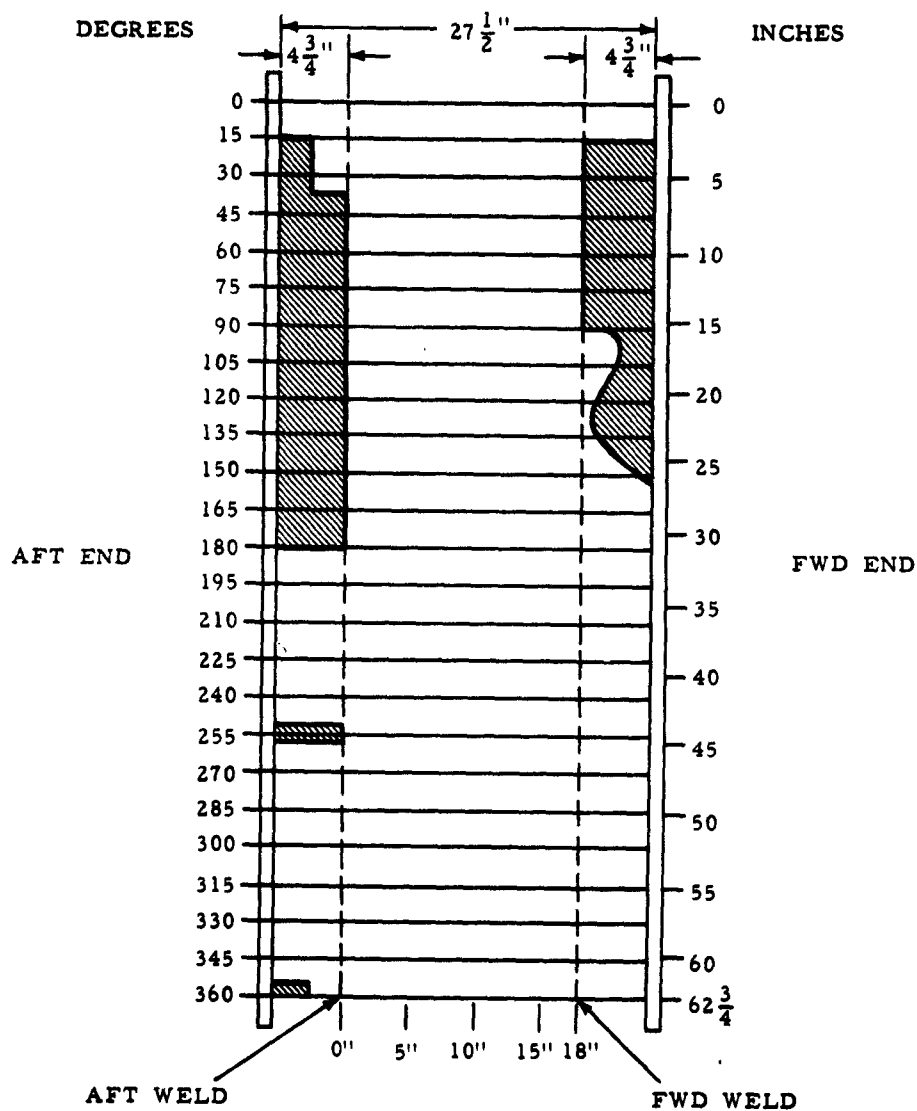
UTC TM-3A DEFECT TEST MOTOR CASE LAYOUT  
S/N 208

- RADIOGRAPHIC INDICATION OF CRACK OR CRACK-LIKE LINE
- RADIOGRAPHIC INDICATION OF PROPELLANT VOID
- RADIOGRAPHIC INDICATION OF PROPELLANT CUT
- RADIOGRAPHIC INDICATION OF HIGH DENSITY AREA IN PROPELLANT
- RADIOGRAPHIC INDICATION OF LOW DENSITY AREA IN PROPELLANT
- ULTRASONIC INDICATION OF CASE/INSULATION SEPARATION

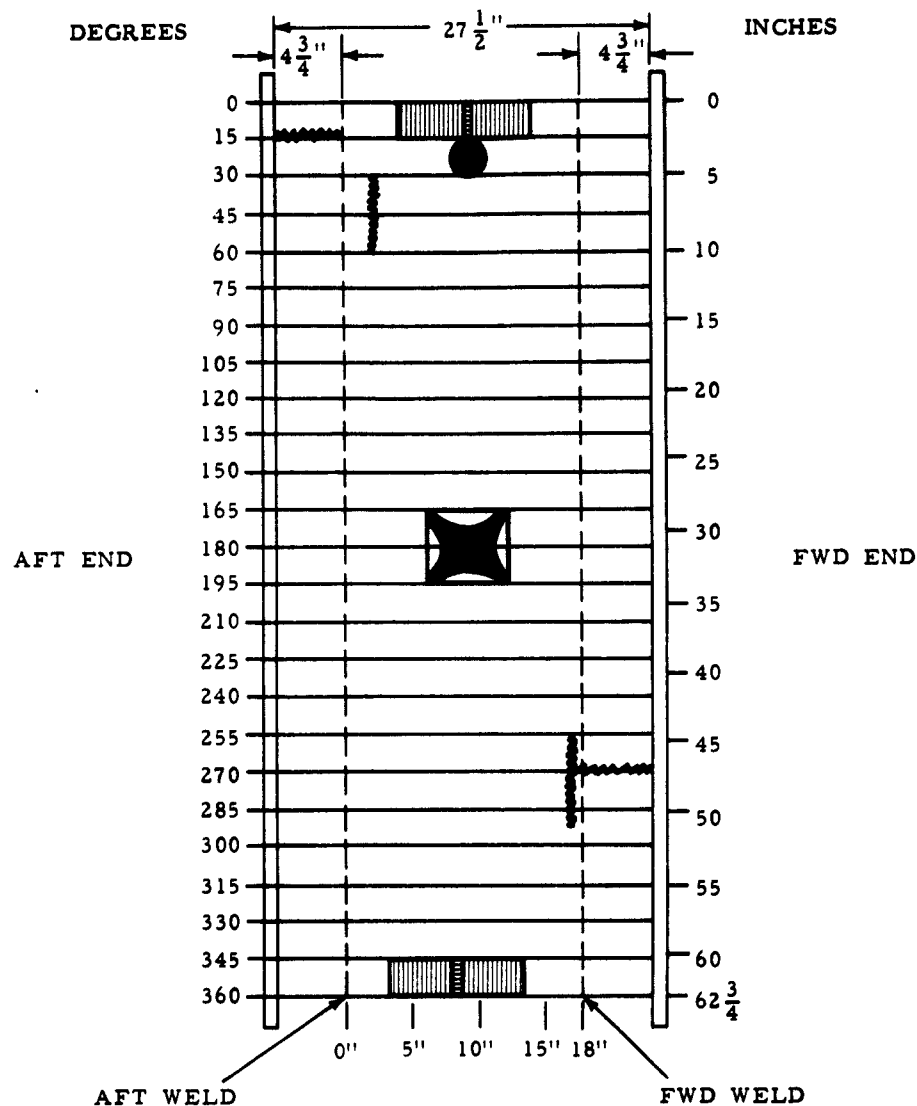
UTC TM-3A DEFECT TEST MOTOR CASE LAYOUT  
S/N 209

- ~~~~~ RADIOGRAPHIC INDICATION OF CRACK OR CRACK-LIKE LINE
- RADIOGRAPHIC INDICATION OF PROPELLANT VOID
- RADIOGRAPHIC INDICATION OF PROPELLANT CUT
- ▨ RADIOGRAPHIC INDICATION OF HIGH DENSITY AREA IN PROPELLANT
- ▩ RADIOGRAPHIC INDICATION OF LOW DENSITY AREA IN PROPELLANT
- ▧ ULTRASONIC INDICATION OF CASE/INSULATION SEPARATION

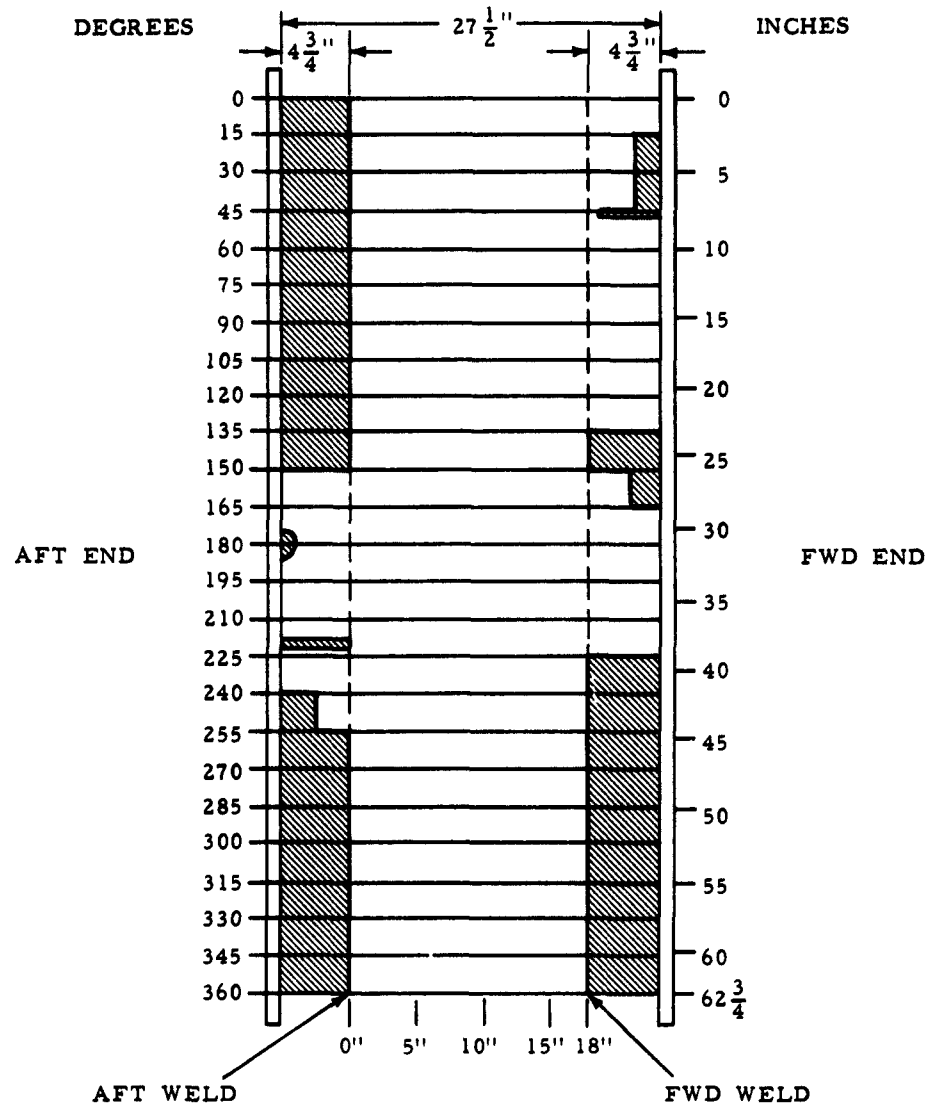
UTC TM-3A DEFECT TEST MOTOR CASE LAYOUT  
S/N 209

- ~ RADIOGRAPHIC INDICATION OF CRACK OR CRACK-LIKE LINE
- RADIOGRAPHIC INDICATION OF PROPELLANT VOID
- RADIOGRAPHIC INDICATION OF PROPELLANT CUT
- ▨ RADIOGRAPHIC INDICATION OF HIGH DENSITY AREA IN PROPELLANT
- ▩ RADIOGRAPHIC INDICATION OF LOW DENSITY AREA IN PROPELLANT
- ▤ ULTRASONIC INDICATION OF CASE/INSULATION SEPARATION

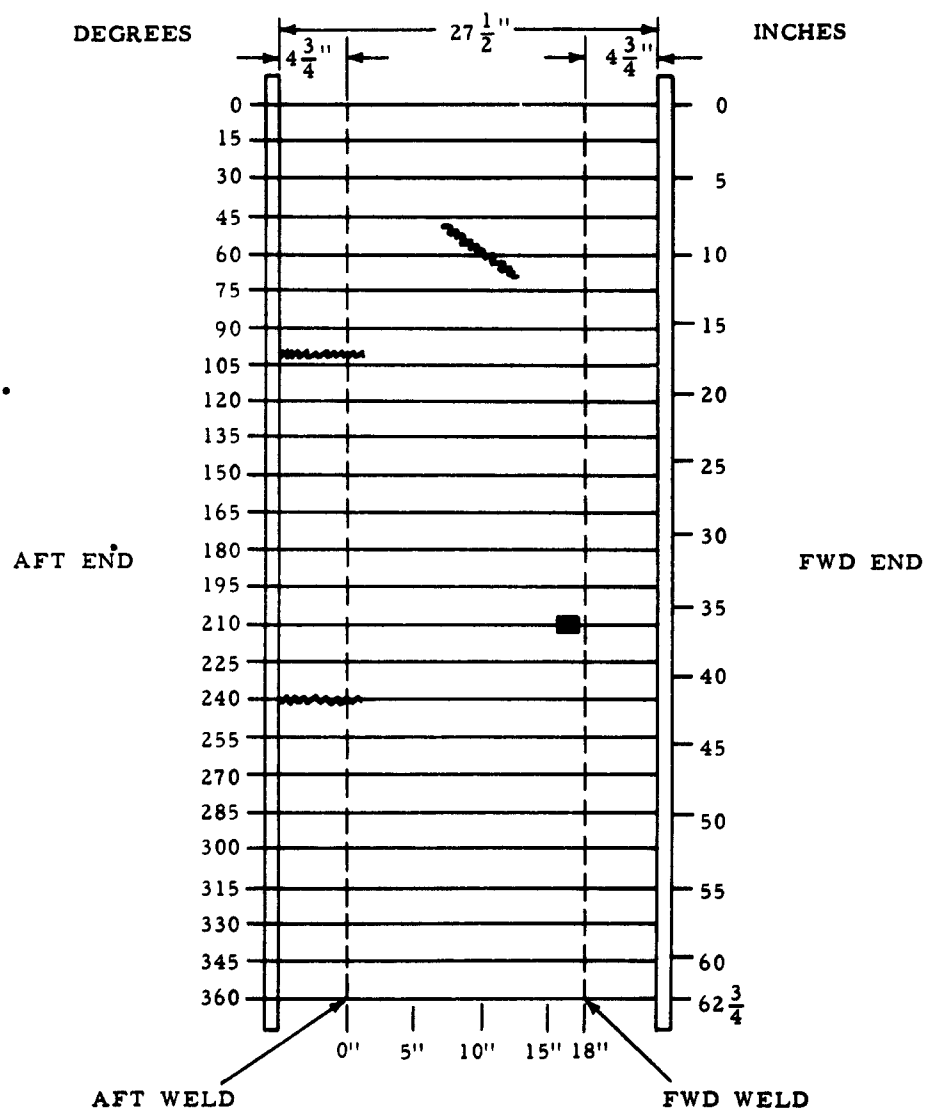
UTC TM-3A DEFECT TEST MOTOR CASE LAYOUT  
S/N 210

- ~~~~~ RADIOGRAPHIC INDICATION OF CRACK OR CRACK-LIKE LINE
- RADIOGRAPHIC INDICATION OF PROPELLANT VOID
- - - RADIOGRAPHIC INDICATION OF PROPELLANT CUT
- ||||| RADIOGRAPHIC INDICATION OF HIGH DENSITY AREA IN PROPELLANT
- ==== RADIOGRAPHIC INDICATION OF LOW DENSITY AREA IN PROPELLANT
- \\\\\\ ULTRASONIC INDICATION OF CASE/INSULATION SEPARATION

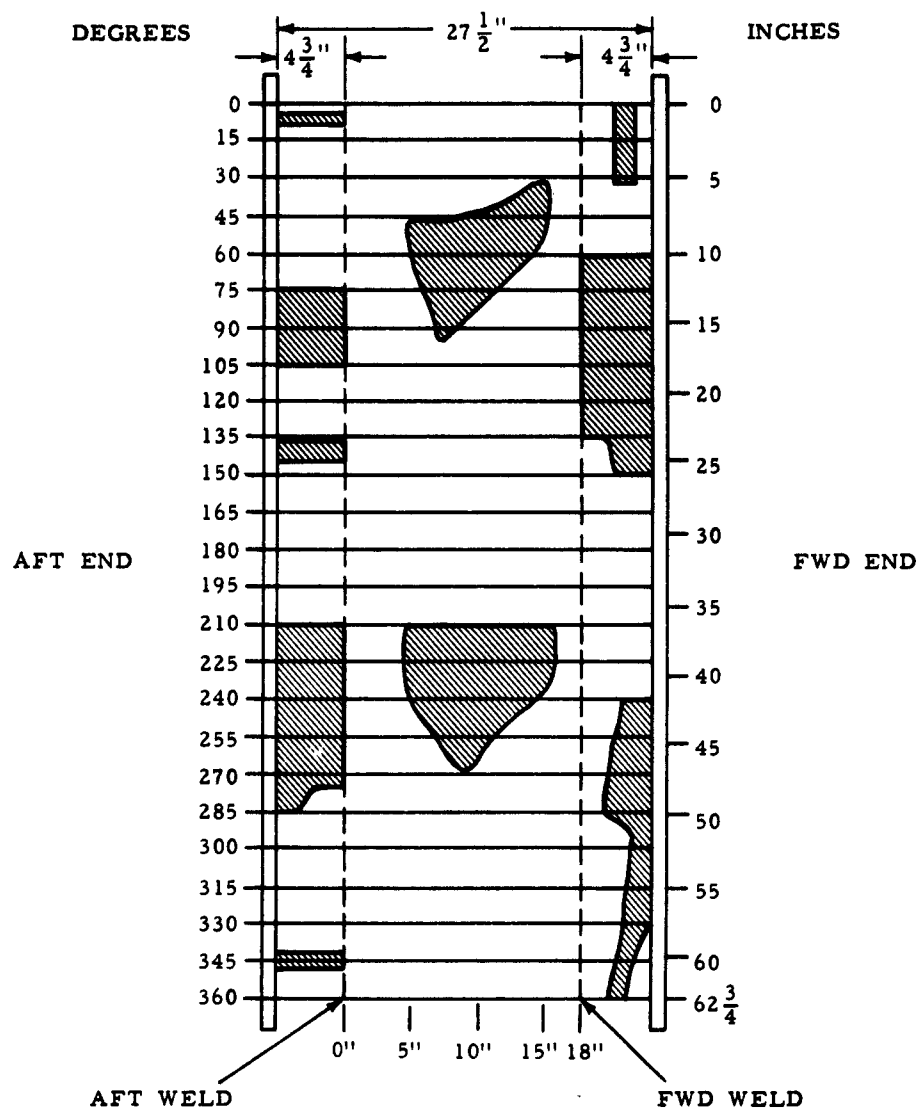
UTC TM-3A DEFECT TEST MOTOR CASE LAYOUT  
S/N 210

- RADIOGRAPHIC INDICATION OF CRACK OR CRACK-LIKE LINE
- RADIOGRAPHIC INDICATION OF PROPELLANT VOID
- RADIOGRAPHIC INDICATION OF PROPELLANT CUT
- RADIOGRAPHIC INDICATION OF HIGH DENSITY AREA IN PROPELLANT
- RADIOGRAPHIC INDICATION OF LOW DENSITY AREA IN PROPELLANT
- ULTRASONIC INDICATION OF CASE/INSULATION SEPARATION

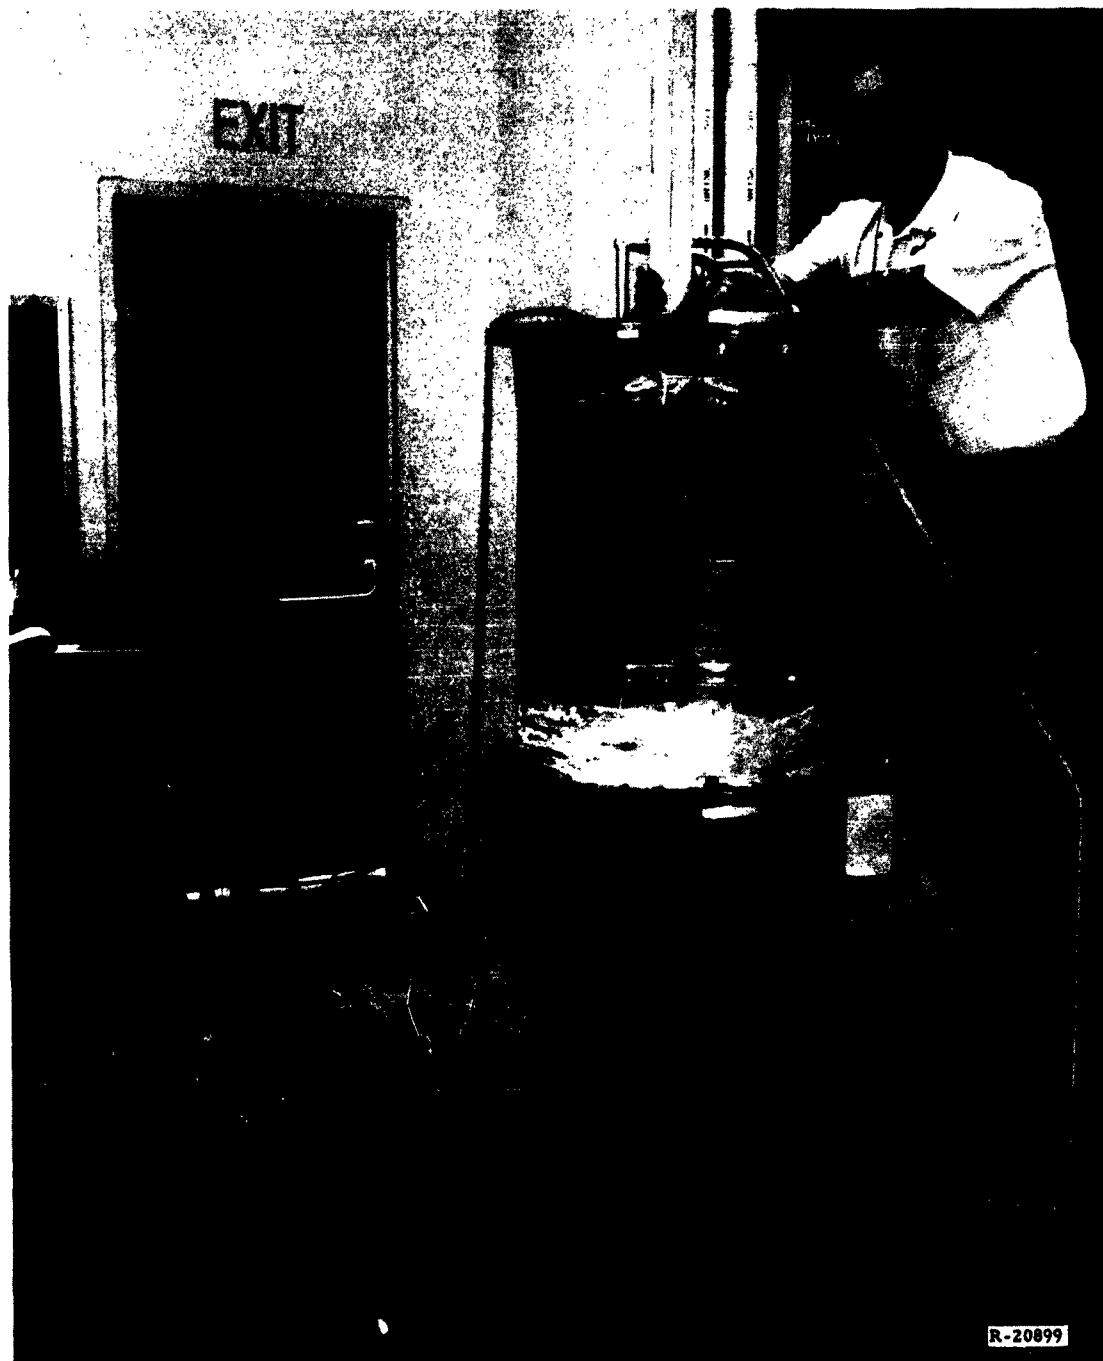
Figure 45. Vertical Segment Orientation

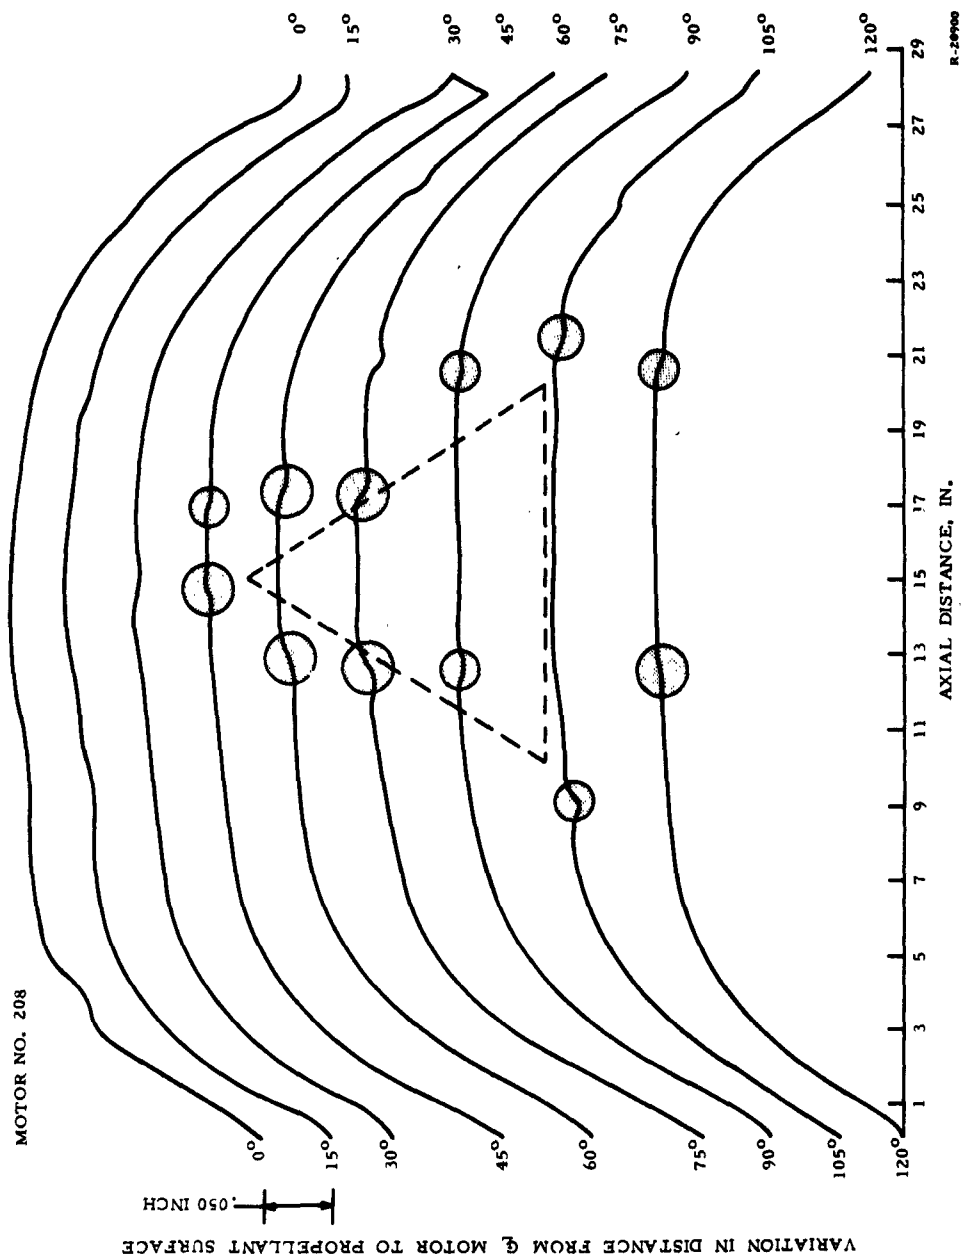
Figure 46. Profilimetric Contours

It will be recalled that this motor incorporated a triangular shaped propellant-liner unbond. This is superimposed over the contour with dotted lines. The basic outline of the triangle can be discerned. Although it is obvious that considerable work remains to reduce this technique to routine use, the ability to find this unbond, which was undetectable by radiographic means, is intriguing.

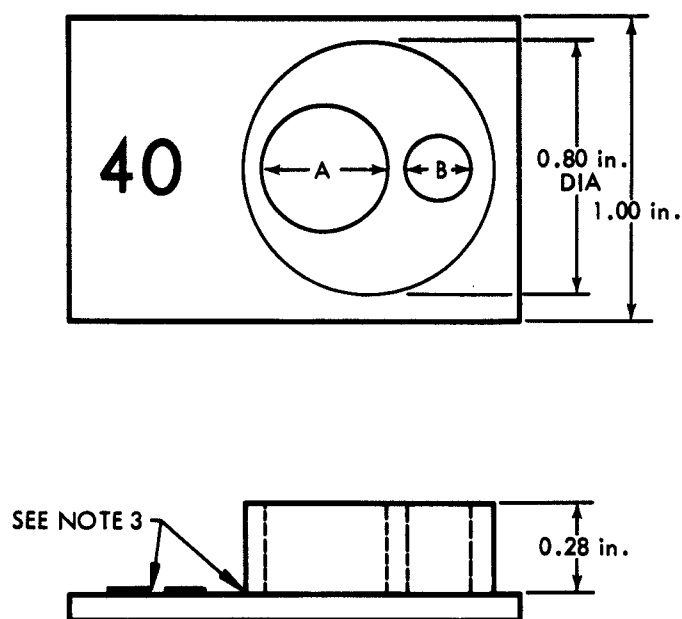
- NOTES: 1. Material - Lucite (Density 1.1 to 1.2 gm/cm<sup>3</sup>)
2. Use for Path Length Which Consists of the Equivalent Thickness of 40 inches of Propellant to Demonstrate 0.5 % System Sensitivity
3. Lead Numerals and the Penetrameter Adhere to a Plastic Strip
4. Dimensions were Determined as Follows:
- Thickness =  $40 \times 0.5\% \times \left(\frac{1.7}{1.2}\right)$
- Diameter =  $40 \times 2\%$
- Diameter A =  $40 \times 170$
- Diameter B =  $40 \times 0.5\%$

Figure 49. Penetrameter for Inert Load Radiography (TM-120)

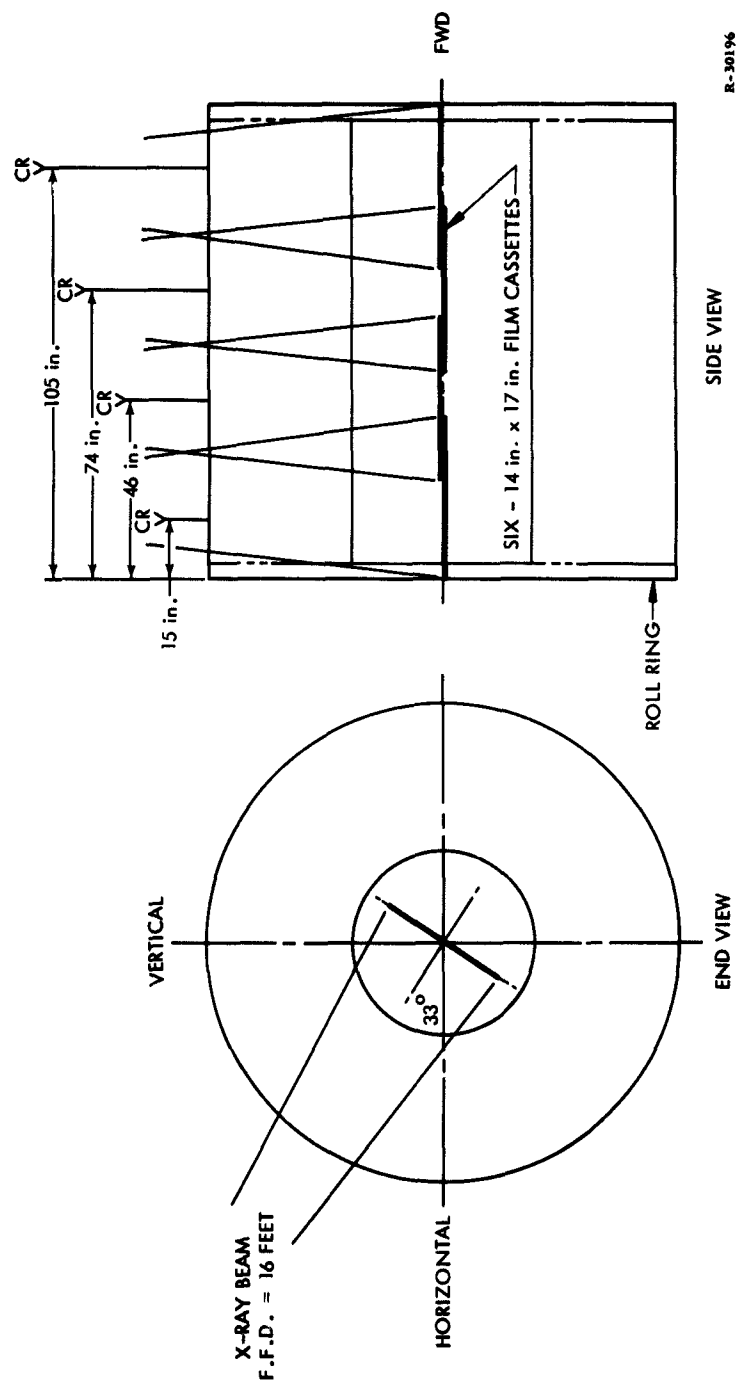
Figure 50. TM-120 10-mev Inert Load Radiographic Exposure Plan

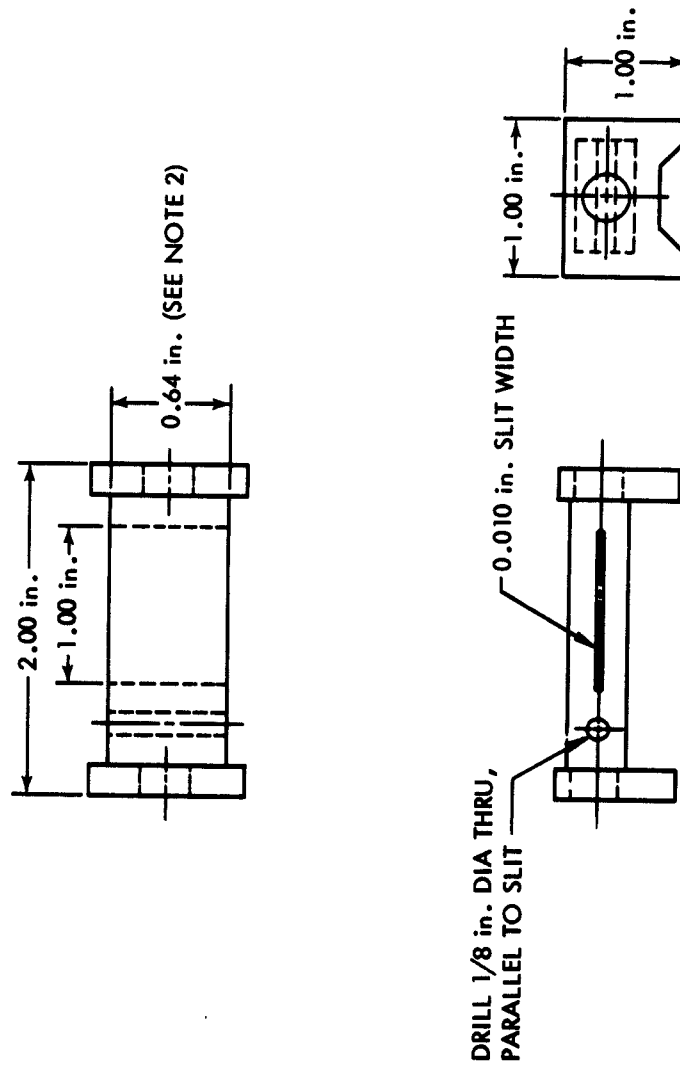
- NOTES: 1. Material - Lucite ( $1.2 \text{ gm/cm}^3$ )
2. Penetrometer Thickness Based on:
- $$T = (1\%) \frac{\text{(Propellant Thickness)}}{\text{(Lucite Density)}}$$

Figure 53. Penetrometer for Tangential Radiography

Tangential radiography was conducted in accordance with the exposure plan and technique sheet contained in Table XVI and Figures 53 and 54. Figure 55 shows the arrangement of shielding, film cassette holder, and the position of the 10-mev linac for a typical tangential exposure. The film support and shielding, which consisted of 32 sheets of lead, each 1/4 inch thick, is shown in Figure 56. Both wire and slit-type penetrameters, fabricated to demonstrate system sensitivity of 1%, were used in these procedures. A tabulation of the discontinuities and anomalies detected in the peripheral area of the segment by tangential radiography is contained in Table XVII.

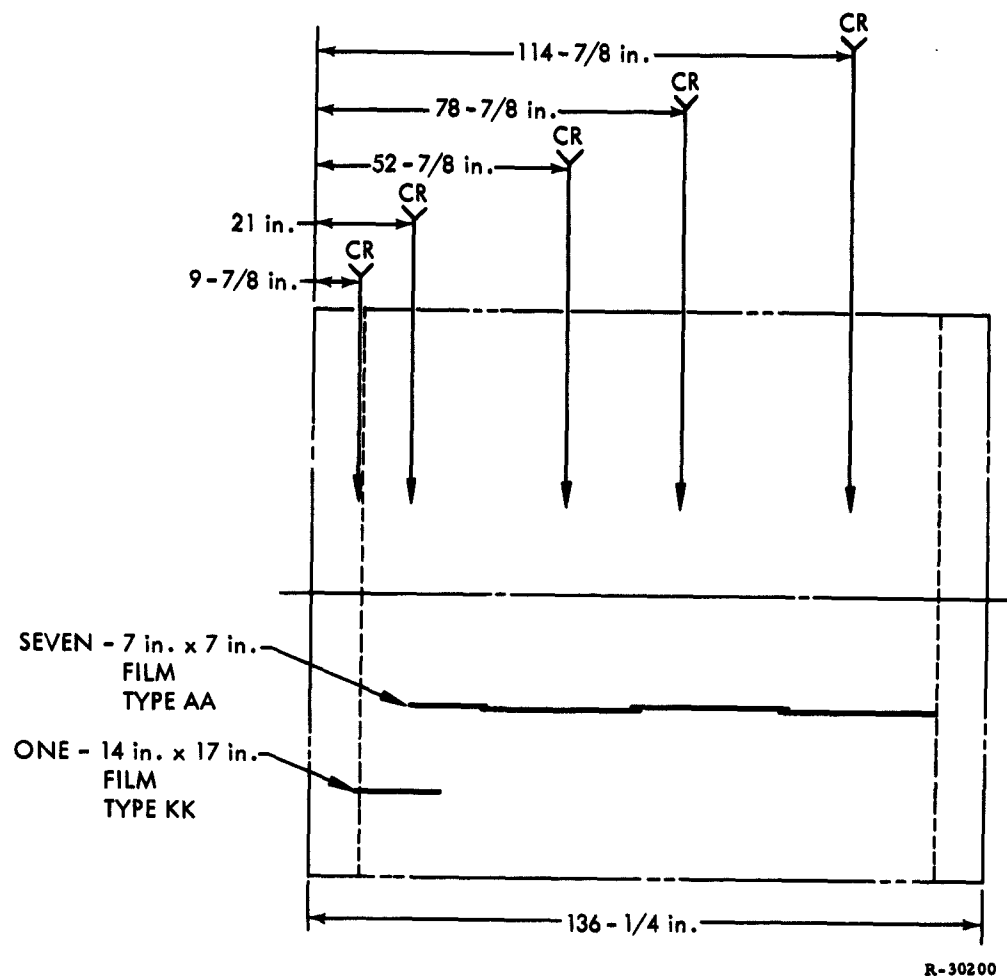
Figure 54. Exposure Plan for Tangential Radiography
