APPROACH ROADS GREENLAND 1956-1957 PROGRAM

TECHNICAL REPORT NO. 3-505

Report 2

April 1963

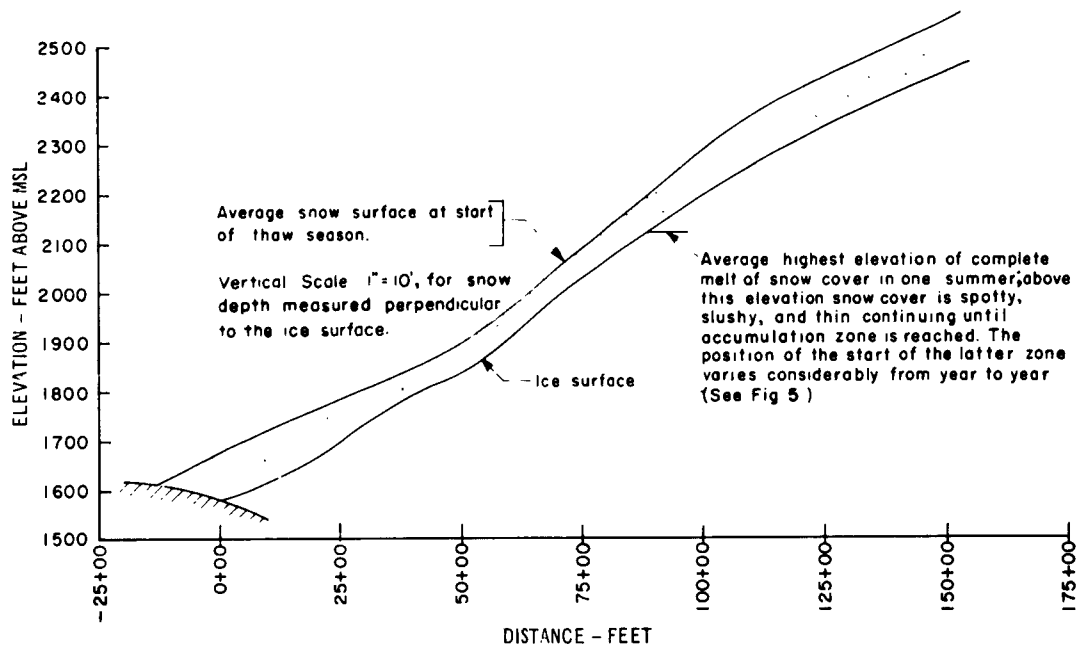
Figure 6. Average snow cover at start of thaw season, TUTO Ramp.

On the relatively smooth surface of the ramp, the snow cover is more consistent, returning annually in approximately the same pattern. Figure 6 shows the average snow depth on the ramp at the start and end of the thaw season. Note that the snow depth is greatest on the first 1/2 mile of

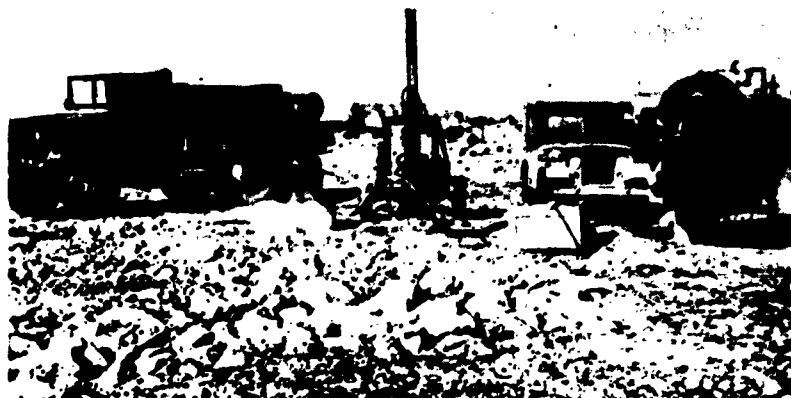
Figure 26. Test of steam-thawing of frozen ground. Tank-car heater for steam supply is shown at right center. Wagon drill for drilling holes in frozen ground to insert steam points shown in center (30 June 1956).

Procedure. The source of steam was a tank-car heater of 3-car capacity (Fig. 26). It was supplied with water from a 500-gal tank (trailer type). A special connector was attached to the heater

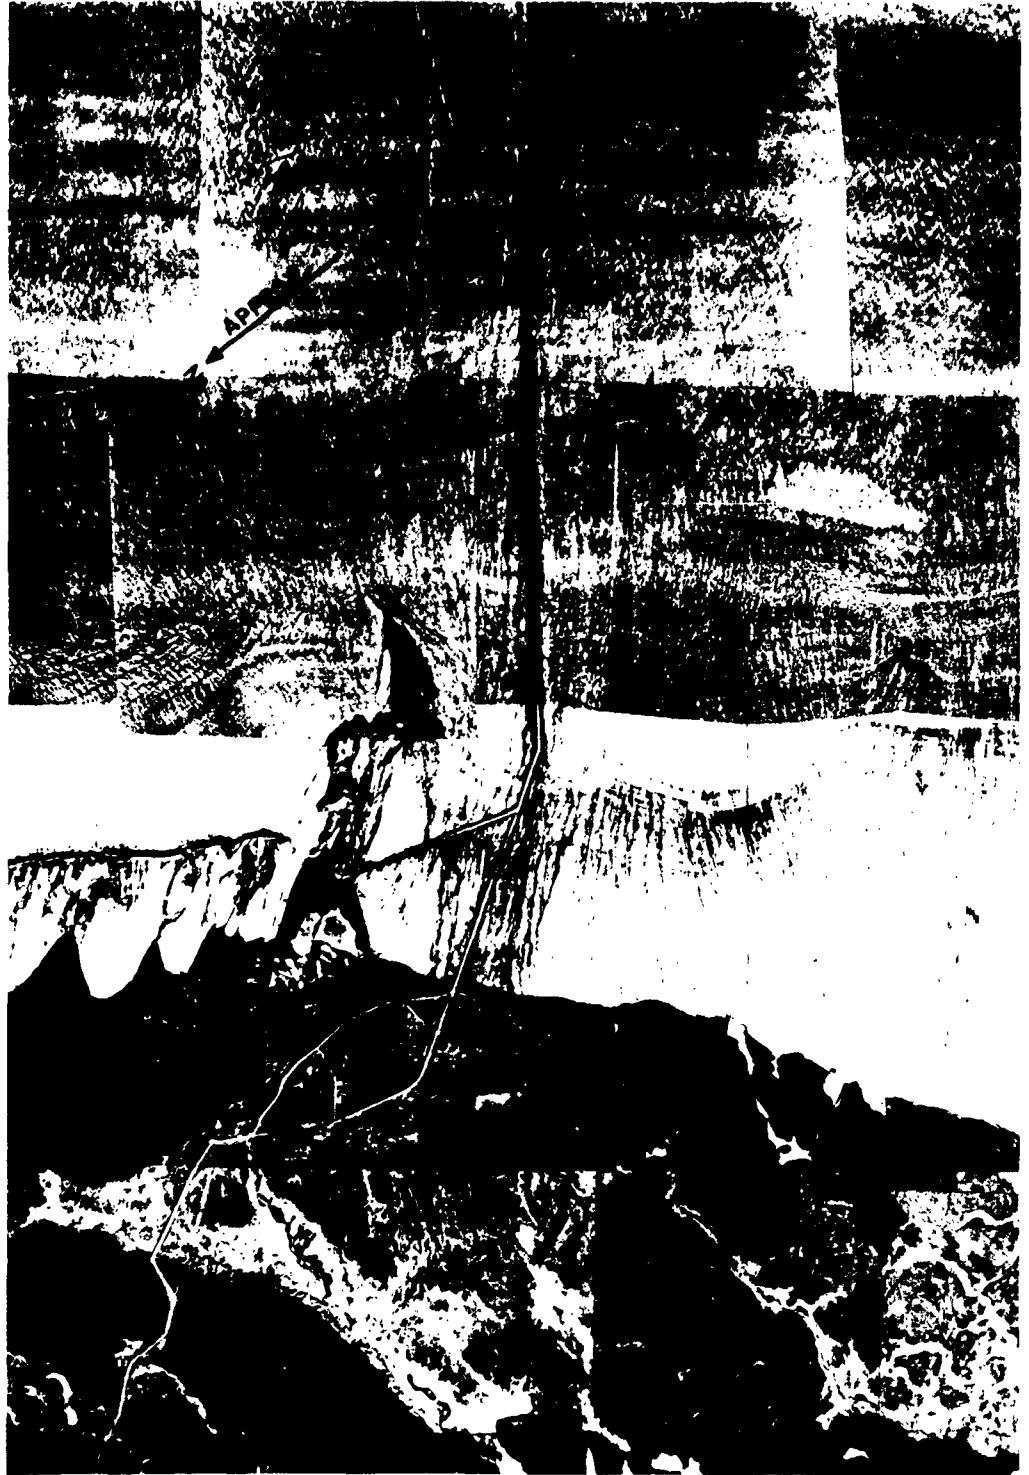
Figure 29. TUTO Ramp and vicinity, August 1956, approximate scale, 1:28,800.

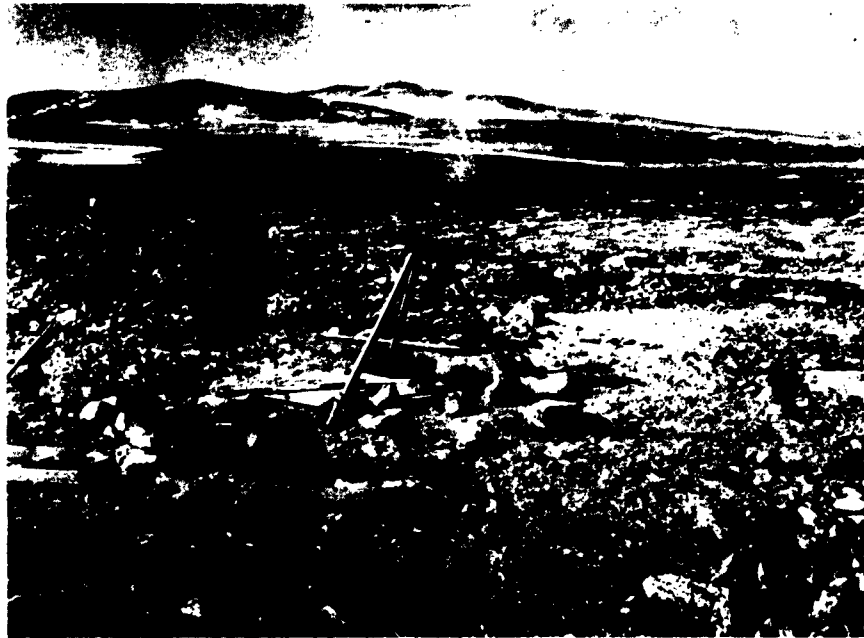
Figure 30. NN base point. The tripod is removable and is used to support a range pole (5 July 1957).

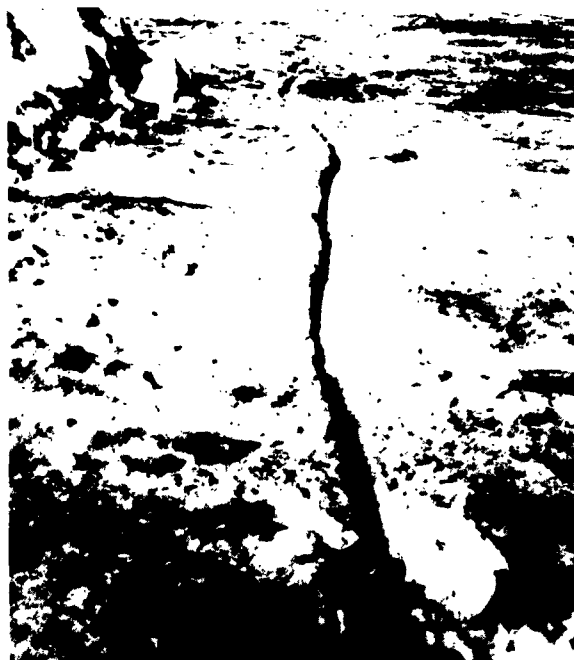
Figure 38. Close-up of typical crack in ice surface (5 June 1957).

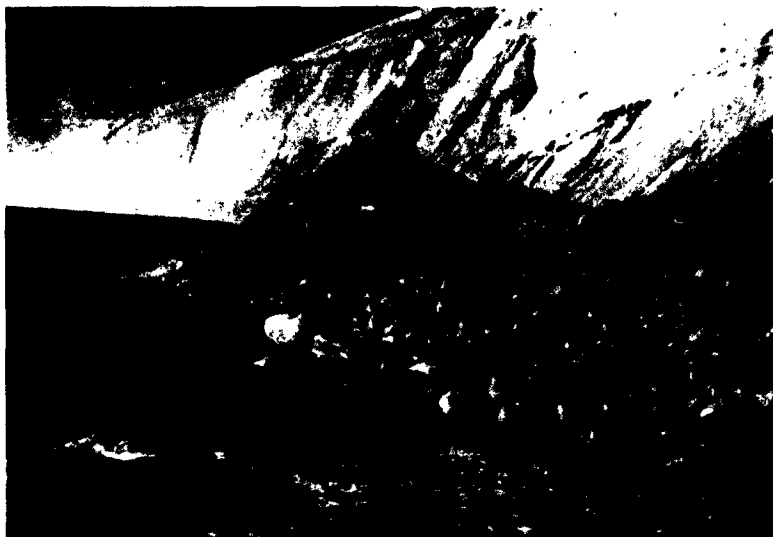
Figure 55. Moraine formation (coarse gravel covering ice core) at site of entrance to ice tunnel (Aug 1955).
