Technical Note N-458

EMPLACEMENT OF THE FIRST SUBMERSIBLE TEST UNIT ON THE SEA FLOOR - ONE MILE DEEP

18 February 1963

U. S. NAVAL CIVIL ENGINEERING LABORATORY
Port Hueneme, California

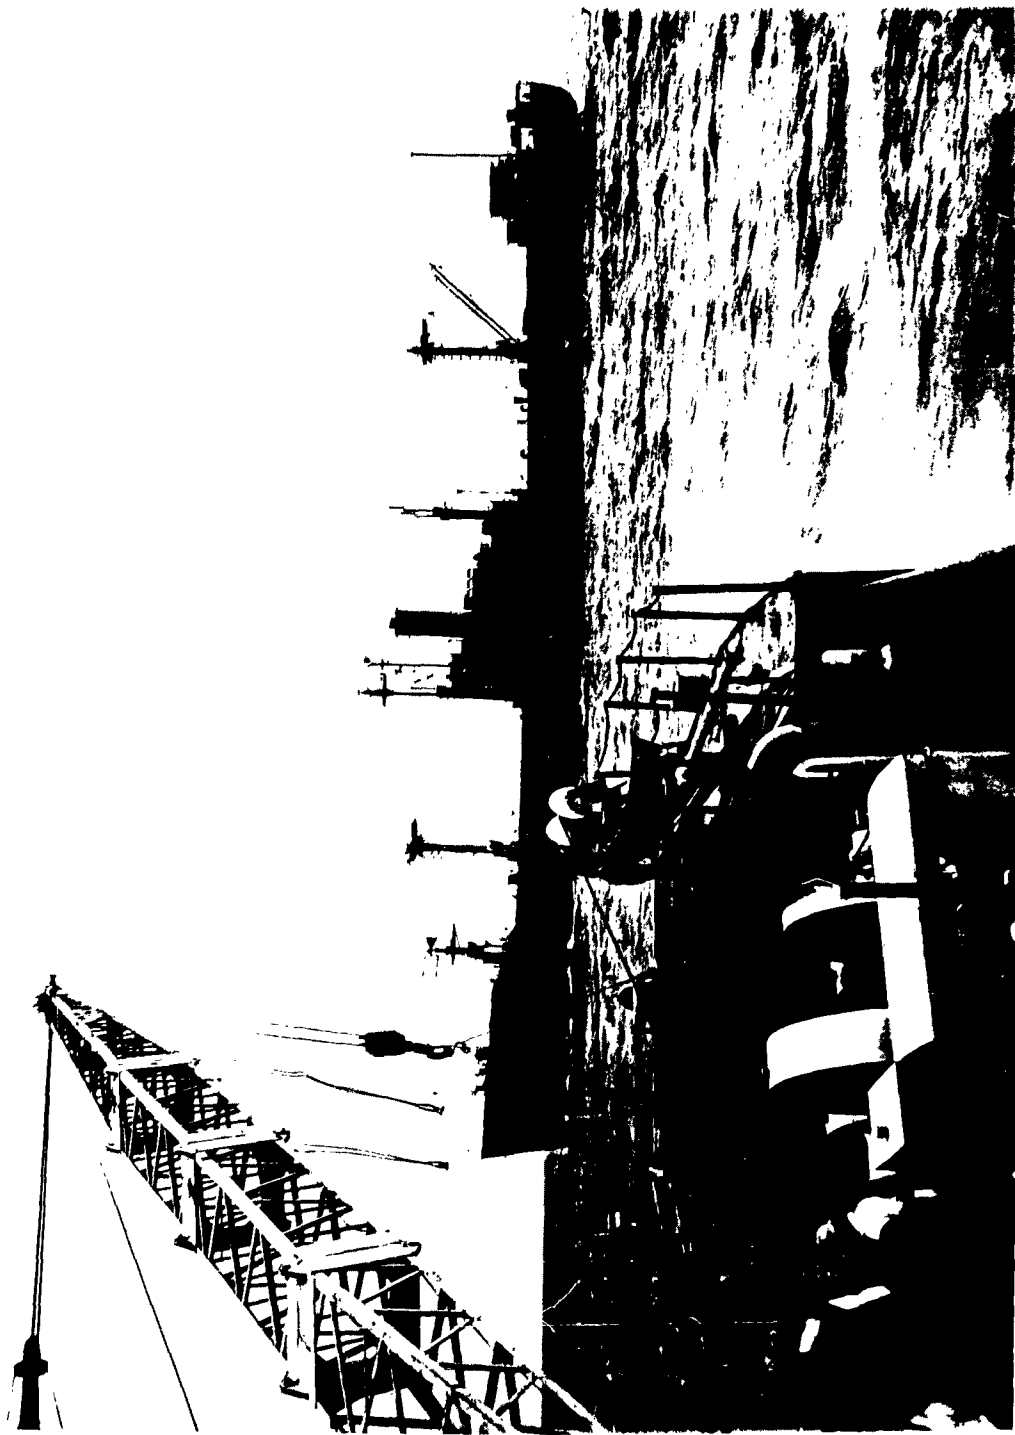
Figure 9. USNS RICHFIELD - a stable platform for locating Tellurometers.

The general location of the STU site, chosen on the basis of information available from C.&G.S. charts, was checked for depth using a precision depth recorder aboard the USNS RICHFIELD (Figure 9). When a satisfactory position with regard to depth and bottom slope was found, surveyors at Station Farrell on Santa Rosa Island and Station San Miguel 4 on San Miguel Island computed from observations the position for the mooring. Conventional surveying equipment and Tellurometers were used to accurately guide the ship to the location chosen. The ship then dropped a dye-marker and moved off allowing the YFU to occupy the position and lower the anchor for the temporary mooring. During the time taken (about 40 minutes) for the lowering operation the YFU drifted. The resulting location was in shallower water than anticipated being 5300-feet deep rather than the desired depth of 6000-feet. Surveyors established the new location after the surface buoy had been connected (Figure 10). The distance from submarine transit lane Sierra Venus was carefully checked to avoid any hazard to submerged craft.

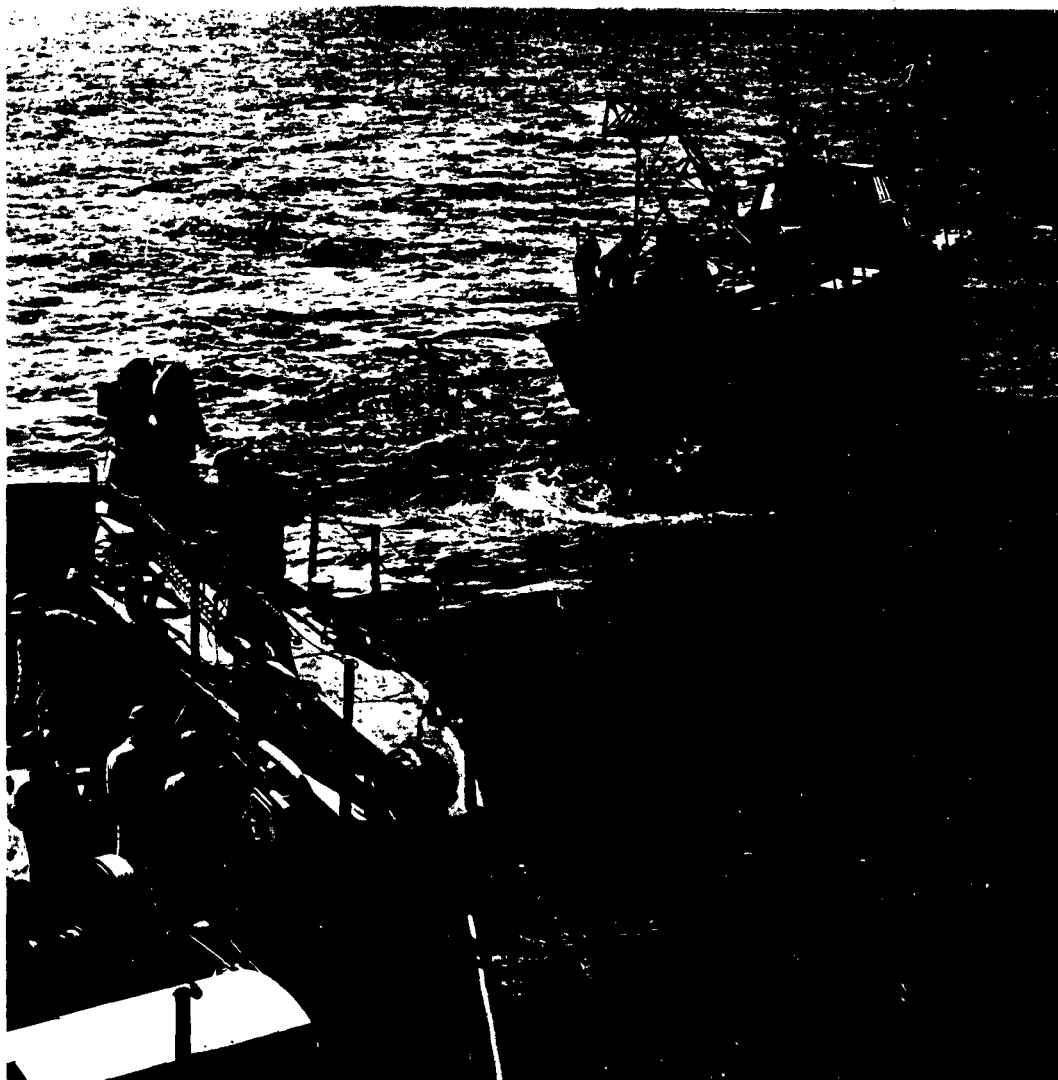
Figure 12. P.T. boat lays electrode cable and tag line from recorder mounted near base of STU.

With the position of the YFU controlled by the length of line and the heading, preparations were made to lower the STU. The electrode line was passed over (Figure 12) from the PT boat and it was secured to the

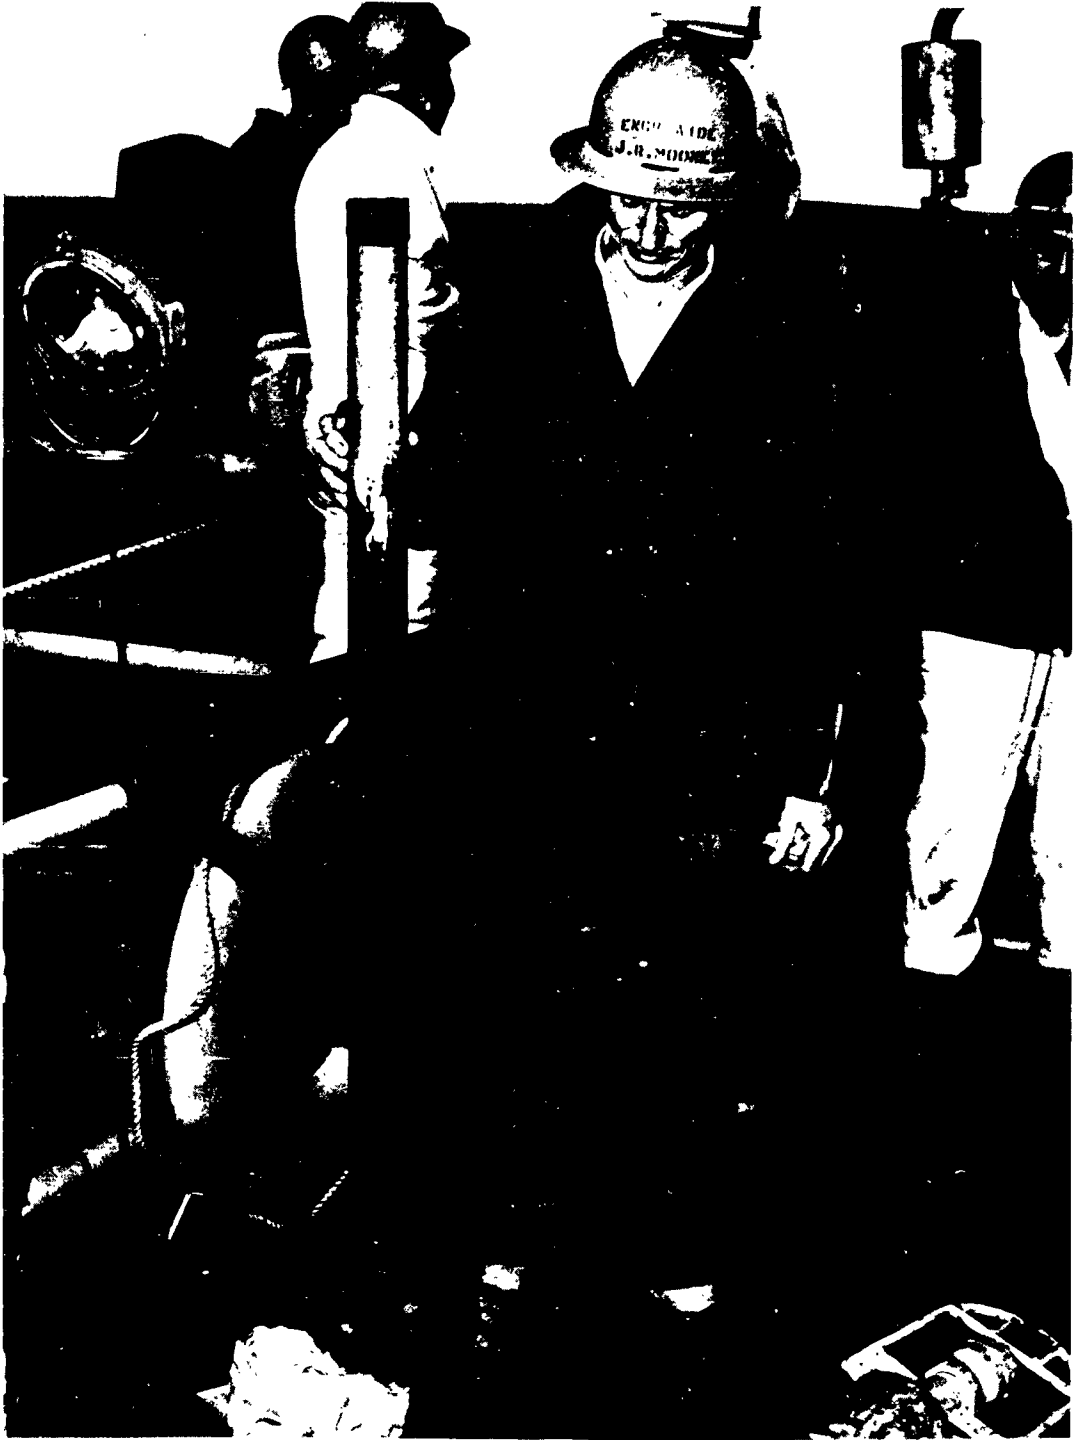
Figure 18. Core retrieved from 5300 ft contained in plastic liner capped at both ends for storage in a vertical position.

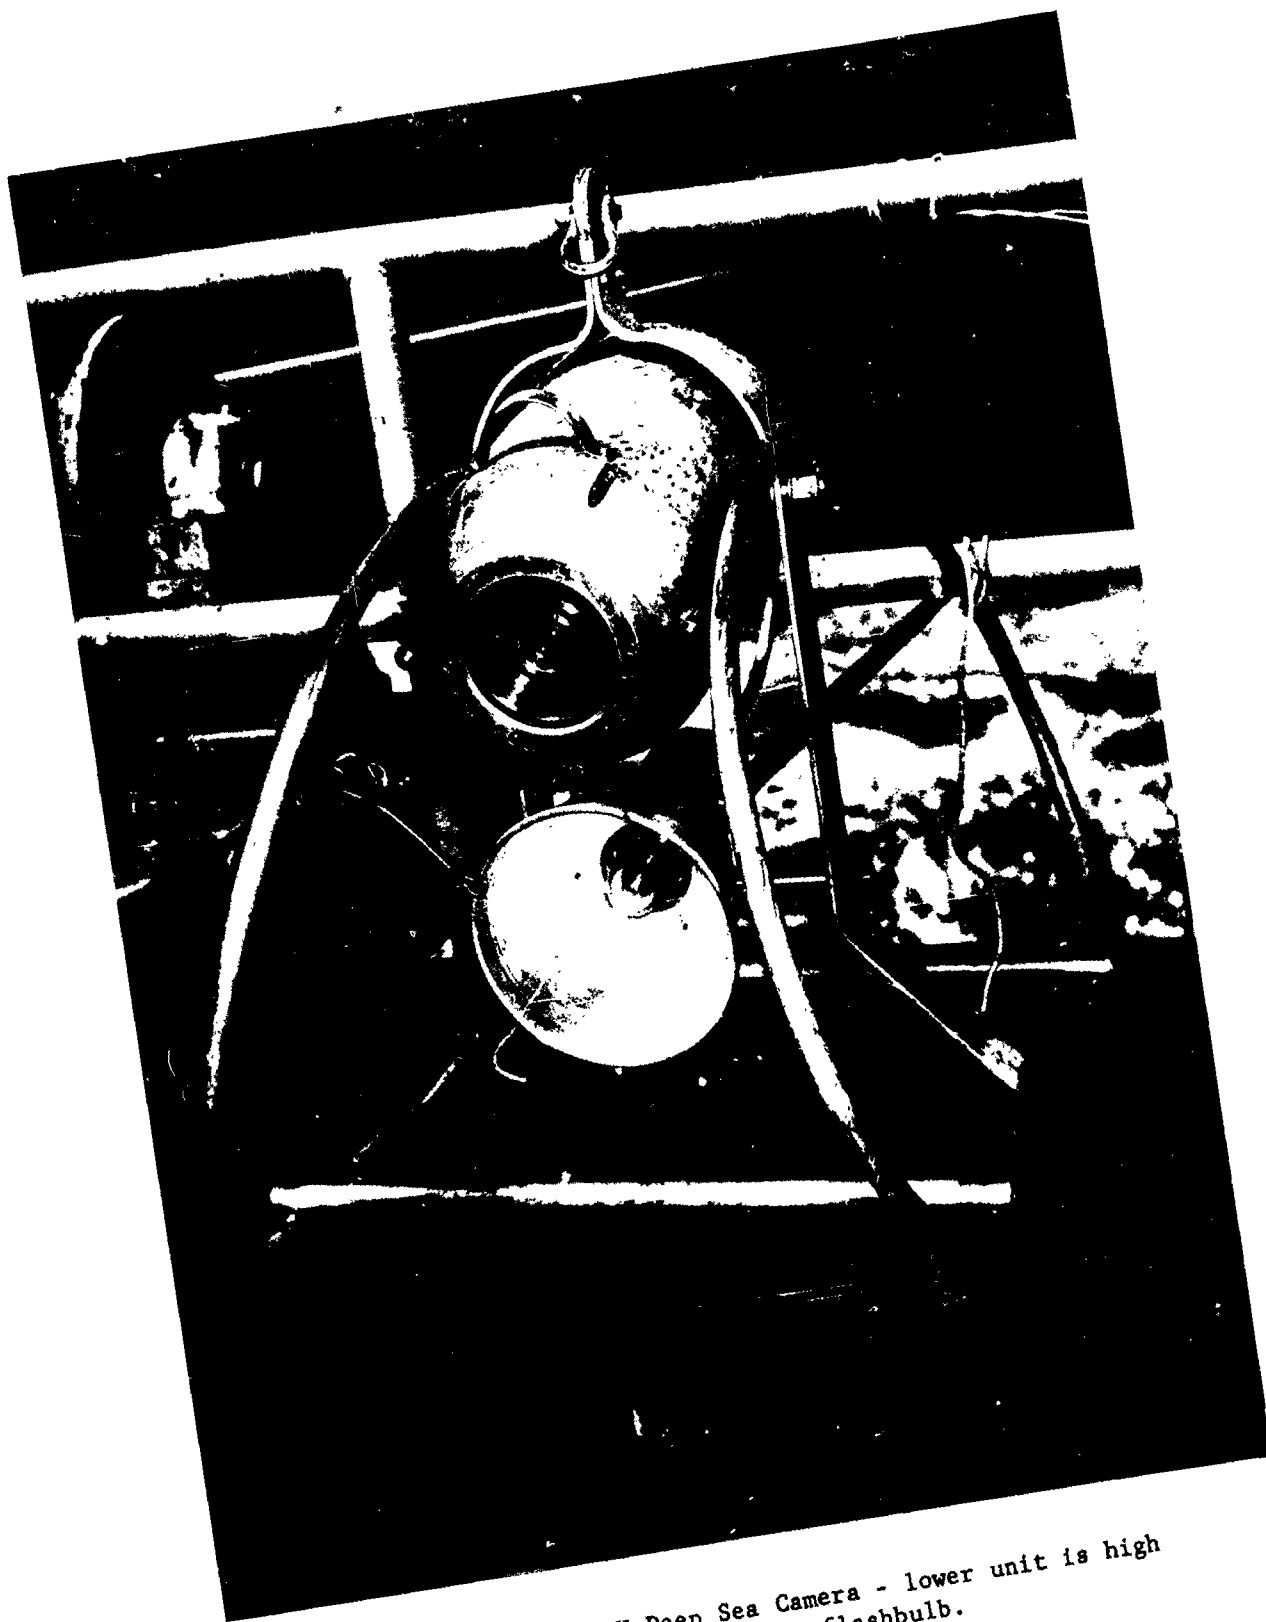
Figure 20. NEL Mk V Deep Sea Camera - lower unit is high intensity electronic flashbulb.

Sea floor photographs were obtained using the NEL Mk V camera (Figure 20) over seventy useful frames were obtained. Two examples are presented in Figures 21 and 22.

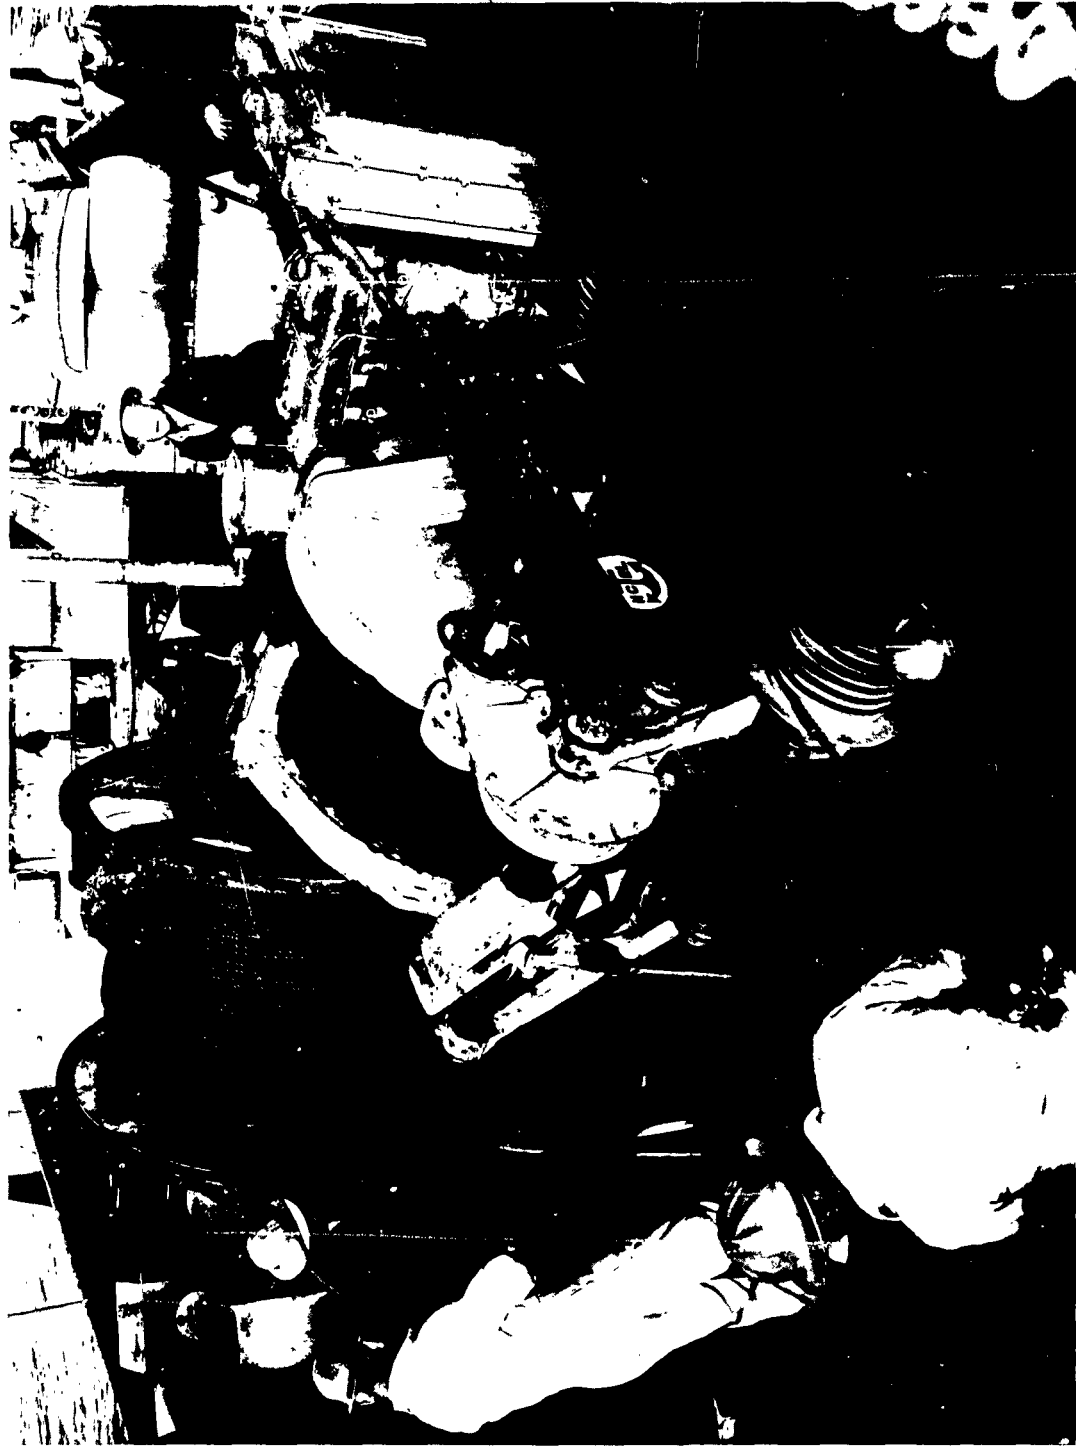
Figure 23. Storage drum and winding winch for polypropylene rope.

A single drum torque-converter winch with a gypsy head was located at the port side near the bow. Modifications were made in order to handle polypropylene (or other plastic lines) as shown in Figures 23 and 24 where 1-inch diameter polypropylene line was reeved over a grooved capstan and idler. An air-driven storage drum was located nearby for winding line at low tension (Figure 23).

The grooved rollers shown in Figures 23 and 24 were designed to develop sufficient friction between rope and groove to prevent slippage when winding and thus eliminate burning. The roller in the foreground was driven by the winch and replaced the cat-head. The other roller is an idler. The low-tension end of the rope was led onto an air driven storage spool (Figure 23) (capacity: 12,000-feet). Tests of this system were conducted by dragging a mule (heavy towing vehicle) across a concrete pavement. A pull of 7000-lbs (measured on a Dillon dynamometer) was obtained with no rope slippage and a slack line at the spool end.

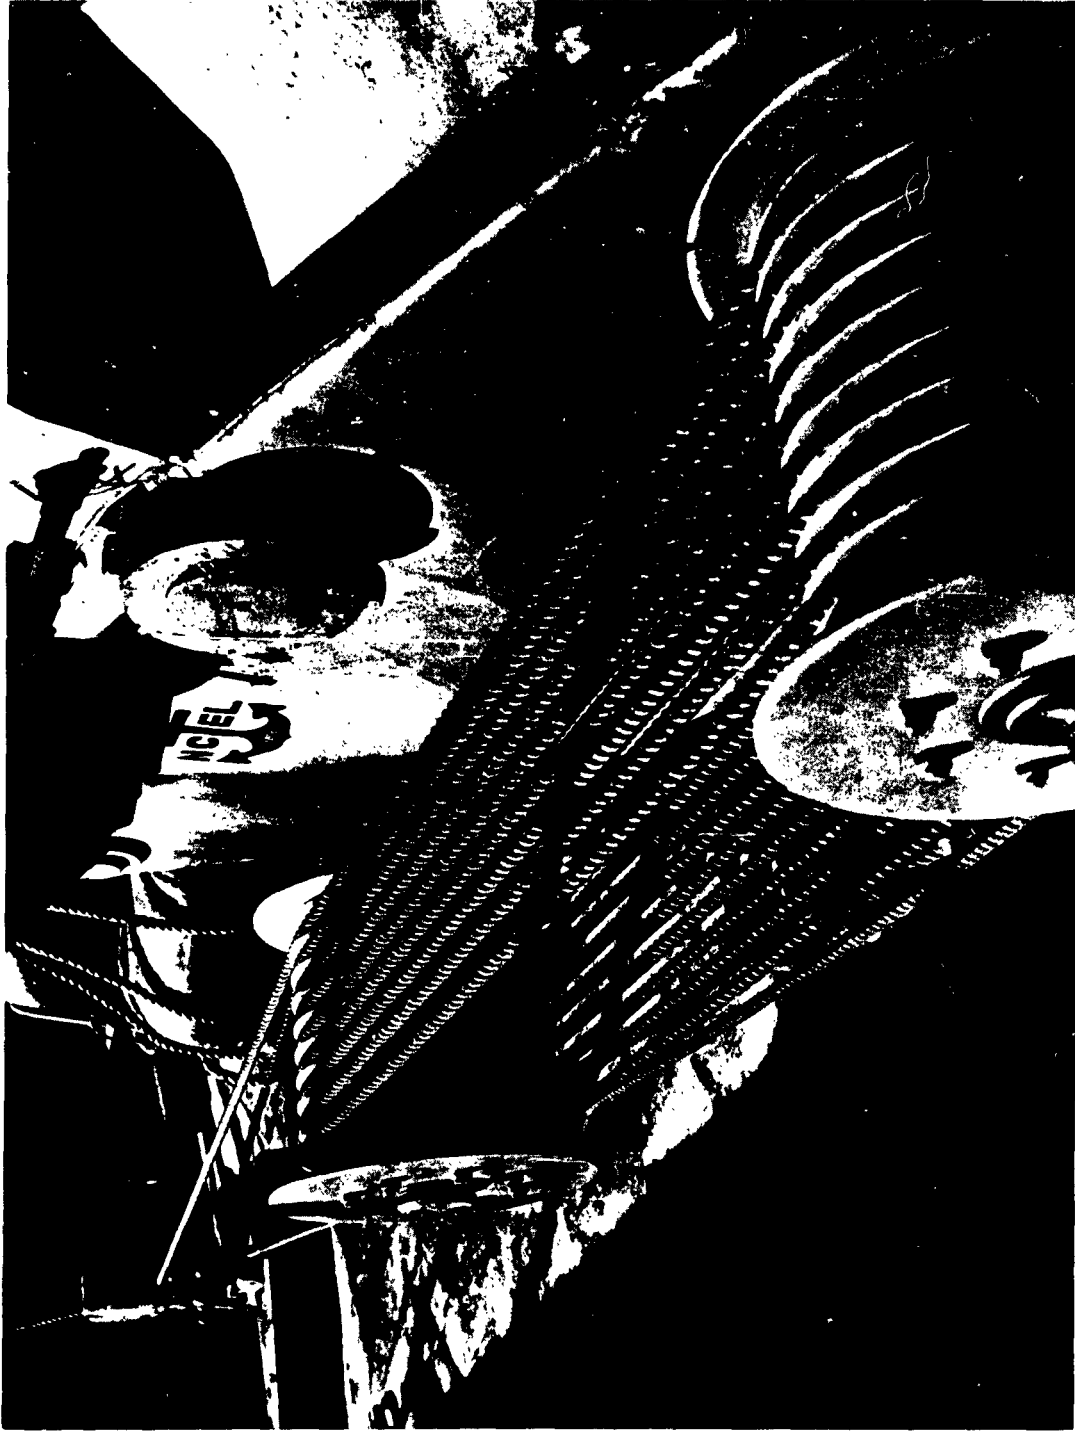
Figure 24. Close-up of winding mechanism for polypropylene rope.
