PRODUCTION ENGINEERING MEASURE

HIGH VOLTAGE  
SILICON  
RECTIFIER  
STACKS

#### QUARTERLY PROGRESS REPORT NO. 7

DECEMBER 25, 1962 TO MARCH 25, 1963

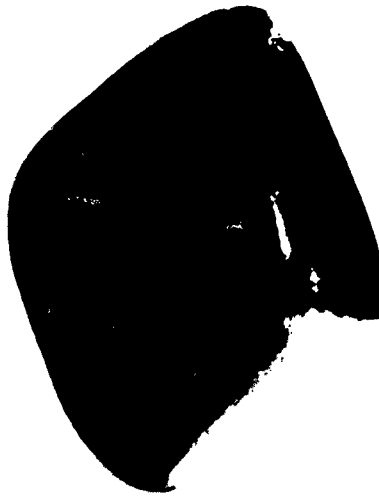
**Fig. 15**

A new series of tests were instigated, using the previously made electrodes for testing both the stresses across the laminations and along the surface of the material. This is shown in the Figures 13 through 18. Figure 13 shows the test of a solid tube, Figure 14 of a smaller section, both using the large electrodes. A new top electrode was made, shown on Figure 15, which has a dimension of 1x1". Figure 16 shows the two metal electrodes, together with five pieces of insulating material, ranging from 2x2" to 4x4" in  $\frac{1}{2}$ " steps. Figure 17 shows the tester with the small electrode and a small piece of insulating material. Figure 18 shows the tester with a larger piece of insulating material.
