**RESULTS OF THE PHASE II LONG-TERM  
ENVIRONMENTAL STORAGE TEST PROGRAM FOR  
THE RJ43-MA-11 RAMJET ENGINE  
OCTOBER 1960 THROUGH OCTOBER 1963**

**Contract AF 33(657)-7770**

**Project 273**

**Model RJ43-MA-11**

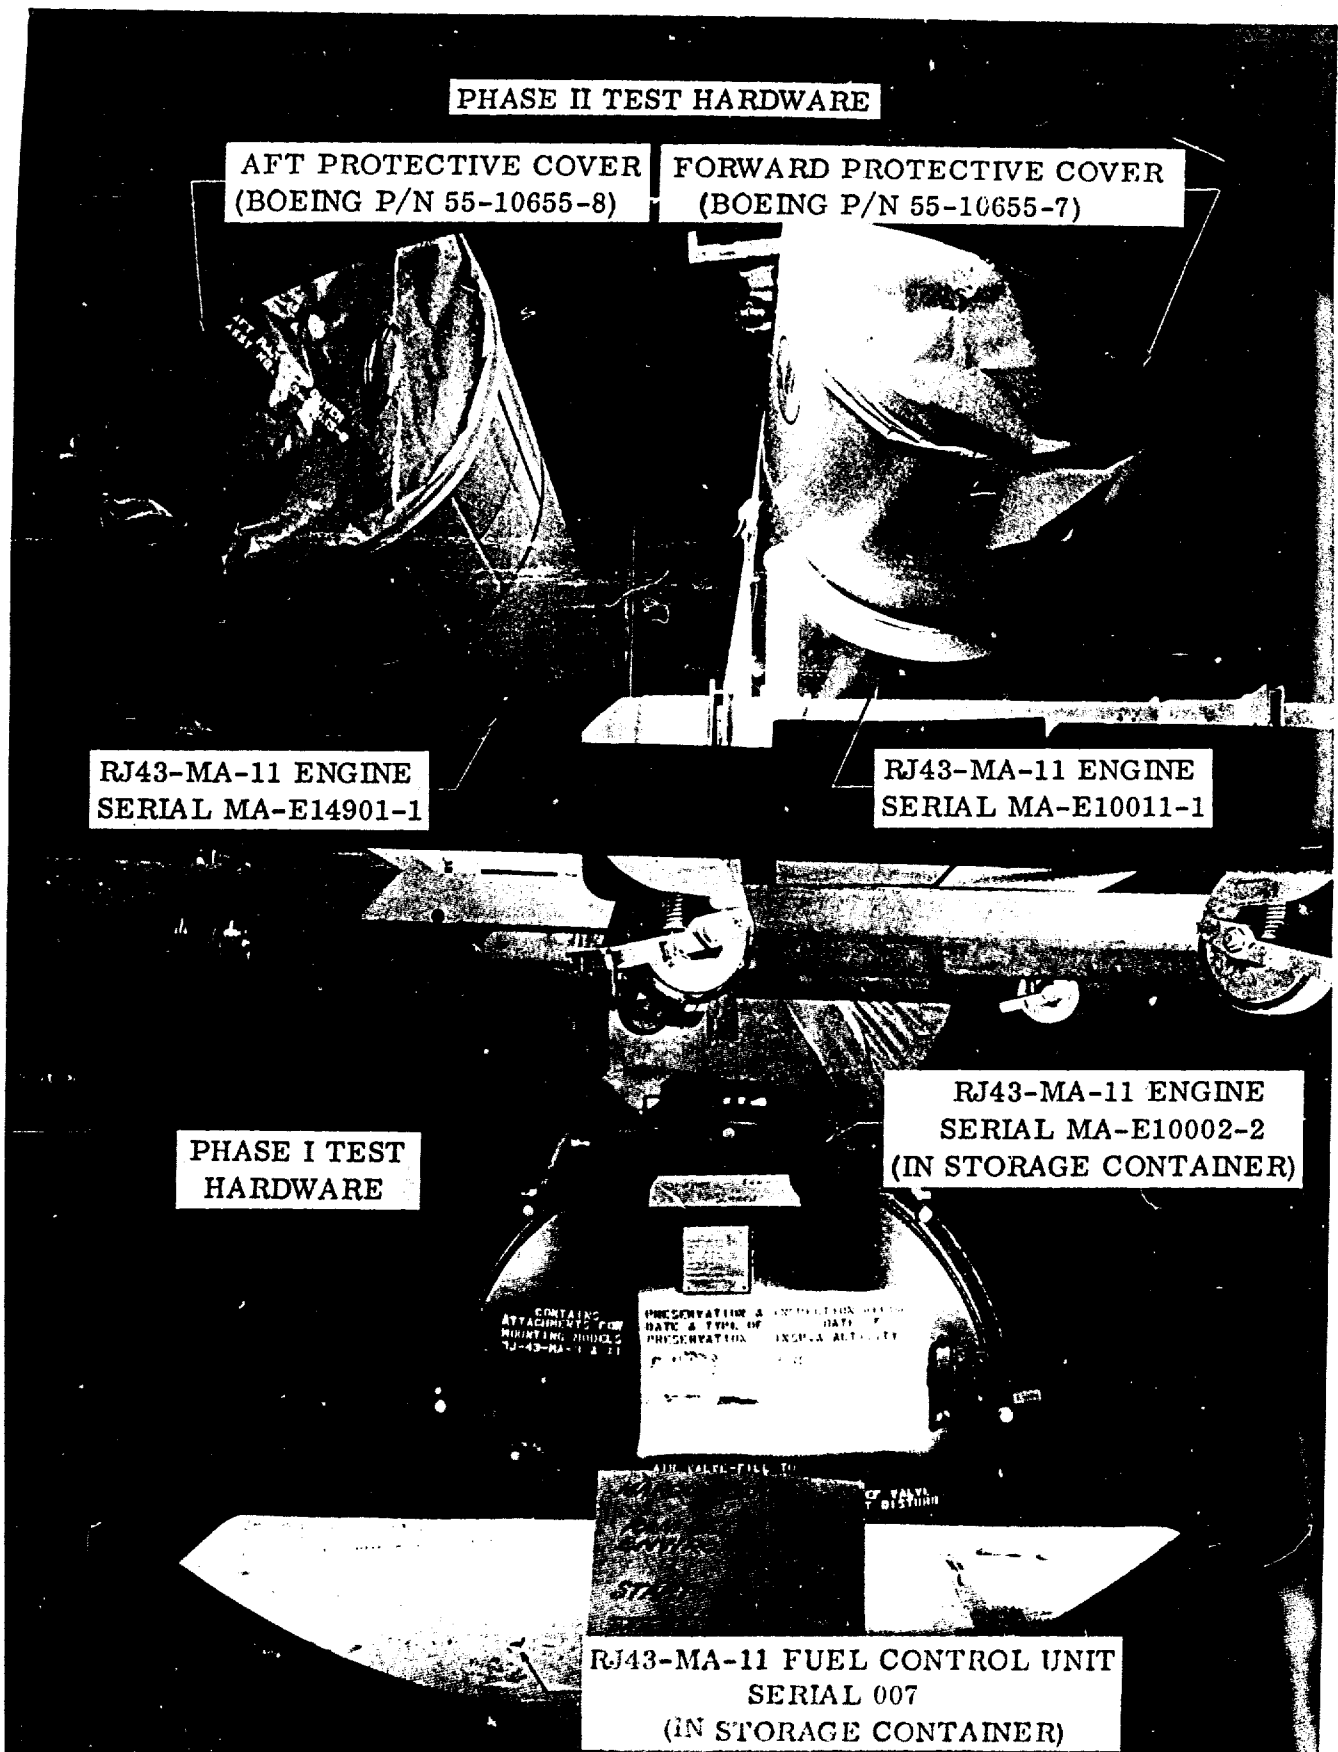
FIGURE 1 - RJ43-MA-11 Test Hardware Installed in Environmental Test Chamber at the Start of the Accelerated Storage Test Phase of the RJ43-MA-11 Long-Term Storage Test.

The test items for both Phase I and Phase II storage tests were placed together in a test chamber, Figure 1, equal to that described in Military Specification MIL-E-5272C (ASG), Environmental Testing, Aeronautical and Associated, General Specification for (Reference 5). The test chamber was vented to the atmosphere to prevent the buildup of pressure. Prior to the start of the test, the chamber temperature was between 68°F and 100°F with uncontrolled humidity.

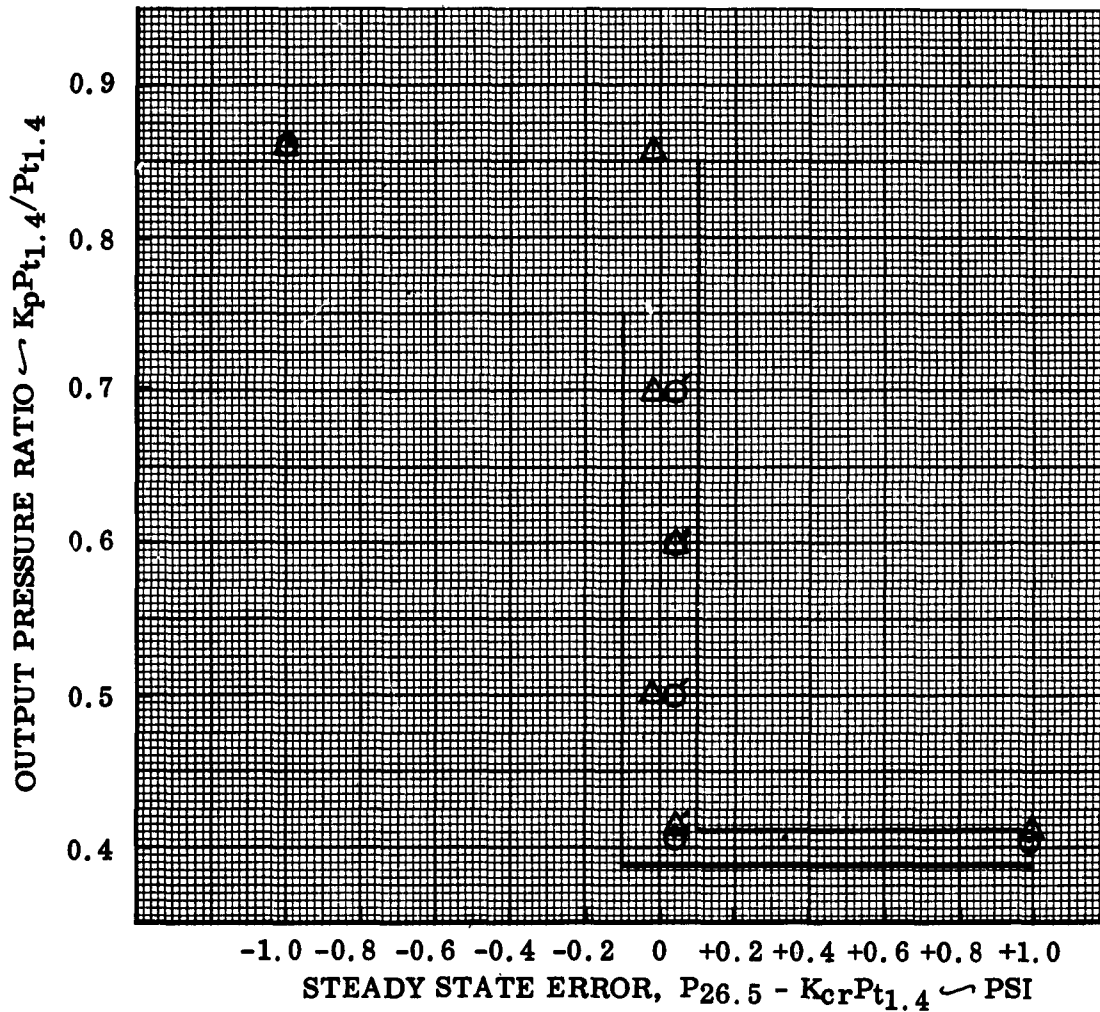
**FIGURE 7 - RJ43-MA-11 Ramjet Engine Serial MA-E14901-1 Shock Position Control Calibration Data Before and After the RJ43-MA-11 Phase II Accelerated Storage Test.**

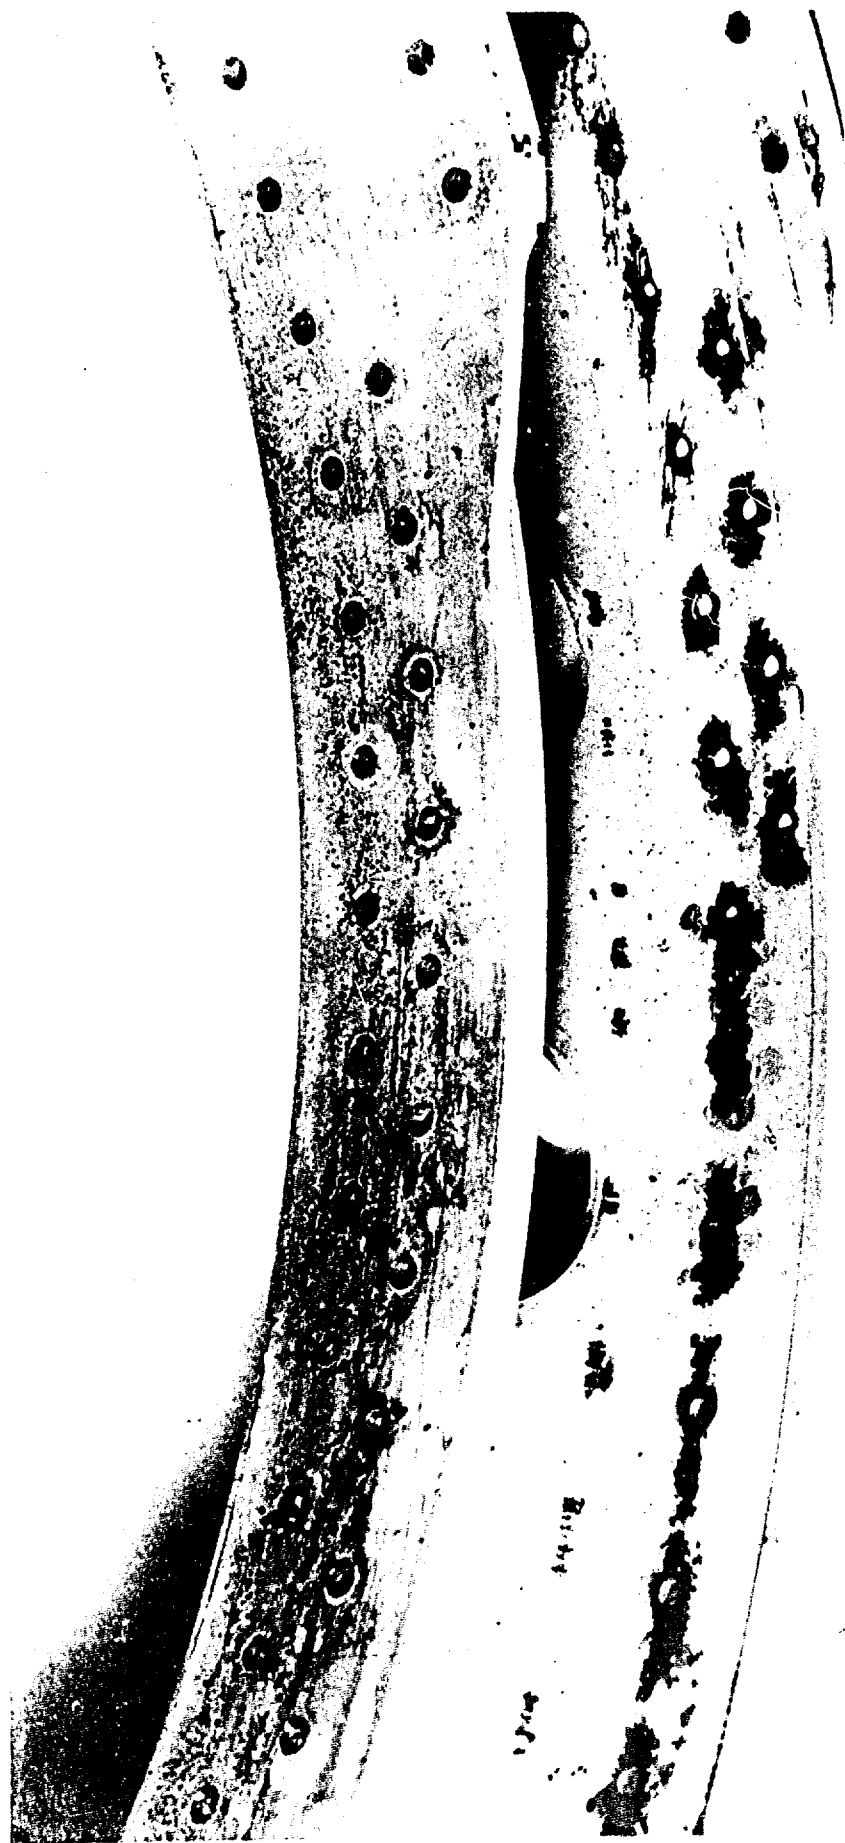
FIGURE 12 - Station 75.75 Ring Frame From RJ43-MA-11 Engine Serial MA-E10011-1 Showing Corrosion, Due to Deburring and No Subsequent Protective Touch-up, Which Occurred Around Attach Holes During the Accelerated Storage Phase of the RJ43-MA-11 Phase II Long-Term Storage Test.

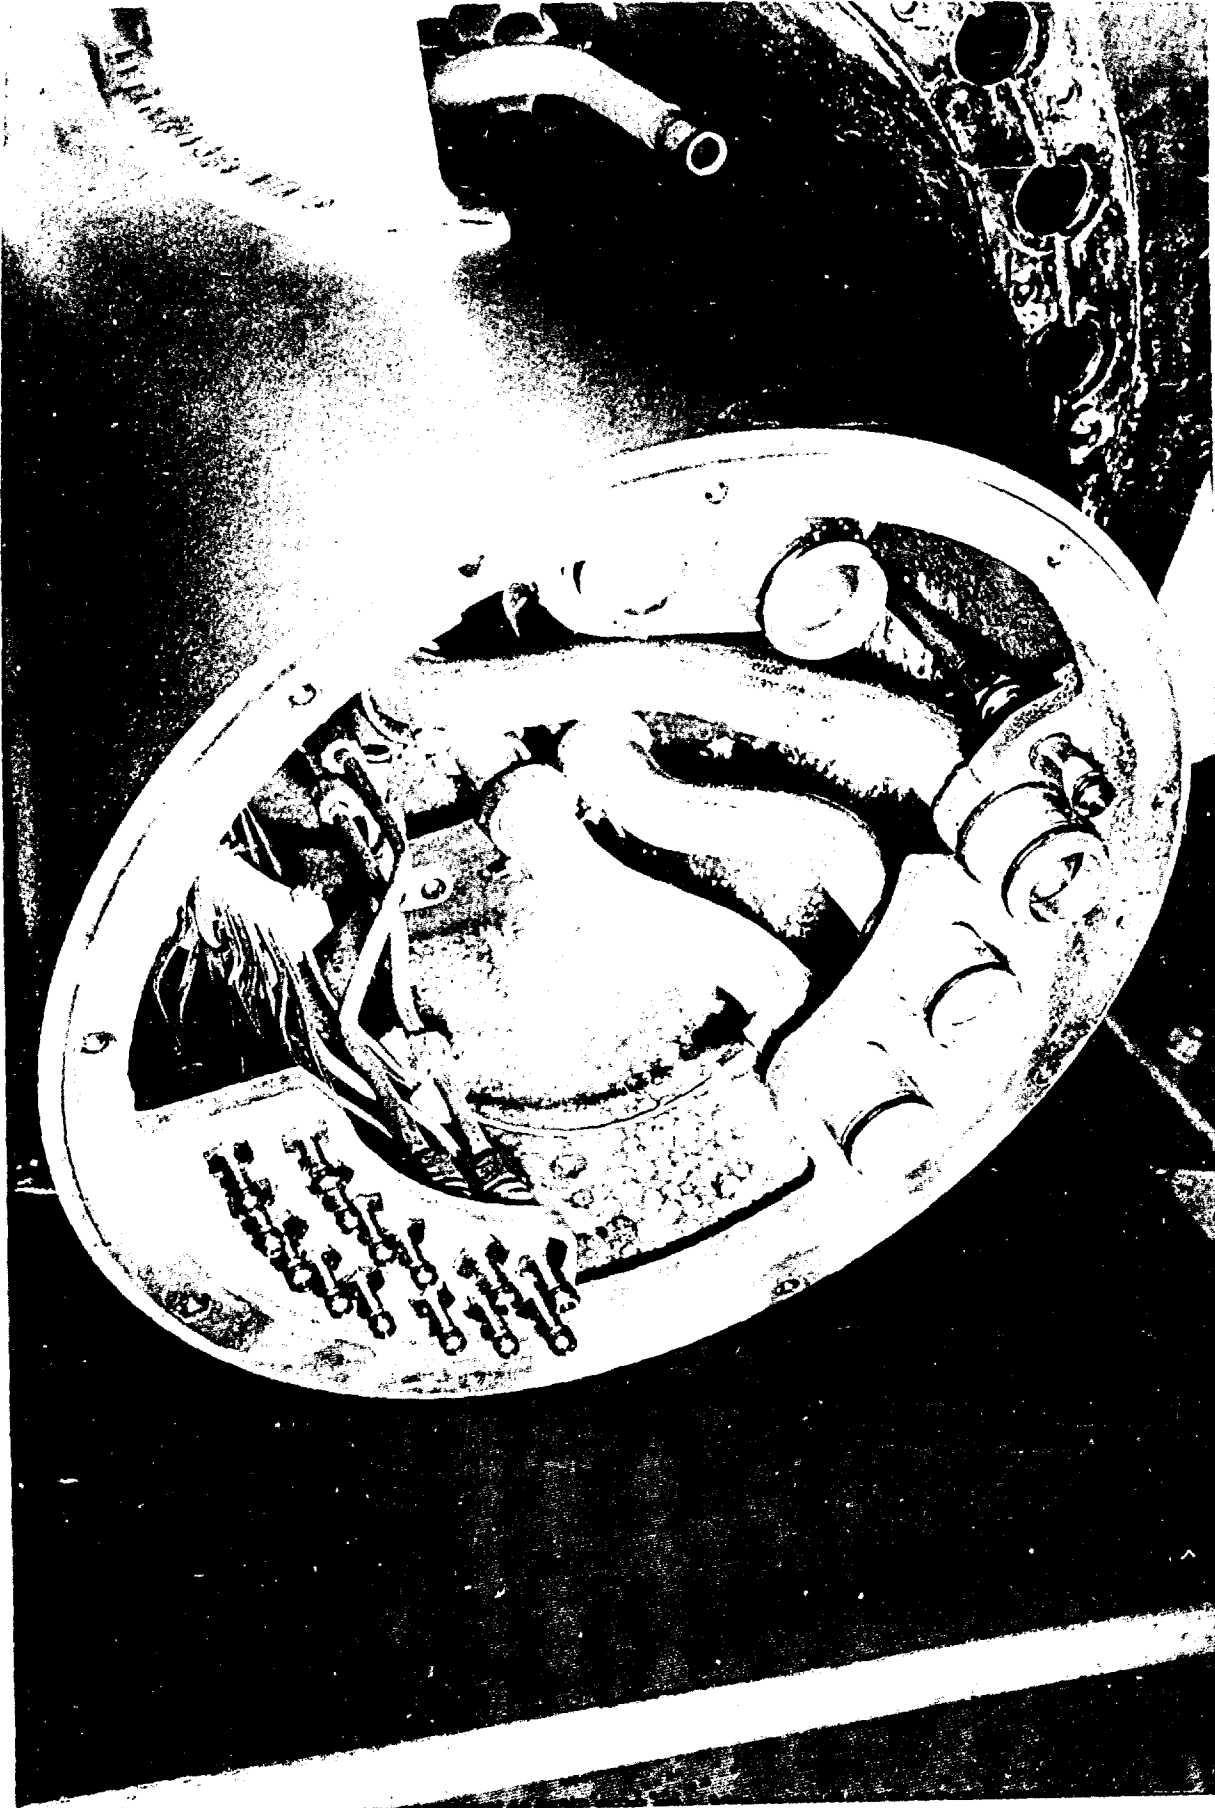
FIGURE 19 - Aft Innerbody Assembly From RJ43-MA-11 Engine Serial MA-E10011-1 Showing Magnesium Corrosion at Junctures with Steel Details, Rusted Spirolox Rings, and Corrosion of Aluminum Fuel Lines Which Occurred During the Accelerated Storage Phase of the RJ43-MA-11 Phase II Long-Term Storage Test.

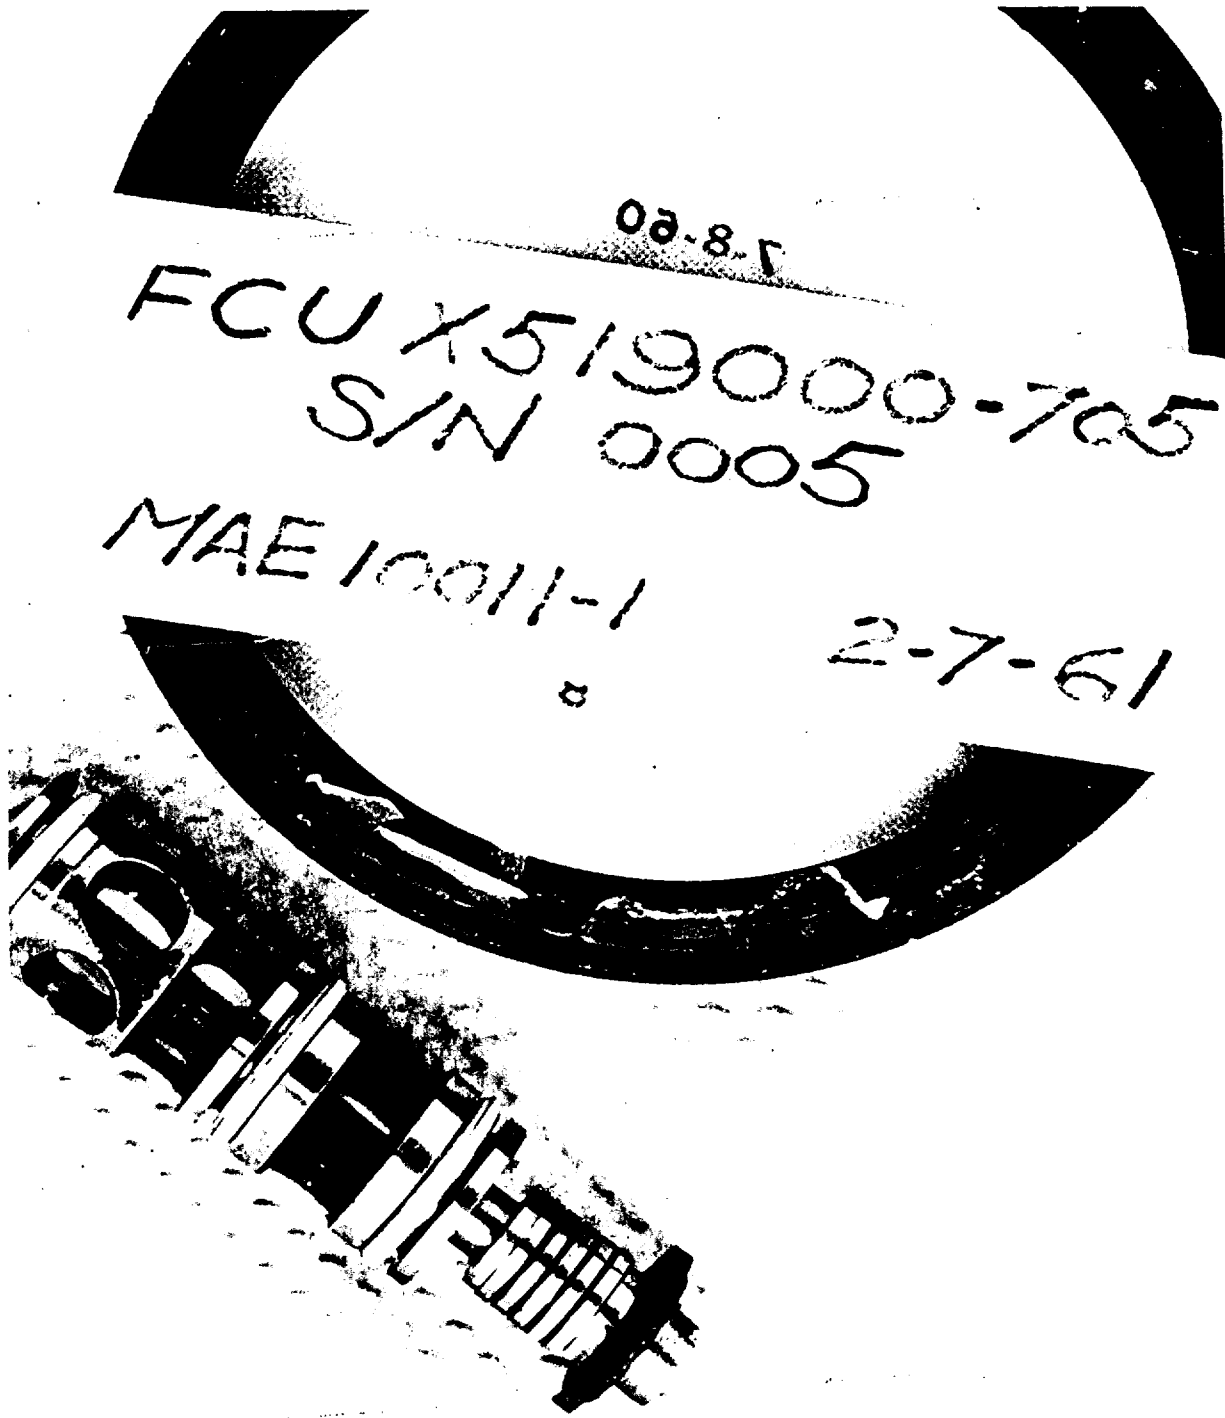
FIGURE 28 - Mach Senser Valve-Sleeve Assembly and Diaphragm from RJ43-MA-11 Engine Serial MA-E10011-1 Showing Corrosion and Diaphragm Disintegration Which Occurred During the Accelerated Storage Phase of the RJ43-MA-11 Phase II Long-Term Storage Test.

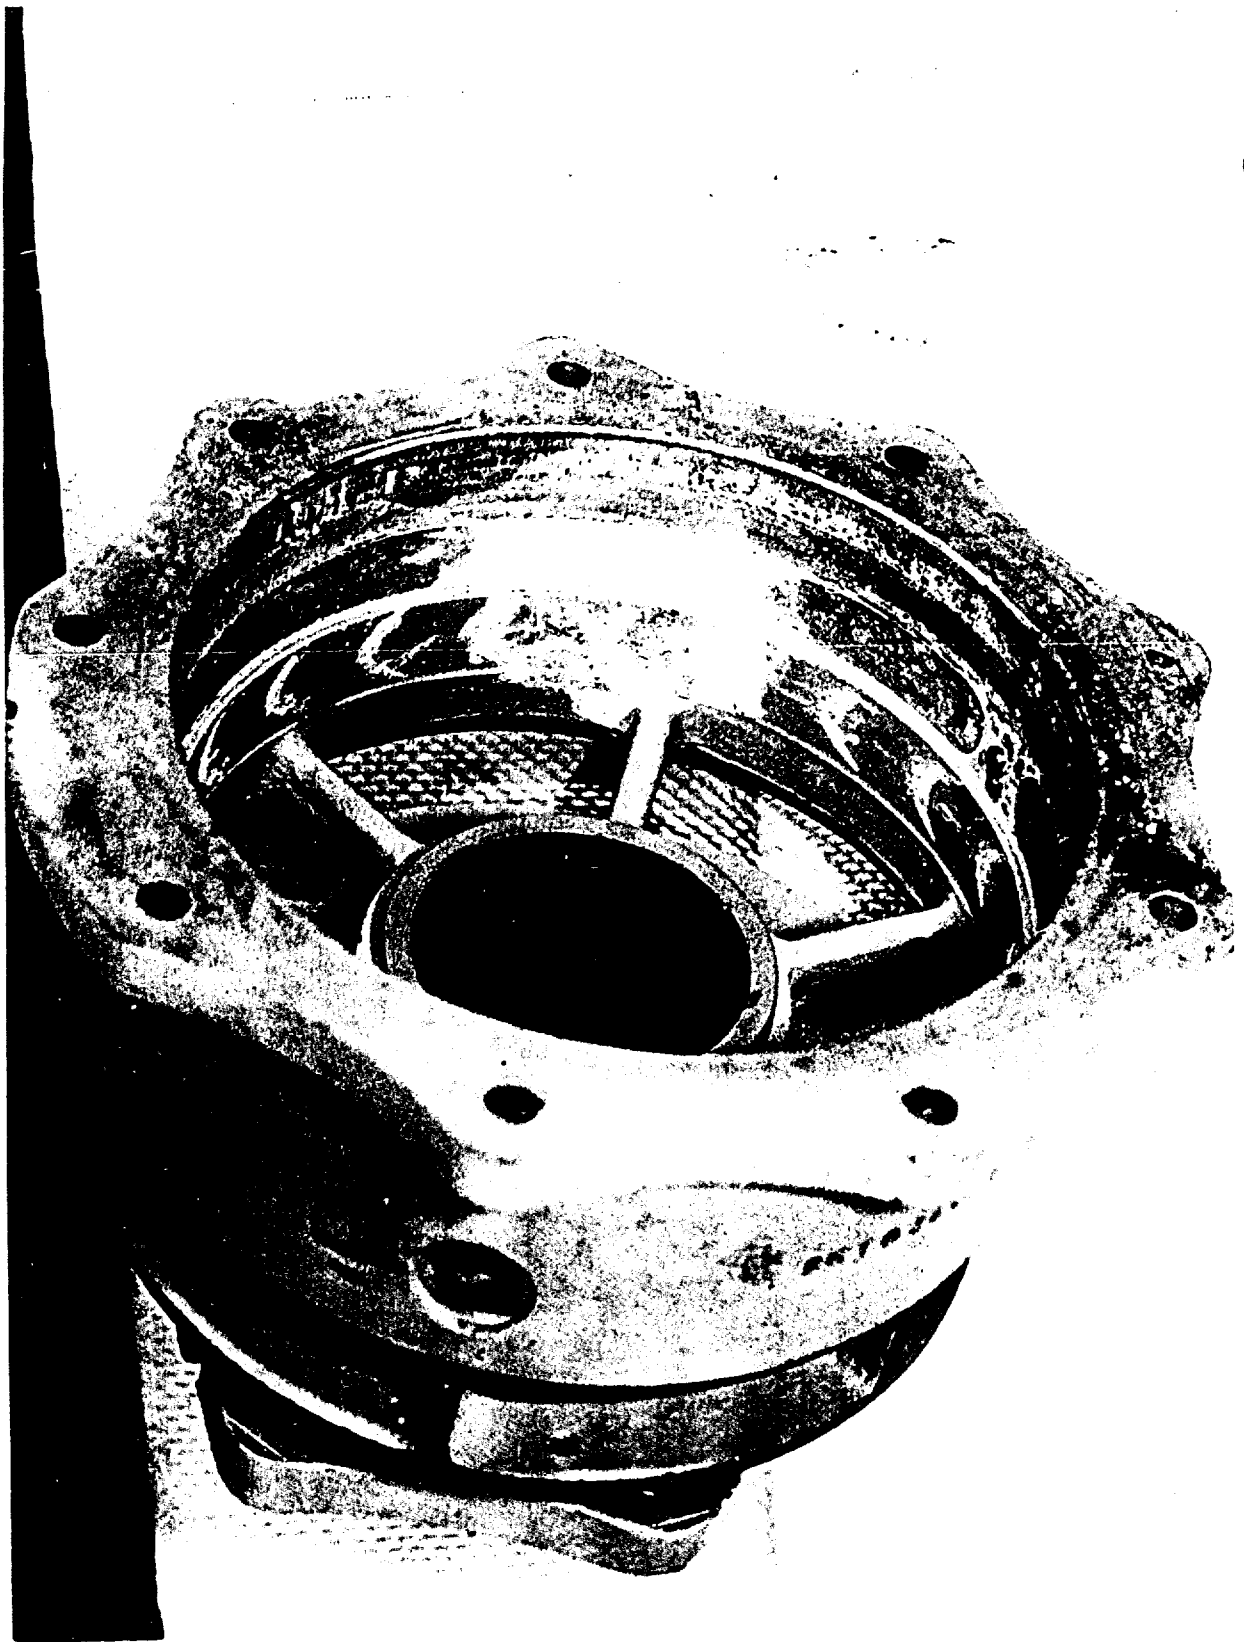
FIGURE 37 - Turbine Housing Assembly From RJ43-MA-11 Engine Serial MA-E10011-1 Showing Corrosion Deposits Where Water had been Trapped Inside Housing During the Accelerated Storage Phase of the RJ43-MA-11 Phase II Long-Term Storage Test.

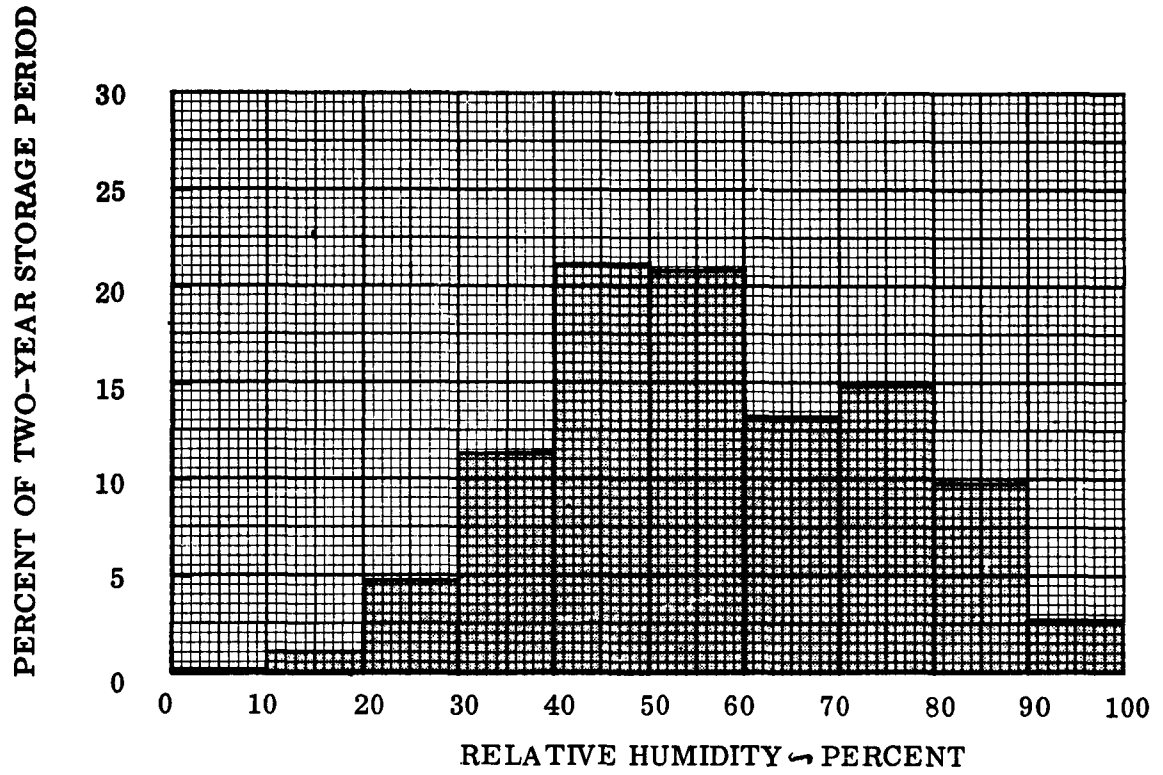
FIGURE 41 - Storage Enclosure Temperature and Relative Humidity Histograms for the RJ43-MA-11 Phase II Long-Term Storage Test.

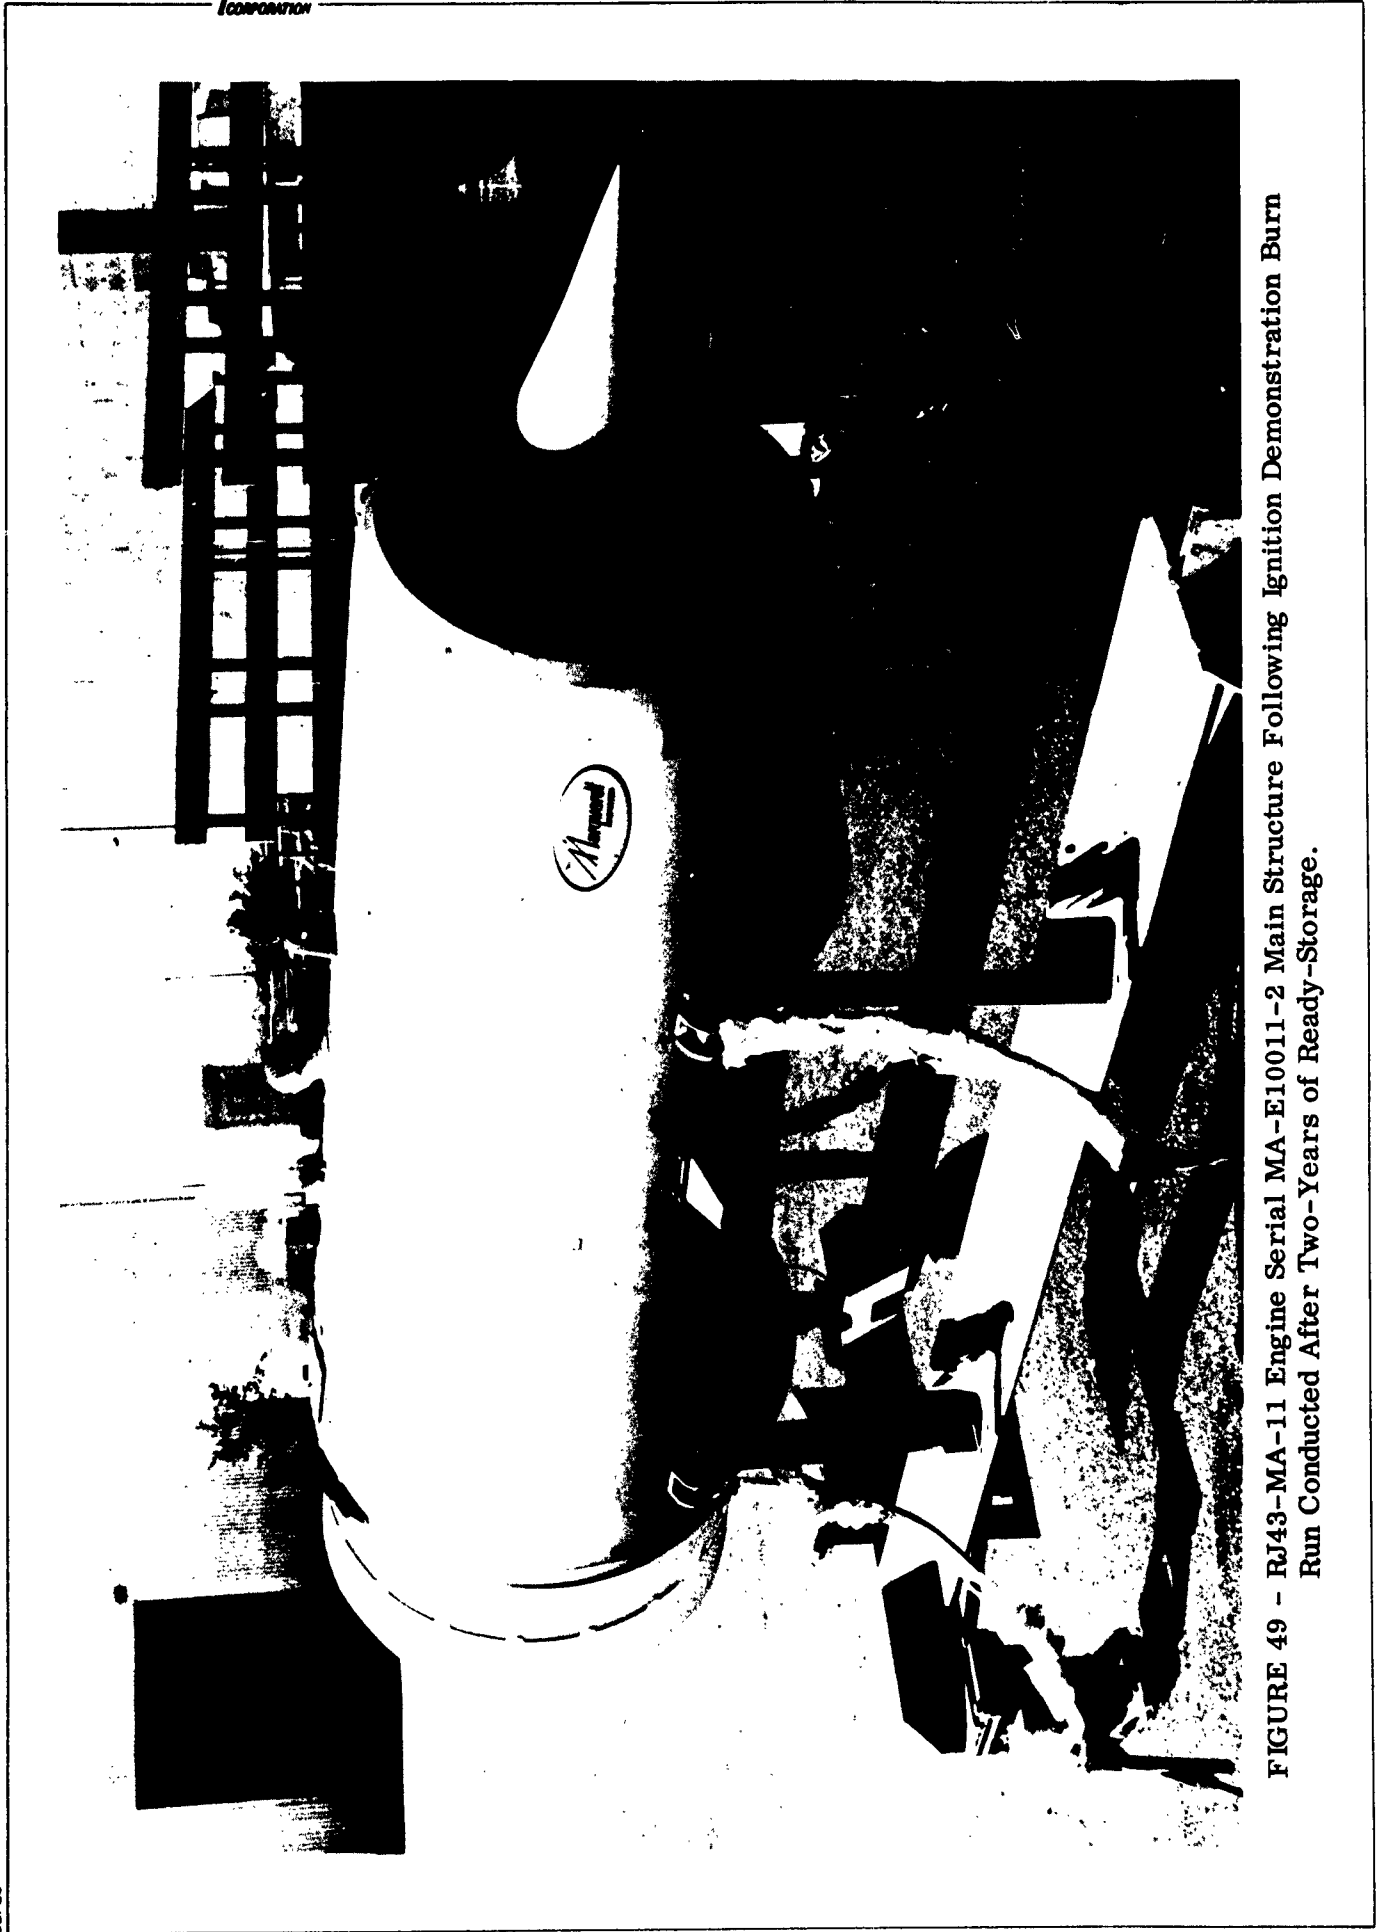
FIGURE 49 - RJ43-MA-11 Engine Serial MA-E10011-2 Main Structure Following Ignition Demonstration Burn Run Conducted After Two-Years of Ready-Storage.
