Alkali Metal Resistant Wire

TECHNICAL DOCUMENTARY REPORT NO. APL-TDR-64-42

AF Aero-Propulsion Laboratory
Research and Technology Division
Air Force Systems Command
Wright-Patterson Air Force Base, Ohio

(Prepared under Contract No. AF33(657)10701 by Westinghouse Electric Corporation, Aerospace Electrical Division, Lima, Ohio; E. S. Bober, R. E. Stapleton, and W. H. Snavely, authors)

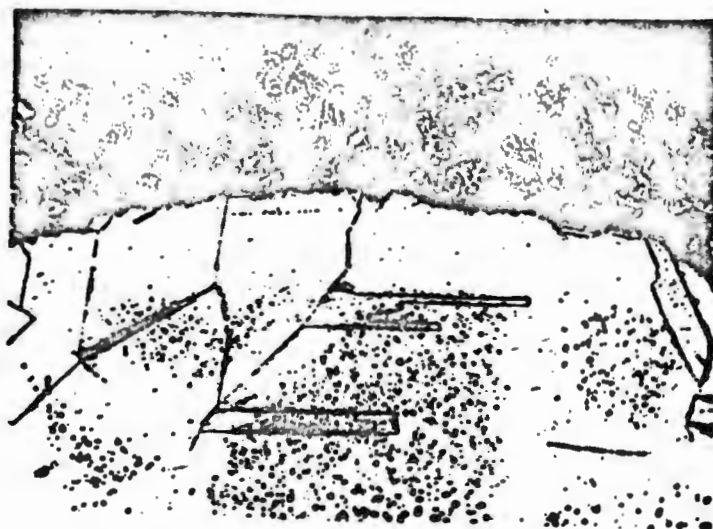
Figure 7. Oxalloy 28, Stainless Steel Clad (28%) Copper
After 340 Hours Exposure to Mercury Vapor
at 538°C - 25OX SS Clad CU-7 C-0982

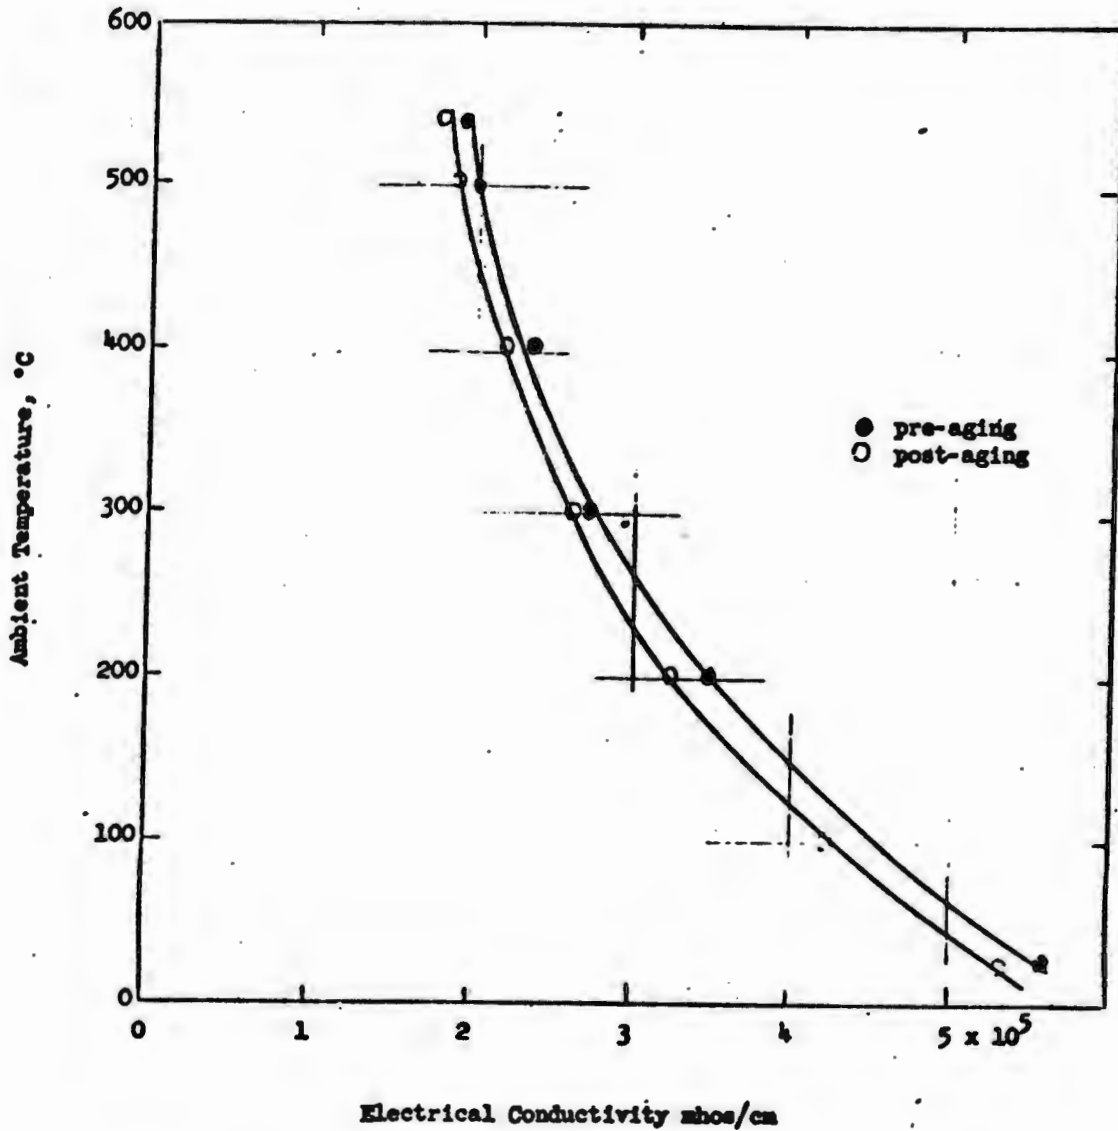
Figure 17- Pre- and Post-Aging Characteristics of Bare Copper Wire at Temperatures to 540°C In Tank Argon.

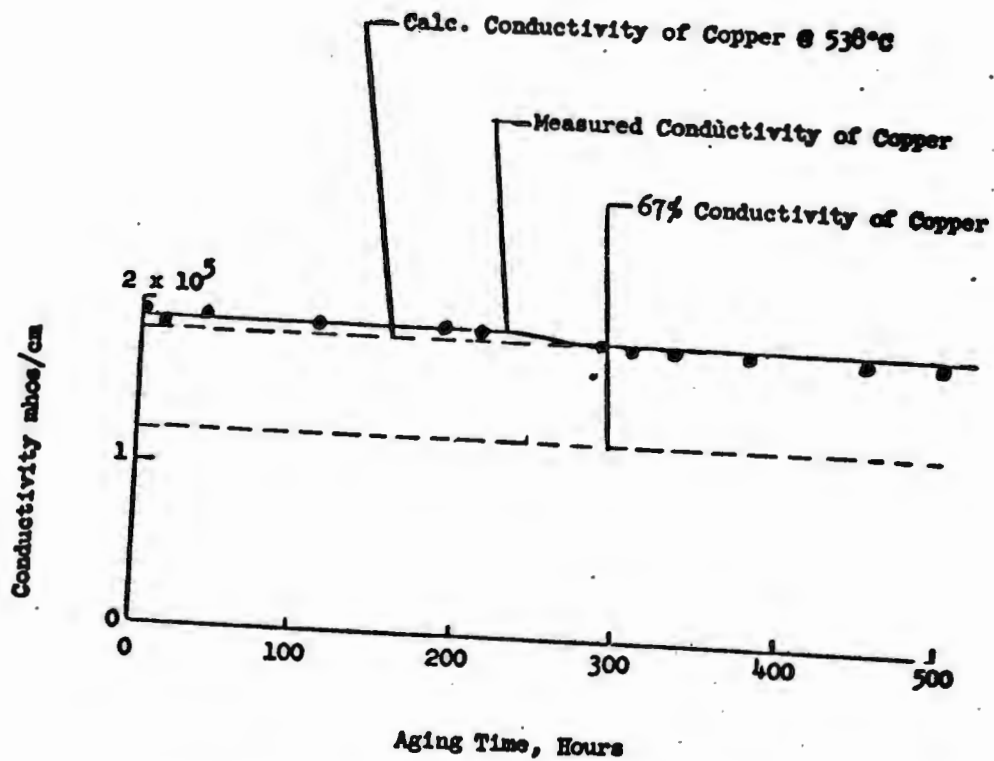
Figure 19- Temperature Aging-Conductivity Characteristics of Copper Wire in Tank Argon at 540°C.

The measured and calculated conductivity values for the commercial grade copper sample are shown in Figure 19. The measured conductivity of Oxalloy 28 is compared with the calculated value for commercial copper in Figure 20. The calculated conductivity of copper at 538 C and a corresponding 67% limiting value are shown by the dashed lines. The measured conductivity of Oxalloy 28 remained quite constant throughout the 500 hour aging period and the average value (1.37×10^5 mhos per cm) is 77% of the calculated value for

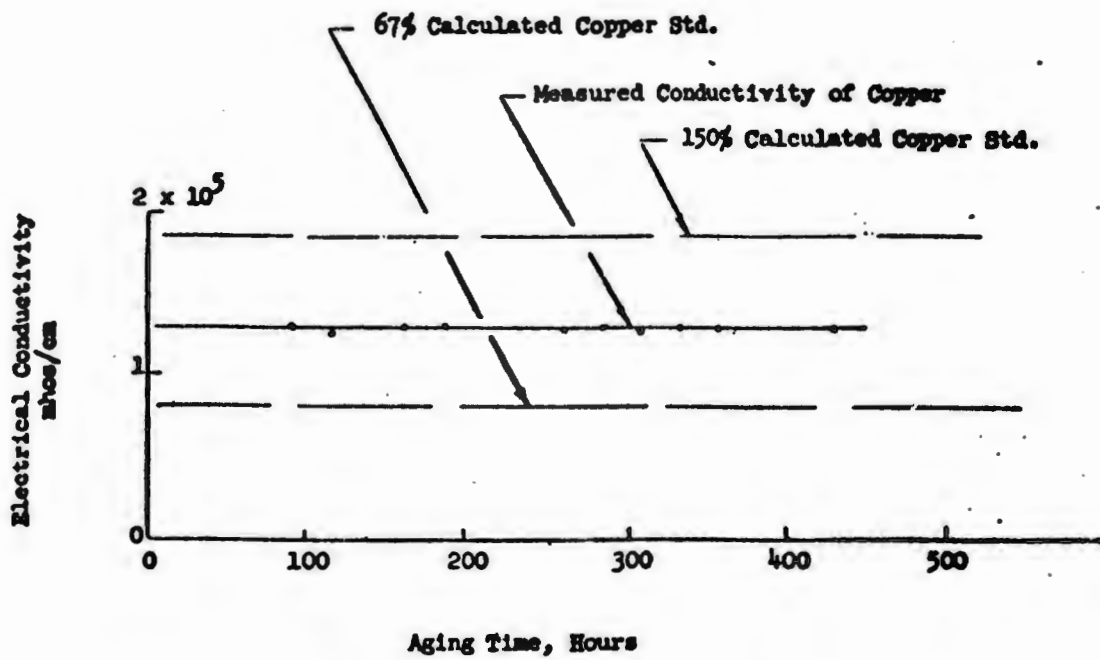
Figure 21- Temperature Aging-Conductivity Characteristics of Copper Wire in Purified Argon at 850°C.

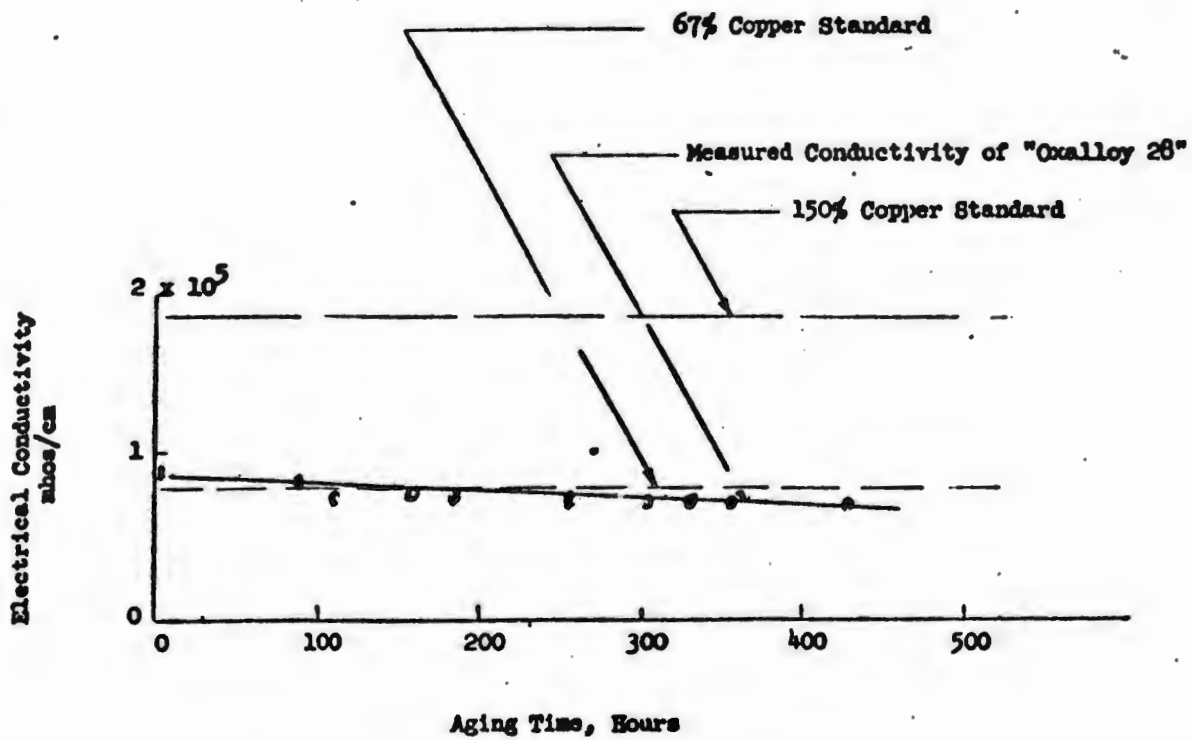
Figure 22- Temperature Aging-Conductivity Characteristics of "Oxalloy 28" in Purified Argon at 850°C.

The conductivity of "Oxalloy 28" decreased with time and fell below the lower allowable limit, 67% of the electrical conductivity of copper, after 400 hours of aging at 850 C. As previously reported, a second test of a similar sample of

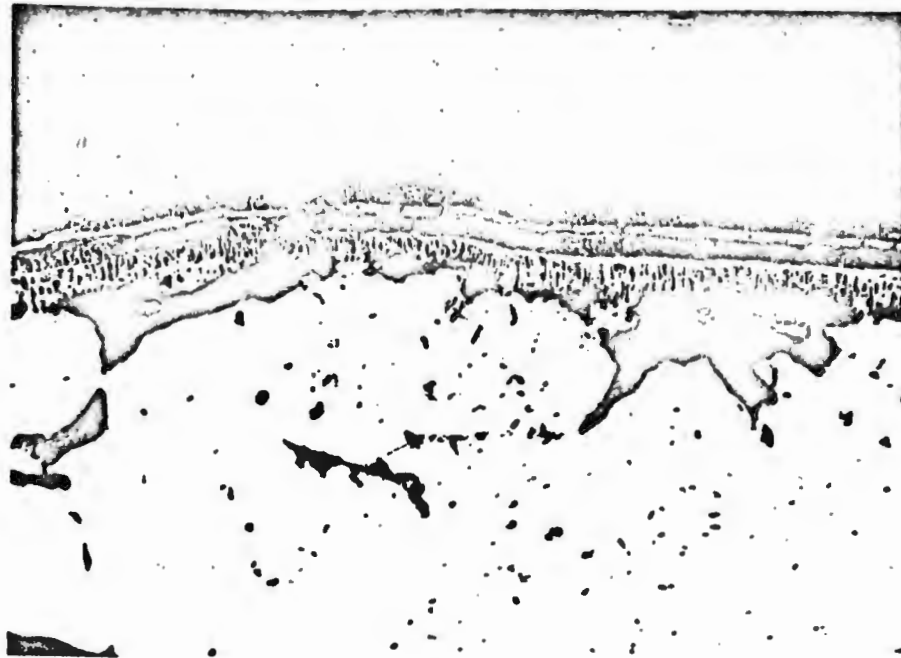
The brazing alloy (67% Zr-29% V-4% Fe) exhibits a bonded structure, which probably consists of a solution of Al_2O_3 in the brazing alloy. White light and unetched.

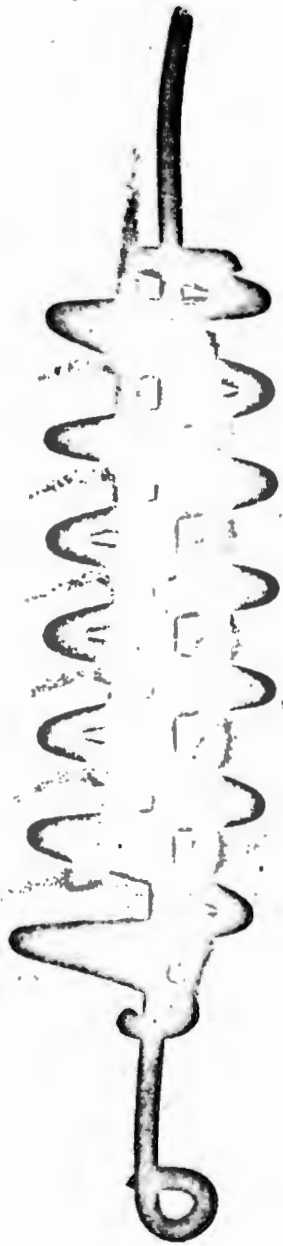
Figure 39. BN Coated Oxalloy 28 Wire

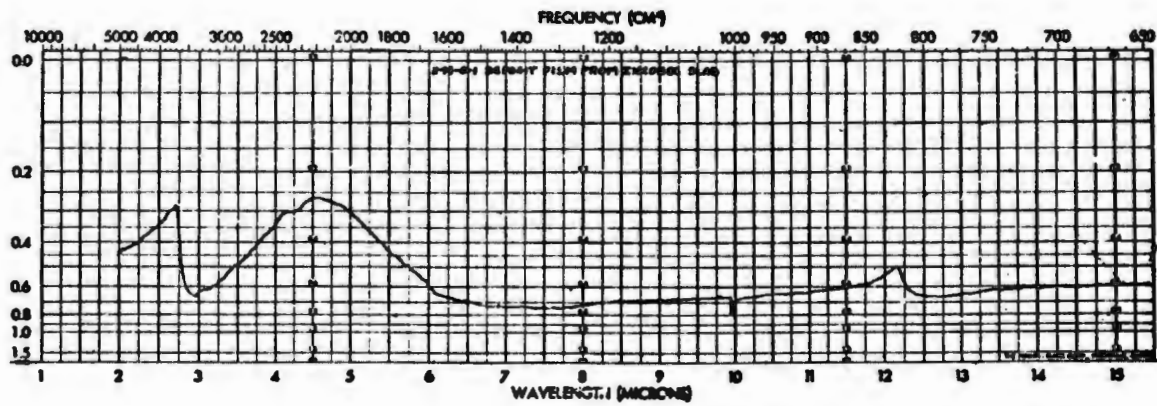
Figure 46. Infrared Spectra For Specimens R50Q-1, R53R-2 and R44-0-1
