Technical Note N-662

UNDERWATER MOORING SYSTEM

7 April 1965

U.S. NAVAL CIVIL ENGINEERING LABORATORY
Port Hueneme, California

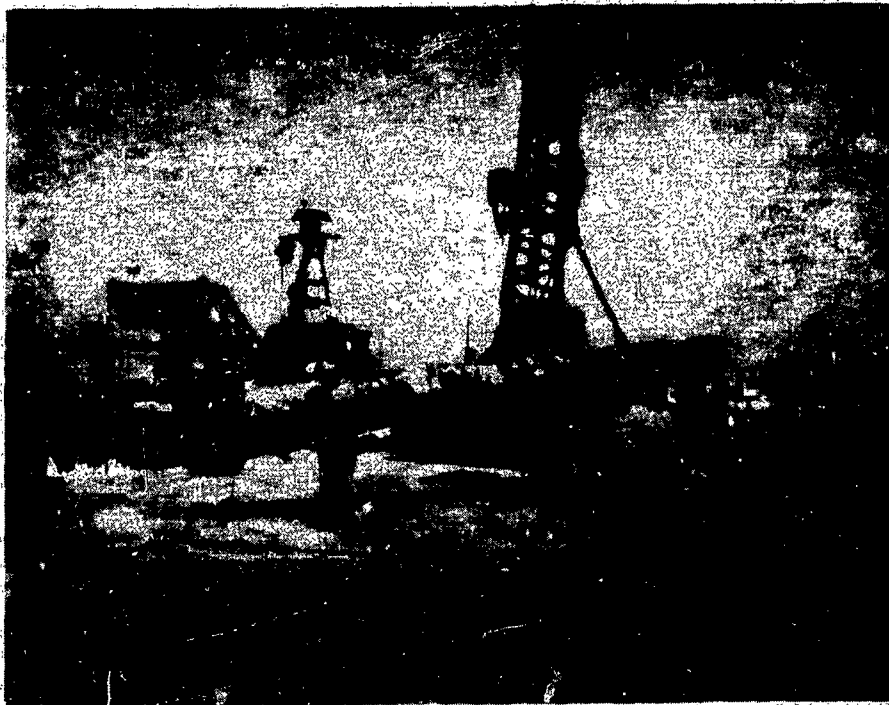
Figure 20. Test container arriving dockside upon delivery by Retrieving Boat, WTB 12.

Figure 20 shows the container as it arrived dockside. This photograph shows the extent of sea animal growth accumulated during the period of submergence. This growth (Figure 21) included:

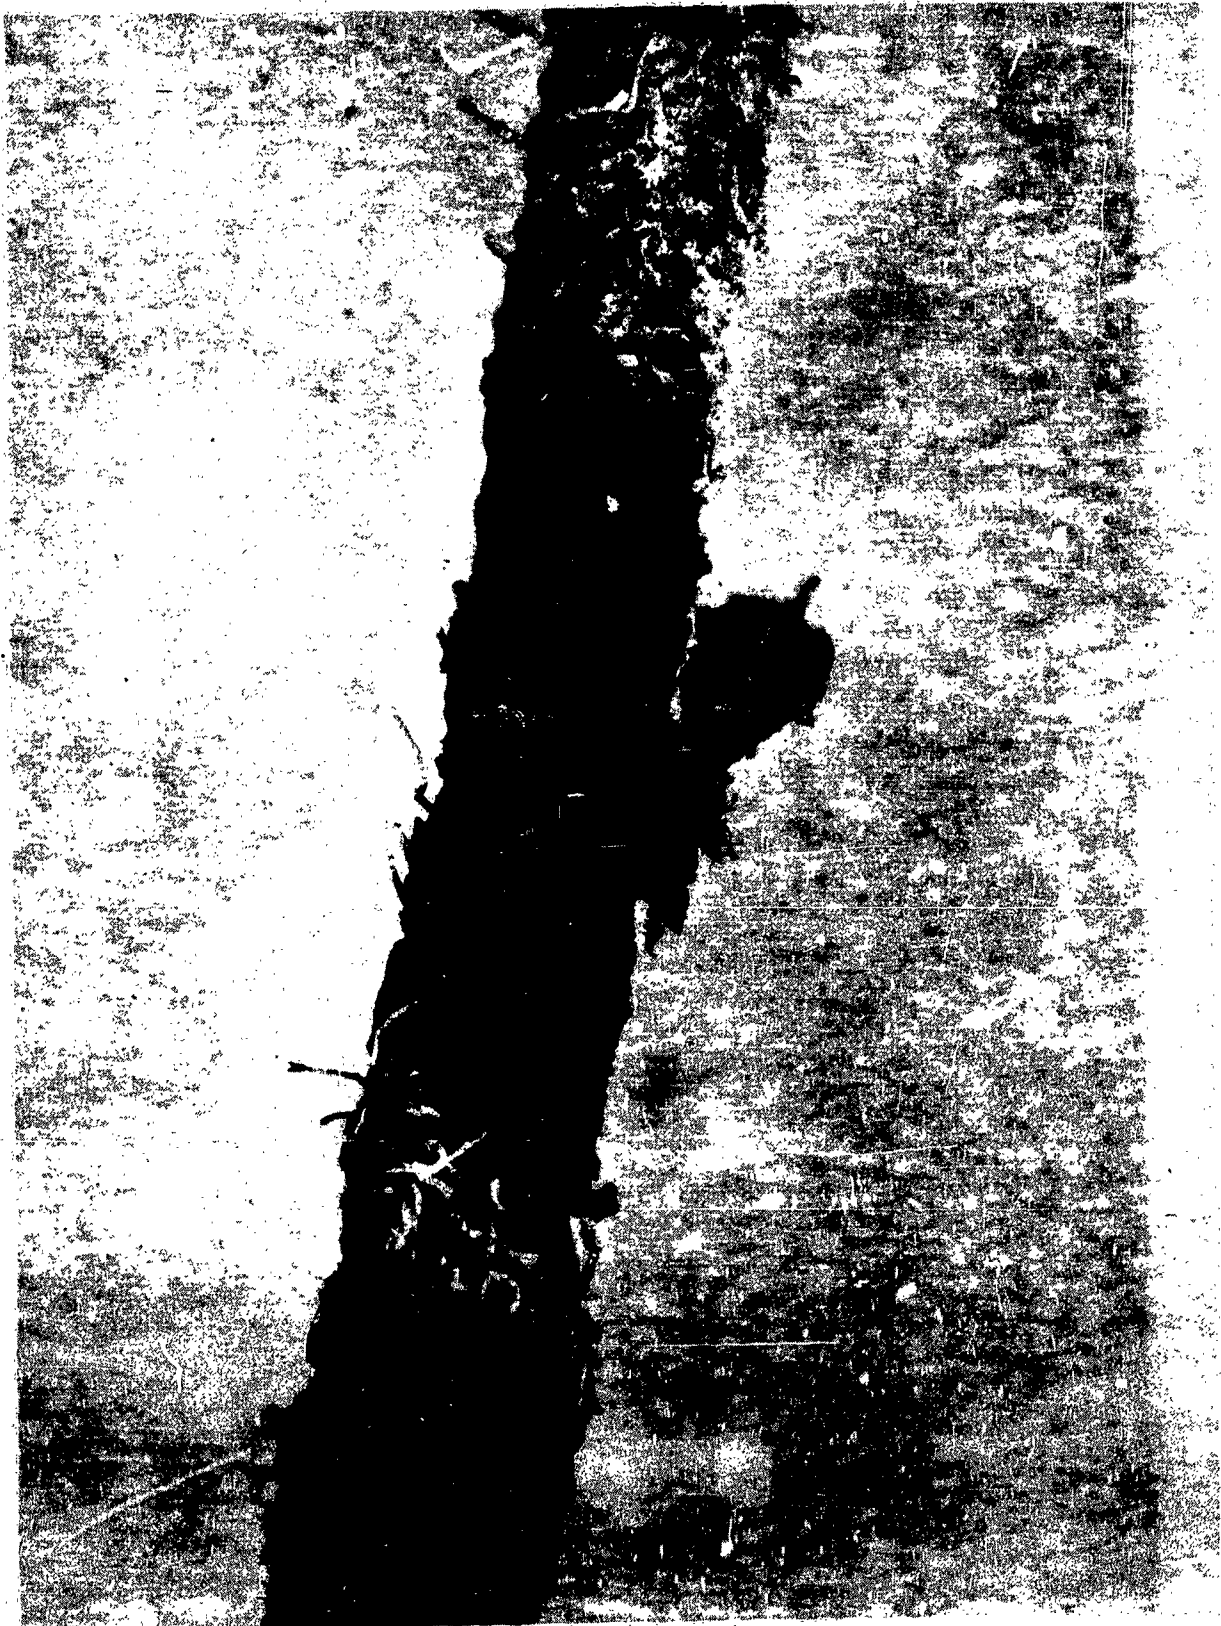
Figure 28. Close-up of the condition of unprotected mild steel shaft of slipring.
