CONFERENCE ON ENVIRONMENTAL  
EFFECTS ON AIRCRAFT PROPULSION

A Compilation of the Papers Presented

U. S. Naval Air Turbine Test Station  
Trenton, ~~New Jersey~~ N. J.

June 22 and 23, 1961

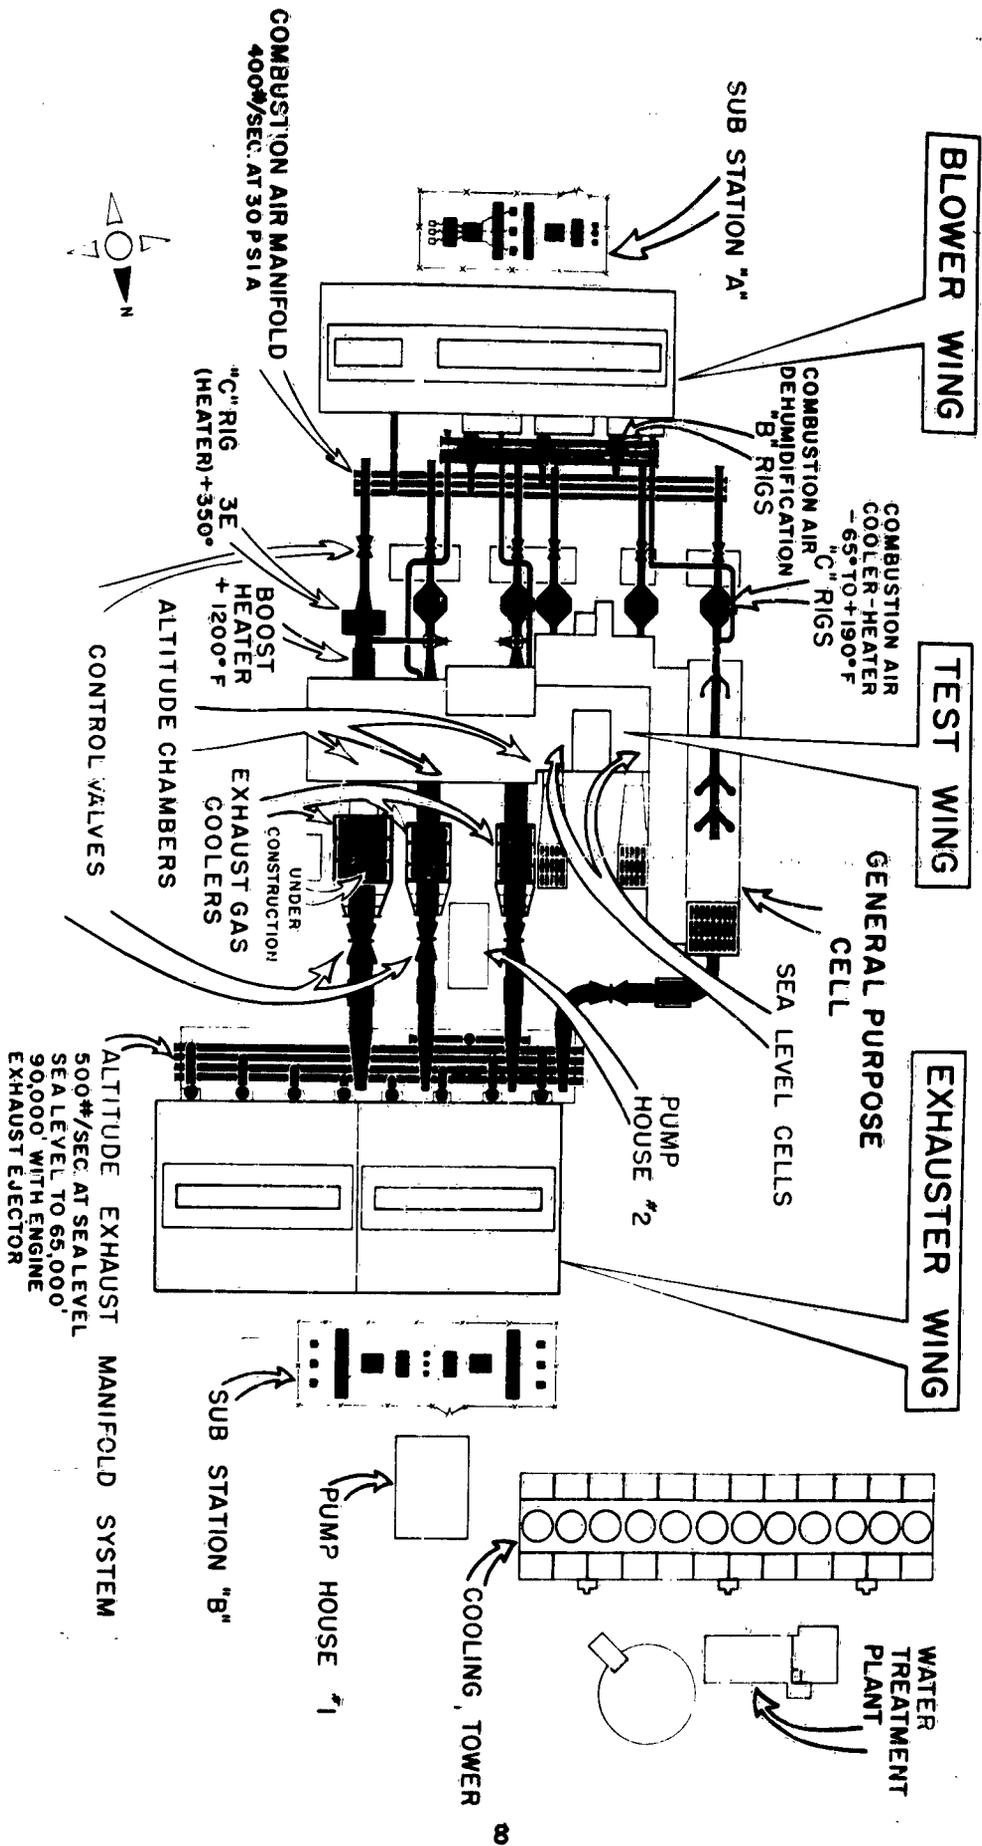
FIGURE 1

Figure 1 shows schematically the layout of the entire laboratory. At the extreme left is electrical sub-station A where (25,000 KVA) incoming 132,000 V is broken down to 13,200 V for driving the 6,500 HP ram blow motors. The ram blowers are housed in the blower wing and are capable of putting out 400 lbs/sec. airflow at 30 PSIA.

# AERONAUTICAL TURBINE LABORATORY

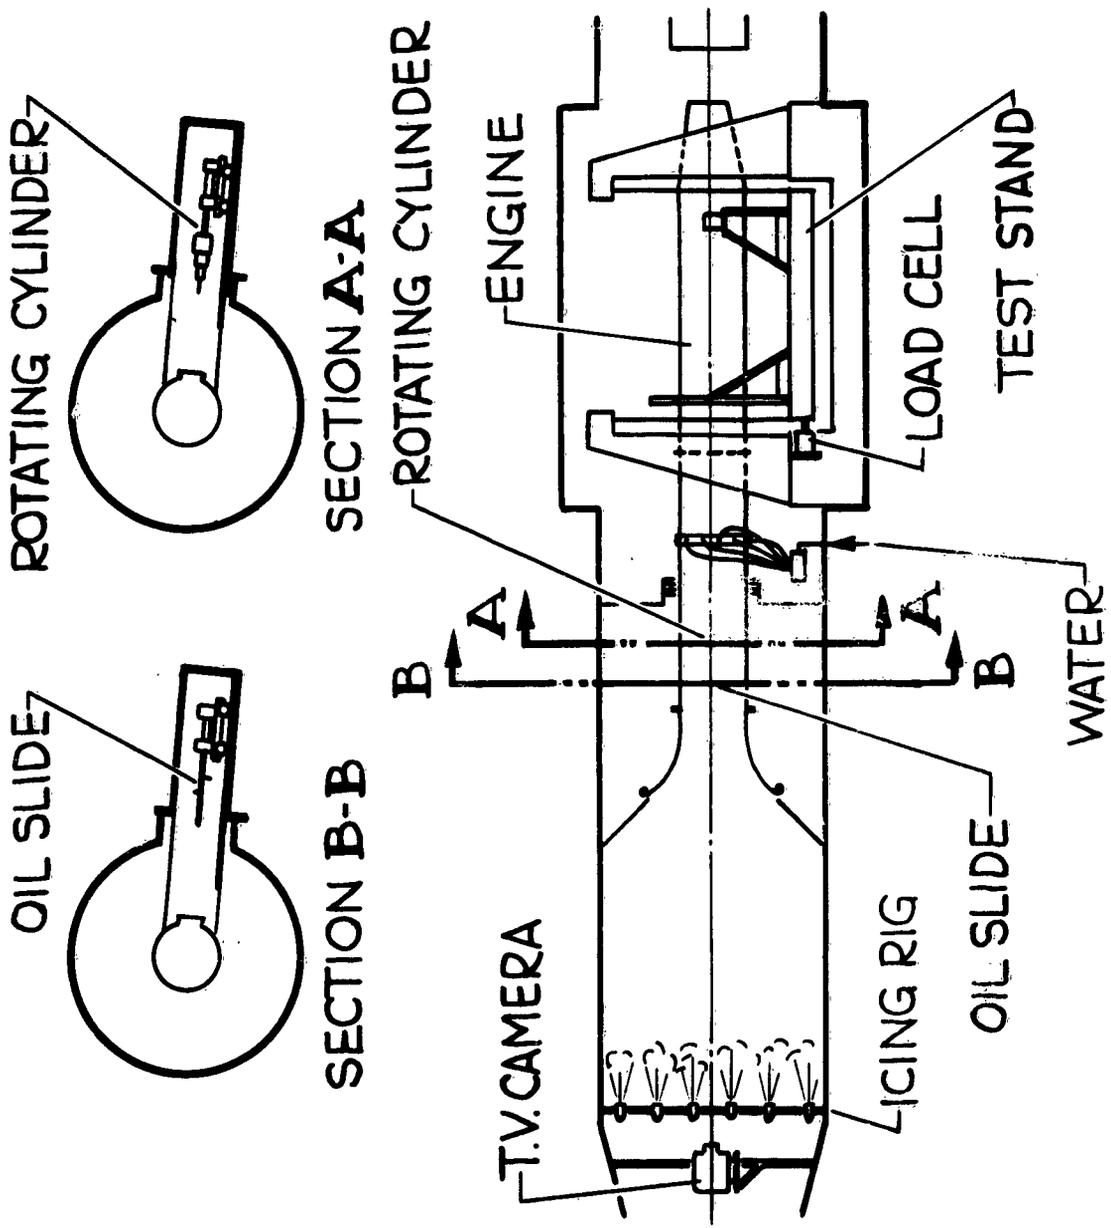
FIGURE 2

Figure 2 is a simplified drawing of the engine in the test cell showing the location of the water sprays and icing rig in the inlet pipe. At the extreme left is the T.V. camera which is used to monitor the condition of the engine during test. Photos of the T.V. monitor provide for a permanent record of these conditions. Conditioned combustion air enters the inlet pipe at the left, flows over the T.V. camera around the spray bars, where it picks up the icing fog, down the large inlet pipe and into the bellmouth and engine inlet duct. In this inlet duct are the two drop size measuring stations at sections A and B, and the water ingestion station. The engine is shown mounted in a typical thrust stand which is suspended from flexures for measuring thrust.

TEST CELL WITH WATER AND ICING RIGS

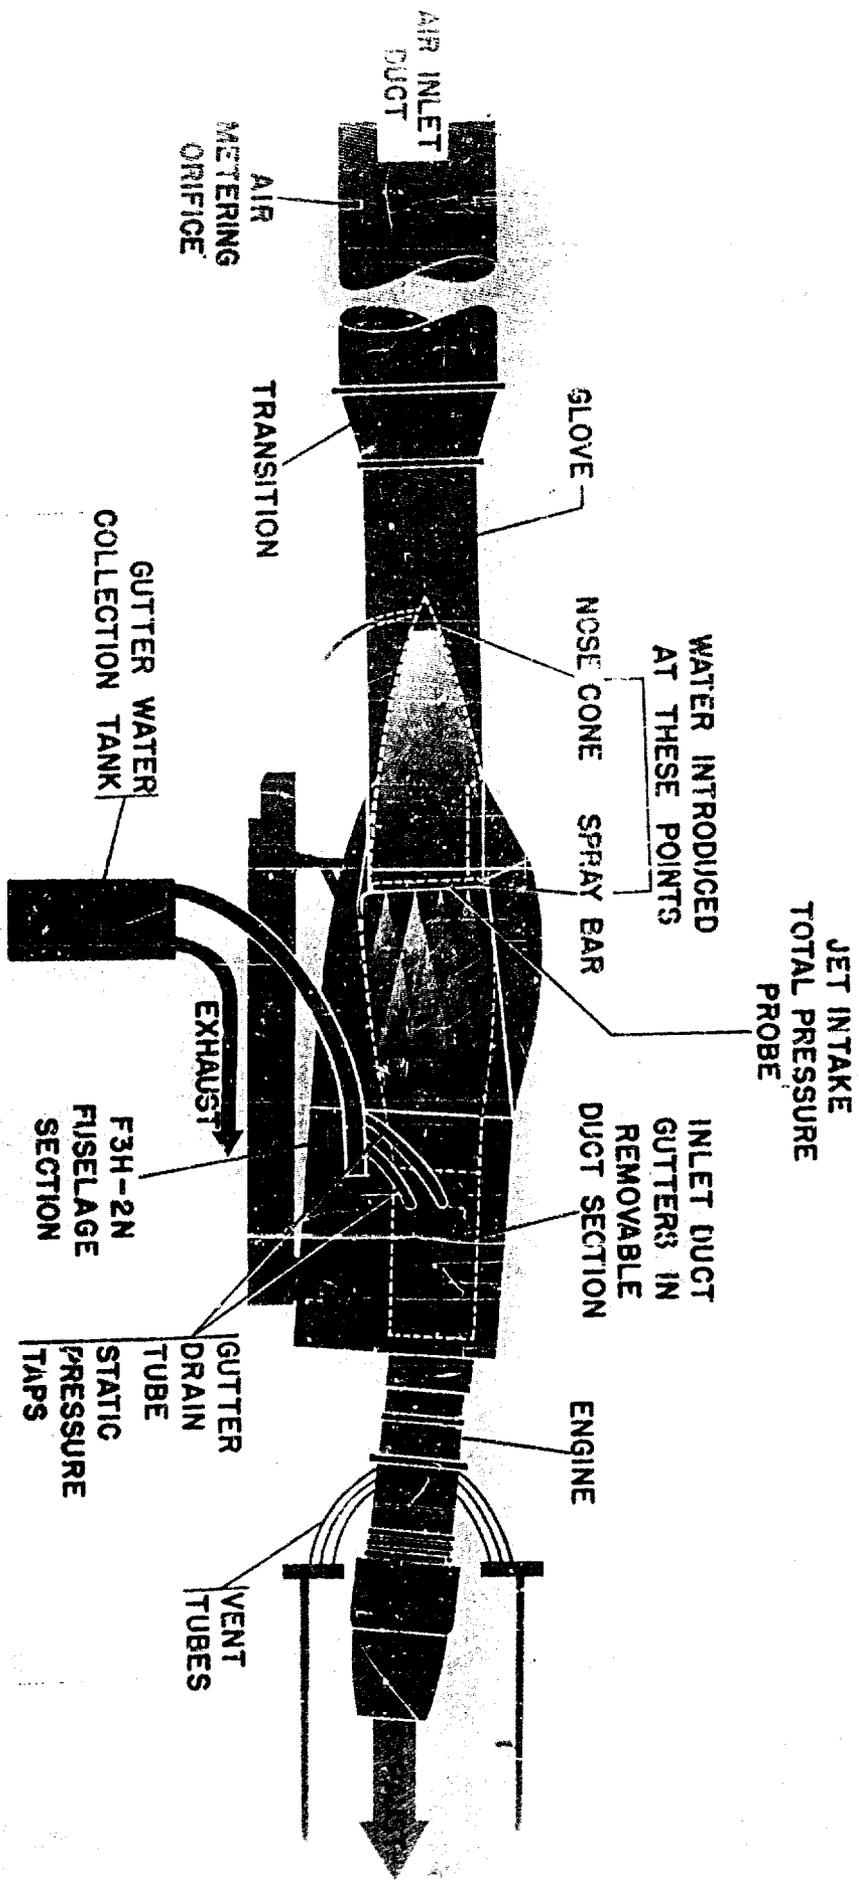
FIGURE 5: TEST INSTALLATION SCHEMATIC

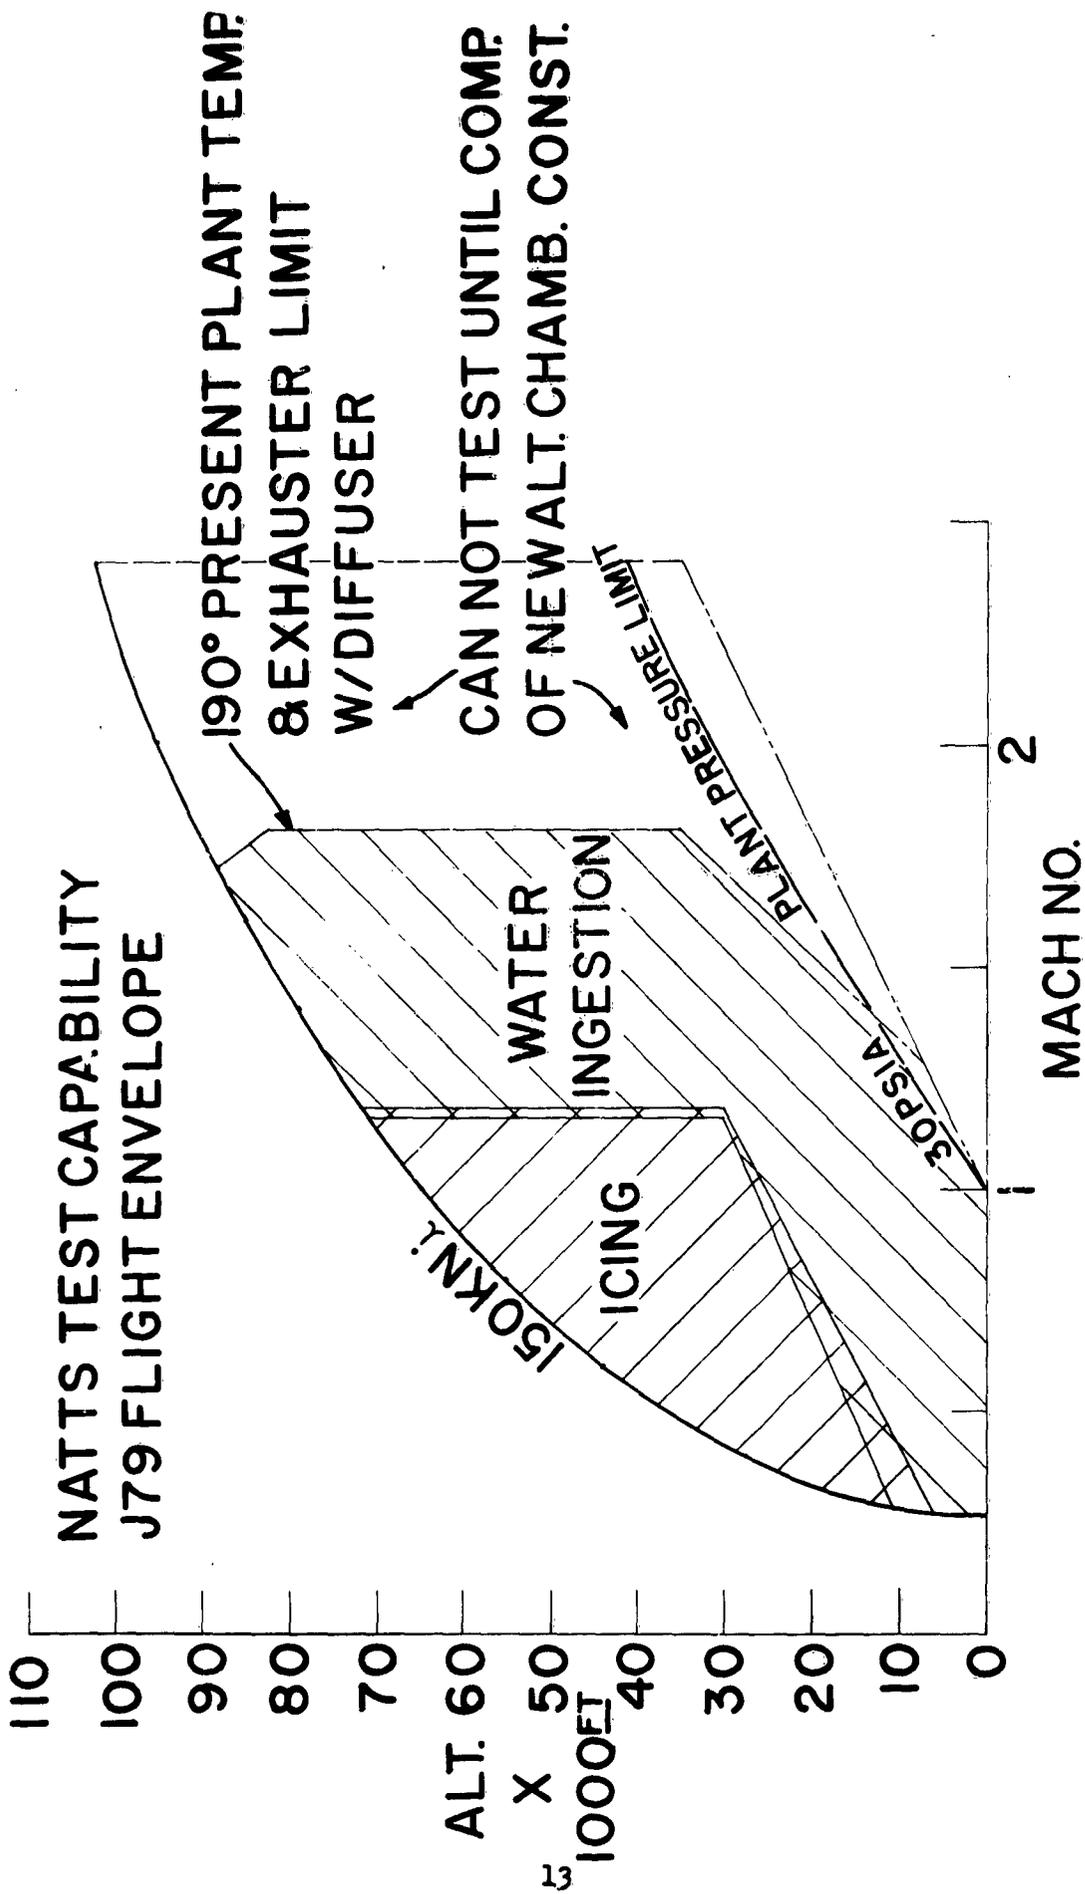
FIGURE 6

Figure 6 shows the operating envelope for the J79 engine superimposed on the plant facilities capabilities. Flight mach number is plotted against altitude. The plant pressure limit is shown along the bottom of the envelope and is not a significant limitation. The 1.8 mach number limitation is based on present inlet air temperature of 190° and present exhaust capacity. The two shaded areas show that NATTS is capable of icing and water test over the entire engine envelope. Inlet air temperature dictates whether icing or water ingestion conditions will take place. The overlapping region between icing and water ingestion is in the temperature range of 32° to 23°F.

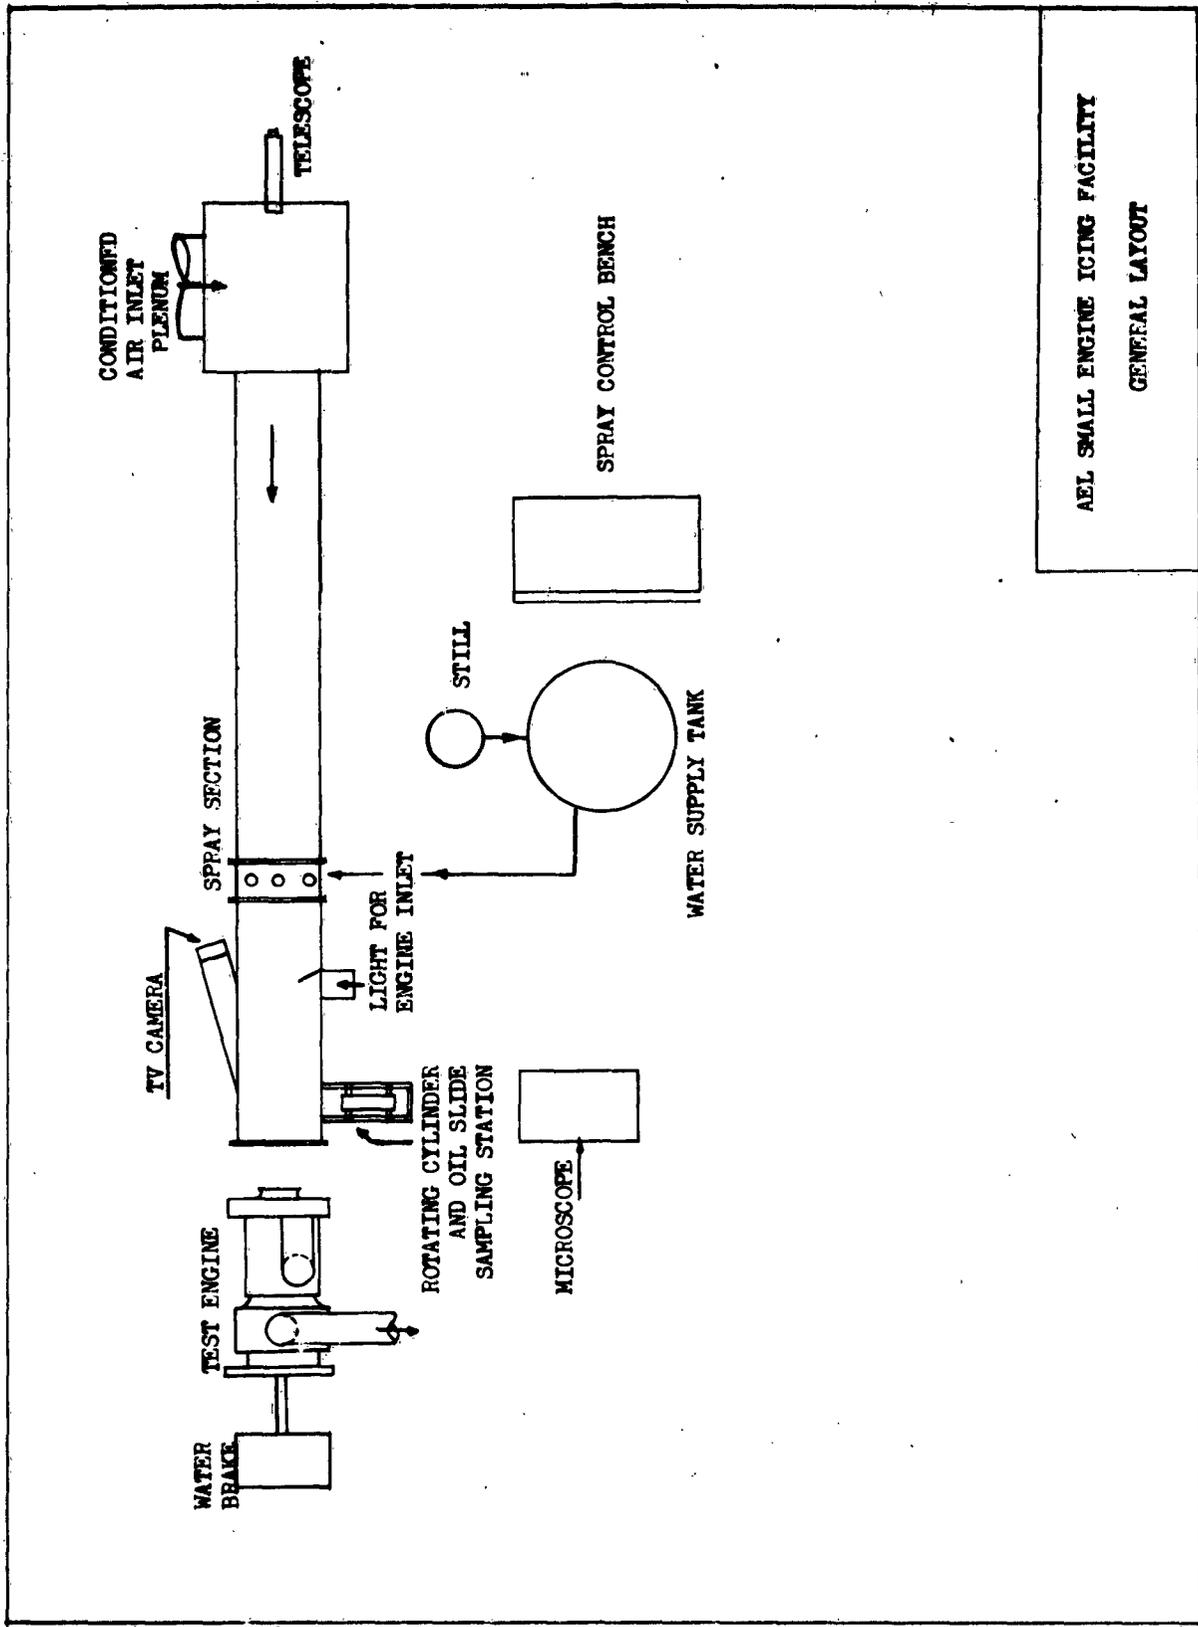
PLATE #1

Plate 1 is a sketch of the facility as it now exists. Air, near saturation conditions, is provided by the laboratory refrigeration system to the plenum of the conditioned-air inlet. Test temperatures are run at either  $-4^{\circ}\text{F}$  or  $+23^{\circ}\text{F}$  in accordance with the test specification. Extending from the plenum, the 24-inch diameter ducting carries the conditioned inlet air to the fog inducing spray section. The water preparation equipment supplying this section may be seen in detail on plate 3. One advantage present in a small engine test facility is the relatively low noise level (a maximum of 110 decibels, and this only in an unvisited area) which permits personnel with ordinary ear protection to perform their duties on the site. Thus, the water and compressed-air control system may be located close to the test engine.

AEL SMALL ENGINE ICING FACILITY  
GENERAL LAYOUT

The location of the television camera as installed in icing inlet duct is shown. The television receiver was located in the upper deck engine control room where any dangerous engine inlet icing condition, as well as rotating

The gap between the engine and 24-inch duct is readily discernible. This distance of approximately 1 foot was found to be optimum for our test purposes, and we also believe that this arrangement may be a more accurate simulation of actual operating conditions since the cold wet air is impinging on the entire frontal area of the engine and flowing over the compressor case. Another advantage of the gap was that photographs of the icing formations could be made through the gap.

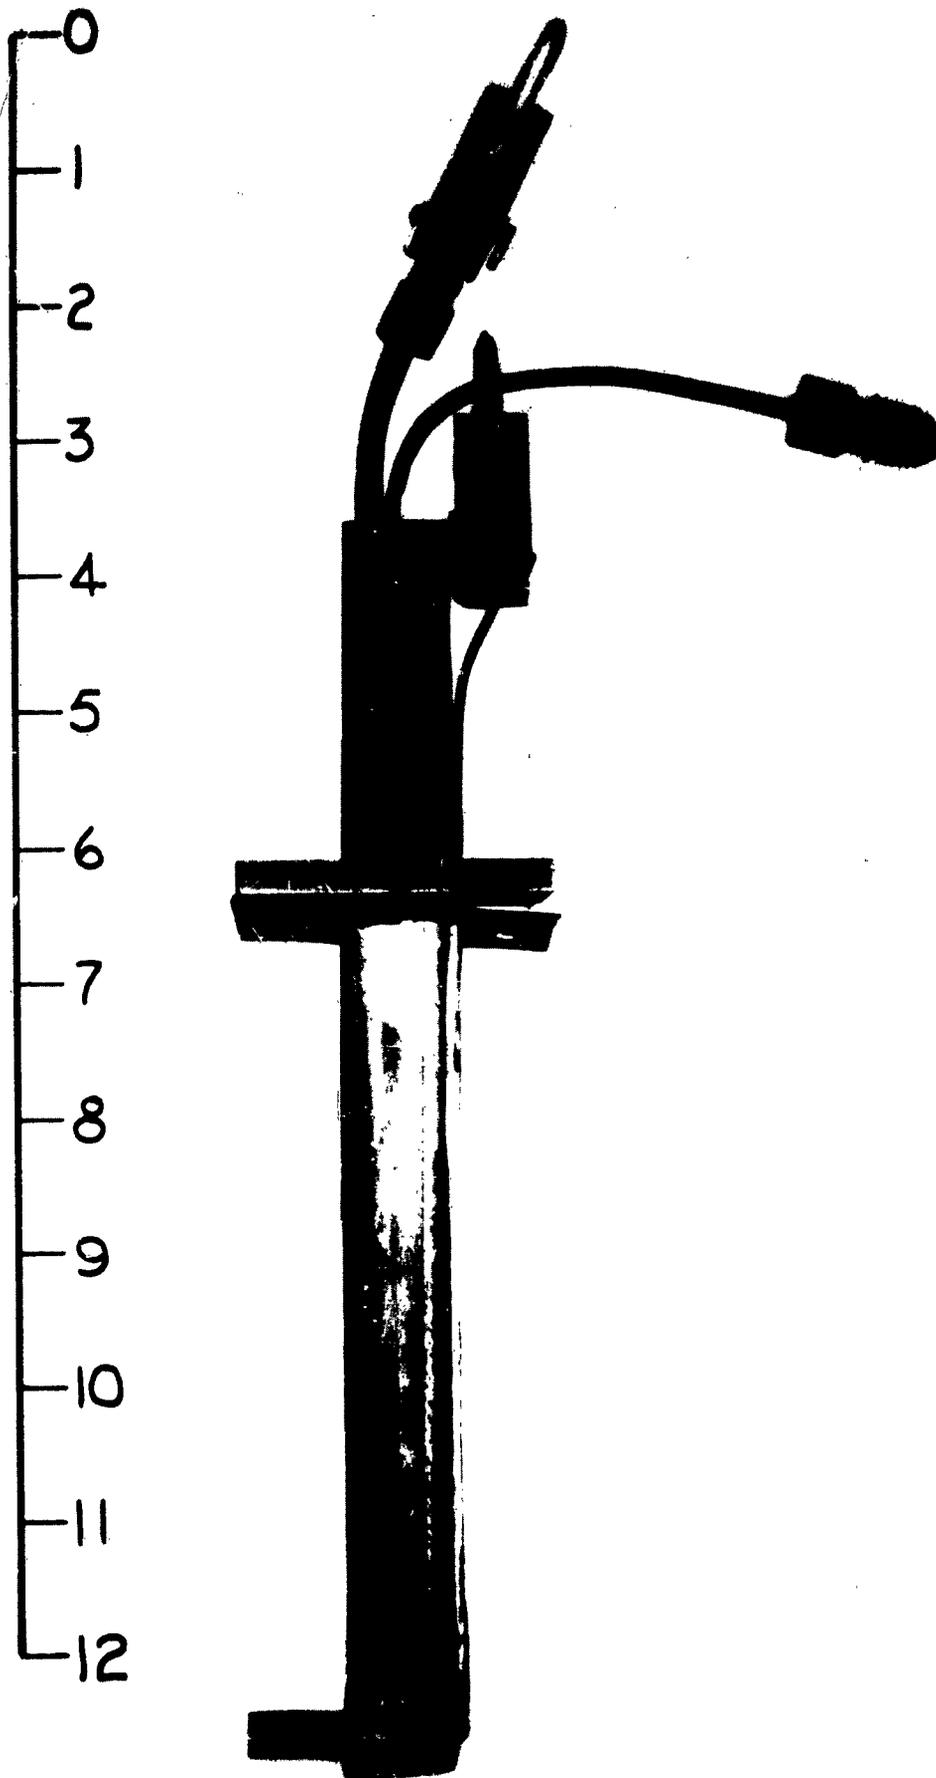
FIG. I-HEATED TOTAL PRESS. PROBE

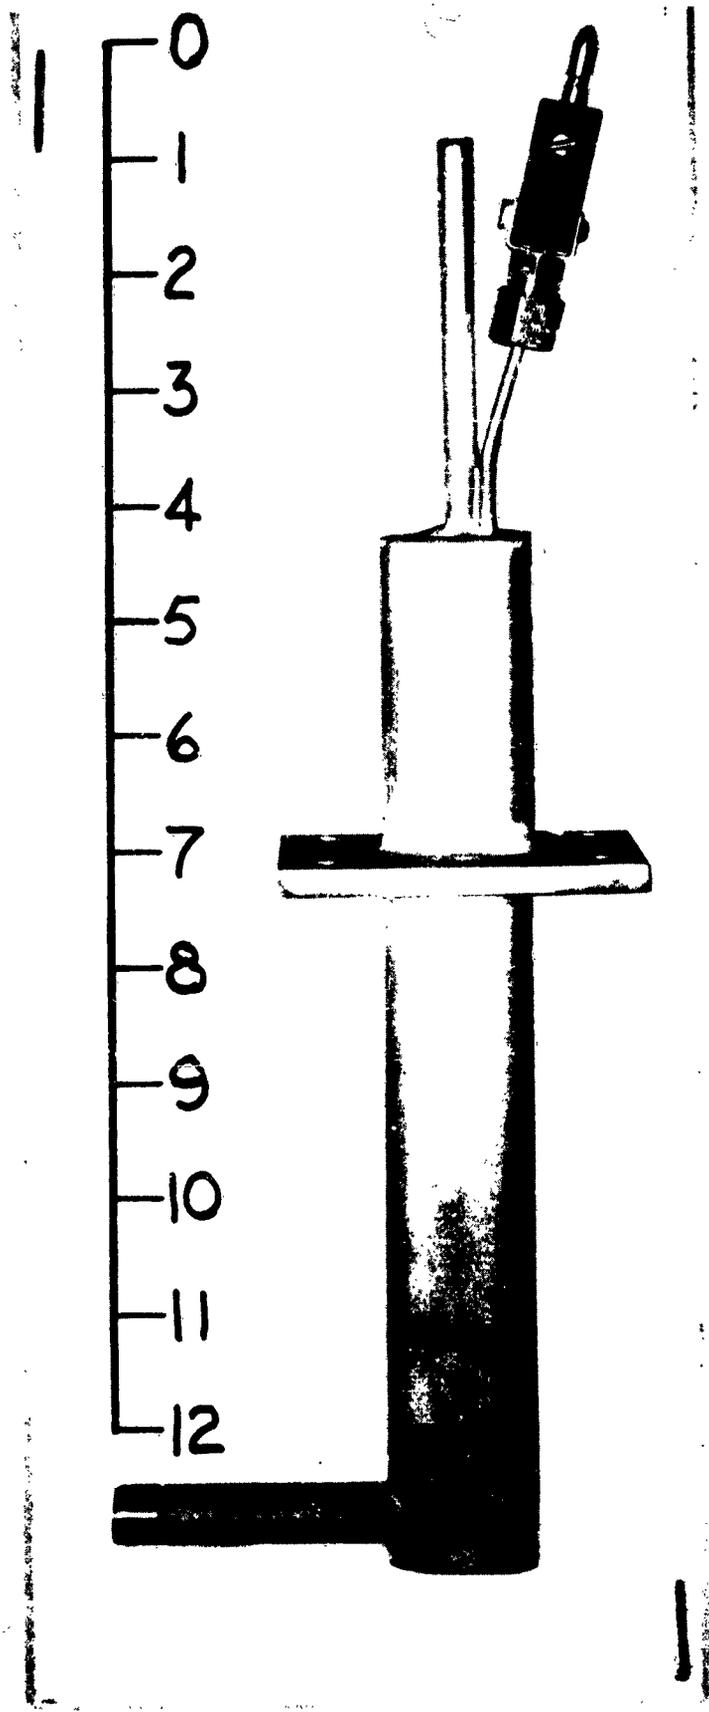
FIG. 2- HEATED TOTAL PRESS. PROBE

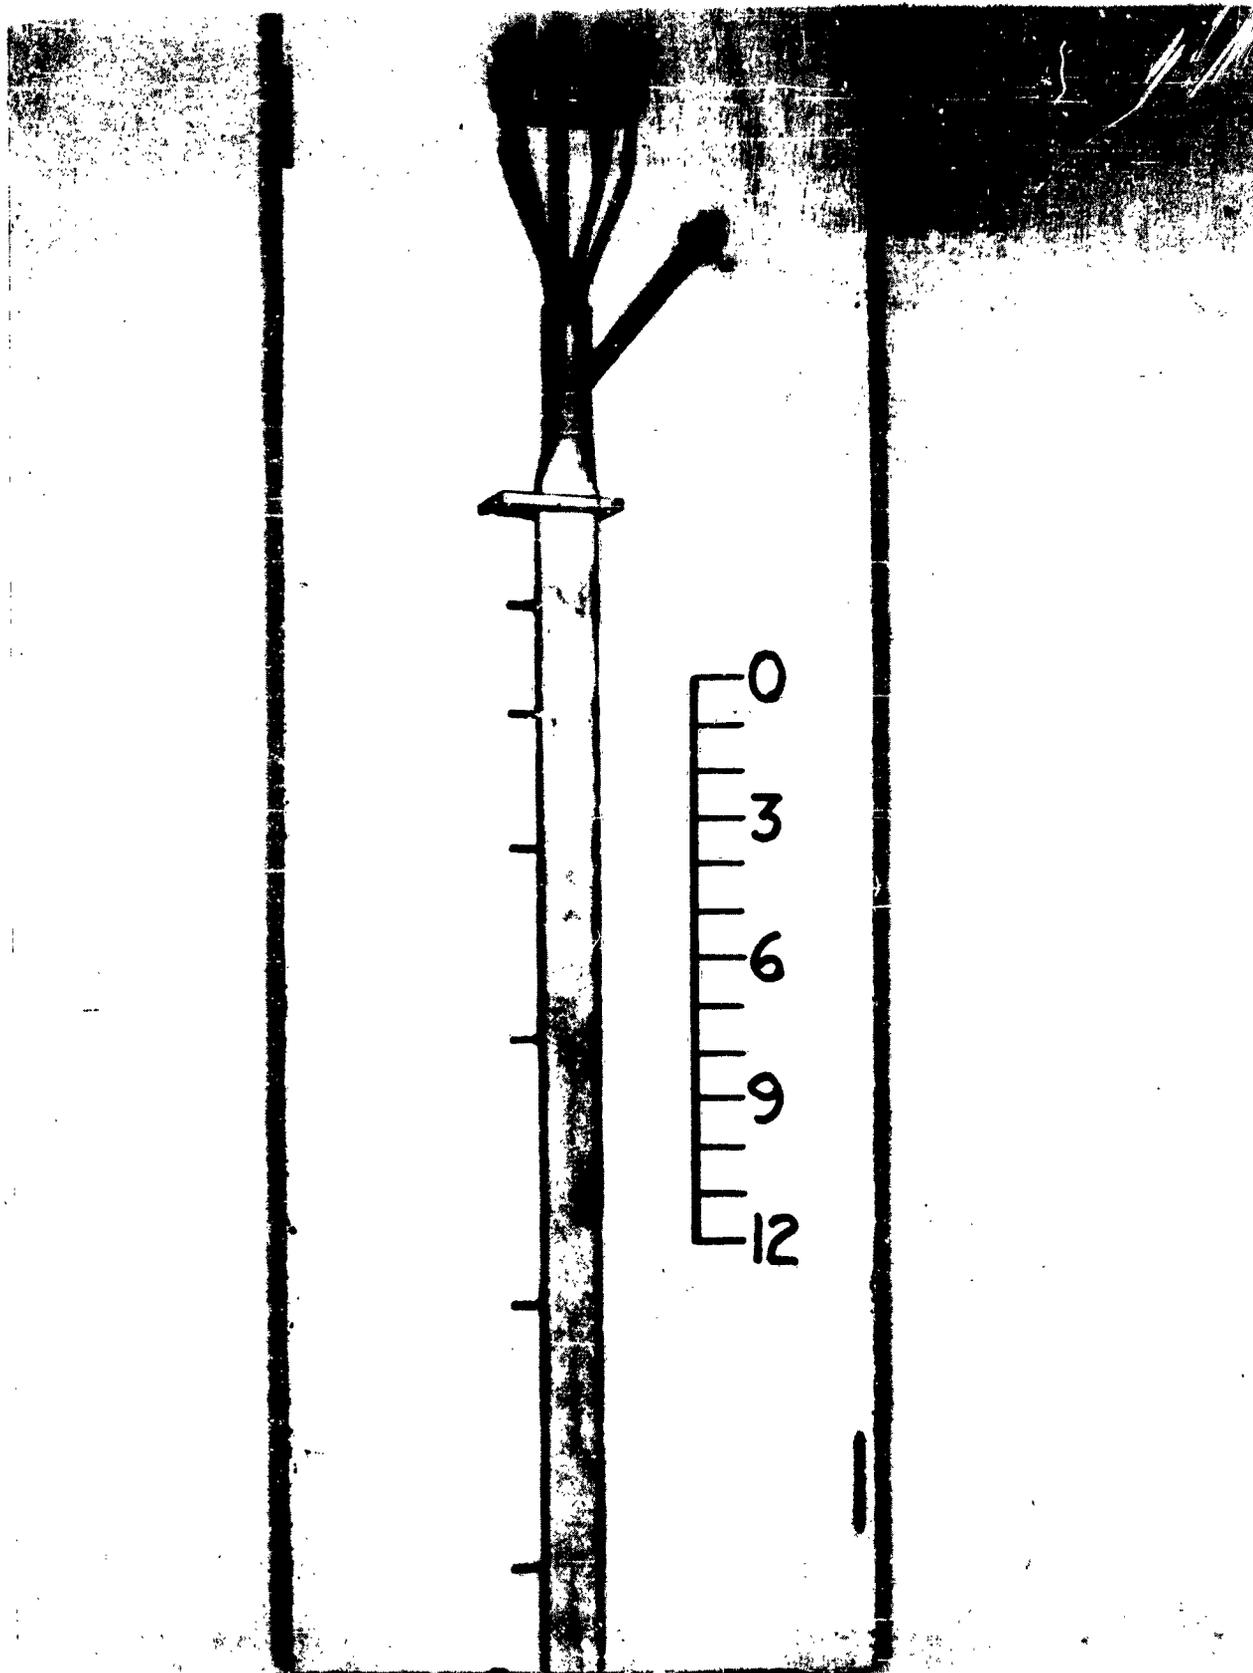
**FIG. 3-STEAM HEATED MULTI-FINGER  
PRESS. RAKE**

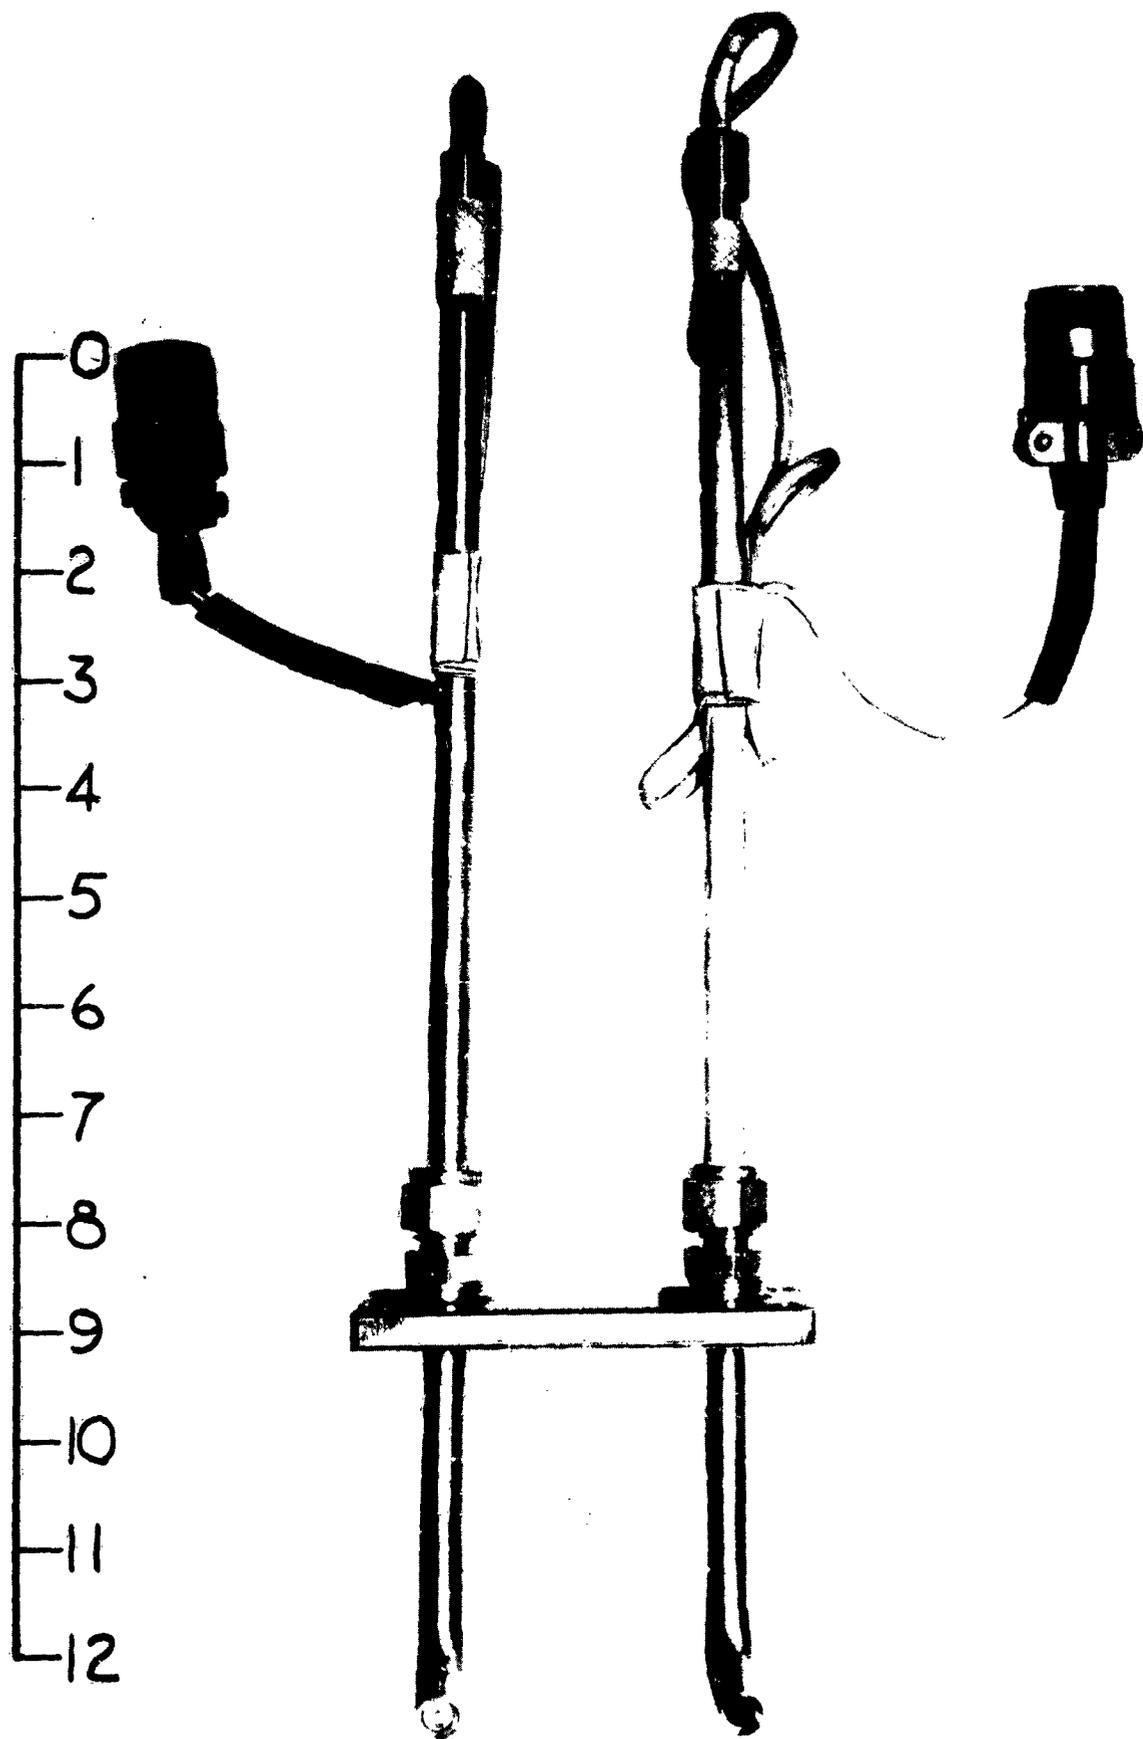
FIG. 4- TRANSDUCER TYPE PRESS. PROBE

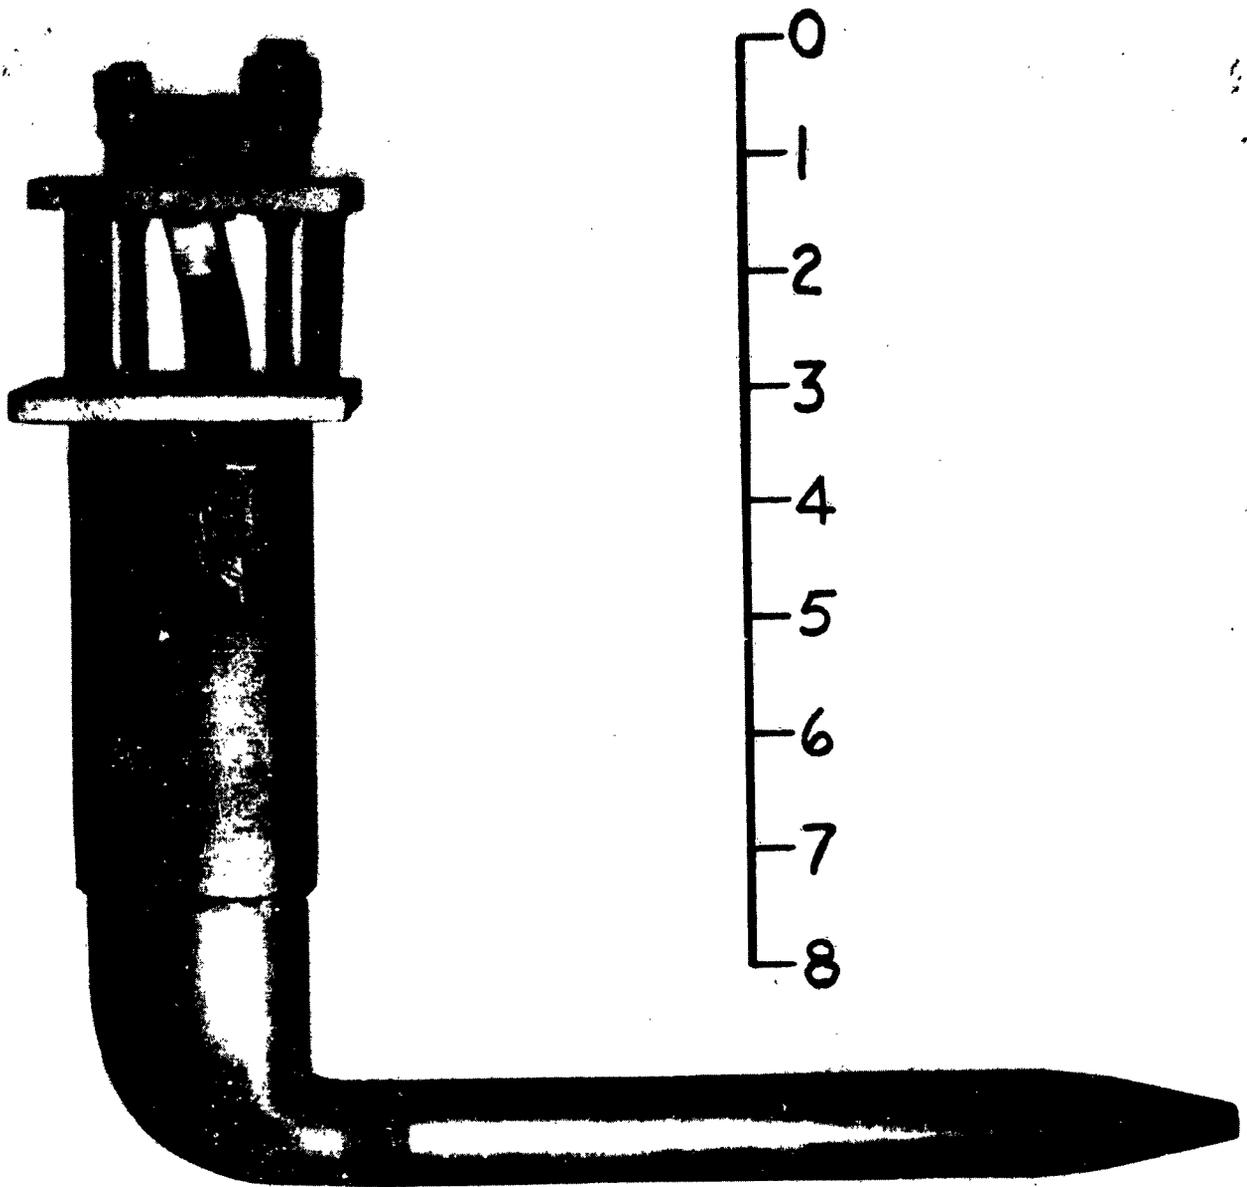
FIG.6-AIRCRAFT TYPE PITOT-STATIC PROBE

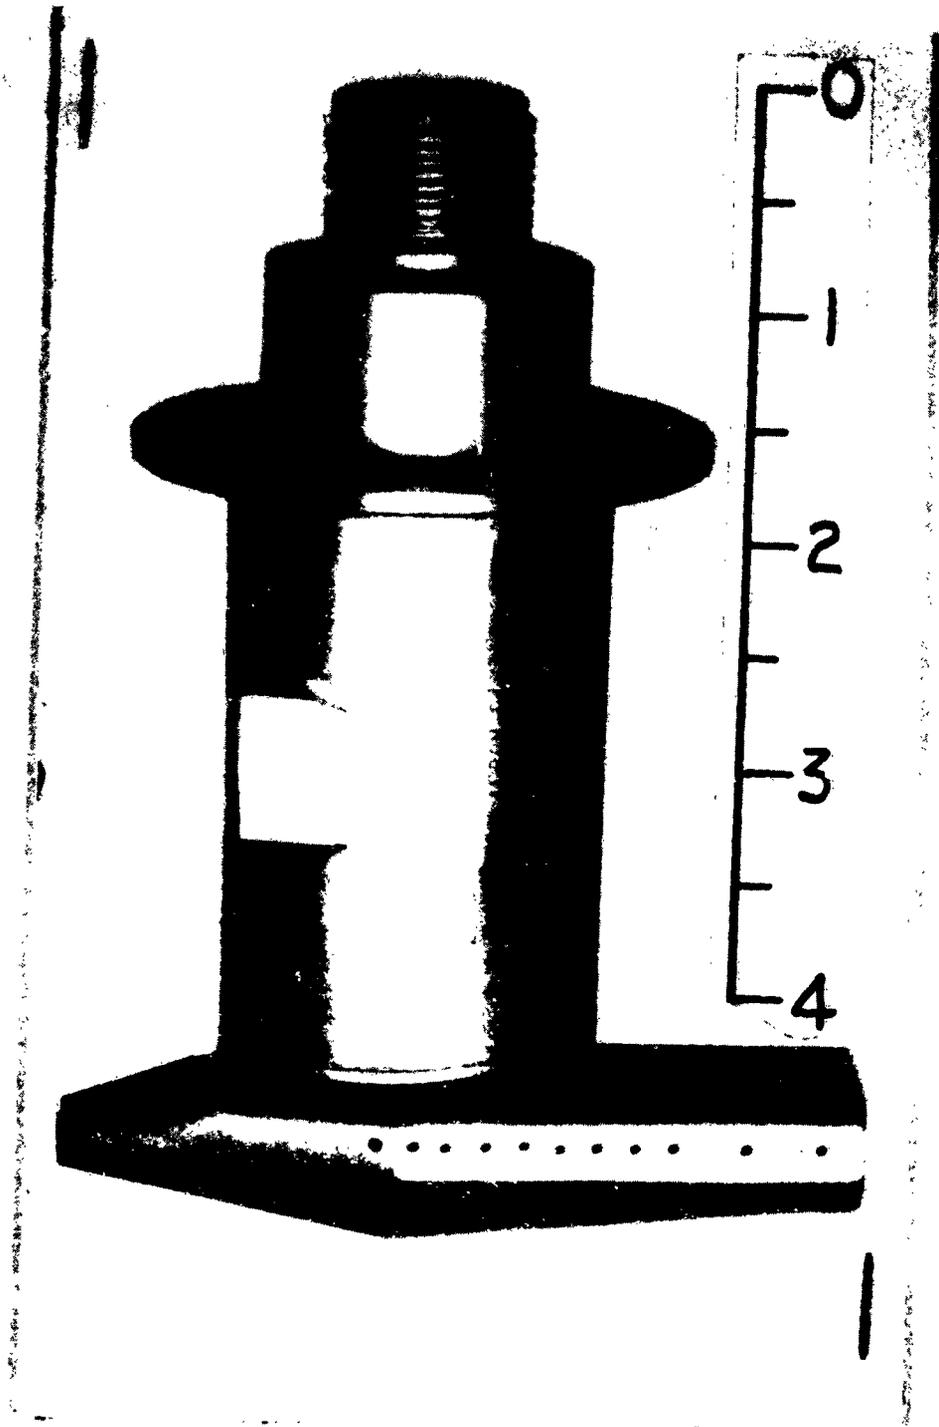
FIG. 8-ROSEMONT CORP. TEMP. PROBE

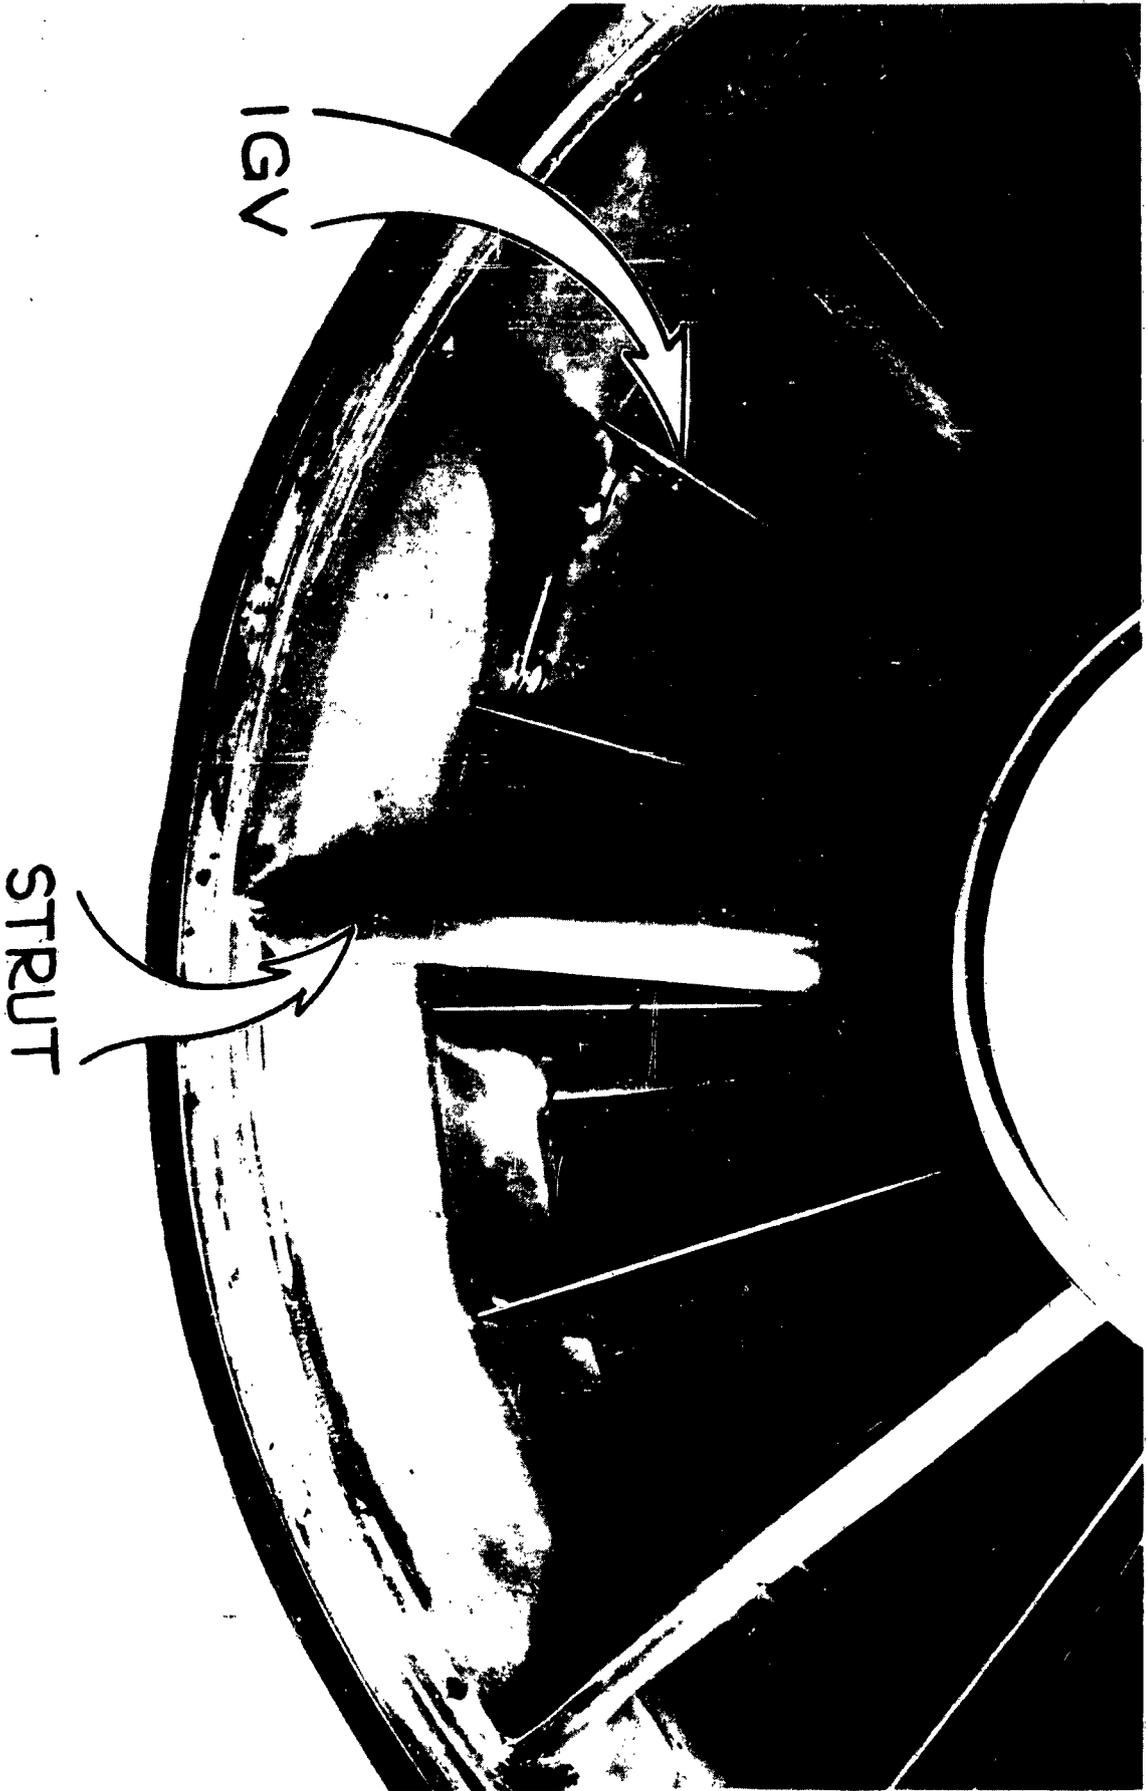
FIG. 9- INLET SKIN THERMOCOUPLES J79 ENGINE
