CONFERENCE ON ENVIRONMENTAL  
EFFECTS ON AIRCRAFT PROPULSION

A Compilation of the Papers Presented

U. S. Naval Air Turbine Test Station  
Trenton, ~~New Jersey~~ N. J.

June 22 and 23, 1961

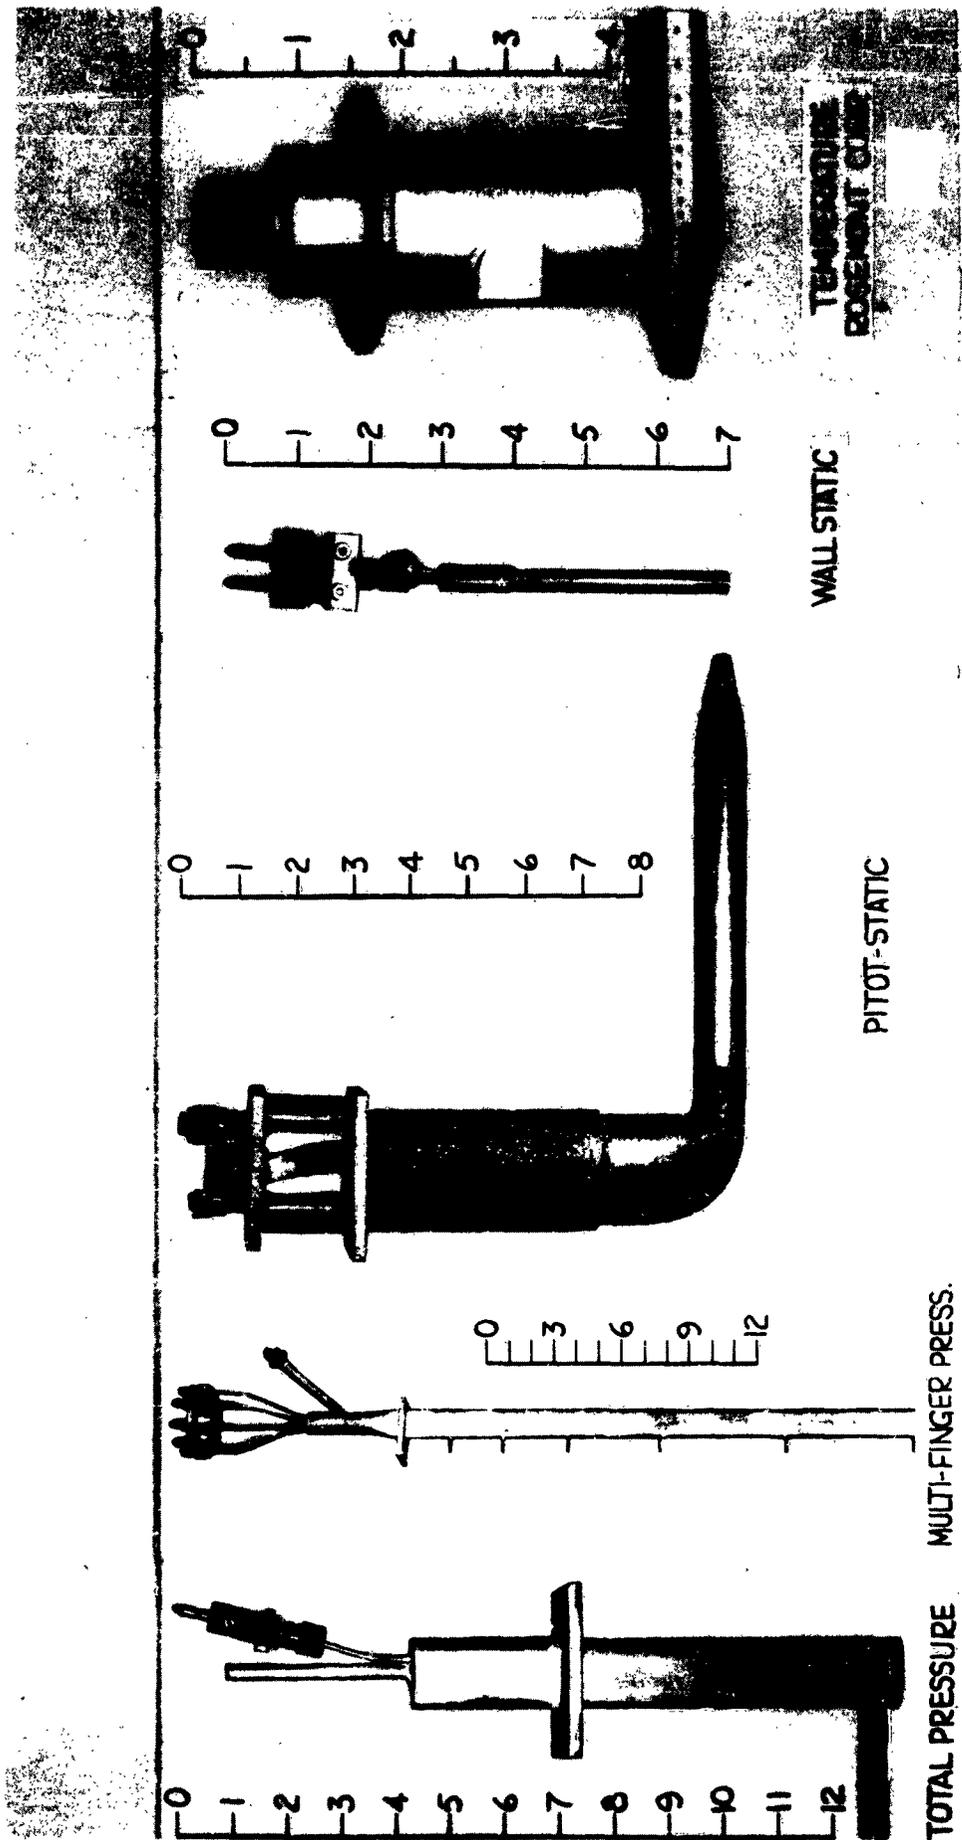
FIG. 10 - SUMMARY OF NATTS USED PROBES

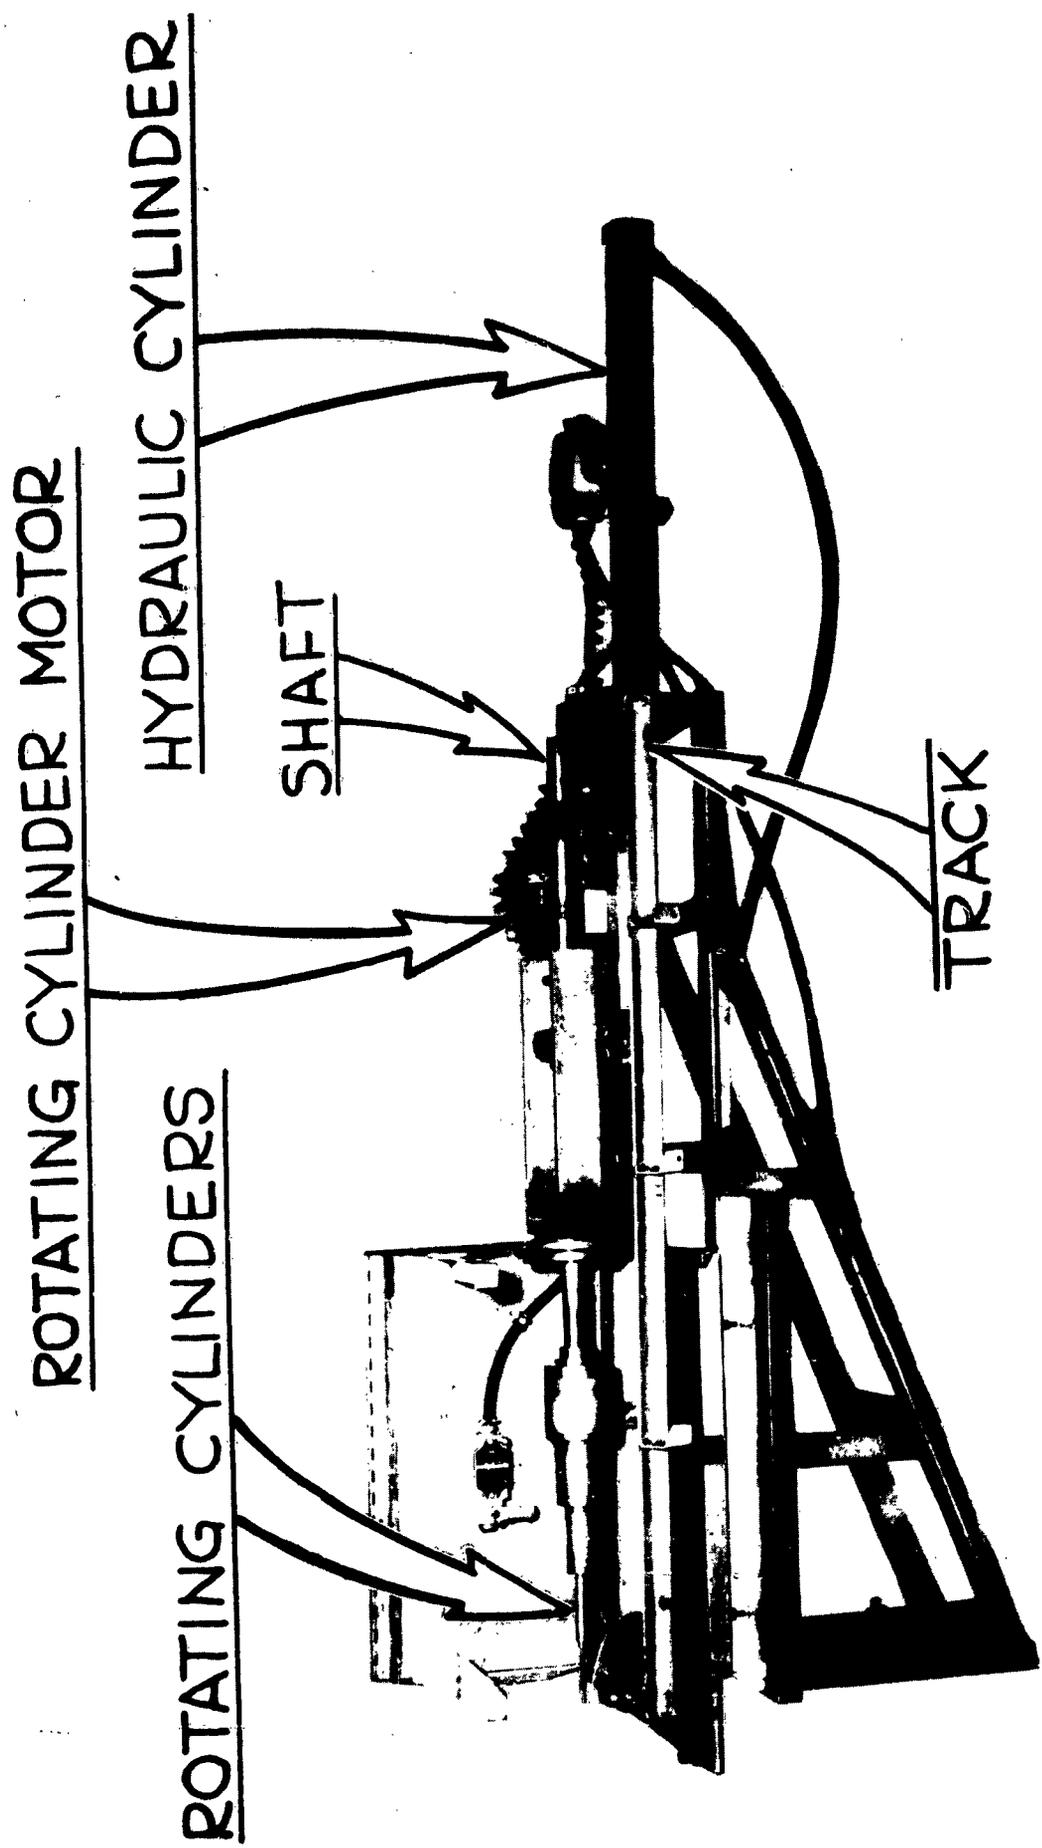
FIGURE 1 ROTATING CYLINDER ASSEMBLY

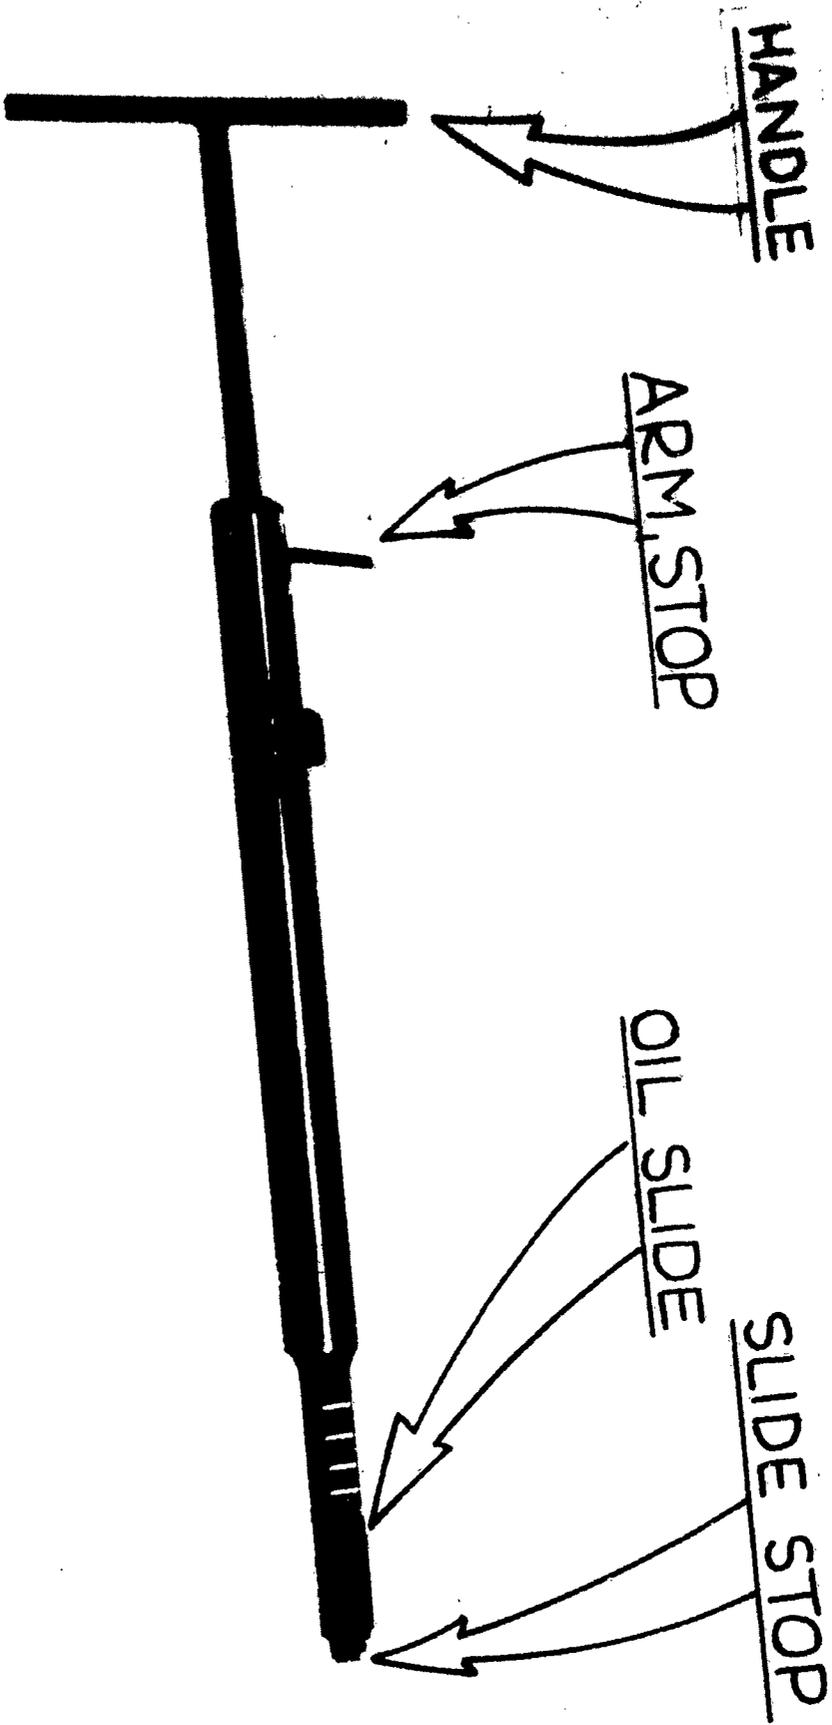
FIGURE 2

OIL SLIDE INJECTOR ROD

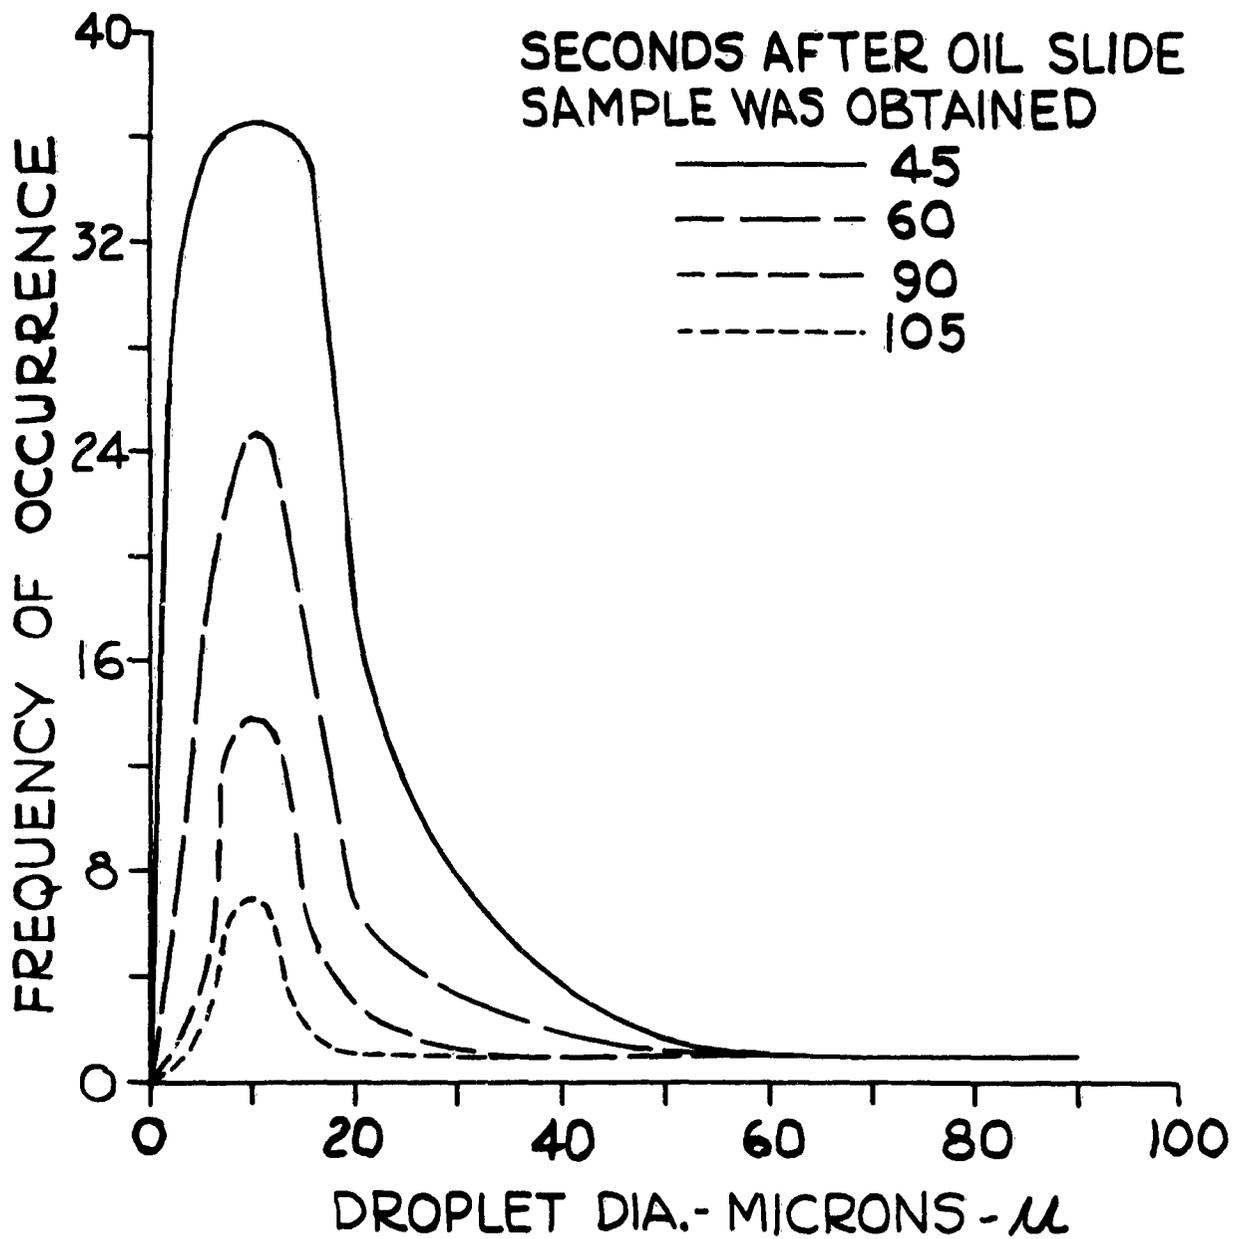
FIGURE 4 DROP-SIZE FREQUENCY FOR THE DROP-SIZE DISTRIBUTION PHOTOGRAPHS OF AN OIL SLIDE SAMPLE TAKEN AT VARIOUS TIME INTERVALS

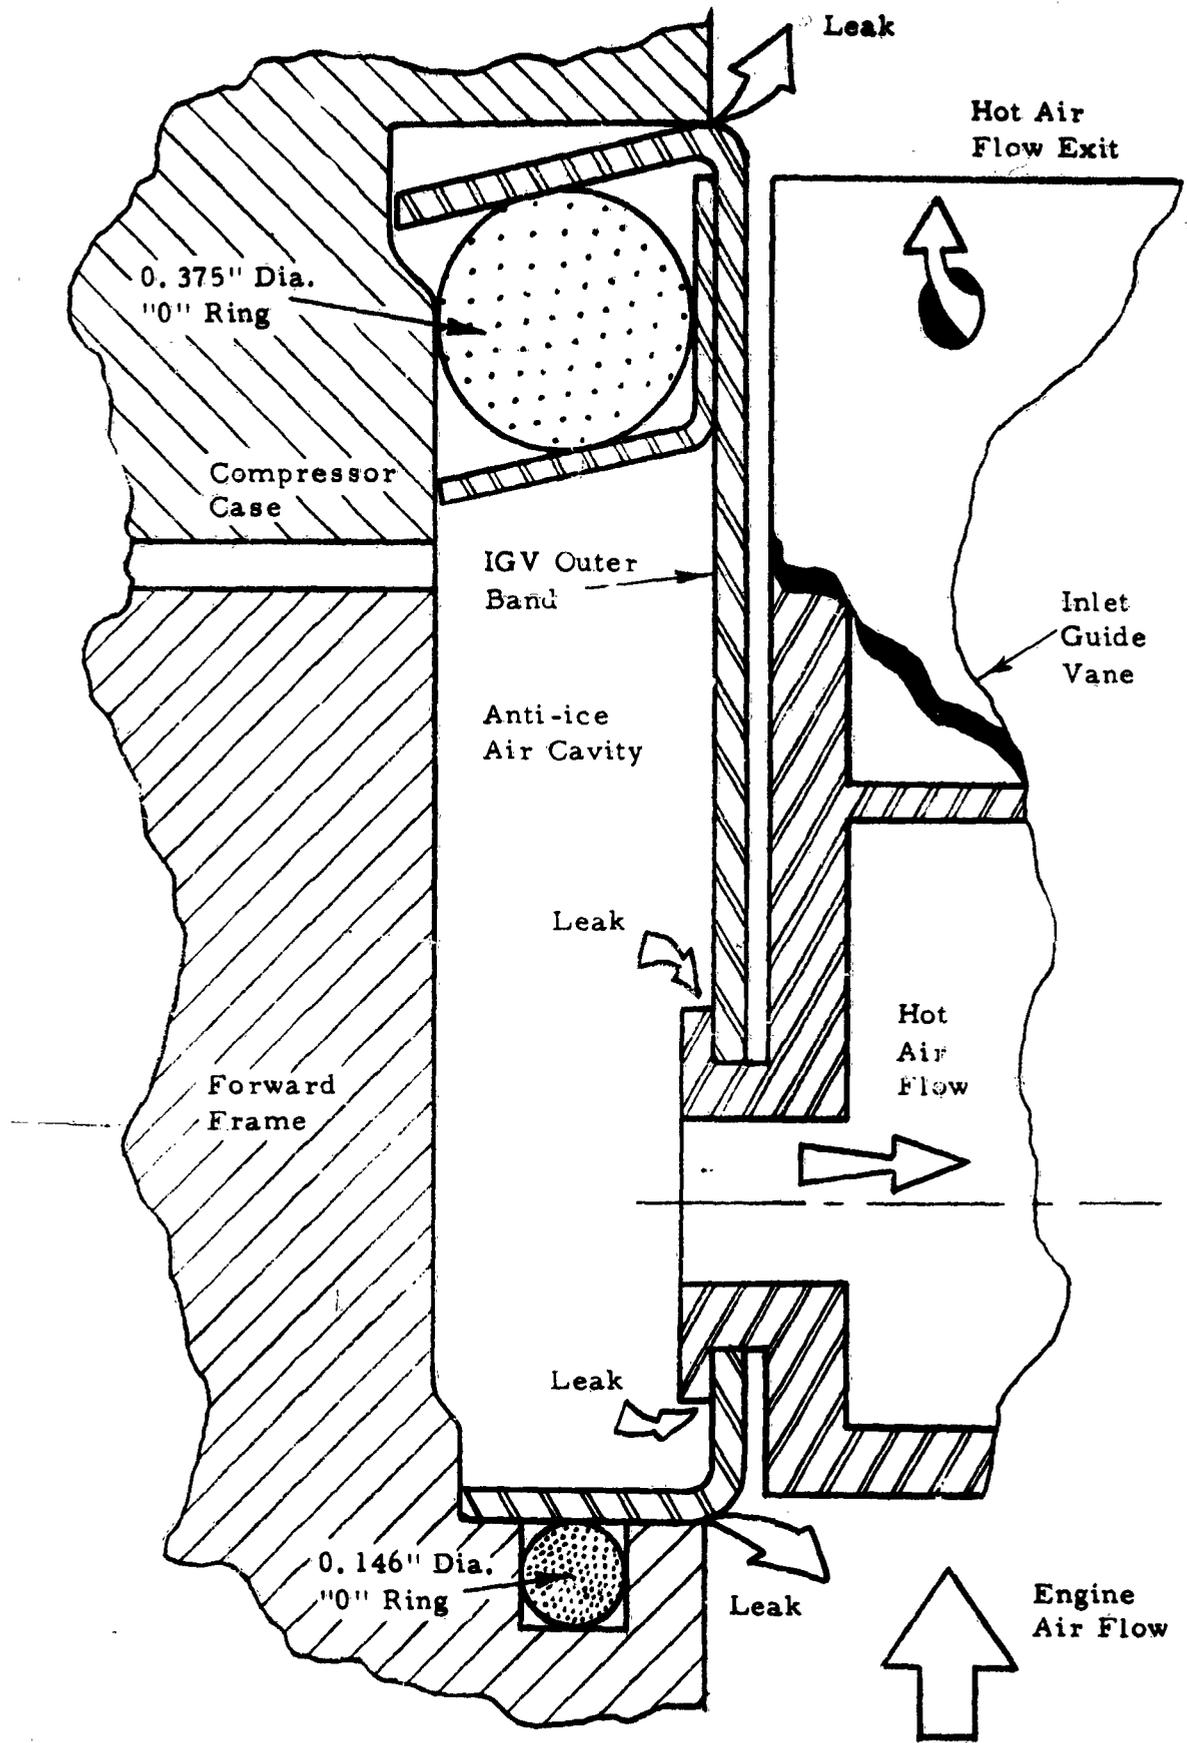
FIGURE 1 - CROSS SECTION OF J71-A-2E ANTI-ICING AIR CAVITY

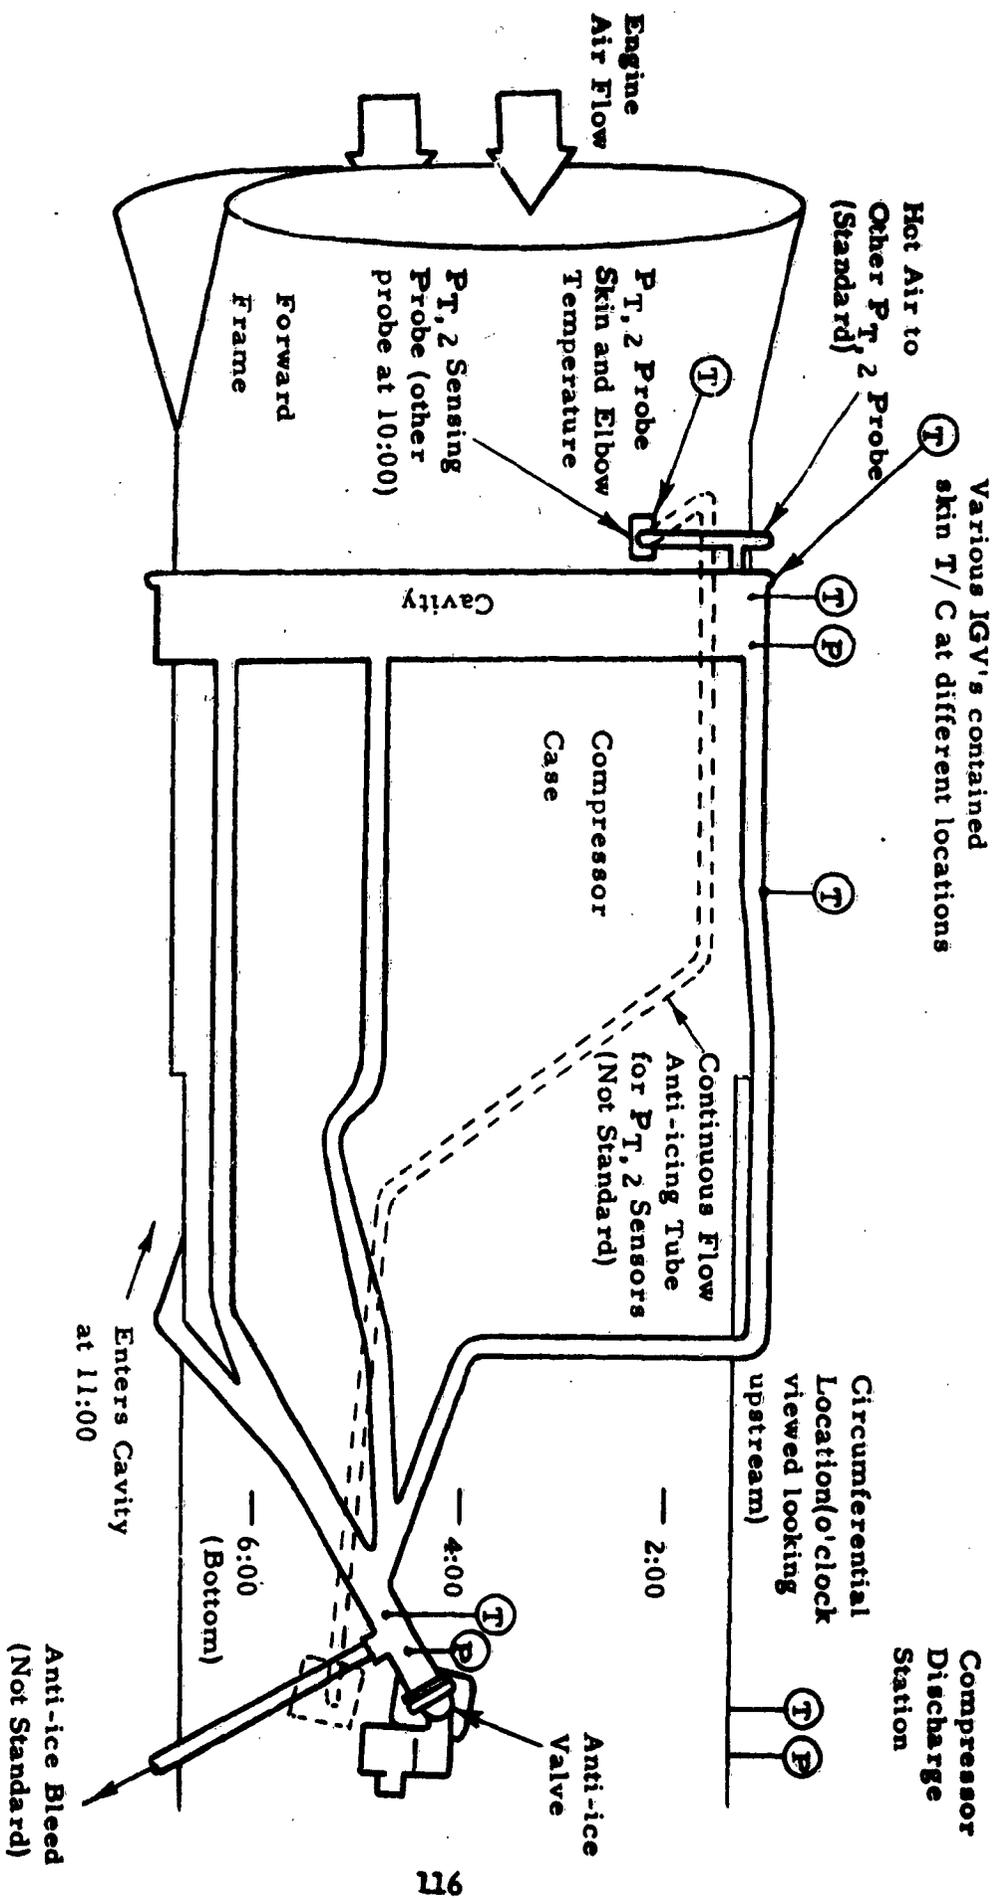
FIGURE 2 - SKETCH OF J71-A-2E ANTI-ICING SYSTEM

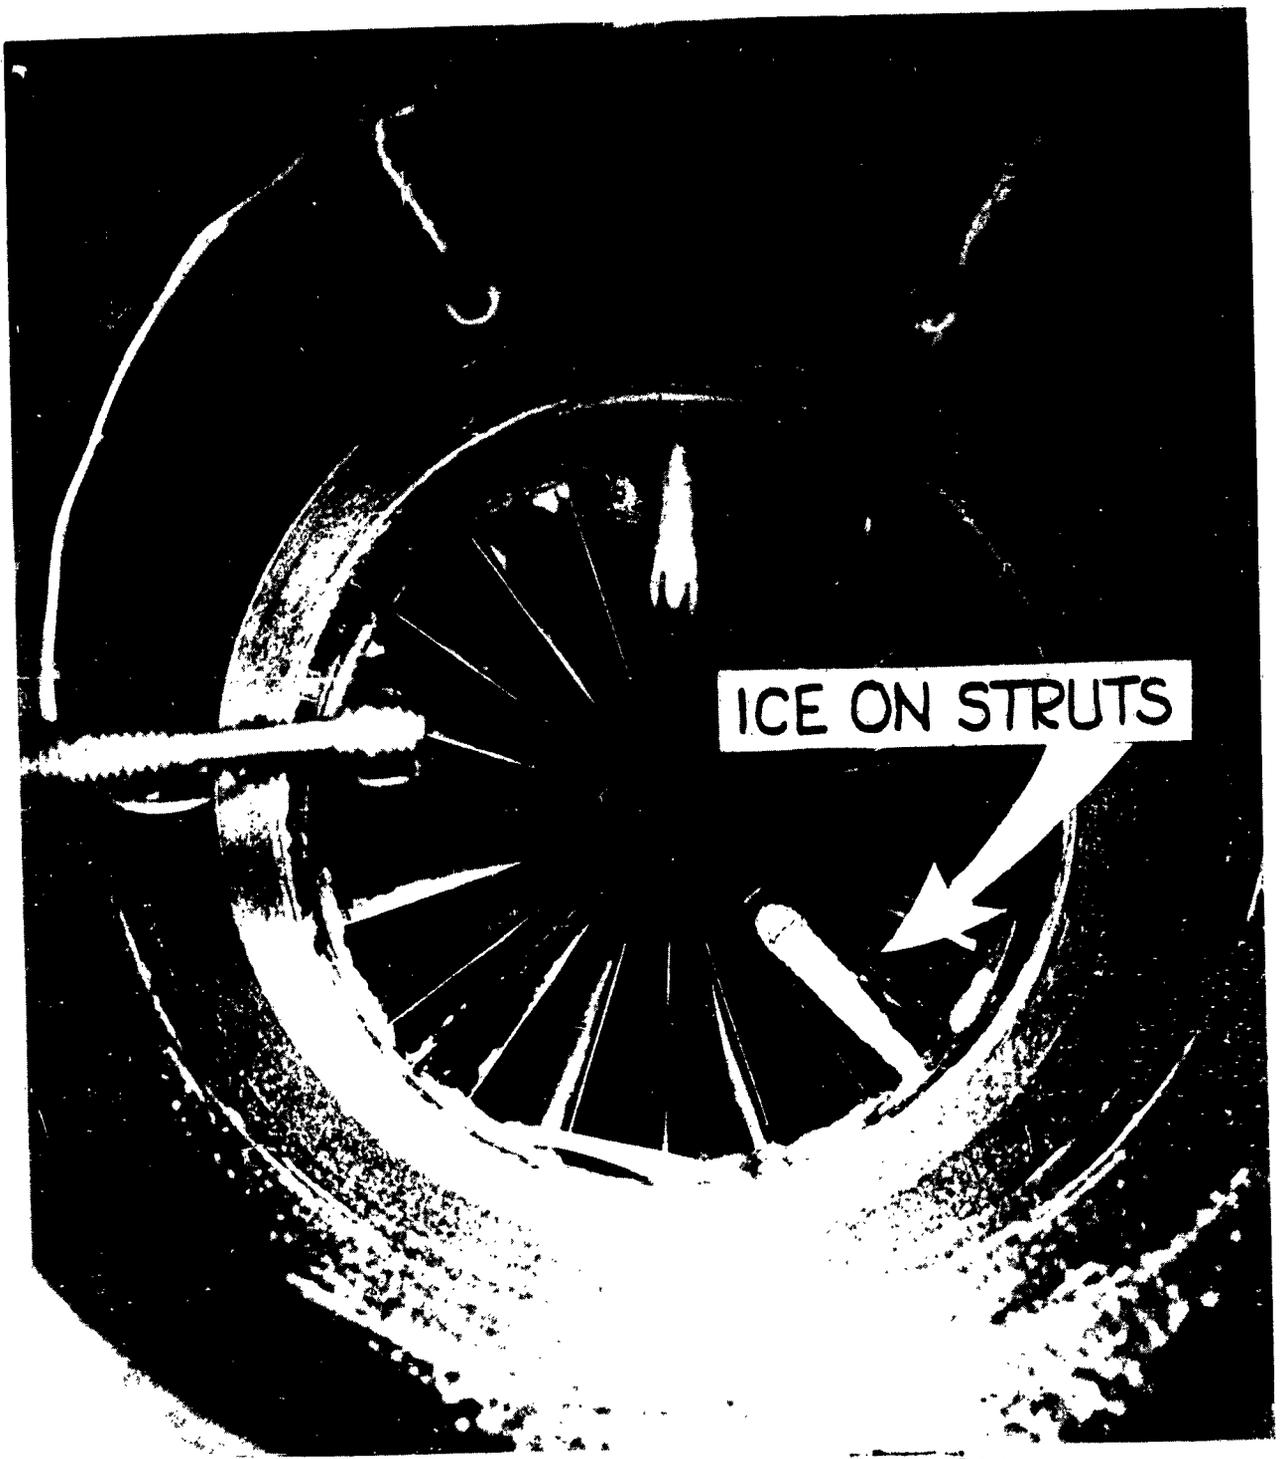
**FIG.9- J79-GE-2 ENGINE INLET WITH  
ICE FORMATION ON STRUTS**

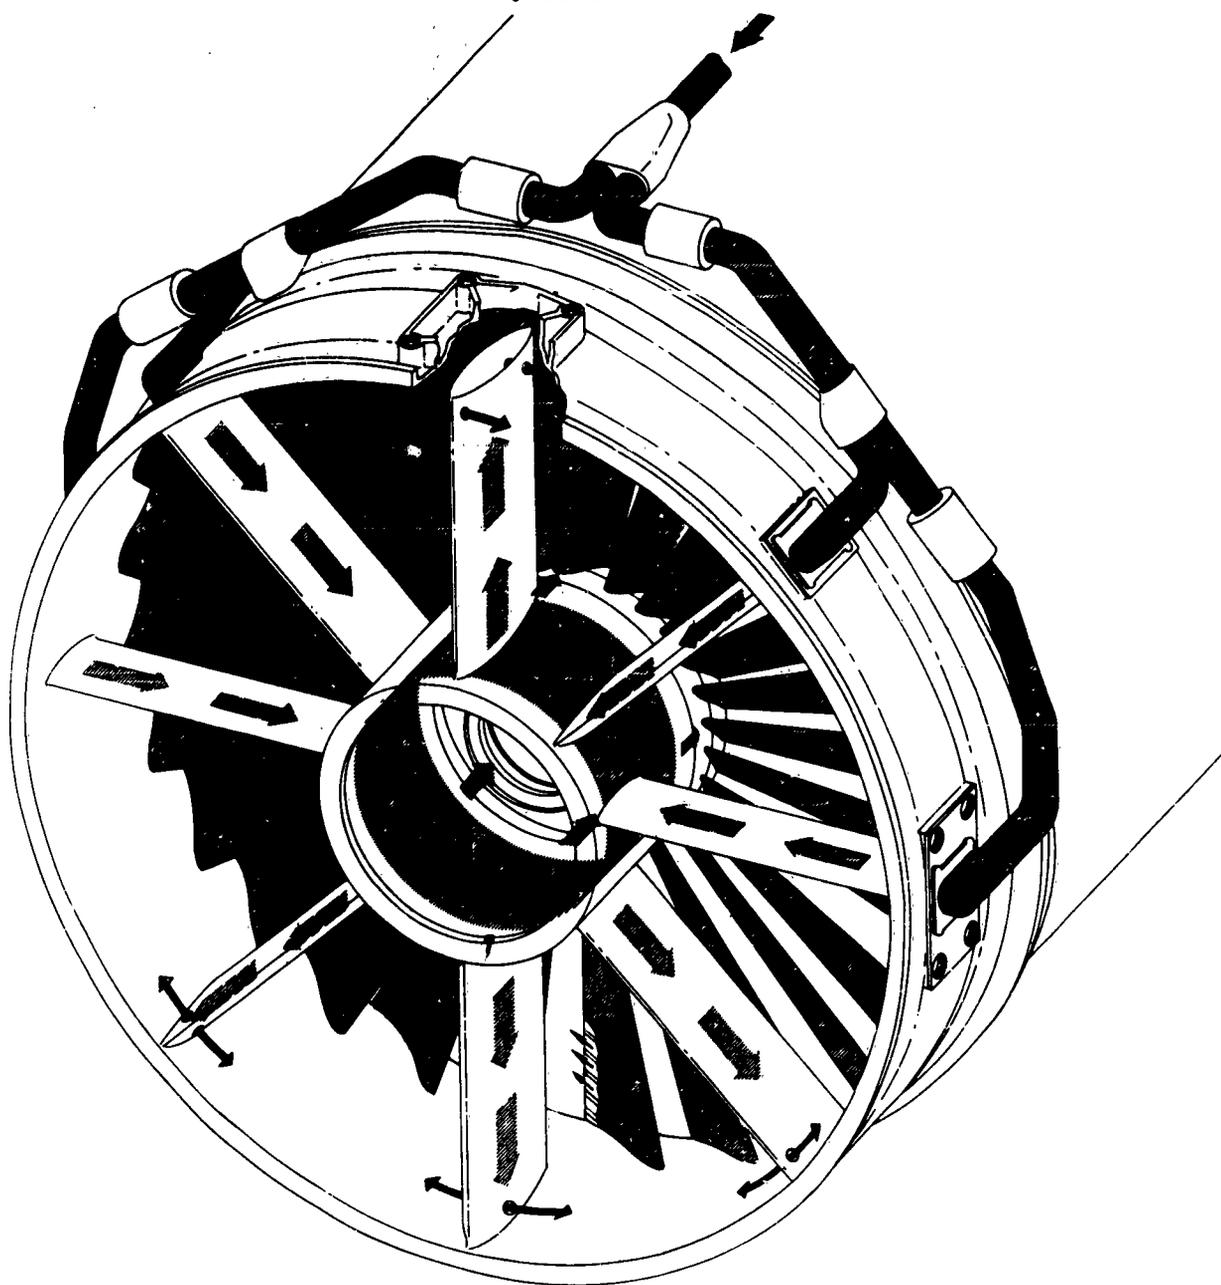
**FIG.10- STANDARD J79-GE-2  
ANTI-ICING SYSTEM**

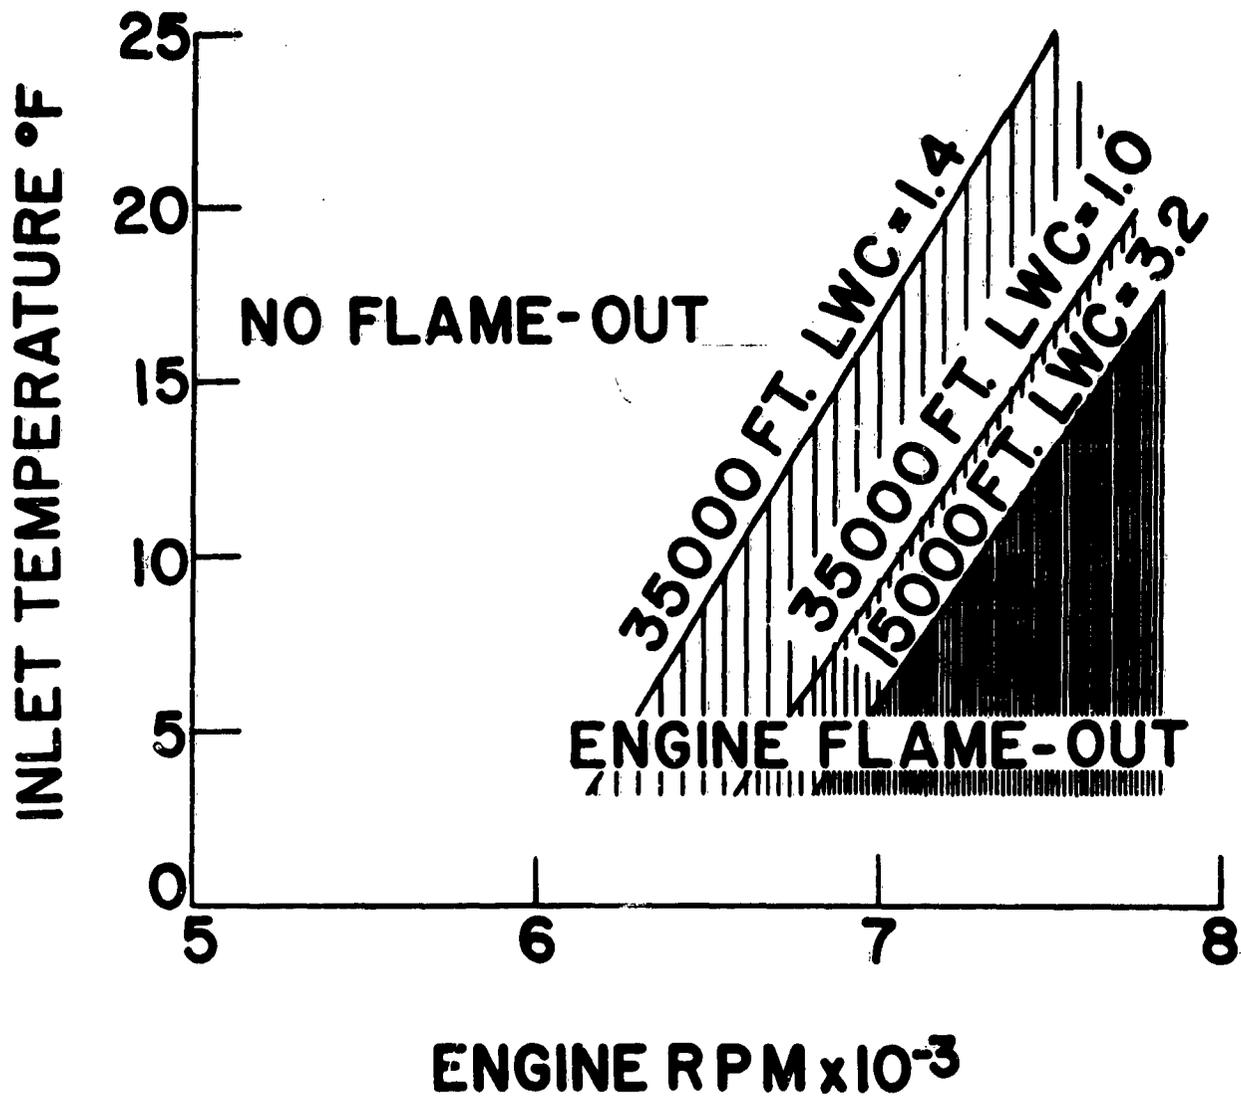
FIG.12-J79-GE-2 ENGINE FLAME-OUT ENVELOPE AS A RESULT OF ICING AT ALTITUDES OF 15000 FT. AND 35000 FT.  $M_N = 0.6$

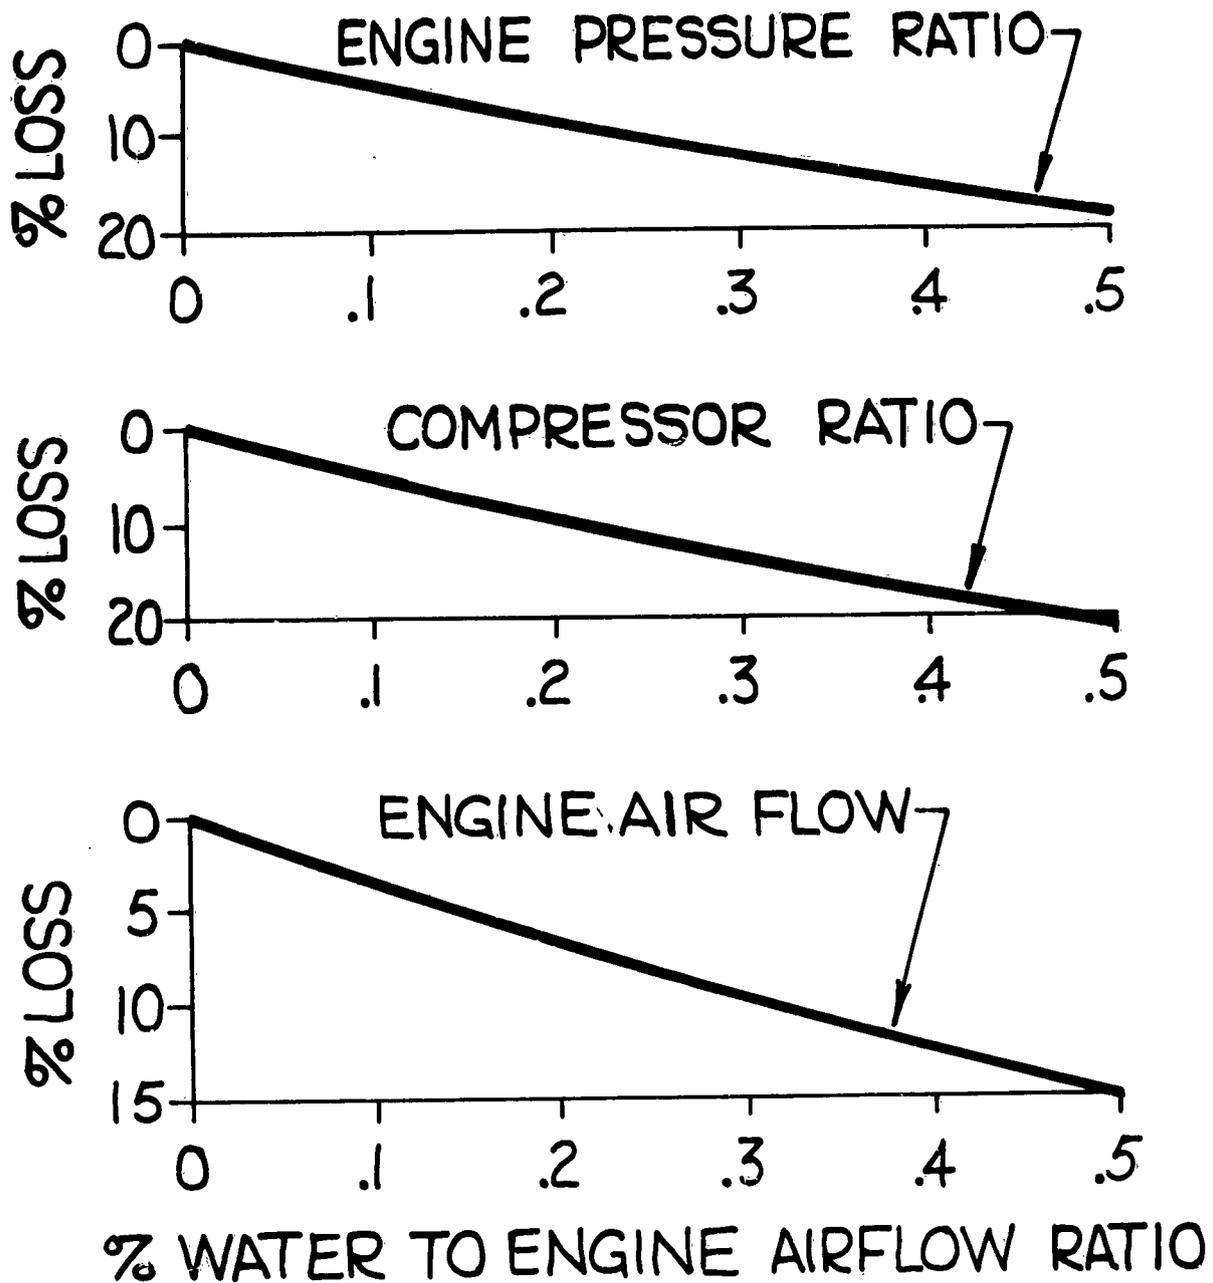
**FIG.14-EFFECT OF ICING ON ENGINE PRESSURE RATIO, COMPRESSOR RATIO AND ENGINE AIRFLOW**

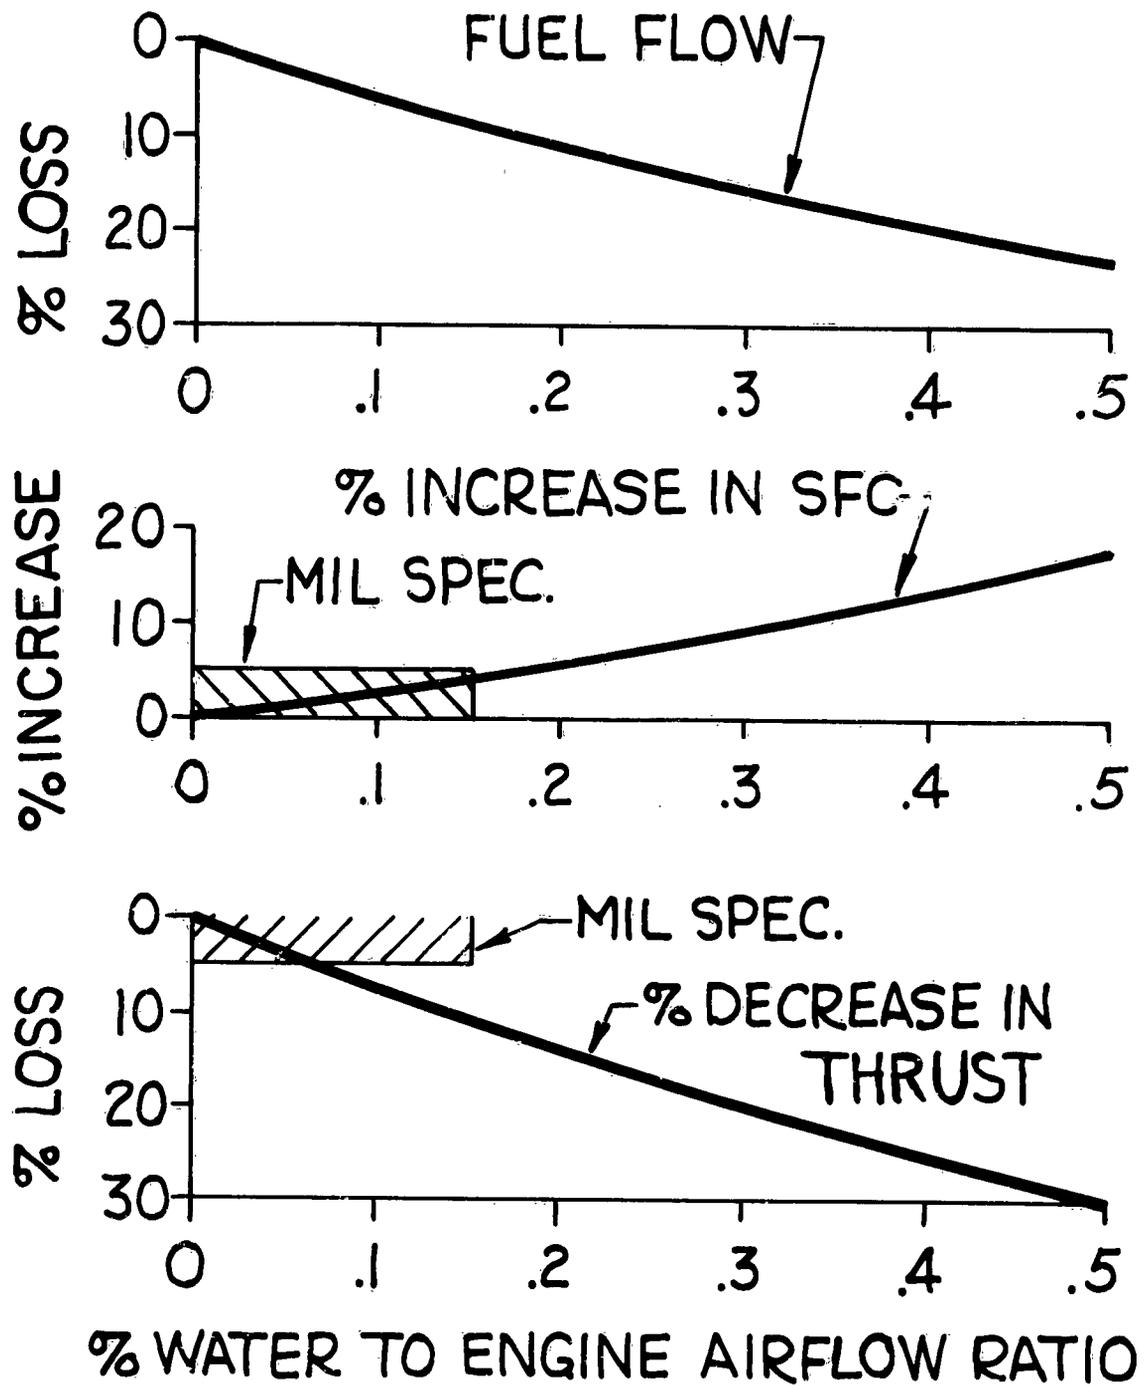
FIG.15- EFFECT OF ICING ON ENGINE FUEL FLOW, THRUST AND S F C

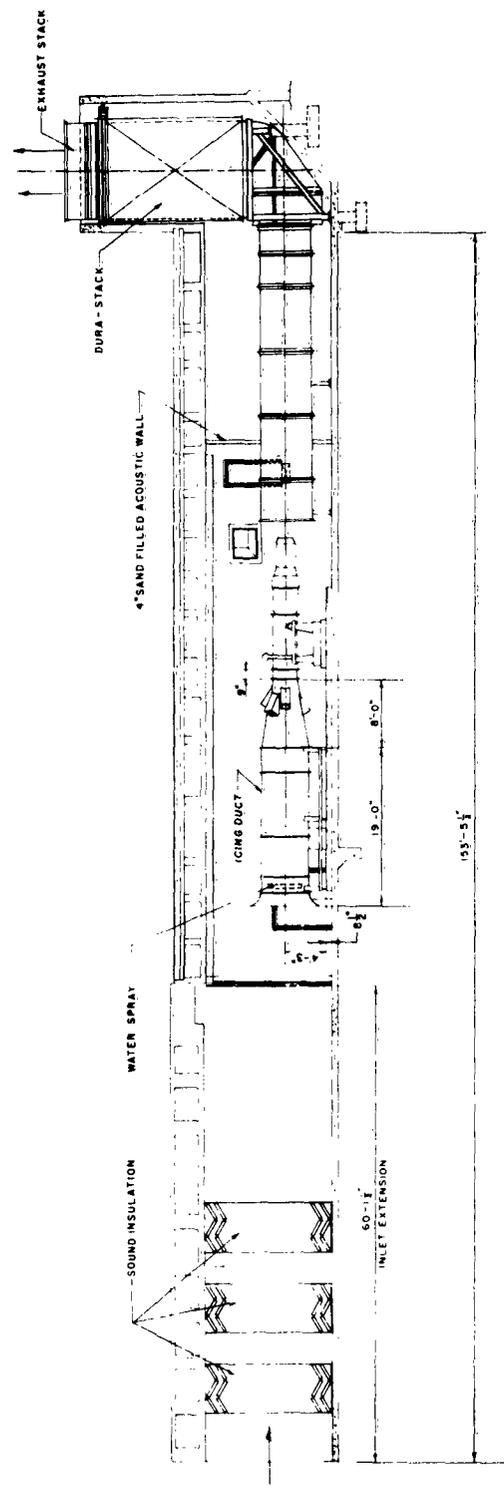
FIG. 1  
LR-305

TURBOJET ENGINE INSTALLED IN NO. 5 TEST CELL FOR ICING TESTS

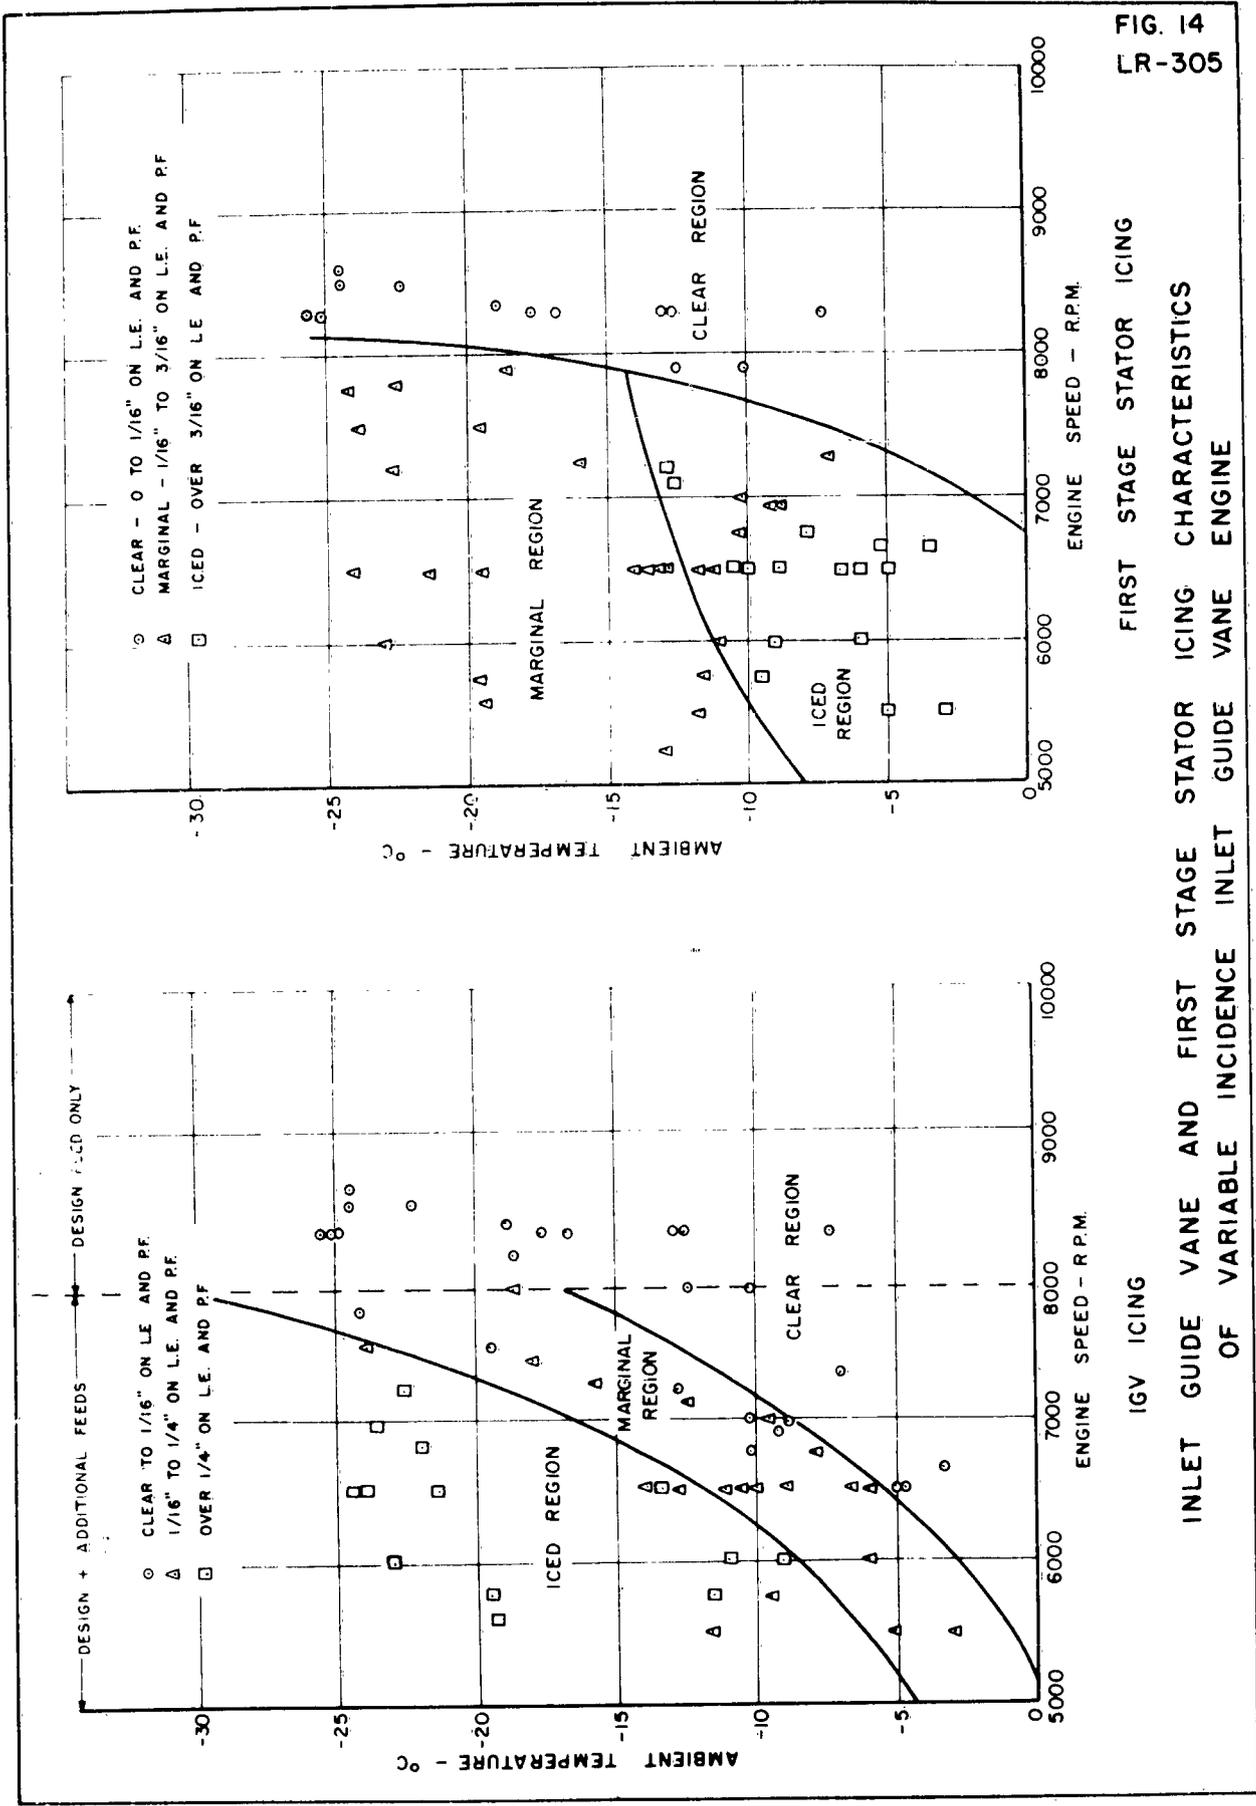
FIG. 14  
LR-305

INLET GUIDE VANE AND FIRST STAGE STATOR ICING CHARACTERISTICS  
OF VARIABLE INCIDENCE INLET GUIDE VANE ENGINE

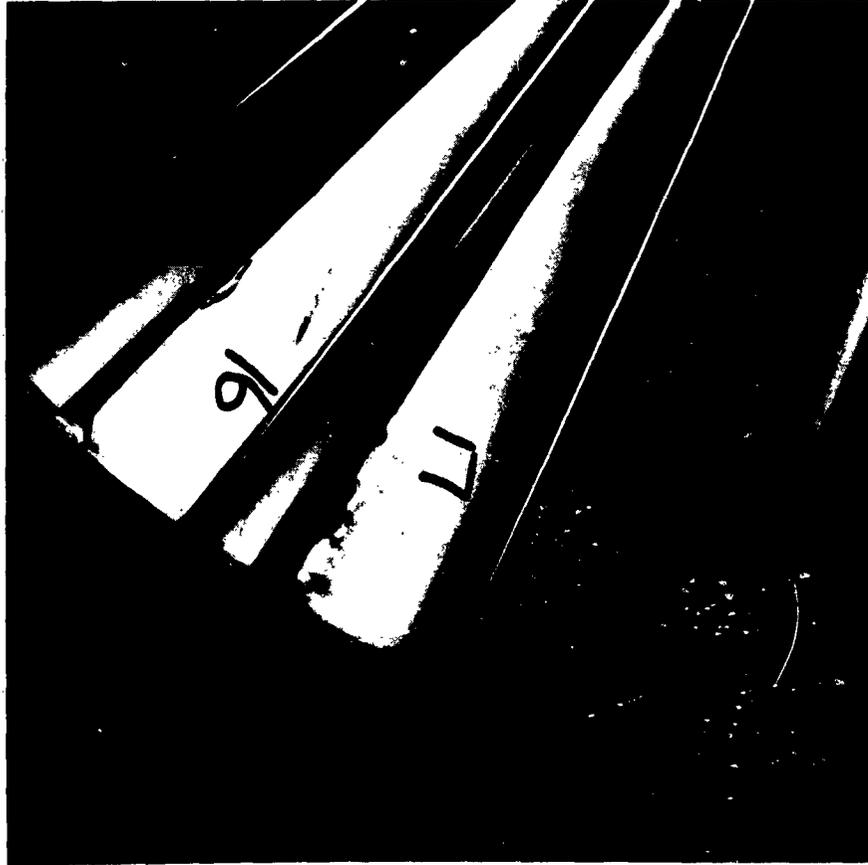
DAMAGE TO LIGHT ALLOY TRANSONIC COMPRESSOR BLADE  
CAUSED BY INGESTION OF SMALL PIECES OF ICE
