CONFERENCE ON ENVIRONMENTAL  
EFFECTS ON AIRCRAFT PROPULSION

A Compilation of the Papers Presented

U. S. Naval Air Turbine Test Station  
Trenton, ~~New Jersey~~ N. J.

June 22 and 23, 1961

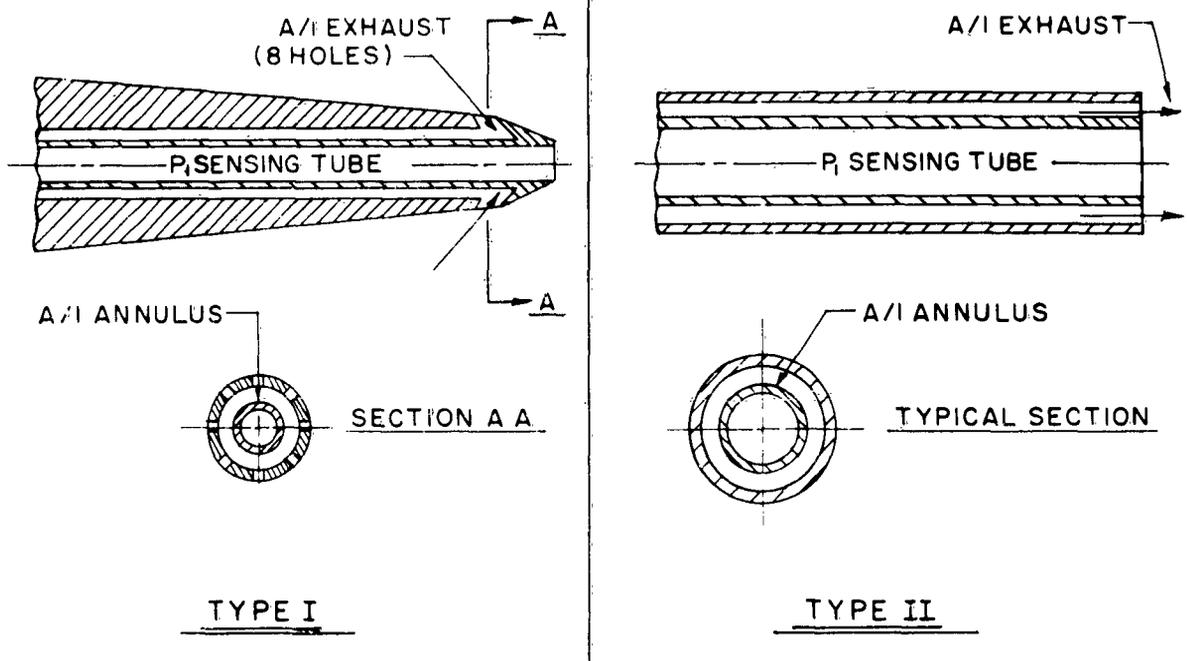
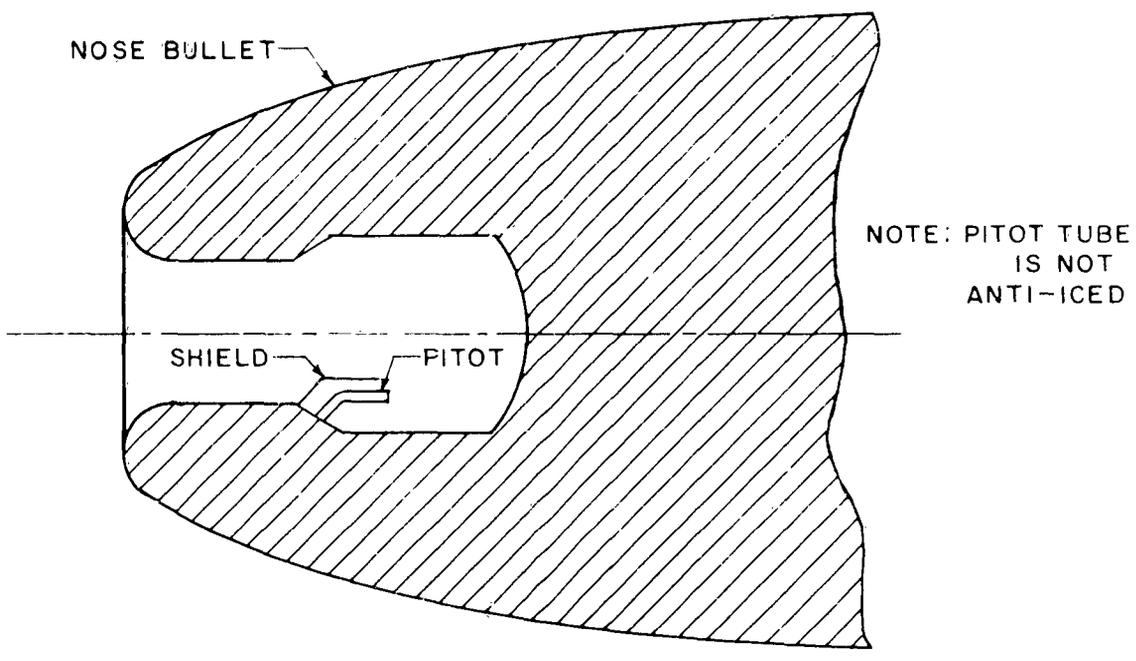
SHIELDED PITOT LOCATION

**RAM HEAD PITOT TUBE PROTECTION**

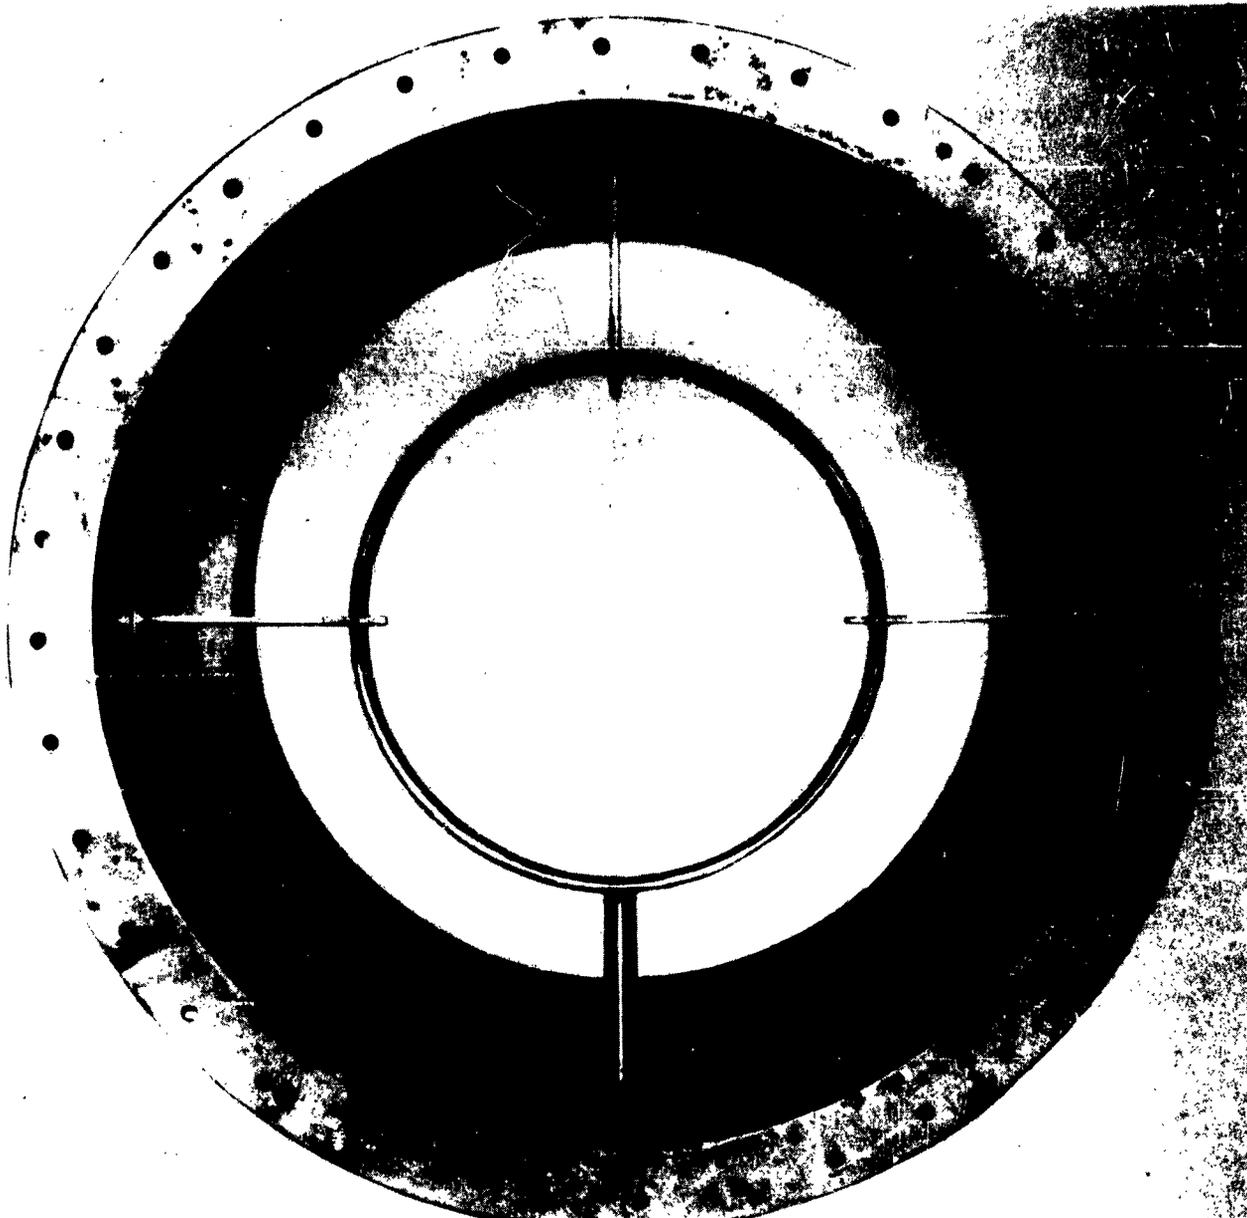
**FIG. I-WATER SPRAY MANIFOLD**

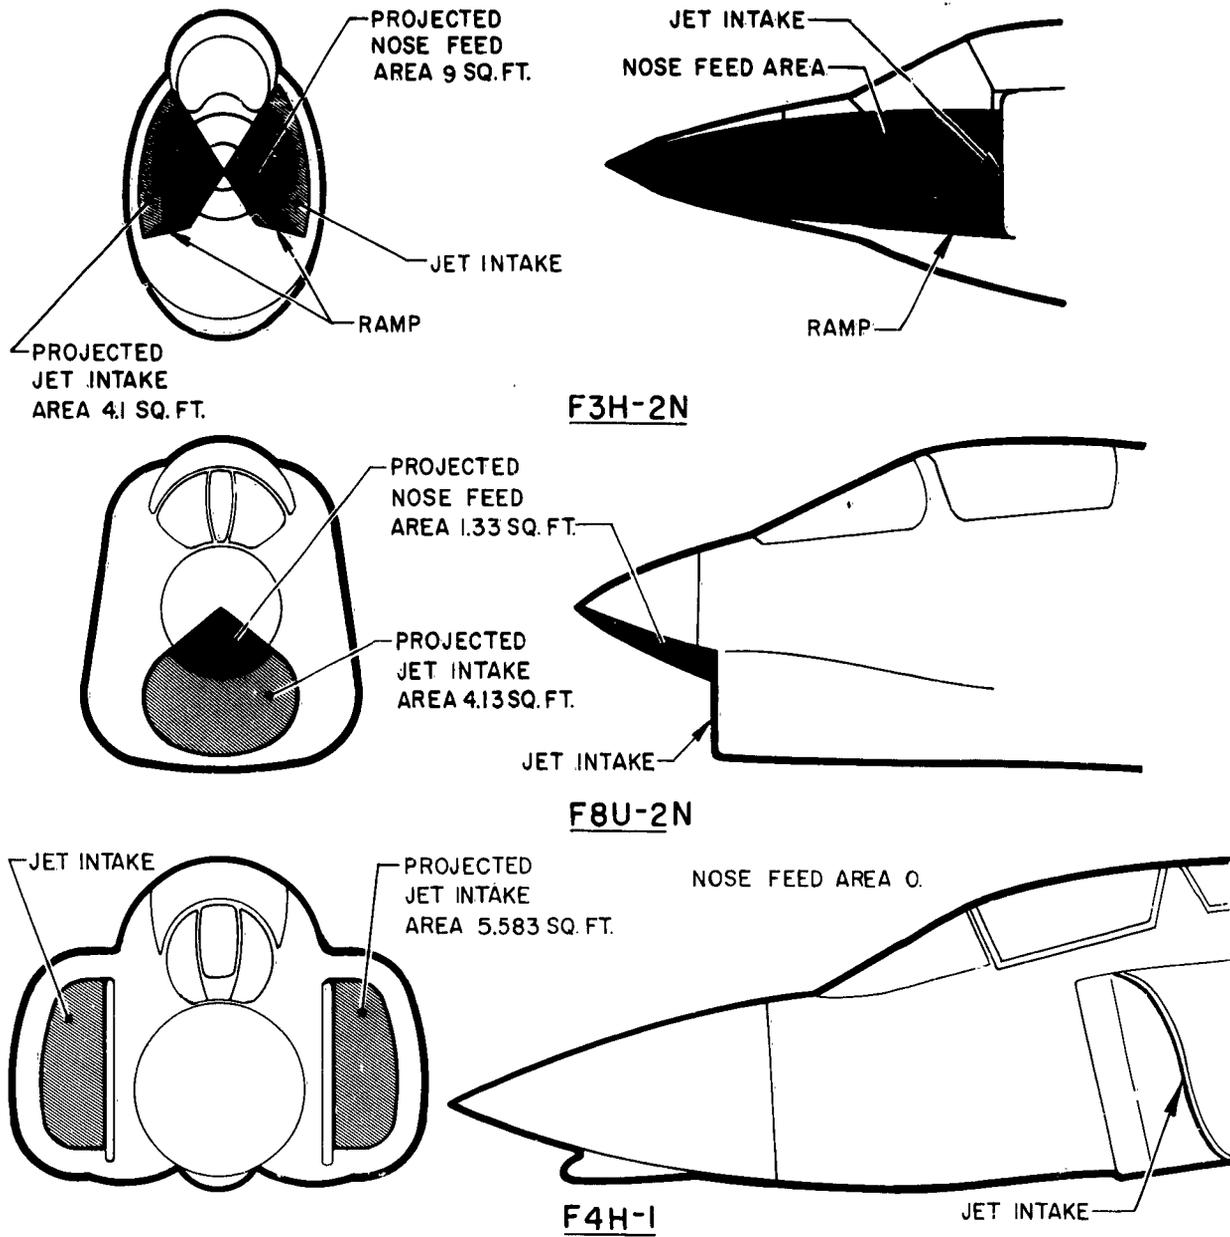
FIG. 2-EFFECTIVE INGESTION AREAS OF F8U-2N, F3H-2N AND F4H-1 AIRCRAFT

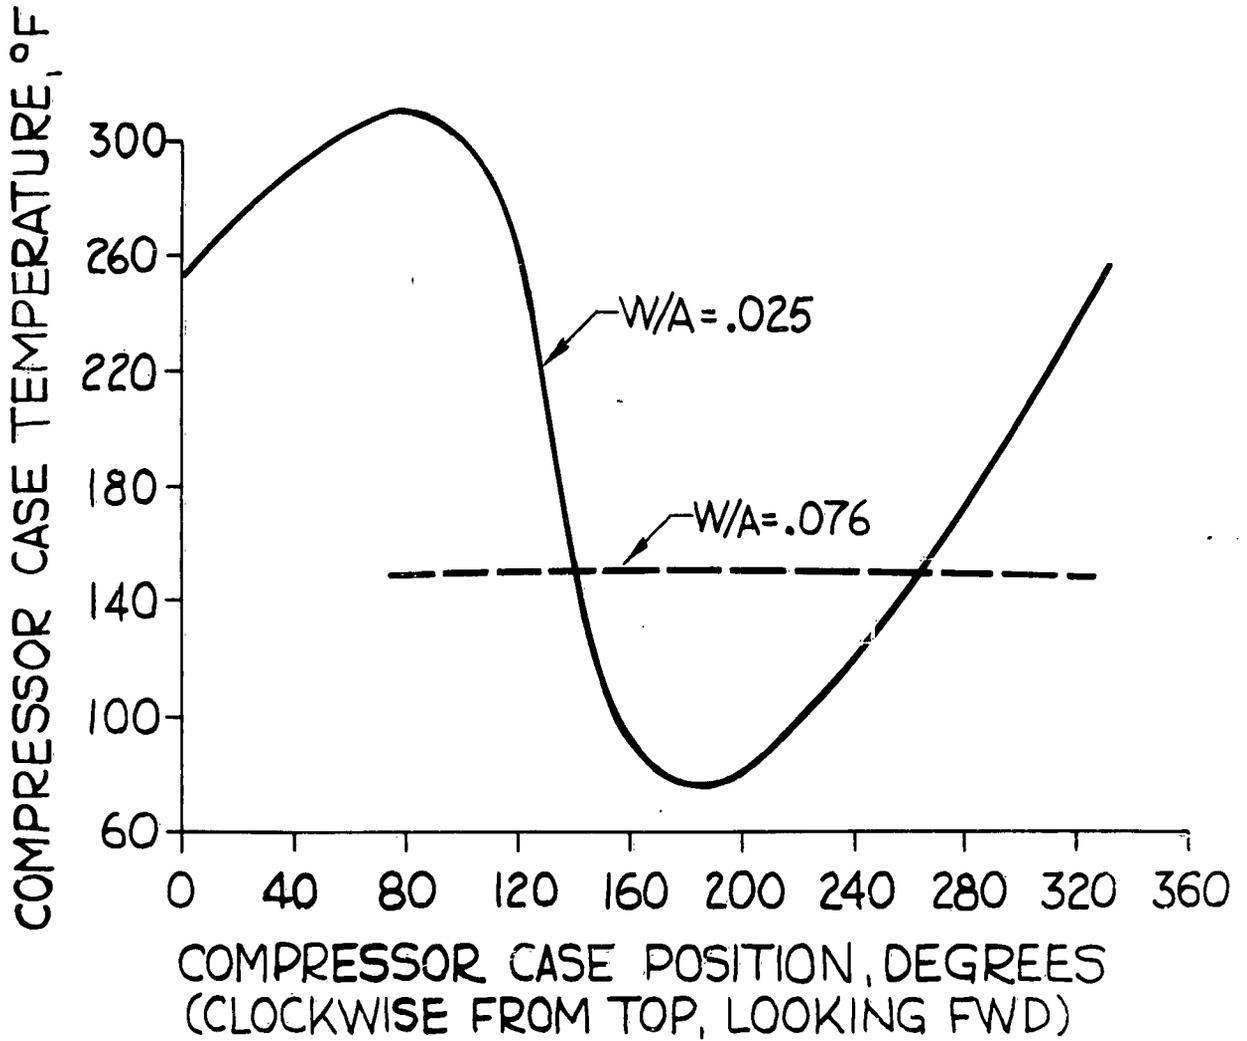
FIG. 4 - EFFECTS OF WATER INGESTION ON  
COMPRESSOR CASE TEMP GRADIENTS  
ON J71 ENGINE

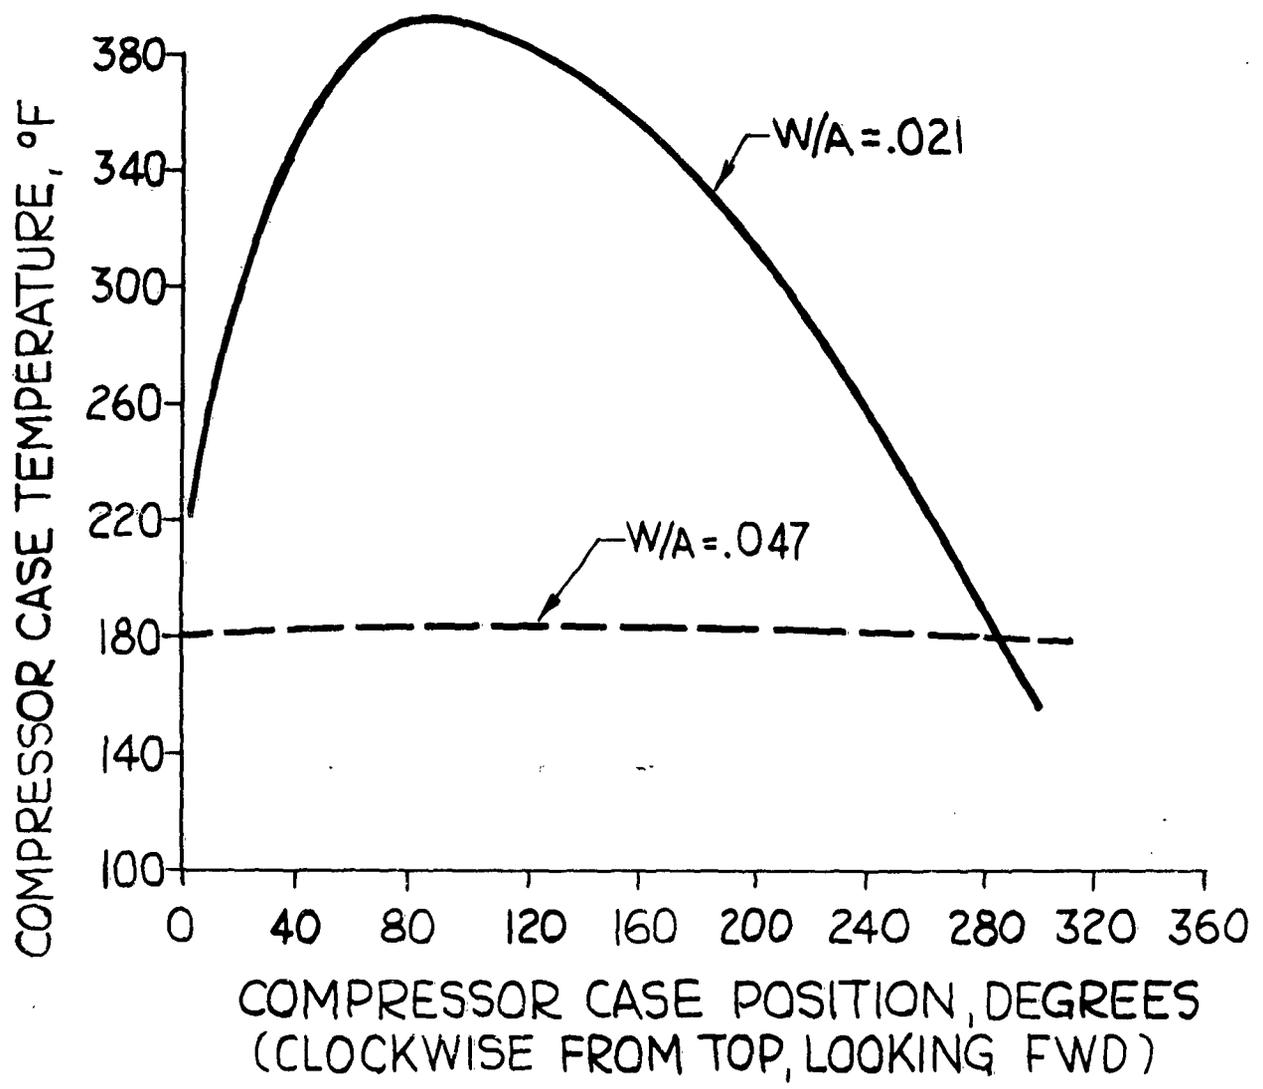
**FIG. 6 - EFFECT OF WATER INGESTION ON COMPRESSOR CASE TEMPERATURE GRADIENTS ON J79 ENGINE**

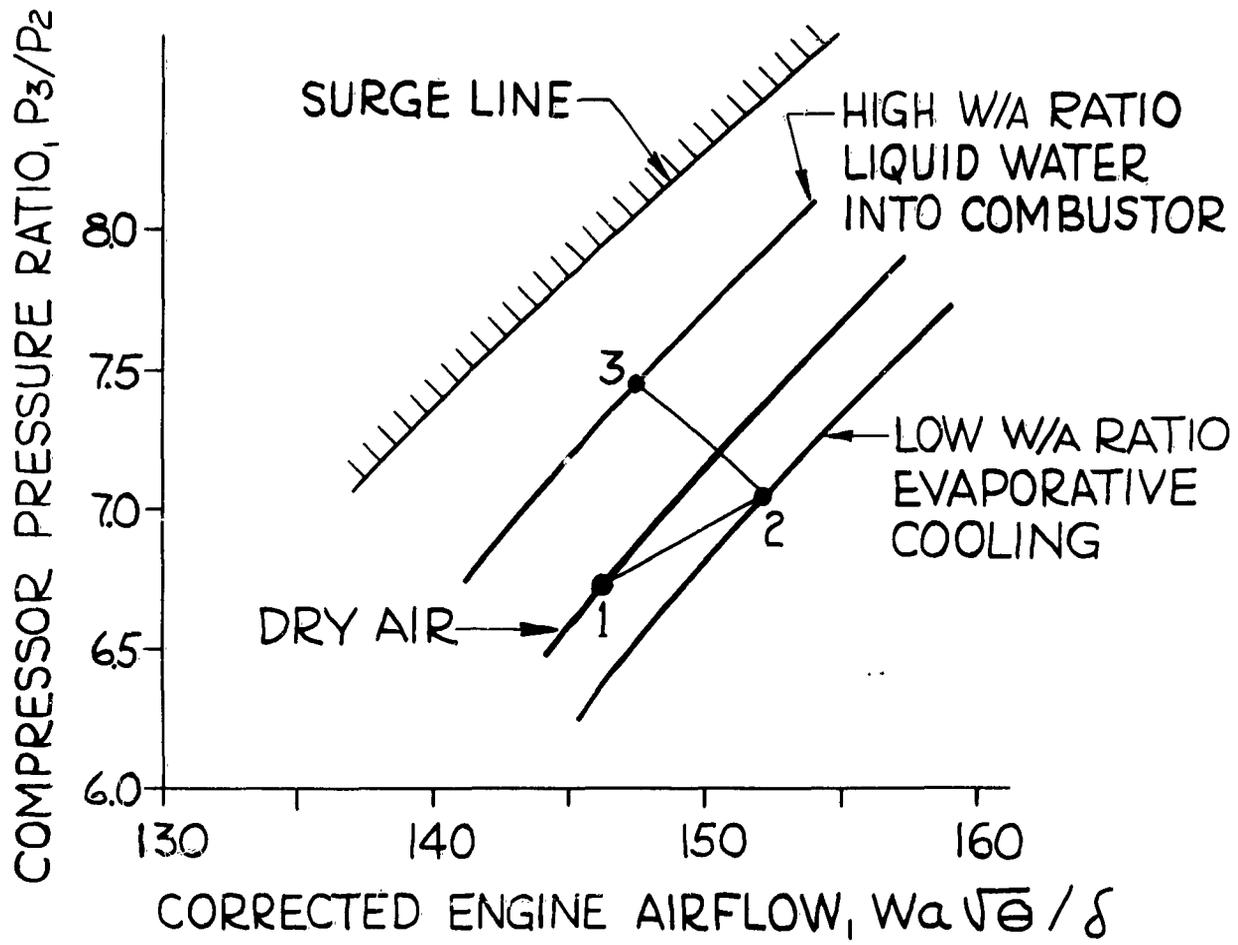
FIG.7- TYPICAL EFFECT OF WATER INGESTION ON COMPRESSOR OPERATING LINE

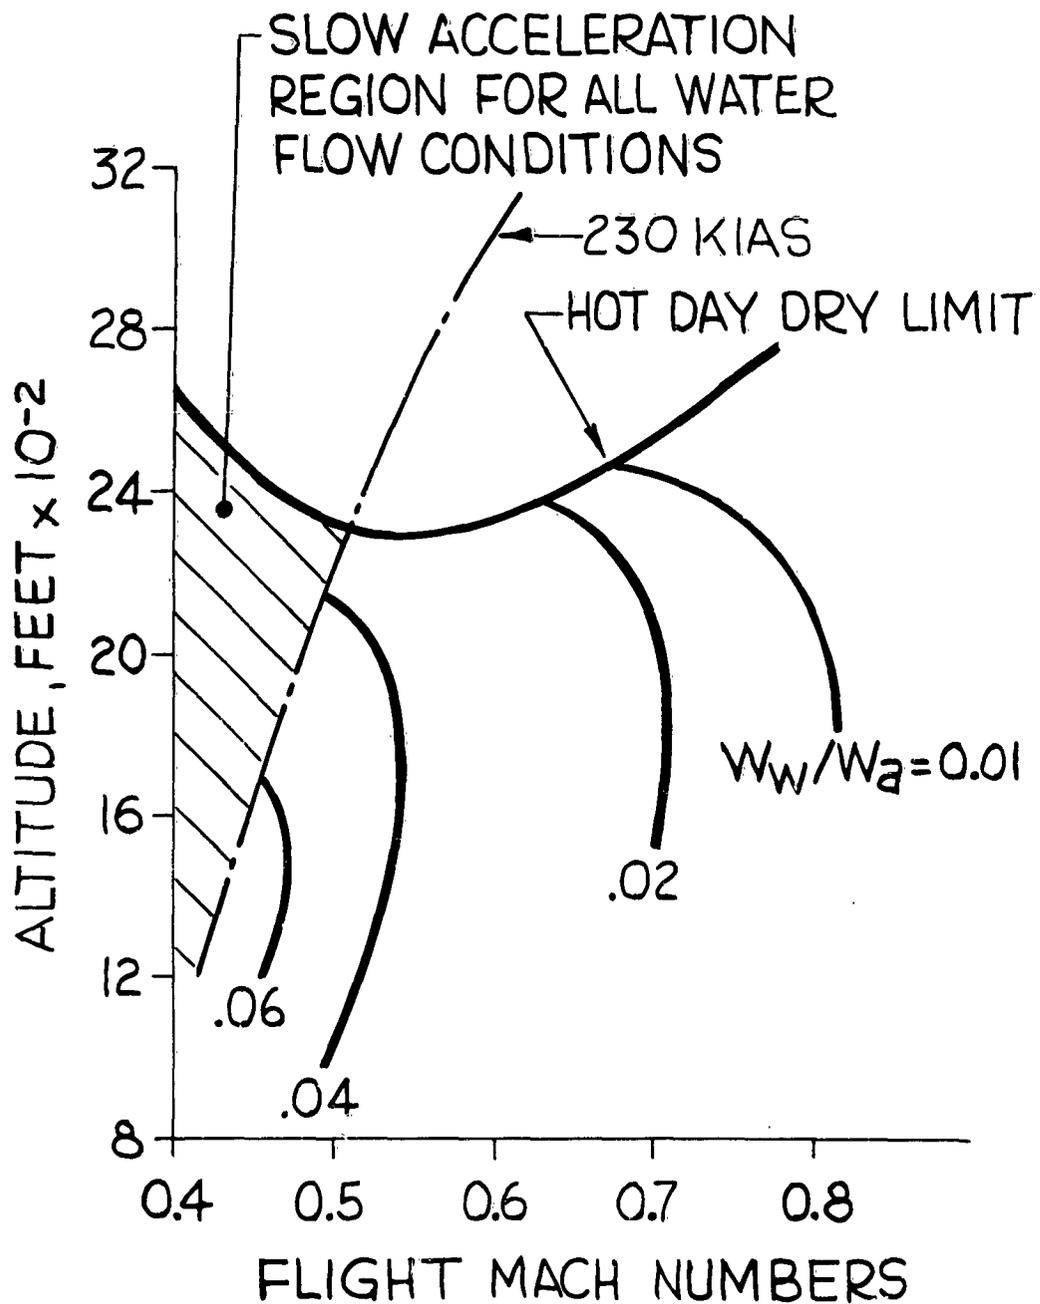
**FIG.8-EFFECT OF WATER INGESTION ON THE ENGINE STARTING CHARACTERISTICS OF THE J71 ENGINE**

Third general problem area is the effect of water ingestion on the windmill starting characteristics. Windmill starting tests with water ingestion were conducted at the Aeronautical Turbine Laboratory on the J71-A-2 engine. The effect of water ingestion on the starting envelope is shown on Fig. Number 8. It is noted from this figure that as the water ingestion rate was increased, there was a reduction in the windmill starting envelope. At the higher water to air ratios, the maximum starting altitudes occurred at 230 KIAS, the recommended glide speed of the F3H-2N aircraft. Water seemed to have little effect on the starting characteristics in the low speed-high altitude region. At the high speed-high altitude portion of the envelope, low water to air ratios (.01 or lower) had a marked effect on the engine's starting characteristics. At a flight Mach number of 0.80 for example, a water to air ratio of .01 caused approximately a 7000 feet reduction in maximum light-off altitude. This area is normally a region of very lean starting fuel-air ratios. With the addition of water, the compressor discharge temperature is lowered, causing less fuel vaporization and even leaner fuel-air ratios so that a non-combustible mixture results. Another factor is that at windmill speeds, liquid water is carried into the combustor where it absorbs some of the heat energy of the igniter plugs which further decreases the starting ability of the engine. With the J71 engine during the windmill starts, the compressor

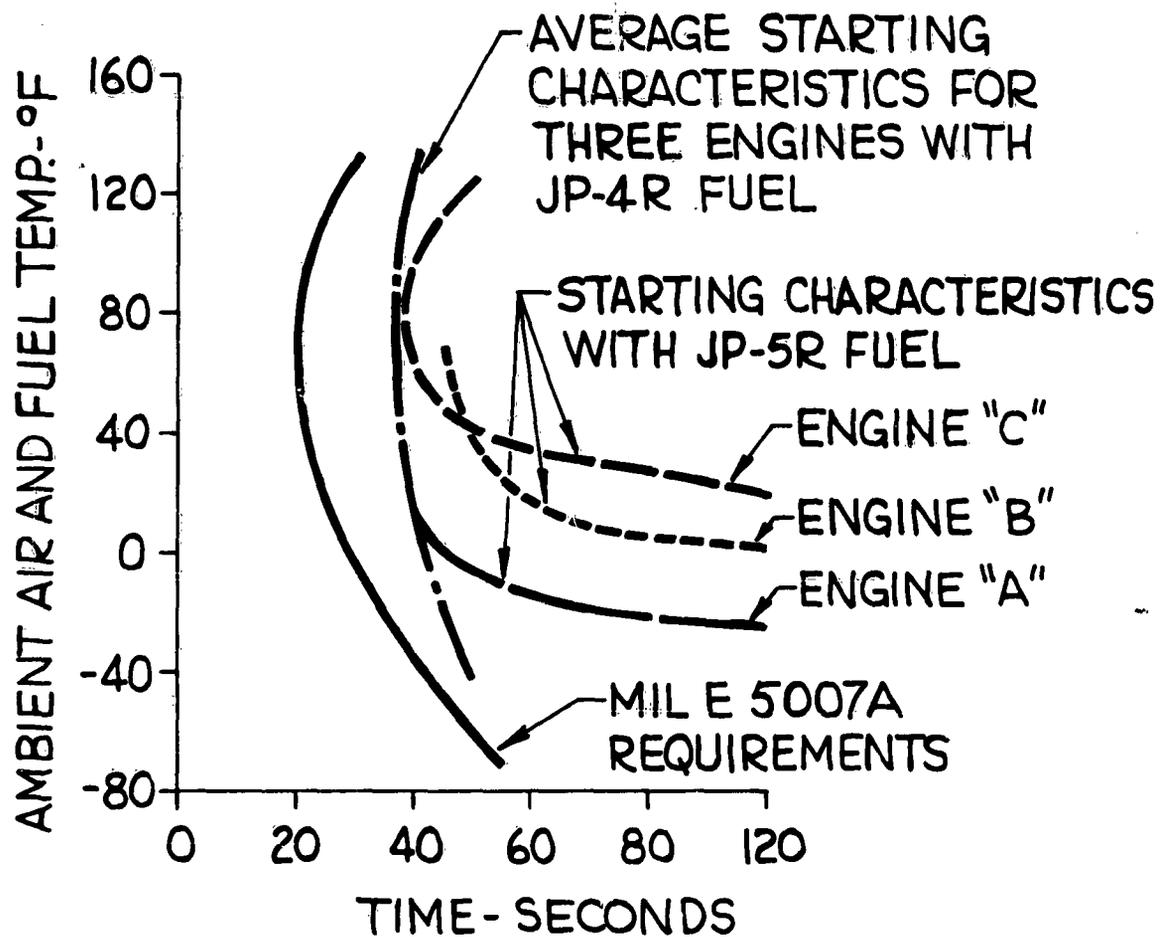
FIG. 1— EFFECT OF JP-5R FUEL ON ENGINE STARTING CHARACTERISTICS OVER COMPLETE AMBIENT TEMPERATURE RANGE

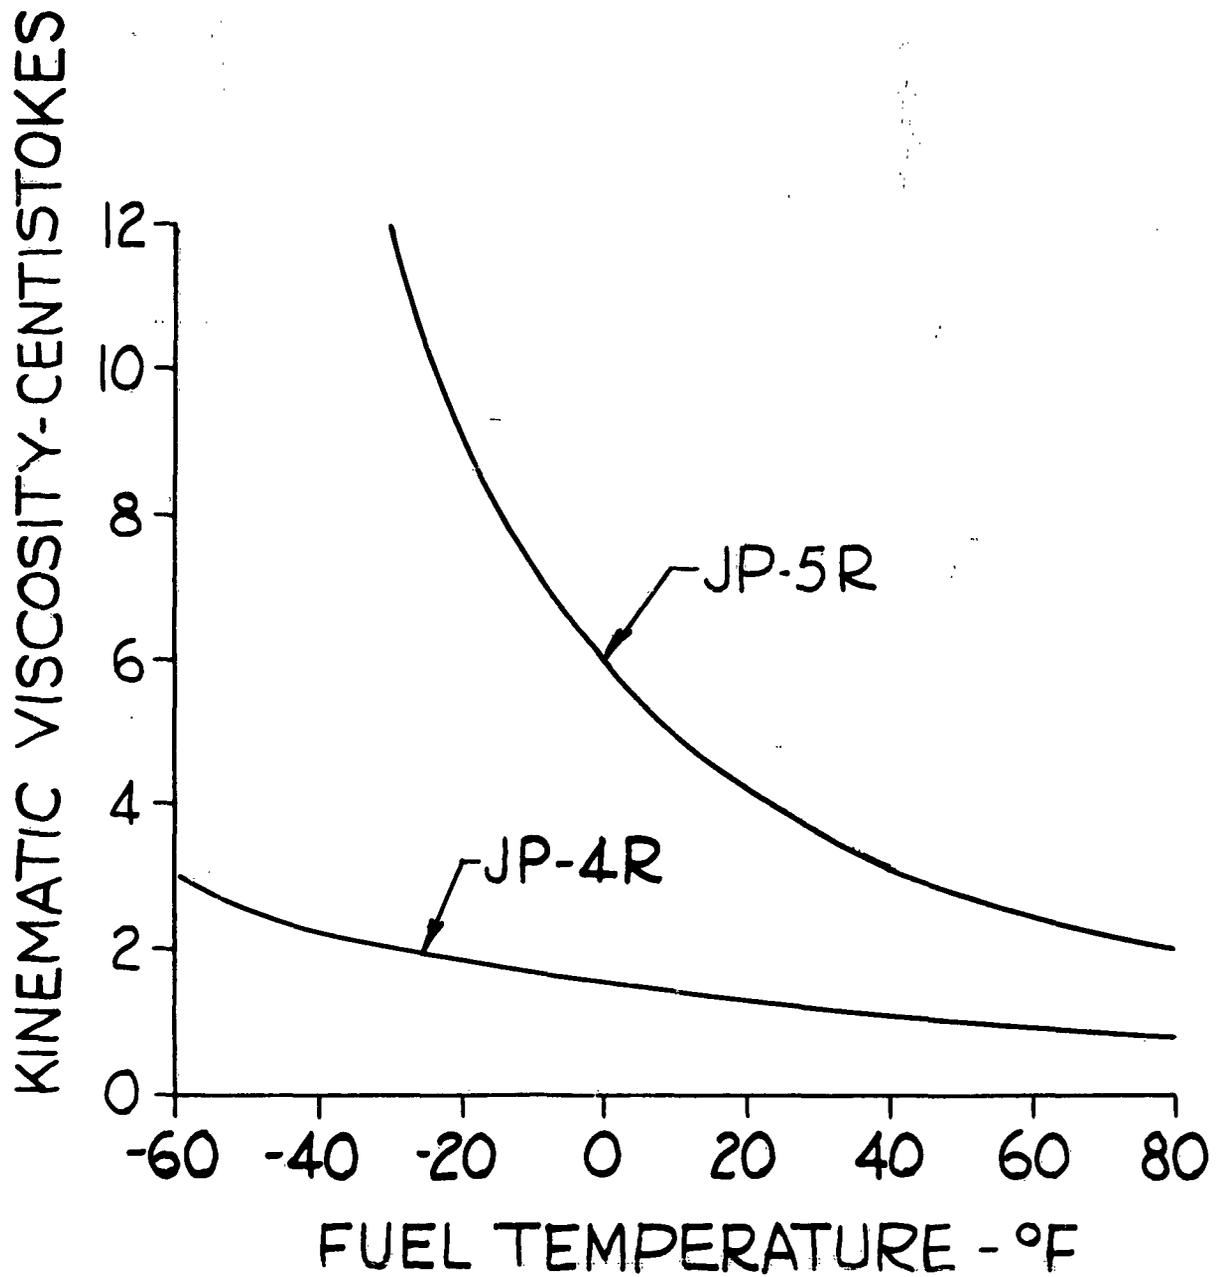
FIG.2 - KINEMATIC VISCOSITY FOR JET ENGINE REFEREE TEST FUELS

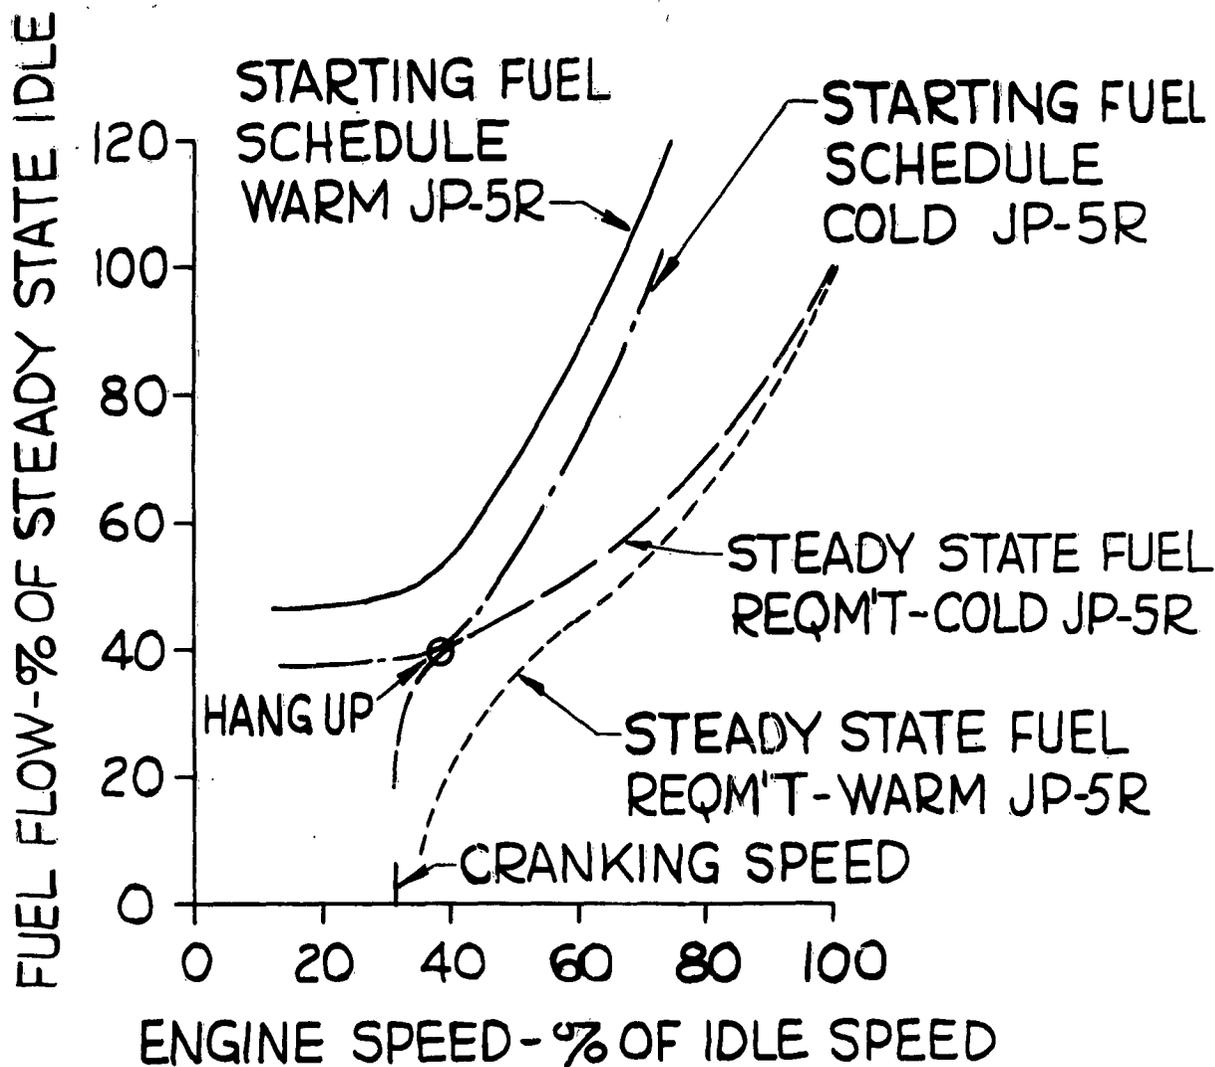
FIG. 3 — EFFECT OF JP-5R FUEL TEMPERATURE ON STARTING PERFORMANCE-ENGINE A

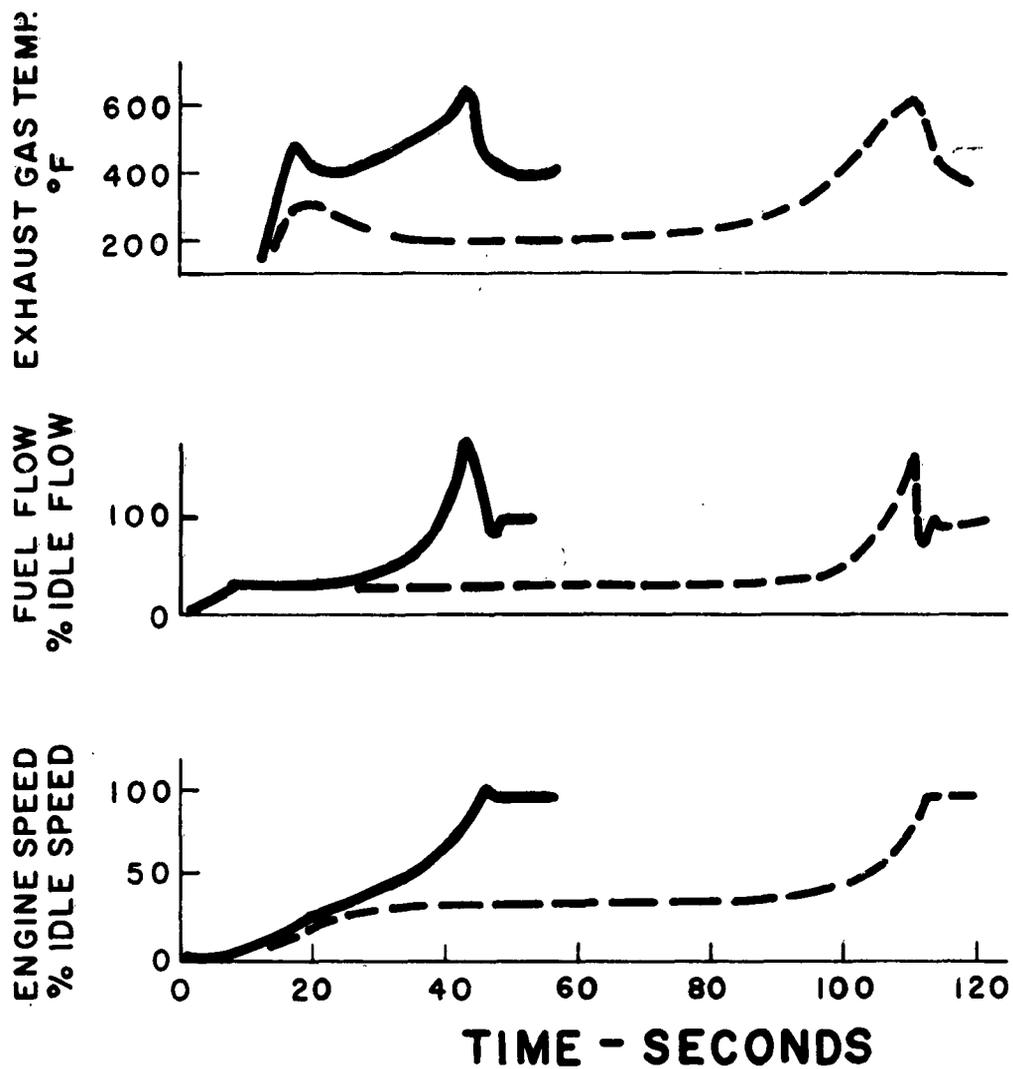
**FIG. 4 - COMPARISON OF A SUCCESSFUL AND A HANG-UP START WITH JP-5 FUEL FOLLOWING  $-30^{\circ}$  F COLD SOAKS.**

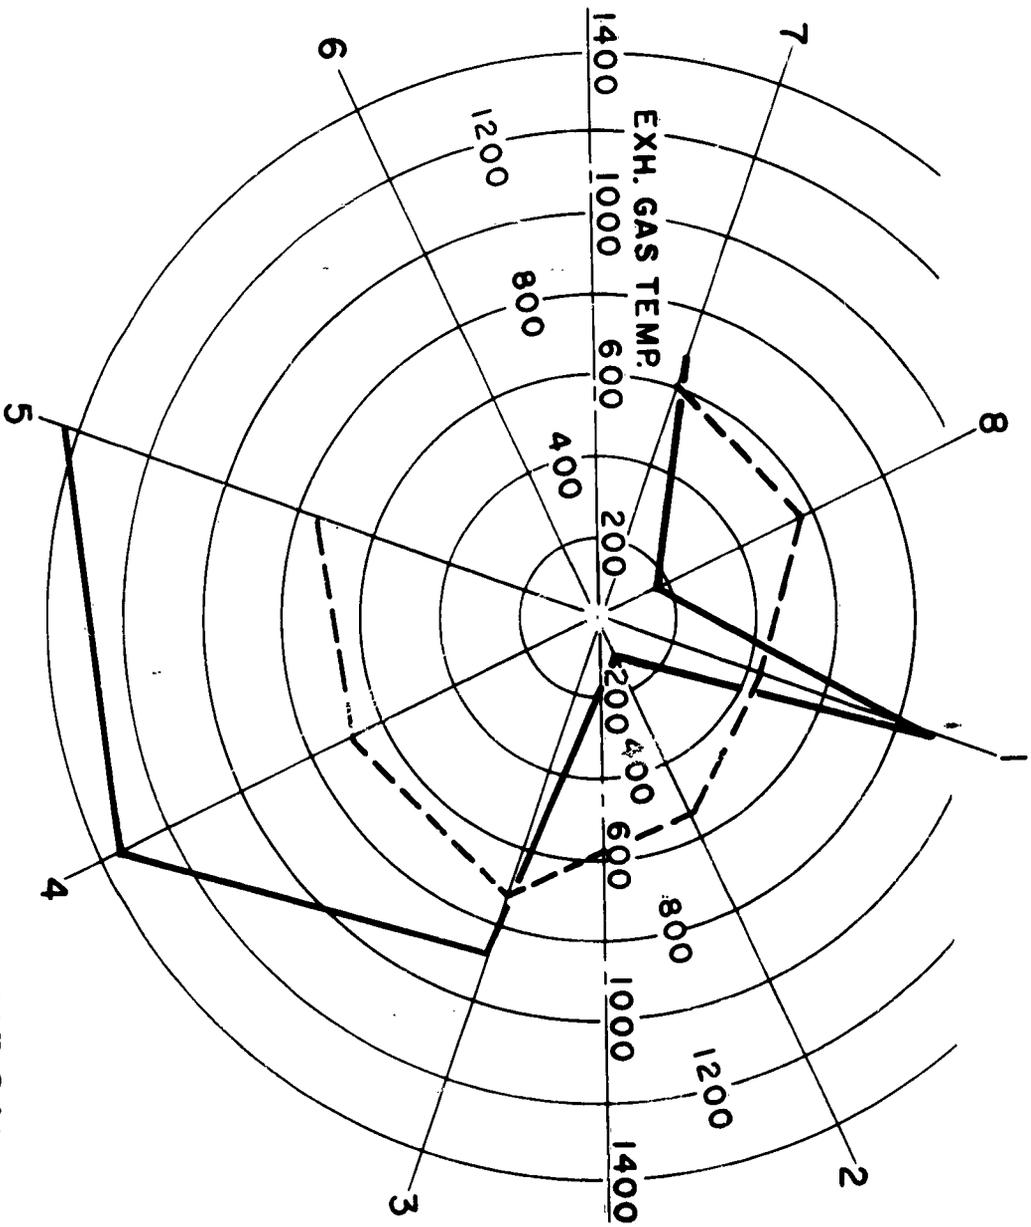
FIG.8-ENGINE "B" EFFECT OF JP-5R FUEL UPON  
 LOW TEMPERATURE OPERATION IN THE  
 ENGINE STARTING RANGE
