⑤ Research Labs. Div.
Bendix Corp., Southfield, Mich.

⑥ DEVELOPMENT OF AN ATMOSPHERIC SOUNDING
DROPSONDE, GROUND RECEIVING AND
DATA PROCESSING STATION.

FIELD TEST REPORT.

⑪ February 1965,

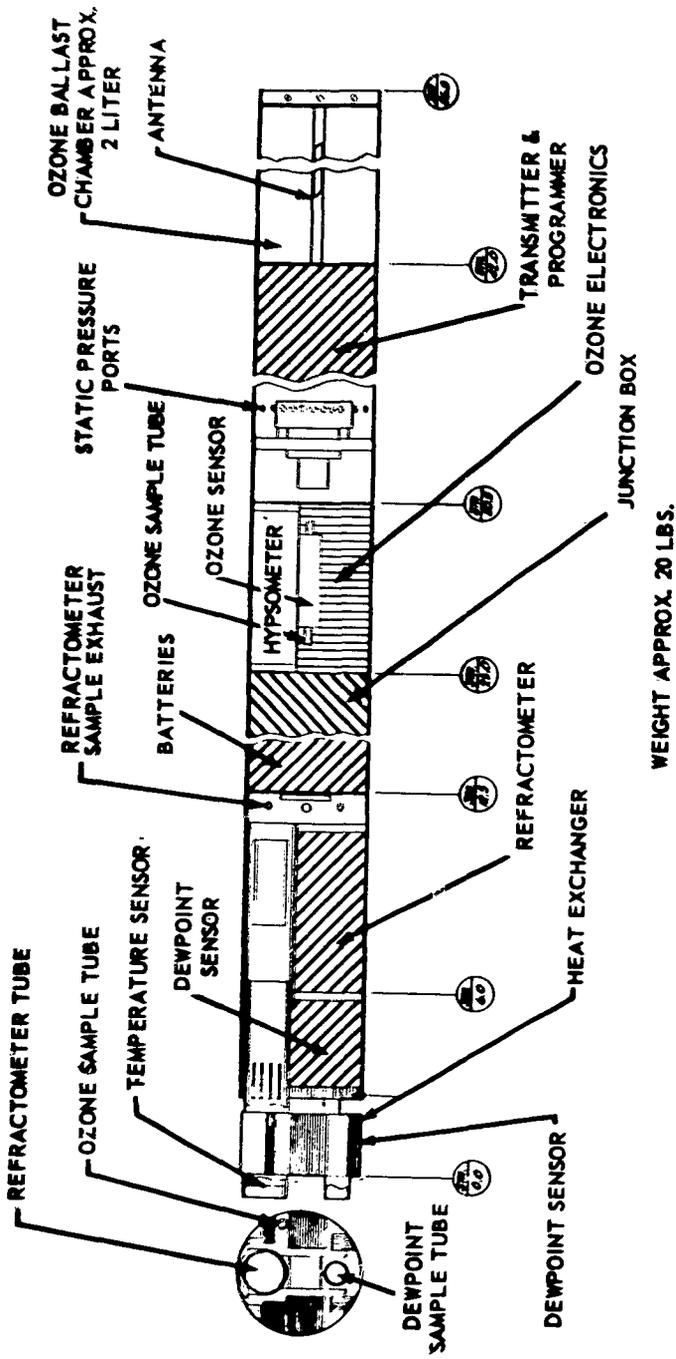
Figure 1 - Outline Drawing of VST Sonde Model 1

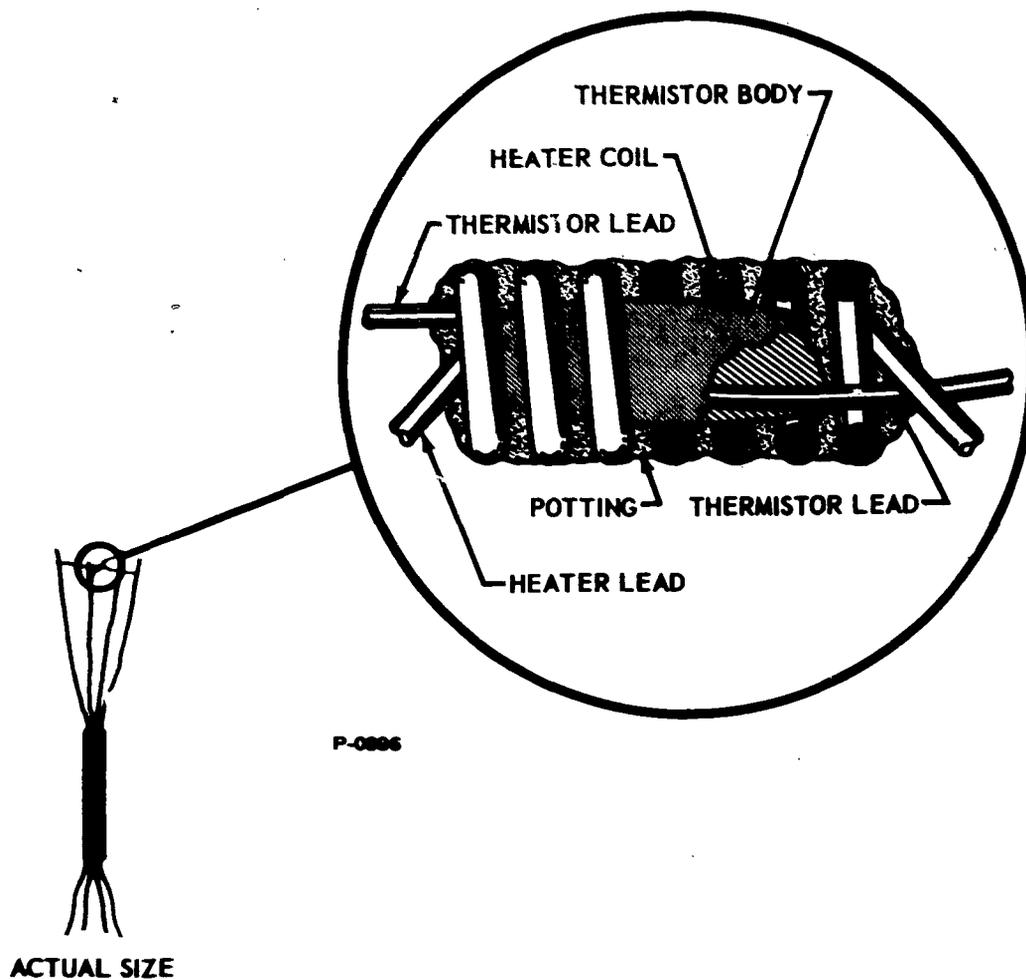
Figure 2 - Air Velocity Sensor

Several experimental models (Figure 2) were built. Tests were performed to ascertain the optimum heater power to be used and to observe the high altitude performance. Good resolution was obtained with 20 milliwatts dissipated in the heater of the sensor. The sensor was tested in a 3/16 inch flow tube using a Hastings flowmeter for comparison. The thermistor air velocity sensor showed accuracy within ± 20 percent up to an altitude of 80,000 feet without altitude correction. Partially smoothed calibration data for one sensor is presented in the August 1961, AF 33(600)-41821, Monthly Progress Report. A second unit which was calibrated at the same time yielded nearly identical results.

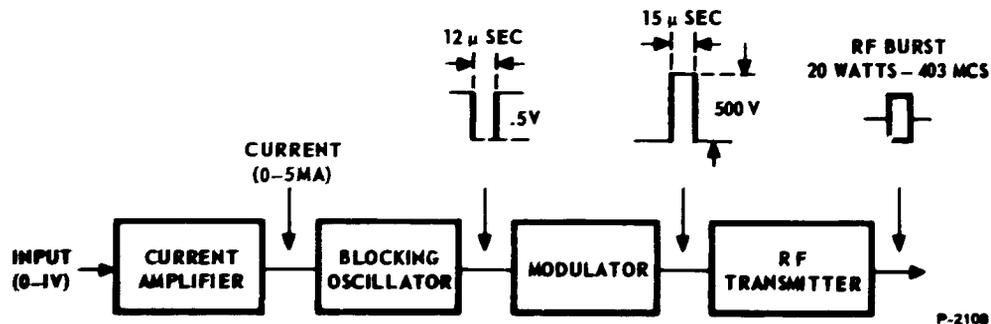
Figure 5 - Block Diagram Sonde Transmitter

One unit was of the single tube keyed oscillator type while the other was a two-tube class C grounded grid power amplifier type. Under test, both units appeared to put out the same amount of power and both exhibit the same amount of frequency drift with respect to time. The two tube r-f section, however, was insensitive to the loading of the antenna caused by the proximity of metallic objects. In view of the fact that such loading of the antenna would not occur with the proposed flight plan, it was decided to utilize the single tube version, as shown in the block diagram, Figure 5, in all transmitters, as it afforded a

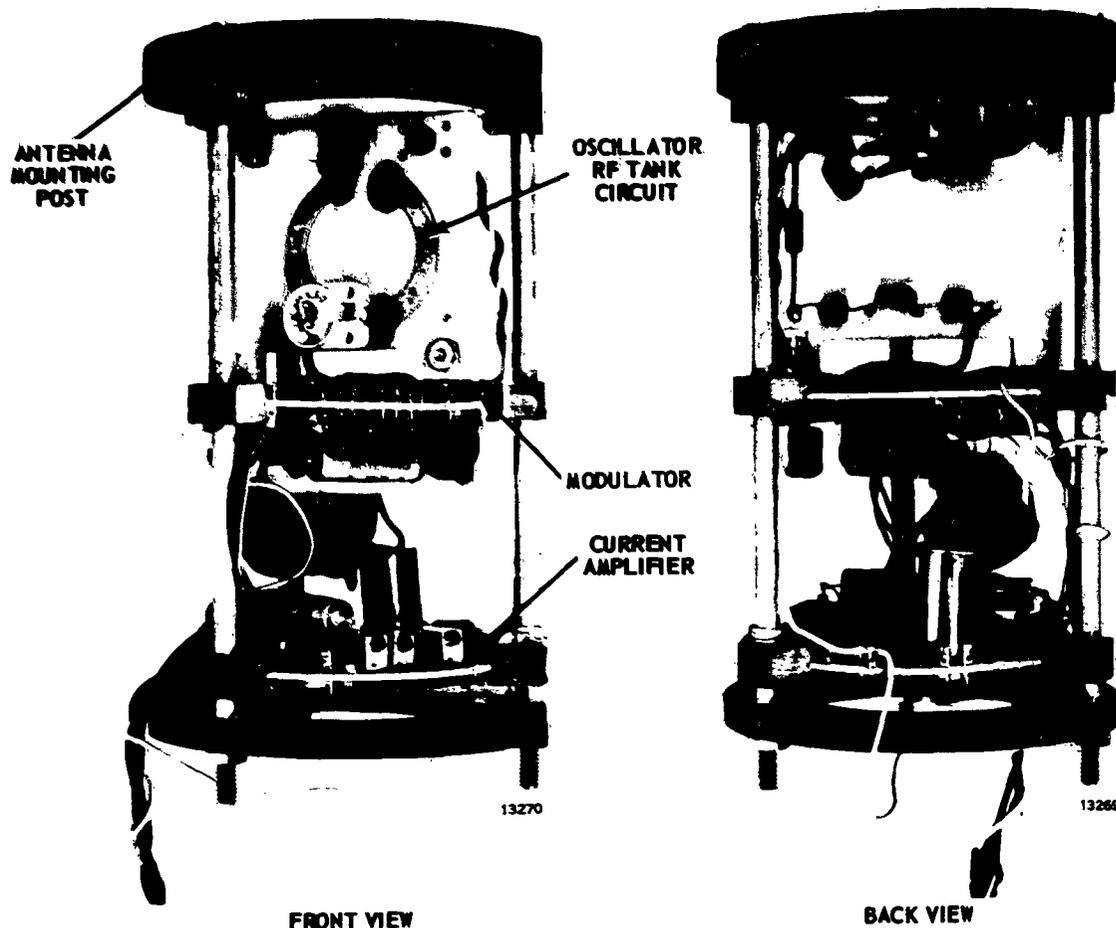
Figure 6 - One-Tube Transmitter

The single tube keyed oscillator sonde transmitter (Figure 6) was tested for frequency variations with respect to changes in filament voltage, plate voltage temperature, and antenna loading. The effects of the first two were found to be negligible. In the initial packaging of the r-f oscillator, the plane of the tank circuit was made perpendicular to the antenna axis to conserve space. However, frequency shift due to proximity of nearby objects became more pronounced than in previous designs.

From this it was determined that when the plane of the oscillator tank circuit was made parallel to the axis of the antenna, the shift was reduced considerably. The r-f section was then repackaged with the oscillator parallel to the antenna axis and was tested satisfactorily.

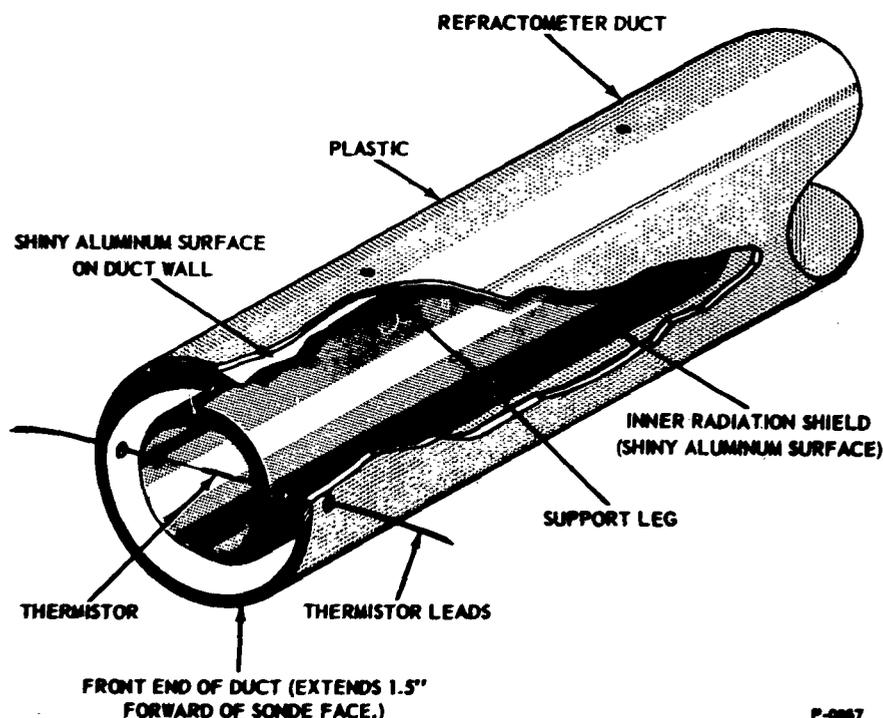
Figure 7 - VST Test Sonde Temperature Sensor

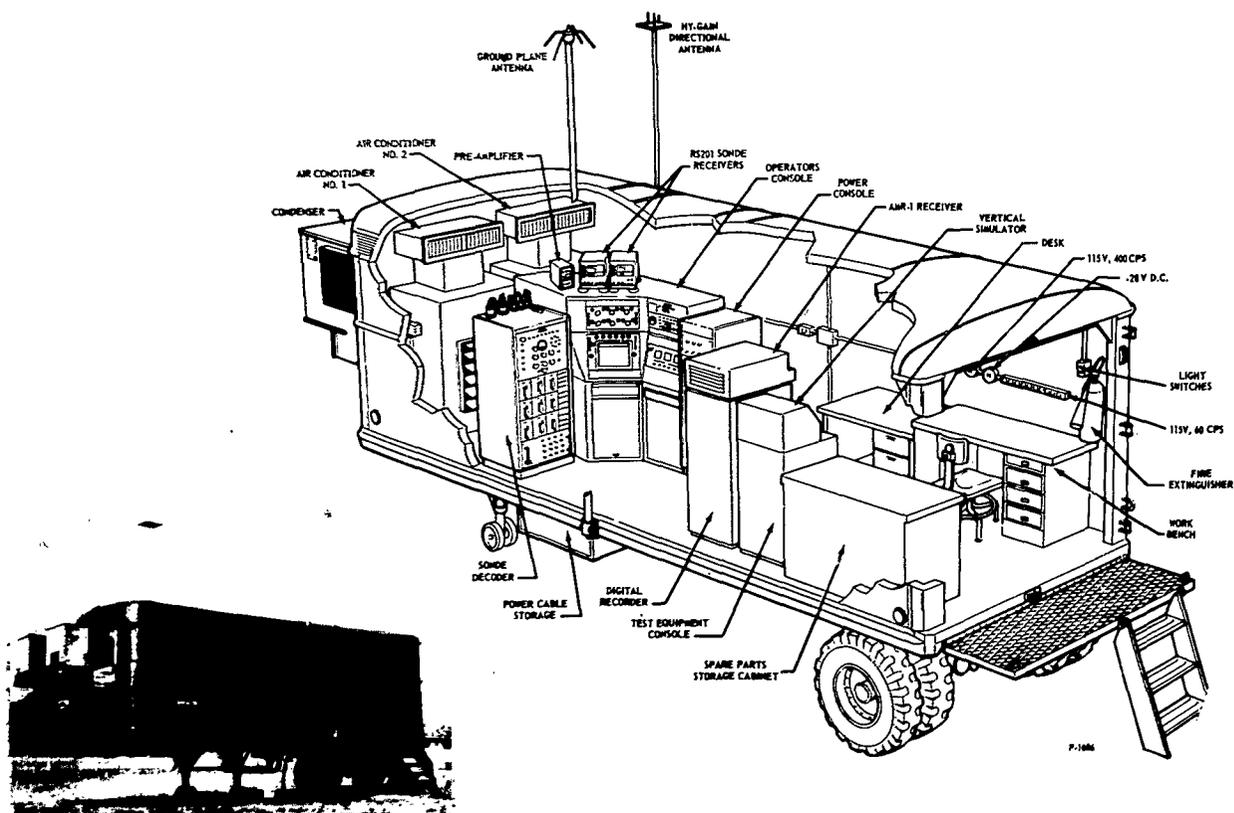
Figure 8 - VST Ground Station

The purpose of the ground station equipment is to provide a reliable, accurate, and automatic means of receiving, decoding, and recording the transmitted meteorological data from the sonde package during the in-flight evaluations of the various sensor techniques. The ground station equipment is installed in the GFE trailer van as shown in Figure 8, and consists, for the most part, of airborne equipment originally developed for the Air Force AN/AMQ-15 Meteorological Reconnaissance System.

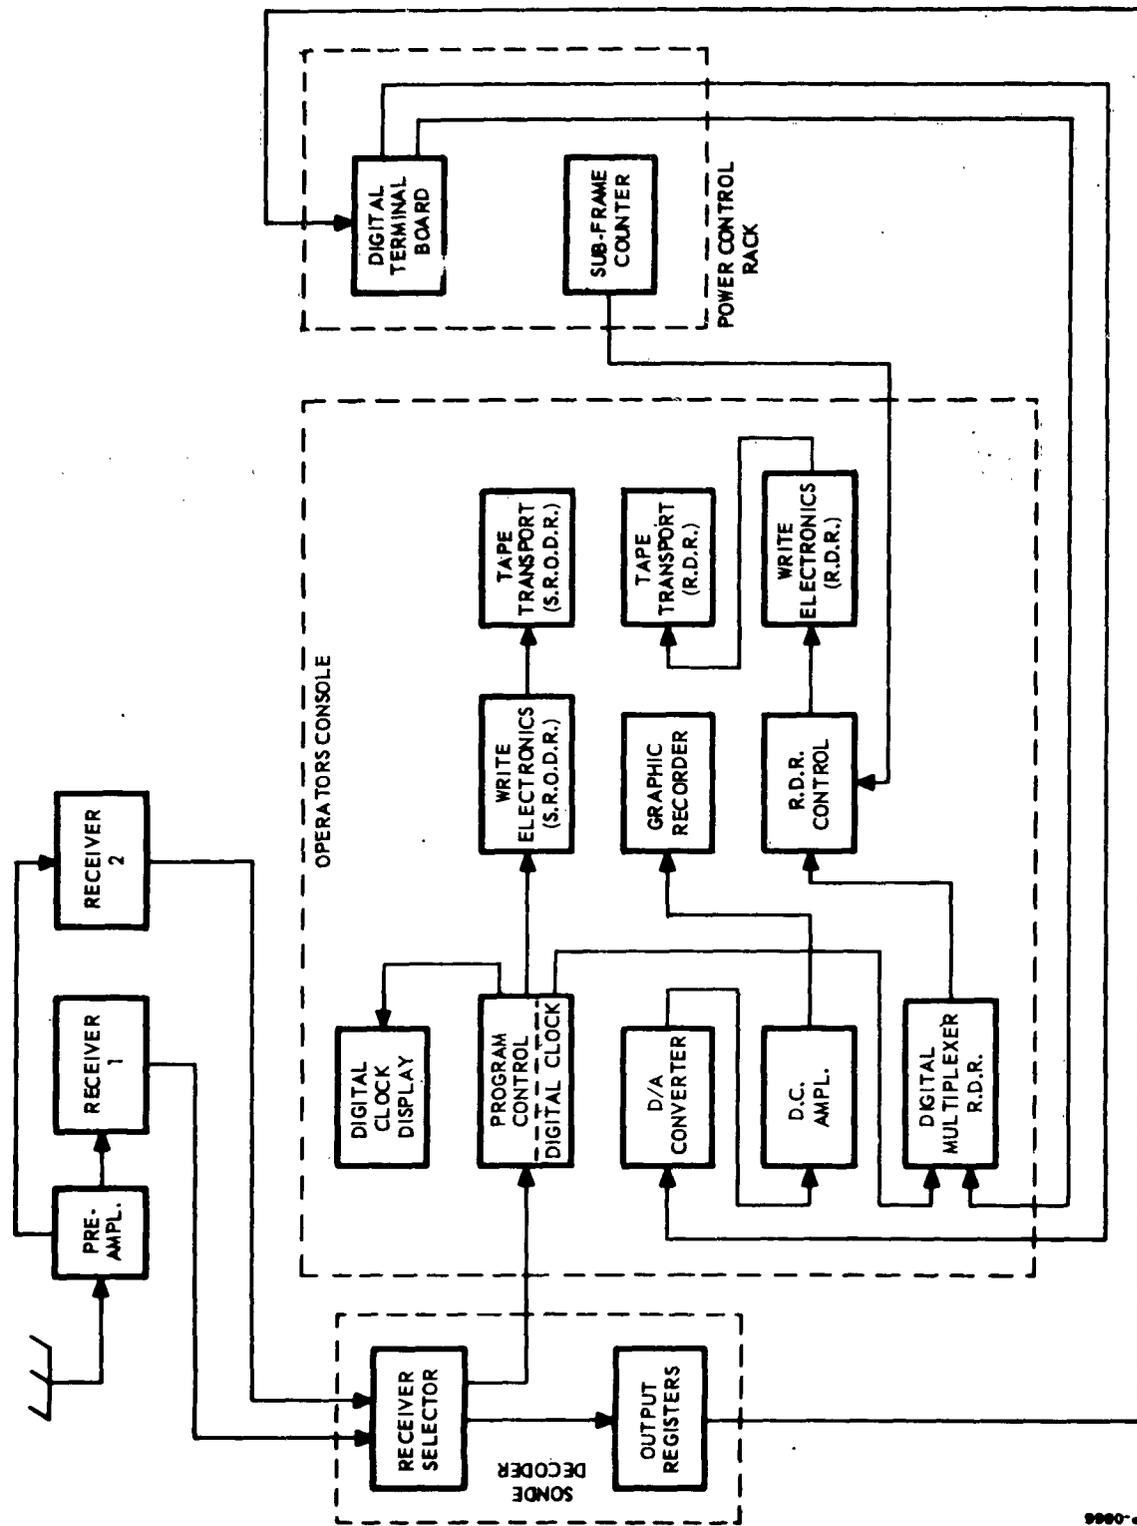
Figure 9 - VST Ground Station Signal Flow

As the block diagram (Figure 9) indicates, the signal, after being picked up by the antenna, is fed into a pre-amplifier which has a 5 micro-volt sensitivity. The output of the pre-amplifier is sent to two receivers. One receiver is in the stand-by condition, while the other

sends its output to the sonde decoder. Both outputs are controlled by the operator from the sonde decoder monitor panel. The receivers are set to a center frequency of 403.0 megacycles and each has a total bandwidth of 1.5 megacycles. The output signal from the receiver, is a 1 to 3 microsecond pulse of -9 volts amplitude, and is fed to the sonde decoder receiver selector relay. From the relay the signal is divided; one signal is connected to the program control panel. Here the receiver output signal is frequency divided by two in order to stay within the frequency response limits of the sonde receiver output data recorder (SRODR). The output of the program control panel is fed to this recorder through switching circuits on the operation monitor panel. The other signal from the selector relay enters the sonde decoder logic circuitry. Two ranges of frequency are used in this signal. One is an identifier pulse train consisting of eight individual codes with a pulse interval range of 40 microseconds to 635 microseconds and the other a value pulse train with a pulse interval range of 640 microseconds to 10.235 milliseconds. As the identifier pulse train enters the logic circuitry the first pulse starts the forward counter; the second pulse transfers the count of the forward counter to the backward counter and the backward counter starts counting toward zero. If the backward counter reaches a zero count or a near zero count by the time the third pulse is received, and the frequency of the in-coming signal is within the limits of one of the eight identifier codes, the decoder stops counting and opens a logic gate corresponding to the identifier received and is ready to accept a value pulse train. This pulse train is counted in the same manner as the identifier pulse train and is stored in the register previously identified. In the manner just described a serial pulse train is converted to eight parallel 10-bit binary outputs.

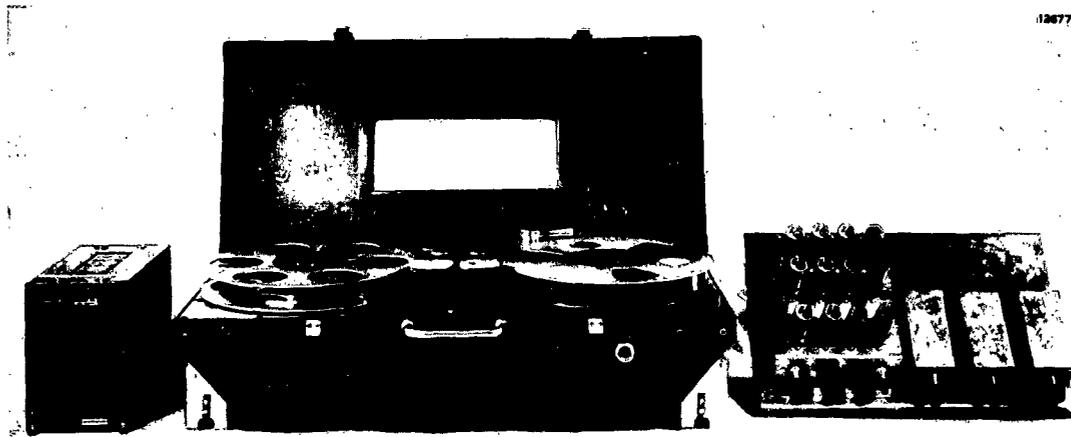
Figure 11 - Components of the Sonde Receiver Output Data Recorder

The primary purpose of the sonde receiver output data recorder, Figure 11, (SRODR) is to provide a back-up recording facility for the ground station data link, so that in the event of decoder or raw data recorder failure during a flight test, the data would not be lost. To accomplish this the SRODR must record the intelligence picked up by the Sonde Receiver, as well as real time; and it must also be capable of playing back the information in its original form.

An Ampex Model 800B tape transport and its associated electronics are the basic building blocks for the scheme. This recorder, which has a 16 channel recording capacity and utilizes a non-return-to-zero mode of recording, was residual inventory from the AN/AMQ-15 airborne equipment.

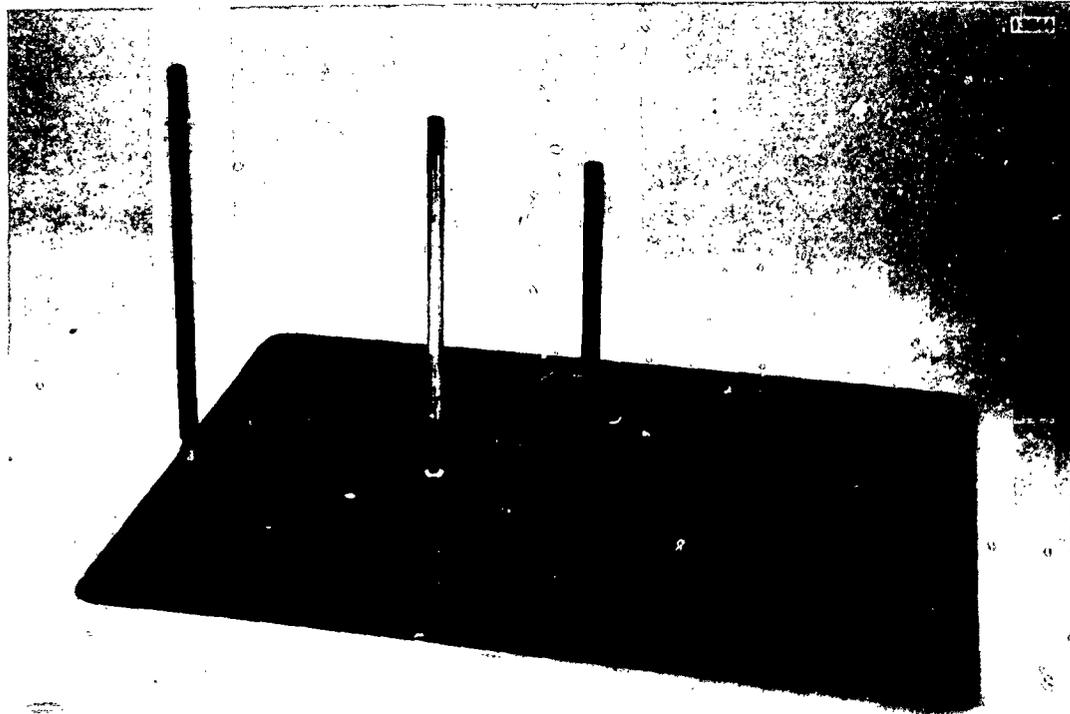
Figure 12 - Experimental Sonde Directional Receiving Antenna

To obtain improvement in signal reception, a directional ground plane antenna (Figure 12) was constructed with movable directors and reflectors. Tests were conducted in an antenna test chamber to determine optimum spacing of the inactive elements. The final configuration has a director spaced at 0.1 wave length and a reflector located at 0.2 wave length away from the active element. Test patterns (Figures 13 and 14) were run which indicate the antenna pattern to be fairly uniform from 0 to 60 degrees of elevation angle, and at the same time, the vertical sensitivity remained good. The horizontal pattern was uniform over approximately 120 degrees.

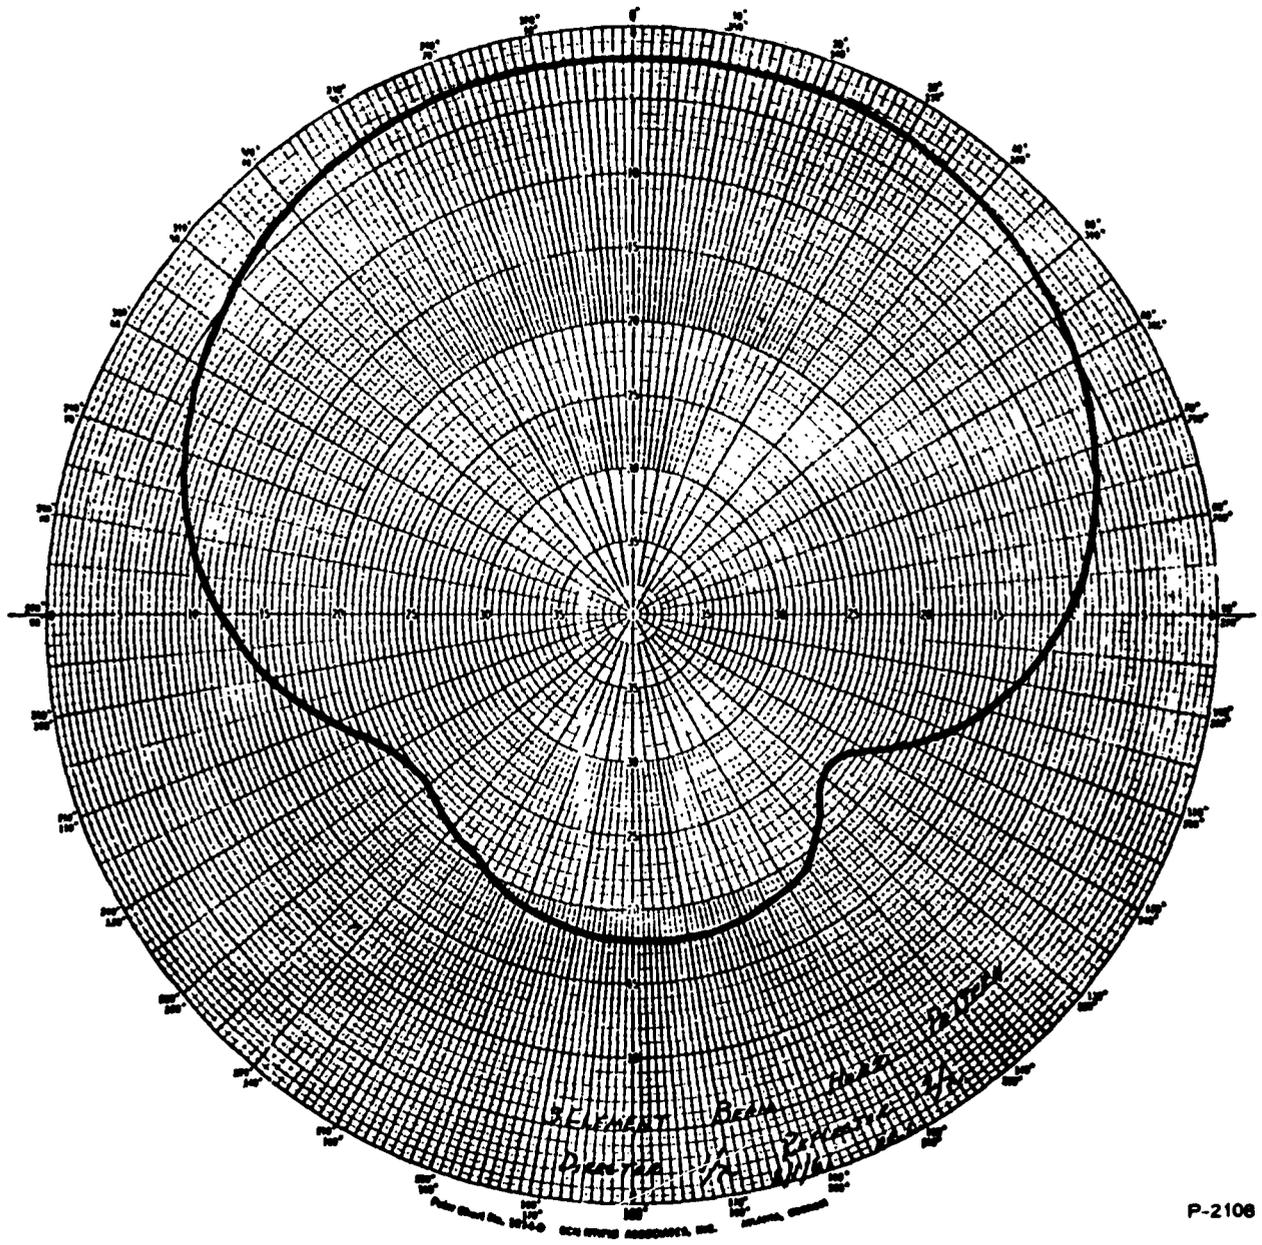
Figure 13 - Three Element Beam, Horizontal Pattern

This antenna has a 6.5 db gain in sensitivity over the quarter wave dipole. The front-to-back ratio of this antenna is 15 db, which is another improvement over the dipole antenna. In operation, this antenna can be manually oriented to the direction of flight the sonde takes at launch, or if the GMD-1 is near by, visual correspondence with the GMD-1 antenna can be made.

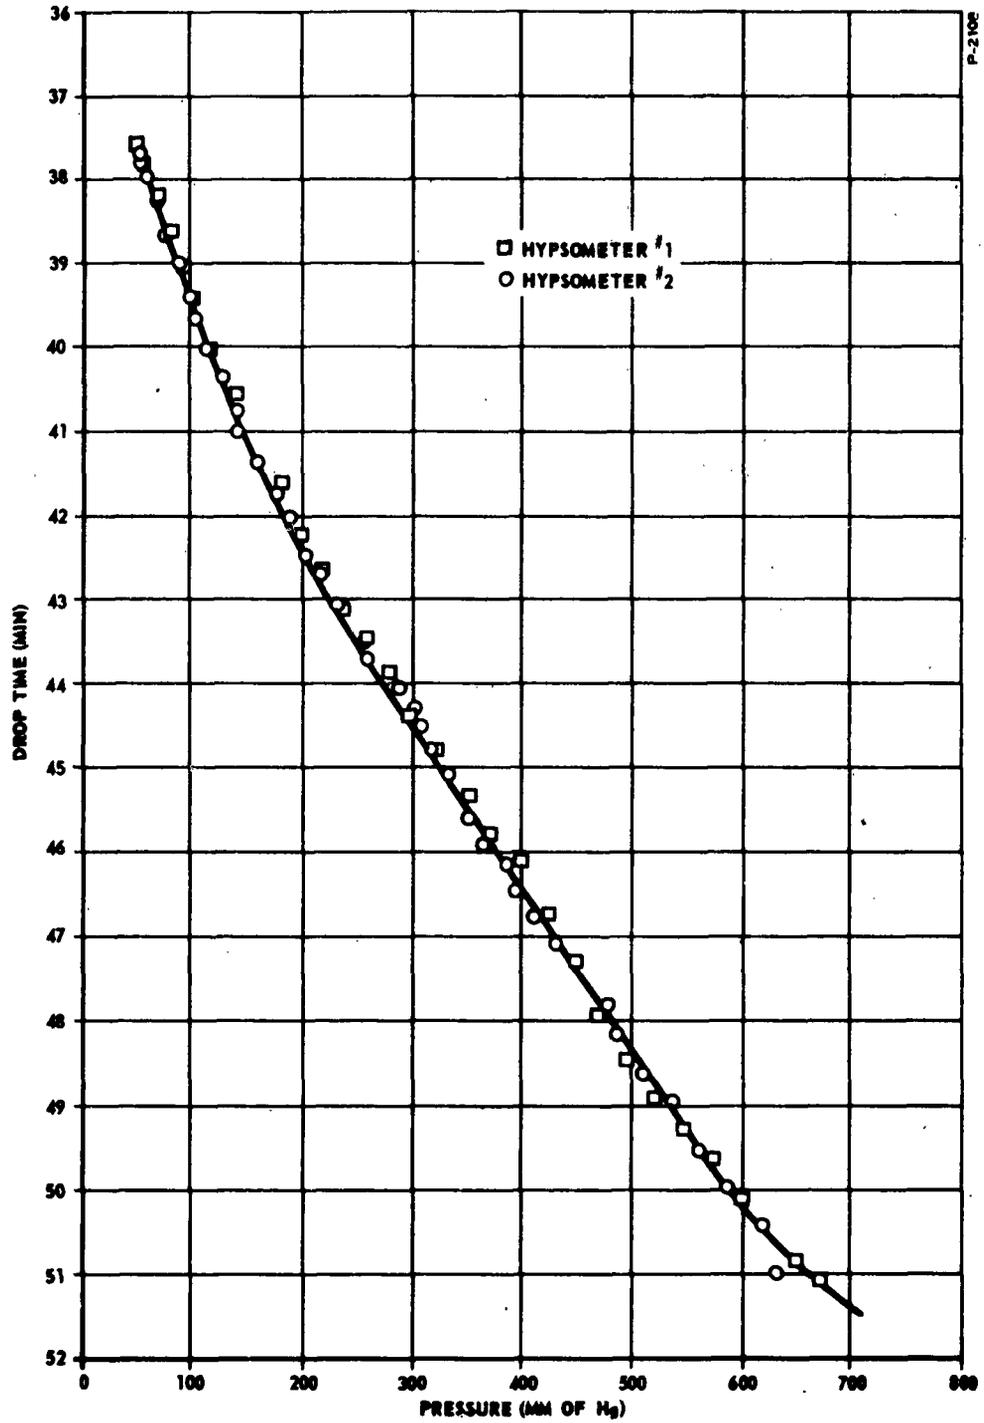
Figure 15 - Hypsometer Output, Flight No. 1

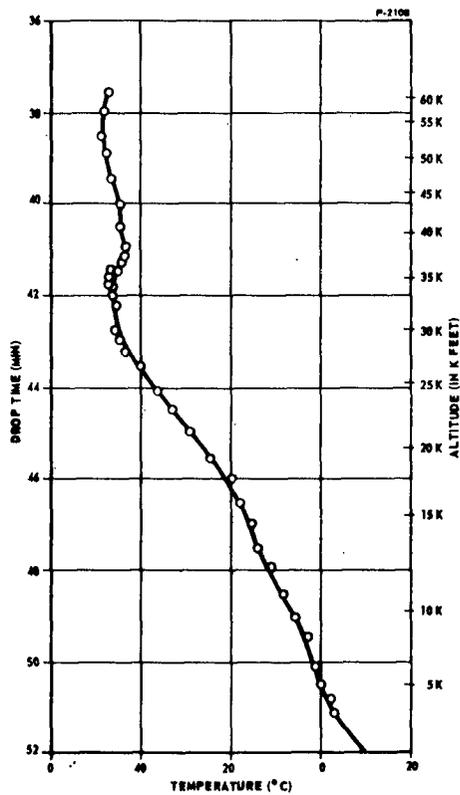
Figure 16 - Temperature, Flight No. 1

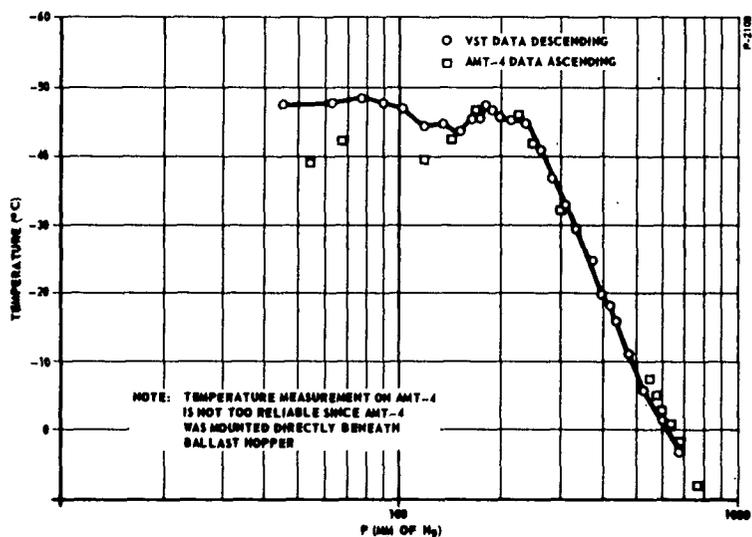
Figure 17 - Pressure-Temperature Comparison, Flight No. 1

After the pressure-temperature data had been reduced a comparison chart was constructed (Figure 17) with the AMT-4 data received from the balloon in the ascent portion of the flight. It was known however, that the particular mounting place selected for the AMT-4 did not lend itself to accurate temperature measurement due to the reflective surfaces of the ballast canisters on the launch vehicle. The curves for both data sources show a definite agreement at the lower altitudes with the main difference at the higher altitudes being temperature as noted above.

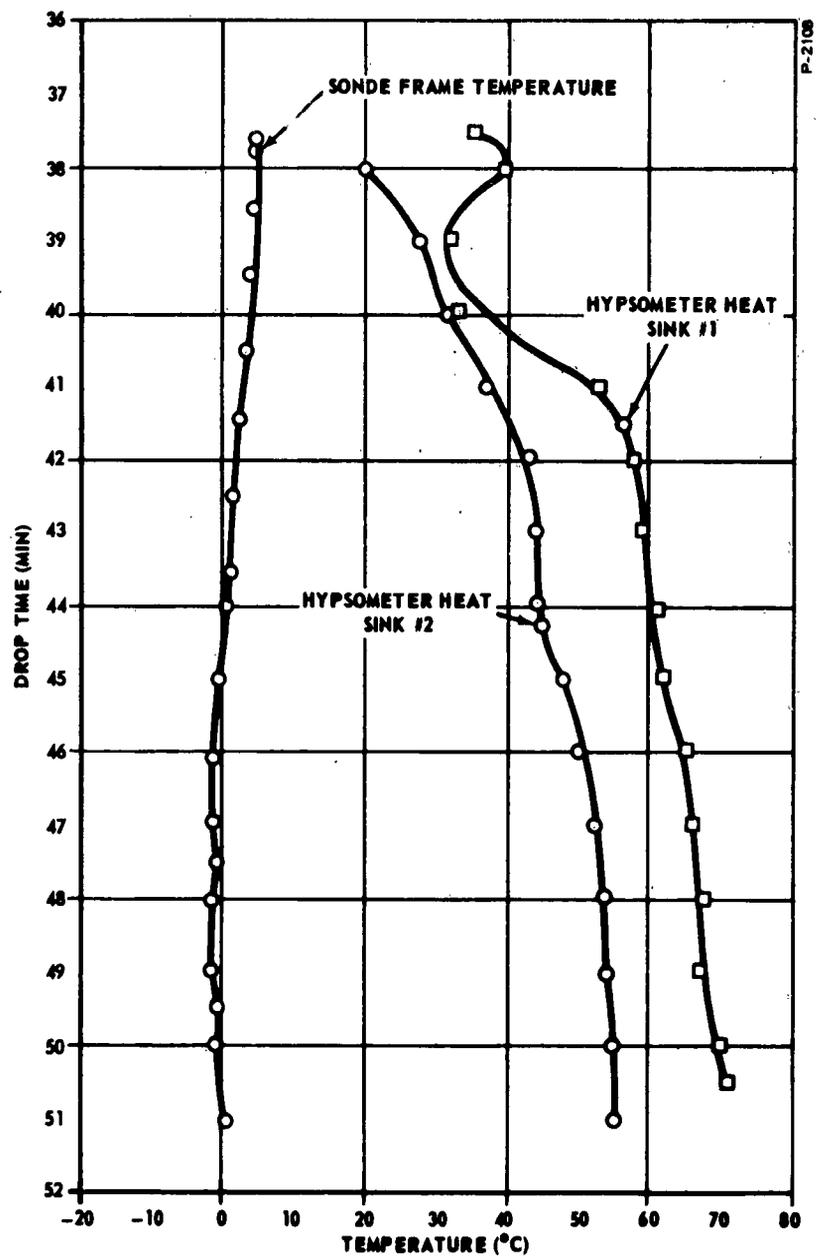
Figure 18 - Hypsometer Data, Flight No. 1

The associated readouts referenced to the hypsometer were also graphed. The sonde frame temperature data (Figure 18) indicated that the temperature variation was from a +5 °C at the beginning of the flight to a -1.25 °C after nine and a half minutes had

elapsed. The final temperature indicated a 0 °C reading at the termination of the flight. The two heat sink temperature sensors, one for each hypsometer, indicate an offset between the two of about 15 °C. The heat sink temperature referenced to No. 1 hypsometer shows a steady increase in temperature from a +20 °C to a +55 °C. However, the heat sink temperature referenced to No. 2 hypsometer starts off at a +35 °C, with an erratic display after three minutes of flight and remaining for the rest of the flight. This erratic display of heat sink temperature could be due to a faulty thermistor.

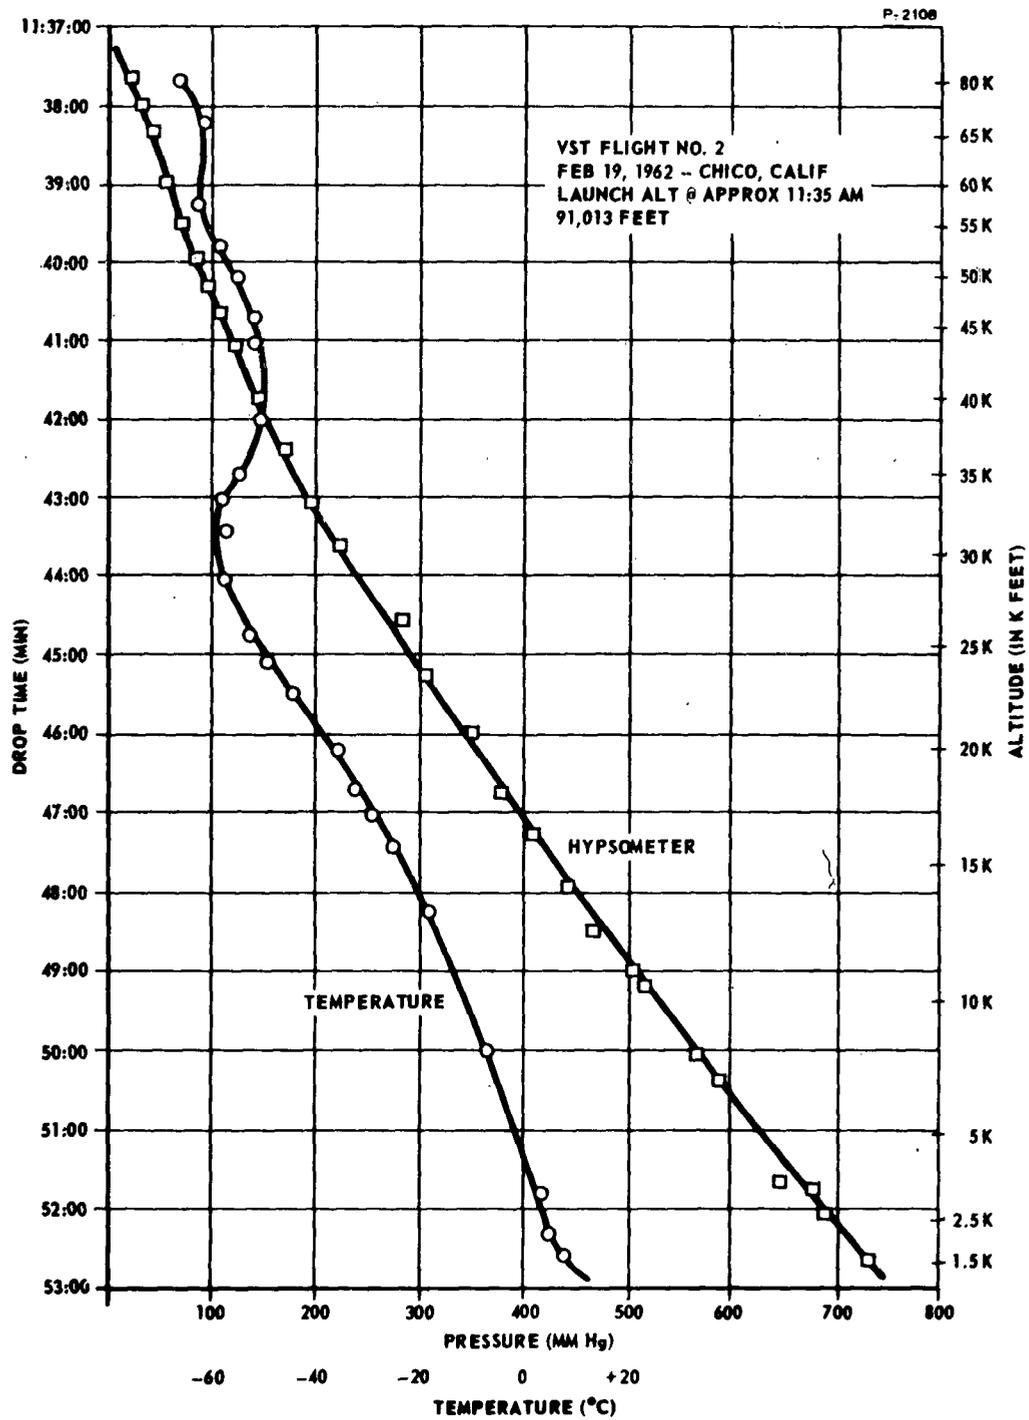
Figure 19 - Temperature-Pressure, Flight No. 2

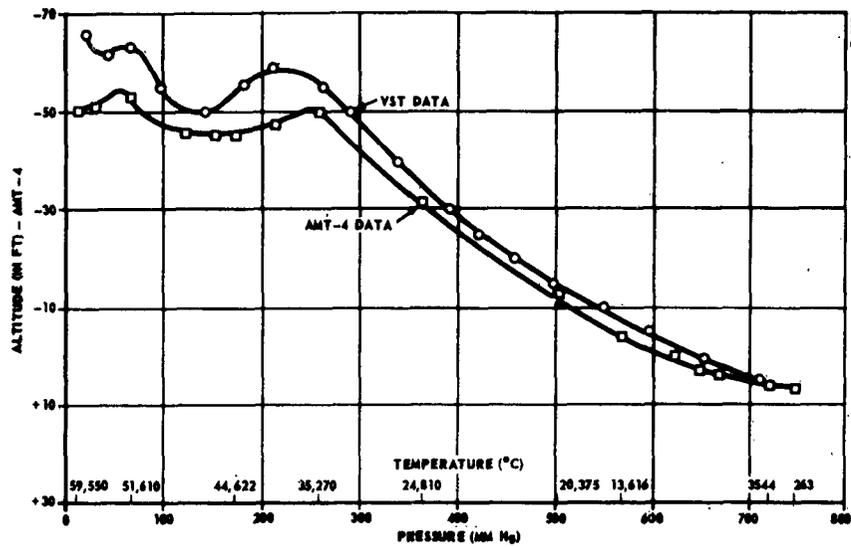
Figure 20 - Temperature-Pressure Comparison, Flight No. 2

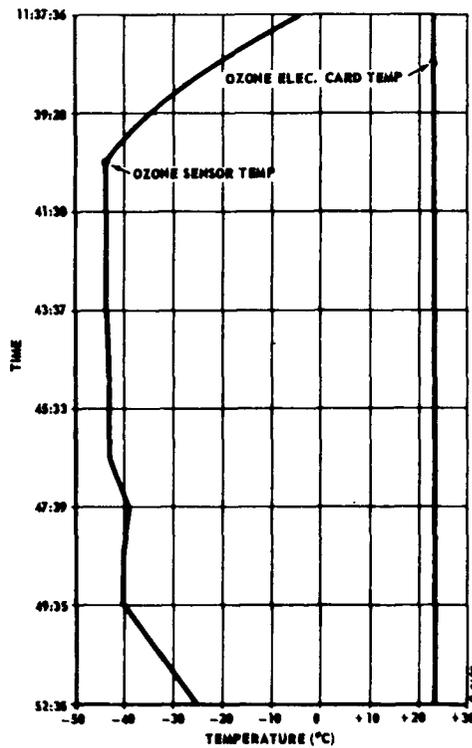
Figure 21 - Ozone Data, Flight No. 2

The first ozone sensor was also flown in this particular sonde. The data recorded at the beginning of the sampling period indicated saturation of the film. There is a reasonable possibility that a high concentration of ozone was present at the start of the flight. Additional points were monitored in the ozone sensor such as the electronic card temperature (Figure 21) which maintained a temperature of a +23 °C throughout the flight. The temperature of the sensor chamber itself was steady at a very low temperature indicating possible heater blanket failure. However, this sonde was recovered after the flight and the thermistor used for the ozone sensor temperature measurement was broken.

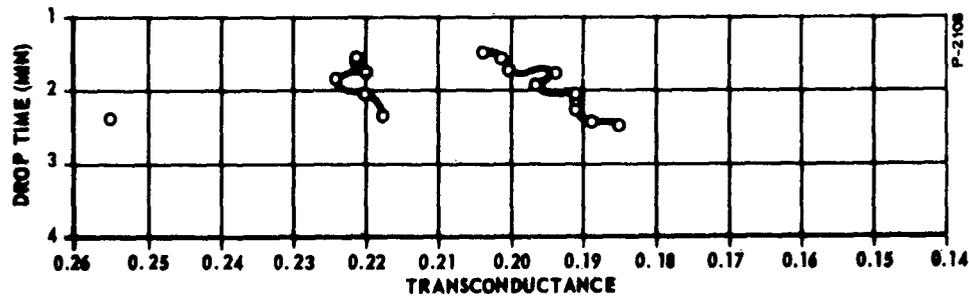
Figure 22 - Ozone Output, Flight No. 3

Data was gathered from the ozone sensor on this flight during the first minute of signal reception. However, due to the limited points recorded and the inconsistency of these points, it is impossible to draw any firm conclusions with respect to the content of the data received (Figure 22). Information on the ozone sensor temperature was recorded indicating an average temperature of +24 °C which was not available due to a broken thermistor on the previous ozone flight.

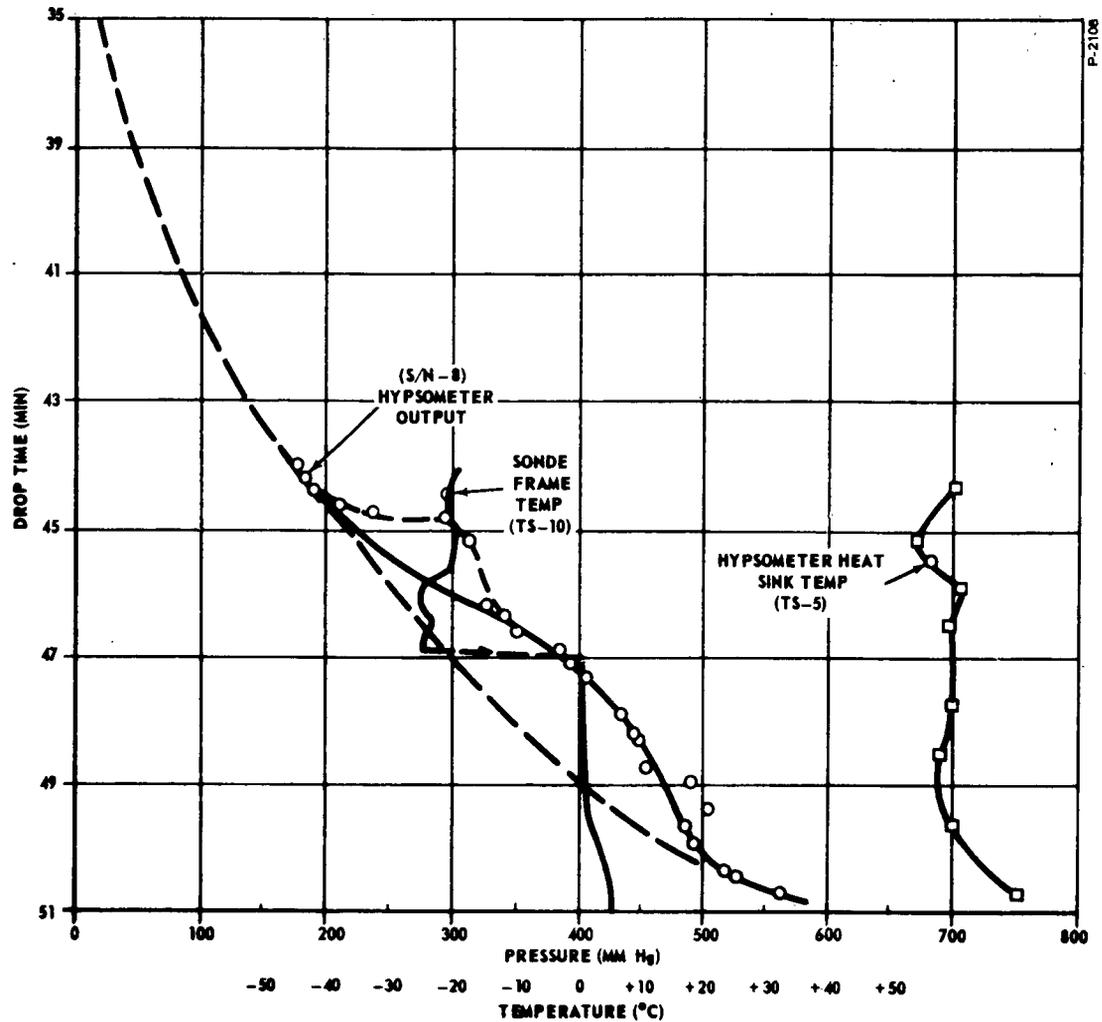
Figure 23 - Hypsometer Data, Flight No. 4

The data for the hypsometer pressure sensor (Figure 23) was the first to be reduced, but only that portion later in time with respect to the above mentioned voltage point. The remainder of the pressure profile received seems to be in agreement with those observed previously. The sonde frame temperature sensor data started at a point with a negative trend; however, after about three minutes there appeared to be a step change in output in the positive direction. From this point to the end of the flight the trend was positive as has been experienced before. There is at this time no explanation of what could have occurred to give the step change referenced. The hypsometer heat sink temperature was fairly constant until the last minute of flight data and then started to increase rather rapidly.

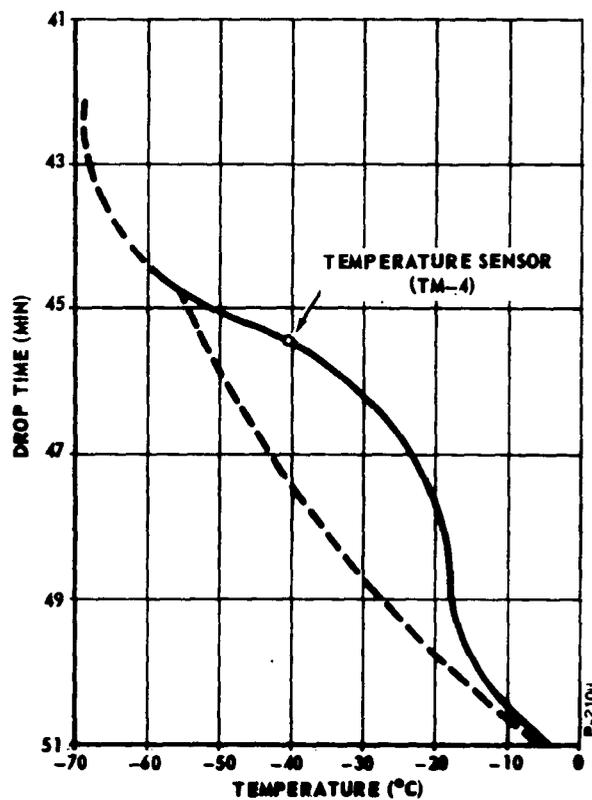
Figure 24 - Temperature, Flight No. 4

The data corresponding to the temperature sensor output (Figure 24) in general look similar to those reproduced on foregoing flights. However, there appears to be a discontinuity in the curve as

appears in the hypsometer curve starting after 10 minutes of elapsed flight time and settling out around 14 minutes after drop. There is a possibility that the low battery voltages at turn on produced a detrimental effect in the sensor electronics that cannot be compensated for with the applied error correction factor.

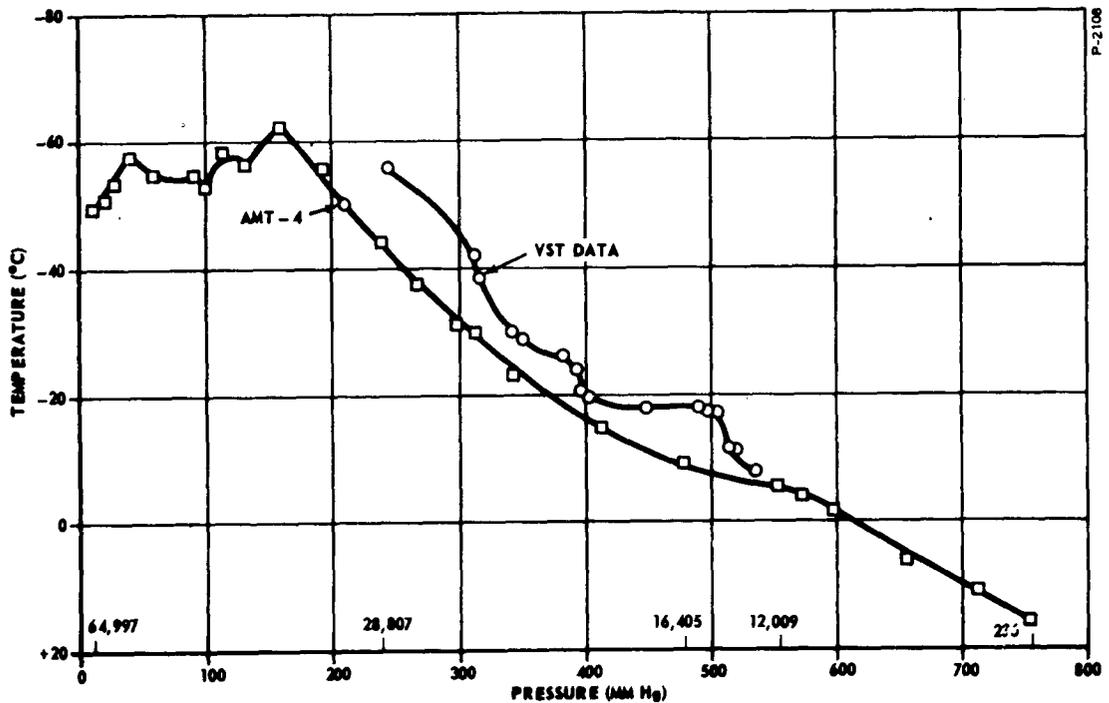
Figure 25 - Temperature-Pressure Comparison, Flight No. 4

With both the temperature and pressure data available, a comparison chart was constructed with the AMT-4 data acquired on the flight ascent. It was observed that there was an offset of data points between the two with several irregularities in the VST sonde data. With an averaging curve drawn from the sonde data, the curve characteristics (Figure 25) are quite similar to those of the AMT-4.

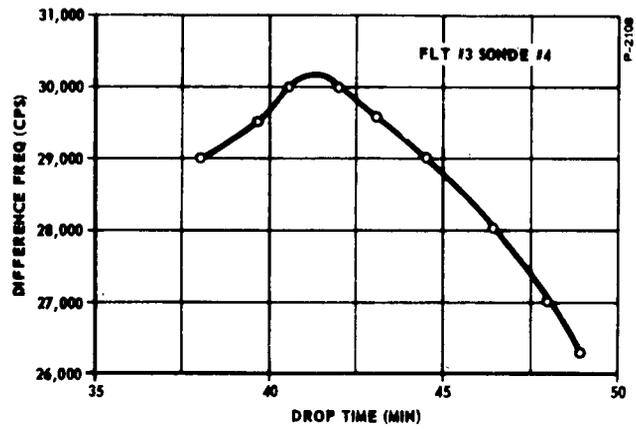
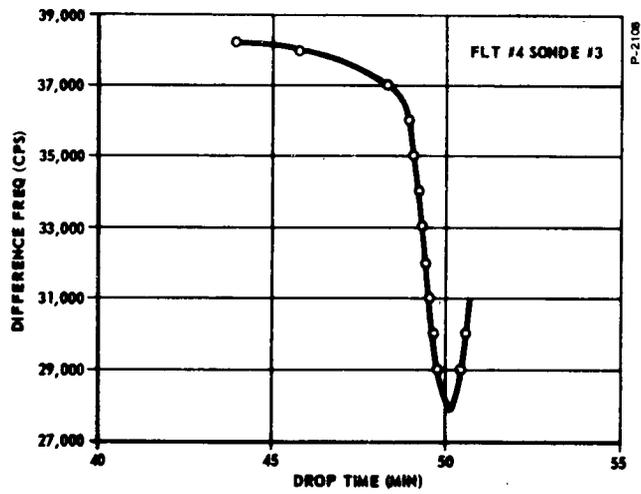
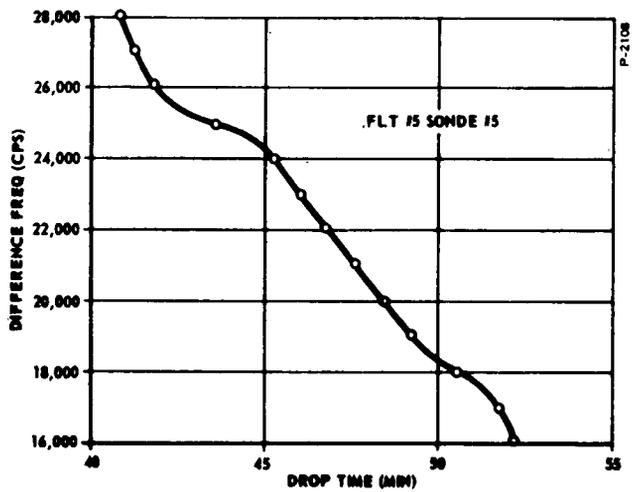
Figure 26 - Index of Refraction Output, Flight Nos. 3, 4, and 5

The index of refraction sensor output on board this sonde appeared to be on several segments of the commutator. A curve of the index of refraction sensor output was plotted (Figure 26) using the data received from this sonde and was shown to be very similar to that of flight number four, the main difference being that the slope was more gradual and always in the same direction. The signal received time was about 30 seconds after launch so the information gathered is over the entire drop profile.
