⑤ Research Labs. Div.
Bendix Corp., Southfield, Mich.

⑥ DEVELOPMENT OF AN ATMOSPHERIC SOUNDING
DROPSONDE, GROUND RECEIVING AND
DATA PROCESSING STATION.

FIELD TEST REPORT.

⑪ February 1965,

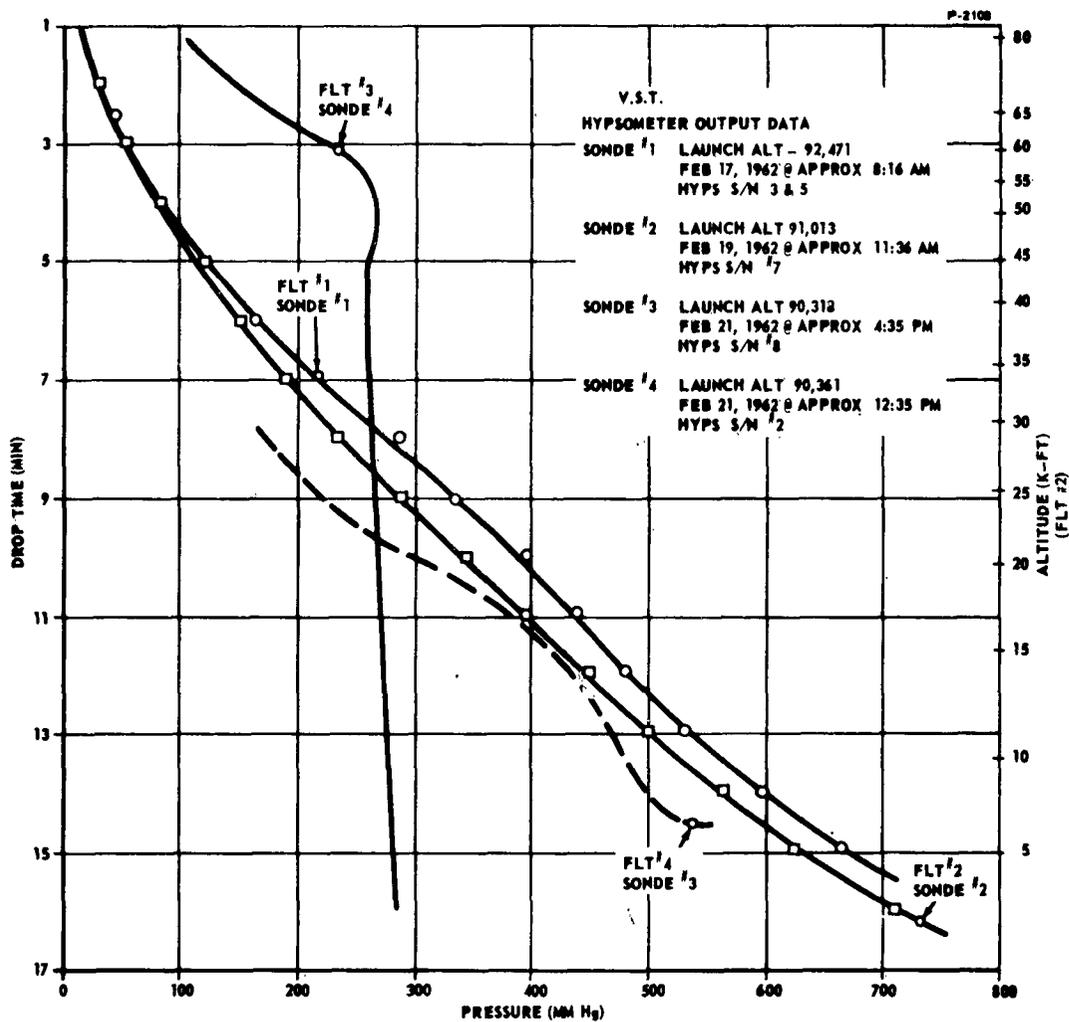
Figure 27 - Composite Graph of Hypsometer Output Data Flight Nos. 1, 2, 3, and 4

Each sonde that was flown contained a pressure measuring device or hypsometer. Of the six hypsometers that were flown, four of them provided information that is generally considered as being reliable (Figure 27). Of the remaining two hypsometers, it is believed that the one flown on flight number three experienced a malfunction in the heater. This was verified by the indications supplied by the associated points monitored within the hypsometer sensor. The remaining hypsometer output was not obtained due to an internal problem in the sonde affecting data transmission. It was learned, after the return of the sonde flown on the second flight, that the water used in the hypsometer had condensed out on the surface of the commutator. This conclusion was drawn by the evidence of what appeared as an oxide coating on the commutator board and was further confirmed by a second sonde recovered and returned at a much later date. As this information was available after the last flight was terminated, remedial action could not be taken.
