Report No. NATF(SI)-EI-115

6 May 1965

AIRFIELD TELEVISION CONTROL CENTER MOBILE UNIT EVALUATION

BUREAU OF NAVAL WEAPONS PROBLEM ASSIGNMENT NUMBER RSSH-99-059/204/8

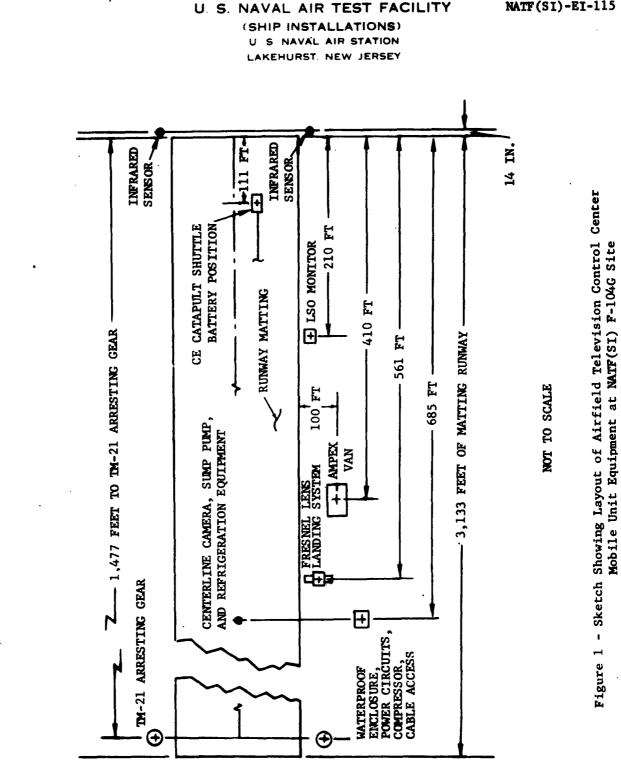
(1) One camera with extend/retract mirror assembly and variable glide-slope presentation capability is installed in a pit on the F-104G site runway centerline, 685 feet from the approach end of the matting. A special matting section is required for installation. The pit also contains equipment to heat or cool the camera to maintain proper operating temperature. A sump-pump installation is provided to keep the pit dry. Located to the left side of the runway and connected to the pit by two underground 6-inch pipes is a waterproof enclosure. This enclosure contains an air compressor for operating the pop-up mirror assembly and the centerline camera, ventilating fans for the camera pit, and circuit breakers for equipment in the waterproof enclosure and pit. (See Figures 1, 2, and 3.)

(2) One tripod-mounted observation camera with panning and zooming capabilities is mounted on the roof of the trailer located on the left side of the runway, 410 feet forward of the approach end of the matting: it can also be located up to 200 feet from the equipment trailer, whichever affords the optimum vantage point. The camera is equipped with a 400-millimeter zoom lens for use as a pan camera for overall aircraft coverage, and is connected by a video control cable to a camera control unit in the equipment trailer (see Figures 1, 4, and 5).

(b) Installation of system components in relation to the overall site is illustrated in Figure 1. Located as indicated, the system imposes no obstruction to ground or air traffic.

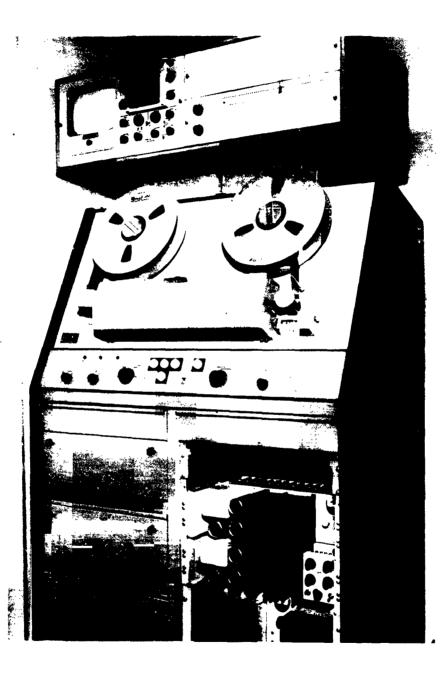
Figure 7 - Video-Tape Recording/Playback System

(b) Video-tape recording/playback system - Ampex Model VR-1100 (see Figure 7).

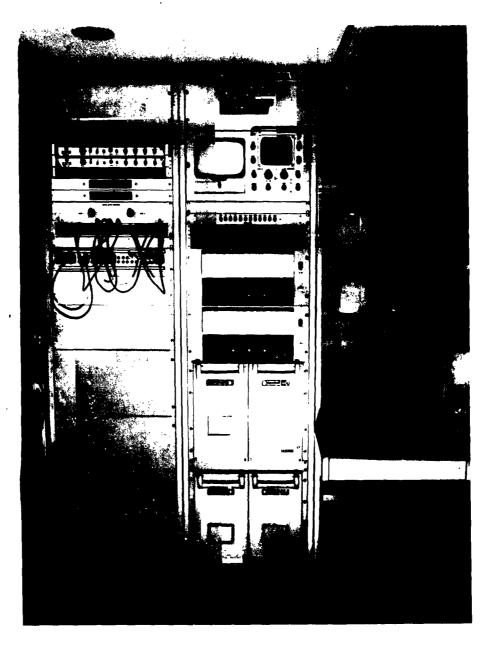
Figure 8 - Setup and Adjustment Controls for Both Centerline and Trailer-Mounted Cameras

(c) Set-up and adjustment controls for both centerline and trailer-mounted cameras (see Figure 8).

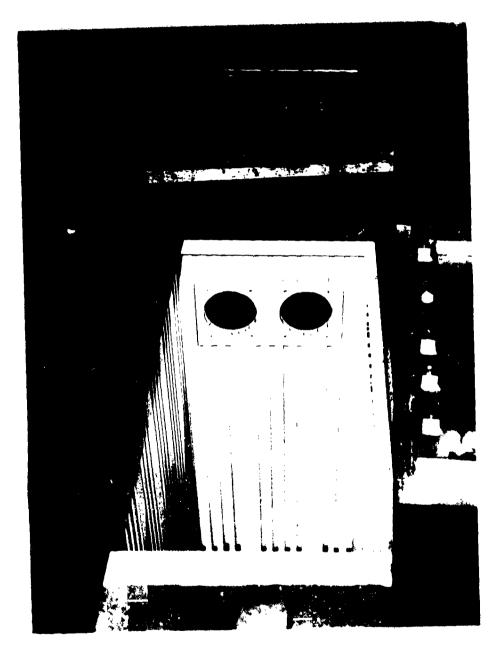
Figure 11 - Six-Inch Pipeline Leading to Centerline-Camera Pit Liner

(f) In its present design, the two 6-inch pipes that connect the centerline pit liner and the waterproof enclosure must be placed in position prior to matting installation. Because the matting joint locations can not be exactly controlled, it is unlikely that the 6-inch pipes will line up with the holes in the pit liner as was the case at NATF(SI) (see Figure 11); therefore, some type of flexible joint is required. For this installation, NATF(SI) provided sheet-metal transition sections.

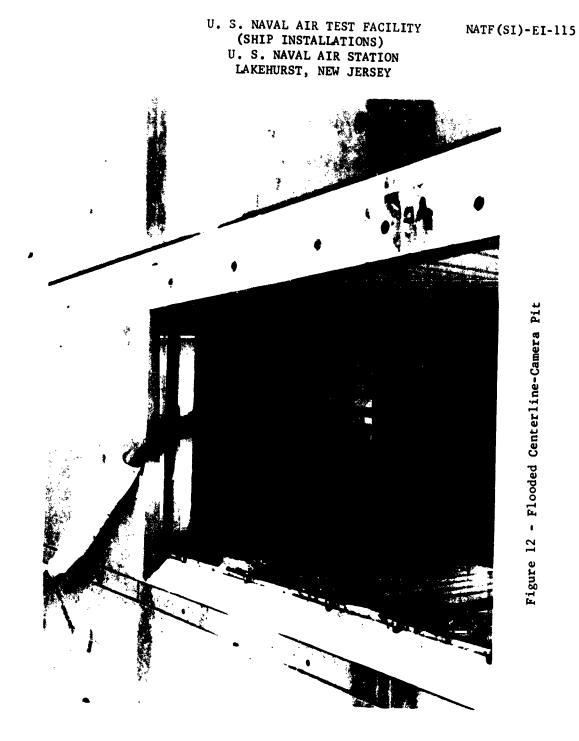
Figure 12 - Flooded Centerline-Camera Pit

(h) The centerline pit installation is not adequately protected against flooding. The pit filled with water to within one foot of the runway surface during a heavy rainstorm (see Figure 12). A largercapacity sump pump and outlet lines were provided by Ampex, but the program was concluded before this change could be properly evaluated. In addition, it is not possible to prevent dirt and condensation from entering the pit; consequently, the centerline camera must be removed once a week (a four- to six-hour operation) to clean the system optics. An accumulation of dirt or ice can prevent the mirror from being raised or lowered as required. The watertight seals on the centerline-camera case were damaged during initial installation, thereby making it impossible to properly pressurize the case. During a heavy rainstorm, four gallons of water entered the case. Evaluation of this component could not be conducted because the proper design configuration (a sealed, pressurized, waterproof housing) was never realized. Although structural tests were not performed, the pit assembly was analyzed as structurally adequate for withstanding the maximum impact and shock loads of the F-104G aircraft main wheels.

(3) The pit sump-pump system was inadequate. The substitute, a larger-capacity pump and lines, may have resolved the pit flooding situation, but time did not permit complete evaluation of the new components furnished by Ampex.

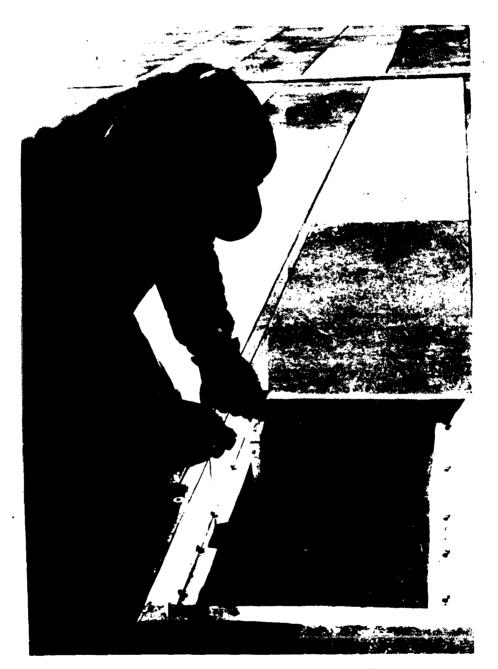
Figure 13 - NATF(SI) Modification to Centerline-Camera Pit -Required Before Camera Could be Installed

(j) From a maintenance standpoint, the centerline camera and equipment is too large for the present-size pit. Further, a NATF(SI) field modification (see Figure 13) was necessary to enable accomplishment of camera installation and removal. Some metal was removed to allow the reticule lamp housing to pass through.

g. Reduce the size of the centerline-camera assembly so as to fit into a smaller pit liner and facilitate handling.
