**X-20 HIGH TEMPERATURE SIDE WINDOW
TEST EVALUATION**

JOHN C. McGINNIS
THE BOEING COMPANY

TECHNICAL REPORT No. AFFDL-TR-65-155

NOVEMBER 1965

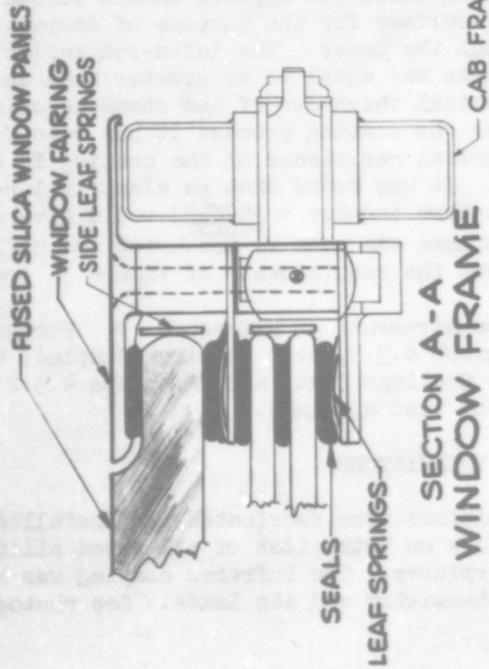
X-20 SIDE WINDOW ASSEMBLY

The window test specimen as shown in the photograph on page 5 is defined in detail by the window test assembly drawing (25-86200) which includes three triangularly shaped flat glass panes with rounded corners, a retaining frame, mounting seals, mounting springs, and retaining frame support bearings. A portion of the glider cab frame was included to correctly simulate the support conditions at the three bearing locations. A special vacuum box was also fabricated to allow for the application of air loads without structural interactions.

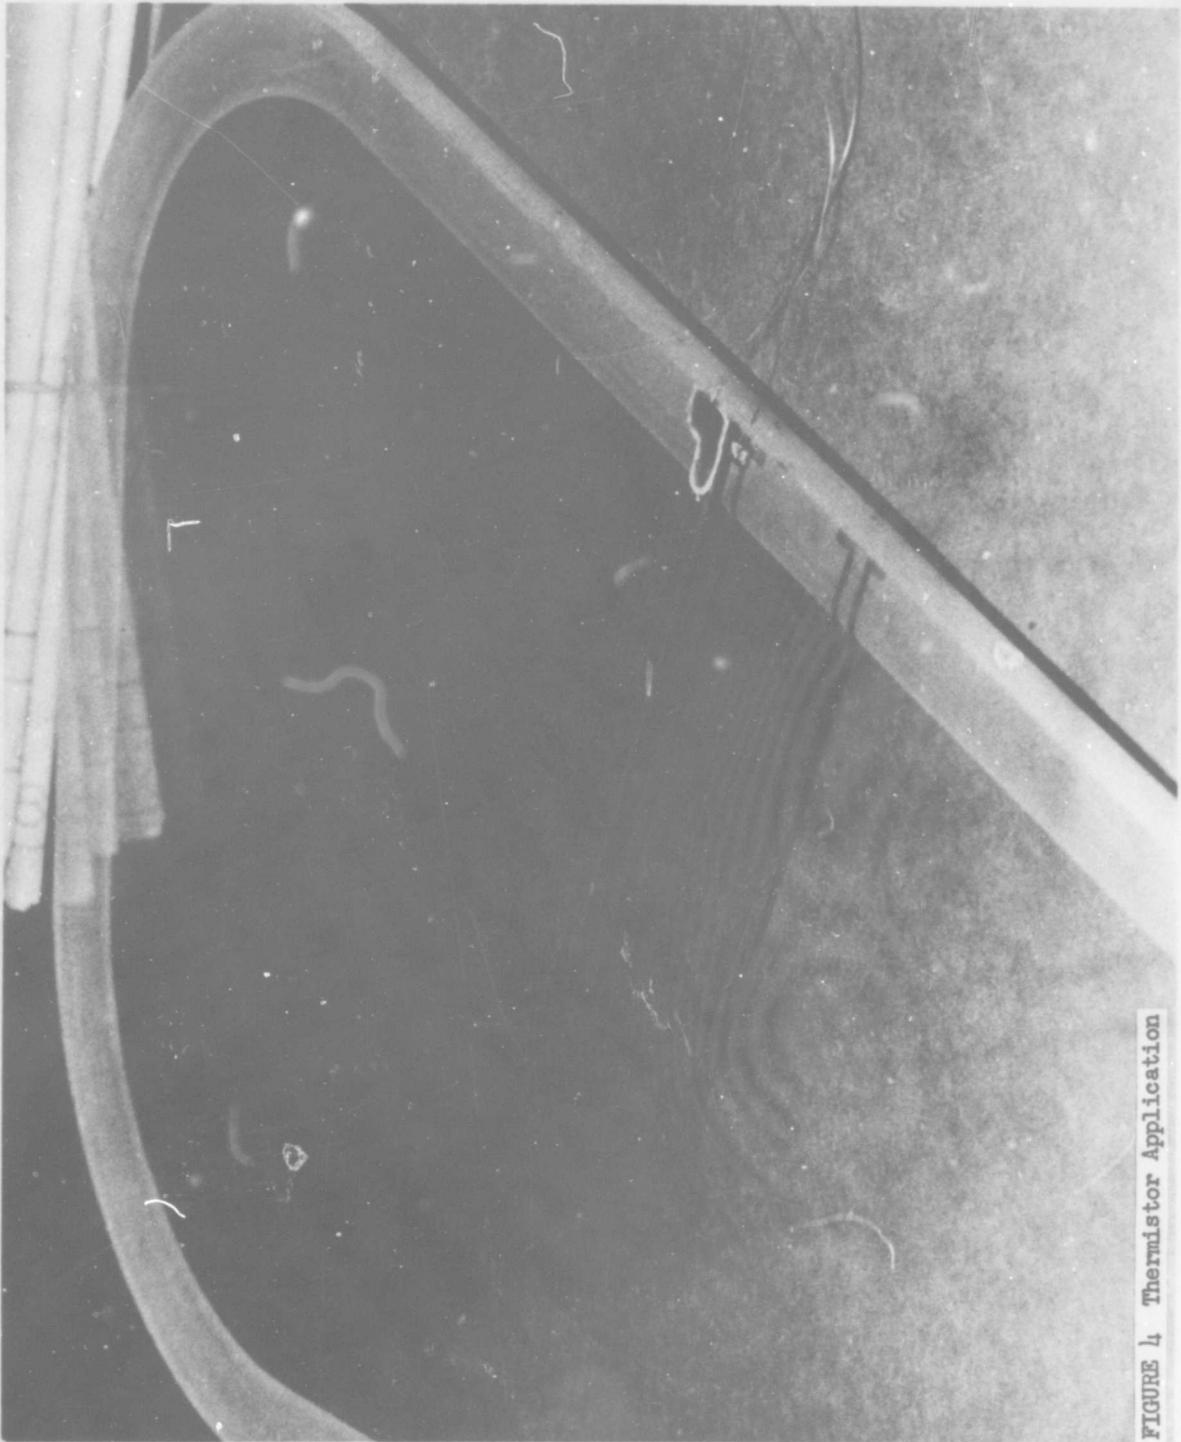
FIGURE 4 Thermistor Application

An external electrical connection is made using a .010 diameter gold wire as a lead through the window frame. The end of the .010 diameter gold wire is flattened to a thickness of .001 to .002. The flattened end is thermo-compression bonded (spotwelded) to the thermistor lead at the edge of the glass using a layer of .001 gold foil superimposed. This bonded connection then has a one square inch refrasil tape pad, .010 inch thick, impregnated and tapered out with "Ecco-ceram" compound to act as an electrical insulator. See photograph on page 11. The gold wire is insulated with refrasil tubing except for the leads of the outer pane which must be sealed. At this location 1 mm quartz tubing is used for sealing purposes. Expansion loops are provided. The photograph on page 11 shows the thermistor lead wires. This installation was expected to withstand the vibration and heat environment without failure due to the malleable characteristics of the gold wire with adequate expansion loops provided.

The photograph on page 9 shows one thermistor lead wire after the spotwelded connection was made while the other lead has "Ecco-ceram" compound applied over the connection. The photograph on page 10 shows a close-up view after the same operations have been completed. Figures 6&7 pages 11&12 shows how the thermistor lead wires were routed through the window frame and seals. Only four lead connections occurred at the same location, however.

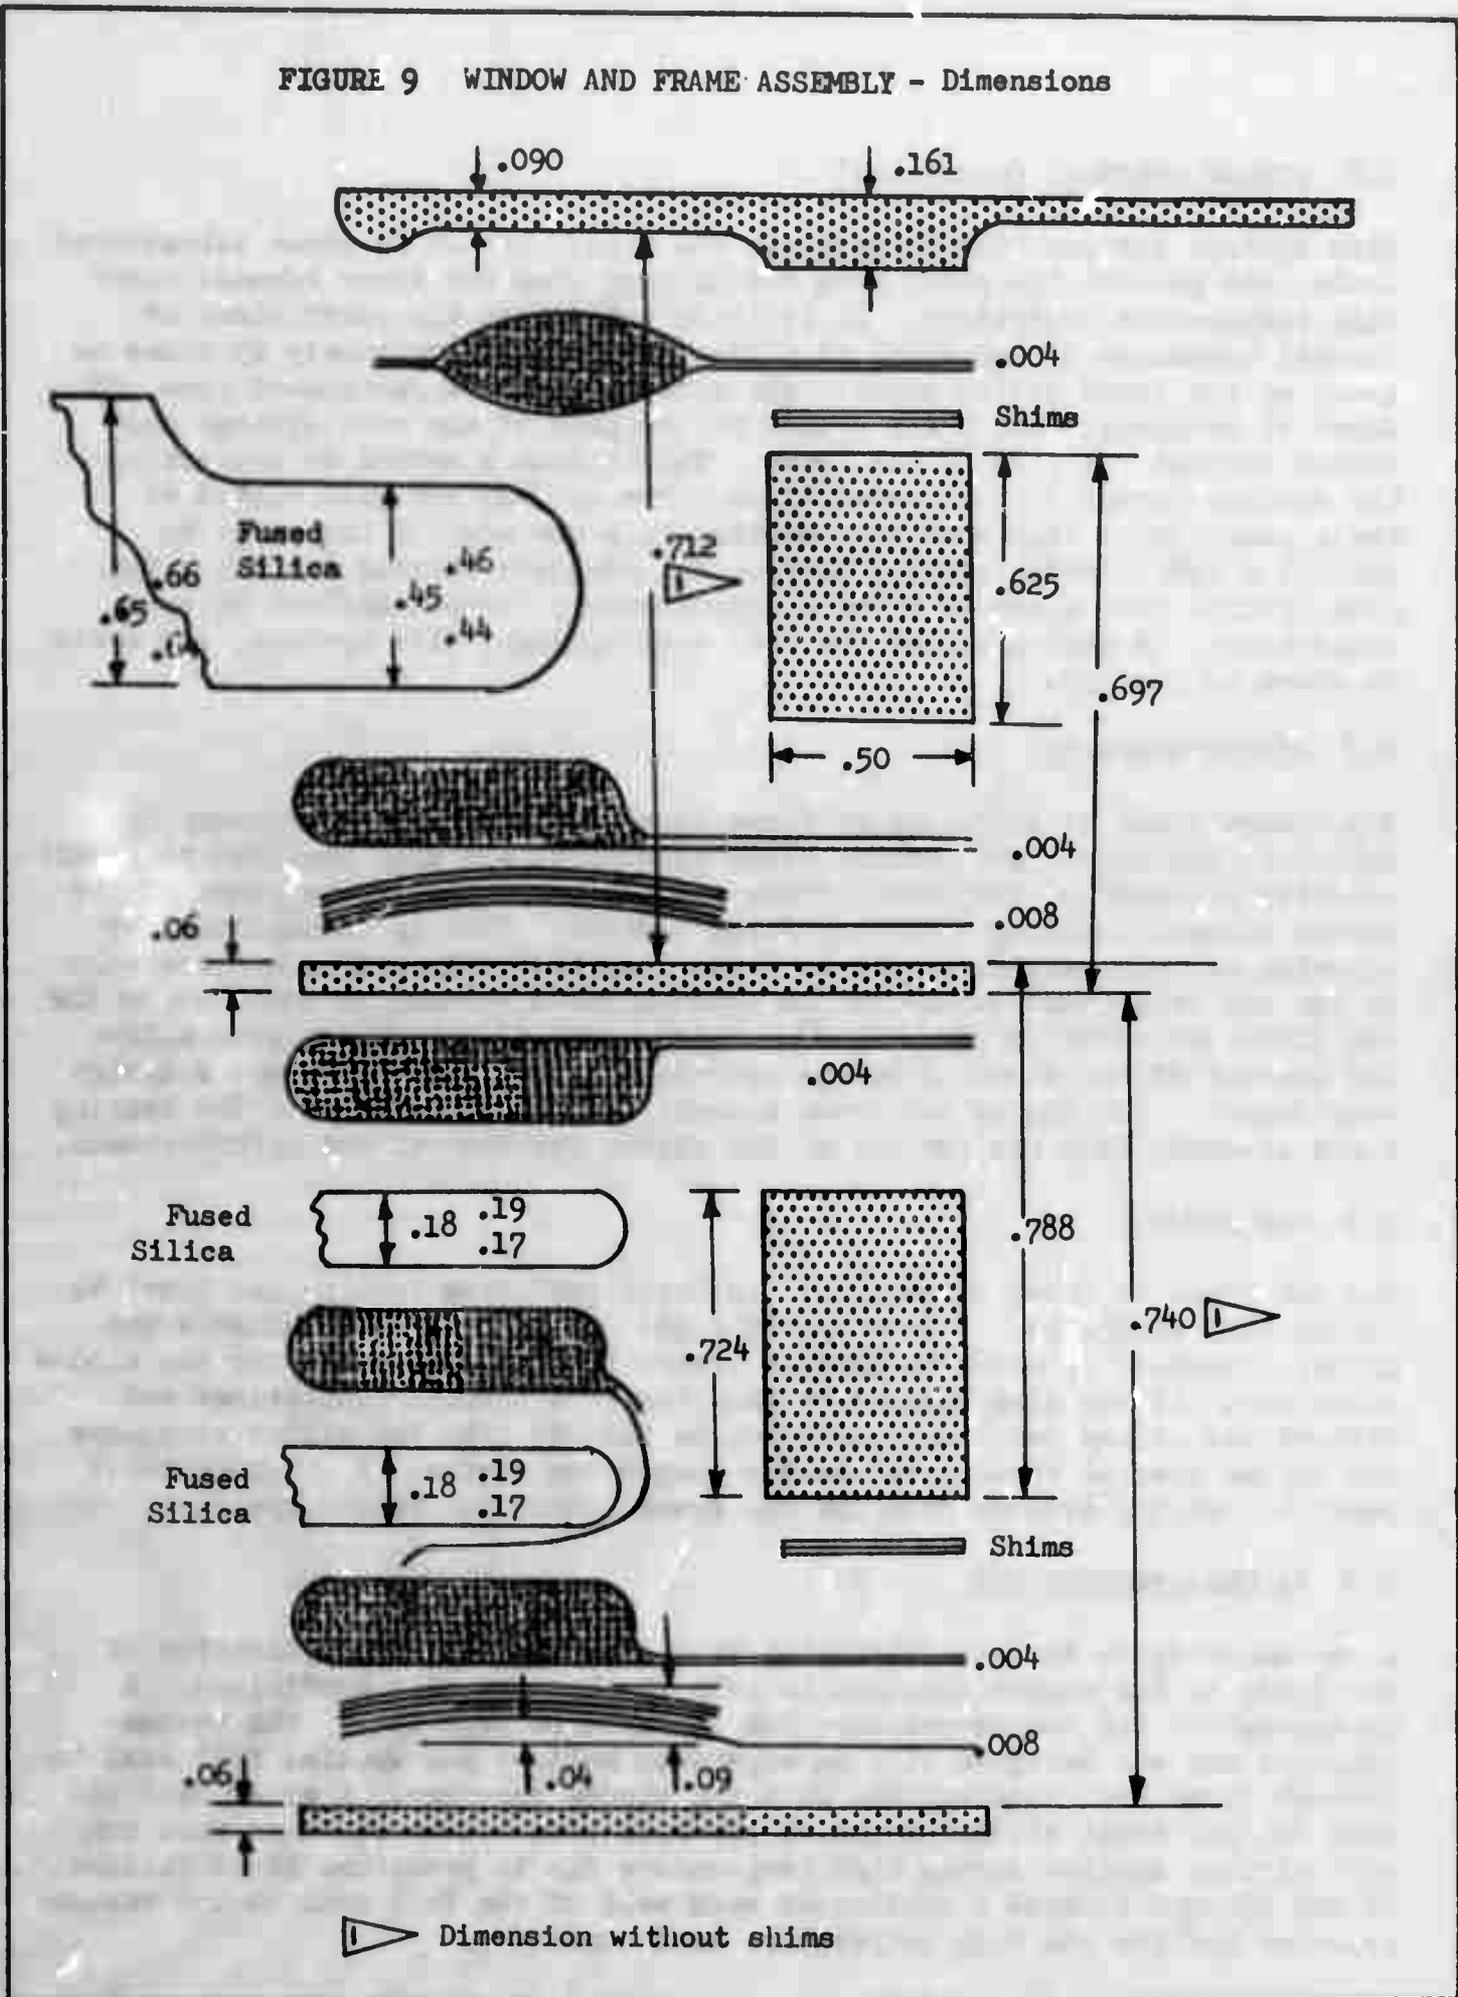
FIGURE 9 WINDOW AND FRAME ASSEMBLY - Dimensions

Shims removed where leads exit.
 No tabs on seal where leads exit.
 Hastelloy X wire mesh enclosed in Hastelloy X foil.

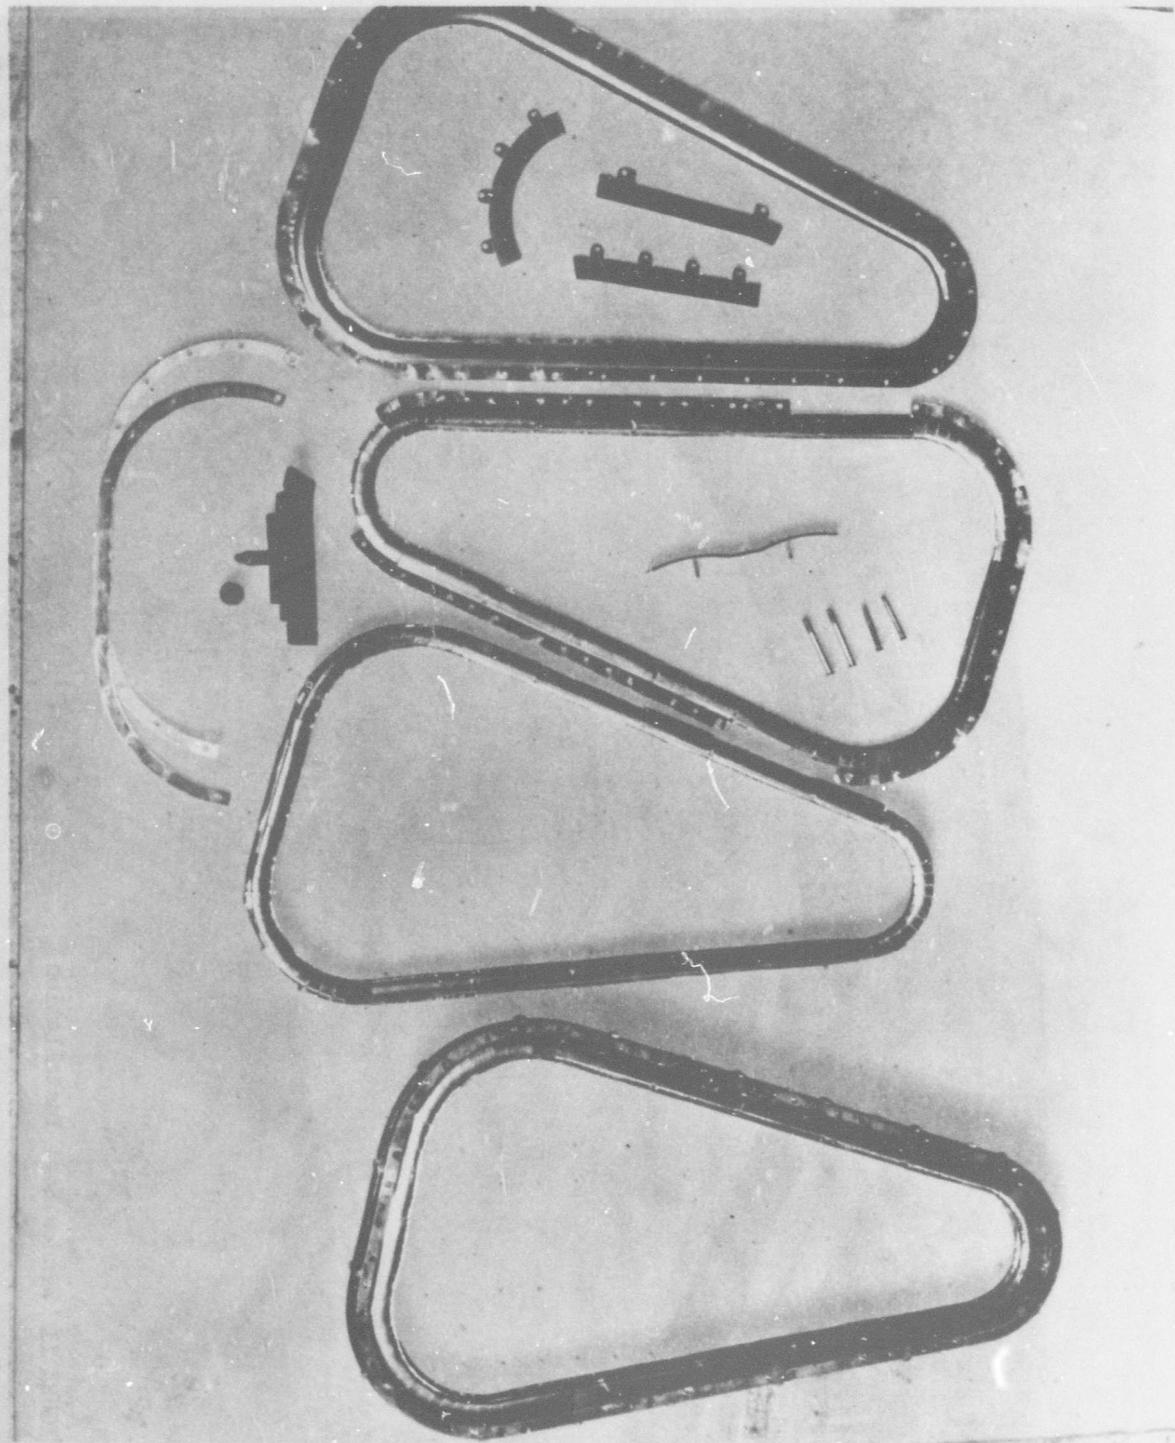
FIGURE 10 WINDOW SEALS AND SPRINGS

Side springs are provided to position the glass, absorb in plane vibrational loads, and prevent the glass from coming free when the frame expands under high temperature conditions. It is to be noted that the coefficient of thermal expansion of the Rene' 41 window frame is approximately 25 times as great as the fused silica glass. The side springs are fabricated from .05 Rene' 41 material. Studs are welded to the peak of the side springs and extend through the side of the frame. This allows a method of retracting the springs during window installation. The springs are gold plated at their peaks where they come into contact with the edge of the glass to provide a low friction sliding surface and adequate bearing surface. The side springs have a spring rate of approximately 720 pounds/inch at room temperature. A photograph of the leaf seal springs, side springs, and seals is shown on page 17.

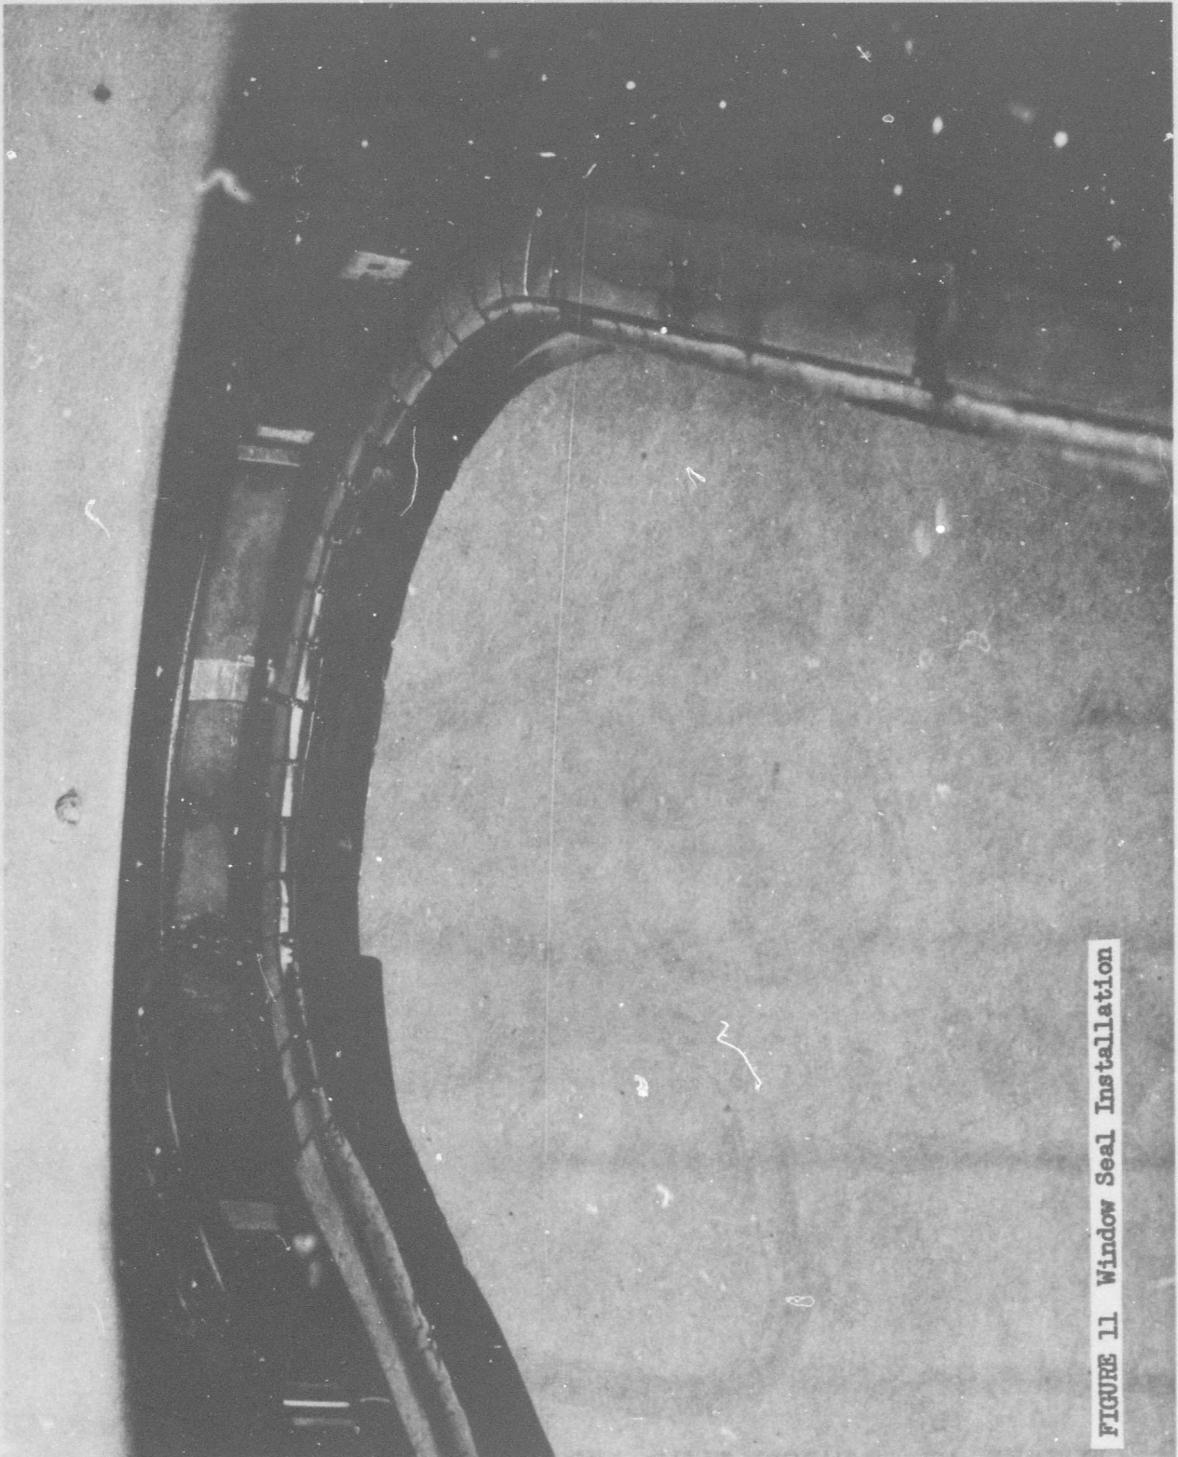
FIGURE 11 Window Seal Installation

The seals are made of a Hastelloy-X wire matrix manufactured by Johns-Manville and enclosed in a wrapping of Hastelloy-X foil which is .002 inch thick. All seals are made from the same size oval-shaped Hastelloy-X wire mesh. The outer seal is made with a continuous covering to act as a seal plane to restrict the flow of hot gas plasma into the fuselage cavity. All seals are wrapped in a jacket that is .80 inch wide except the seal that is between the two .18 inch thick inner glass panes. This seal has a jacket width that is .60 inch wide to give a greater window spacing between these glasses to assure adequate clearance during out of phase vibrations. The seals are approximately .21 inch to .25 inch thick in the uncompressed position. The seals offer a cushion for the glass panes as they are clamped between the layers of the window frame. Tests were run on the window seal configuration to obtain their spring rate and the stress relaxation at high temperature. This information is presented in the Appendix on page 181. A photograph showing the complete seals is shown on page 17. Figures 11 and 12 show positioning of the metallic window seals during assembly.

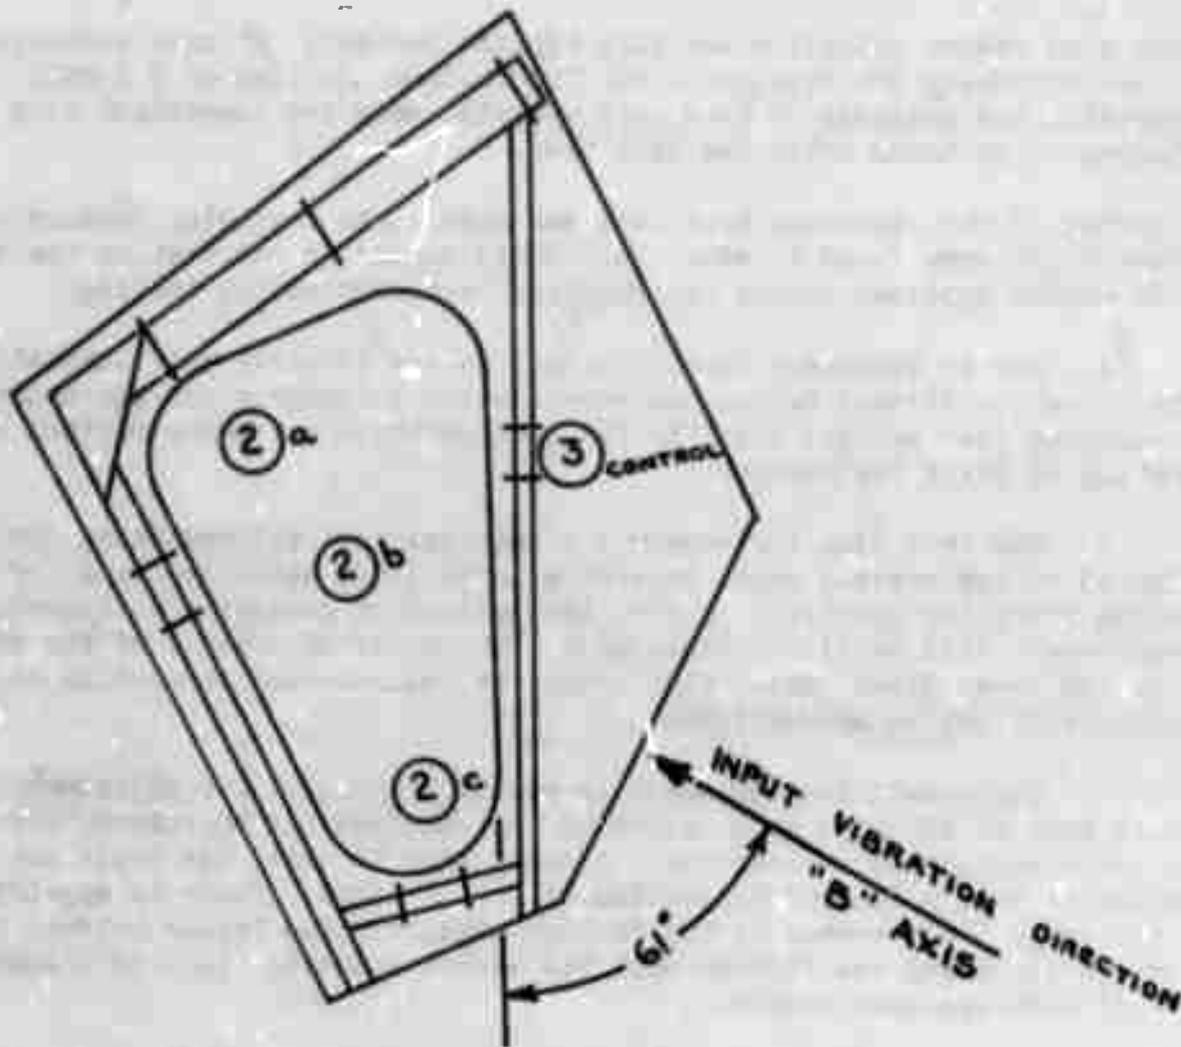
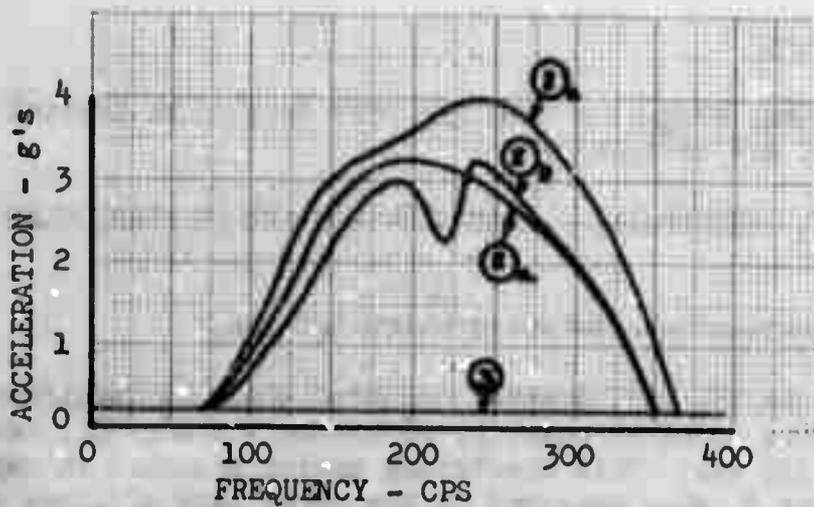
FIGURE 23
ACCELEROMETER LOCATIONS AND RESULTS - HORIZONTAL VIBRATION

b. 120 cps to 150 cps, chatter occurred which was manifested in movement of the sliding joint at point D, Reference 4 & page 42. Maximum chatter was observed at 135 cps. This chattering motion resulted in amplification factors as high as 6, when measured on the upper pane of glass and on the frame immediately adjacent to the glass. (See Figure 22 page 42).

c. The only resonances of the upper glass pane for which a mode shape could be drawn were observed at 293 cps and 429 cps. The frequency of 293 cps was attributed to a fixture resonance. The frequency of 429 cps is the only authentic glass pane resonance found. (See Figure 22 page 42). It has an amplification factor of 15 at the center of the glass.

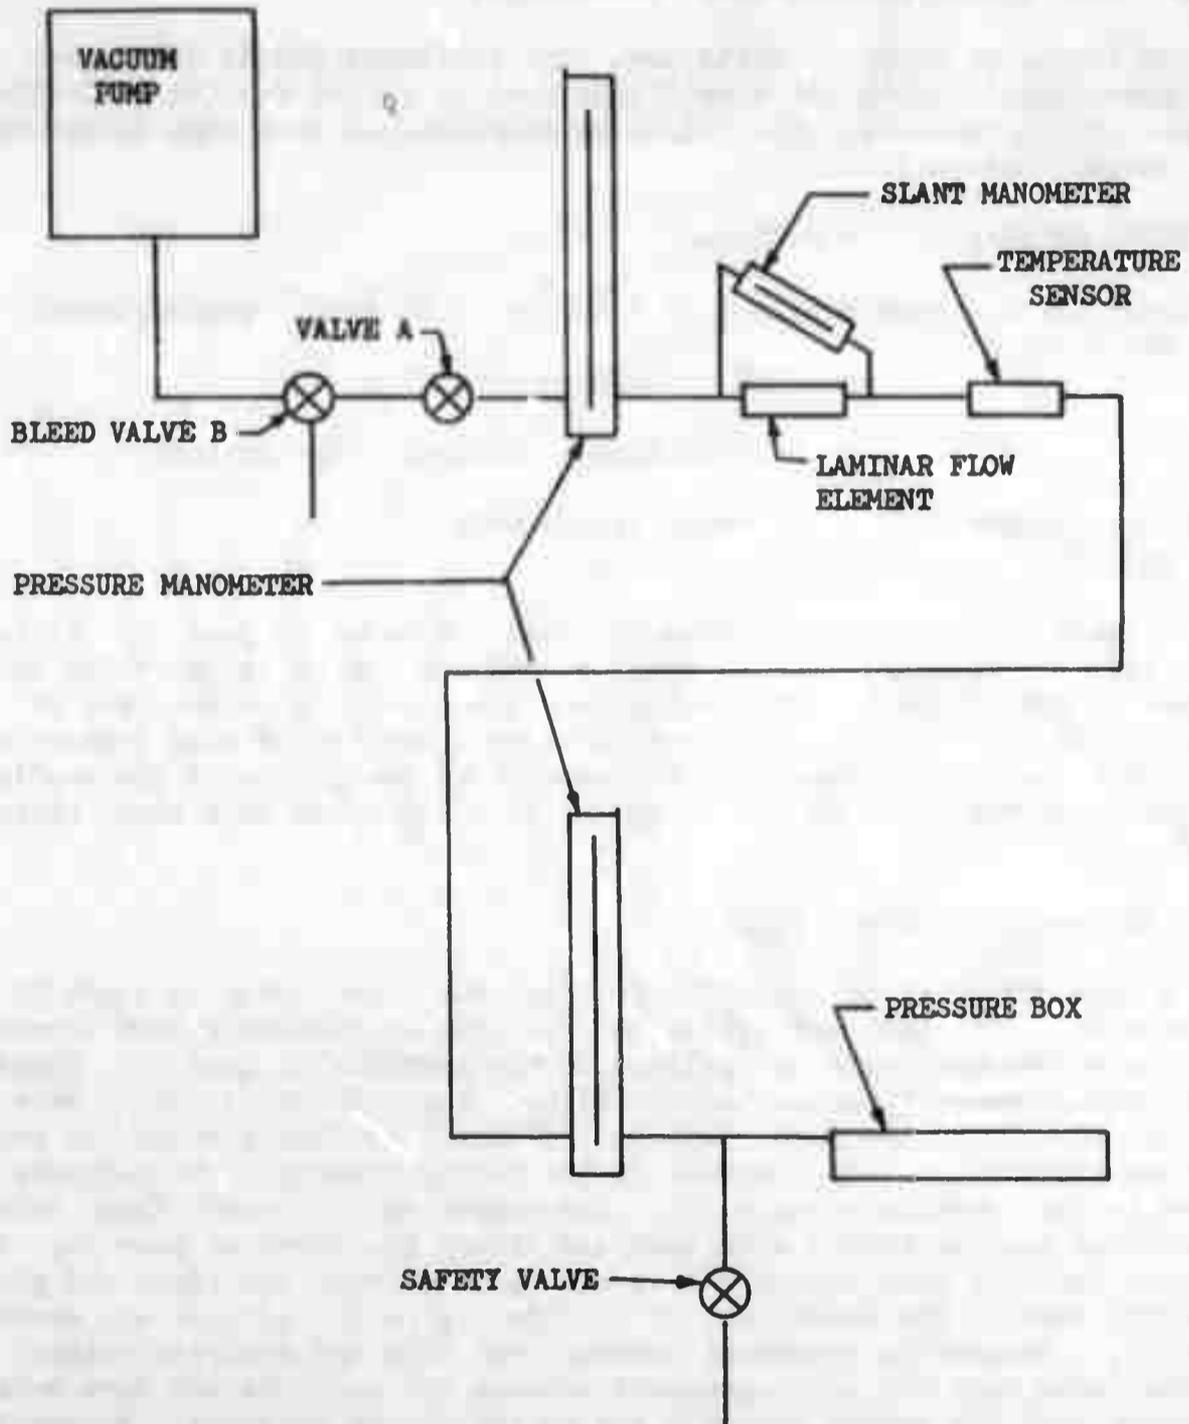
FIGURE 24 VACUUM SYSTEM SCHEMATIC TEST CONDITION 2

A schematic of the apparatus for measuring the air leakage is shown on page 47. Prior to the test, the vacuum line was capped off at the test specimen. The valve was closed and the pump shut off to assure that no leakage existed.

The procedure followed during the test was to close Bleed Valve B until the pressure manometers read the correct pressure in the pressure box and then read the Meriam Flow Meter. This indicated the amount of air flowing back to the vacuum pump and thus the amount leaking into the pressure box through the window seals. The flow meter was calibrated to read up to 1.6 SCFM with water in the manometer. When it became apparent the leakage was going to exceed 1.6 cfm, mercury was substituted for the water in the inclined manometer to extend the range.

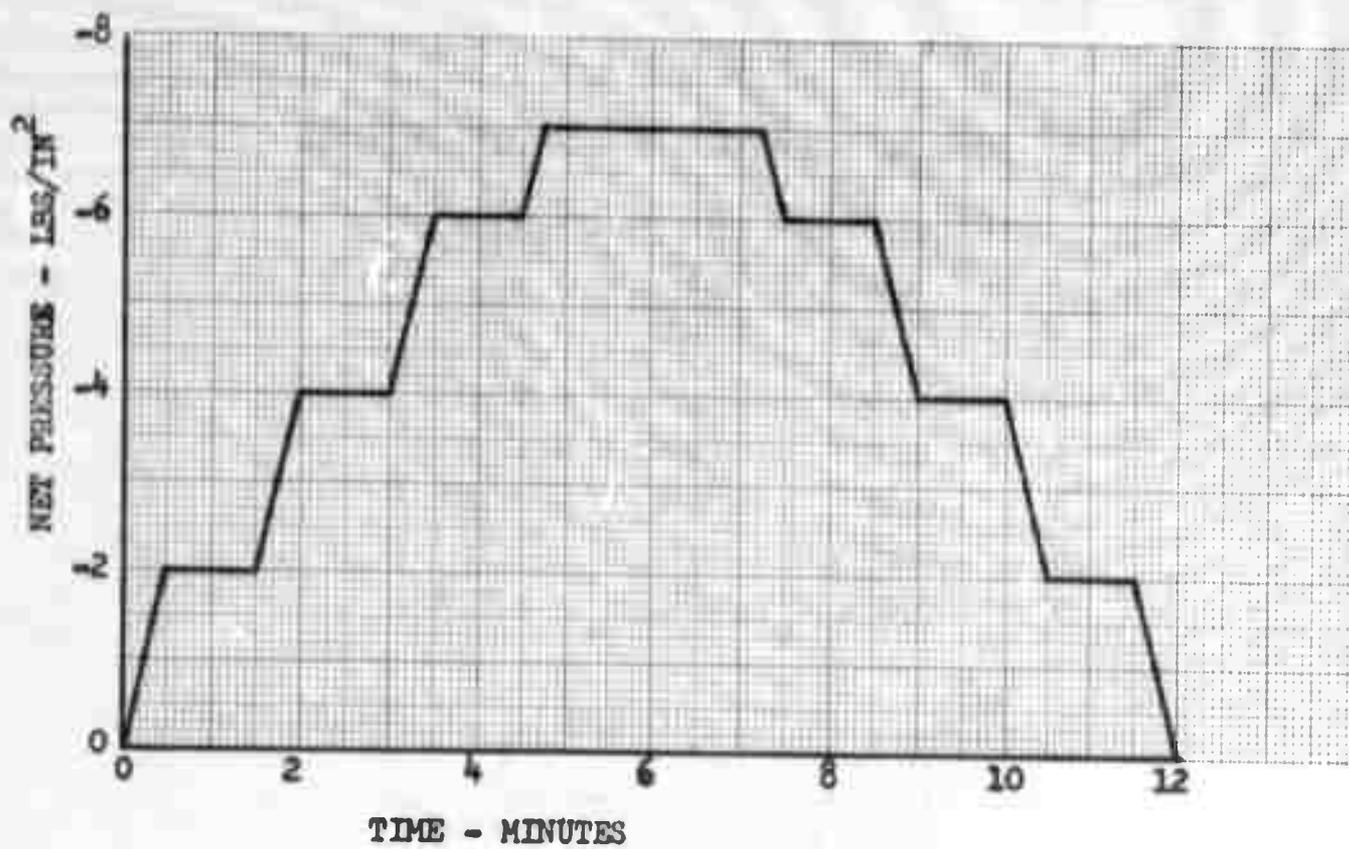
FIGURE 25 TEST HISTORY - TEST CONDITION 2 (BOOST PRESSURE)

Pressure was applied to the specimen as shown on page 49. The pressure leakage rate, and window and cab frame deflections were recorded for all test times.

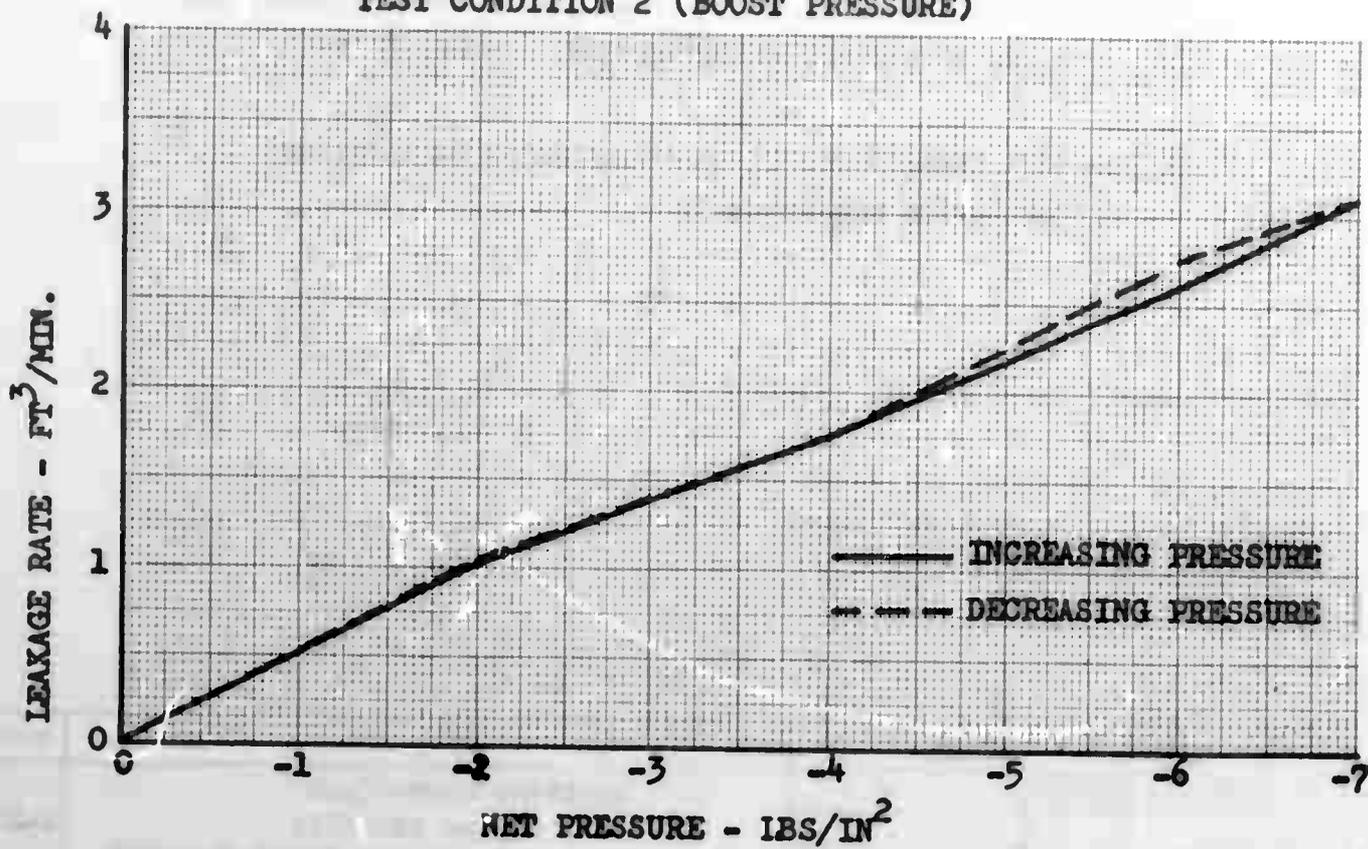
FIGURE 26 WINDOW SEAL LEAKAGE RATE TEST CONDITION 2 (BOOST PRESSURE)

The target leakage rate as defined in Reference 2 is 1.17×10^{-4} ft² per foot of seal with a corresponding leakage rate of $.55 \times 10^{-5}$ pounds/second per foot, for choked flow at standard conditions. These target requirements were set-up to control the design from the standpoint of aerodynamic heating. The above sealing capability was desired at the time of high heating during re-entry in order to seal the hot gas plasma from heating the internal fuselage cavity. Fortunately the maximum pressure during the critical heating

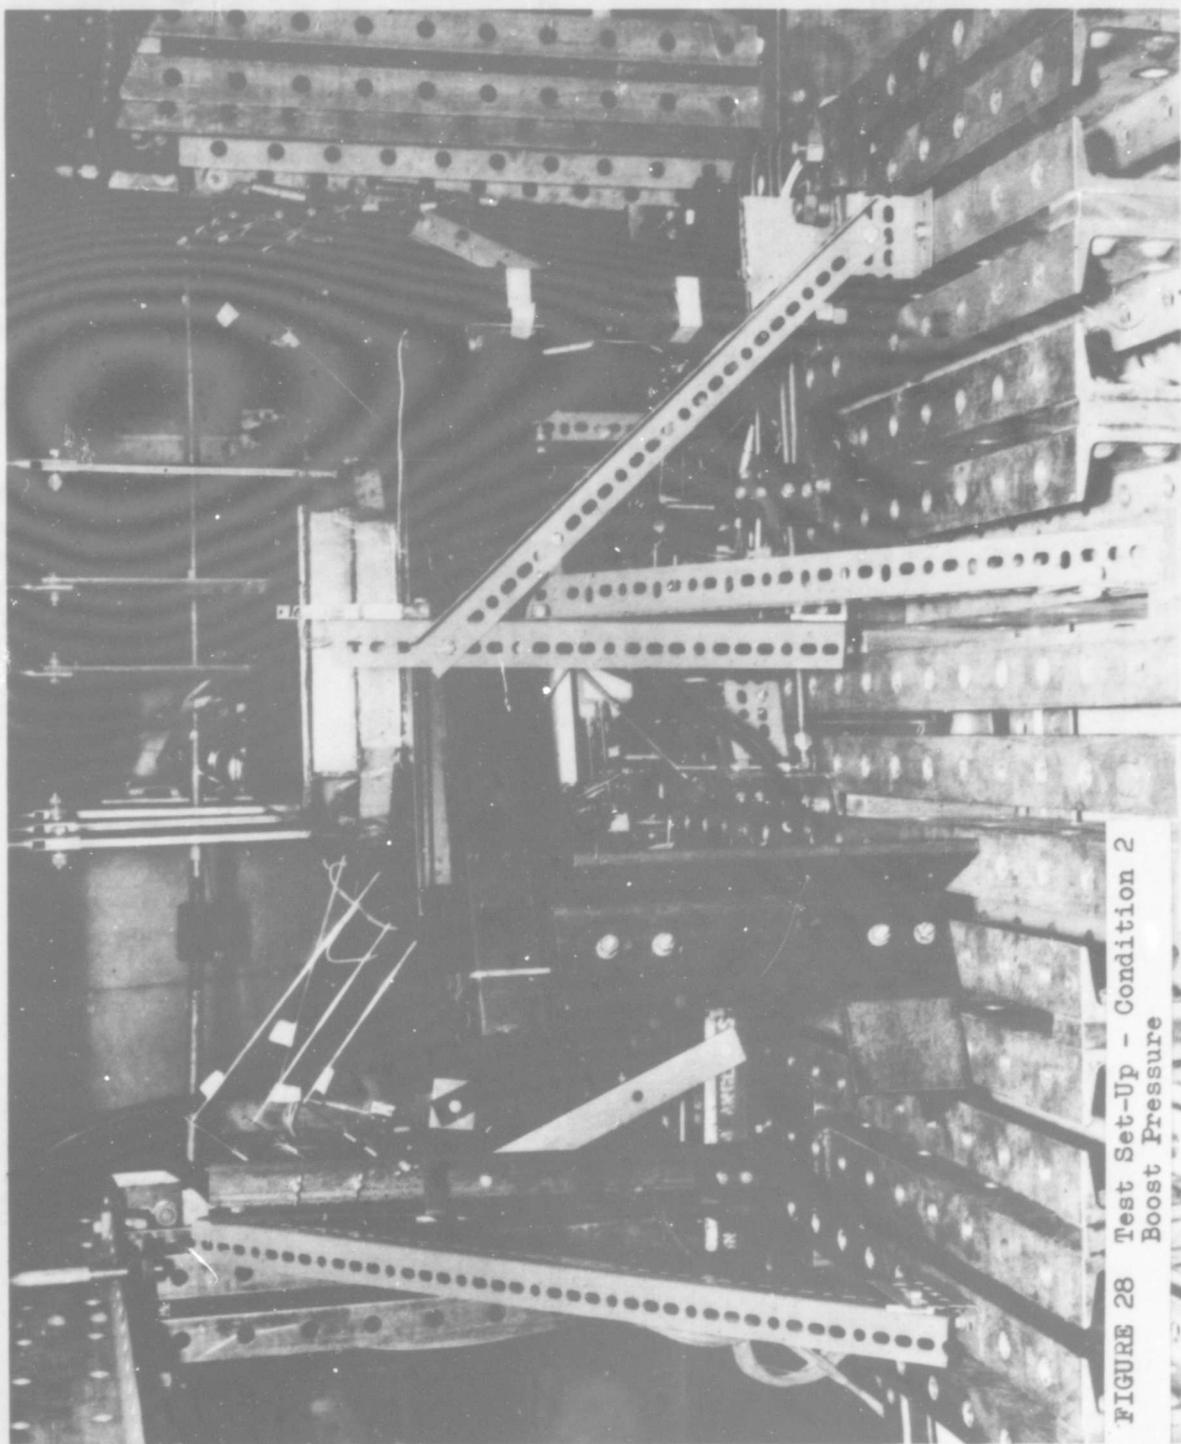
FIGURE 28 Test Set-Up - Condition 2
Boost Pressure

The window was mounted securely to the test stand. The pressure-vacuum box was mounted on the window. Mylar was initially proposed to seal the pressure box to the window frame for this test condition. The mylar was installed but did not provide a satisfactory seal. It was removed and zinc chromate putty was used to make a satisfactory seal. A photograph of the test set-up is shown on page 52.

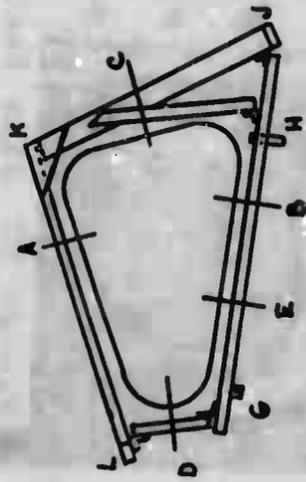
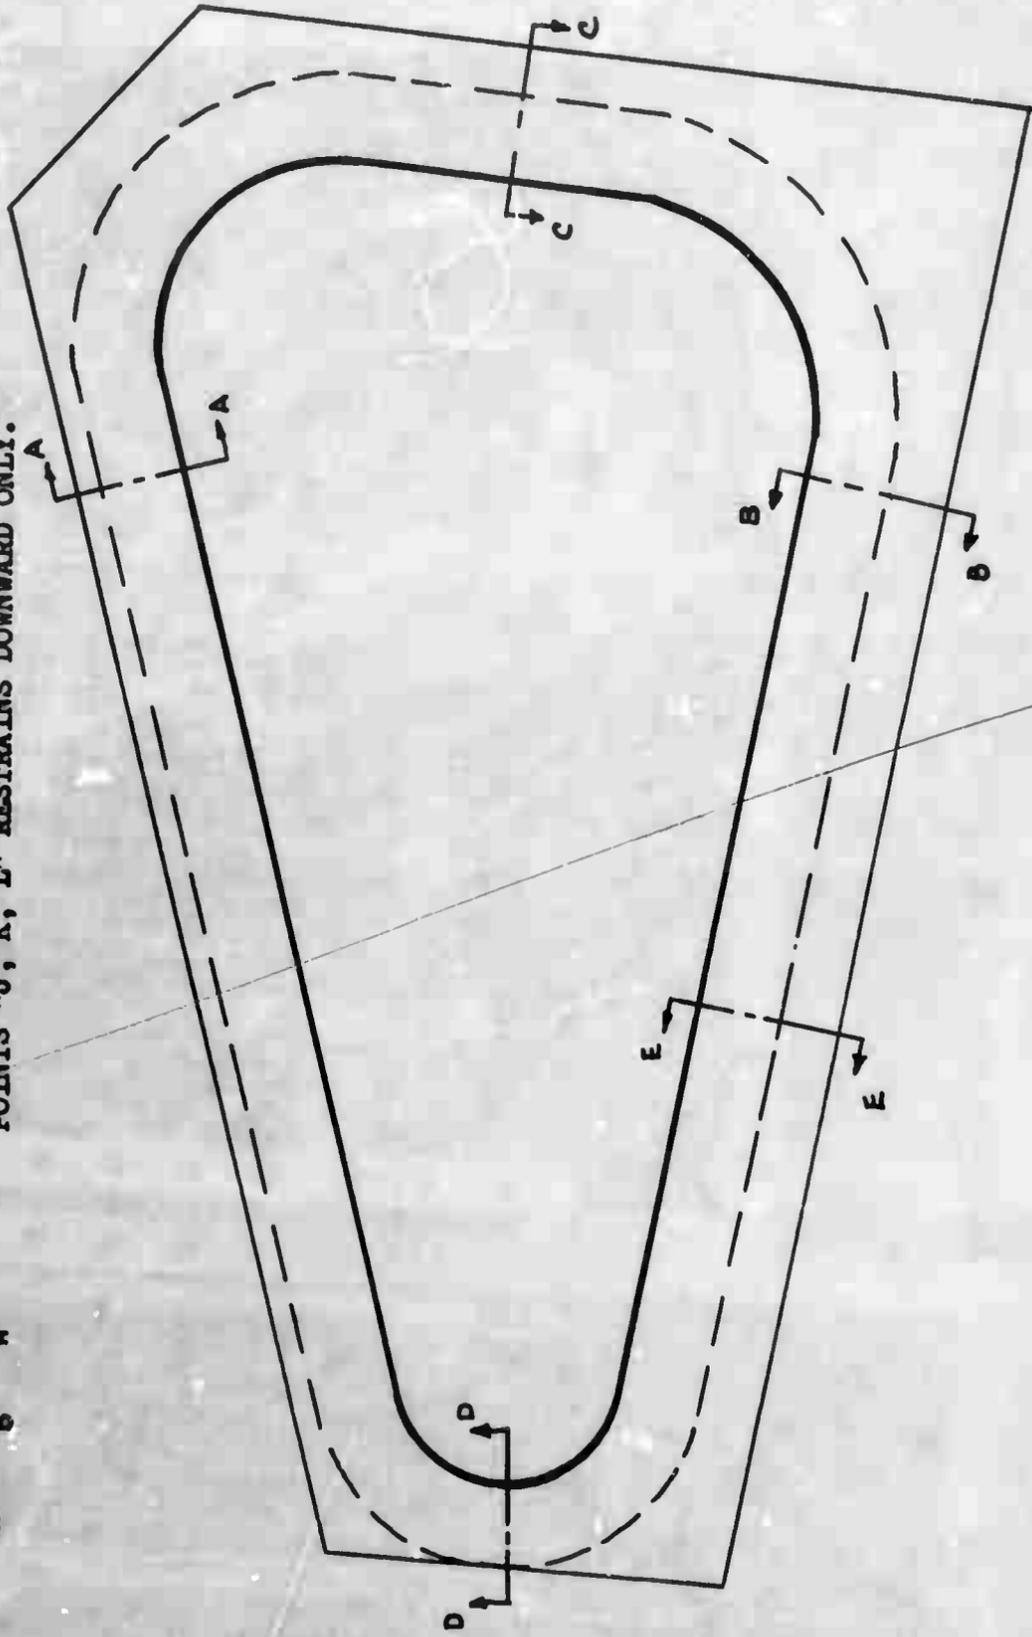
FIGURE 31 WINDOW SUPPORT FOR TEST CONDITION 3

POINT "G" RESTRAINS IN ALL DIRECTIONS.
 POINT "H" RESTRAINS DOWNWARD & TRANSVERSELY.
 POINTS "J, K, L" RESTRAINS DOWNWARD ONLY.

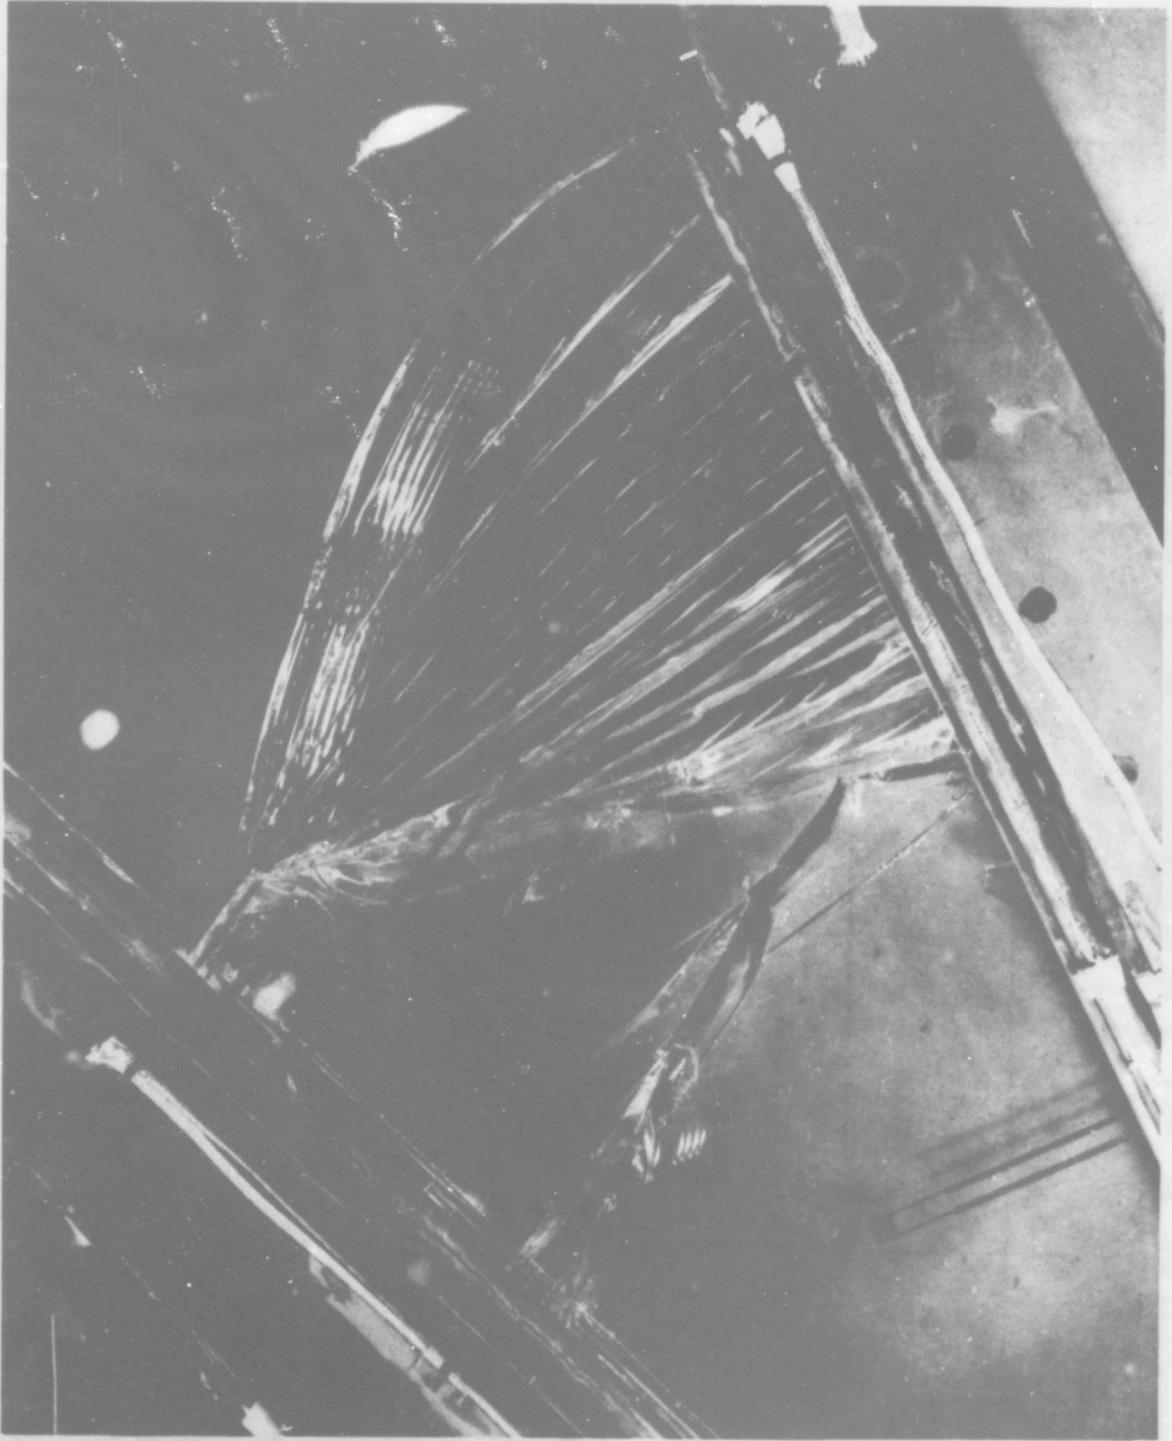
FIGURE 33 Photograph of Window Fracture

The final test was terminated after 380 seconds when it was observed that the top glass had broken. From the data it appears the break occurred after 352 seconds. A photograph of the failed glass is shown on page 61. An accurate drawing of the failed glass is shown on page 63. The test set-up after the glass failure is shown on page 62. Only the top glass failed and no apparent damage was sustained by the rest of the test specimen.
