**X-20 HIGH TEMPERATURE SIDE WINDOW
TEST EVALUATION**

JOHN C. McGINNIS
THE BOEING COMPANY

TECHNICAL REPORT No. AFFDL-TR-65-155

NOVEMBER 1965

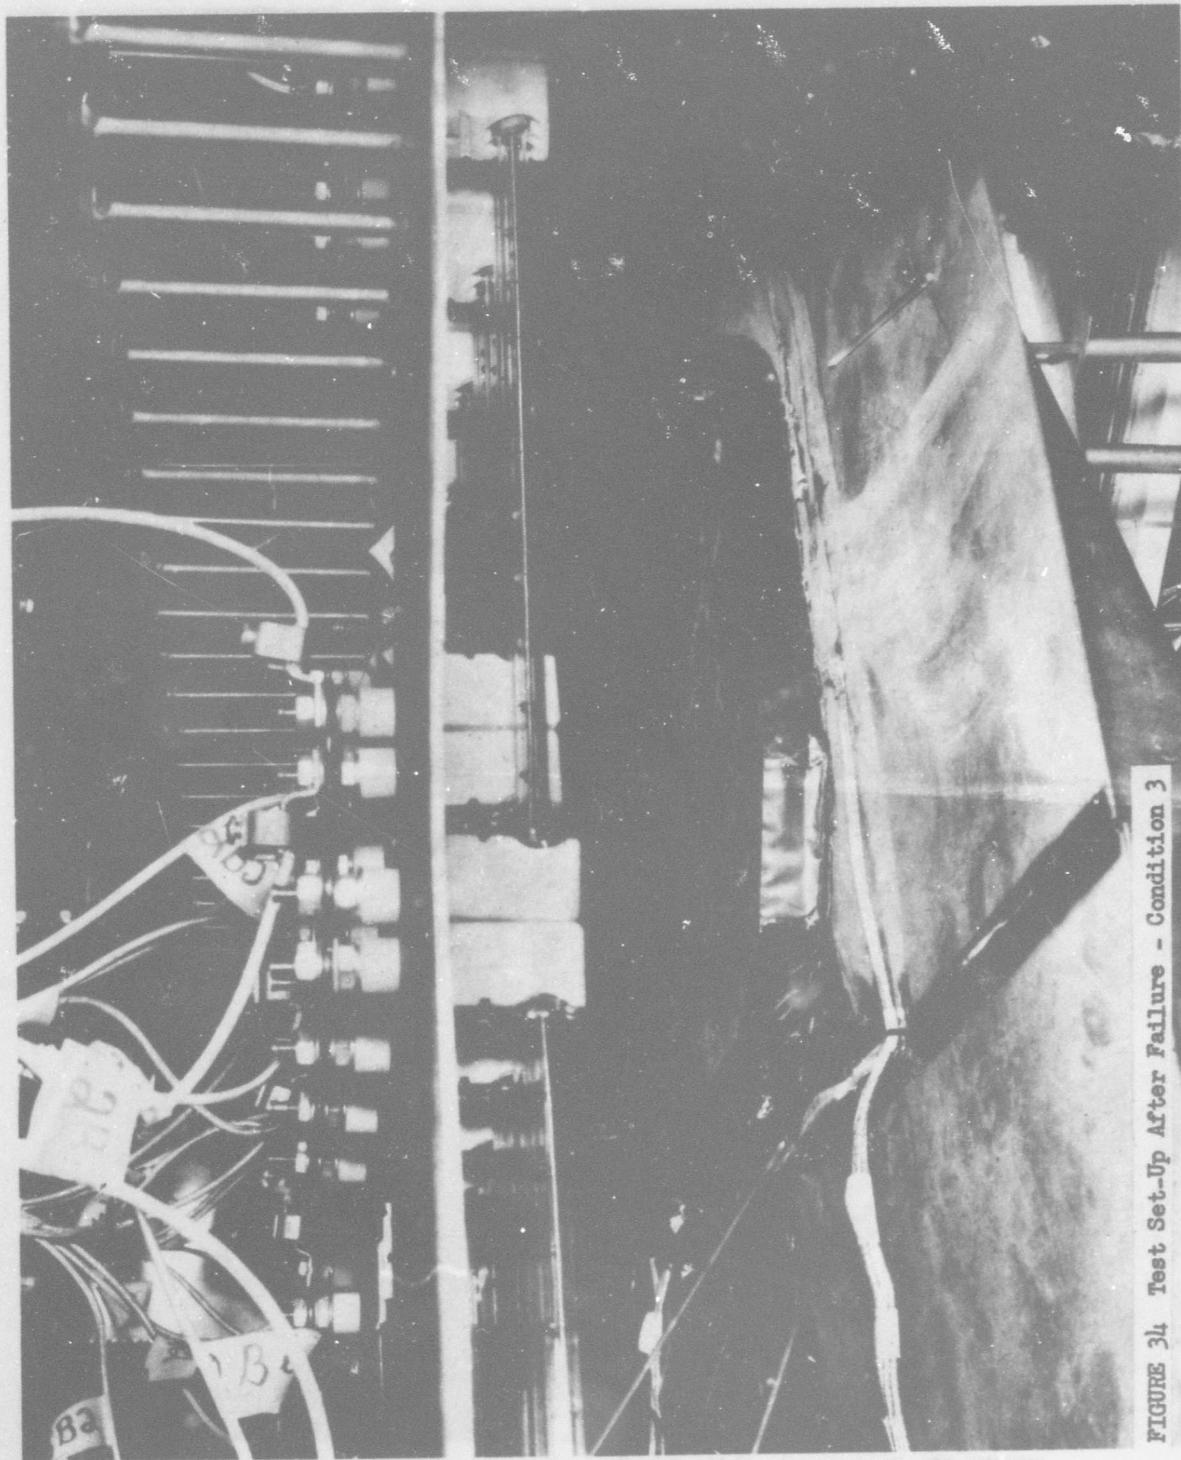
FIGURE 34 Test Set-Up After Failure - Condition 3

The final test was terminated after 380 seconds when it was observed that the top glass had broken. From the data it appears the break occurred after 352 seconds. A photograph of the failed glass is shown on page 61. An accurate drawing of the failed glass is shown on page 63. The test set-up after the glass failure is shown on page 62. Only the top glass failed and no apparent damage was sustained by the rest of the test specimen.

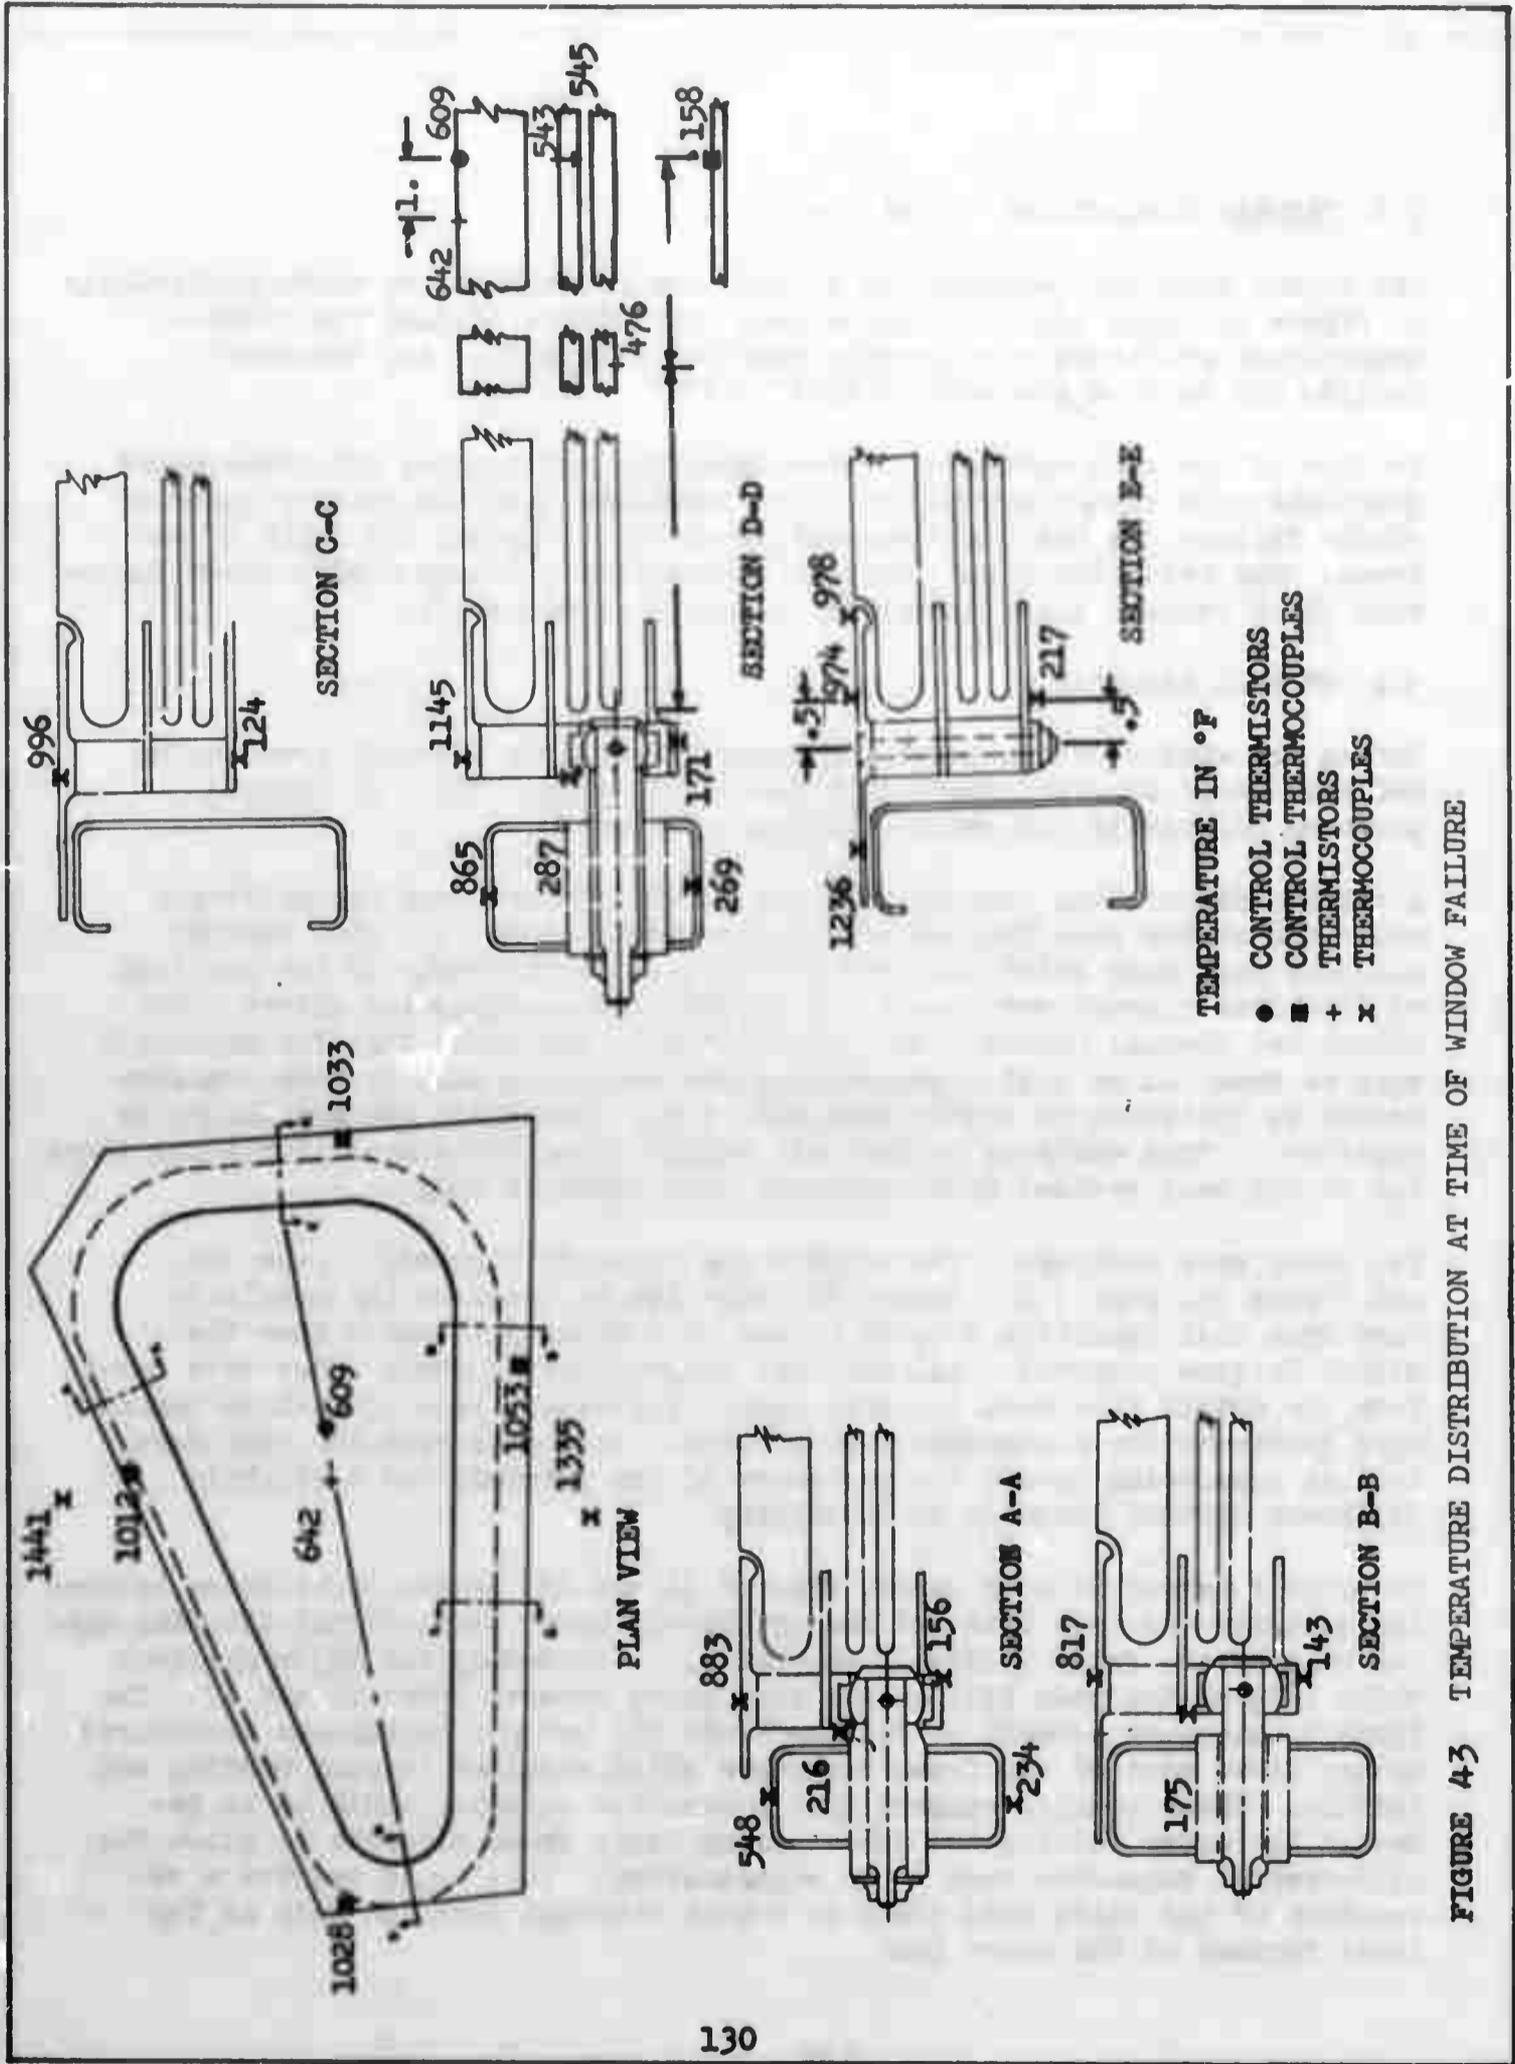
FIGURE 4-3 TEMPERATURE DISTRIBUTION AT TIME OF WINDOW FAILURE

The actual measured temperatures at the time of failure are shown pictorially on Figure 43, page 130. It can be seen from Figure 43 that the frame temperature gradients were greater than the allowable. For instance, Section D-D shows a gradient of $1145^{\circ} - 171^{\circ} = 974^{\circ}\text{F}$.

The window failed during the re-entry temperature cycle. The primary cause of failure was the high temperature gradient through the depth of the window frame of approximately 8500F which exceeded by a factor of 2 the ultimate design value. The extreme thermal gradient caused thermal curvature of the window frame which induced glass curvature in excess of allowable.

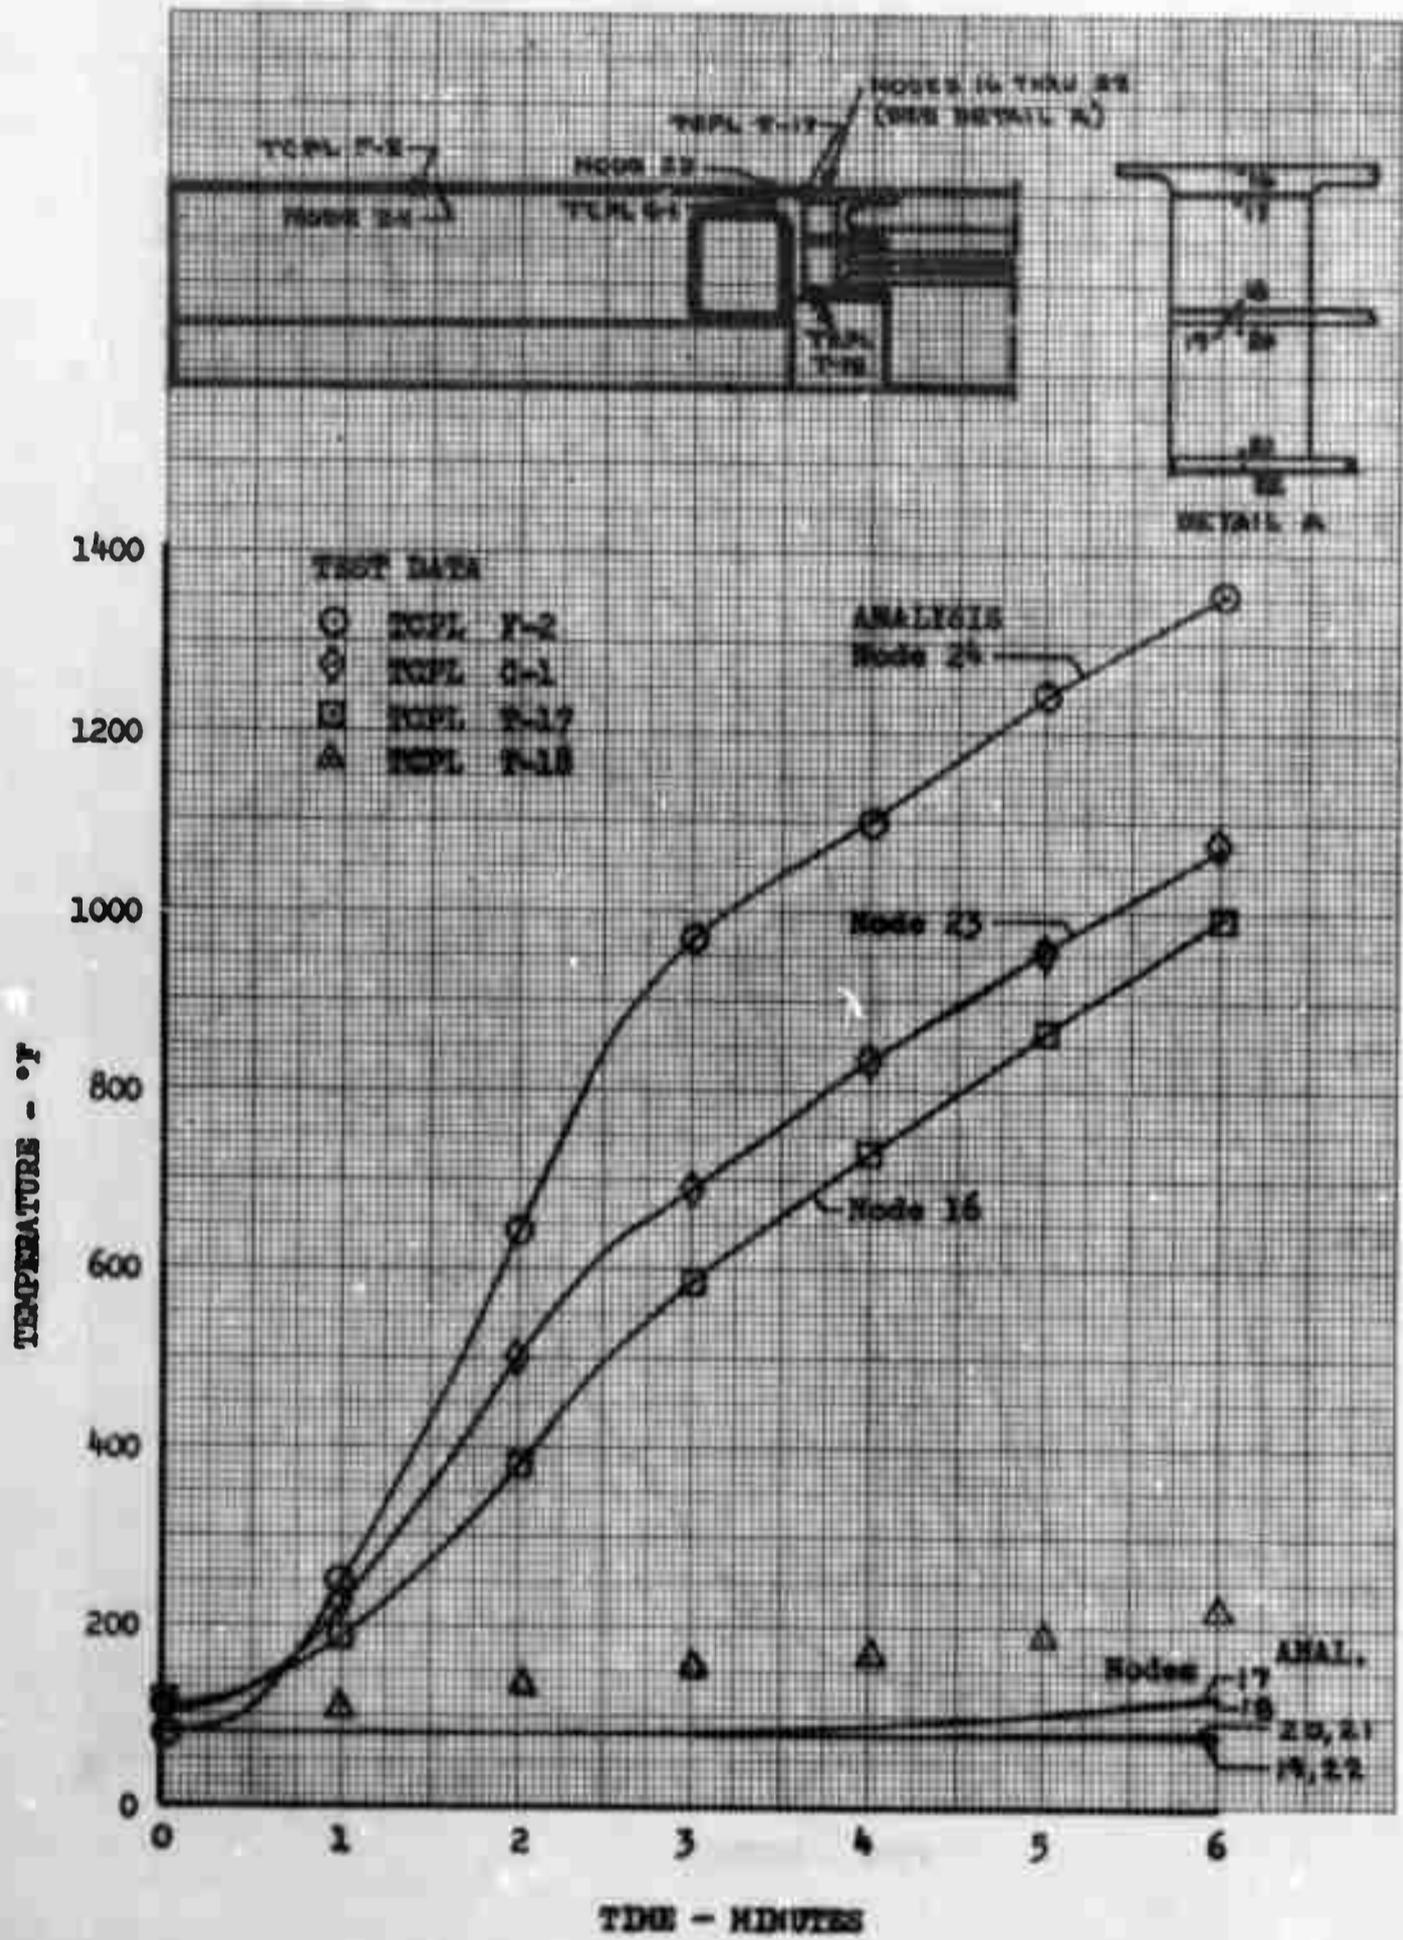
FIGURE 44 THERMAL ANALYSIS OF TEST NO. 3

Two cases were analyzed. The results are shown on Figure 44, page 131, and Figure 45, page 132. Figure 40, page 144, is based on the available data from Test Condition 3 up to a time of 6 minutes at which time the window failure occurred. All external temperature boundary nodes were driven from the actual test data for this case. Figure 45, page 132, shows temperature gradients for a complete test profile. Variances from the test case include insulation around the periphery of the specimen and a slightly different control location on the fairing.

Of prime interest in both cases, Figures 44 and 45, is the correlation between the analysis and test data and the relatively lower gradient existing through the bulk of the frame (Nodes 17 through 21). Evidently the major gradient which induced the pane failure was that shown between Nodes 16 and 17. The frame's outermost element or fairing (Node 16) being a continuous structural member drove most of the frame curvature which resulted in pane bending and failure. These results suggest that a possible solution would be to re-design the outer fairing and inner backup strip frame elements to allow for differential expansion such as by segmentation. This would require a re-location of the basic seal plane to a more internal location such as the inner surface of the outer pane.

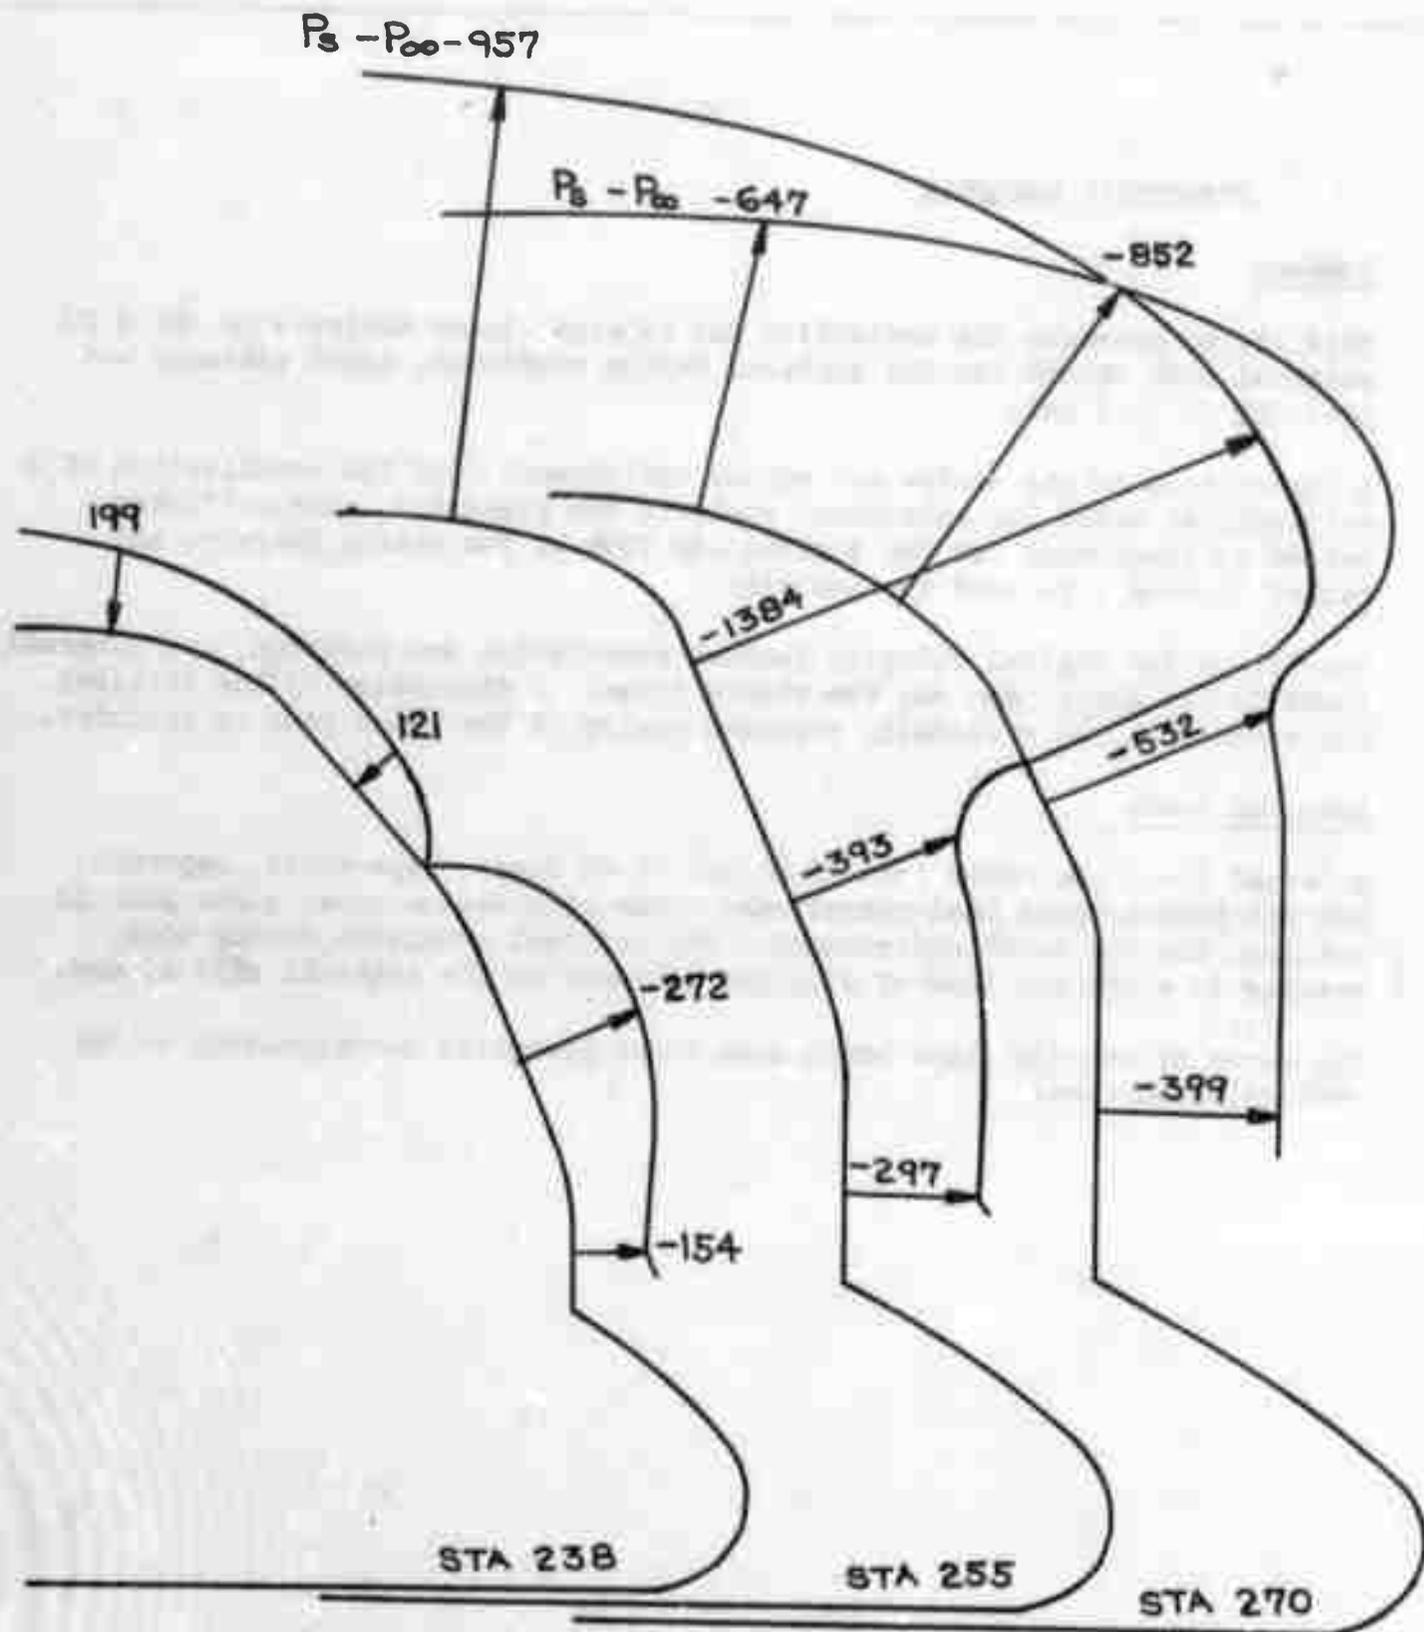
FIGURE 46 Boost Pressure Distribution - Hatch Area

The curve of page 140 shows hatch area boost pressures corresponding to the critical condition.

$-128 \leq P_\infty - P_v \leq +26$ PSF * ULT.
 * POS. PRESS. ACTS INWARD
 REF. 3

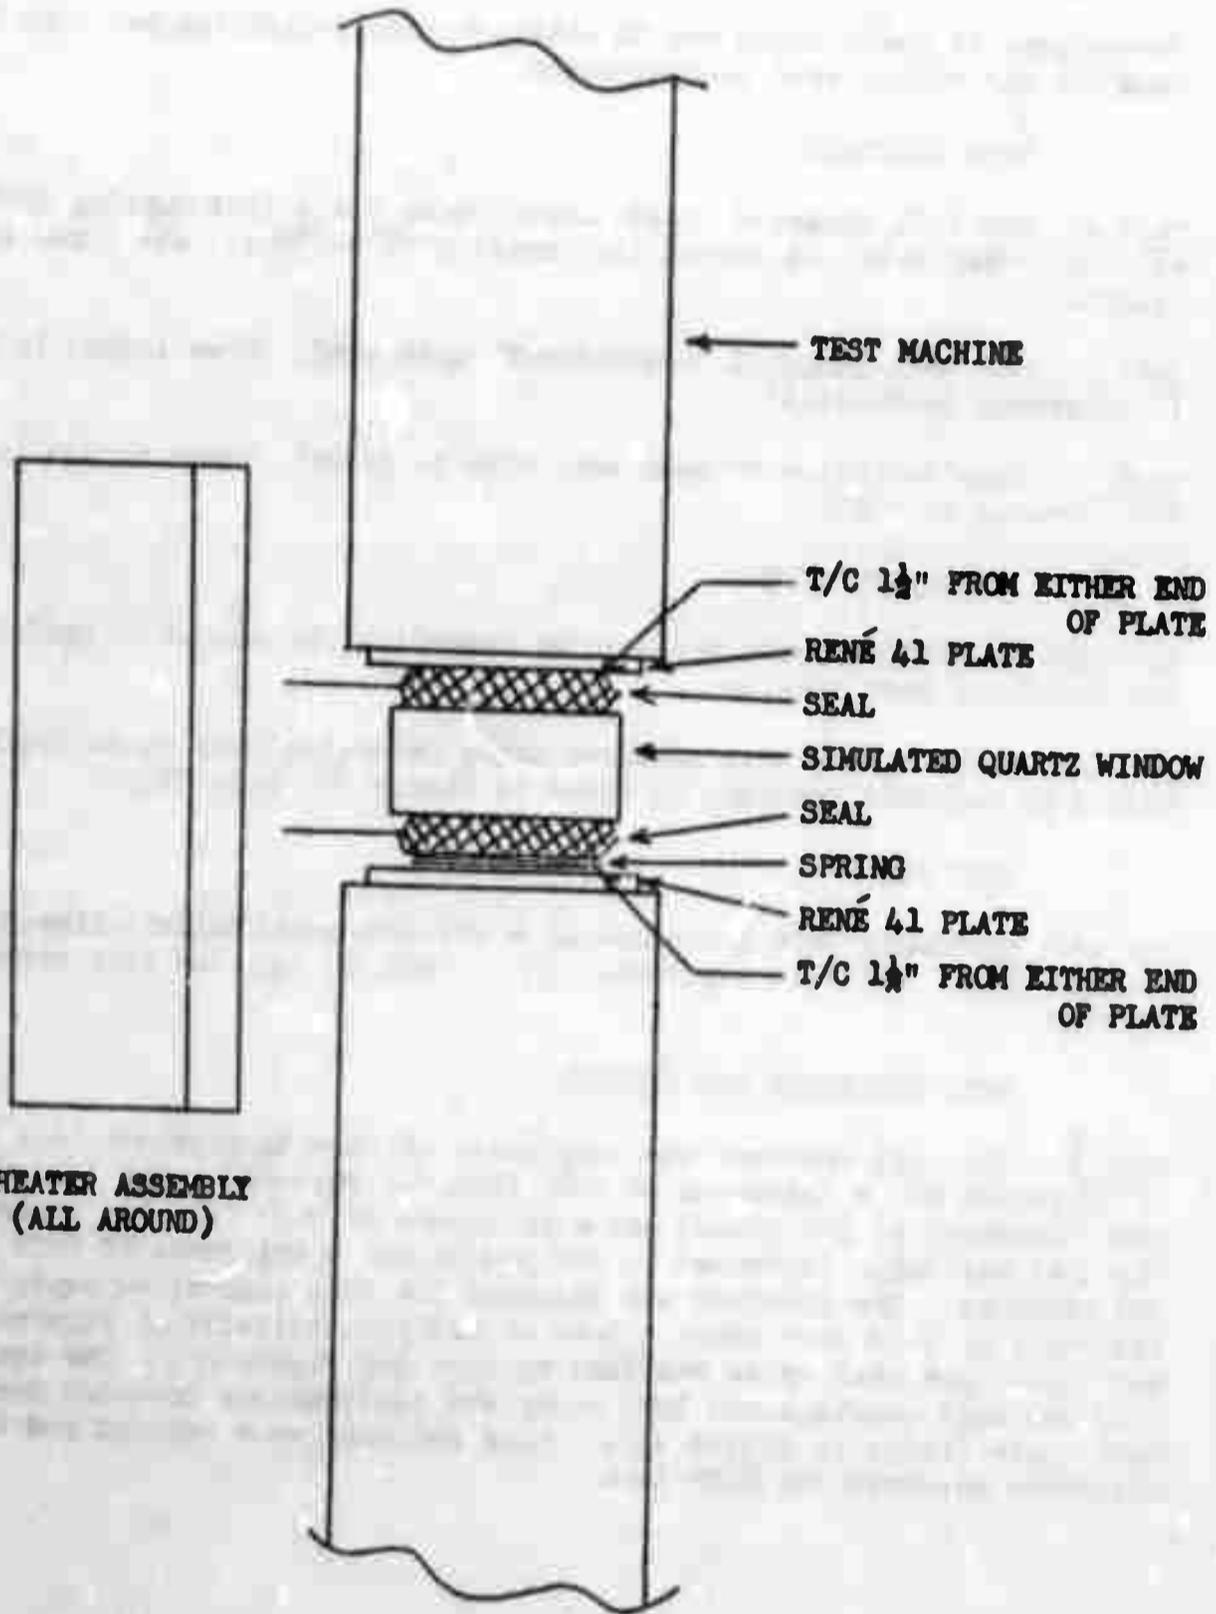
FIGURE 56 TEST SETUP - TEST 1

Test 1: The seal specimen was compressed at room temperature to a load of 90 pounds and a thickness of 0.28 inch was recorded. The load was then increased to 105 pounds and a thickness of 0.27 inch was recorded. The load was again increased to 220 pounds and a thickness of 0.22 inch was recorded. The specimen was unloaded and then compressed again to a thickness of 0.22 inch under a load of 225 pounds (refer to Figures 60 and 61.) The heat cycle was then applied per Figure 59. The seal thickness was held constant and load decay was continuously recorded during the heat cycle (refer to Figure 61). Load and heat were removed and the seal thickness measured was 0.24 inch.
