THE BOEING COMPANY
Aerospace Group
Space Division

LARGE MOTOR CASE TECHNOLOGY EVALUATION

Contract AF 33(615)-1623

Report
June 1966

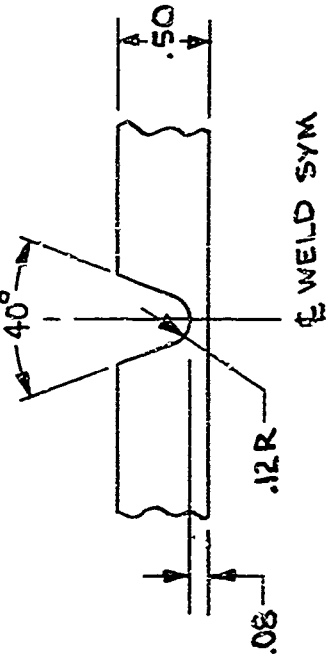
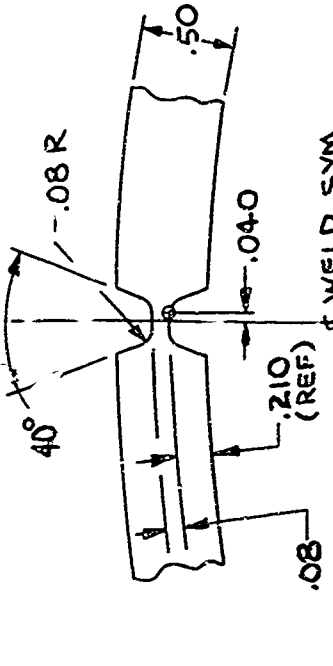
TABLE IV : 9 IN VESSEL WELD PARAMETERS

JOINT CONFIGURATION	GIRTH WELDS	LONGITUDINAL WELDS

PASS	1	1
CURRENT	170 AMPS	190 AMPS
VOLTAGE	12	13
SPEED	6 IN/MIN	6 IN/MIN
WIRE FEED	24 IN/MIN	22 IN/MIN
SHIELD	He	He

weld wire heats, and heat treatment temperature were identical to that of the test panels (see Tables I and II). Because of variation in equipment and part configuration, however, minor weld setting variations were required. These are shown in Table IV.

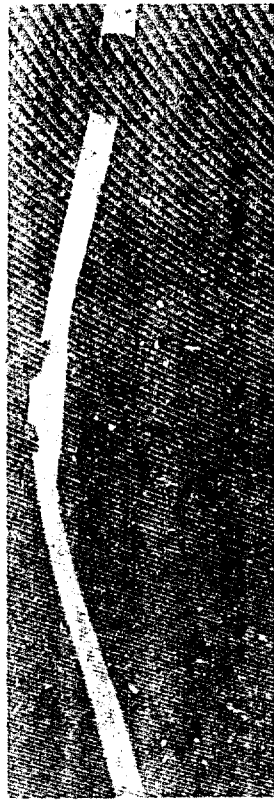
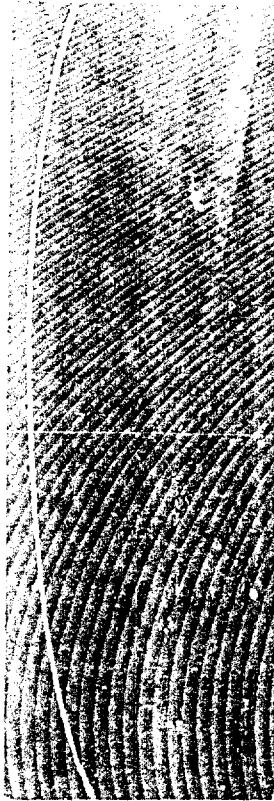
Figure 4: FAILURE ORIGIN

FATIGUE CRACK DEPTH

EDM

MISMATCH

The tank failed at an ultimate pressure of 9840. Overall view of the failed tank is shown in Figure 3. Observation of the vessel indicated that failure initiated in the artificial flaw, the fracture progressing into both heads without fragmenting. All fracture surfaces except just under the flaw exhibited a full shear fracture. Close up views of the flawed area are shown in Figures 4a and 4b. A photomicrograph of the sectioned origin is shown in Figure 4c. It is seen that the fatigue crack extends into the grain coarsened region of the heat affected zone.
