**STRESS CORROSION AND FATIGUE TESTS
ON 7001-T75 ALUMINUM ALLOY**

THE BOEING COMPANY
Wichita Division

TECHNICAL REPORT AFML-TR-66-12

SEPTEMBER 1966

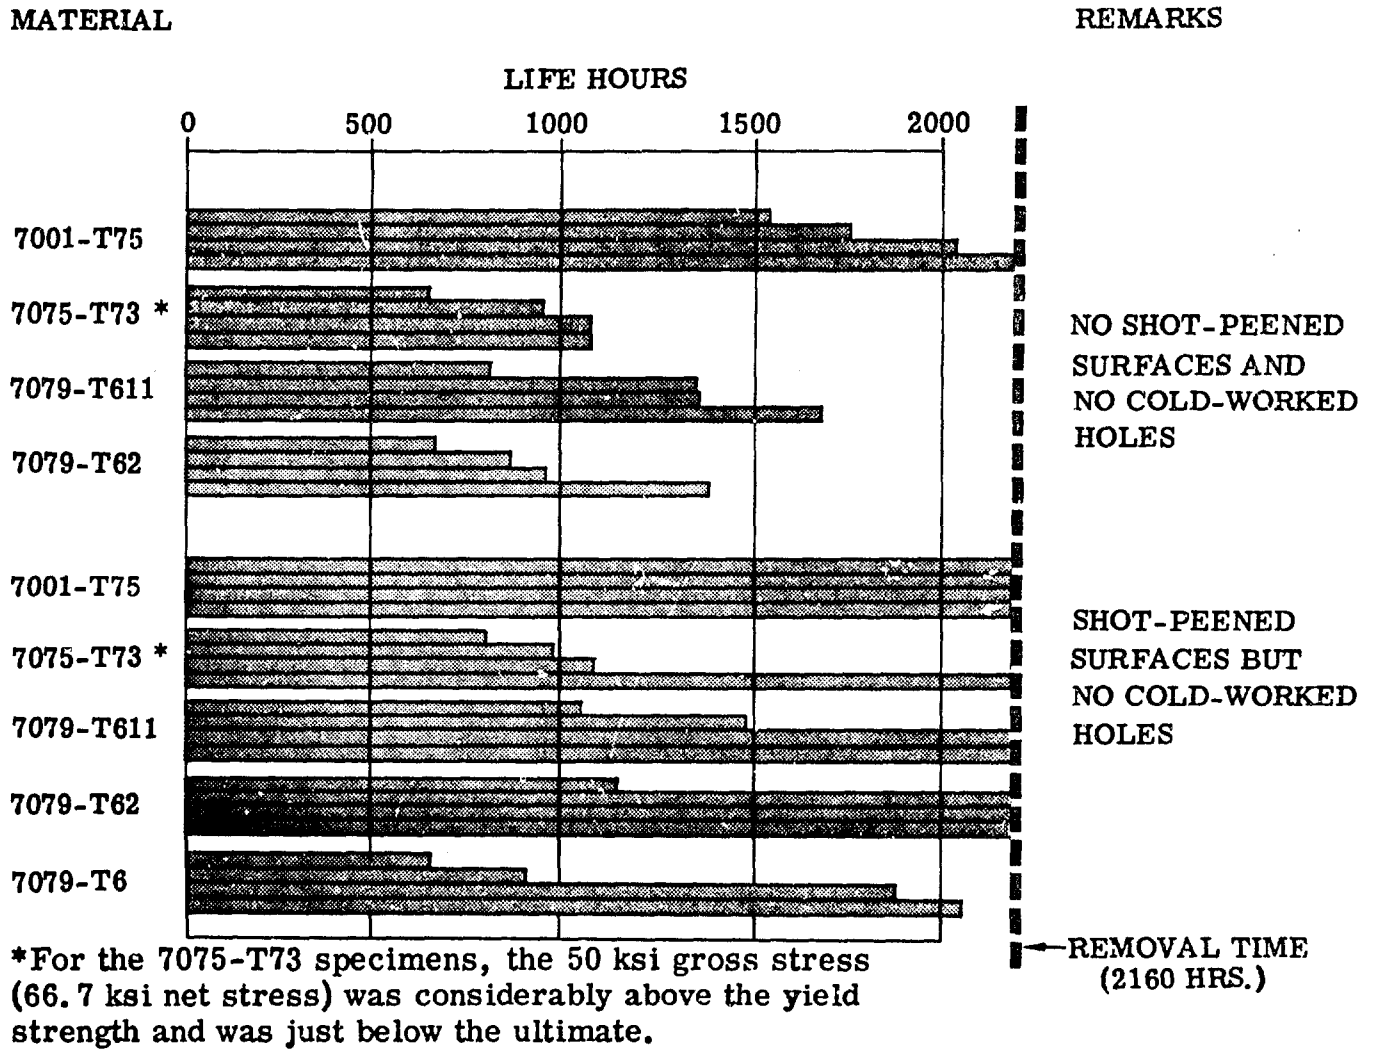
FIGURE 12

**STRESS CORROSION TEST RESULTS AT 50 KSI (GROSS AREA STRESS)
SPECIMENS WITH 1/4-INCH DIAMETER STEEL TAPER-LOK FASTENERS
INSTALLED WITH MEDIUM INTERFERENCE FIT OF .0033 TO .0043**

Stress corrosion results are tabulated in Tables III through XXVI. A comparison of stress corrosion failure times at the highest stress level, 50 ksi gross, is shown in Figures 10, 11, 12, and 13. An insufficient number of samples failed at the lower stress levels of 30 ksi and 20 ksi to make similar comparisons. A short discussion of stress corrosion results for each of the three gross area stress levels follows.

On examining the data at the 50 ksi stress level shown in Figures 10, 11, 12, and 13, the particular heat of 7001-T75 tested in this program did sustain the applied stress better than the other alloys. As discussed previously, the reason for its seemingly superior stress corrosion resistance as compared to 7075-T73 probably was that the 7075-T73 was operating very close to its ultimate tensile strength. However, the 7001-T75 was clearly superior to all tempers of 7079 tested.

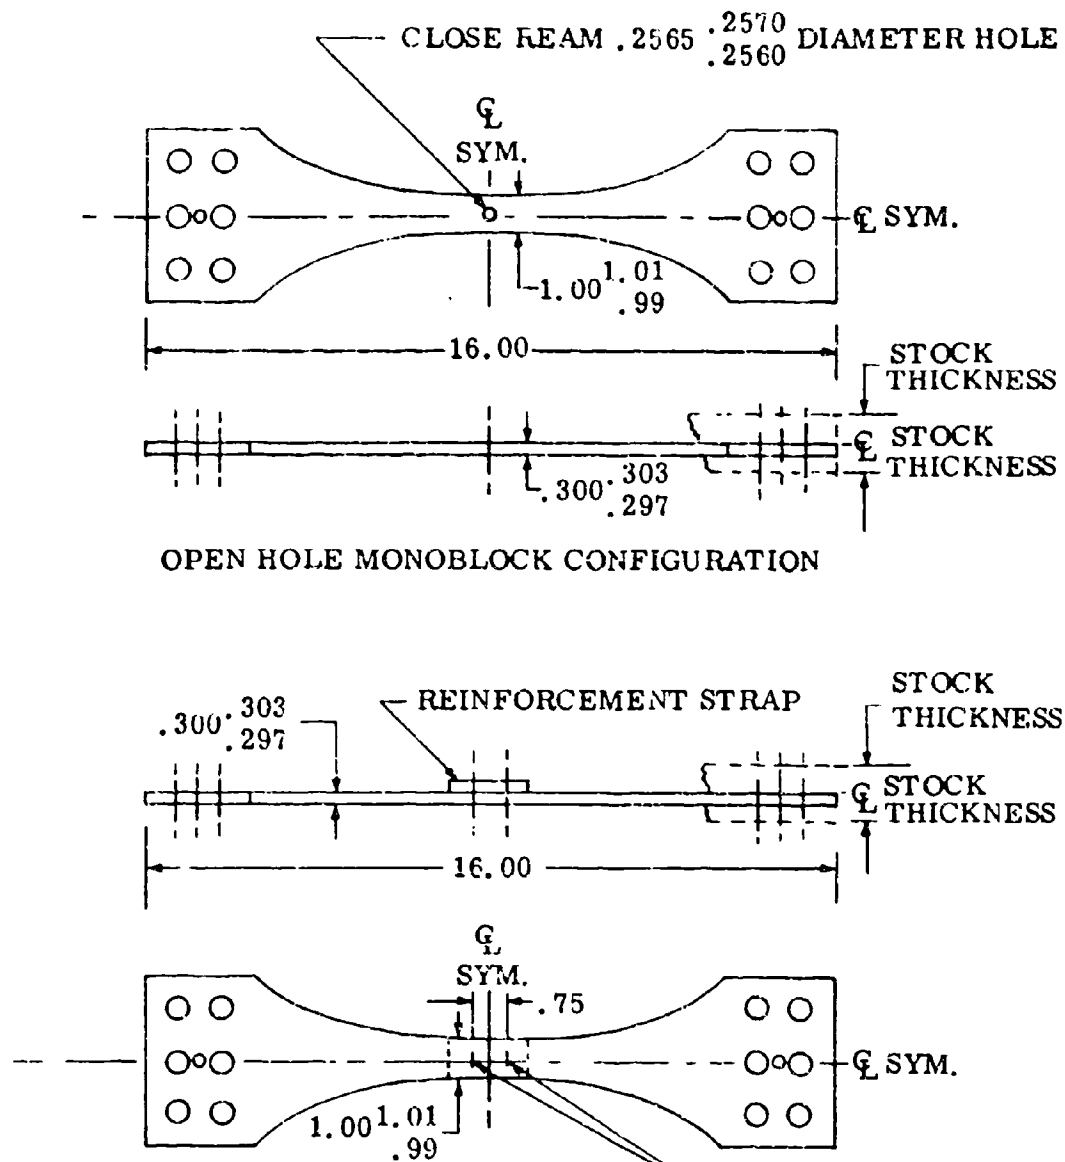
TAPER LOK BOLTS, BAC B30FW-4-9
 (.25 DIAMETER), STANDARD INTERFERENCE
 (PER BAC 5047), WITH FAYING SURFACE
 SEALANT BETWEEN STRAP AND COUPON

STRAP REINFORCEMENT
 SPECIMEN CONFIGURATION - FATIGUE TESTS
