STRUCTURAL INTEGRITY,  
 ACCELERATED CORROSION  
 AND  
 FLOW CAPACITY TESTS  
 OF  
 PARKER AIRCRAFT COMPANY  
 VALVE, CHECK, ONE-INCH, AIRBORNE, FUEL  
 PARKER PART NUMBER 2630014  
 GO/A PART NUMBER 27-02402-5

WYLE LABORATORIES  
 EL SECONDO, CALIFORNIA

TEST REPORT  
 14985

JANUARY 1964

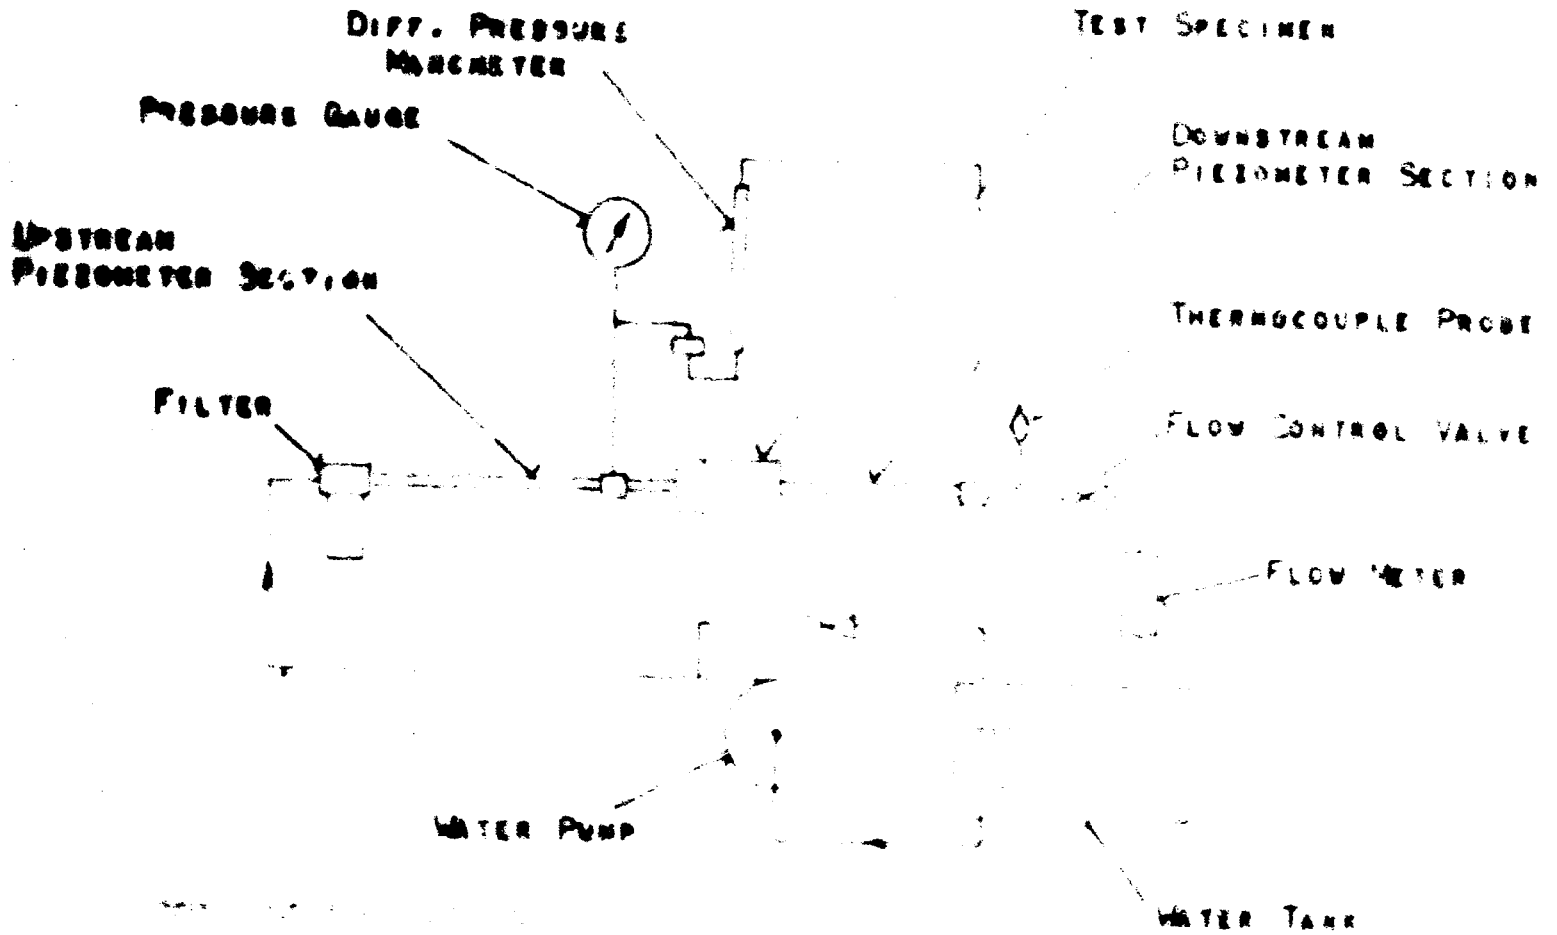
FLOW CAPACITY TEST SETUP

- 5.2.1 THE UNIT SHALL BE INSTALLED AS SHOWN IN FIGURE 2 AND SUBJECTED TO A WATER FLOW TEST IN THE FREE FLOW DIRECTION. WATER FLOW SHALL BE ESTABLISHED AT APPROXIMATELY FIVE EQUAL INCREMENTS BETWEEN 10 GPM AND 30 GPM. AT EACH FLOW INCREMENT, THE PRESSURE DROP ACROSS THE UNIT (GROSS  $\Delta P$ ), THE WATER FLOW RATE AND WATER TEMPERATURE SHALL BE MEASURED AND RECORDED.
- 5.2.2 THE UNIT SHALL THEN BE REMOVED FROM THE TEST SETUP AND AN ANR10-10 UNION SHALL BE UTILIZED TO CONNECT THE UPSTREAM AND DOWNSTREAM METROMETER SECTIONS. THE ABOVE FLOW TEST SHALL BE REPEATED. THE RESULTING PRESSURE DROP IS CONSIDERED TO BE THE SYSTEM OR TARE PRESSURE DROP.
- 5.2.3 THE GROSS PRESSURE DROP MINUS THE TARE PRESSURE DROP AT EQUAL FLOW RATES IS CONSIDERED TO BE THE NET PRESSURE DROP OF THE TEST SPECIMEN.
- 5.2.4 THE RESULTS SHALL BE PLOTTED ON APPROPRIATE LOGGED GRAPH PAPER.
