REINFORCED PLASTIC CONSTRUCTION METHODS
FOR LARGE ROCKET MOTOR CASE

VOLUME IV TU-290 CASE DESIGN AND FABRICATION

FINAL TECHNICAL ENGINEERING REPORT
DECEMBER 1963

THIOLKOL CHEMICAL CORPORATION
WASATCH DIVISION
BRIGHAM CITY, UTAH

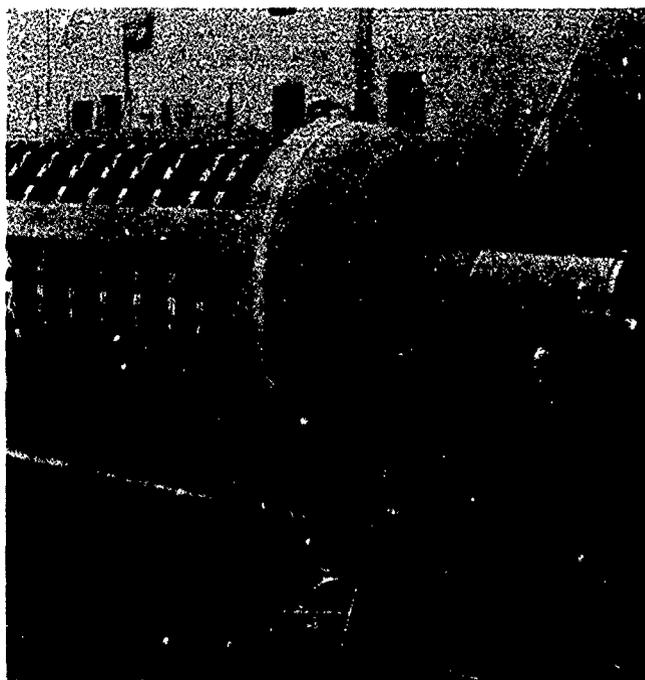
Figure 3. TU-290 Case Mandrel Subsection

**WOOD SUBSTRUCTURE SHOWING
BULKHEADS AND END DOMES**

**COMPLETED WOOD SUBSTRUCTURE FOR
ALLISON MANDREL**

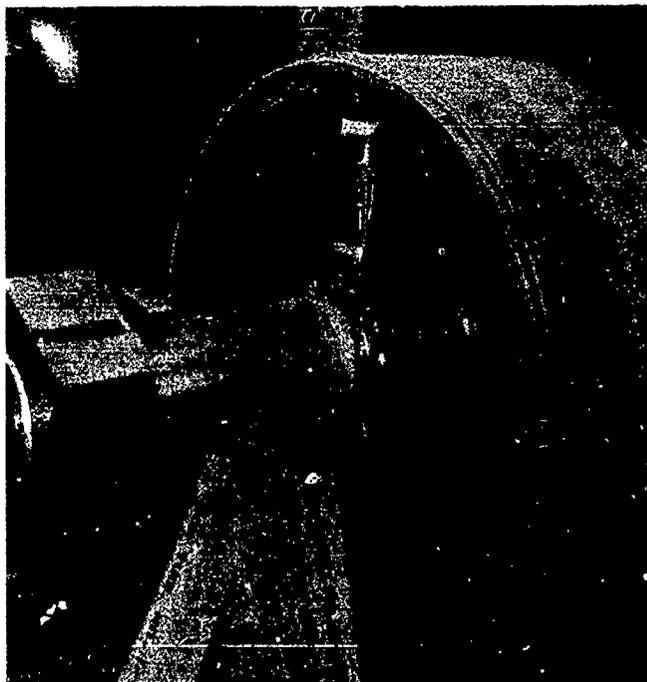
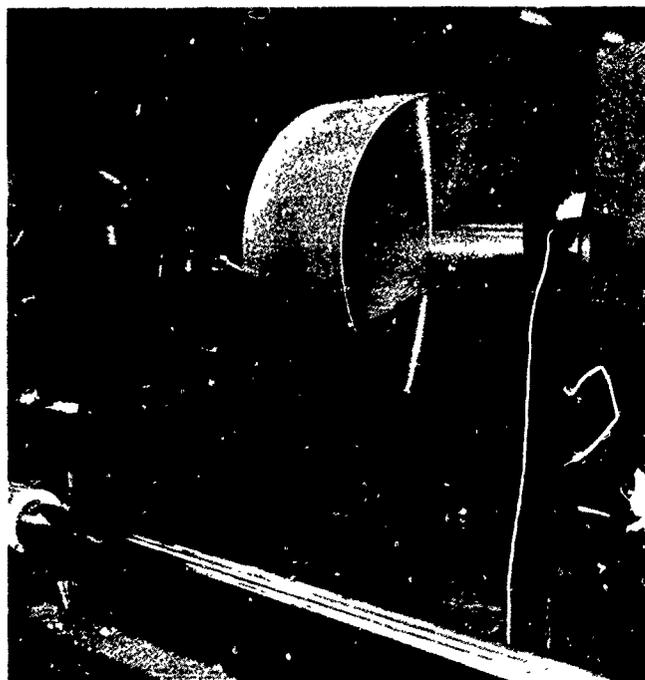
Figure 5. TU-290 Case Skirt Fabrication

Eight layers of helical windings were applied to the case mandrel. The skirts were then removed from storage, cleaned with methyl-ethyl-ketone positioned on the mandrel and secured by hoop windings. Eleven layers of hoop windings were applied between the two tangent points on the case.

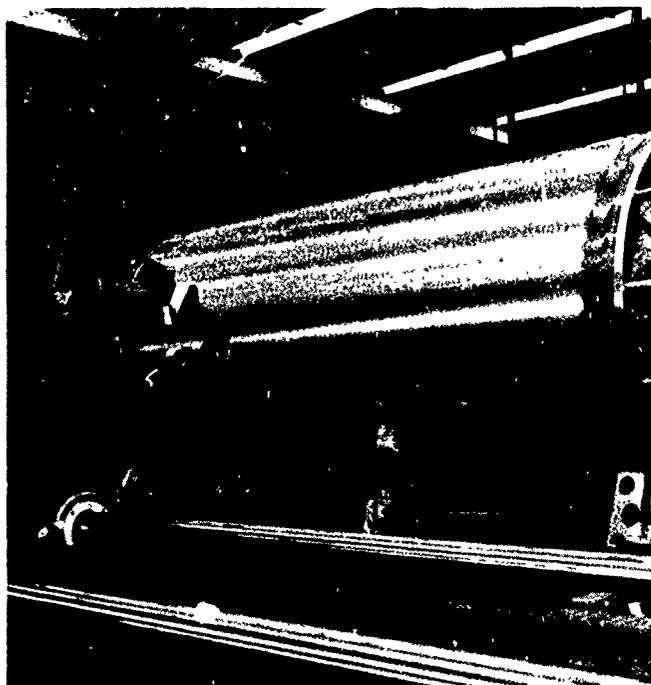
Figure 6. TU-290 Case Fabrication

SKIRT POSITIONING

HOOP WINDING

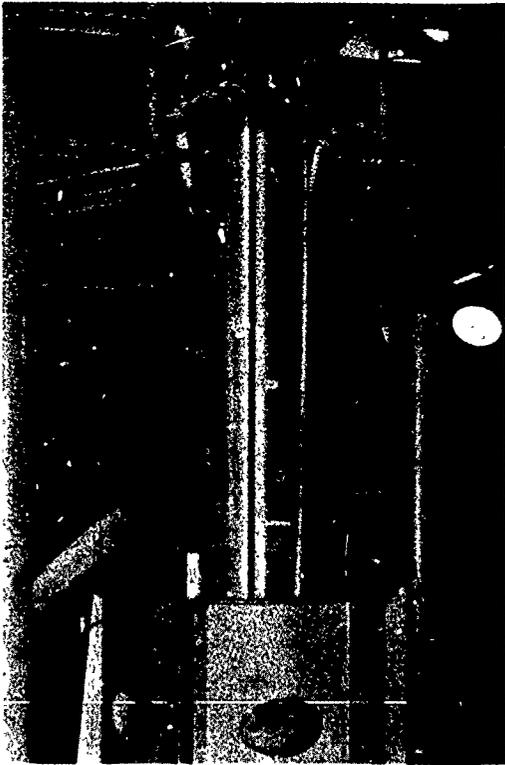
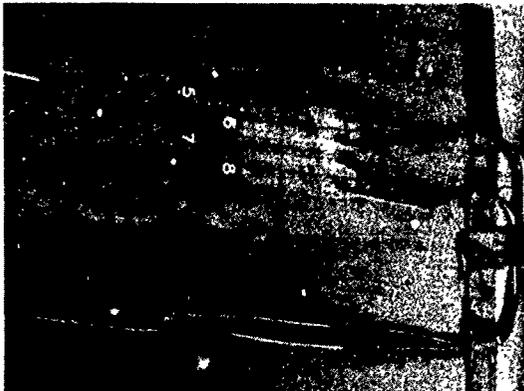
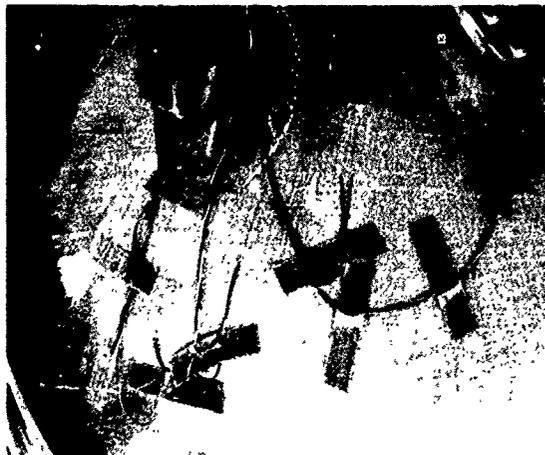
Figure 8. TU-290 Case No. 1 Aft Dome Instrumentation

TU-290 CASE No. 1
IN TEST FACILITY

SOUND REFERENCE AND STRAIN
INDICATOR 4 (TOP OF CASE)

STRAIN INDICATORS 5 THRU 8
(TOP OF CASE)

INDICATORS 13 THRU 17
(TOP OF CASE)

Baldwin PA-3 strain gages (Baldwin-Lima-Hamilton, Waltham, Mass.) were used to measure case growth. The gages were attached to the case with a cement which maintained a bond until the fiberglass was stressed beyond its yield strength. Baldwin AF-7 gages, similarly cemented, were used to measure strain in the PYROGEN igniter cover. Longitudinal and radial case deflections were measured by linear potentiometer indicators (connected to 20 gage piano wire encased in Teflon tubing wrapped around and fixed to the case). Forward dome deflections were measured relative to the forward skirt, and aft dome deflections were measured relative to the aft skirt. The locations of these measurement devices are shown in Figures 8 thru 10.

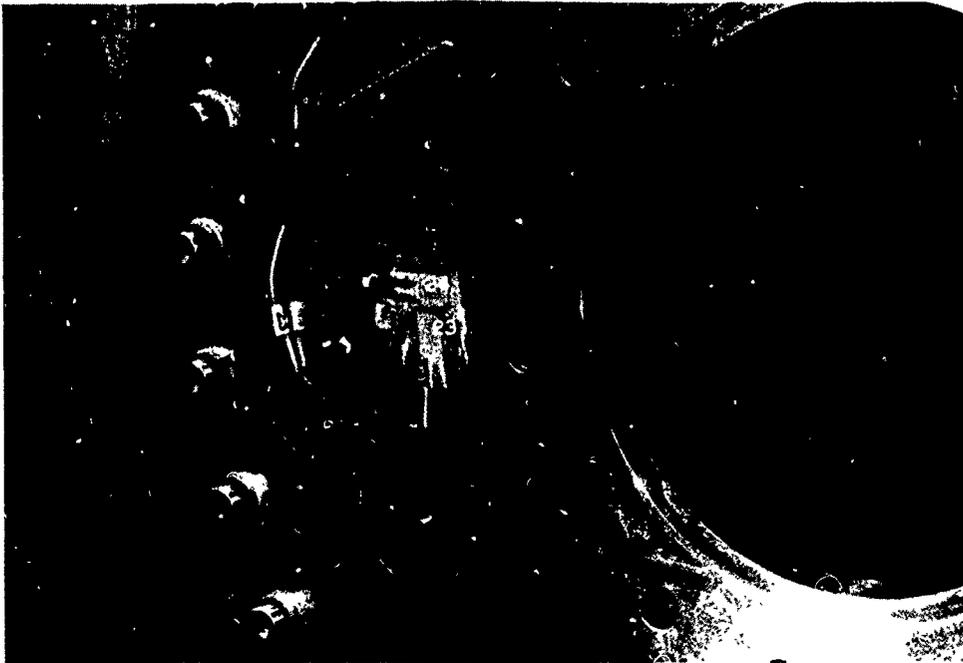
Figure 9. TU-290 Case No. 1 Forward Dome Instrumentation

Indicators 18 thru 22

Indicators 23 and 24

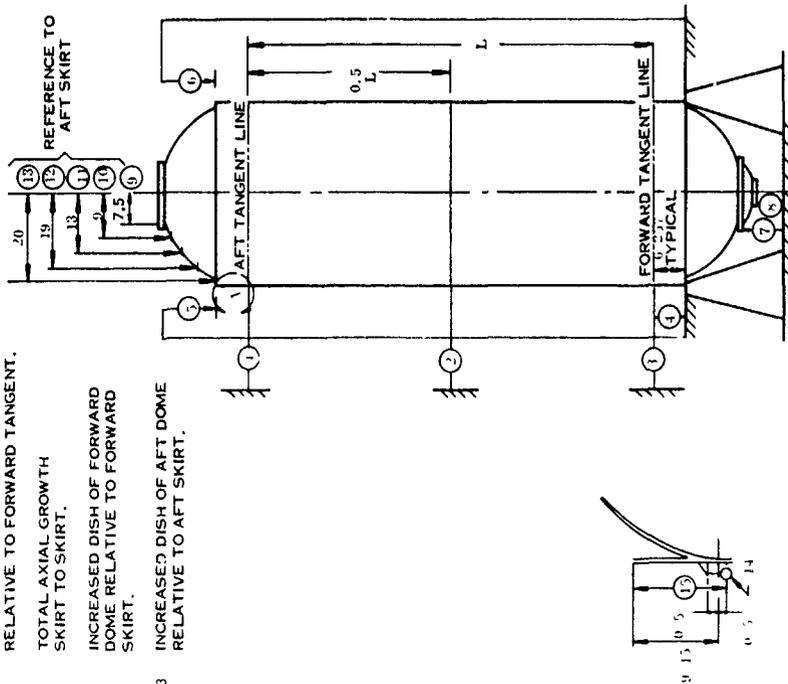
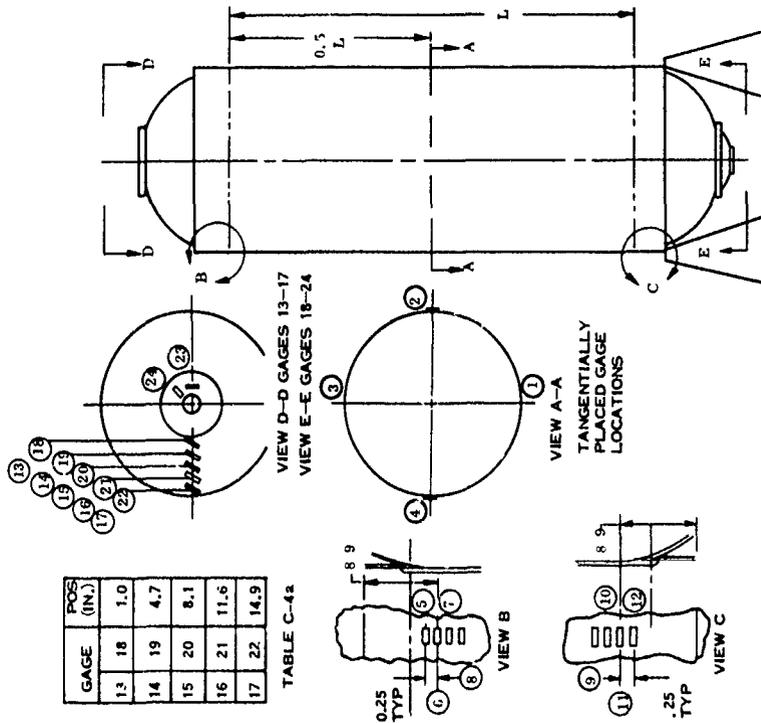
Figure 10. TU-290 Case No. 1 Hydroburst Test Instrumentation Arrangement

- DEFLECTION MEASUREMENT
- 1 2 3 CIRCUMFERENTIAL GROWTH.
 - 4 DEFLECTION FORWARD SKIRT RELATIVE TO FORWARD TANGENT.
 - 5 6 TOTAL AXIAL GROWTH SKIRT TO SKIRT.
 - 7 8 INCREASED DISH OF FORWARD DOME RELATIVE TO FORWARD SKIRT.
 - 9 13 INCREASED DISH OF AFT DOME RELATIVE TO AFT SKIRT.

- NOTES:
1. CONTACT MICROPHONES WERE LOCATED NEAR GAGES 3, 17, AND 18.
 2. GAGE NO. 13 THRU 22 ARE LOCATED PARALLEL TO OUTER FILAMENT AT CONTOUR DISTANCES FROM THE OD OF THE PORT BOSS AS SHOWN IN TABLE C-4a. GAGE NO. 23 AND 24 ARE LOCATED 4.5 IN. FROM THE CENTER OF THE BOSS.

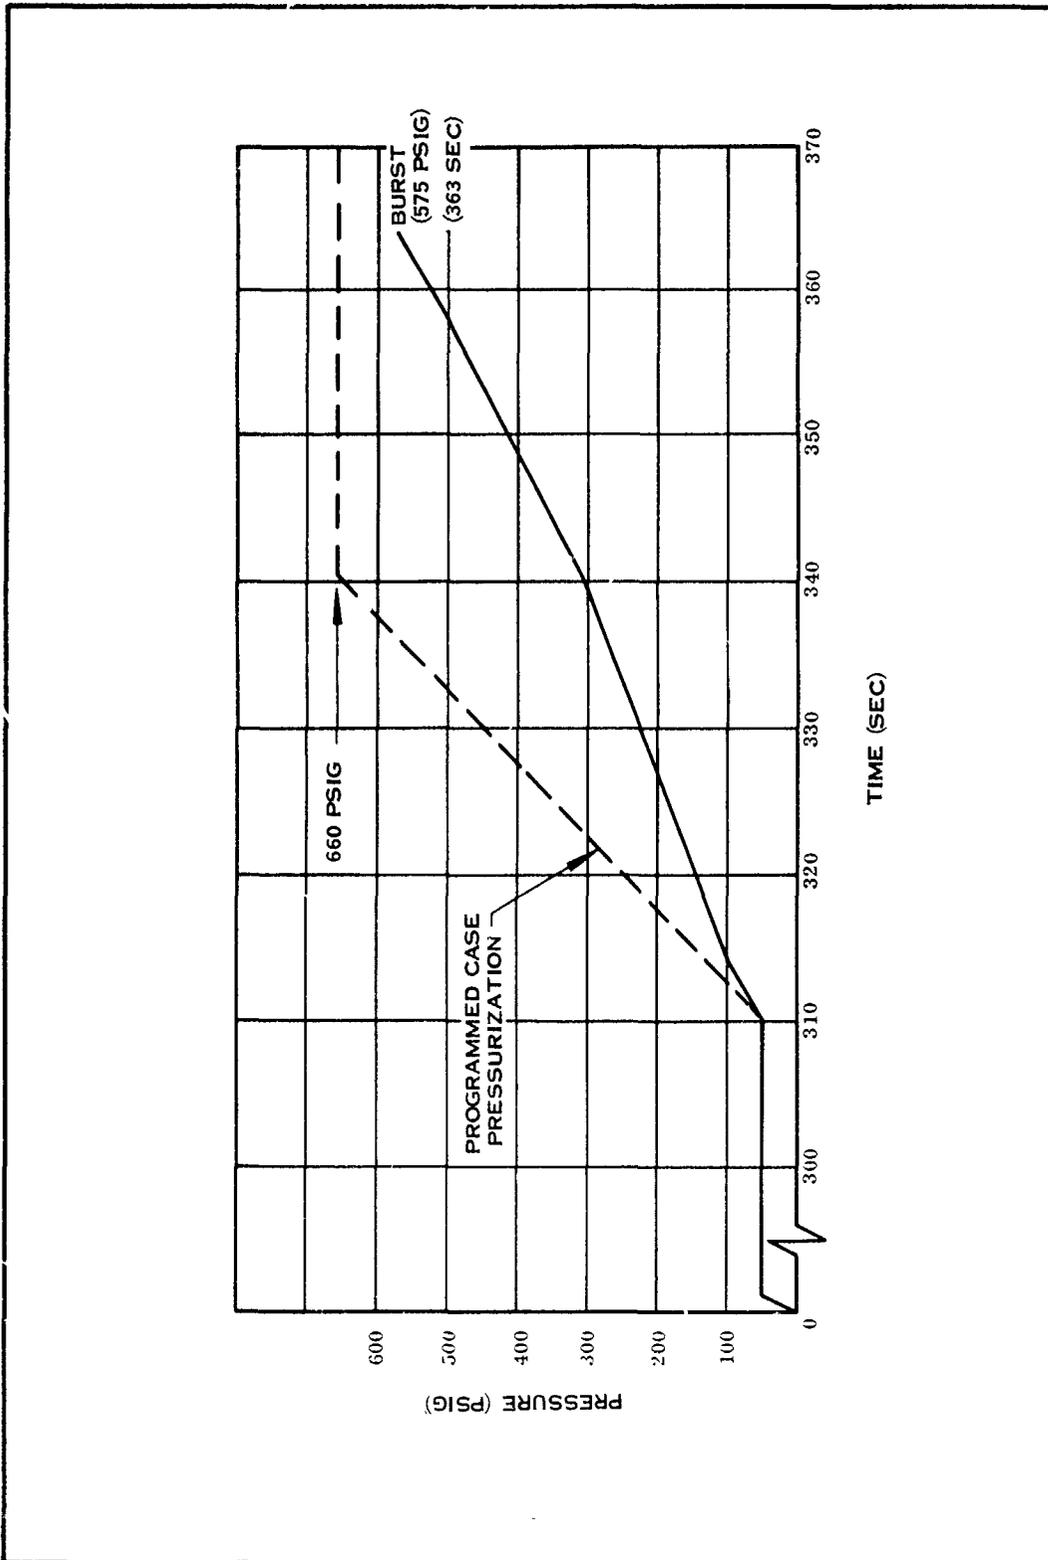
Figure 11. TU-290 Case No. 1 Hydroburst Test Pressure Record

The test program (Figure 11) specified (1) an internal pressure check at 50 psig for 300 sec to condition the instrumentation and establish case integrity, (2) a linear pressure increase to 660 psig in 30 sec to test the case for growth and expansion, and (3) a sustained internal pressure of 660 psig for 60 sec to test the case at proof strength. The pressure medium for the test was water.

The case failed at 575 psig while the internal case pressure was being increased toward the proof pressure level of 660 psig. At the time of failure, the pressure buildup was 53 sec behind the programmed pressure buildup (Figure 11). The failure originated in the hoop fibers of the cylindrical section 47 in. aft of the forward skirt (Figure 13). All strain data appeared to be valid. Premature failure of several gages resulted from severe circumferential resin cracking in the hoop windings on the cylinder.

The premature case failure at 575 psig was attributed to the 53 sec lag of pressure application in the case (relative to programmed pressure application). The failure to apply pressure at the programmed rate permitted glass fibers to abrade adjacent fibers during case expansion, and the abrasions reduced the strength of the E-HTS glass. The manner of adding pumps to sustain water pressure and volume during case expansion was imperfect, which limited the water volume output of pumps during the hydroburst test.

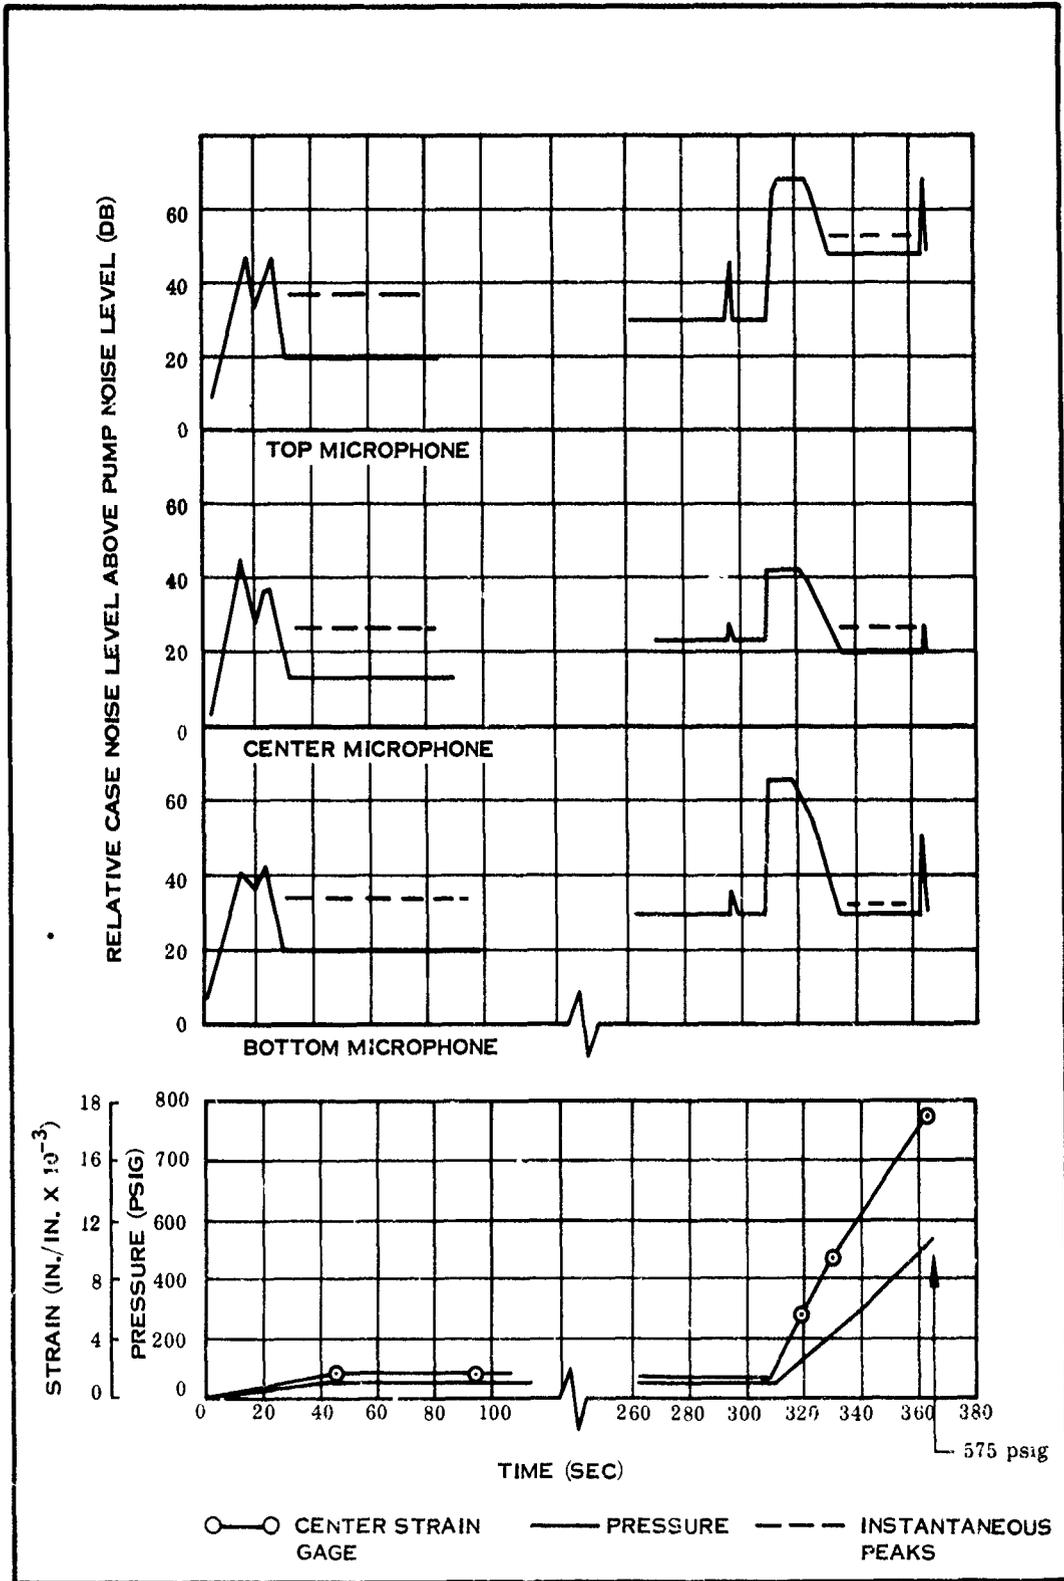
Figure 12. TU-290 Case No. 1 Hydroburst Test Noise Record

Cracking noises were heard immediately when the case internal pressure was raised to 50 psig. The intensity of the cracking noises increased to approximately 40 db above the pump sounds, then ceased while the pressure was held steady at 50 psig. Individual cracking noises were heard during the pressure check at 50 psig, as indicated by the dotted lines in Figure 12. Intense cracking began with the application of additional pressure; the noise level increased to a peak at approximately 30 percent of burst strain pressure, then began to decrease. At approximately 50 percent of burst strain pressure, only occasional minor cracking noises were heard. Since all microphones picked up approximately the same sounds, microphone location was not considered critical.

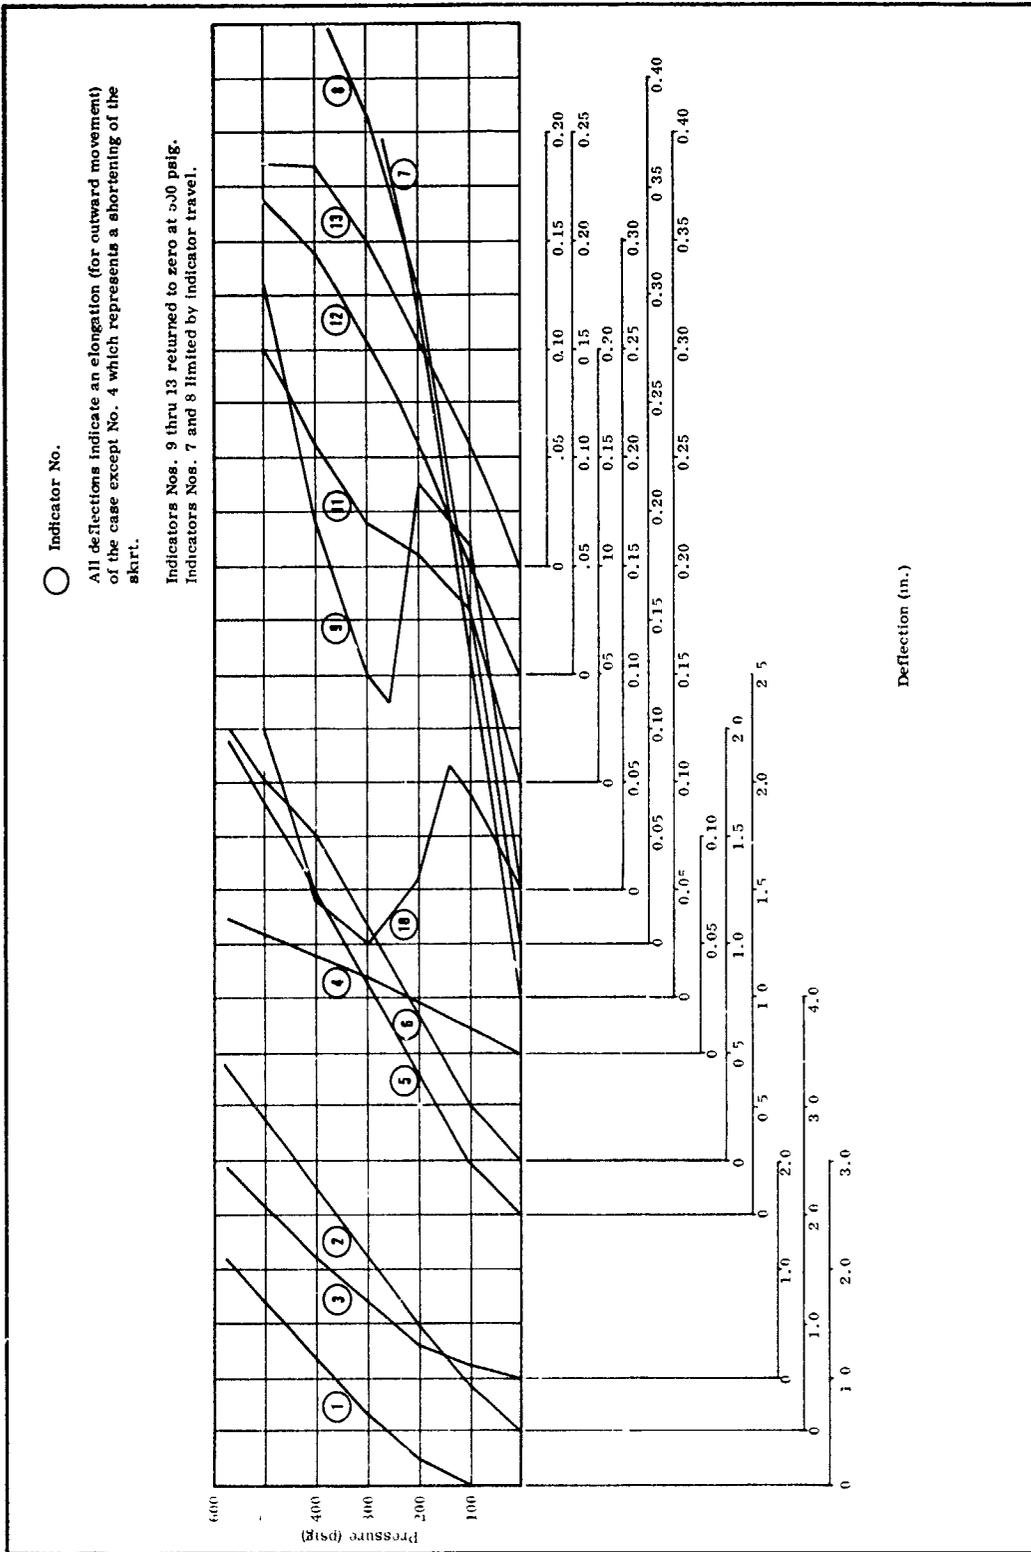
Figure 14. TU-290 Case No. 1 Hydroburst Test Deflection Indications

Because deformation in the forward dome was greater than had been expected, the range of the potentiometers was exceeded. The behavior of potentiometers No. 9 and 11 was erratic (Figure 14). All potentiometers on the aft dome failed at 500 psig. As nearly as can be determined, all instrumentation was working properly (Figure 15).

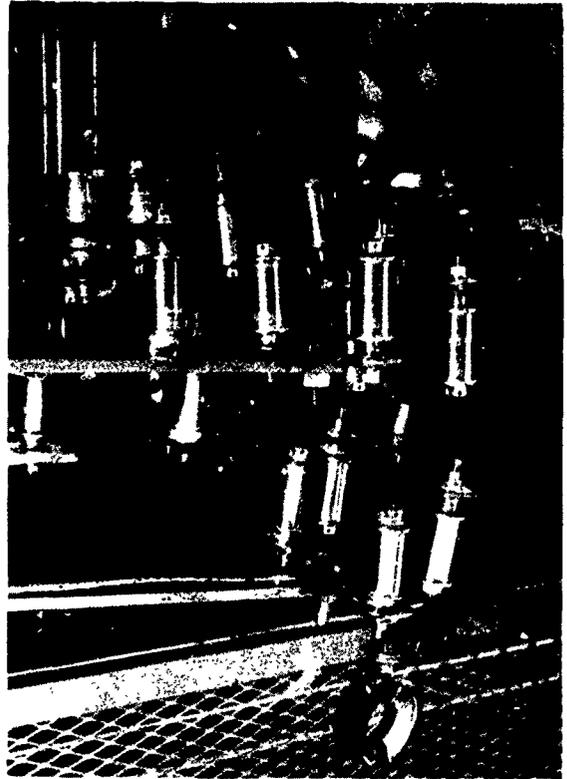
Figure 16. TU-290 Case No. 2 Fabrication - Glass Scuffing

While case No. 2 was being wrapped, considerable fraying and breaking of S-HTS glass fibers was observed as glass was fed onto the case mandrel. Figure 16 shows broken strands of fiberglass on the glass transfer machine and glass fraying on a spool of glass. The exact details of the fraying and breaking were noted and wrapping of the case was completed without additional problems.

BROKEN FILAMENTS, SCUFFED
FIBERS ON SPOOL OF S-HTS
FIBERGLASS

BROKEN S-HTS FIBERGLASS FIBERS
ON GLASS TRANSFER SYSTEM

While case No. 2 was being fabricated, Thiokol and Allison conducted investigations to determine causes for the fraying and breaking of S-HTS fiberglass. Thiokol, contacting other companies in the industry which used S-HTS glass, learned of similar problems with fiberglass wrapping operations. Owens-Corning was informed of Allison's wrapping problem. Owens-Corning could not explain reasons for the glass damage, and could not suggest immediate solutions to the problem. However, a representative was sent to Allison to study the problem.

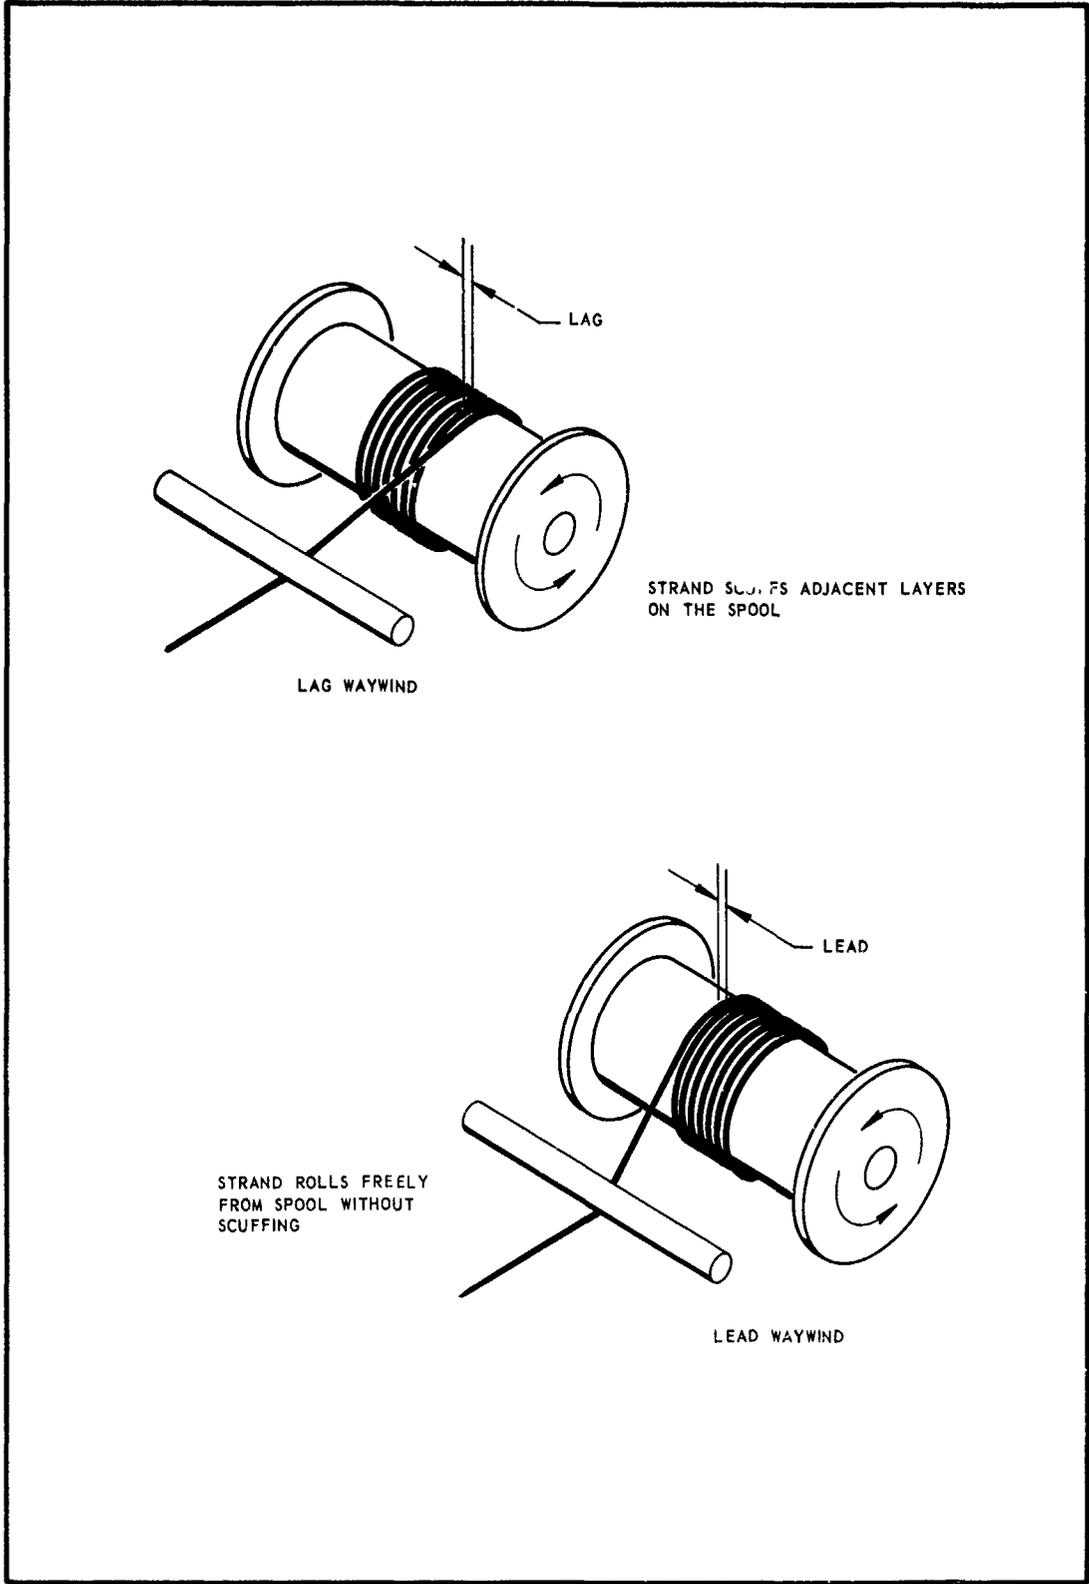
Figure 17. Spool Winding Methods for S-HTS Glass

Allison discovered that the direction of winding on the spools of glass (the direction in which glass strands are wound onto, or unwound from, the spool, known as "waywind," or as "lead" or "lag" in the winding pattern of the spools) differed from that of E-HTS glass. E-HTS glass had a lead waywind, but the S-HTS glass used in case No. 2 had a lag waywind. The difference was not noticeable unless the spools were observed closely while they were unwinding. The difference in waywind caused the unwinding S-HTS glass strands to scuff across adjacent strands (Figure 17) and damage the glass. The scuffing and fraying was particularly noticeable at the ends of the spools. Allison showed that, with a lead direction of waywind, the strand being unwound left the spool without damaging the adjacent strands.

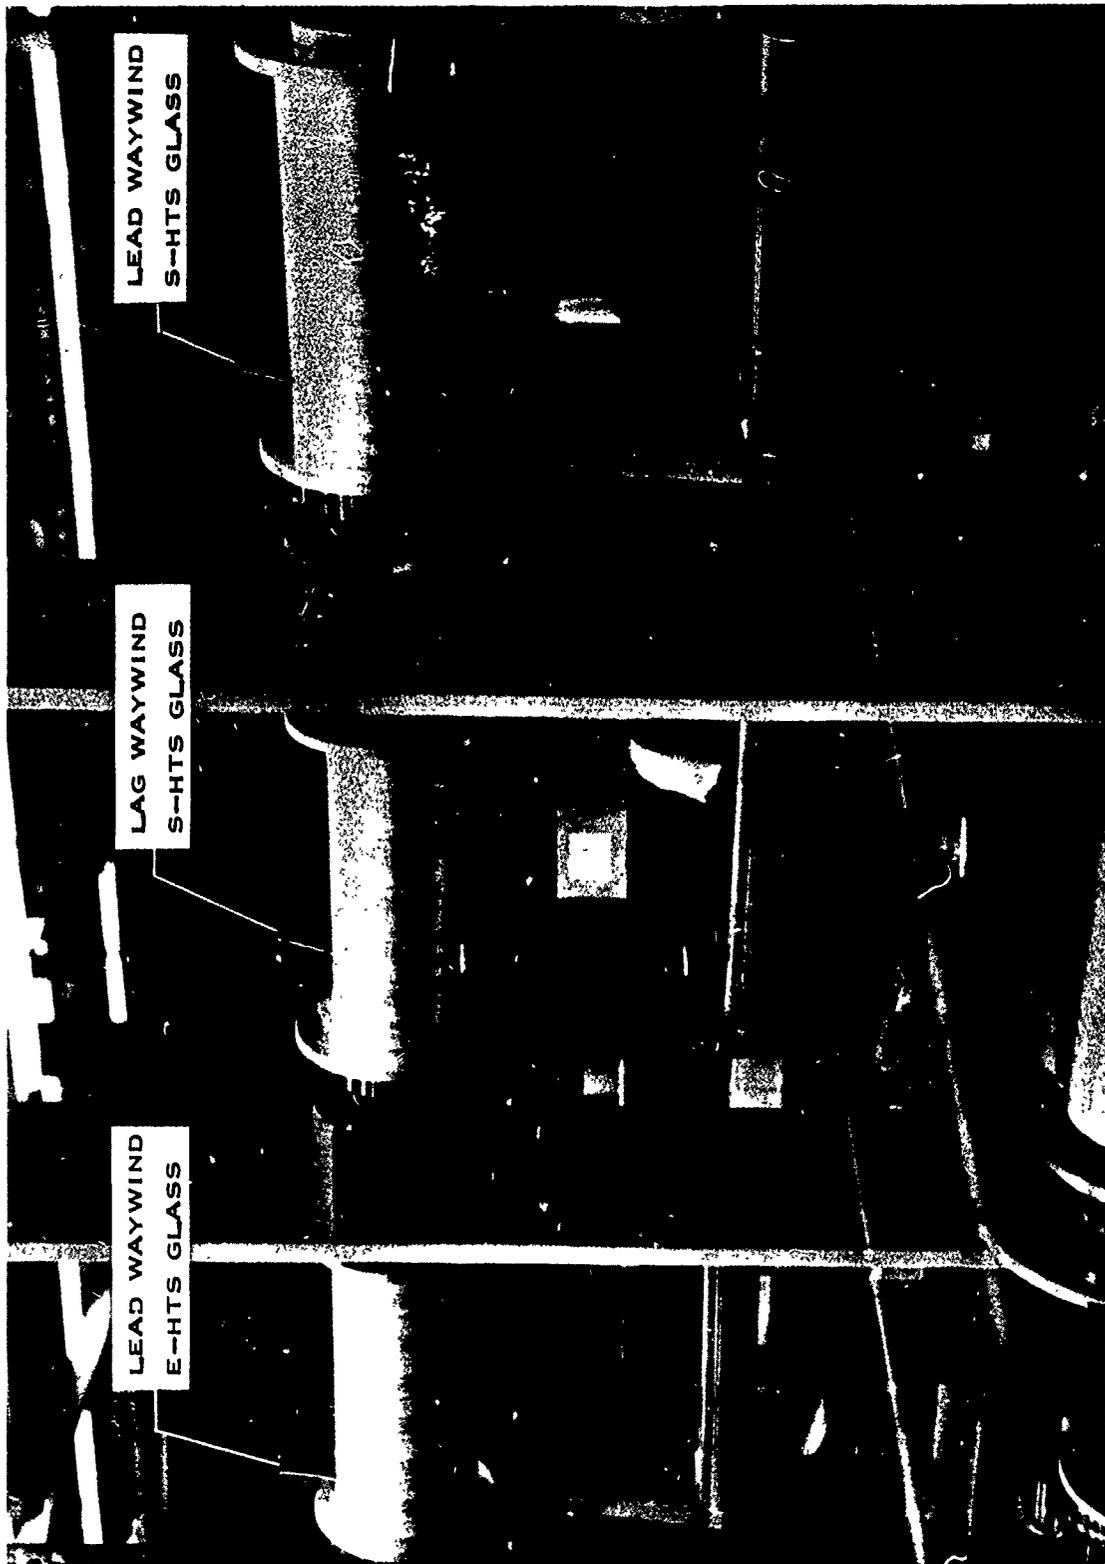
Figure 18. Fiber Damage Due to Lag Direction of Waywind

While Owens-Corning did not feel that the direction of waywind contributed to the frayed and broken strands of S-HTS glass, a spool of S-HTS glass with a lead waywind was forwarded to Allison for additional tests. Transfer characteristics of spools of S-HTS glass with lead waywind and lag waywind, and a spool of E-HTS glass with a lead waywind were compared (Figure 18). The spool of S-HTS glass with lag waywind (center spool: Figure 18) showed the greatest damage to the glass. Glass was frayed at the ends and fibers were found on the roller below the spool. A demonstration was presented to Owens-Corning personnel to show them how the waywind direction affected the strength of the glass.

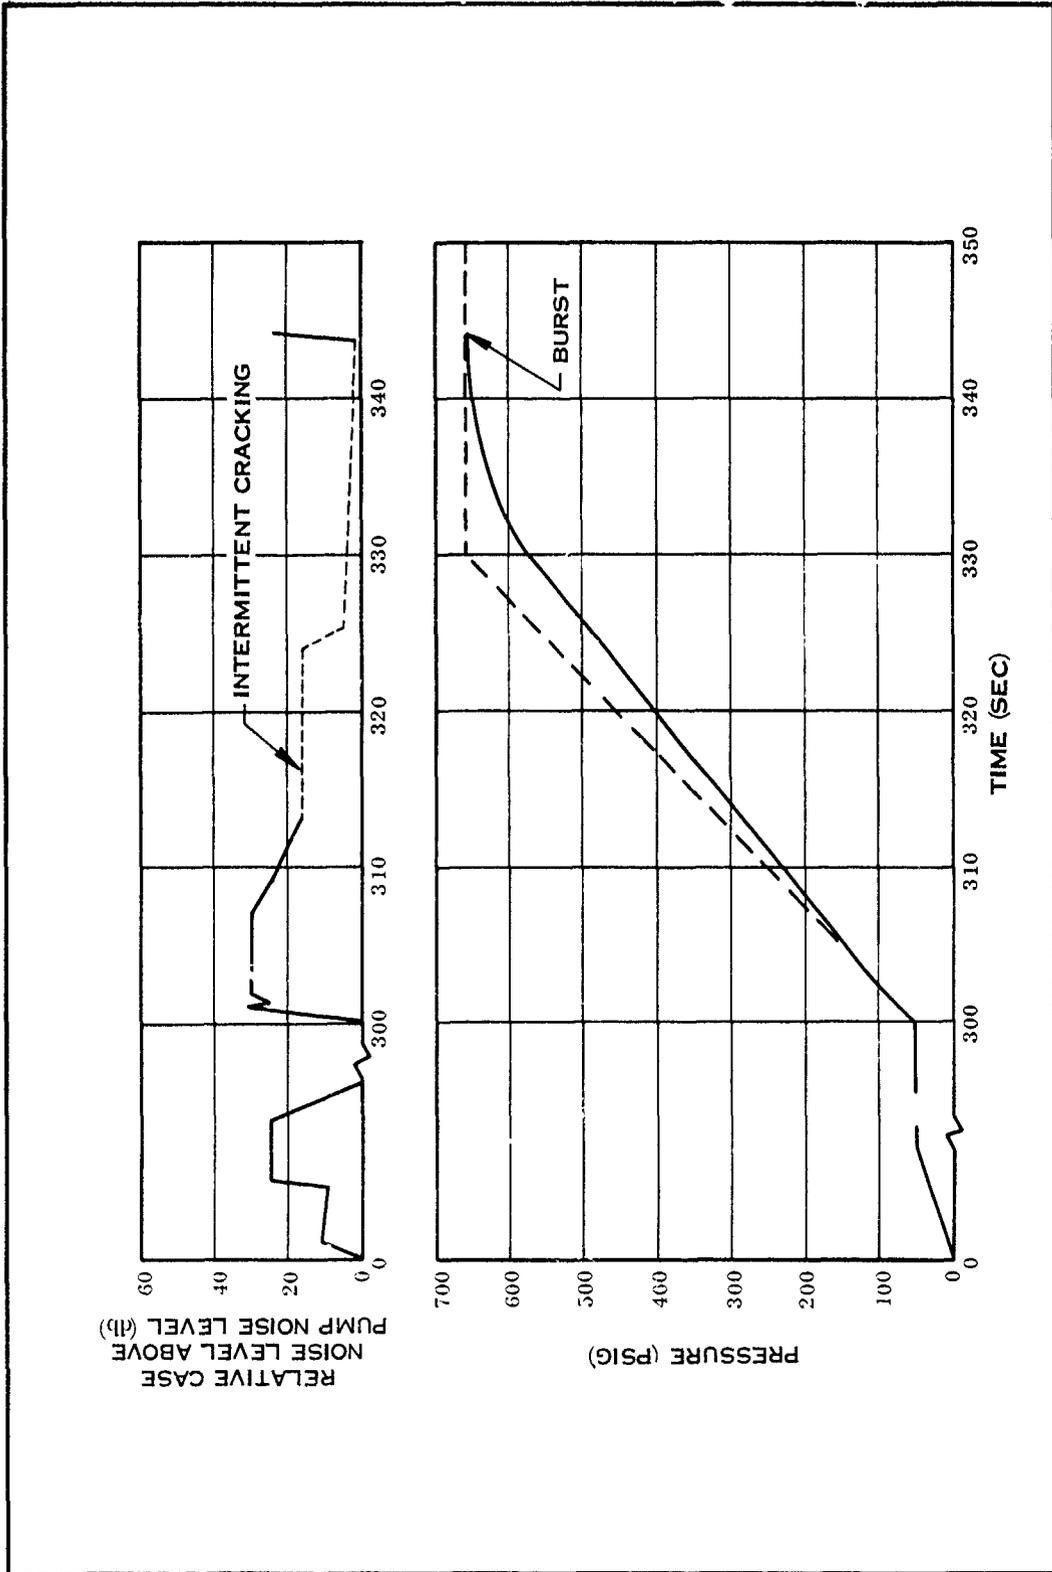
Figure 20. TU-290 Case No. 2 Hydroburst Test Pressure Record

The test program specified (1) a pressure check at 50 psig for 300 sec to condition instruments and verify case integrity, (2) a linear pressure increase to 660 psig in 30 sec to test the case for growth and expansion, (3) a sustained pressure of 660 psig for 60 sec to test the case at proof strength, and (4) a linear increase in pressure until the case failed. This test program is illustrated in Figure 20.

The case failed 5 sec after the internal case pressure leveled off at 660 psig. At the time of the failure, the pressure buildup was only 10 sec behind the programmed

pressure buildup (Figure 20). The failure began in a circumferential crack produced by the separation of hoop windings near the forward tangent line. The same nonlinear deflections recorded for stations 9 thru 11 on the aft dome of case No. 1 were recorded also on case No. 2 (Figure 21). These deflections were attributed to an undefined deflection characteristic of the dome. The early failure of several strain gages (No. 4, 6, 7, and 10; Figure 22) was attributed to severe circumferential cracking of the resin in the hoop windings. The forward dome pole cover plate shear lip failed (Figure 23) either during, or immediately following, the hydroburst test. The lip was found to be separated (for approximately 75 percent of the circumference) from the cover plate.

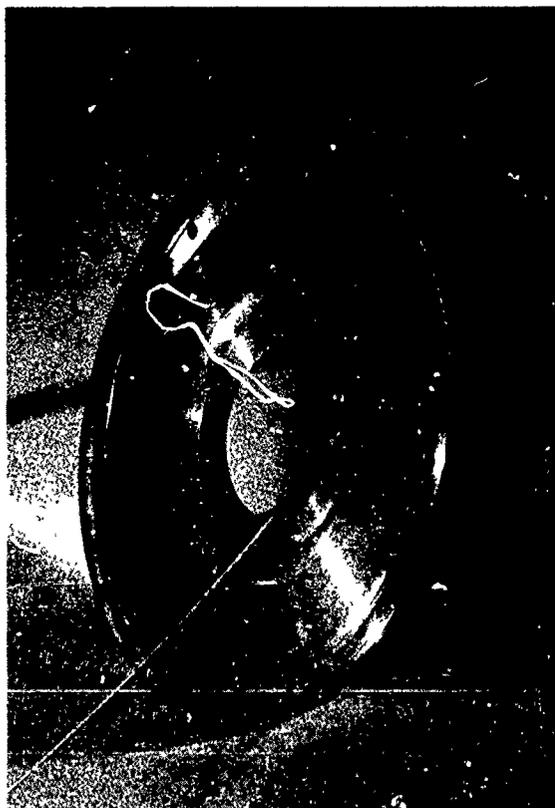
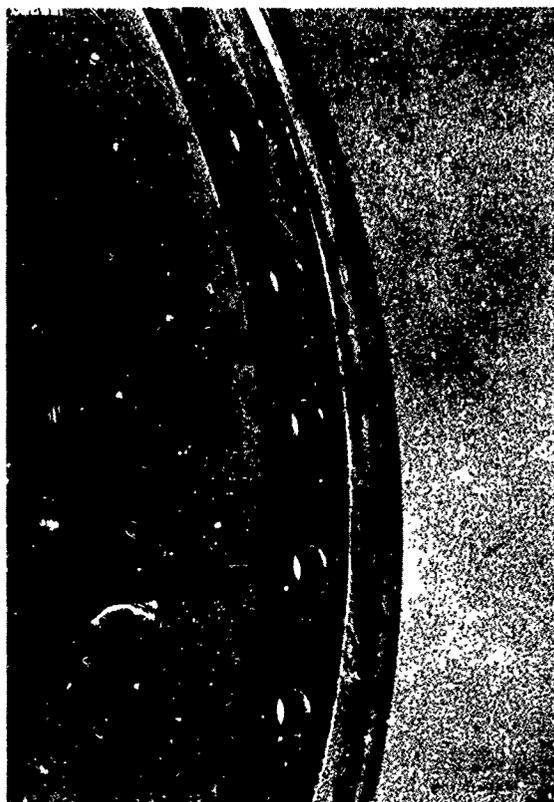
Figure 23. TU-290 Case No. 2 Cover Plate Shear Lip Failure

FORWARD COVER PLATE
SHEAR LIP FAILURE

SHEAR LIP FAILURE
DETAIL

3. The PYROGEN igniter cap must be redesigned to prevent the shear lip from cracking.
4. Methods of adjusting case growth and skirt restraint to prevent premature failure in the case-dome-skirt area must be studied and included in the design of case No. 3.

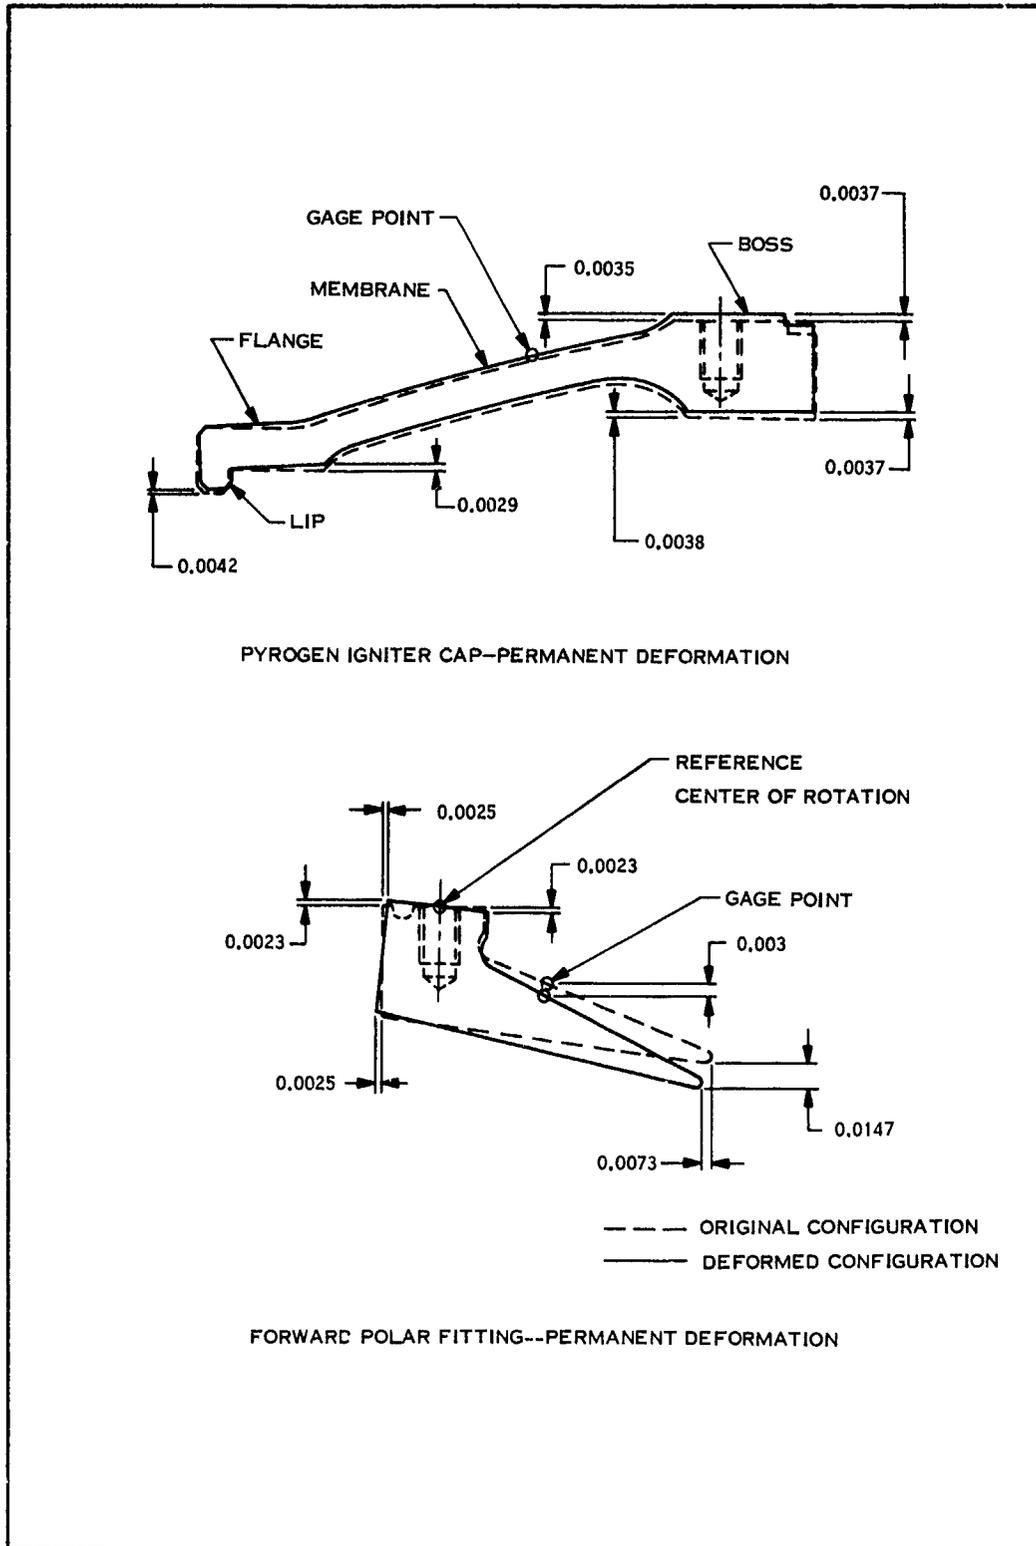
Figure 24. TU-290 Case No. 2 Polar Fitting Deformation

While the failure of the shear lip did not cause ultimate strength failure of the cover plate nor loss of case pressure, the forward polar fitting was permanently deformed due to imposed stresses above yield strength after shear lip failure (Figure 24).

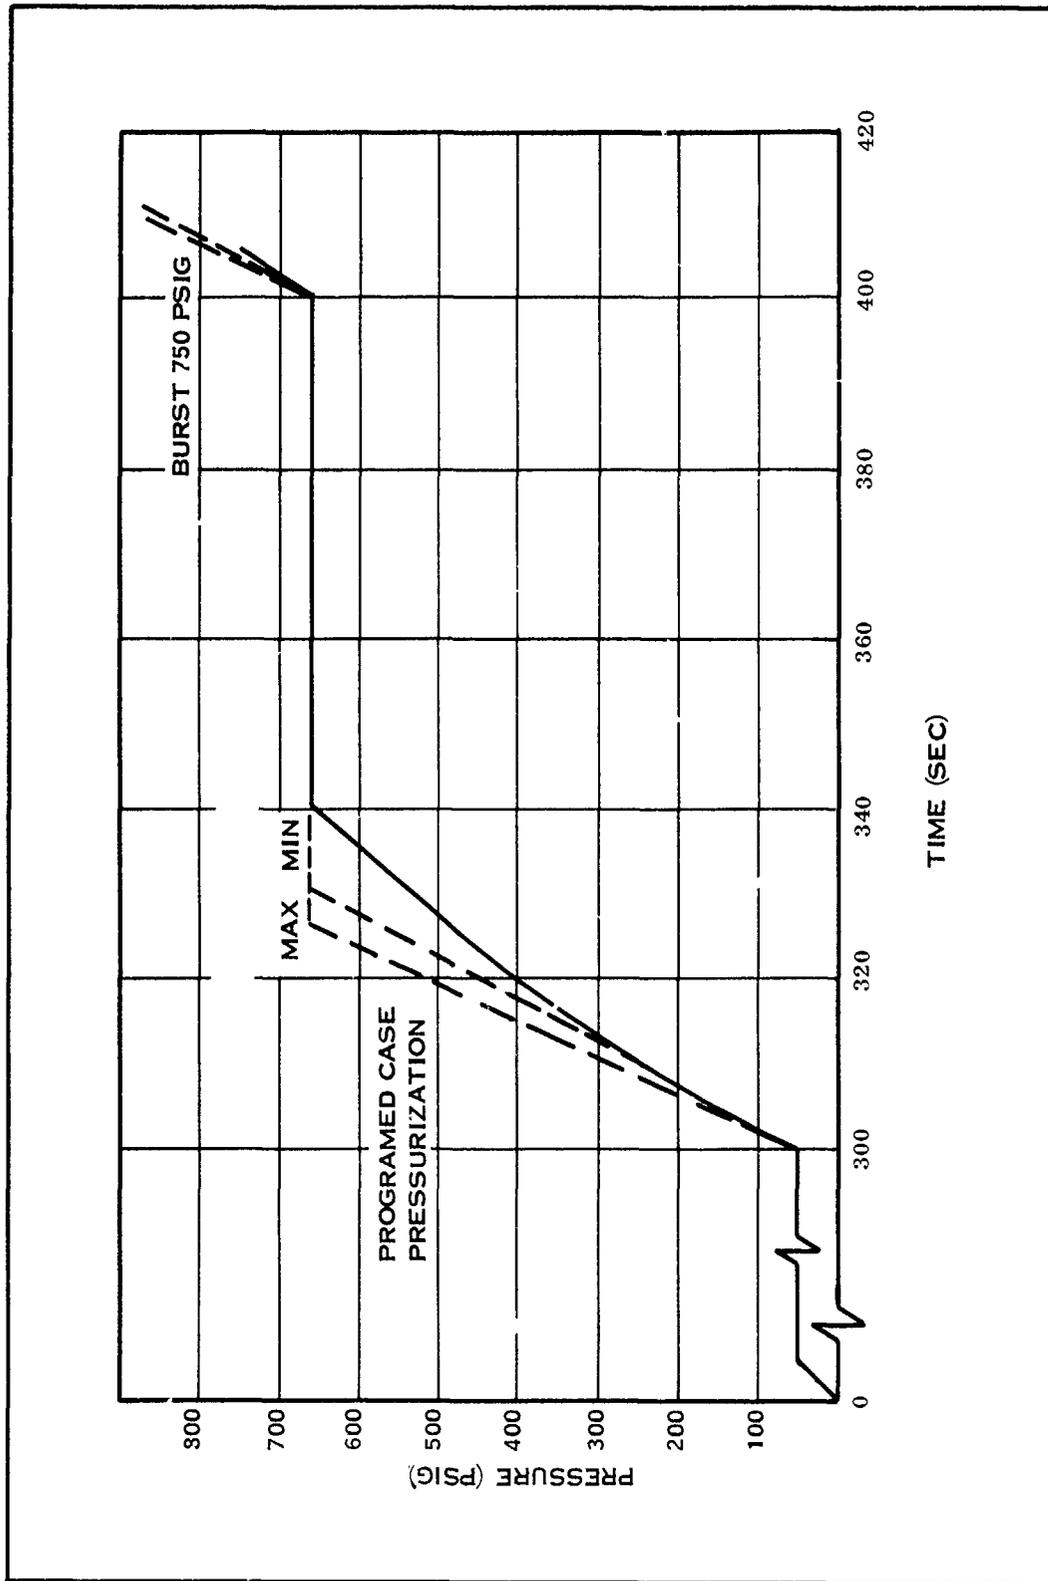
Figure 26. TU-290 Case No. 3 Hydroburst Test Pressure Record

The test program (Figure 26) specified (1) a pressure check at 50 psig for 300 sec to condition the instrumentation and to establish case integrity, (2) a linear pressure increase to 660 psig in 30 sec to test the case for growth and expansion, (3) a proof pressure check at 660 psig for 70 sec, and (4) a linear pressure increase until case rupture (Figure 27).

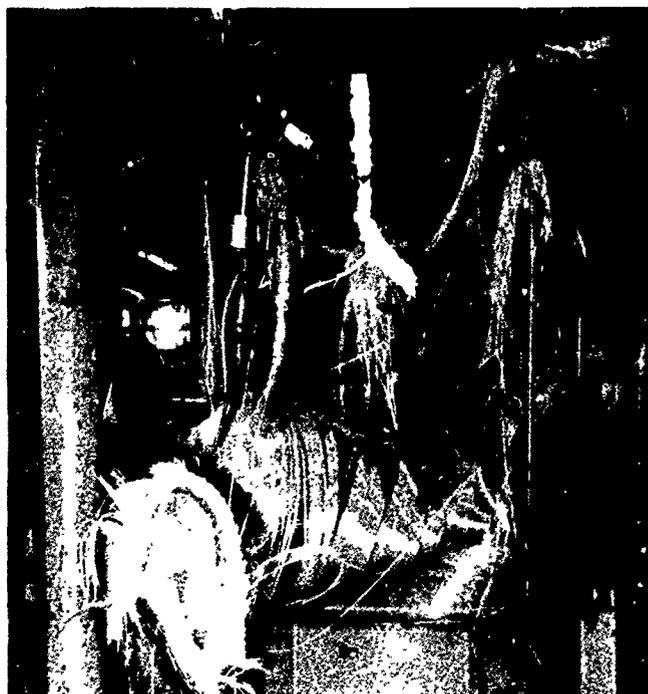
Figure 27. TU-290 Case No. 3 Hydroburst Test

TU-290 CASE No. 3
IN HYDROTEST FACILITY

TU-290 CASE No. 3
AFT RUPTURE

The test program was successfully completed up through and including the proof pressure check at 660 psig for 60 seconds. Case failure occurred at 750 psig. The failure started in a circumferential crack in the aft tangent area. Film coverage (64 and 500 fps) of the burst showed that the failure started at the edge of the aft skirt. Strain gages located in the area of failure indicated that the hoop laminate separated at the forward edge of the aft skirt at approximately 400 psig (Figure 29).
