REINFORCED PLASTIC CONSTRUCTION METHODS
FOR LARGE ROCKET MOTOR CASE

VOLUME IV TU-290 CASE DESIGN AND FABRICATION

FINAL TECHNICAL ENGINEERING REPORT
DECEMBER 1963

THIOLKOL CHEMICAL CORPORATION
WASATCH DIVISION
BRIGHAM CITY, UTAH

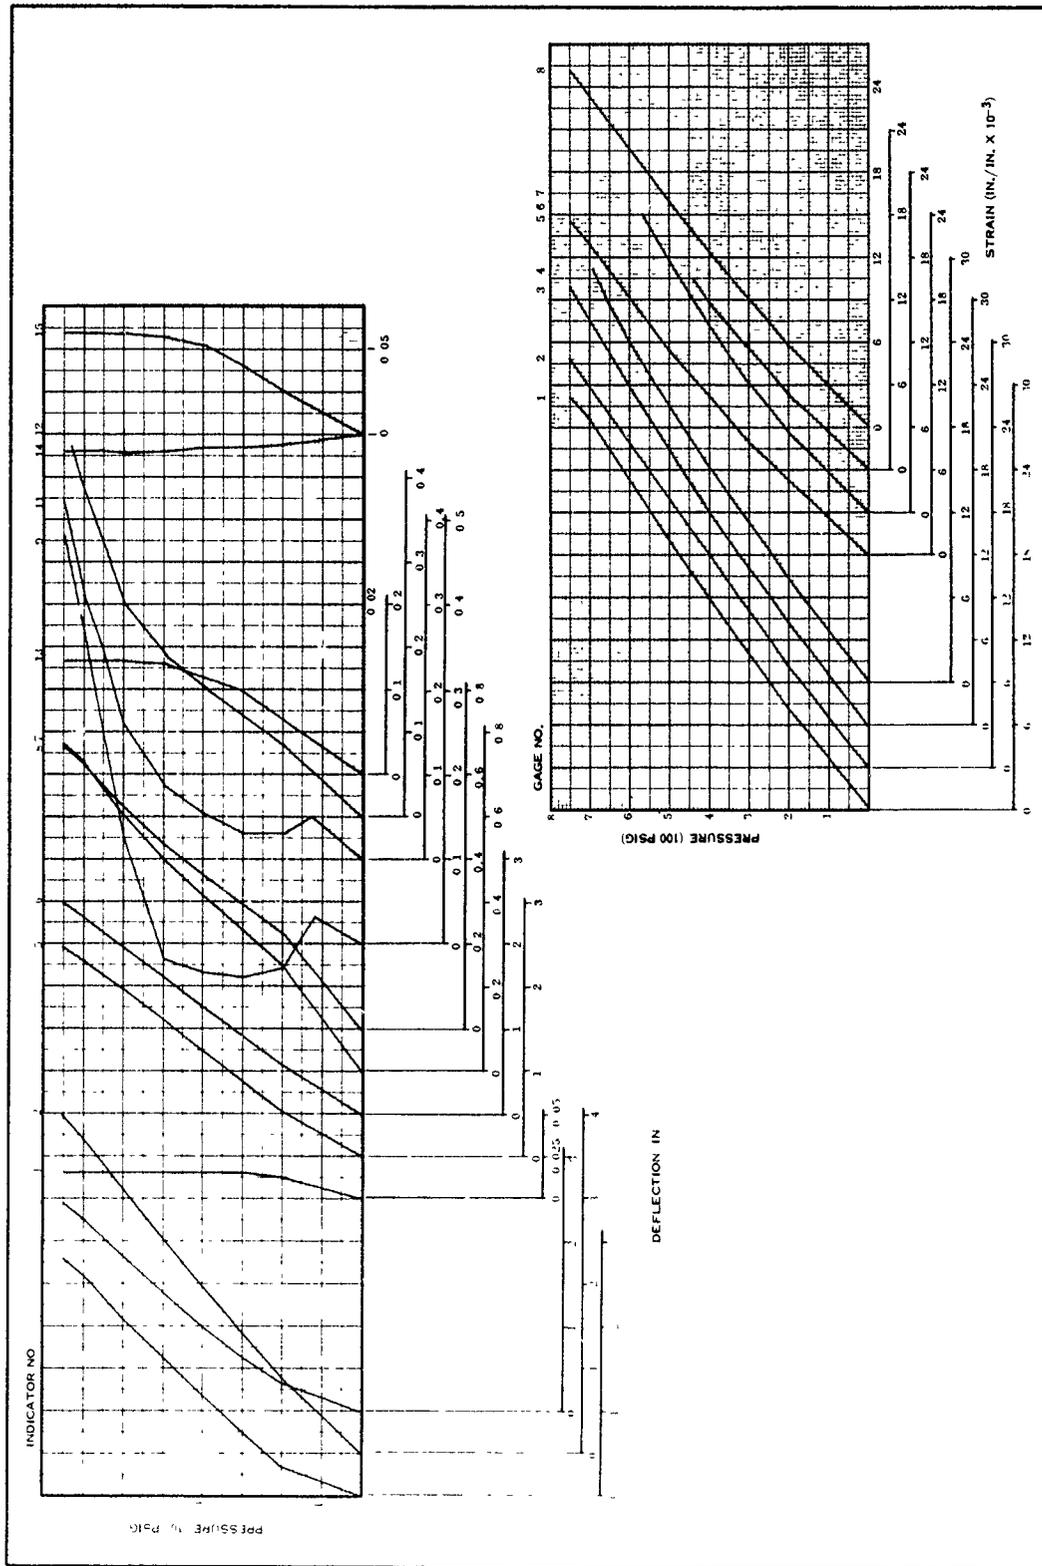
Figure 28. TU-290 Case No. 3 Hydroburst Test Deflection and Strain Indications

Nonlinear deflections were again recorded at extensometer stations 9 through 11 on the aft dome. These deflections were similar to those noted in cases No. 1 and 2, which further indicated the presence of a peculiar deflection characteristic in the dome. Figure 28 shows the deflection and strain measurements for the hydroburst test.

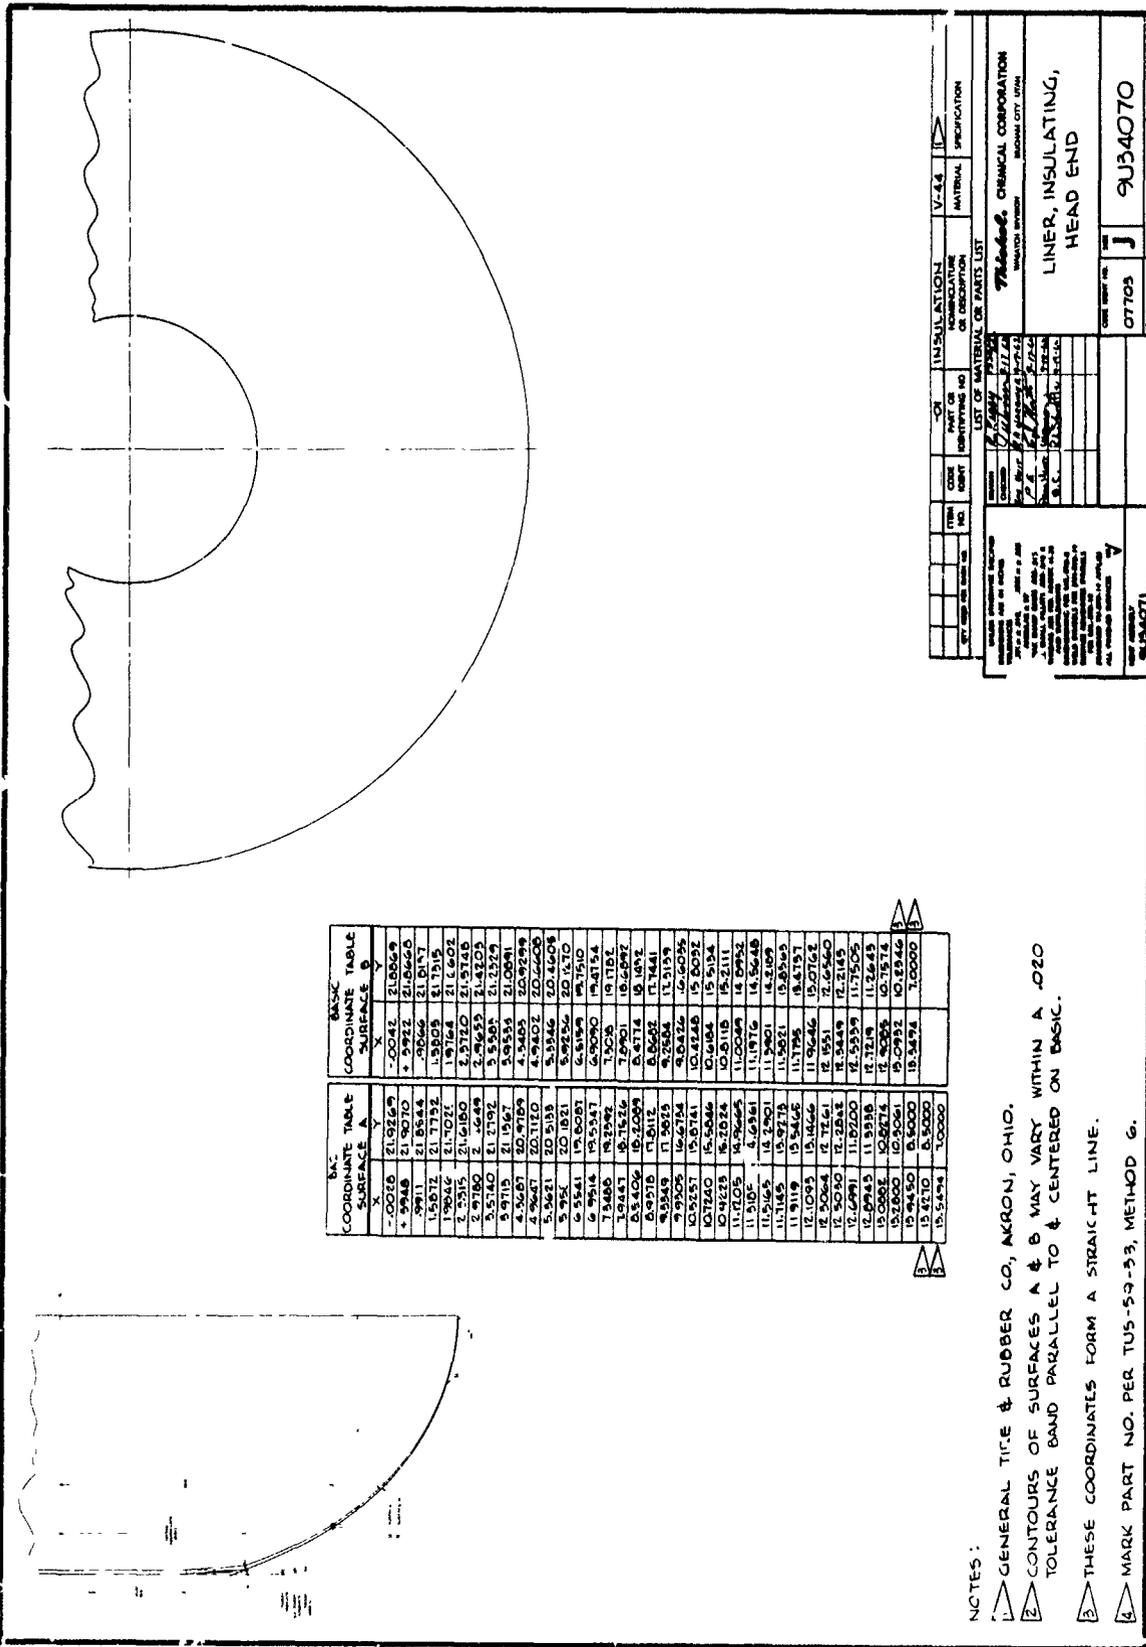
Figure 32. TU-290 Motor Head End Insulating Liner Drawing 9U34070

split flap was removed. Moreover, the dome insulators were changed to a homogeneous solid part (Figures 31 and 32). Two additional small sections of V-44 rubber were added in the aft and forward ends of the cylindrical section of the case to accommodate end burning in the slotted areas.
