**STRESS-CORROSION CRACKING
OF HIGH-STRENGTH ALLOYS**

A REPORT TO
FRANKFORD ARSENAL

REPORT NO. 2914 (FINAL) / AUGUST 1964 / COPY NO. 5

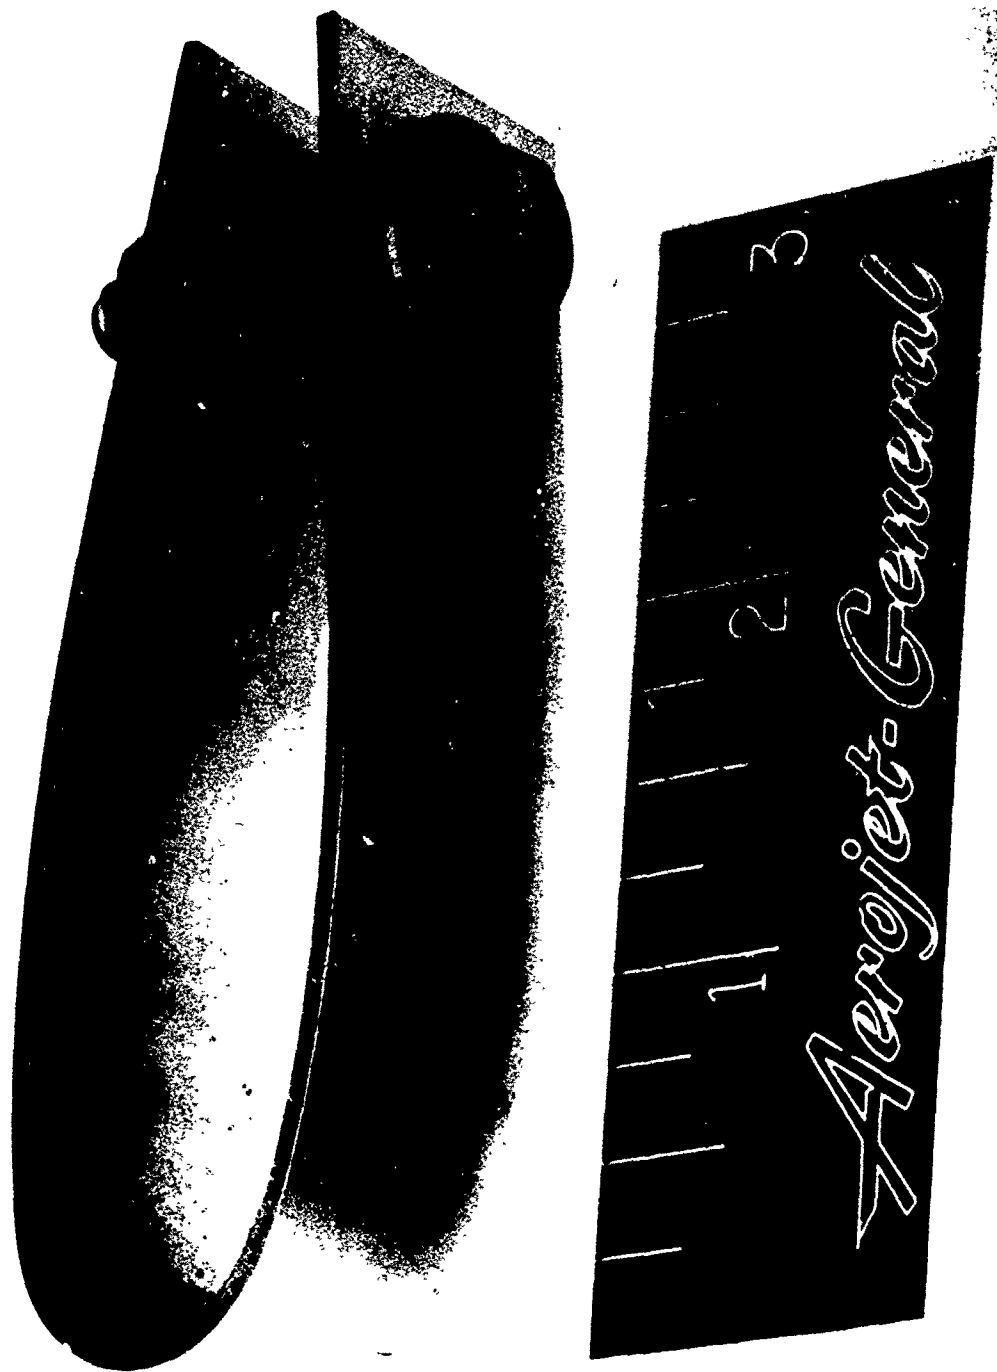
U-Bend Test Specimen

U-bend samples were used to show the effect of elastic stresses on stress-corrosion susceptibility. Figure 3 shows a typical U-bend sample bent around a 1-in. radius. Samples were bent after heat treatment by use of a special guide fixture.

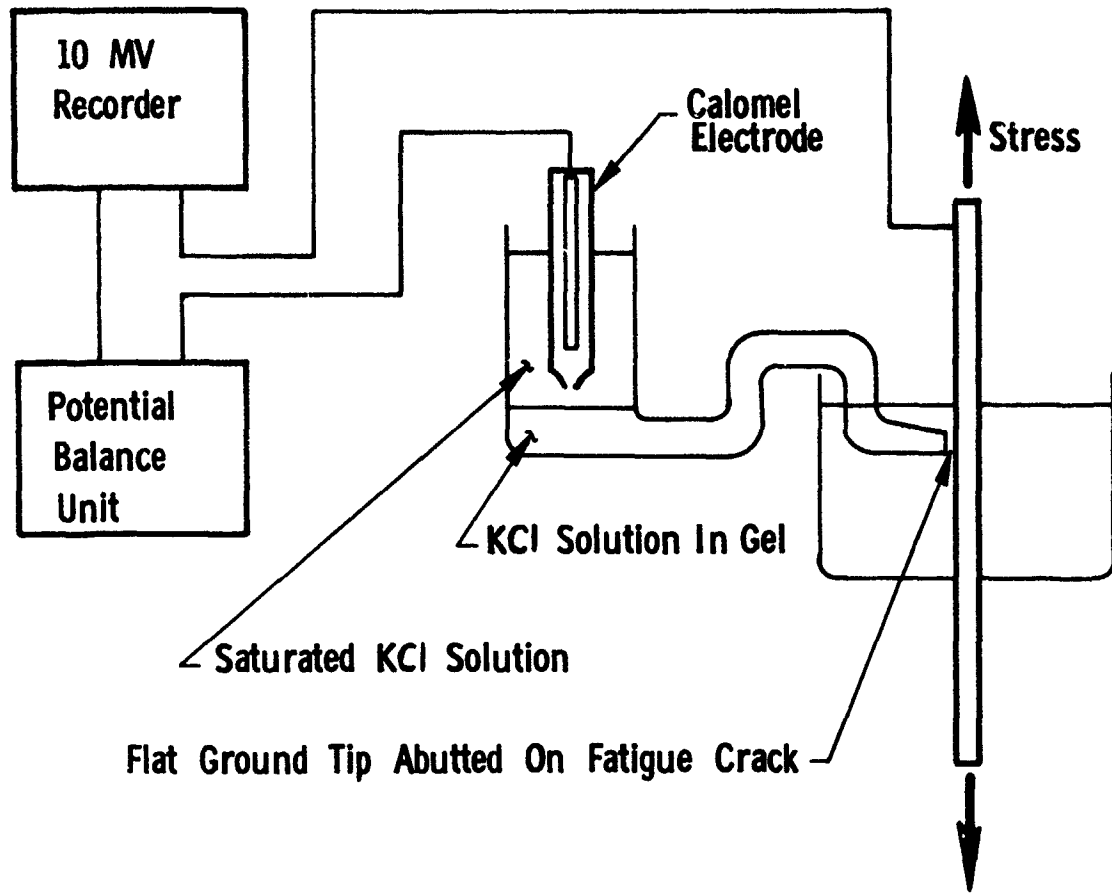
Figure 8

STRESS-CORROSION POTENTIAL MEASURING APPARATUS

A center-notched tensile specimen of the type shown in Figure 4 was used in the applied stress experiment with the setup as shown in Figure 8. The specimen, an 18%-nickel maraging steel sample with 250-ksi yield strength (Heat 396052), was exposed to a 3%-NaCl solution. A capillary tube, containing KCl solution in a gel, was used in this setup to contact the crack tip of the specimen, and lead to a calomel electrode. As the applied stress on the specimen was increased, voltage recordings were made to give the applied stress vs crack-tip corrosion potential relationships shown in Figure 9. This graph indicates that application of stress by incremental loading of the specimen causes a potential shift at the crack tip toward the cathodic side. If the stress-corrosion process is indeed electrochemical in nature, as has been frequently postulated, then the magnitude of such a shift would be expected to materially affect failure time. In fact, if the potential shift caused by the increased stress - rather than the stress itself - is the overriding factor in stress-corrosion cracking, then it should be possible by applying an external potential to the stressed specimen, to alter the failure time.

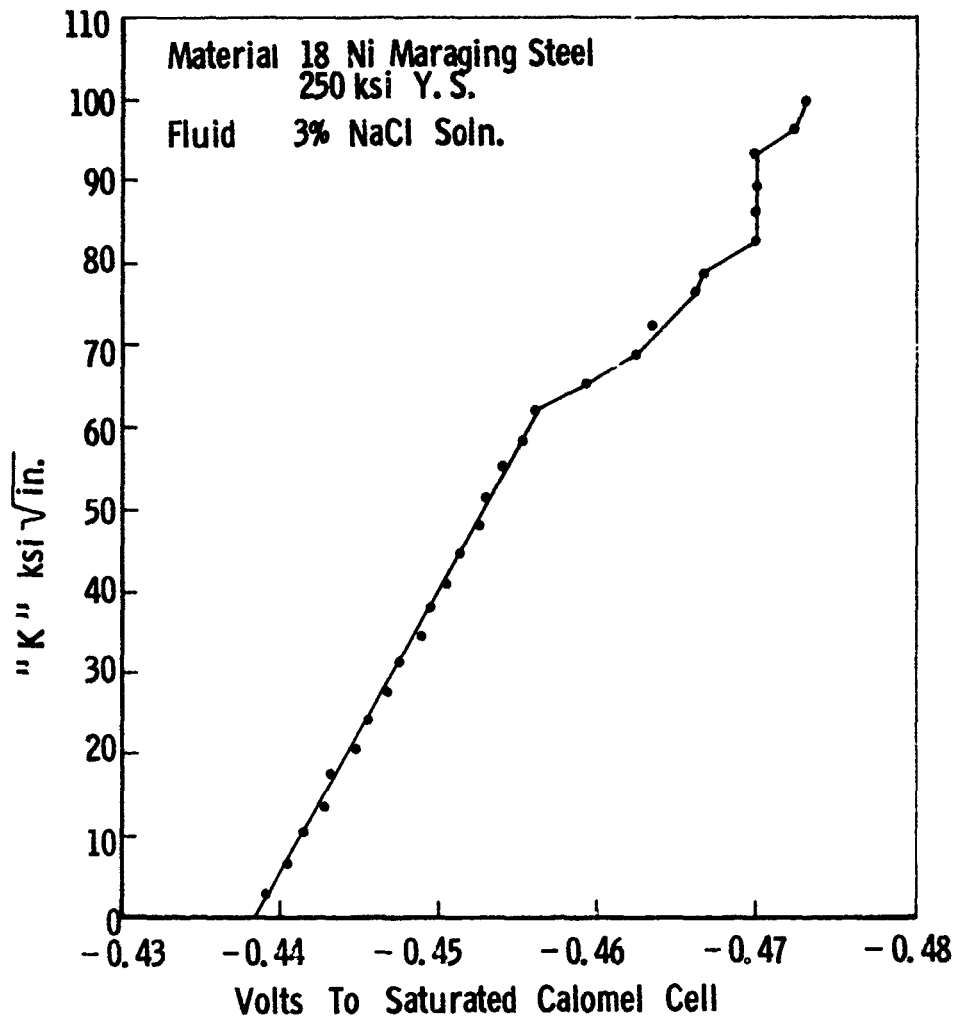
EFFECT OF STRESS FIELD PARAMETER, K, ON CRACK-TIP CORROSION POTENTIAL

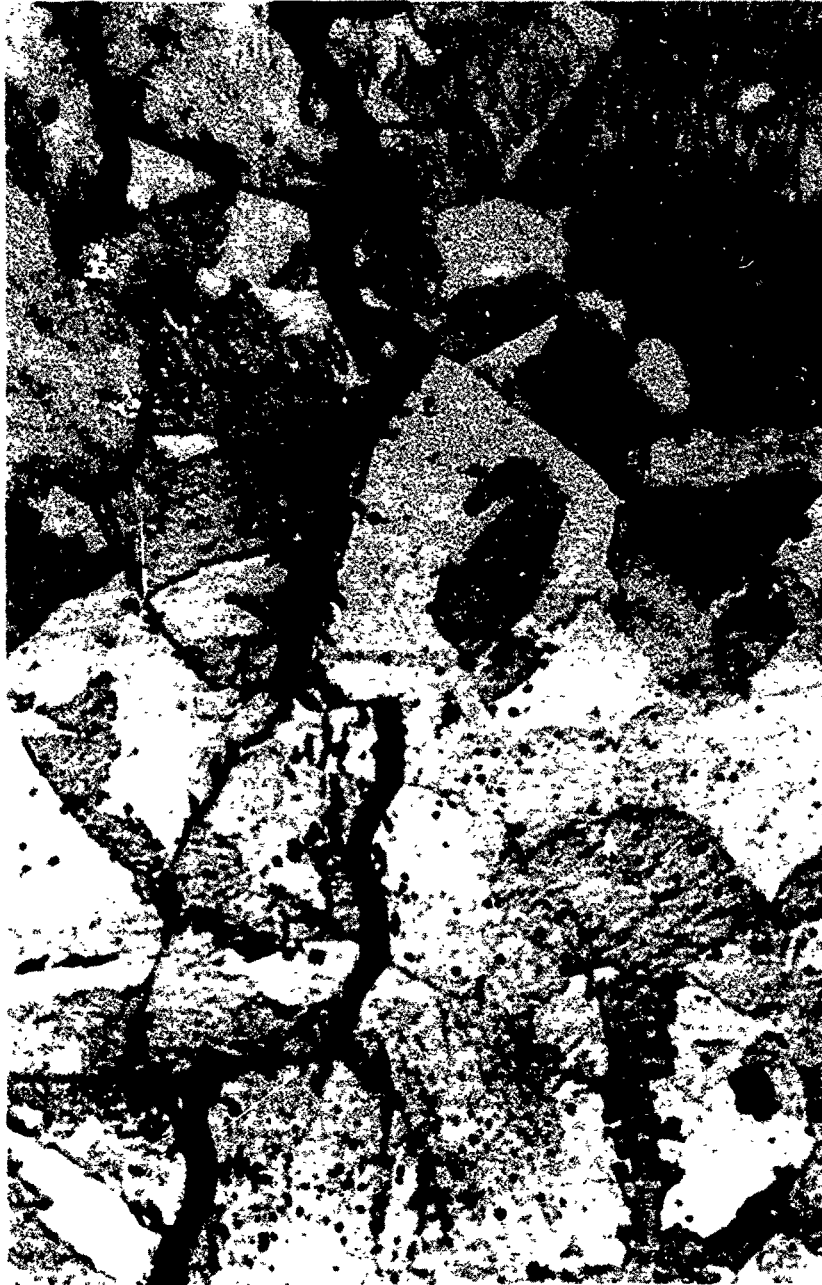
Typical Stress-Corrosion Crack in 18% Nickel Maraging

Heat 3960523

Etchant: Dilute marbles

Magnification: 1400X

Figures 11 to 23 represent a series of macrographs, micrographs, and electron microscope fractographs of typical grain structures and crack patterns associated with stress-corrosion failures in 18%-nickel maraging steel and H-11 steel samples. The descriptions of the views taken are shown below the photographs. The mode of cracking was intergranular.

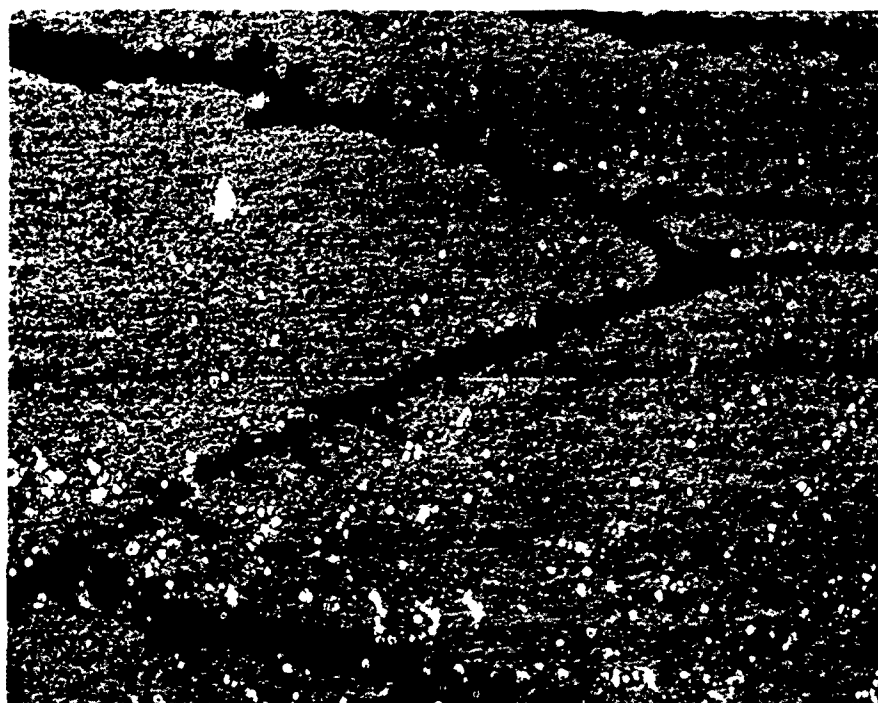
General Structure in Interior of Highly Cracked Area.
Etchant - 10% Ammonium persulphate-electrolytic. (500X)

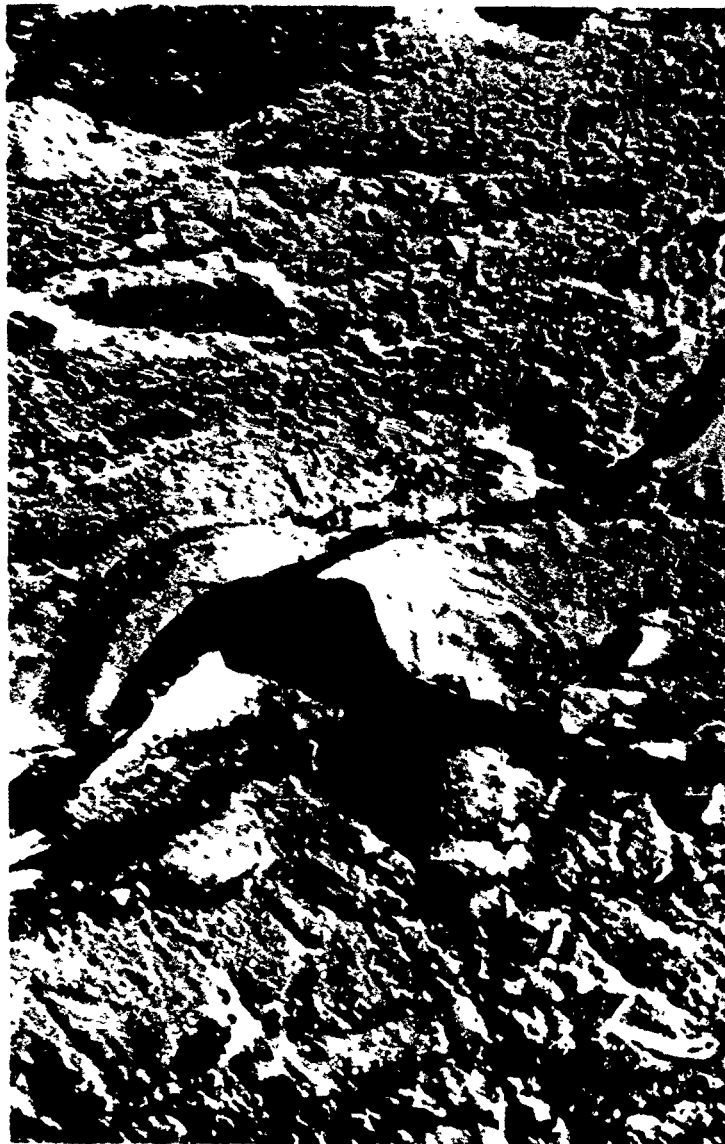
FIG - 19

Electron-Microscope Fractograph (1) of H-11 Steel (17,500X)

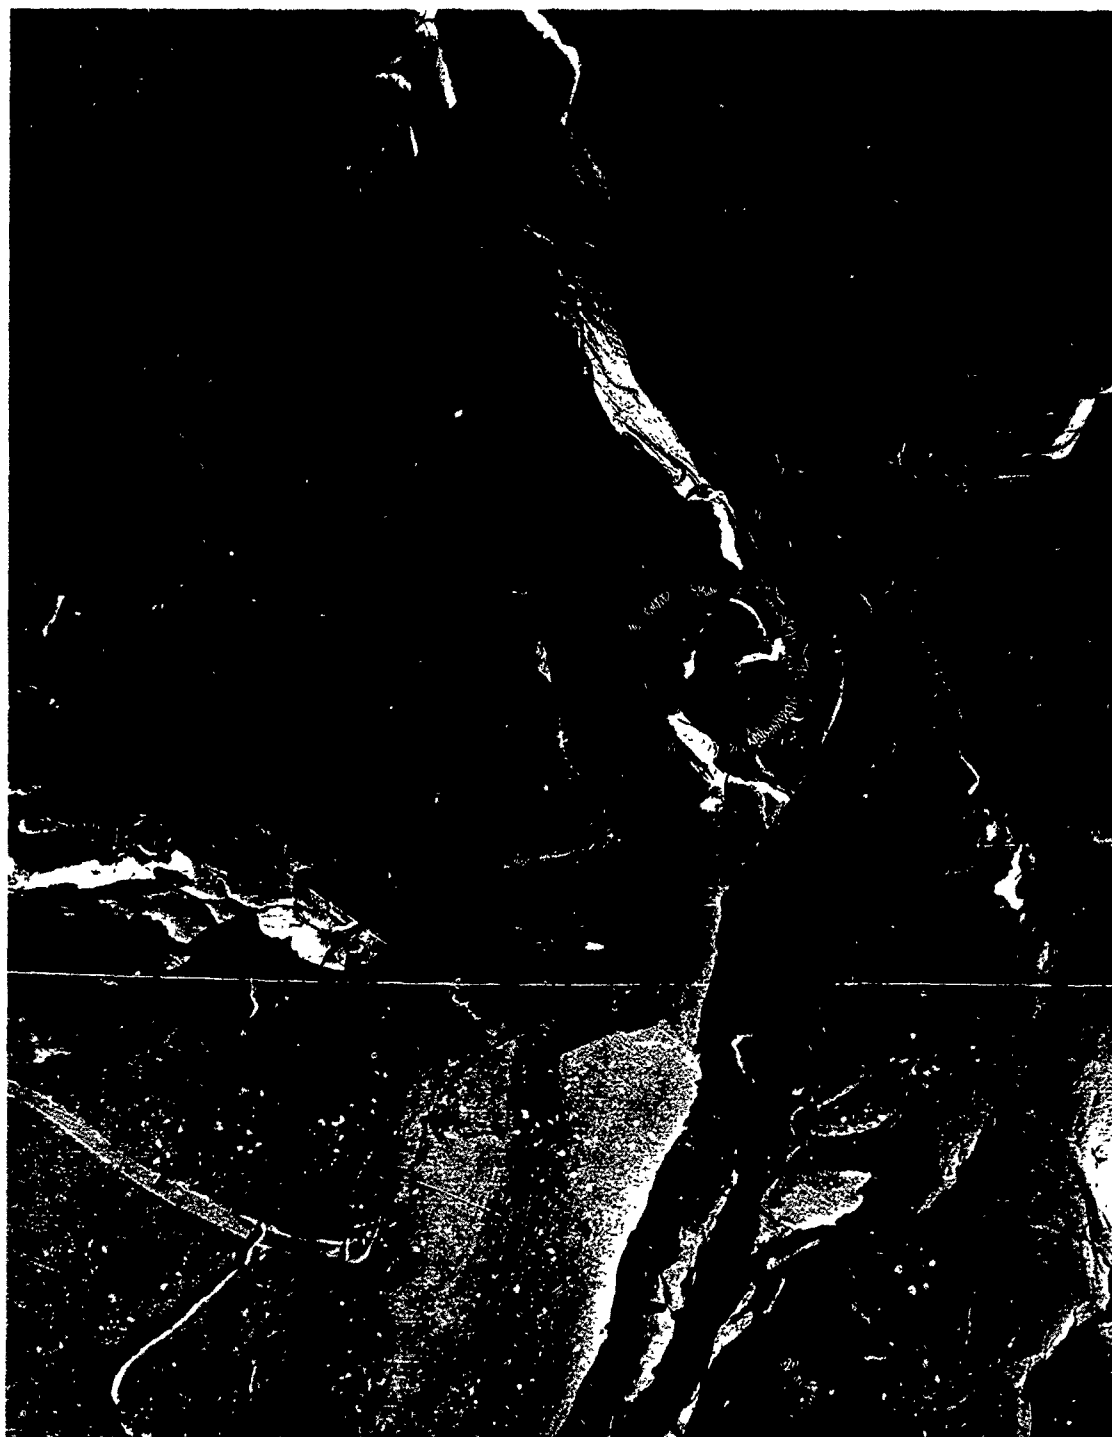
Electron-Microscope Fractograph (2) of 18% Nickel Maraging Steel (20,000X)

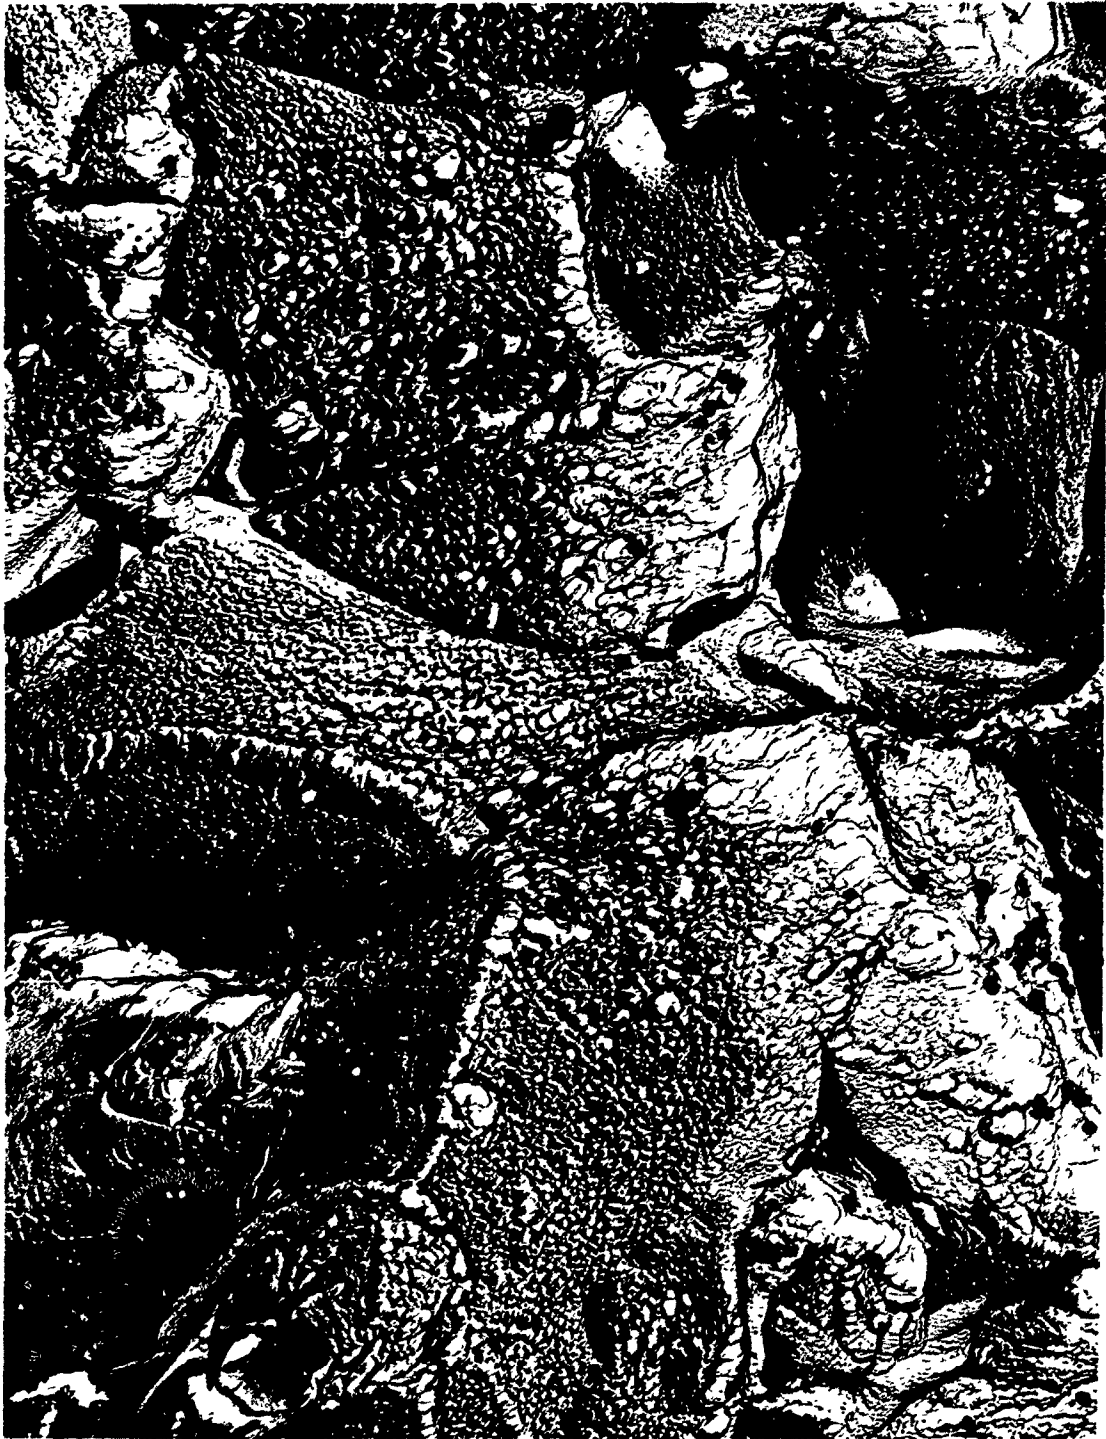
Electron-Microscope Fractograph (3) of 18% Nickel Maraging Steel (20,000X)
