## INVESTIGATION OF THE EFFECTS OF STRESS CORROSION ON HIGH-STRENGTH STEEL ALLOYS

TECHNICAL DOCUMENTARY REPORT NO. ML-TDR-64-3

(Prepared under Contract No. AF 33(657)-8705 by The Boeing  
Company, Airplane Division, Renton, Washington: Gary A. Dreyer  
and Wesley C. Gallagher, authors)

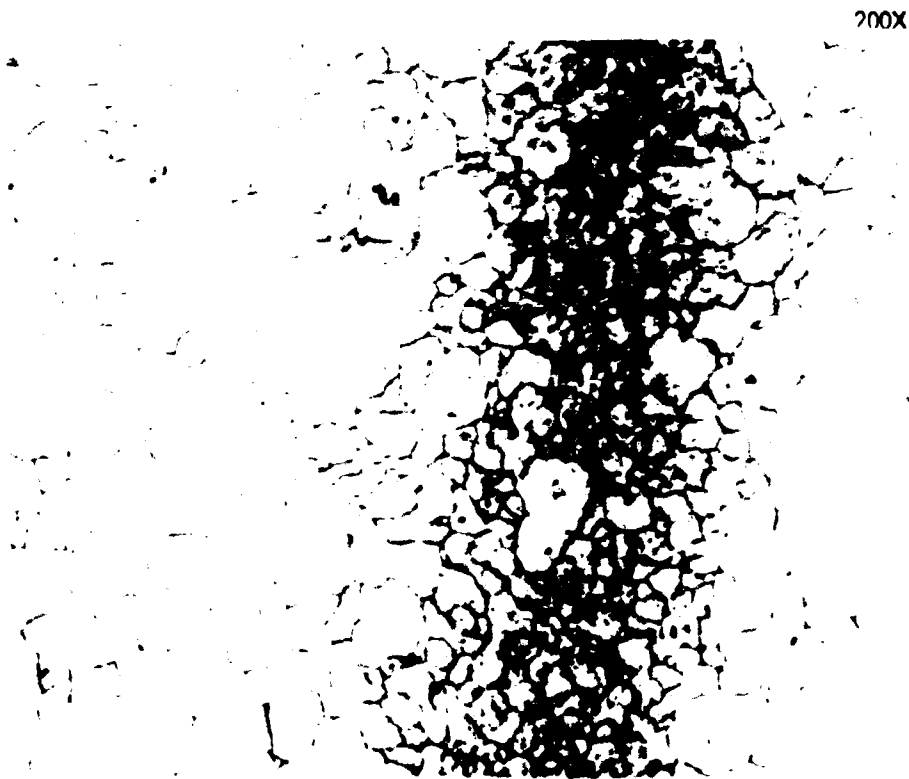
Figure 40 MICROGRAPH OF BANDING IN 4340 BILLET MATERIAL—ADS ETCH

Optical microscopy studies were used primarily to determine grain size and mode of failure. Phase distribution determinations were not possible because of the microstructural complexities of alloy steels. However, some interesting aspects were noted in the stress-corrosion specimens. The optical microscope studies showed that cracking in the 4340, D6AC, and 4335M steels originated intergranularly, but that any transgranular cracking was difficult to identify. Examination of the 0.250-inch (thickness) dimension of the stress-corrosion specimens indicated that the grains in these steels were equiaxed, but bands of slightly smaller than average grains were noted in 4340 that were parallel to the original billet longitudinal grain direction. The grains in the 4340, 4335M, and D6AC ausformed steels were slightly elongated in the direction of rolling. The banding in 4340 and elongated grains in D6AC are shown in Figures 40 and 41, respectively.

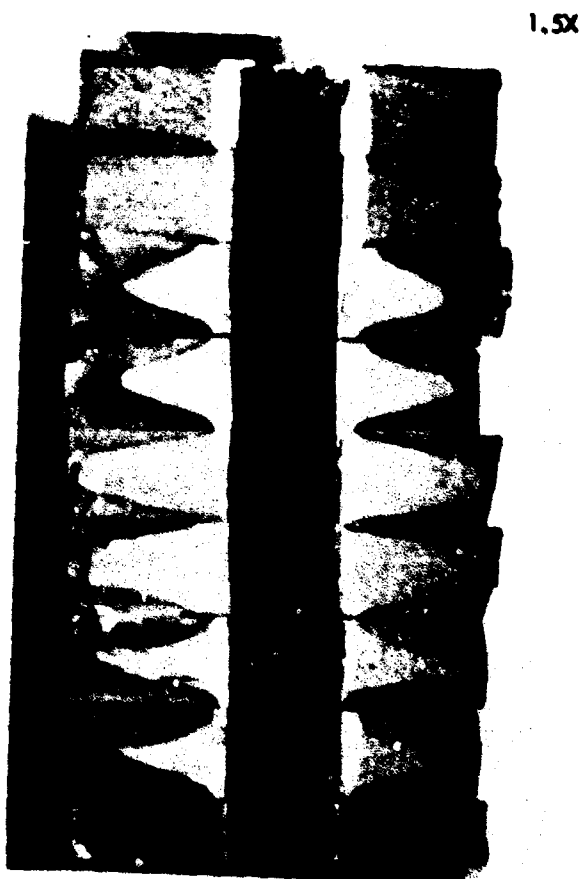
Figure 42 FRACTURE FACES OF THE FRACTURE TOUGHNESS SPECIMENS FROM PLATE MATERIALS

The macro fracture appearances of the fracture toughness specimens is shown in Figure 42, in which the total shear lip area of each specimen is related to the fracture toughness (see Appendix II). As previously noted, the stress-corrosion susceptibility of the materials decreased with increasing fracture toughness. The textures of the plane-strain areas (see Appendix II for description of terminology) varied between the various alloys and were not directly related to the texture from the stress-corrosion specimens.
