# STUDY AND EXPLORATORY FREE-FLIGHT INVESTIGATION OF DEPLOYABLE AERODYNAMIC DECELERATORS OPERATING AT HIGH ALTITUDES AND AT HIGH MACH NUMBERS

TECHNICAL DOCUMENTARY REPORT FDL-TDR-64-35, VOL. I

JULY 1964

AIR FORCE FLIGHT DYNAMICS LABORATORY  
RESEARCH AND TECHNOLOGY DIVISION  
AIR FORCE SYSTEMS COMMAND  
WRIGHT-PATTERSON AIR FORCE BASE, OHIO

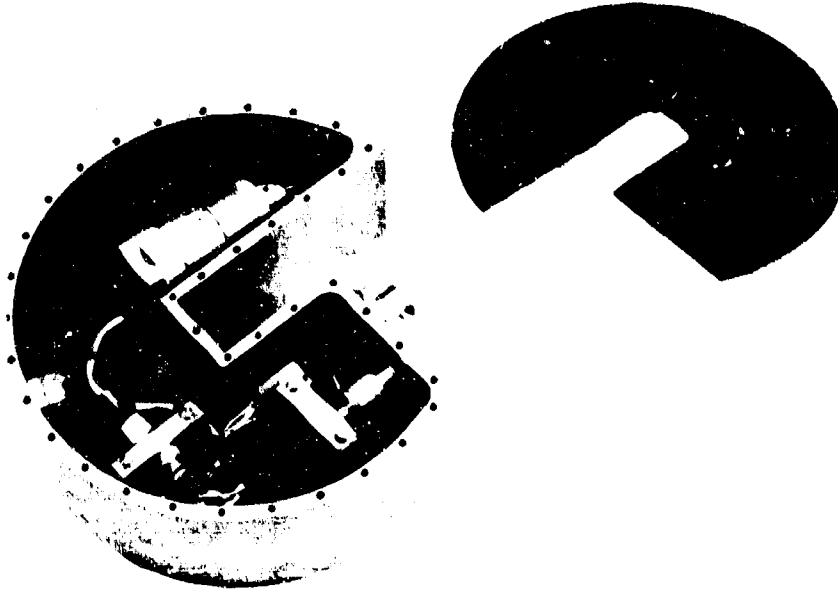
B.4 Transducer Compartment

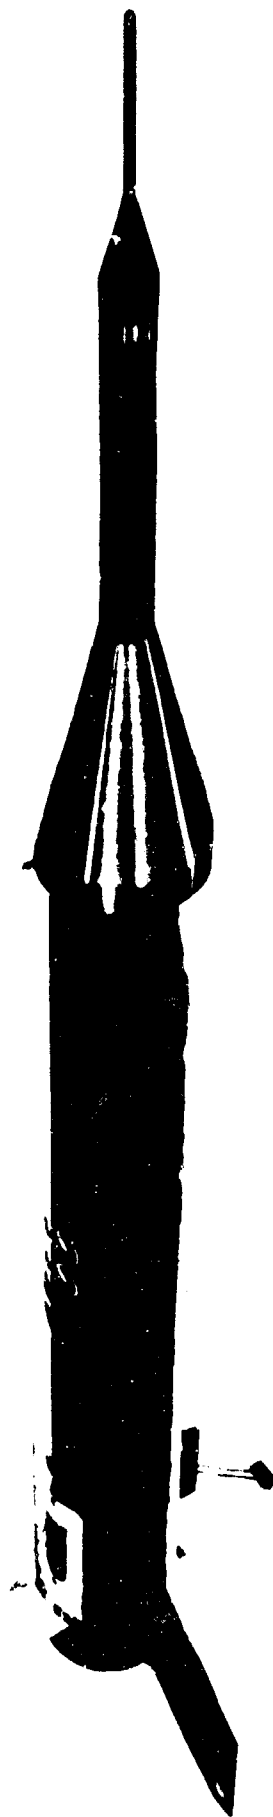
Figure B.7 Cree Vehicle With Dive Brakes Extended
