USATRECOM TECHNICAL REPORT 64-67

ENGINE AND WHIRL TESTS,  
XV-9A HOT CYCLE RESEARCH AIRCRAFT

SUMMARY REPORT

U S ARMY TRANSPORTATION RESEARCH COMMAND  
FORT EUSTIS VIRGINIA

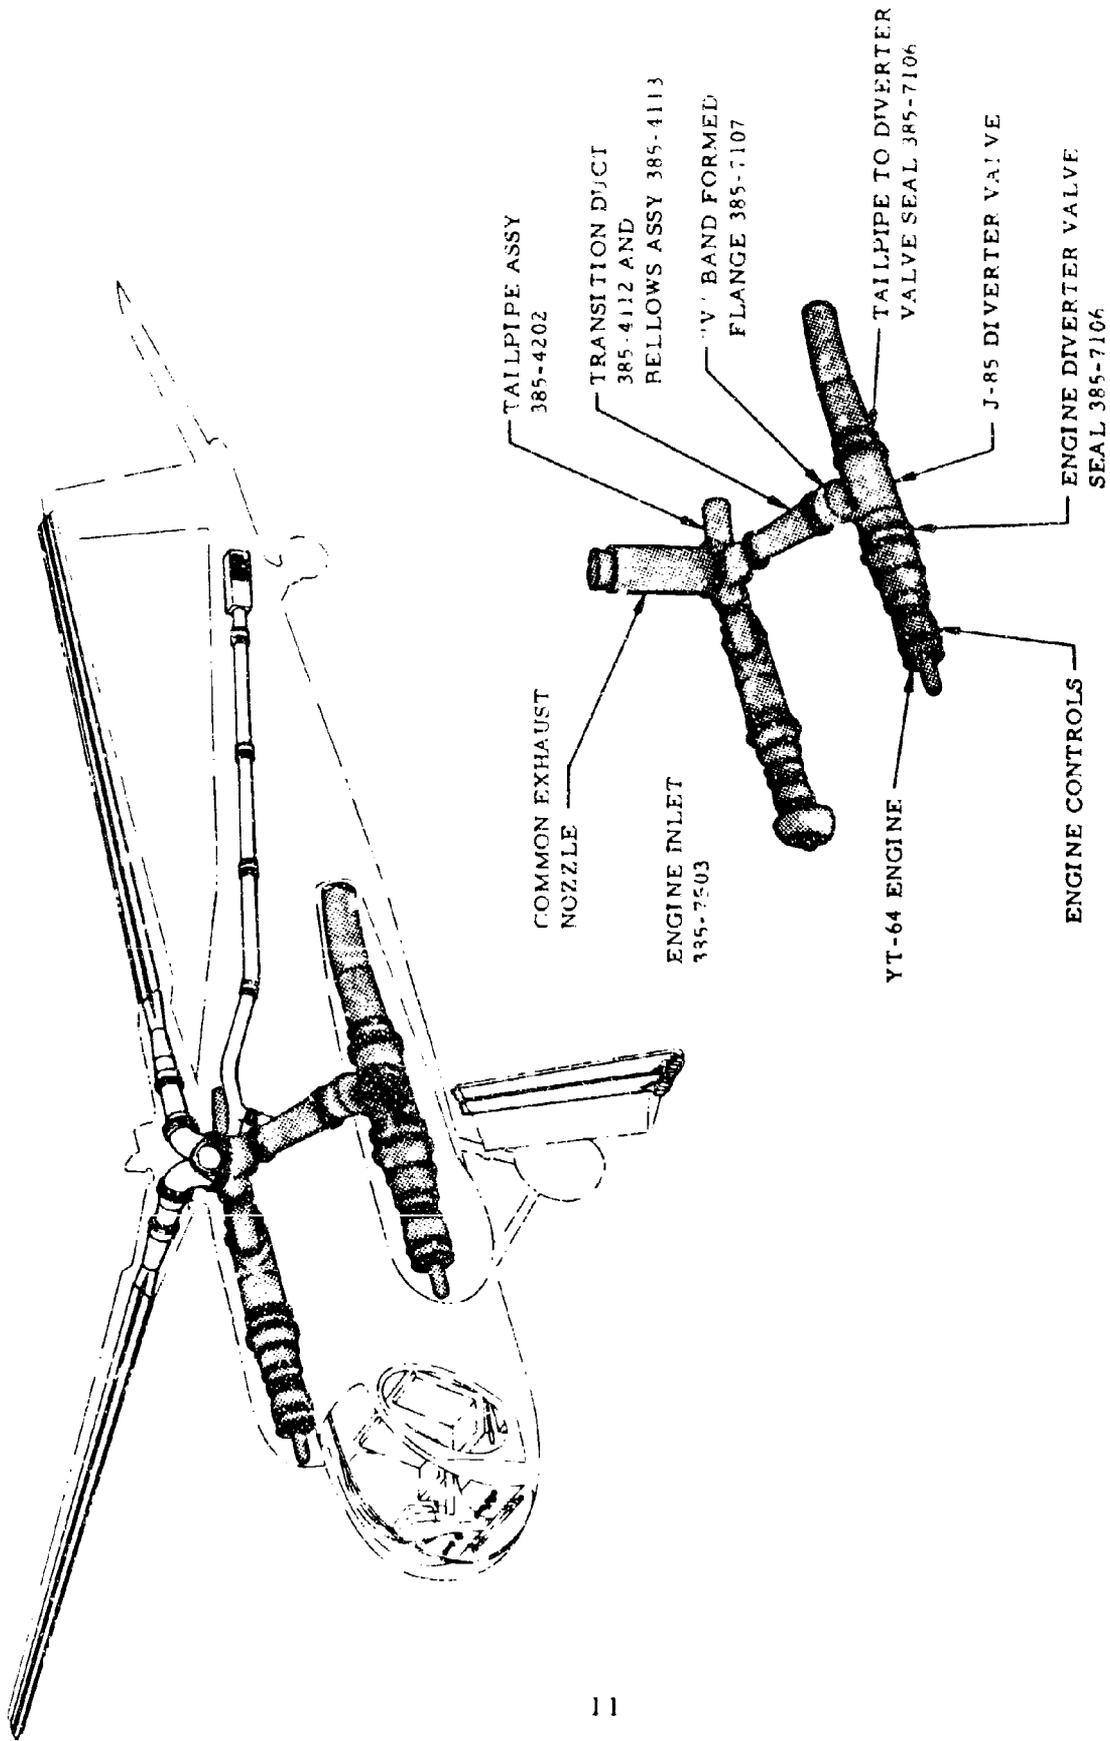
Figure 1. Engine Test Configuration

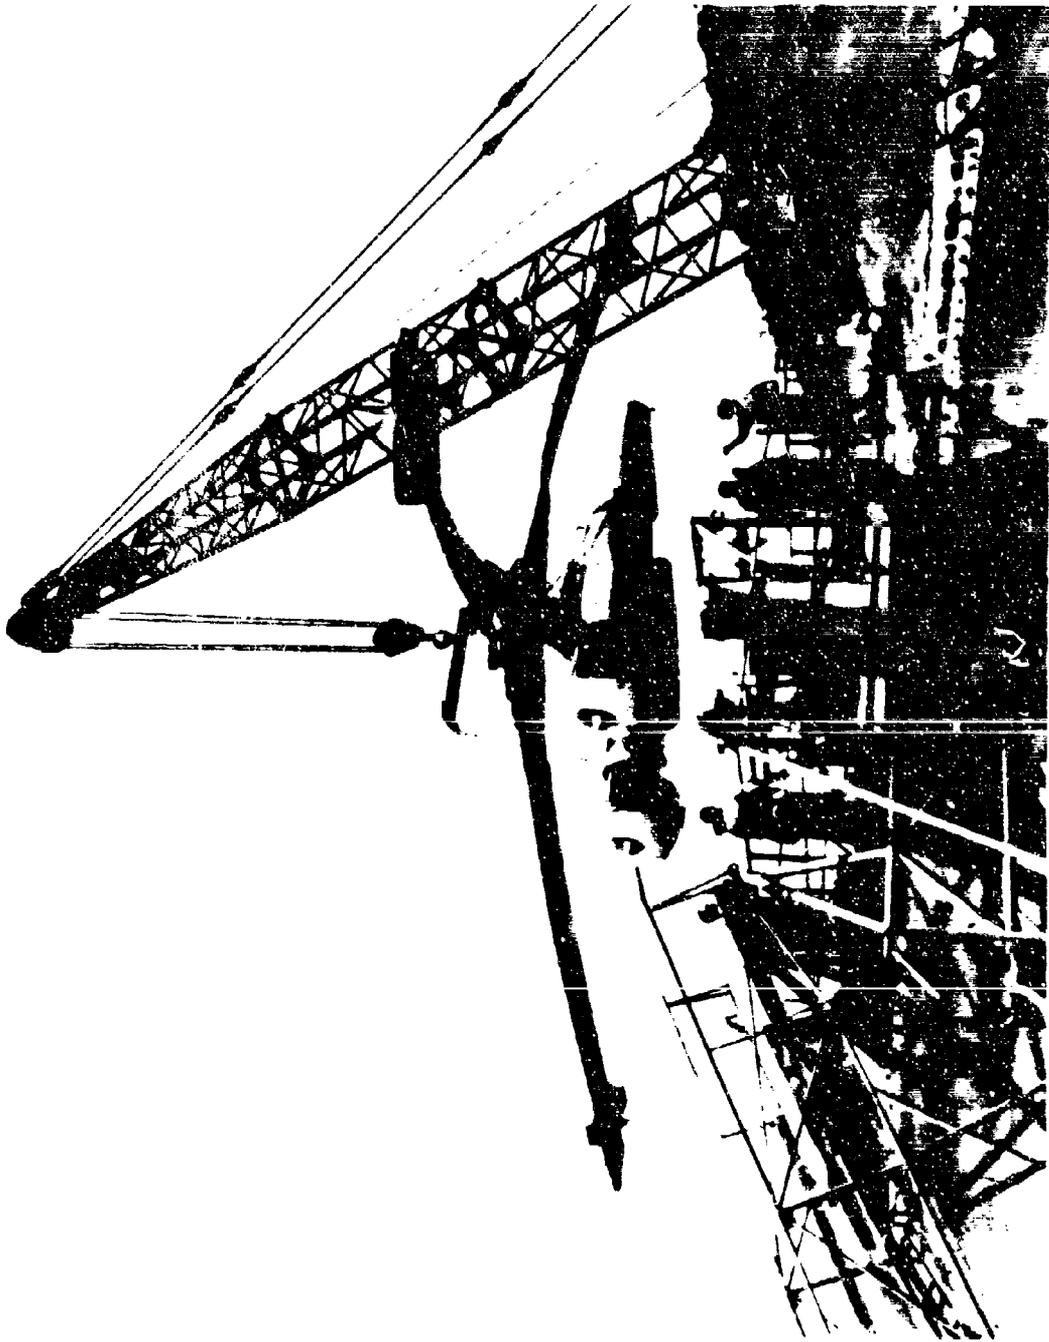
Figure 7. Installation of Power Module and Rotor on Whirl Tower

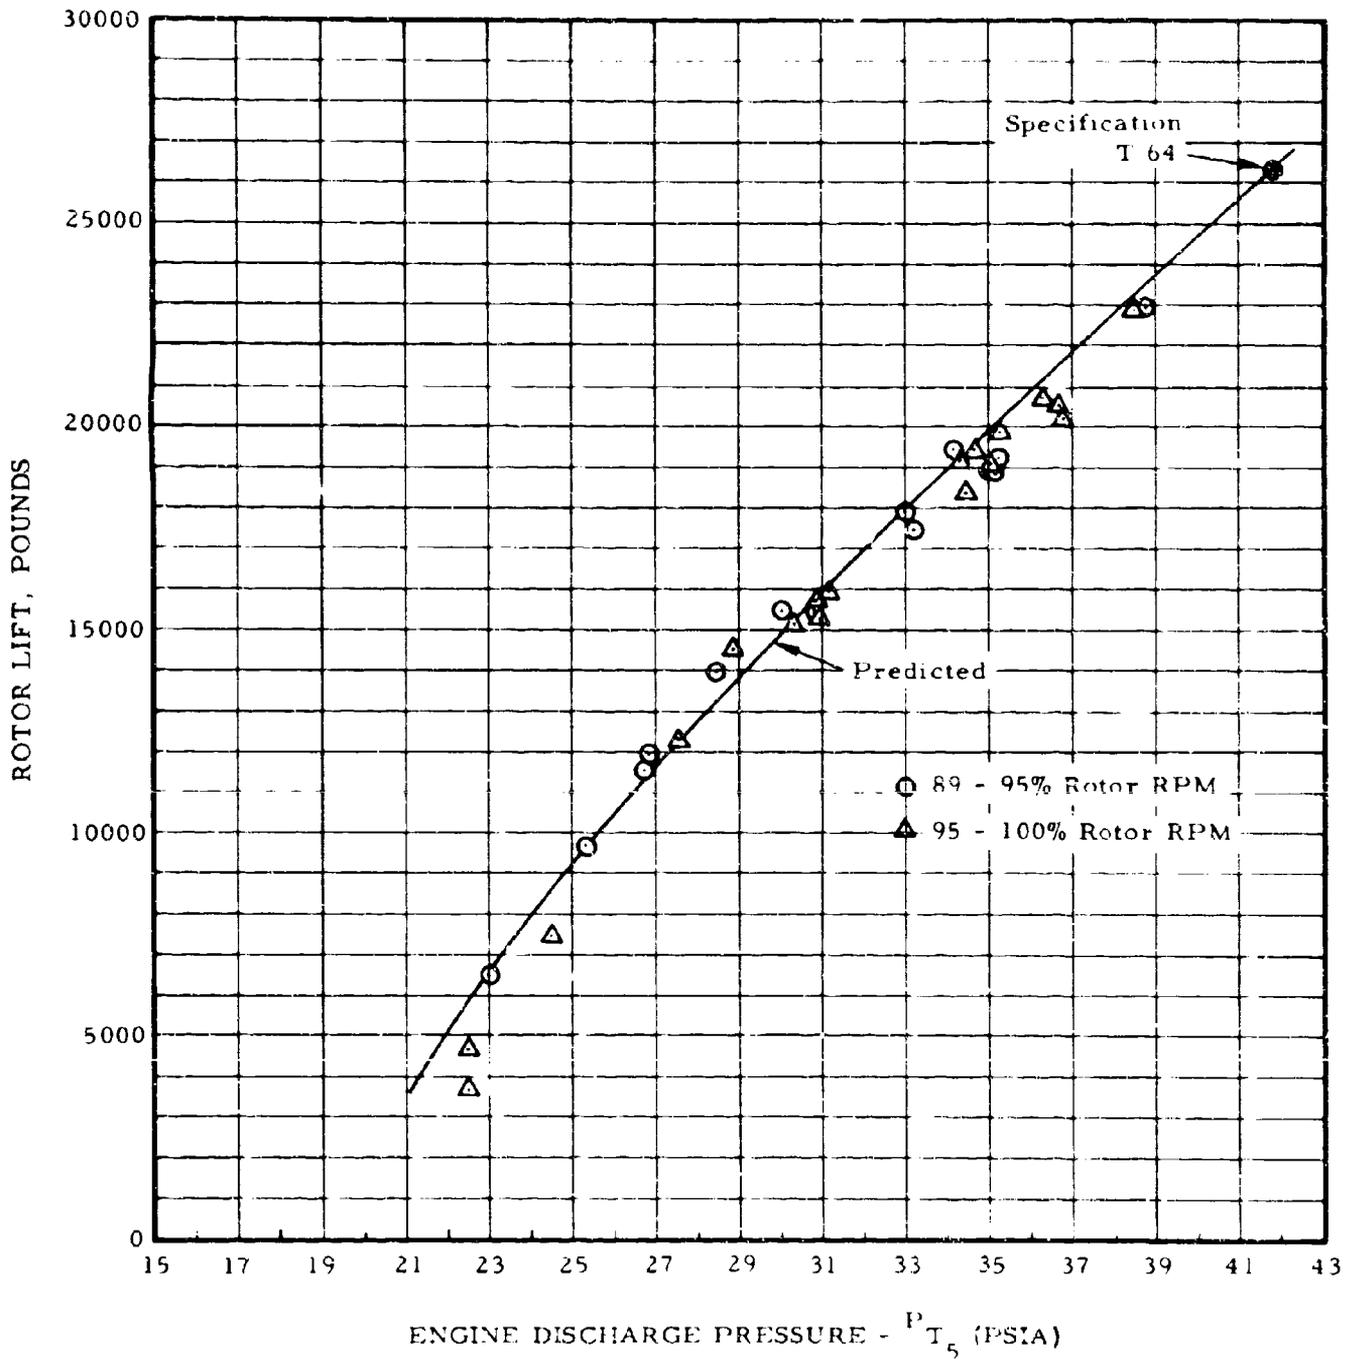
As the ambient conditions prevailing during the test program closely corresponded to a standard day at sea level, for practical purposes the plot represents rotor performance on a standard day at sea level. The effect of parameters other than pressure is negligible. An effort was made to identify the effect of measured wind and rotor rpm. No visible trend due to wind or rotor rpm could be established within the scatter of test points. It was also found that increasing the exit area by opening the yaw control valve did not influence the relation between rotor lift and pressure. However, opening of the yaw control valve did cause a pressure drop and therefore a loss of rotor lift at a constant engine power setting.

The predicted curve of rotor lift vs. engine discharge pressure has been included on the plot for comparison and as a means for estimation of system behavior with specification T-64 engines.

Figure 10. Rotor Lift vs. Engine Discharge Pressure

Evaluating the whirl test results shown in Figure 10, the following conclusions can be made:

It should be noted that the lift performance shown in Figure 10 is obtained in the presence of 2.5-percent diverter-valve leakage. It is anticipated that this leakage can be reduced in future work, with consequent increase in system performance.

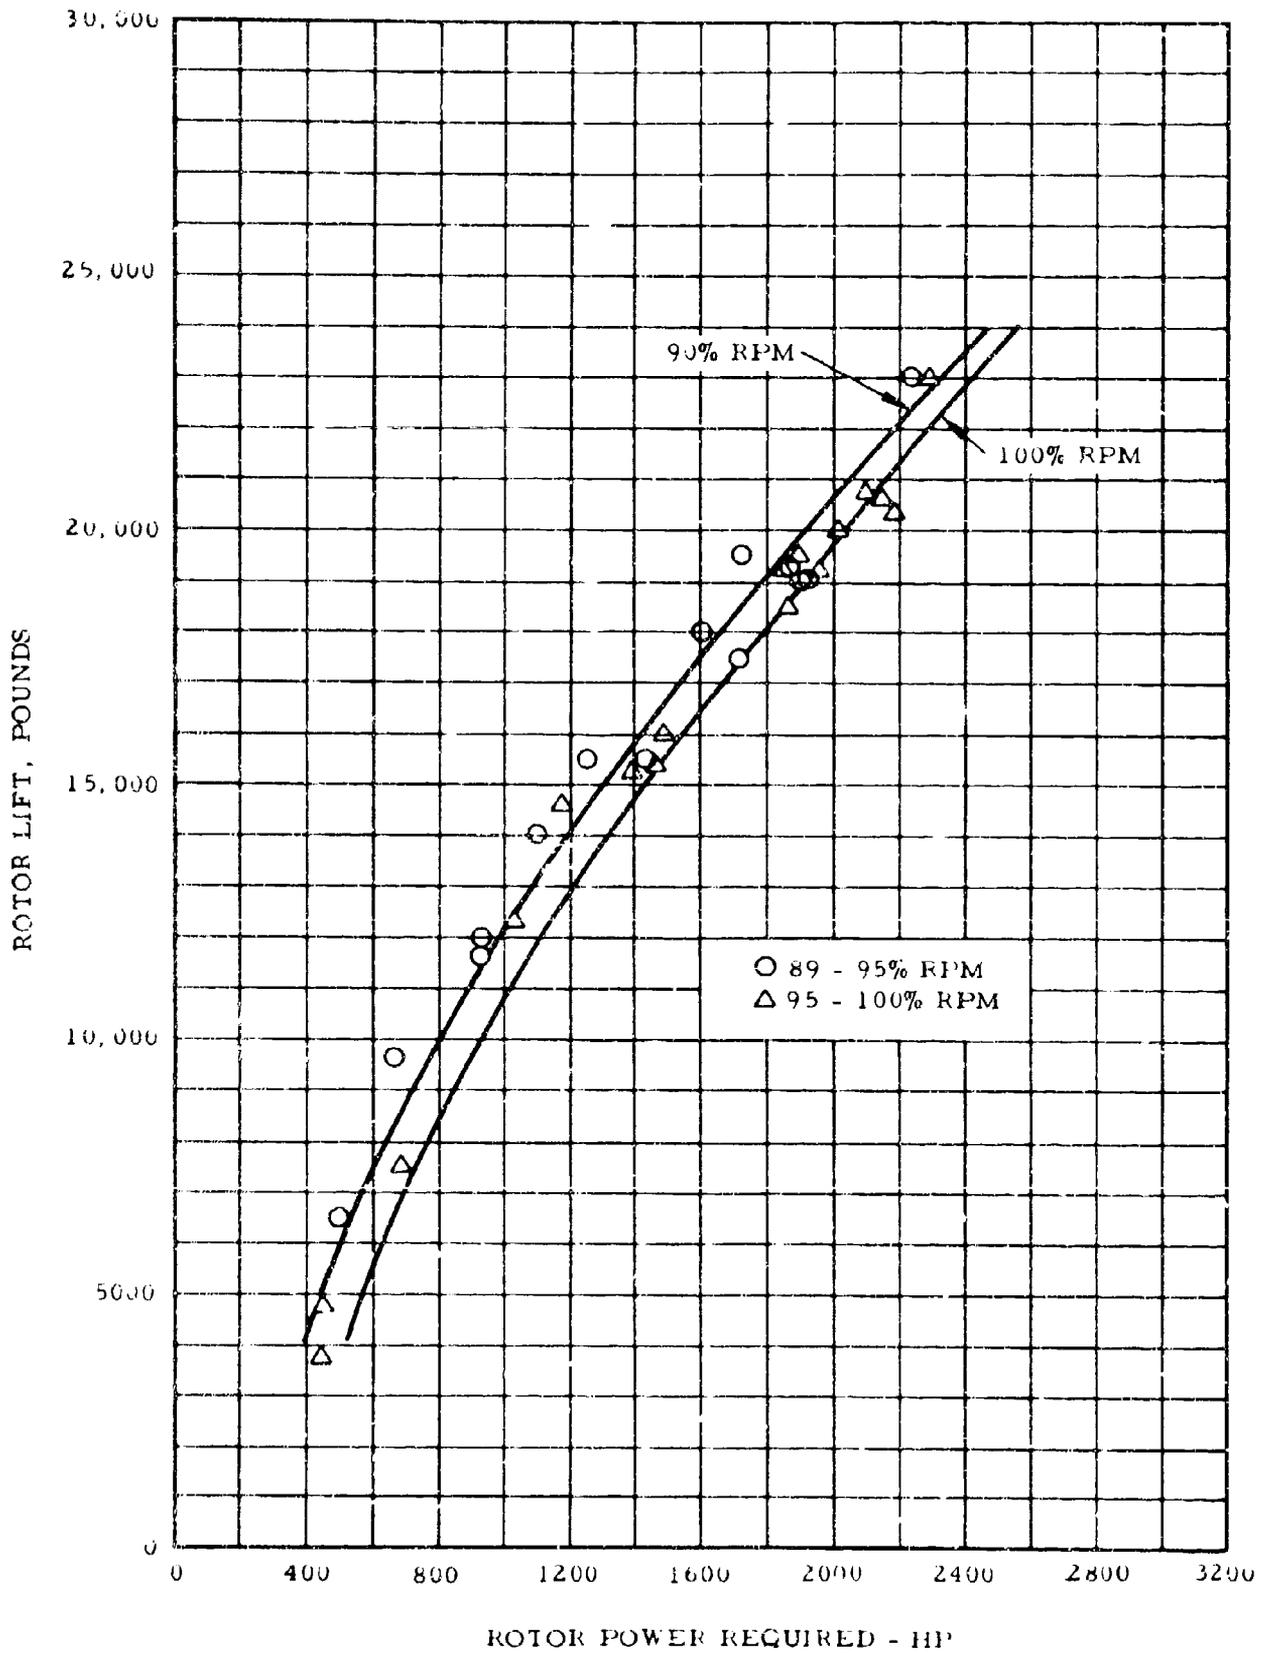
The computed hovering thrust of the rotor vs. power required (as influenced by ground effect on the whirl tower) is shown in Figure 11 for 100 percent and 90 percent rpm. The calculations of induced power, profile power, and ground effect are based on standard NACA methods presented in Reference 3. The profile power coefficient used in the present calculations was increased 17 percent to allow for the 18 percent thickness in the hot cycle blades compared to the blades of 12 percent thickness upon which the profile power coefficient given in Reference 3 was based. The calculations include correction for the design blade twist of -8 degrees as given on page 85 of Reference 3.

Figure 11. Rotor Lift vs. Rotor Power Required

Due to the tight schedule of the whirl test program, a number of tests were unavoidably conducted under wind conditions which developed after the test was in progress. Since the Figure 11 curve of thrust vs. power required was prepared for a zero-wind condition, it was necessary to examine the possible effect of wind on Figure 11. As discussed below, it was concluded that, for the range of rotor parameters tested, and for the highest wind velocities encountered (20 mph), the wind does not change the power-required curve for a rotor in ground effect, which is the case for the whirl tower.

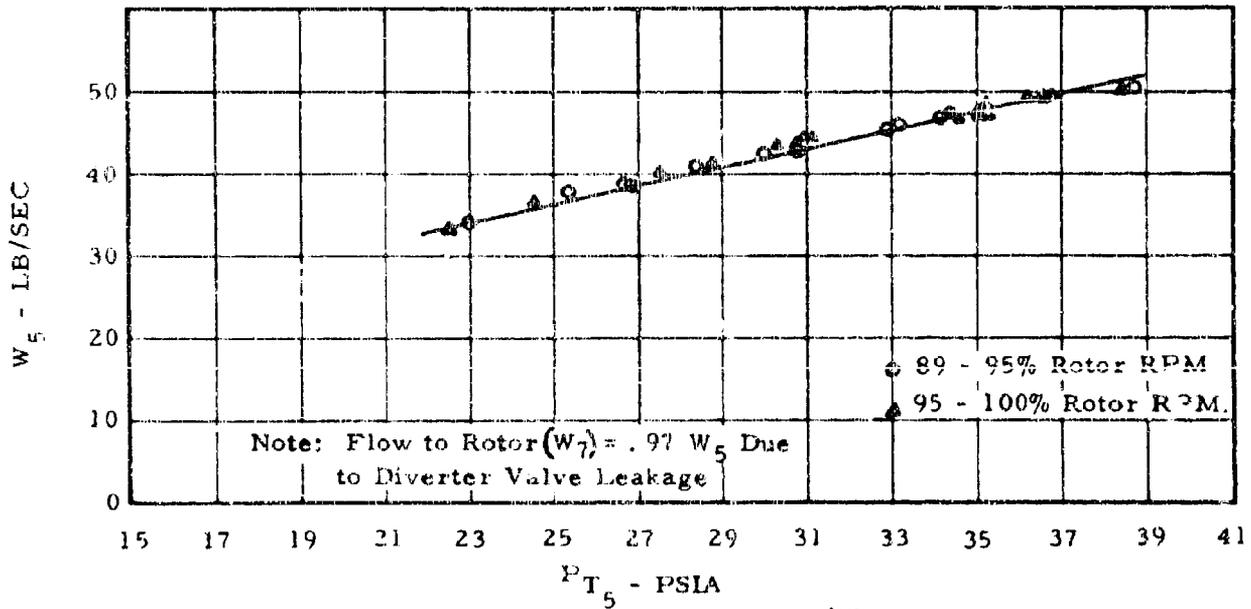
b) Engine Discharge Flow Rate ( $W_5$ ) vs.  
Engine Discharge Pressure ( $P_{T_5}$ )

Figure 12. Engine Discharge Conditions During Rotor Operation

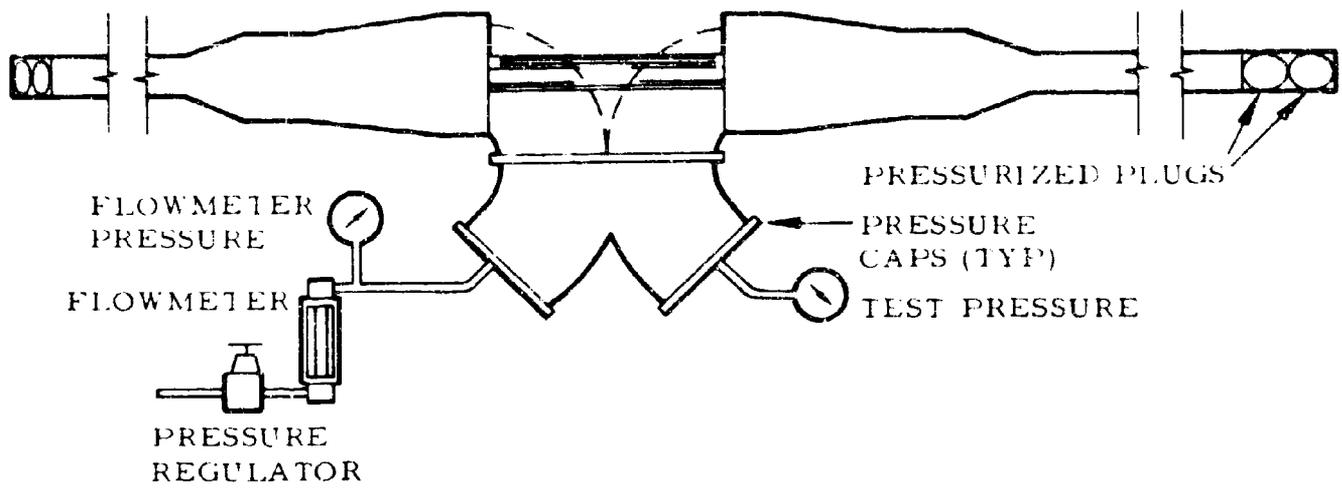
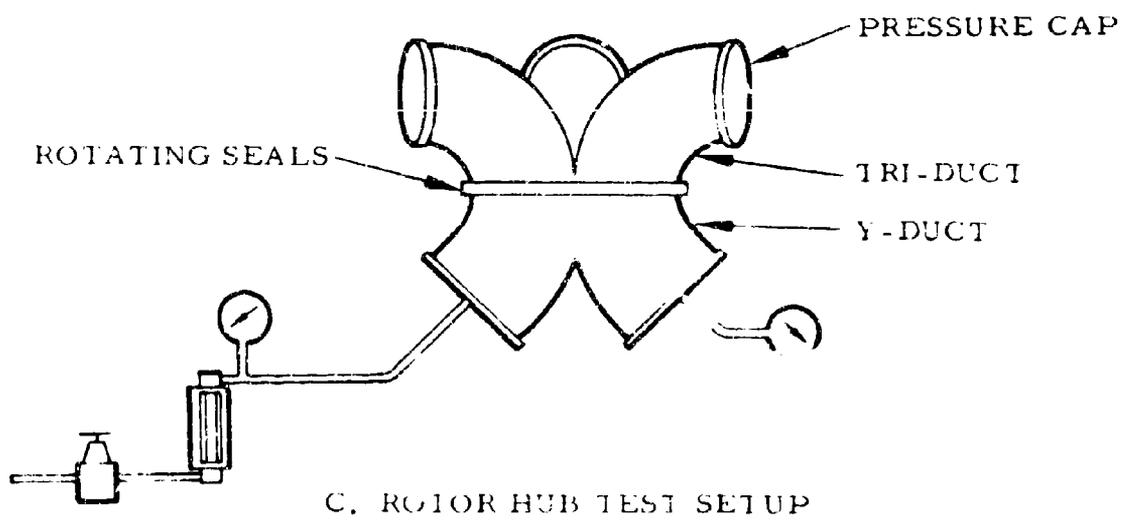
A. ROTOR SYSTEM TEST SETUP

C. ROTOR HUB TEST SETUP

Figure 13. Leakage Measurement - Rotor System

With the exception of diverter valves, all other components and assemblies of the duct system were tested with air at ambient temperature. The typical test arrangements are shown in Figure 13. The shop air supply was used with pressure regulated at 27.5 psig to represent the typical operating pressure. A rotameter in conjunction with two pressure gages was used to measure air flow caused by the leakage. Pressure was measured at the exit end of the rotameter and

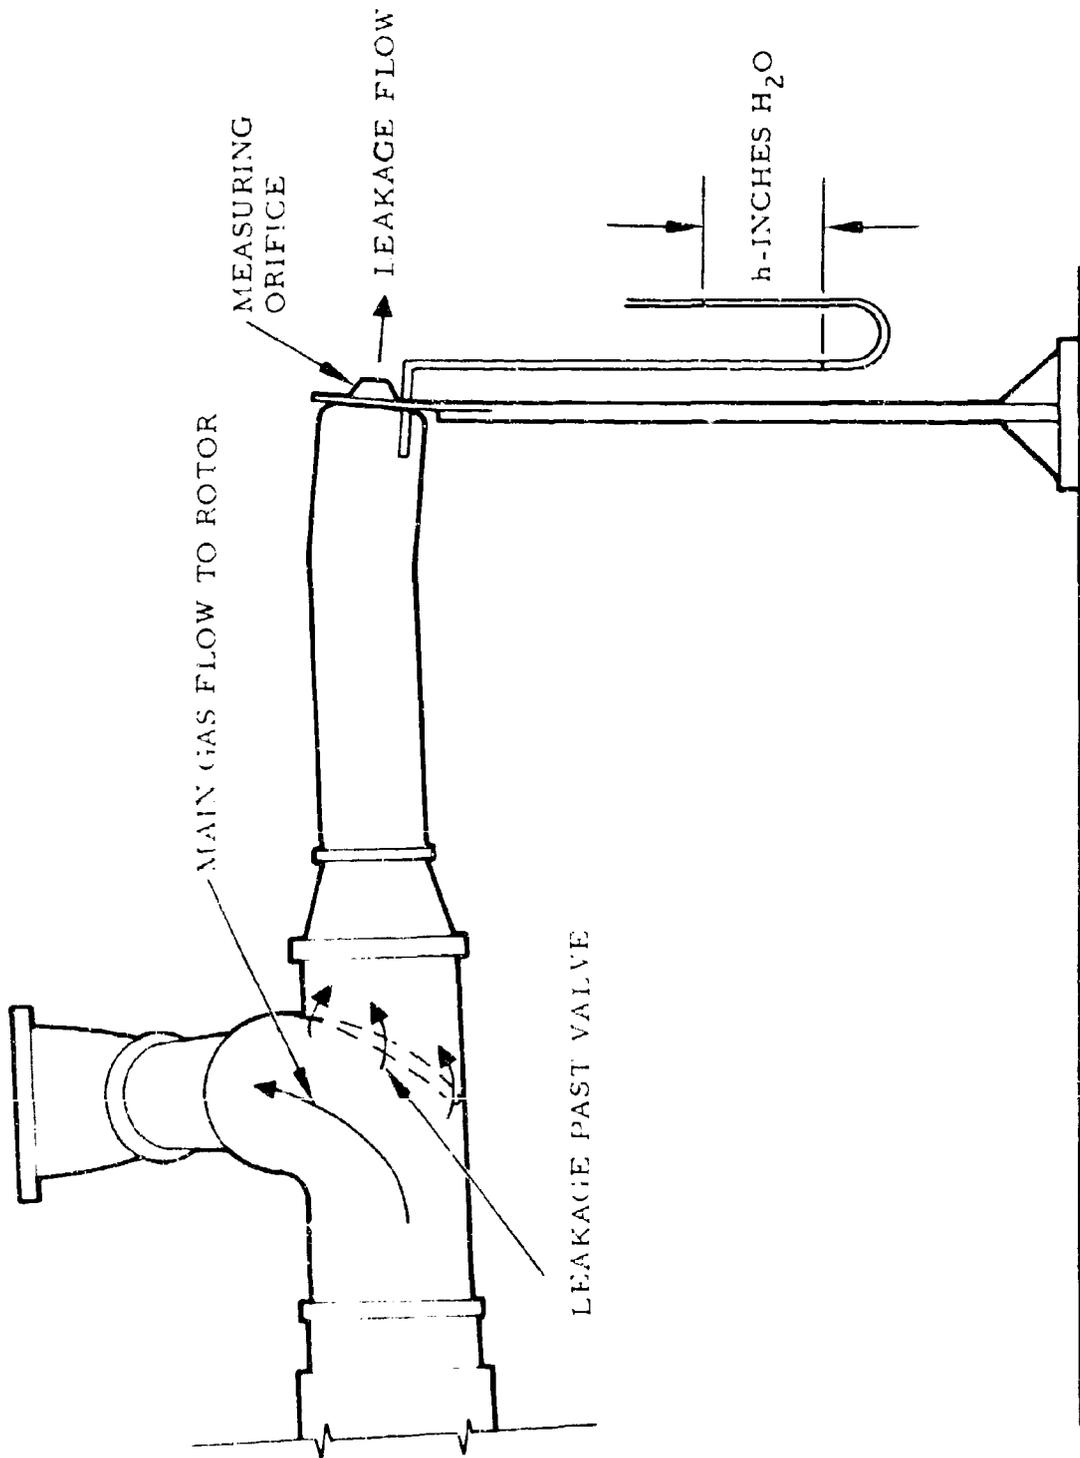
Figure 14. Measurement of Diverter Valve Leakage

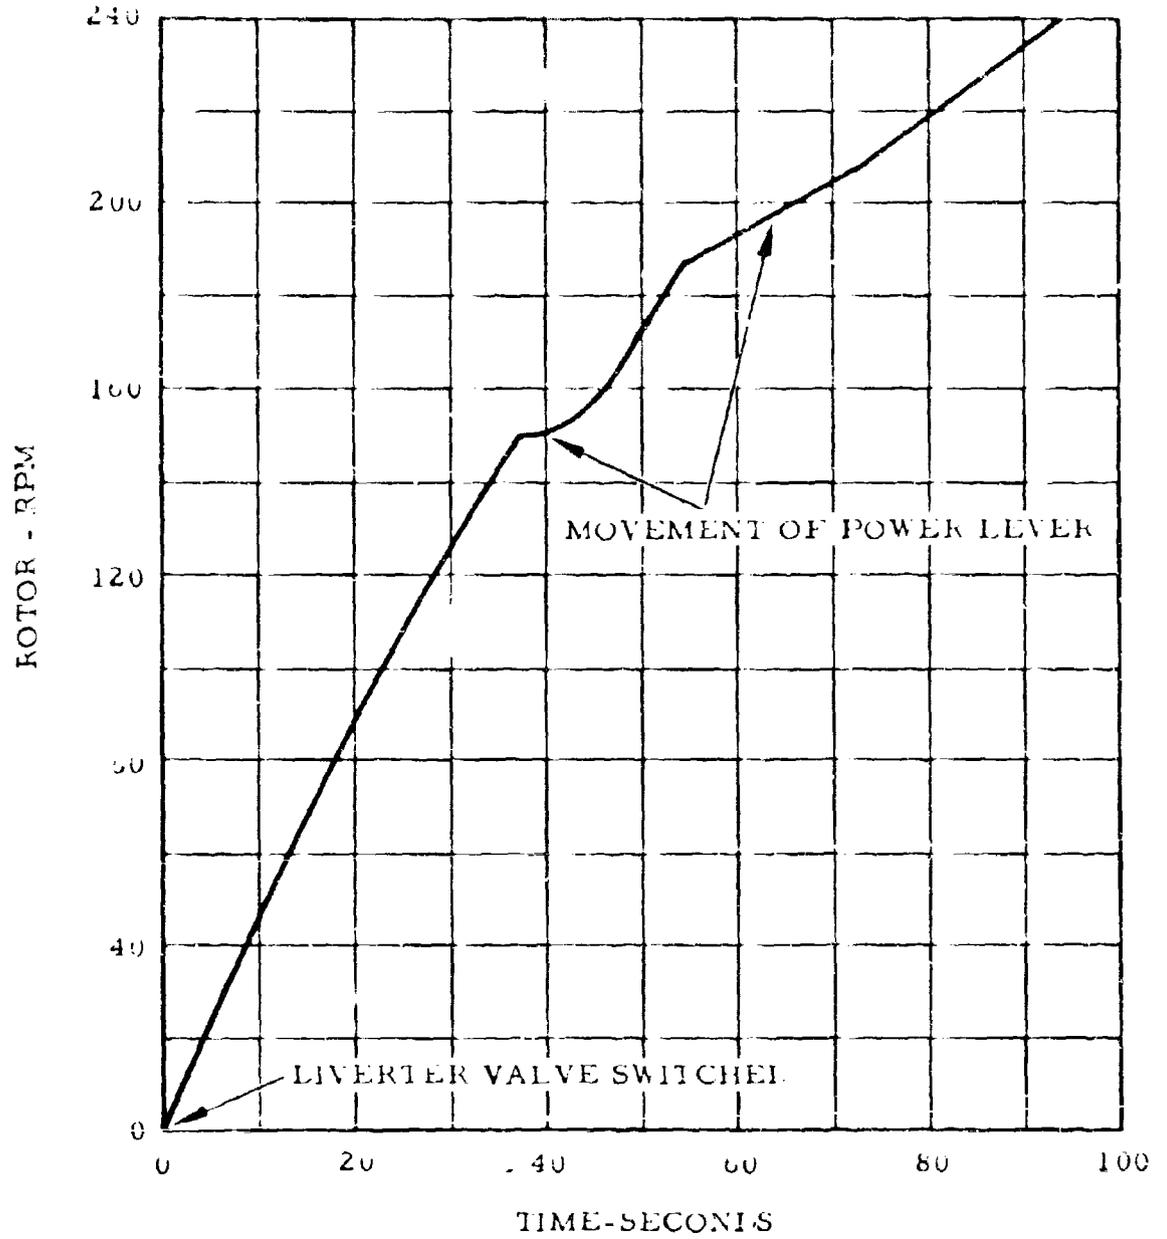
Figure 16. Typical Rotor Start-Up, RPM vs. Time

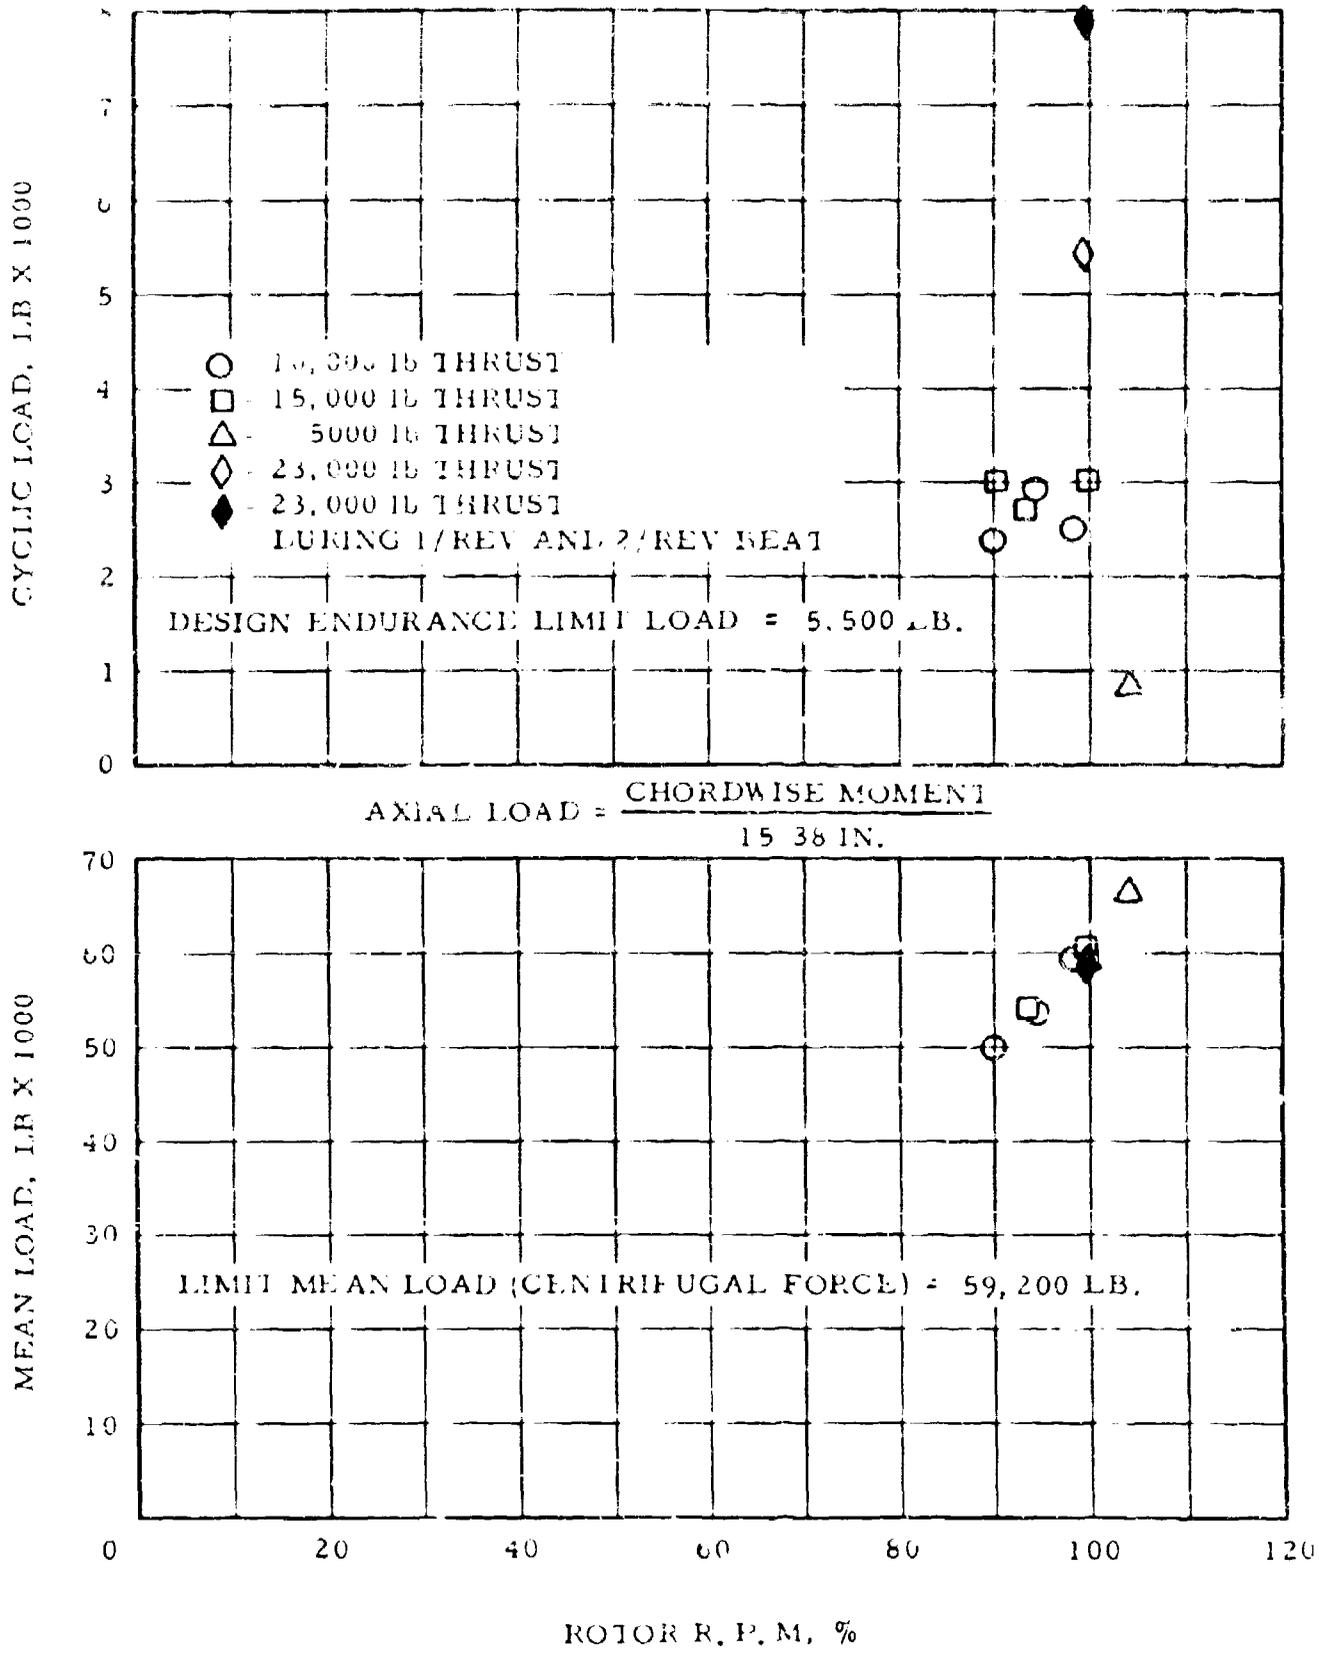
Figure 17. Front Spar Axial Load (Chordwise Moment) at Station 90.75

A correlation was found to exist between 1/rev chordwise moment and 1/rev shaft moment, as shown in Figure 46. During trimmed flight, shaft 1/rev moment is a function of thrust vector tilt with respect to the shaft. Thrust vector tilt is a function of aircraft weight and C. G. position, fuselage drag, and fuselage moment from the down load on the tail surfaces. The bending moments shown in Figure 46 are associated with the rotor mounted on a whirl stand, where untrimmed forces can exist. During hover when all forces on the helicopter are in trim, the only moments that are imposed on the rotor shaft are those due to C. G. offset, and a shaft 1/rev moment of 28,200 inch-pounds will be developed at maximum C. G. offset and design gross weight. From Figure 46 it is seen that this will result in an axial 1/rev load of 4100 pounds, which is only about 75 percent of the chordwise design endurance limit. Calculations at high-speed trimmed flight (125 knots) with the C. G. near the rotor shaft indicate that a shaft 1/rev moment of the same order of magnitude as the 1/rev shaft moment during hover with full C. G. offset will be applied. As a result, this high-speed forward flight condition will have no higher chordwise moments than the maximum value while hovering with full forward C. G. when, as pointed out above, stresses are below the endurance limit. It should be noted that these moments anticipated in forward flight could be reduced by locating the C. G. more forward. Therefore, it appears that chordwise 1/rev moments can be optimized during the flight program by control of aircraft C. G. position and that the high chordwise loads experienced during whirl test (Figures 17 and 18) will not occur during flight test.

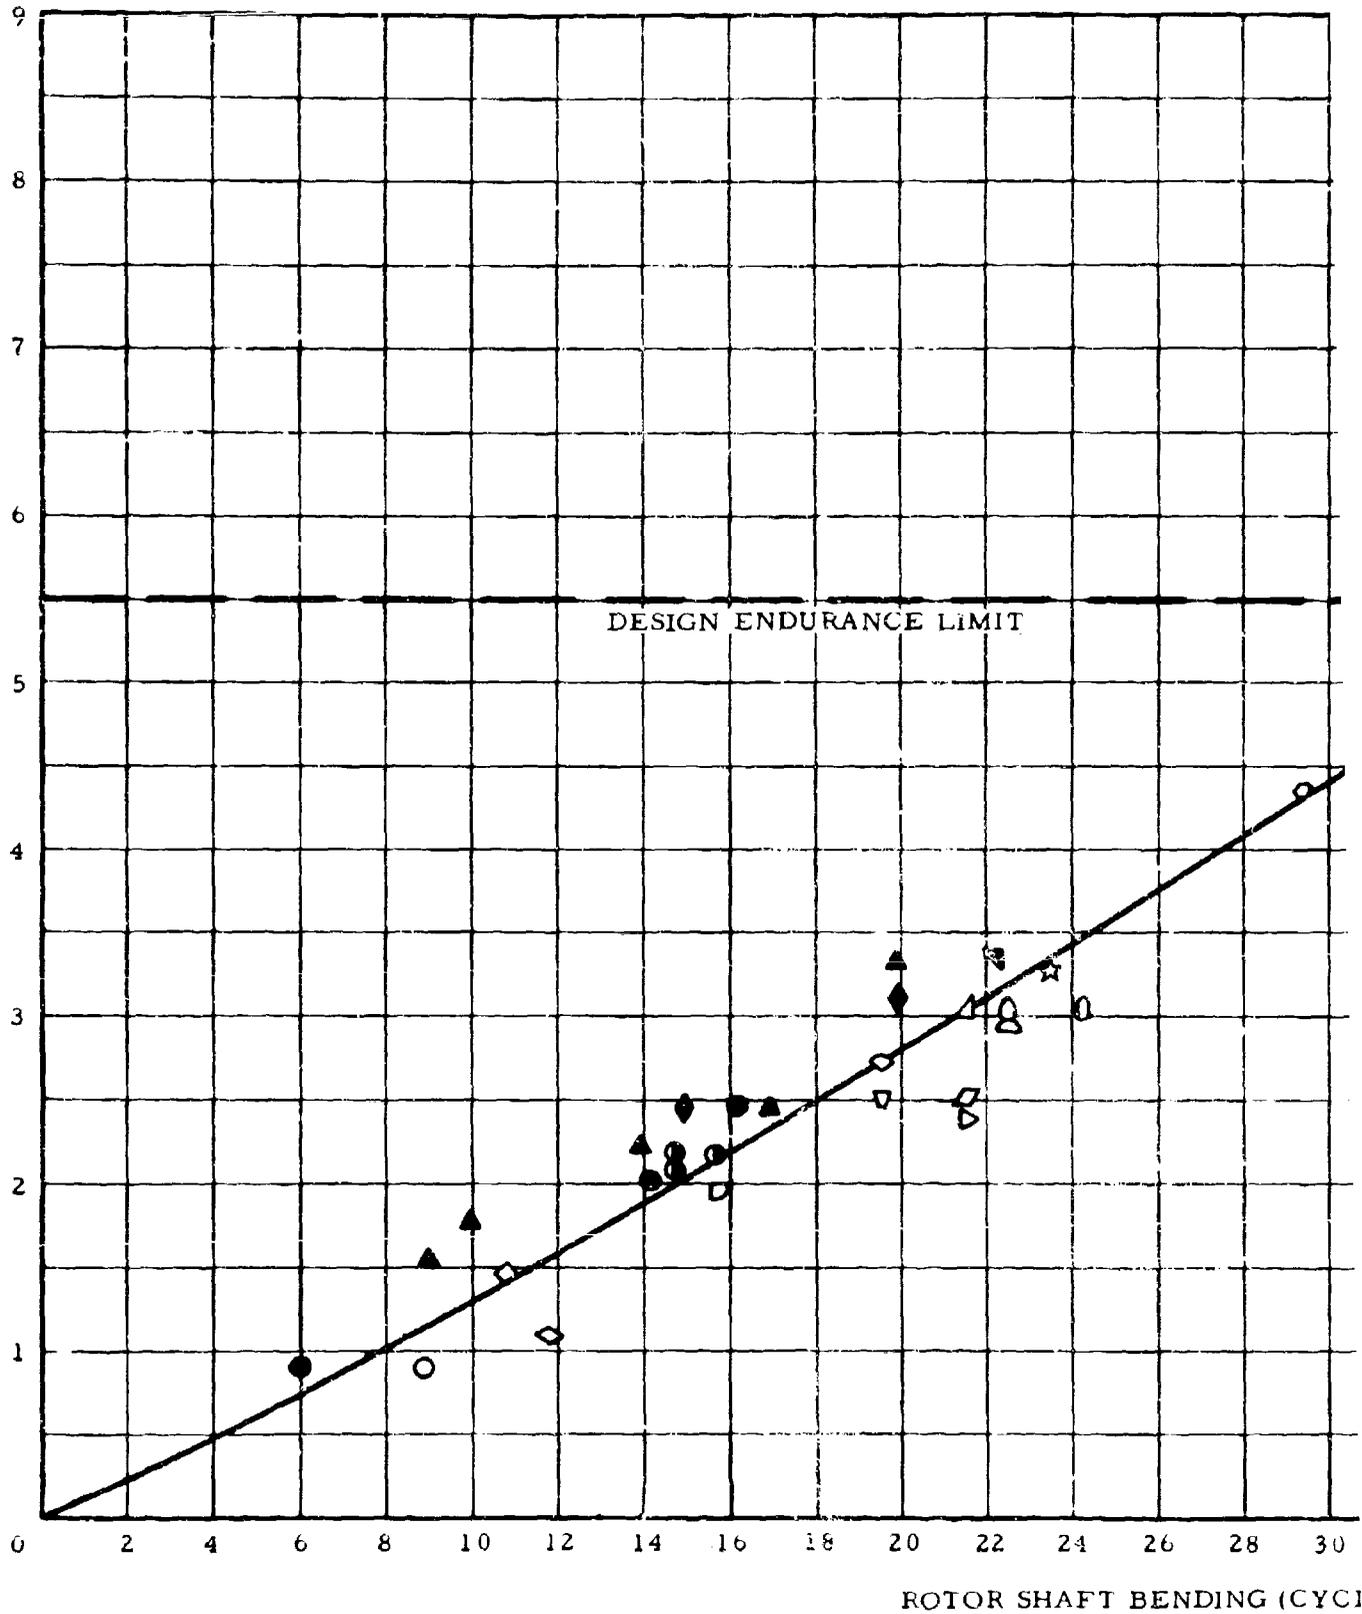
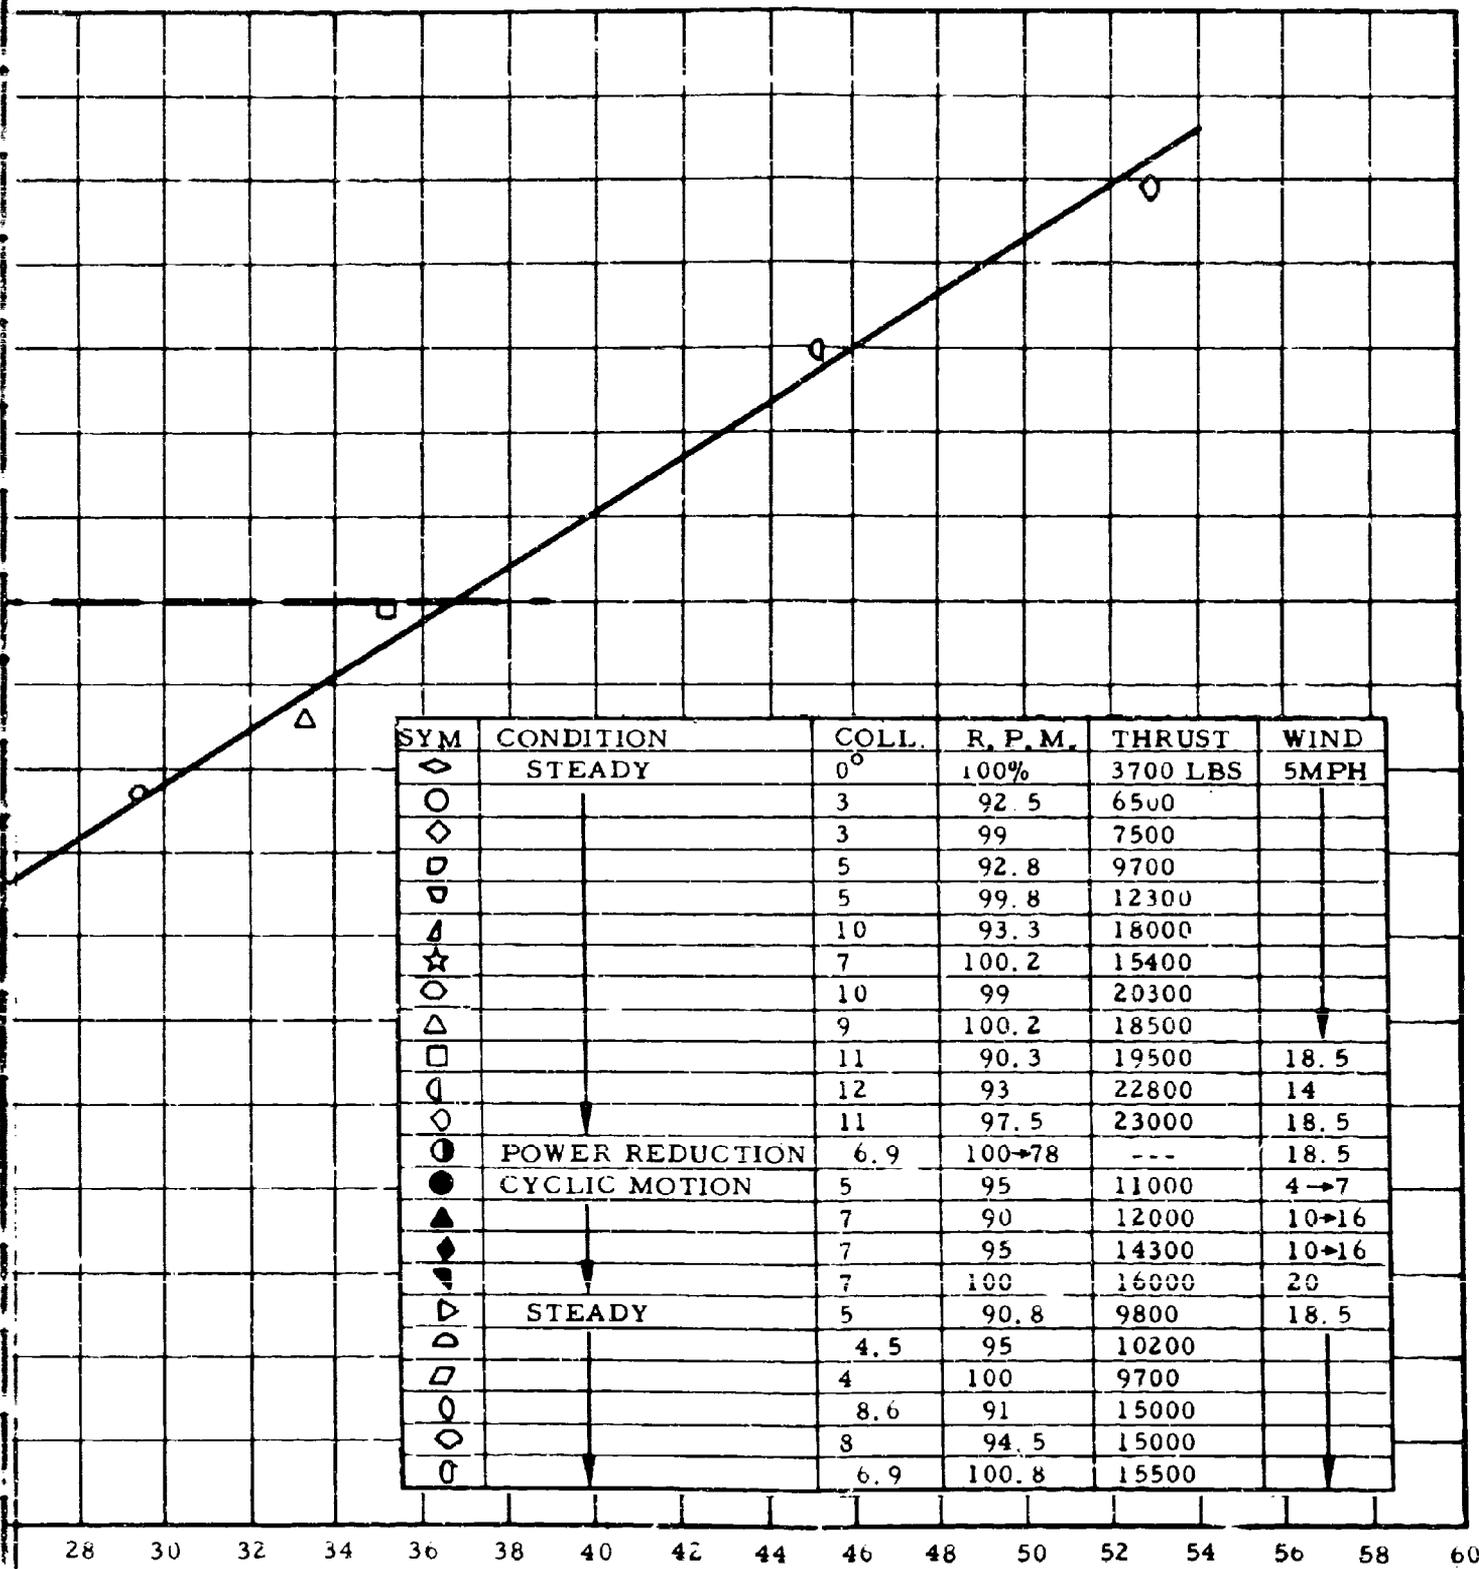
ROTOR BLADE FRONT SPAR AXIAL LOAD (CYCLIC 1/REV)  
(CHORDWISE MOMENT/15.38IN.), LBS X 1000 AT STA. 90.75

Figure 46. Rotor Blade Front Spar Axial

CLF Spar Axial Load vs. Rotor Shaft Bending

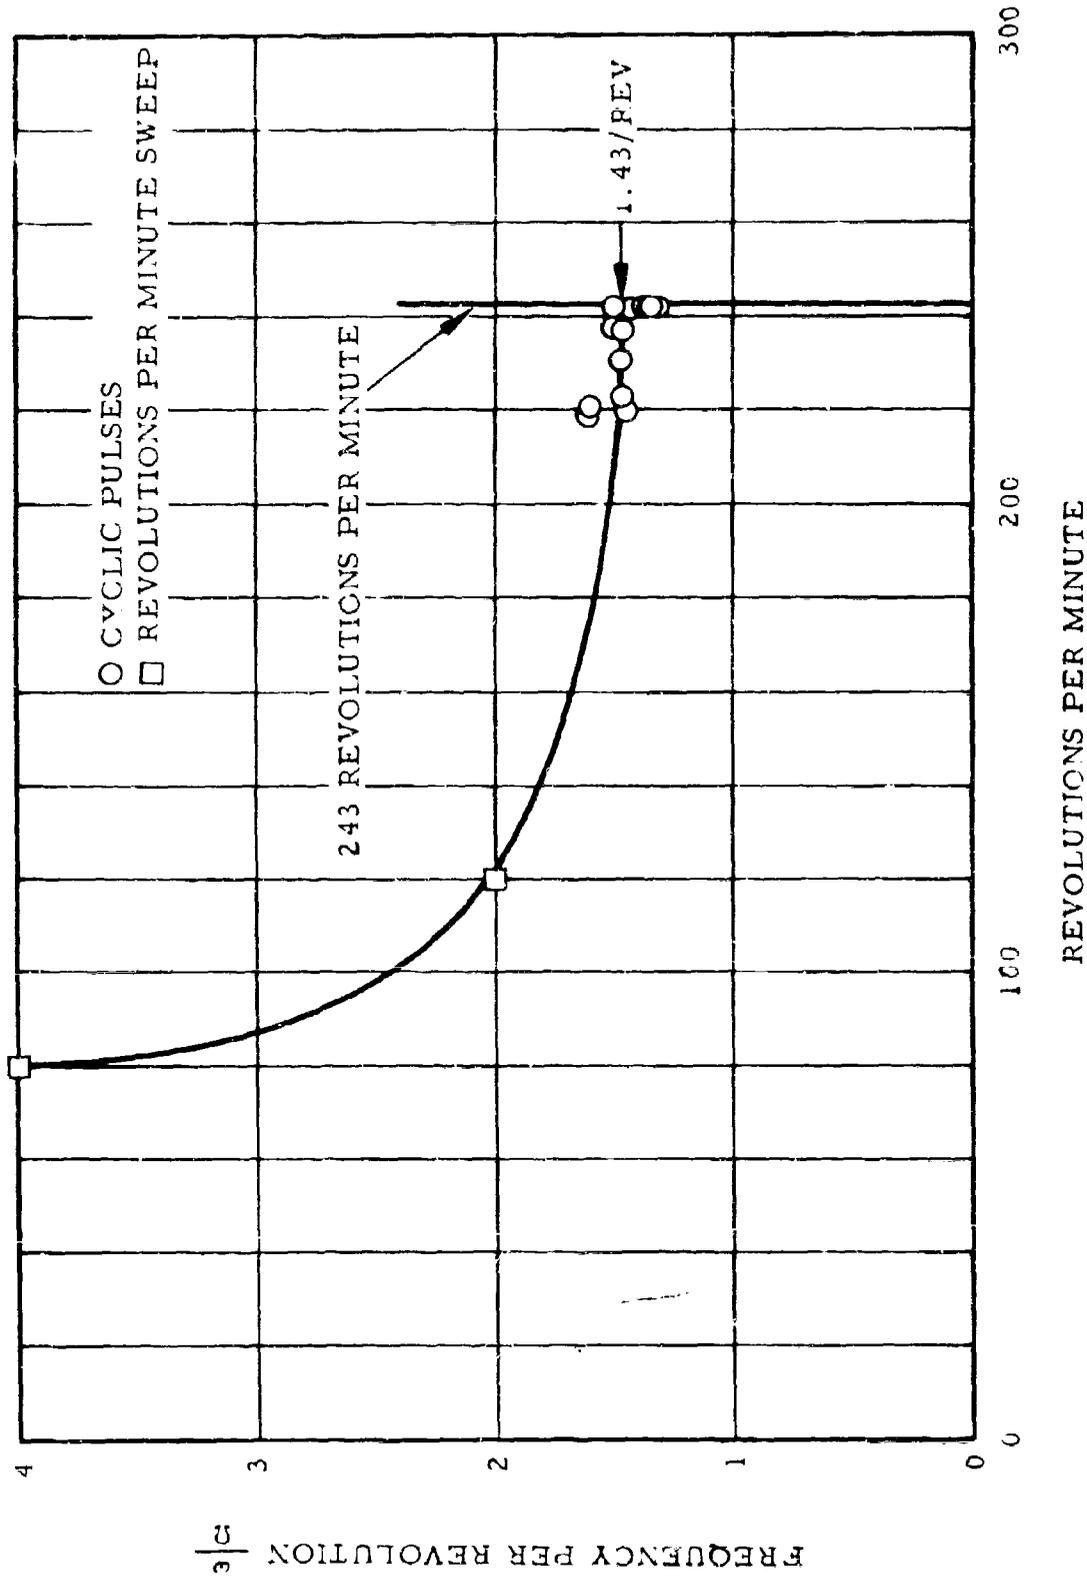
Figure 56. First Chordwise Cantilever Mode Natural Frequency per Revolution vs. RPM

Computations were made of the flapwise (and chordwise) blade bending frequencies for the collective mode (3, 6, 9/rev) and cyclic mode (1, 2, 4, 5, 7, and 8/rev) when the rotor is mounted on a rigid pylon. The results of these calculations are shown in Figures 44 and 45 of Reference 7. These figures indicated that no flapwise resonances should be found in the normal rotor operating range of 225 to 255 rpm. Examination of the flapwise bending gages taken during the whirl tests showed that, as predicted, no flapwise bending resonances are located in the normal rotor operating rpm range.
