USATRECOM TECHNICAL REPORT 64-67

ENGINE AND WHIRL TESTS,  
XV-9A HOT CYCLE RESEARCH AIRCRAFT

SUMMARY REPORT

U S ARMY TRANSPORTATION RESEARCH COMMAND  
FORT EUSTIS VIRGINIA

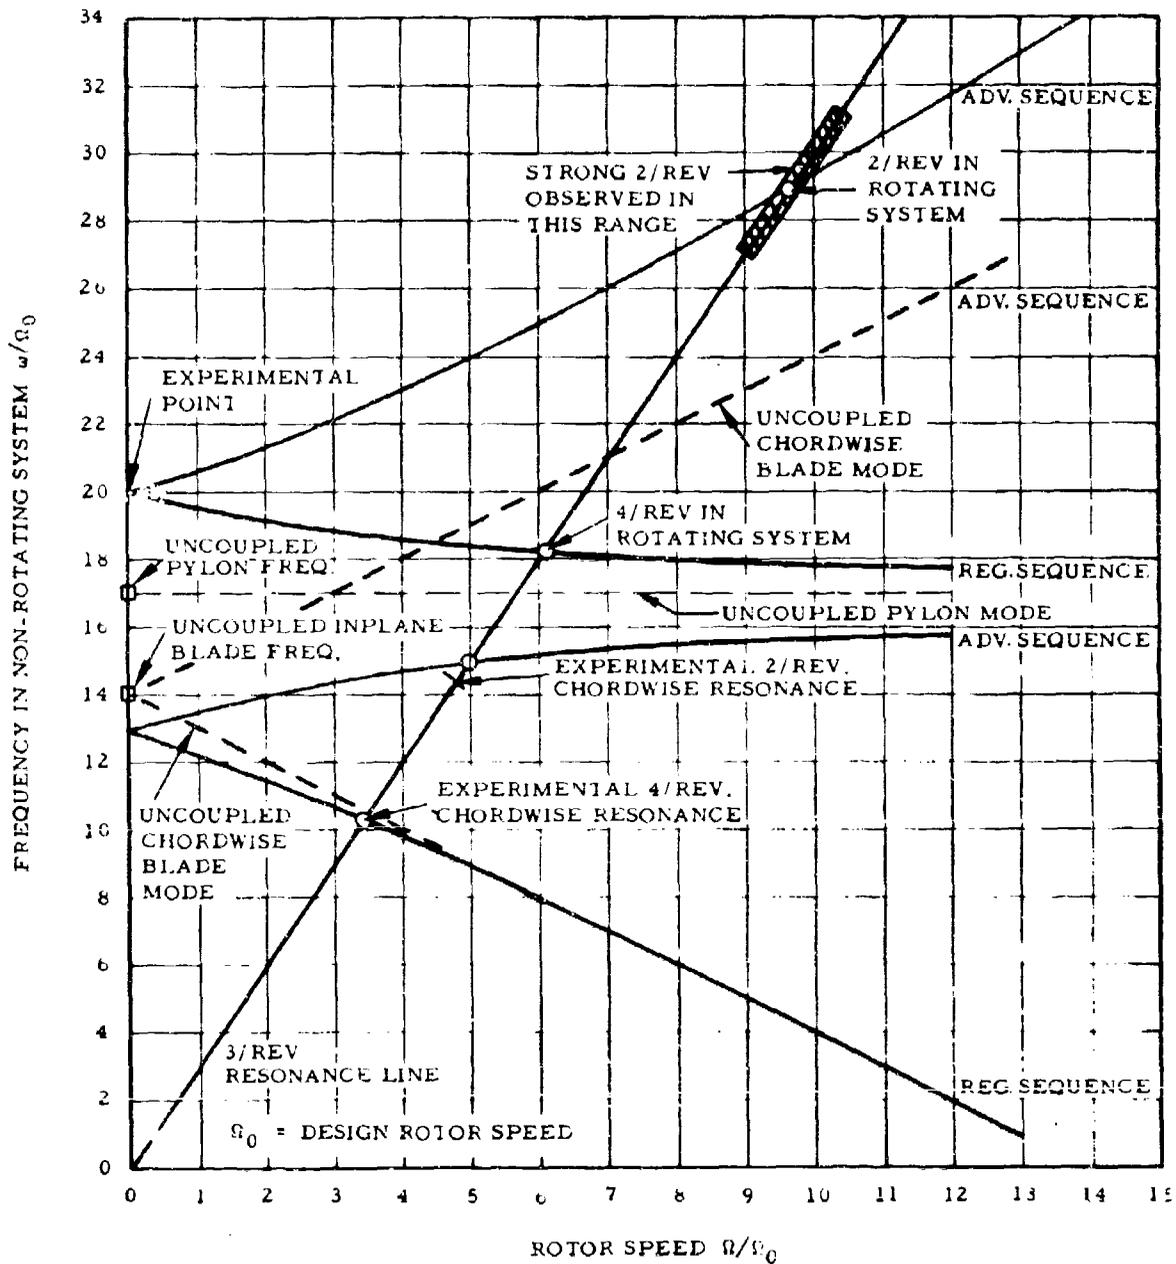
Figure 57. Coupled Pylon Blade Frequencies of Rotor on Whirl Stand vs. Rotor Speed

The results shown here indicate that the observed 2/rev blade stresses near 100 percent rpm are in fact due to coupling of the blade and pylon on the whirl stand. This same coupling was observed in whirl stand tests of a similar 3-bladed jet-driven rotor (the 75-foot McDonnell XHCH rotor) reported in Reference 8.

The 2/rev response noted during whirl testing is therefore characteristic of the system involving the rotor and the pylon mounted on the whirl stand. The situation that will be obtained with the rotor mounted on the actual aircraft will be different, due to different response characteristics of the rotor pylon when mounted on the XV-9A fuselage.

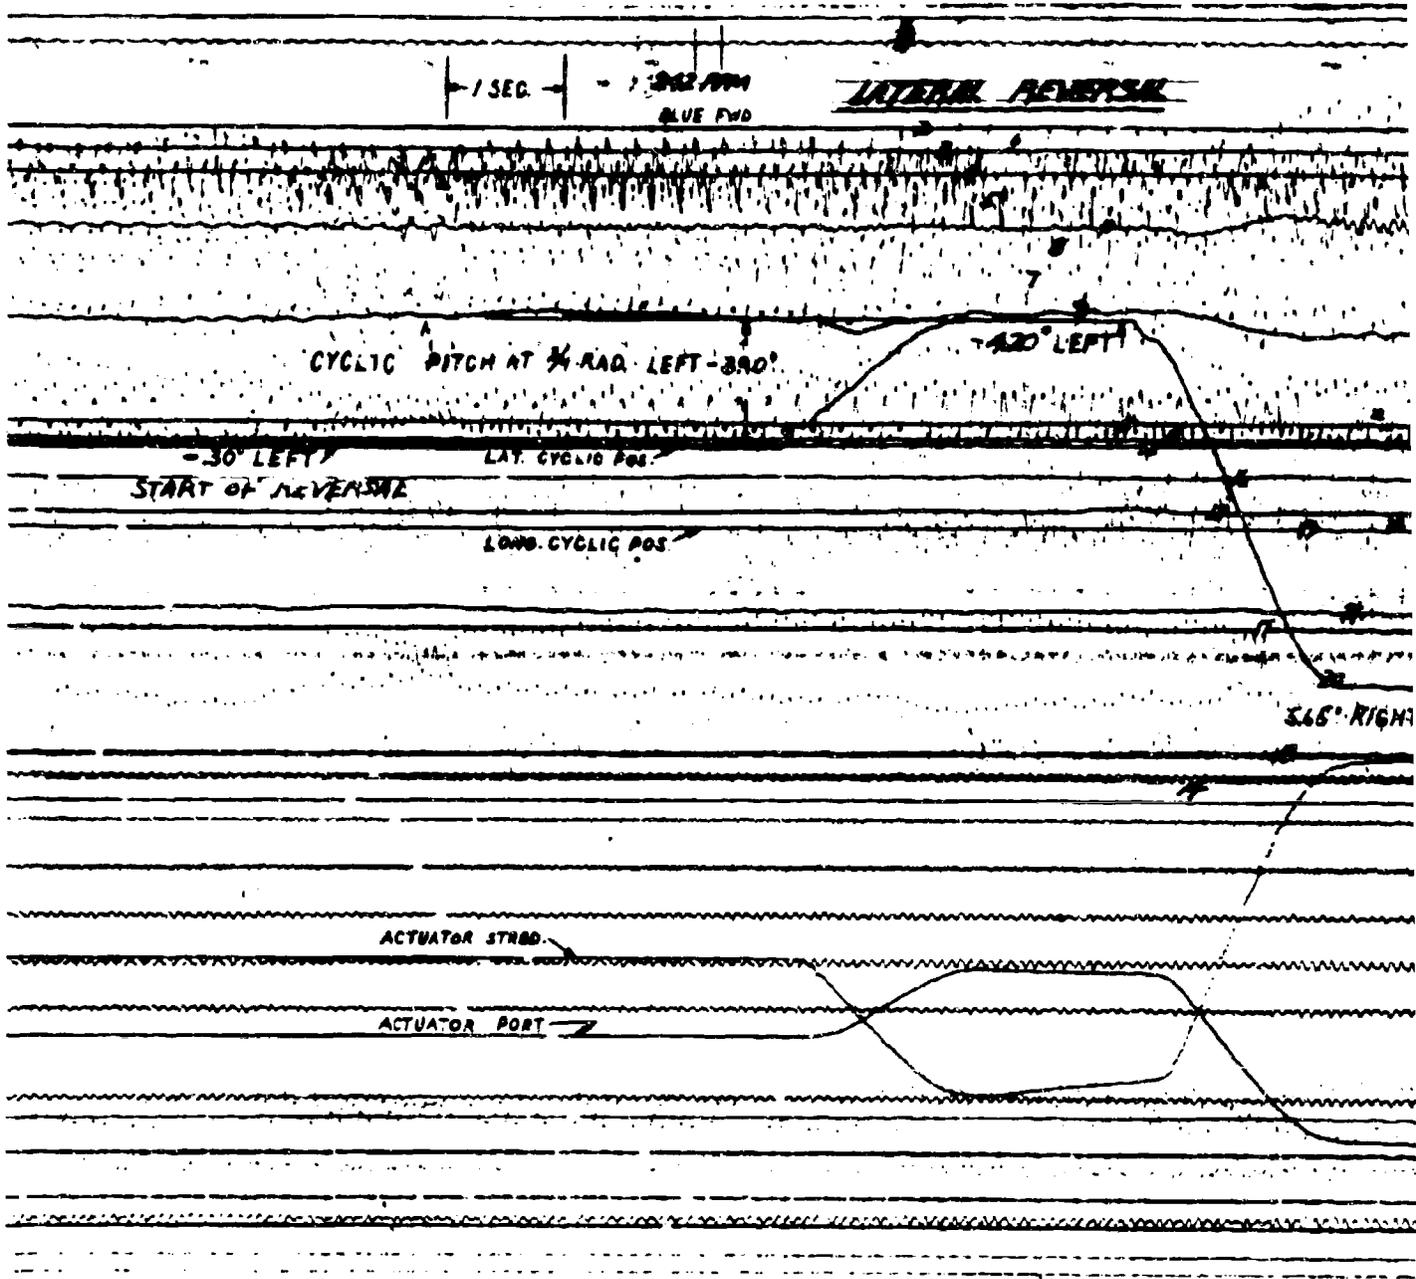
Figure 58. Lateral Cyclic Reversal,  $N_R = 99.6$  Percent

Copies of oscillograph setup sheets showing identification of traces and trace sensitivities for Figures 58 through 63 are included as Table 5.

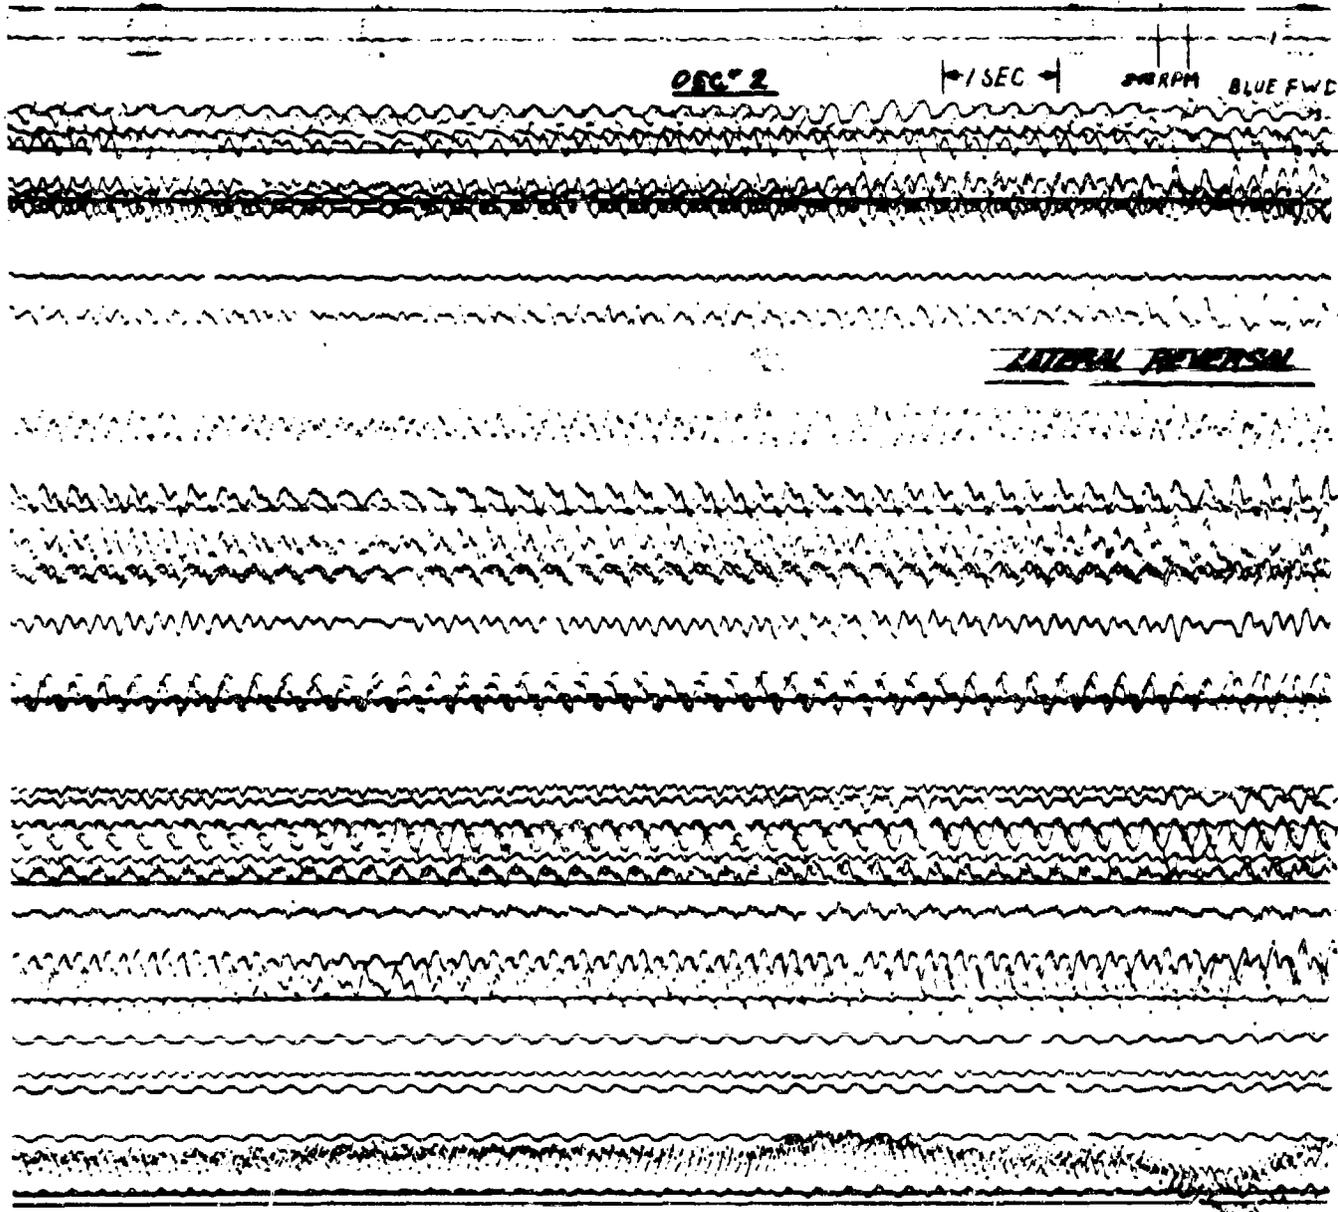
Figure 59. Lateral Cyclic Re  
 $N_R = 99.6$  Perc

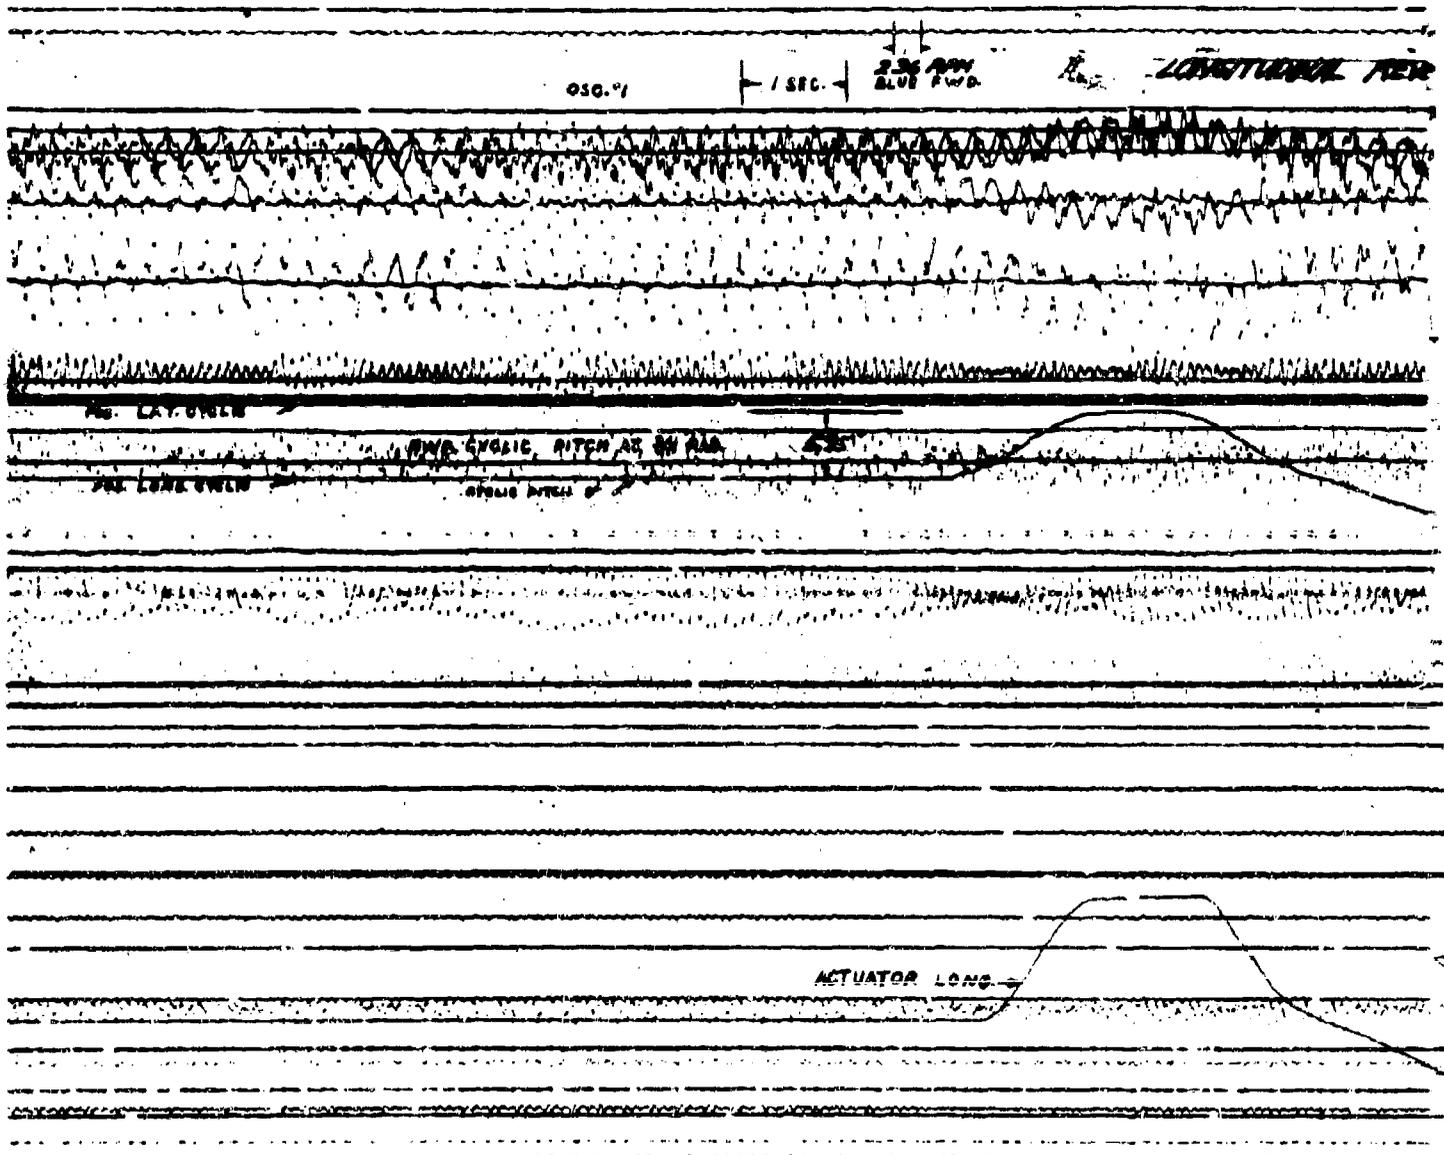
Figure 60. Longitudinal Cyclic Reverse  
 $N_R = 97.1$  Percent

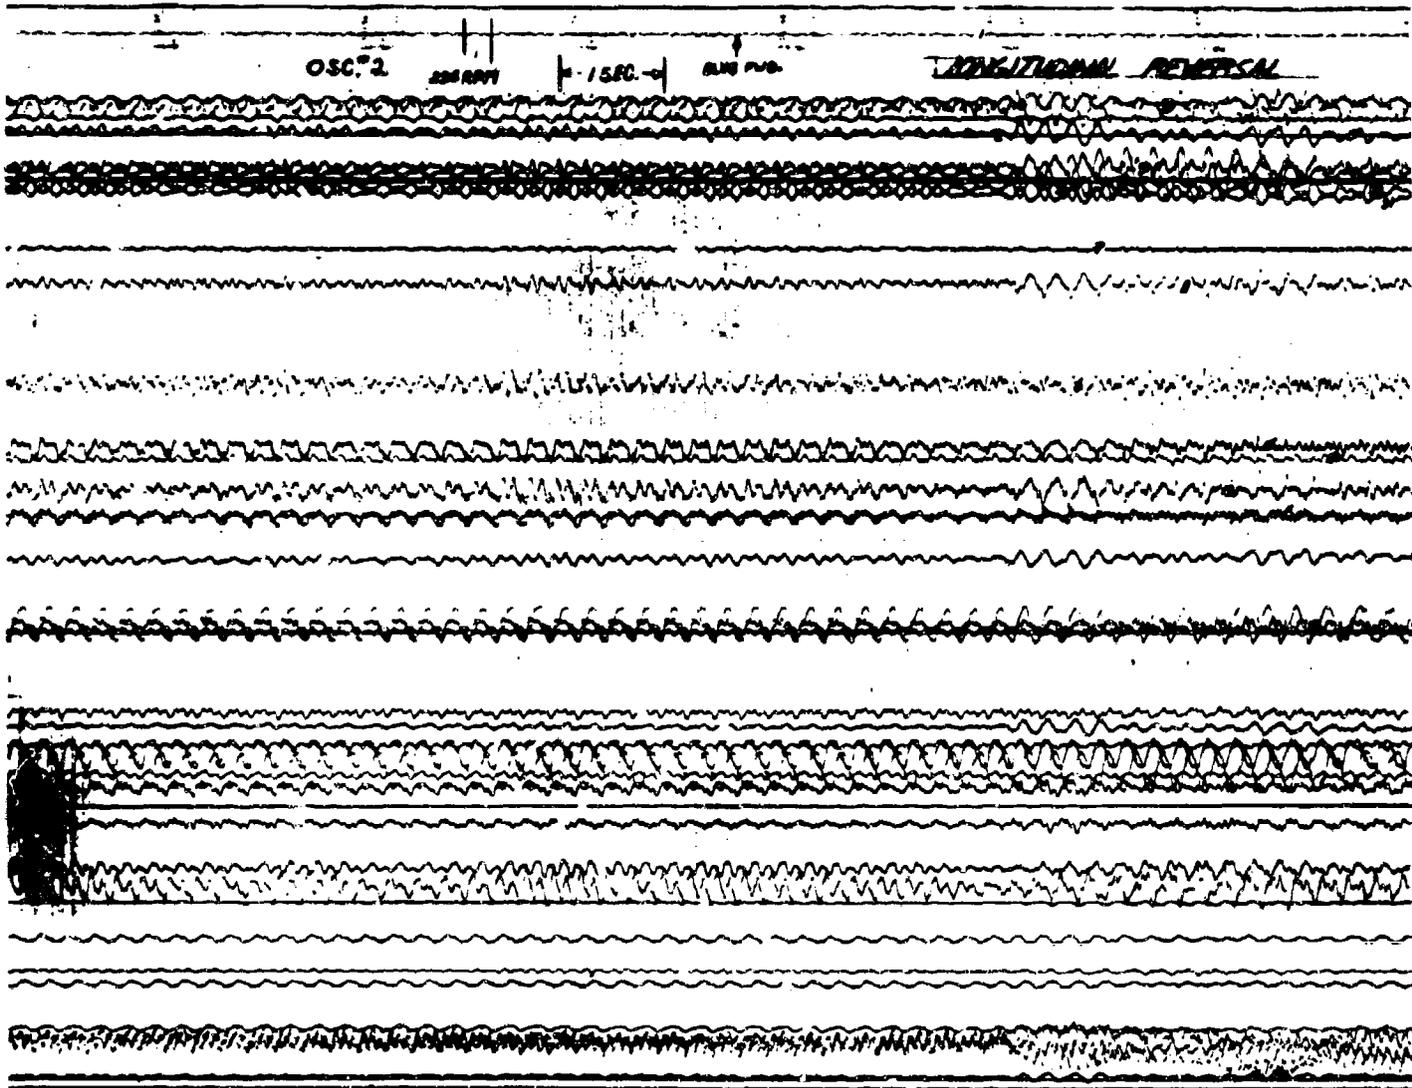
Figure 61. Longitudinal Cyclic Reversal,  
 $N_R = 97.1$  Percent

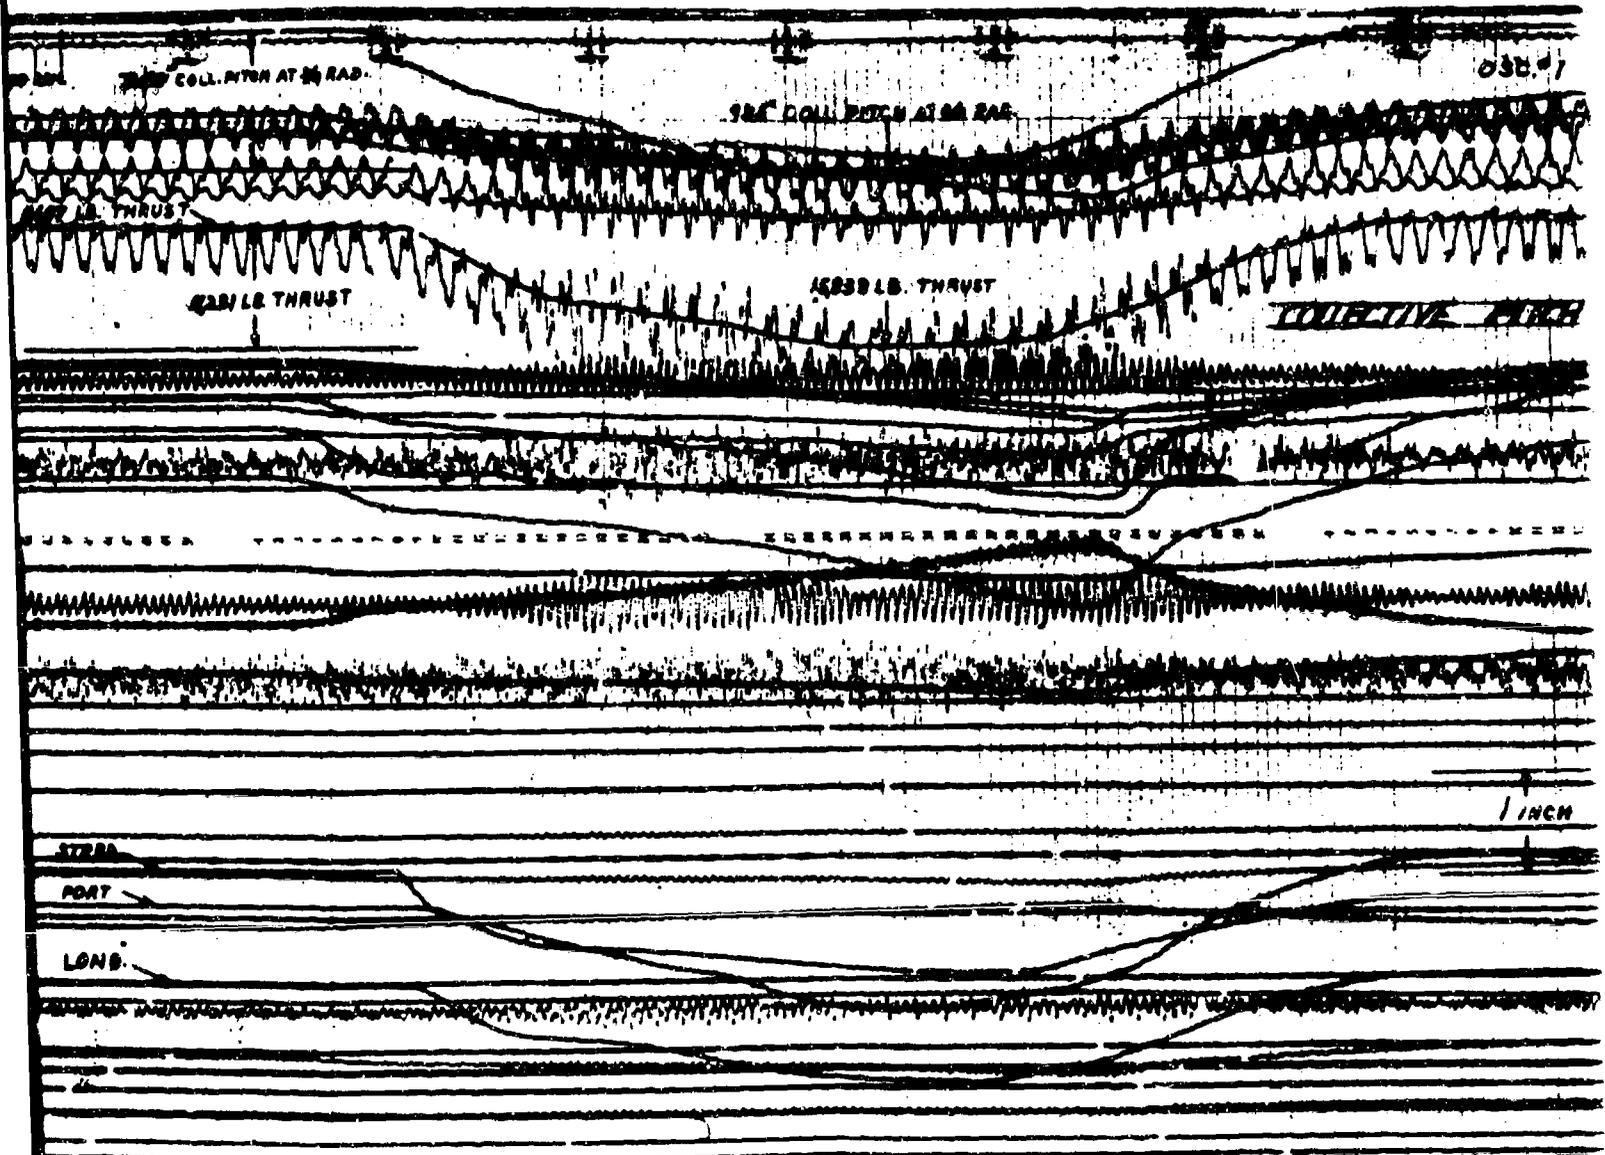
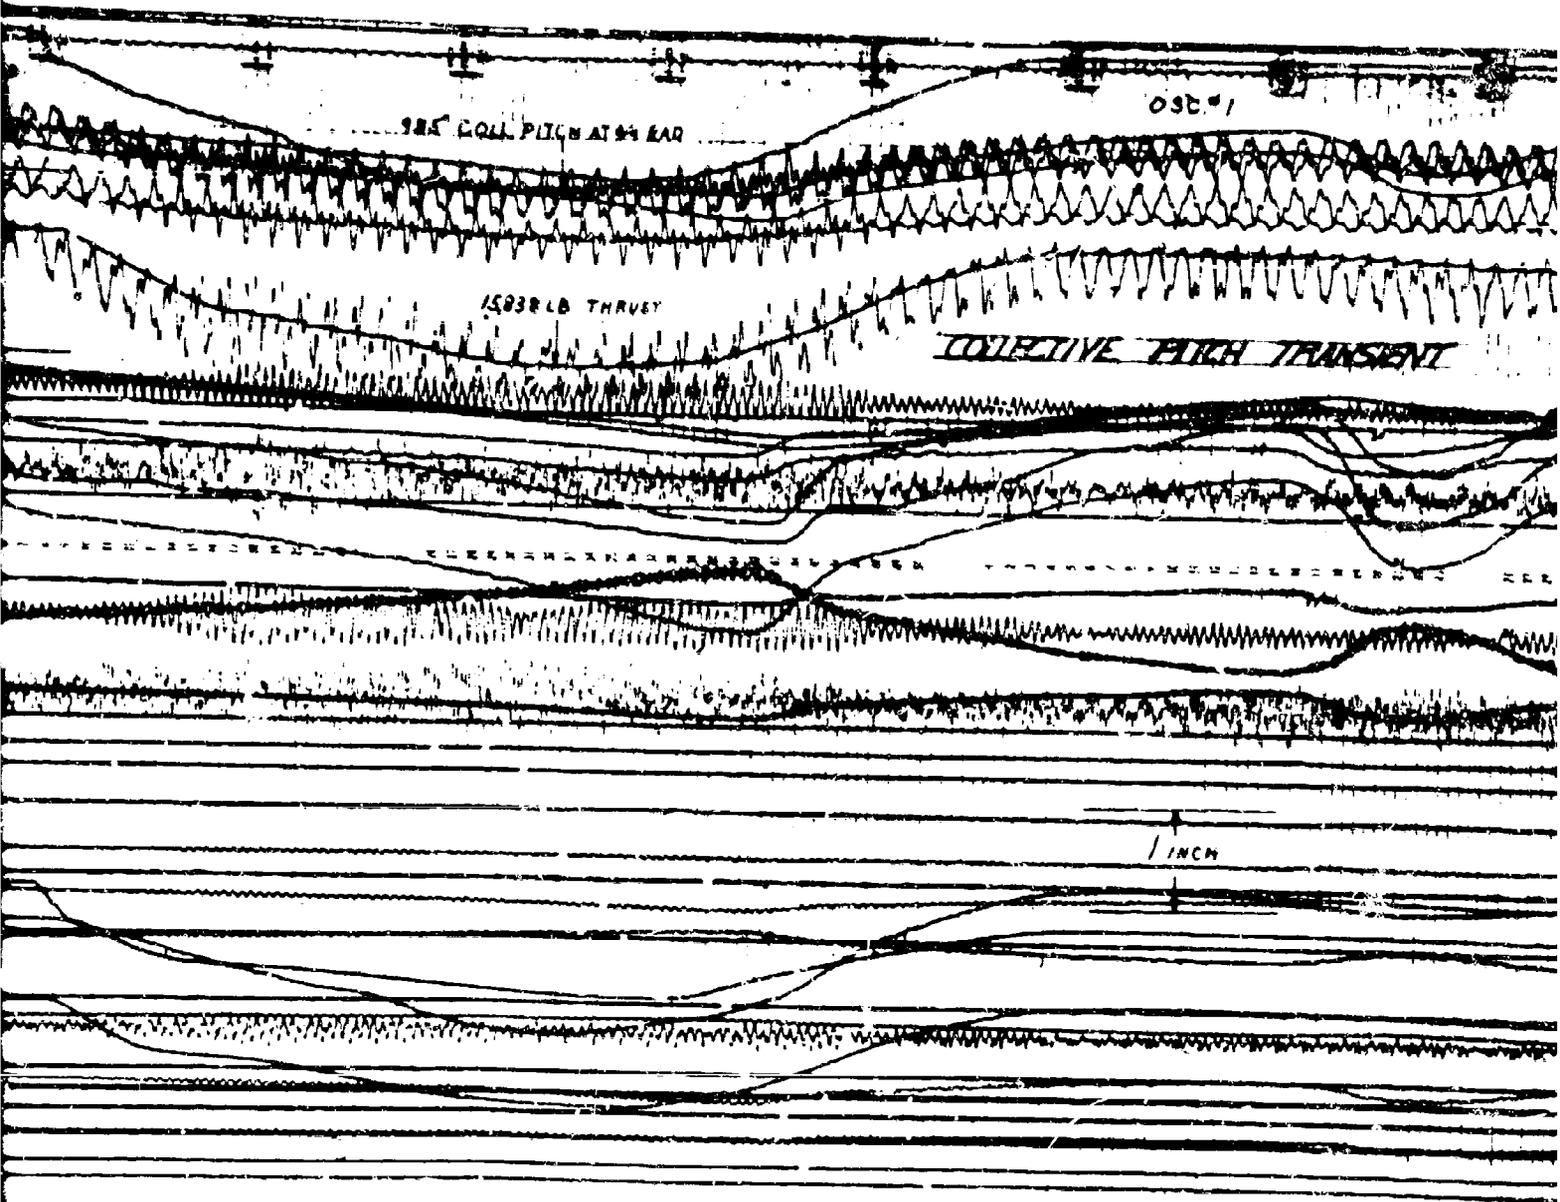
Figure 62. Collective Pitch Transient, Run 30, 11 May 1964  
 N<sub>R</sub> - 98.4 Percent

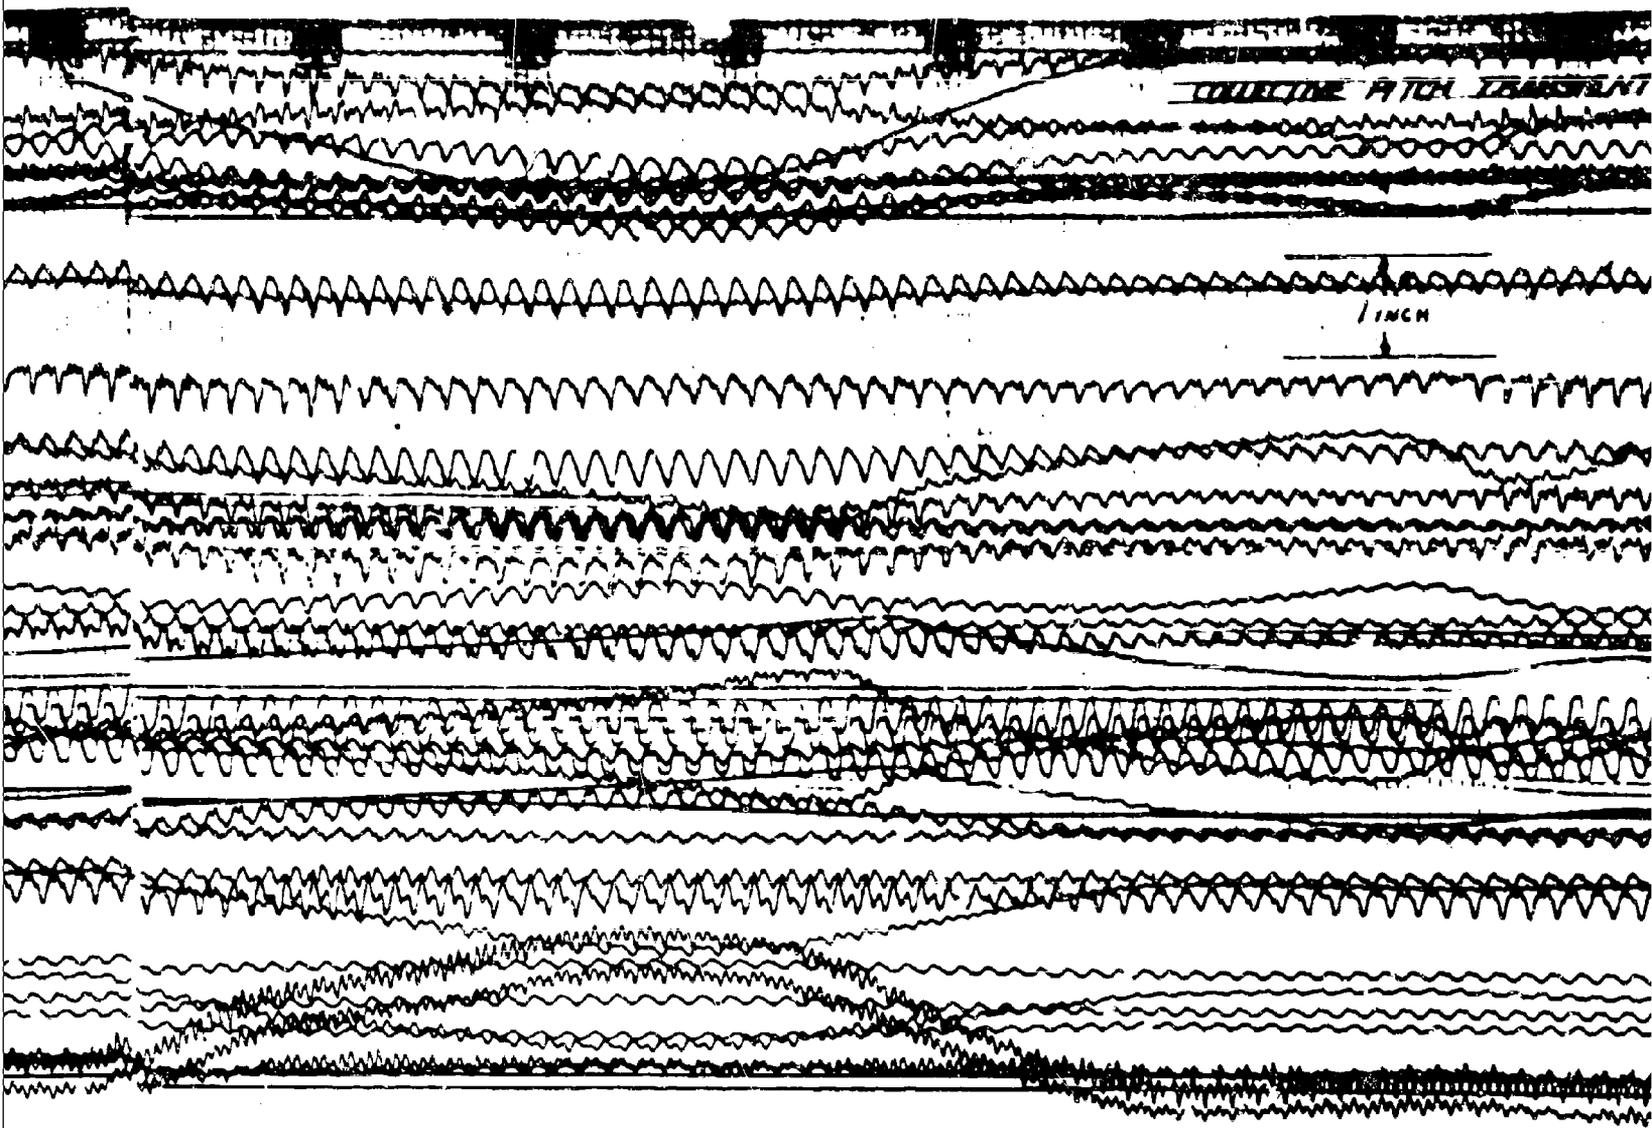
Figure 63. Collective Pitch Transient, Run 30, 11 May 1964  
 $N_R = 98.4$  Percent

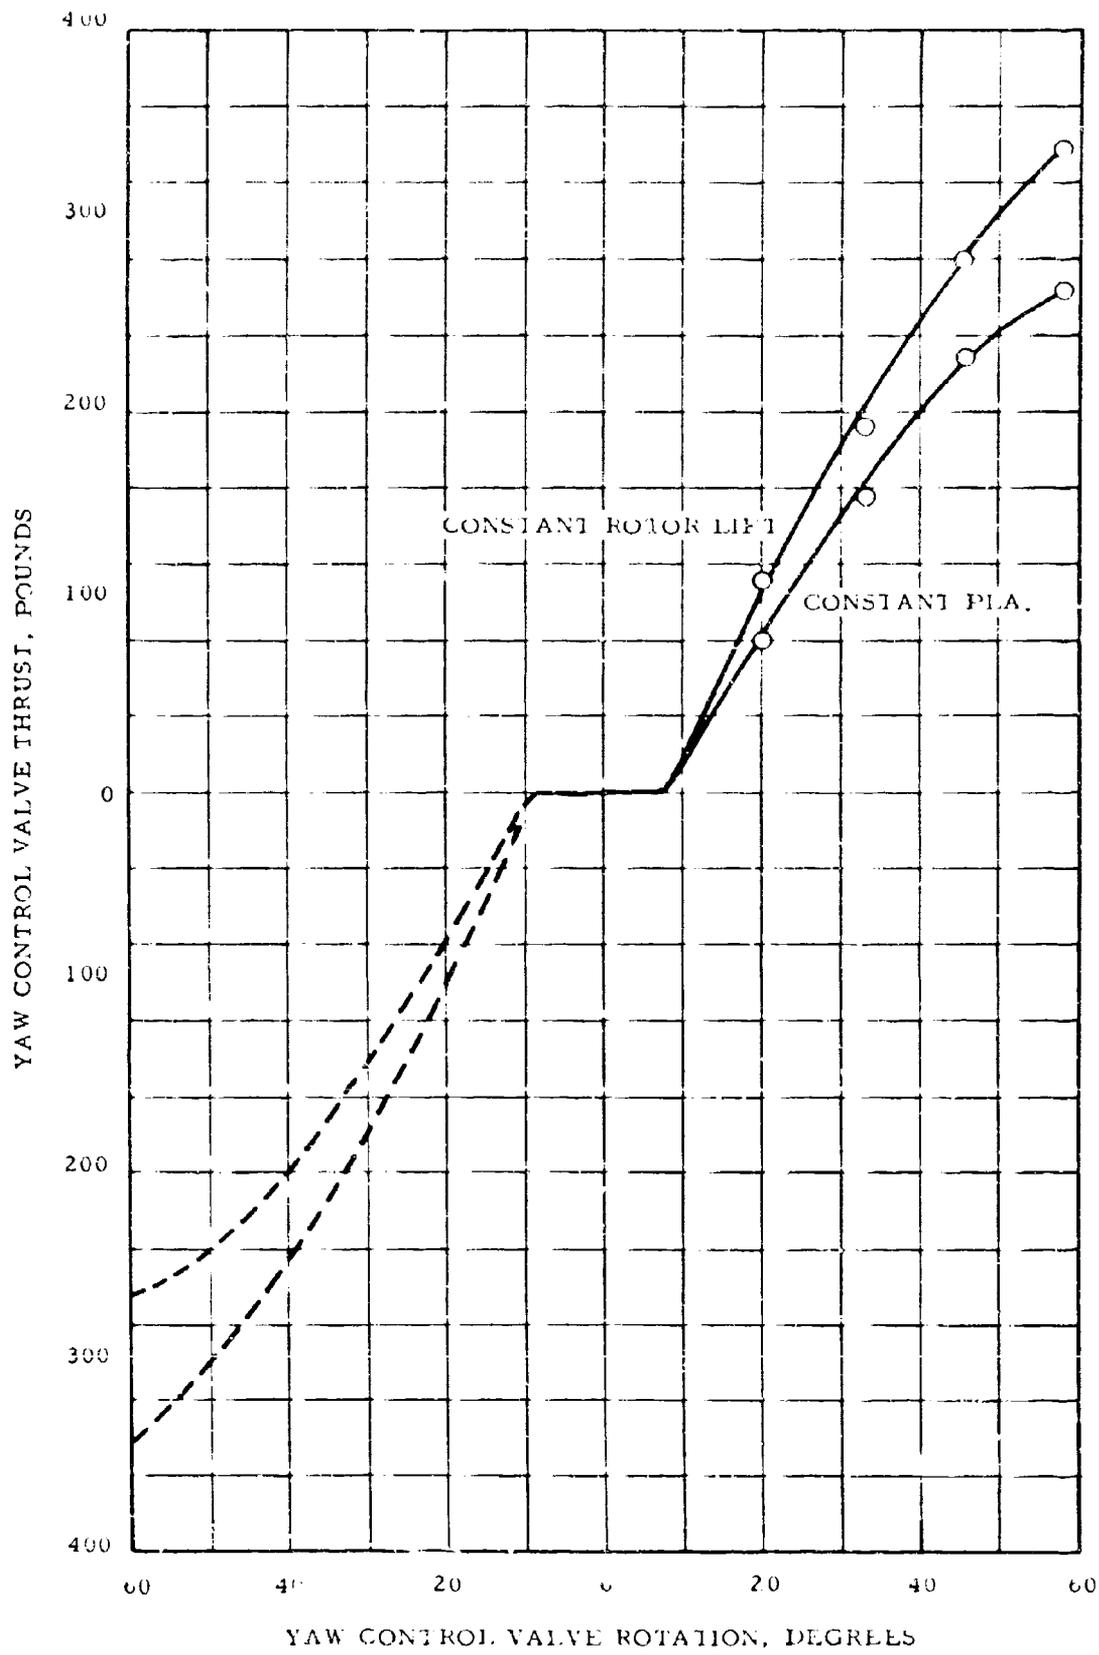
Figure 64. Yaw Valve Thrust Measurement

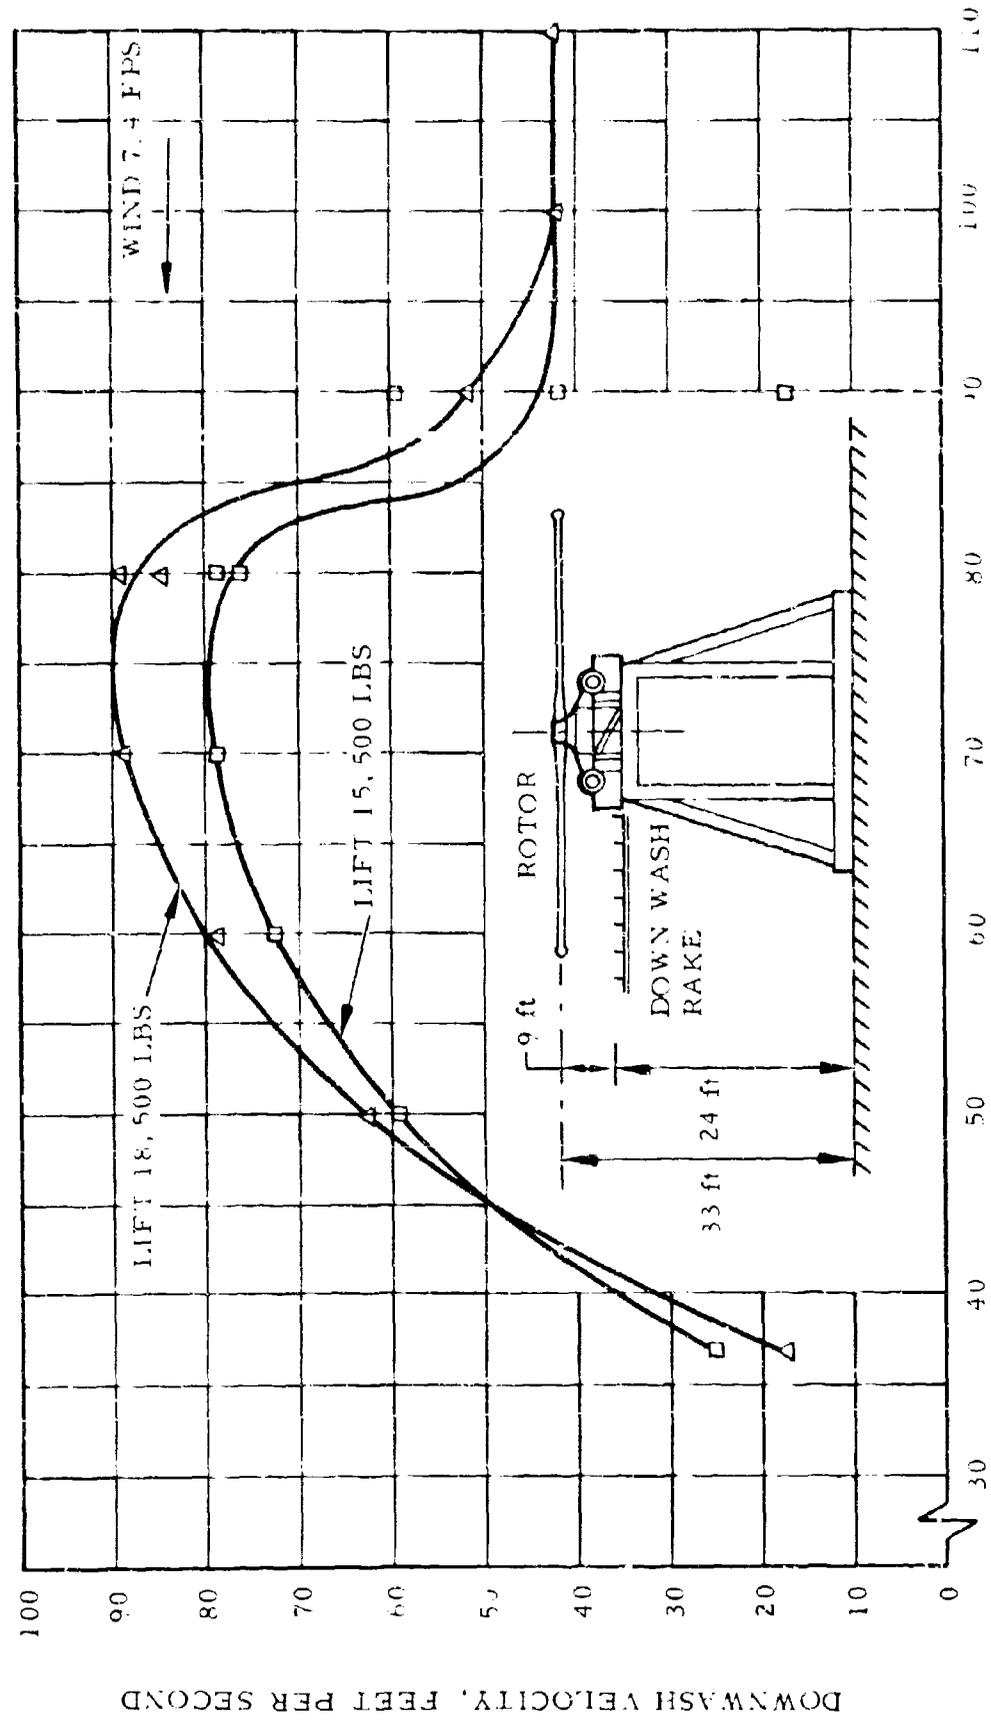
Figure 65. Rotor Downwash Velocity vs. Blade Radial Station

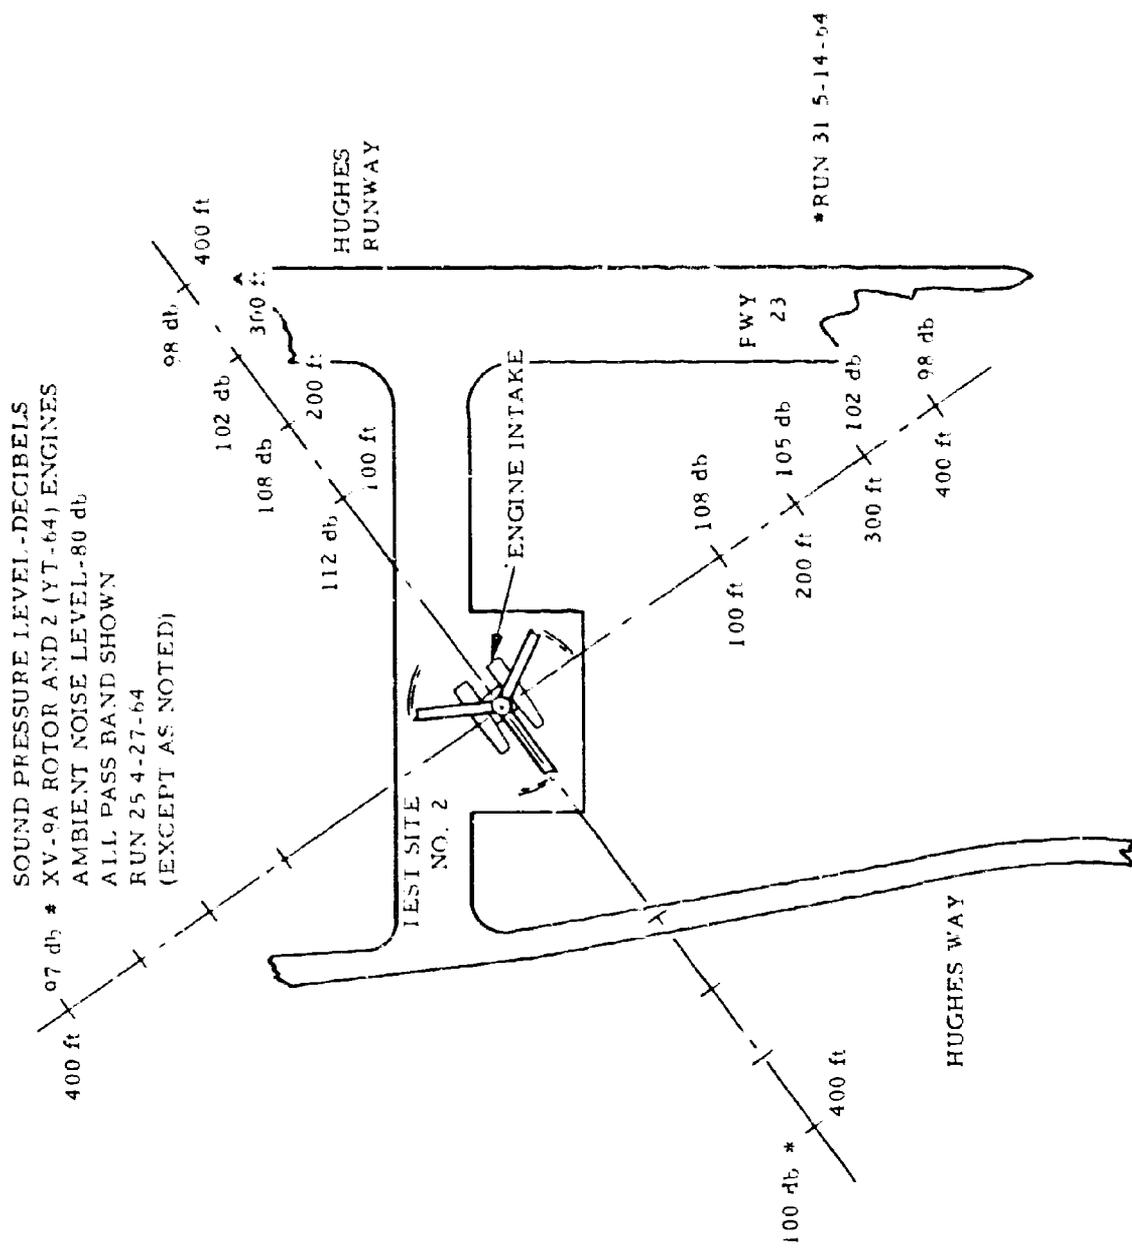
Figure 66. Sound Pressure Level

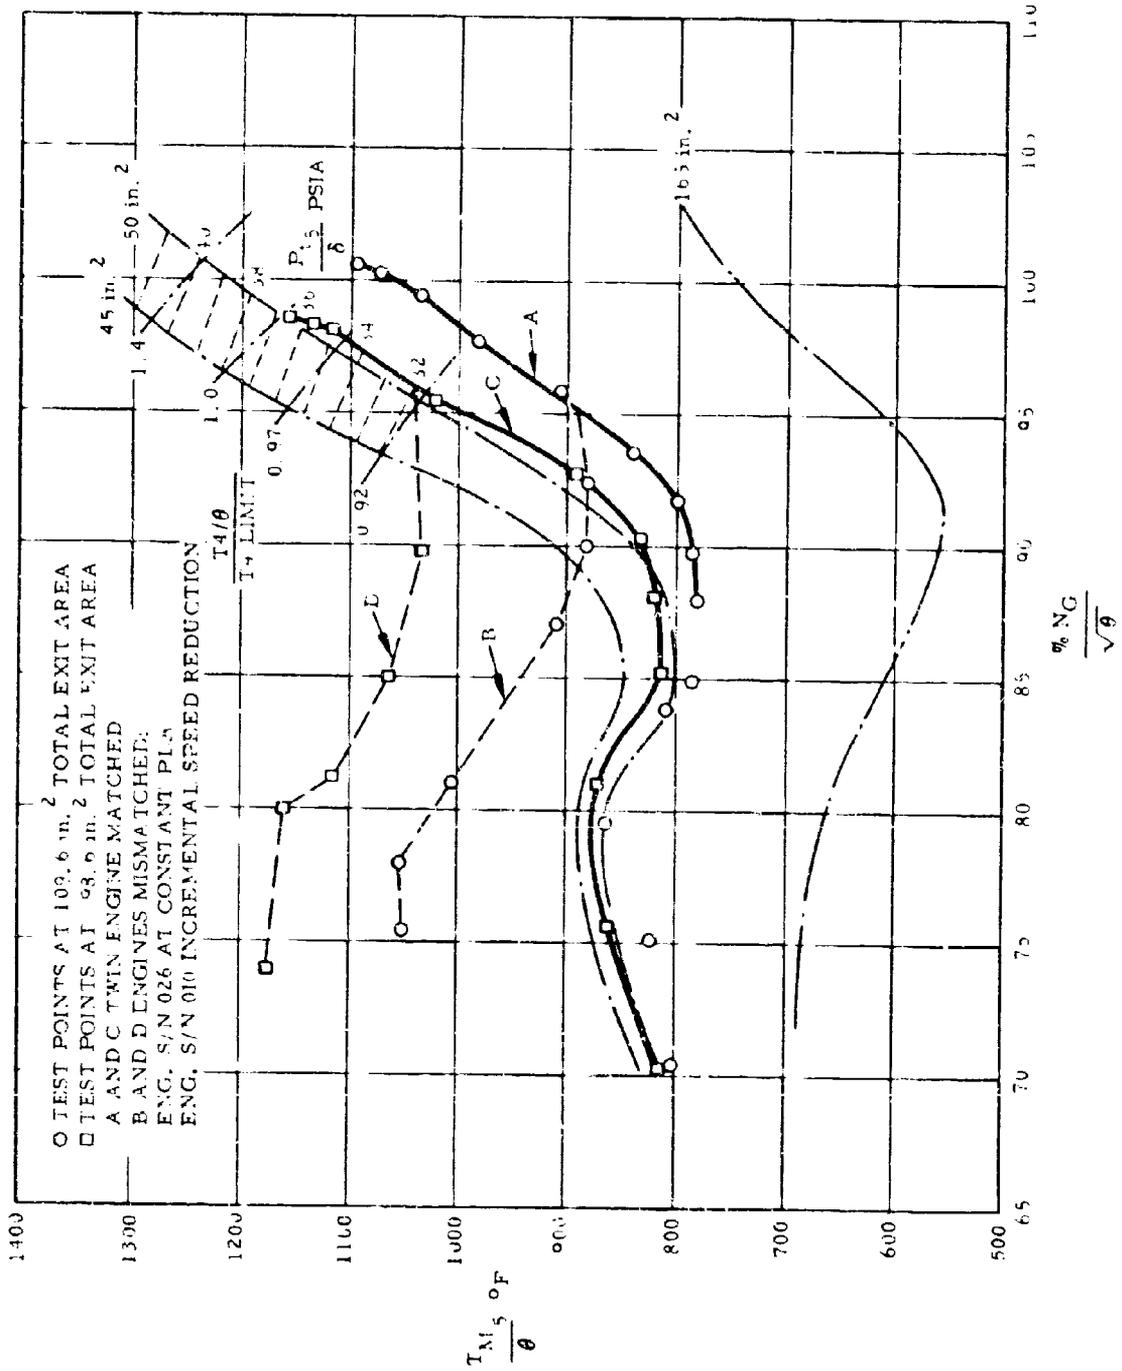
Figure 67. Engine 010 in Twin-Engine Operation

Figures 67 and 68 show a plot for each engine of corrected exhaust temperature  $\frac{T_M}{\theta^5}$  versus corrected engine speed  $\frac{N}{\sqrt{\theta}}$ . The operating lines established by the manufacturer at fixed nozzle areas, together with the turbine inlet temperature limit lines,  $\frac{T_4/\theta}{T_4 \text{ Limit}}$ , and exhaust pressure lines,  $\frac{P_5}{\theta^5}$ , form the background map on which test points and curves are indicated. These maps were used during the tests for a quick determination of operating lines, effective exit areas, and temperature limits. Figure 67 represents the operating record of Engine 010-4 from Runs 15, 16, and 17. Typical twin-engine matched and mismatched test runs are recorded. Each of these operations was run at the total geometric exit area of 109.6 square inches (curves A and B) and 98.6 square inches (curves C and D). The corresponding operating lines of Engine 026-1A (curves A, B, C, and D) are shown on Figure 68. Twin-engine topping was accomplished by topping Engine 010-4 at its temperature limit, while Engine 026-1A was adjusted to equal the lower exit pressure of its weaker counterpart. The power developed at topping speed is indicated on the plot in terms of shaft horsepower (SHP) as defined by the engine manufacturer. The tests showed no significant adverse effects caused by the common exit arrangement. When the engines remained essentially matched through the range of operation, they ran practically as they would run having

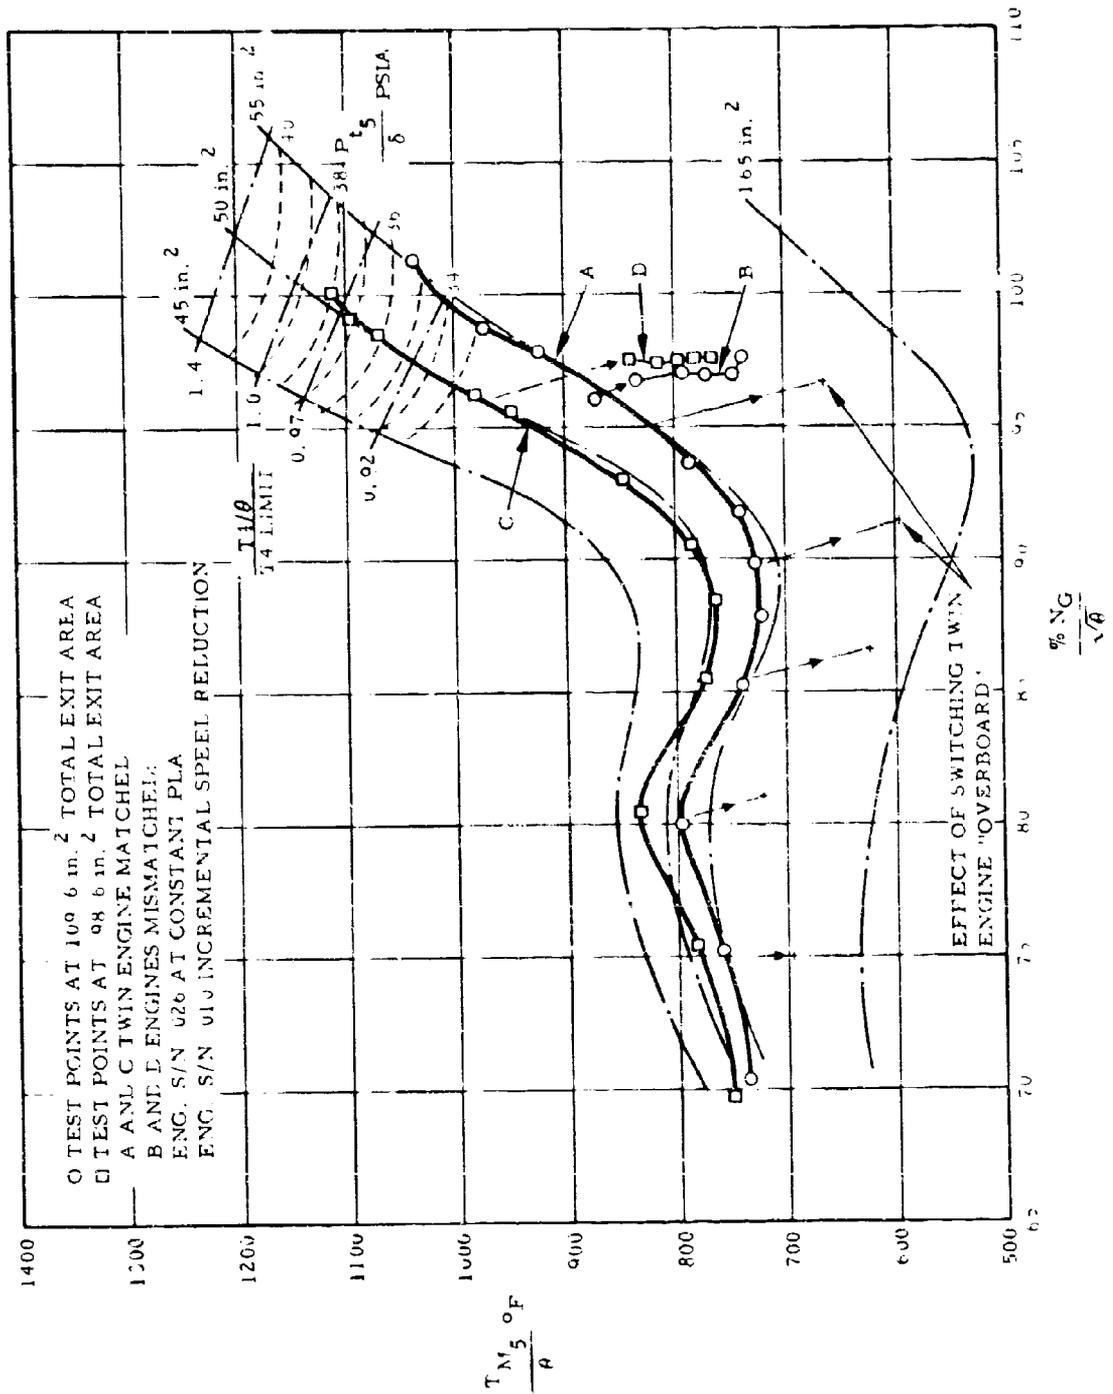
Figure 68. Engine 026 in Twin-Engine Operation

individual discharge nozzles. The steady-state engine operating characteristics at the differential power setting were checked by holding Engine 026-1A at a constant power lever angle of about 97 percent speed while reducing the speed of Engine 010. The degree of mismatch was increased incrementally until the speed ratio in one case was 97.5 : 74. There was no adverse effect of mismatching. Both tests constituted a sequence of stable steady-state points. The temperature of neither engine exceeded the limits.
