USATRECOM TECHNICAL REPORT 64-67

ENGINE AND WHIRL TESTS,  
XV-9A HOT CYCLE RESEARCH AIRCRAFT

SUMMARY REPORT

U S ARMY TRANSPORTATION RESEARCH COMMAND  
FORT EUSTIS VIRGINIA

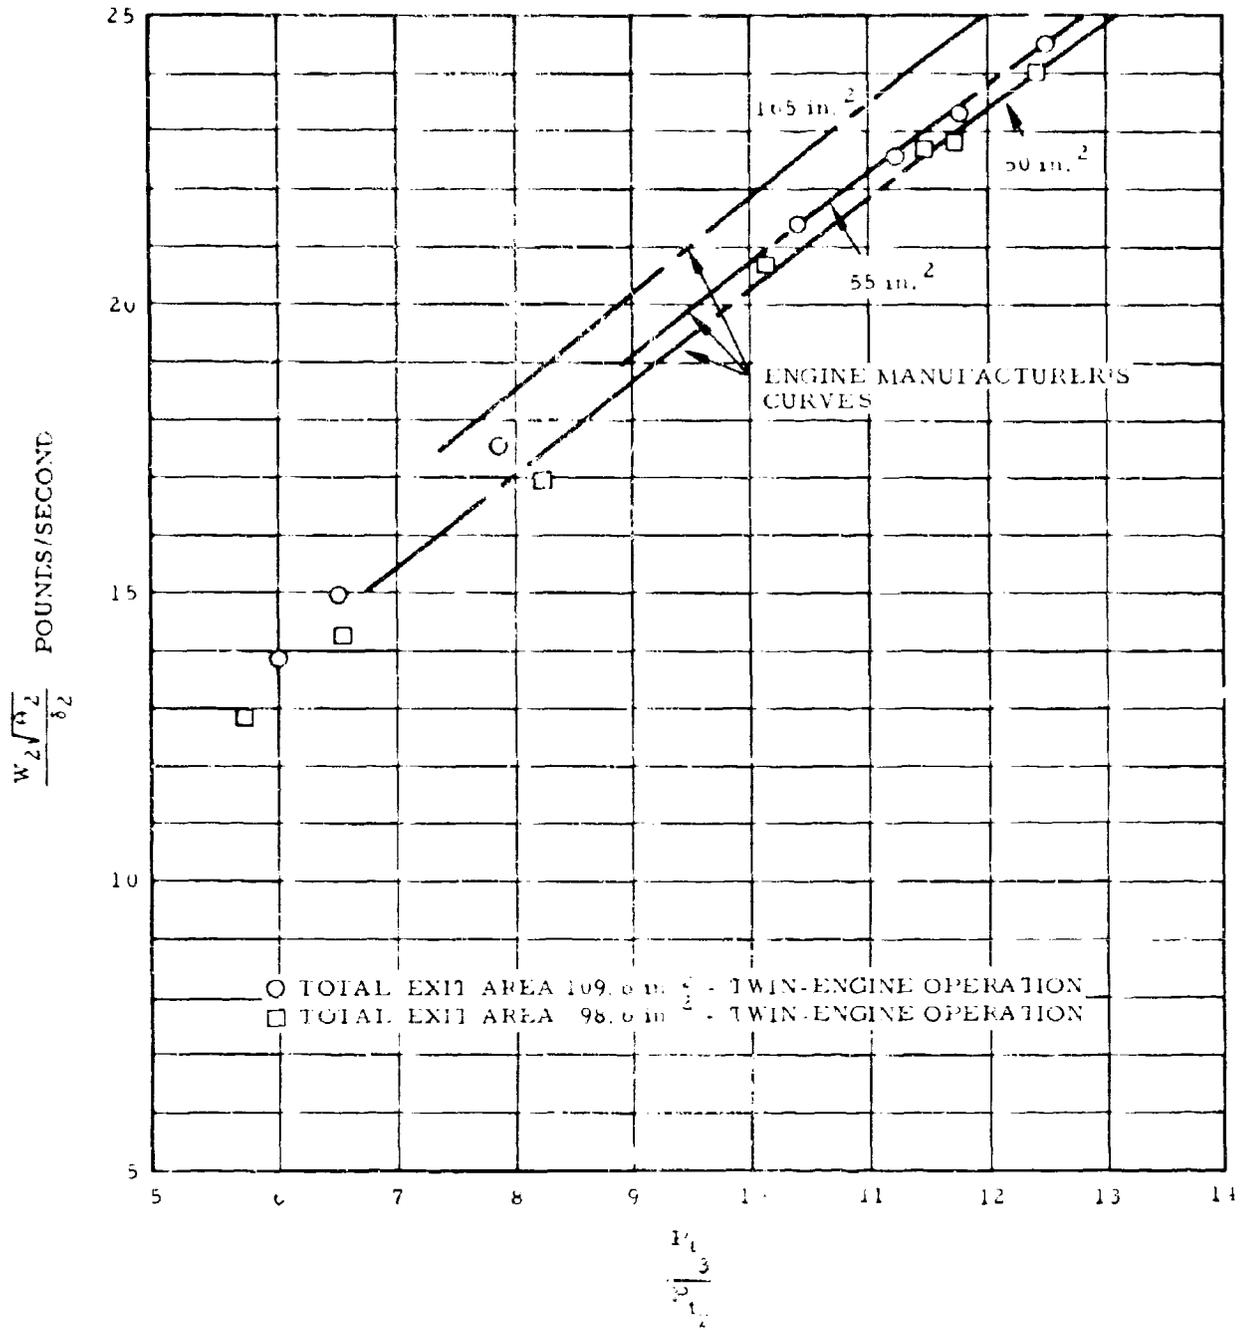
Figure 69. Engine 026 Compressor Corrected Flow vs. Compressor Pressure Ratio

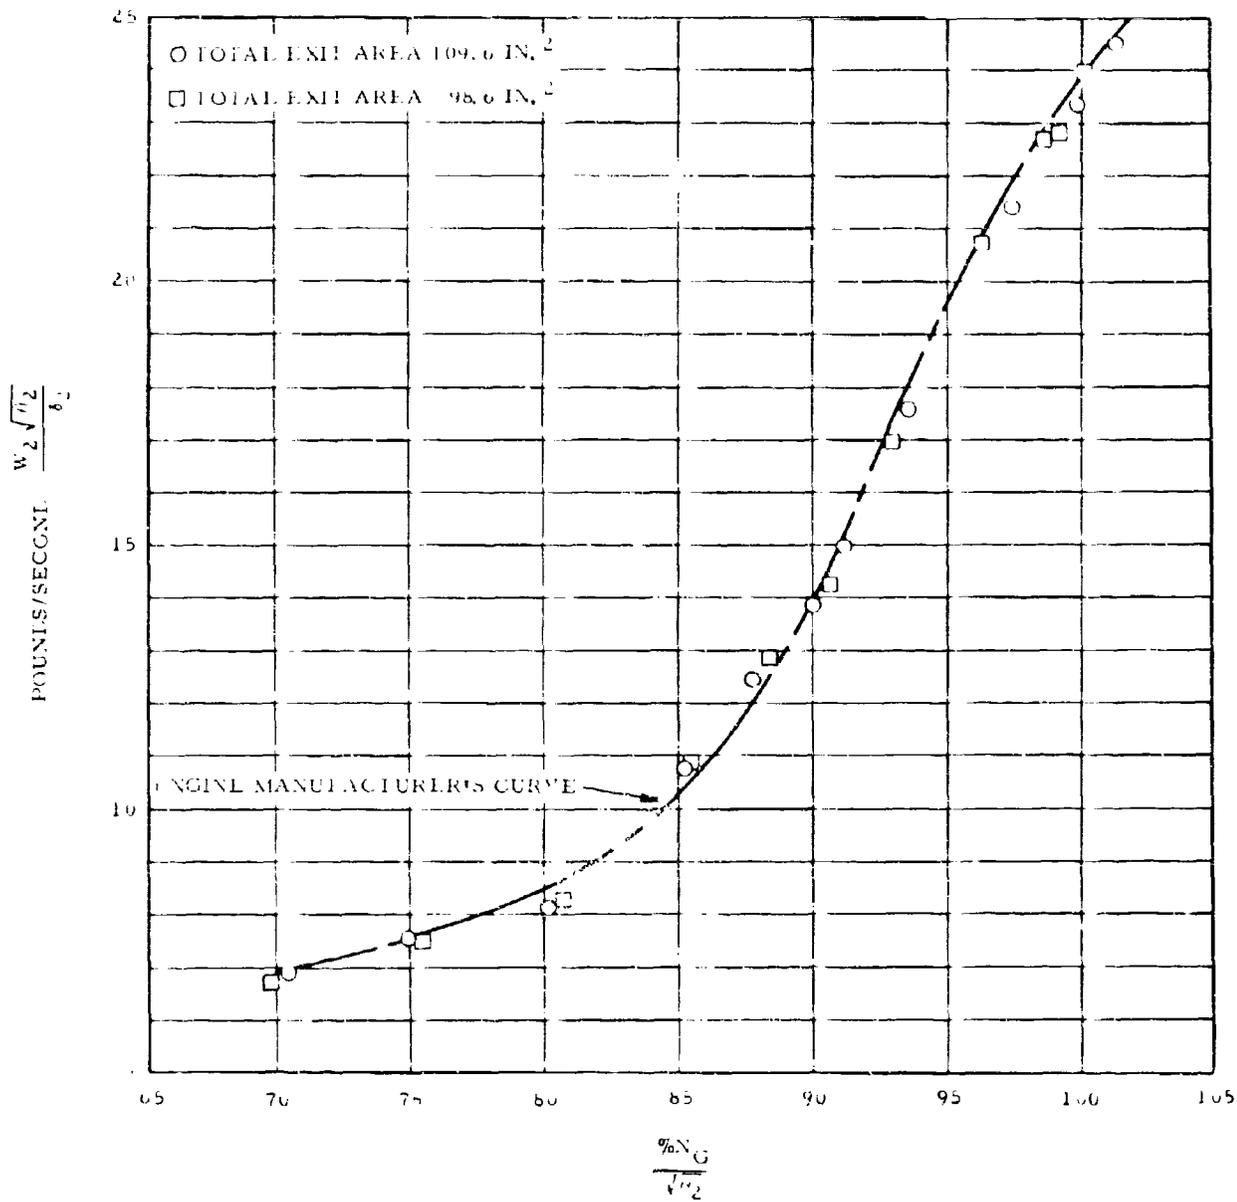
Figure 70. Engine 026 Compressor Corrected Flow vs. Corrected Engine Speed Twin-Engine Operation

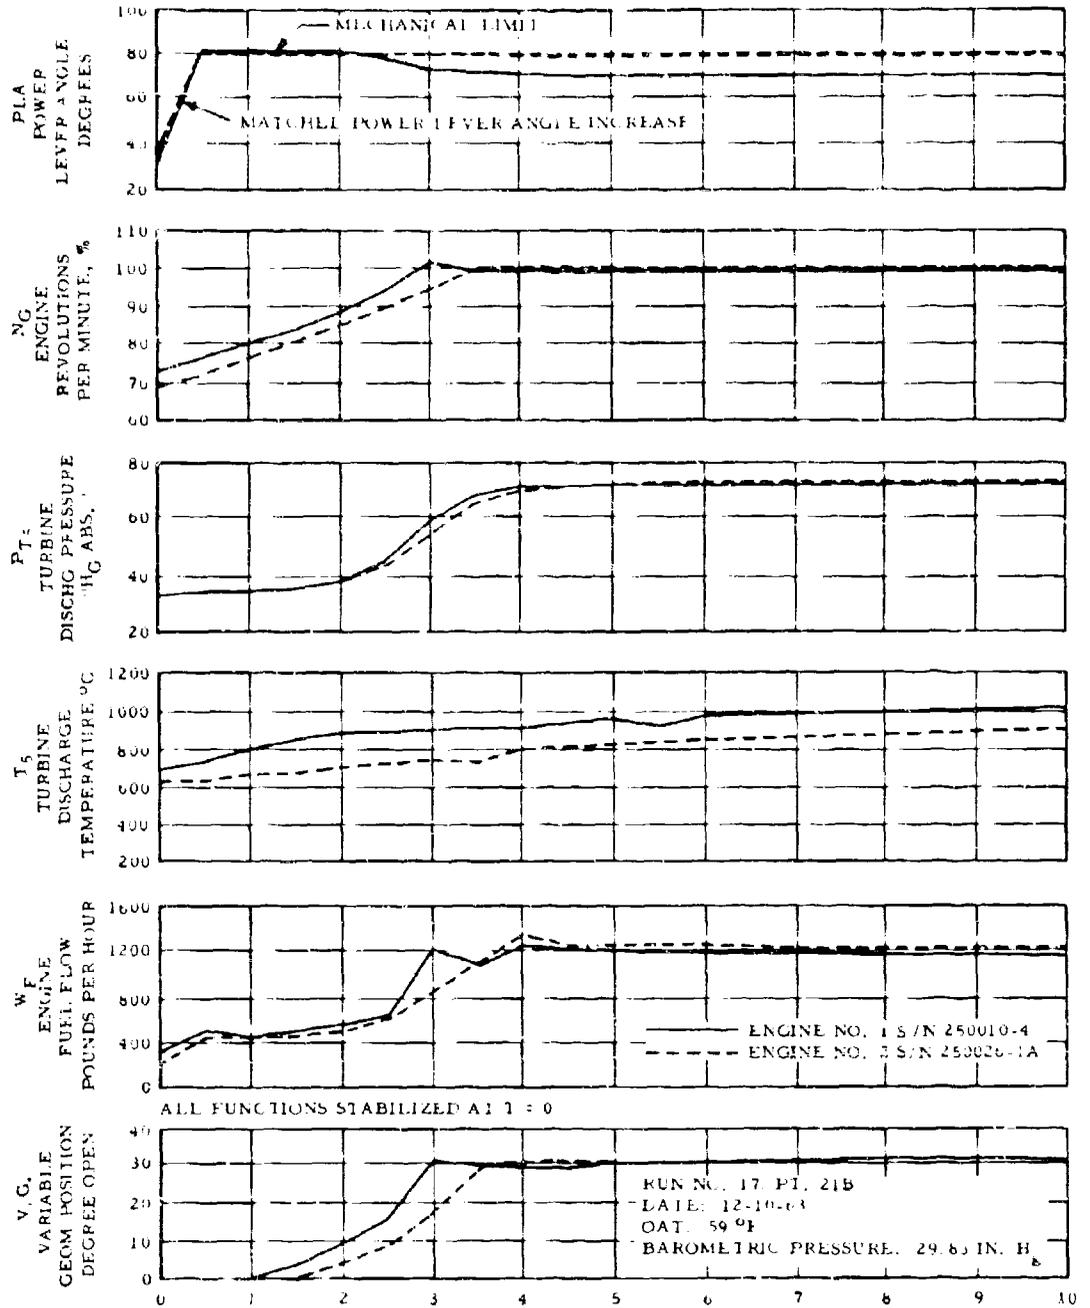
NOTE: GAS FLOW THROUGH DIVERTER VALVES & COMMON EXHAUST NOZZLE TWO Y1-64 GAS GENERATORS NOZZLE EXHAUST AREA = 98.6 IN<sup>2</sup>

Figure 71. Twin-Engine Operating Characteristics Rapid Acceleration from Idle to Maximum Power

The next four figures are transcriptions from the oscillograph record. Figures 71, 72 and 73 show the effect of typical twin-engine transient operations on various engine parameters. They illustrate, respectively, rapid acceleration from idle to maximum power rapid acceleration to maximum power with differential starting speeds, and rapid power change from maximum to 80 percent  $N_G$  and return to maximum. Figure 74 shows a sequence of steady-state conditions at various differential power settings, followed by acceleration of the slow engine to its original power setting. This test is the same as one illustrated by curve D on Figures 67 and 68.

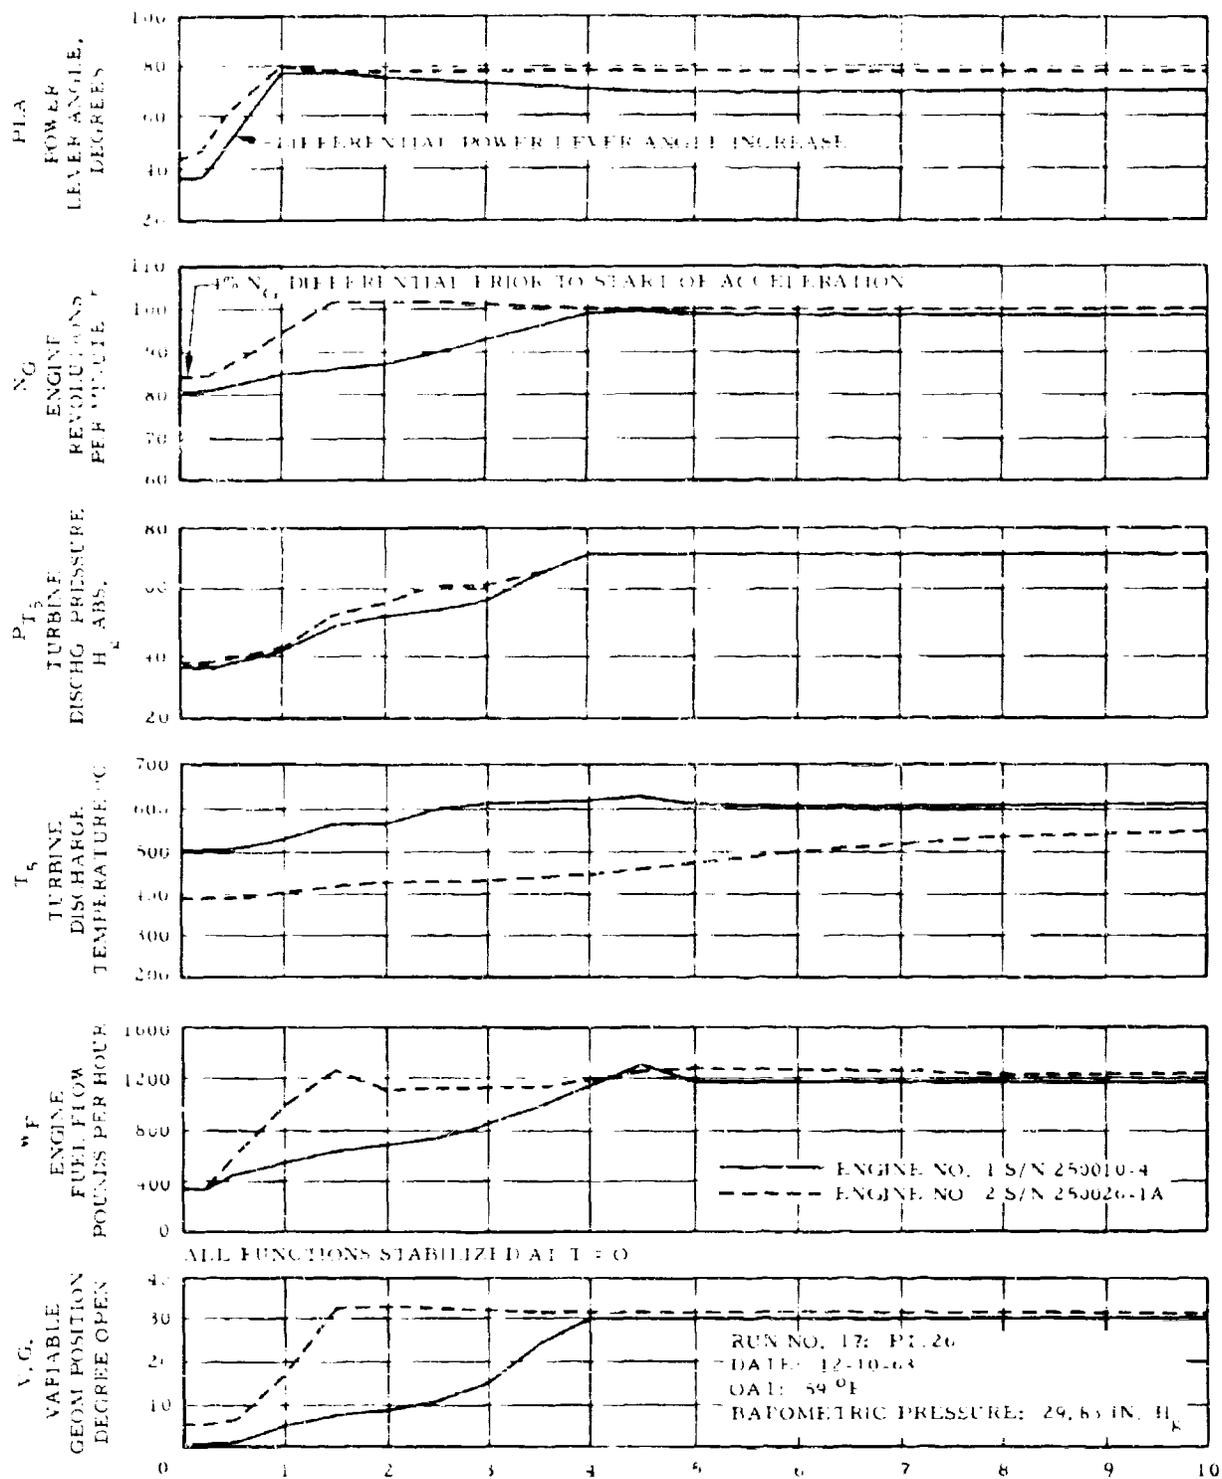
NOTE: GAS FLOW THROUGH DIVERTER VALVES & COMMON EXHAUST NOZZLE TWO Y1-64 GAS GENERATORS NOZZLE EXHAUST AREA = 98.6 IN<sup>2</sup>

Figure 72. Twin-Engine Operating Characteristics Rapid Acceleration to Maximum Power with Differential Starting Speeds

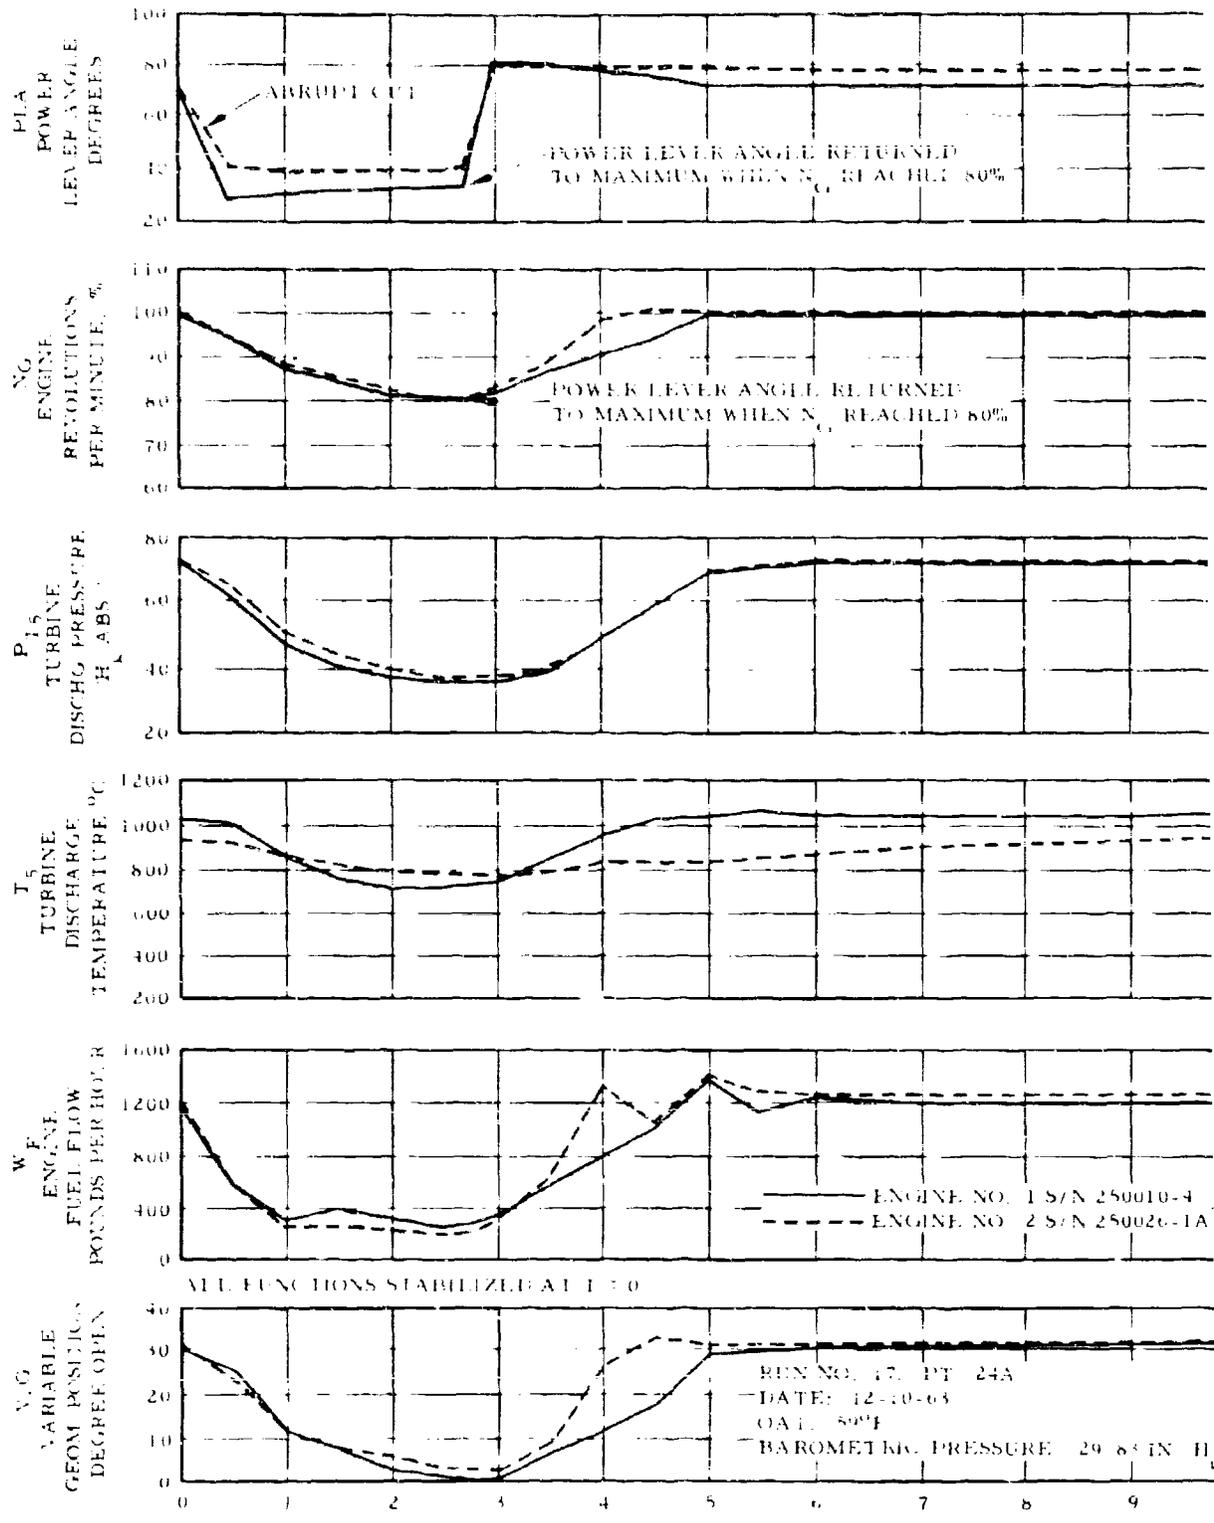
NOTE: GAS FLOW THROUGH DIVERTER VALVES & COMMON EXHAUST NOZZLE  
 TWO Y1-64 GAS GENERATORS  
 NOZZLE EXHAUST AREA 98.6 IN.<sup>2</sup>

Figure 73. Twin-Engine Operating Characteristics Rapid Power Change from Maximum to 80 percent N<sub>G</sub> and Return to Maximum 130

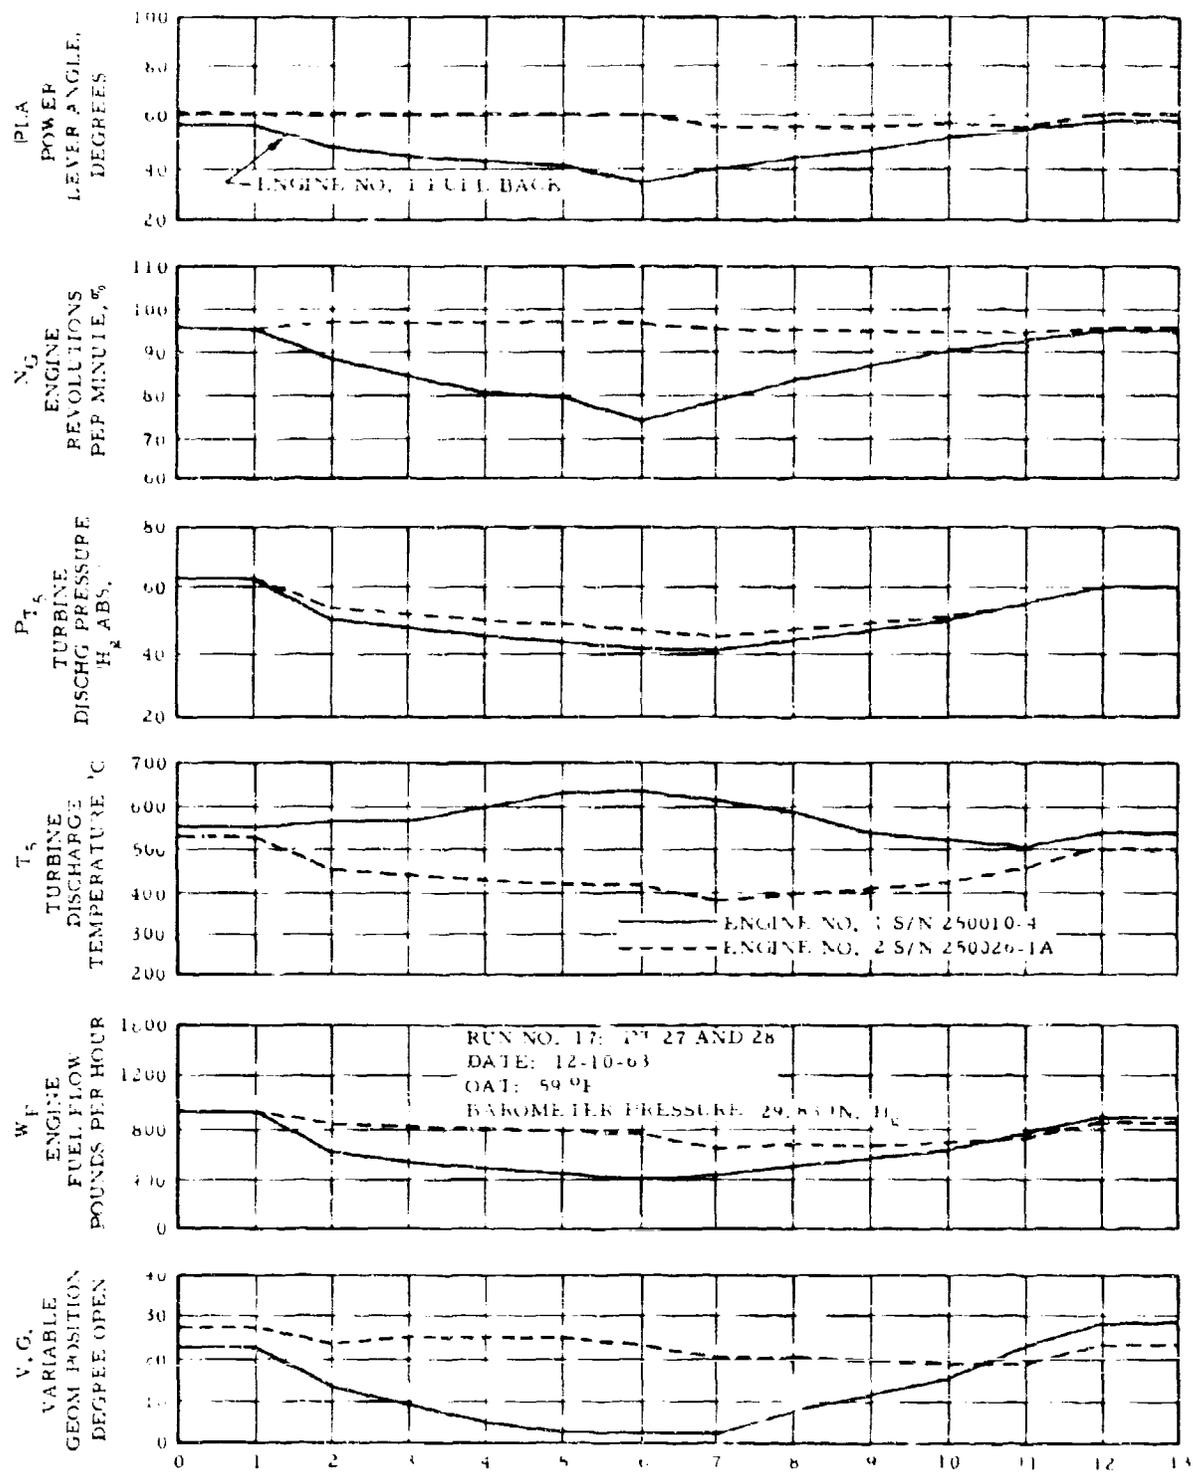
NOPL GAS FLOW THROUGH DIVERTER VALVES (POINT NO. (NO TIME SCALE))  
& COMMON EXHAUST NOZZLE,  
TWO YF-64 GAS GENERATORS  
NOZZLE A EXHAUST AREA = 98.6 IN<sup>2</sup>

Figure 74. Twin-Engine Operating Characteristics Steady-State  
Engine Data at Differential Power Setting

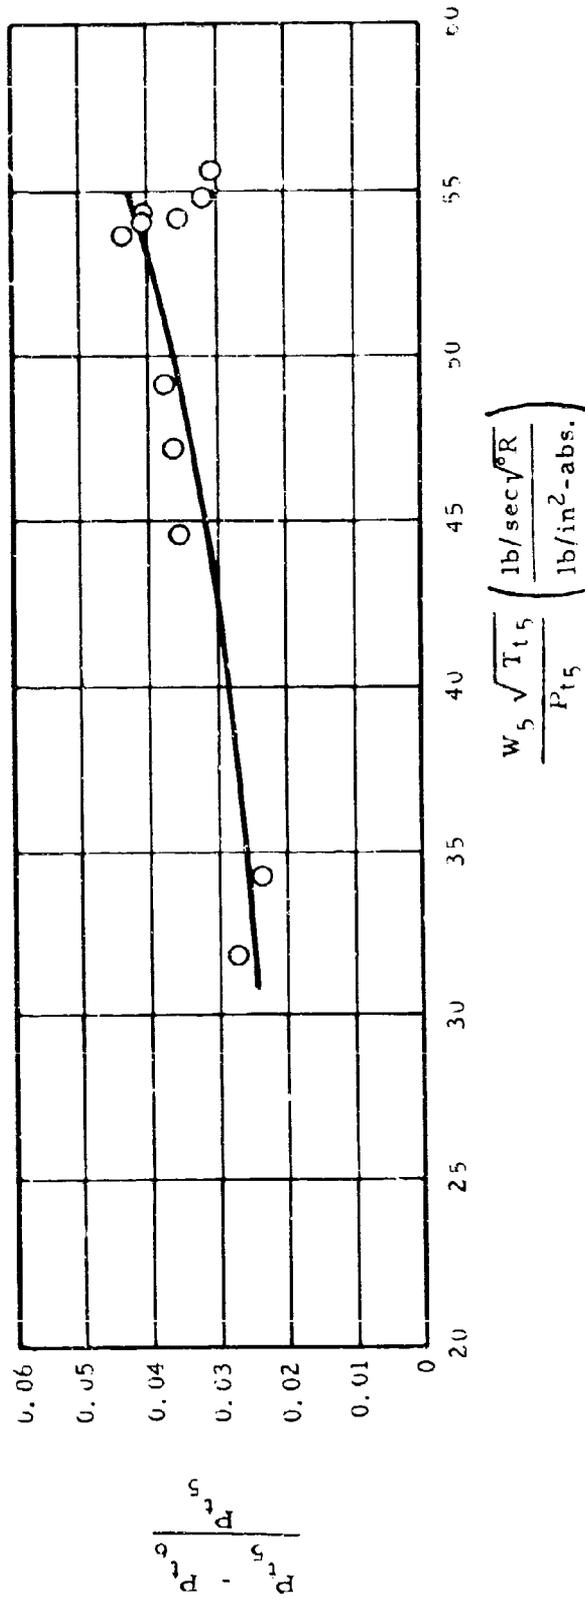
Figure 76. Pressure Loss Between Engine Exit (Station 5) and Hub (Station 6)

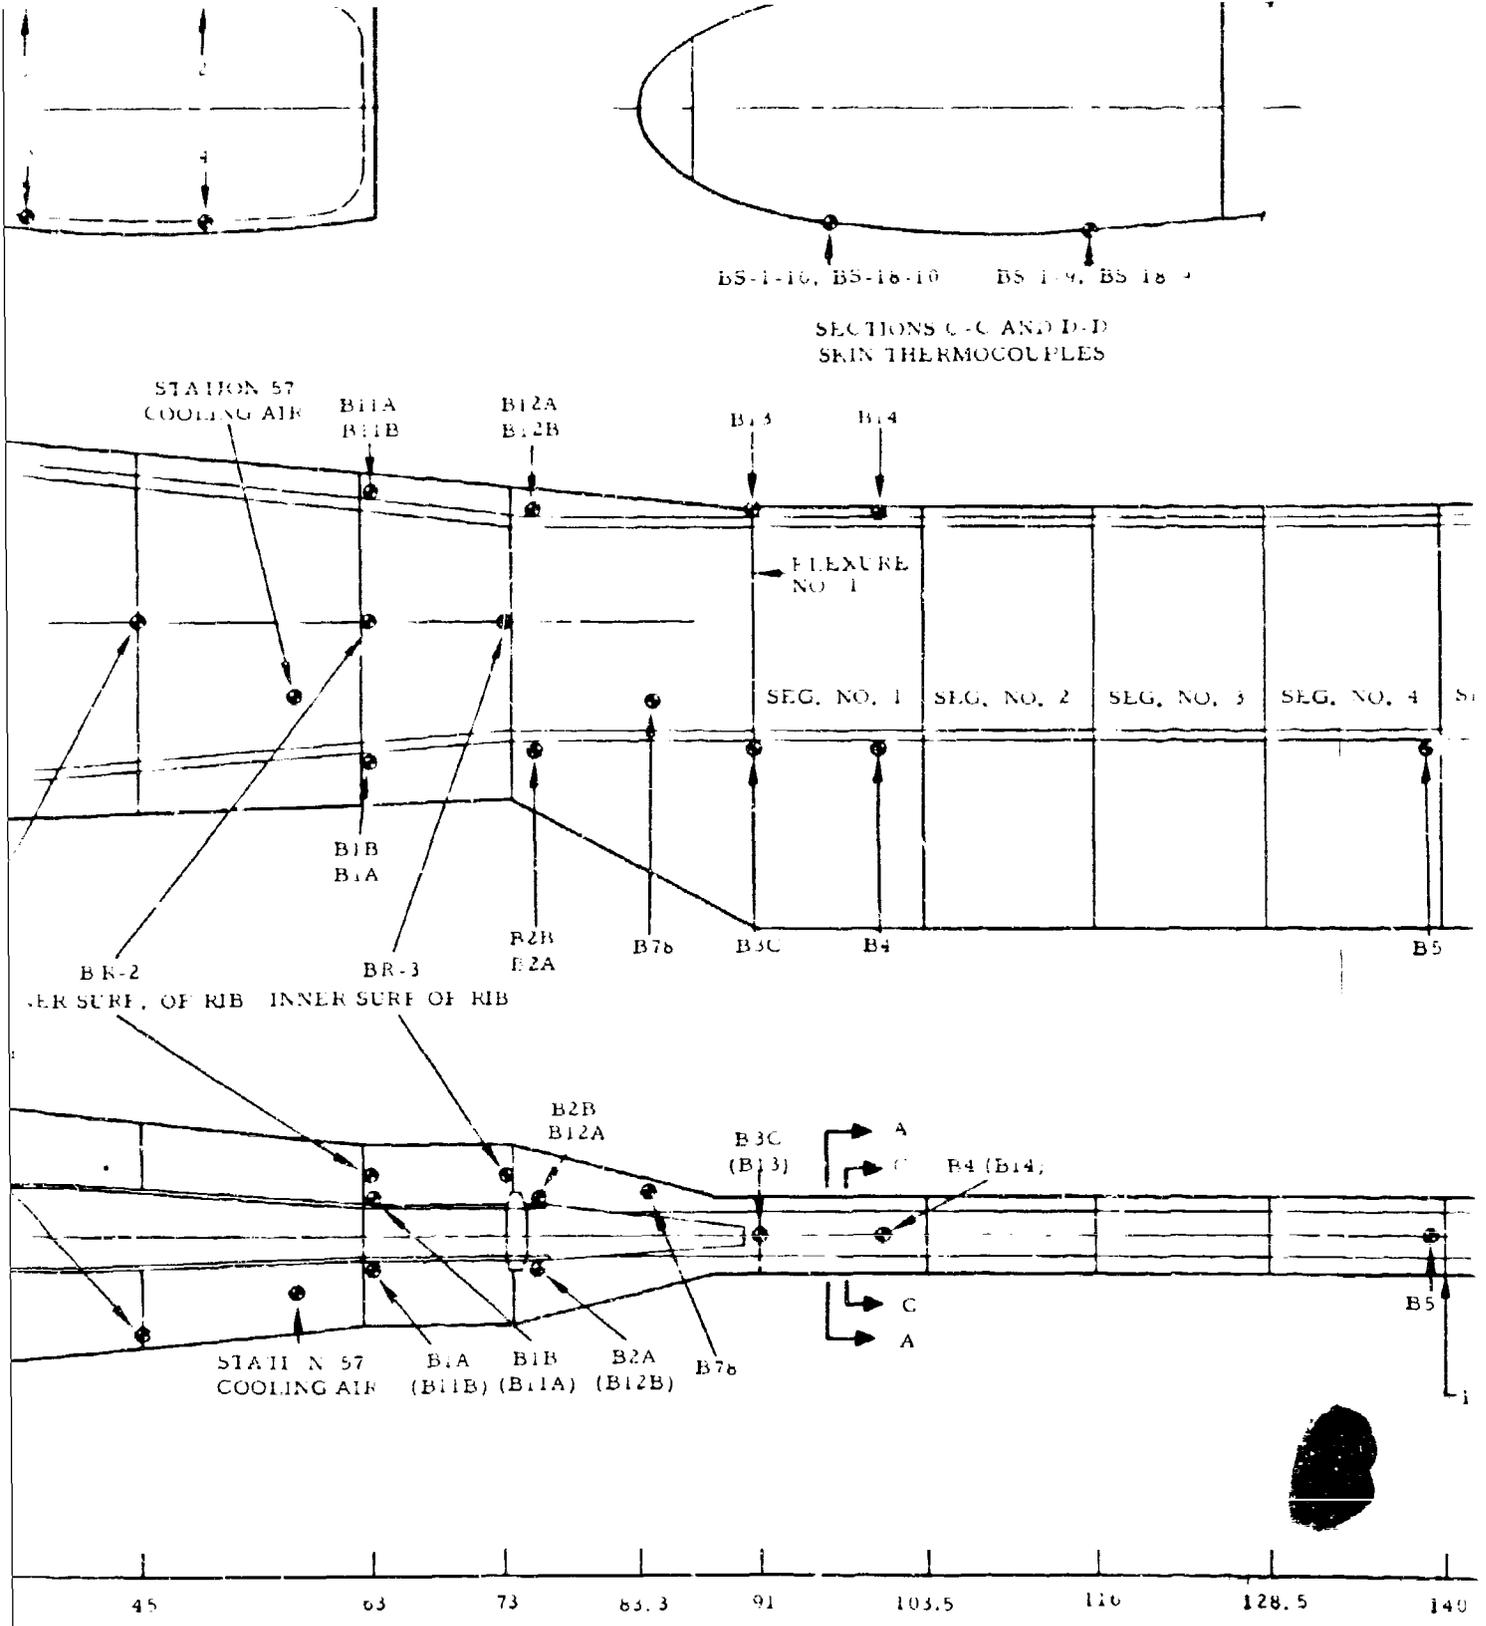
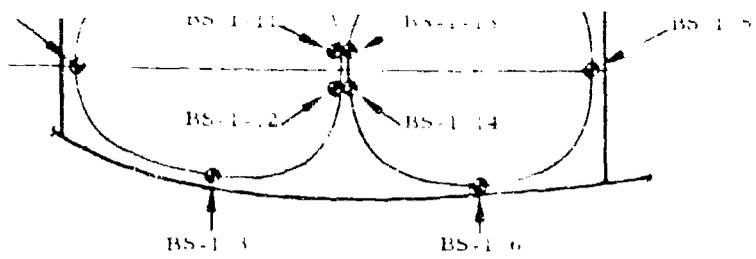
Figure 78. Thermocouple Locations, Rotor I

SECTION A-A  
BLADE SEGMENT NO. 4

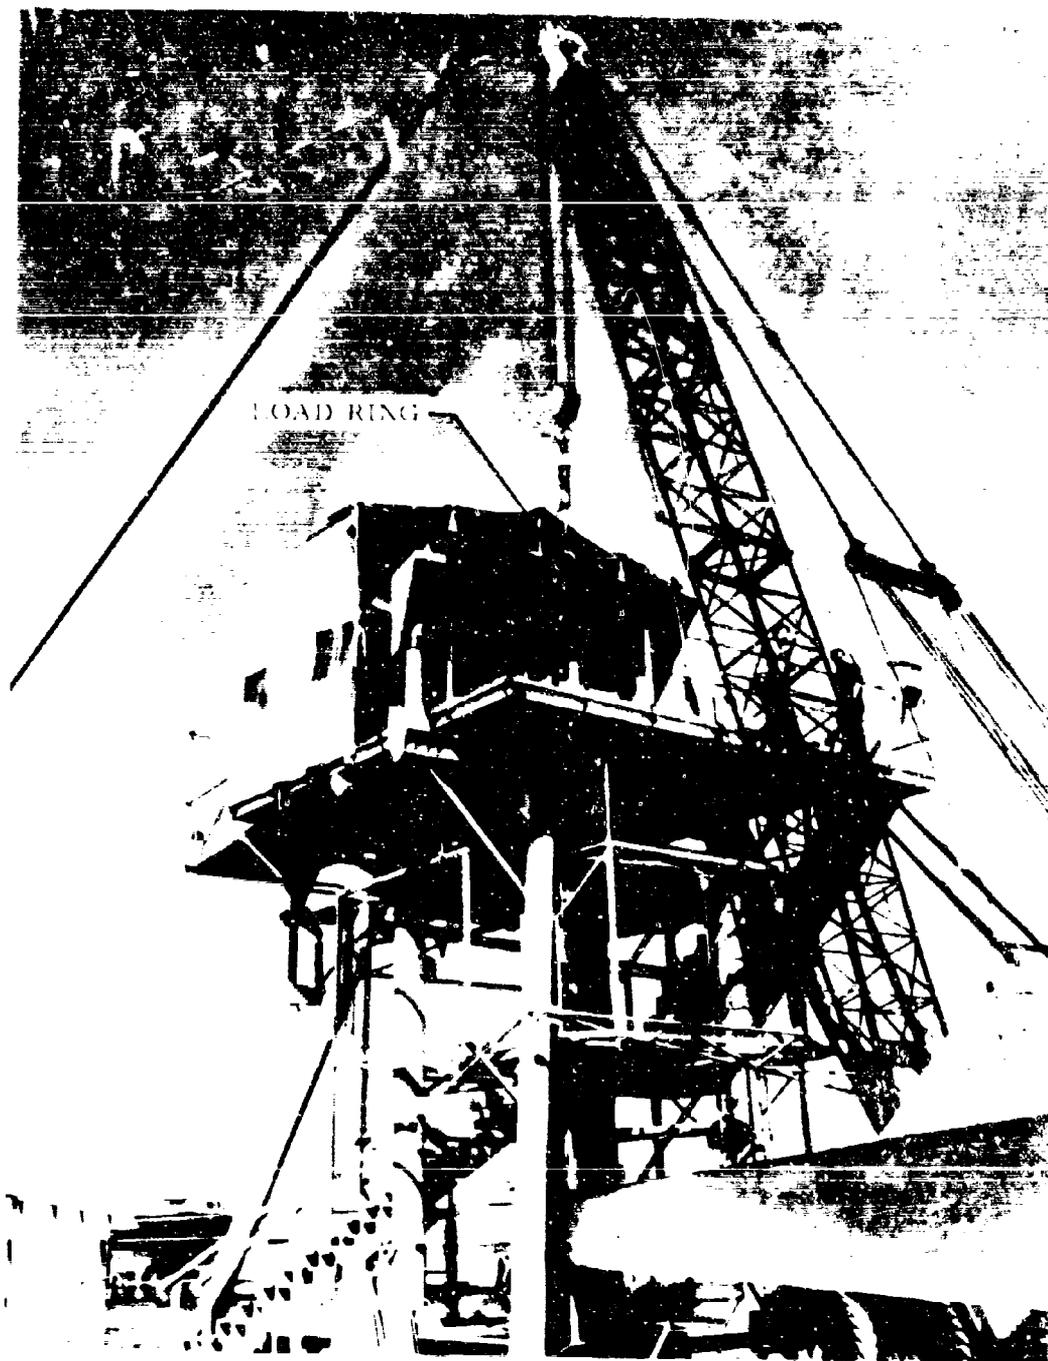
Figure 87. Thrust Measuring System Calibration

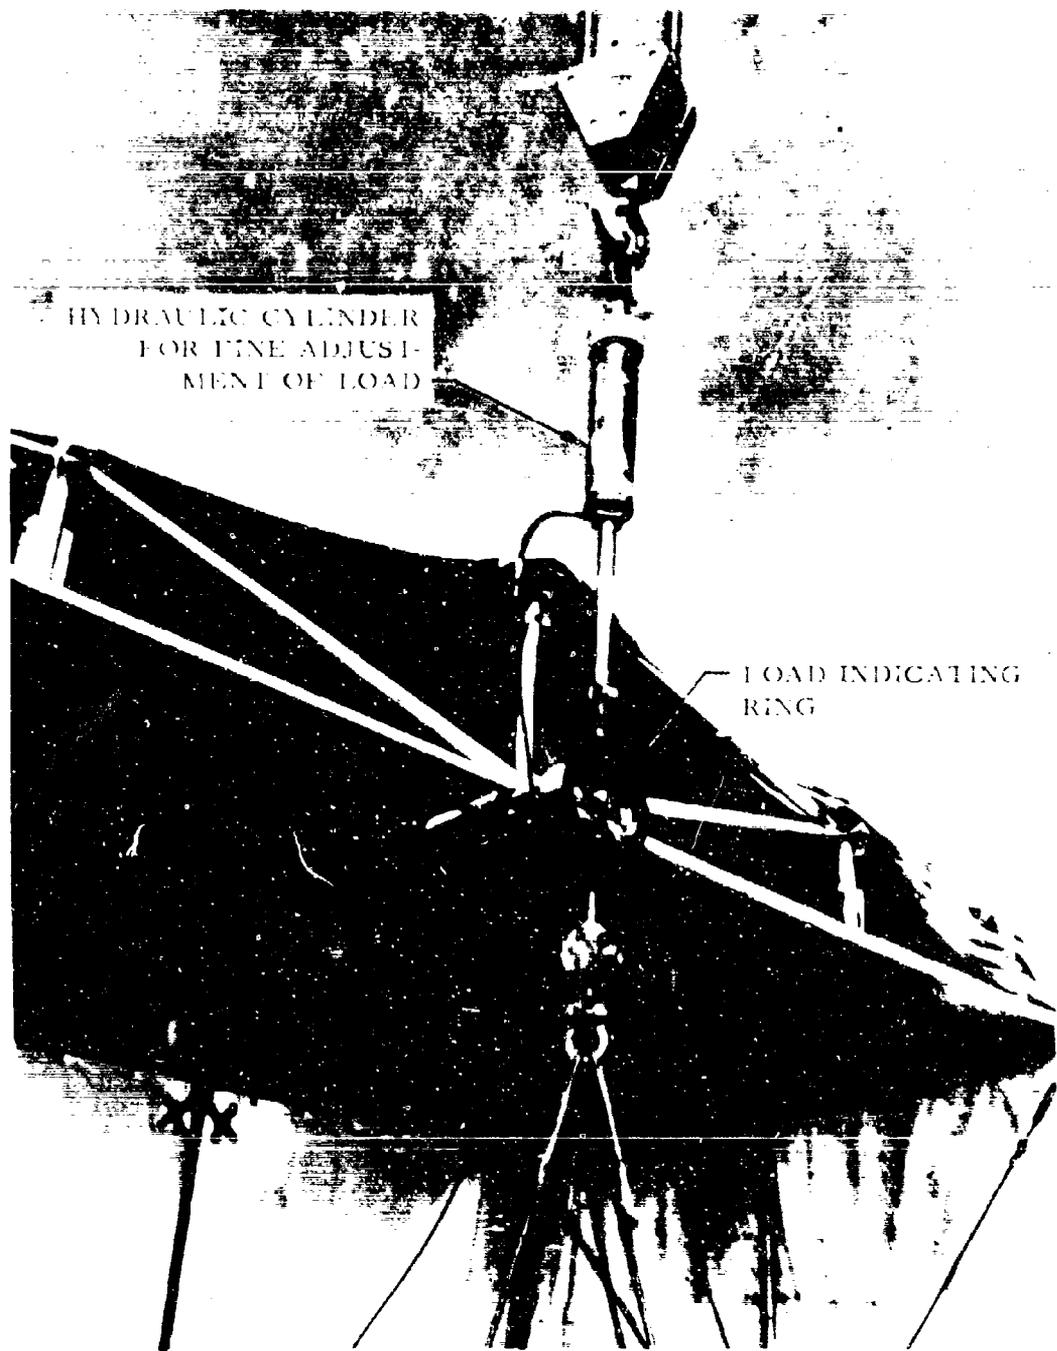
HYDRAULIC CYLINDER  
FOR FINE ADJUST-  
MENT OF LOAD

LOAD INDICATING  
RING

Figure 88. Close-up of Hookup Used To Calibrate Thrust Measuring System

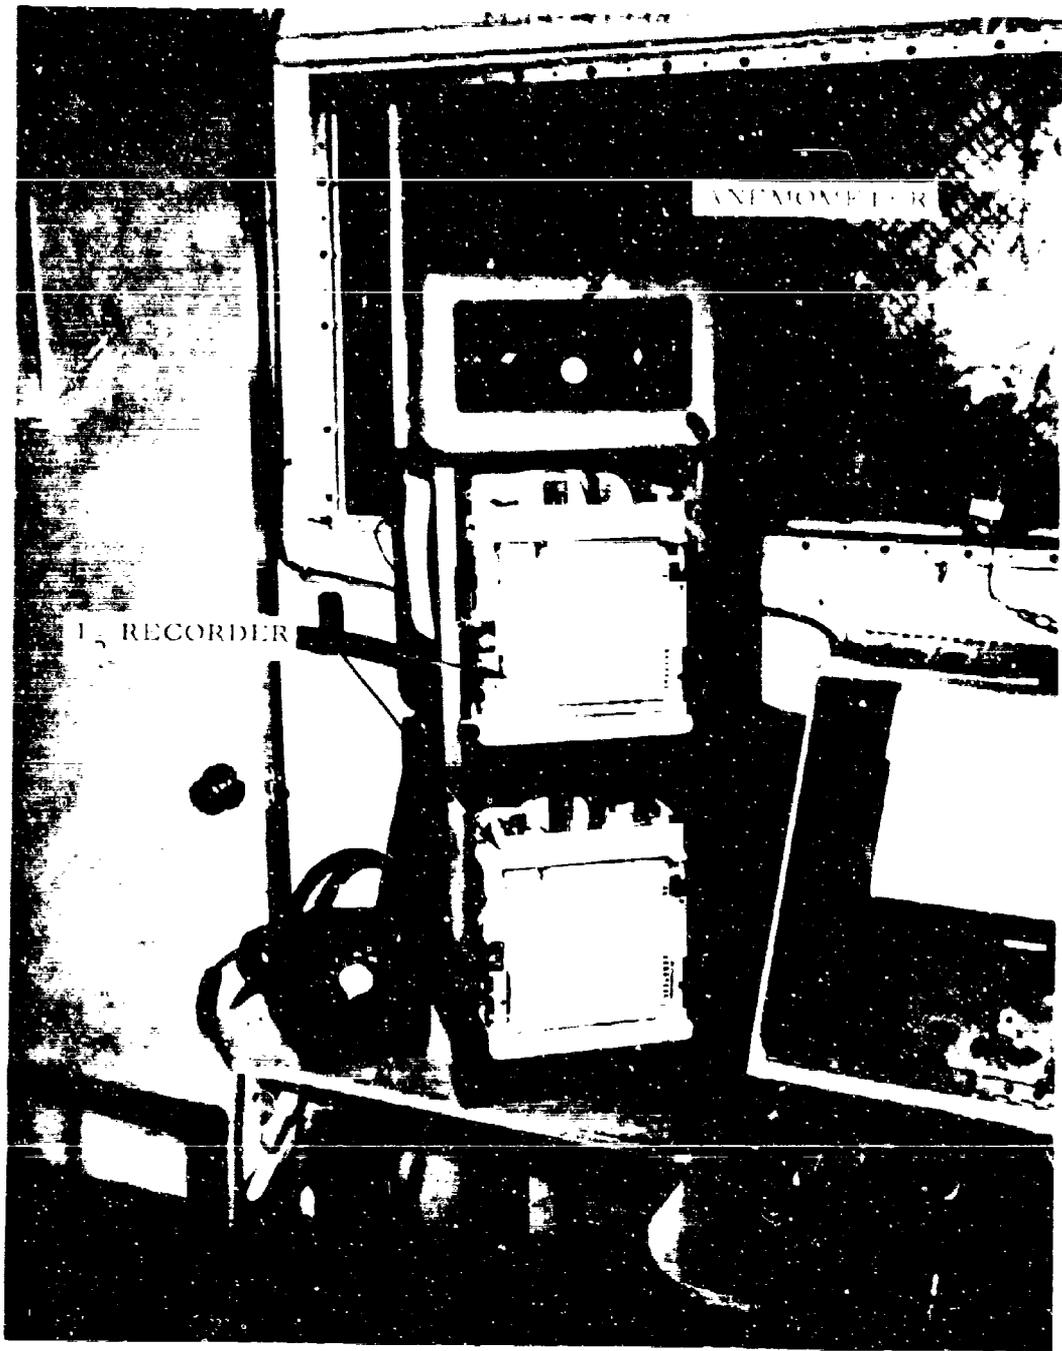
Figure 90. Engine T<sub>5</sub> Recorders
