Technical Paper Number 65-1
1965

TRINCHERAS AND PHYSICAL ENVIRONMENT
ALONG THE RIO GAVILAN, CHIHUAHUA, MEXICO

Laurance C. Herold

Department of Geography
University of Denver

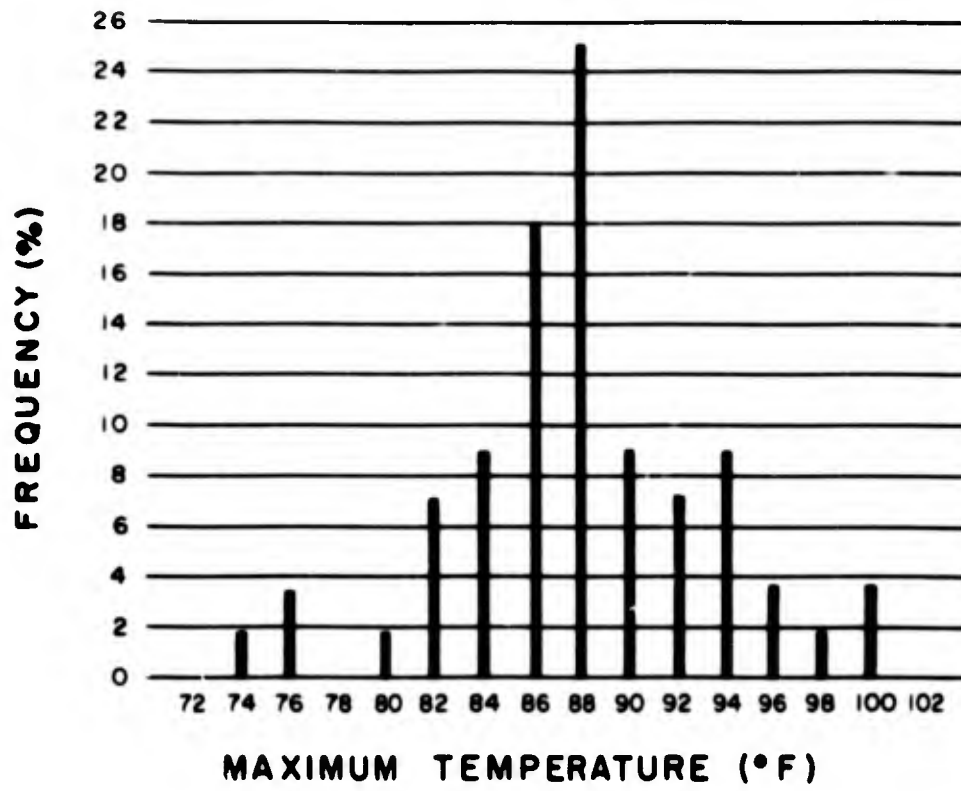
Figure 5. Temperature Frequency (Maximum and Minimum Temperatures), 18 June to 12 August, Base Camp.

Frequency of Minimum Temperatures. Figure 5 shows a range of 25 degrees between the highest minimum temperature of 63° and the lowest minimum temperature of 38°. The 38° minimum was recorded early in the study period before the rains began, under clear sky conditions, and following a period of high diurnal ranges with daytime maximums nearly all above 90°.

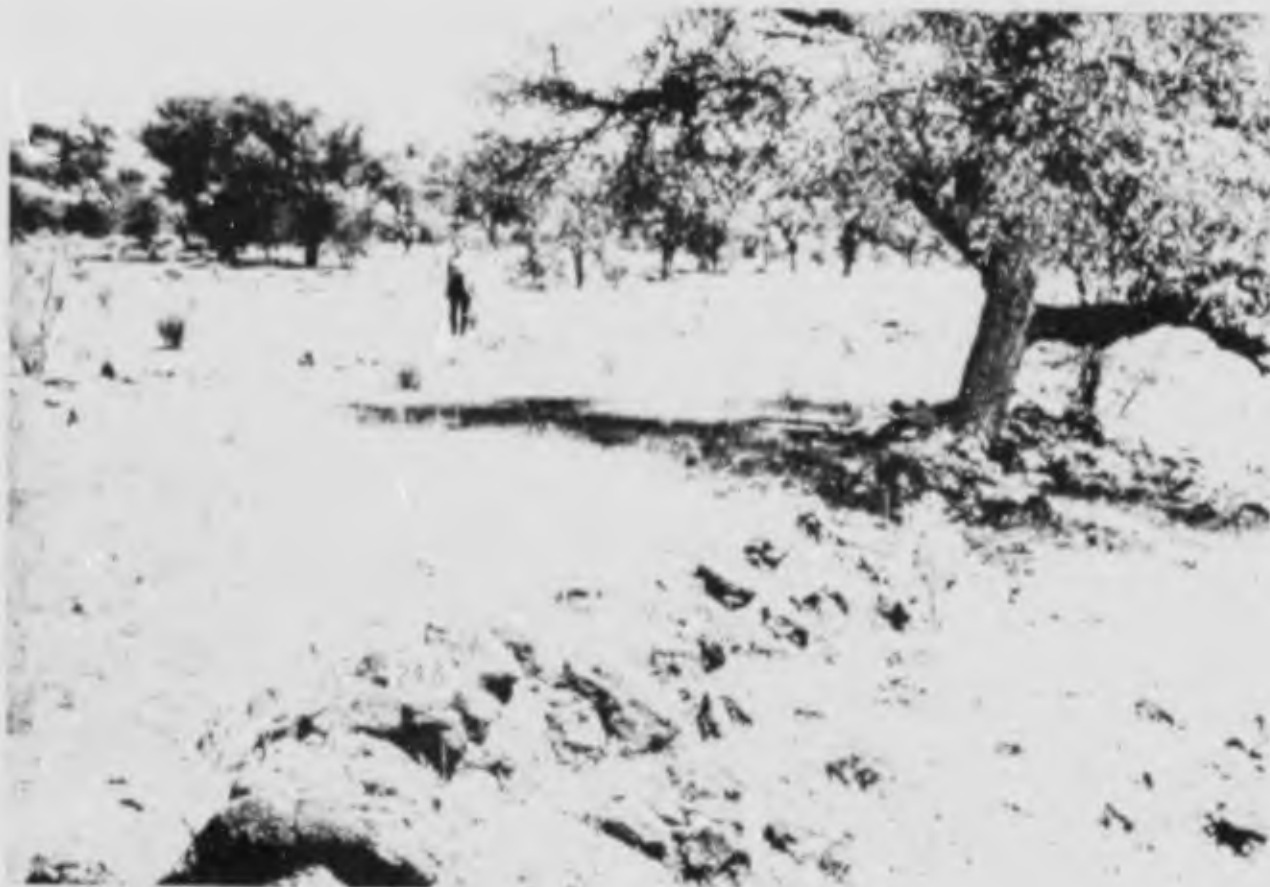
Photograph 7. Trinchera 248. Linear Border. Max. Height 1.9 Feet.

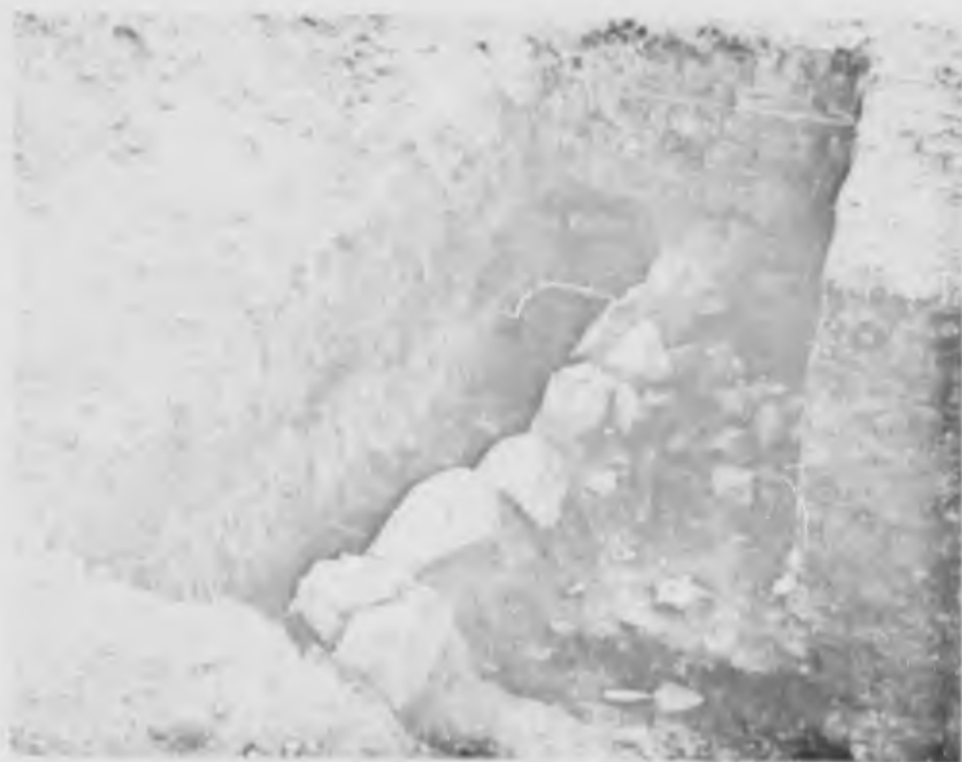
Photograph 20. Buried Trinchera 29a. Layers 1, 2, and 3 are Outlined. Trowel Rests on Bedrock.
