TECHNICAL PROGRESS REPORT 401
NOTS TP 3843
COPY 68

SUMMARY REPORT OF EARTH-COVERED, STEEL-ARCH MAGAZINE TESTS

ABSTRACT. Between January 1962 and December 1963, a series of tests of earth-covered, steel-arch igloo magazines was conducted to determine the minimum spacing distance between adjacent igloos needed to prevent the propagation of an explosion from one magazine to another. It was shown that the distance in feet between the side walls can be determined by multiplying the cube root of the stored explosive weight in pounds by the factor 1.25, and the distance between facing rear walls can be determined by using the factor 1.50.

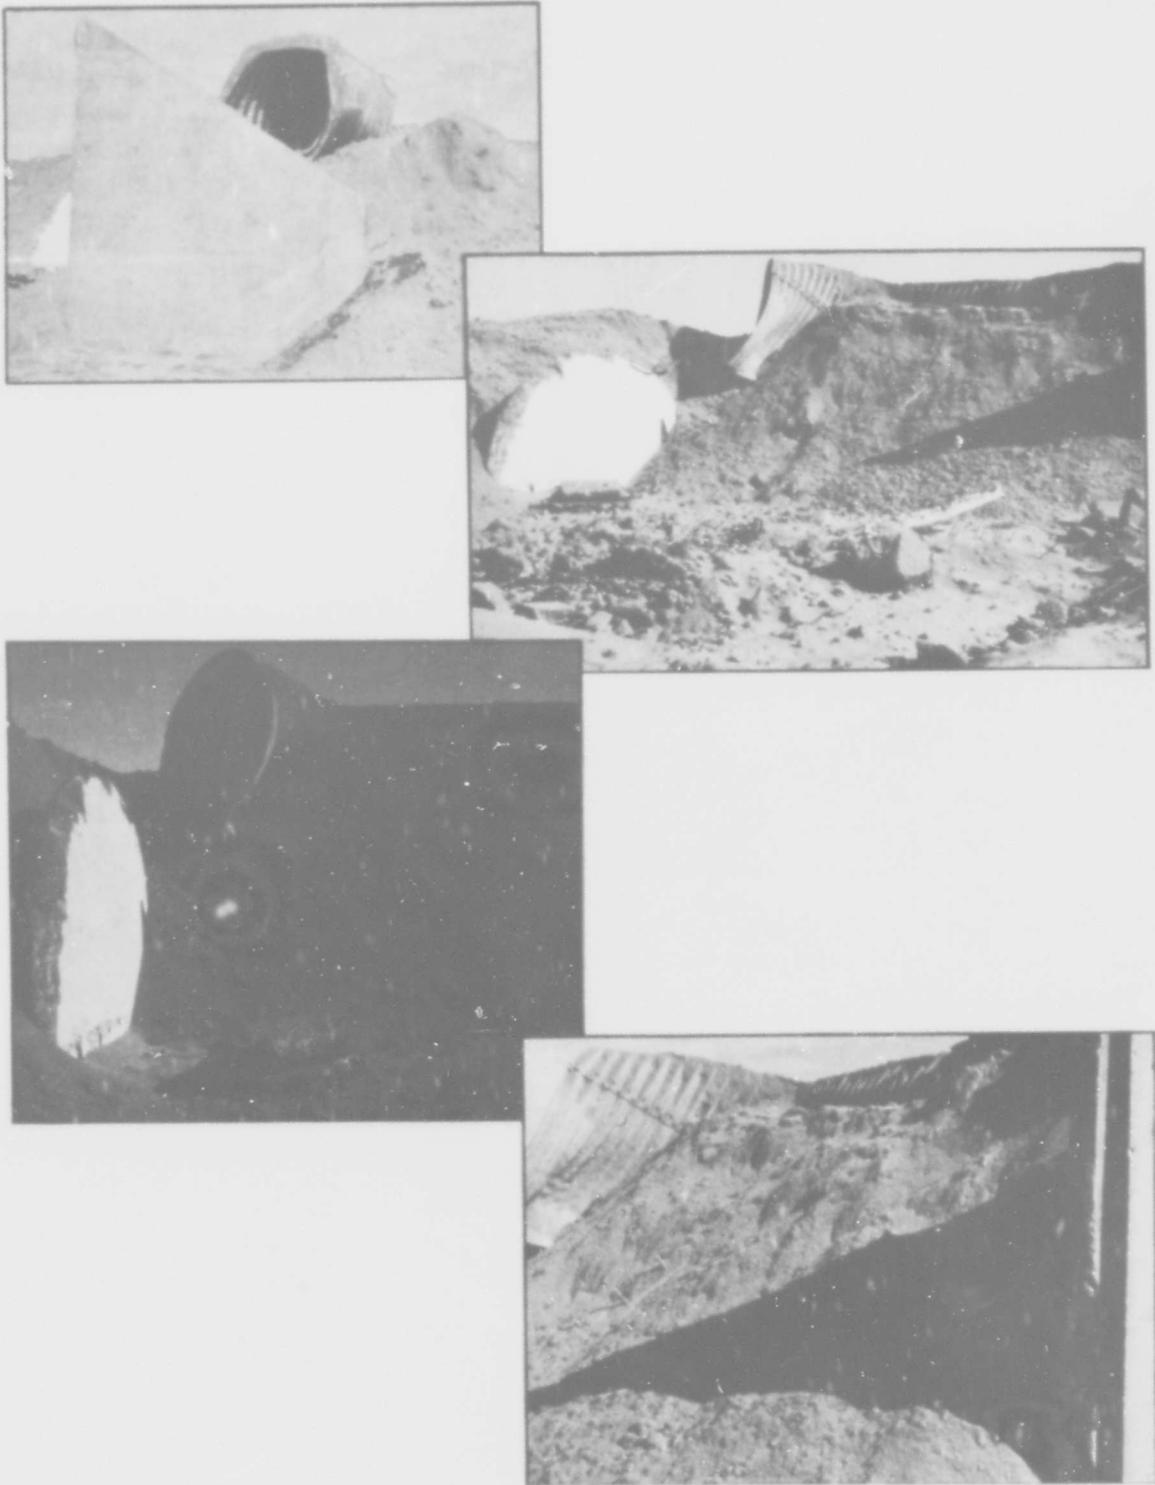
FIG. 8. Magazine at 6.5-Ft Separation.

The simultaneous detonation of the eight donor charges did not propagate to any acceptor charges, although the flanking acceptor igloos were extensively damaged (Figs. 6 and 7). The acceptor igloo located 6.5 ft from the donor igloo ($0.5 \times W^{1/3}$) was well within the resulting crater, and was displaced and almost totally collapsed (Fig. 8). Three of the acceptor charges in this magazine were sheared apart at the flanges, while the other two were extensively dented.

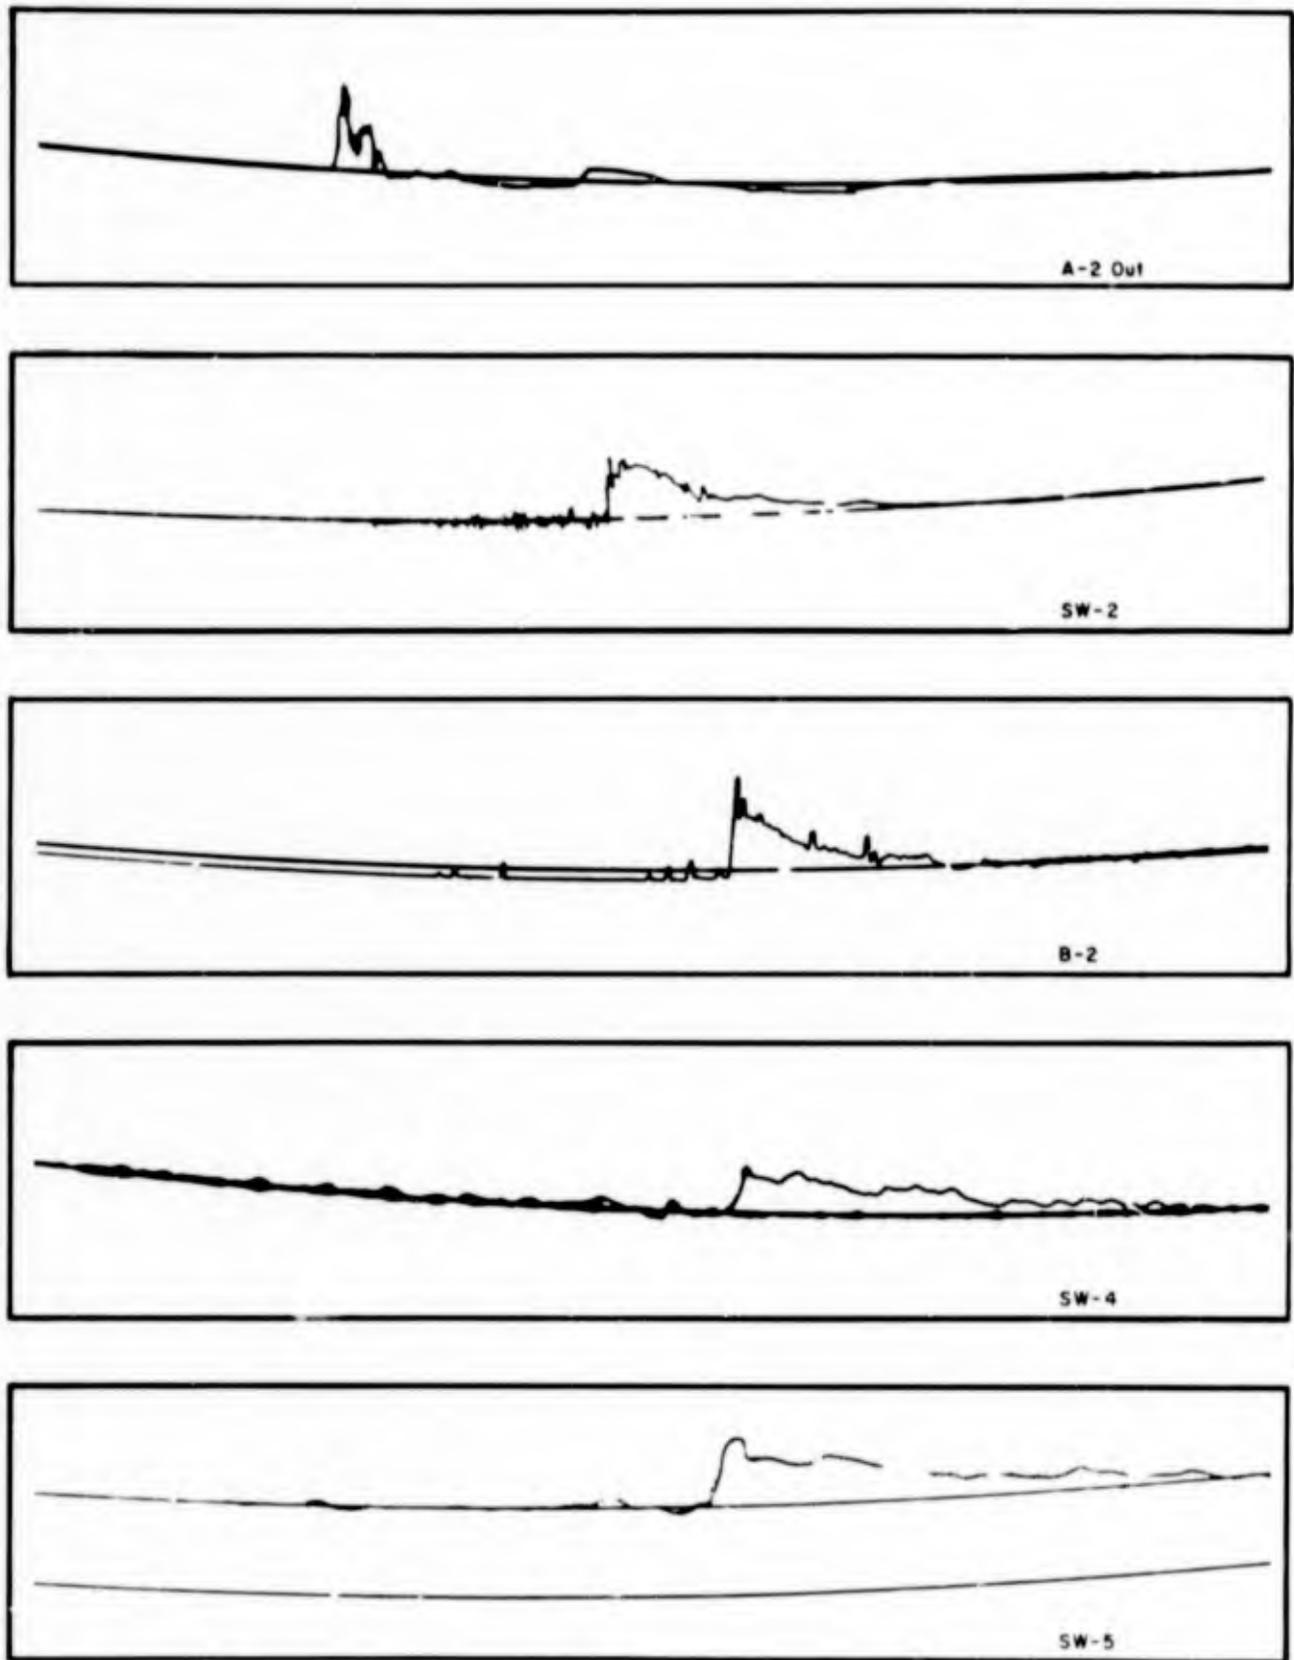
FIG. 12. Records From BRL Gages Along SW Line (Donor Front).

The overpressure recorded at the A-2 OUT position was less than is indicated by the trend of the other pressure data in the open along the SW leg. This may have been due to the inability of the gage to follow the sharply rising pressure front this close to the detonation, or may have been caused partially by a faulty gage. While it was subsequently determined that the motor shaft in this gage was bent, causing the gage to run slow and register incorrect pulse duration time and impulse, this should not have caused an error in the peak pressure recording. The other gages along the SW leg (SW-2, B-2 OUT, SW-4, SW-5) show a pressure wave (Fig. 12) that generally follows the typical pattern.

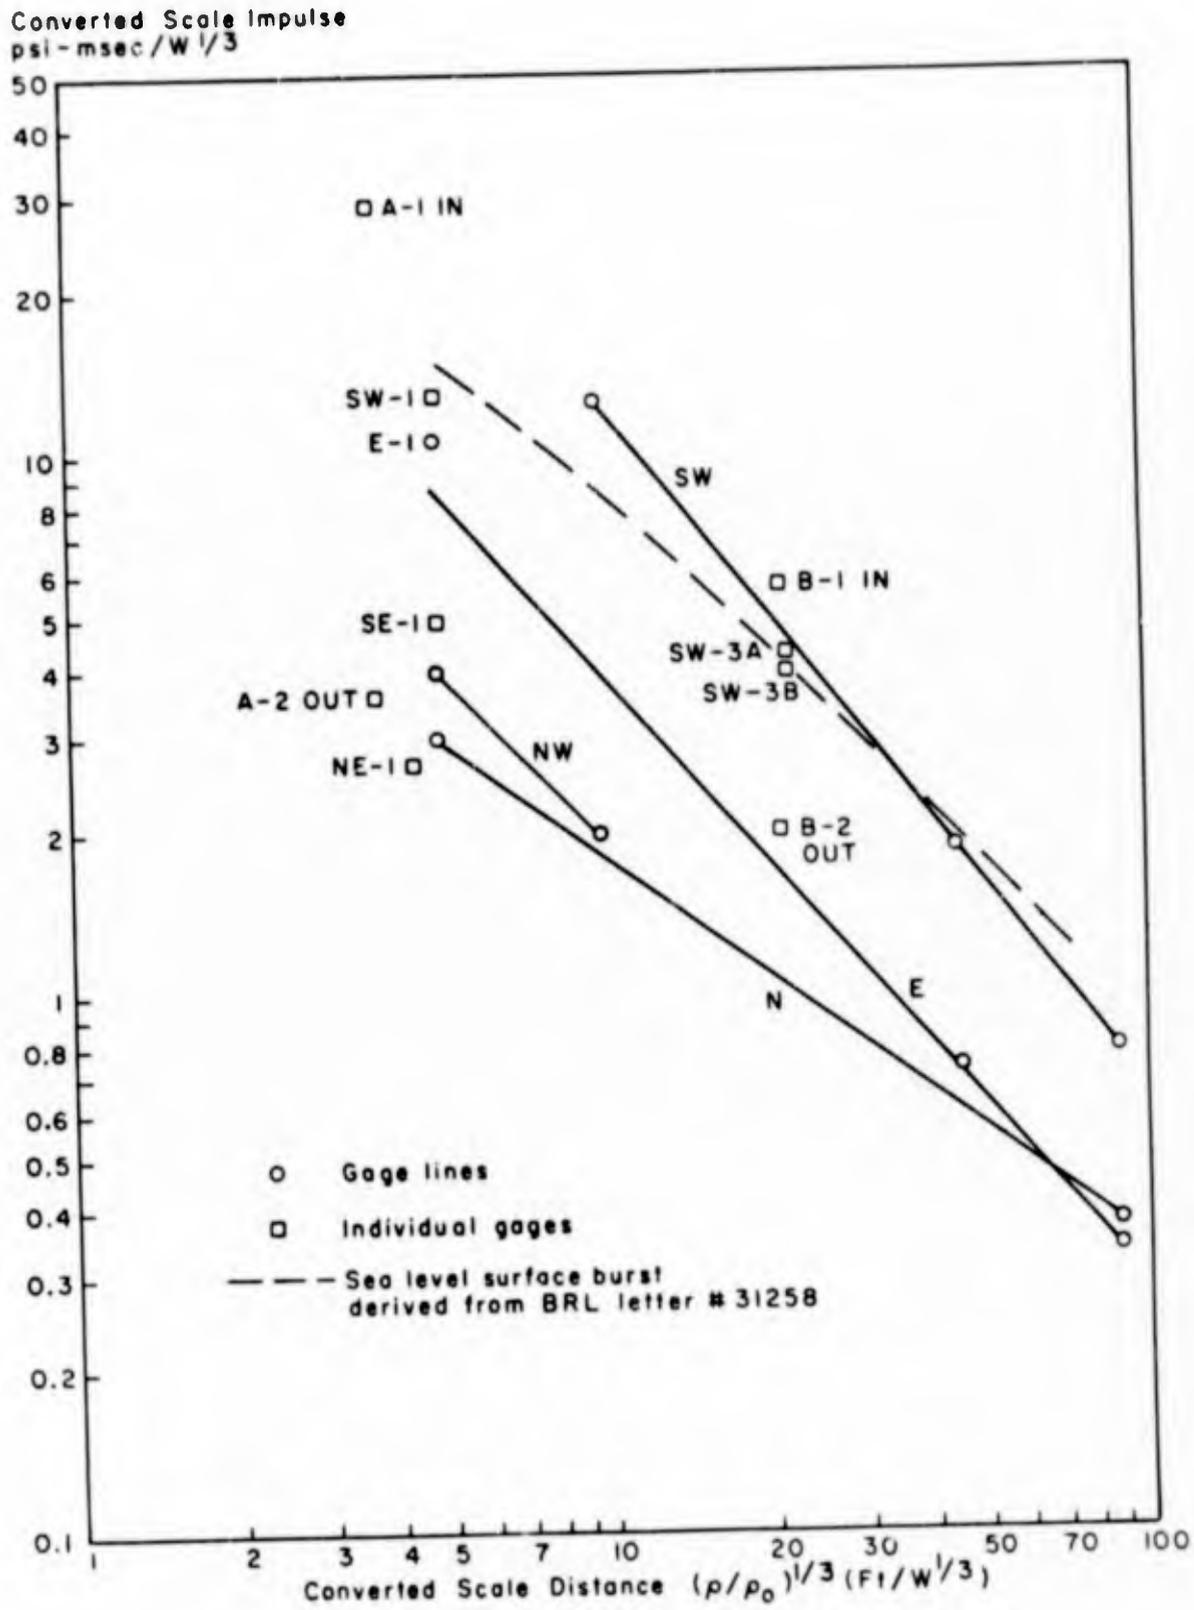
FIG. 17. Scale Impulse Versus Scale Distance.

The scaled impulse and scaled positive phase duration data are shown as a function of scaled distance in Figs. 17 and 18. To obtain scaled impulse, the measured impulse was first converted to values which would be expected under standard sea level conditions according to the equation

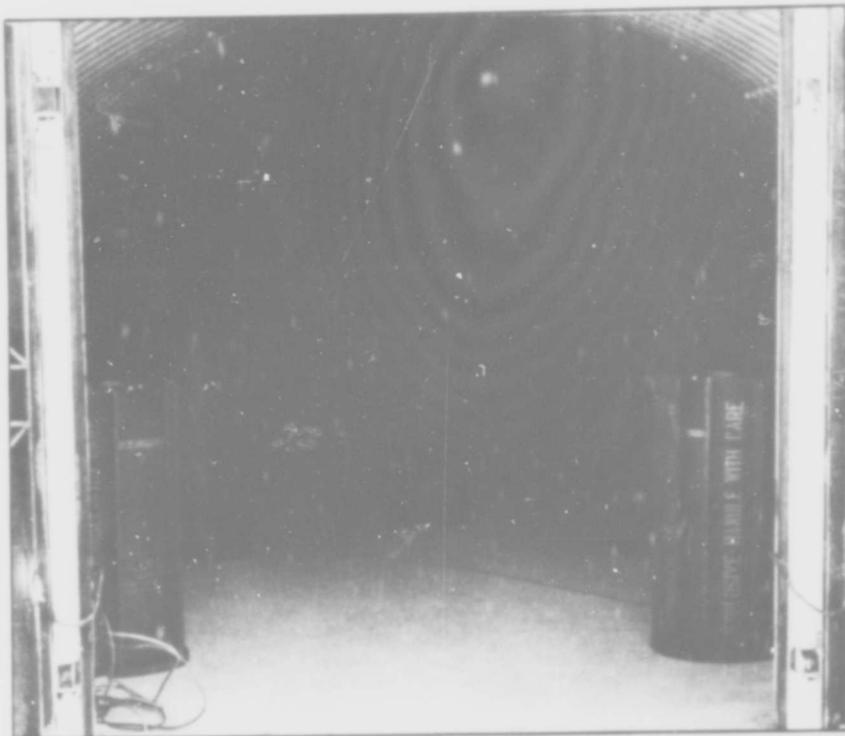
FIG. 21. Donor Charges in Place for Test.

The donor charges for this test consisted of nine 350-lb Mk 54-1 depth bombs, each containing 248 lb of HBX-1, for a total of 2,232 lb of high explosive. While HBX-1 is about 121% as energetic as TNT, the reduction in explosive effect due to the bomb cases permitted the total donor charge to be considered as 2,200 lb of TNT, so that $(W \text{ lb})^{1/3} = 13$. Eight of the depth bombs were arranged in two rows three feet from the sides of the igloo, as shown in Fig. 20, with the ninth bomb in the center. Figure 21 shows the donor charges in place (in their shipping containers) at the completion of test preparations. All nine bombs were detonated simultaneously.

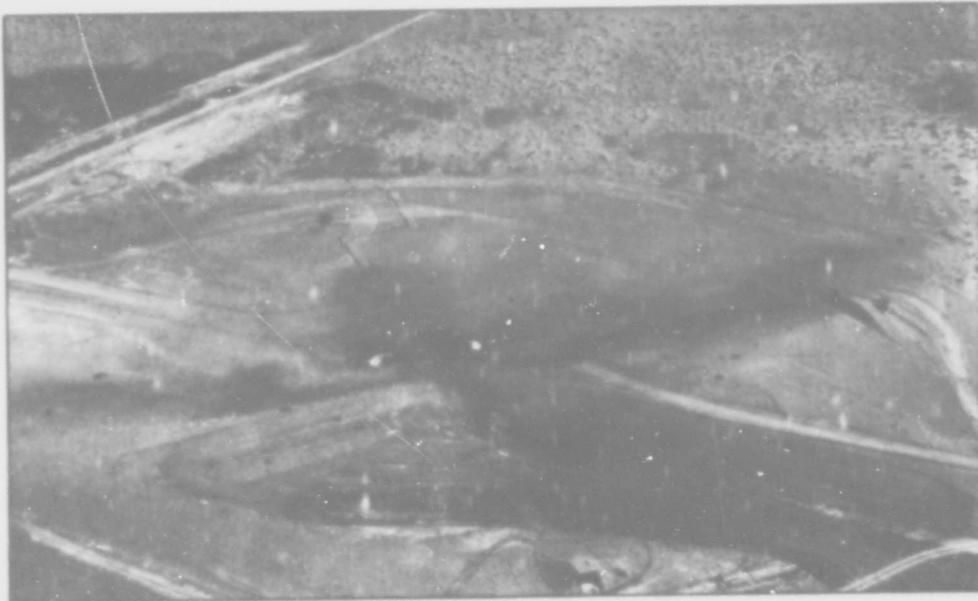
FIG. 24. Three-Igloo Complex After Test.

The simultaneous detonation of the nine donor charges did not propagate to any acceptor charges, although the donor igloo was destroyed (Fig. 24), and the acceptor igloos were damaged (Fig. 25). Each of the donor charges punched a crater in the donor magazine floor (Fig. 26). The earth crater was about 14 ft wide at the base and 48 ft wide at the top; however, the latter measurement applies at a height of one to two feet above the top of the original earth fill where the

Based on the photographic data, the estimated maximum height of the earth-cover travel above the magazine was 1,000 ft, although the bulk of the projected mass probably did not exceed 400 feet. The resulting spread of earth on the ground extended about 500 ft to each side of the igloos, about 100 ft to the front, and about 300 ft to the rear. The general pattern is indicated in Fig. 24.

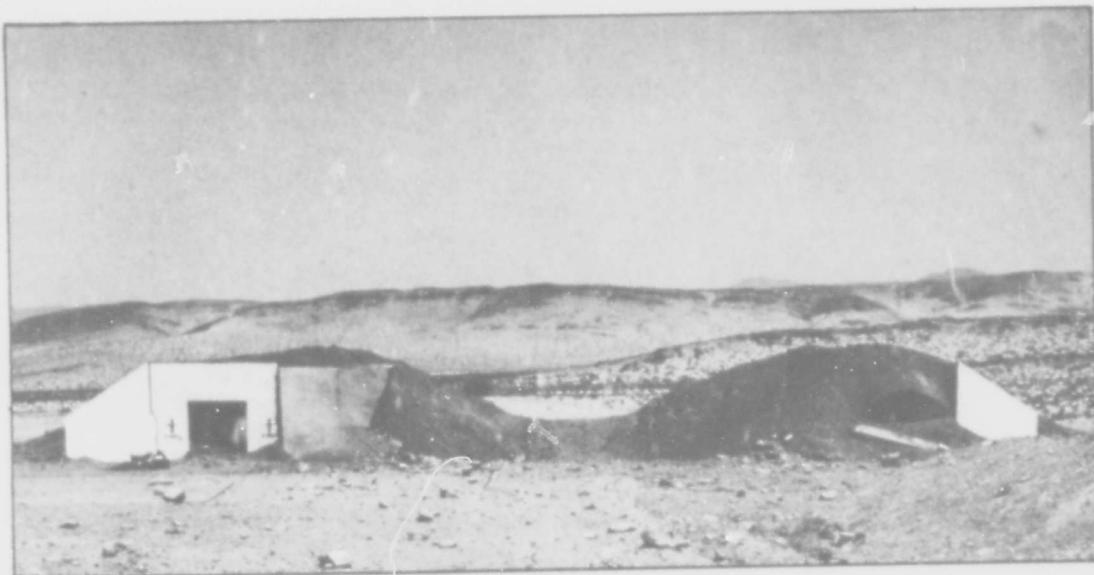
earth was heaped up. The crater was entirely above the original floor level. The remaining mound of earth at the rear was approximately four feet above floor level. The rear concrete closure wall was broken up and thrown approximately 120 ft to the rear of its original position. The minimum thickness of earth cover remaining between the crater and the closer igloo was four to five feet. The corresponding distance at the farther igloo approximated 10 feet.

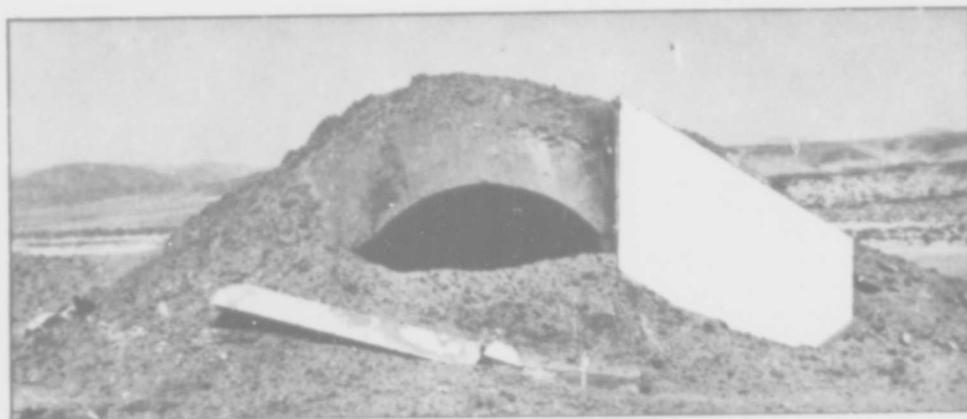
FIG. 25. Acceptor Igloos After Test.

The acceptor igloo spaced 19.5 ft ($1.5 \times W^{1/3}$) from the donor igloo was not destroyed, although the head wall was blown outward and fell forward, and the side of the metal arch nearest the donor igloo was forced inward about 13 inches. A large transverse crack and several smaller cracks occurred in the floor, and multiple cracks developed in the rear concrete wall.

The acceptor igloo located 26 ft ($2.0 \times W^{1/3}$) from the donor magazine suffered less damage than the nearer acceptor igloo. The concrete head wall was separated from the steel arch and forced slightly outward. The side of the metal arch adjacent to the donor charges was forced inward approximately six inches from the original position. The concrete floor cracked, but not as extensively as in the other acceptor magazine. The rear concrete closure wall was also cracked.

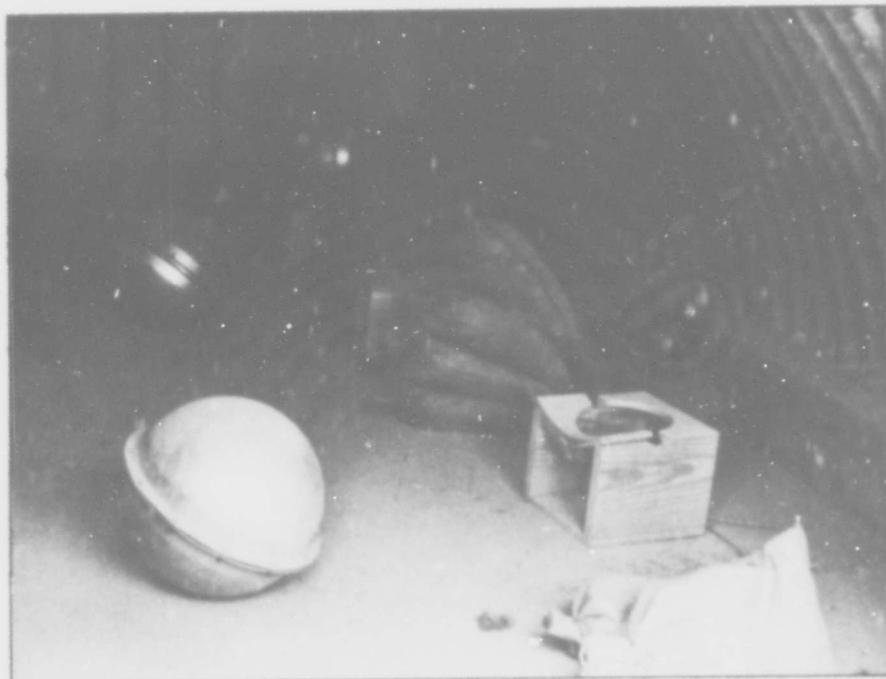
FIG. 27b. Acceptor Charges in Magazine at 26 Feet After Test.

Three of the five acceptor charges were upset from their stands, but again they sustained virtually no damage (Fig. 27b).

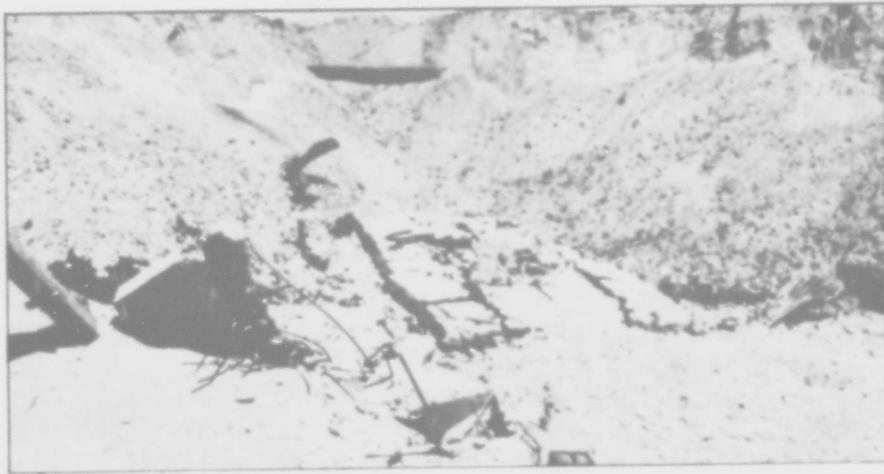
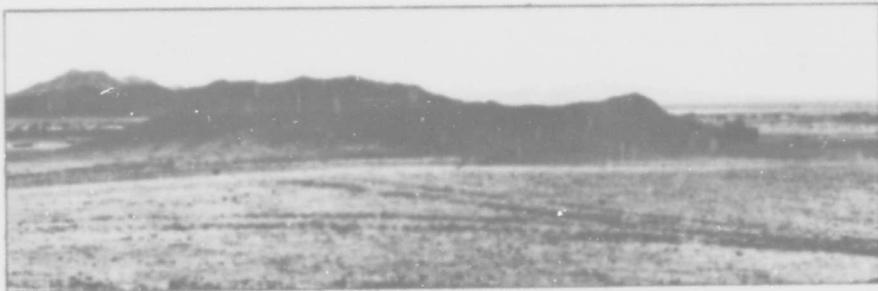
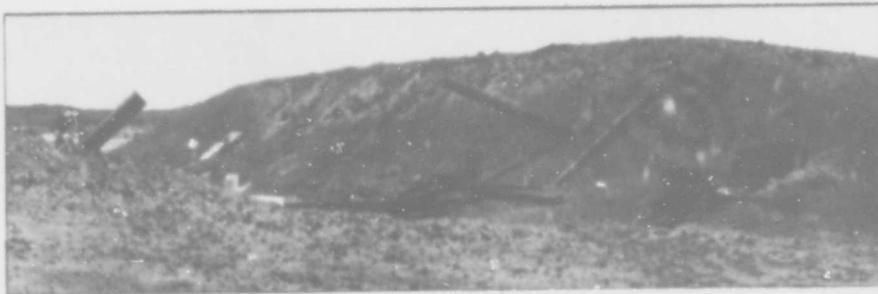
FIG. 44. West Igloo After Test No. 3.

a. Front View.

b. Rear View.

c. Barricade Slope Facing Igloo.

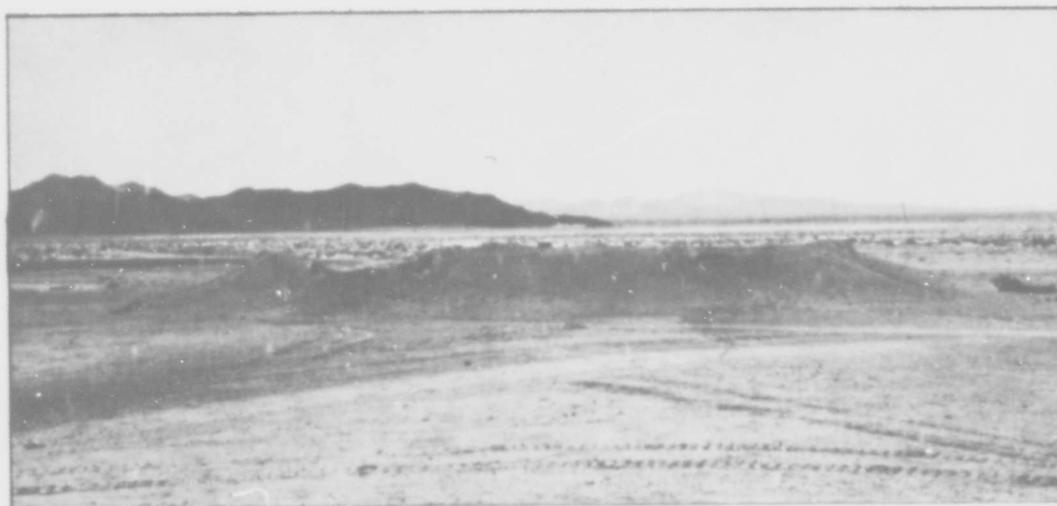
FIG. 45. East Igloo After Test No. 4.

b. Rear View.

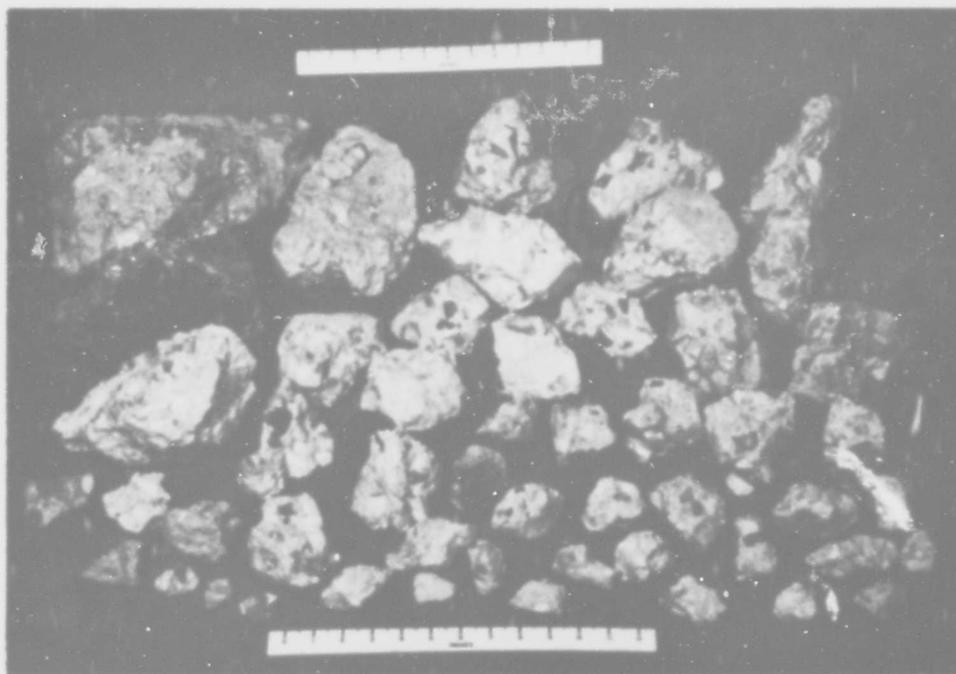
FIG. 46. Fragments From Area 2600 Feet in Front of Igloos After Test No. 4.

A limited survey to determine the fragment dispersion pattern showed that essentially all of the large items of structural debris, such as concrete and steel-arch segments weighing over 200 lb, were spread within a 500-ft radius; however, medium-size fragments of five pounds were thrown up to 2,900 ft on the forward extension of the magazine centerline, or the 6:00 o'clock line. Fragments to 25 lb were thrown to 2,650 ft on the same line. No fragments were found beyond 1,900 ft on the 5:00 o'clock and 7:00 o'clock lines. Since the igloo for Test No. 3, with the ten-foot earth barricade in front, had about two-thirds of the concrete head wall in place, while the igloo for Test No. 4 had about one-third of the concrete head wall in position (Fig. 39), it was not possible to adequately assess the retention effects of the barricade on the fragment dispersion by comparing the tests. The table in Appendix D lists the results of the limited fragment survey conducted after Test No. 4, and Fig. 46 shows the fragments collected in a 100-ft by 150-ft area located 2,600 ft in front of the igloos.

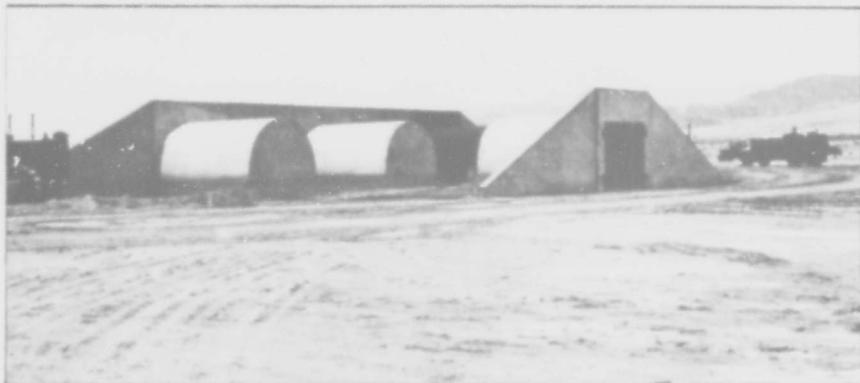
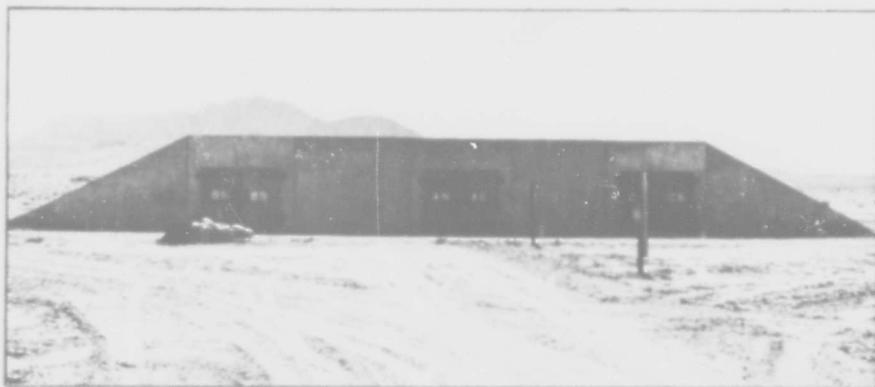
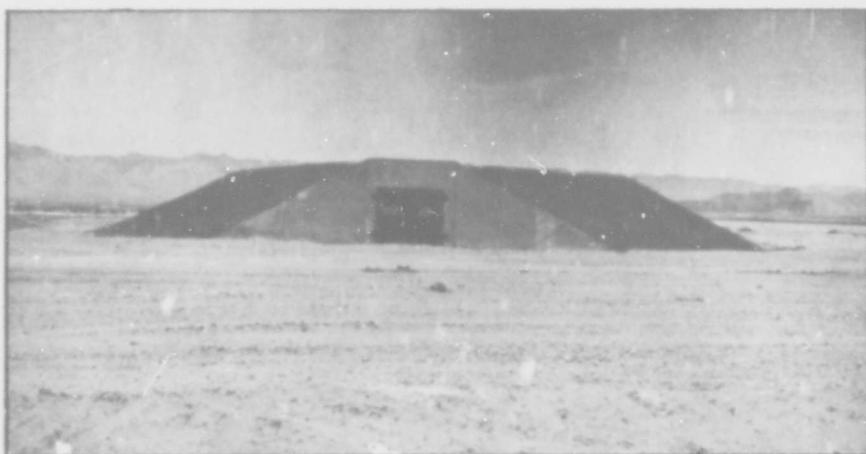
FIG. 49. Test Igloos.

a. Igloo Complex During Construction.

b. Front of Complex.

c. Rear of Complex.

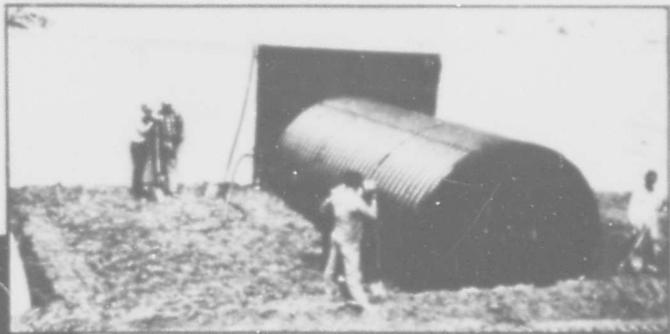
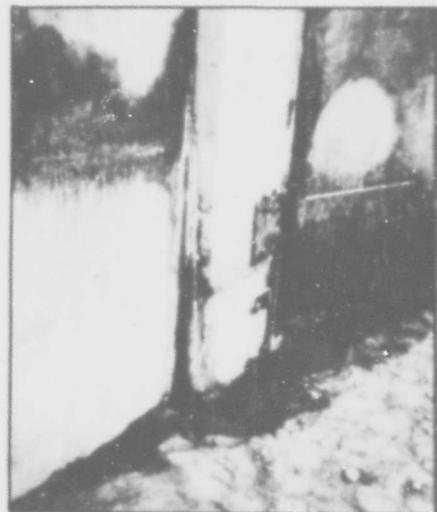
FIG. 50. Water Seepage Test.

b. Water-Proofed Igloo and Headwall.

e. Results of Water-Proofing Test

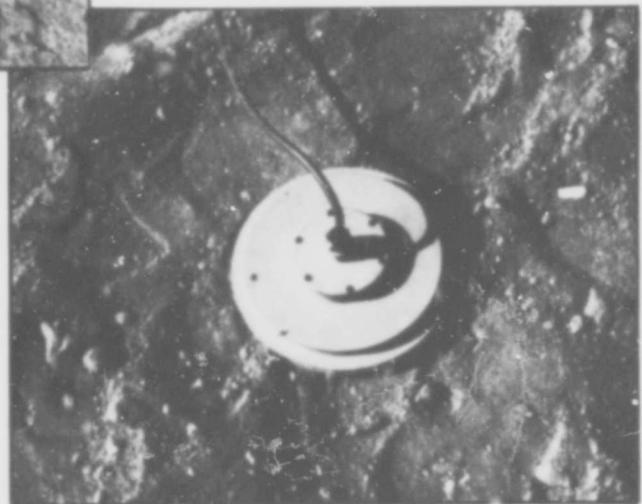
FIG. 51. Pressure and Acceleration Gages.

d. Earth Pressure-Time Gage.

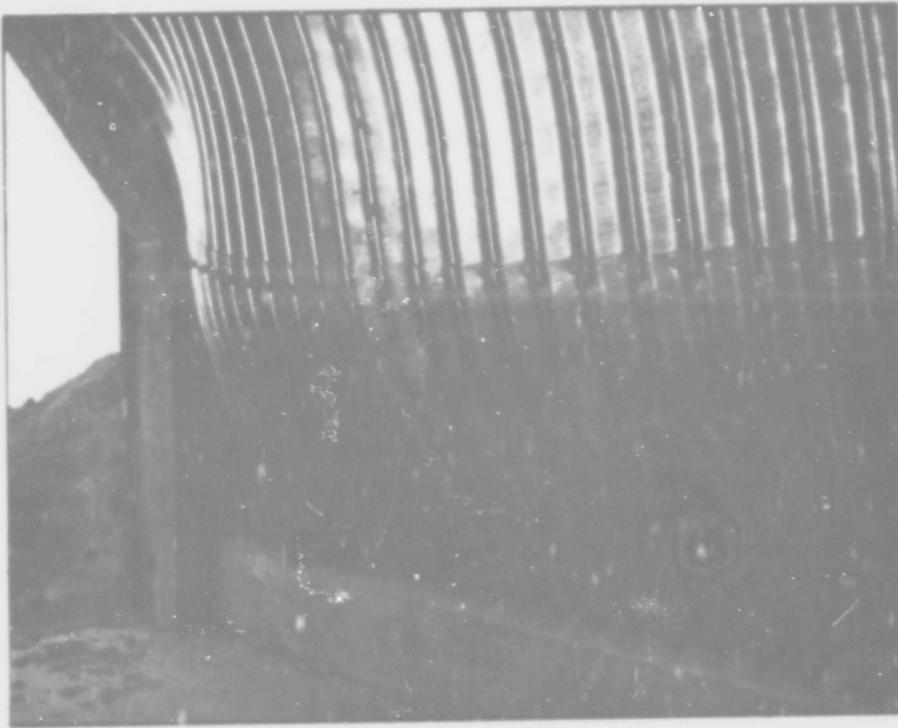
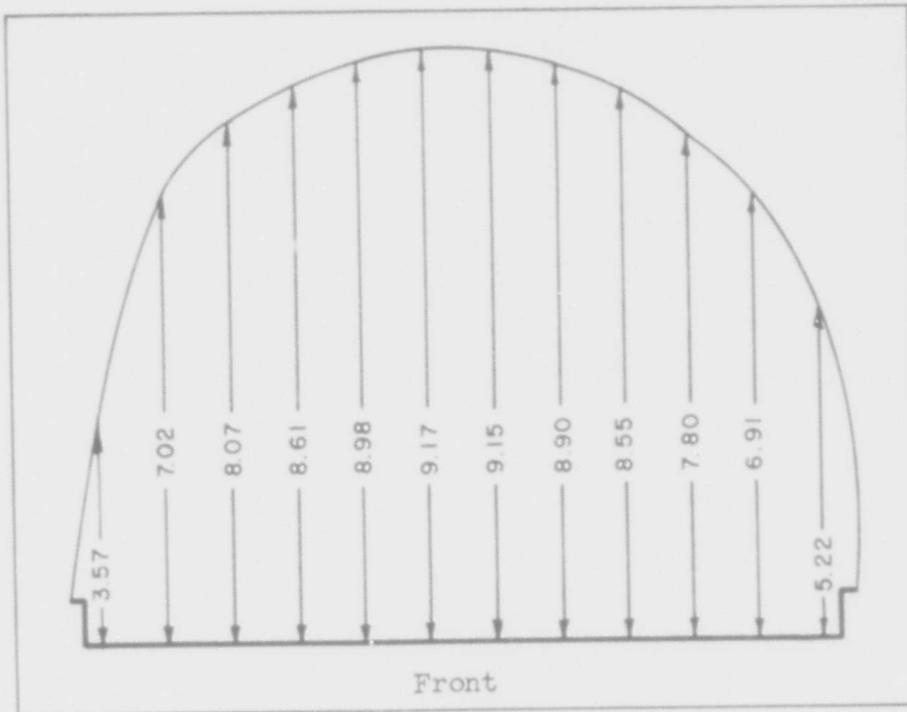
FIG. 56. Igloo C Arch Distortion
(Photo and Front View).

doors were bowed inward, 2.2 inches and 4.0 inches, but could be opened manually. Both door liners were loosened, one falling off. The remaining wingwall, which was cracked, was separated about 1/2 inch from the door pilaster, which was also cracked. Both curbs, the floor, and the rear wall were extensively cracked. The steel arch was bowed inward on both sides as shown by Figs. 56, 57, and 58.

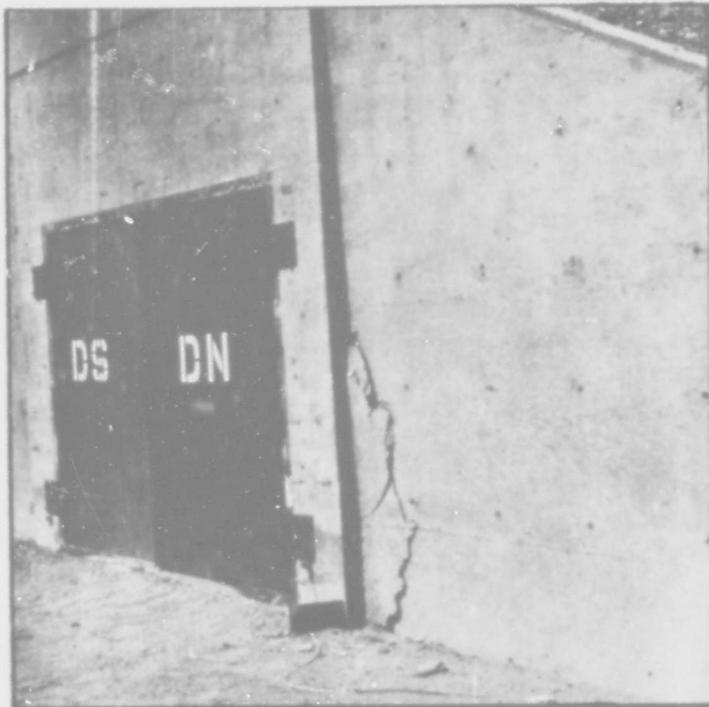
a. Damage to Wing Wall.

The doors on igloo D were undamaged and opened easily. The explosion had forced the entire igloo forward about three inches relative to the wingwalls (Fig. 62a), cracking the wingwalls, and tilted the rear wall inward six to seven inches at the top. The door pilaster was tilted outward about 3/4 inch at the top. When the rear wall moved forward, it was extensively cracked (Fig. 62b), and it struck the noses of all three acceptor missiles, tipping them on their stands causing one missile to strike and puncture a door liner, fracturing the missile wing.

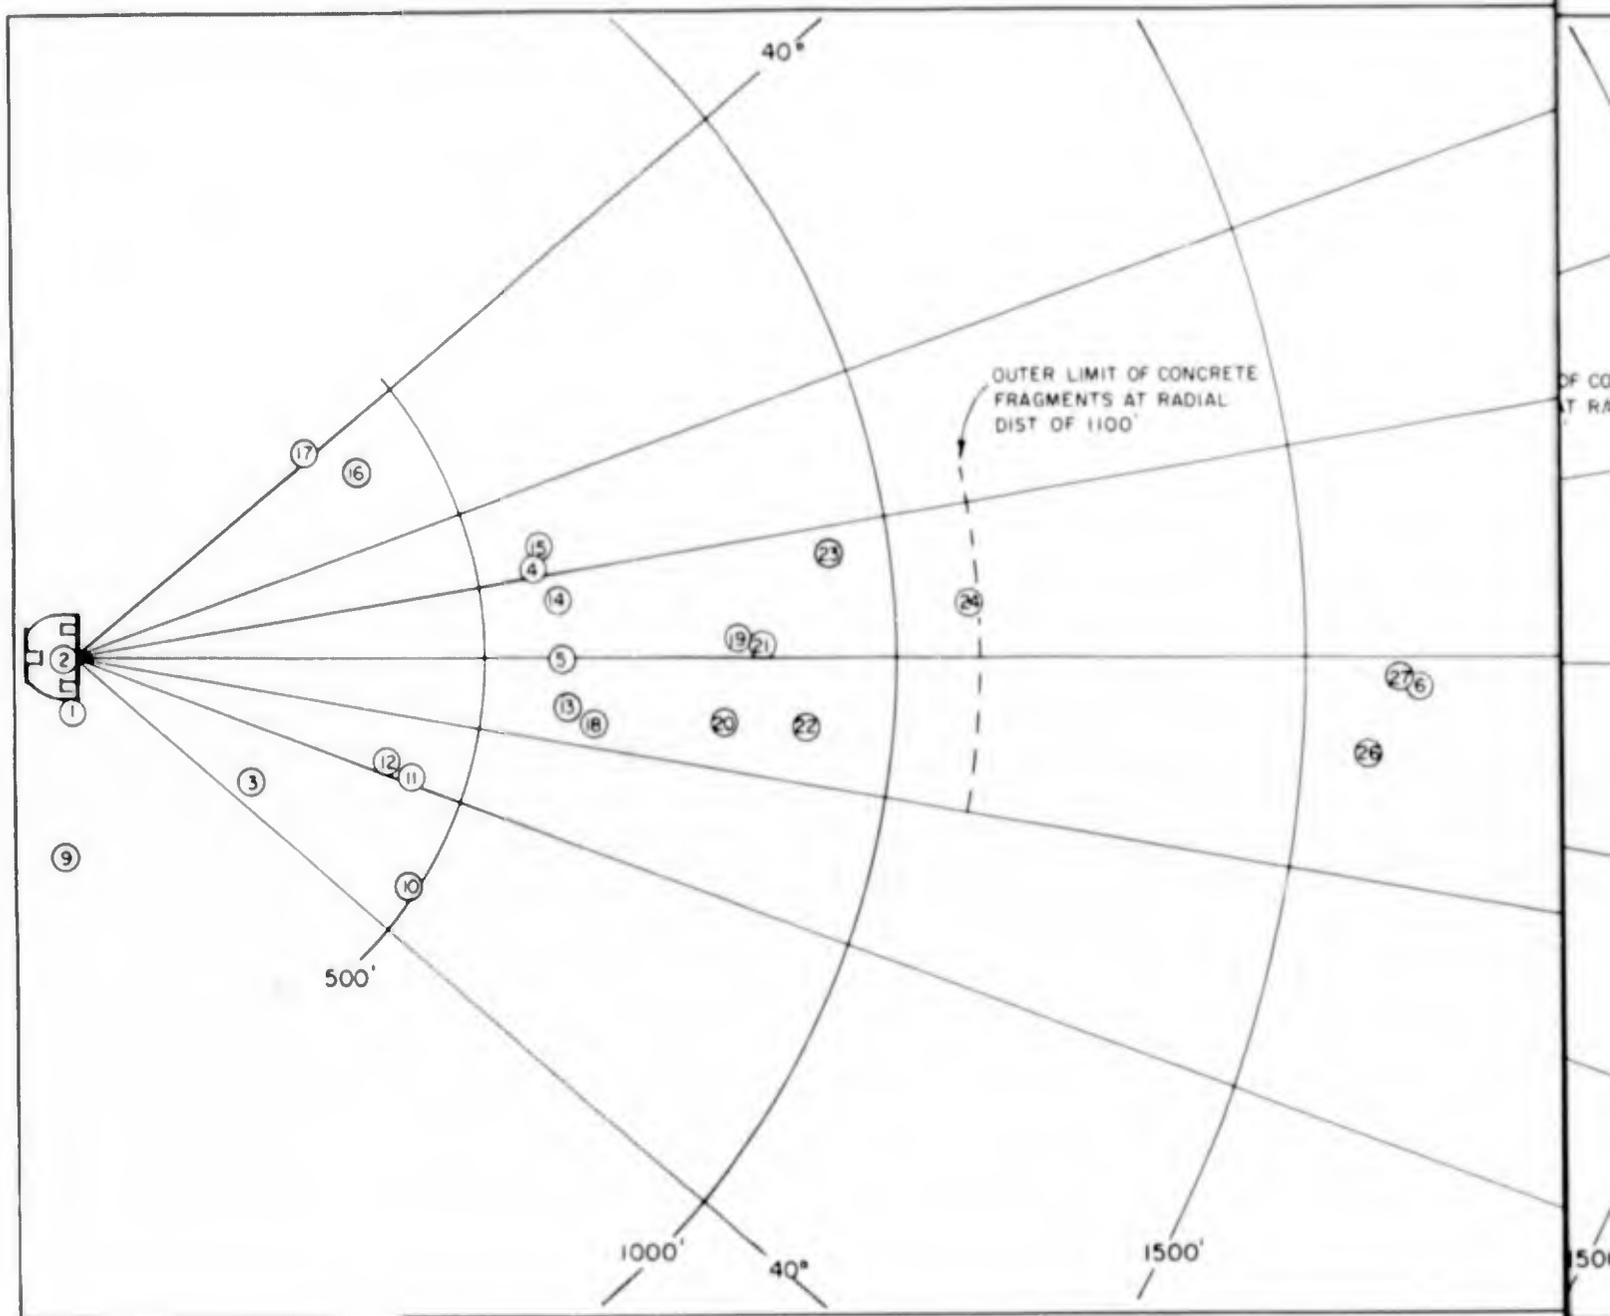
FIG. 63. Fragment Distribution.

A survey of the fragment dispersion showed that it was largely confined to an 80° arc out to 500 ft, to a 40° arc between 500 and 1,000 ft, and to a 20° arc beyond 1,000 feet. No concrete fragments were found beyond 1,100 ft, while part of a metal door was found beyond 3,000 feet. Part of the fragments are listed in Table 4, their location is indicated in Fig. 63, and illustrations of selected pieces are included in Fig. 64.

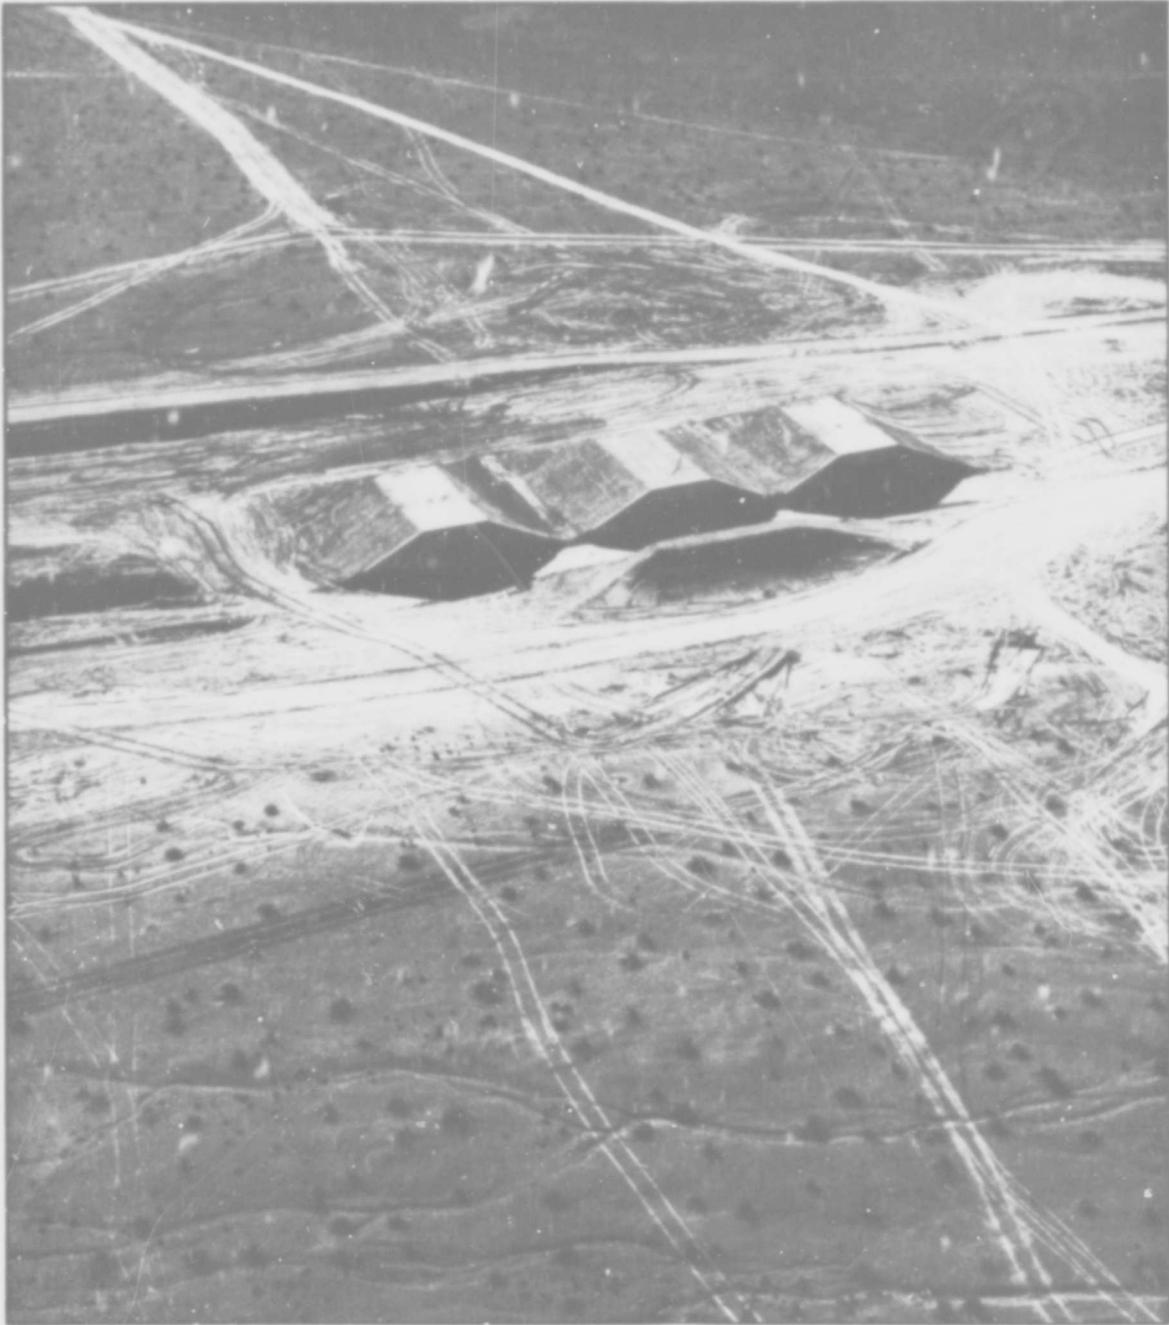
FIG. 69. Magazines and Barricade.

To obtain additional information on the effectiveness of barricades in reducing fragment throw and overpressures, an earth barricade was constructed in front (to the north) of the donor igloo, with a distance of 25 ft between the igloo and the toe of the barricade. The barricade was three feet thick at the top, about 14 ft high, had side slopes of one in two, and was long enough to subtend a full 60° angle to the door of the donor igloo. The only compaction of the soil was that incidental to the passage of earth-moving equipment during construction. The completed igloos and barricade are shown in Fig. 69.

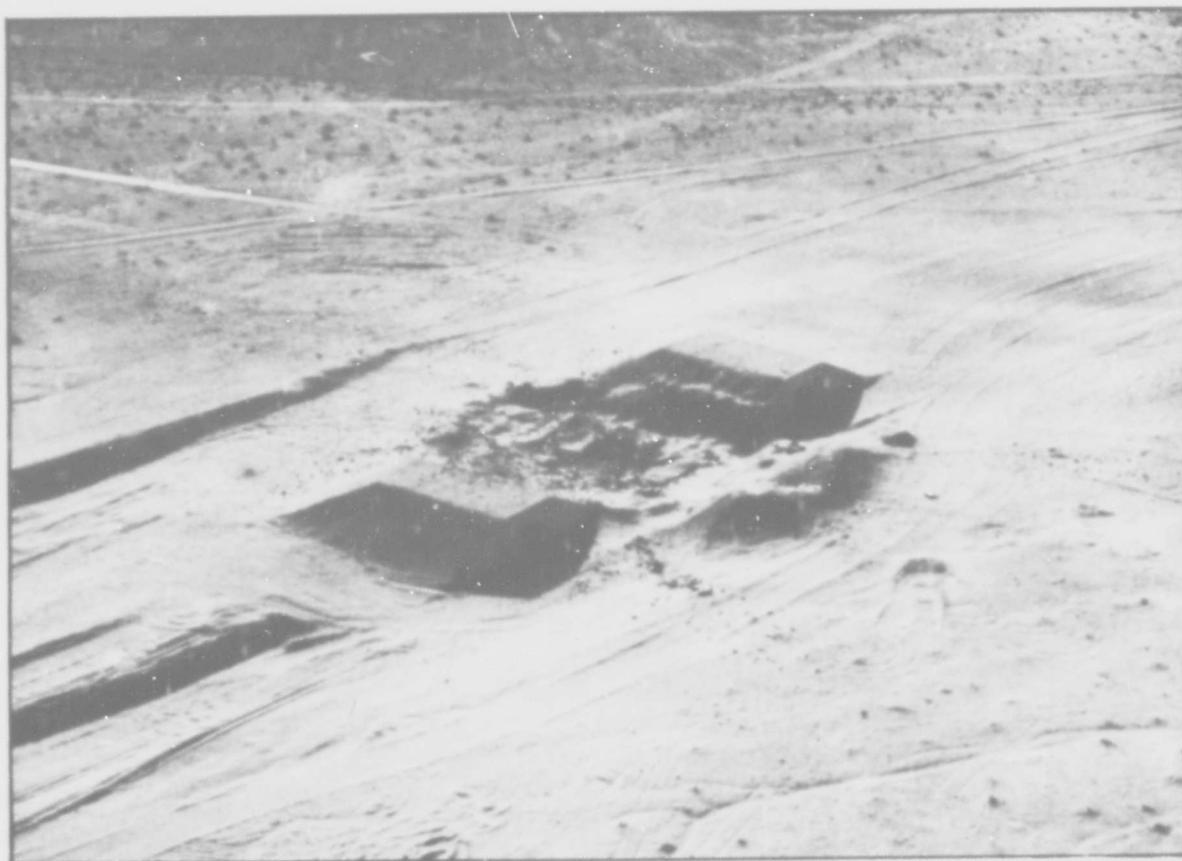
FIG. 74. Igloo Complex Following Test.

Detonation of the 100,000-lb donor (Fig. 73) resulted in complete destruction of the donor magazine (Fig. 74) without uncovering or seriously damaging either acceptor igloo. No propagation to any acceptor charges occurred. Measurement of the crater provided the contours of Fig. 75, which includes the donor igloo location.

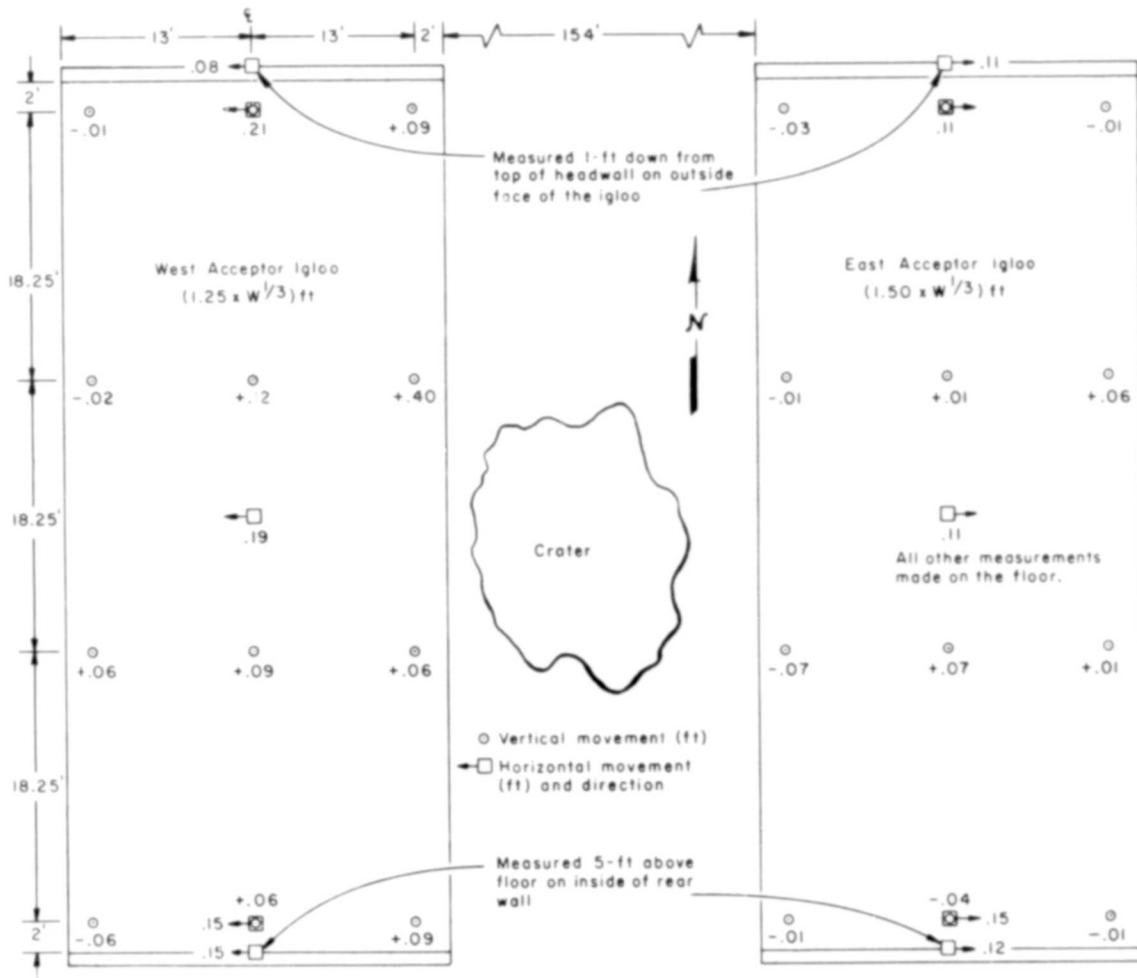
FIG. 77. Horizontal and Vertical Movements of Acceptor Igloos.

The entire west igloo was displaced to the west, and the floor was distorted vertically, as indicated in Fig. 77, and sustained numerous random fine criss-cross cracks. The side of the steel arch nearest the donor was visibly distorted, but to such a minor degree that no actual measurements were attempted.

The entire igloo was moved east, away from the donor, but to a lesser degree than the west igloo movement. The floor was distorted vertically (Fig. 77) and was cracked in a random criss-cross pattern, as in the west igloo. The steel arch did not appear to be distorted.
