TECHNICAL PROGRESS REPORT 401
NOTS TP 3843
COPY 68

SUMMARY REPORT OF EARTH-COVERED, STEEL-ARCH MAGAZINE TESTS

ABSTRACT. Between January 1962 and December 1963, a series of tests of earth-covered, steel-arch igloo magazines was conducted to determine the minimum spacing distance between adjacent igloos needed to prevent the propagation of an explosion from one magazine to another. It was shown that the distance in feet between the side walls can be determined by multiplying the cube root of the stored explosive weight in pounds by the factor 1.25, and the distance between facing rear walls can be determined by using the factor 1.50.

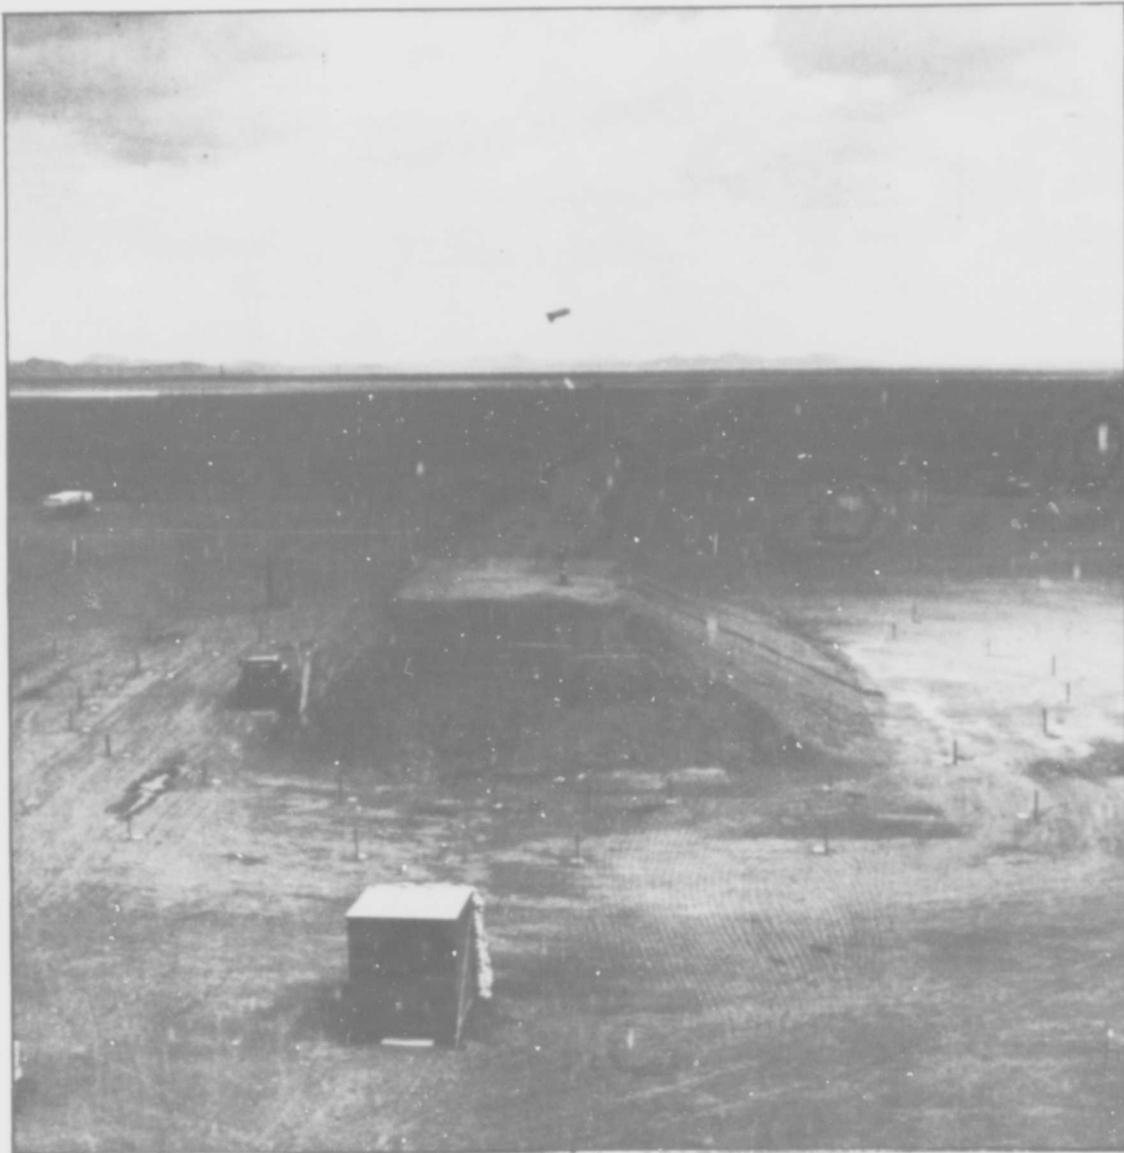
FIG. 85. Igloos Covered With Eight Feet of Earth, Roller Coaster Test.

The test structures pertinent to Test No. 7 consisted of a donor steel-arch igloo and an acceptor igloo covered by a common earth fill to an eight-foot depth at the highest point of the arches, Fig. 85. The igloos were of typical steel-arch construction, 6.5 ft high, 11 ft wide, and 36 ft 4 inches long. The clear separation distance between the igloos was 18 ft, with a spacing factor of $1.5 \times W^{1/3}$.

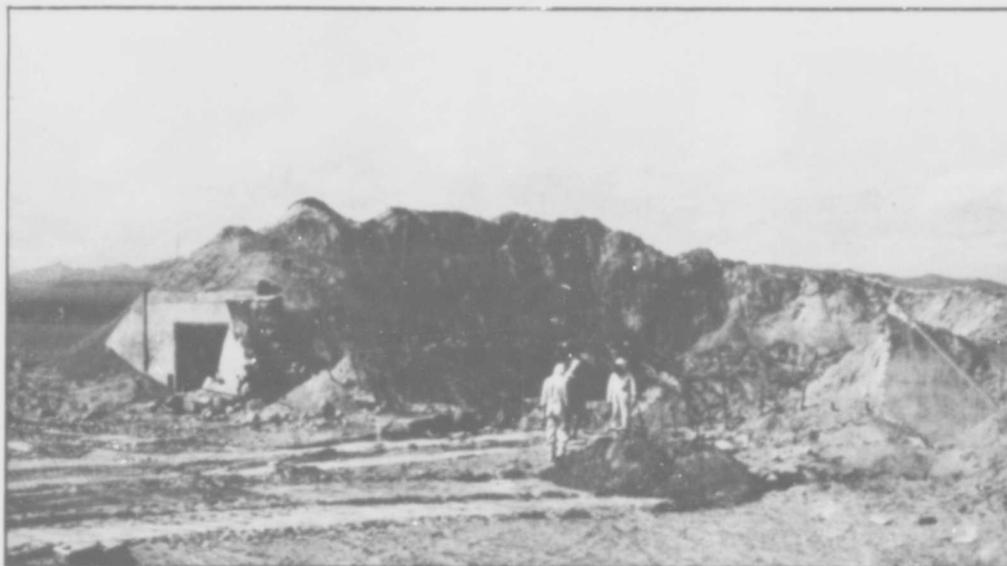
FIG. 87. Donor and Acceptor Igloos Following Test.

Detonation of the donor charges resulted in destruction of the donor igloo (Fig. 87).

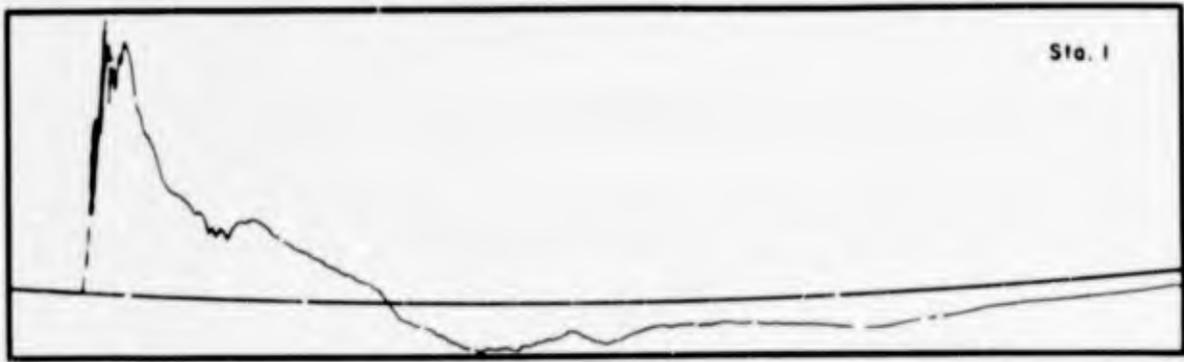
FIG. 89. BRL Gage Records (Donor Front).

The BRL gages also recorded varying shocks ahead of the principal overpressure pulse (Fig. 89). These advance shocks seem to have yielded relatively higher impulses, compared to the earlier tests. This was probably due to the greater weight of earth cover (eight feet of thickness rather than two feet) increasing the apparent focusing effect out the front of the igloo.
