AD-621567

METALLURGICAL CHARACTERISTICS
OF HIGH STRENGTH STRUCTURAL MATERIALS

[Seventh Quarterly Report]

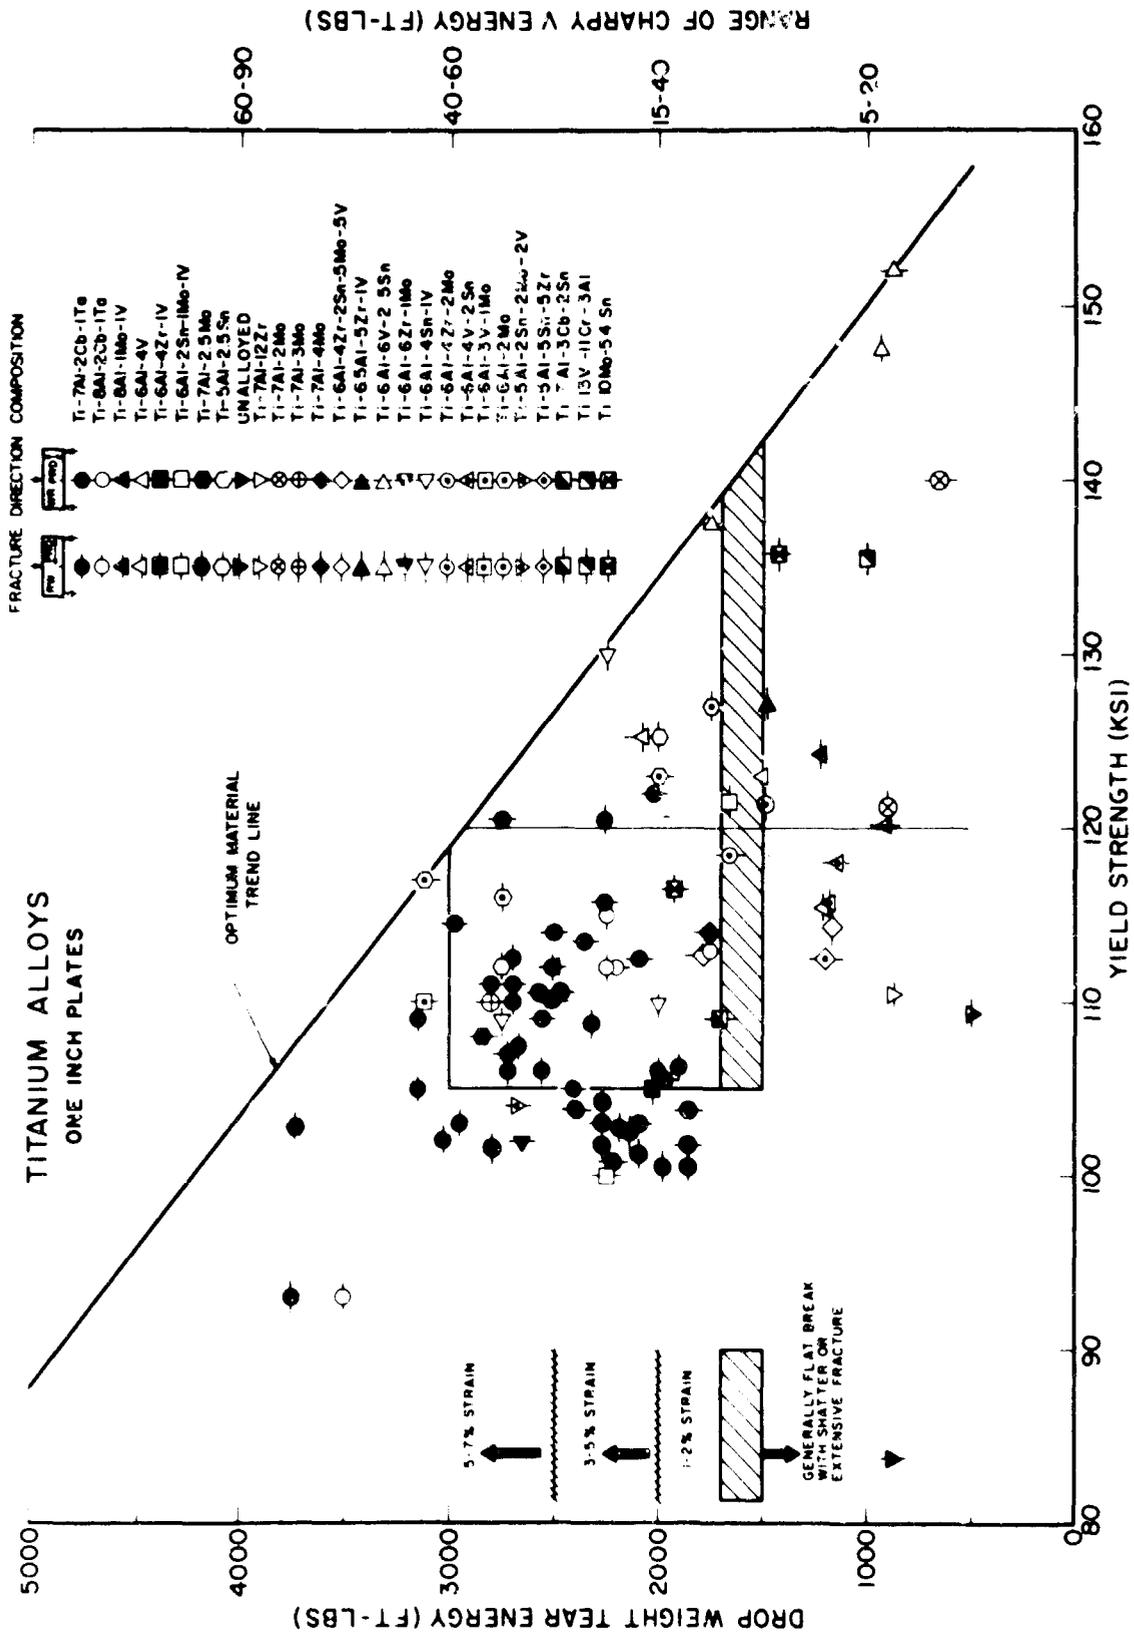
Fig. 1 - Fracture toughness index diagram for titanium. Correlates drop-weight tear test, Charpy V, explosion tear test, and yield strength data for 1-in.-thick titanium alloy plates. Optimum materials trend line indicates estimated highest level of strength for any given level of toughness.

The results of the fracture toughness studies of titanium are presented in the fracture toughness index diagram (FTID) in Fig. 1. This diagram has been up-dated to present the latest information, however, it is considered preliminary in comparison to that evolved for steels which shows a "break out" of effects of metal processing. The fracture toughness, as measured by the DWTT, was determined in the strong (RW) and weak (WR) directions (5). The optimum materials trend line (OMTL) indicates the highest DWTT energy value obtained as a function of yield strength (YS) and establishes a "yardstick" for 1-in.-thick plate properties in alloy development and processing. The variety of alloys investigated are listed and coded for reference. The large number of points for some of the alloys represents different heats, processing, and heat treatments investigated.

The ETT studies have established the approximate limits of plastic strain required for propagation of fracture in terms of DWTT energy. As shown in Fig. 1, DWTT energy in excess of 1500-1700 ft-lb is required to avoid "flat breaking"

The projection of the 1-2% plastic strain limit band at 1500-1700 ft-lb DWTT energy to the OMTL indicates that for "optimized" titanium alloys of 1-in.-thickness the linear elastic analysis criteria of plastic zone size can be maintained on all materials exceeding about 140-ksi YS and that valid K_{Ic} values should be obtainable. Also, alloys above 140-ksi YS should be expected to propagate fractures at elastic load levels and these materials should definitely be analyzed in fracture mechanics terms. On the basis of population density (the "two block" analysis described for steels, titanium, and aluminum in Ref. 6), most materials between 120 and 140-ksi YS should also be expected to propagate fractures at elastic stress levels, unless the material has been metallurgically and process "optimized" to the highest attainable level of toughness.

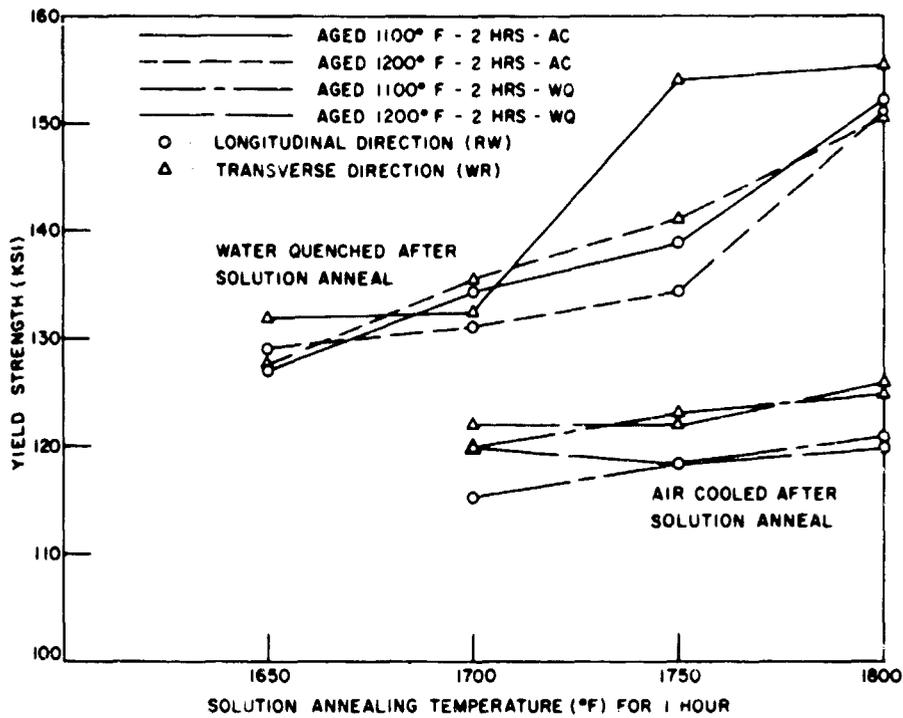
Fig. 2 - Effects of variations in solution annealing temperatures on the yield strength of the alloy Ti-6Al-4Zr-2Mo (T-55) with aging treatment

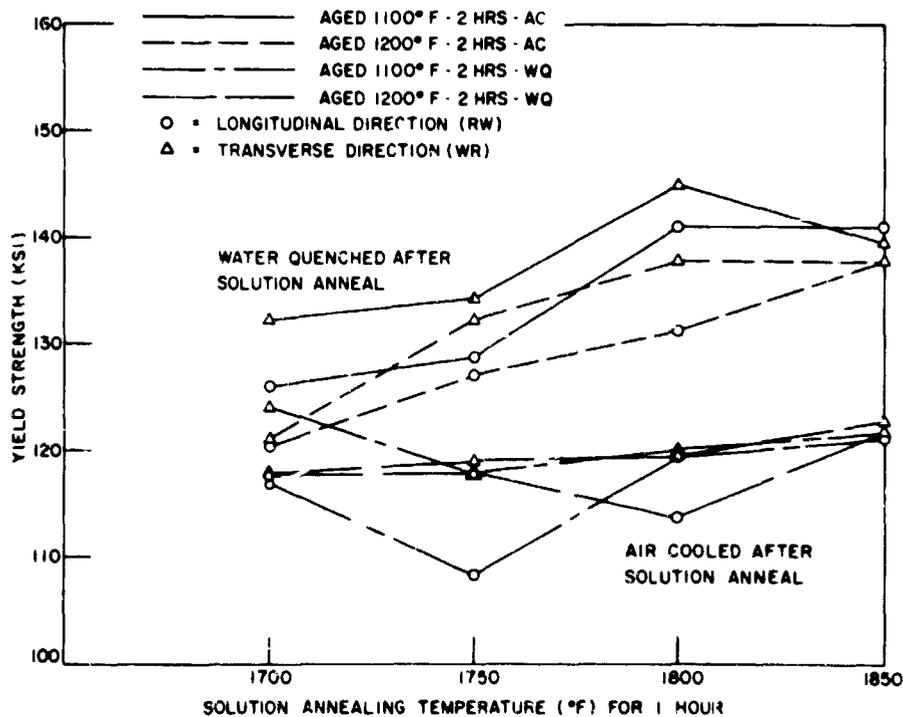
Fig. 3 - Effects of variations in solution annealing temperatures on the yield strength of the alloy Ti-6Al-4Zr-2Sn-.5Mo-.5V (T-68) with aging treatment

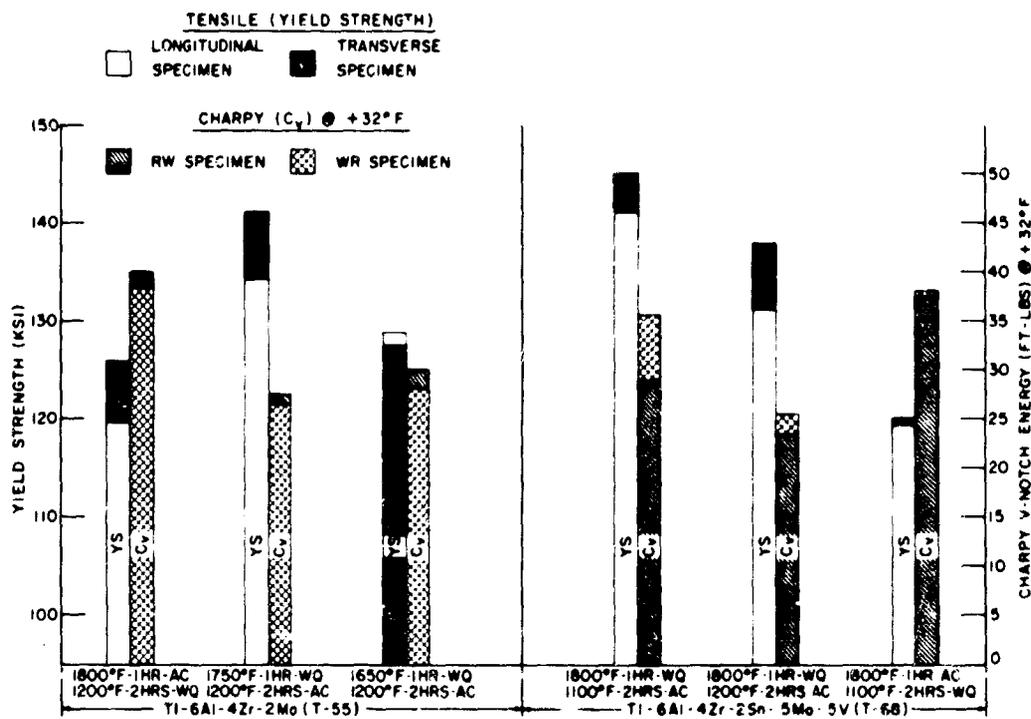
Fig. 6 - Effect of heat treatments on the Charpy V-notch energy of the alloys Ti-6Al-4Zr-2Mo (T-55) and Ti-6Al-4Zr-2Sn-5Mo-5V (T-68) in the 120-145-ksi yield strength range

Figure 6 shows the effect of selected heat treatments on the C_v energy of the alloys Ti-6Al-4Zr-2Mo (T-55) and Ti-6Al-4Zr-2Sn-.5Mo-.5V (T-68) in the 120-140-ksi YS range. The values illustrated and the heat treatments were taken from Tables 1 and 2 and represent the nearest approach to an optimum condition for the alloys.

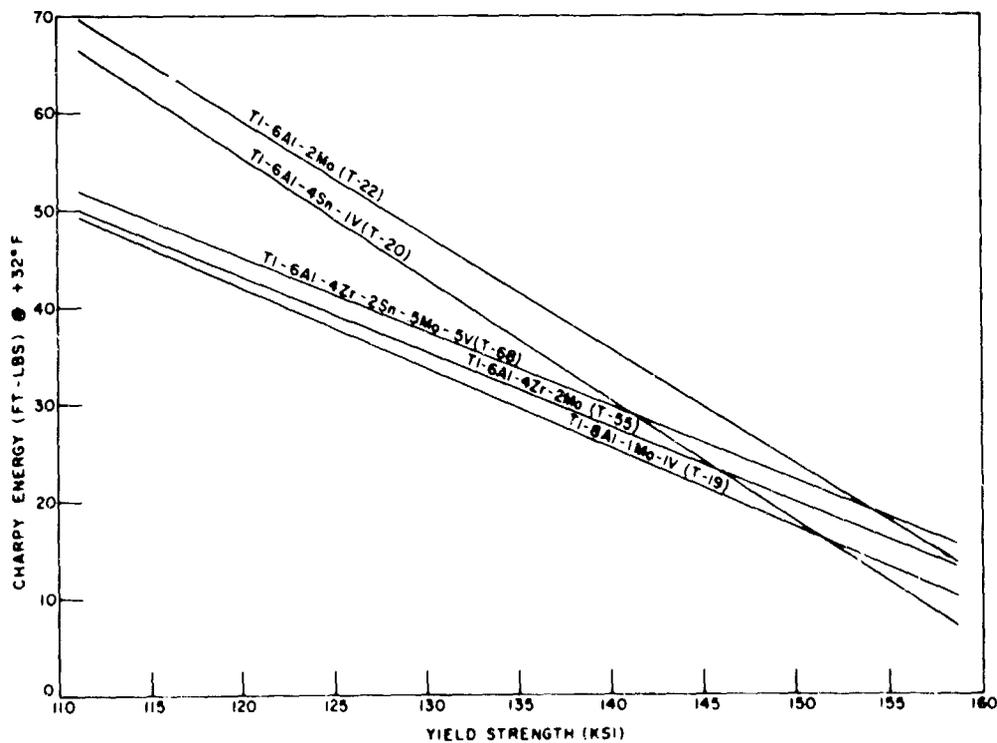
Fig. 7 - Summary of Charpy V energy and yield strength relationships for several titanium alloys

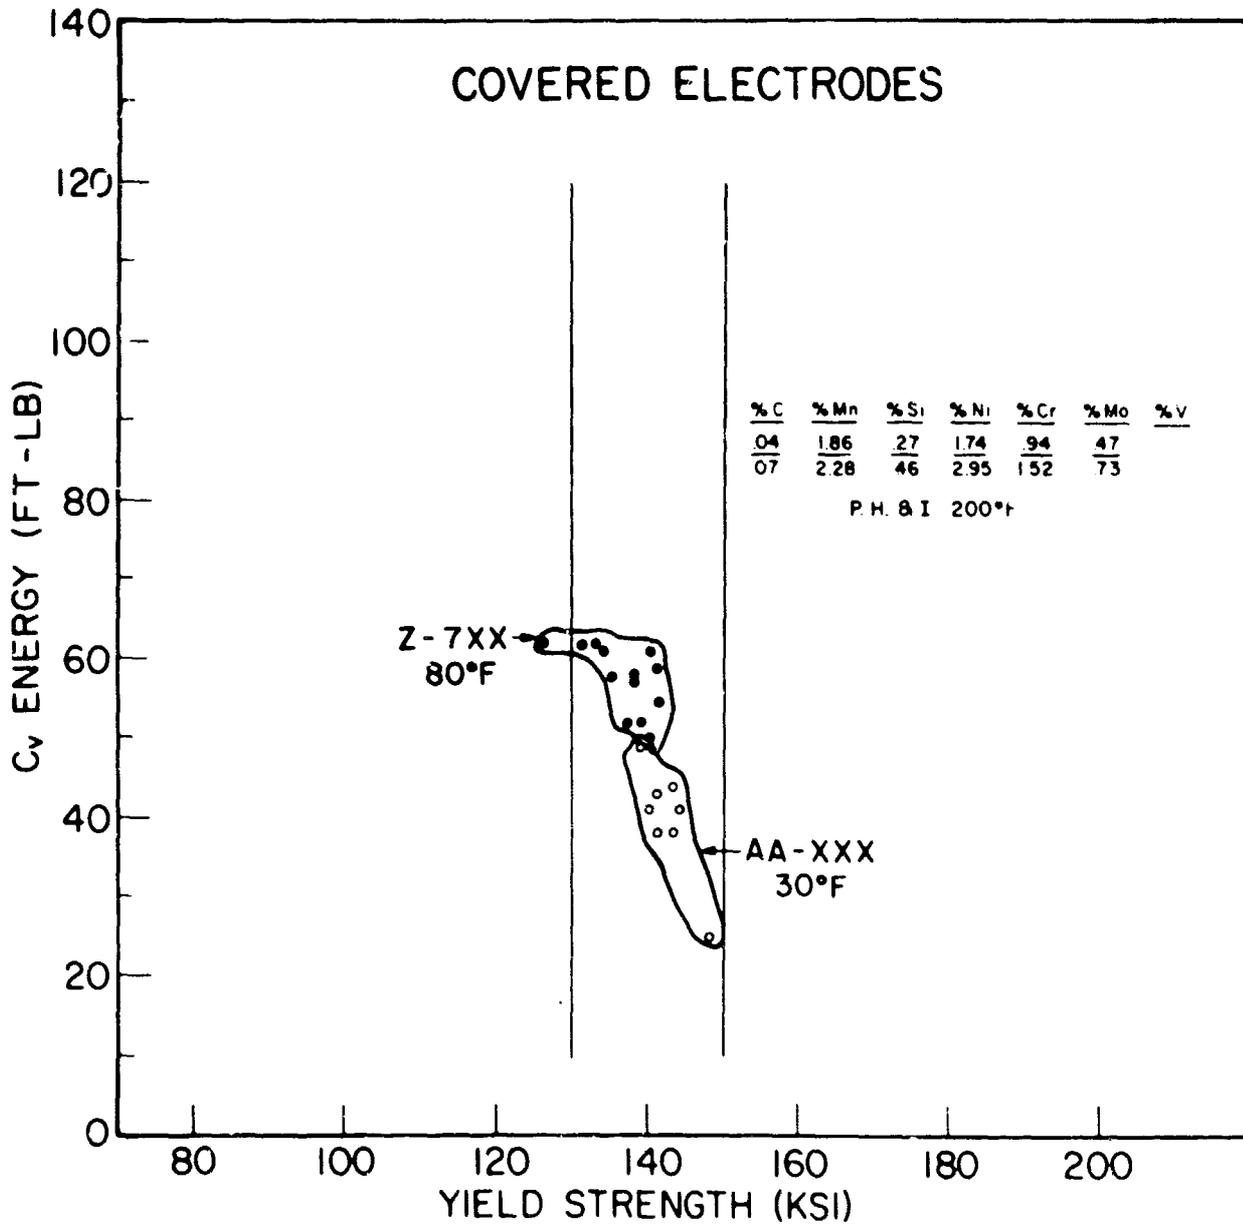
Fig. 8 - Charpy V and yield strength values developed with experimental covered stick welding electrodes

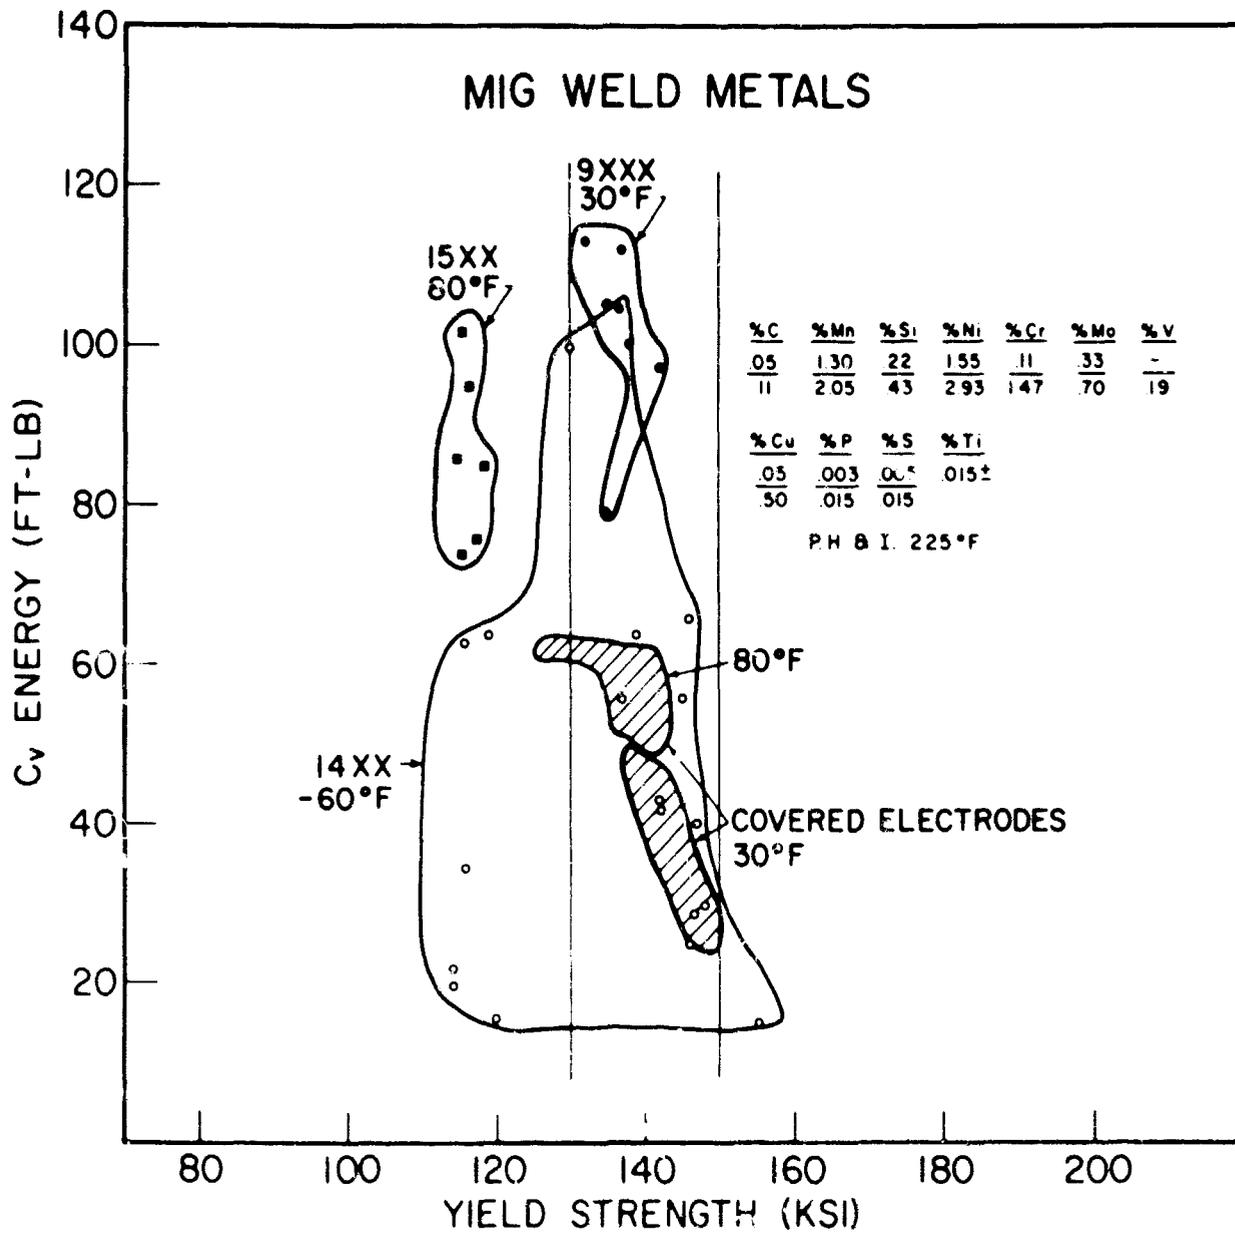
Fig. 9 - Charpy V and yield strength values developed with experimental MIG welding; data zones for stick electrodes from Fig. 1 added for comparison

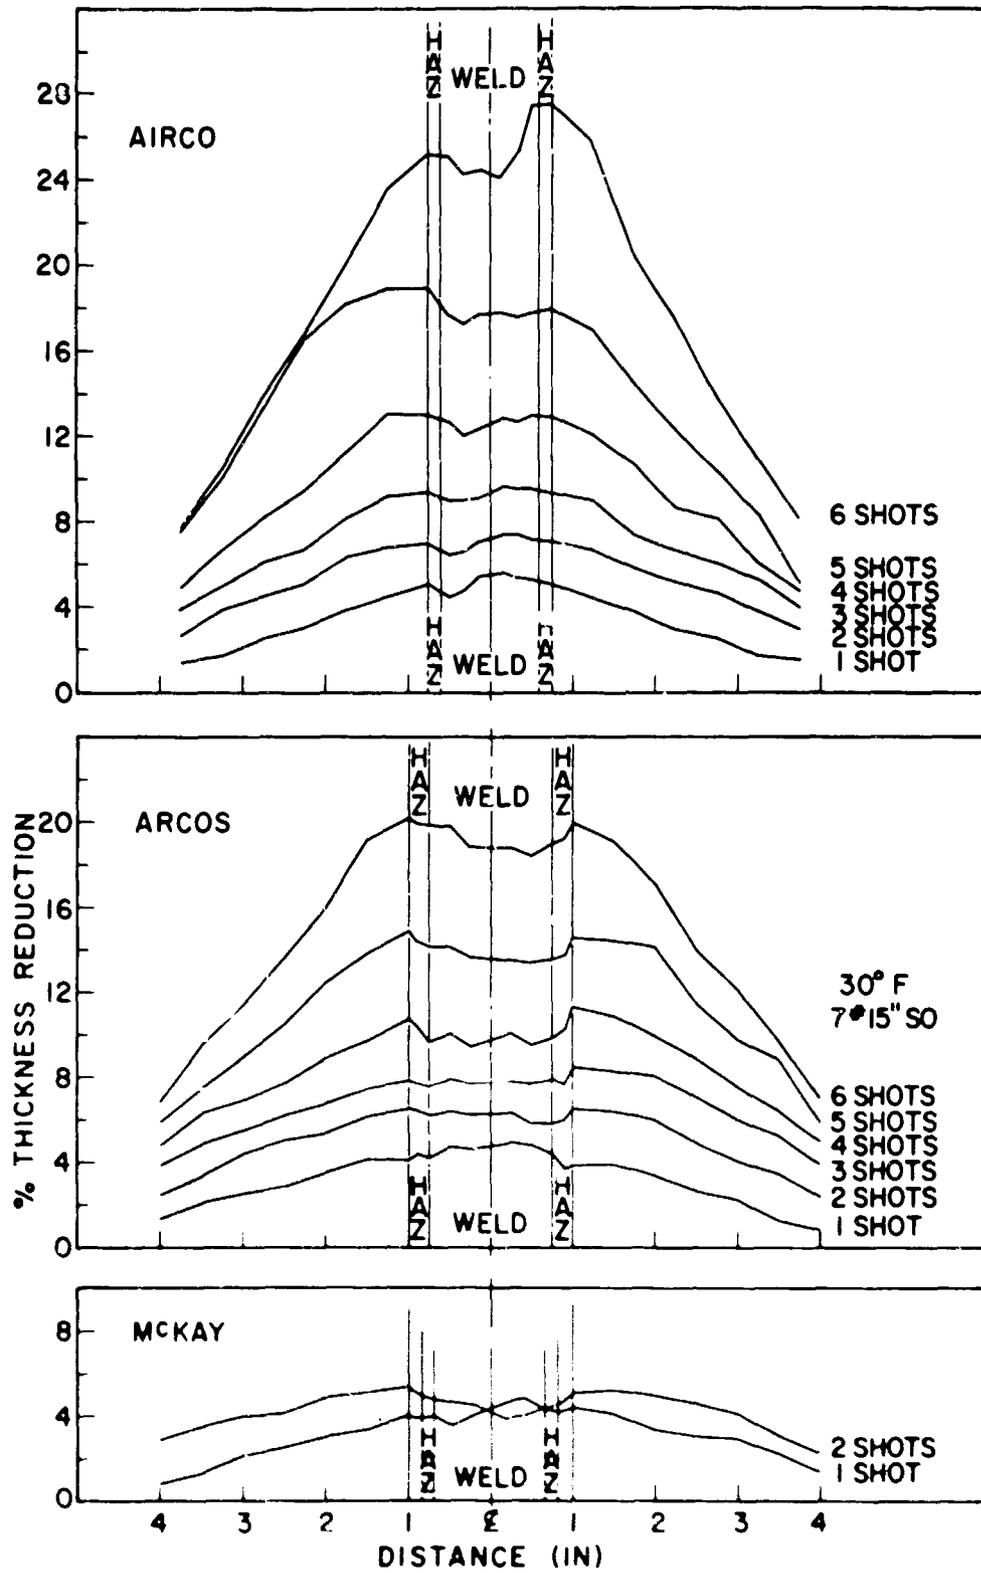
Fig. 14 - Plate and weld metal thickness reduction; explosion bulge testing of 140-ksi yield strength weld metals

The weld crown on one weldment of each set was ground smooth and a scribed grid on each was used to provide precise points at which thickness reduction and surface strain measurements could be made. The curves derived from the thickness reduction measurements made after each shot in the covered electrode weldments are shown in Fig. 14. Generally, similar data were obtained for the MIG interrupted-arc weldments. The weld metal thickness reduction is noted to be slightly less than that of the adjacent plate metal, and an approximately uniform reduction in thickness is developed by each successive shot excepting the final shot applied to the Airco weldment. It is apparent that the much larger thickness reduction developed by the sixth shot on this plate is limited to the apex of the bulge and this is considered to be indicative of secondary bulging.

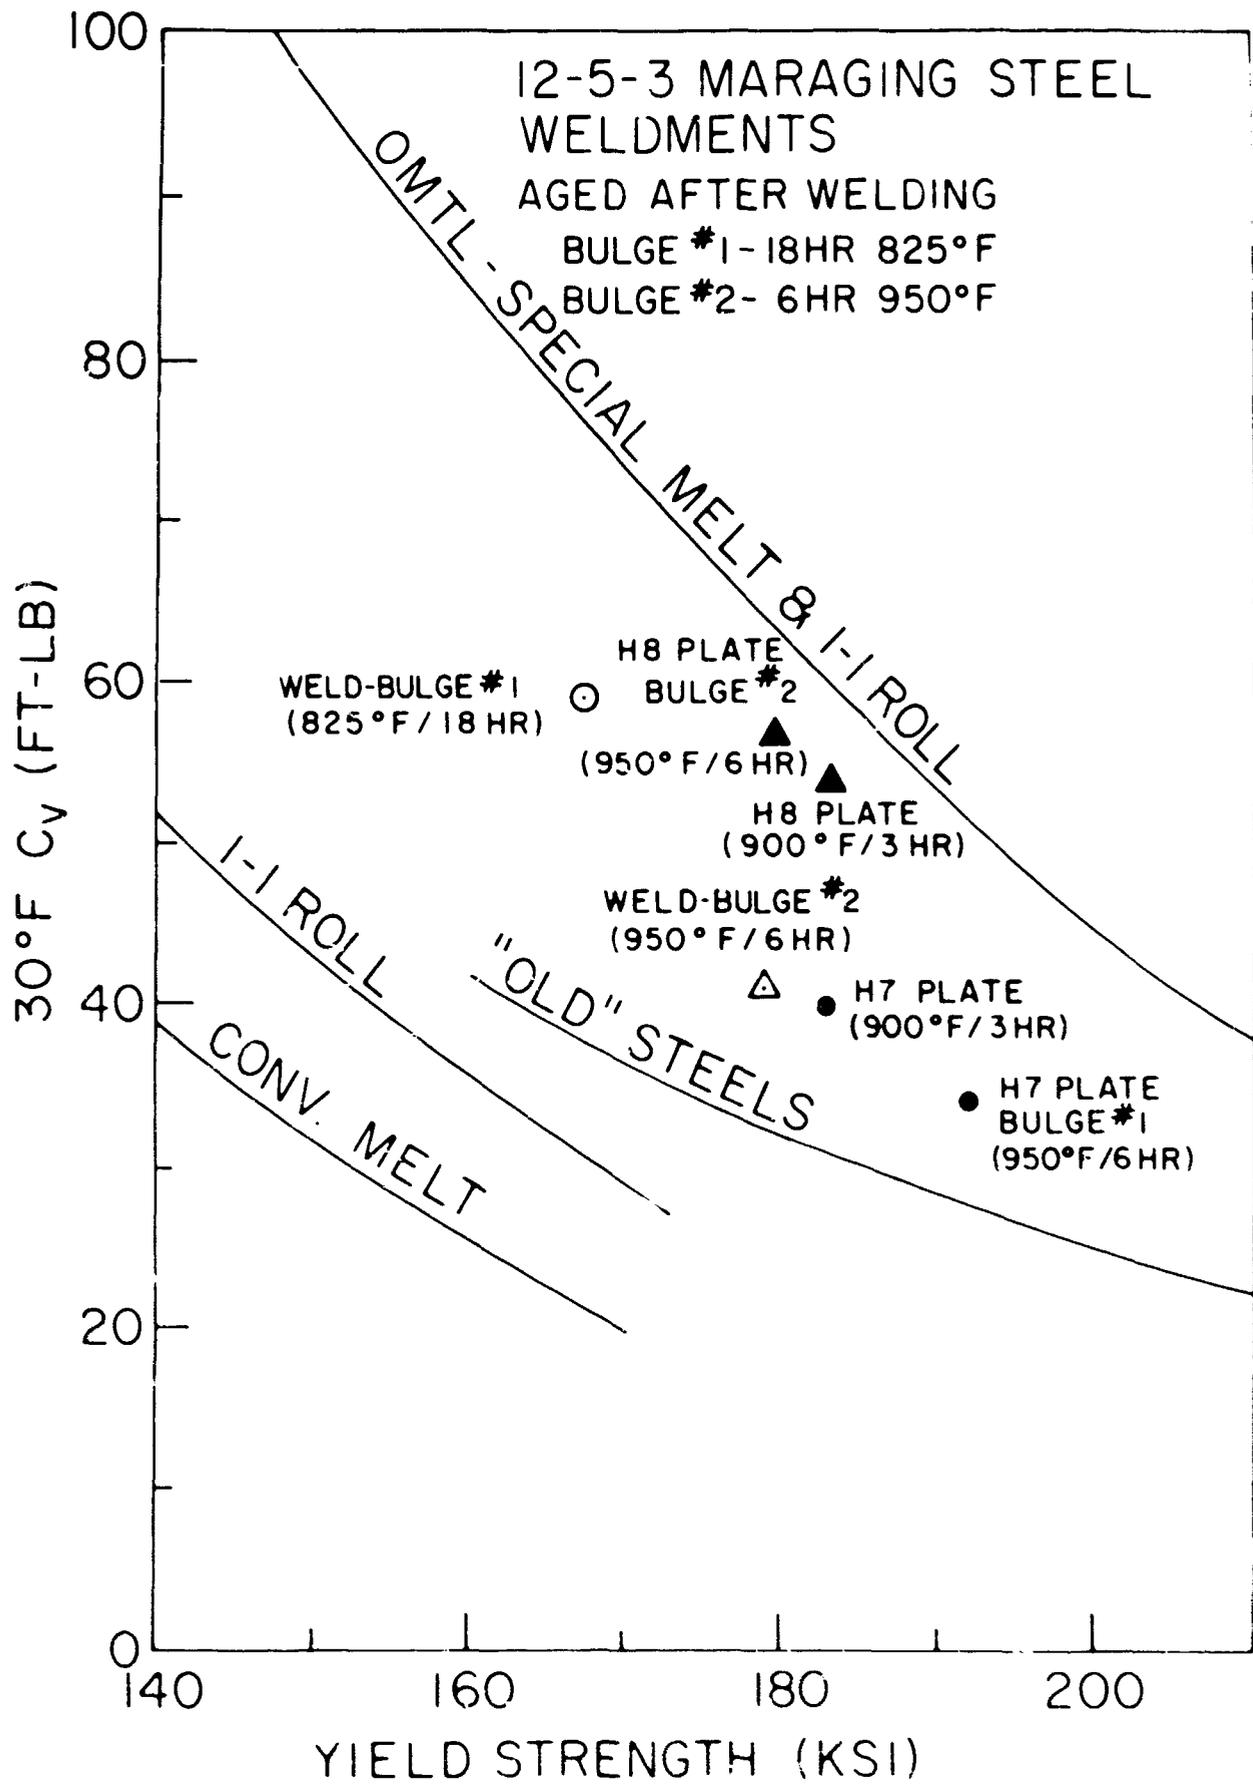
Fig. 21 - Charpy V energy as a function of yield strength for maraging steel plates and TIG weld metals in relation to previous data for 1-in.-thick plates

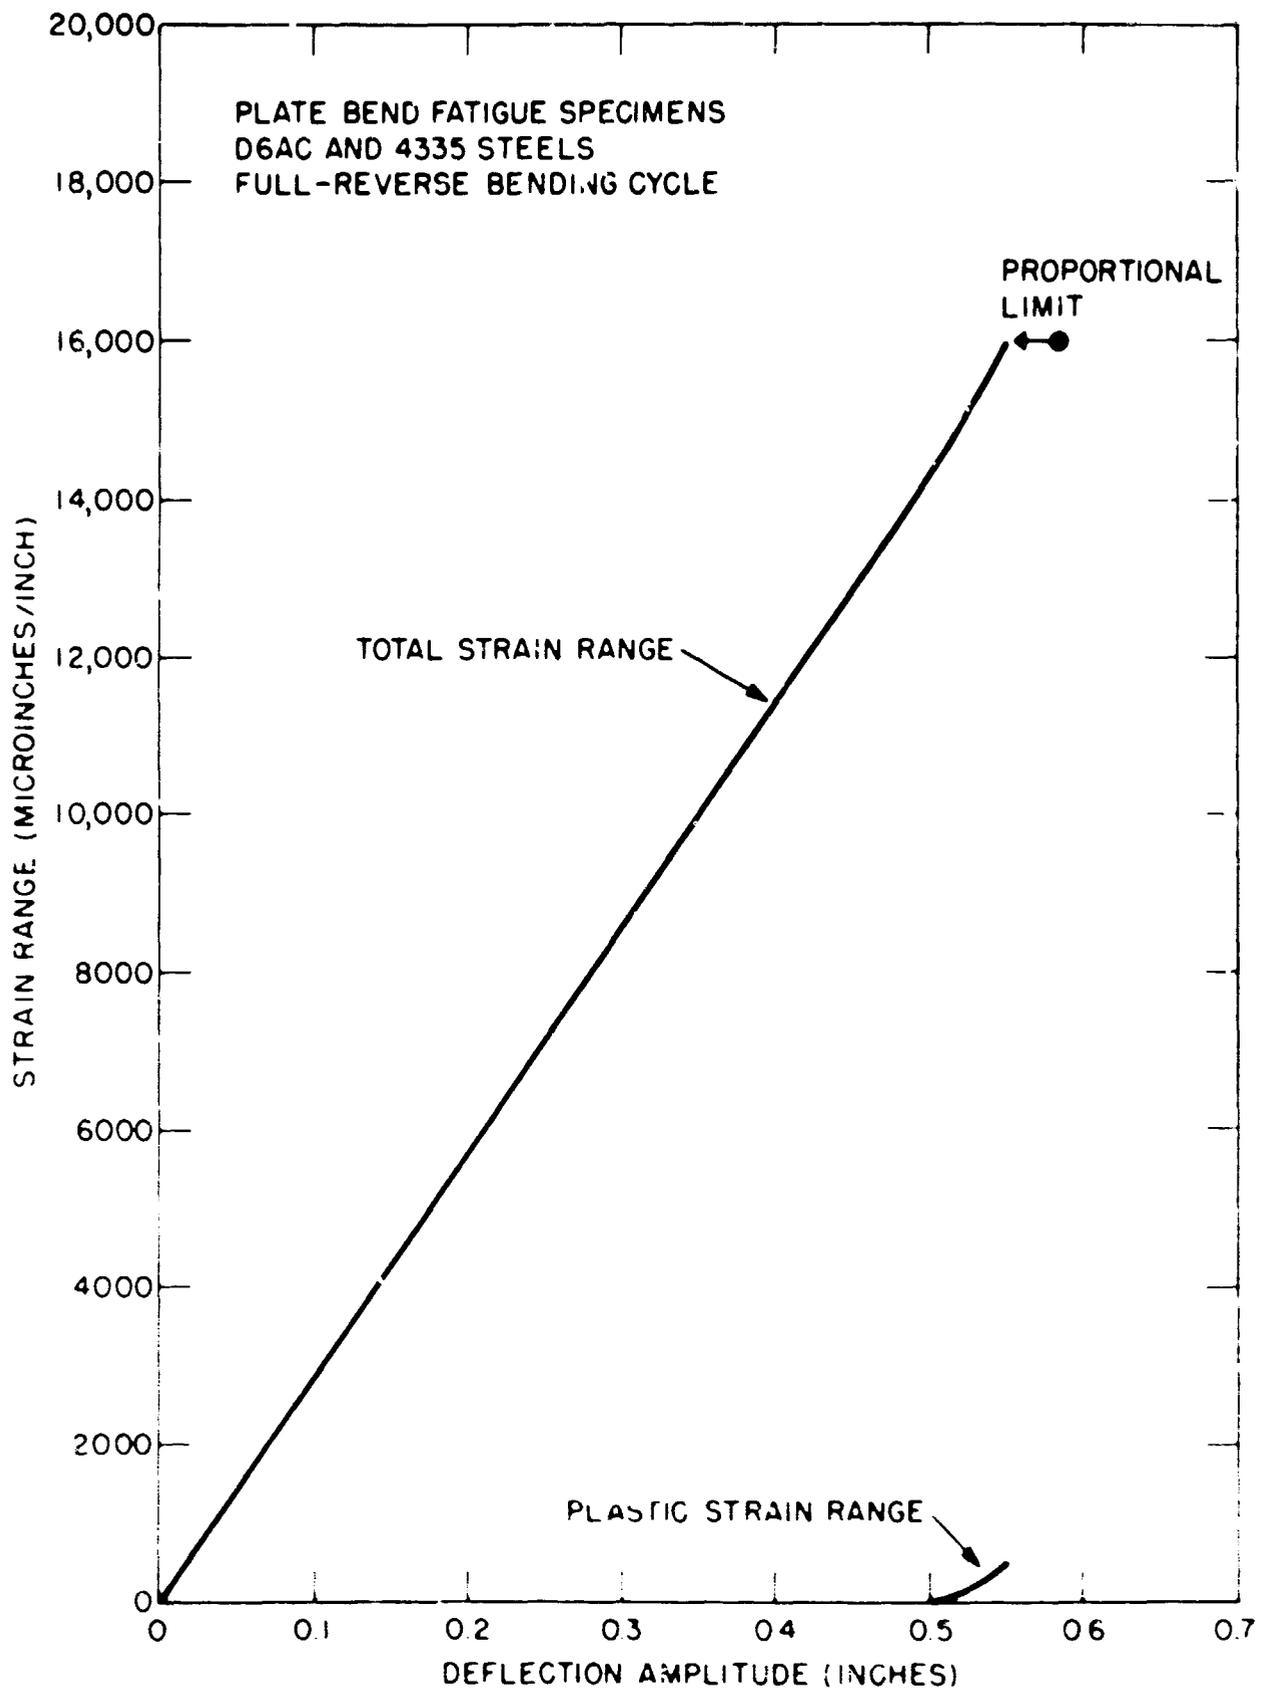
Fig. 22 - Strain range-deflection characteristics of D6AC and 4335 steel plate bend fatigue specimens in full-reverse loading cycle. The proportional limit point of 5000 microinches/inch plastic strain range is nearly identical for both materials.

Experimental data are based on the observed macroscopic growth of fatigue cracks across the surface of center-notched plate bend specimens. These specimens are cantilever loaded under full-reverse cycling in both air and 3.5% salt water environments. Constant total strain range loading conditions are maintained by adjusting deflection, and the corresponding crack growth rate is measured. Nominal surface strains are measured with electrical resistance strain gages. The strain range-deflection characteristics of these materials in the plate bend specimens are shown in Fig. 22.

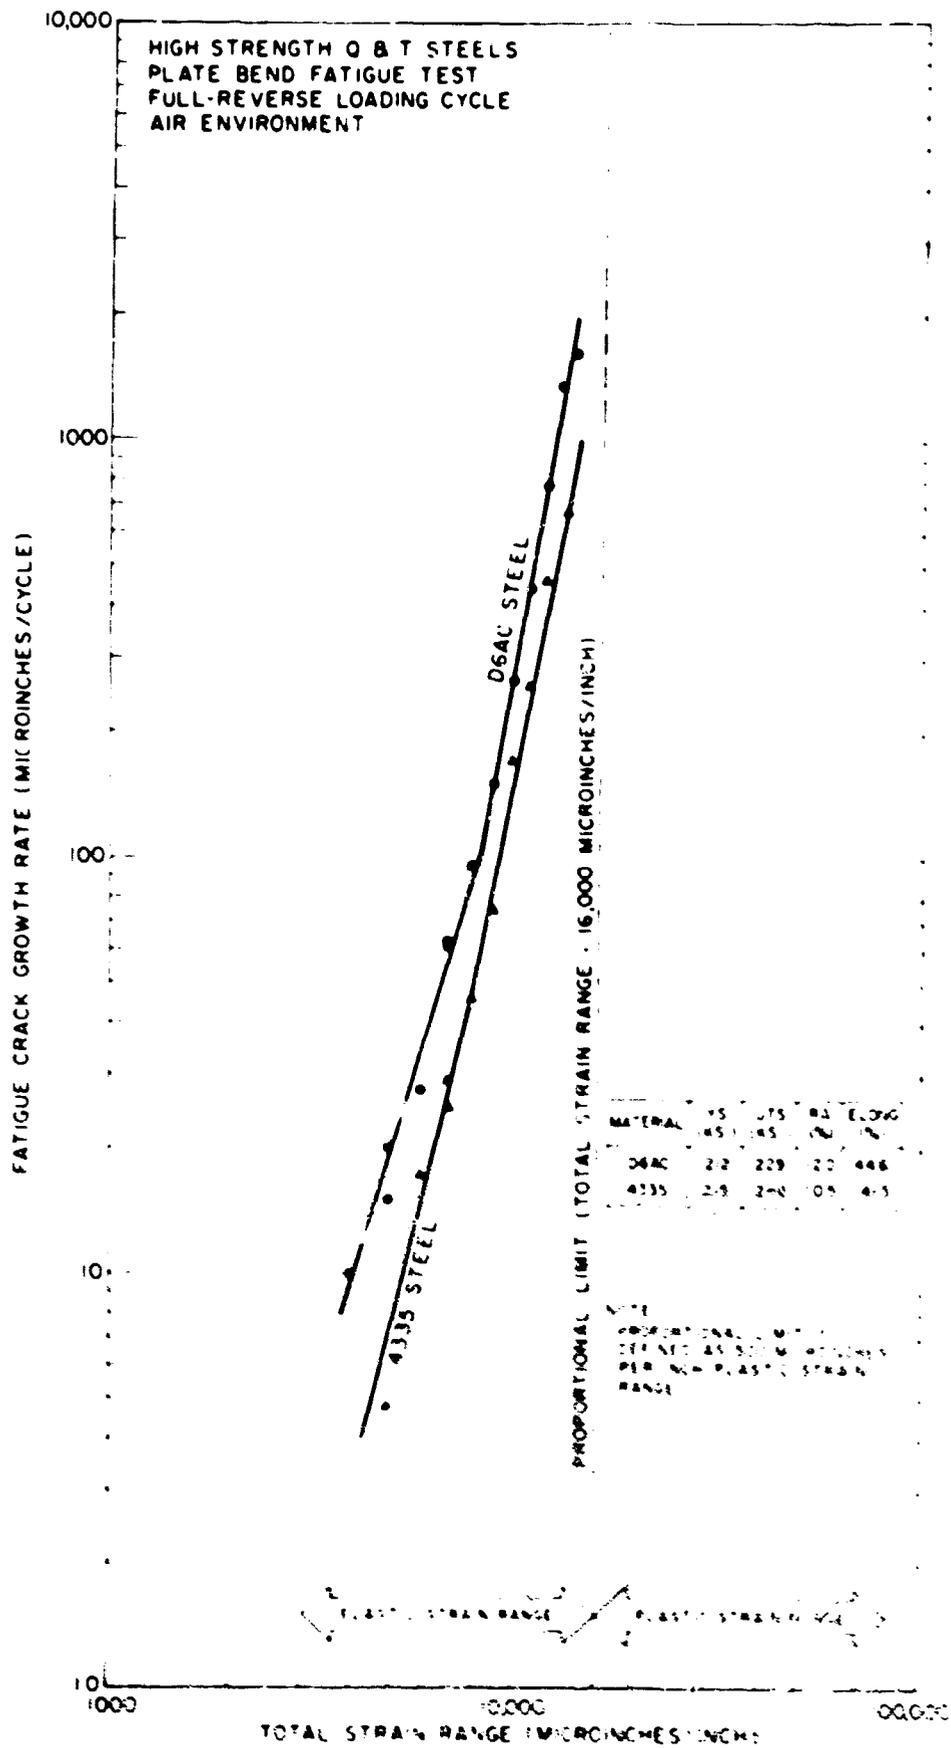
Fig. 23 - Log-log plot of fatigue crack growth rate vs applied total strain range data in full-reverse bending for D6AC and 4335 steels in an air environment

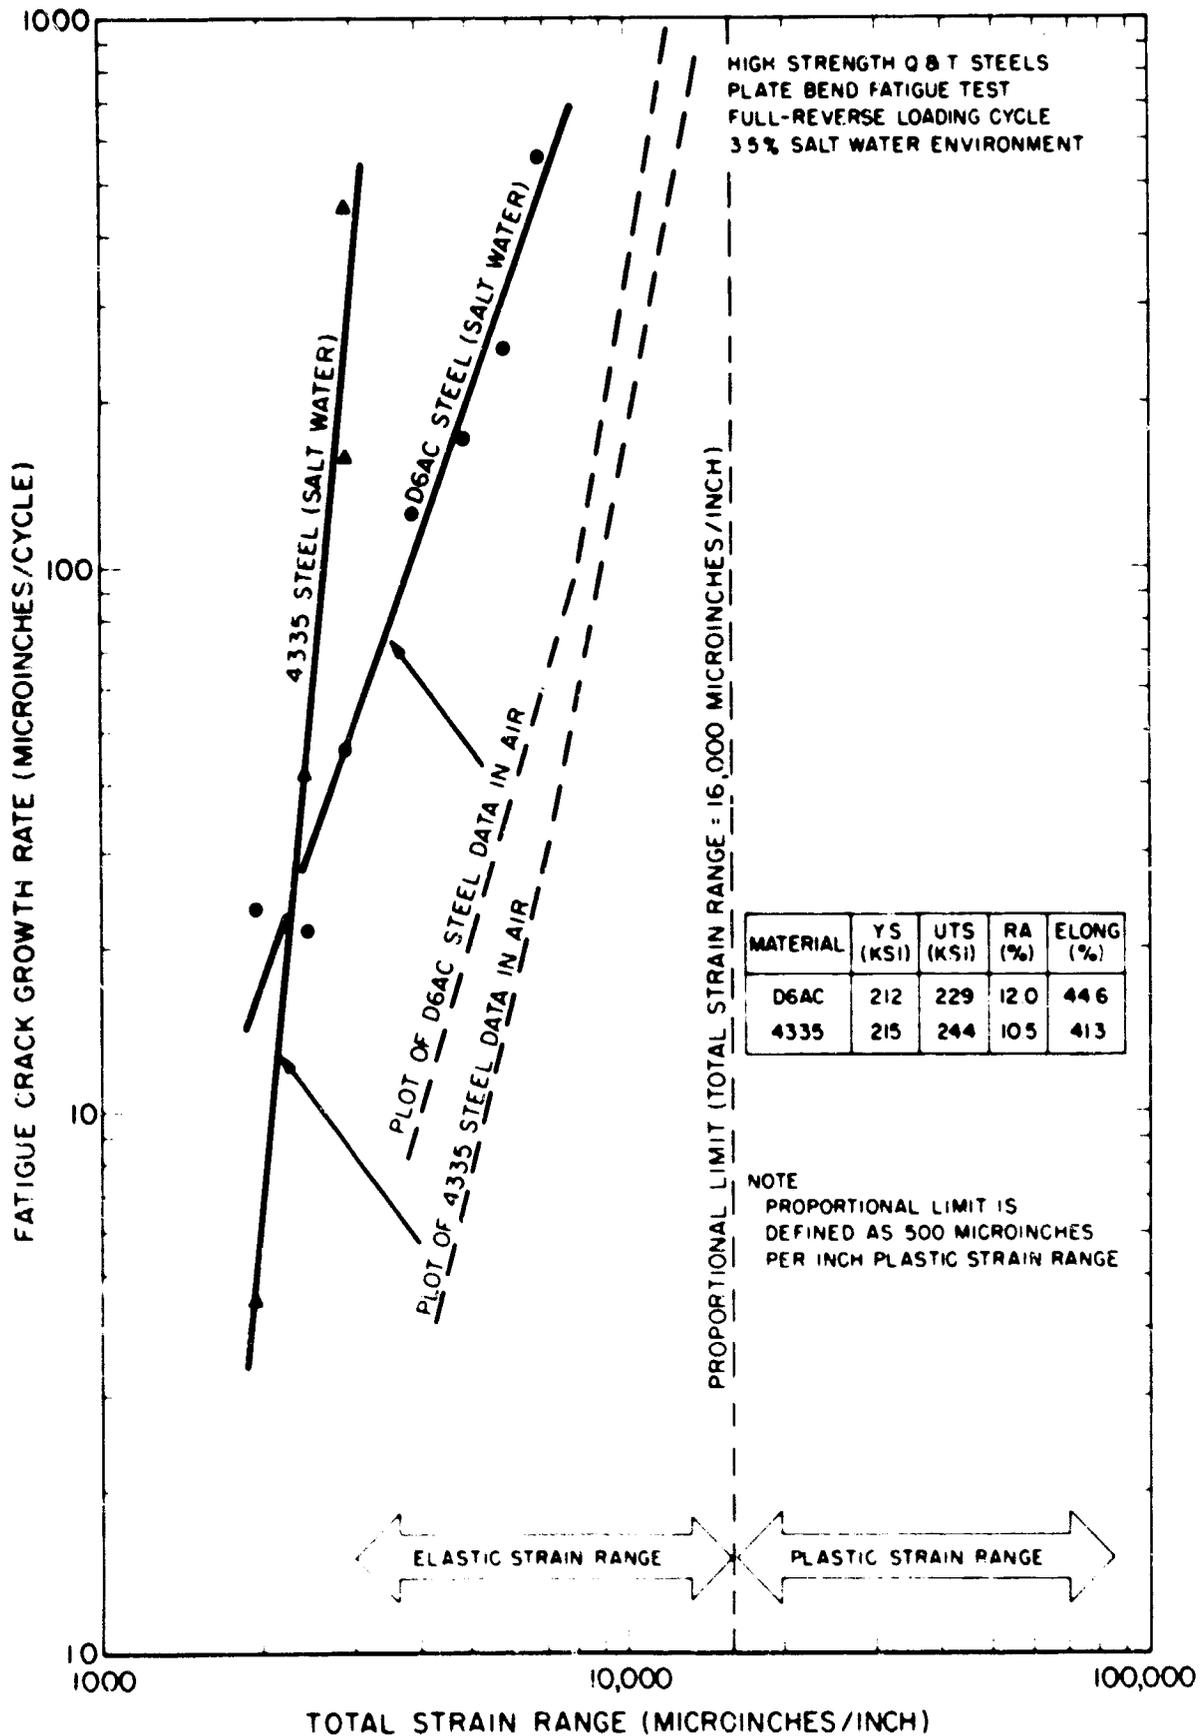
Fig. 24 - Log-log plot of fatigue crack growth rate vs applied total strain range data in full-reverse bending for D6AC and 4335 steels in 3.5% salt water environment. The loci of similar data obtained in an air environment are shown by dashed lines for comparison.

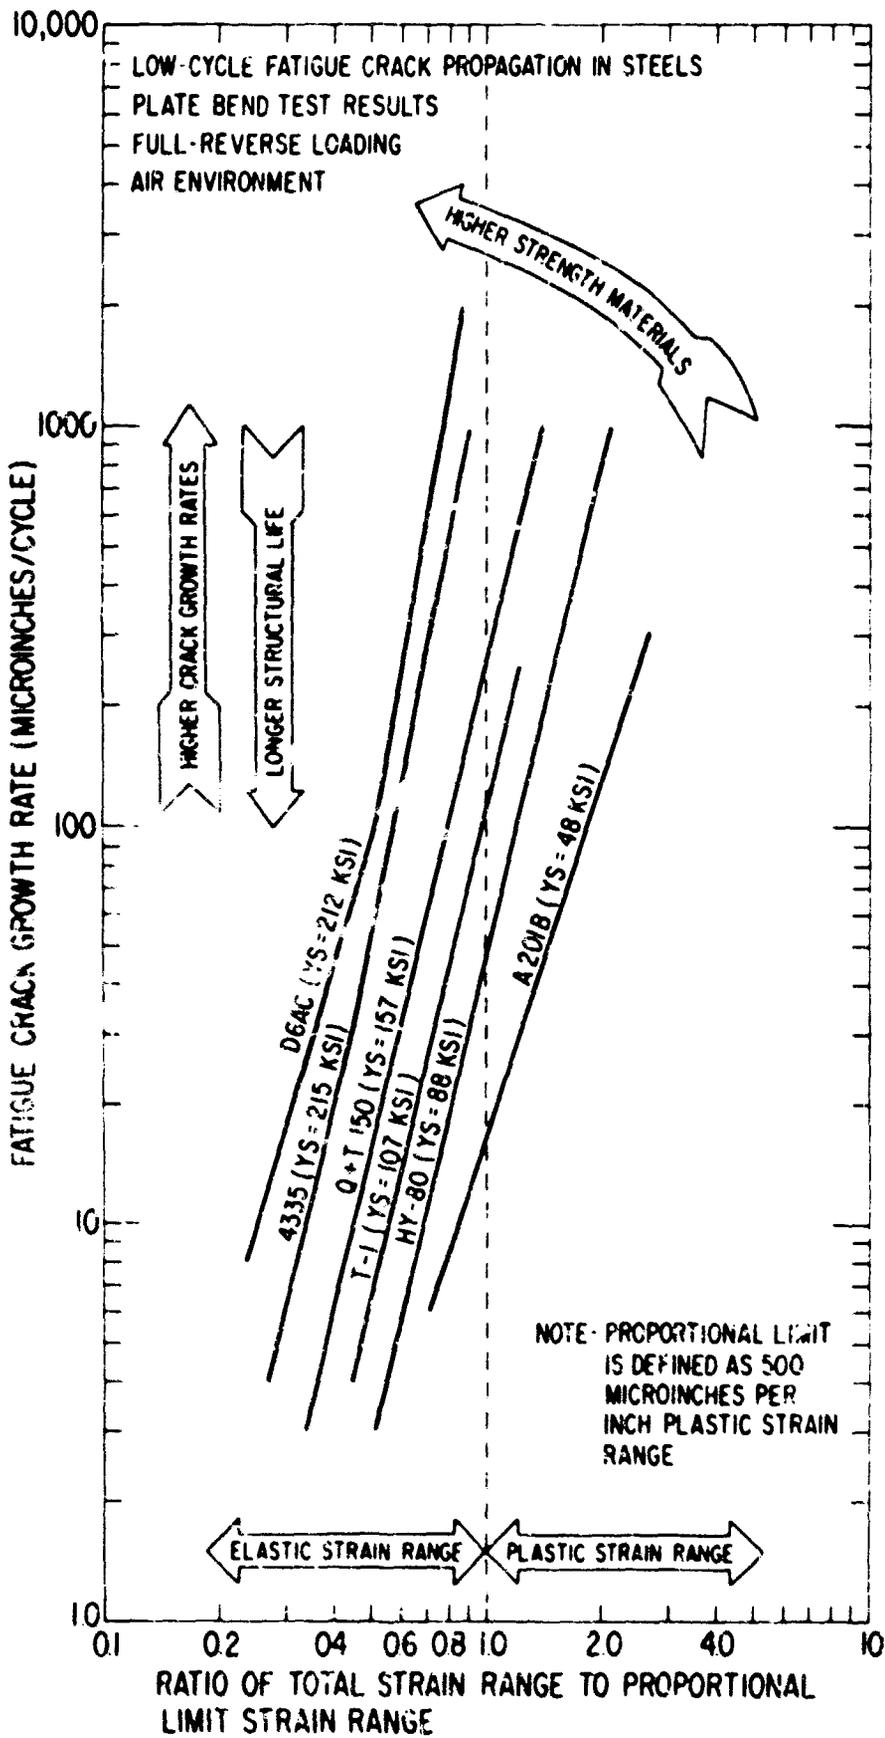
Fig. 25 - Comparative summary of the low cycle fatigue performance of six popular structural steels. Log-log plot shows fatigue crack growth rate vs the ratio of applied total strain range to proportional limit strain range.

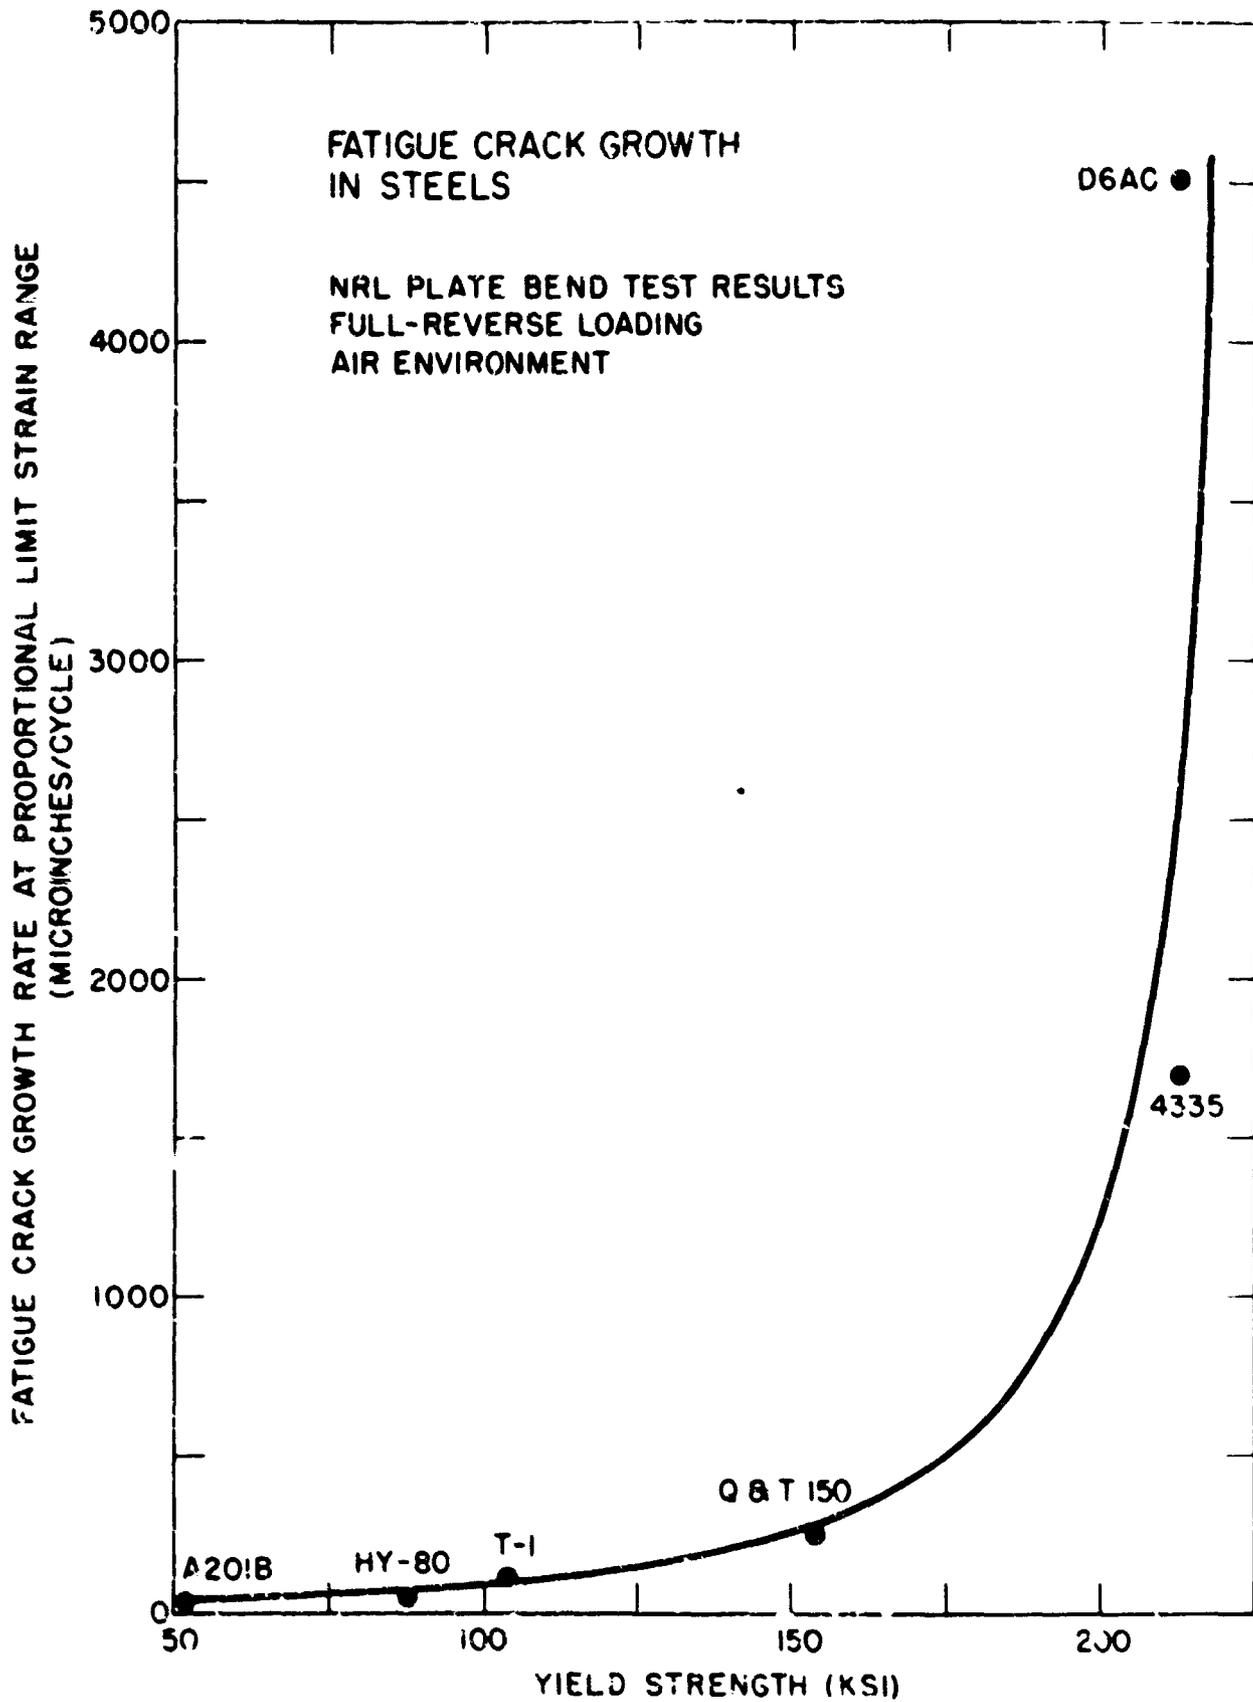
Fig. 26 - Comparison of fatigue crack growth rates at proportional limit strain range vs yield strength level for six popular structural steels
