AD-621567

METALLURGICAL CHARACTERISTICS
OF HIGH STRENGTH STRUCTURAL MATERIALS

[Seventh Quarterly Report]

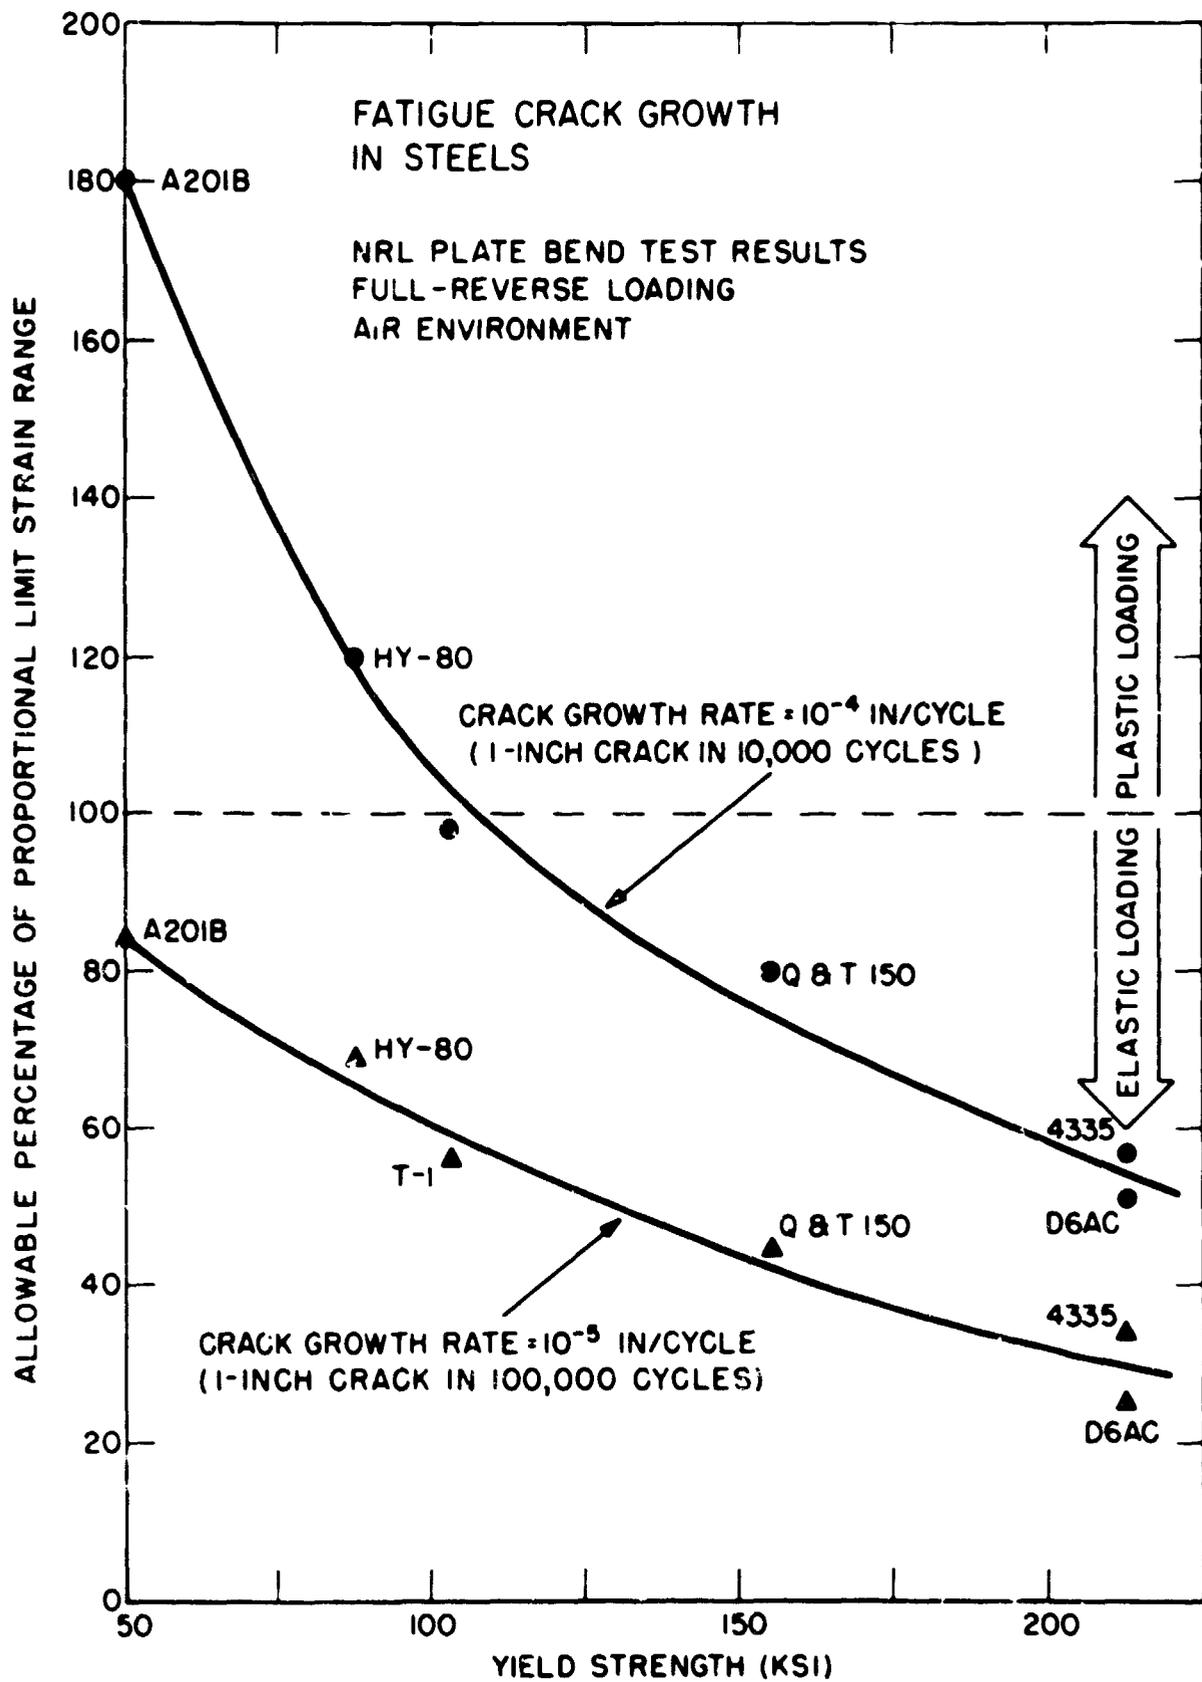
Fig. 27 - Comparison of allowable percentage of proportional limit strain range for finite fatigue life (10,000 and 100,000 cycles) vs yield strength level for six popular structural steels

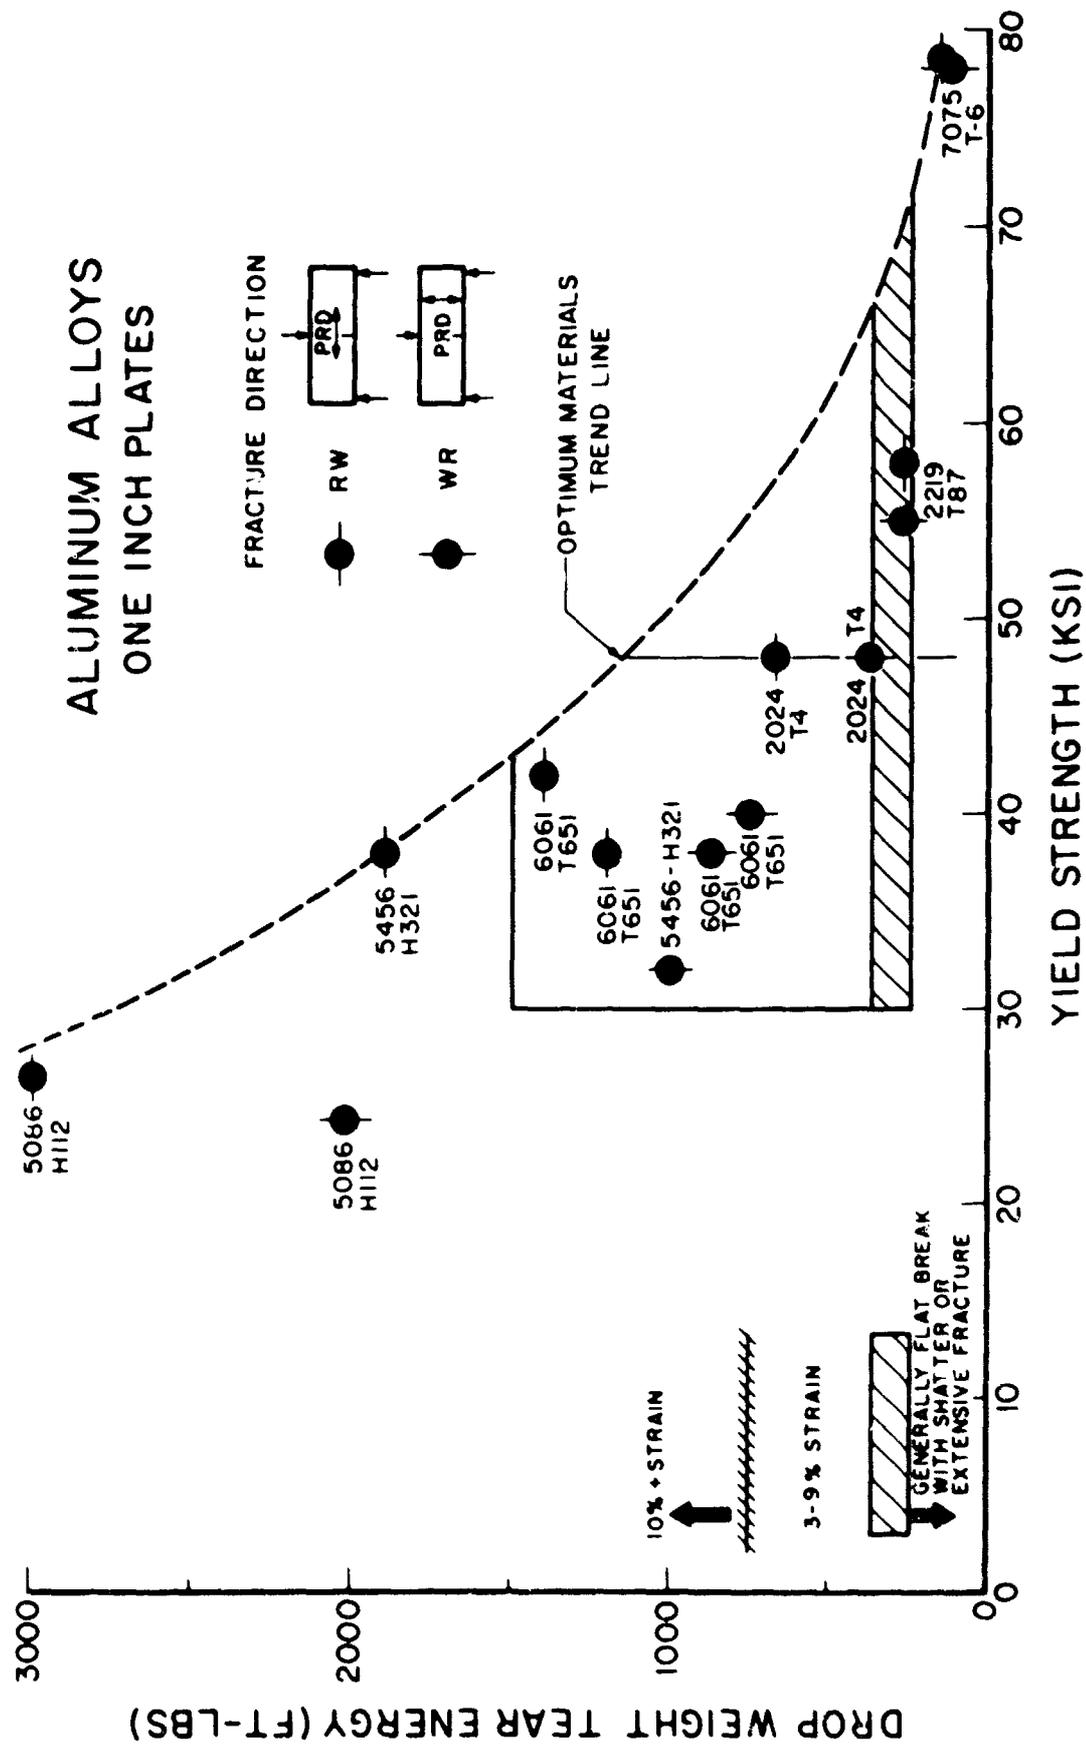
Fig. 28 - Fracture toughness index diagram (FTID) for aluminum alloys

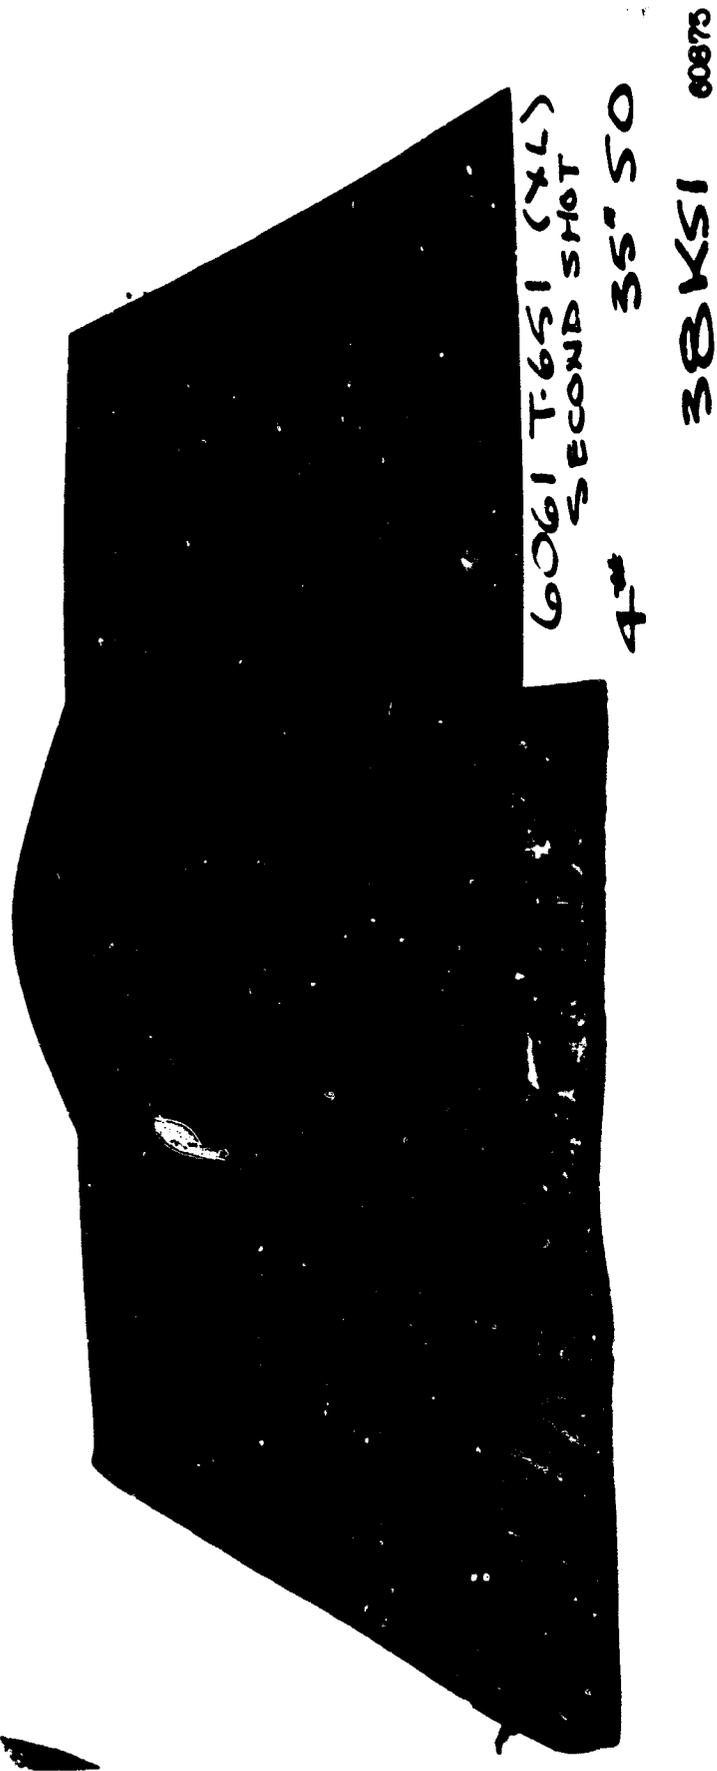
Fig. 30 - Explosion tear plate of 6061-T651 tested twice at 7.3% plastic strain. Fracture ran out at one end of plate. Flaw for the second test was 10-in. crack developed in first test.

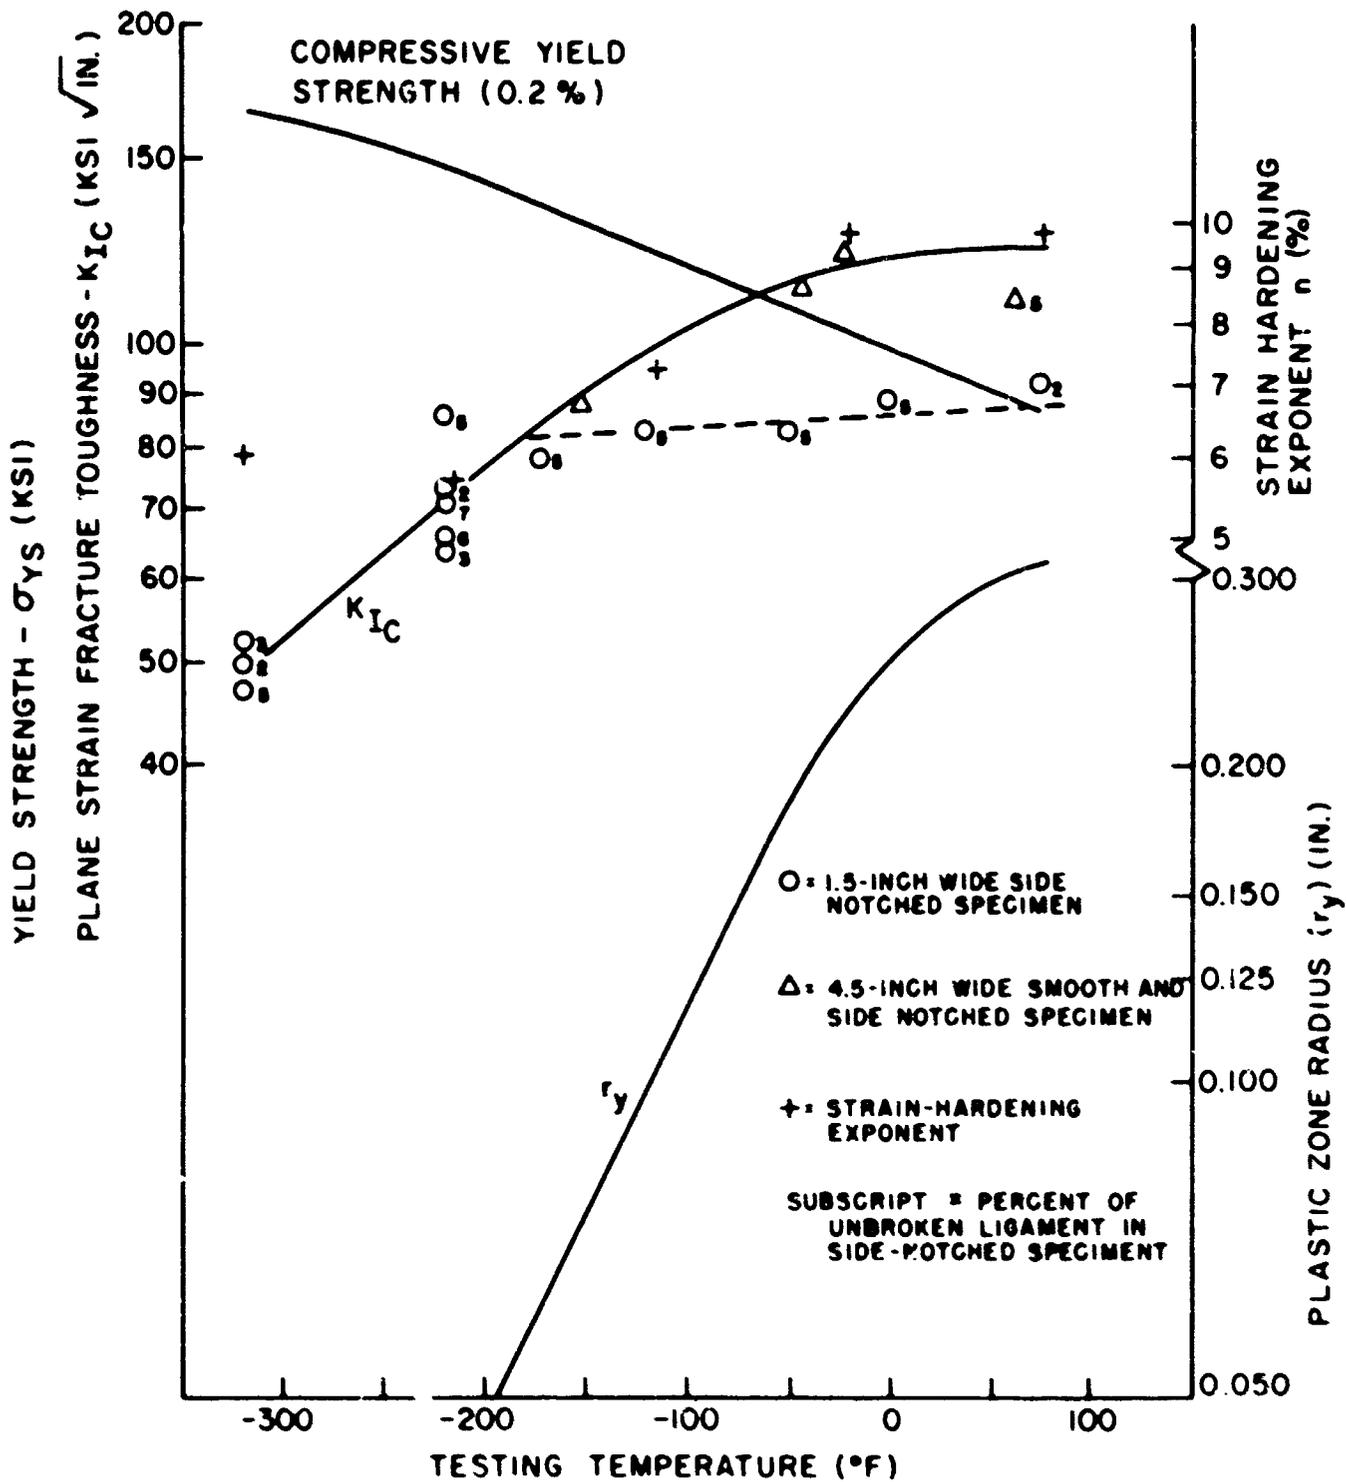
Fig. 34 - Correlation of K_{Ic} with testing temperature for 1.5-in. and 4.5-in.-wide specimens of unalloyed titanium

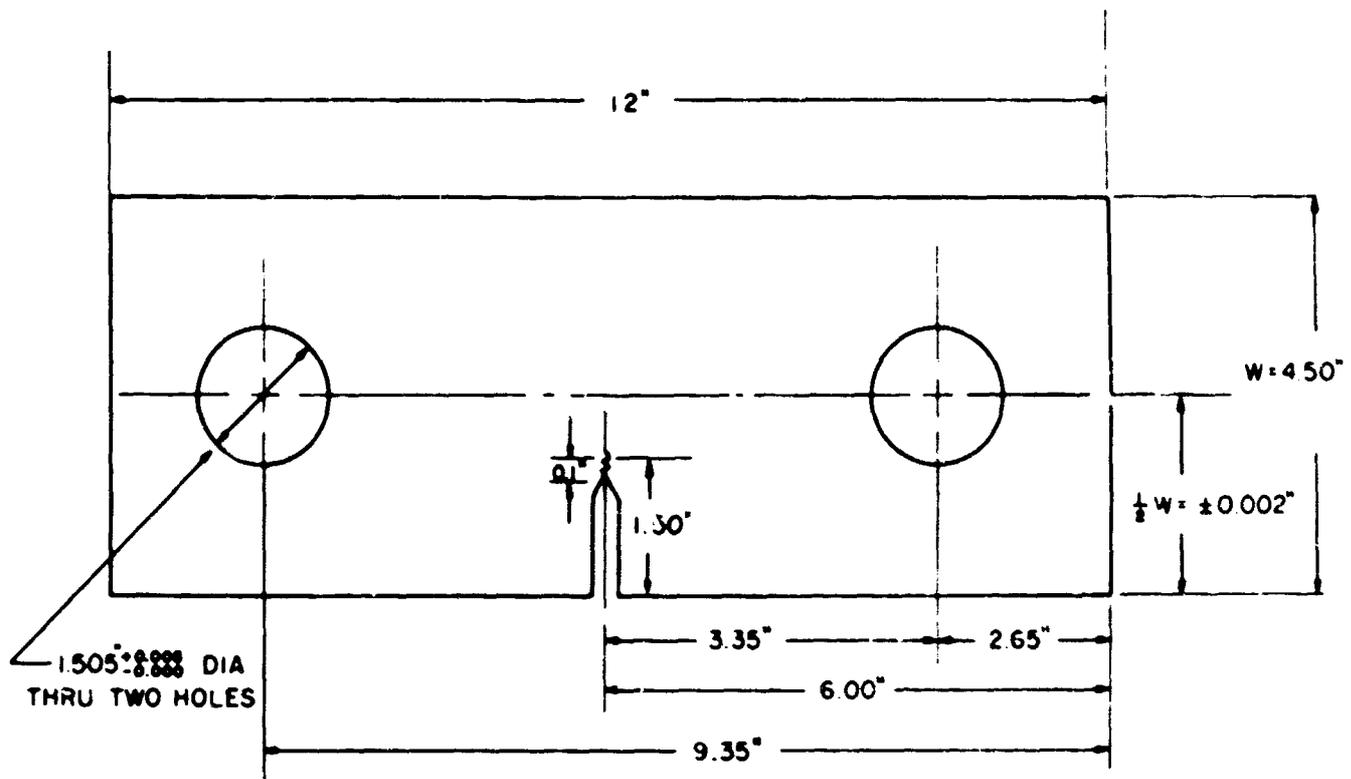
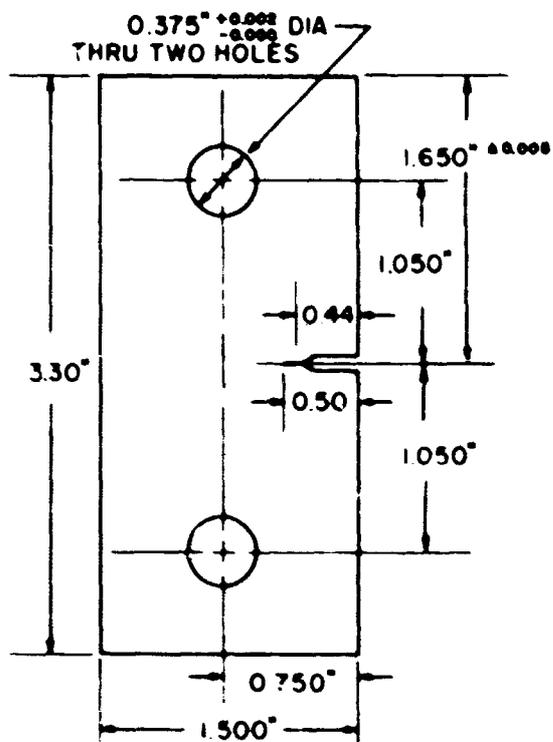
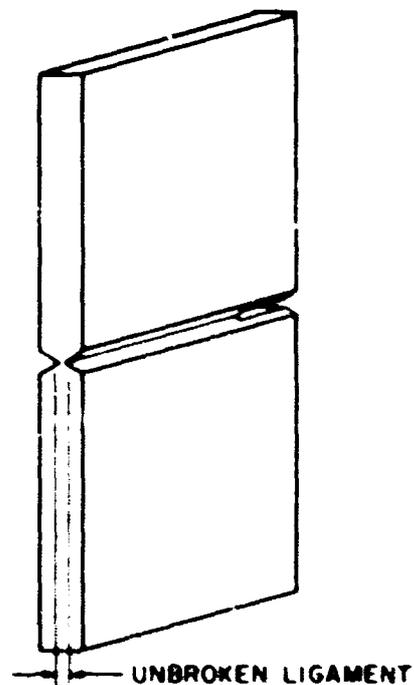
(a) FULL THICKNESS 1-INCH EDGE NOTCHED SPECIMEN

(b) QUARTER-INCH THICK EDGE NOTCHED SPECIMEN

(c) SIDE-NOTCHED SPECIMEN

Fig. 35 - Dimension of specimens used in this report

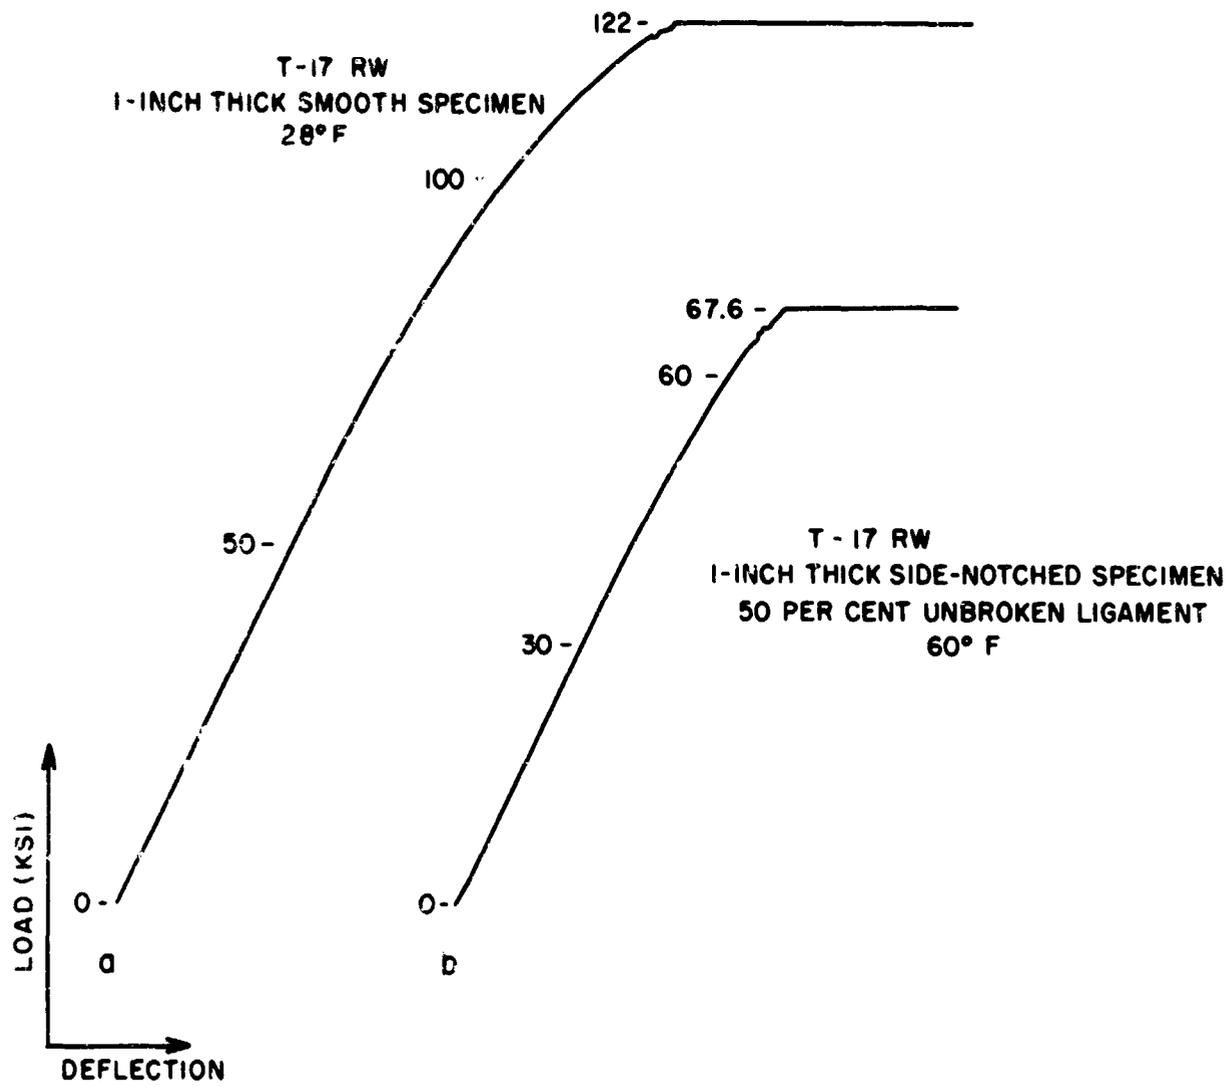
Fig. 36 - Typical load-deflection curves for smooth and side-grooved single-edge-notched specimens

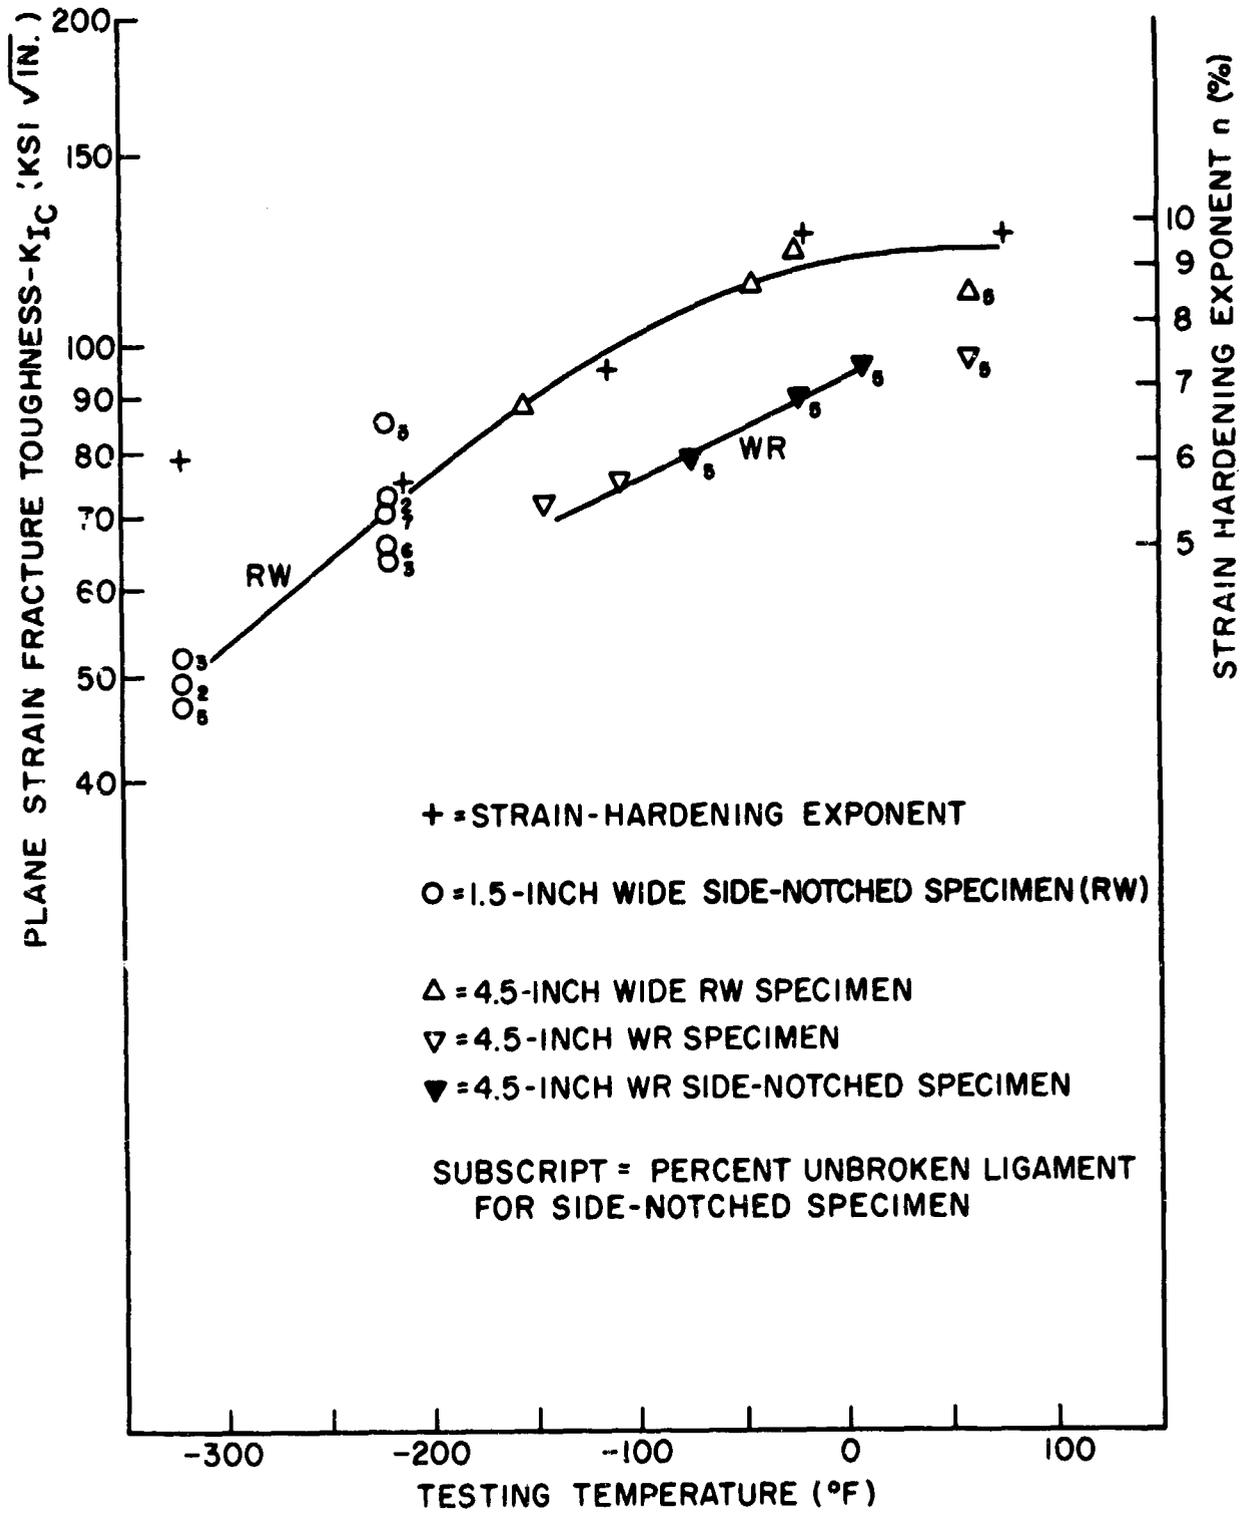
Fig. 37 - Correlation of K_{Ic} with test temperature for unalloyed titanium tested in the RW and WR directions
